Appendix 28

Meadowbank 2020 GN spills reports

GN reference #: 2020-032

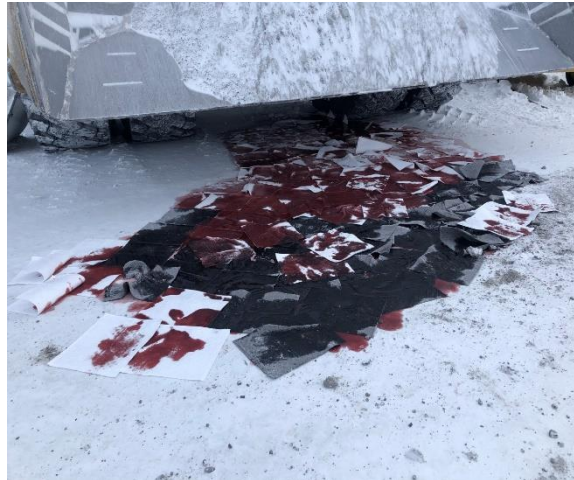
During operations at Meadowbank, HTR22 was being started outside the Maintenance shop. Upon start-up, cold oil pressure built-up against the final drive seal and the seal failed causing hydraulic oil to spill on the ground.

The spill occurred due to a seal failure during cold start-up.

Spill pads were placed on the ground and the seal was replaced. Spill pads were collected and brought to the hazmat area and the ground was scraped clean. Approximately 0.5m³ of contaminated snow and material was collected and brought to the land farm at Meadowbank.

A routine visual inspection of all system is performed during pre-operations checks as a part of the preventive maintenance program.

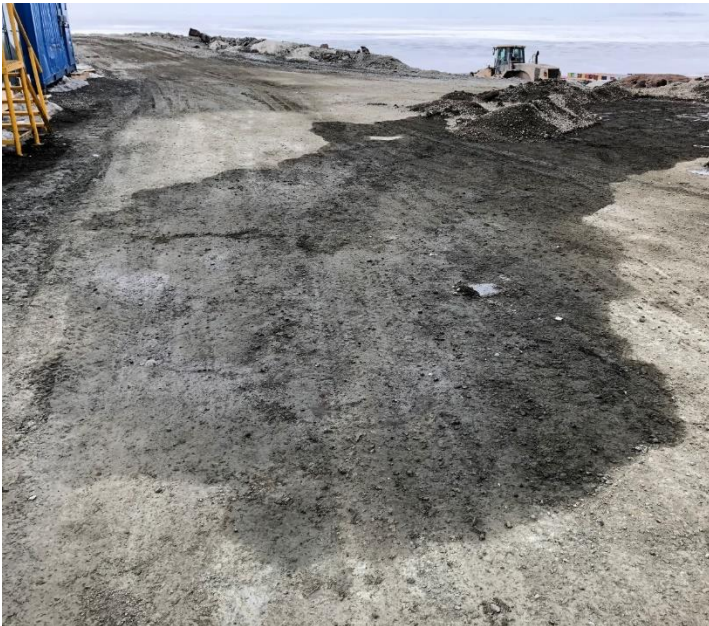
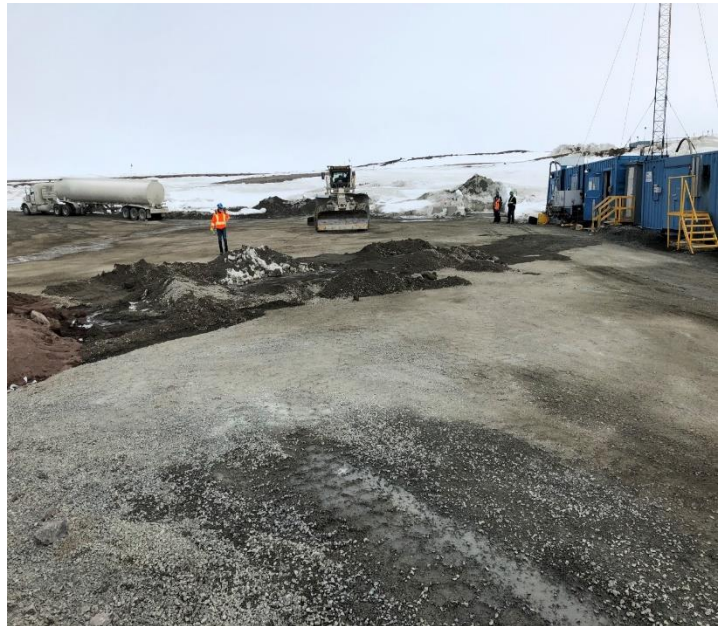
During operations at Meadowbank, Tanker 7 was refueling at the Baker Lake Tank farm. After refueling, the operator pressurized the tanks and fuel started leaking out underneath compartment 5 (rear tank).

The spill occurred due to a ruptured pipe inside compartment 5 (the pipe drains water from the catwalk which runs through compartment 5). After investigation, it is believed the pipe froze due to water build up and when the tank was pressurized, it caused a failure of the pipe which allowed fuel to seep in and spill out the drain valve.

A routine visual inspection of all systems is performed during pre-operations checks as a part of the preventative maintenance program. A visual check of this pipe will be included in future pre-operations checks.

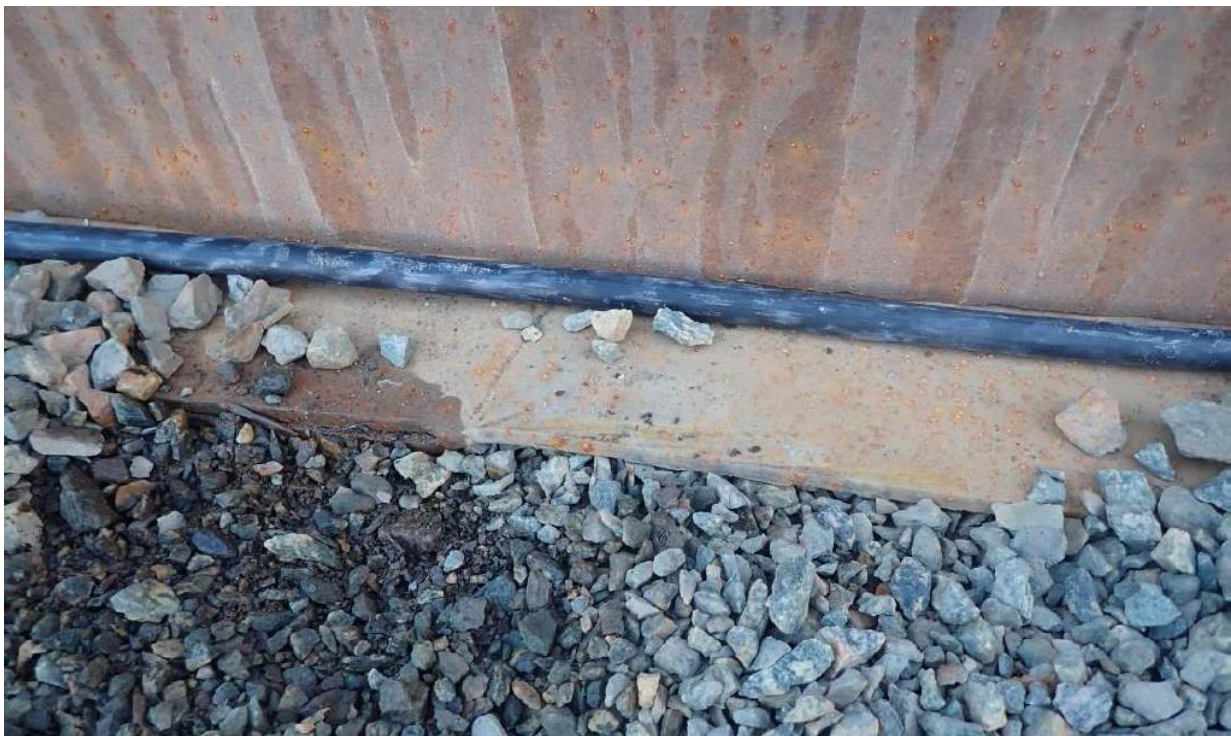
During an inspection at the Baker Lake tank farm, fuel within the secondary containment and a leak at the bottom of tank 5 was observed.

Visual observation of Fuel leaking out of the tank

After investigation, the fuel leak occurred due to a hole forming in the flooring at the bottom of tank 5.

Following the emptying of Tank #5, Agnico Eagle hired Mequaltech to inspect the fuel reservoir. Mequaltech is certified by API to produce out of service inspection, and to return repaired tank in service. The inspection covered the roof, side walls as well as the flooring and foundation of the tank. The inspection revealed the roof and side walls to be in good conditions. There was some settlement in the foundation, however this was within acceptable range to be recertified under API 653 B.2.3. The floor was fully inspected. Some minor imperfections, as well as 1 hole were identified and repaired. Each of the repairs were tested, and all passed the tests. The full inspection report was issued by Mequaltech on October 26th, 2020.

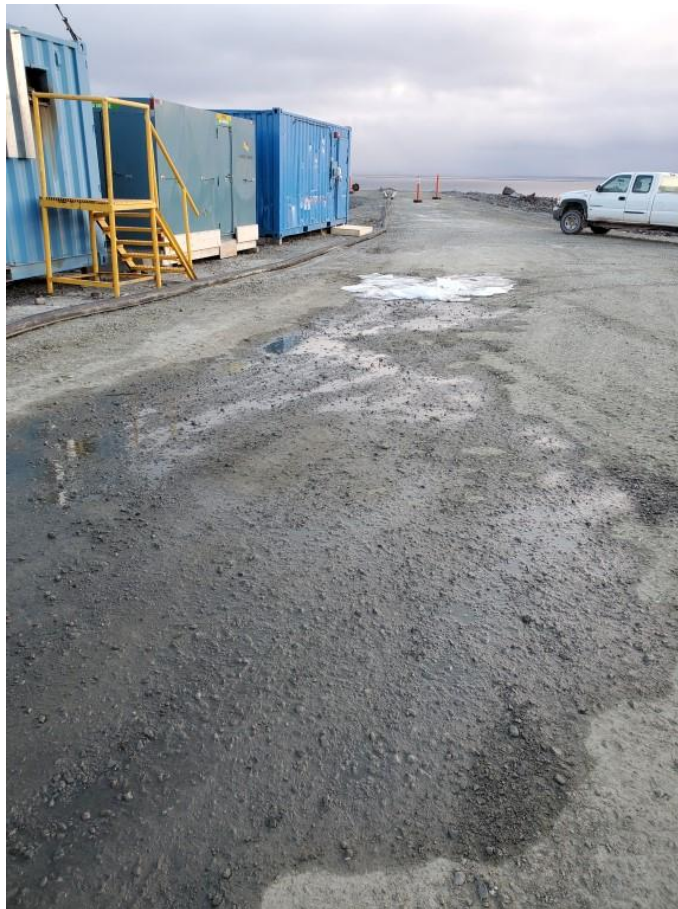
During operations at Meadowbank, a tanker was refueling at Baker Lake. The tanker was filled up faster than anticipated, causing excess fuel to spill onto the ground. A worker nearby used the emergency shutoff to minimize the spill. Absorbent pads were used to contain the spill, which covered roughly 15m². Roughly 5m³ of contaminated ground was immediately collected and disposed of in the contaminated soil bin.

The spill was caused by human error; failure to stop refueling when tank was full.

Absorbent pads were used to collect and contain spilt fuel. Thereafter, ground was scraped and 5 m³ of contaminated soil disposed of in contaminated bin, to be transported to Meadowbank landfarm.

Site wide communication regarding the importance to remain attentive when refueling was sent out.

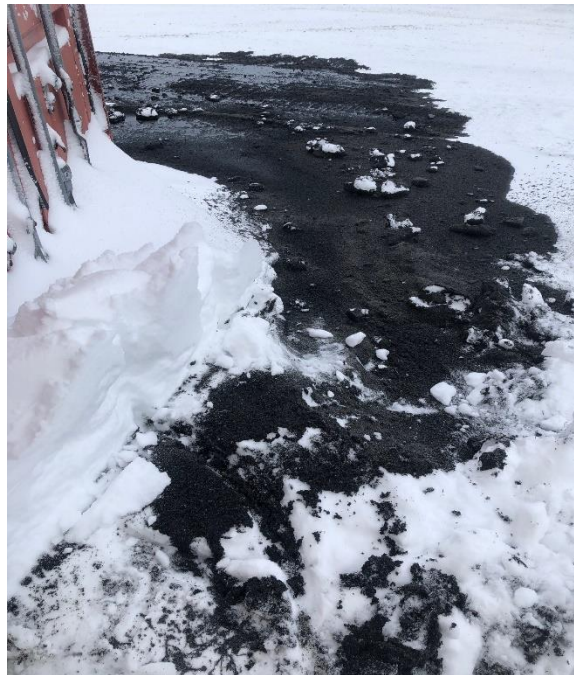
During operations at Meadowbank, the loader operator was moving a tote of waste oil into a sea can with a skid steer when the bottom metal bracket of the tote broke, causing the waste oil tote to slip on the forks and tip on a angle.

The tote was tipped upright, and the lid was replaced. A loader with bucket immediately removed the contaminated material on the ground. Approximately 4m³ of contaminated material was collected and placed into a roll off bin. The roll off bin was then dumped at the Meadowbank land farm.

Operators/workers are advised to secure all tote lids prior to transporting.

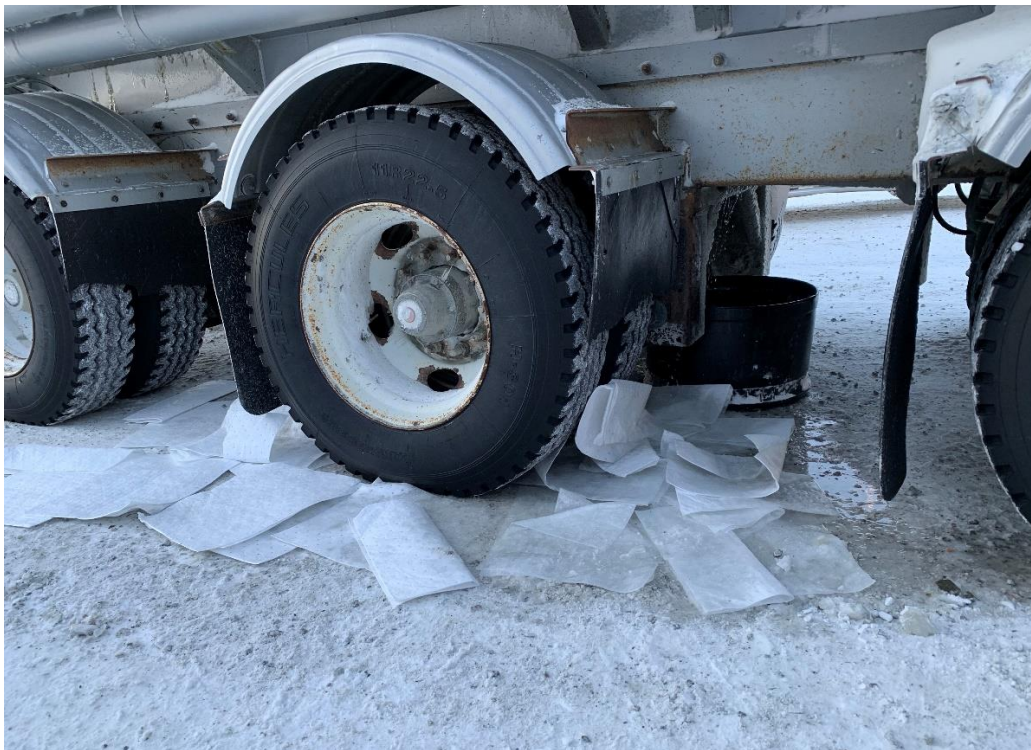
During operations at Meadowbank, a tanker was refueling at Baker Lake. A tanker operator was filling up the 5th compartment of the vehicle, when the breather had a sudden release of pressure, spilling diesel fuel in the process. The breather was frozen, causing a build-up of pressure within the tanker compartment due to the addition of diesel. The spill occurred in the product transfer area of the tankfarm, fully contained within the secondary containment.

The spill was caused by equipment malfunction, caused by cold weather.

Absorbent pads and drums were used to collect and contain the spilt fuel. The 5th compartment of the diesel tanker was emptied into a nearby tanker. Thereafter, 15m³ of contaminated snow and soil was retrieved and disposed in the contaminated soil bin, to be transported to Meadowbank landfarm.

An internal investigation took place to identify root causes and establish an action plan to mitigate the risks of this kind of event from reoccurring. As a result, a checklist was developed and is in the process of being implemented for operators to use during refueling process to ensure proper functioning of the breather valve, as well as other key components of the refueling process.
