Appendix 29

Whale Tail 2020 GN spills reports

GN reference #: 2020-019

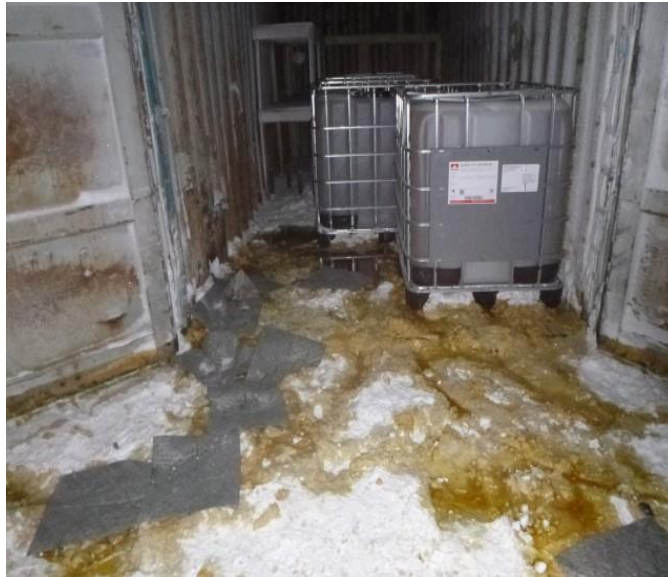
During operations at the Whale Tail pit, a worker was moving totes in and out of a sea can. The operator was unaware he punctured a tote. During night shift, another worker went to get a tote from the sea can and discovered the spill.

The spill occurred due to a punctured tote from the loader forks.

All equipment operators using forks to move material will use a spotter to prevent incident/material damage .

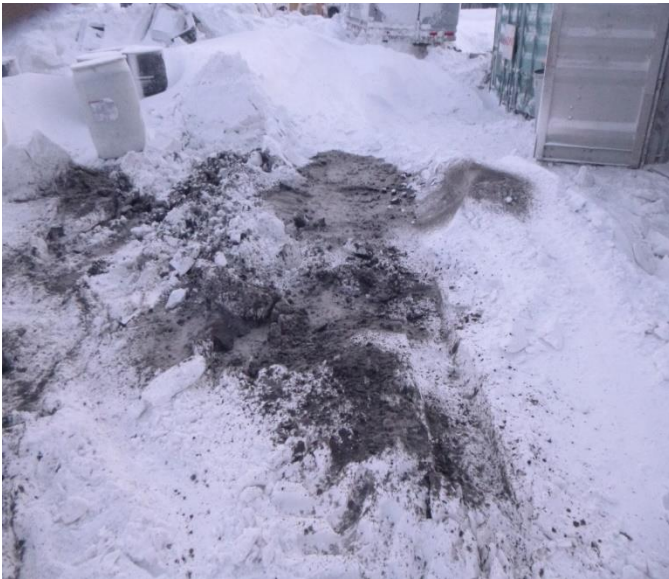
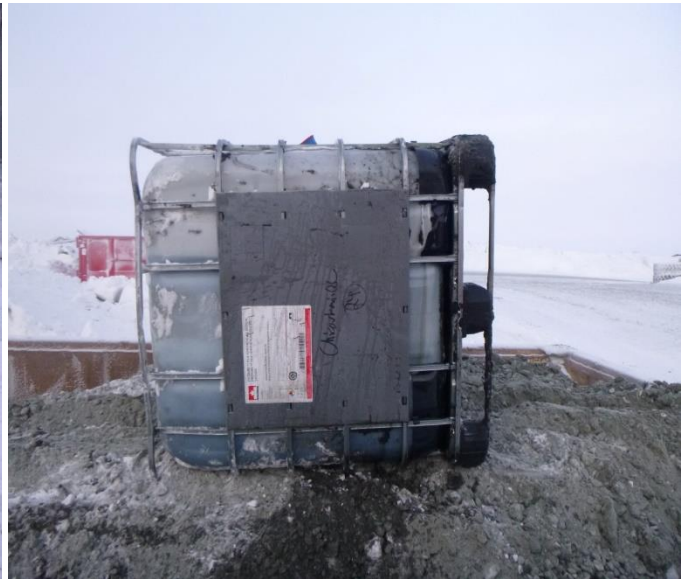
During operations at the Whale Tail pit, an operator was moving totes at the HazMat area and punctured a waste oil tote with the forks.

All equipment operators using forks to move material will use a spotter to prevent incident/material damage .

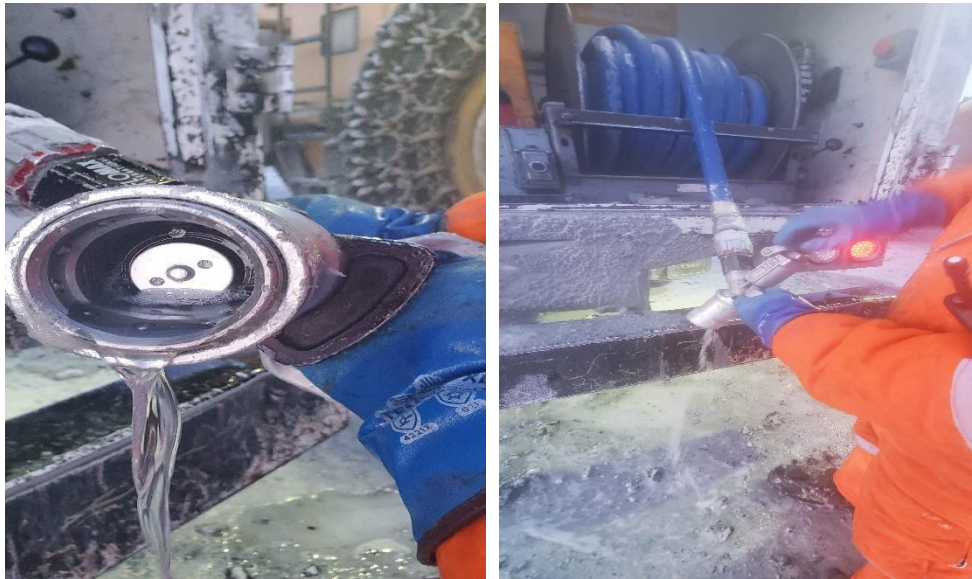
During operations at the Whale Tail pit, the fueltruck operator was engaging the PTO on TRK42 and the Wiggins nozzle malfunctioned causing diesel fuel to spill on the ground.

The spill occurred due to a failure in the Wiggins fuel nozzle.

A routine visual inspection of all system is performed during pre-operations checks as a part of the preventive maintenance program.

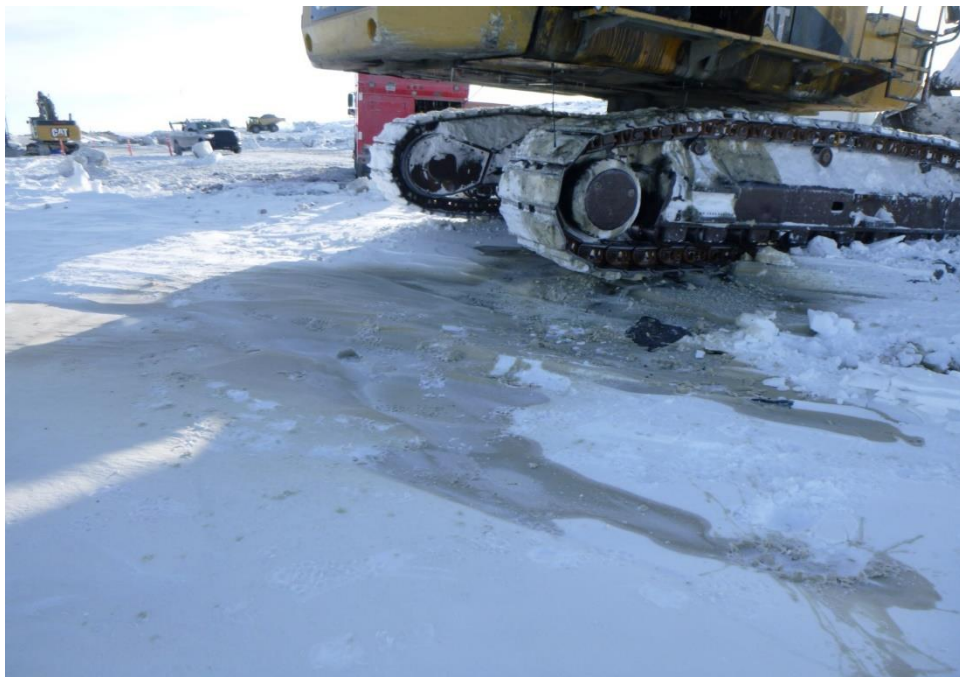
During operations at the Whale Tail south channel construction area, a hydraulic hose failed on excavator 12-0305 causing oil to spill onto the ground.

The spill occurred due to a hydraulic hose failure on the rear left of the machine.

A routine visual inspection of all system is performed during pre-operations checks as a part of the preventive maintenance program.

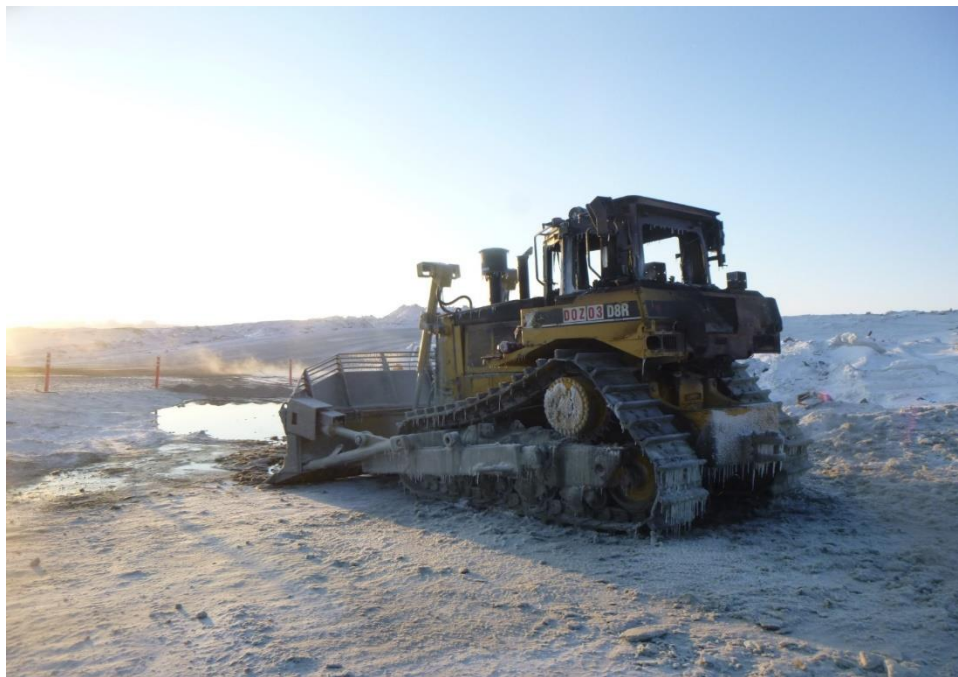
During operations at the Whale Tail pit, DOZ03 was parked and idling when it caught fire. DOZ03 was “down” and waiting for repair.

A policy for “down” equipment, outlining spot checks on the until(s) while running as well as outlining amount of time unit should be left running while in “down” status will be implemented.

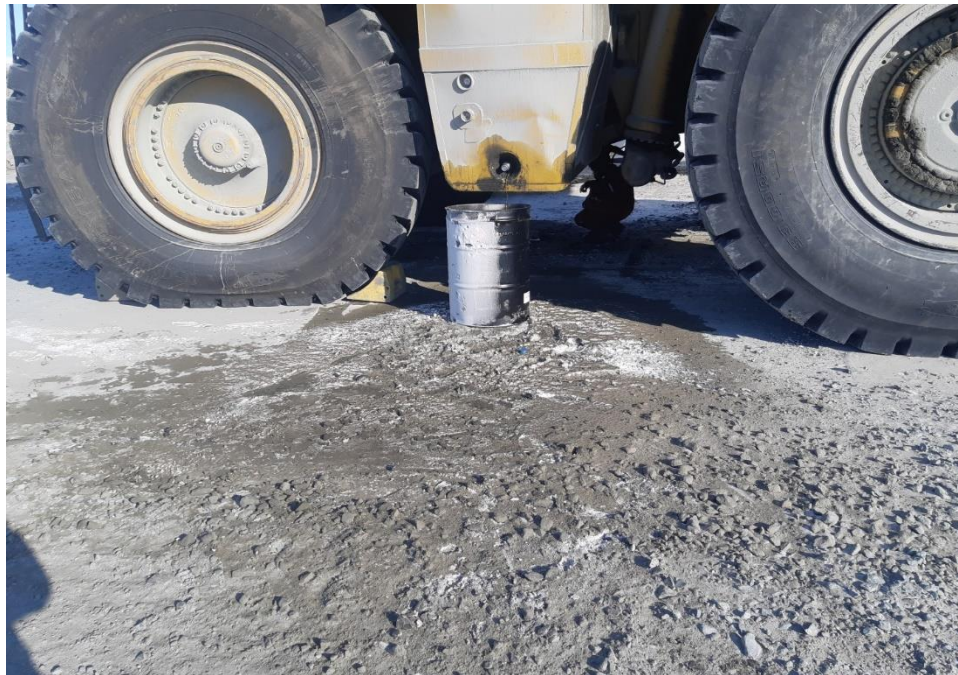
During operations at the Whale Tail pit, HTR22 was parked at the bottom of Phase 2 pit waiting for a hydraulic hose repair. When the fuel truck finished refueling HTR22, the operator noticed that the Wiggins would not fully close and fuel was spilling on the ground.

The spill occurred due to a mechanical parts failure on the Haul Truck.

A routine visual inspection of all system is performed during pre-operations checks as a part of the preventative maintenance program.

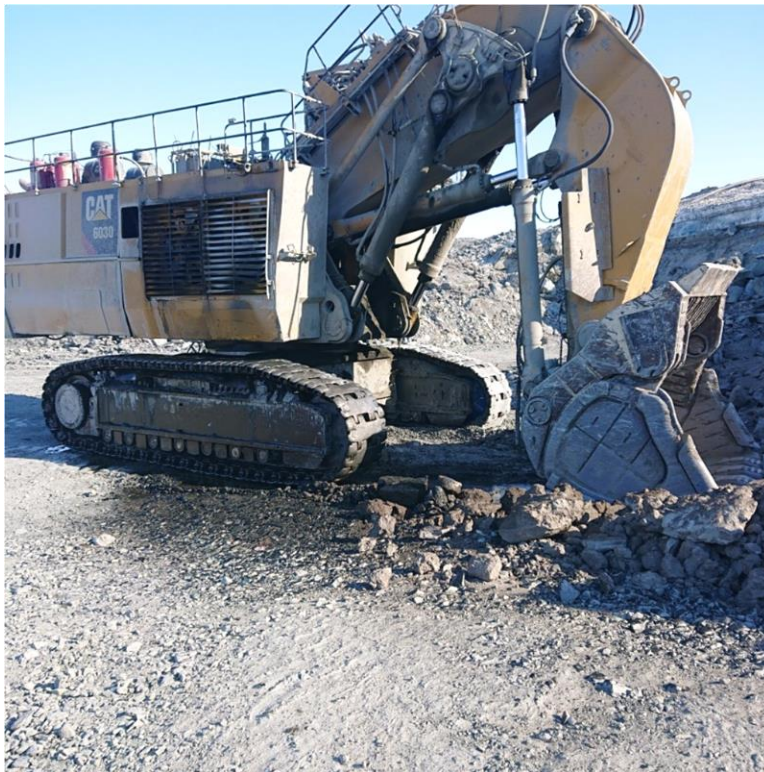
During operations at the Whale Tail pit, the operator of excavator BAC13 was working in the Phase 3 pit, when the operator noticed a hydraulic leak spilling onto the ground.

The spill occurred due to an equipment failure on excavator BAC13 (hydraulic fan valve).

A routine visual inspection of all system is performed during pre-operations checks as a part of the preventative maintenance program.

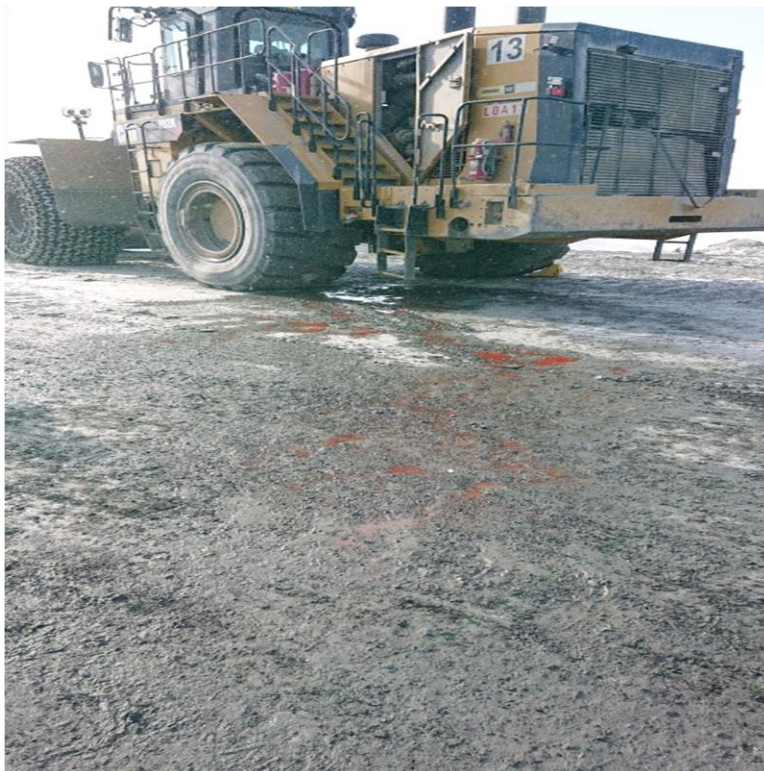
During operations at the Whale Tail pit, the operator of loader LOA13 was working on Ore Pad C, when the operator noticed a coolant leak spilling onto the ground.

The spill occurred due to a coolant line failure on loader LOA13.

A routine visual inspection of all system is performed during pre-operations checks as a part of the preventative maintenance program.

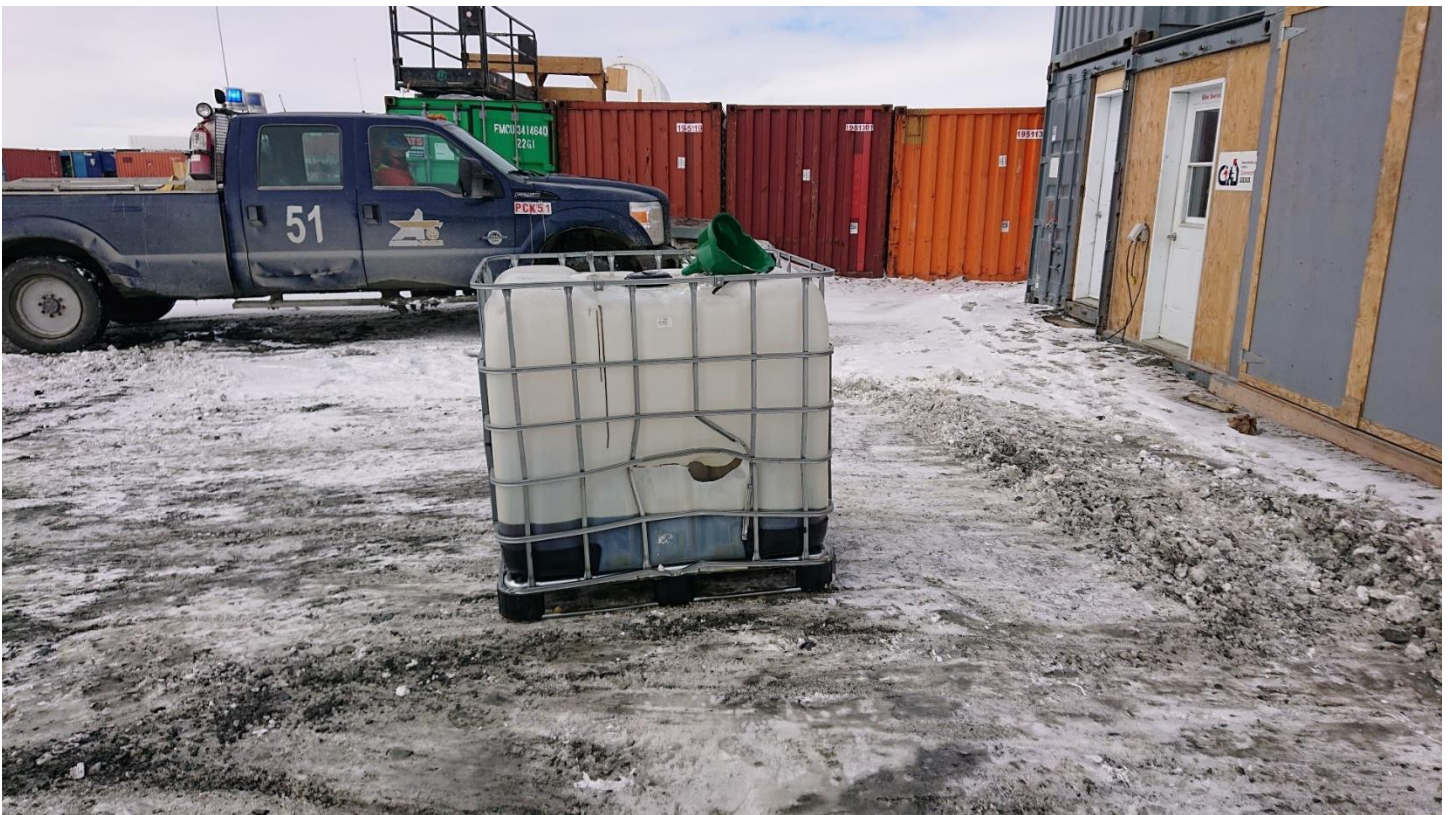
During operations at the Whale Tail pit, an operator was attempting to move an engine oil tote on the ground. The operators swivel forks jumped and punctured the side of the tote.

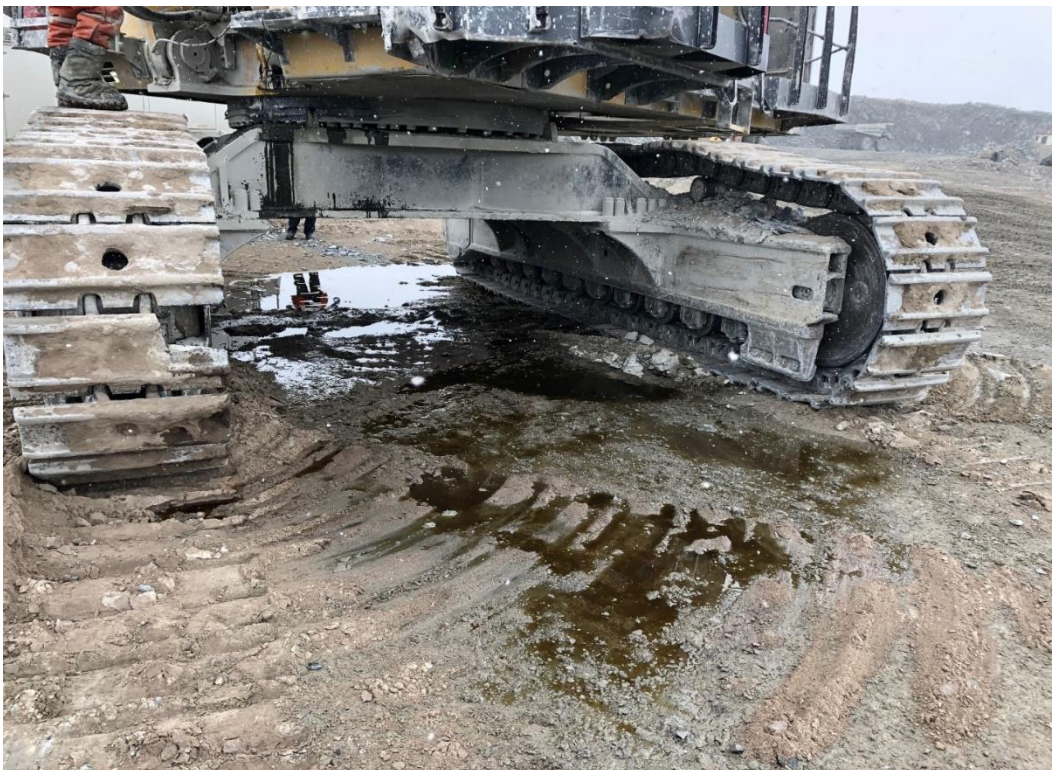
During operations at the Whale Tail pit, the operator of excavator BAC08 was working at the bottom of Phase 3 pit, when a seal blew causing hydraulic oil to spill on the ground.

The spill occurred due to an equipment failure on excavator BAC08.

A routine visual inspection of all system is performed during pre-operations checks as a part of the preventative maintenance program.

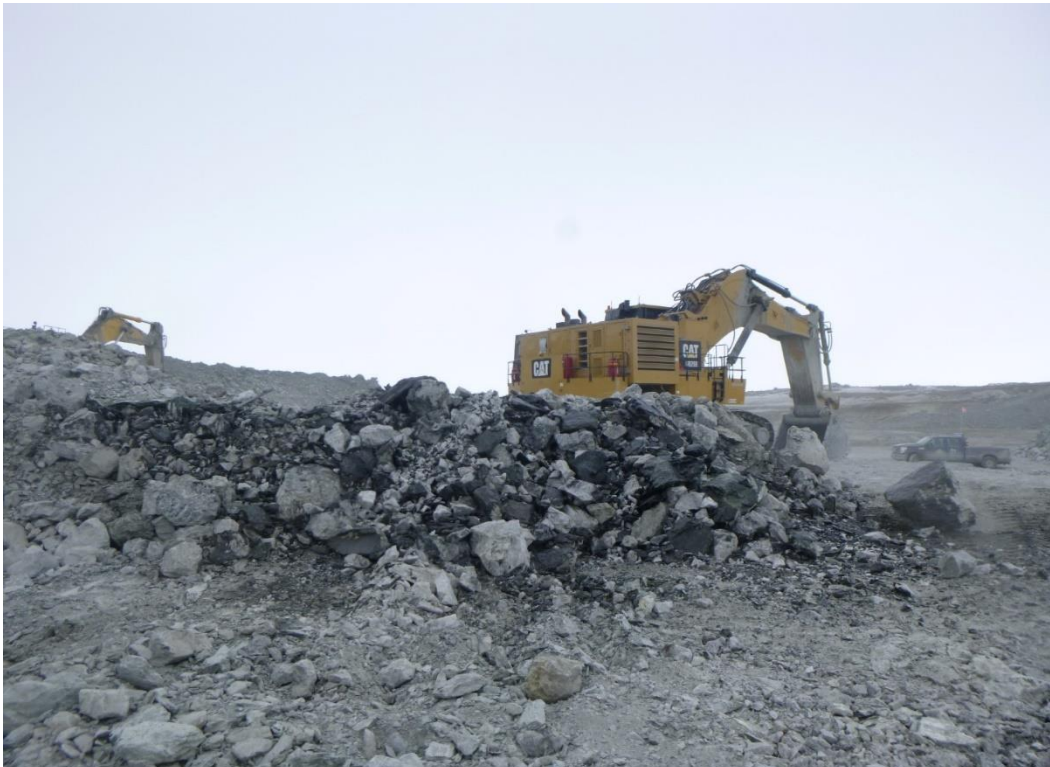
During operations at the Whale Tail pit, the operator of excavator BAC14 was working in the Phase 3 pit, when the operator noticed a hydraulic leak spilling onto the ground.

The spill occurred due to an equipment failure on excavator BAC14.

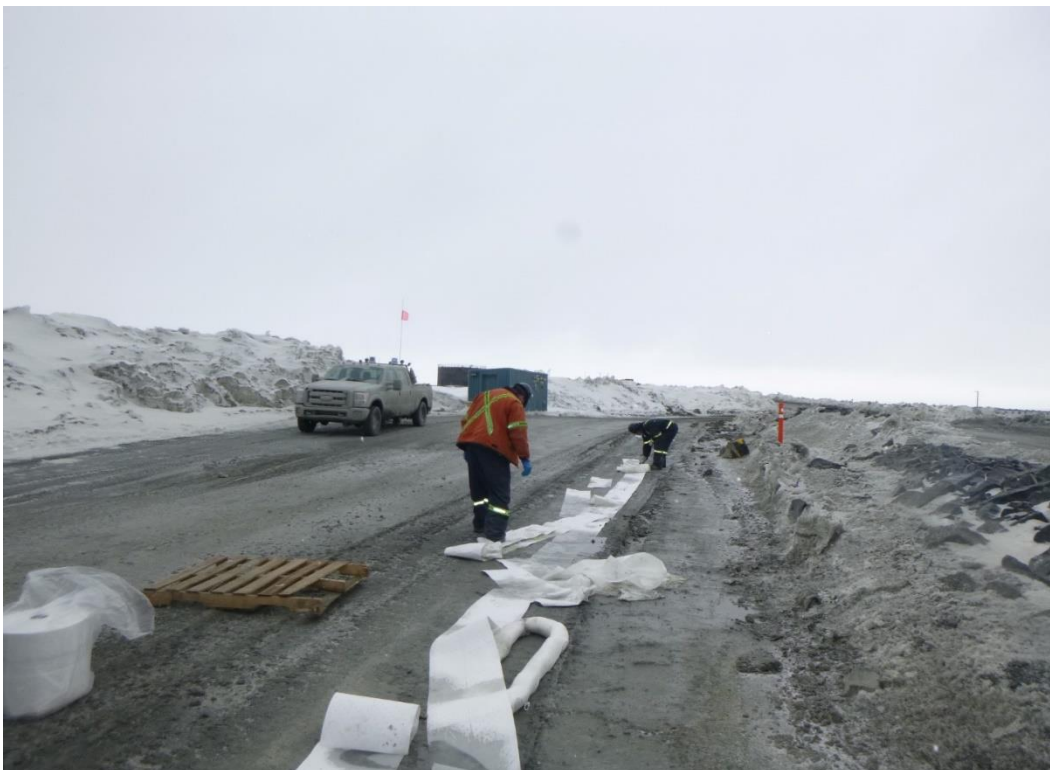
During operations at Whale Tail pit, the operator of long-haul truck LHT16 stopped at the wheel torque area to check his tires, when the operator noticed a diesel leak spilling onto the ground.

The spill occurred due to frozen build up of mud between the tires and the fuel tank. The vibration from the long-haul truck caused that build up of mud to put pressure on the fuel tank, causing a small puncture/crack on the tank.

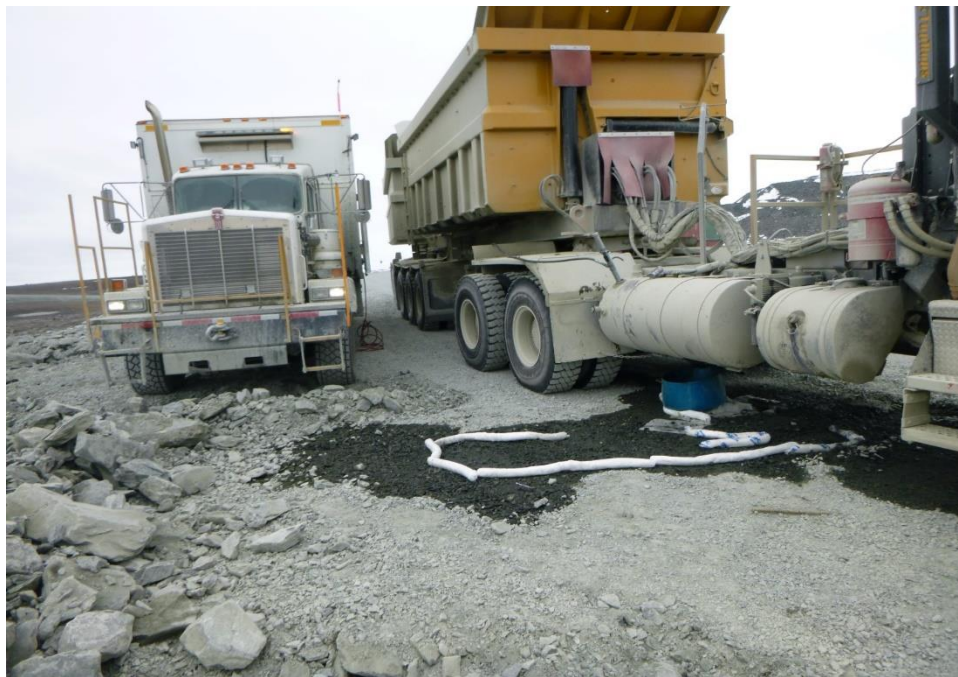
During operations at Whale Tail pit, the drive shaft of long-haul truck LHT15 failed and broke off, puncturing the fuel tank as it fell to the ground.

The spill occurred due to a driveshaft failure on long haul truck LHT15.

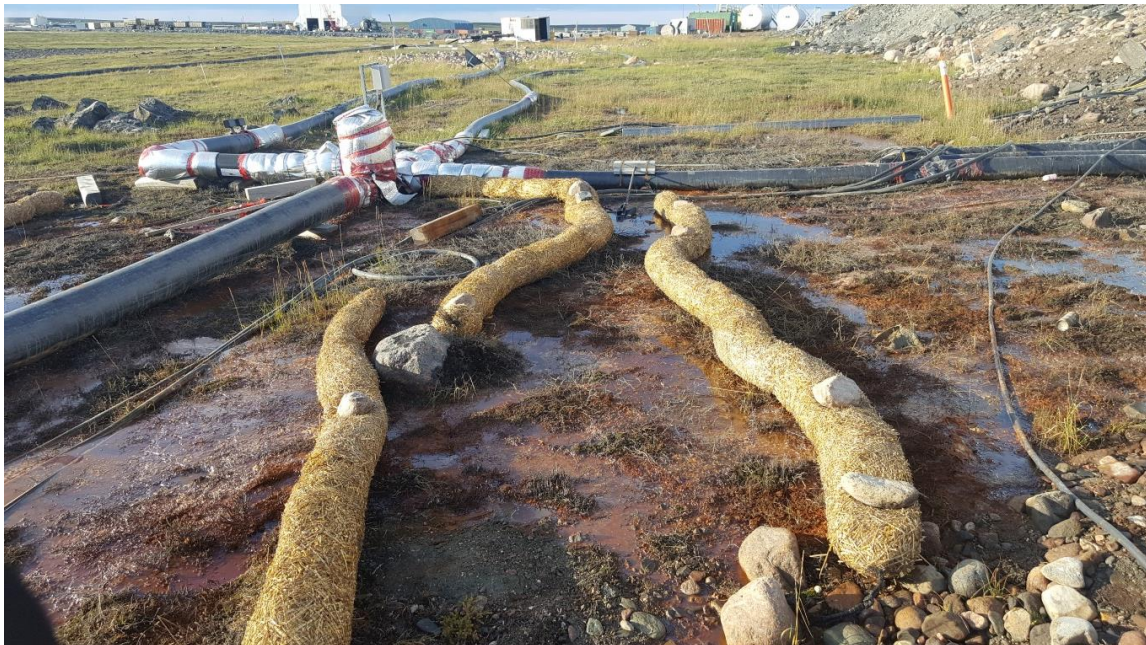
During a regular Whale Tail site inspection by the environment department, turbid water was observed to be running off from one of the pads. The water was sampled, and found to have total suspended solids of 345 mg/L.

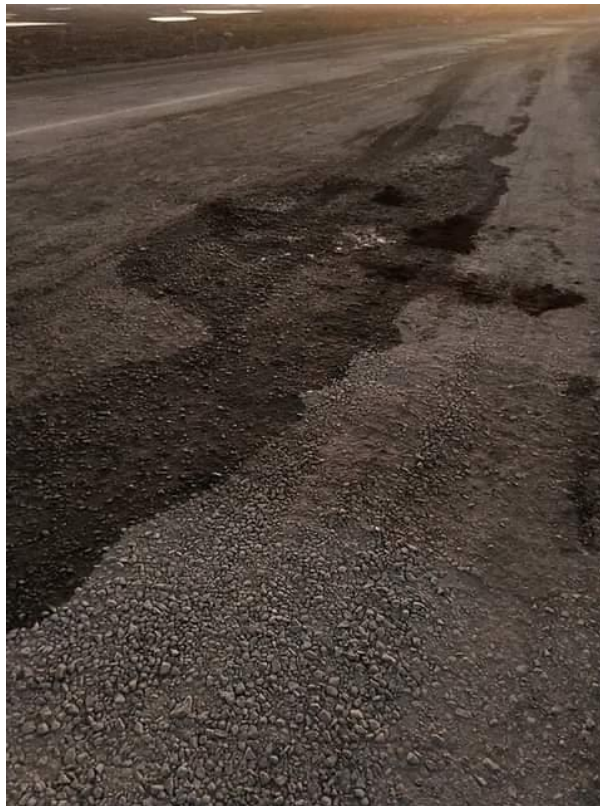
During operations on the Whale Tail Haul Road, the long haul truck sustained a mechanical equipment failure, causing damage to the passenger side fuel reservoir on LHT18. 125L of diesel fuel spilled onto the road. All of the fuel stayed on the road.

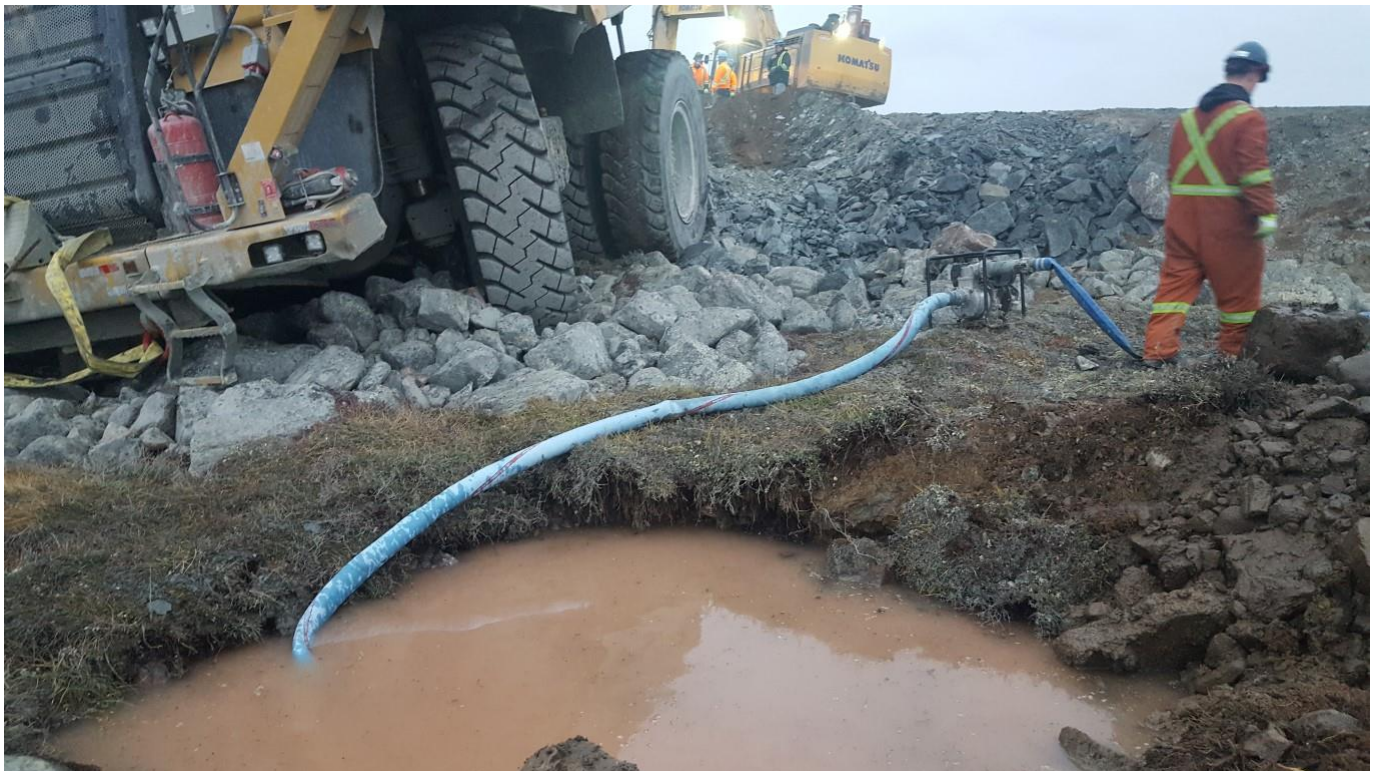
During operation along the Whale Tail Haul Road, Haul Truck 05 pulled onto the shoulder of the road to give way to oncoming traffic. As the operator was pulling over, the shoulder of the road softened up and caused the truck to come to a stop in the tundra, 5 meters from the road. In the process, the haul truck was damaged and some petroleum products (engine oil, hydraulic oil) were spilled. All spilled fluids were contained near the truck, with no impact on any nearby water bodies. It is estimated a total of 650L of fluids were spilled, mainly hydraulic oil.

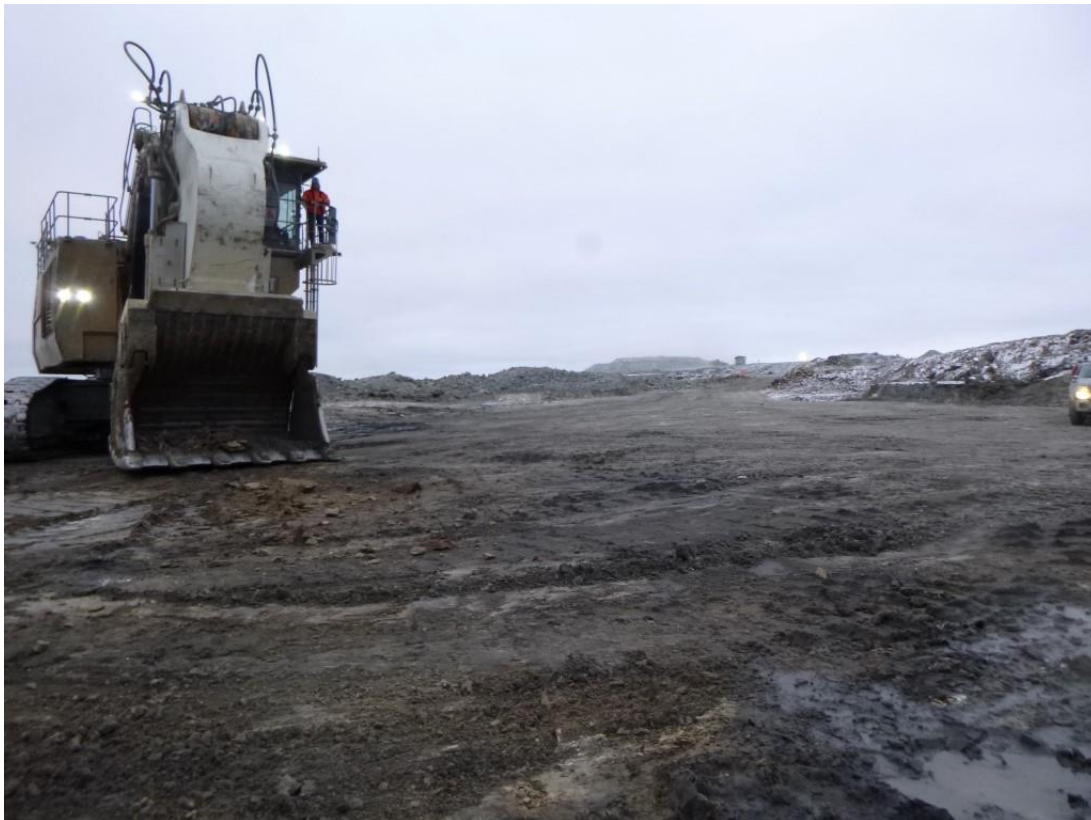
During operations at the IVR pit, excavator BAC13 experienced equipment damage on its hydraulic hose near the engine compartment, resulting in a broken hose. The spill was fully contained under the excavator. The spill covered roughly 10m².

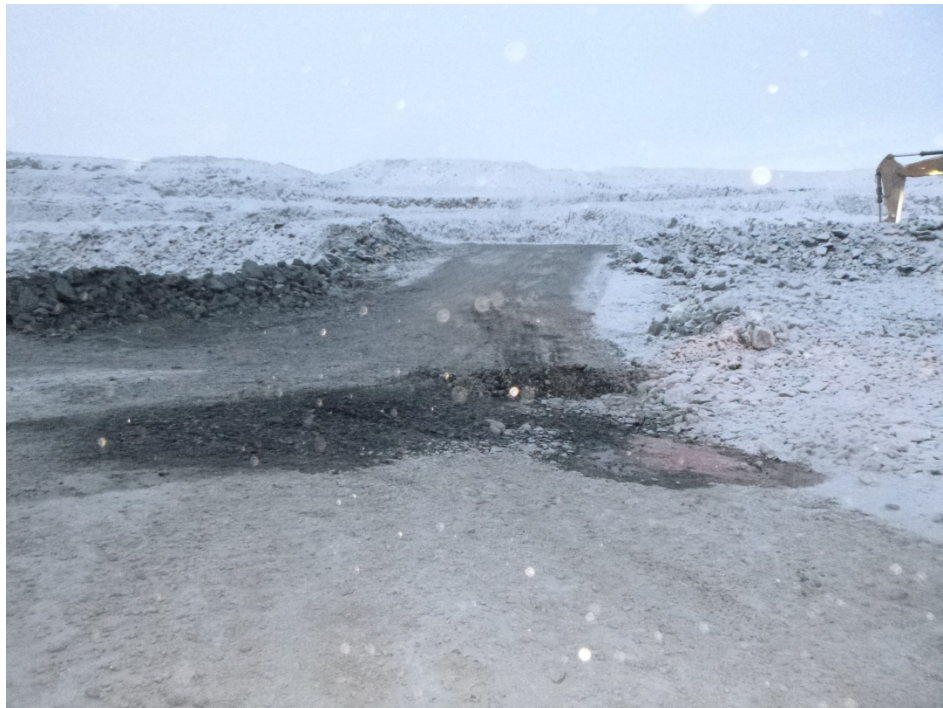
During operations at Whale Tail pit, the fan hub on HTR25 failed and hit the radiator causing 375L of the coolant system to spill onto the ground in Whale Tail pit.

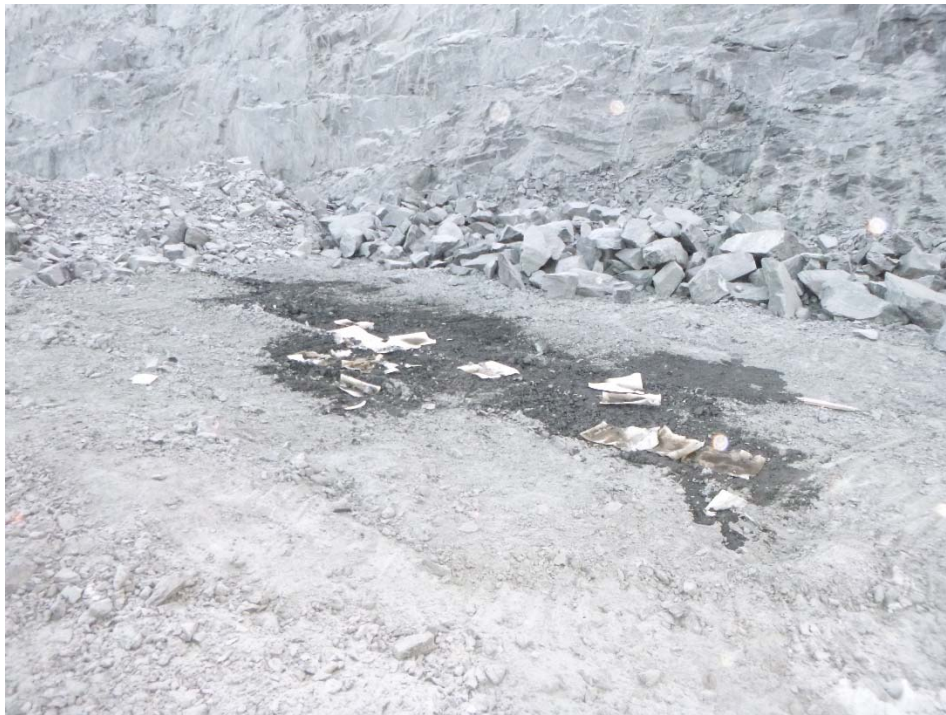
During regular operations at the bottom of Whale Tail pit, the excavator operator noticed a hydraulic hose leak. He moved the machine and stopped the engine. Spill pads were used to contain as much of the spill as possible.
