### **Whale Tail Open Pit - 2020 Annual Inspection**

## **RE: Amaruq Mine - Whale Tail Open Pit - 2019 Annual Inspection**

# Amaruq Project – Whale Tail Open Pit

## 2020 Annual Inspection

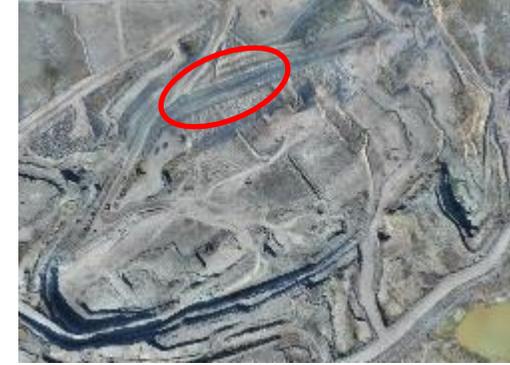
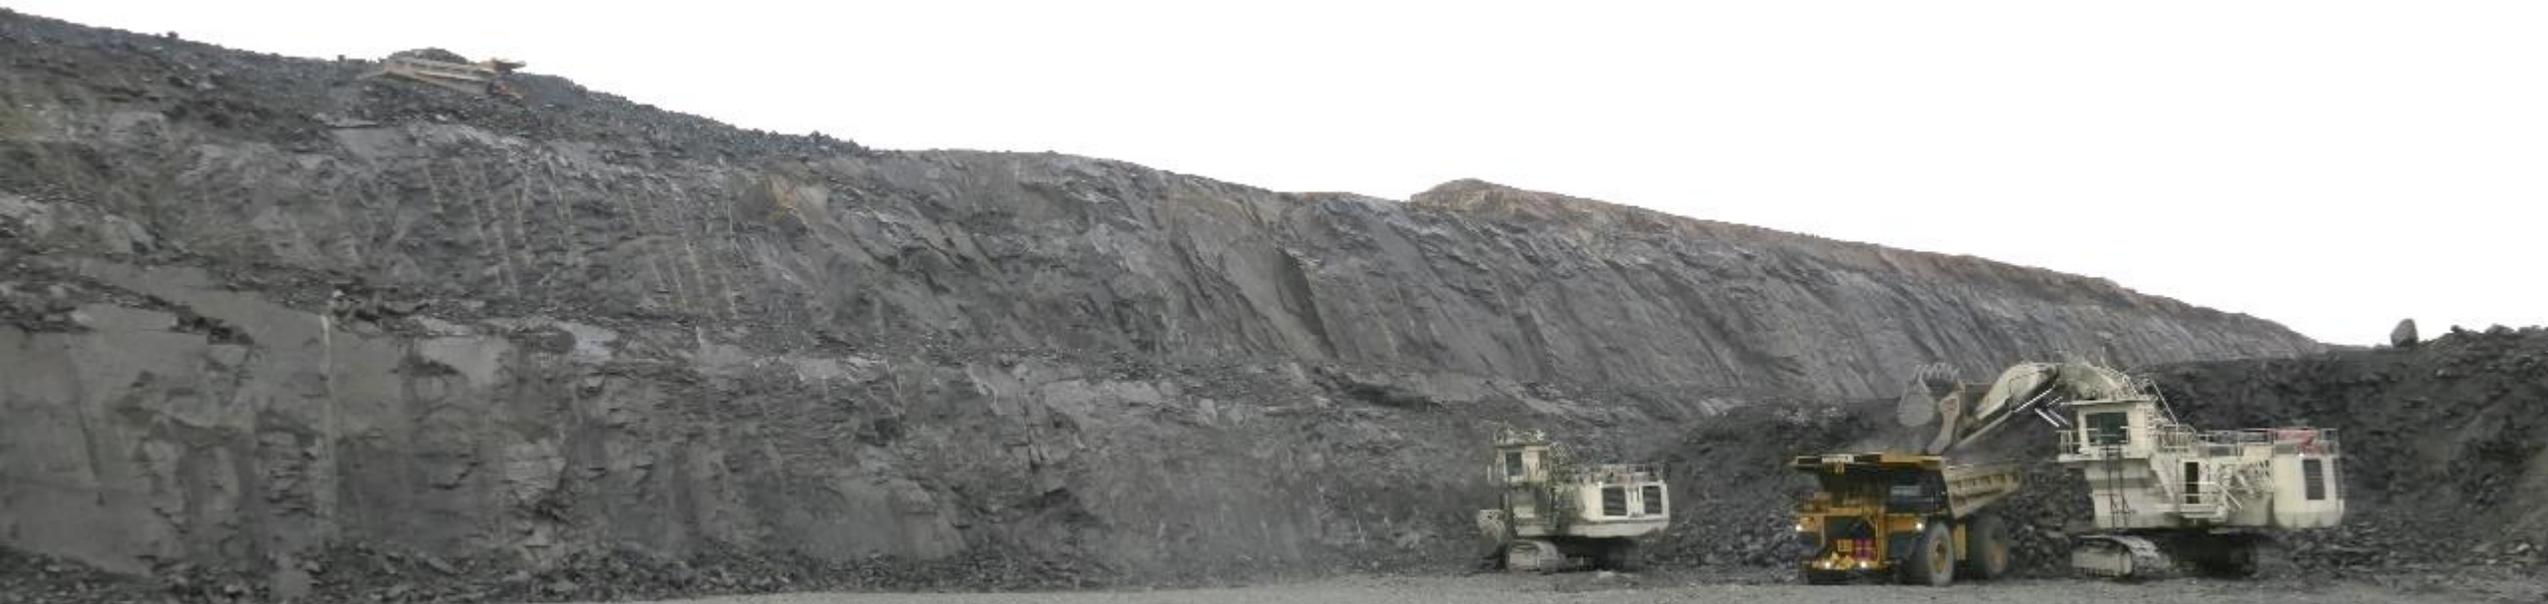
## North Wall

- Final wall in the Greywacke, Design Sector B1 / B4.
- Benches generally performing well. The bench performance is often controlled by the dip of the foliation, as expected. Bench face angle is approximately  $65^\circ$ , consistent with design.
- Material was left along the crest of the most recent bench during scaling. This was identified during the August 15 wall inspection and additional scaling has been requested.

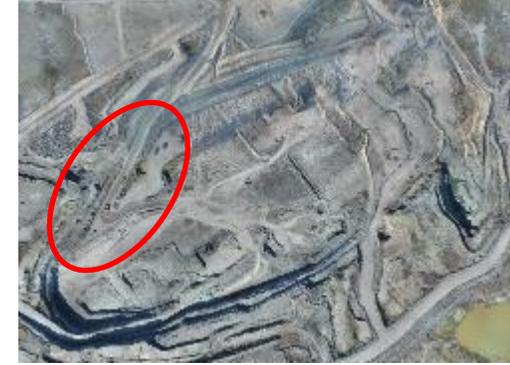
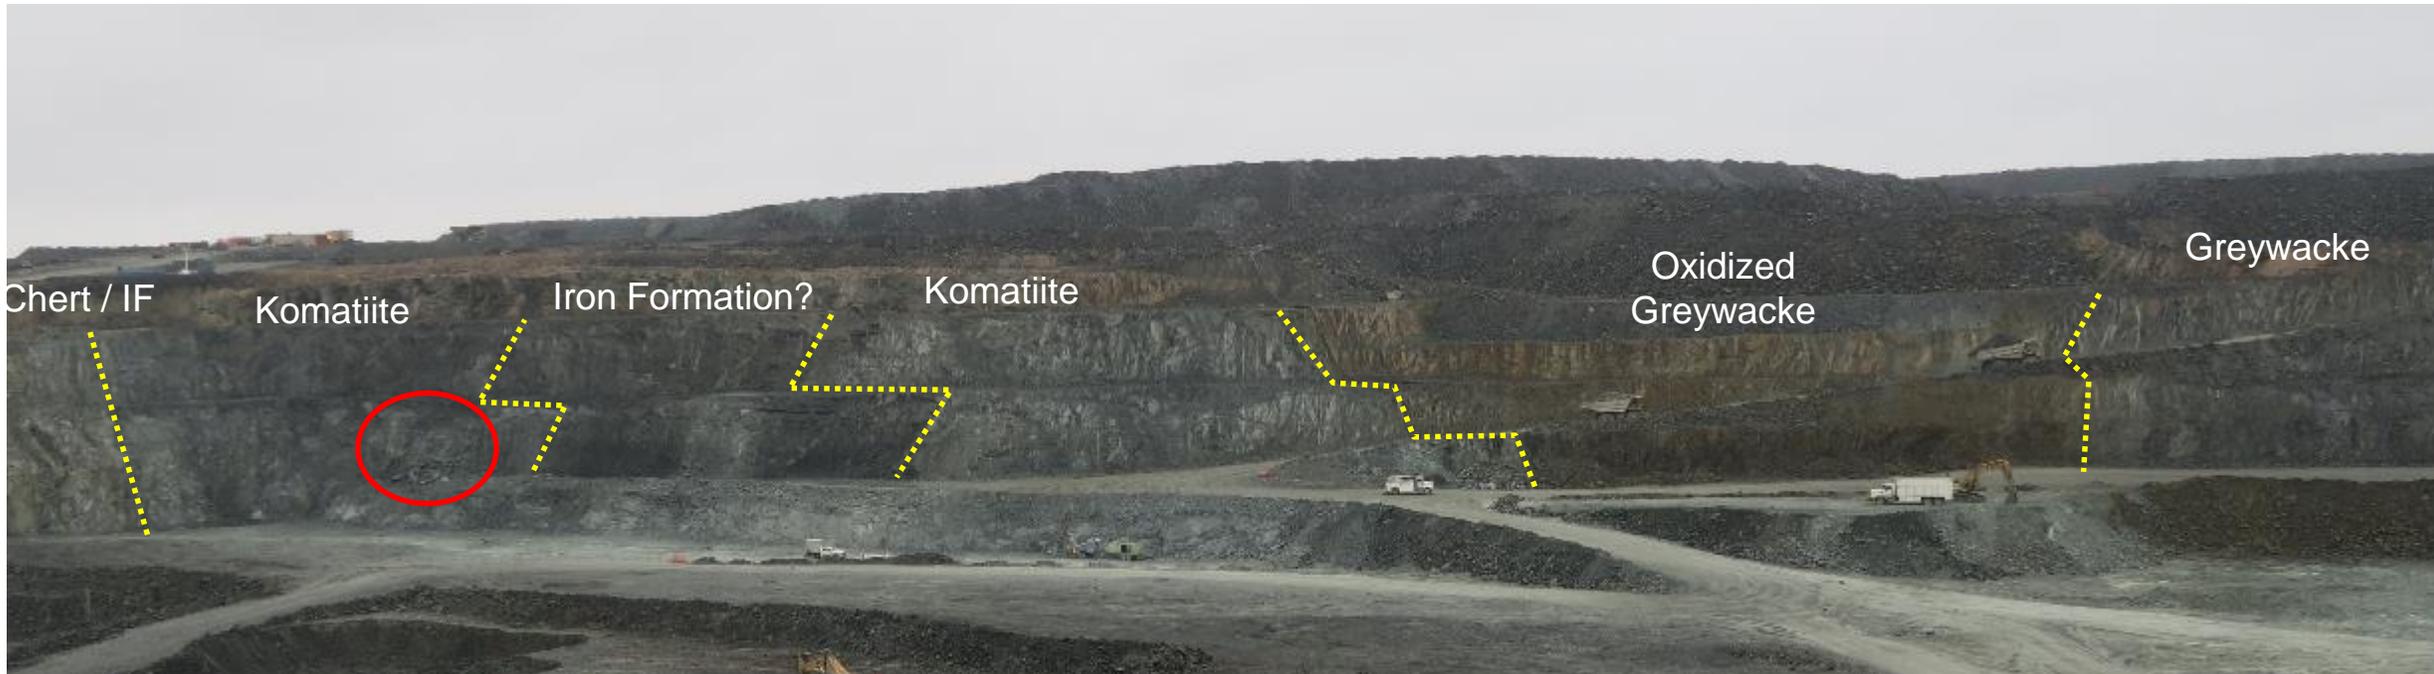
## Northwest Wall Overview

- The upper two benches will form part of the final wall in Design Sector A1. The lowest bench is an interim wall.
- With two exceptions, the wall is generally performing well. These exceptions are discussed in greater detail later in this presentation.
  - The oxidized greywacke was not previously identified during the design of the open pit. It is of lower quality than the greywacke and is generally performing poorly.
  - The interim 7 m high bench in the Komatiite was originally 21 m high and performed poorly over the summer.
- Prior to the inspection, a possible wedge was scaled down in the komatiite (circled in red).

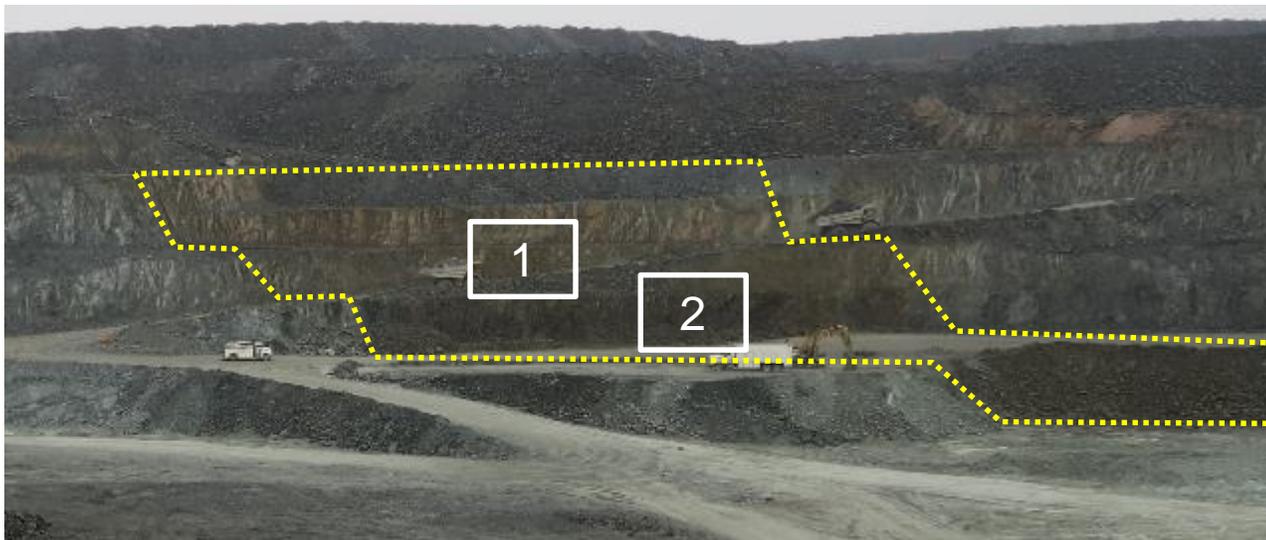
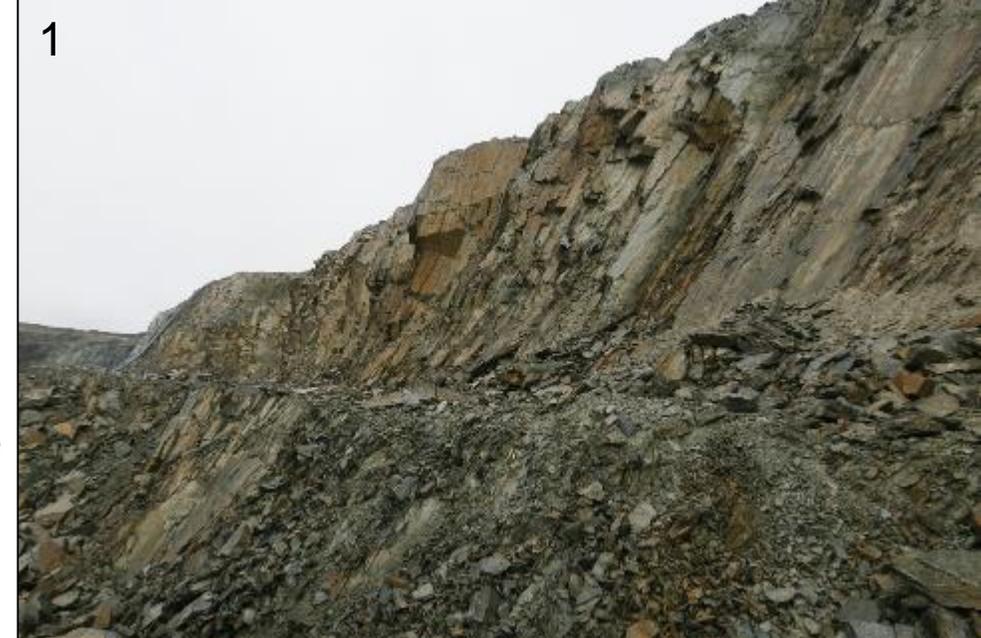
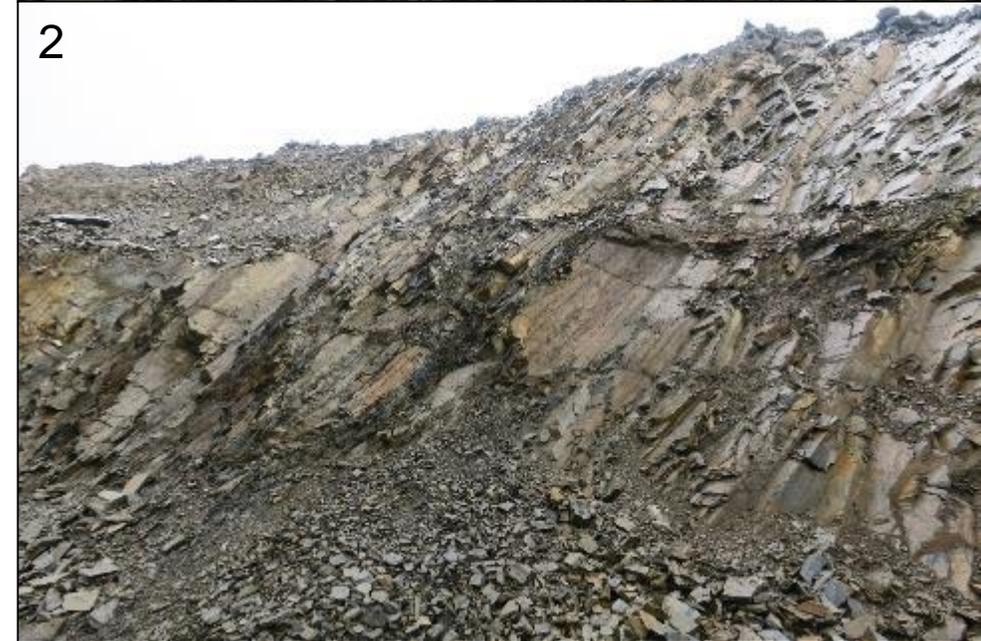
## Northwest Wall – Oxidized Greywacke

- A large interval of oxidized greywacke is present in the northwest wall.
- This unit is of lower quality than the typical Greywacke encountered. The rock mass is tabular to blocky, with Joint Sets A, C and D present, as well as random structures. The joint spacing, particularly of the foliation (Joint Set A) is at a decimeter scale, which is much tighter than observed elsewhere in the Greywacke. This creates smaller blocks.
- Significant backbreak was observed and on-going ravelling is starting to result in the accumulation of failed material on the benches. Over time, this could result in a loss of catch bench capacity and a rockfall hazard.

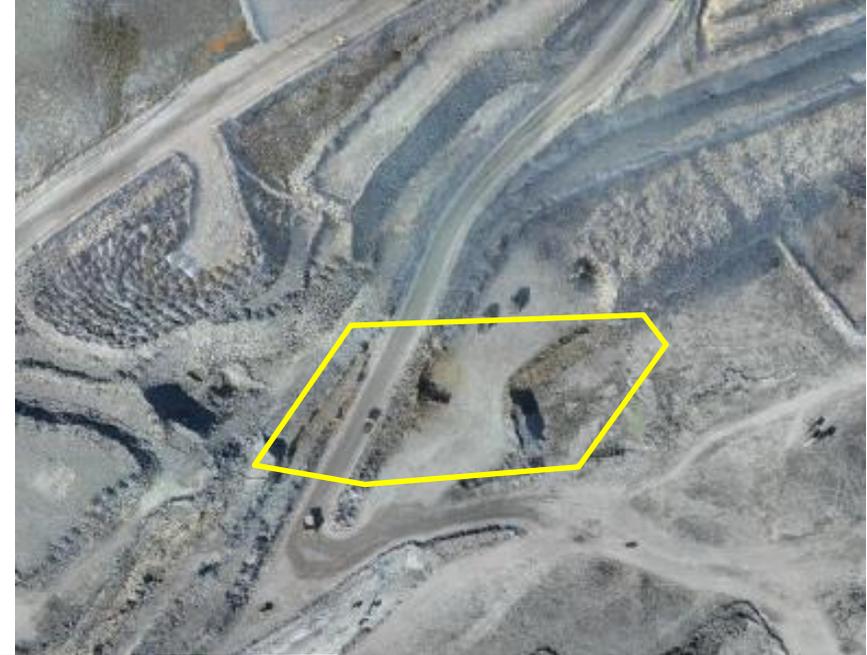
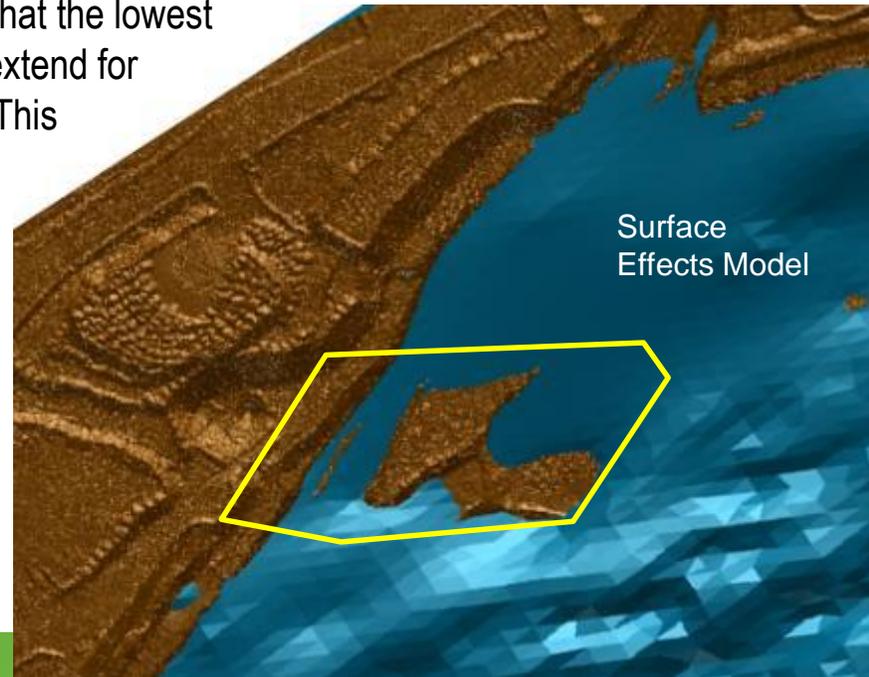
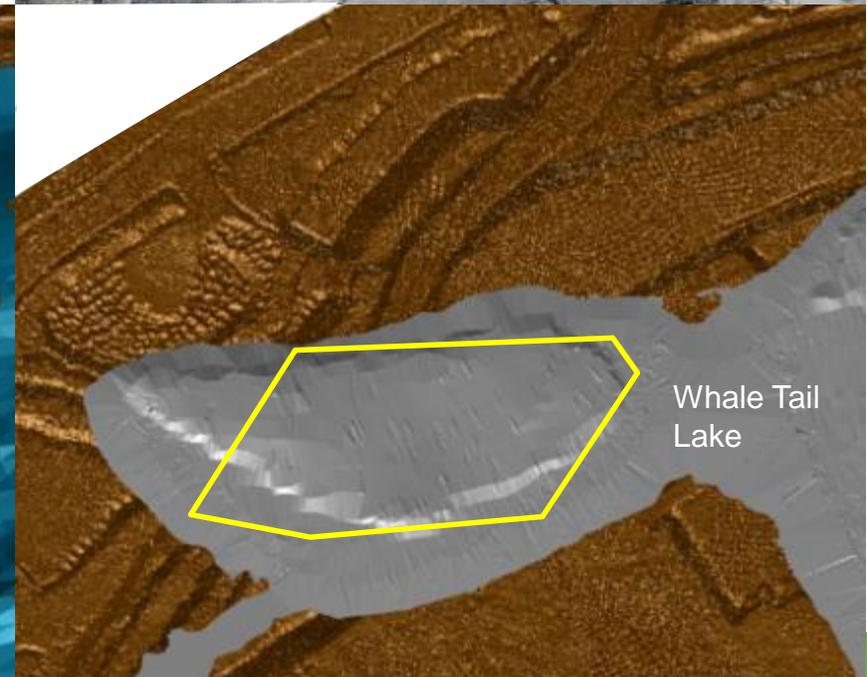
## Northwest Wall – Oxidized Greywacke

- The southern contact of the oxidized greywacke appears to be defined by the contact with the Komatiite. The northern boundary may be gradational.
- The oxidized greywacke appears to be associated with the western lobe of Whale Tail lake (see bathymetry overlain on July pit shell at lower right).
- The area also corresponds to a region of reduced RQD incorporated into a “surface effects” region of the brittle structural model (volume above blue surface in lower left image)
- The brittle structural model suggests that the lowest quality oxidized greywacke will only extend for approximately one more 7 m bench. This should be considered approximate.
- If the oxidized greywacke extends deeper than predicted, it will be necessary to consider how best to manage the rockfall hazard (e.g. increasing bench width directly below this unit).

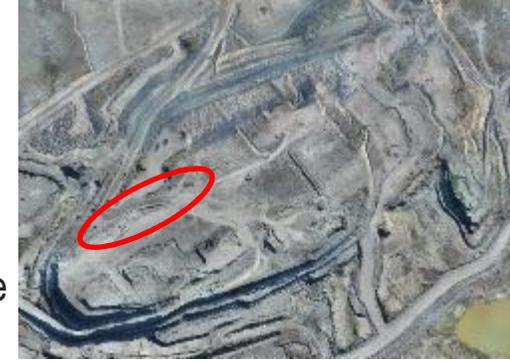
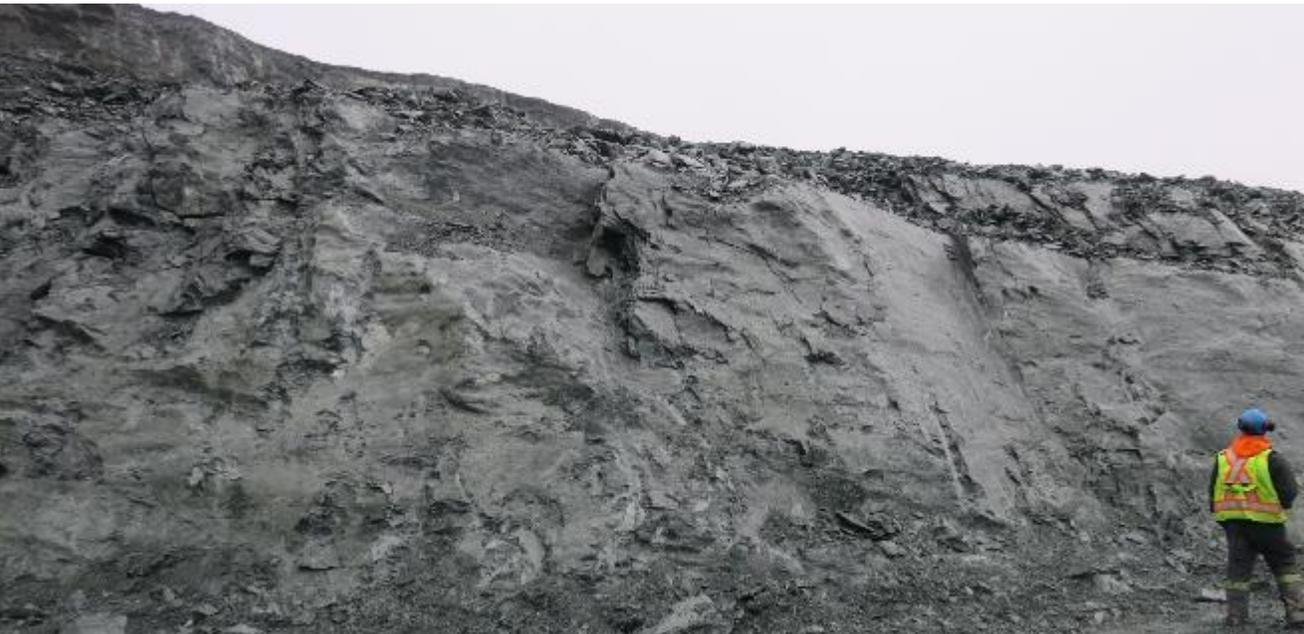
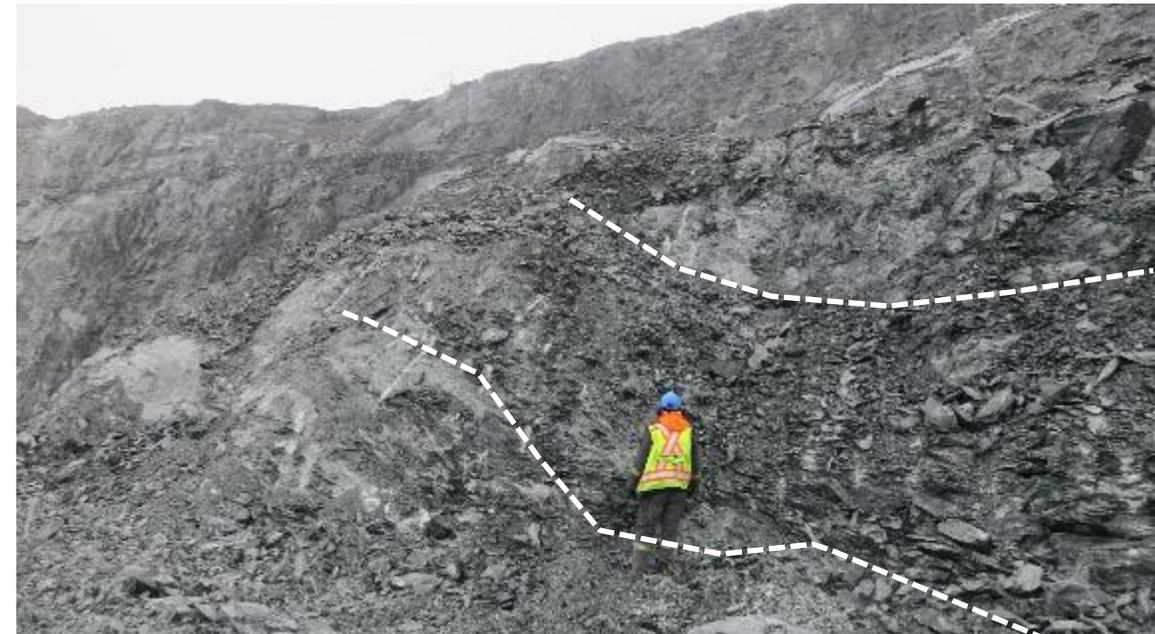
## Northwest Wall – Komatiite

- This wall was the first significant interval where benches were excavated in the Komatiite, parallel to the foliation of the Komatiite.
- The bench was originally 21 m high but has since been reduced to 7 m as mining has progressed. Partially as a result of these activities, the wall has deteriorated compared to its original state. The current condition is shown in the images below.
- The bench geometry was based on the recommended Bench Face Angle (BFA) of  $65^\circ$  and bench width of 10.5 m.
- The bench was partially established within a brittle structure (below right). The brittle structures within the Komatiite result in the lowest rock mass quality encountered at the deposit. Most, but not all, of these structures have been modelled.

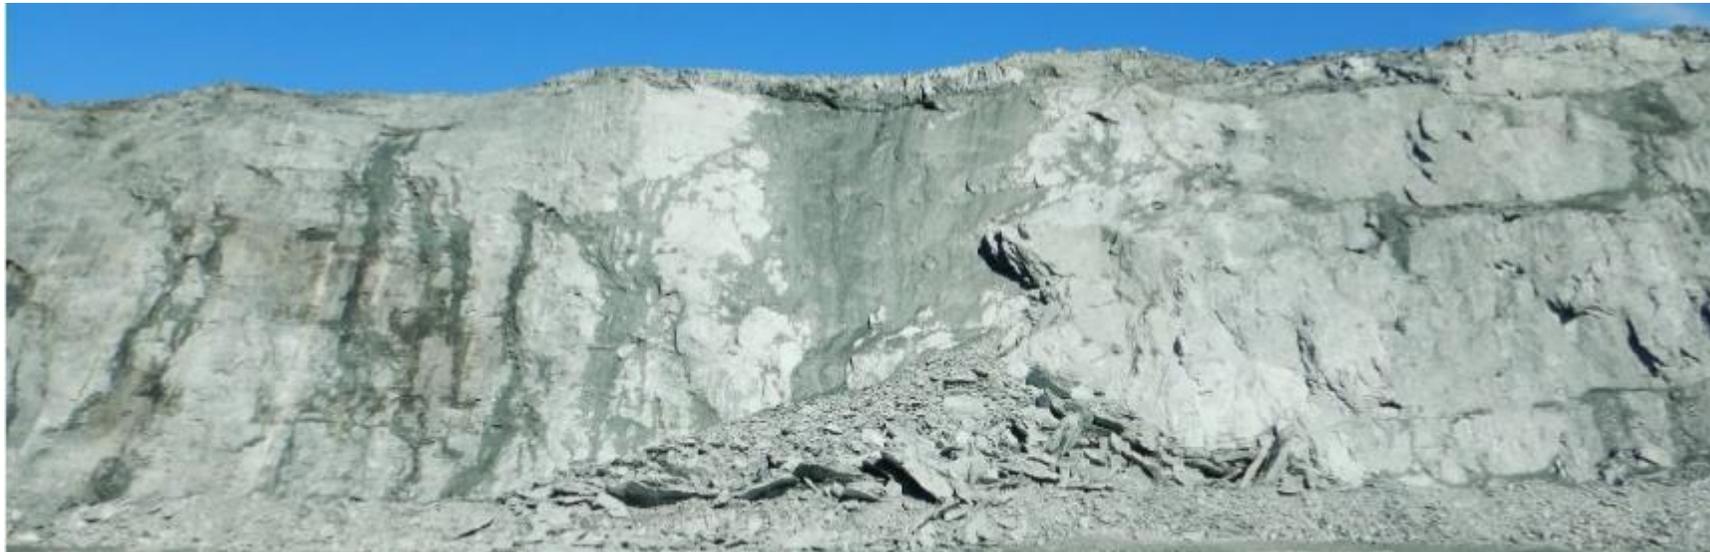
## Northwest Wall – Komatiite

Between June 6 and July 8, 2020, ten bench-scale failures occurred along a bench in the north wall of the Phase 1 open pit. The failures occurred within the Komatiite and ranged in scale from less than 150 tonnes to approximately 1,100 tonnes. Examples are included in Appendix A. These failures resulted in an order from the mine inspector to:

A review of the failures was completed during the site visit and concluded that they were planar and wedge failures on foliation dipping at a shallower angle than the Bench Face Angle (BFA) of 65°. In several cases, an undulation in the foliation results in it forming both sides of the wedge. The dip of the failure plane for six of the failures was measured using a Maptek laser scanner and typically ranged from 55 to 60°, with one plane having a dip of 50°. These dips are within the expected range for the foliation in this area.

- The bench was established over the winter. Starting in the spring, a series of bench scale wedge failures occurred on the 21 m high bench, peaking in June.
- In total, 10 failures occurred, ranging from approximately 100 to 1,100 tonnes. At least two of these failures were a continuation of earlier failures. The largest failure is shown below.
- The mine inspector issued an order in late July to assess the causes of these failures and to develop a plan to reduce their occurrence. This is discussed further later in this presentation.

Design Sector B1 strikes at approximately 100°, parallel to the foliation, and is more applicable to the design of the north wall of the Phase 1 open pit than Design Sector A1. The slope geometry recommendations developed by KP for Design Sector B1 are based on the expectation that the bench face can be reliably established at 55°, which is consistent with the actual performance of the north wall.

As an interim measure, a modified version of the slope geometry recommendations for Design Sector B1 will be applied to all new benches on the north wall of the Phase 1 open pit. The recommendations have been updated to reflect the mine's ability to drill the pre-shear holes at 55° rather than the previously considered limit of 65°. As a precautionary measure, a design bench width of 10.5 m will be used instead of the 8 m minimum to increase the distance between the workforce and the bench face during drilling and loading. The resulting slope geometry consists of a 55° BFA, 10.5 m bench width and 21 m bench height, reducing the IRA of the north wall from 43° to 40°. This measure is expected to reduce, though not eliminate, the bench-scale failures in the Komatiite in the north wall of the Phase 1 open pit. AEM has committed to conducting stability analyses for the revised slope geometry and KP will review the results.

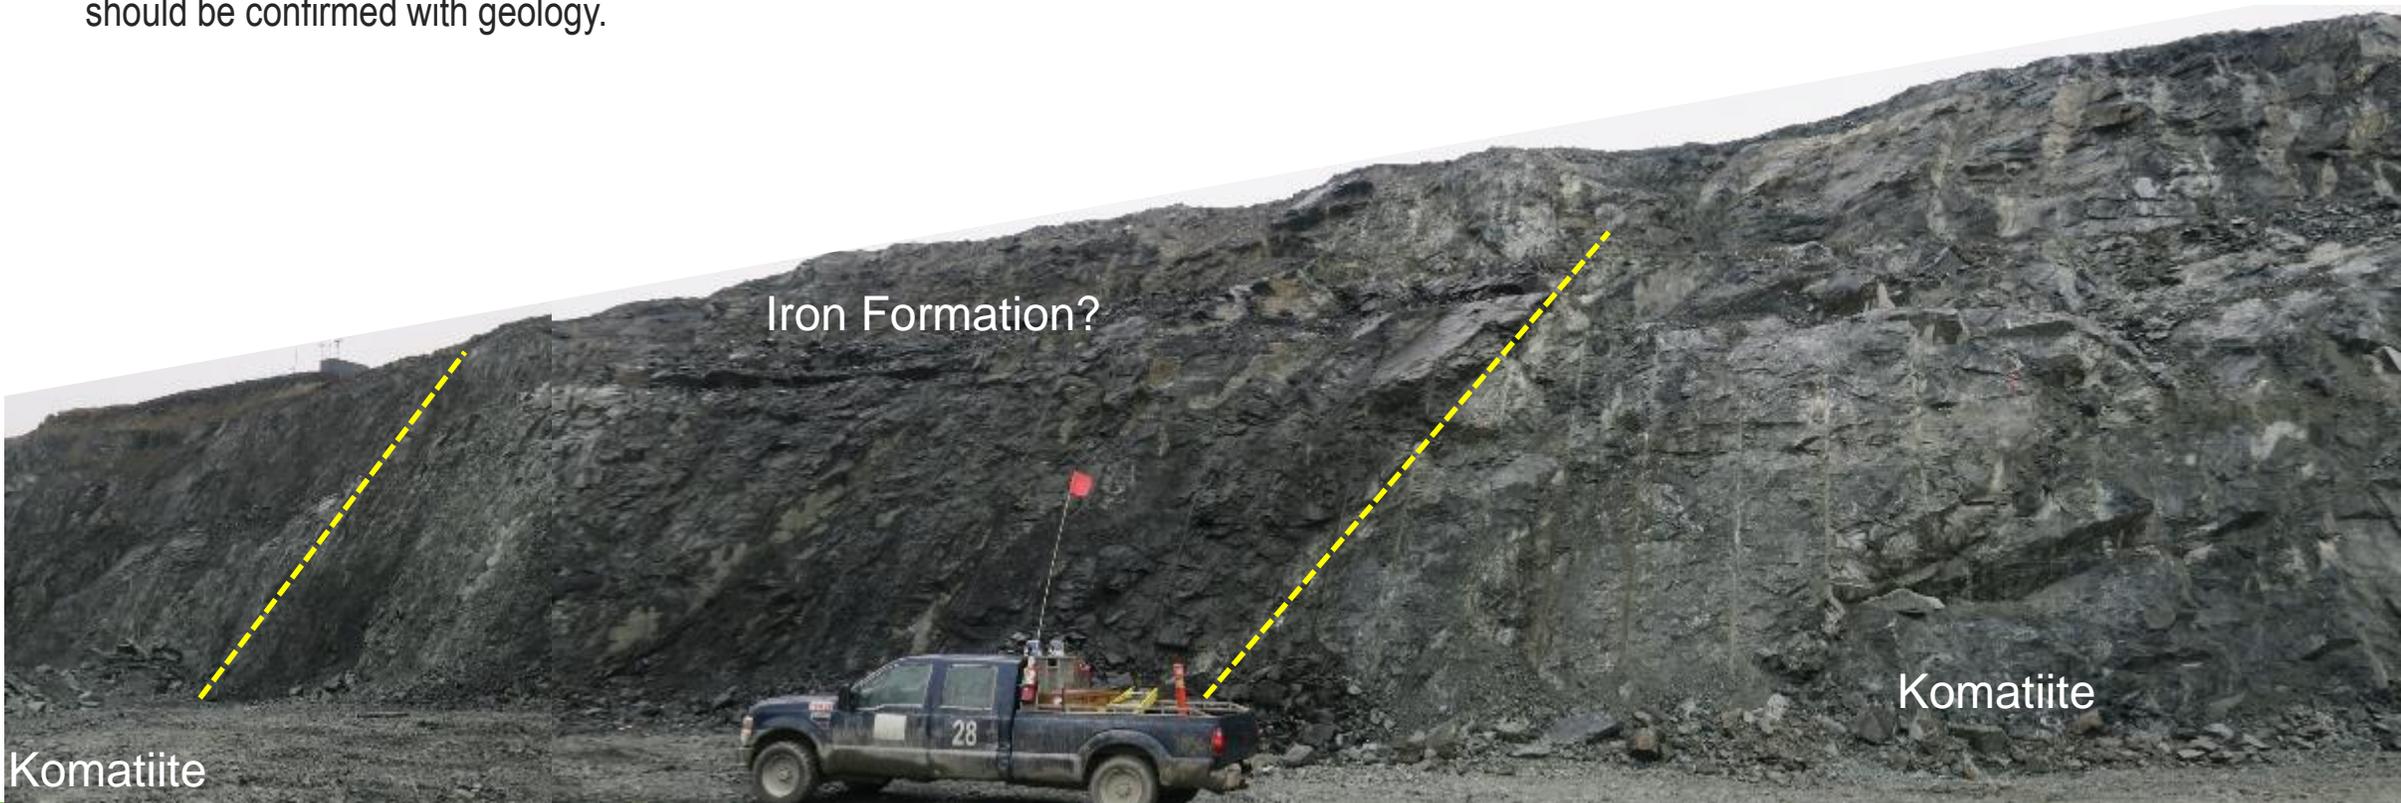
## Northwest Wall – Iron Formation

- Benches performing reasonably well. Half barrels present on most places but there has been some ravelling of the crest and face.
- Previous lithology models predicted that Iron Formation would be present in this wall, and the darker material was confirmed to be magnetic during the inspection. However, the most recent lithology model removed the Iron Formation from this area and predicts it to be Komatiite. The lithology should be confirmed with geology.

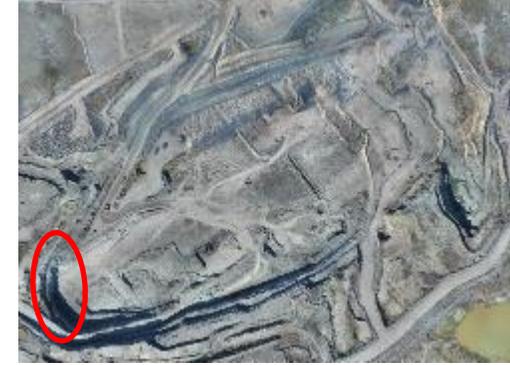
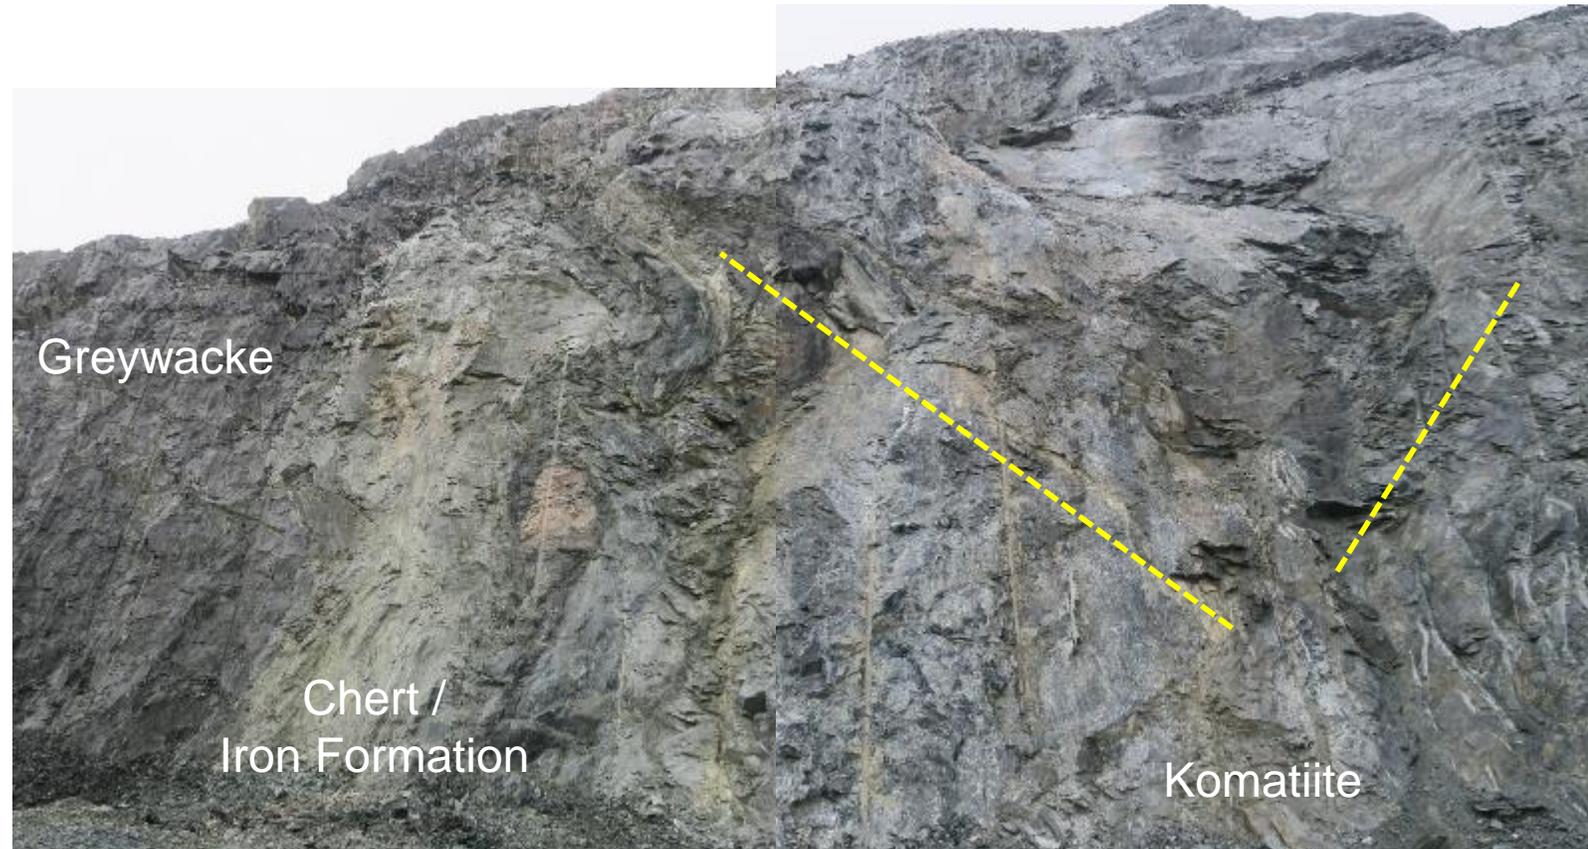
## West Wall

- Final wall in Design Sector A1 / I1
- Benches performing reasonably well, despite being intersected by multiple brittle structures. This is likely because the wall crosses the structures close to perpendicular, which is a favourable relative orientation.
- A possible wedge was identified on one of the brittle structures in the Komatiite and is shown at right. The bounding structures do not conclusively intersect. The wedge should be monitored as part of the regular inspections.

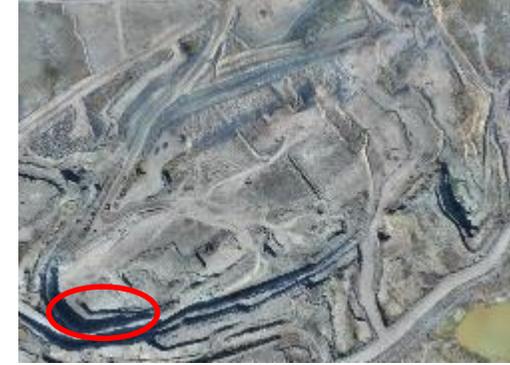
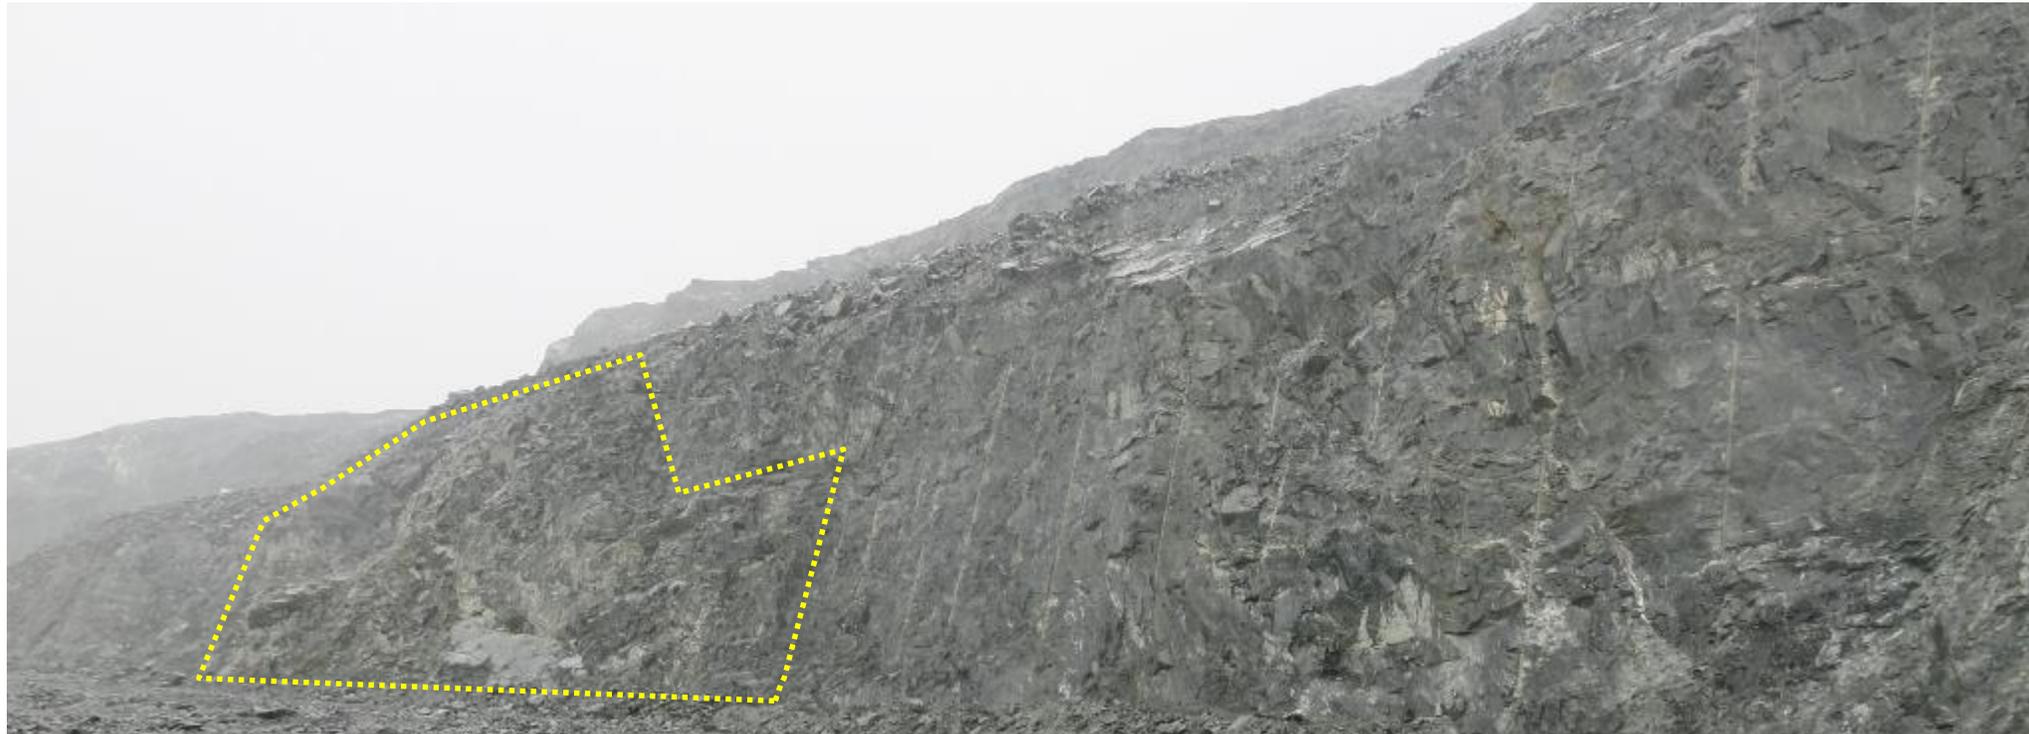
## Southwest Wall

4. **Southwest Wall Rockfall Hazard** – In general, scaling of the bench faces appears to be well done and it is clear that AEM focusses on this aspect of slope management. However, loose material from the construction of the ramp was observed along the crest of the southwest wall. The material represents a rockfall hazard and should be removed.

- Interim wall in the Greywacke in Design Sector I1. The benches are performing well, with half-barrels typically visible.
- The wall has under-broken significantly in some areas (example outlined below) and the blasting practices are being reviewed. As discussed later, it is recommended that the blasting practices vary between lithologies / design sectors to accommodate the wide range of rock mass characteristics.
- Loose material and oversize from construction of the ramp is present along the crest of the most recent bench and should be removed.

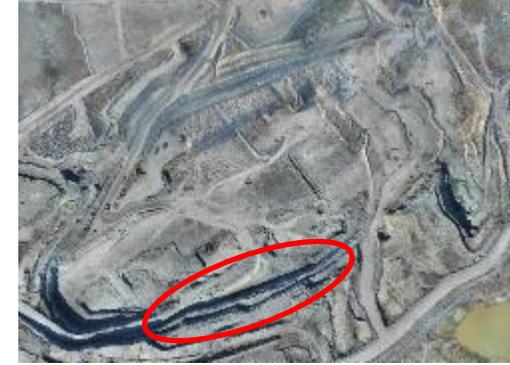
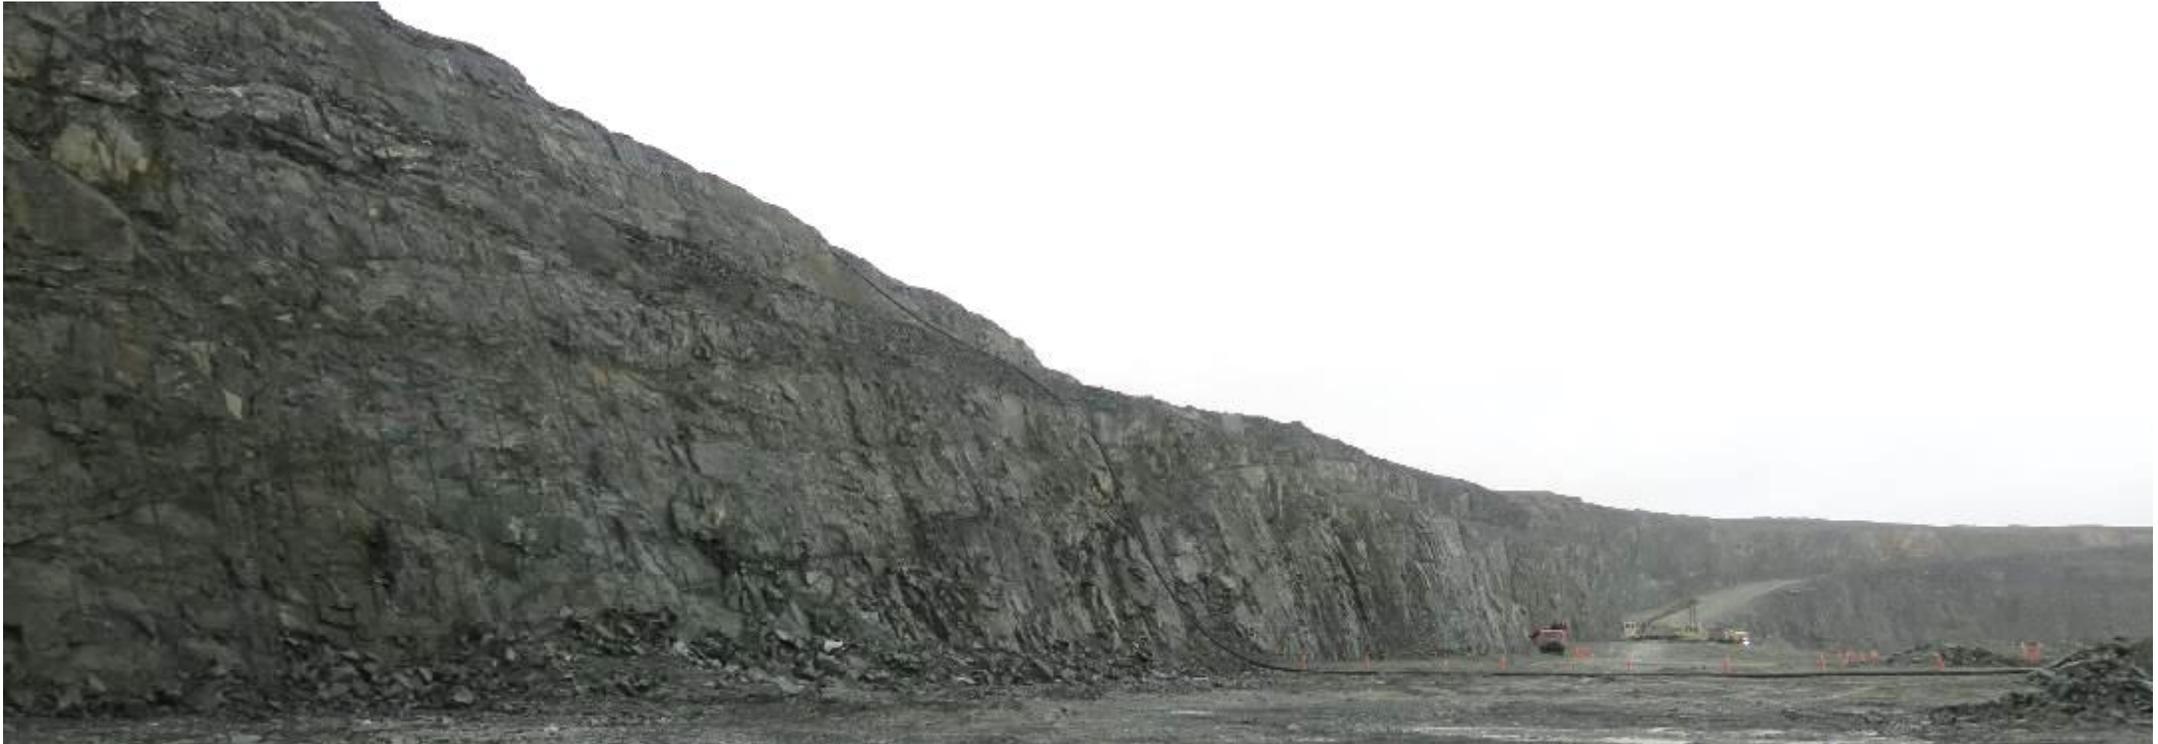
## South Wall

- Interim Wall in the Greywacke and Diorite in Design Sector I1.
- The benches are performing well, with half-barrels visible. It is understood that hard toes are a recurring problem along this wall.
- The wall consists of several benches ranging in height from 7 to 21 m, above which there is a 7 m bench of till and fractured bedrock, offset by a 30 to 80 m temporary step-out. The till has slumped along most of the length of the wall but has been contained by the step-out.

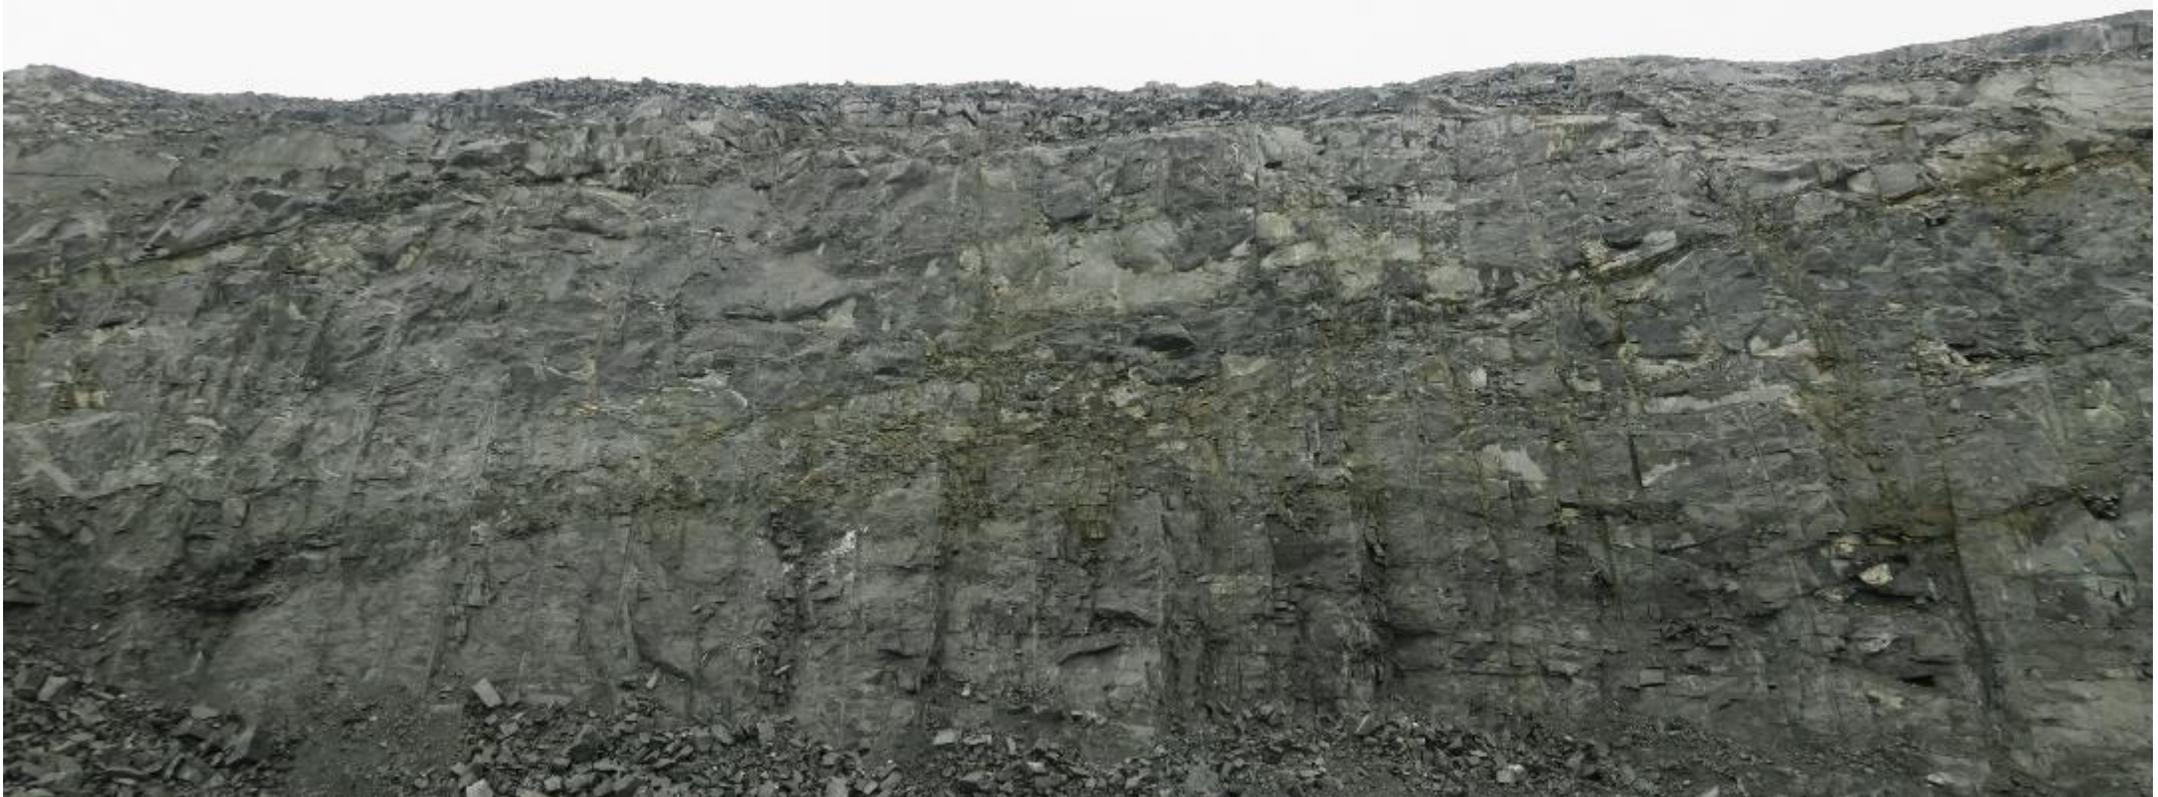
## South Wall – Faults/Shears

- Several discrete low angle faults or shears were observed towards the eastern end of the south wall. The shears are centimeters to a few decimeters thick and have not meaningfully affected the bench performance. The shears are not included in the structural model.
- It was not possible to measure the orientation of these structures but they appear to be similar to the expected orientation of the Ramp Fault.

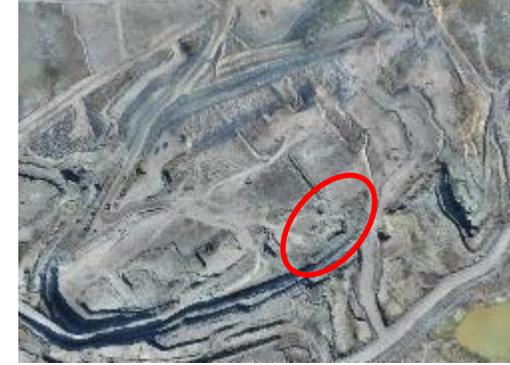
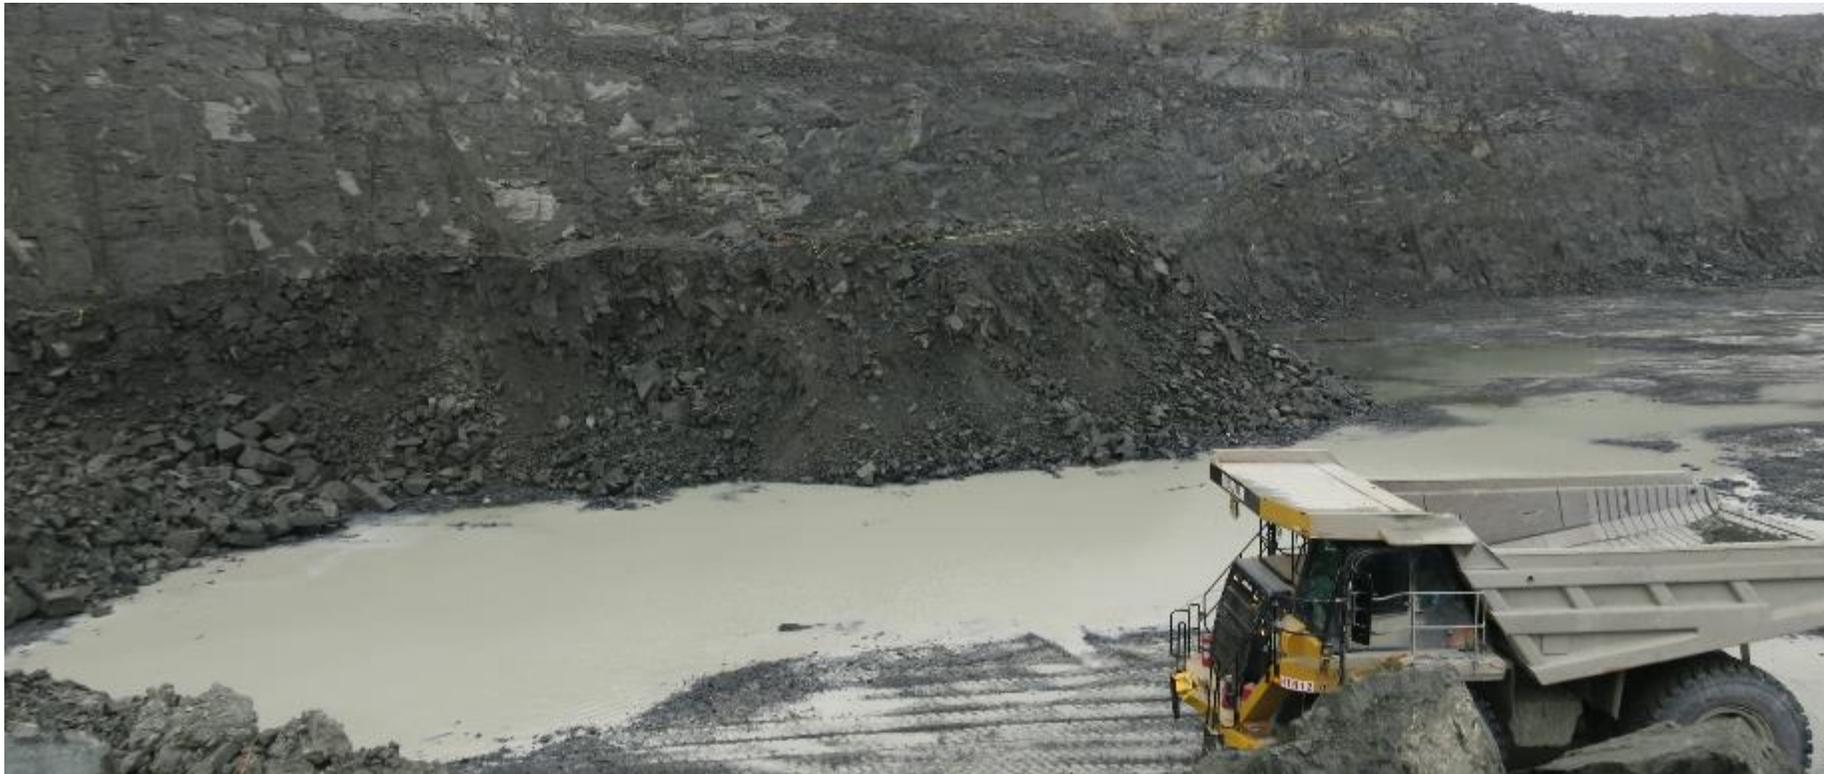
## Lower Southeast Wall

- The area was being mucked during the inspection and access was limited. No specific geotechnical issues were identified.
- Significant groundwater was observed in this area and is discussed further later in this presentation.
