### **Whale Tail Open Pit - 2020 Annual Inspection**

## **RE: Amaruq Mine - Whale Tail Open Pit - 2019 Annual Inspection**

# Amaruq Project – Whale Tail Open Pit

## 2020 Annual Inspection

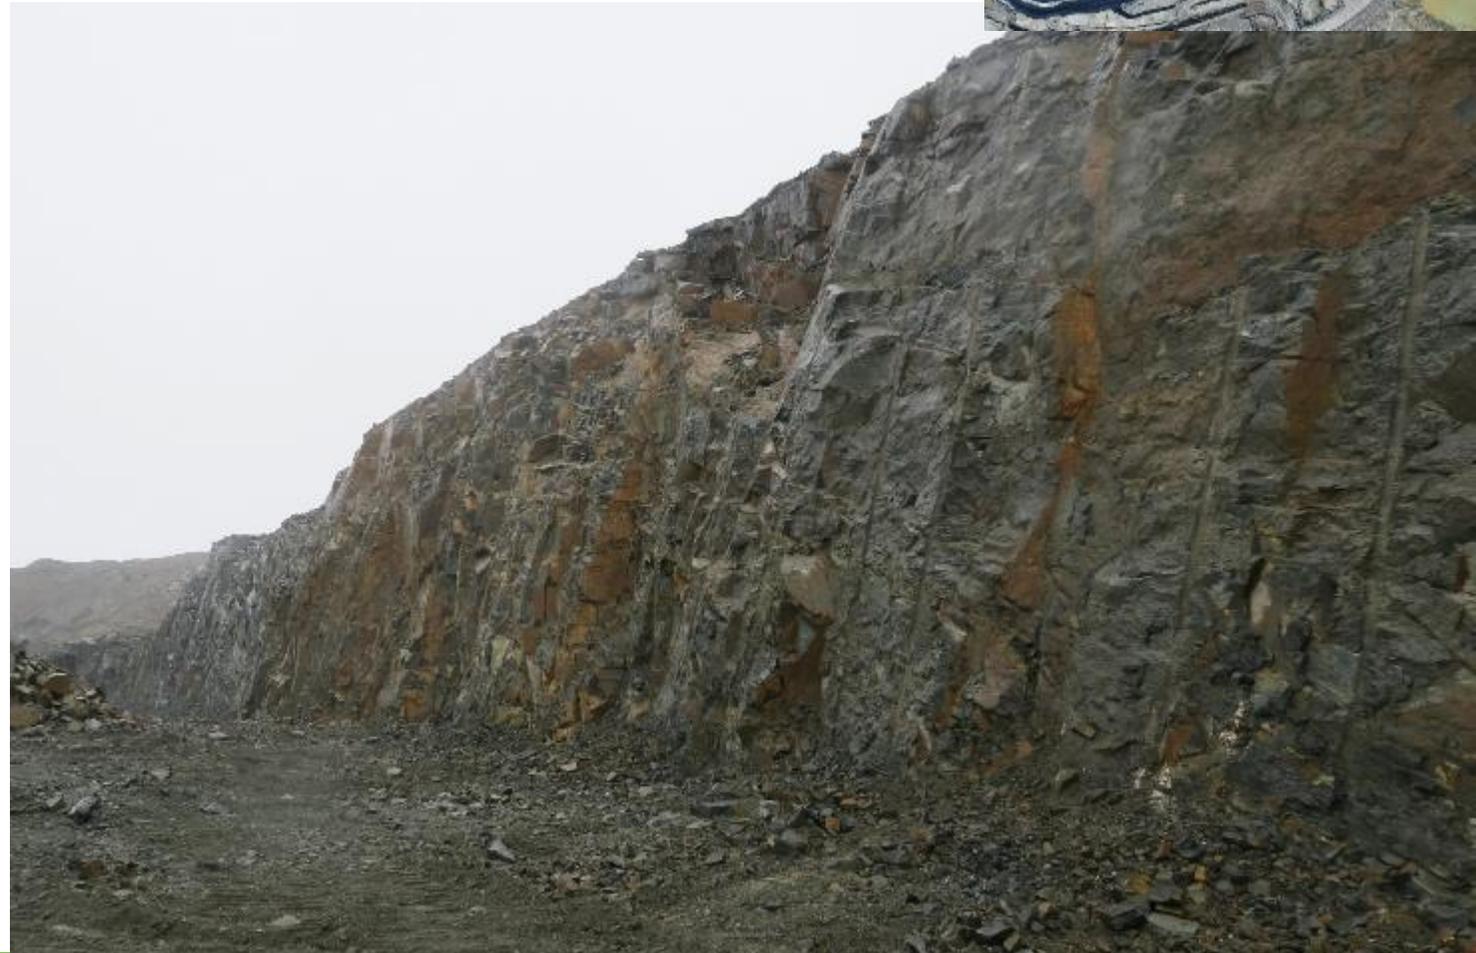
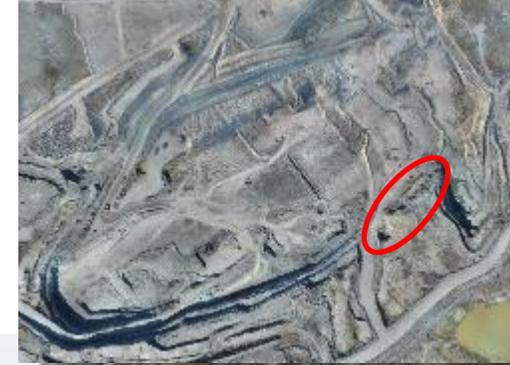
## Upper Southeast Wall

- Interim wall in the Diorite and Greywacke in Design Sector E4 / F6.
- The bench is performing reasonably well, with half barrels visible in some areas and variable back-break at the crest.
- Increased back-break was observed in areas where the rock mass becomes blockier and the joint spacing tighter. Experience elsewhere in the pit and underground suggests the Greywacke is blockier along the contact with the Diorite.
- The performance of this bench suggests that relatively intensive scaling will be required for new benches in this sector of the pit.
- Note that this bench is the first 7 m bench so is also influenced by surface effects.

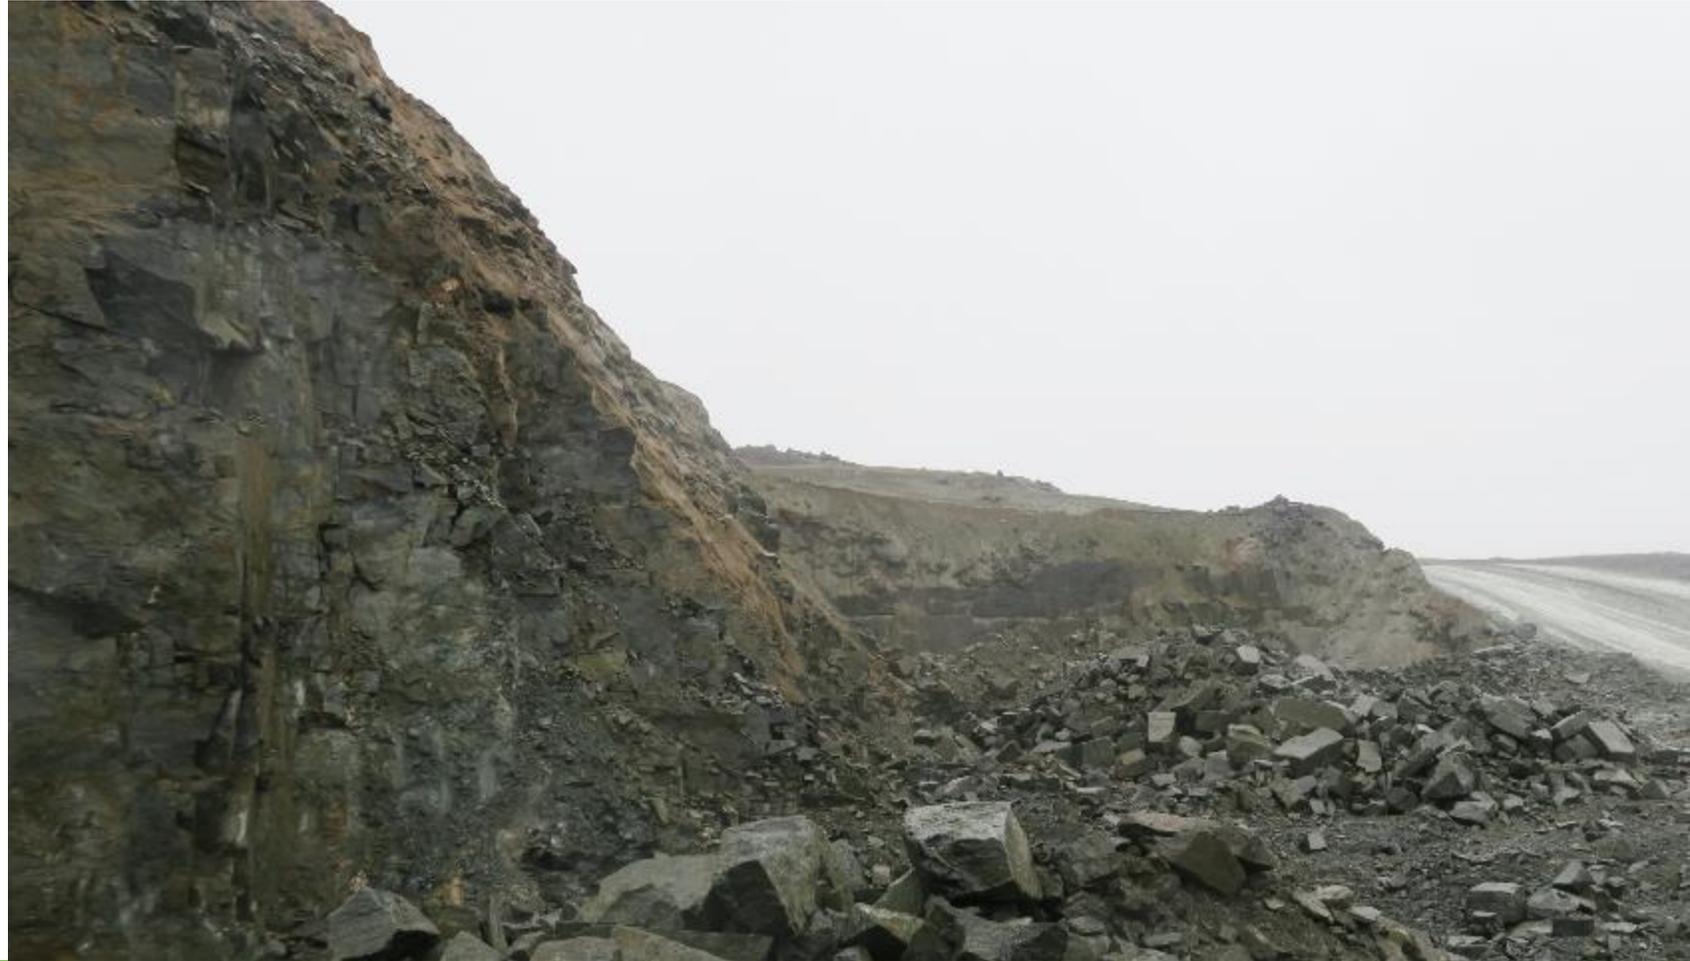
## Upper Southeast Wall

1. **Southeast Wall Overburden** – Lakebed sediments are present at the crest of a portion of the upper southeast wall, near the ramp. The overburden represents a hazard for any activities directly below this bench, especially in the summer months when the active layer thaws. Access below the affected portion of the bench is currently prevented by a berm and it is understood that the wall is planned to be pushed back within the next year. The Nunavut Mine Health and Safety Act (2011) requires a minimum offset of 2 m between the toe of the overburden and the crest of the bench. Access below the bench should

- A sump was established adjacent the ramp in the southeast wall.
- Lakebed sediments are present at the crest of the slope in this area and need to be excavated back either 2 m from the crest and thermal capped or excavated back the full 10 m from the crest.
- The muck was noted to be very blocky, close to being orthogonally jointed.

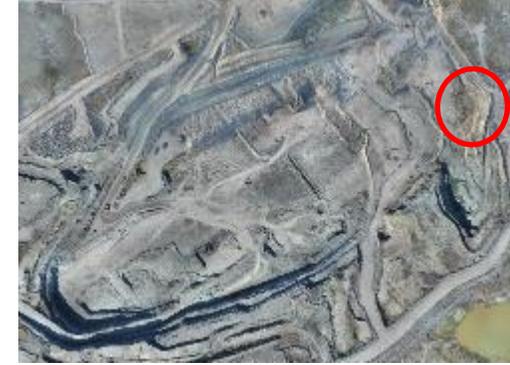
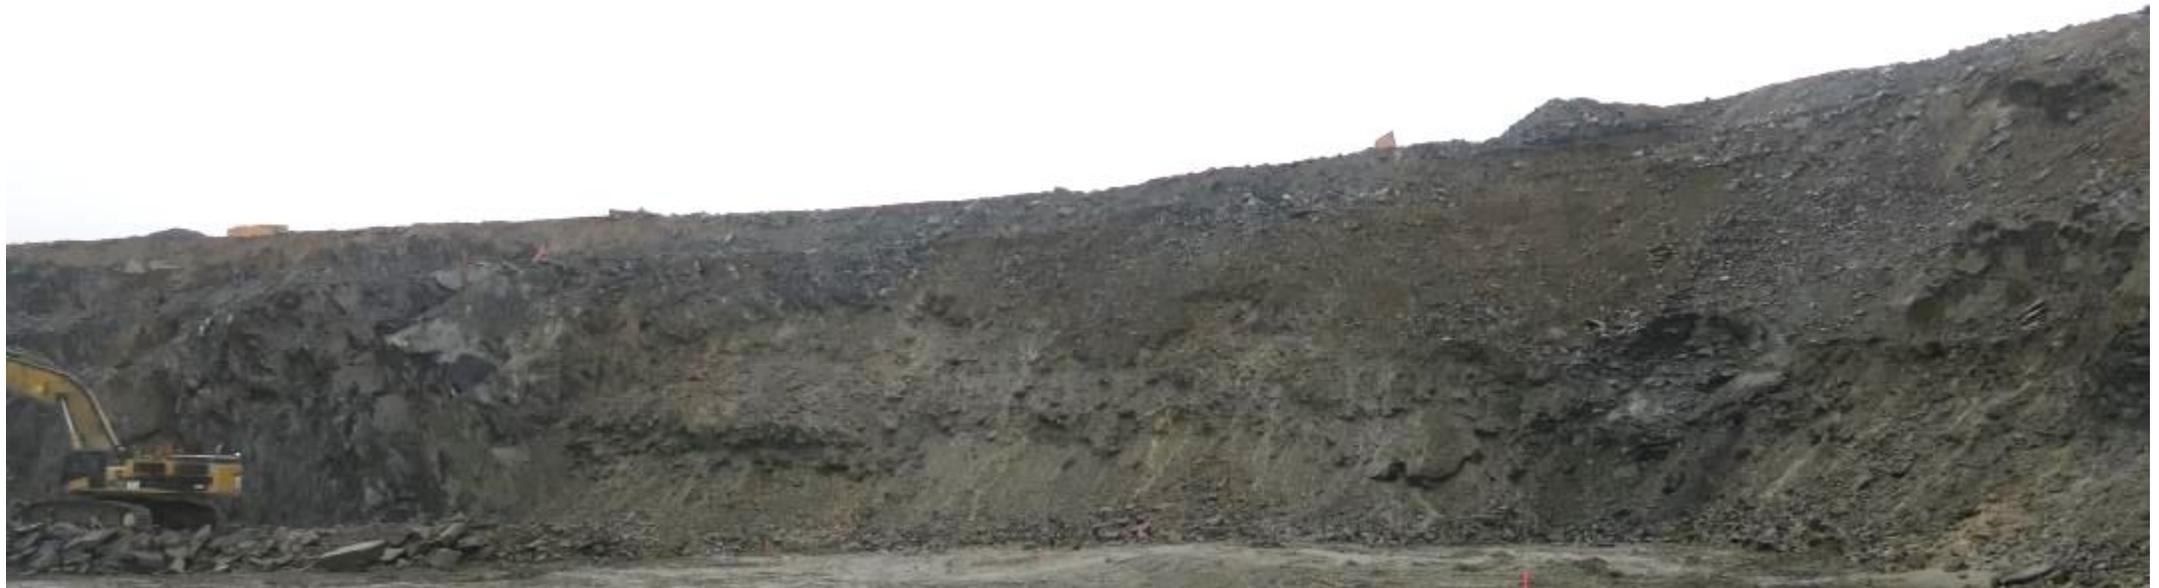
## East Wall

- Final wall, primarily within the Greywacke, in Design Sector E4.
- This wall formed part of Quarry 1. Early in the mine life, waste was end dumped into this portion of Quarry 1 and subsequently froze. Frozen muck now covers the bench face and is progressively ravelling as it thaws.
- It is understood that the mine intends to scrape back the muck as far as practical and then build a buttress and thermal cap over the remaining muck.
- The area should be bermed off until the muck has been buttressed/capped or excavated. This was done during the site visit.

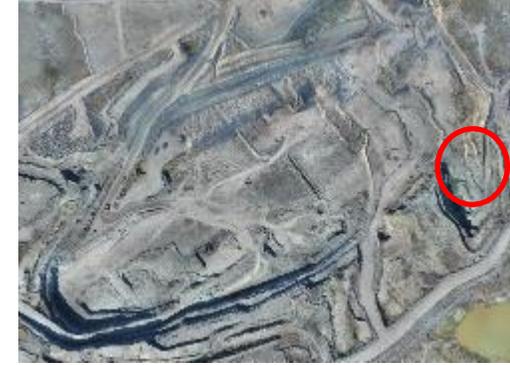
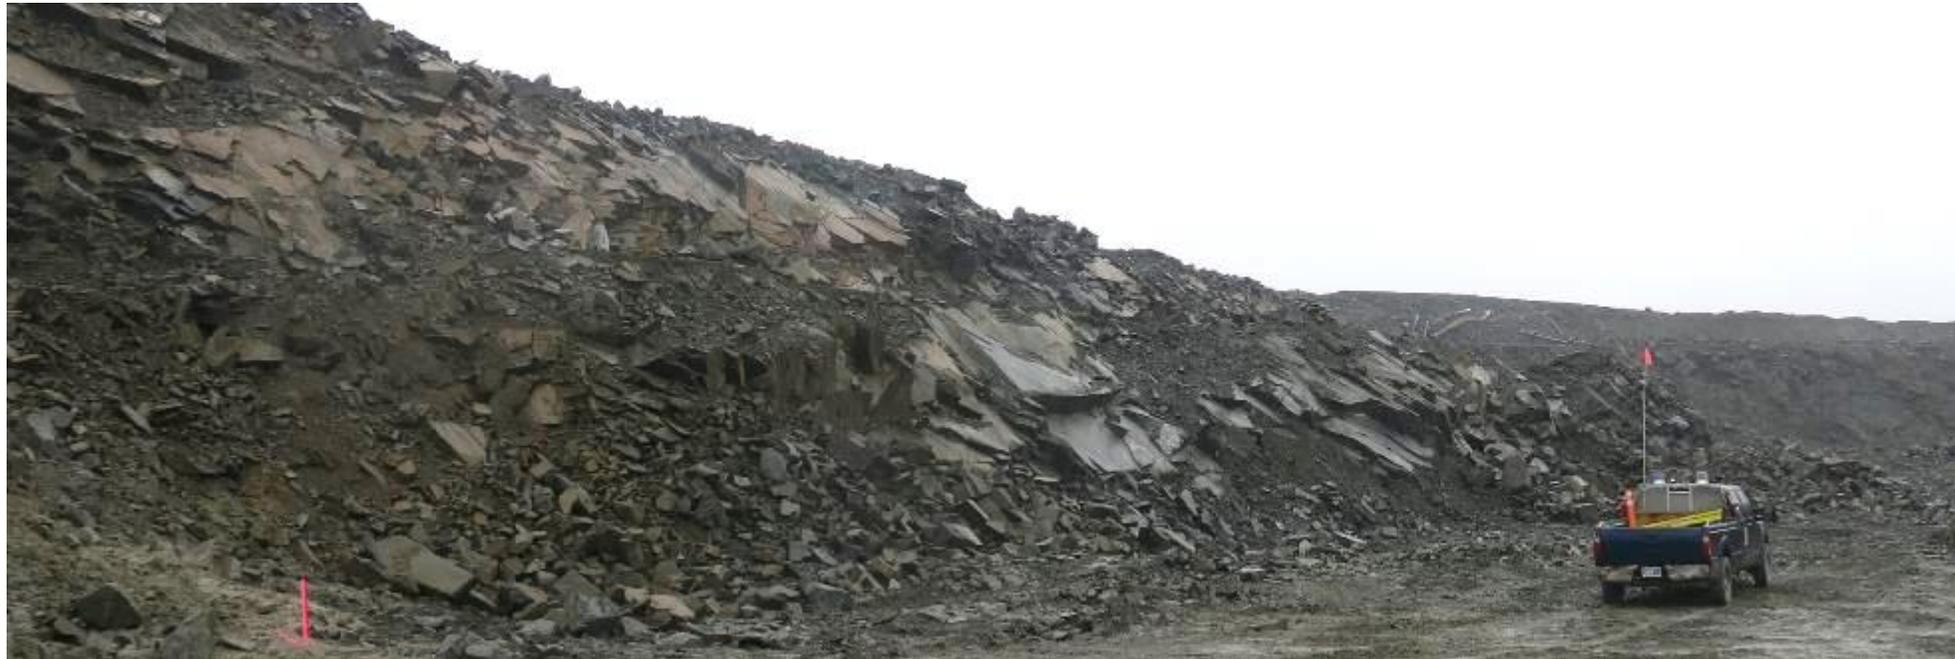
## East Wall

3. **Access below East Wall** – The southern portion of the east wall was one of the earliest walls excavated as part of Quarry 1. The benches were established without pre-shear blasting and the bench performance was controlled by planar failures in the Diorite. There is a significant amount of loose rock on the wall and limited catch bench width, both of which contribute to a rockfall hazard. It is understood that regular access to this area is not required until the Phase 3 expansion and that the wall will be re-established with pre-shear blasting at that time. Measures should be implemented to restrict access to the Quarry 1 area (e.g. the construction of a berm) until the wall is re-established or the rockfall hazard mitigated.

- Interim wall in the Diorite in Design Sector F6.
- Wall was originally developed as part of Quarry 1 without pre-shear and the achievable bench geometry has been controlled by planar failure. There is a large amount of failed material on the slope. Access to the area should be restricted.
- This wall will be re-established with pre-shear for the final pit wall. The recommended bench geometry for this sector accounts for the expected planar failures.

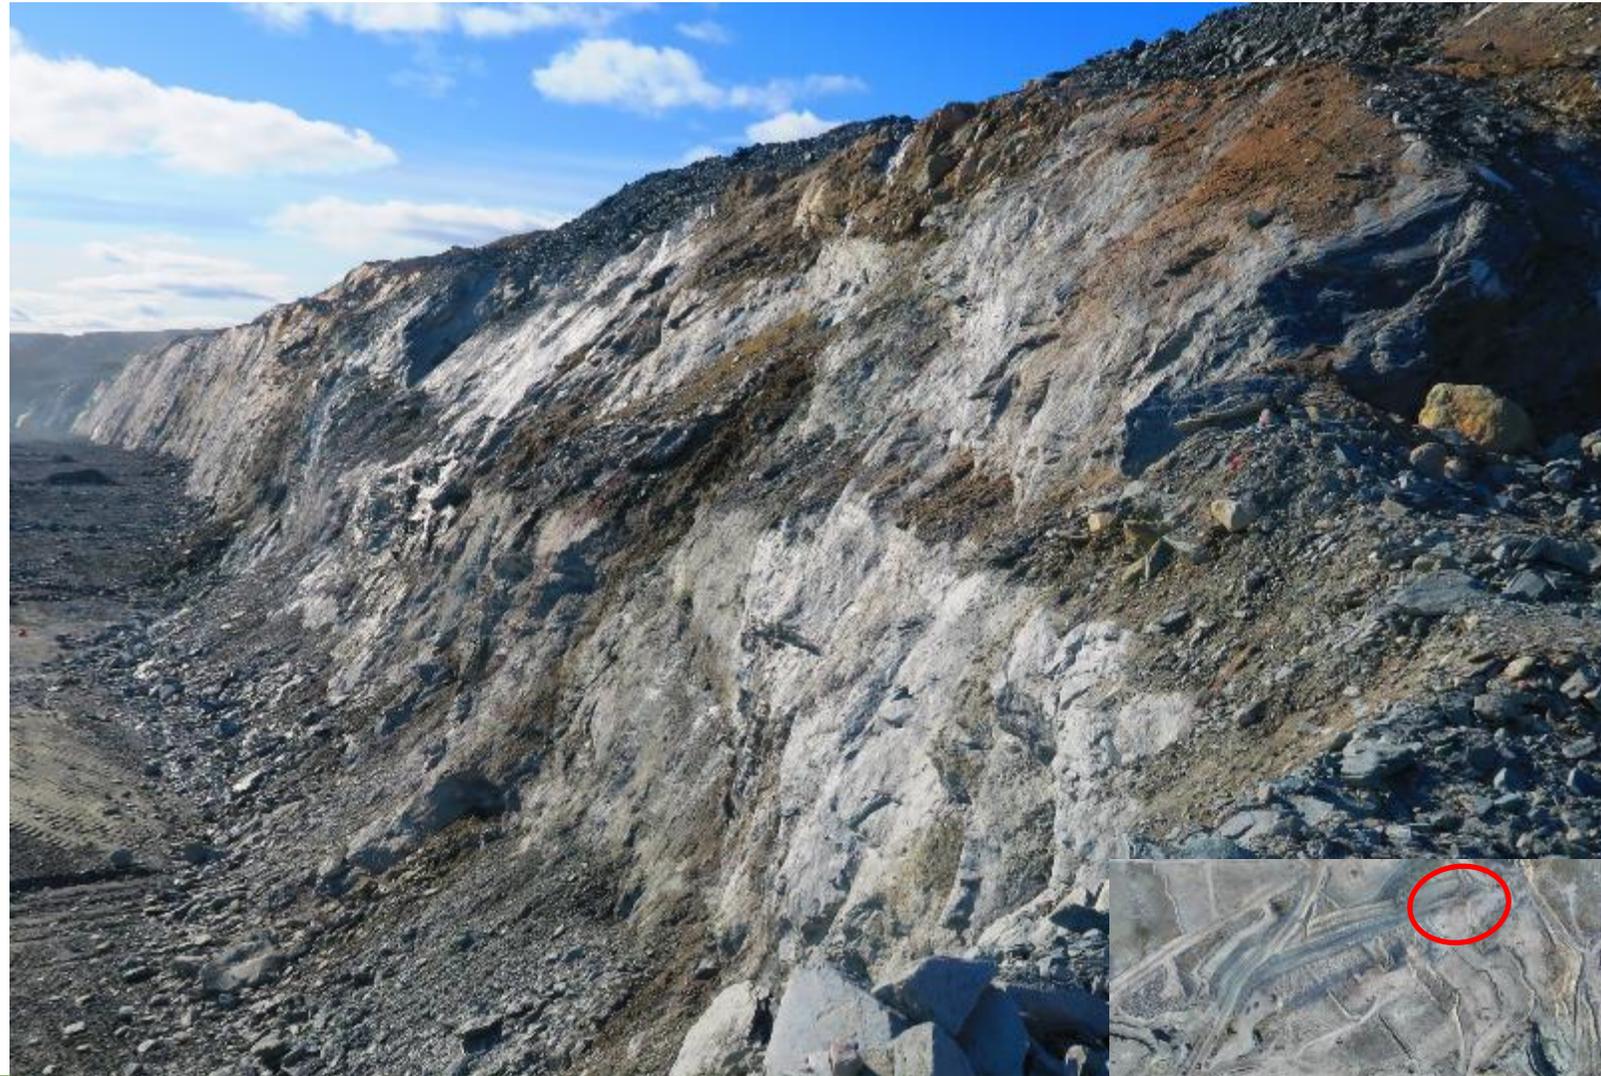
## Northeast Wall

- Final wall in the Komatiite in Design Sector D4, 14 m in height.
- The upper 7 m bench has broken back to the foliation, while the lower 7 m bench has held at the design bench face angle of  $75^\circ$  (steeper than the foliation). The reason for this is not currently known. Possible causes include variation in scaling practices, blasting practices, discontinuity strength, etc.
- The dip of the foliation is estimated to be approximately  $45$  to  $50^\circ$  (to be confirmed). The foliation was expected to have an average dip of between  $55$  and  $60^\circ$  in this sector.

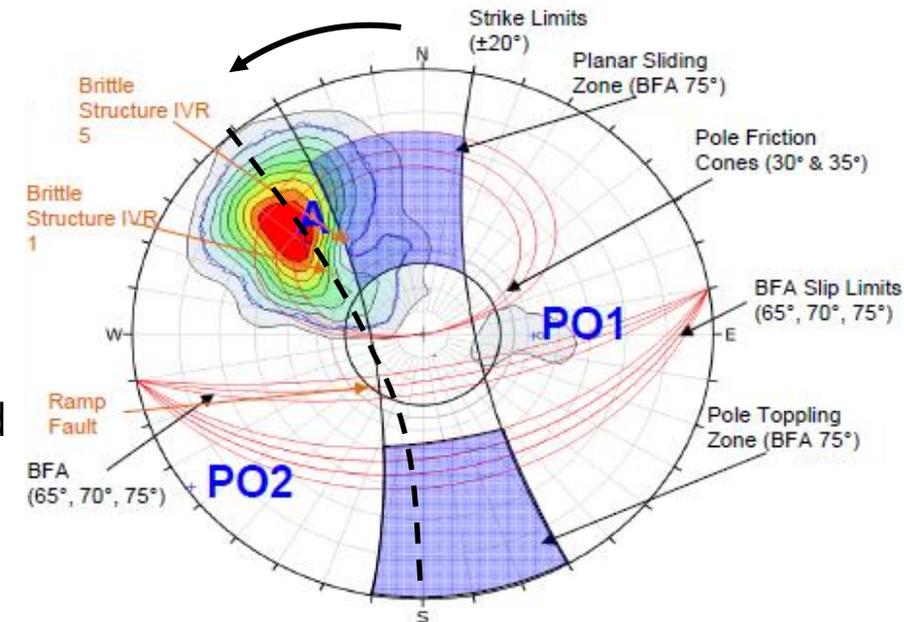
- The recommended bench geometry is based on the expectation that the bench face is not parallel to the foliation. The recommendations were developed using the 10F pit design (analysis shown at right). In the current 11C pit design, sector D4 strikes 10° closer to the strike of the foliation, increasing the potential for planar failure (represented by dashed line overlain on figure at right).

- If the benches frequently fail back to the foliation in this sector, the recommended bench geometry will need to be revised (BFA reduced or bench width increased).

- The bench has not yet been scanned with the Maptek (system is being calibrated). It is important that this bench be scanned so that the foliation orientation and bench back-break can be confirmed.

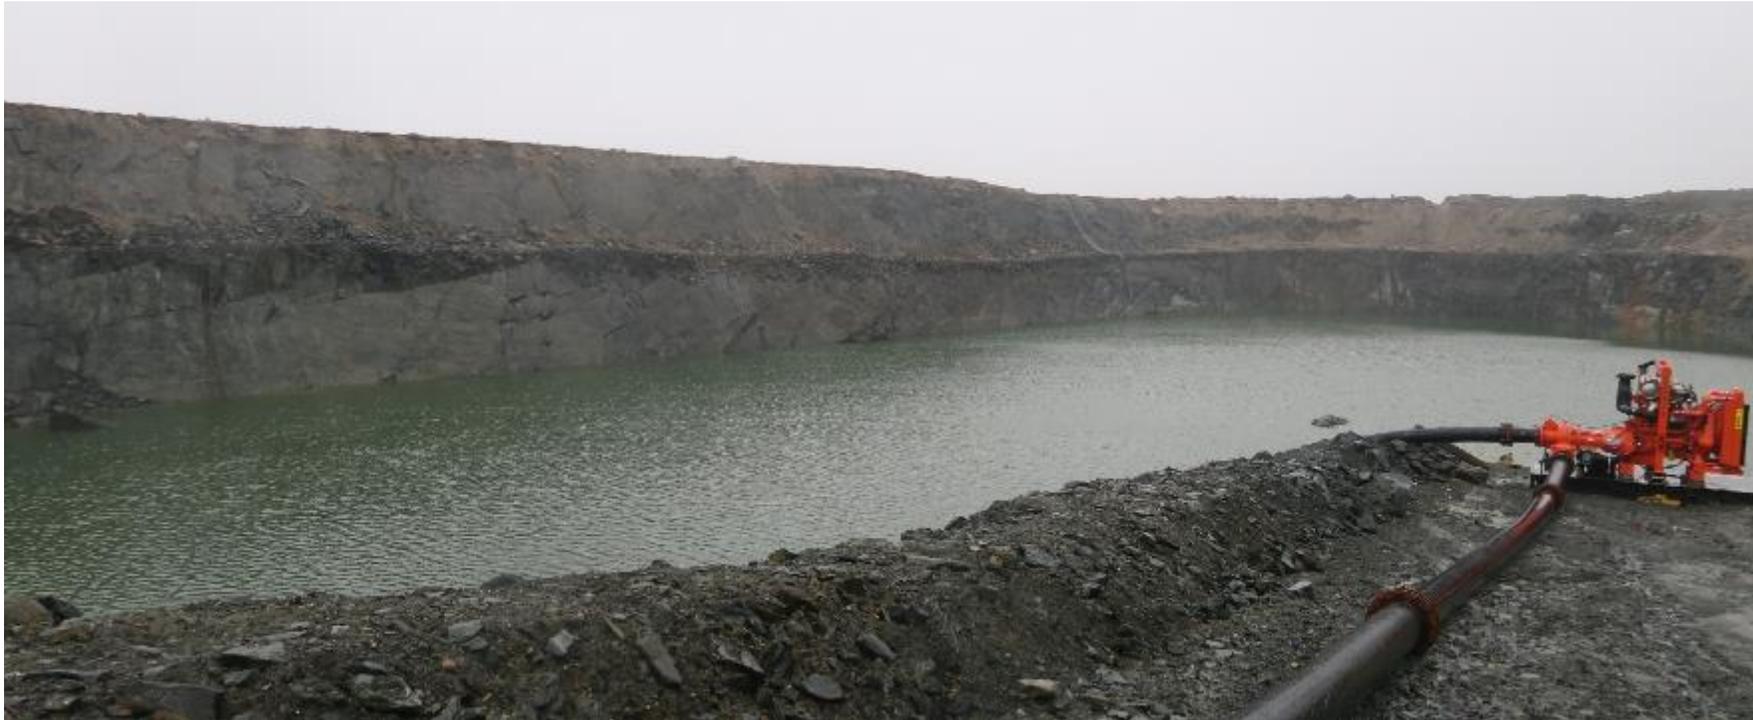
## AP5

- Attenuation Pond 5 is located to the east of the Whale Tail Open Pit.
- The pond is largely flooded and a detailed inspection could not be completed.
- No stability concerns were identified in the exposed slopes. A protection berm is in place adjacent the access ramp to the pumping system.

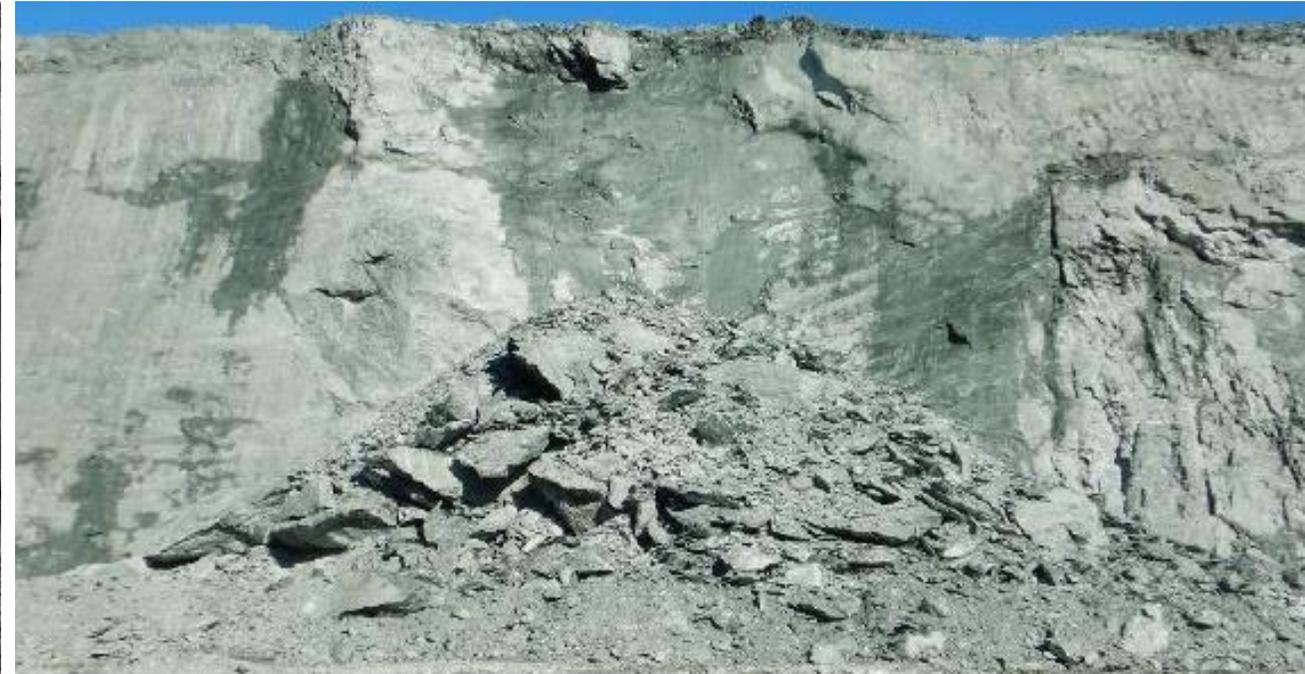
June 23, 942 tonnes

In one instance, a brittle structure in the Komatiite may have contributed to an initial failure on June 23 that undercut the bench face. The face then failed back to the foliation six days later.

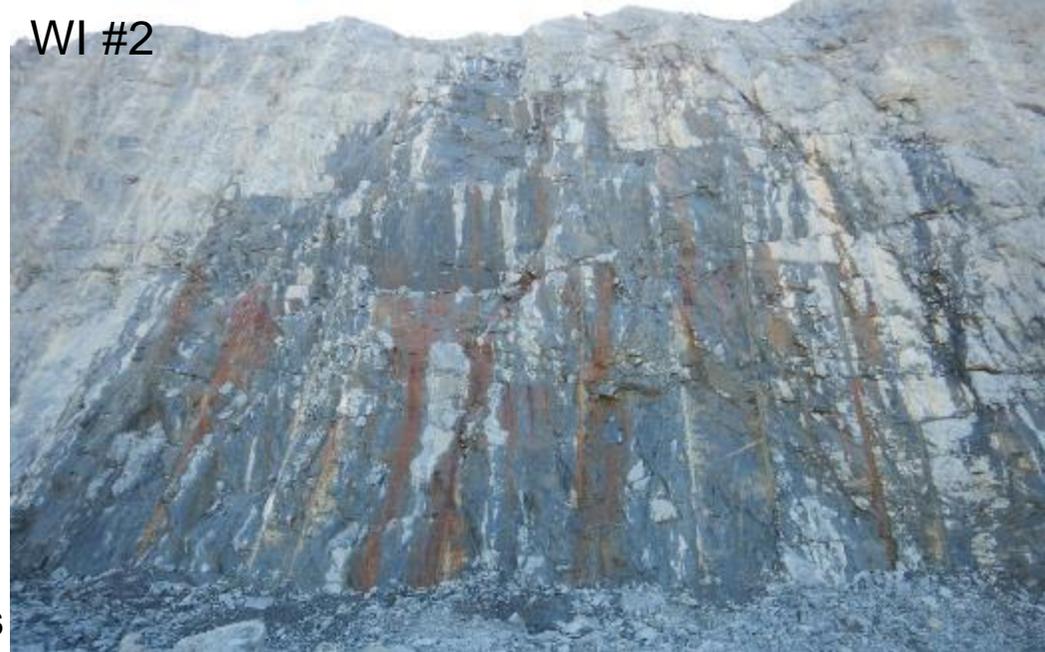
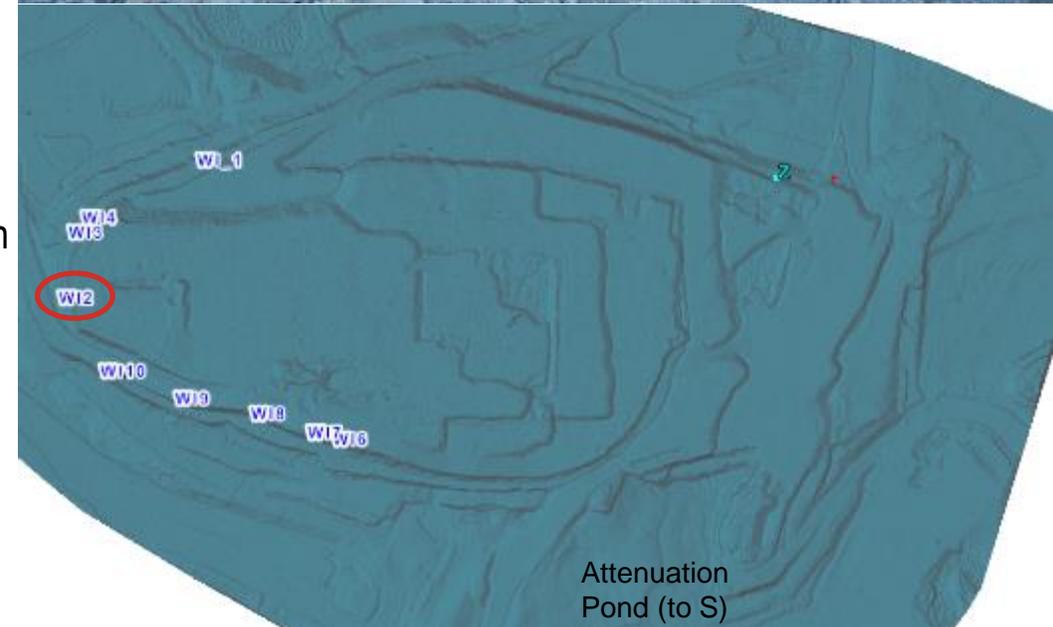
- The flow at Water Inflow #2 is expected to form an ice wall over the winter. The seep is located above the planned ramp for the Phase 1 pit and the risk of an ice fall will need to be managed.

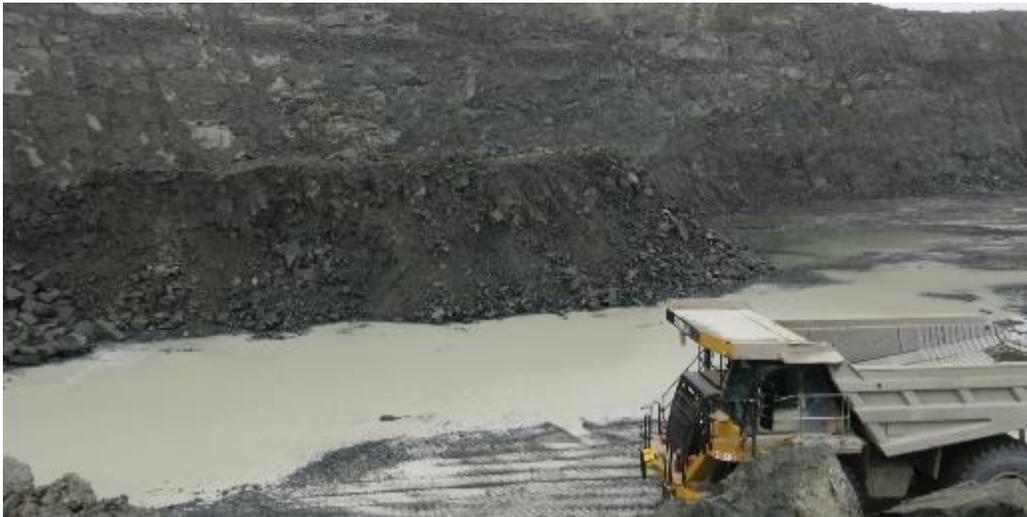
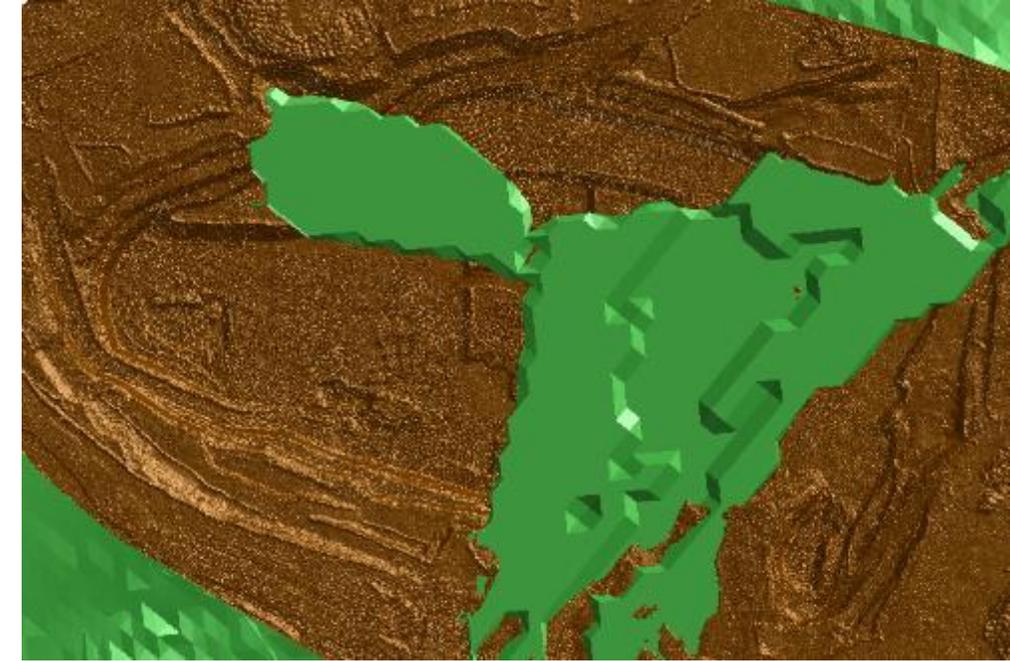
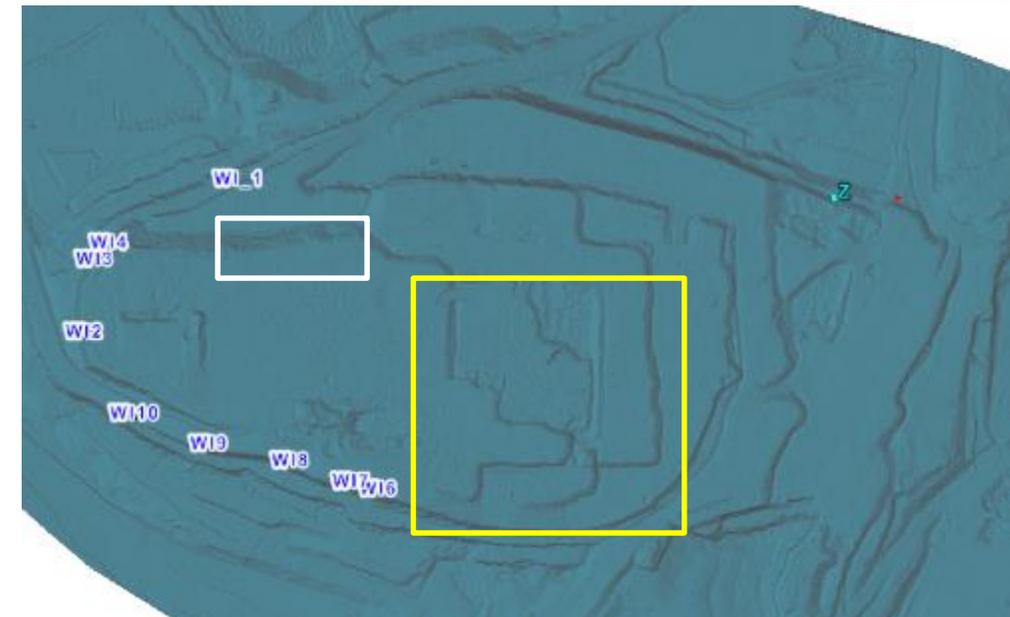
- While seeps have not been observed to date in the south/southeast walls, a significant accumulation of groundwater has been noted in the floor of the pit and the drillers report water when drilling in the area approximately outlined in yellow.
- During the visit, a driller also reported water filling his holes and then freezing in the area outlined in white.
- The areas where groundwater is accumulating in drillholes or on the pit floor agree well with the extents of the talik/cryopeg predicted by the thermal model (Cryopeg predicted by Scenario 2 shown at upper right in green). The source of the water is discussed on the next slide.
