### **Meadowbank 2021 Annual Open Pit Geomechanical Inspection**

**RE: Meadowbank Complex - Meadowbank Site - 2021 Annual Open Pit Geomechanical Inspection**

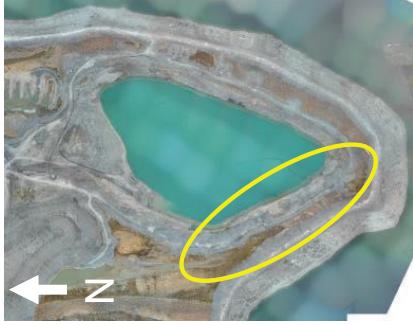
- A portion of a single bench is exposed above the current pit lake.
- The wall is performing well.
- No particular geomechanical concerns were noted.

South Wall, Looking Southwest

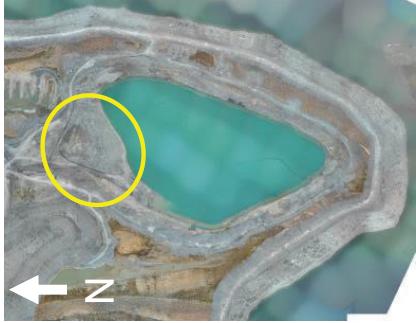
- The dump has been subsiding since 2015. The settlement is attributed to the deposition of water in the open pit, through a combination of thawing snow/ice lenses within the dump, thawing frozen contacts between rock blocks, and increasing porewater pressure. An example of one of the scarps formed by the settlement is shown at lower right.
- The settlement is monitored visually as part of monthly inspections by the Geotechnical team.
- The dump is inactive and access is prevented by both a rockfill berm and the presence of water pipes across the access point.
- Recommend continuing the monthly visual monitoring as long as access is still required to the open pit. There is an opportunity to use the drone imagery already collected by the mine to do a photogrammetry assessment of the subsidence on an annual basis.

Looking North at the Dump, with Settlement and Scarps Visible

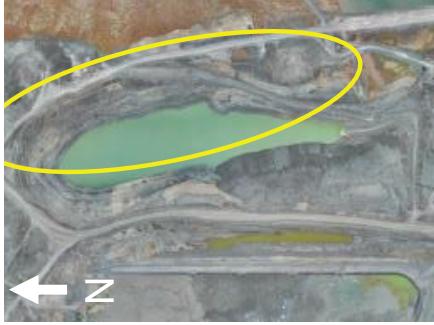
- Approximately three benches are exposed above the pit lake in this area.
- Access to the East Ramp was limited by pylons and partial berm was present halfway down the ramp and at the base of the ramp at the time of the inspection. It is understood that the ramp is no longer used. Recommend constructing a berm at the top of the ramp to prevent access.
- The wall is performing well.
- No particular geomechanical concerns were noted.

Composite of Pit A East Wall, Looking East

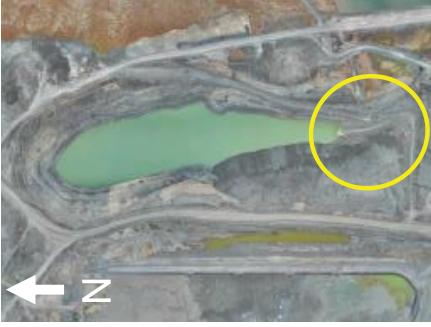
- The south ramp is used to access the pit lake and water management infrastructure is present along the ramp.
- A rockfall berm is present along both sides of the ramp. The berm is in good condition and has capacity to retain any future rockfall.
- The PTO / Pump controls are located well up the ramp, away from the areas of greatest rockfall hazard associated with the dump and the highwall. The controls are also well away from the pit lake, mitigating the risk associated with a wave caused by a failure of the open pit slope or the dump. This is a good practice.
- Specific geotechnical considerations relating to Dump B are discussed on the next slide. Bulging of the toe of the dump slope was not observed.
- No particular geomechanical concerns were noted.

South Ramp, Looking North with PTO/Pump Controls at Left

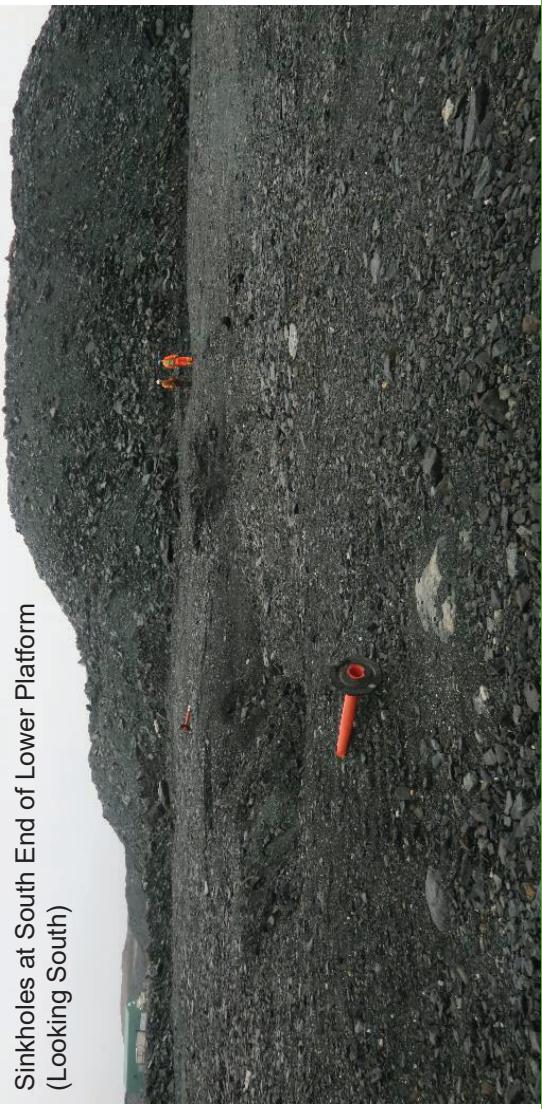
Sinkholes at South End of Lower Platform  
(Looking South)

2. The infiltration of surface water is likely contributing to the settlement observed at the B Dump. Grade the upper and lower platforms of the B Dump and fill the sinkholes/depressions in order to prevent water ponding and to limit further infiltration.

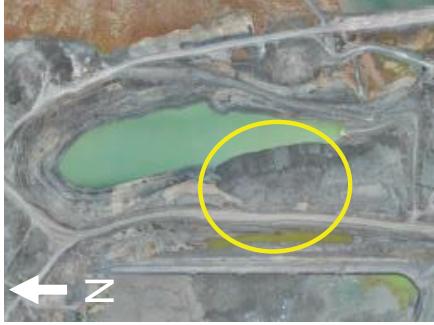
Settlement and Tension Cracks at North End of Lower Platform  
(Looking South)

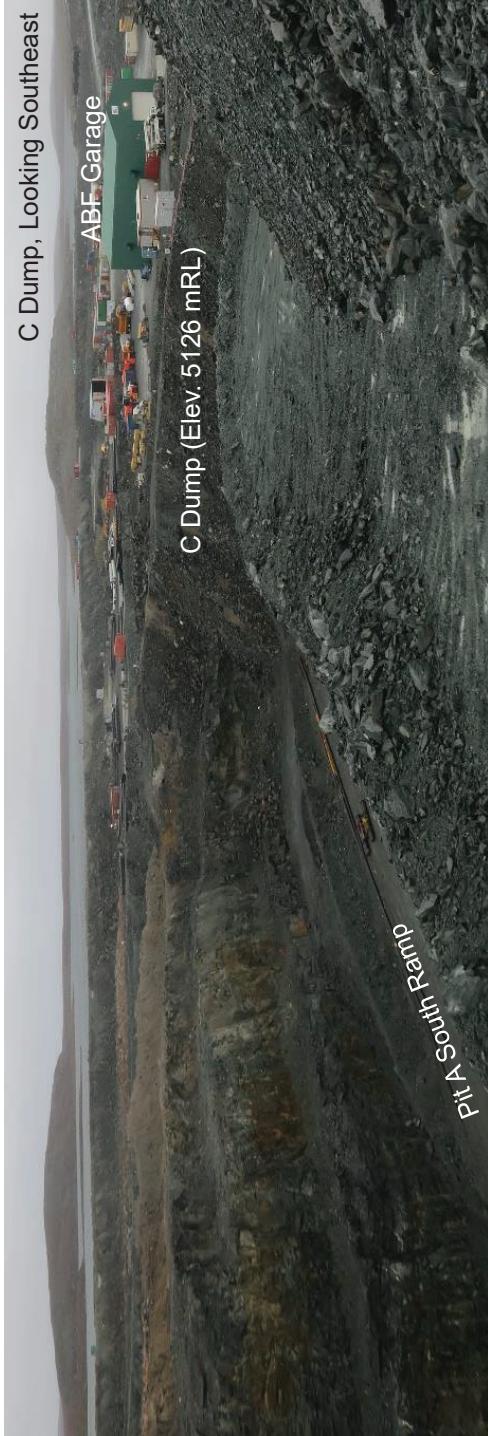
- Note that the 2020 inspection report identified a water/tailings elevation of 85 masl as a possible threshold for migration of water below the C Dump. The water elevation in Pit A at the time of the 2021 inspection was just under 81 masl. No evidence of instability was observed at the time of the 2021 inspection.

C Dump, Looking Southeast

5. The ABF Garage has been constructed on top of the C Dump. Settlement of the dump, and potential structural damage to the garage, is likely once the water level in Pit A and Pit E reaches the base of the dump and the potential for thaw of the waste rock increases. The garage and its associated infrastructure should be relocated away from the waste rock dumps and the tailings management areas. Once the garage has been relocated, construct berms to prevent access to the C Dump platform.

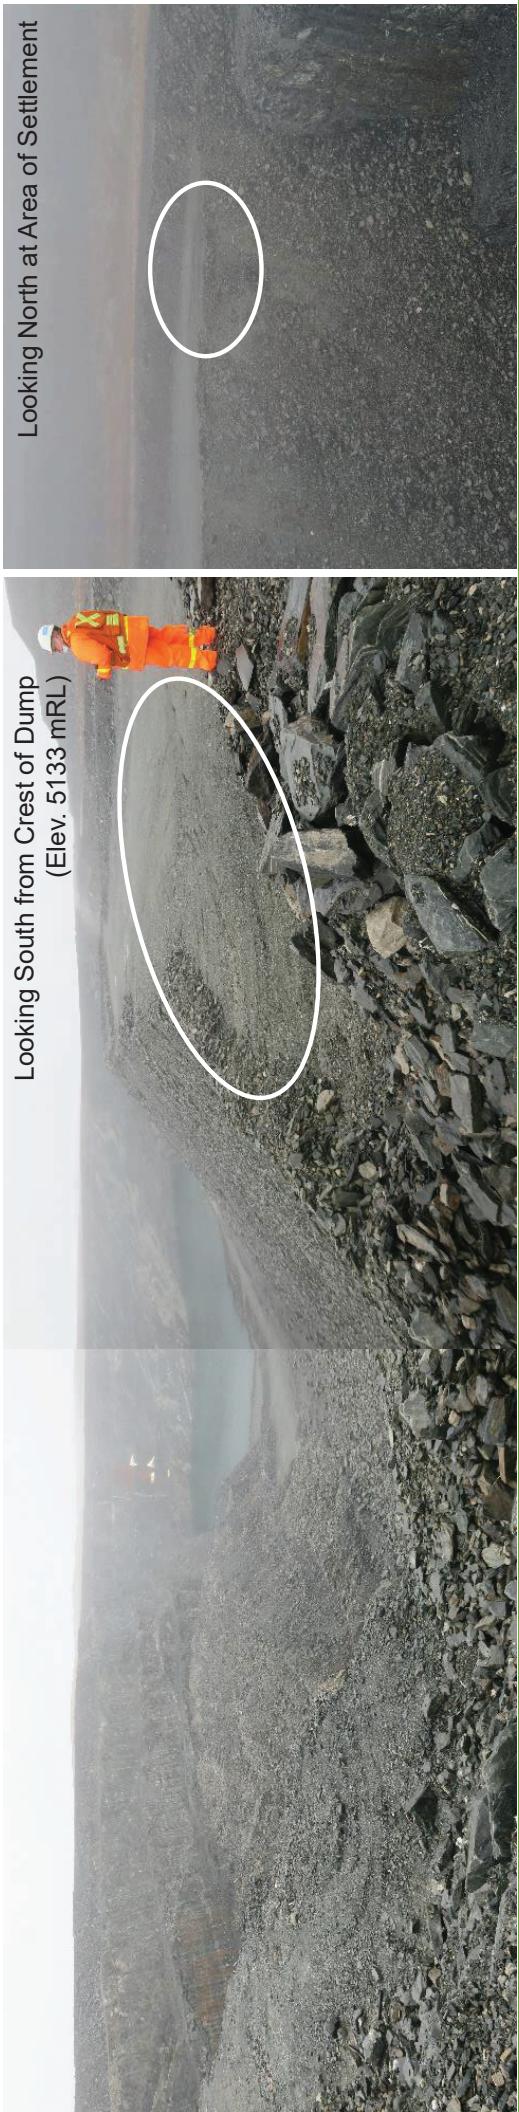
- A waste rock dump was constructed at the north end of the Vault Pit. The dump is inactive and consists of two platforms with elevations at approximately 5133 mRL and 5082 mRL.
- Settlement and tension cracks were observed at the crest of the upper platform at the north end of dump during the 2019 inspection. There appears to have been little change since that time. The affected area is relatively small and is not above the ramp. Consider including this area in the monthly visual inspections.
- No other evidence of instability was observed during the inspection.
- Access to the dump was not restricted at the time of the inspection. Recommend installing a berm to prevent access as the dump is inactive.

Looking North at Area of Settlement  
Looking South from Crest of Dump  
(Elev. 5133 mRL)

3. Include the Vault Pit North Waste Rock Dump in the monthly visual inspections, focussing on the area of settlement.
4. The Phaser and BB Phaser Pits are inactive, and flooding of the open pits has reduced the exposed rock slopes to a single bench or less. As a result, the geomechanical hazards associated with these open pits are limited. Recommend approaching the Nunavut Worker's Safety and Compensation Commission (WSCC) about ending the third-party annual inspections for these open pits.

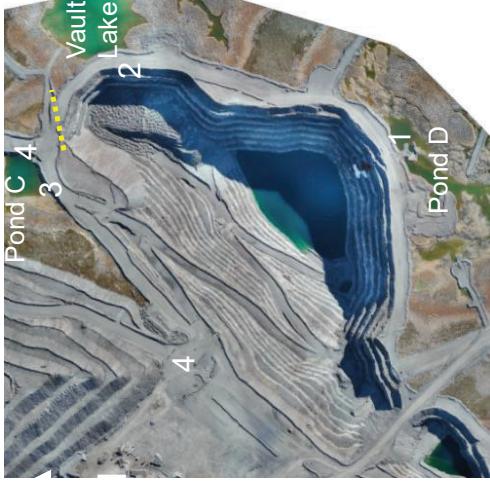
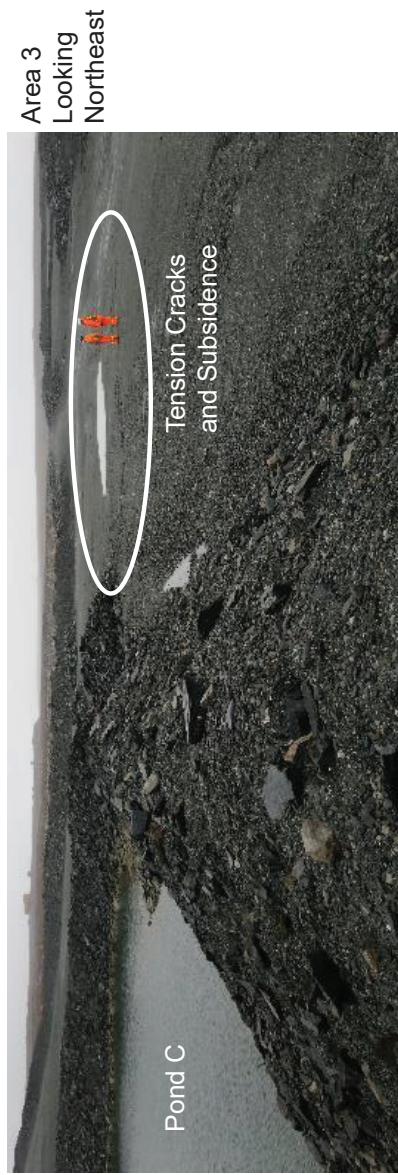
- 3. Subsidence of the road has occurred adjacent Pond C. Only part of the road is affected and the road is still used to access exploration drill sites. Recommend filling the subsidence or clearly marking the area of settlement with cones. Note that seepage from Pond C has likely contributed to the formation of tension cracks and subsidence at the northern end of the North Waste Rock Dump.
  - 4. The ramps to the waste rock dump are only partially blocked by berms. Recommend extending the berm so that access is restricted.
- As a general comment, recommend reviewing access requirements along the Ring Road and constructing berms to restrict access to portions of the road that are no longer needed. Areas that continue to be used should be included in the monthly geotechnical visual inspections.

4. The Vault Pit Ring Road has subsided adjacent Pond C and represents a hazard to vehicle traffic and access is still required. The area should be filled and graded or the area should be clearly marked with pylons.

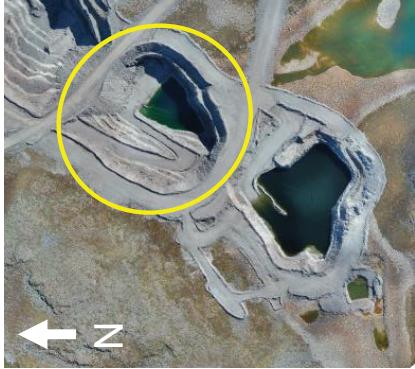
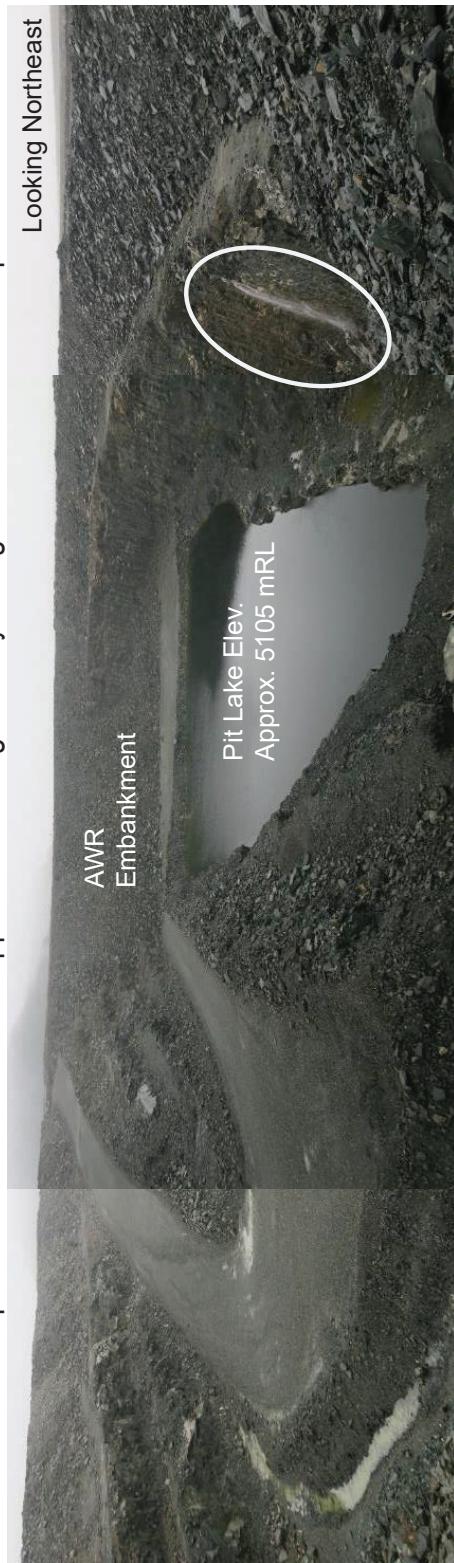
- Water inflow, likely from the BB Phaser pit, was noted at the south end of the pit (circled below). The pit lake elevation is approximately 20 m higher in the BB Phaser pit than in the Phaser pit. The stability of the Amaruq AWR embankment could be adversely impacted if the water level in the Phaser pit increases and water ponds behind the embankment. A visual assessment of the water level in the open pit should be incorporated into the monthly inspections. Note that the pit lake elevation does not appear to have significantly changed since the 2020 inspection.

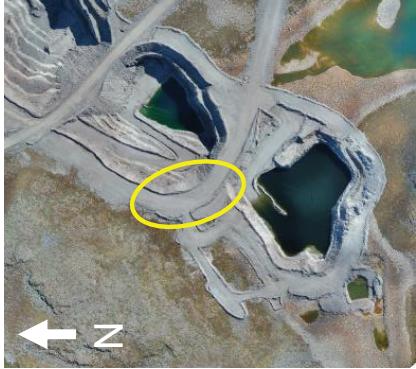
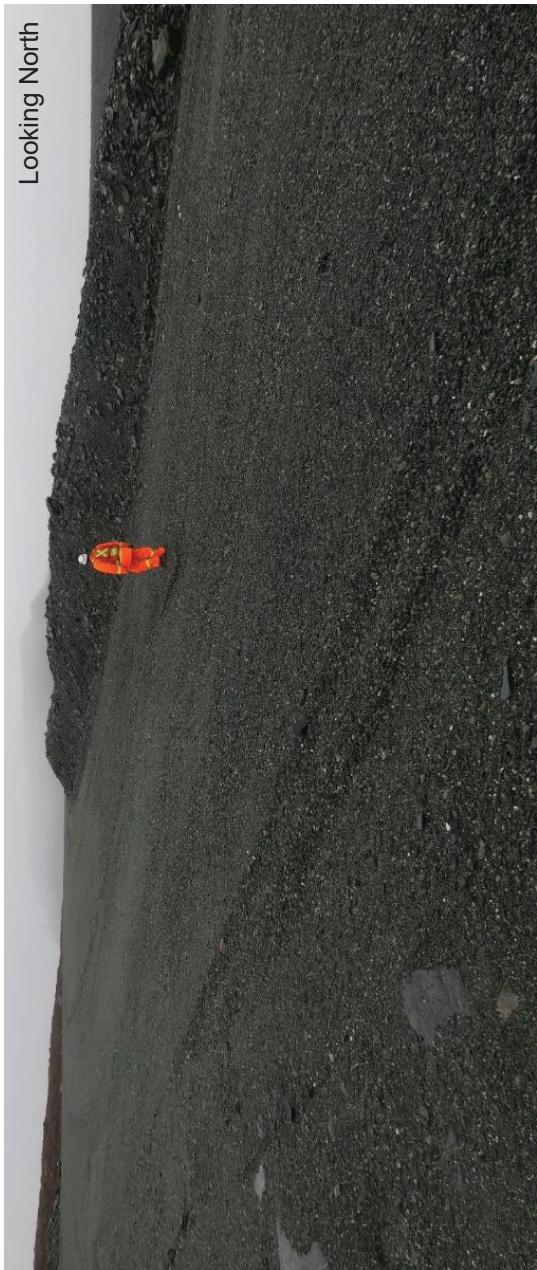
- Subsidence was observed on the ring road between the Phaser and BB Phaser pits.
- Recommend preventing access to the ring road by constructing a berm at the southern entrance to the road. A berm is already in place at the northern entrance. If access is required to the road in the future, a geotechnical inspection should be completed in advance.

The access road separating BB Phaser Pit from Phaser Pit is still accessible. Sinkholes noted in 2019 are absent in 2020.	Deactivate road and berm off to prevent use.	The road remains accessible at its southern entrance. A berm should be constructed to prevent access to the road.	P2
