Whale Tail 2021 Annual Open Pit Geomechanical Inspection

March 24, 2022

RE: Meadowbank Complex - Amaruq Site - 2021 Annual Open Pit Geomechanical Inspection

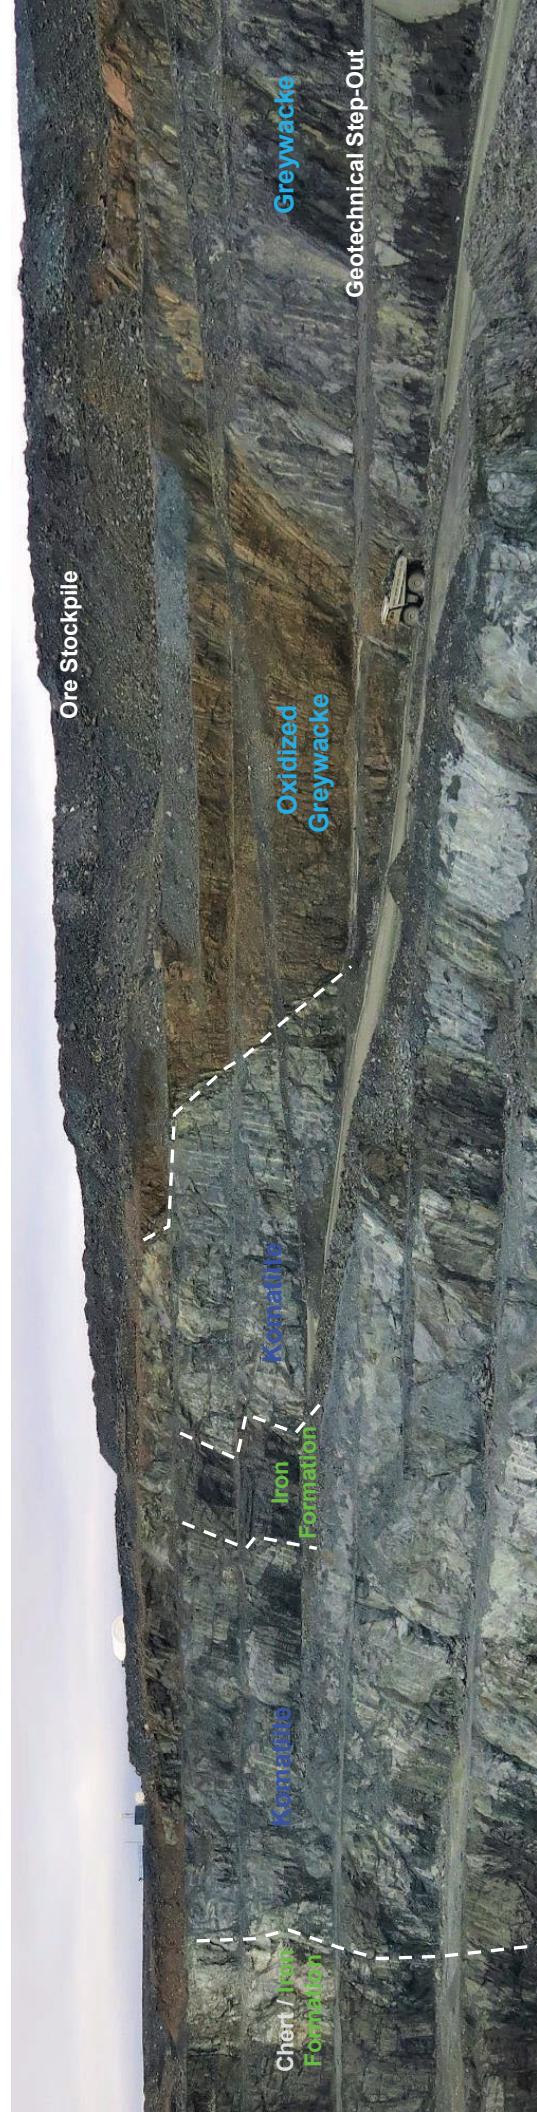
Whale Tail Open Pit Observations - Northwest Wall

- Final wall in Design Sector A1.
- The benches are generally performing well. There have been no further failures in the Komatiite since the last inspection.
- The Oxidized Greywacke is thought to be associated with a talik zone below what was the western end of Whale Tail Lake. It is of lower rock mass quality than the Greywacke and is prone to ravelling. The exposures along the ramp are limited in height and rockfall has not been a concern to date. If ravelling increases, a rockfall berm could be constructed along the inside of the ramp through this unit.
- Seepage was observed along the sheared contact between the Oxidized Greywacke and the Komatiite.

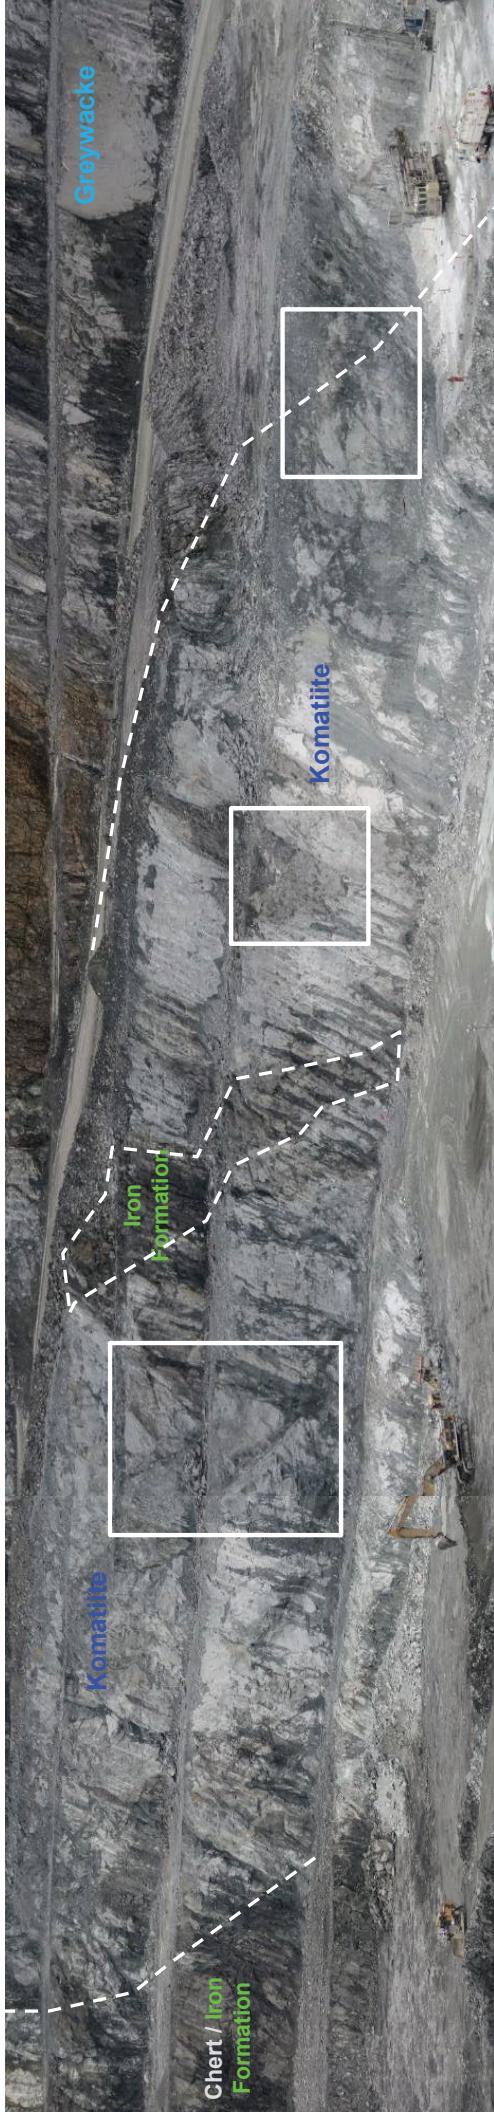
Observations - Phase 1 North Wall

- Interim wall in Phase 1.
- Performance of the revised bench design introduced following the last annual inspection is consistent with expectations. Several bench-scale failures have occurred on benches established using the revised design in this sector, when the foliation locally dips at a shallower angle than the bench face. However, the frequency and size of these failures (< 250 tonnes) has reduced. The failures are outlined in white below.
- AEM continues to complete extensive scaling in this sector in order to remove potential hazards and reduce the likelihood of a failure.
- It is expected that bench-scale failures will still occur in the Komatiite, predominantly during freshet.

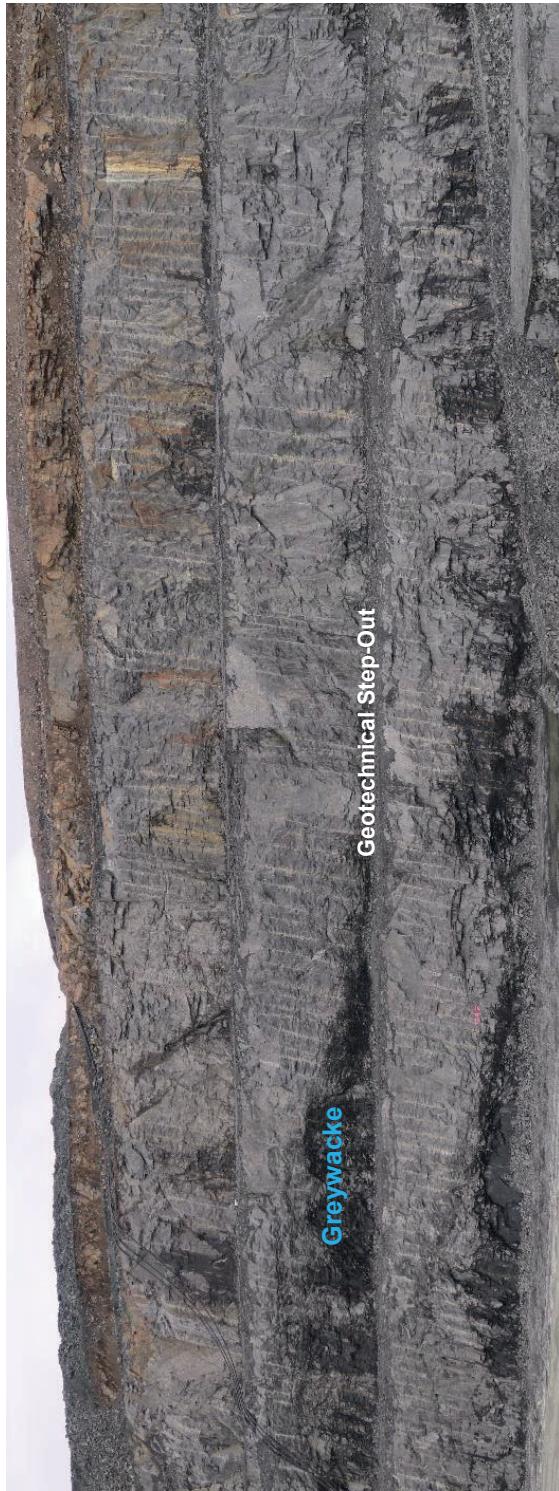
Observations - North Wall

- Final wall in Design Sector B1 / B4.
- The benches are performing better than expected, with the bench face often standing steeper than the foliation.
- However, many of the pre-shear drillholes have been drilled at an angle shallower than the planned 60° , reducing the effective bench width.
- Drill and blast practices have been discussed in detail as part of the on-going design verification review of the WHL open pit. A drilling and blasting study has been undertaken by the mine and a drill and blast quality control program has been recommended.

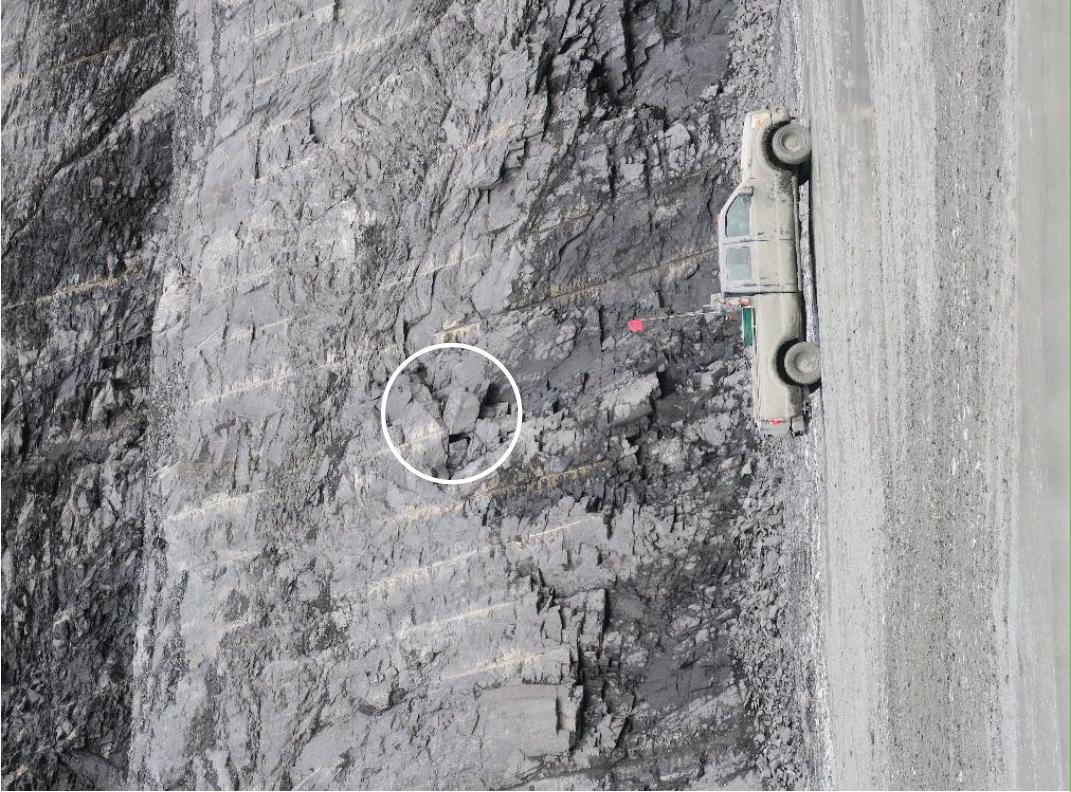
Observations - North Wall (Cont'd)

- The toes of the benches have been locally undercut. This has the potential to result in rockfall or bench-scale instabilities.
- A loose block was observed on the face during the visit (shown at right). The block should be scaled down.
- Drilling, blasting, and/or excavation practices are the likely cause of the undercutting. It is understood that this area has been reviewed with the shovel operators in an effort to avoid similar conditions in the future. The potential contribution of drill and blast should be considered during the drilling and blasting study.

1. **WHL North Wall Rockfall Hazard** - In general, scaling of the bench faces appears to be well done and it is clear that AEM focusses on this aspect of slope management. However, a block was observed on the north wall. The material represents a rockfall hazard and should be removed.

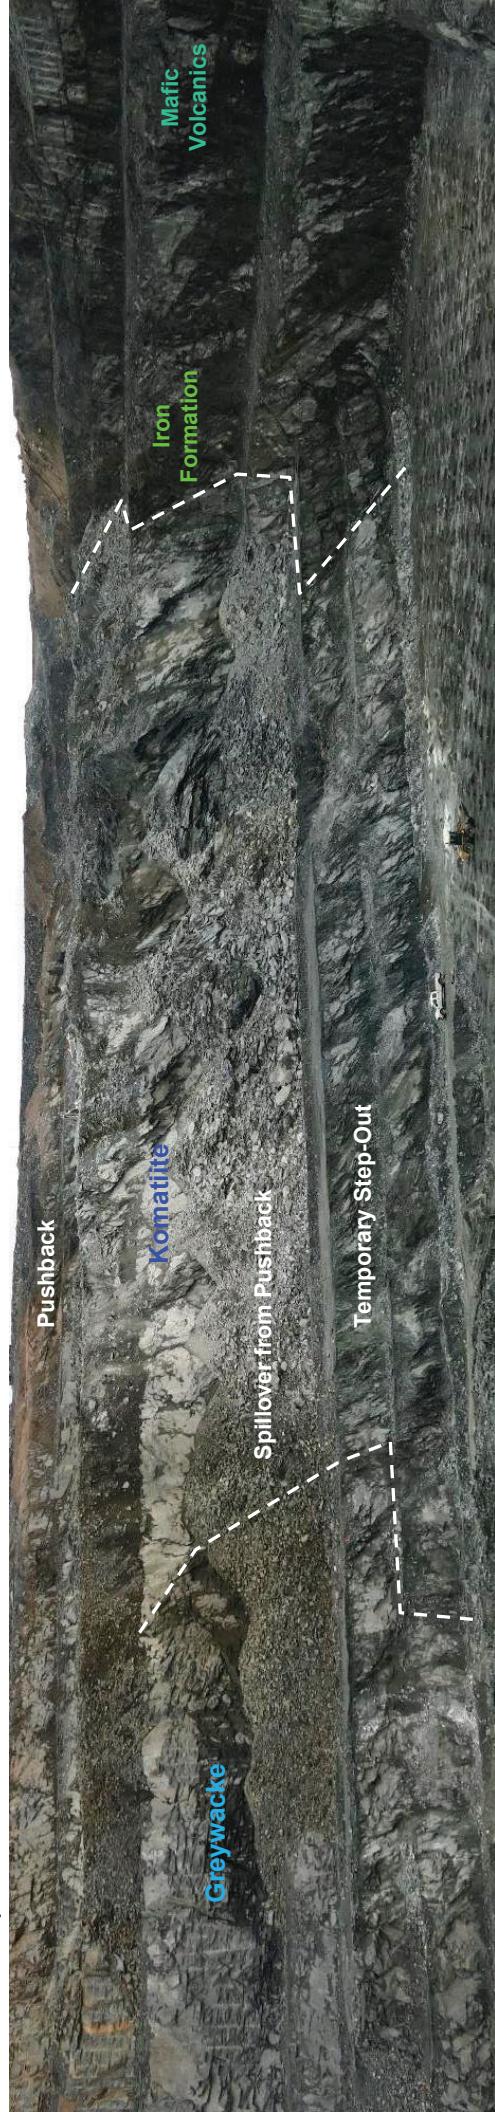
Observations - Northeast Wall

- Final wall in Design Sector D4.
- Four bench-scale failures have occurred along the foliation within the Komatiite in this sector in 2021. The failures have been reviewed in detail as part of the on-going WHL open pit design verification review. The failures are primarily kinematic but contributing factors include a reduction in rock mass quality within the Komatiite, the presence of brittle structures, and the infiltration of surface water due to the presence of talik.
- A rockfall berm was constructed below the failures and a temporary step-out left in order to separate mining activities from the failures.
- A revised design has been developed for this design sector and a pushback has been initiated to re-establish the slope. Further analyses are planned.

7. **WHL Northeast Wall Design Study** - Additional rock mass characterization and stability analyses are planned in order to confirm the revised slope design for this design sector. This study should be completed. On-going structural mapping of the pushback is recommended to support this process.

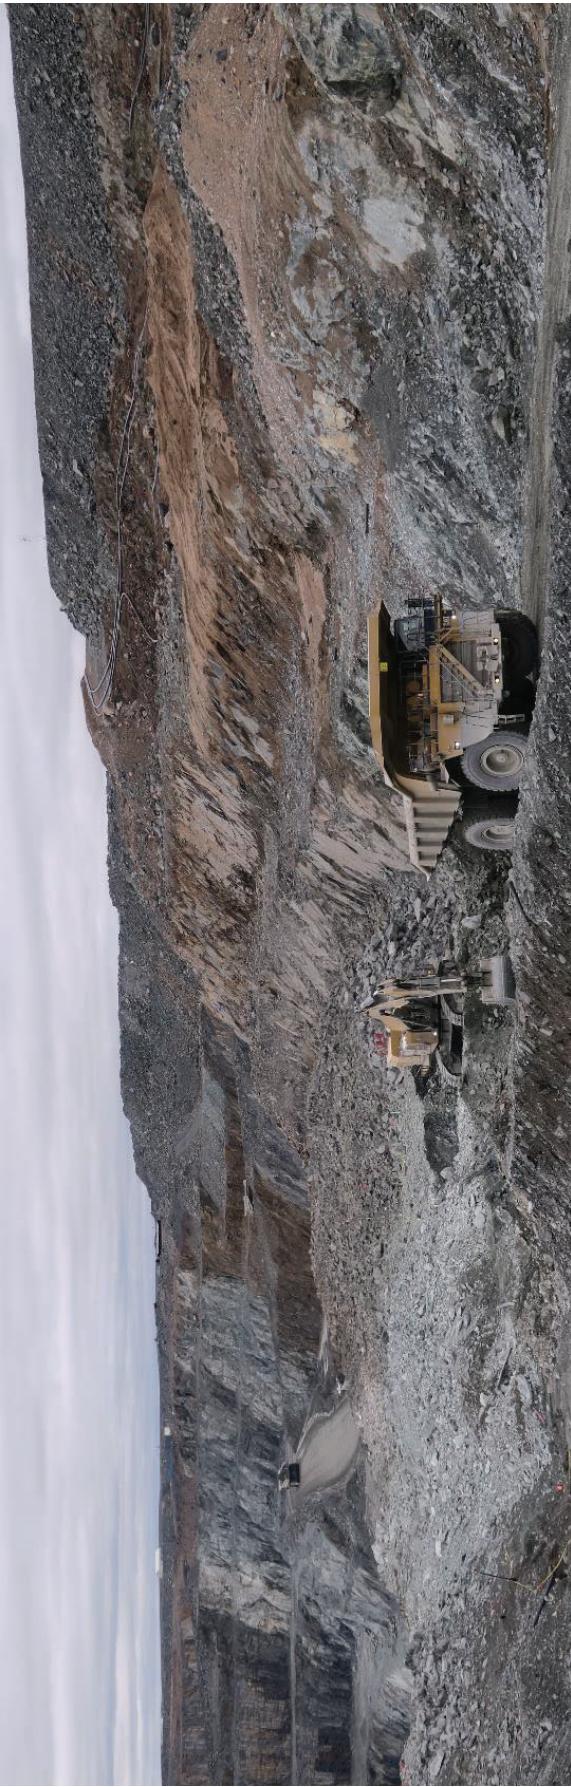
Observations - Northeast Wall Pushback

- Pushback to re-establish the final wall in Design Sector D4.
- Revised design incorporates a reduction in BFA to 55° , a reduction in bench height to 14 m (double benching) and an increase in bench width to 11 m
- While only two benches had been established at the time of the inspection, the bench faces were breaking back to the foliation as expected and were performing well.
- On-going rock mass characterization, with a particular focus on the orientation of the foliation, is recommended for this sector.

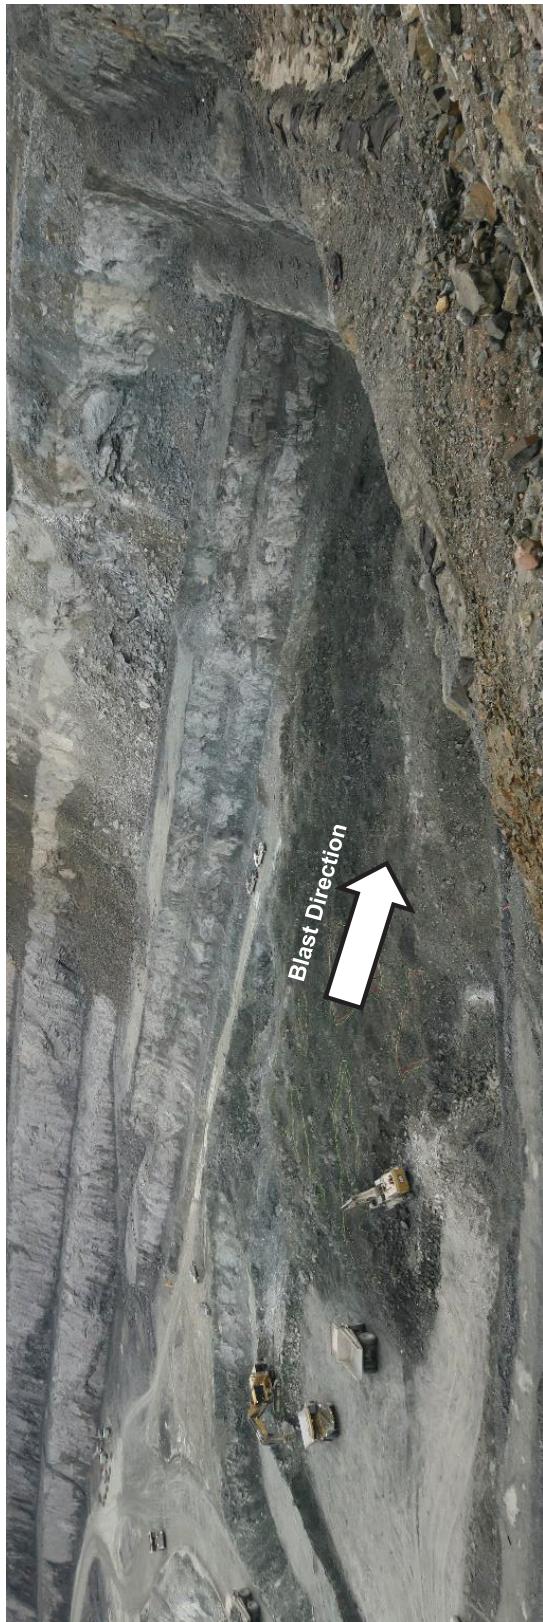
Observations - Blasting

- During the site visit, a relatively large choke blast was taken in the northeast corner of Phase 2. The blast was sequenced so that energy was directed towards the final wall. This will result in increased blast damage to the final walls, particularly when the dominant structure is oriented perpendicular to the wall (as the foliation is in the end wall in this case).
- As part of the on-going blasting study, recommend reviewing the blasting strategy. Where practical, direct blasts away from the final walls.
- From discussions with site staff, there is also a need to implement a drill and blast quality control program and a blast monitoring program.

12. **Blasting Study** - Drill and blast practices have been a factor in poor bench performance in both of the open pits, including increased backbreak, undercutting of the bench face and hard toes. The blast design does not vary to account for different lithologies or the orientation of the foliation and quality control is limited. A blasting study is on-going and should be completed. It is recommended that opportunities to sequence blasts away from the final open pit walls be considered.

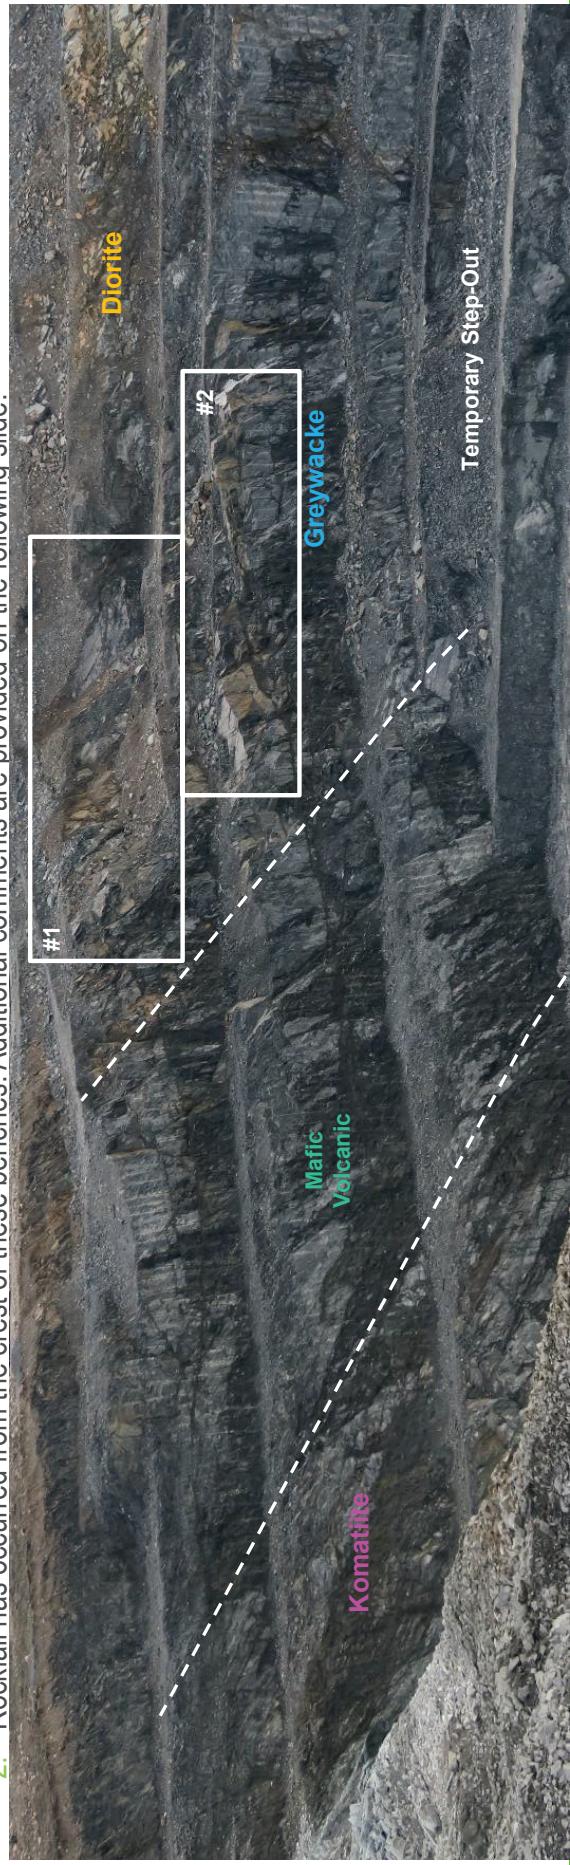
Observations - East Wall

- Final wall in Design Sector E4.
- The wall is performing well in the Komatiite and the Mafic Volcanics. The Greywacke near the Diorite has not performed as well, with crest loss, rockfall, and hard toes occurring. Specific areas of note are listed below and outlined on the photo.
 1. Material from a former in-pit dump remains on the face of the upper bench. A rockfall berm was constructed to retain ravelling material and has adequate capacity to retain future rockfall.
 2. Rockfall has occurred from the crest of these benches. Additional comments are provided on the following slide.

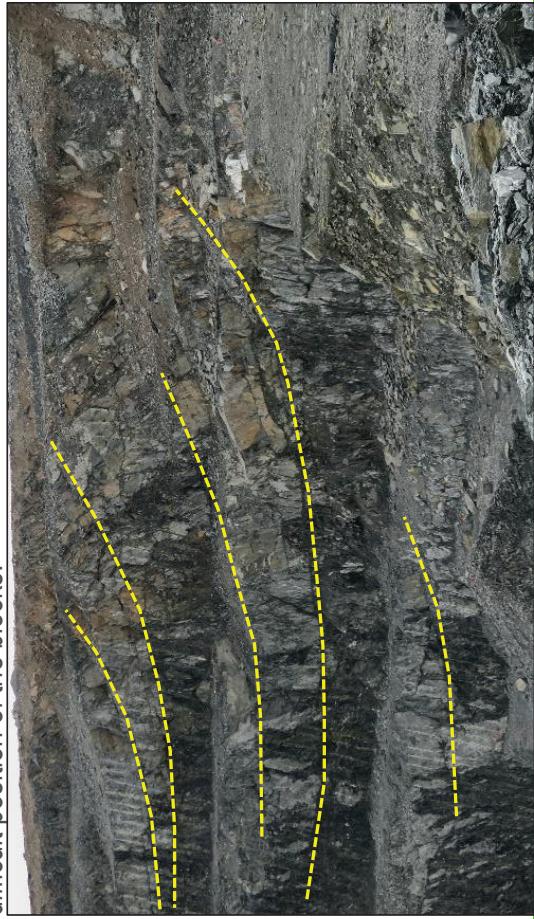
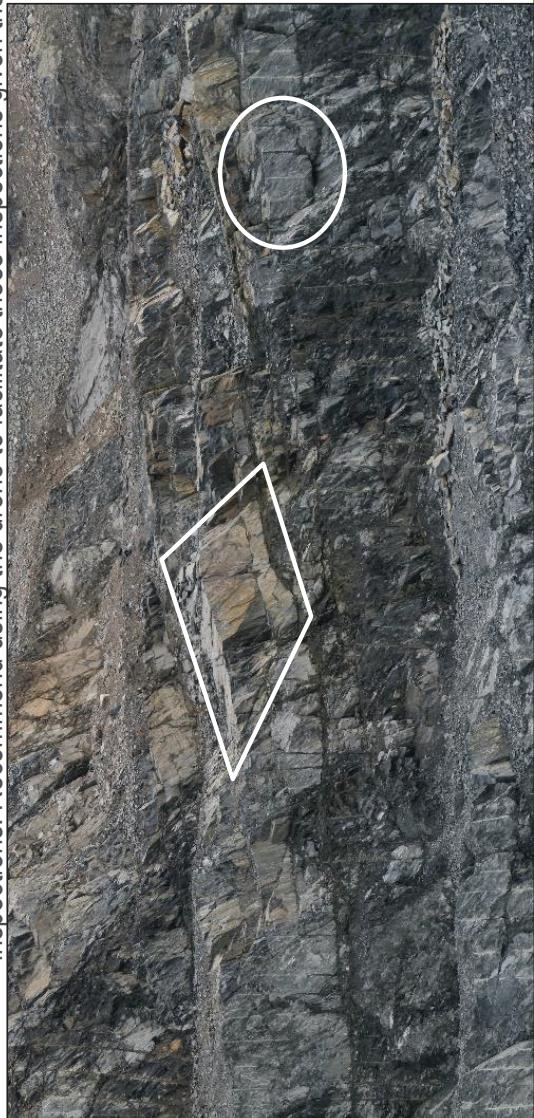
Observations - East Wall (Cont'd)

- A rockfall occurred in the southeast corner of this sector in 2021. In response, a rope scaling contractor (Vertika) was brought in to scale the wall (resulting in the loose observed on the catch benches). A series of curvilinear features, potentially associated with Whale Tail lake, are present in this area (outlined in yellow, below right) and likely contributed to the rockfall.

- Two potentially unstable blocks were observed during the visit (outlined in white, below left). These blocks should be monitored as part of the regular visual inspections. Recommend using the drone to facilitate these inspections given the difficult position of the blocks.

1. **WHL East Wall Rockfall Hazard** - Several potentially unstable blocks have been identified along the crest of one of the benches on this wall. The area was previously scaled by a rope crew. The blocks should be included in the regular visual inspections. As the blocks are difficult to observe, the inspections should be periodically supplemented with monitoring using the drone.

- A temporary step-out has been left below the area to reduce the exposure to personnel. The intention is to scale the area, clean the catch benches and recover the step-out as part of the Phase 3 pushback. This is a reasonable plan. If rockfall hazard persists, could consider additional measures such as mesh.

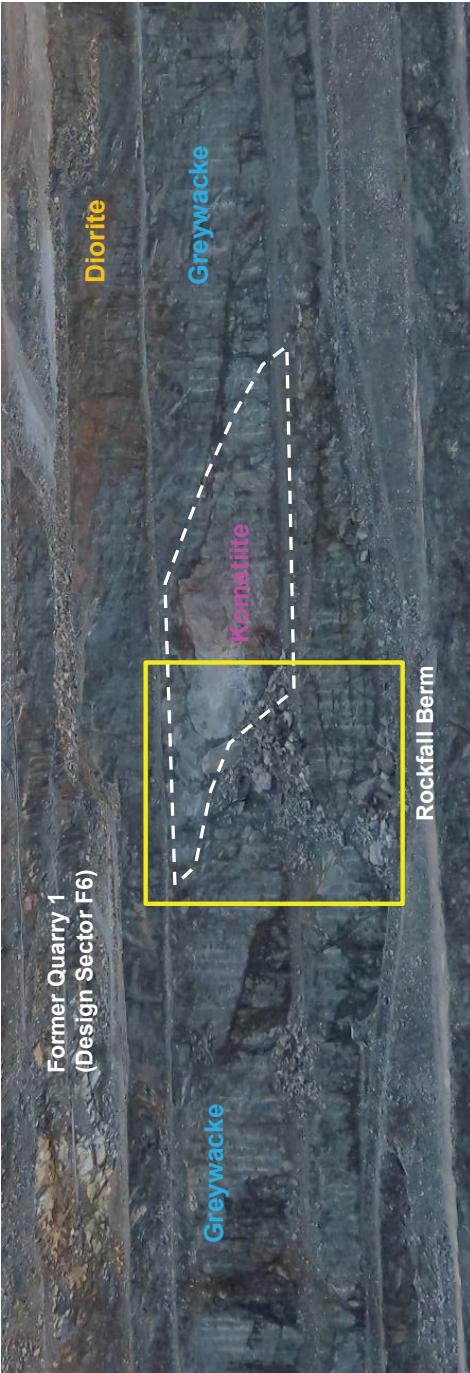
Observations - Phase 2 Southeast Wall

- Interim wall approximately within Design Sector G5. Also referred to as Phase 2 South (G5).
- A progressive bench-scale failure occurred along a sub-vertical contact between the Komatiite and the Greywacke between June and July 2021 (outlined in yellow below). The cumulative tonnage of the failed material was approximately 1,700 tonnes, the majority of which was retained on the catch bench immediately below the failure. A rockfall berm was constructed below the failure. The failure will be mined out during the Phase 3 pushback. It is likely that localized bench-scale failures will occur on adversely oriented contacts as mining progresses.

- Otherwise, the wall is generally performing well.
- Water is ponding at the base of the former Quarry 1 and infiltrating water may be the cause of the seeps observed in the wall. Access to the area is currently restricted by berms. The water level should be monitored visually. If seepage is contributing to bench instability or ice build-up, the water should be removed.

2. **WHL Southeast Wall Ponded Water** - Surface water is ponding at the base of the former Quarry 1. Access to the area is restricted. Infiltration of this water may be associated with seeps in the southeast wall and could contribute to slope instabilities. The regular visual inspections should document the ponded water.

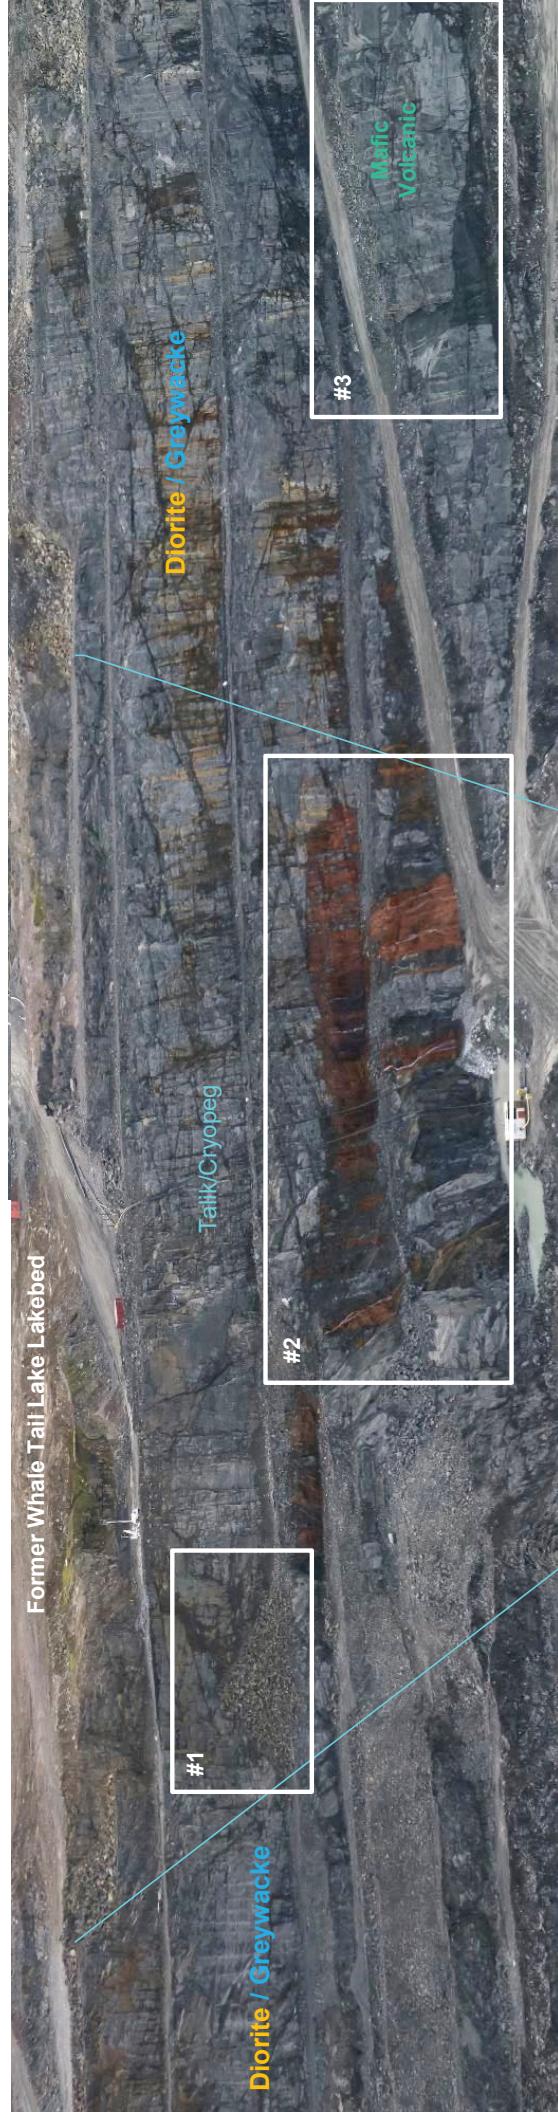
Observations - Phase 2 South Wall

- Interim wall approximately within Design Sector H5. Also referred to as Phase 2 South (H5).
- The wall is generally performing well. Specific areas of note are listed below and outlined on the photo. Details are included on the following slides.
 1. A bench-scale failure occurred along a sub-vertical contact between the Diorite and Greywacke in July, 2021.
 2. Seepage within with the talik associated with Whale Tail occurs in this sector.
 3. A possible unstable block was identified below the ramp.

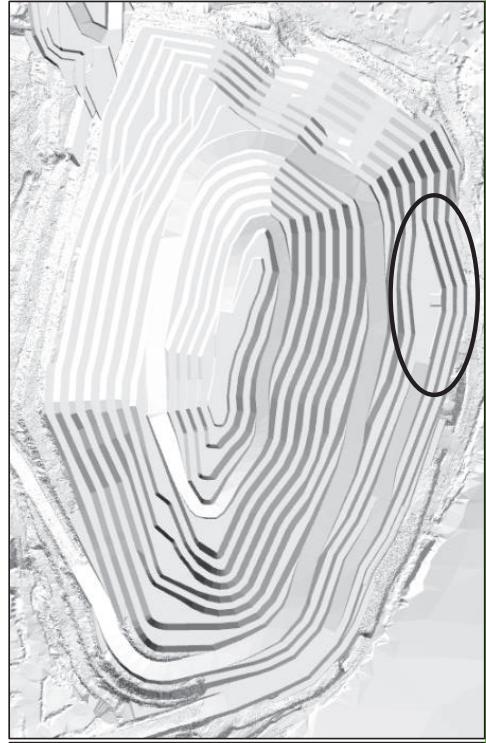
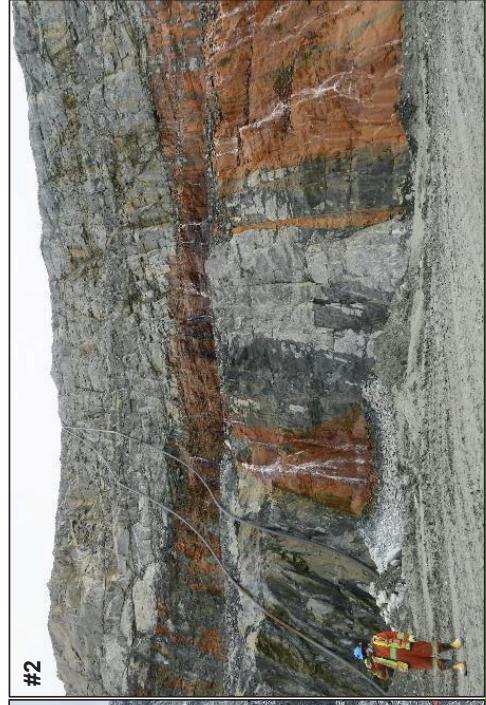
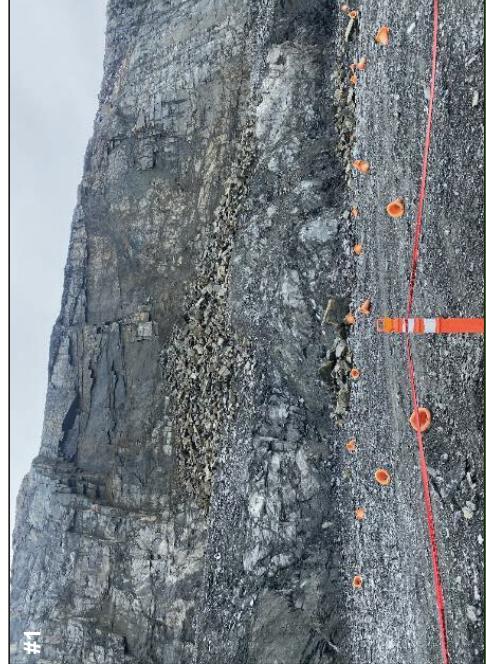
Observations - Phase 2 South Wall (Cont'd)

1. The 750 tonne failure occurred along a sub-vertical contact between the Greywacke and Diorite. The Greywacke is notably blocky in proximity to the contact. All but a few blocks were retained on the catch bench immediately below the failure. The failure will be mined out during the Phase 3 pushback. It is likely that localized bench-scale failures will occur on adversely oriented contacts as mining progresses.

2. Prominent seeps are present in the lower South Wall, concentrated along sub-horizontal structures. The estimated inflow rate varies between 60 to 80 m³/hr over the winter months, increasing to 160 to 180 m³/hr over the summer months. The seepage is expected to result in the formation of ice walls that will pose an ice fall hazard, particularly in the spring. A water-management pushback has been planned (circled at lower right) to help mitigate this risk, which is endorsed. The groundwater flow into the open pit should continue to be studied so that mitigation measures can be refined.

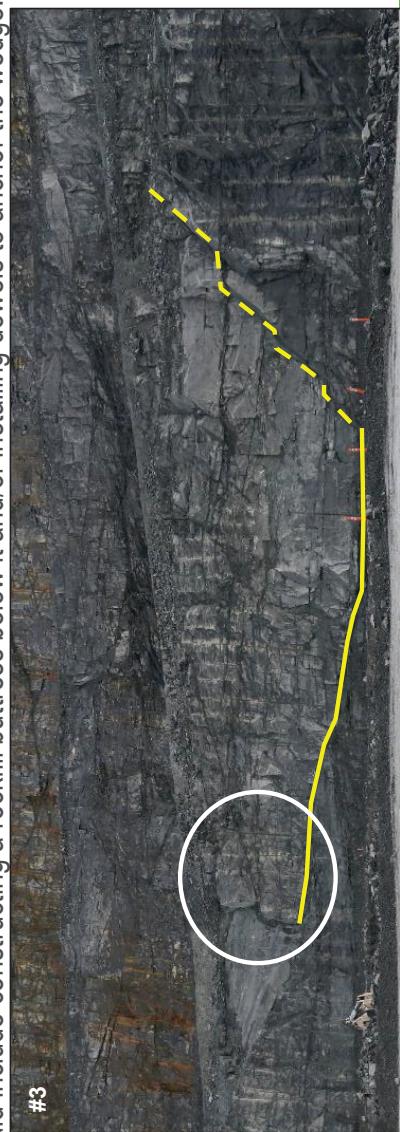
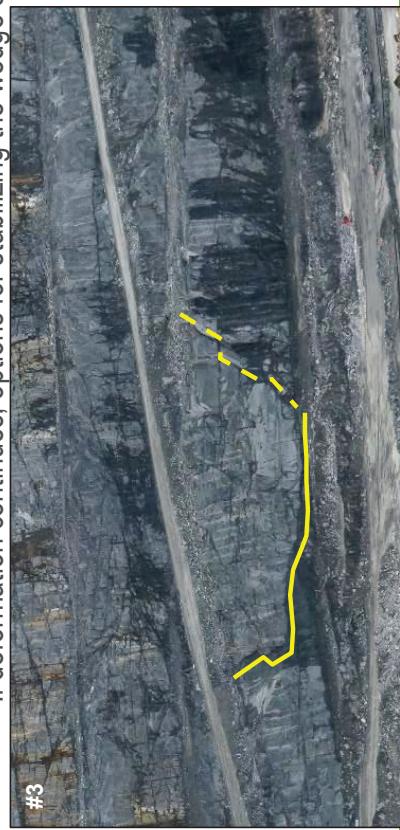
Observations - Phase 2 South Wall (Cont'd)

2. **WHL South Wall Wedge** - A potentially unstable wedge has been identified below the ramp in the south wall. Radar data suggests that the wedge is deforming in response to blasting. Instrumentation (e.g., a crackmeter) should be installed to allow the deformation to be more accurately monitored. A Trigger Action Response Plan (TARP) should be developed for the instrumentation. If deformation of the wedge continues, options for stabilizing the wedge should be reviewed.

- If deformation continues, options for stabilizing the wedge could include constructing a rockfill buttress below it and/or installing dowels to anchor the wedge.

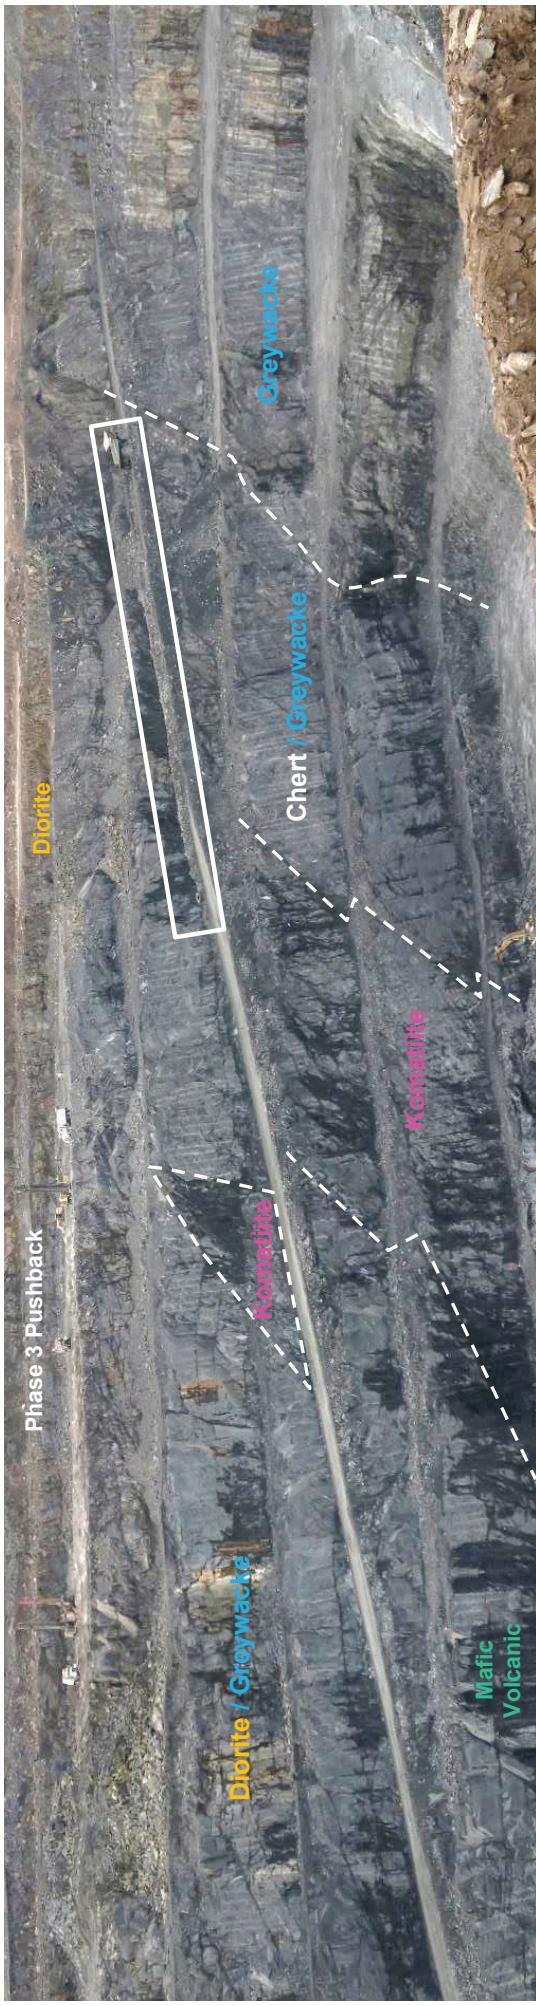
Observations - Phase 2 Southwest Wall

- Interim wall approximately within Design Sector I1. Also referred to as Phase 2 South (I1).
- The wall is generally performing well.
- The Phase 3 pushback is in progress above this wall. Spillover represents a rockfall hazard for traffic on the ramp. A rockfall berm has been constructed on the inside of the upper ramp, where rockfall has occurred (outlined in white below). The berm had limited capacity remaining at the time of the visit. The berm should be cleaned out and extended along the full length of the ramp below the pushback. The berm should be inspected and cleaned periodically.

3. **WHL Southwest Wall Rockfall Hazard** - The Phase 3 pushback has resulted in overspill and rockfall on the ramp and the benches above the ramp. A rockfall berm has been constructed along the inside of the upper portion of the ramp. However, the berm is now close to being full and does not cover the lower portion of the ramp. The rockfall berm should be extended so that the full length of the ramp below the Phase 3 pushback is protected. The existing berm should be cleaned out to re-establish

- adequate capacity for future rockfall and periodic inspections of the berm completed in order to identify if future cleaning is required.
4. **WHL Phase 3 Pushback Rockfall Hazard** - A temporary wall was developed in the blocky diorite without pre-shear. The bench face represents a rockfall hazard and a rockfall berm should be established below the temporary wall.

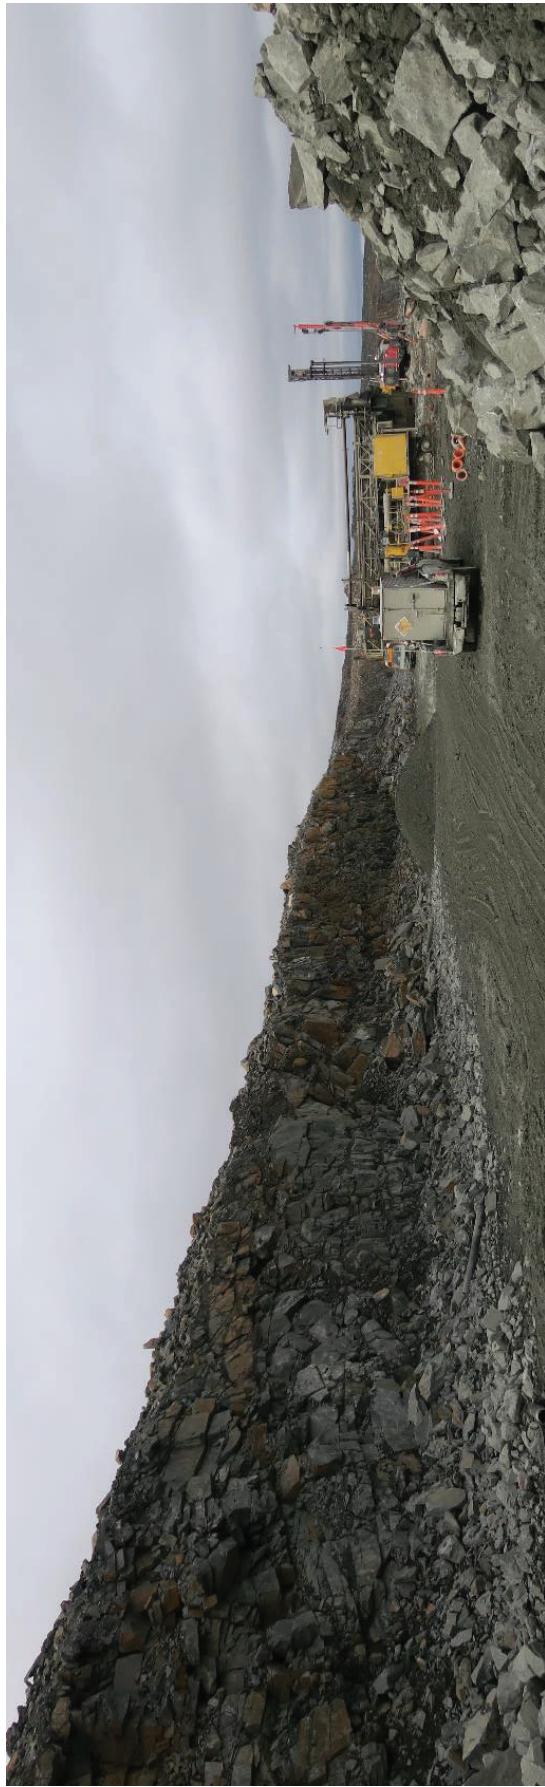
Observations - Phase 3 Pushback

- Temporary wall within the Phase 3 Pushback. Approximately corresponds to Design Sectors H6 and I6.
- The wall was established without pre-shear, as is standard practice for temporary walls. As a result, the condition of the face and crest is poor, and a rockfall hazard exists.
- Due to the pushback geometry, the working area is limited in places. A vehicle was observed parked at the toe of the bench. This is not consistent with the site's Work Close to Pit Wall procedure. The vehicle was moved. A berm should be constructed below the wall to prevent access and retain any rockfall.

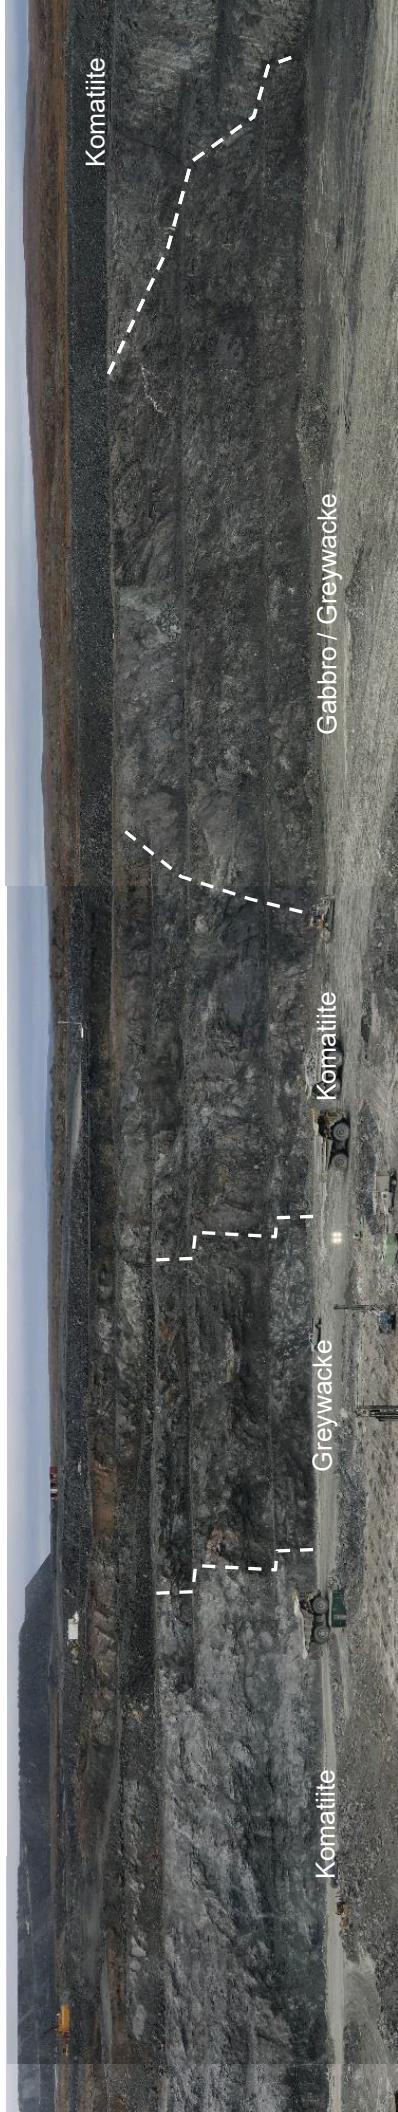
IVR V1 Open Pit Observations - Northwest Wall

- Final wall in Design Sector V0A. This sector encompasses the footwall of the deposit. The slope geometry was expected to be controlled by the potential for bench and inter-ramp scale planar failures on the foliation (Joint Set A).

- While the initial benches broke to the foliation, the remainder have not performed as expected. This is discussed further on the following slide.
- The slope was expected to be established in the Komatiite and to be intersected by numerous brittle structures. However, mapping by Geology has identified intervals of Greywacke and Gabbro in the slope. These units are more competent.

5. **IVR V1 Northwest Wall Rockfall Hazard** - The poor performance of the bench faces and the reduced catch bench width in this sector represent a rockfall hazard and a rockfall berm should be established below the wall.

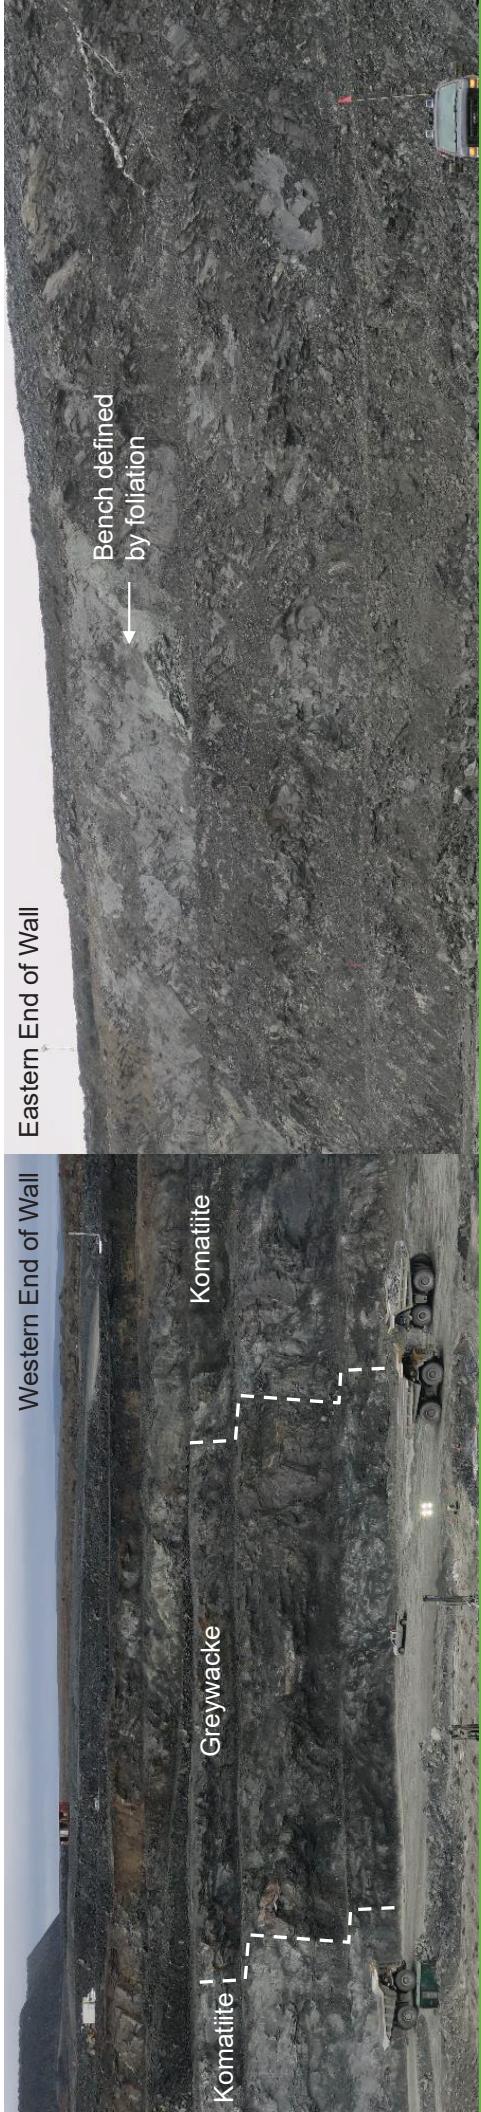
Observations - Northwest Wall (Cont'd)

- **Drilling and Blasting:** Discussions with the Drill & Blast Engineer suggested that the depth of the blast holes is poorly controlled and over-drilling is a common problem. Poor depth control will strongly influence the effectiveness of the staggered blastholes used to establish these benches.

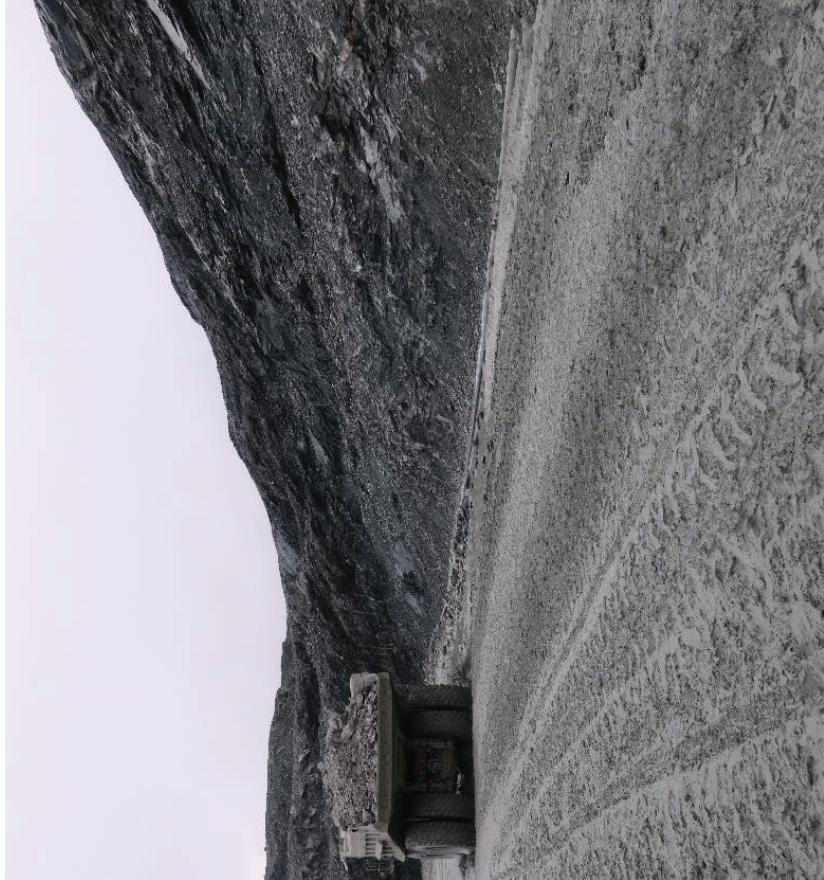
Observations - Northeast Wall (Cont'd)

- It was noted that the upper two to three benches will be mined out when mining of the adjacent IVR V2 open pit begins.
- The reduced catch bench capacity and poor condition of the bench faces represent a rockfall hazard (as shown in the photo on the right). A rockfall berm should be constructed at the toe of the slope, along the ramp.

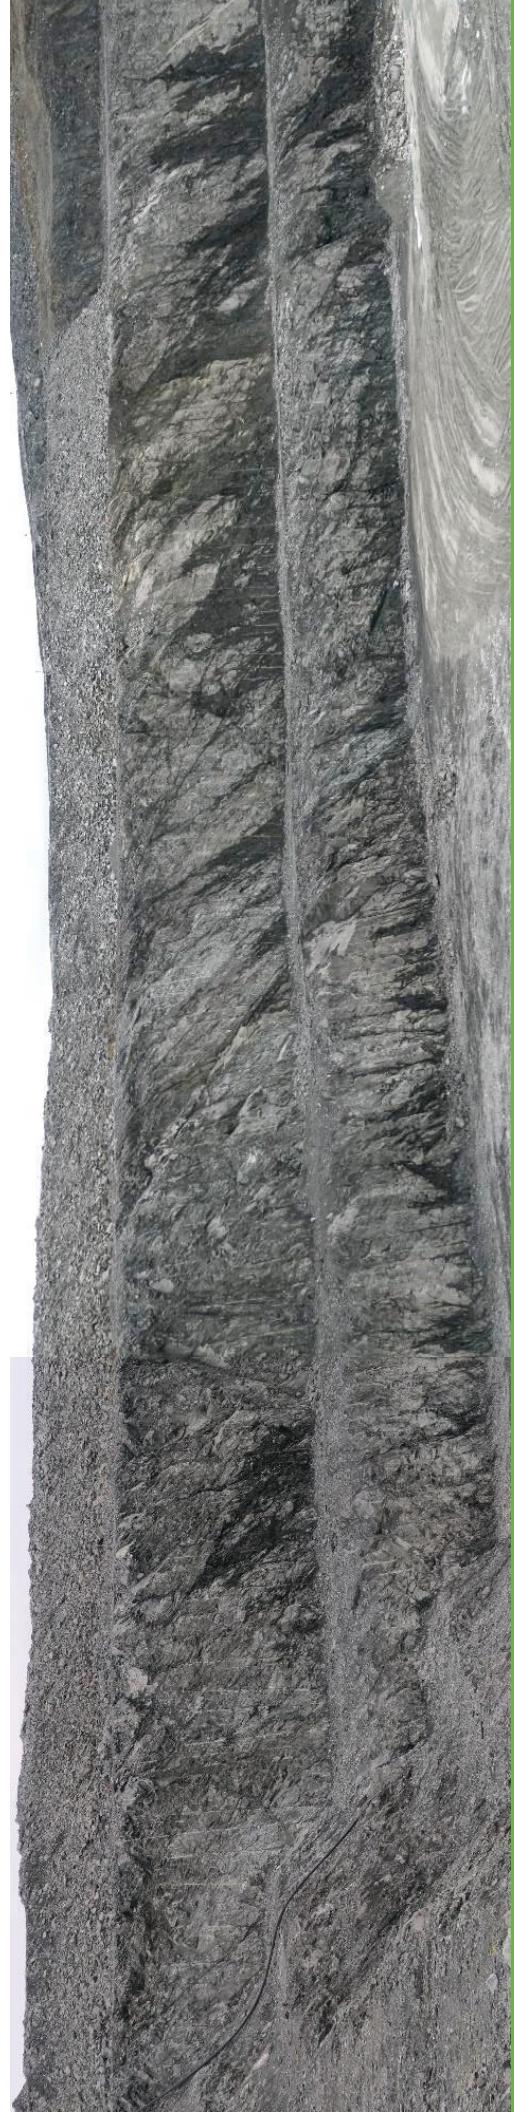
Observations - Northeast Wall

- Final wall in Design Sector V0B.
- In general, the wall is performing well. The foliation is oriented perpendicular to the wall.
- However, cross-cutting structures have resulted in numerous small wedges and it is understood that significant scaling was required when the benches were established. It is expected that the benches will ravel over time. At the time of the inspection, very little material was observed on the catch benches.
- Several potential wedges were observed and are described on the following slide.
