Whale Tail 2021 Annual Open Pit Geomechanical Inspection

March 24, 2022

RE: Meadowbank Complex - Amaruq Site - 2021 Annual Open Pit Geomechanical Inspection

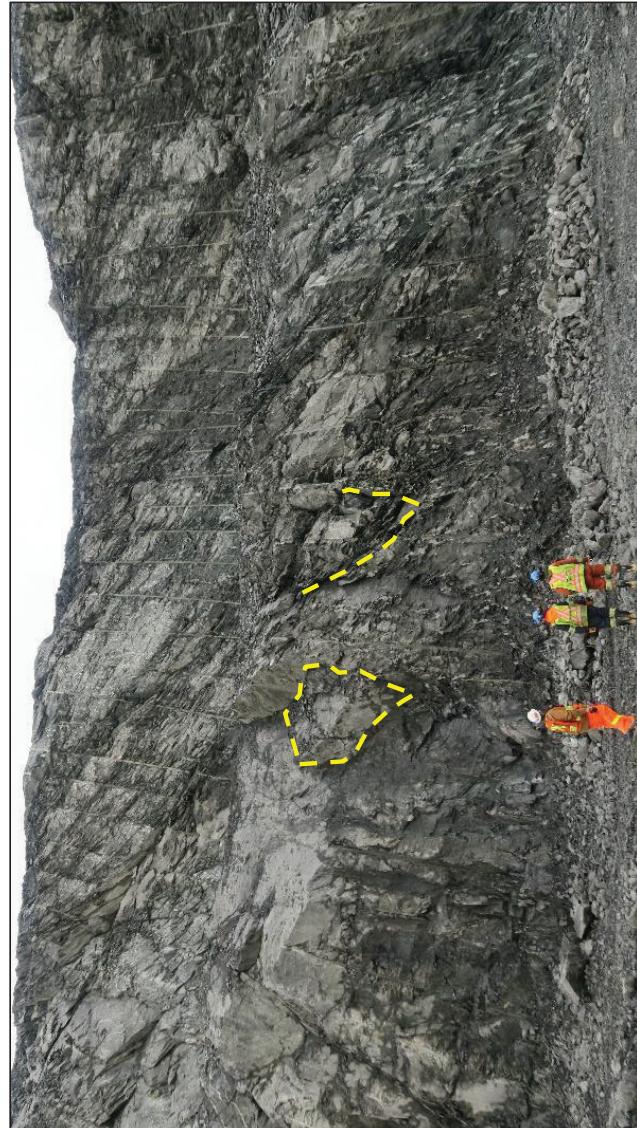
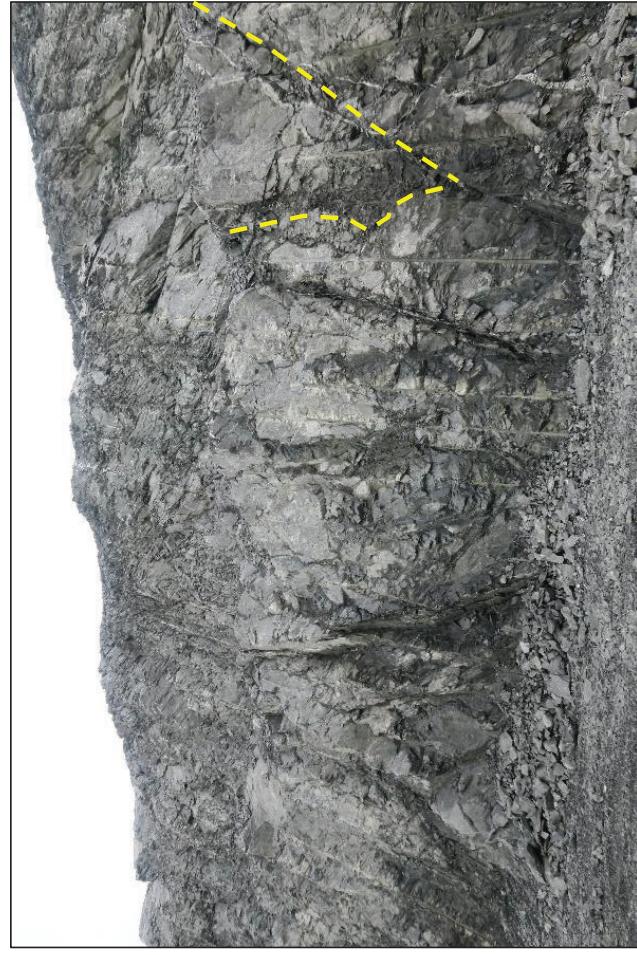
Observations - Northeast Wall (Cont'd)

- Several potential wedges were observed (examples are shown below). Recommend attempting to scale these wedges to eliminate the potential hazard.
- The wedges appear to be forming on persistent, planar, and relatively widely spaced cross-cutting features (the right hand structure in the examples below). Recommend mapping these structures so that potential wedges on future benches can be anticipated.

6. **IVR V1 Northeast Wall Rockfall Hazard** - Several potentially unstable wedges were observed on the north wall. The wedges represent a rockfall hazard and should be removed.

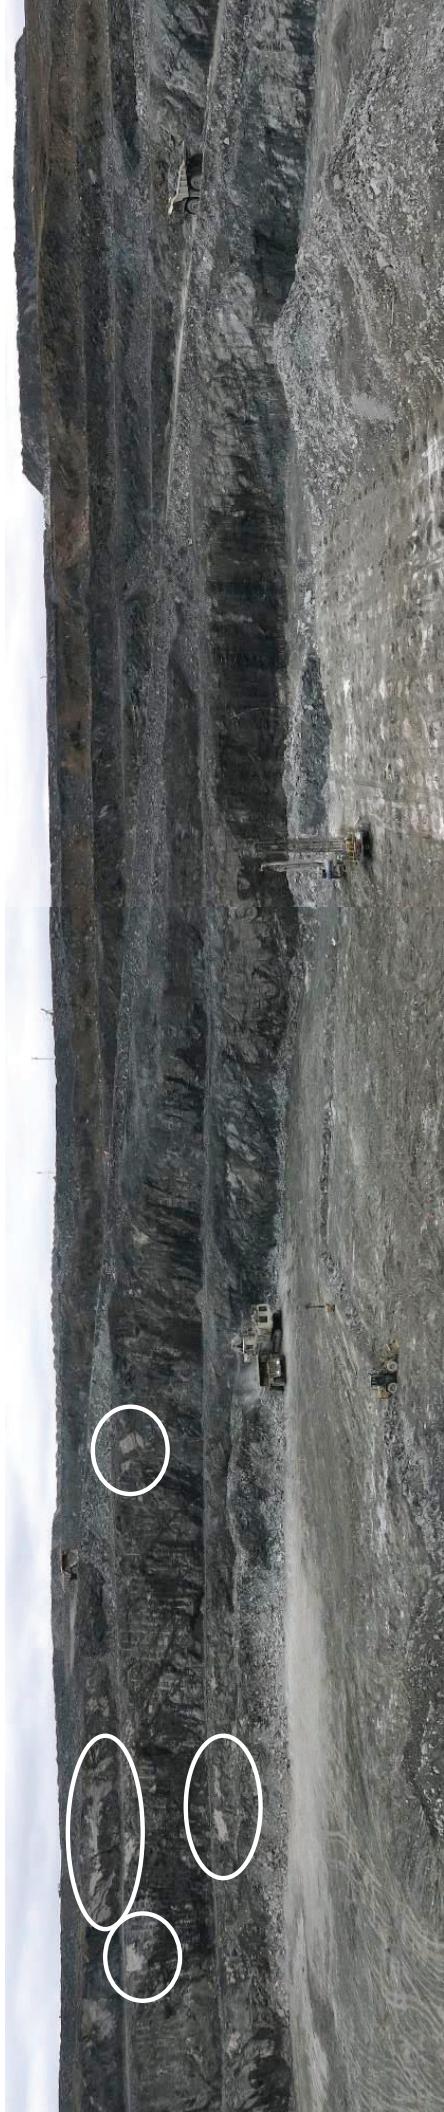
Observations - Southeast Wall

- Final wall in Design Sector V0C.
- In general the wall is performing well.
- The persistent cross-cutting features that were associated with the potential wedges in the Northeast Wall are also present in this sector and have locally controlled the achieved bench geometry (examples circled below). These structures were not prominent in the discontinuity orientation data used to design the open pit. The structures should be mapped and their potential impact on the slope performance reviewed.

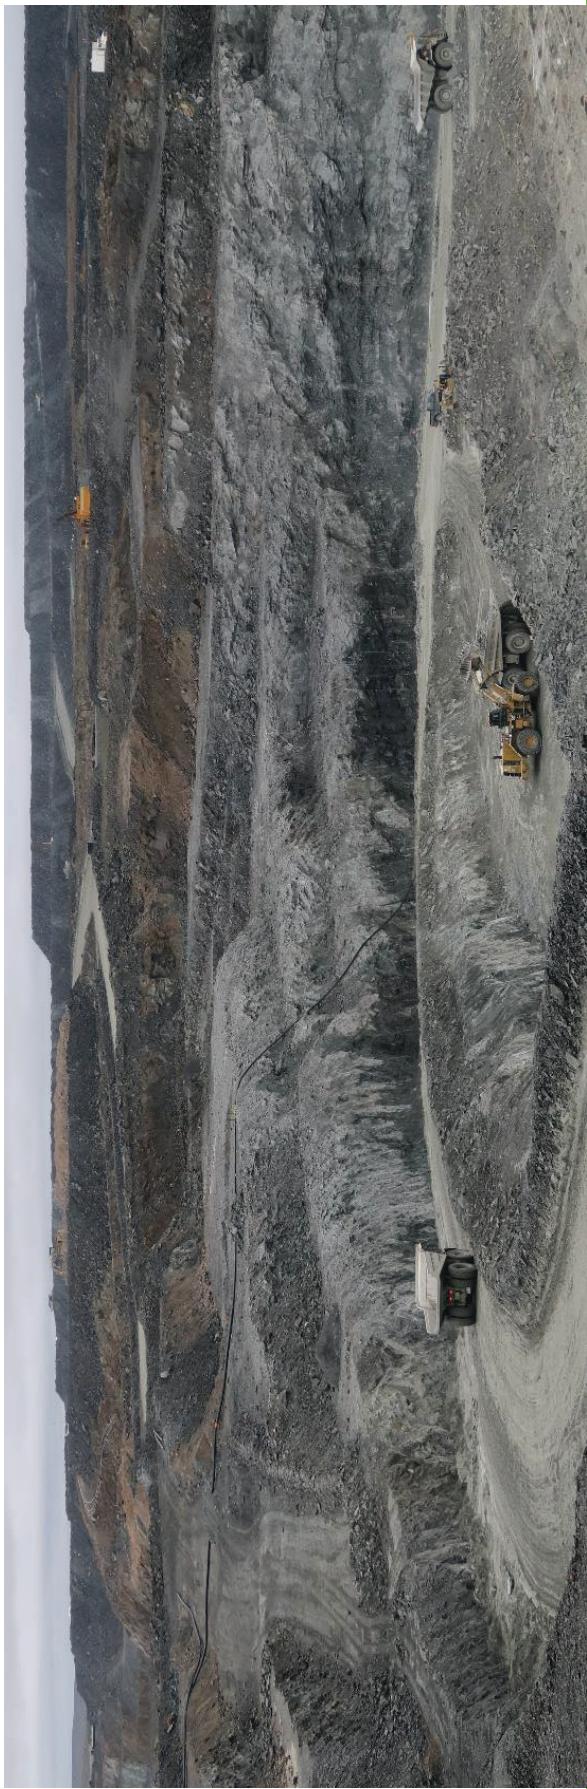
Observations - Southwest Wall

- Final wall in Design Sector V0D.
- The wall is generally performing well. While the benches are primarily within the Komatiite and Brittle Structures, the wall is oriented perpendicular to the foliation.

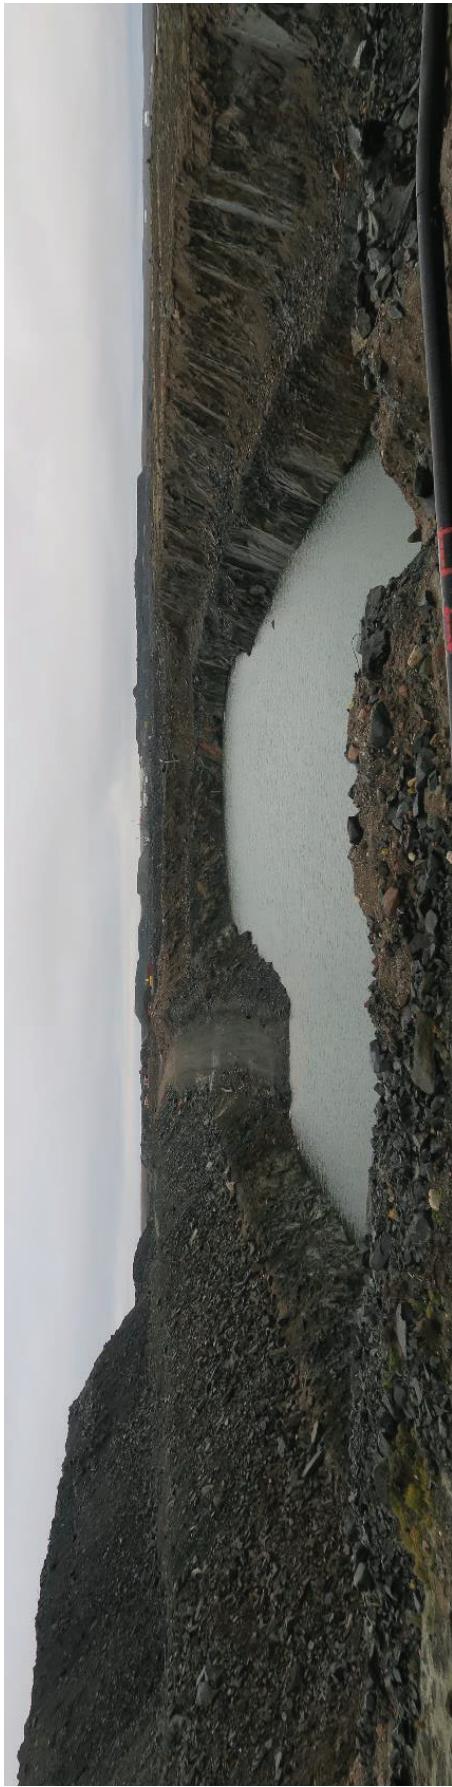
Observations

- Attenuation Pond 5 is located to the east of the WHL open pit and was inspected on September 17, 2021.
- The pond is partially flooded, with one to two benches exposed above the pond water level. As a result, a detailed inspection could not be completed.
- No stability concerns were identified in the exposed slopes.
- The pumps and pipelines have been removed from the pond.
- The pond is not currently being used and access to the ramp and the pond is not restricted. It is understood that water management infrastructure will be installed in the future. Recommend placing pylons at the top of the ramp to restrict access while it is not being used.

4. **AP5 Access** - As access to AP5 is not currently required, recommend constructing a berm at the top of the ramp to restrict access.
