### **Meadowbank and Whale Tail MDRB Report No.29**

Report No 29  
Meadowbank Mine Dike Review Board (MDRB)  
Site visit August 24<sup>th</sup> to 26<sup>th</sup>, 2021 and Conference call of November 22<sup>nd</sup>.

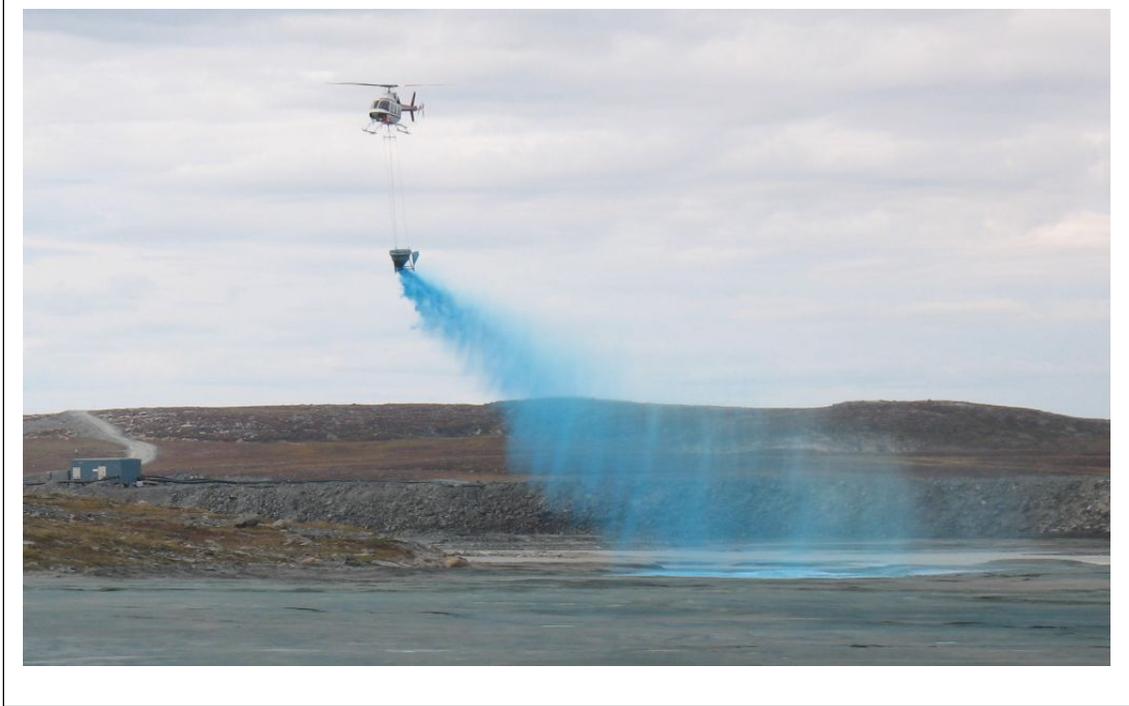
In anticipation that the capping will not be immediate, AEM has embarked on a surface sealing exercise to suppress the potential for dust generation at certain times of the year. (Photo Nos 3, 4 and 5)

Photo No. 3 Meadowbank TSF, sealant spreading

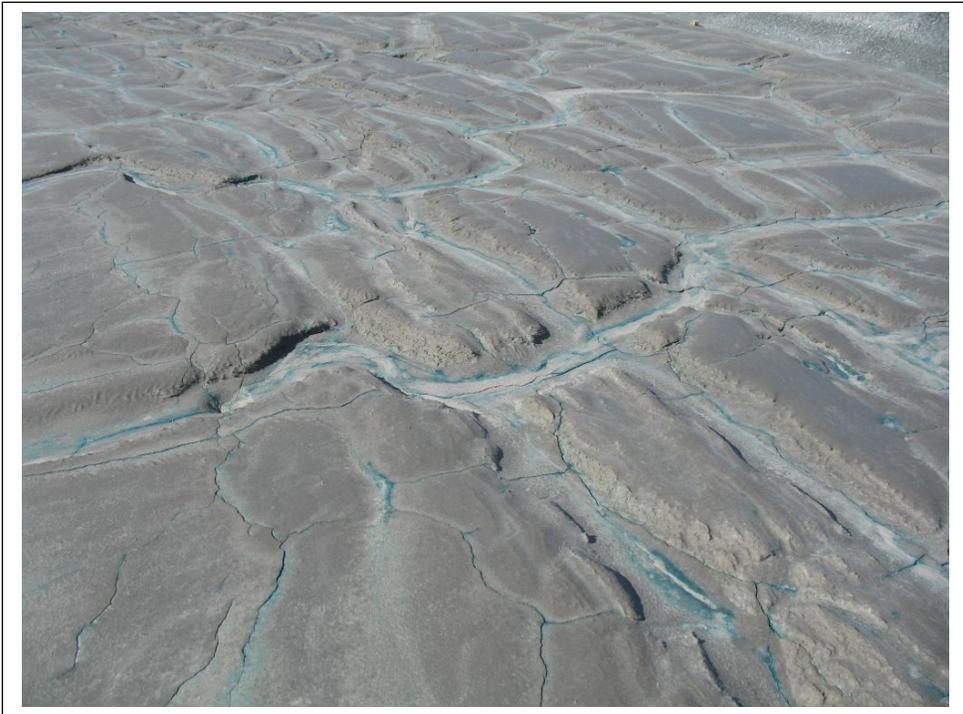
Photo No. 4 Meadowbank TSF, sealant on surface of tailings

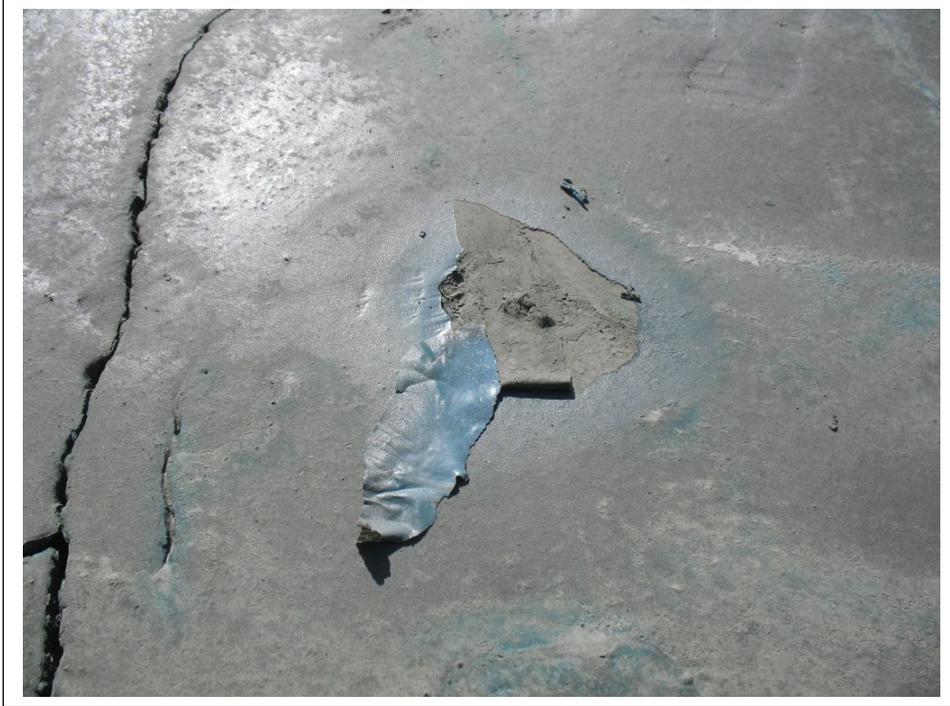
Photo No. 5 Meadowbank TSF, sealant film on tailings

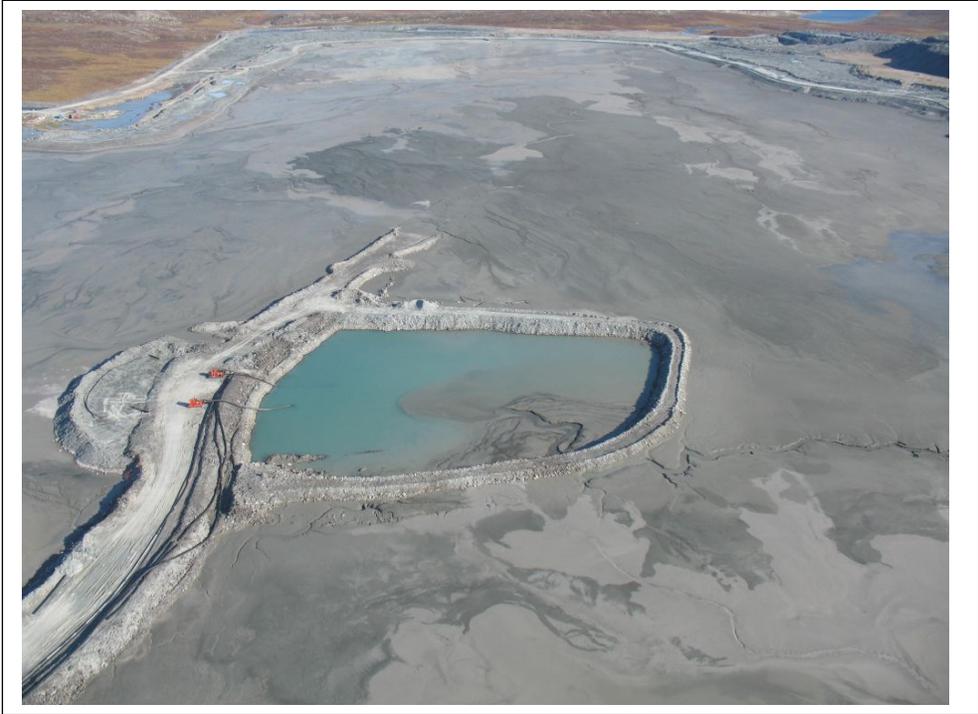
Photo No. 8 Meadowbank. Water collection sump in the North Cell of the TSF

- The potential for advancing the construction of the permanent spillway between the NC and SC should be evaluated to permit some of the water transfer to be accommodated by gravity flow instead of pumping from the problematic collection sump. (Photo No. 8)

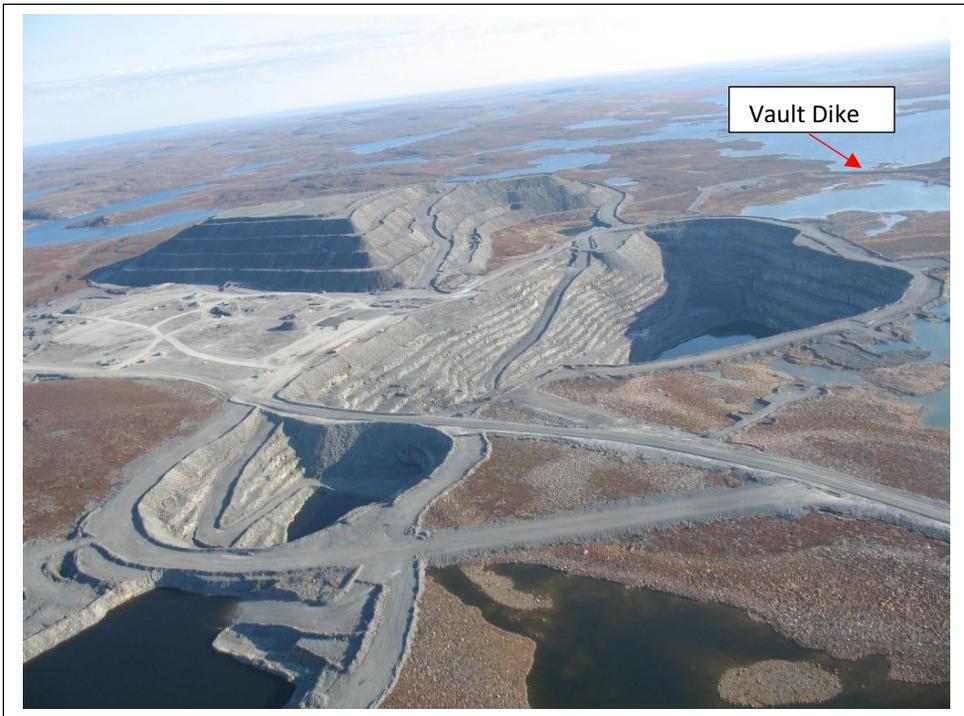
Data presented under this heading included the Vault dike where the water head across the structure has not yet been reduced by the rising water level in the now worked-out Vault Pit. (Photo No. 10) The dike and its foundation remain frozen and thus, the performance is satisfactory.

Photo No. 10 Vault Pit. Vault Dike in background

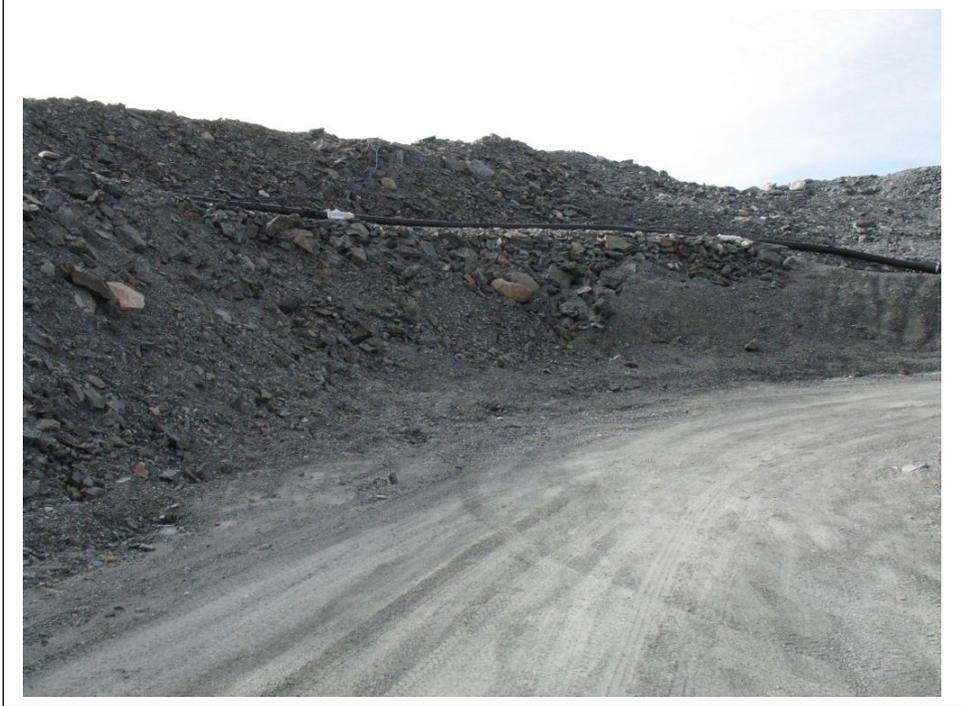
At East Dike, one of the oldest structures at Meadowbank, the continuing ingress of freezing in the foundation, as seen from the temperature measurements, is apparently also manifested by restricted seepage flow outlet points. At Stn. 60+195, (Photo No. 11) water was seen to be flowing over the downstream road in March, 2021. The Board concurs with the hypothesis that the change in flow paths is associated with ground freezing. Instrument data shows a steady rise in the piezometric levels at section 60+190 downstream since 2014. It is suggested that snow removal to maintain access to the pump station may actually exacerbate the situation by encouraging the frost penetration. In August, the Board suggested that AEM explore ways to enhance the drainage into the sump during the winter months so that ongoing monitoring of seepage rates can be continued. Ensuring free water escape pathways may be achieved by a combination of a rockfill thermal cover, and/or encouraging early snow accumulation. In fact, AEM acted on this suggestion and collector drains and a culvert were installed in October together with improved flow measuring equipment in the pump house. However, diligent visual surveillance will still be required to detect any tendency for freeze-up and provisions for snow management, extra insulation, heat tracing or steam thawing should be made.

Photo No. 11 Meadowbank. Area of seepage in March 2021 at East Dike Strn. 60+195

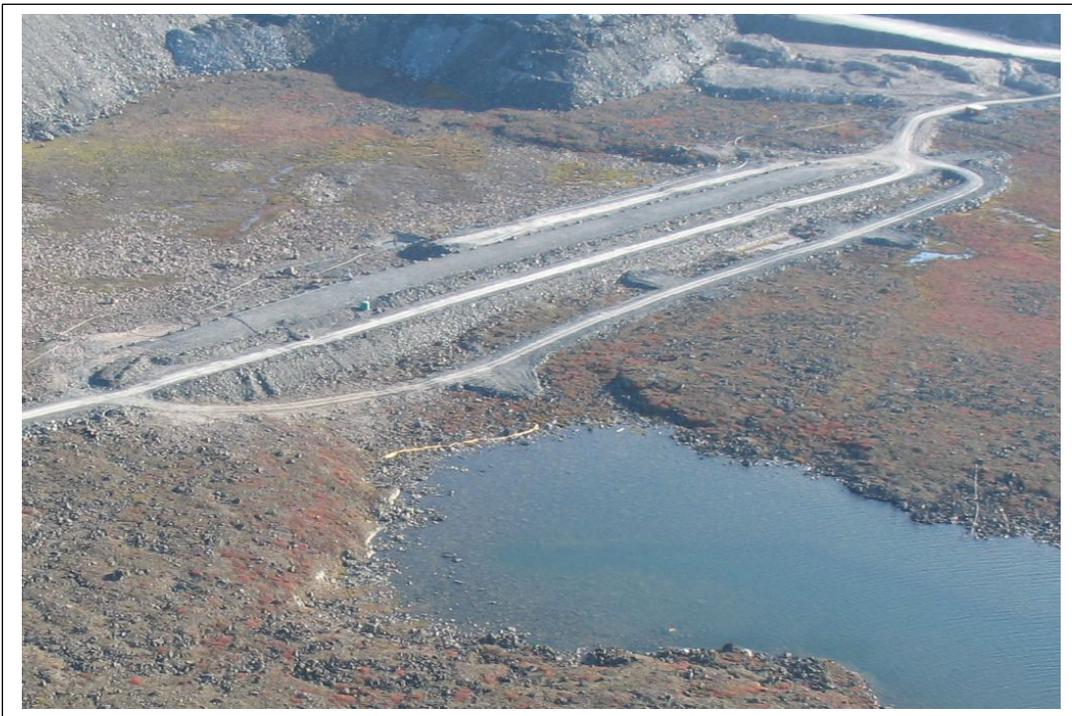
The structure is performing well. With no periods of high water in Mammoth Lake being recorded this last spring, the foundation was able to freeze back. Also, there is little or no ponded water on the upstream side. (Photo No. 12)

Photo No. 12 Amaruq. WRSF Dike

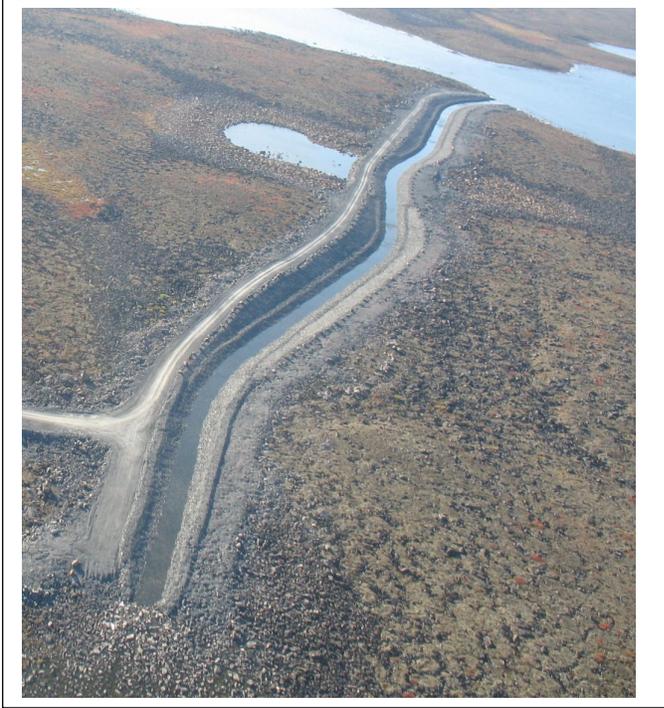
This channel (Photo No. 13) was constructed to divert run-off from the Whale Tail catchment directly towards Mammoth Lake thus by-passing the Amaruq mine site. Snow removal was performed in the invert prior to freshet. Good performance is noted.

Photo No. 13 Amaruq. South Whale Tail Diversion Channel

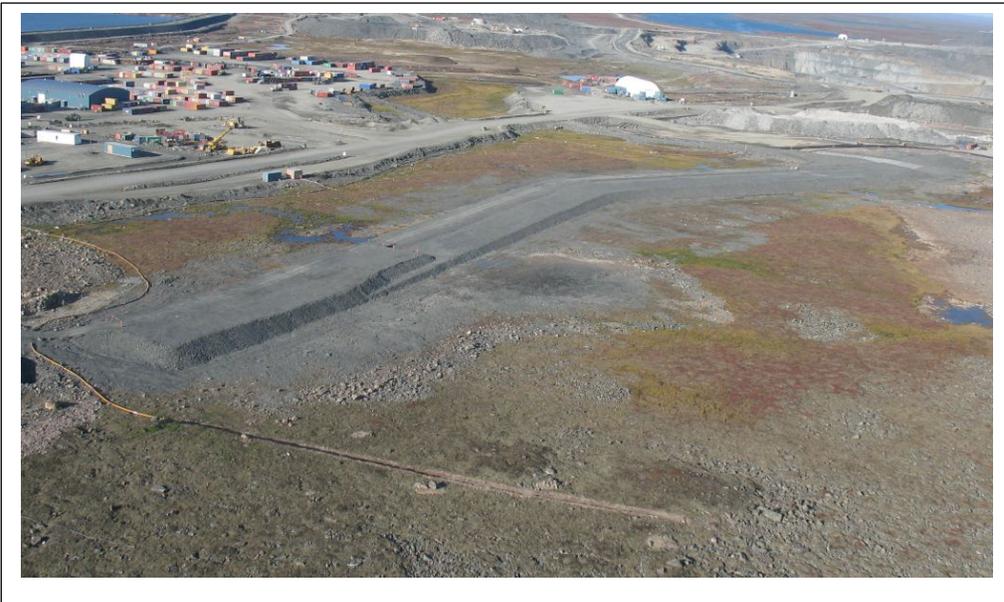
This is the first season of operation. The dike was constructed in early 2021. (Photo No. 14) In November, the Board was provided with a summary of the construction activities. Quality assurance was provided by GAL. Field-fit modifications were communicated to and accepted by the designer (SLI). It will be important to ensure that documentation of any change be included in the As-Built Reports for the structure.

The Board notes that from Stn. 0+205 to 0+312, the invert of the key trench is described as being on ice-rich till. The natural ground elevation is such that part of this sector is below the maximum operating pond level. The horizontal thermistor string extends from Stn. 0+145 to 0+217 and, therefore, does not entirely cover this sector. Close visual inspection will be needed in 2022 with the possible addition of vertical thermistors to complement the current array.

During the 2021 summer, some longitudinal cracking was noted on the shoulders, likely due to active zone thaw of the foundation at the toe. However, the instruments indicate that the foundation remains frozen at depth.

Water ponding was noted on the downstream side near the East abutment and a drainage trench was excavated to minimize accumulation. Additional rockfill to extend the downstream berm in this area and thus enhance ground freezing was also placed.

Photo No. 14 Amaruq. IVR Dike

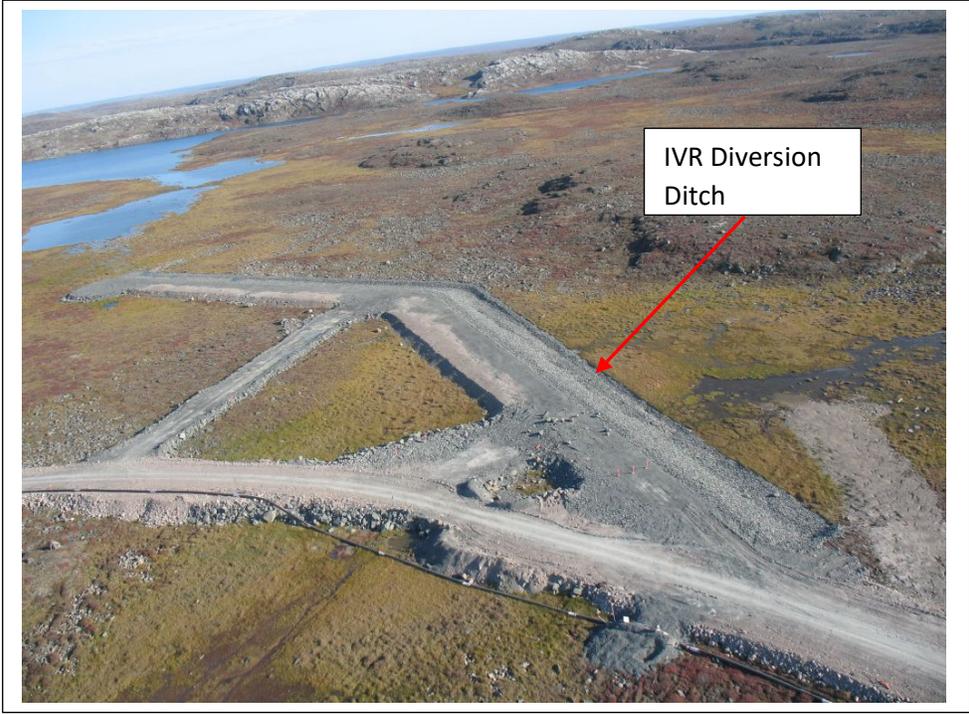
This was the first season of operation for this component. (Photo No. 15) The channel functioned as intended. Some longitudinal cracking similar to IVR Dike has been observed. Water ponding

at the downstream toe will be addressed by additional fill placement so as to enhance permafrost preservation.

Photo No. 15 Amaruq. IVR Diversion Ditch and retaining berm

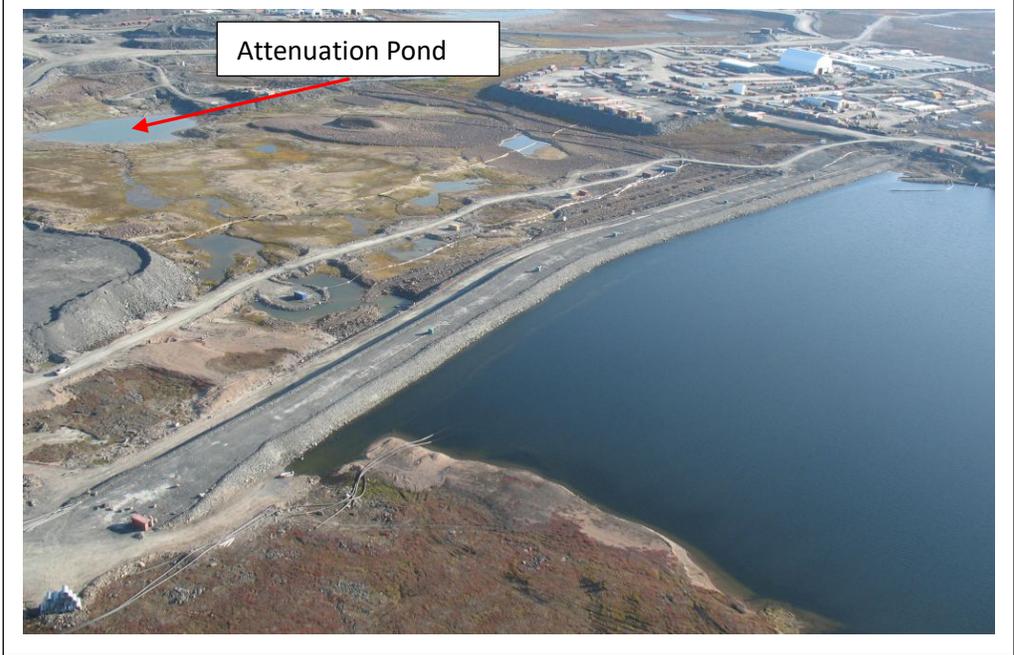
The dike has been in operation since 2019. (Photo No. 16) Seepage and thaw of the foundation were noted shortly after commissioning. A remedial grouting program was undertaken from Nov 2019 to March 2020. This had a successful outcome, insofar as considerable reduction in seepage, was achieved. This is currently believed to be of the order of 80 m<sup>3</sup>/h. However, seepage flow rates are not accurately documented, given that part of the seepage reports by surface flow to the attenuation pond and part becomes groundwater recharge. The Board was advised that water quality is not satisfactory for direct discharge to South Whale Tail Lake. Consequently, the pump system is currently shut down.

Ice build-up was noted in the downstream area denoting artesian pressures generated by seepage below the dike and/or freezing ingress. Thermistor data indicates that equilibrium conditions have not yet been attained at the dike. Previously frozen areas at the abutments have likely thawed since the grouting program of 2019-2020. Seepage pathways may have increased but presently there are no means available to assess the change.

Elevated TSS levels have been observed in the seepage from the dike during the first half of 2021. It is unclear what has caused this trend, although it appears to have improved since June 2021. AEM intends to continue to investigate and monitor this situation.

Given the positive secant pile cut-off, the Board does not see an immediate concern for the integrity of the Whale Tail Dike. However, a gradual increase in seepage quantities through the thawed fractured bedrock should be considered a real possibility. The Board sees the need for a more in-depth interrogation of the available data to identify potential scenarios of deterioration.

Photo No. 16 Amaruq. Whale Tail Dike

The Board also wishes to re-iterate a previous recommendation to construct berms to an elevation above the waterline on the upstream side at both abutments to enhance ground freezing or at least encourage maintenance of existing permafrost. As an illustration of the different freeze-back performance, attention can be drawn to the East abutment thermistors. The August and November presentations included graphs for the thermistors WTD TH 0+750 and 0+772. From this data, it can be seen that freezing of the foundation is occurring at 0+772 where no ponding is observed in the aerial photo but the thaw bulb at 0+750, where open water is in contact with the dike, is increasing with time. The thermistor WTD TH-US0+710 gives ample evidence of the heat flux provided by the lake water in this vicinity.

The attempt to re-construct the weir at Stn. 0+430 was described in a November presentation. Unfortunately, frost heave nullified the effort and seepage once again by-passes the V-notch. As was mentioned in the discussion relating to East Dike (see 4.3 above), it is generally recognized that measurement of seepage flow provides a better indicator of overall dike performance as

compared to the discrete point measurements of piezometric pressure or temperature. However, it is often the most difficult to accomplish. The Board commends the effort and would like to see further attempts possibly using a weir plate welded to a section of corrugated steel culvert over which fill could be placed to provide weight to counteract frost heave. Low permeability fill around the upstream part of the pipe and filter material around the downstream part could help to reduce the risk of erosion.

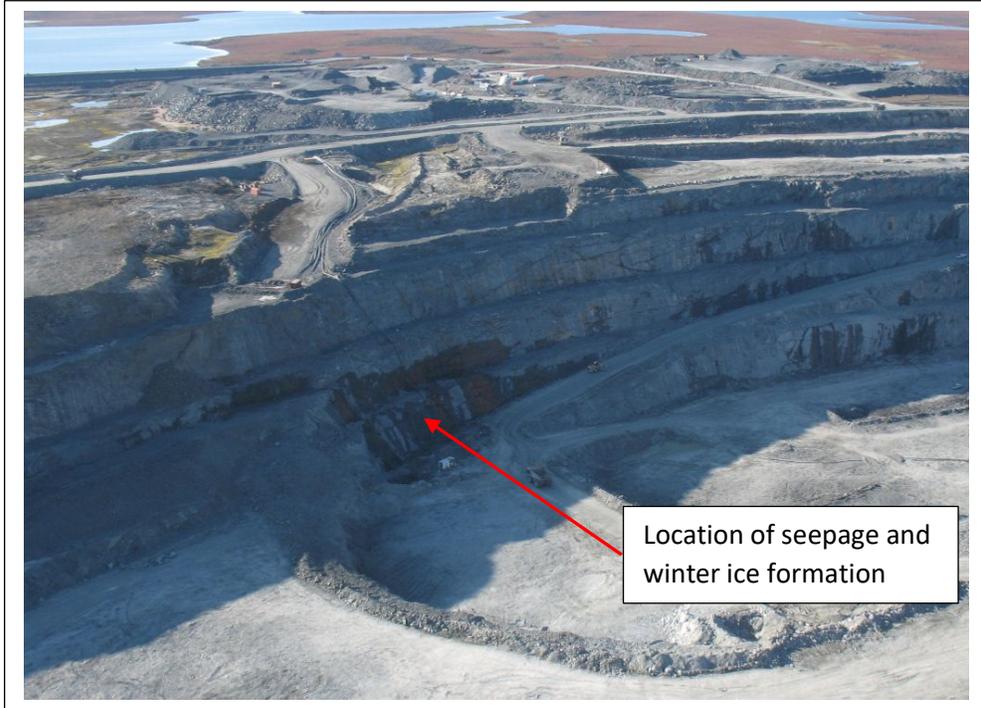
The current system of pumping from the attenuation pond is manageable at present but possibly not optimal for mining. Seepage is noted on the south-east wall of the Whale Tail Pit (Photo No. 17) and significant ice accumulation has been observed. This is presumed to be related to the talik (unfrozen lakebed) below the Whale Tail Lake.

Photo No. 17. Amaruq. Whale Tail Pit

The Board was unable to take a first hand look at the pit wall. Mapping of the exposures and associated seepage observations may provide insight into the major conductors within the talik zone. A compilation of all investigation data in the sector between the Whale Tail Dike and the Pit, including information of the thickness and nature of overburden beneath the attenuation pond would be useful. A preliminary evaluation of the practicality and economic viability of lining the attenuation pond to reduce infiltration may be of interest.
