## **Appendix 28**

### **Meadowbank 2021 GN spills reports**

## 2021-01-13 MBK 150KG Sulphur Prill

GN reference #: 2021-010

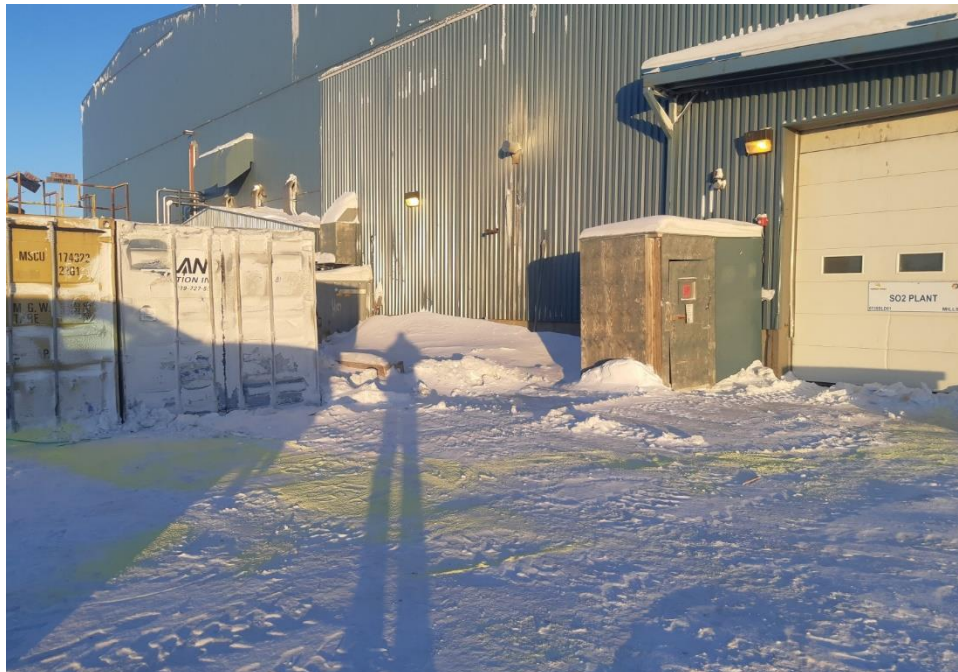
During operations, an operator was removing a mega bag of sulphur prills from a sea can into the Mill. The operator was not aware of the rip and during transport, sulphur prills spilled onto the ground and on the sea can floor.

Ripped mega bag of sulphur prills.

A routine visual inspection will be completed prior to the removal of Mega bags when transporting from sea can into the Mill.

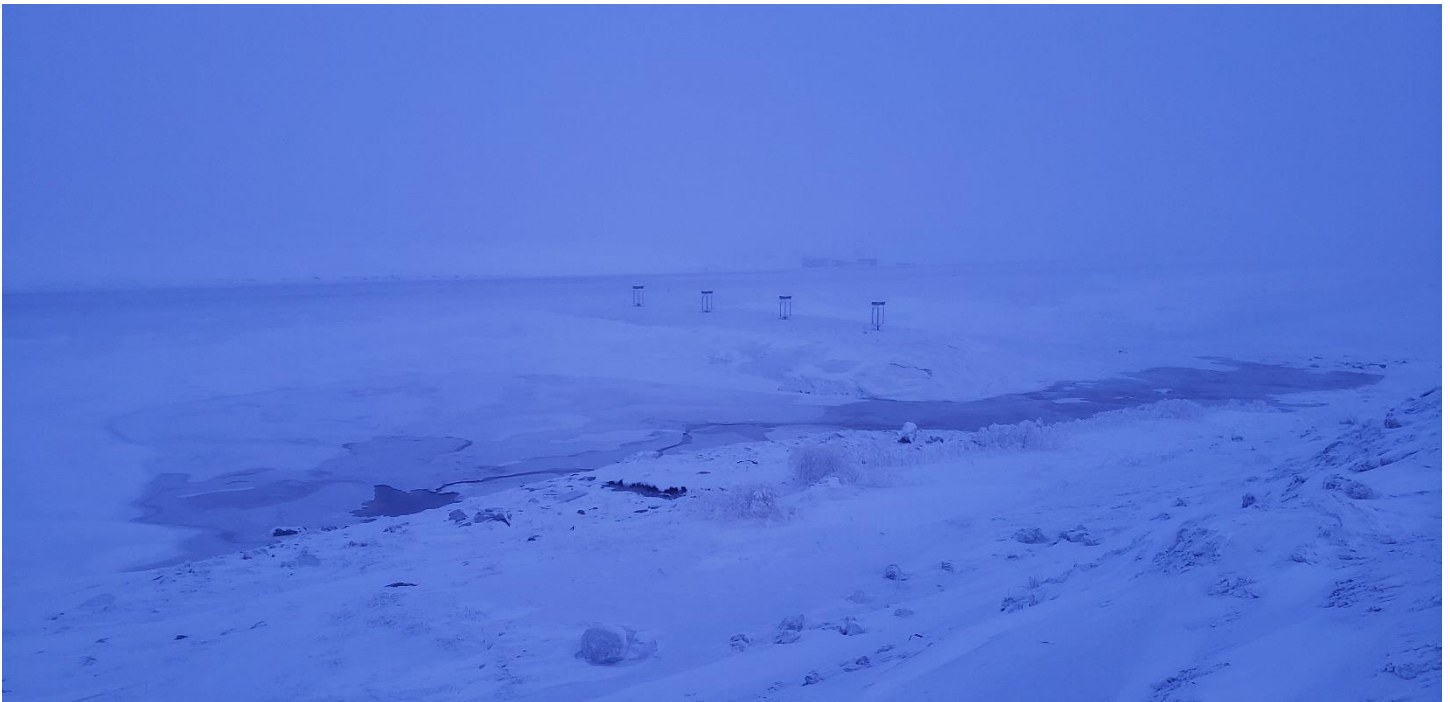
During inspection of the Meadowbank site, water was found near the air strip. Upon further inspection, water was determined to be originating from discharge line of treated greywater towards Stormwater Management Pond.

The end of the discharge pipe froze and plugged resulting in damage further up the pipeline from the discharge.

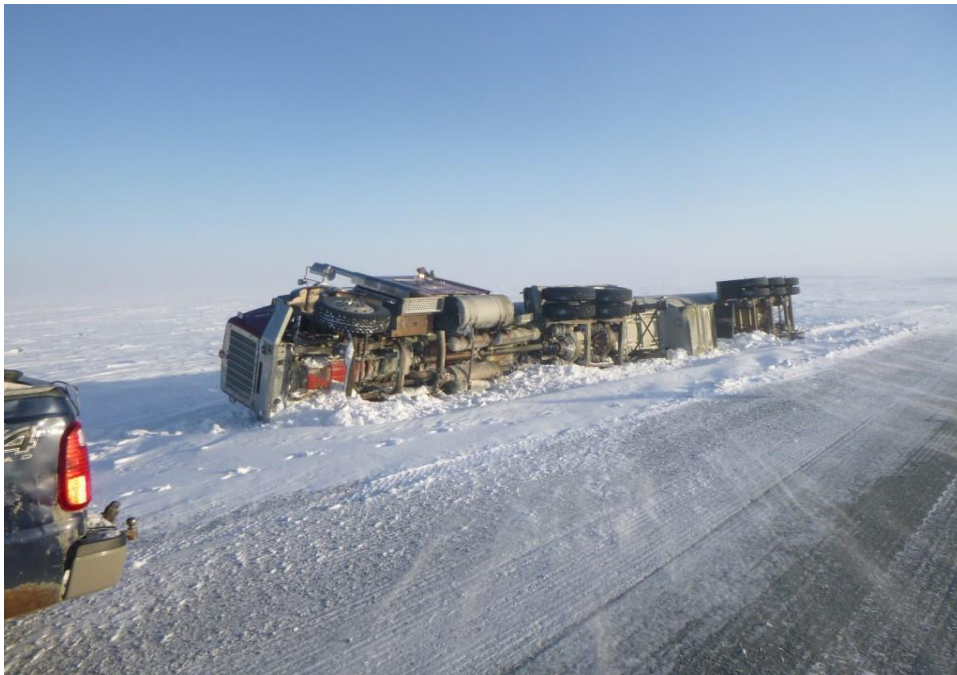
During operations, an operator was traveling North on the All Weather Access Road (AWAR), when it went off the road and tipped over on it's side.

A routine visual inspection of all systems is performed during pre-operations checks as a part of the preventive maintenance program. A review of AWAR procedure will also be completed by the AFS drivers.

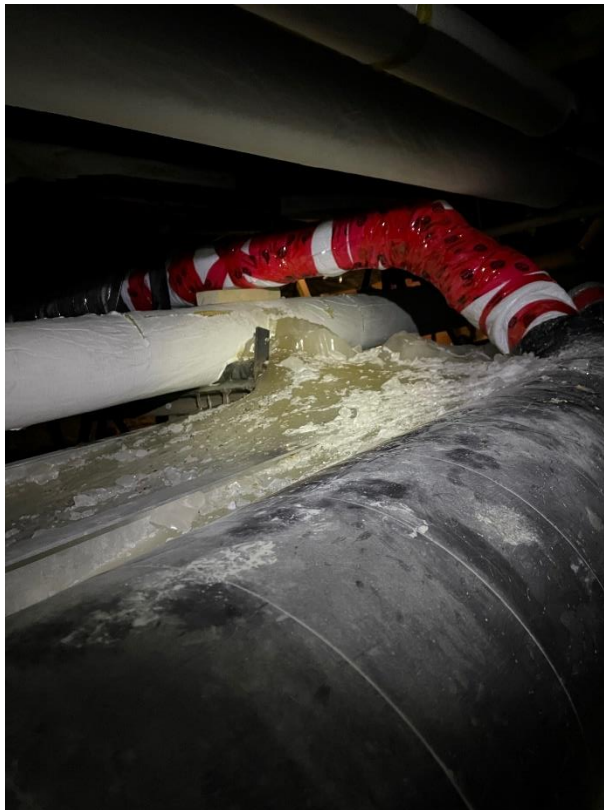
During process of investigating issues in the sewage drain piping of wing #4 of the Meadowbank Camp, the sewage piping was found to be cracked and frozen. In the process of repair and clearing of ice, roughly 50L of sewage water was spilled under the building and froze in place, covering 2m<sup>2</sup>.

Damaged sewage line due to freezing temperatures.

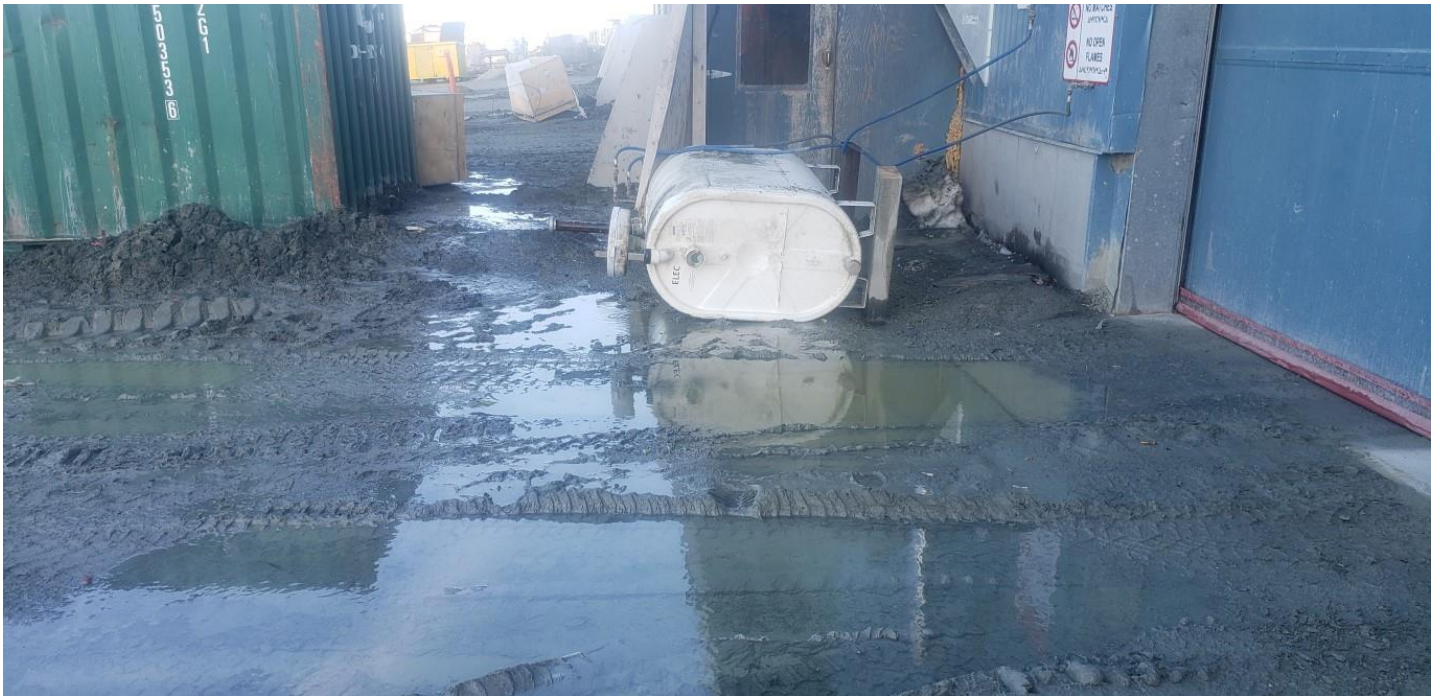
During operations at Meadowbank, a 1000L fuel tank was found to have tipped over near the maintenance shop, due to melting of ice under the tank. 500L of fuel leaked from the breather valve while tank was on its side.

All tanks around site were inspected, and anchoring requirements reviewed to mitigate reoccurrence potential. Furthermore, heating design of maintenance shop is being reviewed to explore possibilities to remove the need of supplemental fuel in this location.

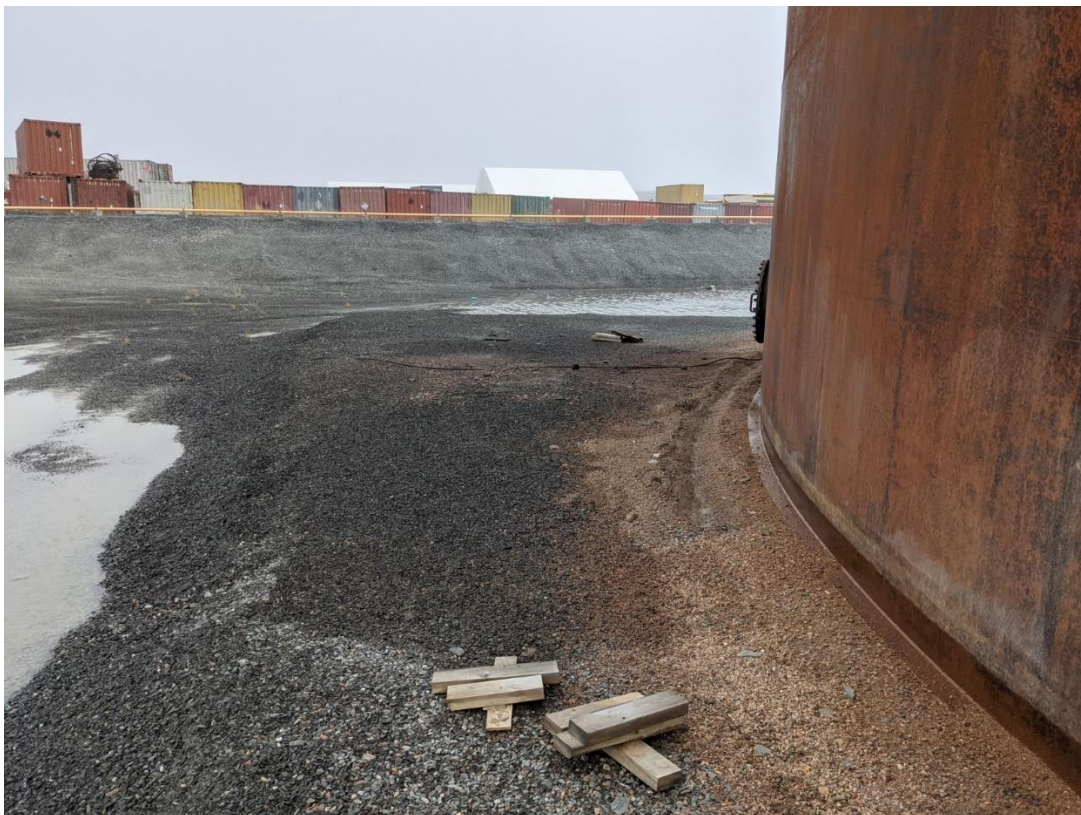
During a routine inspection, a small presence (10m<sup>2</sup>) of diesel fuel was observed in the secondary containment of the Meadowbank Fuel Tank. Further investigation has failed to demonstrate any new inflow of fuel in the secondary containment. No conclusion has come to as the origin of the fuel. The spill report was communicated in the spirit of transparency, and by due diligence, as the fuel is fully contained within the secondary containment.

Any potential deficiency identified in the inspection process of the fuel reservoir will be addressed and corrected to recertify the tank.

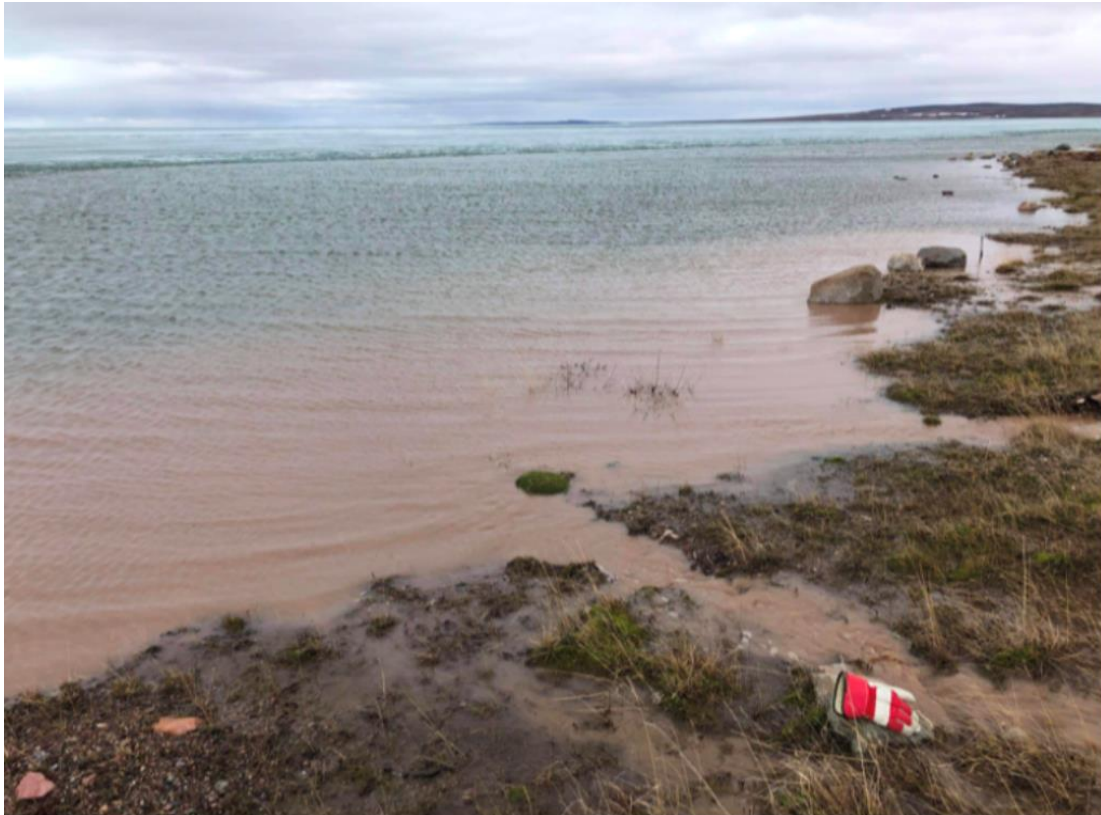
The pad extension works were immediately stopped and sampling was performed. Internal TSS sampling results, taken at the time of the event about 1 meter into the lake where visible plume was noted, indicated 335 mg/L of TSS. Upon return to Baker Lake with the appropriate sampling material the following day (June 26<sup>th</sup>), various parameters were sampled, at the same location as the internal sample, through an external accredited laboratory (TSS, metals, oil & grease, C10-C50 hydrocarbons) as well as an acute lethality of effluent to *Daphnia magna* and *Rainbow Trout* sample. The result of these analysis showed no result of concern, as all tested parameters, with the exception of TSS values of 3 mg/L, are within the water quality baseline range of Baker Lake, and no toxicity to *Daphnia Magna* nor *Rainbow Trout*.

View of the shore of Baker Lake – June 25, 2021

Fully saturated overburden excavation, combined with surface runoff from rain and snowmelt, caused turbid water runoff into Baker Lake. This TSS event was caused by the lack of temporary mitigation measures to minimize the migration of TSS during the construction works.

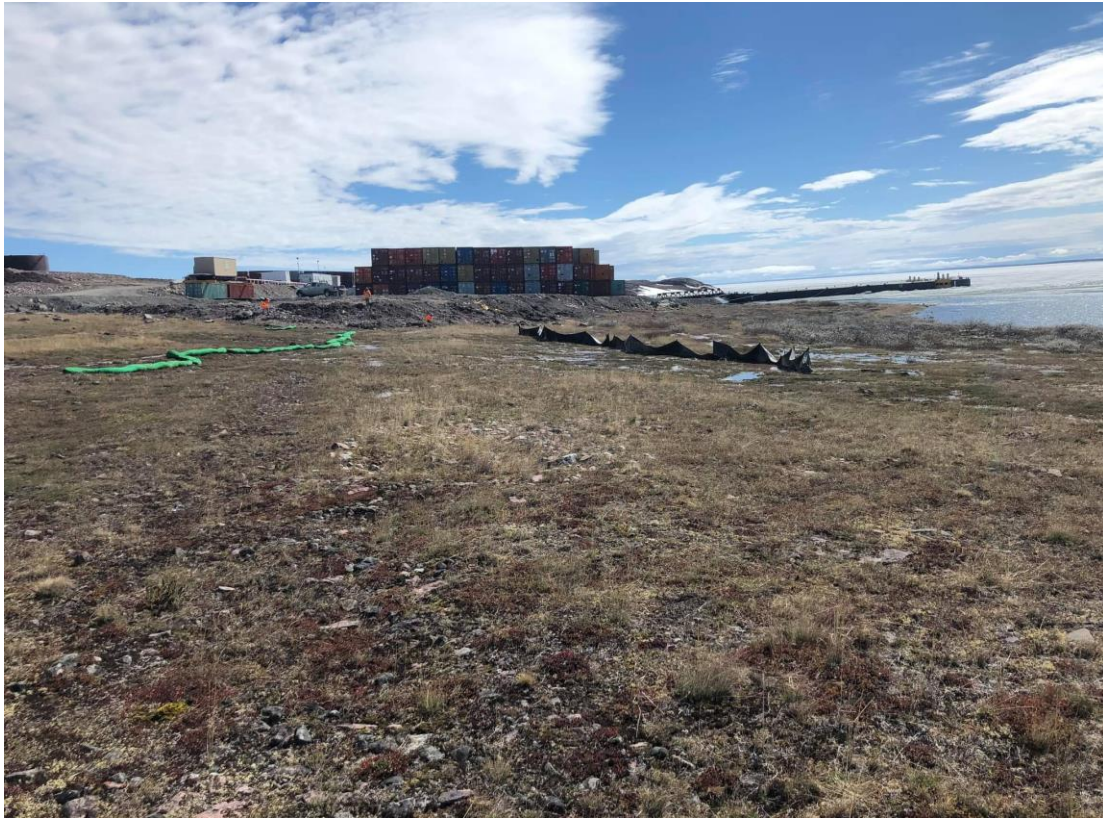
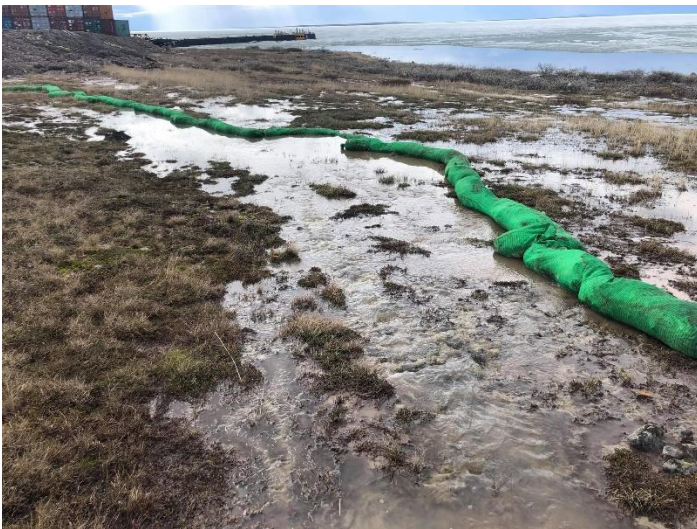
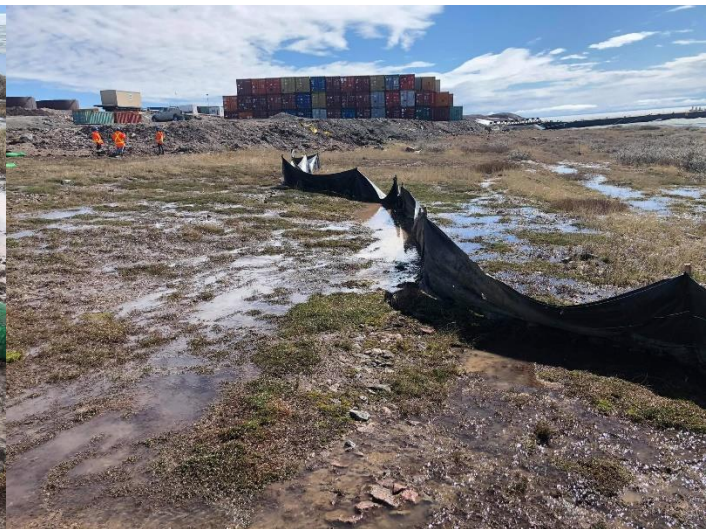
Implemented Mitigation Measures – June 26, 2021

Besides, internal samples were immediately collected on June 25<sup>th</sup>, and external sample were collected the morning of June 26<sup>th</sup>. Water quality monitoring was performed on a weekly basis thereafter to ensure sustained normal water quality, and stopped as no lasting water quality impacts on the shoreline could be identified. As part of the Core Receiving Environmental Monitoring Program, water chemistry and phytoplankton community sampling will occur in Baker Lake over the course of the summer. Following resumption of construction activities, environmental inspections of the area were increased until July 16<sup>th</sup>.

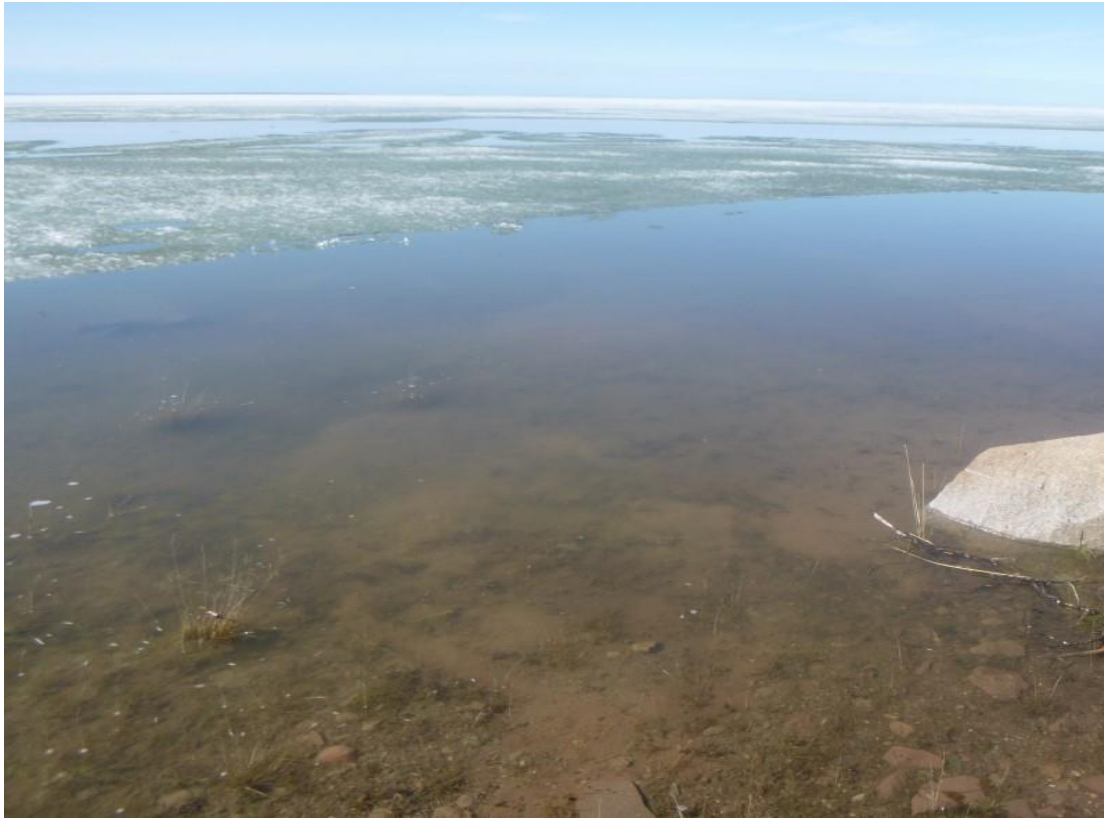
Baker Lake Shore – July 2, 2021

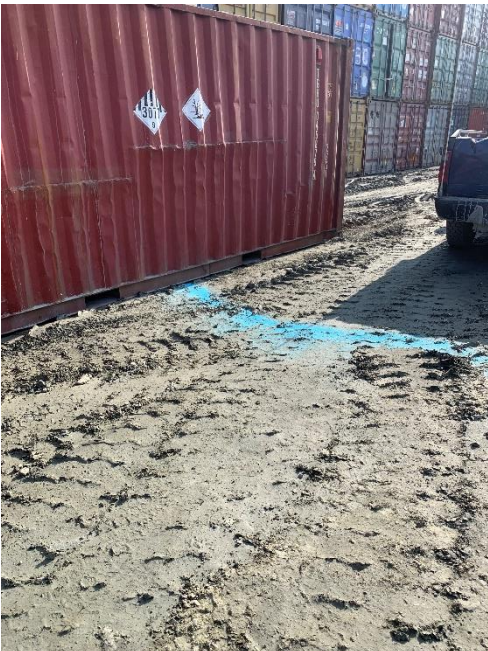
During operations at Meadowbank Complex, a seacan containing bags of cupric sulphate was being removed from a flatbed. Upon lifting the seacan the Hyster operator noticed the cupric sulphate leaking out from the seacan. The seacan was placed on the ground, the faulty container was discovered, and the spill stopped.

Faulty container of Cupric Sulphate coupled with damaged sea can.

A reminder to our logistics department regarding the importance of performing proper inspections of sea cans before moving them, along with the importance of moving sea cans with dangerous goods safely.

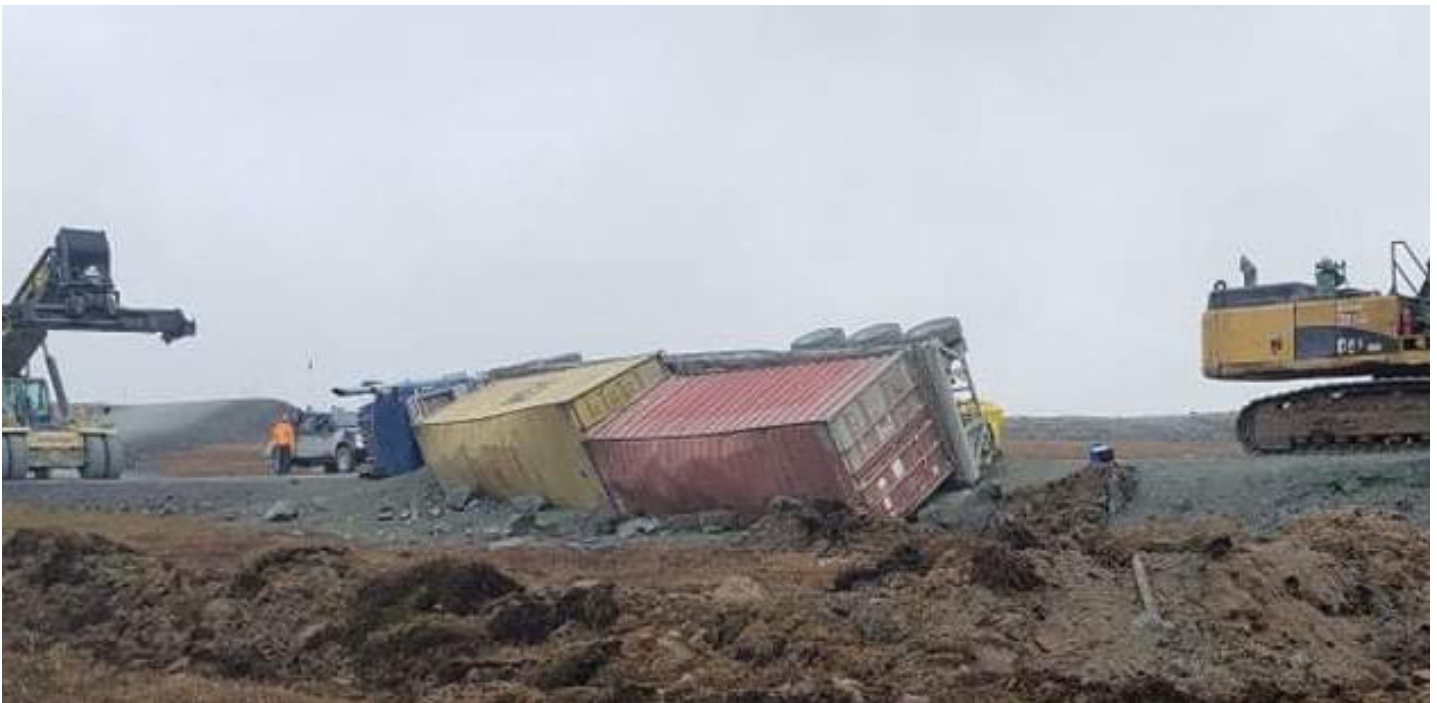
During operations at the Meadowbank Mine Complex, a tractor-trailer, operated by Arctic Fuel Services, transporting one shipping container with coolant, and one with transmission oil, tipped over near KM 103 of the AWAR. Upon the impact with the ground, the containers and part of the cargo were damaged, causing a leak of 9,000L of coolant, 2,600L of oil and 50L of diesel fuel.

*Figure 1. General View of the Incident Location (2021-09-09)*

The spill was caused due to the loss of control of the tractor-trailer, which was caused by excessive speeds.

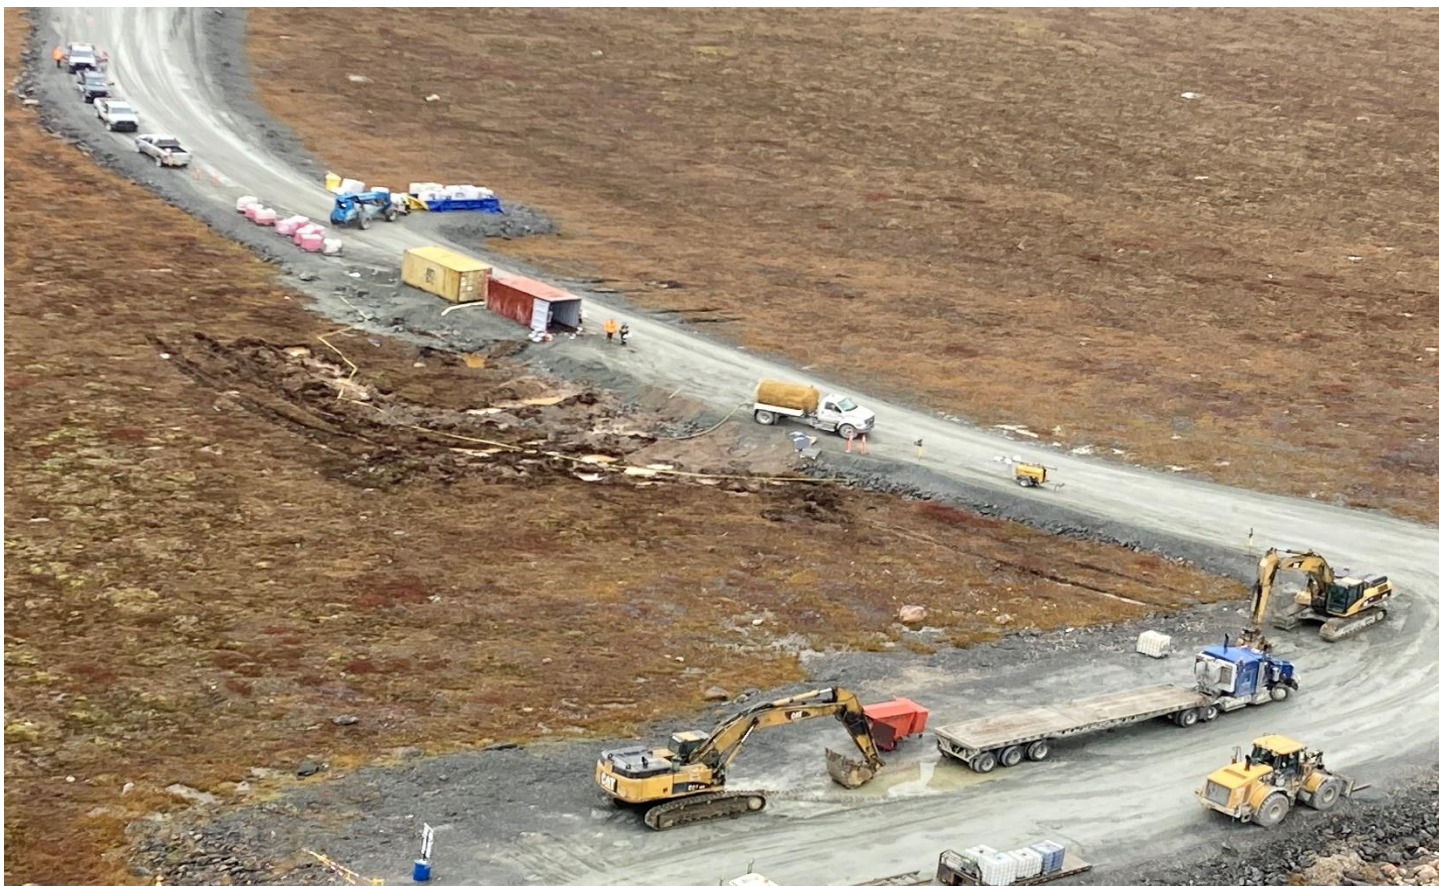
Figure 4. Handling of the Contaminant Source (2021-09-09)

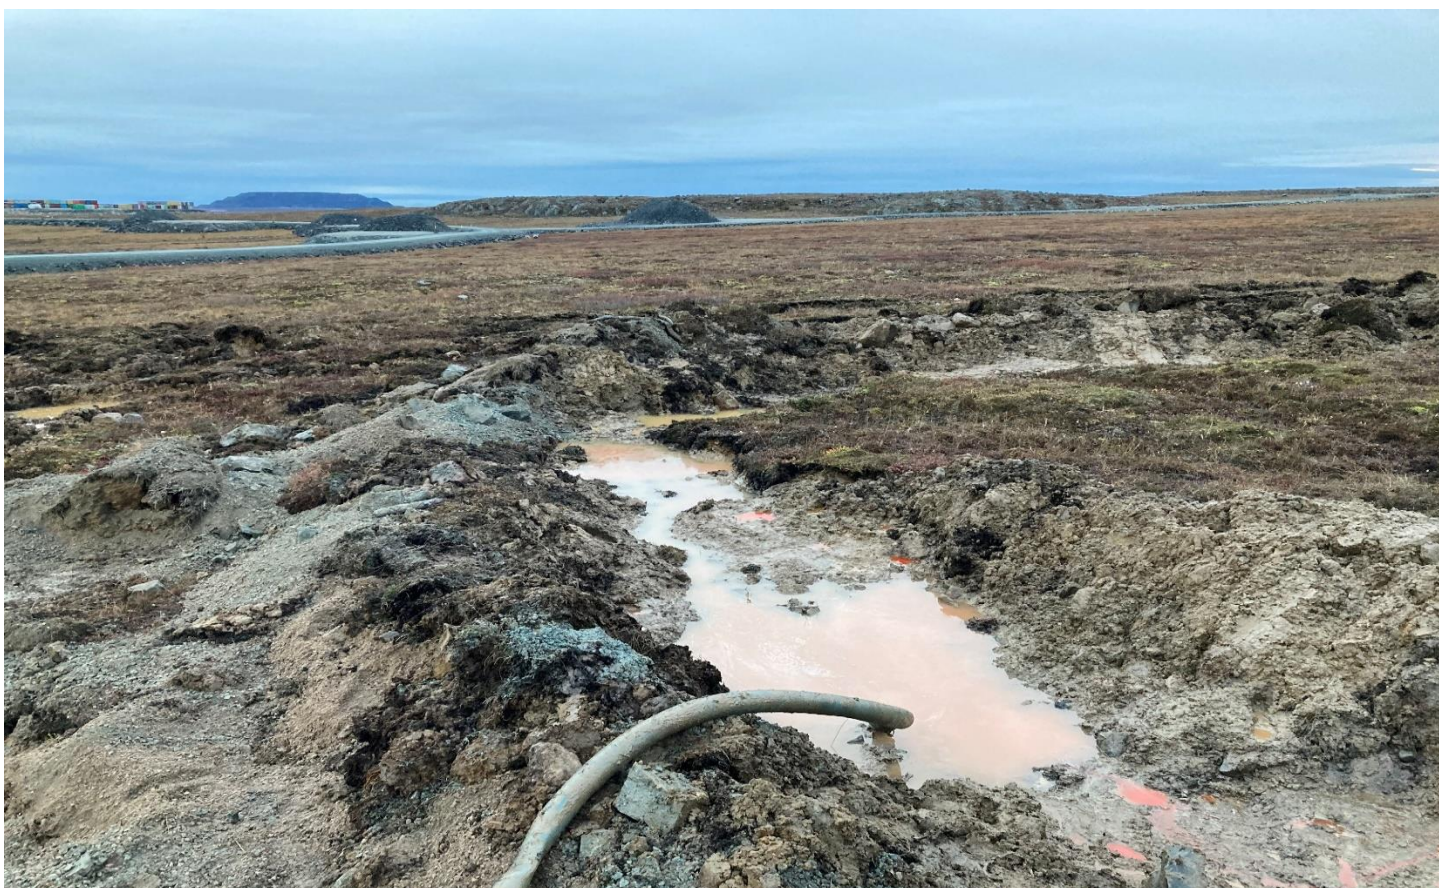
Figure 5. Sump, Trench & Berm Containing Contaminated Runoff (2021-09-09)

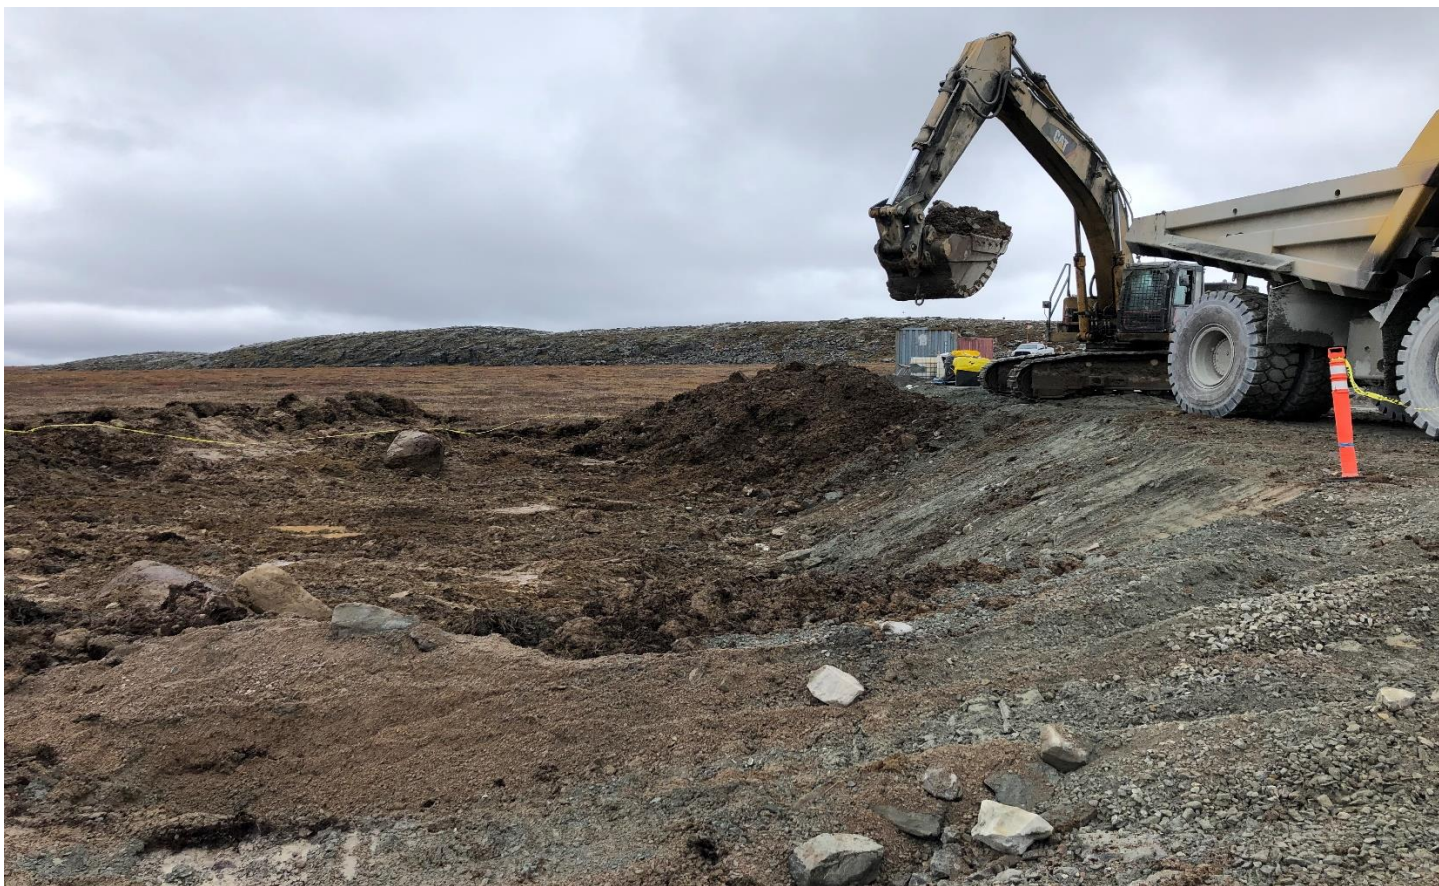
Figure 6. Excavation of Contaminated Soil (2021-09-10)

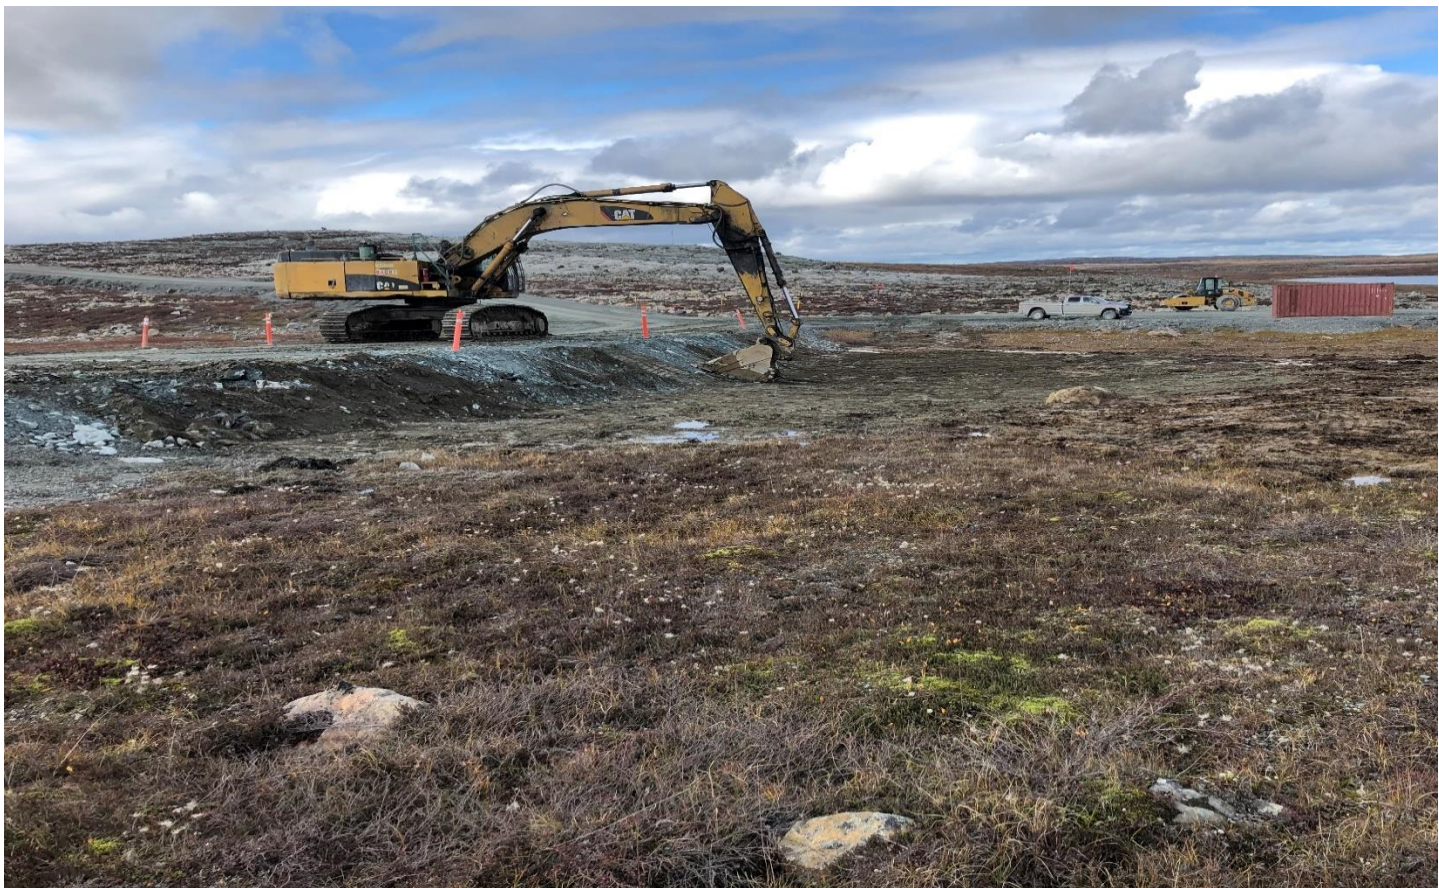
*Figure 8. Incident Location Backfilled with Till Material (2021-09-12)*

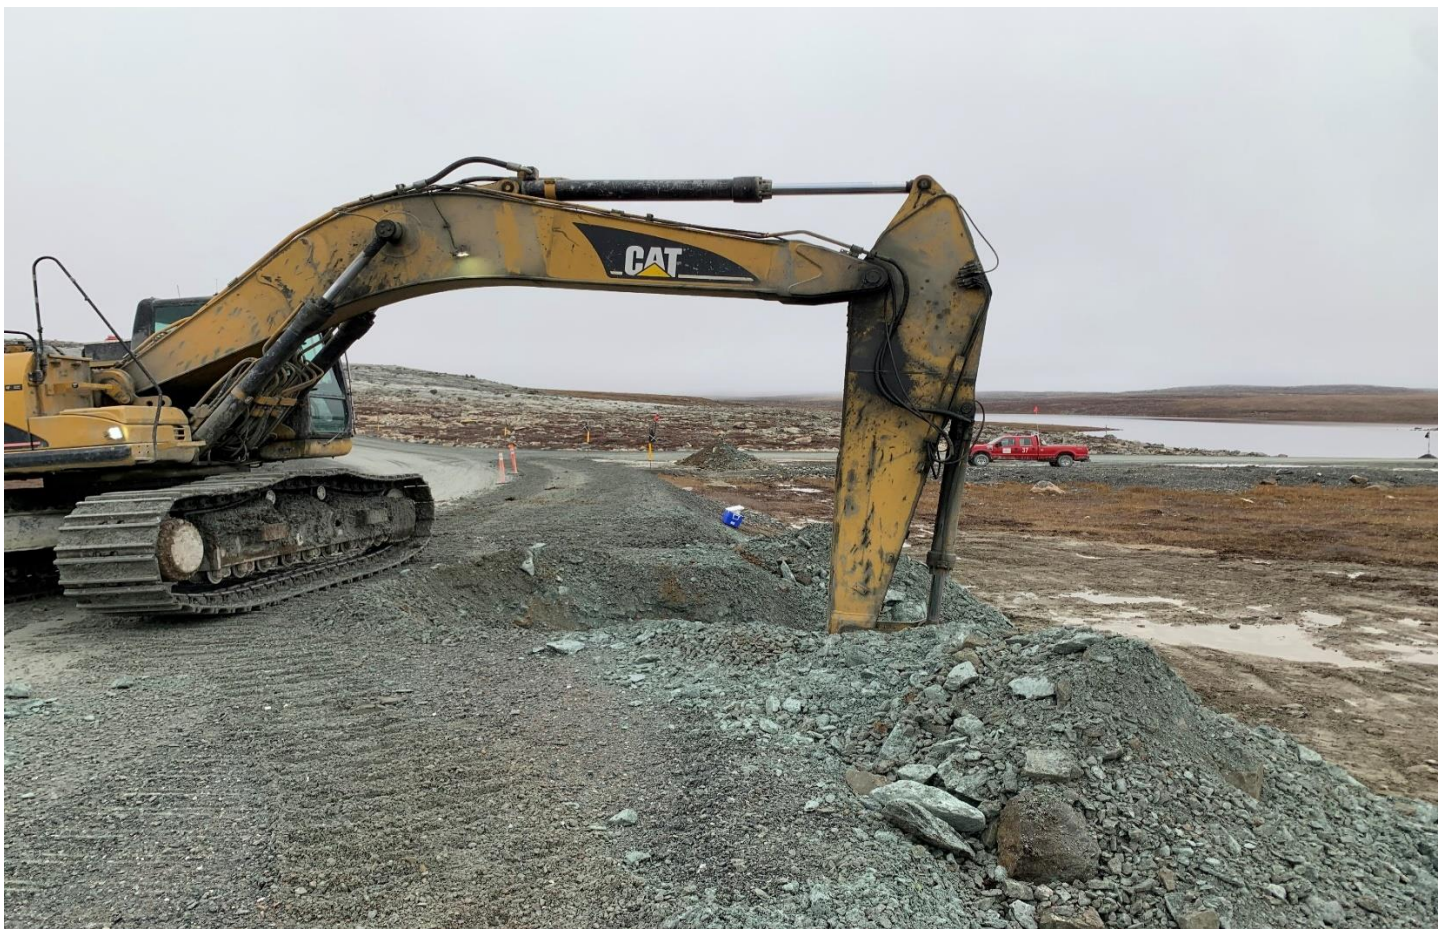
*Figure 9. Additional Excavation - Spill KM103#2 & 5(2021-09-26)*

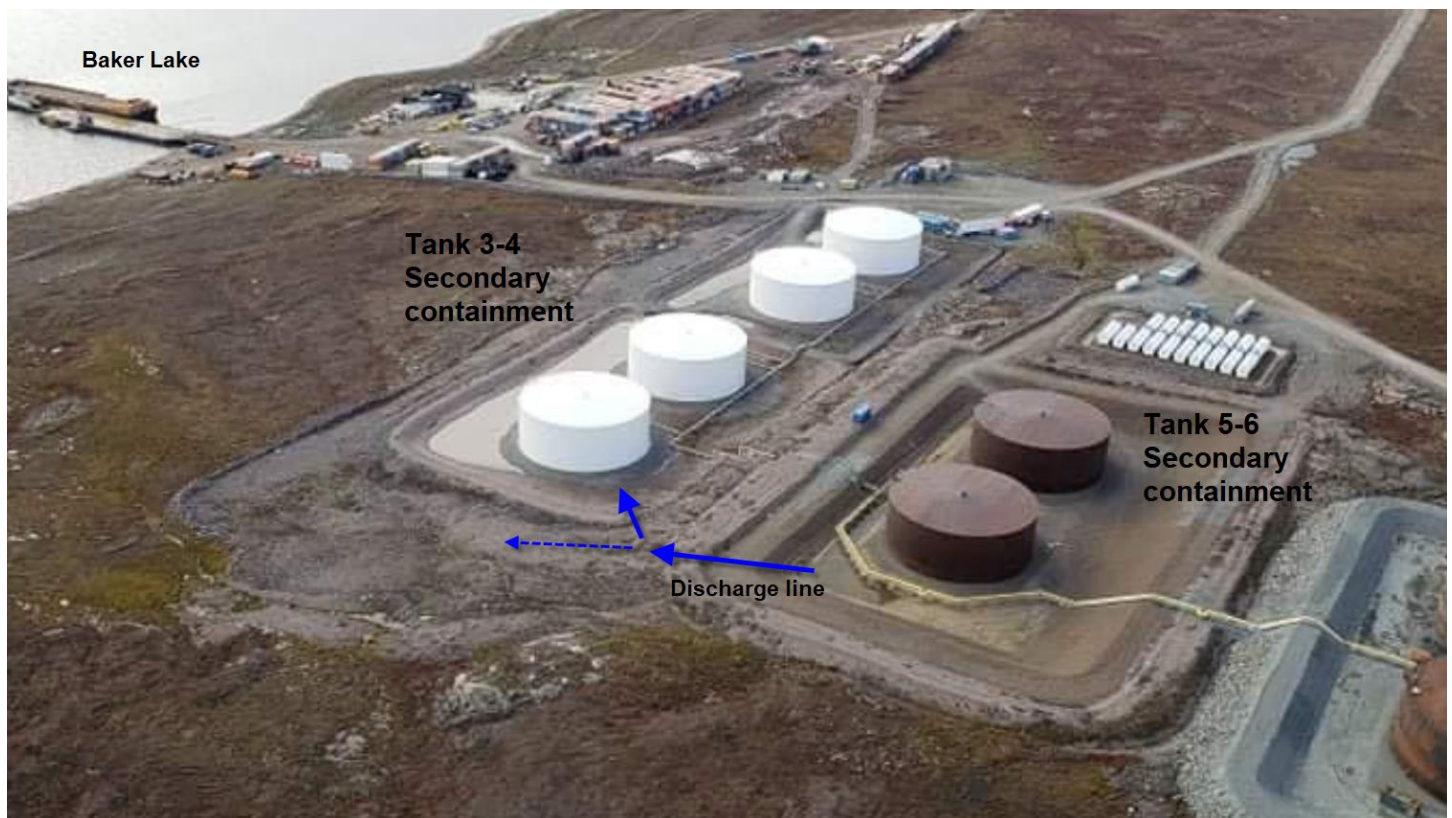
*Figure 1. Aerial view of the spill location (2021-09-11)*

The spill was caused due to the misplacement of the discharge pipe of water transfer between ST-40.1 and ST-40.2. The employee intended to place the discharge pipe in an area for the water to report directly into the secondary containment of tanks 3 & 4, but the actual water flow did not fully report there.

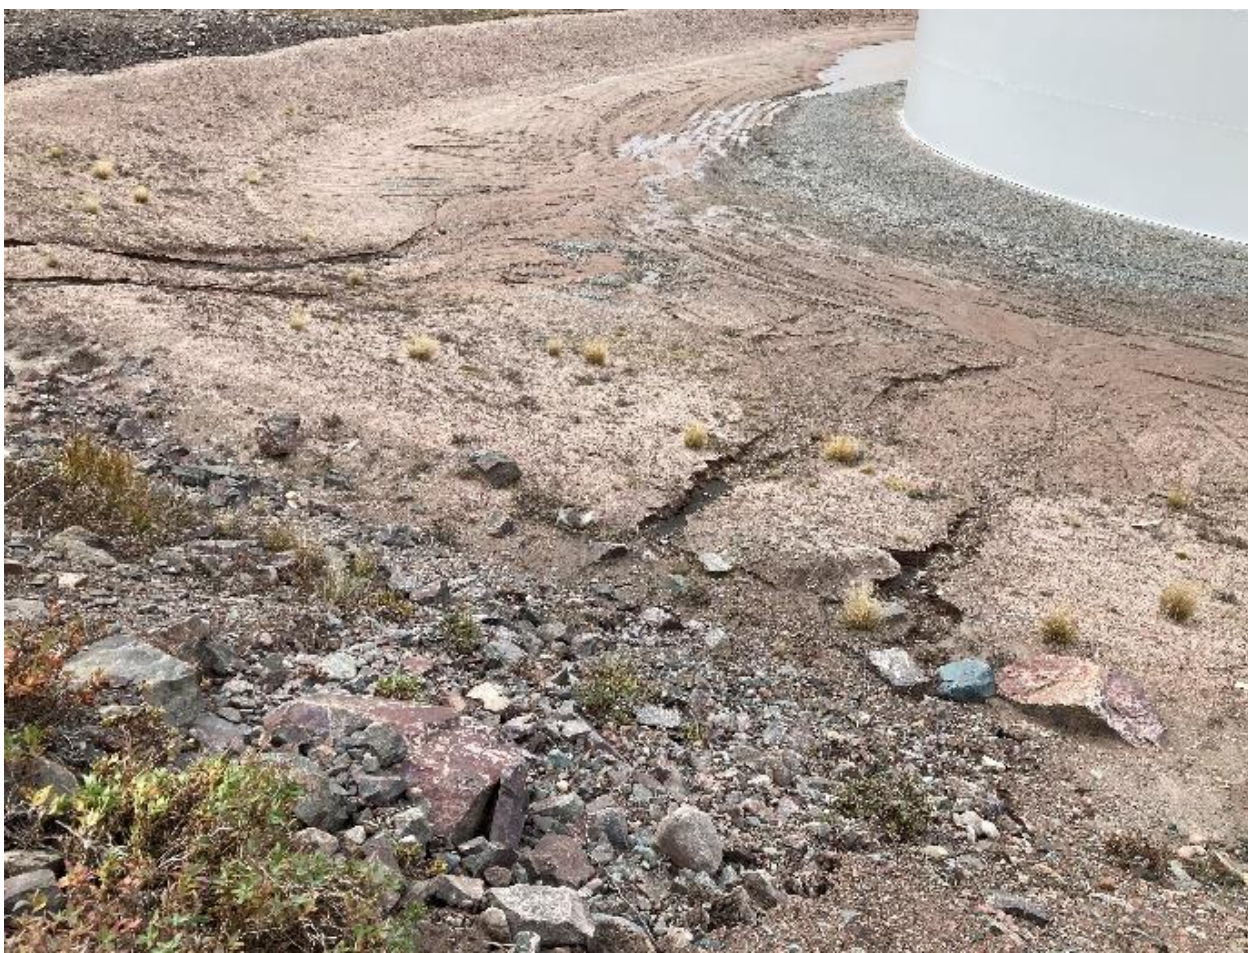
*Figure 5. Discharge Area in Secondary Containment of Tanks #3-4 (2021-09-11)*

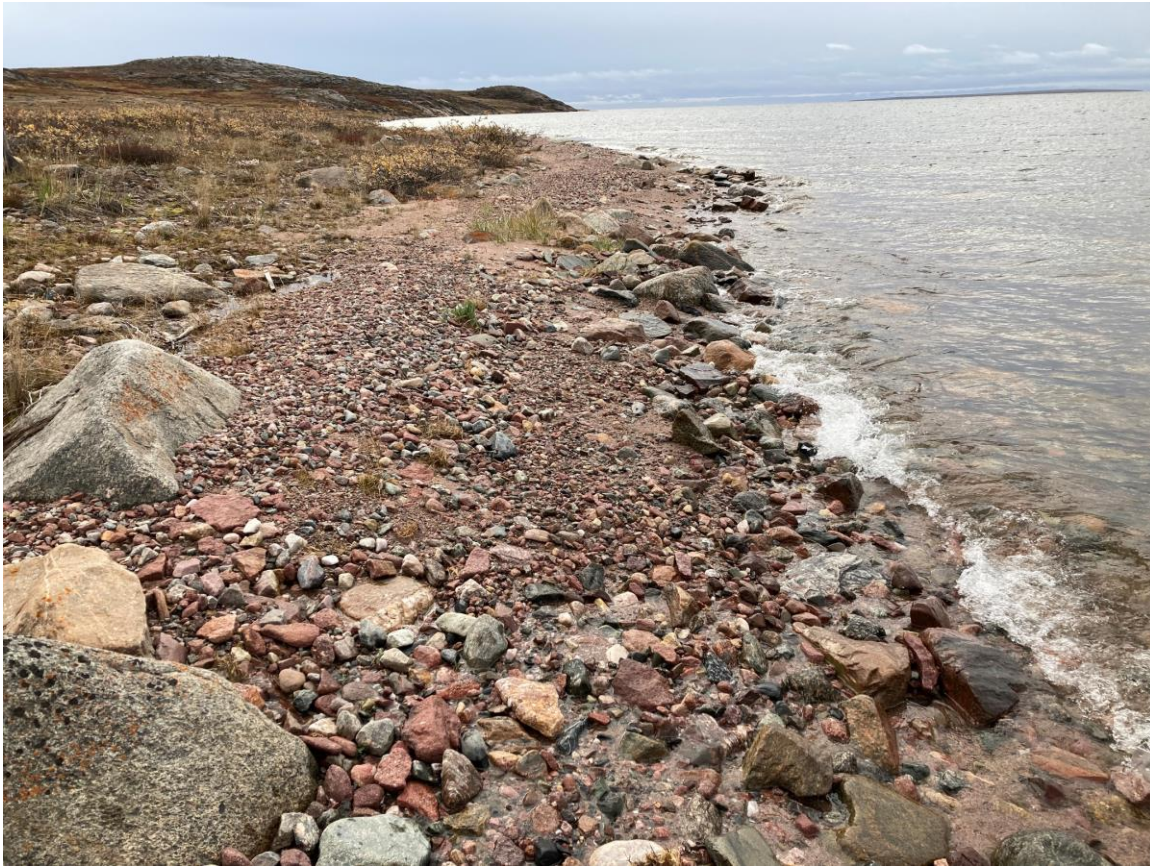
*Figure 6. Baker Lake Shoreline (2021/09/11)*

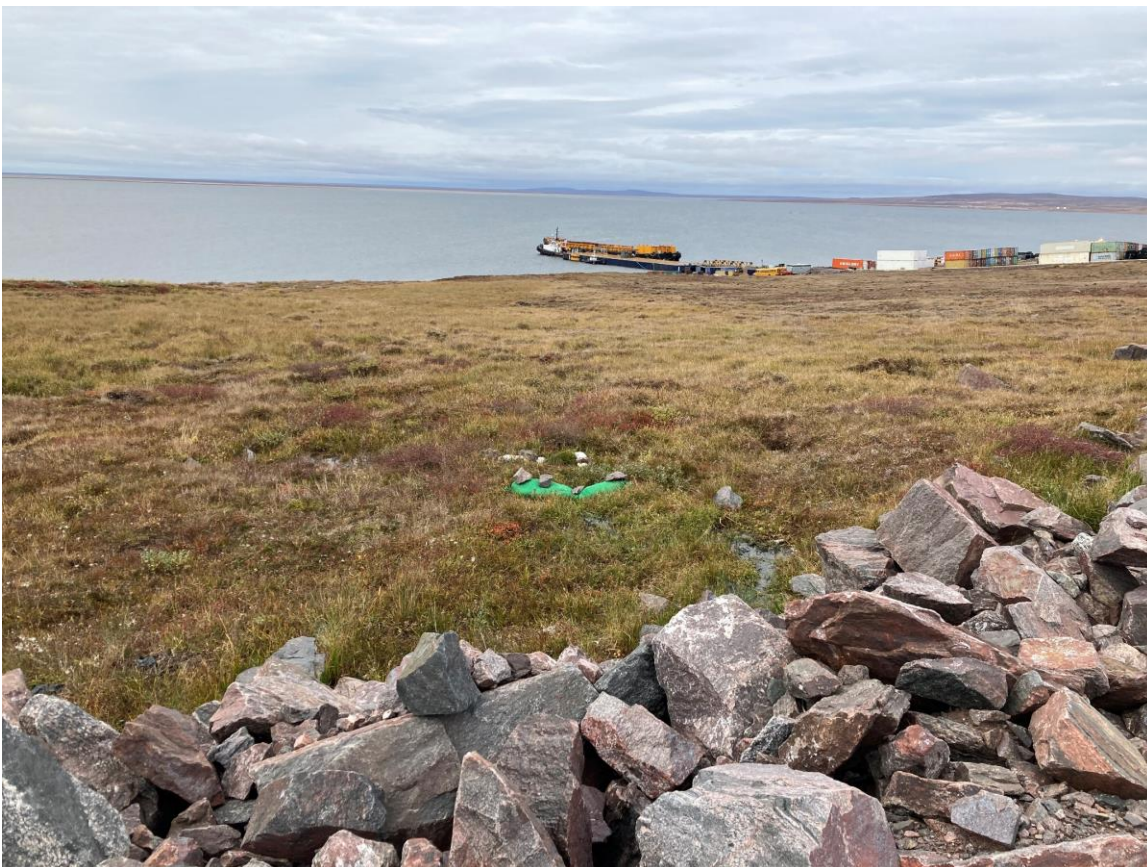
*Figure 7. Woodchip and Hydrocarbon boom (2021/09/11)*

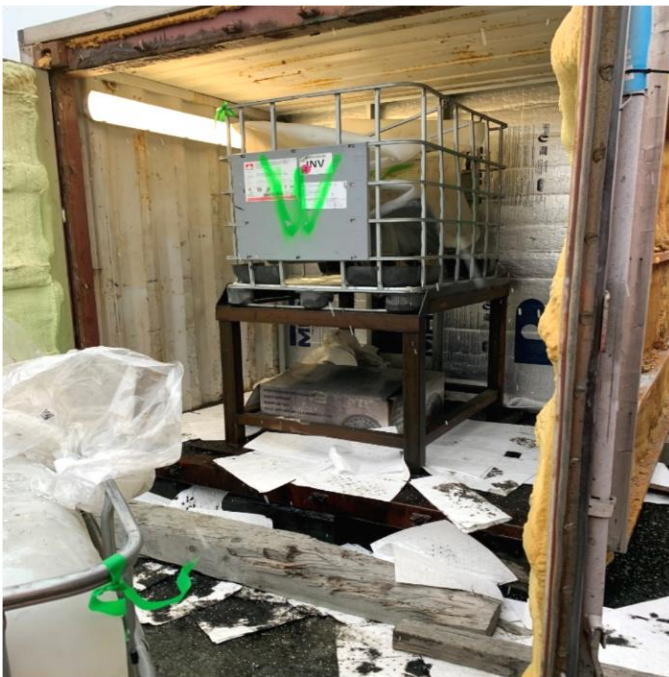
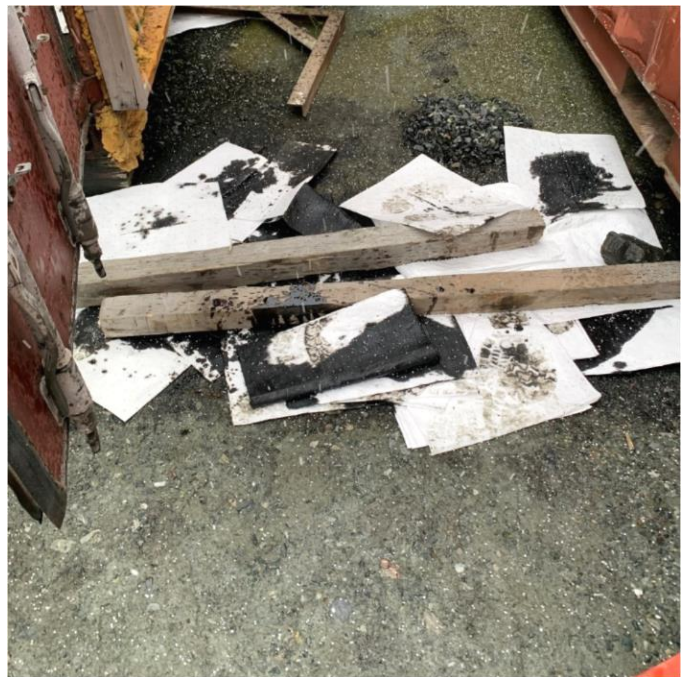
During a furnace inspection at the Meadowbank CAT dome, a spill from the waste oil tote feeding the furnace was observed.
