## **Appendix 28**

### **Meadowbank 2021 GN spills reports**

## 2021-01-13 MBK 150KG Sulphur Prill

GN reference #: 2021-010

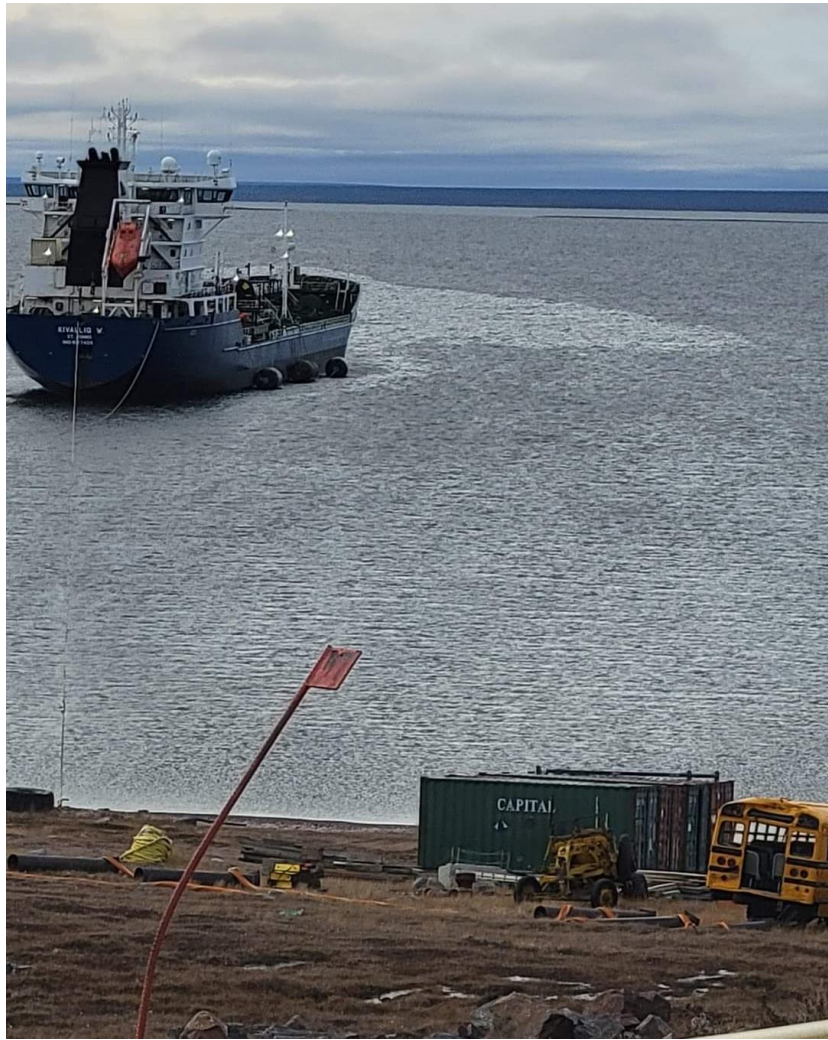
Figure 1. Sheen observed near Kivalliq W. vessel (October 12<sup>th</sup>)

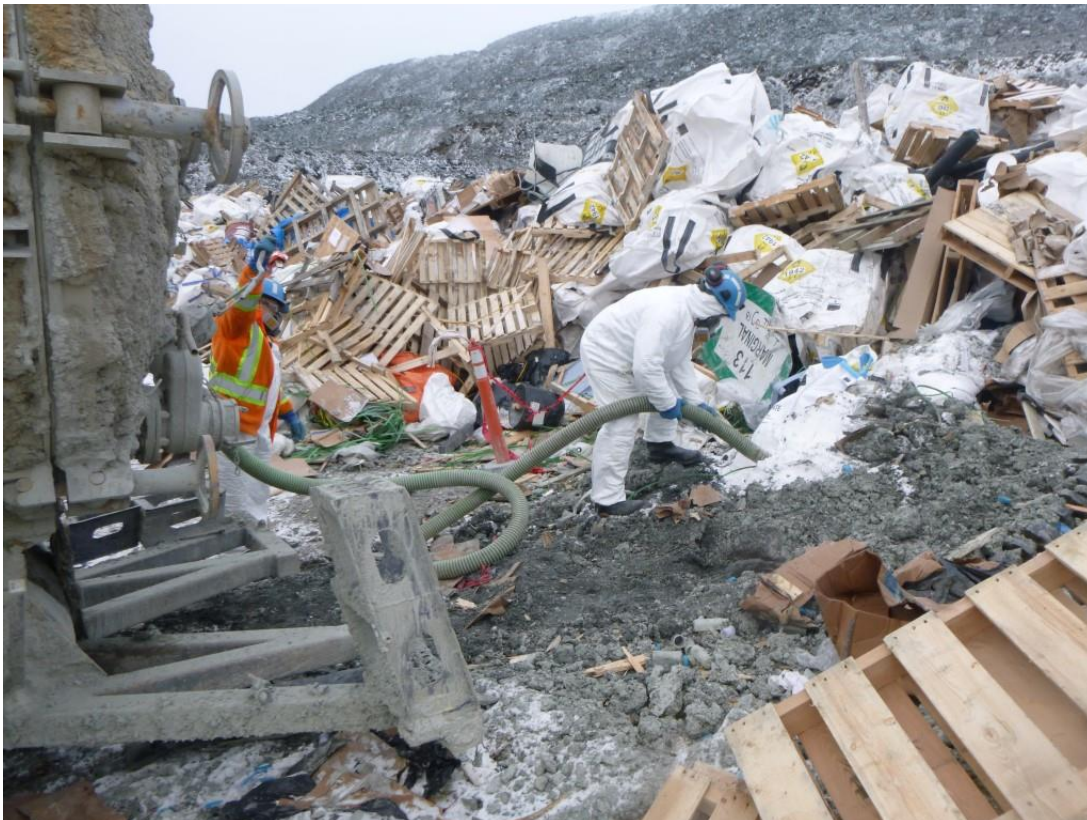
During operations at Meadowbank, a damaged lead nitrate bag was placed into a secondary mega bag to prevent a spill. The mega bag was not properly identified and mistaken for general waste during the next shift and brought to the landfill.

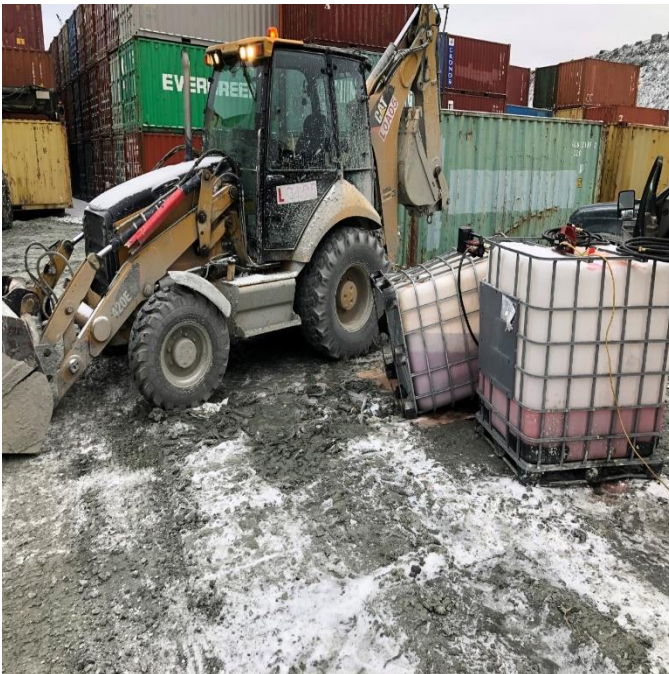
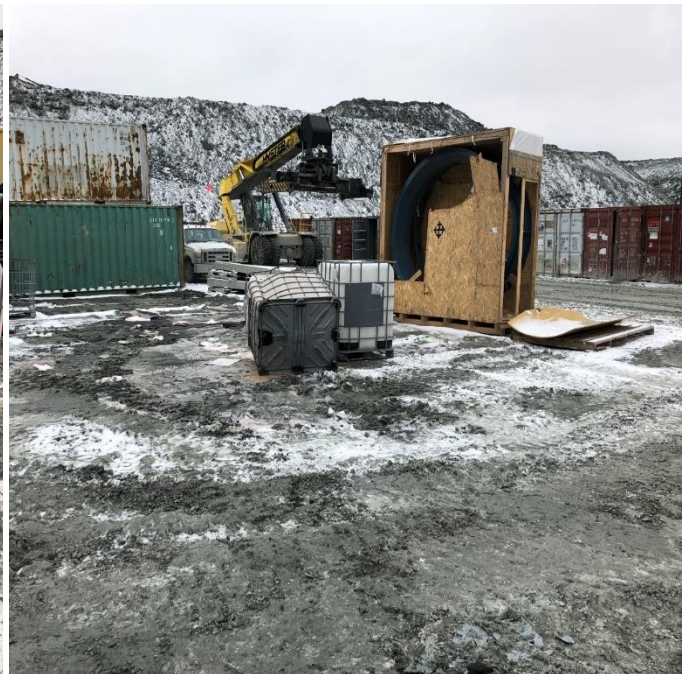
During operations at Meadowbank, an operator was preparing to move totes of coolant in the warehouse transit area. As the operator approached the tote with his boom extended, the forks punctured the tote causing coolant to spill on the ground.

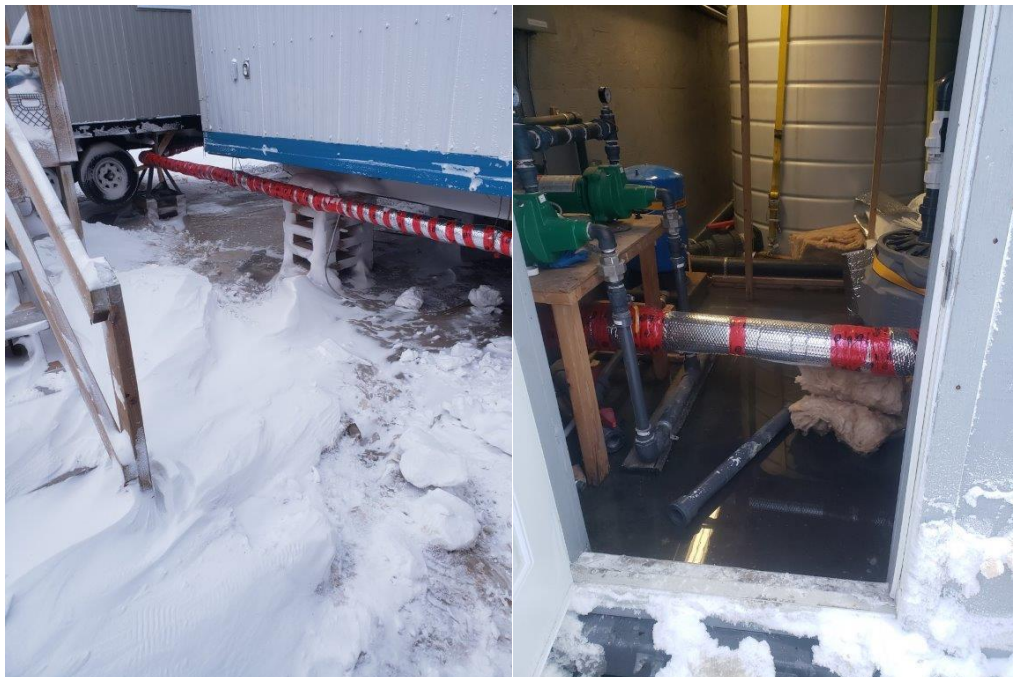
On December 7<sup>th</sup>, 2021 a sewage spill at the Baker Lake Camp was reported to the environment department by the Baker Lake Conservation Officer. A septic tank had overflowed into the seacan and ultimately overflowed to the environment. The line was believed to have been frozen. After investigating the spill, it was determined that ~150L of sewage was spilt.

*Figure 1. Photographs Submitted by Conservation Officer, dated December 7th*

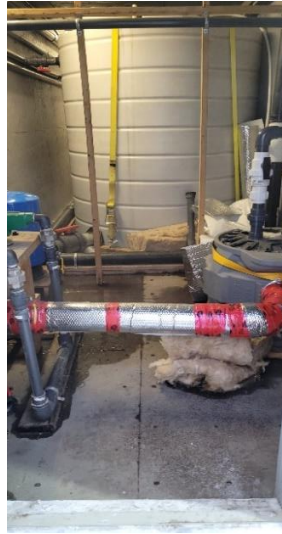
*Figure 2. Septic tank dated December 8th*

The septic tank was drained immediately to stop the spill. Approximately 0.5 cubic meter of the accessible ice has been chipped away and an excavator will be sent to remove further material. Contaminated material will continue to be collected and brought to the Meadowbank Landfarm.
