## **Appendix 29**

### **Whale Tail 2021 GN spills reports**

## 2021-01-01 AMQ 92L Diesel fuel

GN reference #: 2021-003

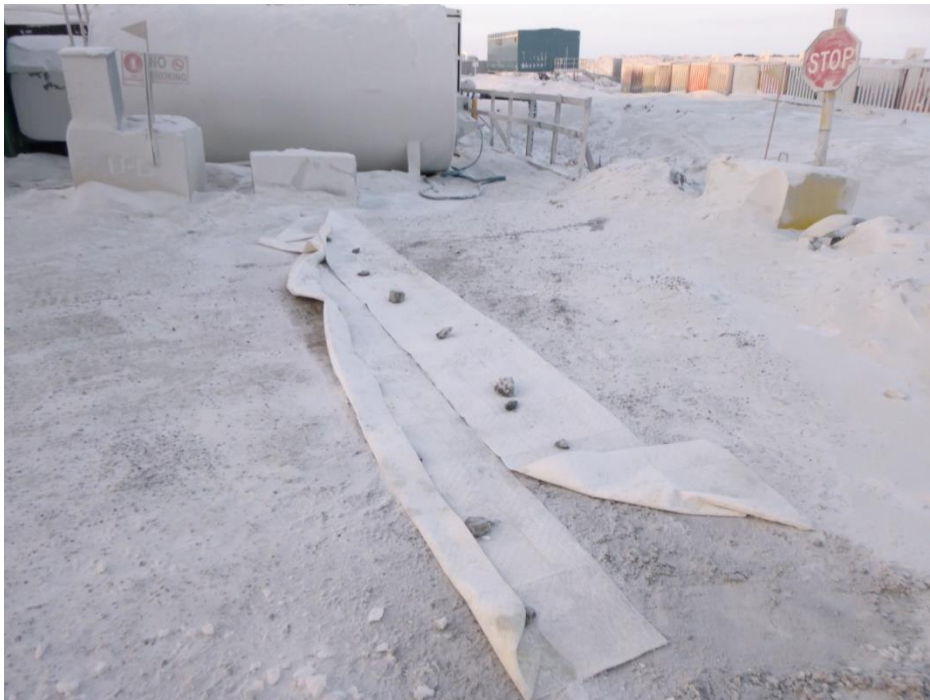
At surface, during refueling of a scoop, the equipment was accidentally overfilled causing 92L fuel to spill onto the ground beside underground equipment maintenance shop.

Scoop #61sco02 was overfilled, by operator error.

Refueling procedure was revised with workers.

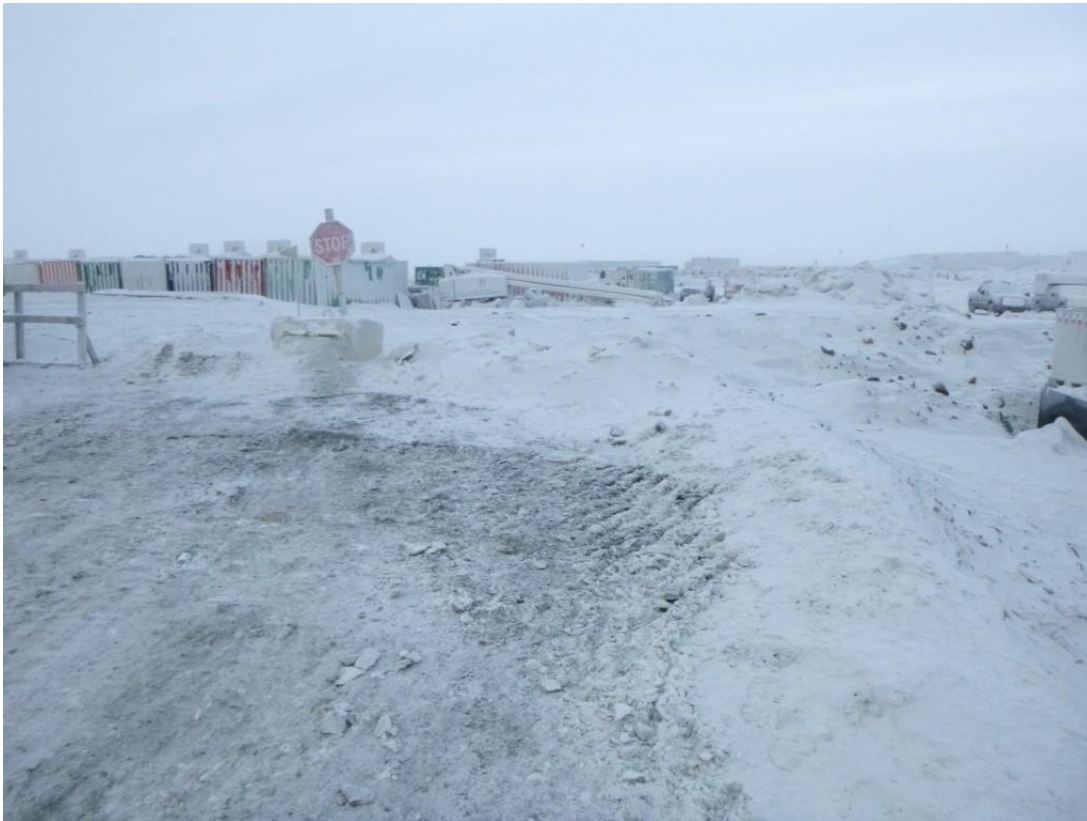
The operator stopped the process and absorbent pads were immediately used to contain the spill, which covered around 6m<sup>2</sup>. Approximately 1m<sup>3</sup> of contaminated ground was collected, and disposed of, in the contaminated soil bin to be brought at the land farm in Meadowbank.

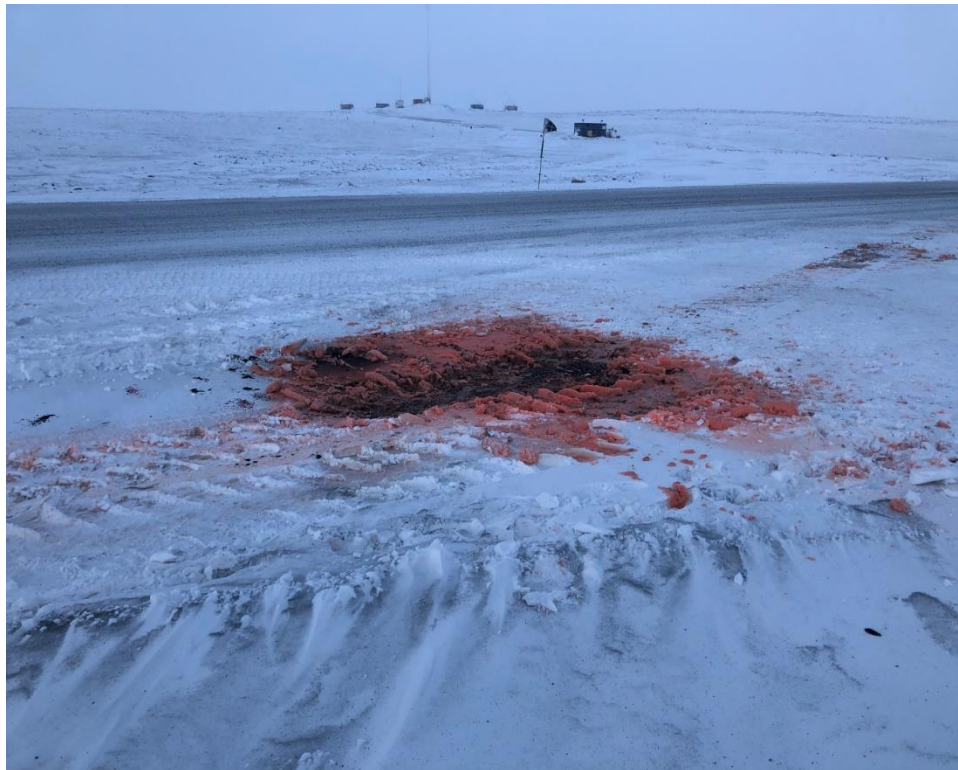
During operations, a radiator hose failure occurred on a haul truck while travelling on the Whale Tail Haul road, spilling coolant on the road.

Radiator Hose failure on Haul Truck 21.

A routine visual inspection of all systems is performed during pre-operation checks as a part of the preventative maintenance program.

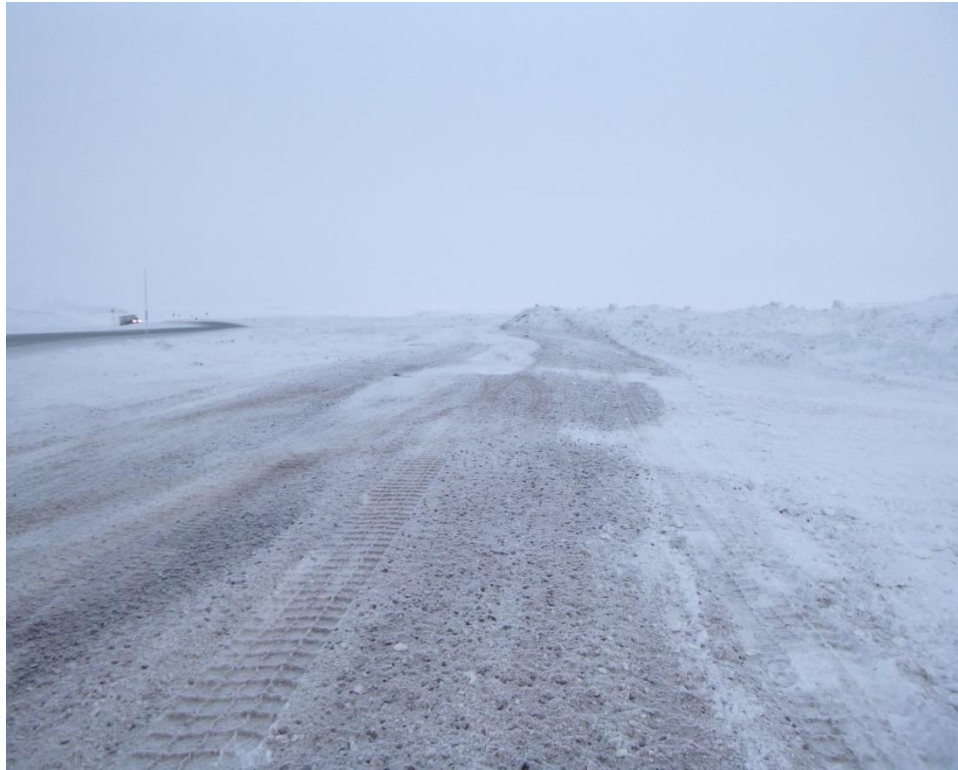
The operator stopped the truck in one of the pull outs and called maintenance. Approximately 6m<sup>3</sup> of contaminated snow and material was collected and brought to the tailings at Meadowbank.

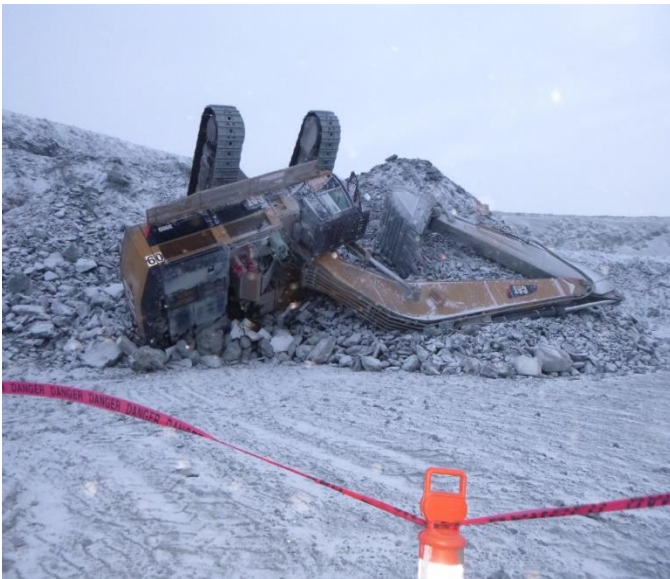
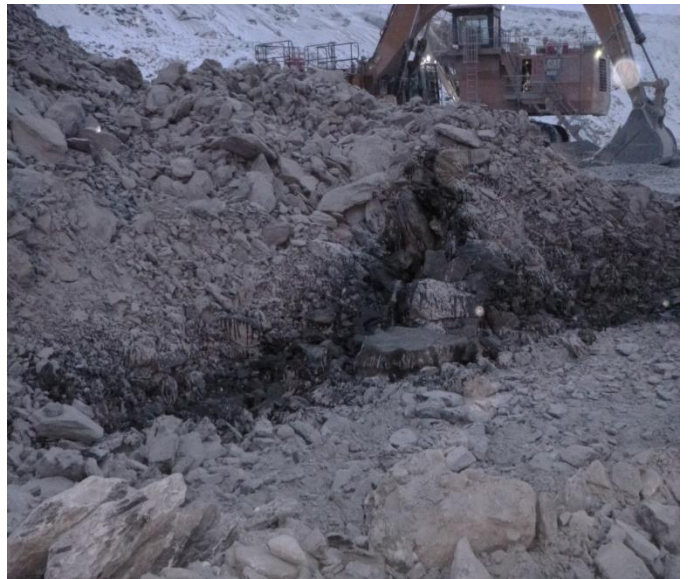
During operations, excavator BAC09 was scaling in IVR pit on top of a catch bench. As he was working to bring down the loose material, the tracks of BAC09 went off the pad causing the operator to lose control and flip the shovel off the catch bench.

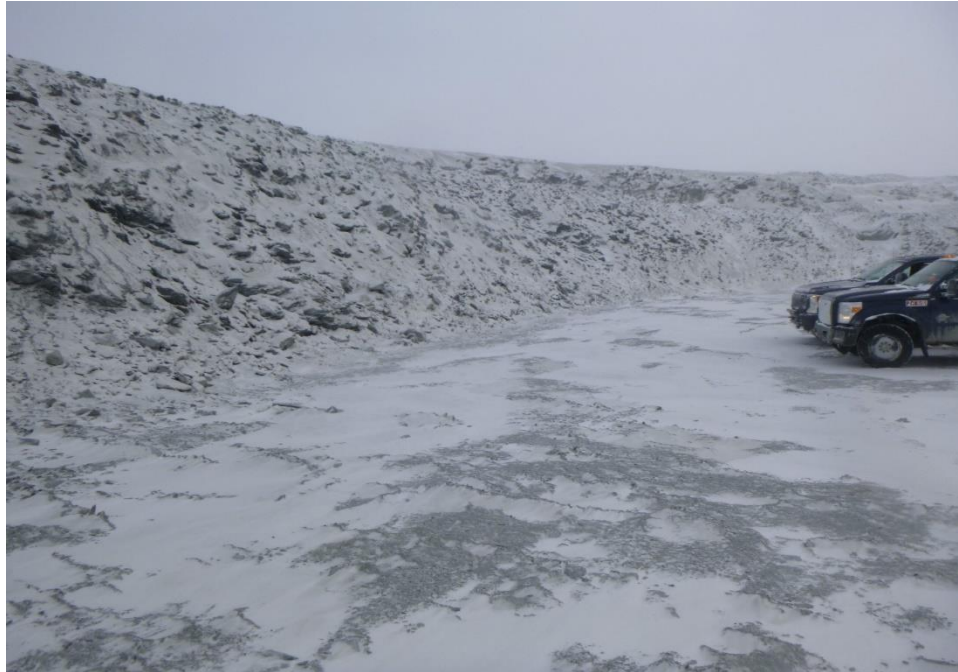
BAC09 flipped causing some damage to hydraulic lines and parts of hydraulic system.

The scene was frozen until a full investigation of the incident could take place. Once the shovel was removed, the hydraulic spill was determined based on the volume remaining in the tank. Approximately 12m<sup>3</sup> of contaminated material was collected and brought to the land farm at Meadowbank.

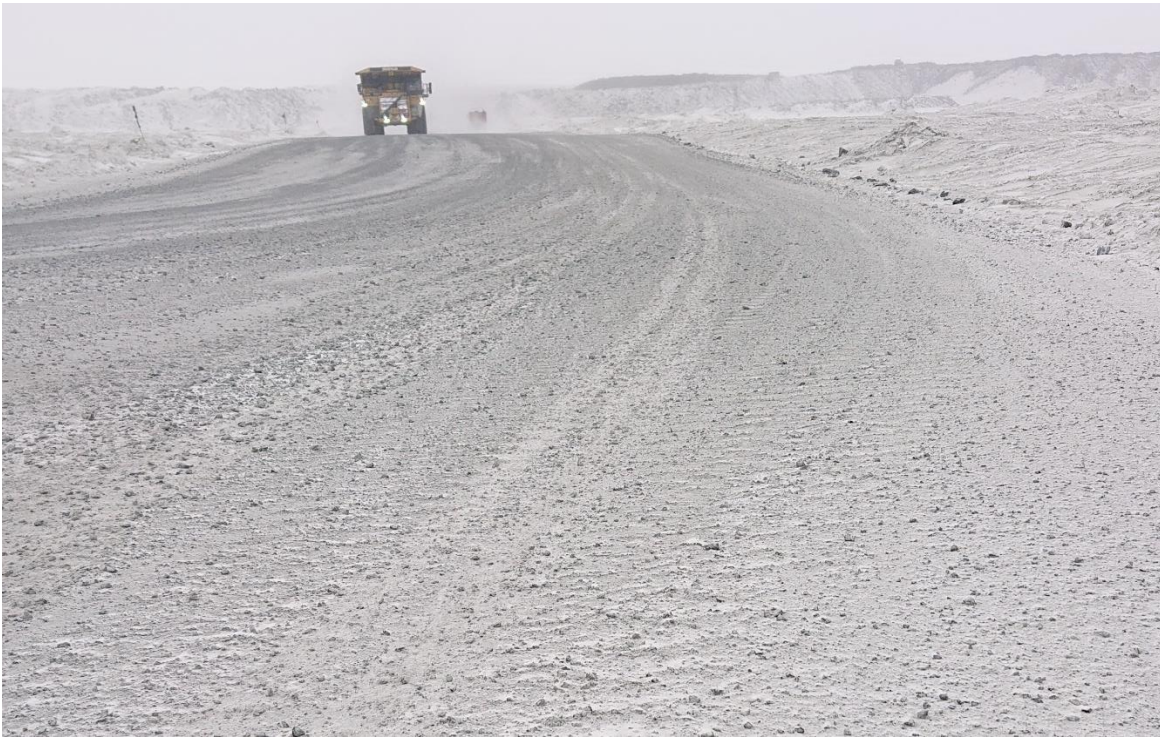
The operator turned off the equipment and called maintenance. Approximately 8m<sup>3</sup> of contaminated snow and material was collected and disposed of in the contaminated soil bin, to be disposed in the Meadowbank landfarm.

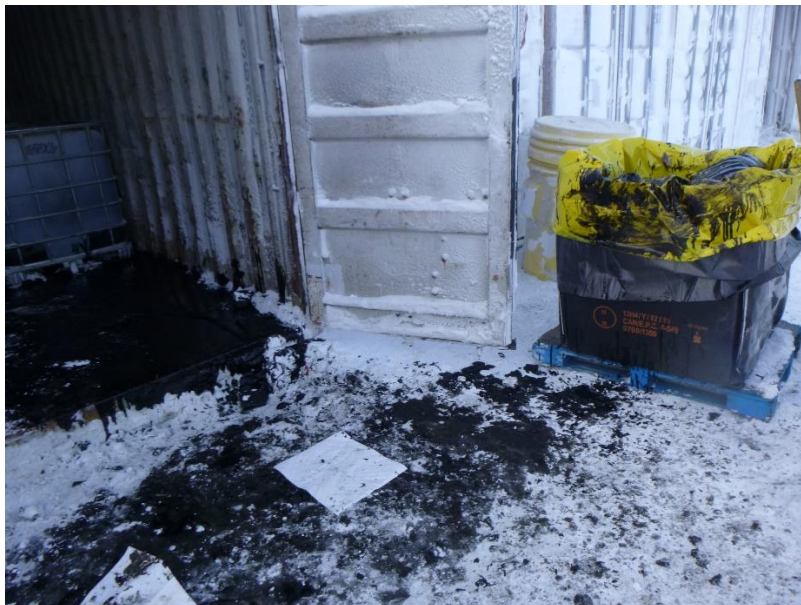
During operations at Whale Tail Pit Project, a waste oil tote containing 1000L of oil was punctured by a telehandler at the Hazmat area. The operator of the equipment quickly flipped the tote and placed it to drain in secondary containment. Approximately 8m<sup>2</sup> of the ground surface was contaminated. Contaminated soil was collected and transported to the Meadowbank land farm.

Use of improper tools resulted in the punctured tote. Forks of the telehandler were too long.

A discussion with Hazmat crew regarding the use of the proper tools for the job. Ensure that the equipment has the correct sized forks for the activity.

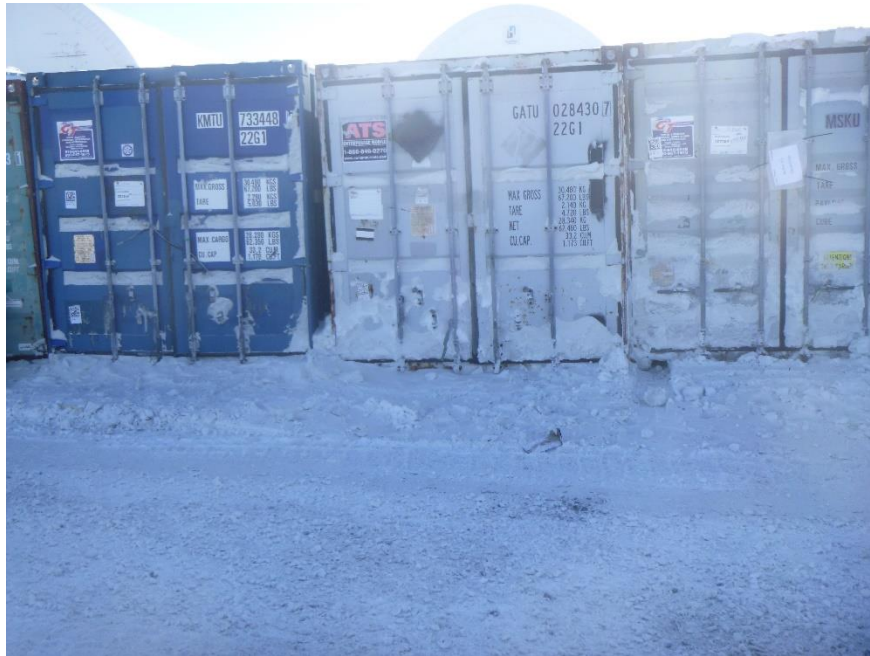
The operator quickly placed the punctured tote into secondary containment. Approximately 3m<sup>3</sup> of contaminated snow and material was collected and disposed of in the contaminated soil bin, to be disposed in the Meadowbank landfarm.

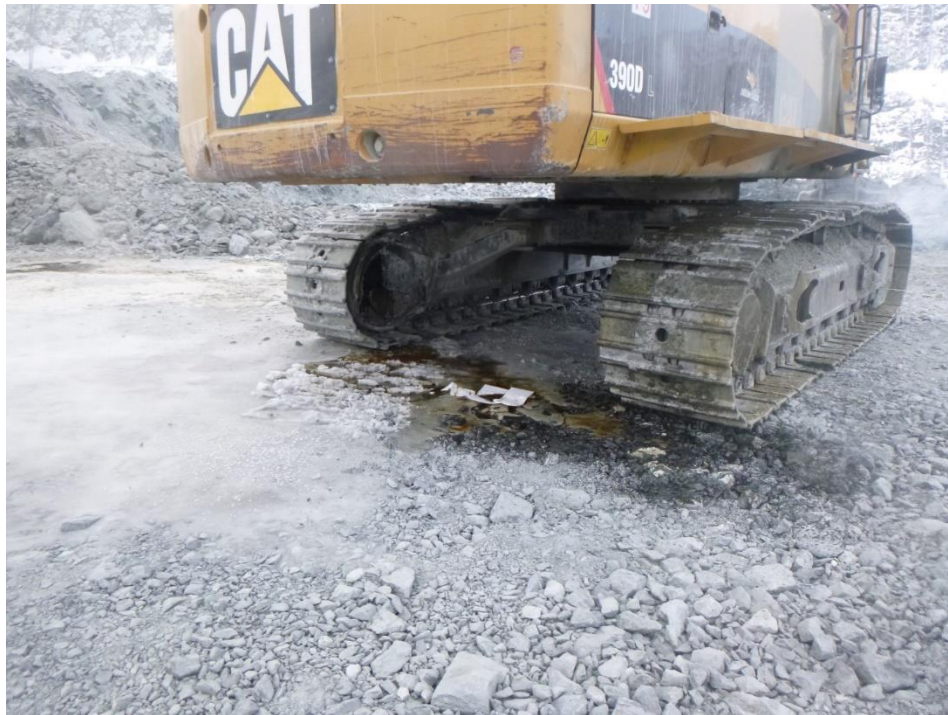
During operations at Whale Tail Pit, a fitting on the hydraulic pump of BAC19 failed causing oil to spill on the pit floor. Once the operator noticed the leak, they turned off the machine and called the mechanic to fix the issue. Approximately 20m<sup>2</sup> of the road surface area was contaminated.

Failed hydraulic pump fitting on BAC19.

A routine visual inspection of all systems is performed during pre-operation checks as a part of the preventative maintenance program.

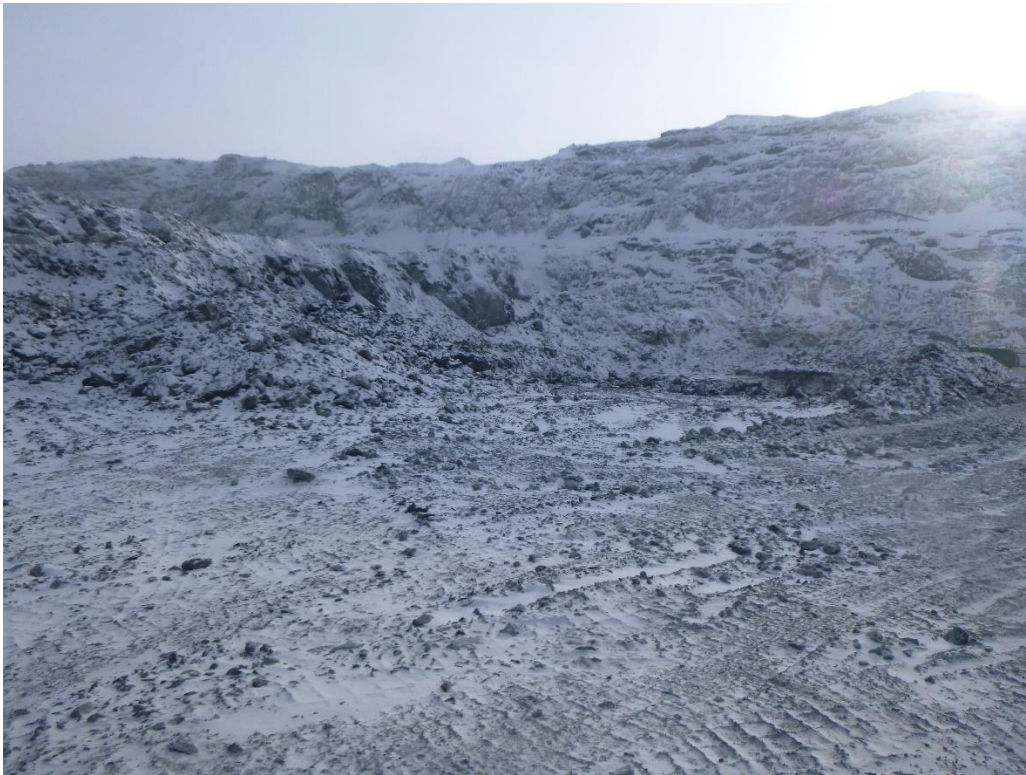
The operator turned off the equipment and called maintenance. Approximately 8m<sup>3</sup> of contaminated snow and material was collected and disposed of in the contaminated soil bin, to be disposed in the Meadowbank landfarm.

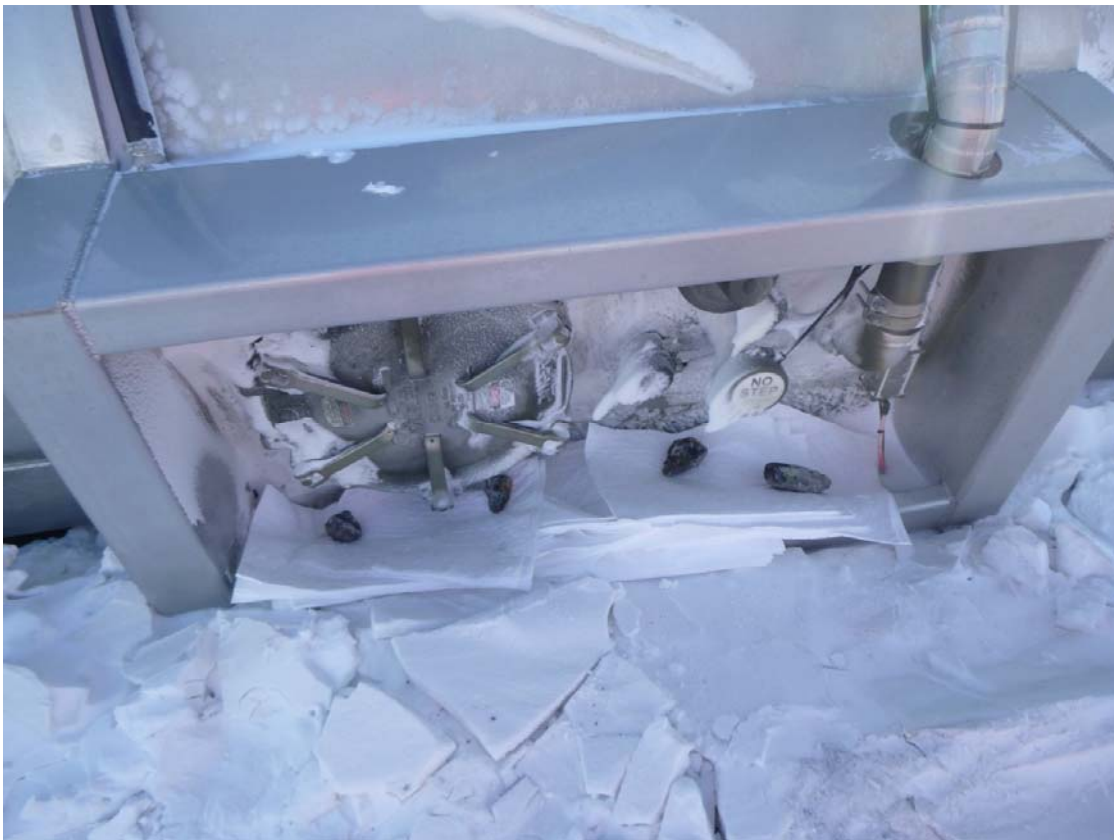
During operations at the Whale tail Pit, a loaded fuel tanker loss sight of the Whale Tail Haul Road due to poor visibility, and ended up on its side. A small slow fuel leak was observed from the top valve. It is estimated roughly 20L of diesel fuel was spilled into the snow, covering less than 1m<sup>2</sup>.

A safety standdown was done by the fuel operators to review procedures and to ensure equipment are parked if visibility is reduced. Agnico Eagle has a strict safety protocol in place concerning road status when low visibility is present.

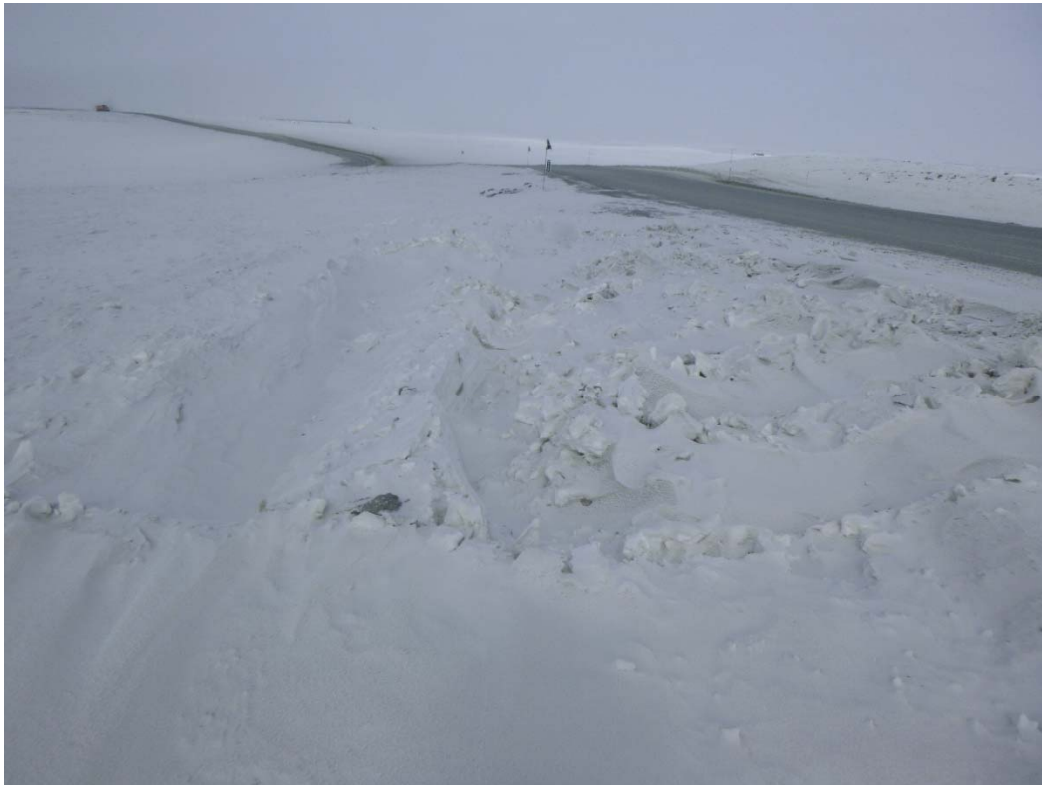
Absorbent pads were deployed under the leaky valve, and changed regularly until the tanker was emptied. Once emptied, tanker was removed from location, and contaminated snow retrieved. A total of 3 m<sup>3</sup> of contaminated snow was brought to the Meadowbank landfarm.

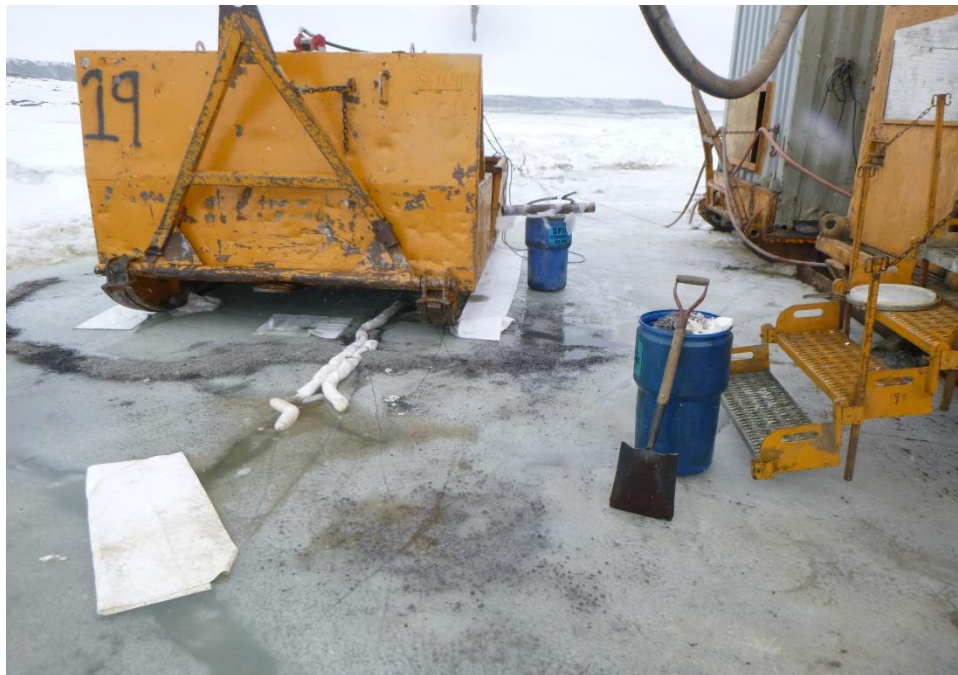
During operations at the Whale tail Pit, while refueling equipment around Drill 4, the fuel pump fitting on an over pack fuel tank came loose causing diesel fuel to spill on the ice.

Loose fitting on over pack fuel tank.

The Orbit Garant drill crew was met and reviewed the pre-op inspection for refueling.

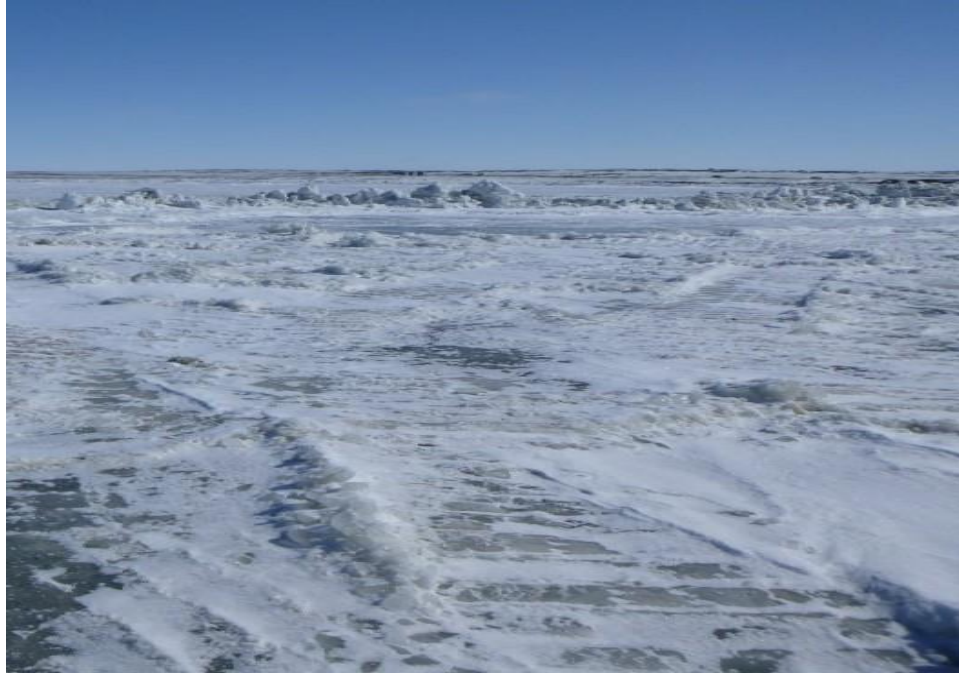
Spill pads and spill booms were immediately placed around the fuel tank. The area was scraped clean and additional spill pads were placed on the ice to collect any residue. Additional spills were placed on the ice over the following days. Approximately 2 m<sup>3</sup> of contaminated snow and ice were collected and placed into empty 100L open totes and disposed of at the Meadowbank tailings storage facility.

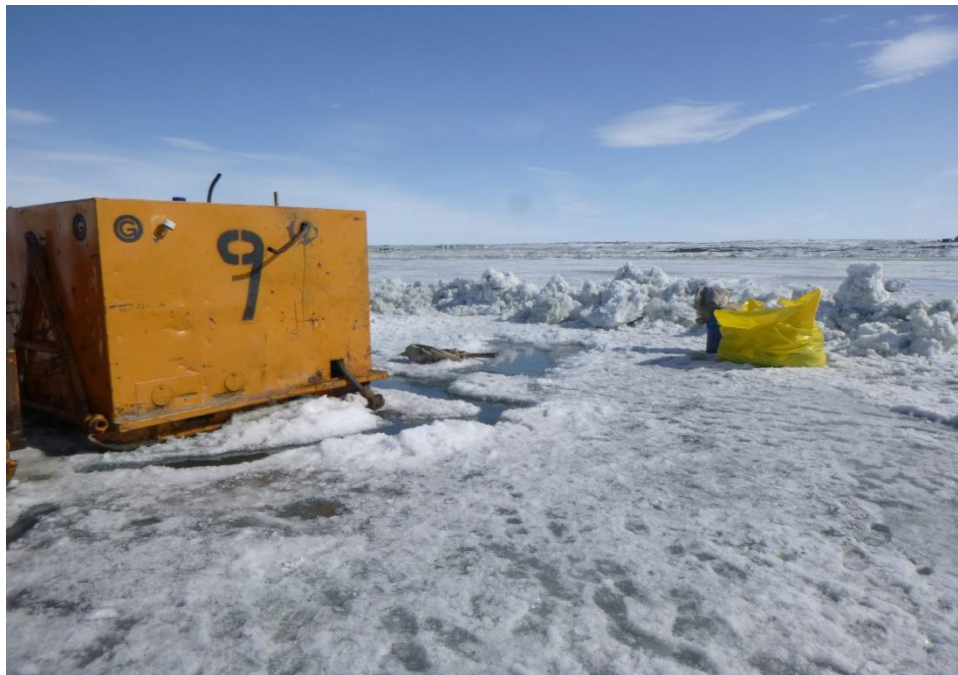
During operations at the Whale tail Pit, after refueling equipment around Drill 4, the fuel nozzle was placed incorrectly on the overpack tank. While storing the fuel line, the ball valve on the fuel nozzle remained open causing diesel fuel to spill into the tanker sloop and overflowed onto the ice.

Improper storage of fuel nozzle.

The Orbit Garant drill crew held a stand down meeting regarding refueling. Environment will continue toolboxes on spill prevention with all departments.

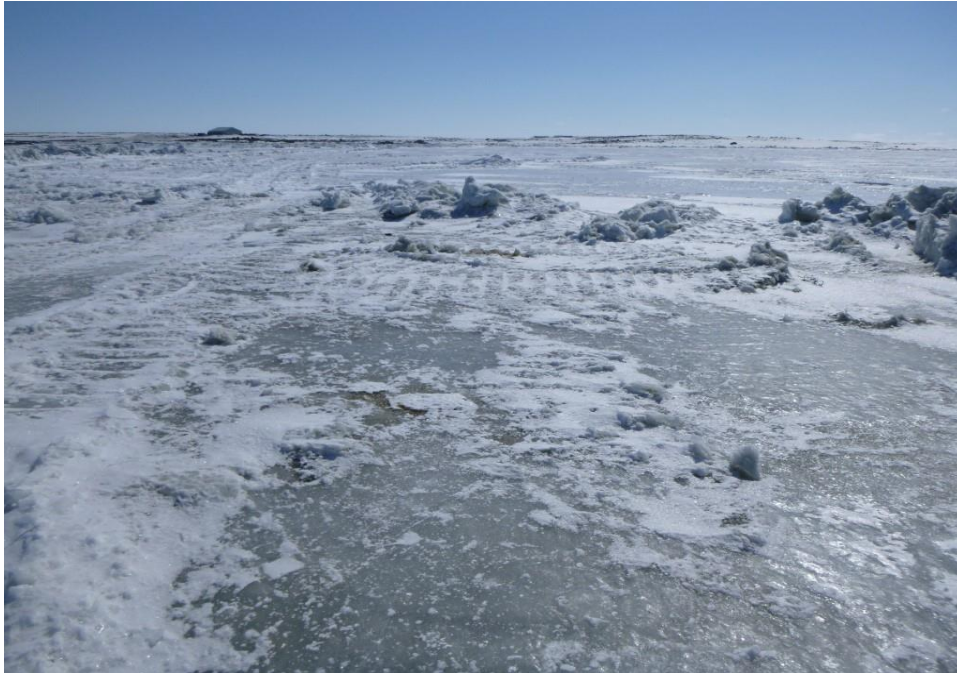
Spill pads, spill booms were immediately placed around the fuel tank. A snow fence was also built around the area. The area was scraped clean and additional spill pads were placed on the ice to collect any residue. Additional spill pads were placed on the ice over the following days. Approximately 5m<sup>3</sup> of contaminated snow and ice were collected and placed into empty 100L open totes and disposed of at the Meadowbank tailings storage facility.

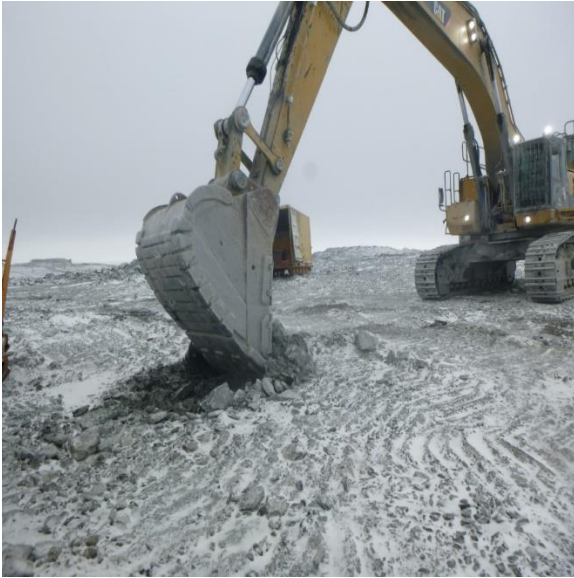
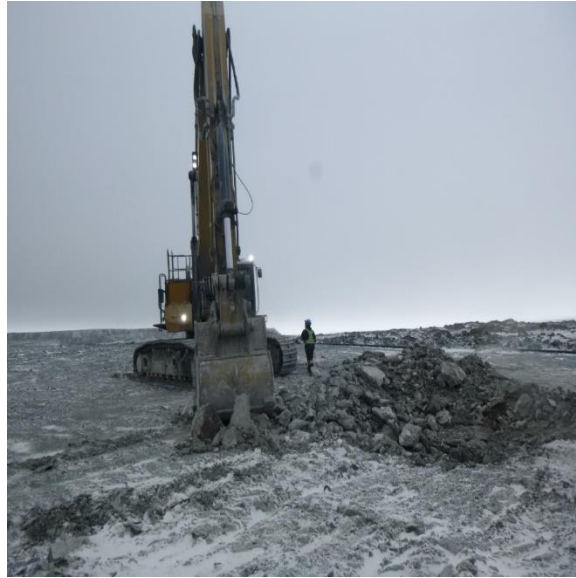
Operations supervisor requested equipment to start recovering the contaminated material immediately. The area was scraped and cleaned with a backhoe. Approximately 8m of contaminated material was collected and disposed of in the contaminated soil bin, then disposed in the Meadowbank landfarm.

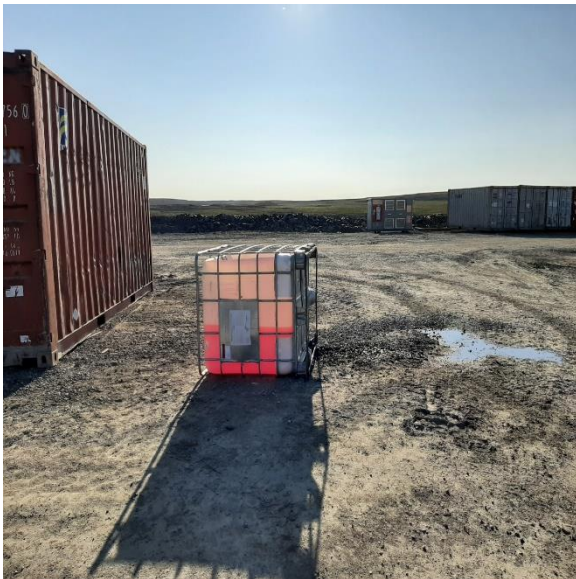
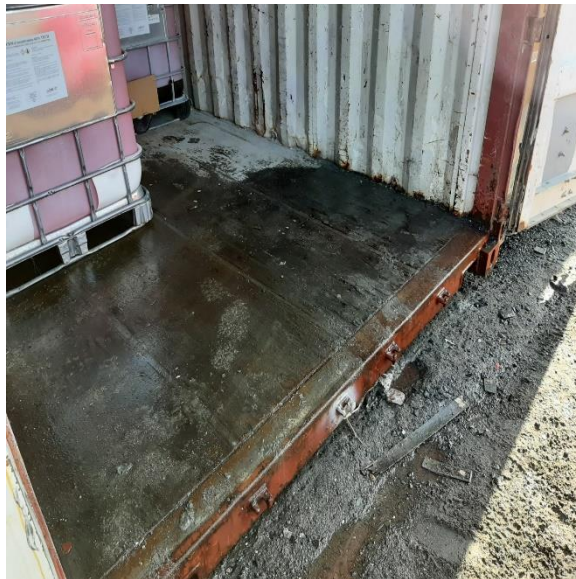
During operations at Whale Tail Pit project, coolant totes were being transported for storage to a shipping container on Pad Q. During transportation of tote, the operator noticed it had been punctured, causing coolant to leak onto the ground.

Punctured tote caused by human error.

A routine visual inspection of all systems is performed during pre-operation checks as a part of the preventative maintenance program.

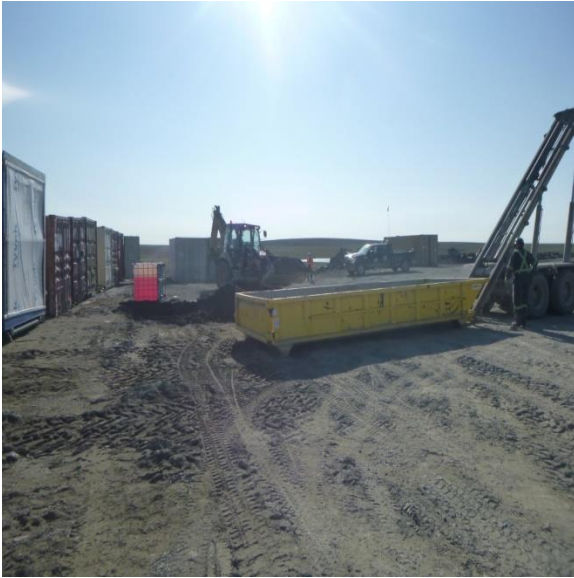
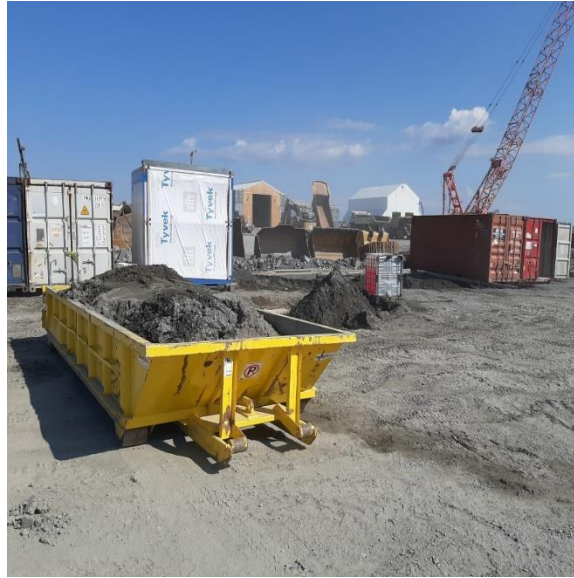
The operator placed the tote on its side to stop the leak. Spill pads were placed in the sea can and the contaminated material was picked up and placed in the contaminated soil bin, to be disposed in the tailings area at Meadowbank.

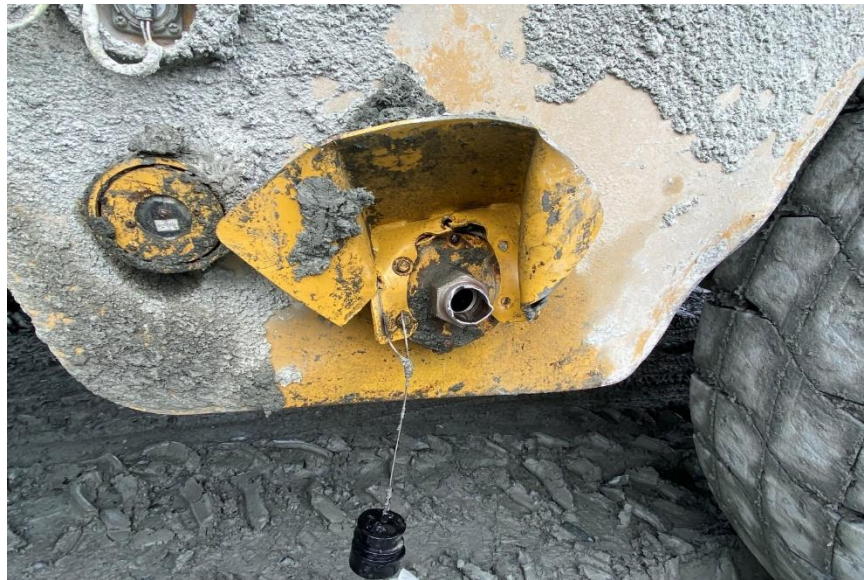
During operations in the IVR pit at Whale Tail Pit project, a rock contacted the gas cap on Haul Truck 04, damaging the fuel cap along with the top portion of the fuel tank and spilling diesel fuel on the IVR pit ramp.

Damaged Fuel cap and Fuel Tank on HTR04.

A reminder to operators to complete a 360 visual inspection of all work areas as part of the inspection phase prior to starting a task.

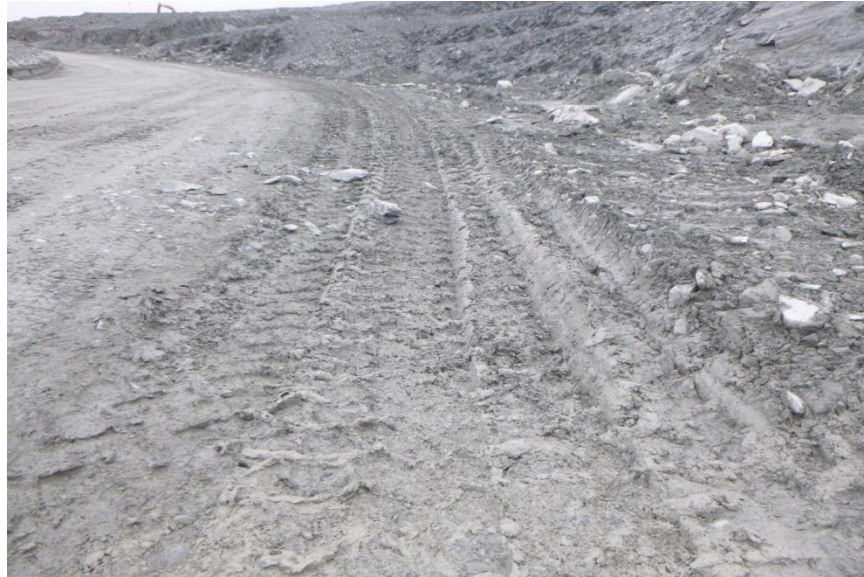
The operator turned off the equipment and called maintenance. The spill was contained by placing a half-cut drum under the leak, a small berm, along with spill pads. 20m<sup>3</sup> of Contaminated material was collected in a Haul truck and brought to the Meadowbank landfarm.

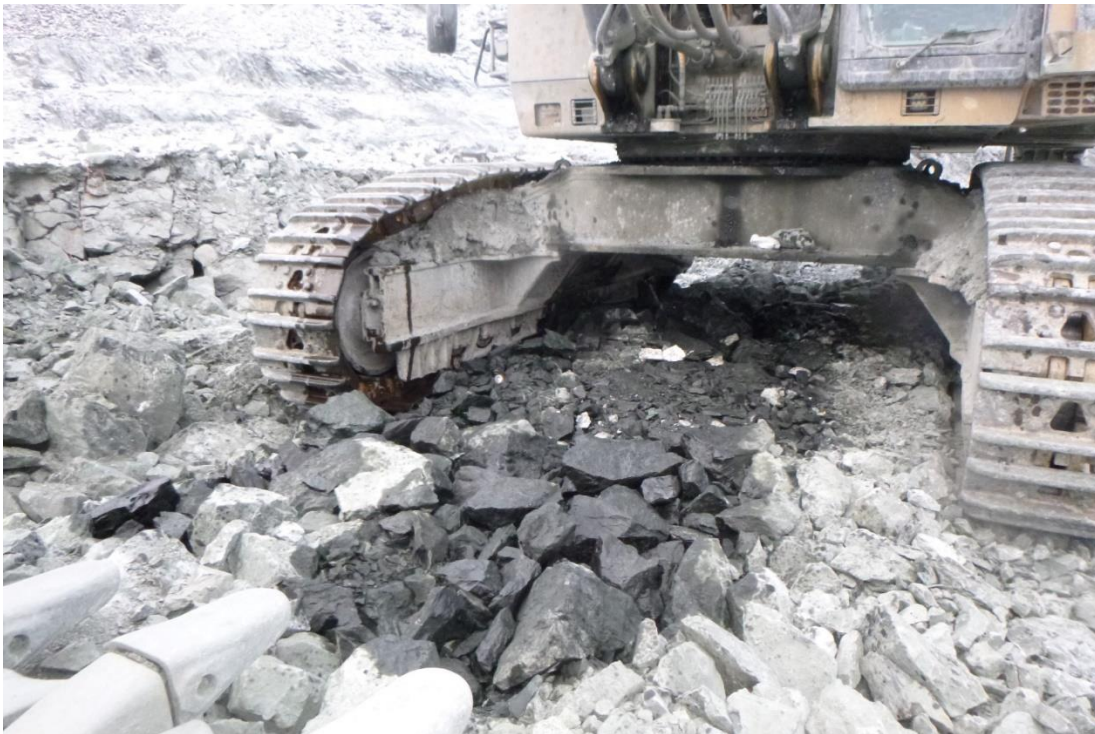
During mining operations at the Whale Tail Pit, the O-ring on BAC15 failed causing a hydraulic oil spill on the pit floor.

Equipment failure of the O-ring

General reminder to operators to perform thorough pre-ops of equipment before use. Maintenance department to continue preventative maintenance program.

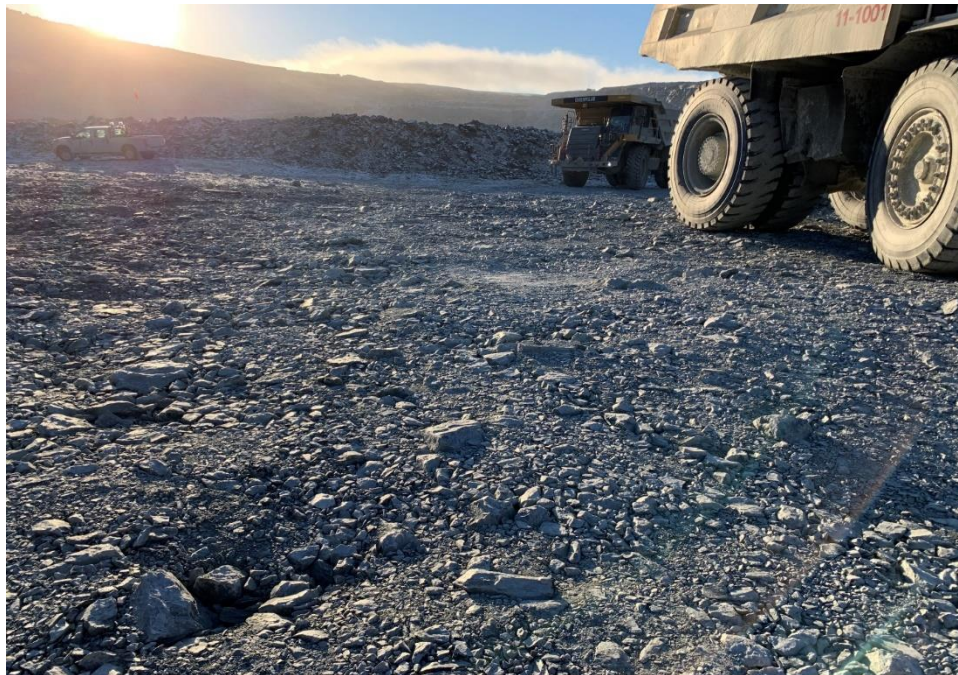
The contaminated material was collected and brought to the Meadowbank landfarm for remediation. Approximately 20 cubic meters of material was excavated.
