Meadowbank and Whale Tail 2021 Annual Geotechnical Inspection

2021 Annual Geotechnical Inspection

Meadowbank Complex, Nunavut

21468006-1606-R-Rev0

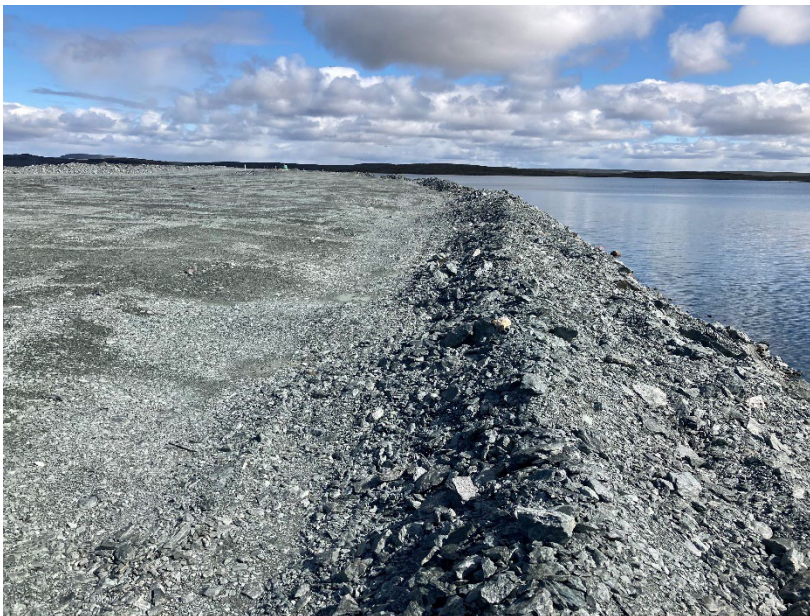
Photograph A3-20 Bay Goose Dike

Description: From approximately Sta. 31+475, looking west at the crest. Old cracks are disappearing.

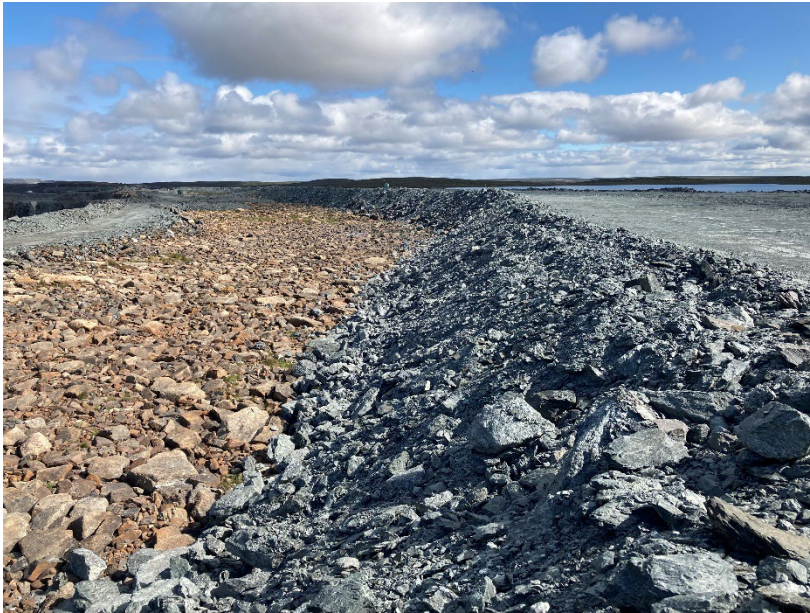
Photograph A3-21 Bay Goose Dike

Description: From approximately Sta. 31+475, looking northeast at the crest. Old cracks are disappearing.

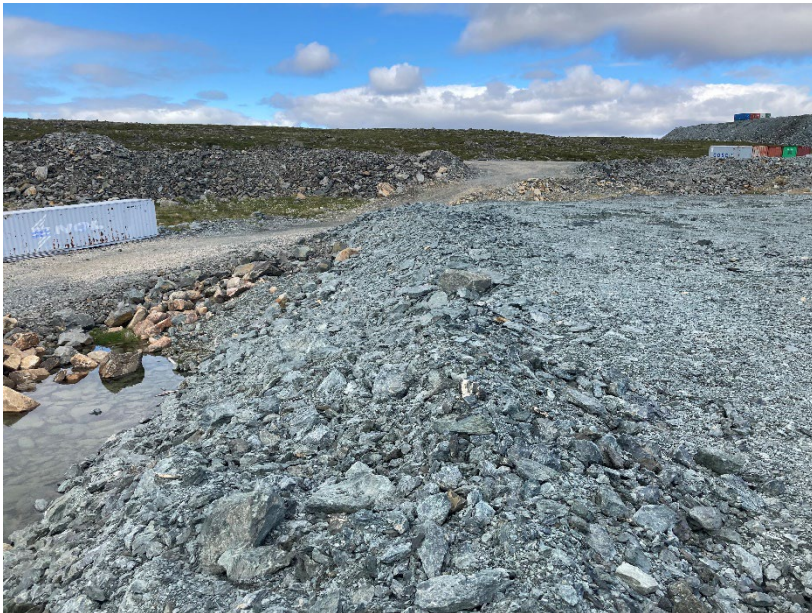
Photograph A3-40 Bay Goose Dike

Description: From approximately Sta. 32+025 (south abutment) looking east at the crest and upstream slope. Zone of high magnitude settlement in the ultramafic cap. The tension cracks seem no longer active.

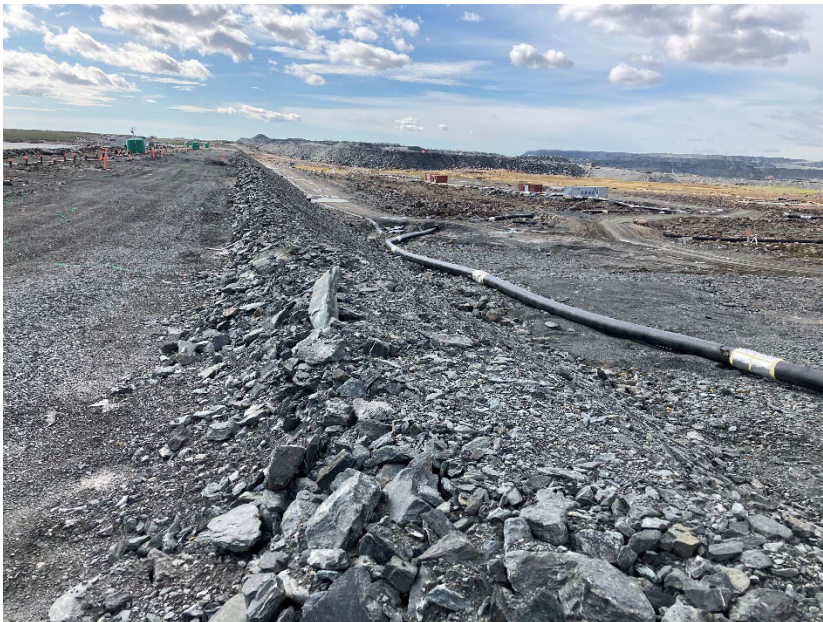
Photograph A5-6 Whale Tail Dike

Description: From approx. Sta. 0+725 (east abutment), looking west at the crest. Presence of tension cracks and settlement on the crest.

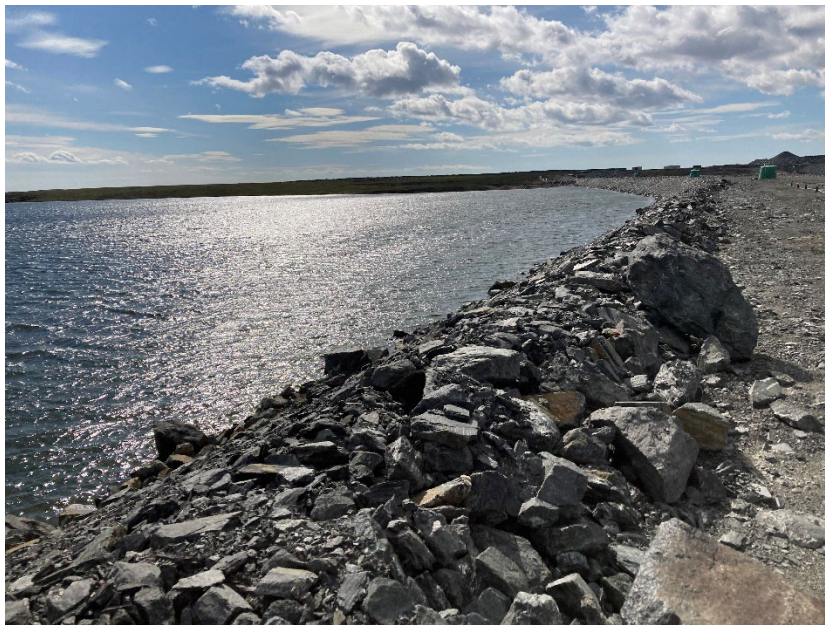
Photograph A5-8 Whale Tail Dike

Description: From approx. Sta. 0+700 (east abutment), looking west at the crest. Tension cracks (150 mm wide).

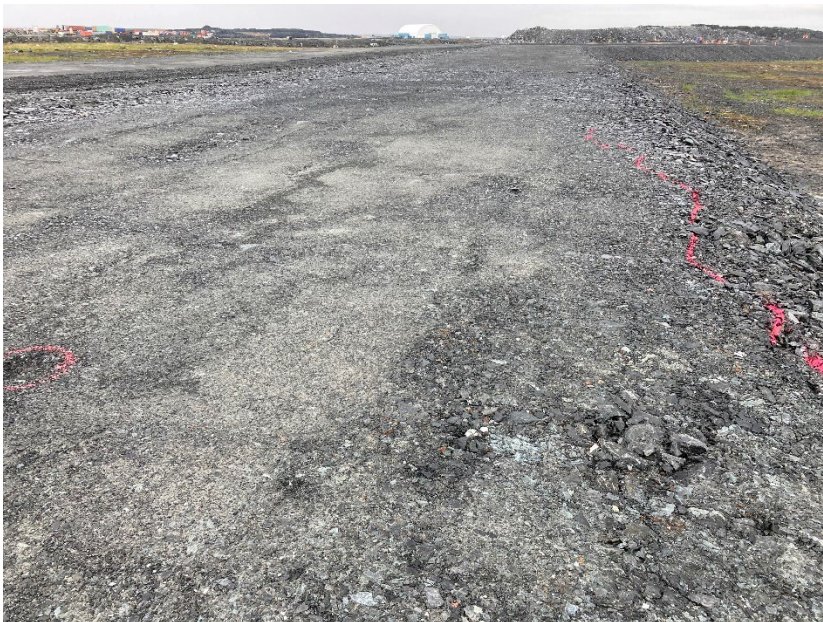
Photograph A6-4 IVR Dike D-1

Description: From approx. Sta. 0+480, looking west at the crest (thermal cap) and upstream slope. Presence of tension cracks in the rockfill of the thermal cap.

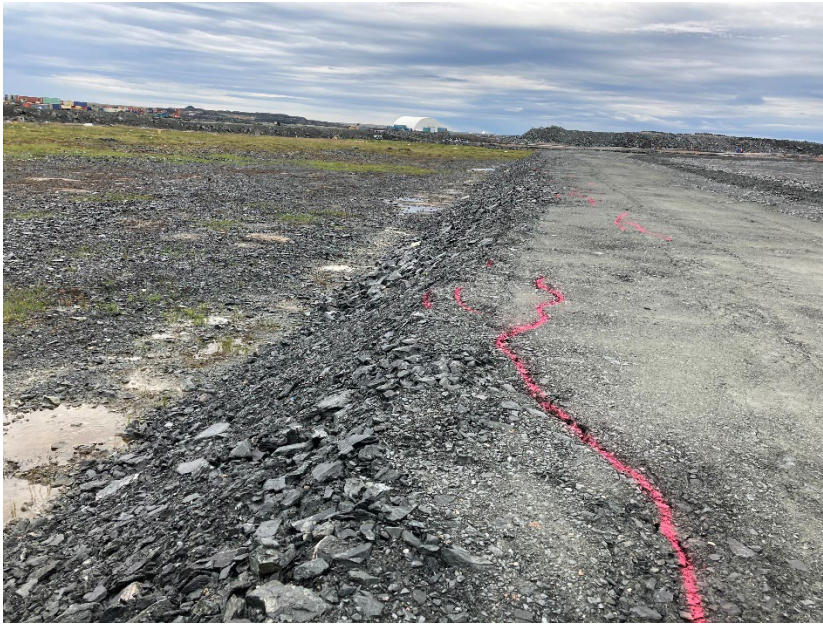
Photograph A6-5 IVR Dike D-1

Description: From approx. Sta. 0+430, looking west at the crest and upstream slope. Presence of tension cracks and a pothole.

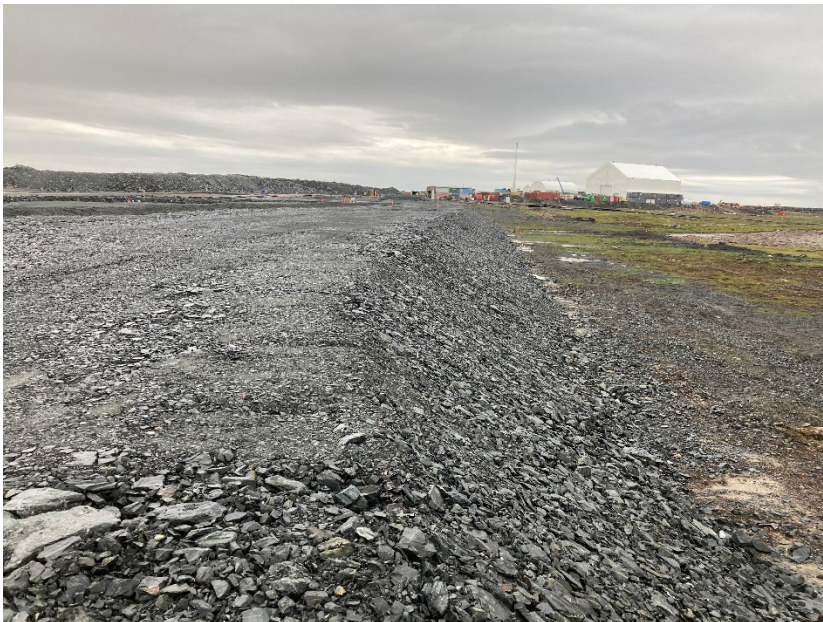
Photograph A6-6 IVR Dike D-1

Description: From approx. Sta. 0+430, looking west at the crest and downstream slope. Presence of tension cracks.

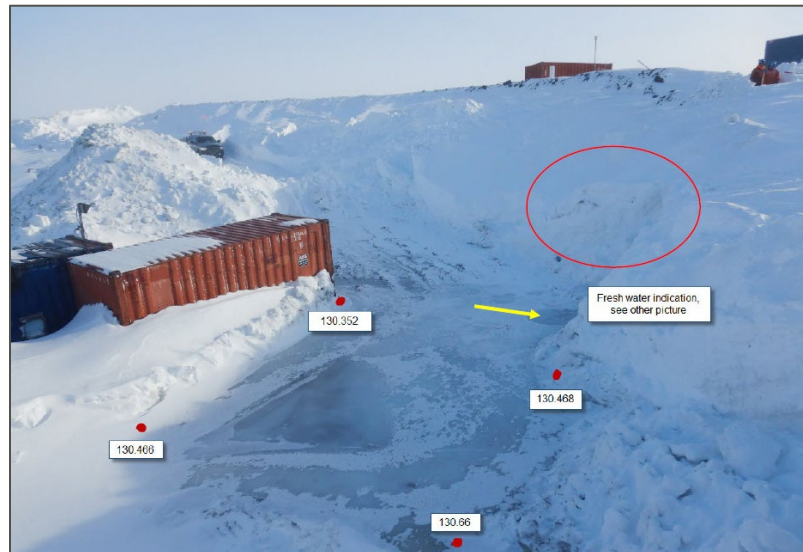
- Snow removal in the downstream toe area.
- Significant water was released when snow was excavated. Water source identified at El. 130.3.
- Following the snow removal, piezometric level instantaneously dropped by 0.5 m

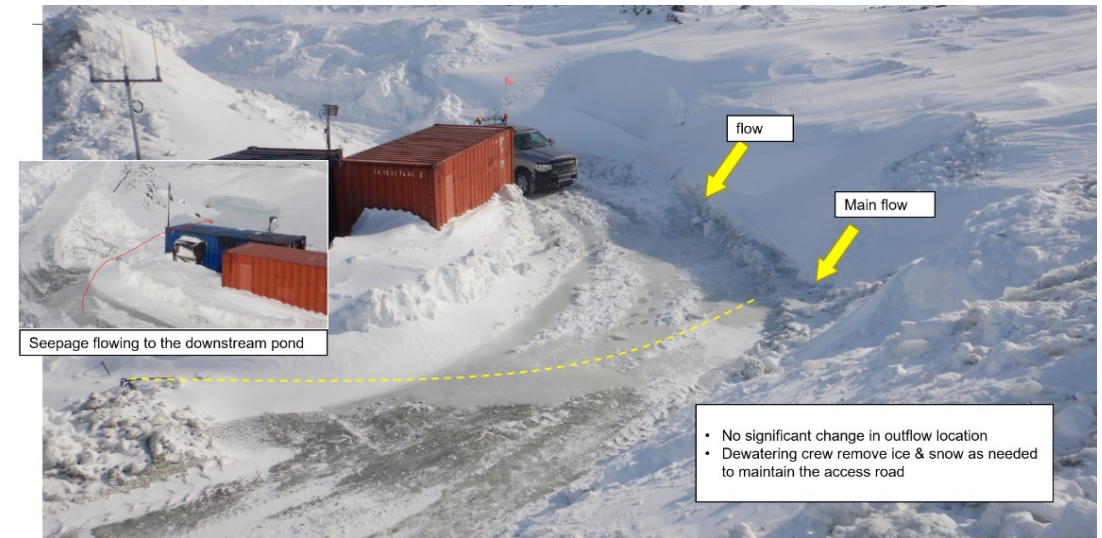
April 18, 2021:

- Water observed flowing on ground surface and toward downstream pond.
- Both seepage stations are dry (flow rate was 6 m³/h from March 16 to 22)

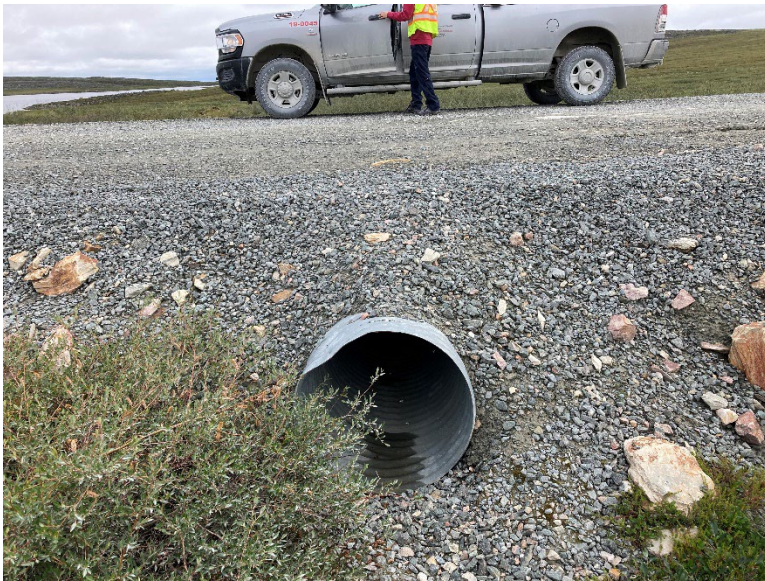
Photograph D2-2: PC-11 km 39+552

Description: View of the culvert outlets. No sign of degradation and the flow is stable south of the culverts (5-10 m away).

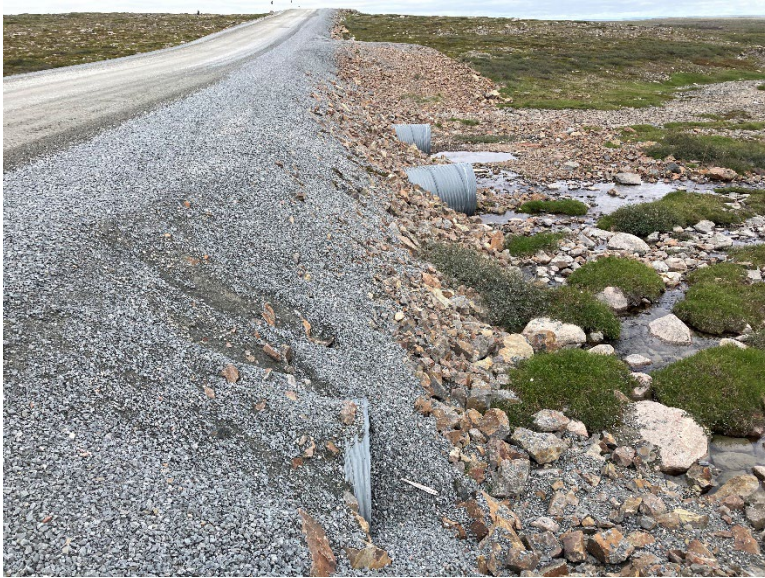
Photograph D2-3: R-14 km 67+840

Description: View of the culvert inlet. Installed high but in good condition.

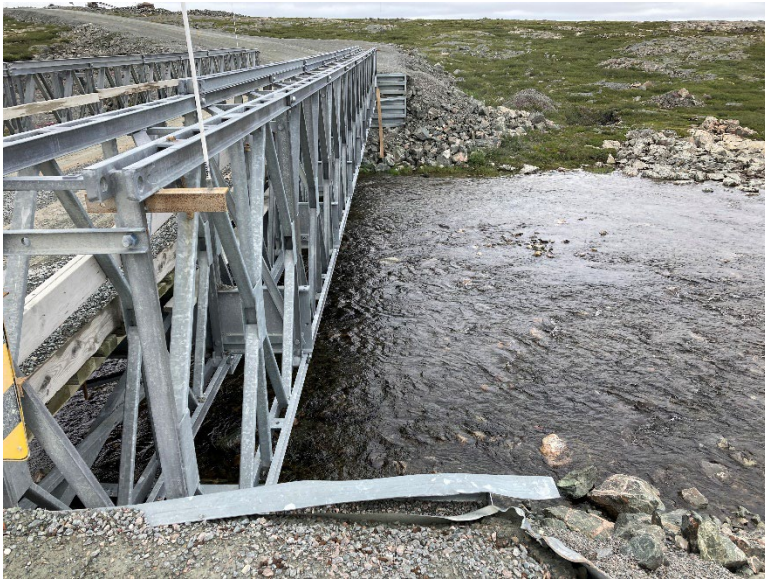
Photograph D3-5 Bridges 3 – R06 km 23+100

Description: Looking at the south abutment. Minor damage to the bin wall.

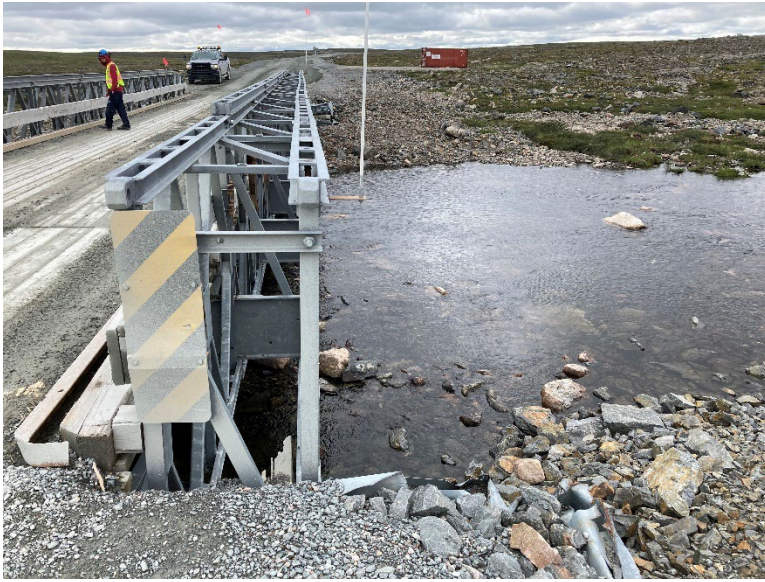
Photograph D3-13 Bridges 6 – R15 km 69+200

Description: Looking at the north abutment. Damage to the bin wall likely caused during snow removal activities. Bridge is tipping toward the west side on the abutment.

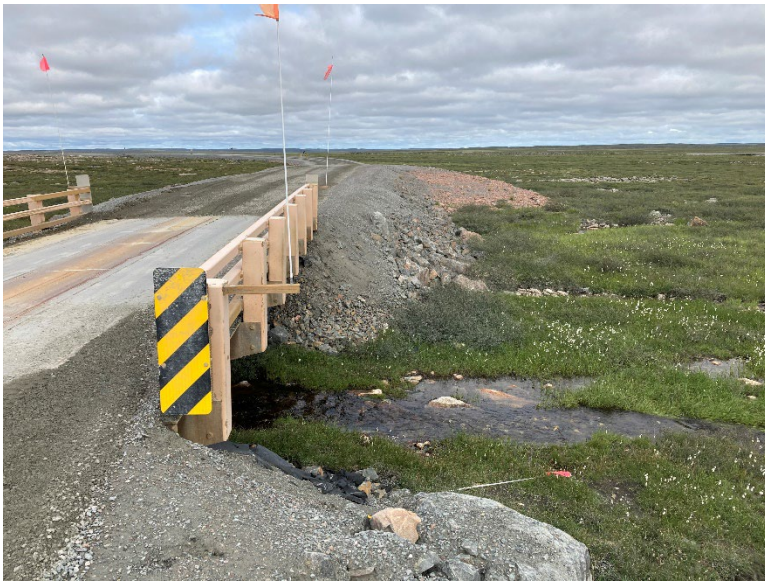
Photograph D3-14 Bridges 7 – R16 km 73+800

Description: Looking at the south abutment. Damage to the bin wall likely caused during snow removal activities. Bridge is tipping toward the west side on the abutment.

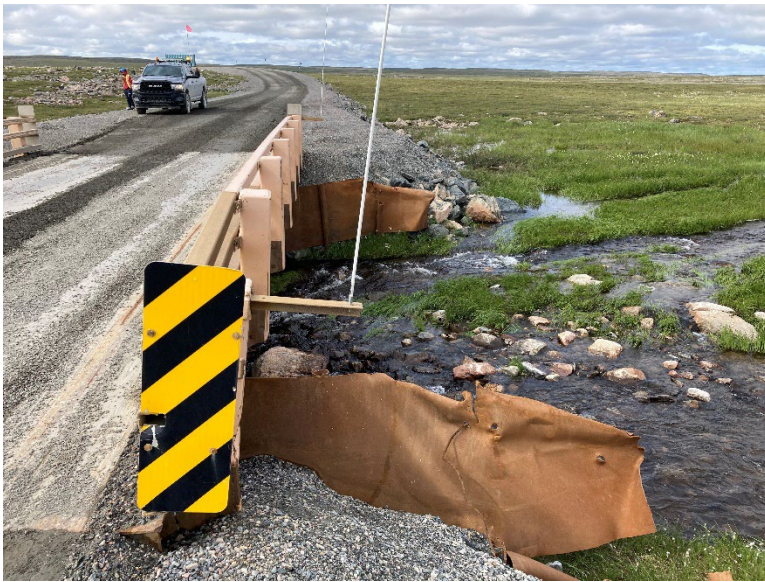
Photograph D3-19 Bridges 9 – R19 km 83+150

Description: Looking at the north abutment. Minor damage to steel plate due to snow removal activity.
