Appendix 6: 2021 Annual Geotechnical Inspection Report

2021 Annual Geotechnical Inspection Meliadine Gold Project, Rankin Inlet, Nunavut

Agnico Eagle Mines Limited

MARCH 17, 2022 ISSUED FOR USE

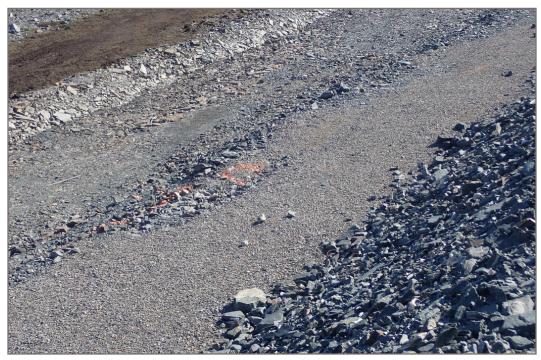
- Overall, the dike appeared stable, with no significant geotechnical concerns identified.
- Minor cracking and small settlement were observed along portions of the upstream and downstream crest (e.g., Photos 6, and 7, Appendix B). The largest cracks were up to 3 cm wide. The cracking was less prevalent than observed in August 2019 or August 2020.

Photo 6: Dike D-CP1 - Downstream crest, minor cracking.

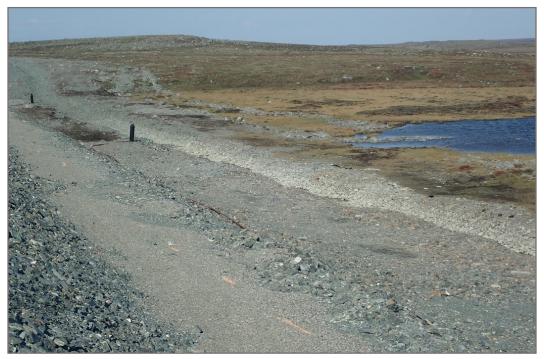
Photo 7: Dike D-CP1 - Downstream crest and former construction road downstream of dyke.

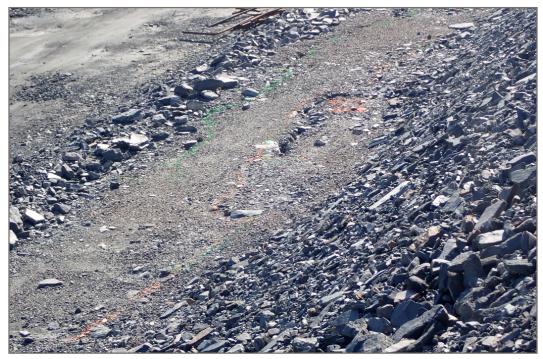
Photo 9: Dike D-CP1 - Downstream dyke crest, minor cracking, similar to previous years.

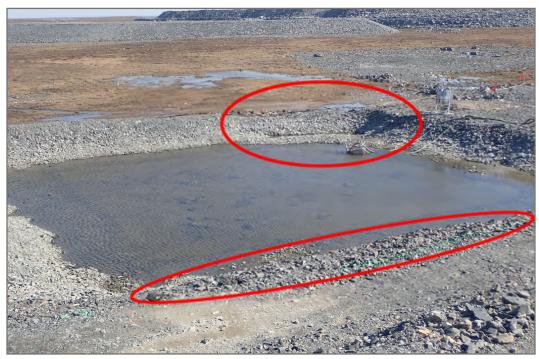
Photo 10: Dike D-CP1 - Seepage collection pond downstream of dyke. Fill deformed in southeast corner of pond, exposing top layer of tundra. Cracks between the fill and geotextile on west side of pond adjacent to C-CP1.

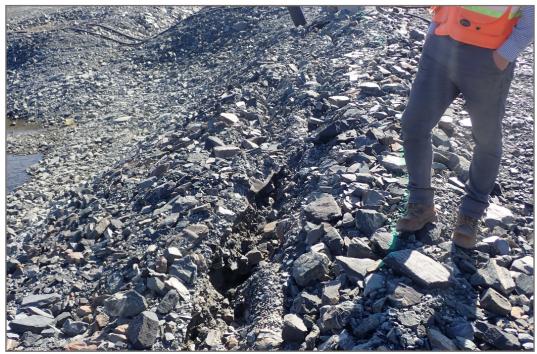
Photo 15: Dike D-CP1 - Subsidence and cracking at water collection pond downstream of the dike.

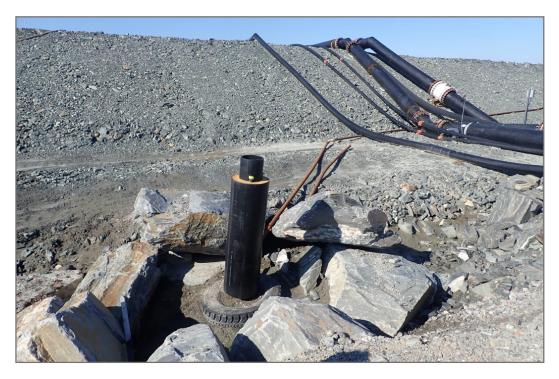
Photo 16: Dike D-CP1 - Horizontal Ground Temperature Cable HGTV5 extension connection point in low area. Ponds and freezes throughout winter months causing reading errors.

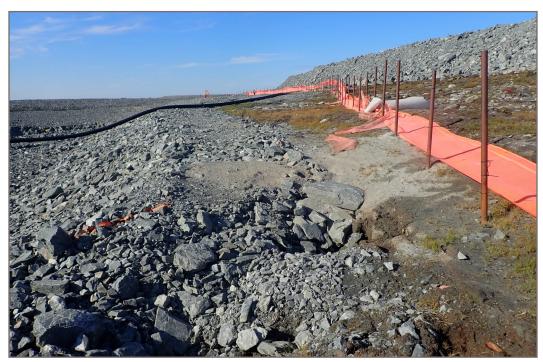
Photo 5: Pond CP4 - Settlement and cracking above north slope.

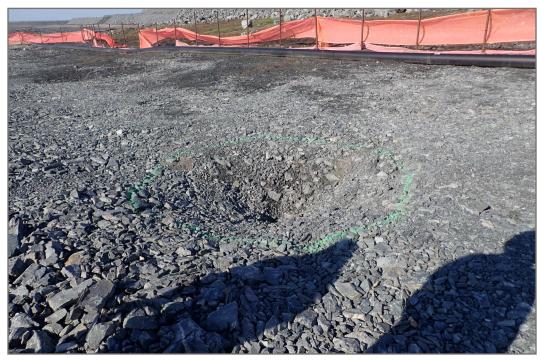
Photo 6: Pond CP4 - Small subsidence above north slope close to original ground contact.

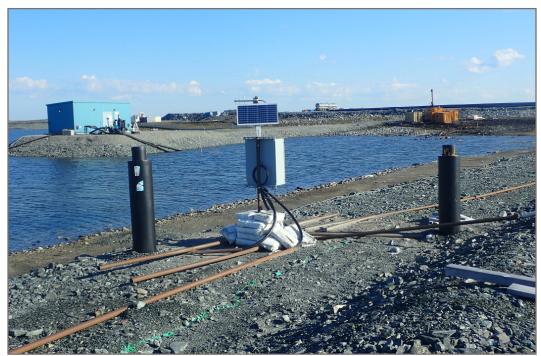
Photo 5: D-CP5 Dike - upstream, data logger, and GTC housings. Minor crack marked in green.

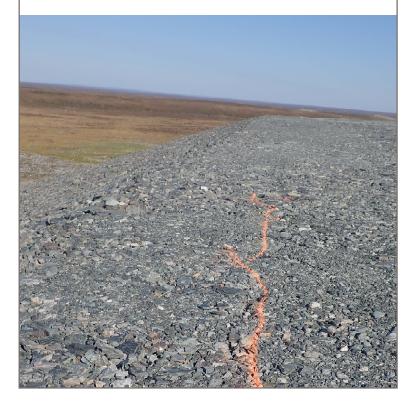
Photo 10: Pond CP6 - Berm CP6—Minor Cracking along downstream crest.

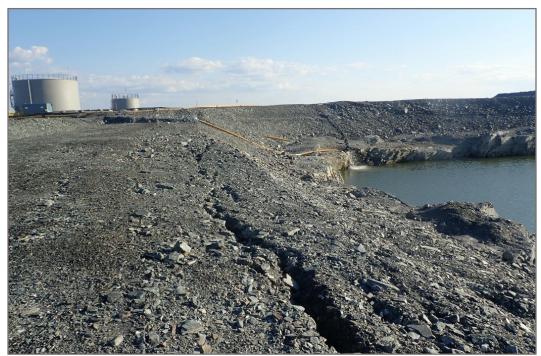
Photo 3: SP1 Saline Pond - Deformation and cracking in top of overburden protected slope, southwest corner of pond.

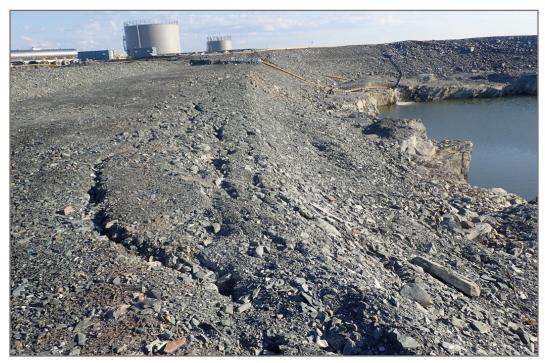
Photo 4: SP1 Saline Pond - Deformation and cracking in top of overburden protected slope, southwest corner of pond.

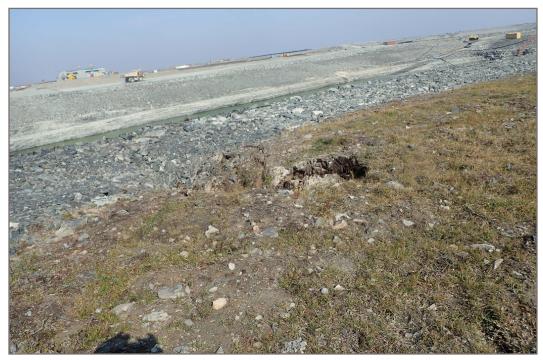
Photo 18: SP4 Saline Pond—Cracking in disturbed overburden above rockfill covered slope.

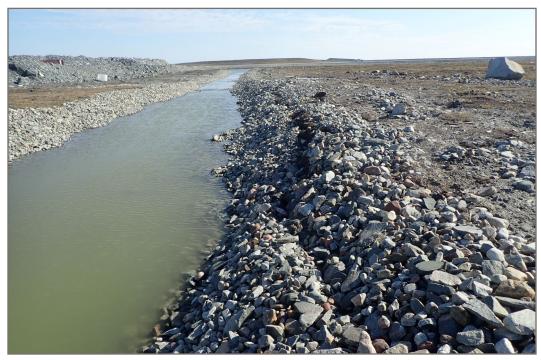
Photo 6: Channel 1—Rip settlement and cracking along crest of overburden.

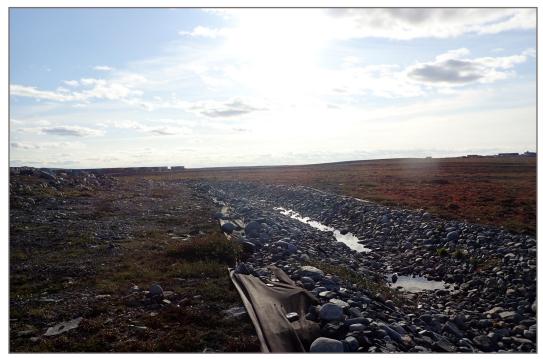
Photo 9: Channel 2—Some settlement in base of channel allowing water to pool.

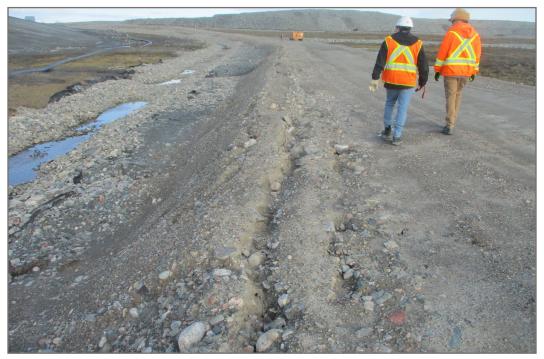
Photo 15: Channel 3—Cracking along road side slopes adjacent to channel.

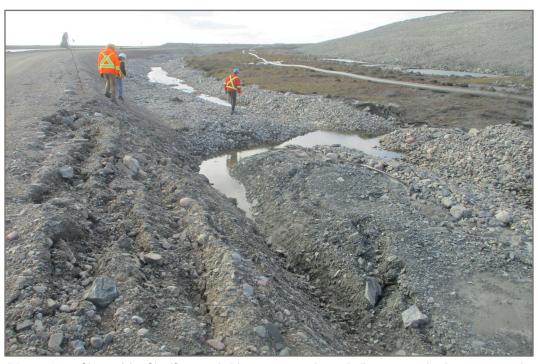
Photo 16: Channel 3—Significant subsidence across channel alignment and subsequent cracking along road side slope, looking northwest.

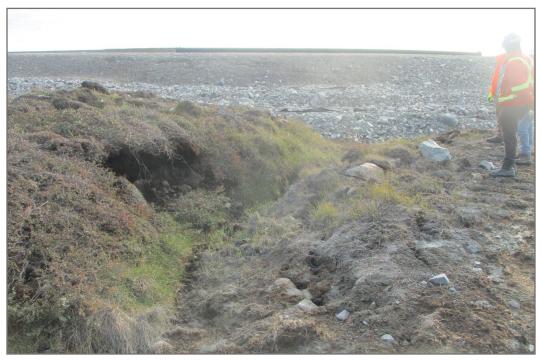
Photo 18: Channel 3—Thermal degradation of ground upstream of Channel 3.

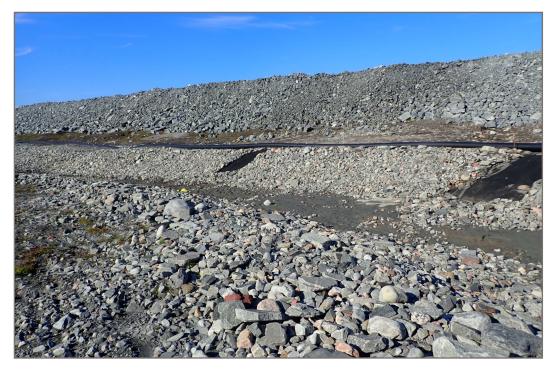
Photo 28: Channel 4 - Rip rap slope failures at areas of surface flow into channel.

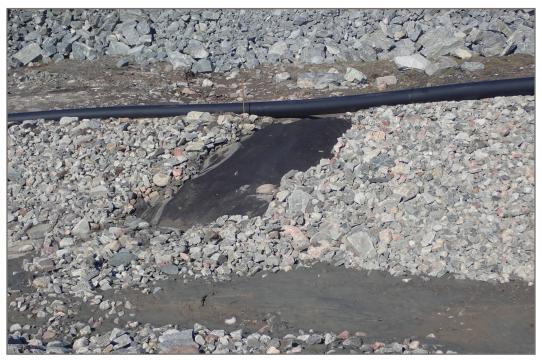
Photo 29: Channel 4—Rip rap slope failures at areas of surface flow into channel.

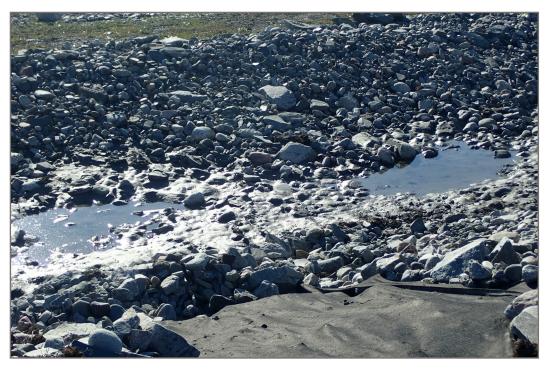
Photo 30: Channel 4—Point of rip rap slope failure, looking west.

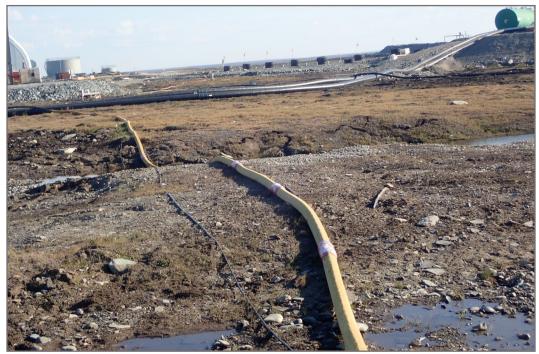
Photo 33: Channel 5—Upper reach, south of Portal2, significant subsidence and cracking along slopes with rip rap settled below water level in channel.

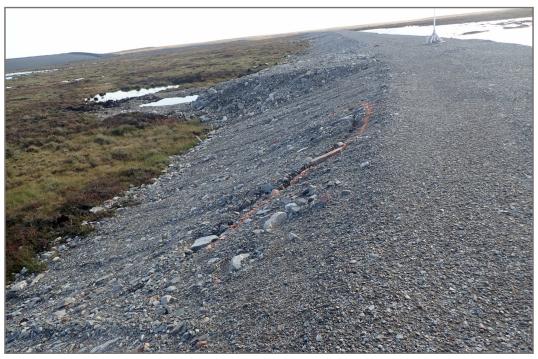
Photo 43: Berrm 2—Cracking on slope.

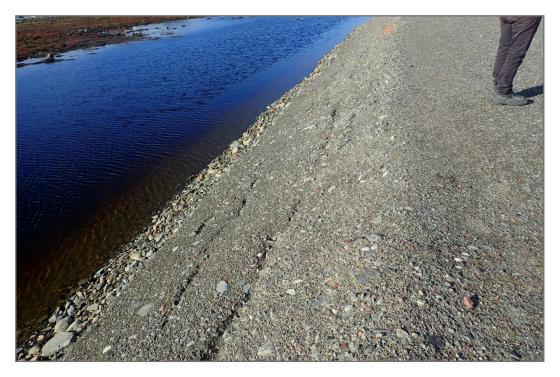
Photo 44: Berm 2—Cracking on upstream slope.

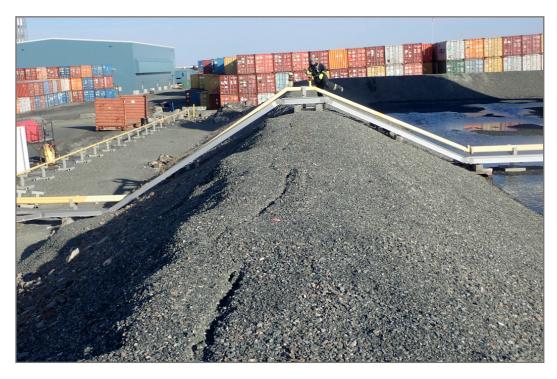
Photo 22: Industrial Fuel Storage Tanks. Cracking on top of berm. Small amount of settlement on crest pipes.

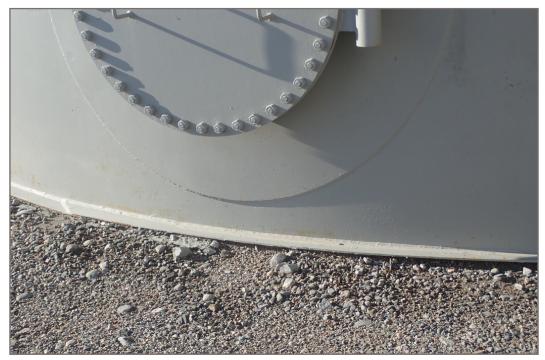
Photo 23: Industrial Fuel Storage Tanks. Small amount of erosion on tank pedestals.

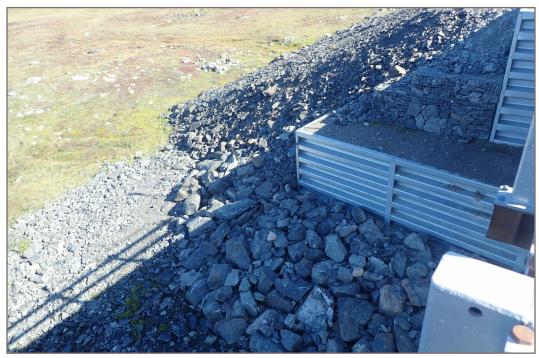
Photo 8: Culvert km 7.4—Damage to culvert inlet

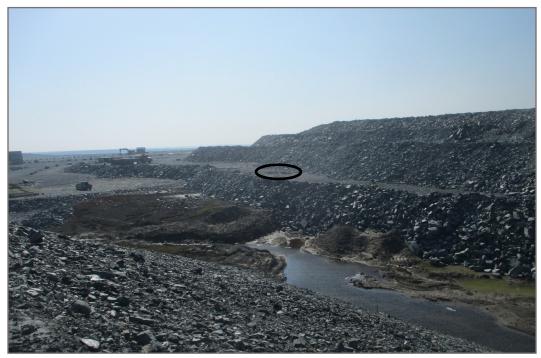
Photo 3: WRSF1—Viewed from Paste Plant Ramp—Ground conditions at settlement in first bench surface. Settlement area circled in photo.

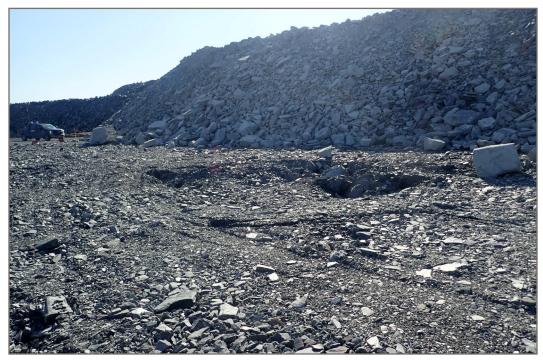
Photo 4: WRSF1—Settlement zone on first bench, shown in Photo 3.
