Appendix 16: 2021 Reportable Spills

Follow Up Report: #21-004

January 5, 2021 – 170 L Hydraulic Oil Spill

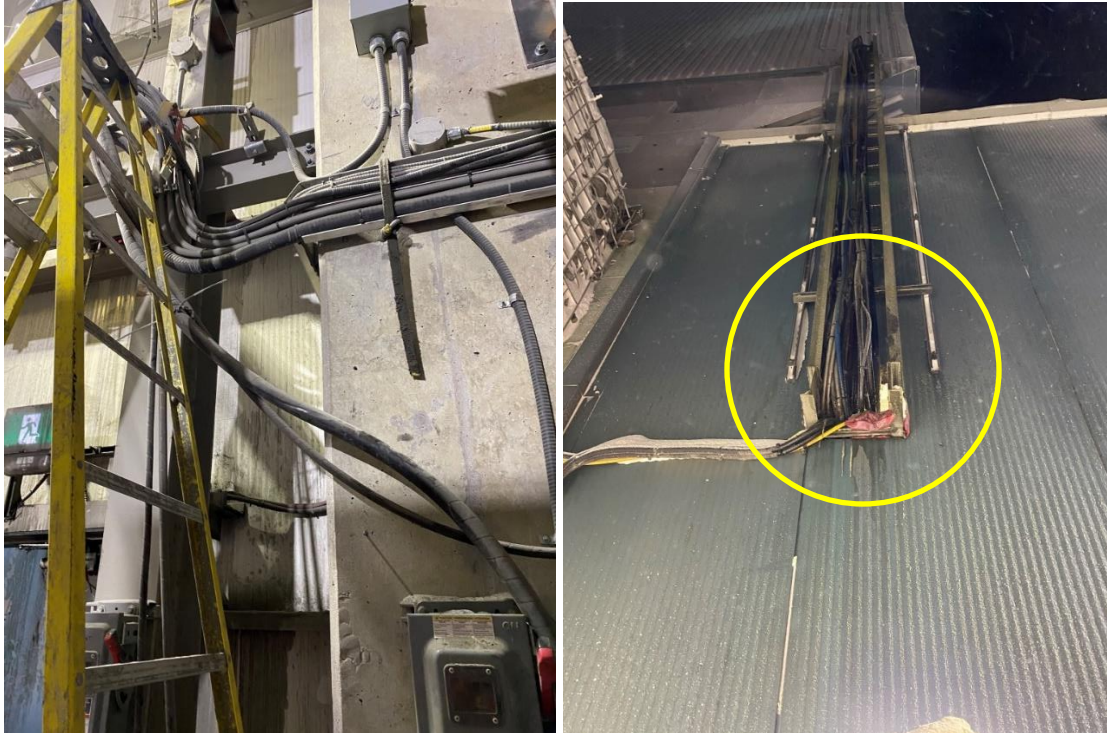
Figure 2: A hydraulic line breakage occurred on the exterior of the building (circled area).

The specific cause in this incident is attributed to wear and tear on the hydraulic lines, compounded by the cold temperatures the lines are exposed to. The strong vibrations caused by mechanical equipment inside the building, put additional stress on these lines and fittings. Although these lines are currently insulated and heat-traced to prevent temperature drops in the hydraulic system, a plan is in place to install a heated seacan to contain the hydraulic tanks and keep the overall system warmer. Ridged piping will also be installed over the current lines which will help with insulation and wear and tear.

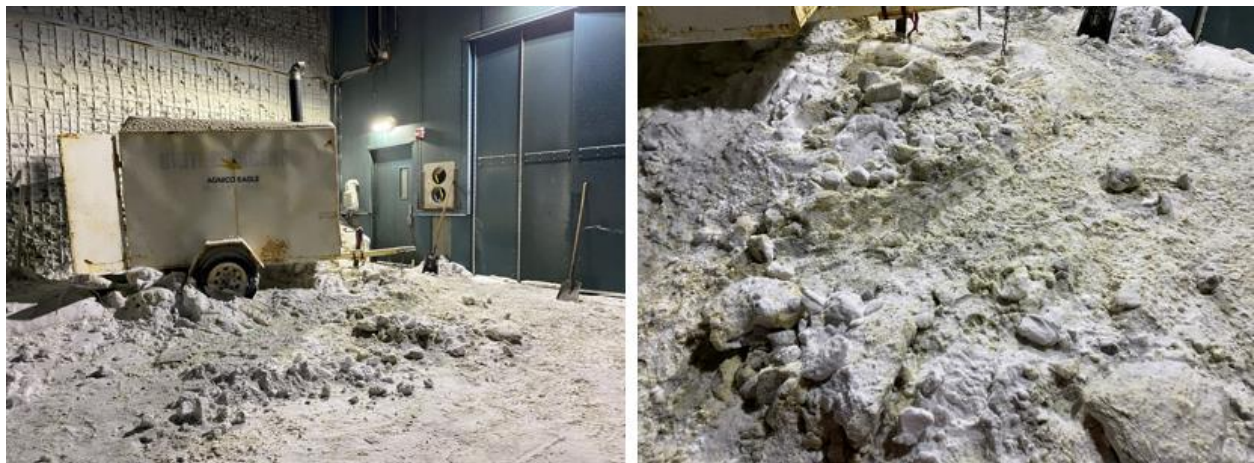
Figure 3: Contaminated snow beneath the broken hydraulic line.

Spill pads were immediately placed on the affected area to contain and catch the oil. The Process Plant Supervisor and Environment Department. organized a clean-up of the area. The area was cleaned up using a loader, bobcat and shovel. All contaminated snow was disposed of in the Landfarm.

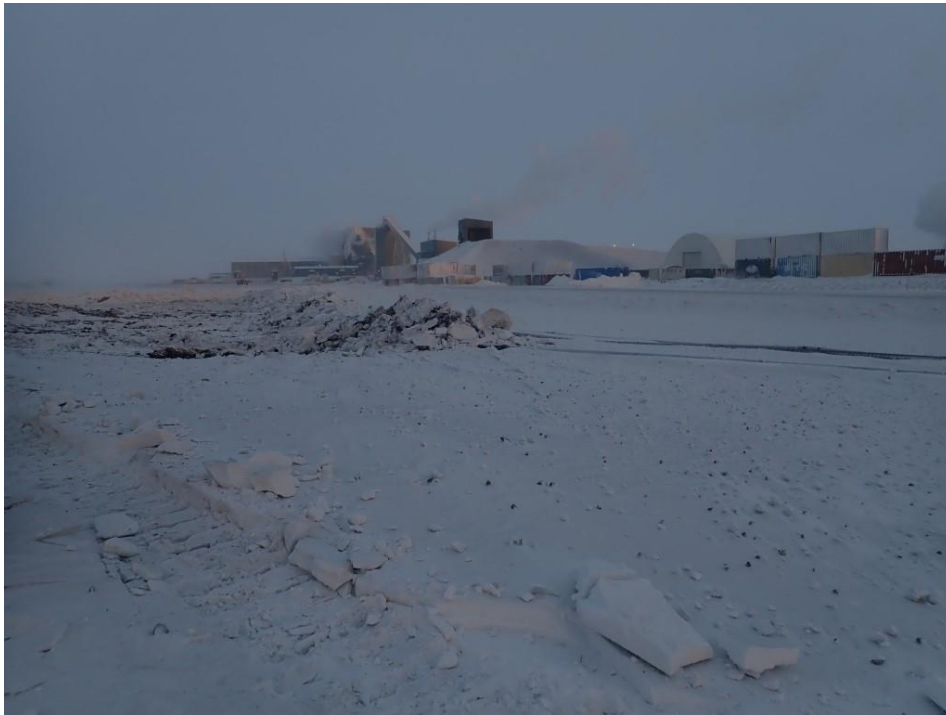
On January 18th, at approximately 1:00 pm, an estimated 165 m³ of heat recovery water was spilled as water was being conveyed via a 16" heat recovery waterline. Equipment was pushing snow near the heat recovery waterline. This action caused the line to break and the water within the line was released. A portion of the water froze on surface, with the remainder migrating below surface.

Figure 2: Snow pushed into heat recovery waterline.

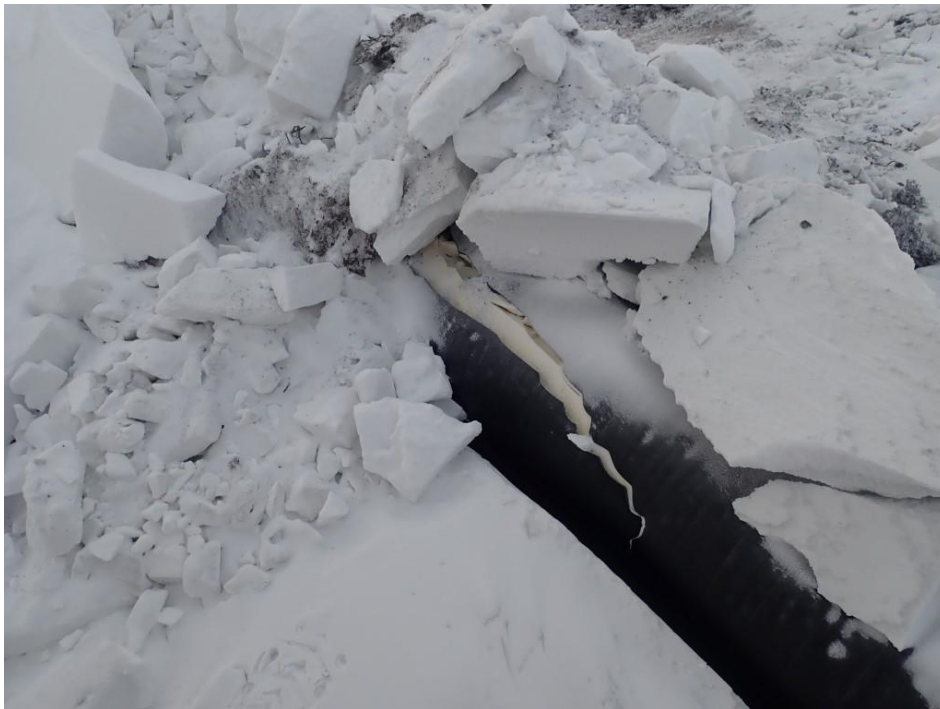
Figure 3: Damage to heat recovery waterline.

The waterline has been disabled until it can be replaced in summer. Energy and Infrastructure (E&I) department will inspect the new line during recommissioning before resuming operations.

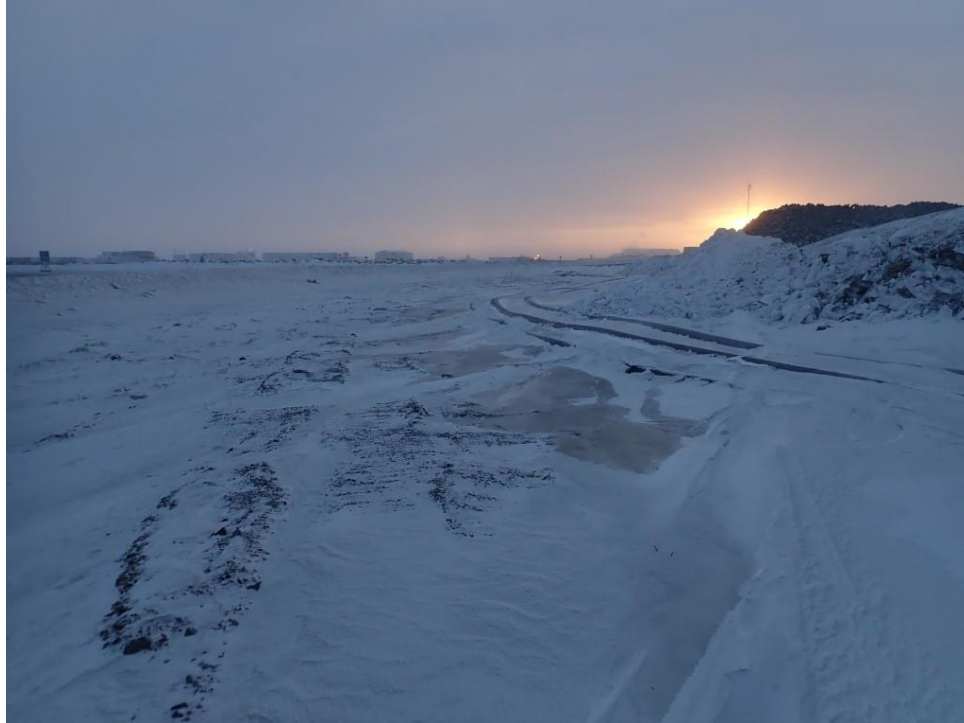
Figure 4: Heat recovery water flowing from east side of WRSF 1 toward CP-1.

No clean-up was required as the water was completely contained in the site catchment area and will migrate to CP1 when thawed. The source of the heat recovery water is the Meliadine Lake freshwater intake, which directs the water through the water treatment plant. Water quality is monitored at this licensed compliance monitoring location, Mel-11. Given the source and containment of the water spill, the incident is not expected to have an environmental impact.

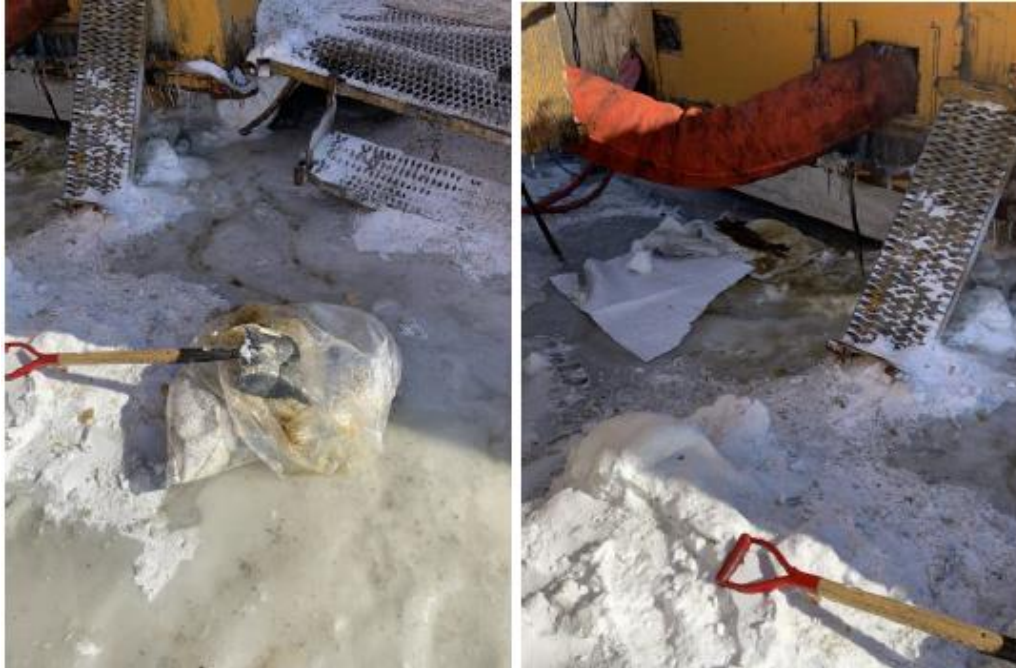
On March 29, at approximately 16:00 Environment Technicians were called to conduct an inspection of the surface drill rigs, operated by contractor Orbit Garant. Two drill rigs were operating on Lake A8 (Figure 1). During the inspection both rigs were found to have areas with small amounts of hydraulic oil dripping from inside the rigs onto the lake ice. Drill #1 was estimated to be approximately 20L (Figure 2), and Drill #7 was estimated to be approximately 3L (Figure 3).

Figure 2: Contaminated snow outside of Drill #1.

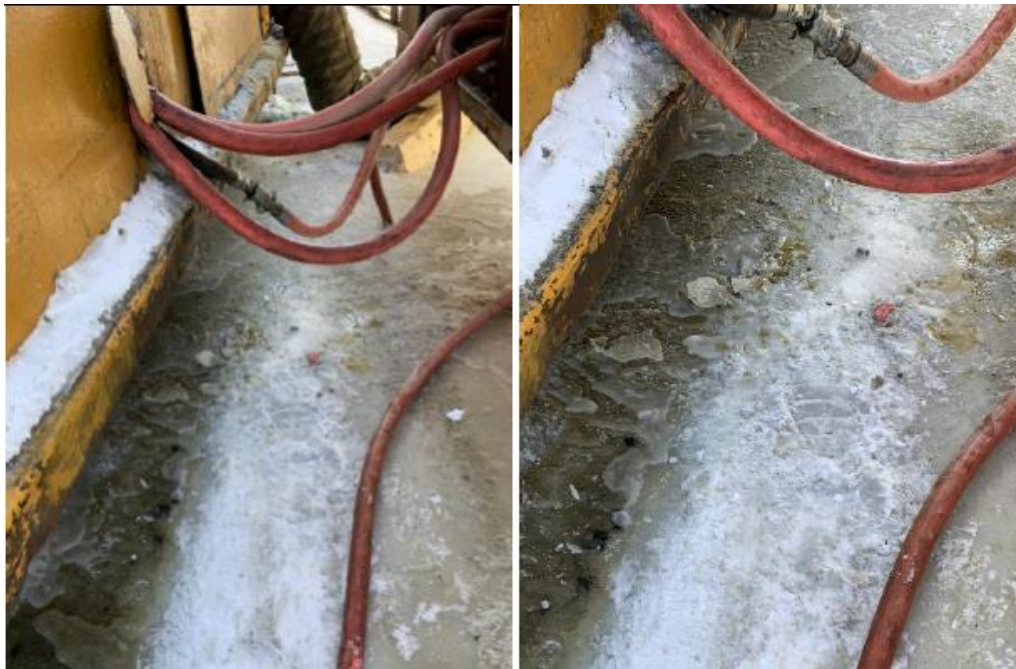
Figure 3: Hydraulic oil dripping from hoses outside of Drill #7.

The leaking fittings on the exterior hoses were repaired, and drip pans were installed beneath the ledges where oil was leaking from inside the rigs. The Orbit Garant supervisors held meetings with both shifts to discuss the importance of routine, regular inspections of their rigs. Due to the high worker turnover rates of Orbit Garant drillers, supervisors will ensure to reiterate these messages to new workers, and the Environment department will continue conducting regular inspections.

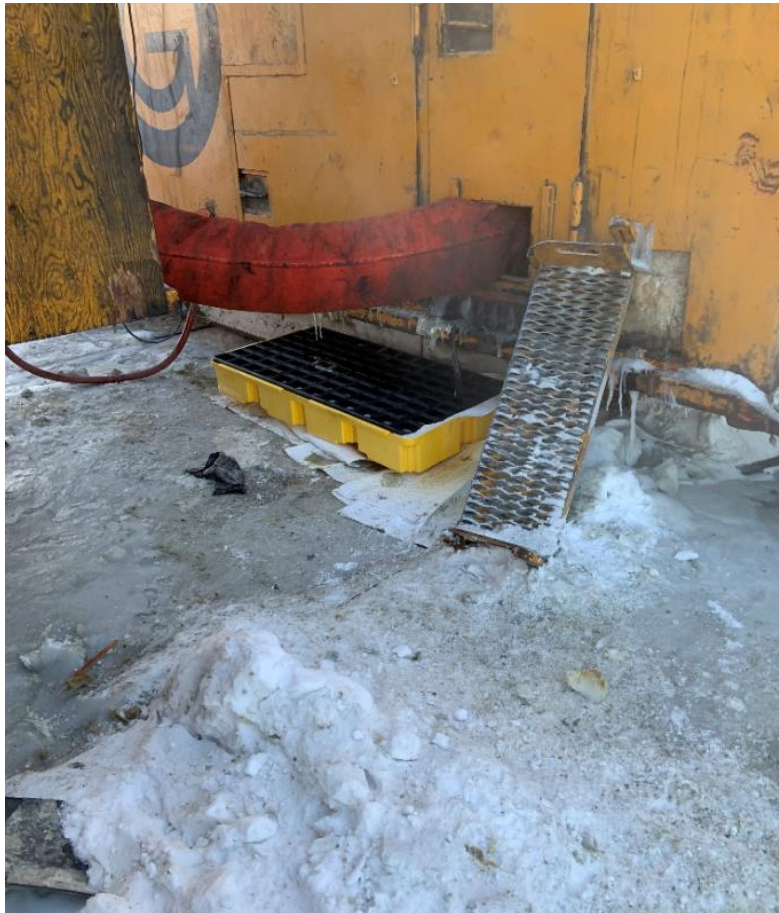
Figure 4: Drill #1 on March 30 after clean up and installation of drip pans and absorbents.

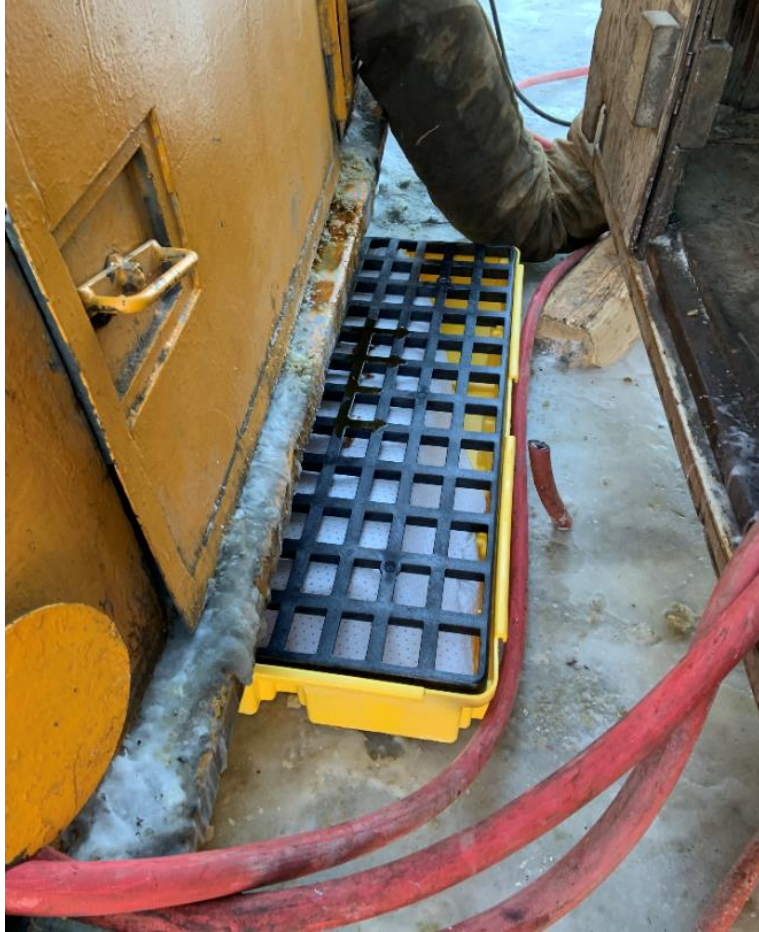
Figure 2: Drill #7 on March 30 after clean up and installation of drip pans and absorbents.

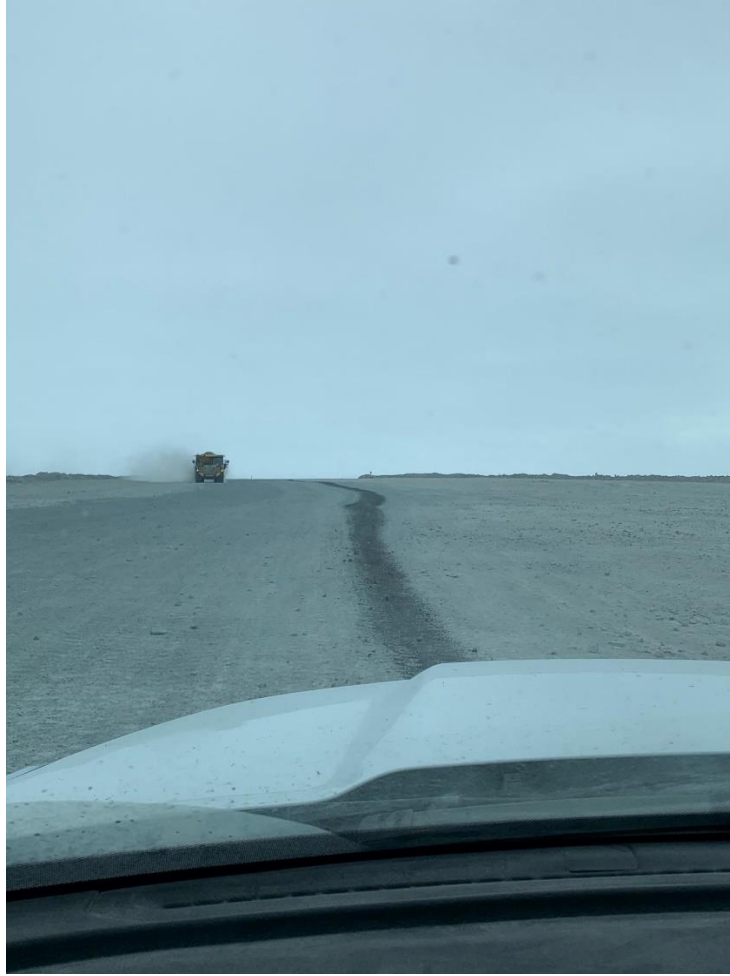
Figure 2: A hydraulic line ruptured on a haul truck and oil leaked between TIRI1 and WRSF1.

The specific cause in this incident is attributed to wear and tear on the hydraulic lines, compounded by the cold temperatures the lines are exposed to and the vibrations caused by rocky roads in this area. Regular preventive maintenance is performed on all haul trucks and workers perform daily vehicle inspections. In this case, the hydraulic line was repaired and the truck was put back into service.

The vehicle was shut down as soon as the driver was notified that a leak was observed. Absorbent spill pads and drip pans were placed beneath the parked vehicle to prevent oil from continuing to leak onto the road. The Pit Operations and Environment Department organized a clean-up of the area which involved using a grader and loader to scrape up the material along the entire oil trail. All contaminated material was transferred to the Landfarm A for remediation.

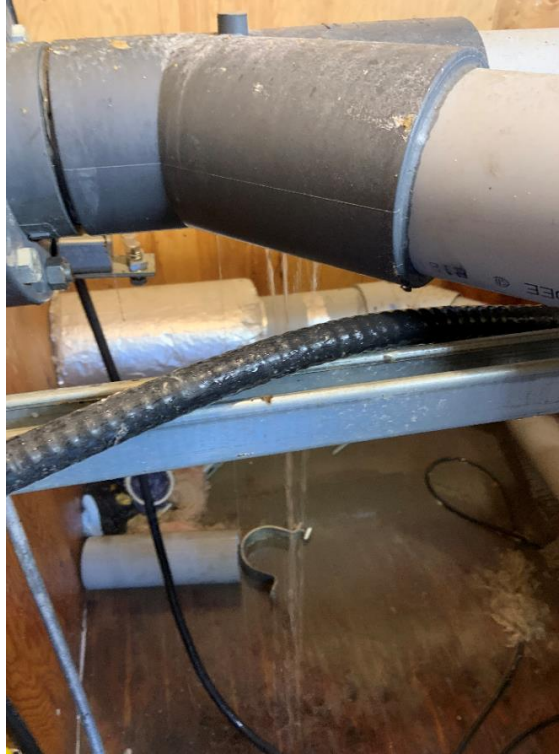
At approximately 05:15 am on May 13, 2021, the operator of the sewage treatment plant (STP) arrived to low level alarms in the EQ tank. The supervisor was then notified of a discrepancy with the amount of water consumed not matching the raw water received for the past 12 hours, suggesting that there may have been a breakage in the line somewhere. The lift station of the main camp was then inspected and upon arrival the access door was found open. With night temperatures dropping below zero, this likely led to freezing within the pipe/Y joint and eventually failure of the joint.

Figure 2: Cracked and leaking pipe joint inside the lift station.

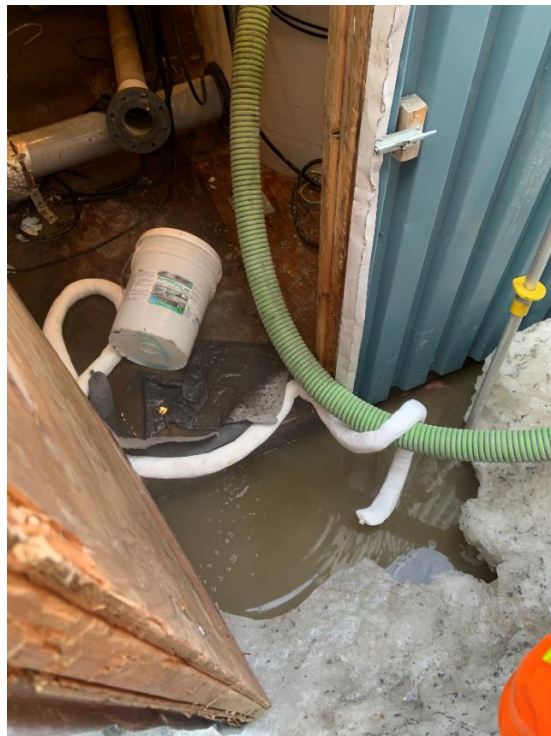
Figure 3: Entrance door of the lift station and water pooling directly outside.

The incident occurred as a result of the access door of the lift station being left open overnight. It is unknown whether it was left open accidentally, or if it was blown open by the wind, but the locking mechanism and door did not appear to operate properly. This led to the freezing and cracking of a pipe due to overnight temperatures below zero. The cracked pipe was replaced the same day and the systems were restored. Repairs are scheduled for the door and locking mechanism to allow it to close fully and lock more securely from the outside. A low temperature alarm is planned to be installed inside the lift station, and other sensors and alarms are being considered (pressure sensors, moisture alarm on the floor, etc.). A full inspection of all exterior drainage systems throughout the MSB and camp is planned to be completed this summer.

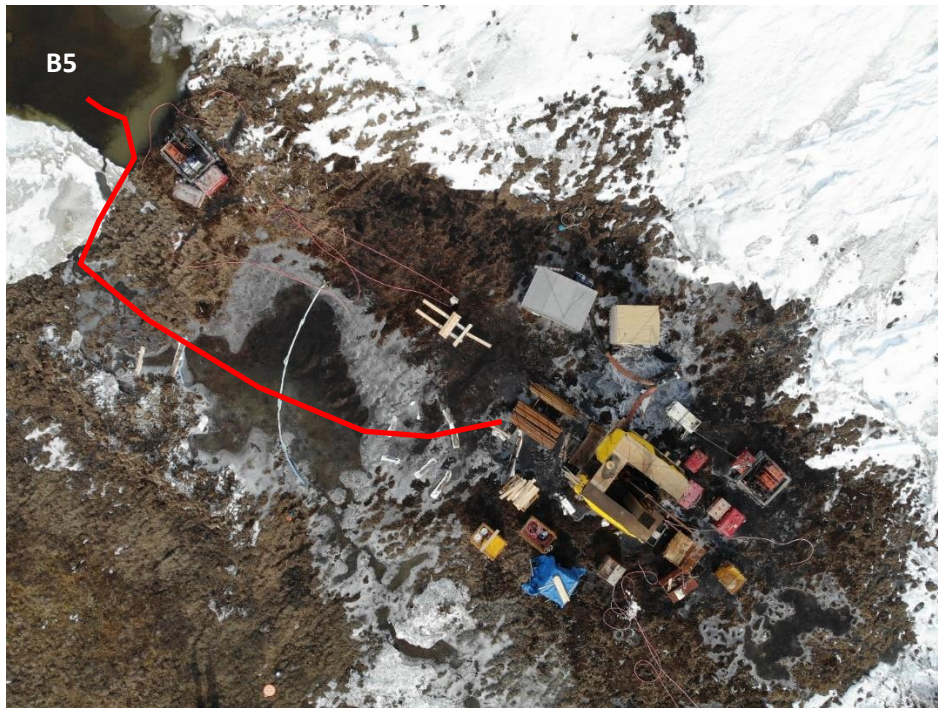
Figure 3: Observed hydrocarbons sheen flow path between drill and B5 Lake.

The specific cause in this incident is attributed to the selection of the location and timing for drilling (in relation to freshet onset). In this case and as previously mentioned, the drill was shut down and materials such as fuel tanks, hoses and other equipment which may contain hydrocarbons contaminated surfaces were moved to higher ground away from freshet runoff. The Environment department will continue conducting regular inspections. Orbit Garant supervisors will ensure to reiterate the importance of inspections of their rigs to their workers to prevent any environmental incident. The procedure for drilling just prior and during freshet is being modified to ensure that drills are not operational during this period where large freshet inflows can be problematic.

The drill was shut down on May 31st to address the issue and materials such as fuel tanks, hoses and other equipment which may present hydrocarbon contaminated surfaces were moved to higher ground away from freshet runoff. Absorbent pads and booms were put in place to capture the hydrocarbons at the surface of water. The contaminated absorbent materials were recovered into Quatrex hazmat bags.

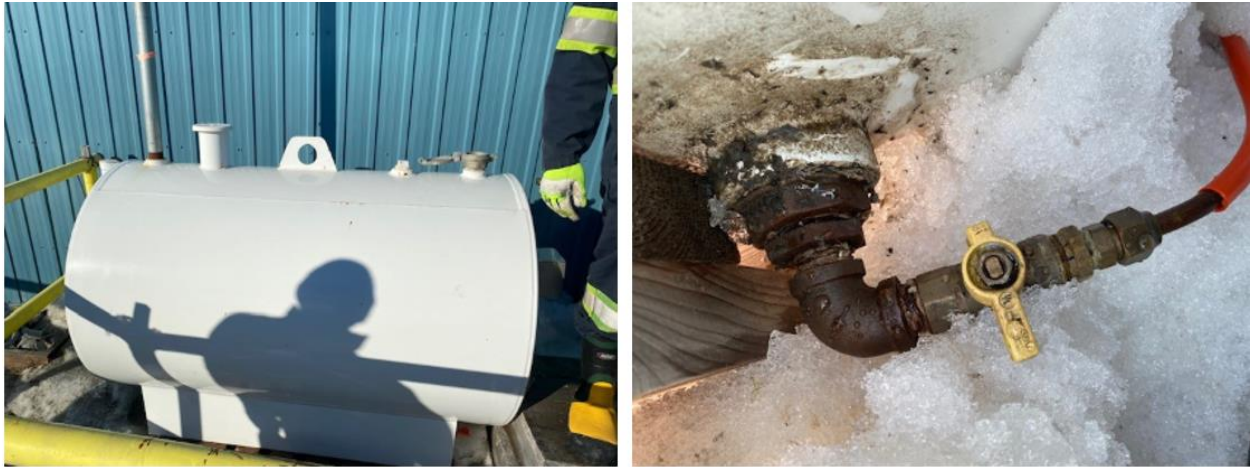
The supply copper line to a furnace located approximately 10 m away cracked, likely due to the cold conditions and the presence of water in the line.

Figure 2: The exterior fuel tank and damaged fuel line which led to the spill.

The remaining fuel in the tank was pumped out and the tank was disconnected from the building. An identical tank on an adjacent building was inspected to ensure the fuel line was in a safe condition. The contaminated wood was removed and disposed of as hazmat, and the water was treated through the oil/water separator.

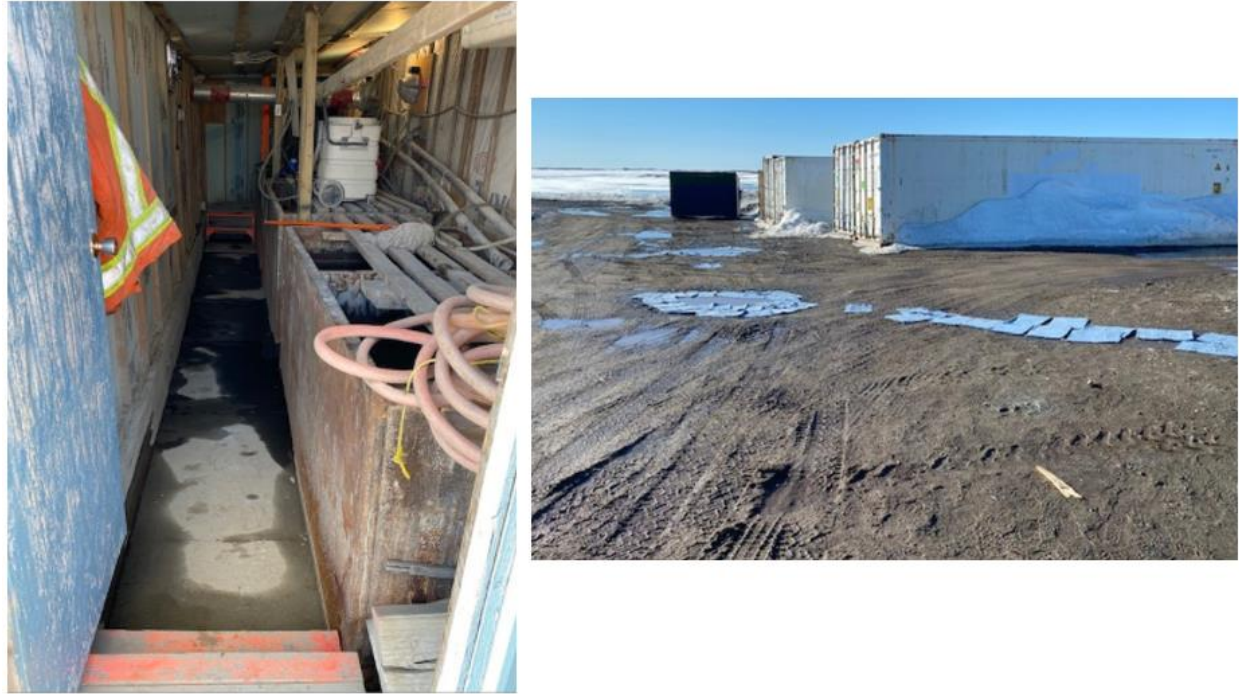
Figure 3: Initial extent of the contaminated areas inside the decantation room, and into the parking area.

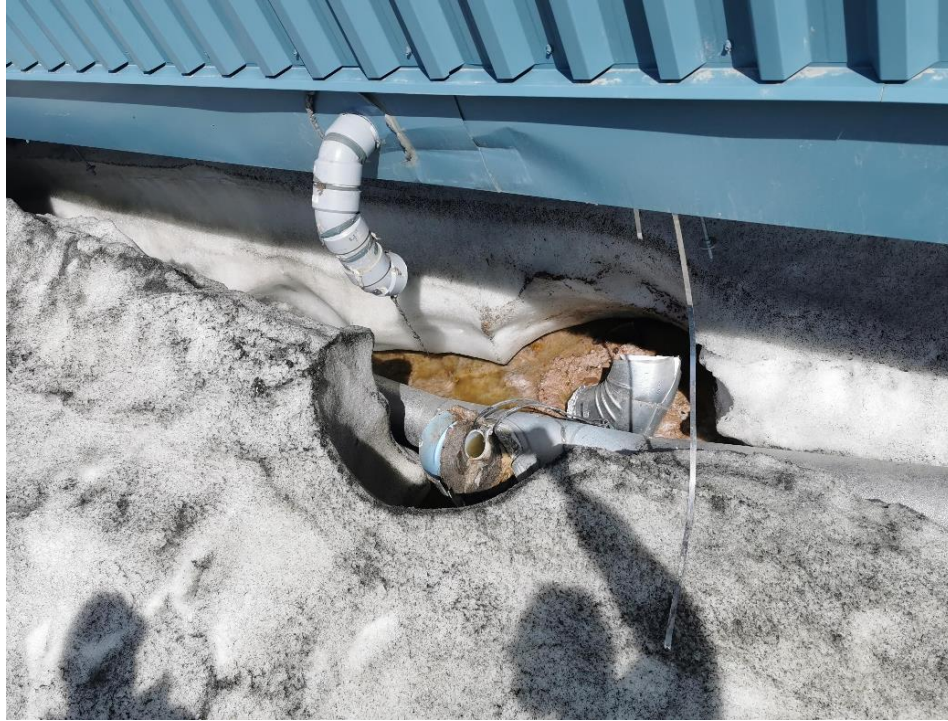
Figure 2: Drainpipe on the exterior of Wing 12 that separated from the building due to the weight of snow.

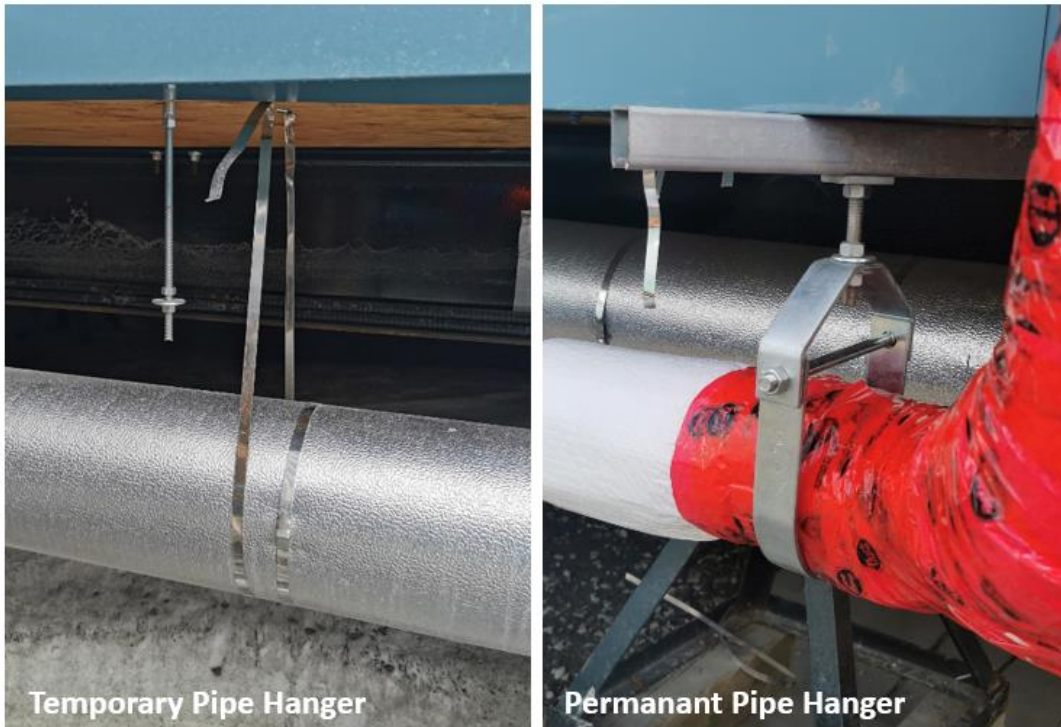
Figure 3: Example of the temporary pipe hanger that was in place prior to the spill, versus the permanent pipe hanger that is now installed.

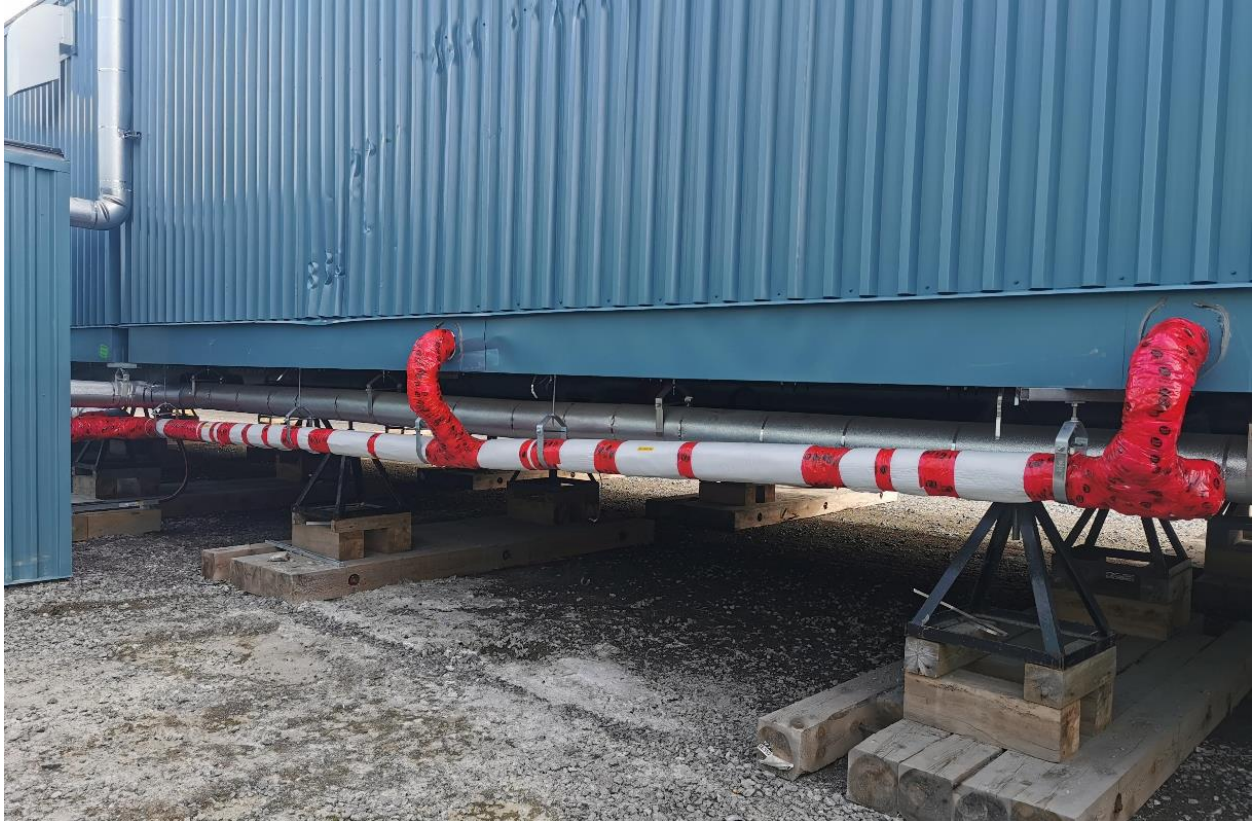
Figure 4: Clean up of the area and reinstallation of the drainpipe with heat trace and insulation.

The initial action was to close out the usage of the Wing 12 bathrooms so until the pipe could be fixed, in order to prevent any more water from being released. The sucker truck was used to recover as much standing liquid and debris from the ground as possible, which was deposited back into the lift station of the main camp to be treated through the Sewage Treatment Plant. The snow was removed from the area in order to better assess and repair the damage.

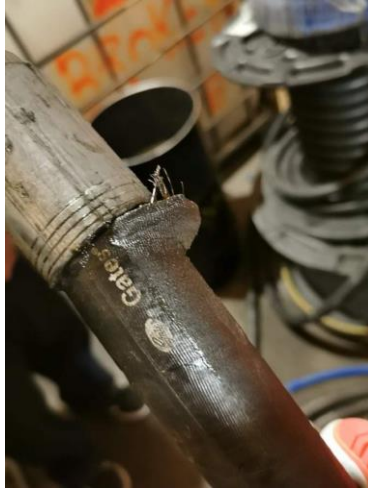
Figure 2: Failure of the hydraulic line of excavator.

The excavator was shut down as soon as the operator noticed the stick (bucket) was not responding. Sorbent pads were placed under the excavator to collect the hydraulic fluid. The spill was contained within the immediate area around the excavator and remained on the crusher pad. The Pit Operations organized the clean-up of the area which involved using excavator to remove the material. An approximate volume of $\frac{1}{4}$ of a bucket from the 980 loader of contaminated material was recovered and brought to the Meliadine Type A Landfarm.

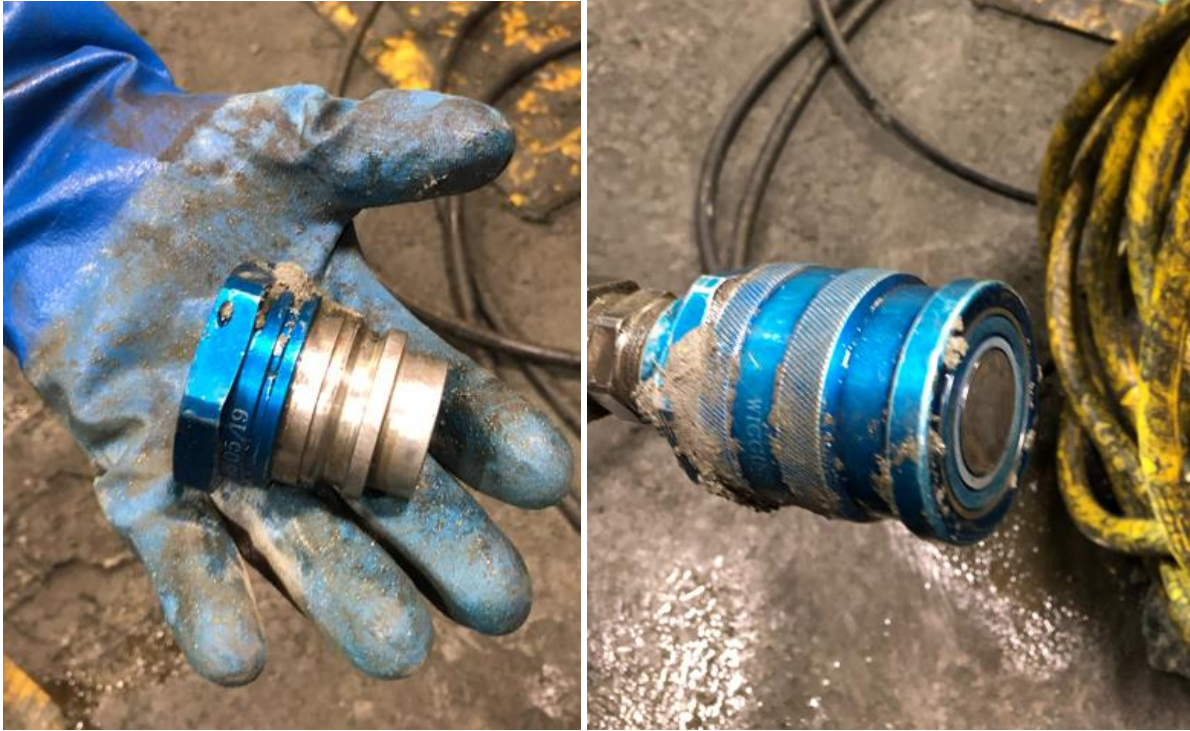
Figure 2: Broken hydraulic line connection from Fuel/Lubrication truck.

Spill pads were immediately placed on the affected area and a berm was constructed to contain the oil. The Underground Mine Supervisor and Environment Department organized a clean-up of the area. The area was cleaned up using an excavator and haul truck. All contaminated material was disposed of in the Landfarm.

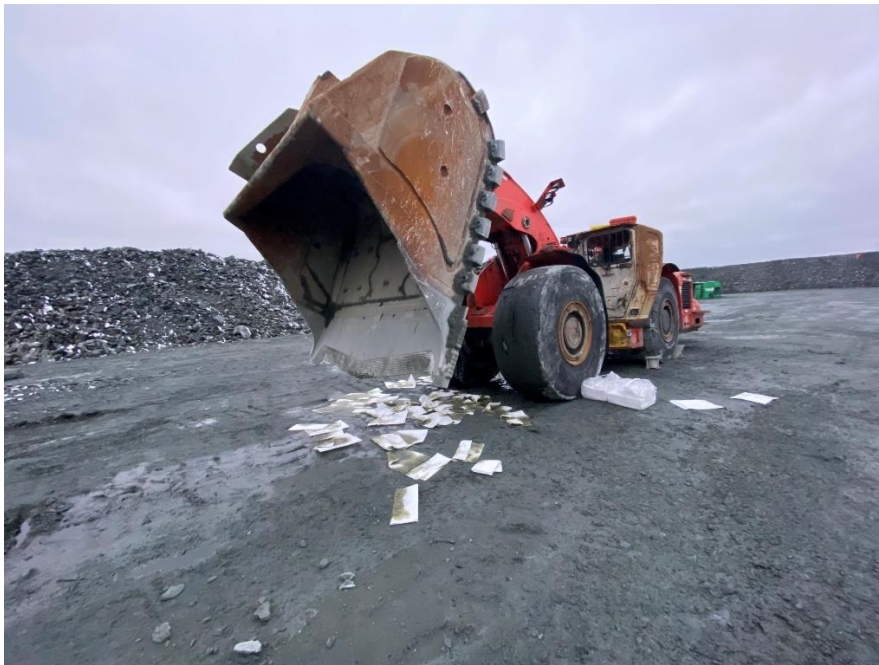
Figure 2: Hydraulic line failure during operation

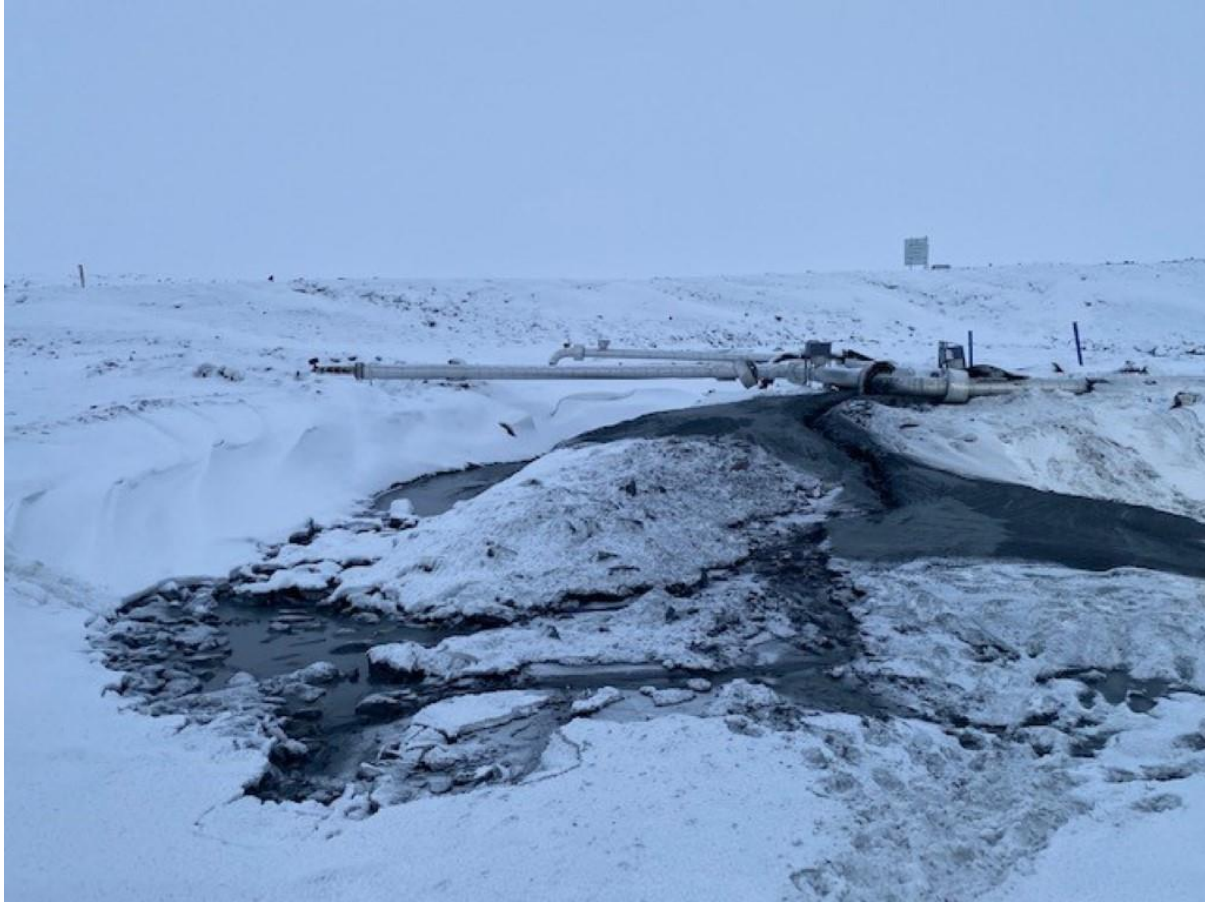
Figure 2: Cement paste leak

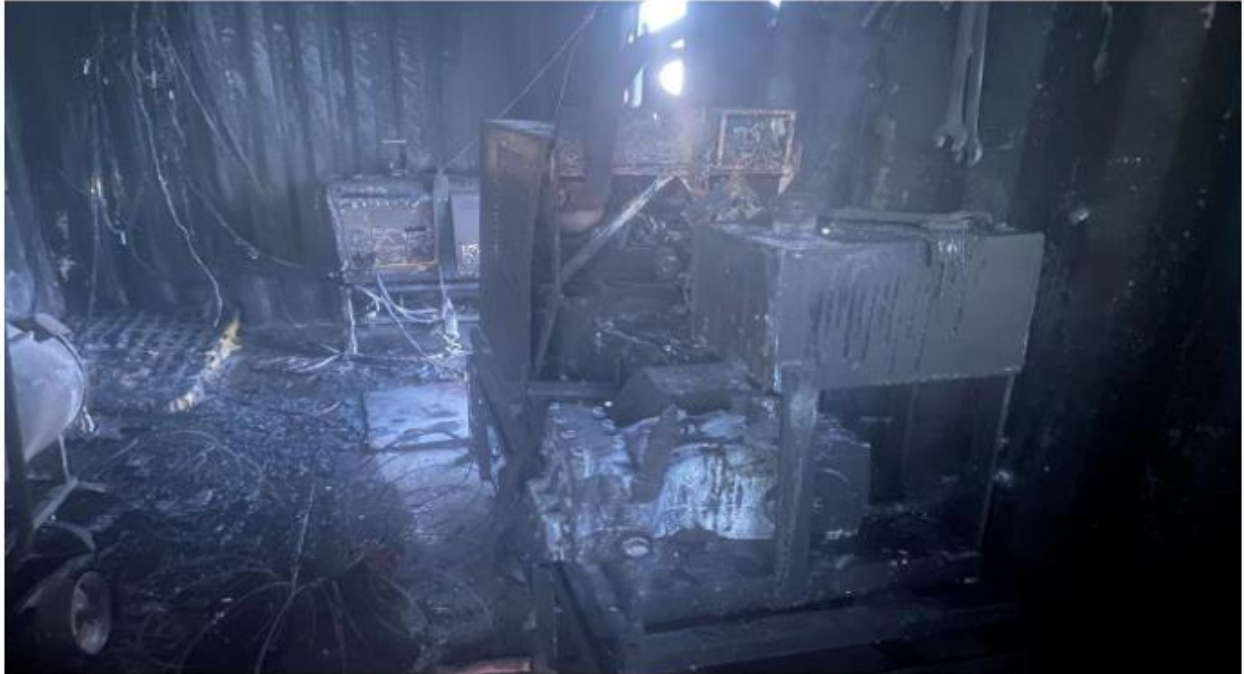
Figure 2: Photos of the pump shack after the fire was suppressed and the shack was towed back to the shop.
