## Appendix 16: 2022 Reportable Spills

# Follow Up Report: #2022019

## January 25<sup>th</sup>, 2022 – Thickener Water Spill

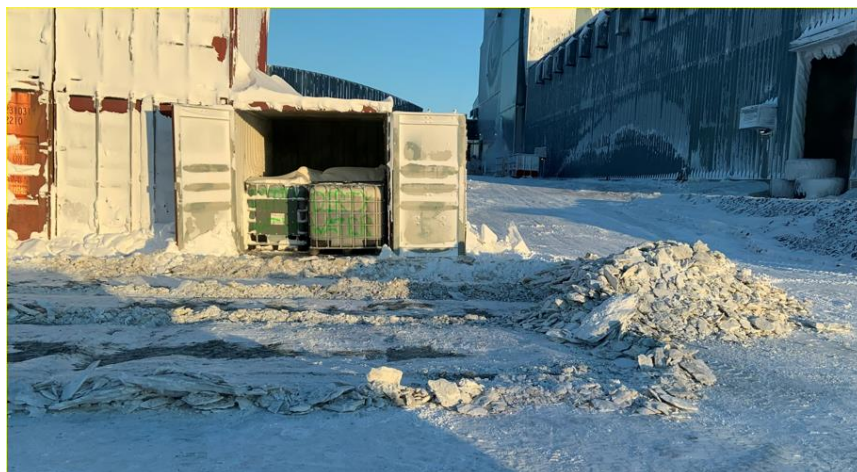
Figure 3: Initial cleanup process. Stockpile material later taken to the contaminated snow cell.

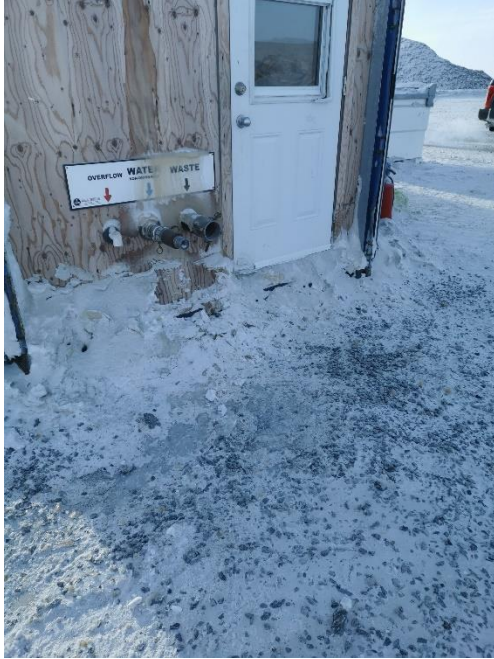
**Figure 2:** Spill cleanup area (contaminated ice removed and material put down to prevent slipping)

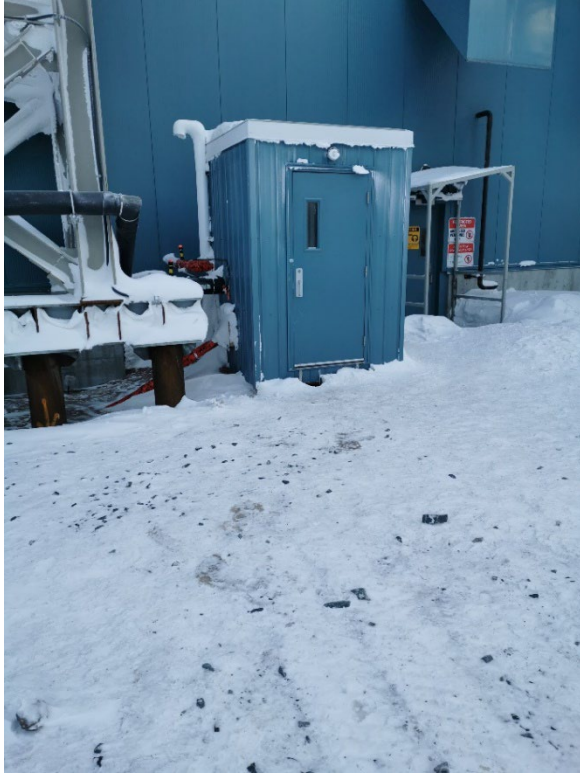
**Figure 2:** Power plant lift station spill clean up

A malfunction on the pump discharge line caused wastewater from the process plant to backfill into the power plant lift station, causing an overflow.

Following this event, a plumber was sent to inspect and repair the line. The check valve on the pump discharge line was replaced and the high-level float preventing the pump from continuously running was also serviced. Furthermore, daily lift station checks are being conducted by the Energy and Infrastructure Department.

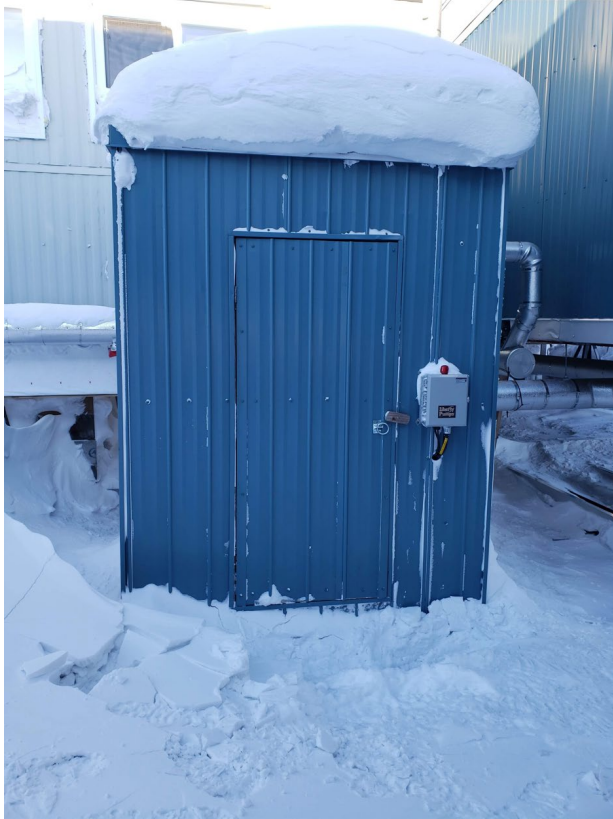
**Figure 2:** Lift station spill general area was cleaned with sucker truck and shovel

The door of the lift station was found opened. This led to the discharge lines freezing and resulted to an overflow in the lift station. Additionally, the alarm in the lift station froze in the cold weather, rendering it inoperable.

A door latch has been installed to keep the door closed and a frost fighter was also installed to prevent the line from freezing in the future.

Furthermore, an electrician has performed an inspection of all safety/warning systems (strobes and horns) on all lift stations to ensure that safety systems are working as designed and has recommended installation of alarms supporting colder conditions which will be installed in the upcoming weeks.

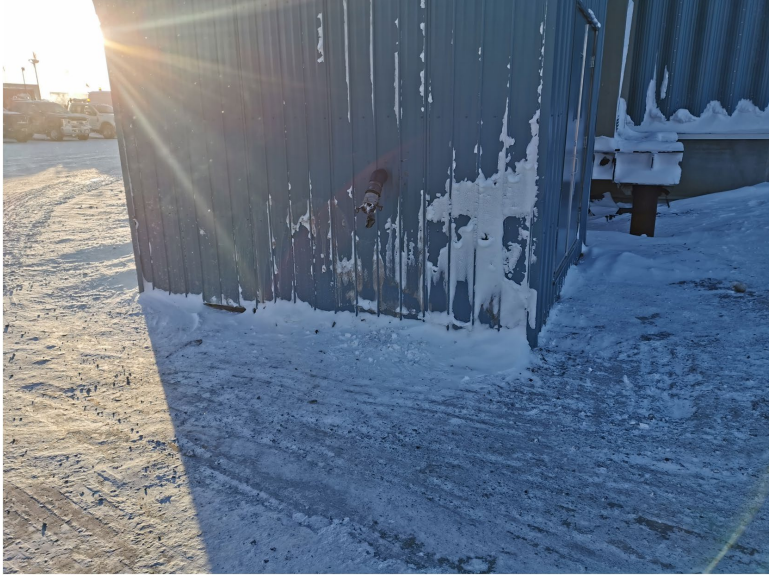
**Figure 2:** MSB lift station spill clean up

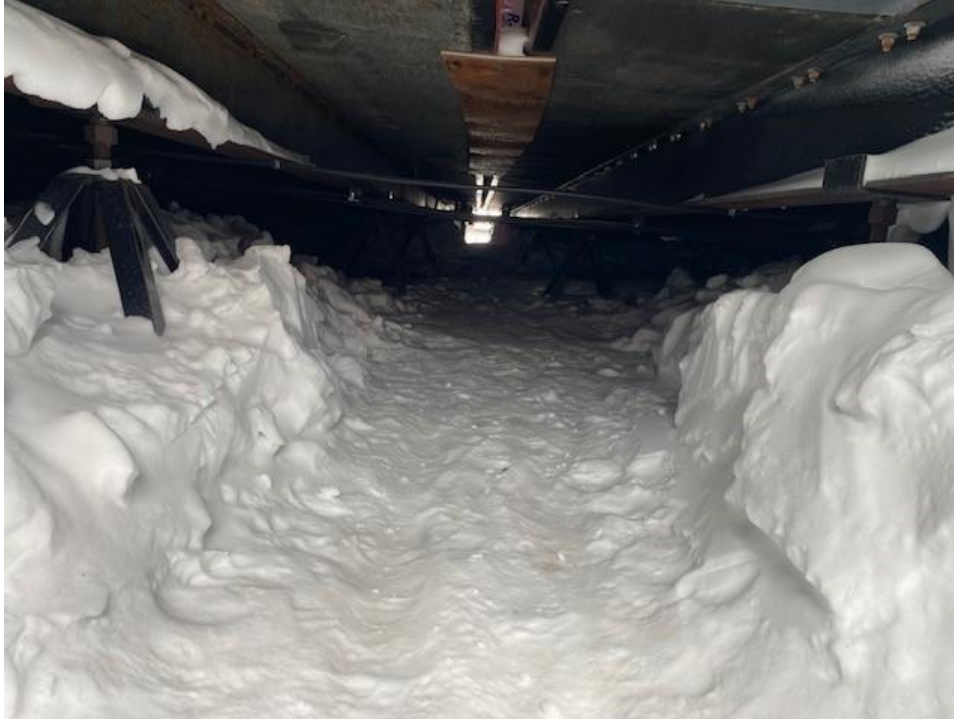
**Figure 2:** Spill clean-up area

It was determined that the difference in temperature between the warm grey water and the cold PVC plumbing caused the plumbing to expand and crack.

Astro foil was installed as a temporary fix around the pipe on March 9<sup>th</sup>, 2022 until the rigid pipe insulation could be installed. The plumbing installation of the rigid pipe installation started on March 9<sup>th</sup>, 2022 and finished on March 11<sup>th</sup>, 2022.

The repair on the grey water pipe started immediately on March 9<sup>th</sup>, 2022 and finished on March 11<sup>th</sup>, 2022.

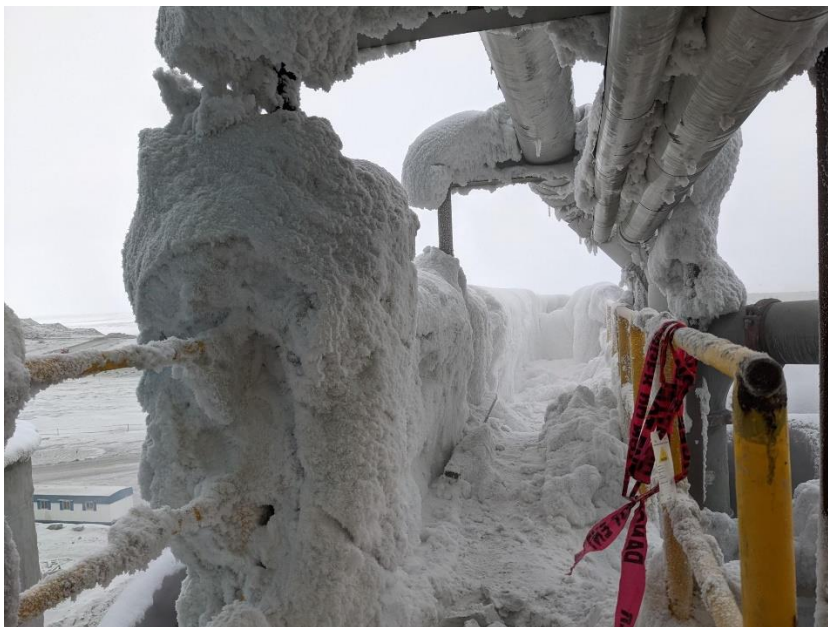
**Figure 3:** Pre-clean up of the overhead ice on the thickener tank (caused by humidity)

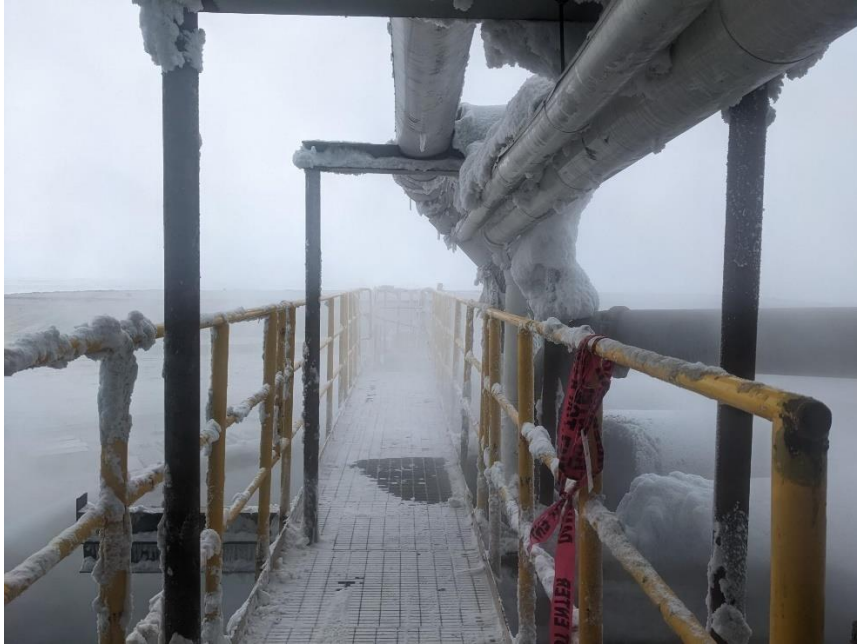
**Figure 4:** Post-clean up of the overhead ice on the thickener tank

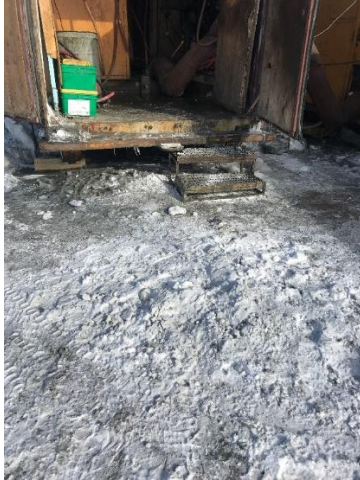
**Figure 2: Spill Location- Post-clean up**

The cause of the release was identified as human error as an outlet valve was not in the closed position. To prevent a similar situation from occurring Orbit Garant is developing a Drill Cutting Vacuum Pump Operations Procedure to ensure proper operation of the drill cuttings vacuum pump. Additionally, it is now mandatory to use a spill containment under the outlet valves during drill cutting vacuuming operations. A spill containment is also available with the drill cutting vacuum pump for use in case spill containments are not available at the drill site.

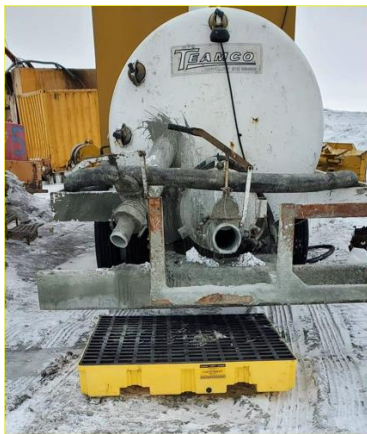
**Figure 3: Secondary containment is now available with the drill cutting vacuum pump**

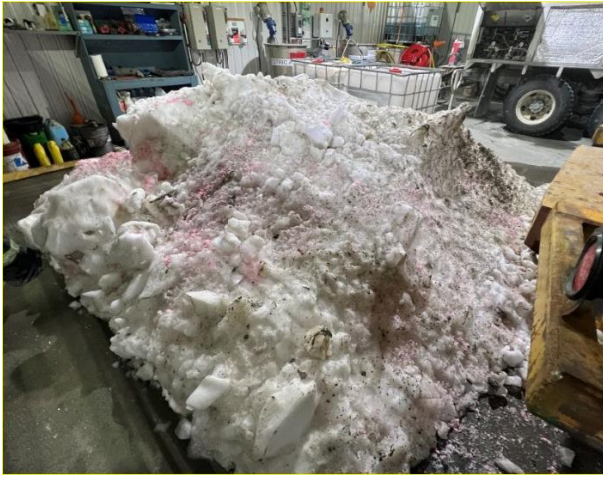
**Figure 2:** Impacted material in Dyno Equipment Shop to melt

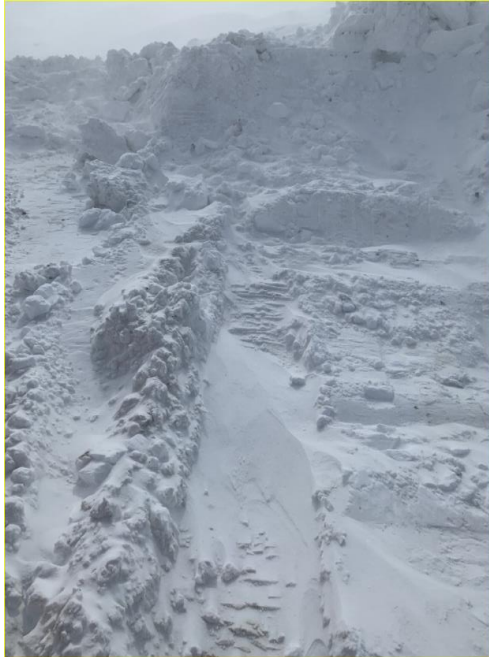
**Figure 4:** Final cleanup

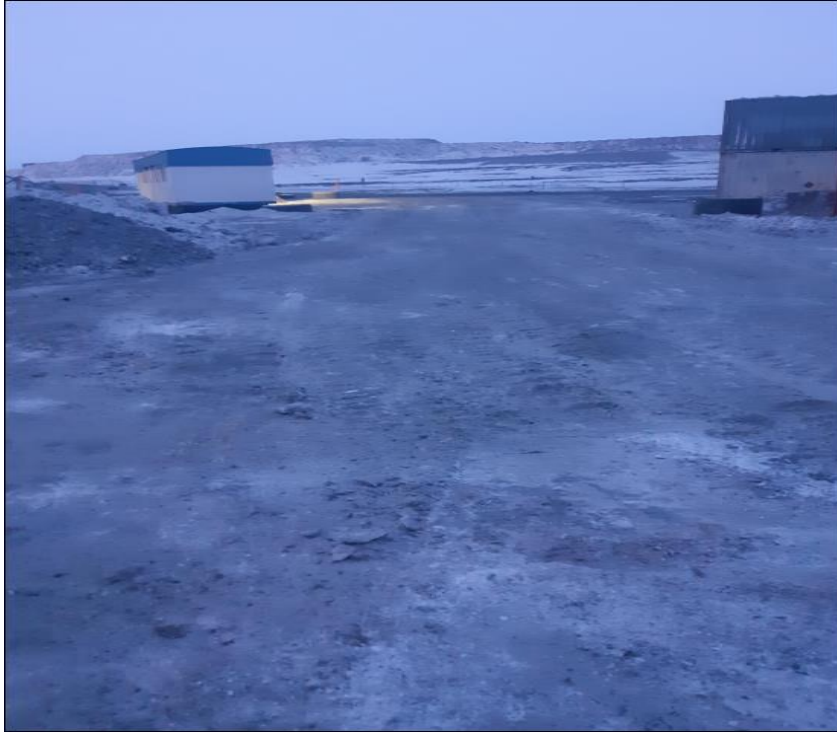
**Figure 2:** Thickener process water spill cleanup

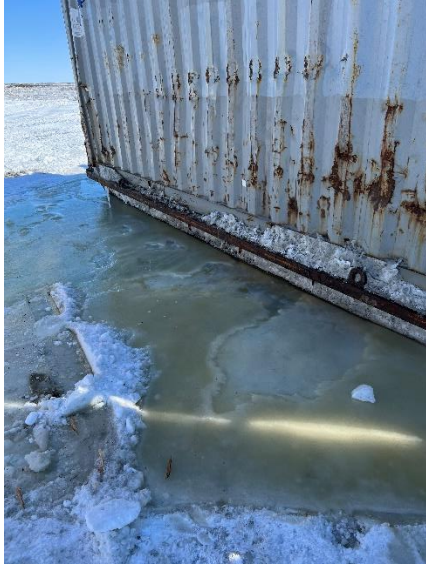
**Figure 2:** Spill location prior to clean-up. A post clean-up photo is not available. The corrective measures to follow to address this discrepancy are in the updated procedure EXP-ENV-001 as outlined below.

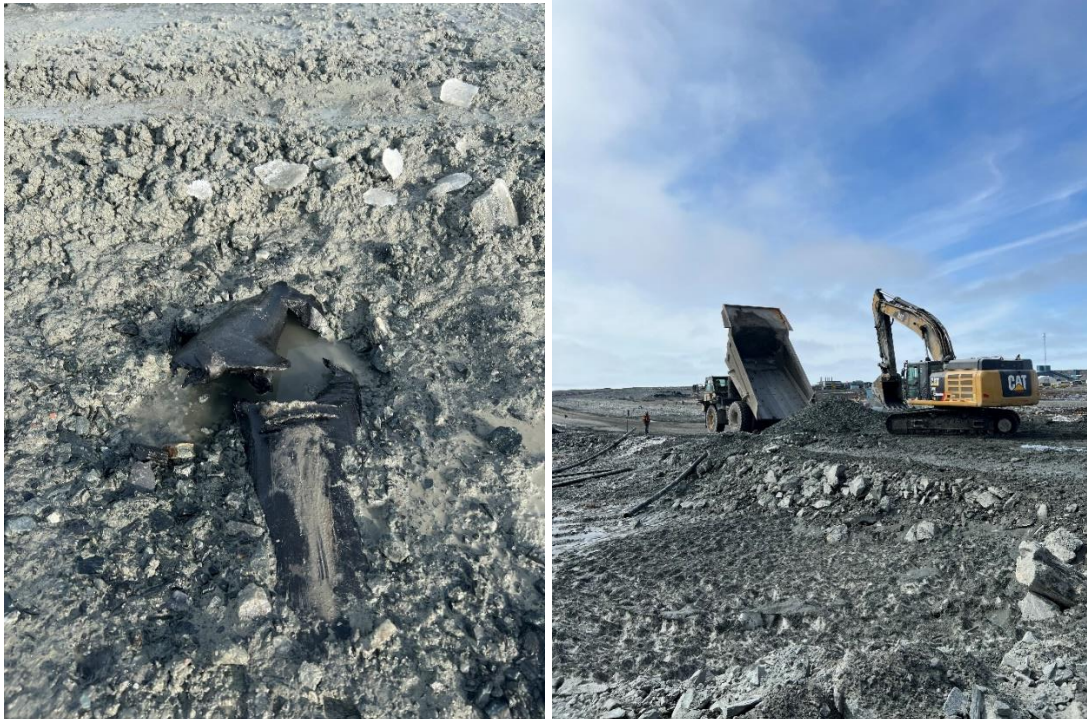
**Figure 2 and 3:** Damaged pipe which saline water flowed out of (left) and repairs made the same day (right).

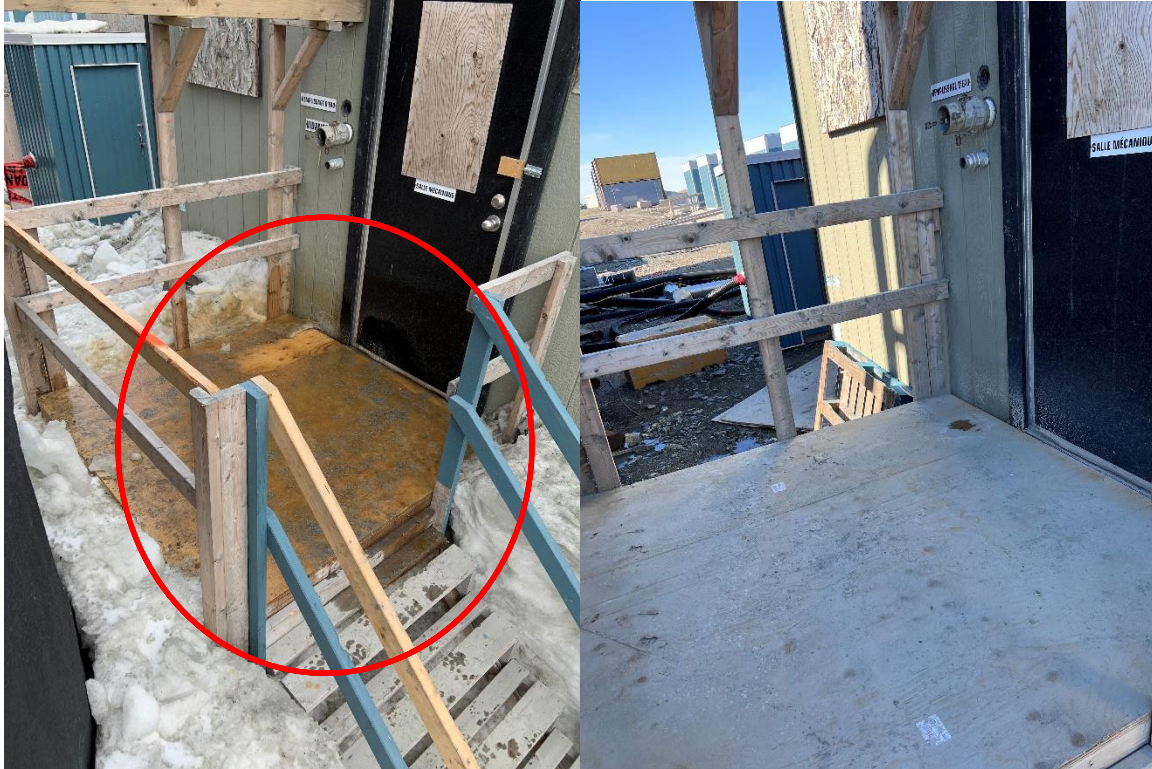
**Figure 2:** C wing lift station spill and cleanup

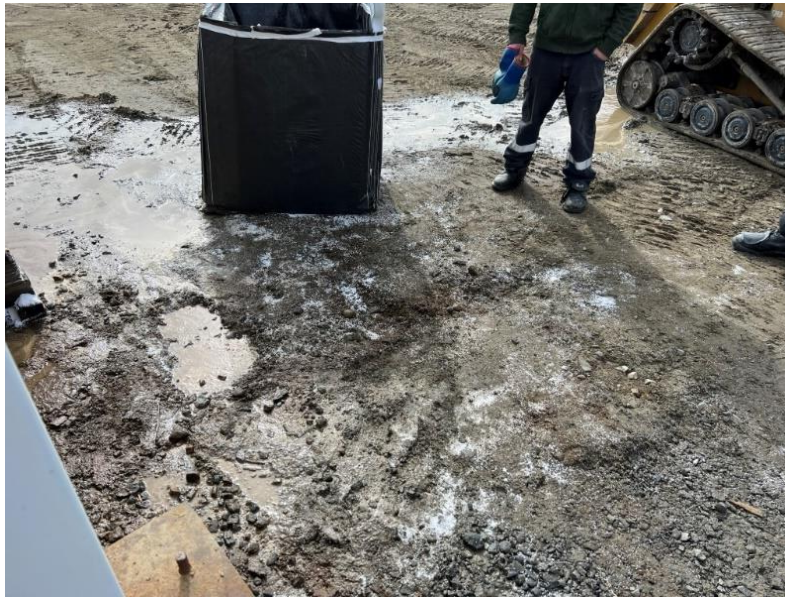
**Figure 2:** 100 kg Ammonium Nitrate spill

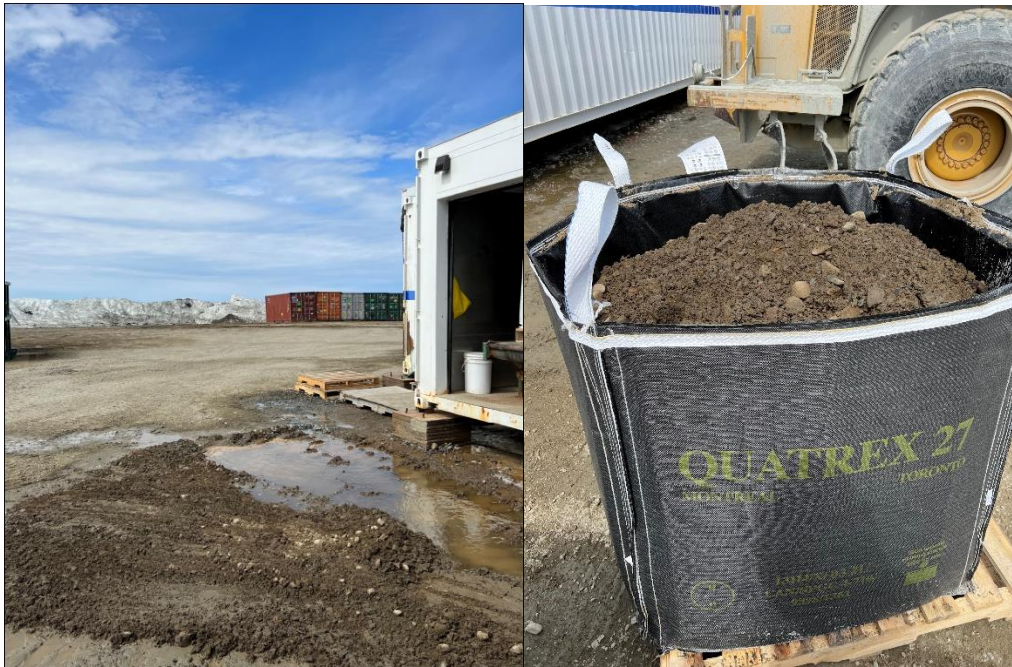
**Figures 3-4:** Spill area final cleanup and contaminated material packeted and ready to be disposed
