Appendix 6: 2022 Annual Geotechnical Inspection Report

2022 Annual Geotechnical Inspection Meliadine Gold Project, Rankin Inlet, Nunavut

PRESENTED TO
Agnico Eagle Mines Limited

FEBRUARY 17, 2023
ISSUED FOR USE
FILE: 704-ENG.EARC03140-31
AGNICO EAGLE DOCUMENT NUMBER: 65-600-230-TCR-001

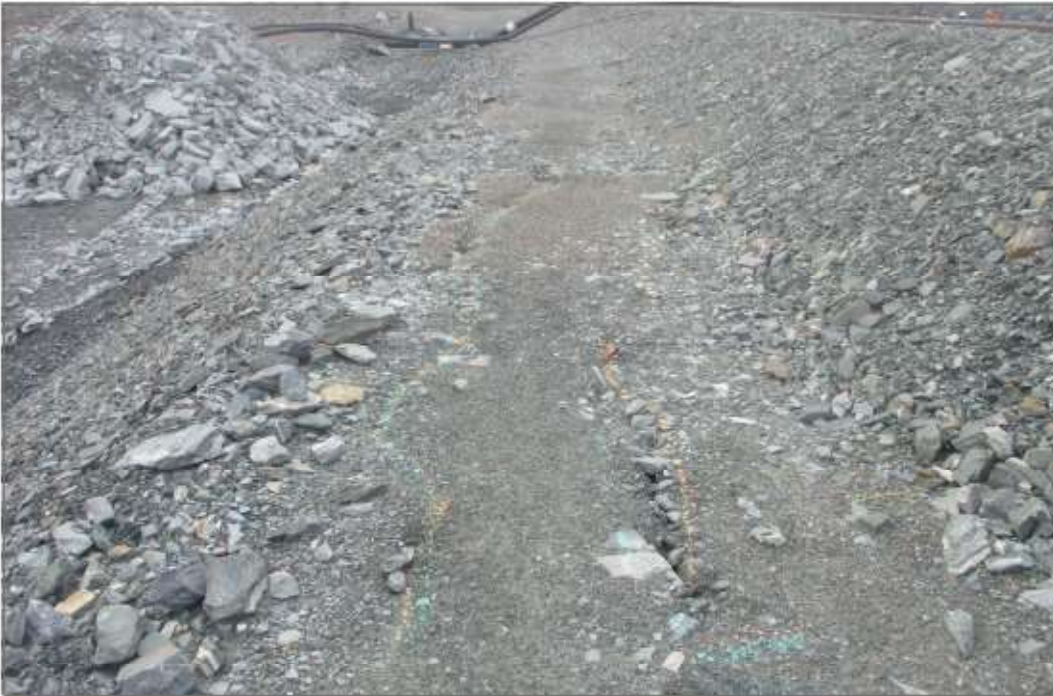
- Minor cracking and small settlement were observed along portions of the upstream and downstream crest (e.g., Photos 6, Appendix B). The largest cracks were up to 3 cm wide. The cracking shows no significant change from previous years.

Photo 6: Dike D-CP1 - Downstream crest, minor cracking, no change from previous year.

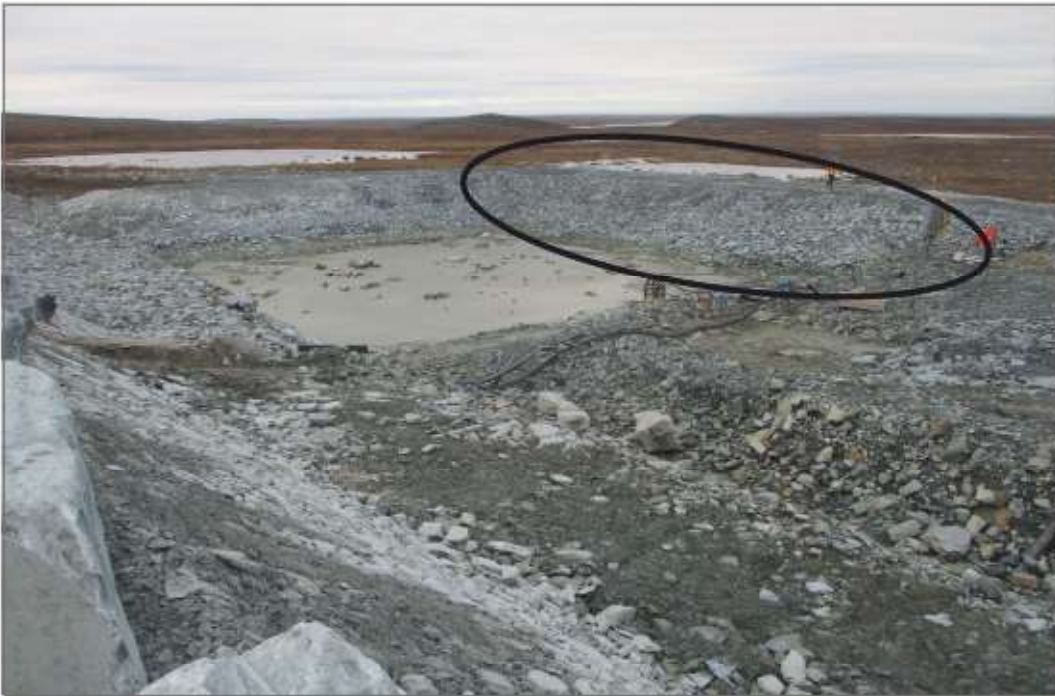
Photo 10: Dike D-CP1 - Seepage collection pond downstream of dike. Deformation of fill at southeast corner of pond has been rebuilt and rockfill cover placed on exposed tundra.

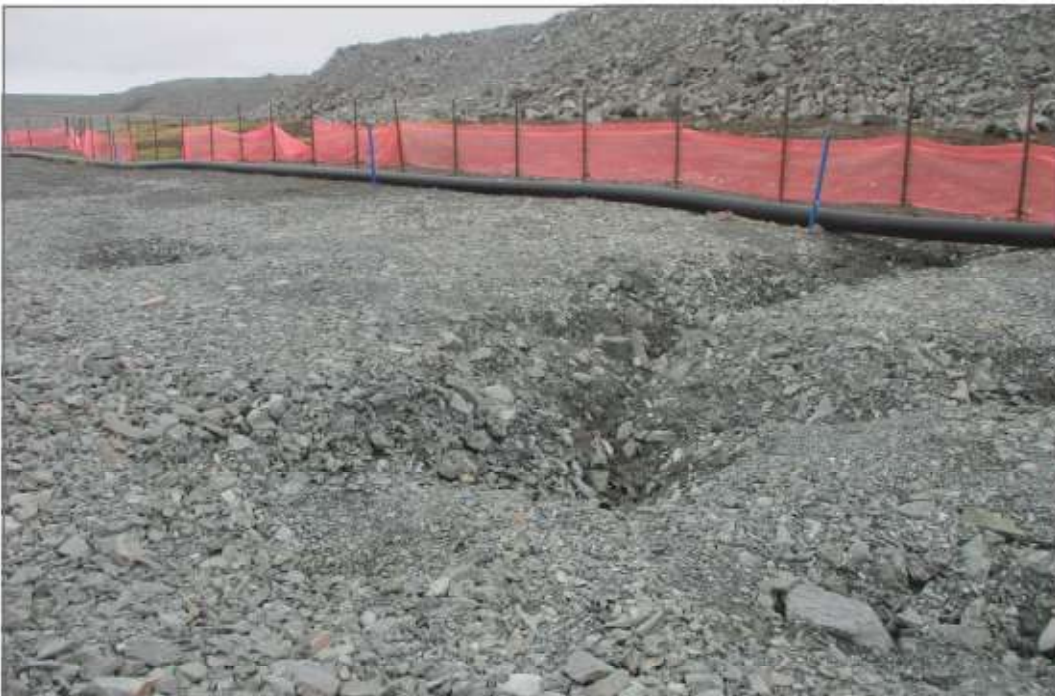
Photo 5: Pond CP4 - Settlement and cracking above east slope.

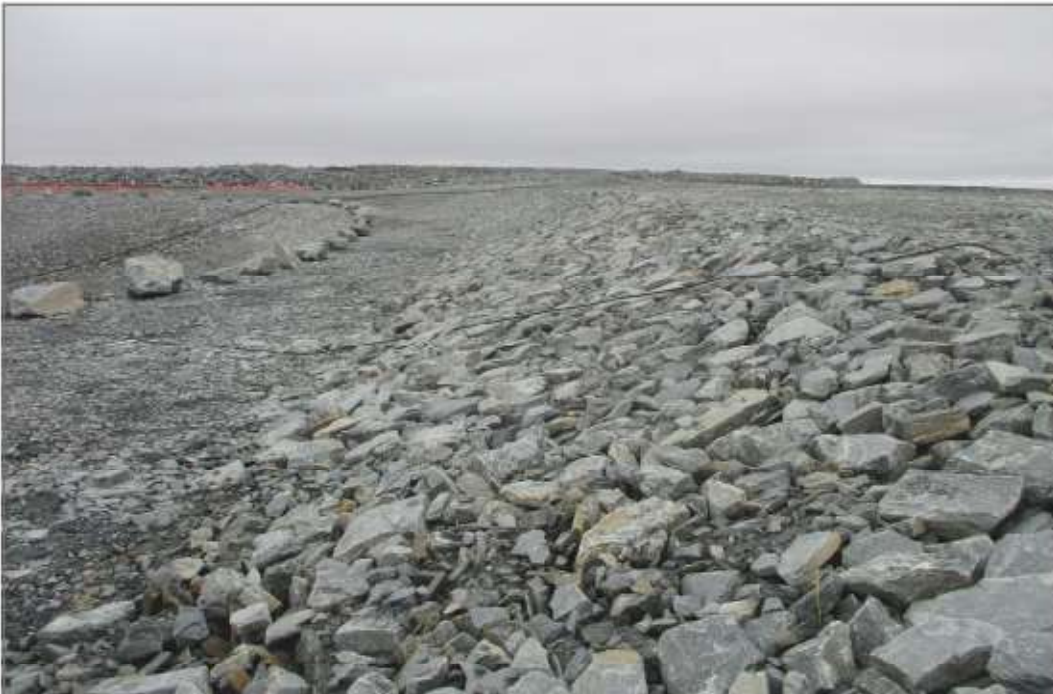
Photo 9: Pond CP4 - Rockfill placed between CP4 slope and berm to reduce thaw subsidence observed in 2021 inspection.

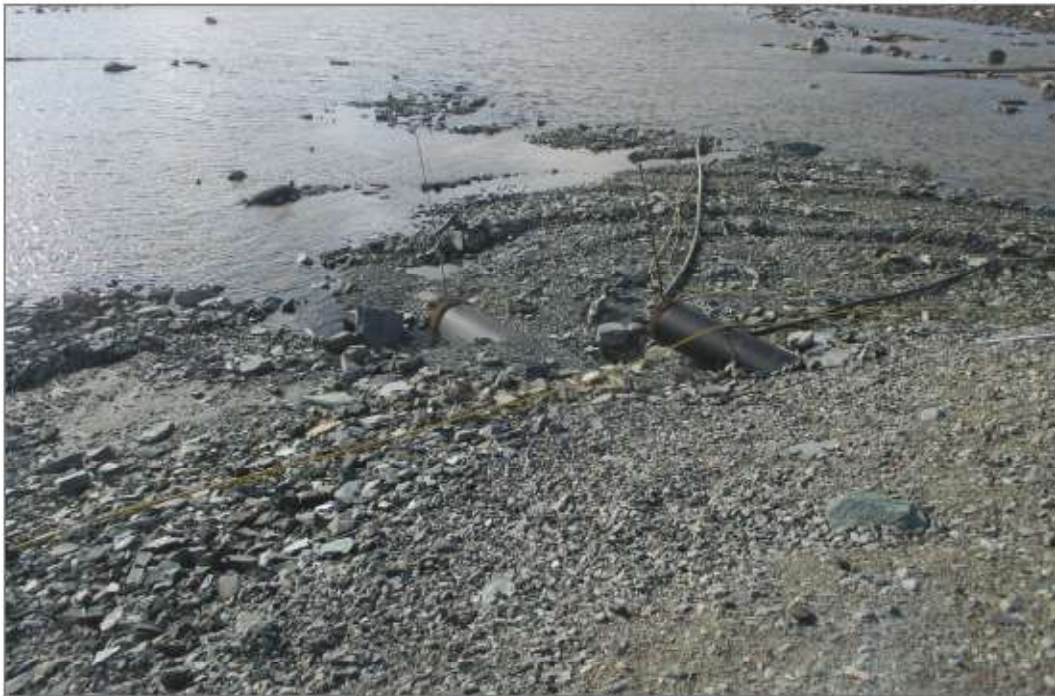
Photo 9: CP5 Jetty 5 - Repaired footing erosion from 2021.

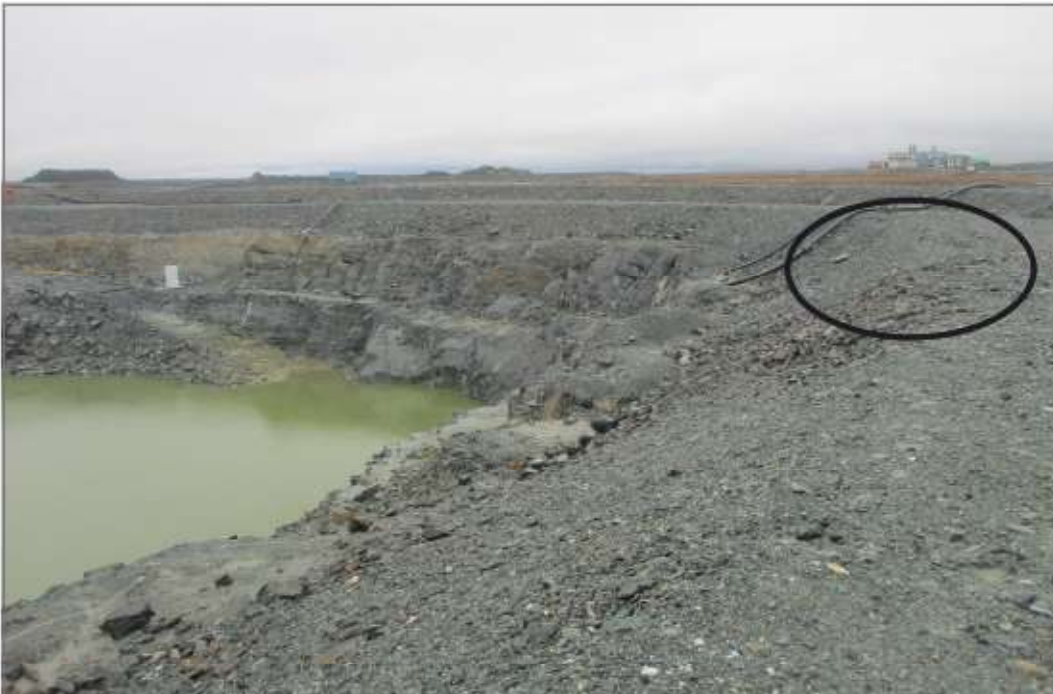
Photo 3: SP1 Saline Pond - Deformation and cracking in top of overburden protected slope, southwest corner of pond.

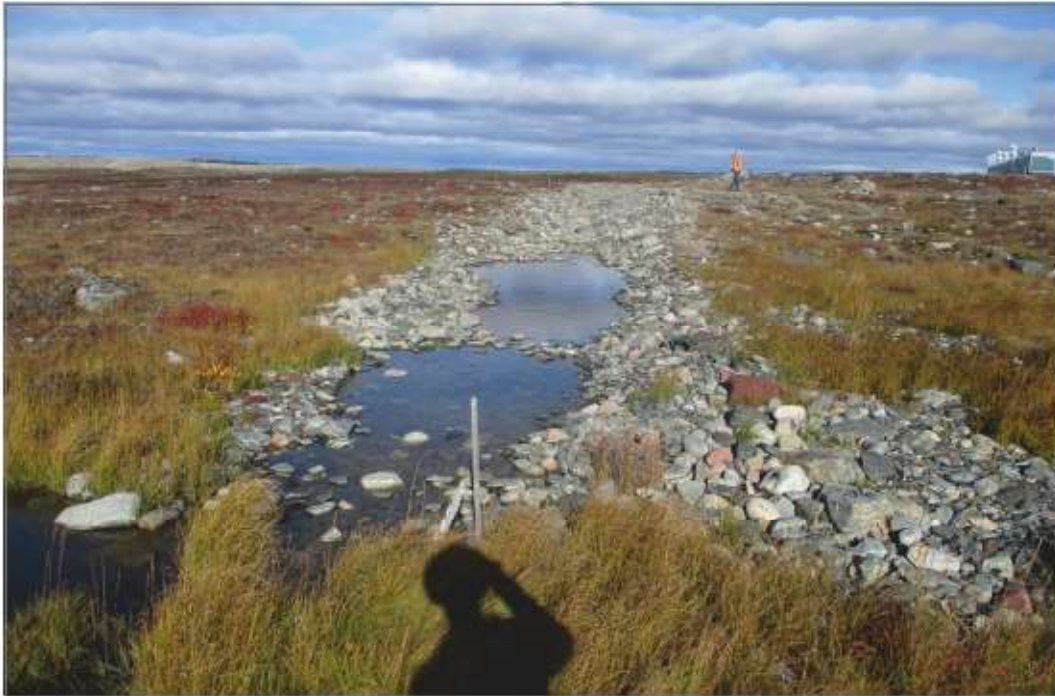
Photo 11: Channel 2—Some settlement in base of channel allowing water to pool.

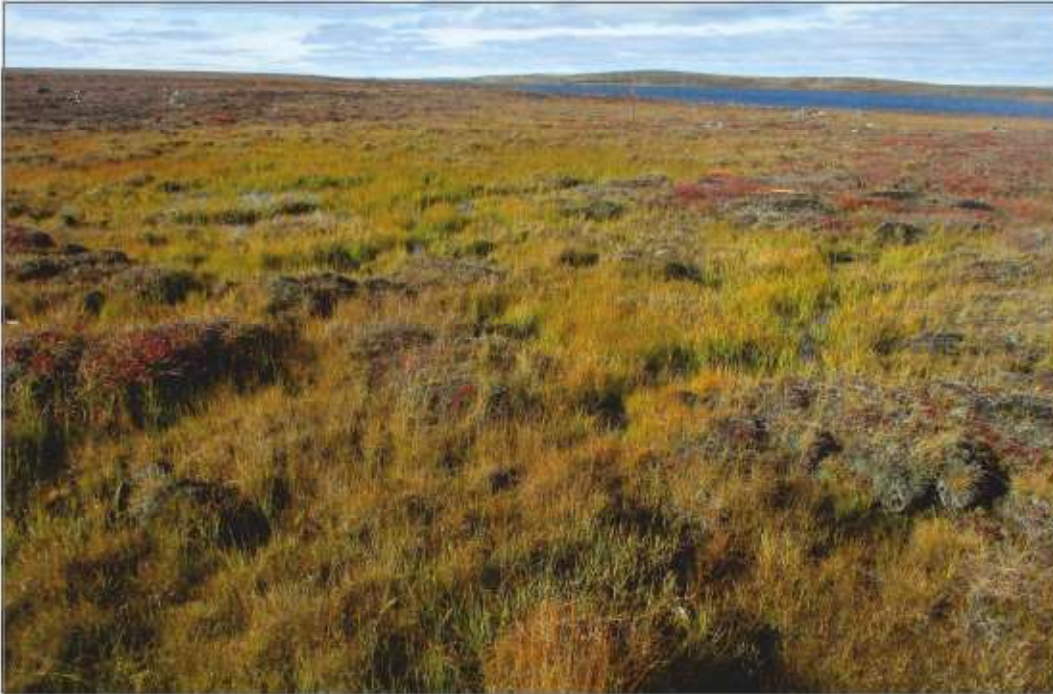
Photo 13: Channel 2—Discharge water potentially able to flow towards Lake G2 due to wet conditions and low lying area, looking north.

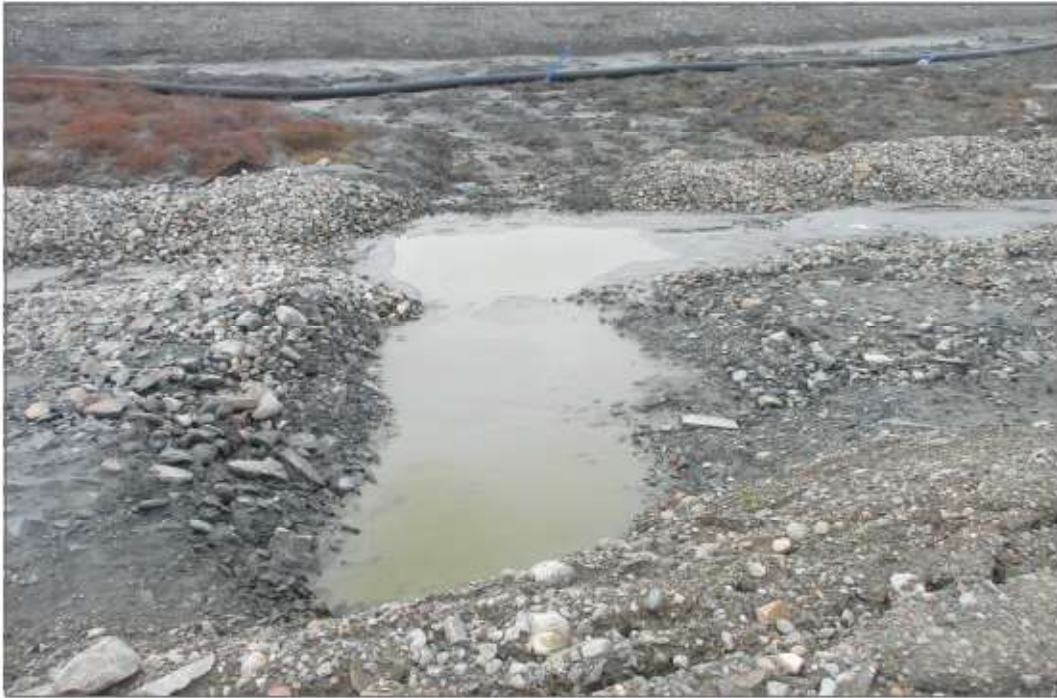
Photo 18: Channel 3—Significant subsidence across channel alignment and subsequent cracking along road side slope, looking east.

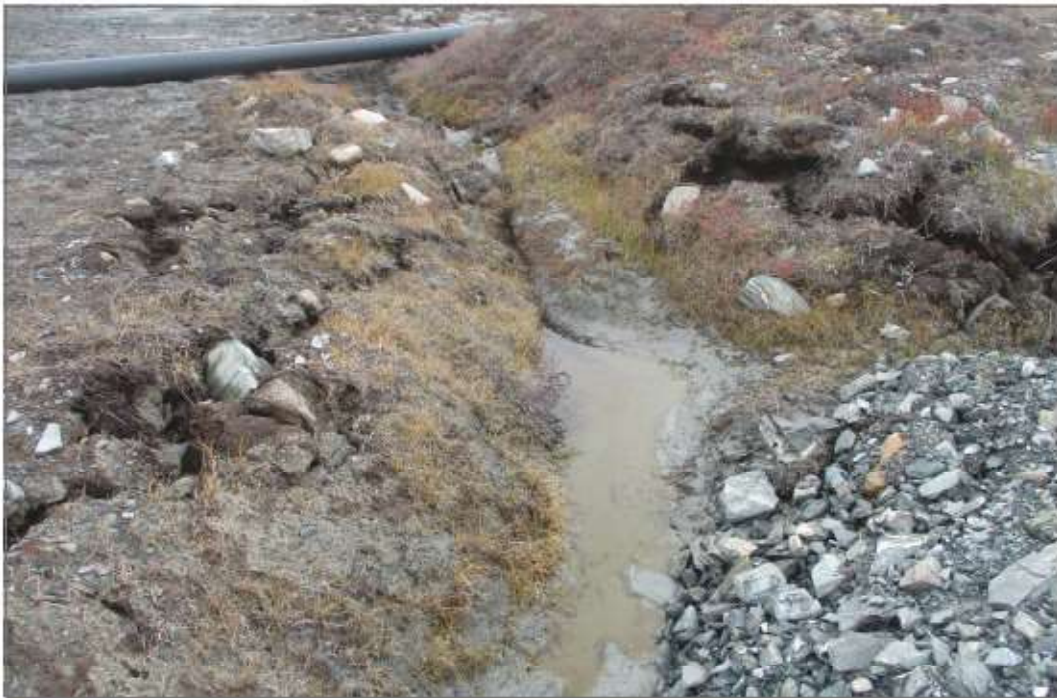
Photo 19: Channel 3—Subsidence across channel alignment, looking southeast.

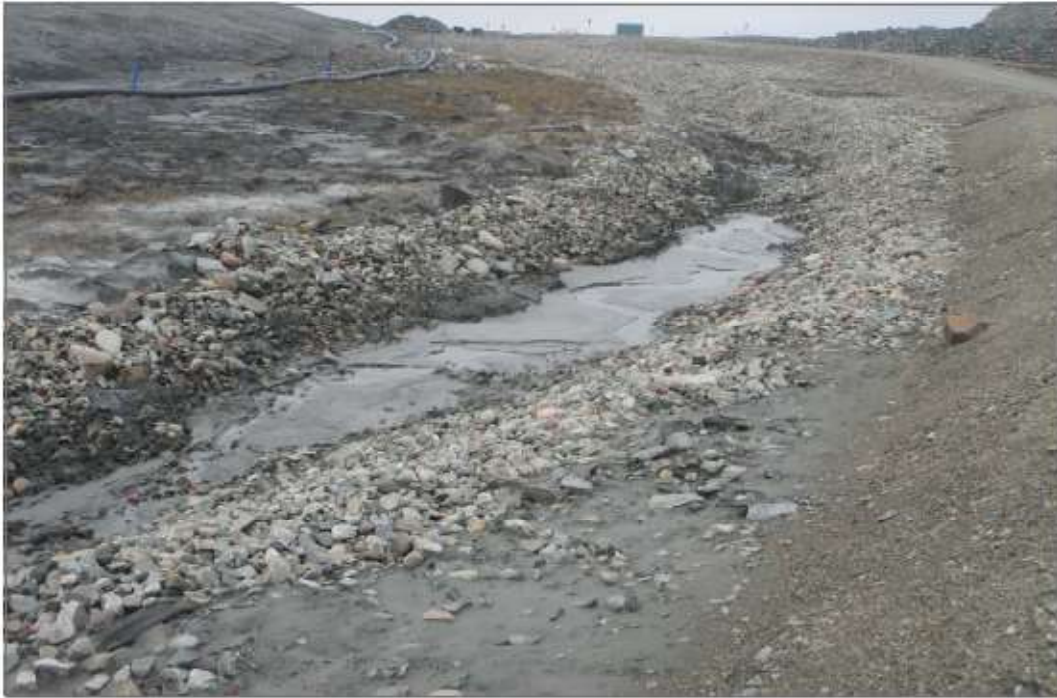
Photo 20: Channel 3—Thermal degradation of ground upstream of Channel 3.

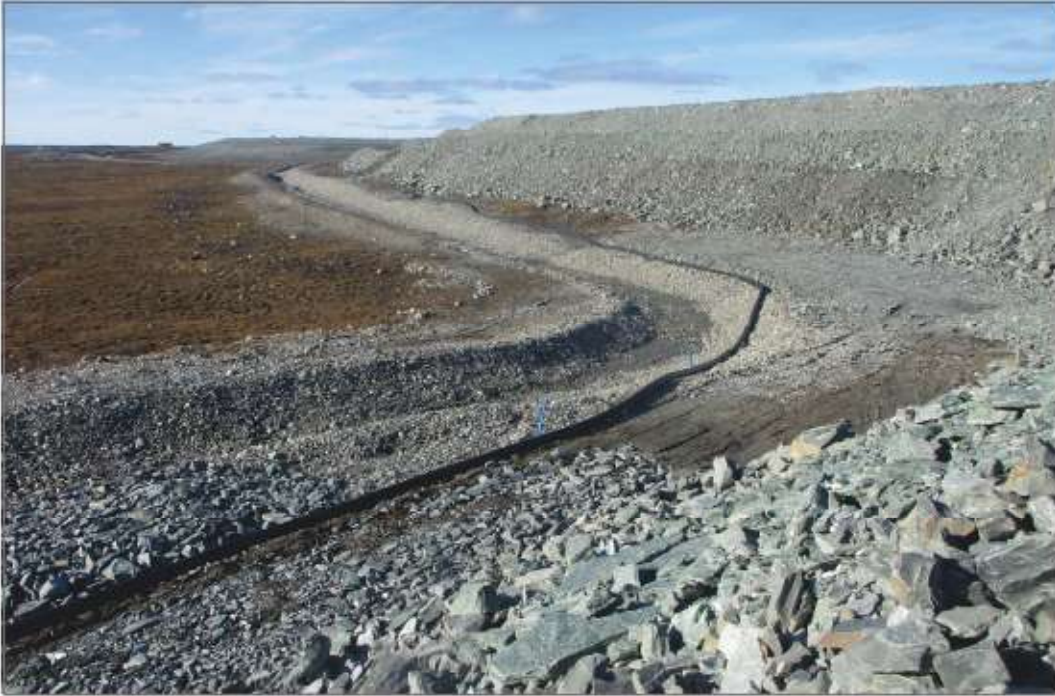
Photo 28: Channel 4 - Migration of fines from un-armoured overburden berm.

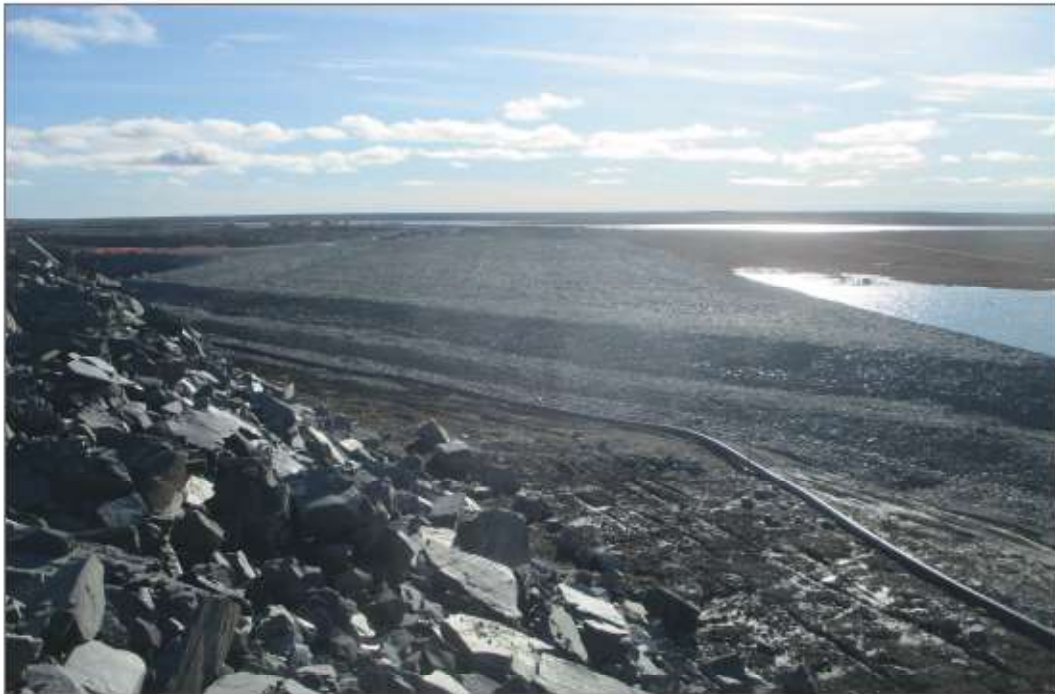
Photo 29: Channel 4 - Repaired rip rap slope and rockfill capping over preferential flow area between WRSF1 and Channel 4.

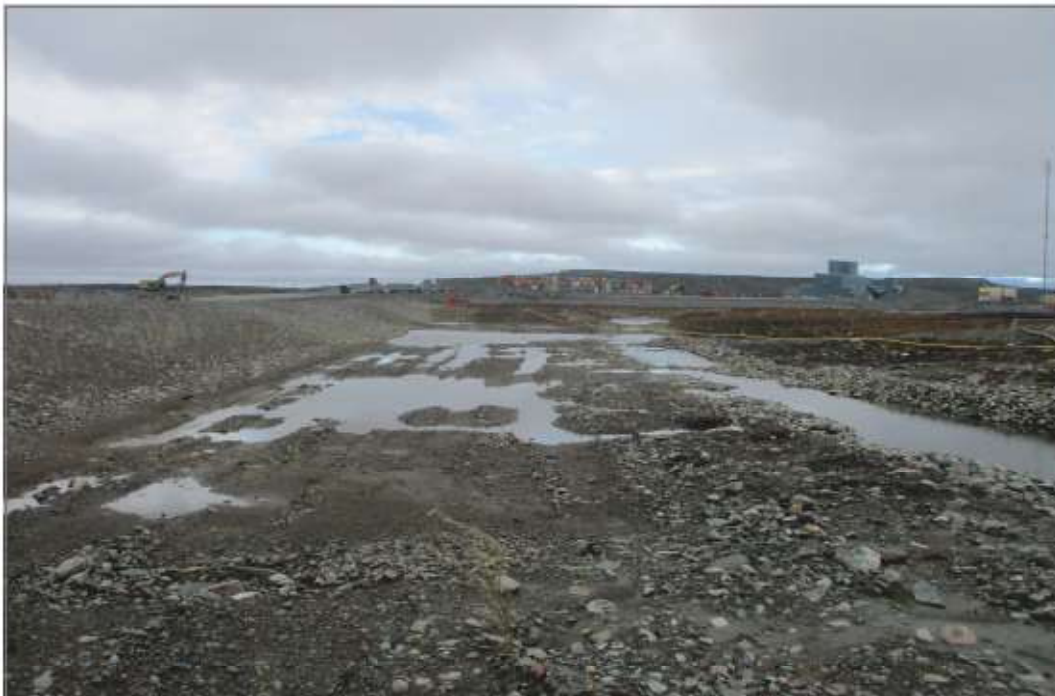
Photo 31: Channel 5—Upper reach, south of Portal2, significant subsidence and cracking along slopes with rip rap settled below water level in channel.

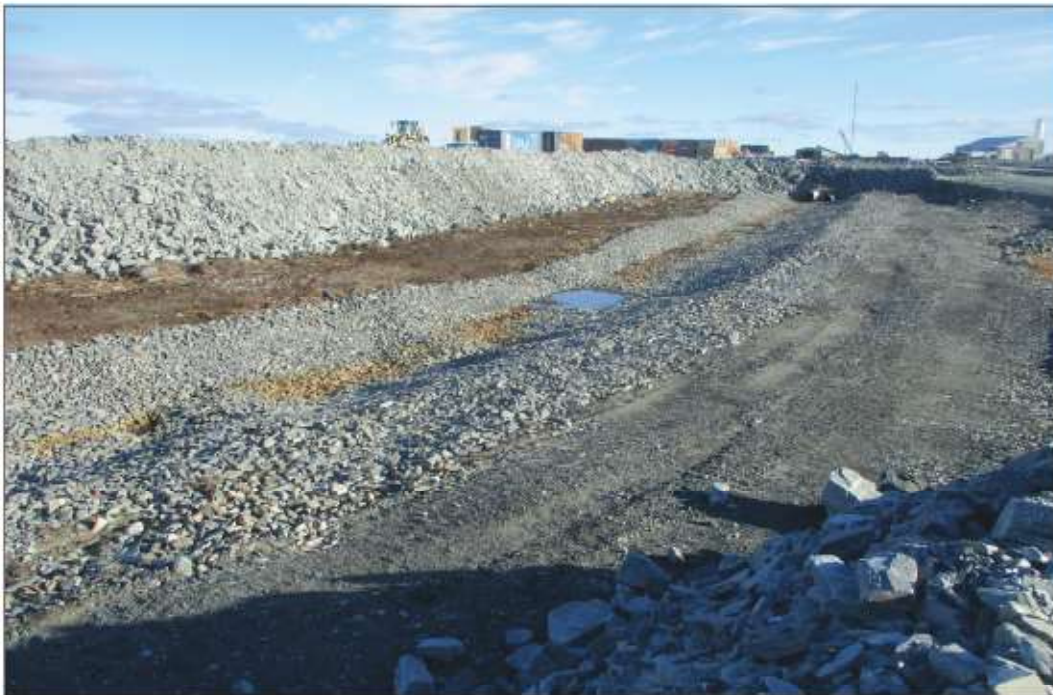
Photo 35: Channel 7—Upper reach, minor subsidence and pooling at bottom of channel, looking north.

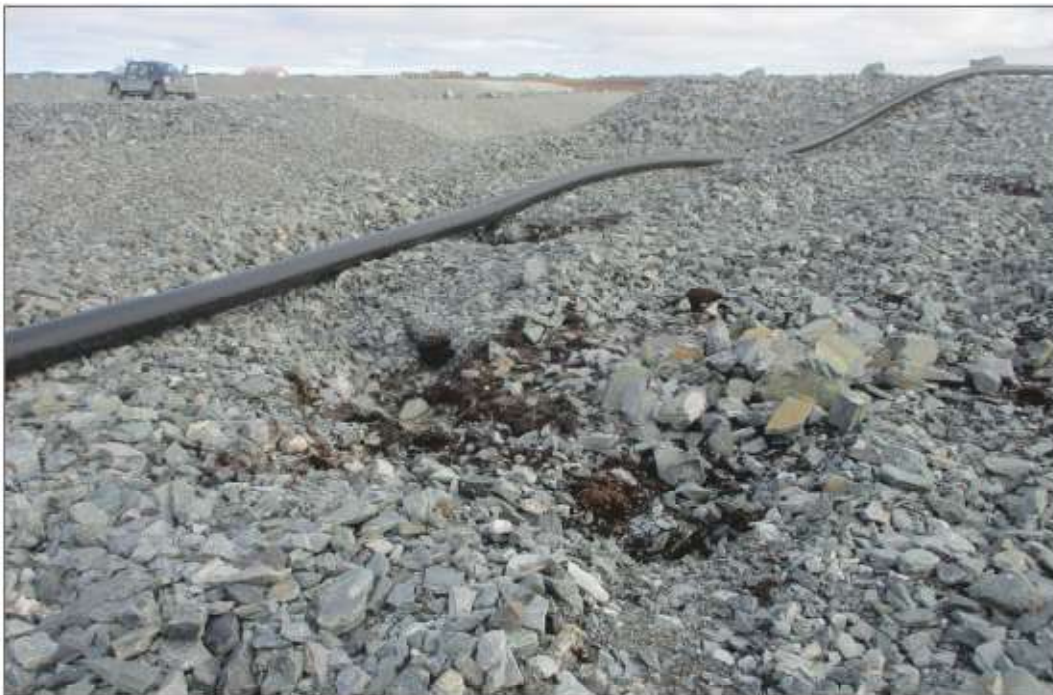
Photo 41: Channel 9—Thermal degradation of original ground upstream of channel.

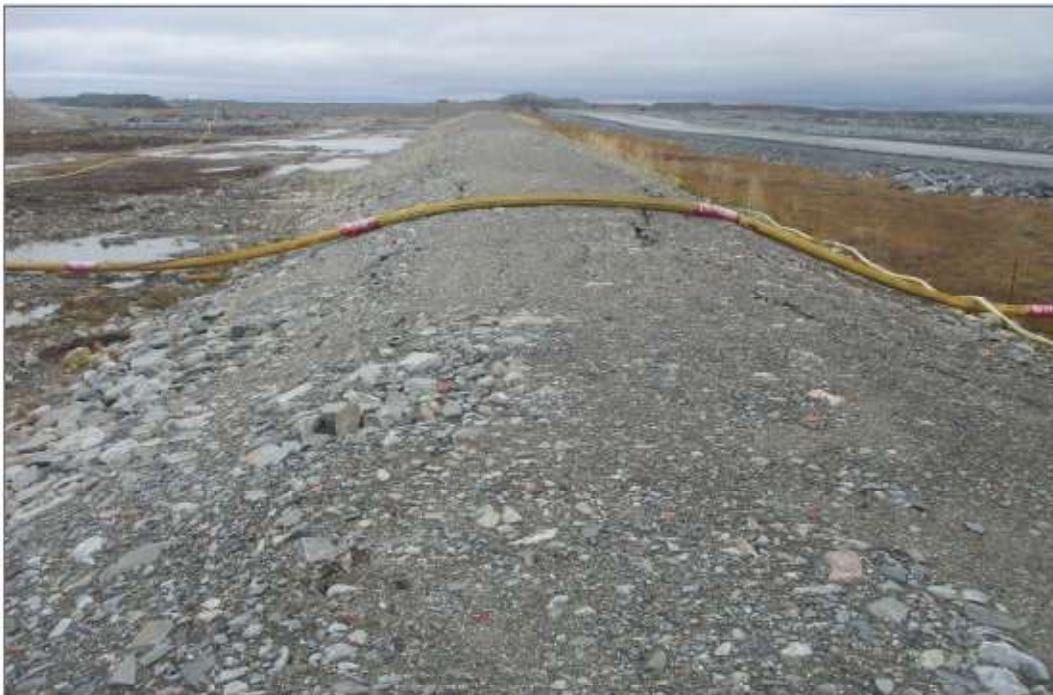
Photo 53: Berm 3—Cracking along slopes and crest.

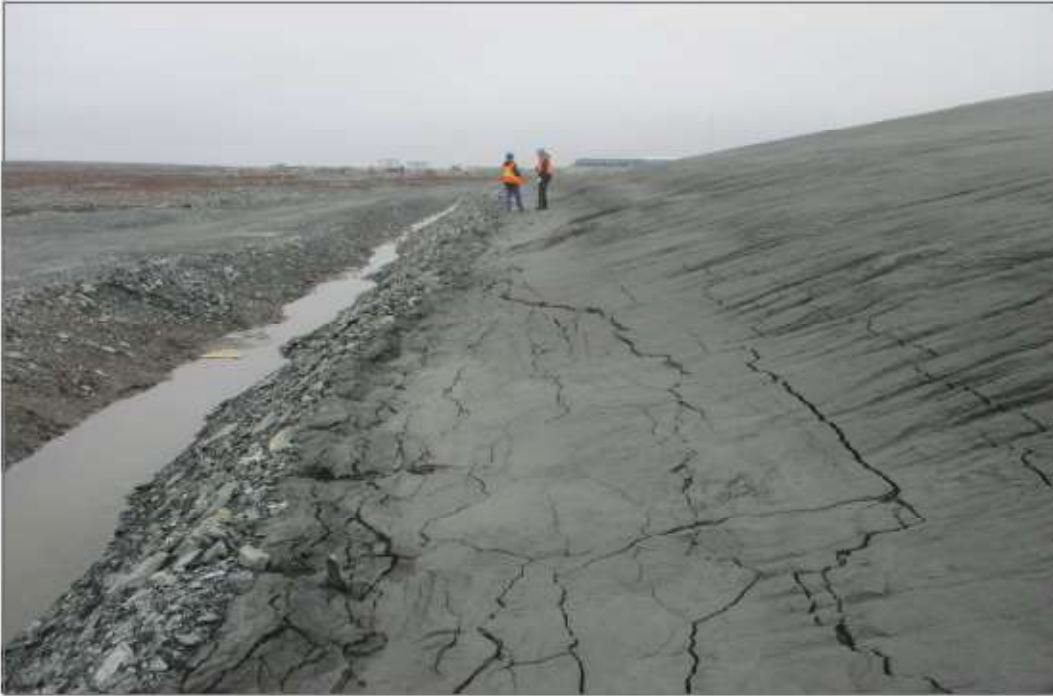
Photo 10: TSF - Erosion channels on exposed north embankment.

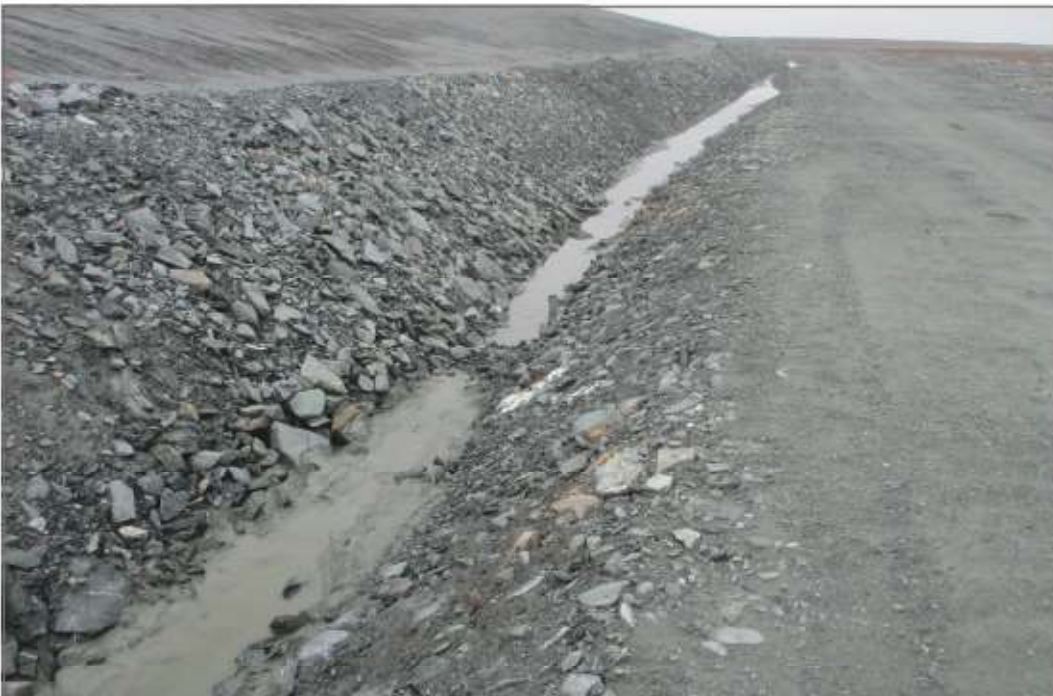
Photo 11: TSF - Sedimentation, cracking, and piping along north embankment toe.

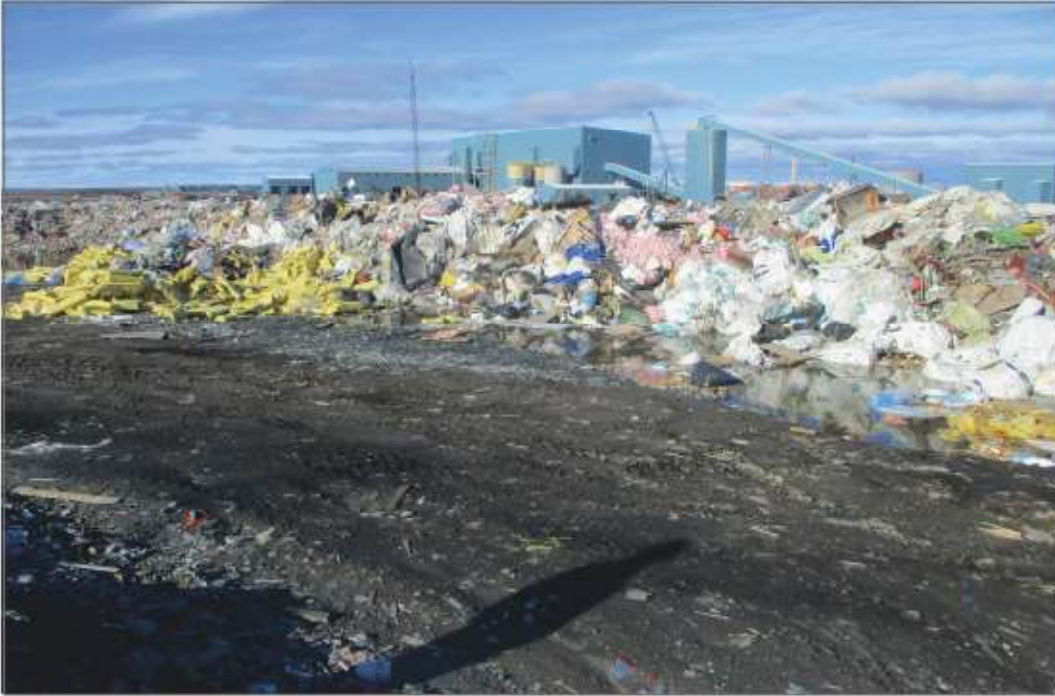
Photo 10: Landfill - WRSF1 Landfill with ponded water.

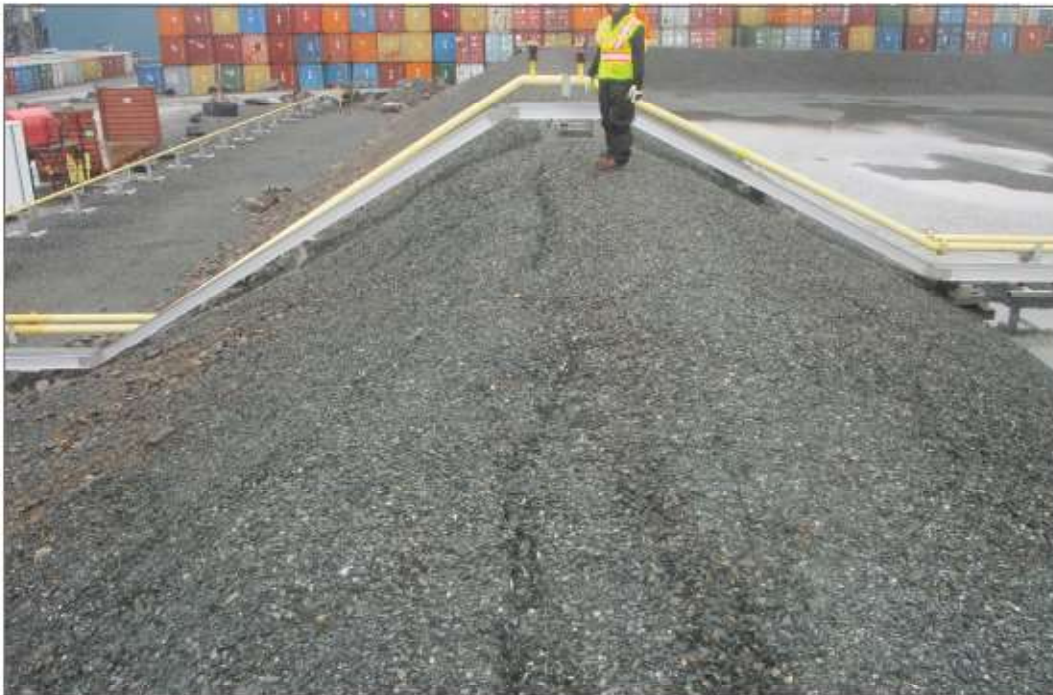
Photo 25: Industrial Fuel Storage Tanks.—Ponded water in tankfarm.

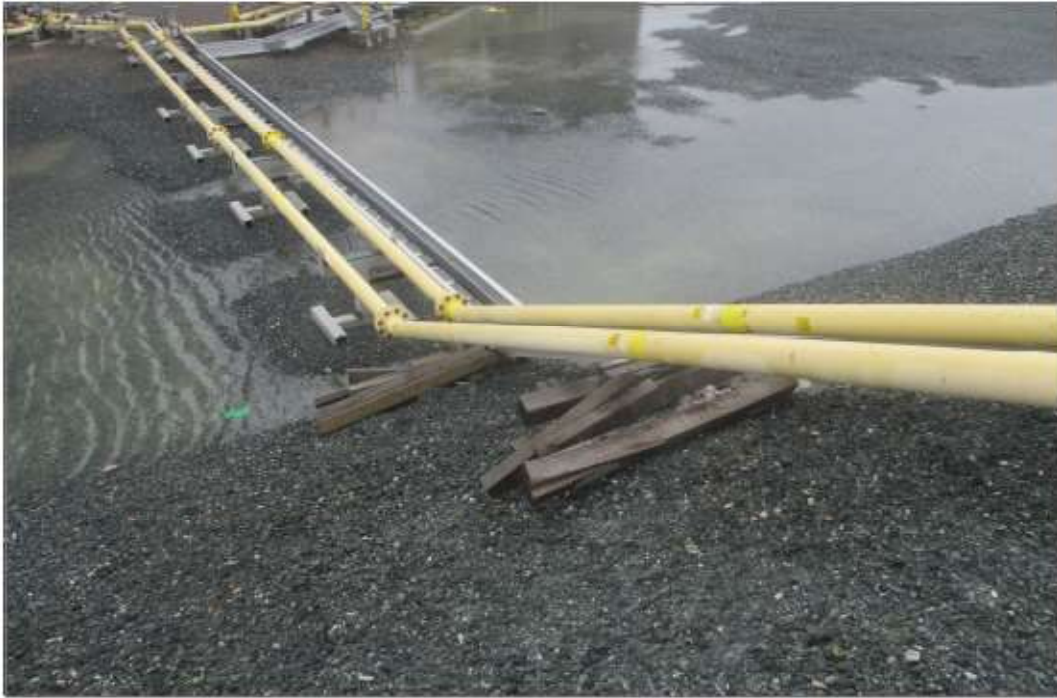
Photo 26: Industrial Fuel Storage Tanks—Cracking on top of berm. Settlement and erosion under pipe infrastructure.

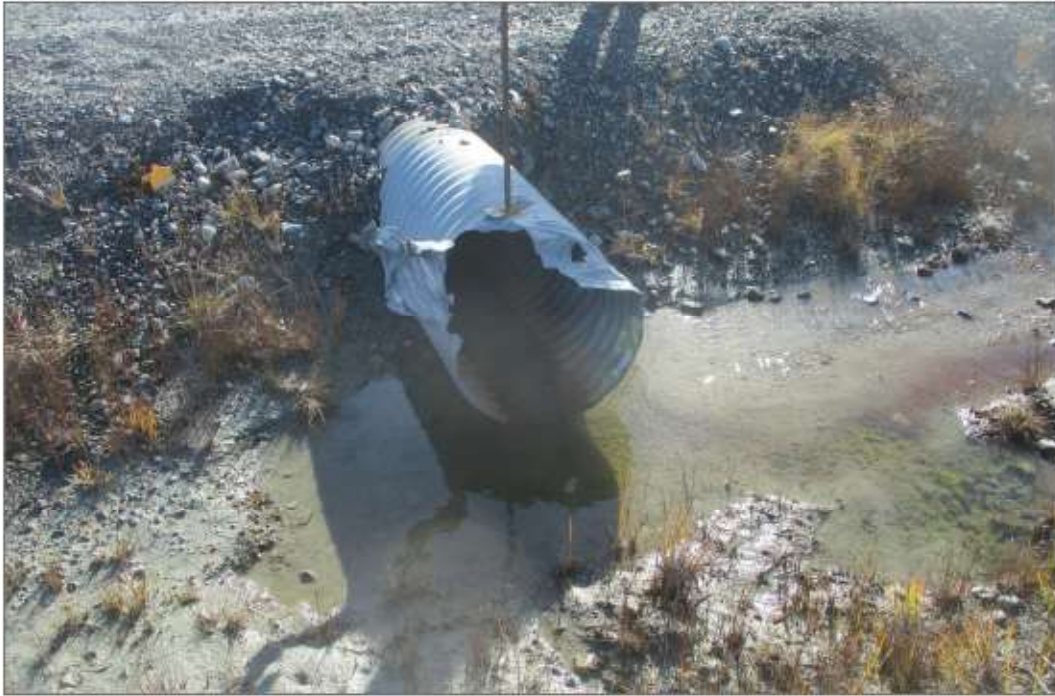
Photo 1: Culvert km 5.5—Damage to inlet.

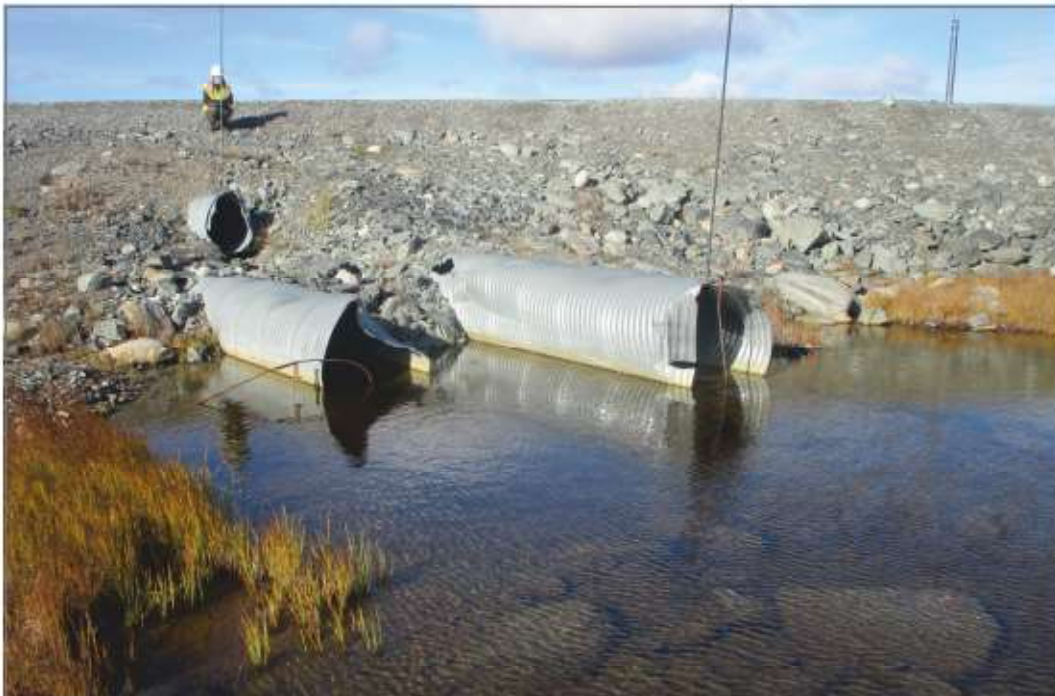
Photo 8: Culvert km 7.4—Damage to culvert inlets

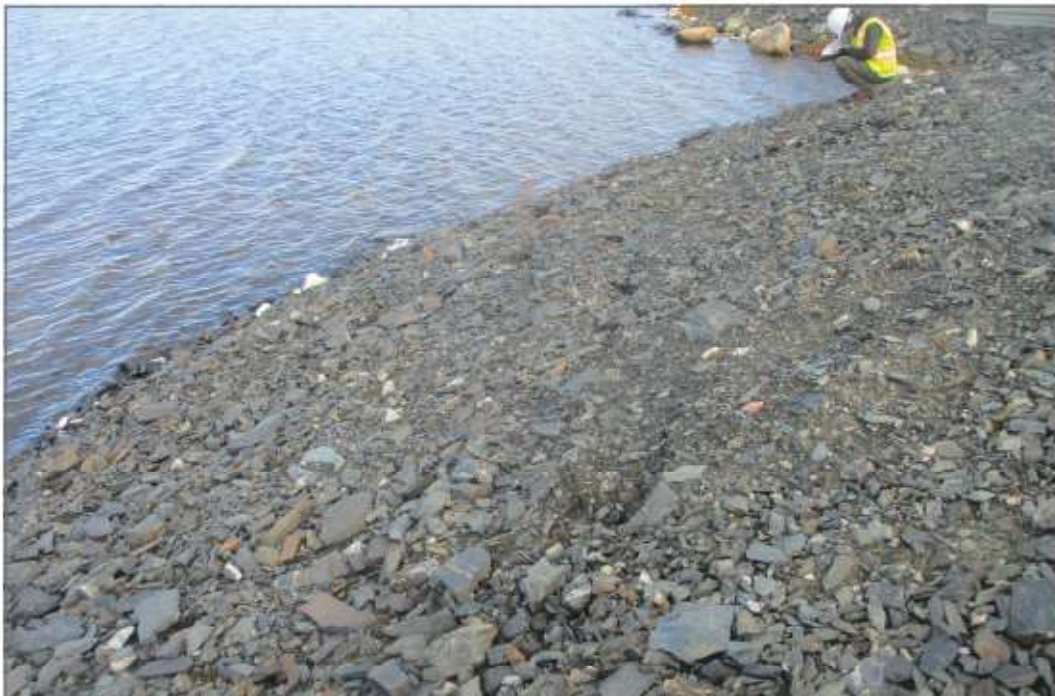
Photo 18: M-5 Bridge—South Abutment cracks along east side.

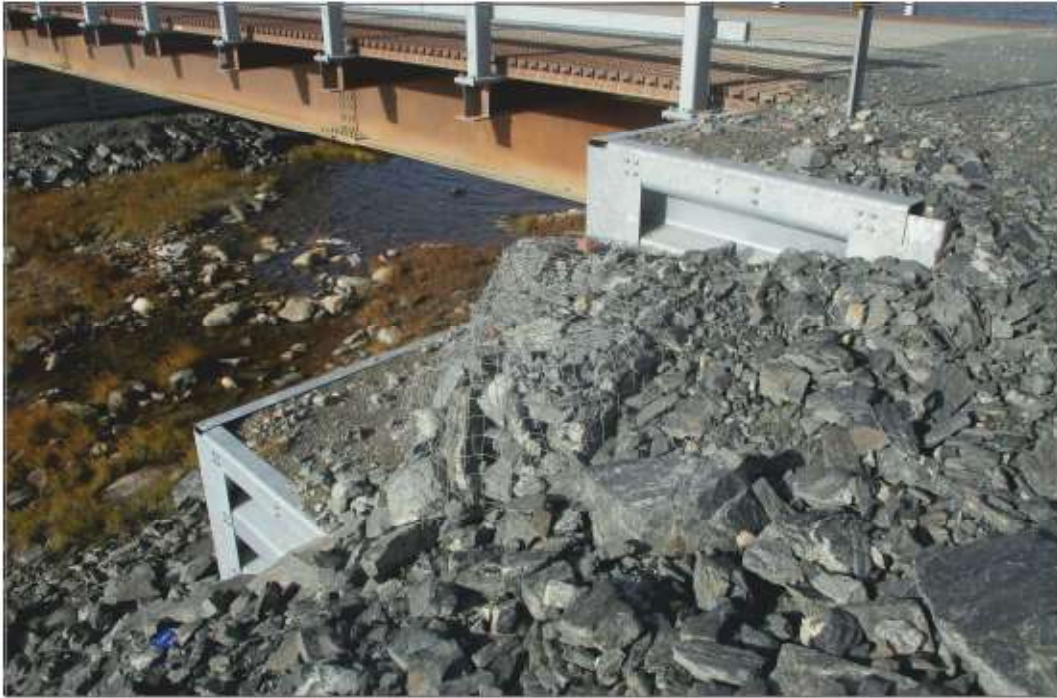
Photo 19: M-5 Bridge—Gabion North Abutment damaged

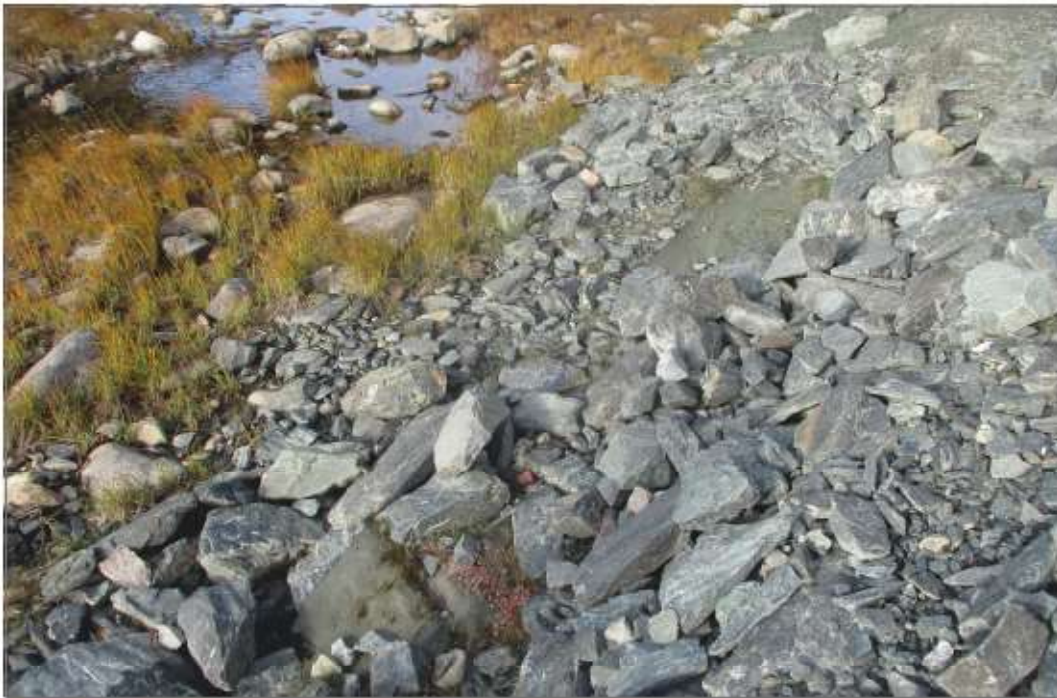
Photo 20: M-5 Bridge—Geotextile exposed at north abutment .

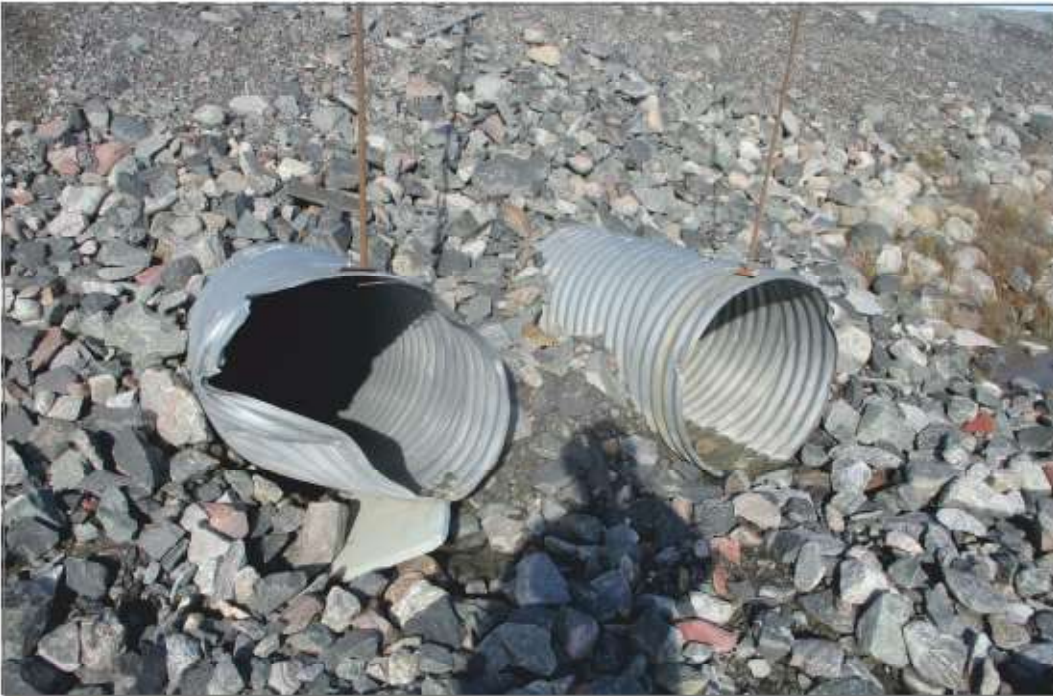
Photo 8: Culvert C13—Damage to culvert,
