### **Meadowbank 2022 Annual Open Pit Geomechanical Inspection**

**September 2, 2022**

**RE: Meadowbank Complex - Meadowbank Site - 2022 Annual Open Pit Geomechanical Inspection**

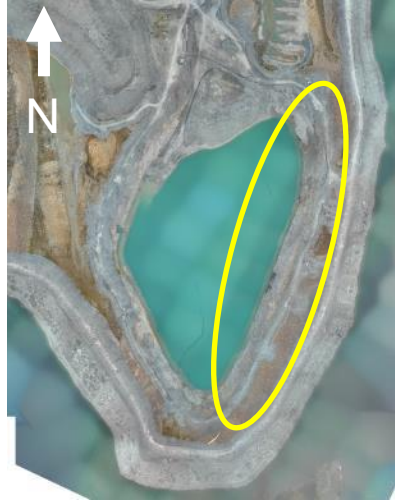
East Wall, Looking Southeast

- A portion of a single bench is exposed above the current pit lake.
- The wall was established in the Intermediate Volcanics and is performing well.
- The former tailings discharge point is circled below. No erosion of the slope was noted.
- No particular geomechanical concerns were noted.

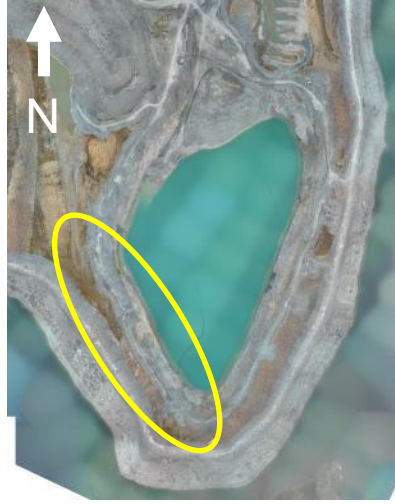
South Wall, Looking Southwest

- A portion of a single bench is exposed above the current pit lake.
- The wall is performing well.
- No particular geomechanical concerns were noted.

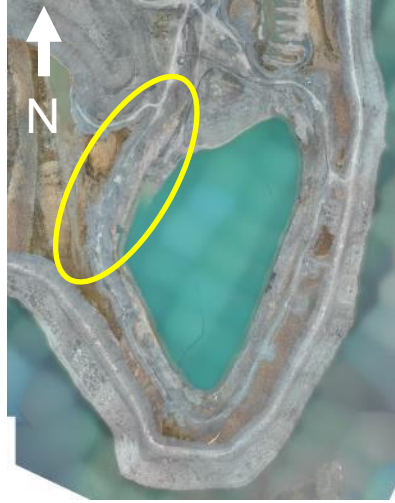
Looking West at Base of Ramp

- At the time of the inspection, barricades were in place at the base of the ramp. These were moved to the top of the ramp during the inspection in order to better to restrict access to authorized personnel.
- The exposed bench faces along the ramp are relatively low and there is ample room to transit and work away from the wall. As a result, the rockfall risk is considered to be low.
- No particular geomechanical concerns were noted.

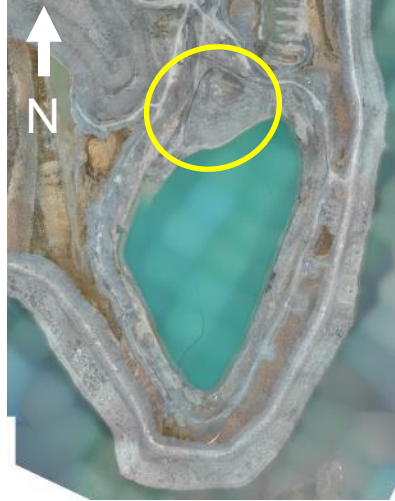
Looking Northwest at the Dump, with Settlement and Scarps Visible

- The dump has been subsiding since 2015. The settlement is attributed to the deposition of water in the open pit, through a combination of thawing snow/ice lenses within the dump, thawing frozen contacts between rock blocks, and increasing porewater pressure. An example of one of the scarps formed by the settlement is shown at lower right.
- The settlement is monitored visually as part of monthly inspections by the Geotechnical team.
- The dump is inactive and access is prevented by both a rockfill berm and the presence of water pipes across the access point.
- Recommend continuing the monthly visual monitoring as long as access is still required to the open pit. There is a need to better quantify the extents and rate of deformation. Survey pins, extensometers or drone photogrammetry are possible options.

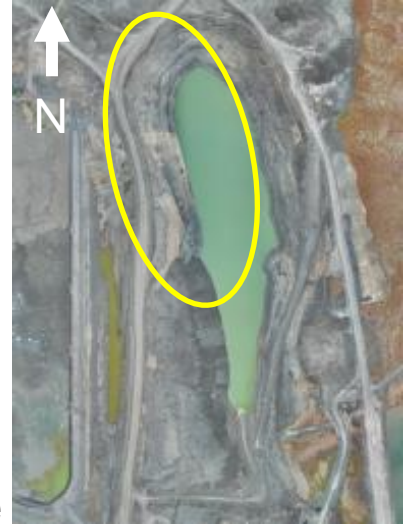
Pit A West Wall, Looking Northwest

- Approximately two benches are exposed above the pit lake in this area.
- Local bench scale failures have previously occurred within the Ultramafics on this wall. No significant change was observed in the failures remaining above the pit lake since the 2020 and 2021 inspections.
- Several large voids are present within the Quartzite and were previously identified as a rockfall hazard. No significant change was observed since the 2020 and 2021 inspections.
- No particular geomechanical concerns were noted.

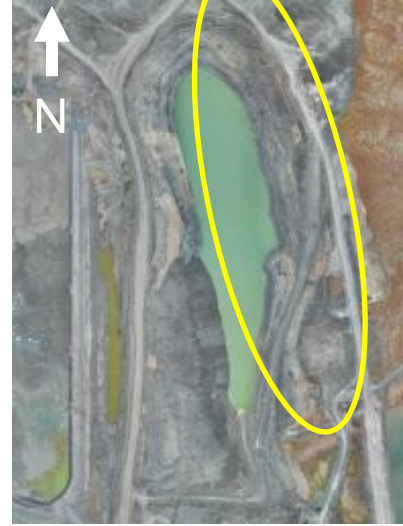
Pit A East Wall, Looking Northeast

- Approximately two benches are exposed above the pit lake in this area.
- Access to the East Ramp is now restricted by berms at the top and bottom of the ramp (circled in image below).
- The wall is performing well.
- No particular geomechanical concerns were noted.

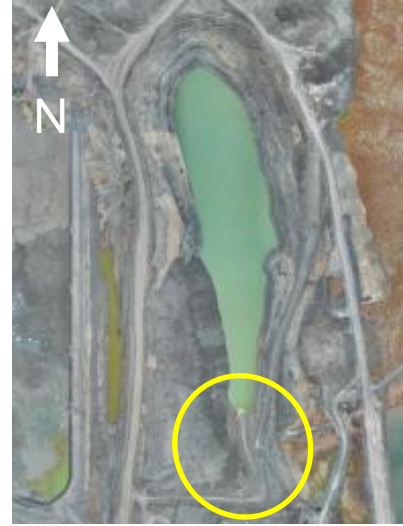
South Ramp, Looking North with PTO/Pump Controls at Left

- The south ramp is used to access the pit lake and water management infrastructure is present along the ramp.
- A rockfall berm is present along both sides of the ramp. The berm is in good condition and has capacity to retain any future rockfall.
- The PTO / Pump controls are located well up the ramp, away from the areas of greatest rockfall hazard associated with the dump and the highwall. The controls are also well away from the pit lake, mitigating the risk associated with a wave caused by a failure of the open pit slope or the dump. This is a good practice.
- Specific geotechnical considerations relating to Dump B are discussed on the next slide. Bulging of the toe of the dump slope was not observed.
- No particular geomechanical concerns were noted.

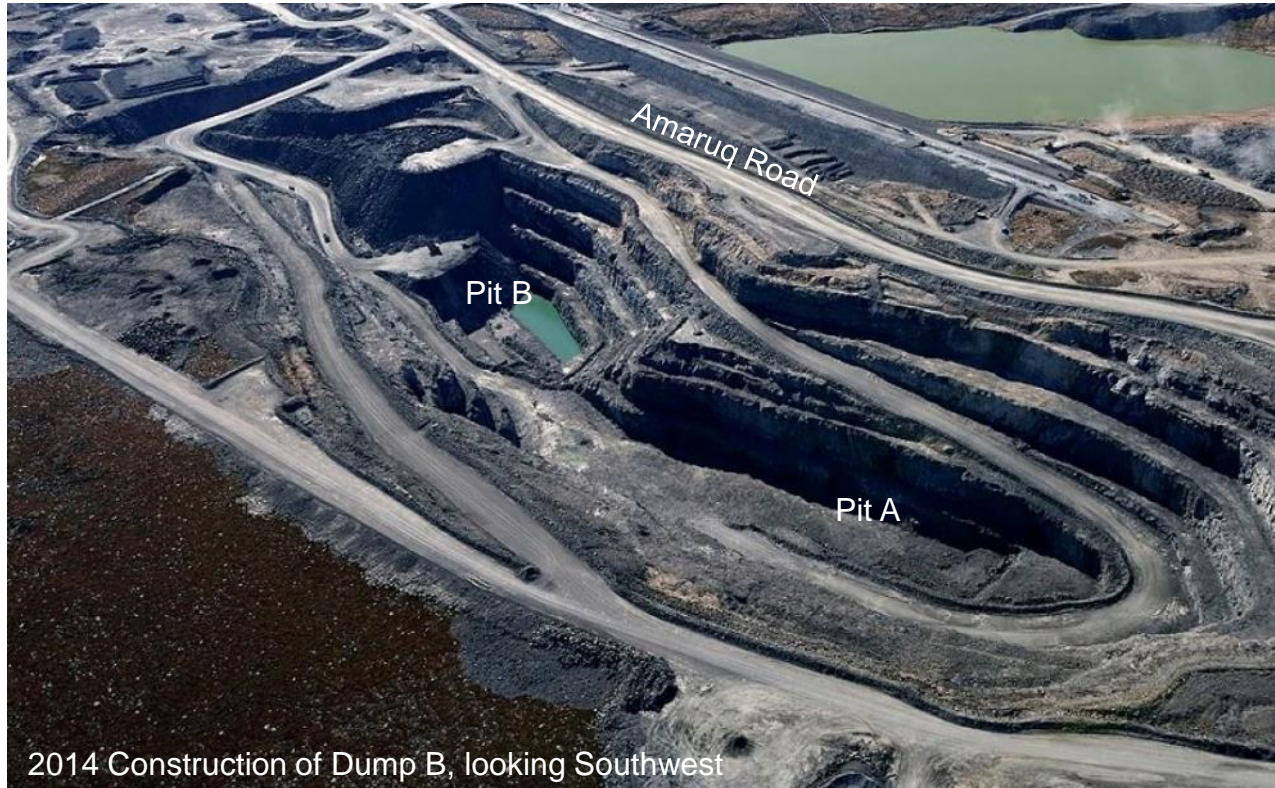
2014 Construction of Dump B, looking Southwest

- The potential for a failure of the dump back towards the Amaruq Road was identified in 2021 as it was not clear if the road is partially constructed on the dump.
- Further discussions in 2022 and photos provided by AEM during construction of the dump in 2014 and 2015 suggest that the portion of the dump closest to the road is founded on the Pit A ramp and a failure of the dump would not extend back to the Amaruq Road. It is understood that SNC Lavalin is completing a detailed review.

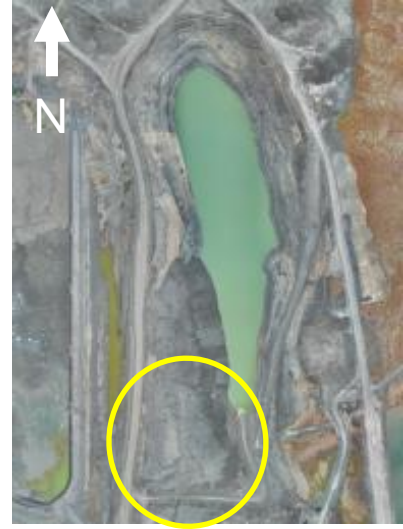
On Upper Platform, Looking North

- Evidence of instability was not observed on the Upper Platform.
- The Upper Platform is graded so that water flows to a low point above the area of the Lower Platform where sinkholes have formed. This is a likely cause of the sinkholes. The recommendations from the previous annual inspection remain applicable; recommend filling the low point and re-grading the dump so that water is directed away from this area.
- Recommend constructing a berm to prevent access to the Upper Platform.

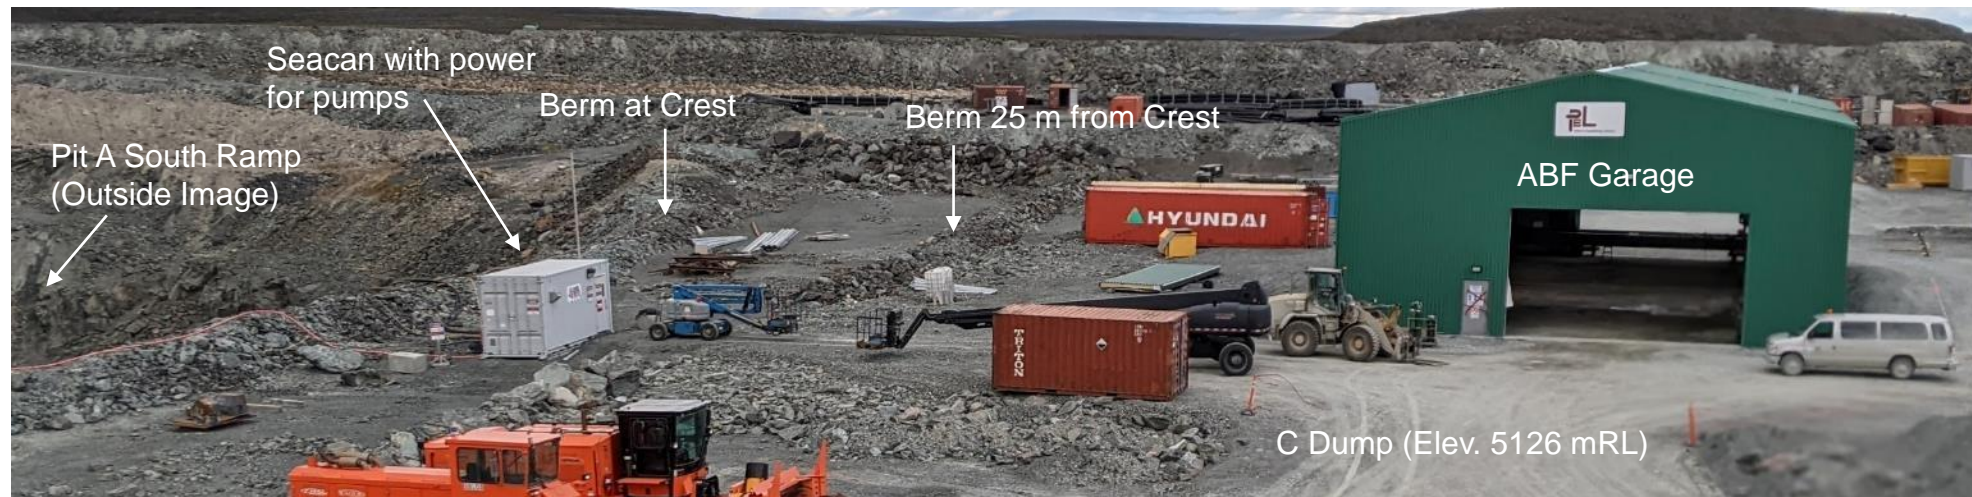
C Dump, Looking East

- As no evidence of instability has been observed, the on-going use of the dump as a laydown is considered acceptable (at least for now).

- As part of the 2020 annual inspection report, it was recommended that the garage be relocated outside of the immediate vicinity of the open pits, waste dumps and tailings/water management areas and that access to the C Dump be prevented with a berm.

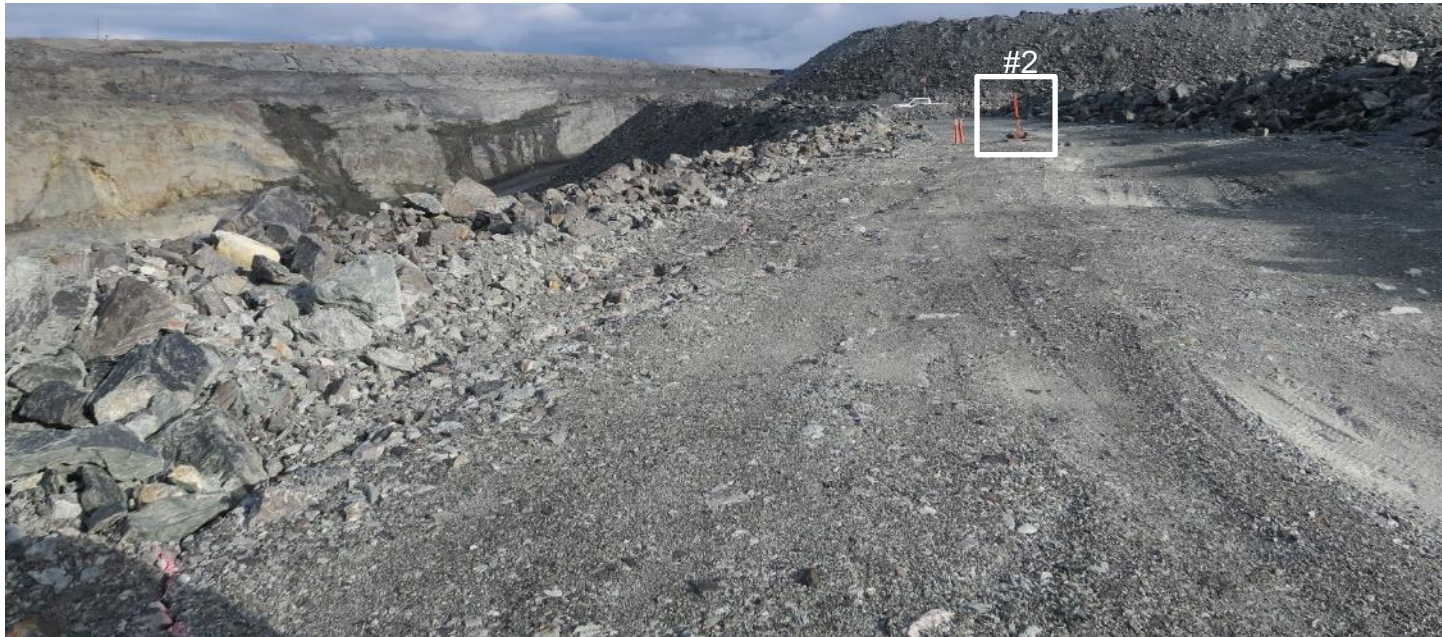
Tension Cracks at  
Crest by  
Extensometer #2,  
Looking North

- The north end of the dump is adjacent the Pit E Northwest ramp. Tension cracks previously formed along the crest of the dump in this area. There has been limited change in the tension cracks since the 2020 inspection and bulging of the toe of the slope was not observed.

- Wireline extensometer #2 was installed at the crest of the dump in the area of the tensions cracks in 2019. The extensometer is monitored monthly. The data are discussed later in this presentation but the deformation rate is currently less than 1mm/day.

- The monitoring and the monthly visual inspections should continue while access to the Pit E Northwest ramp is still required.

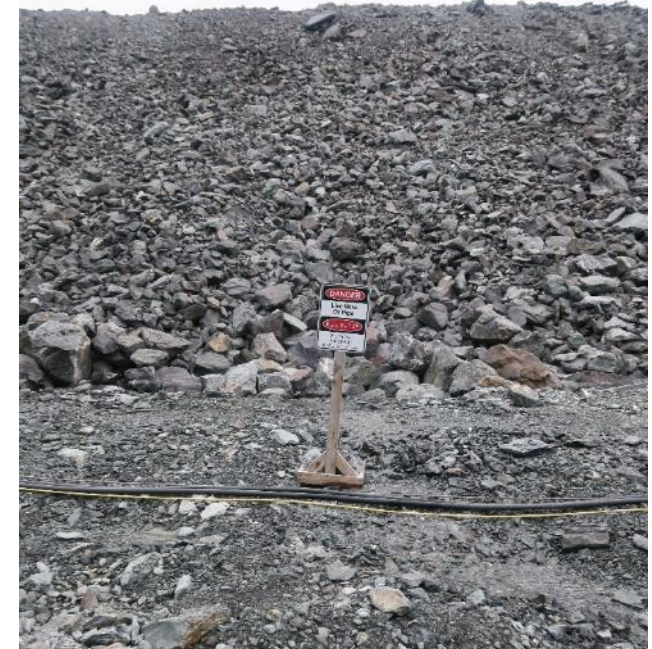
Seepage from  
Toe of Dump

- Seepage was observed at the toe of the dump in this area for the first time during this inspection. The seepage is clear. The source has not been confirmed, but is speculated to be water from the East Dyke that is discharged into Dump C and flows through the dumps. The seepage should be monitored.

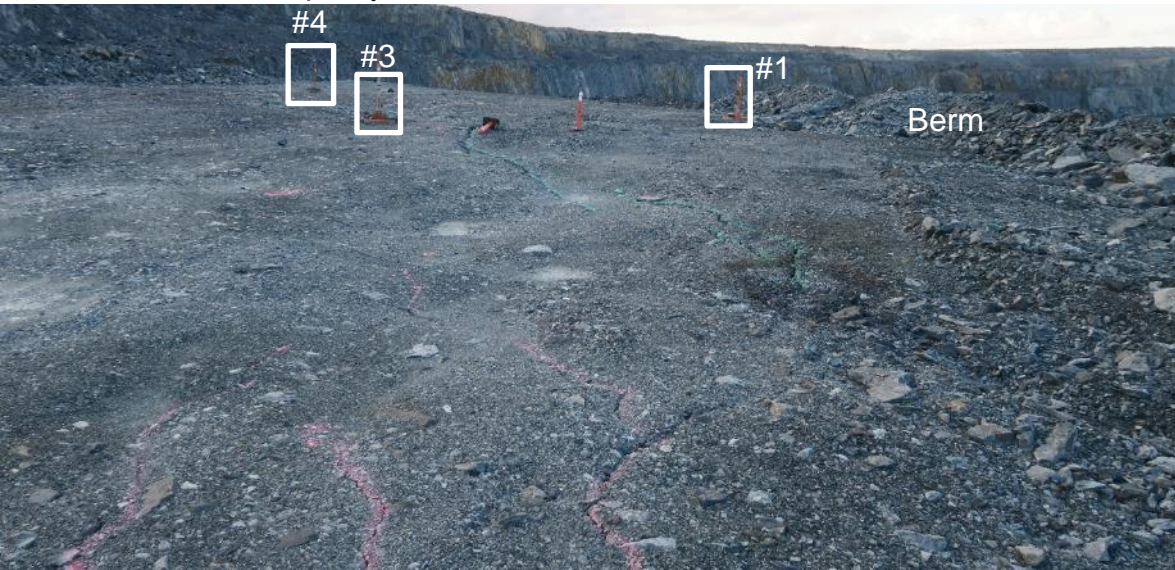
Tension Cracks on Dump, Looking Southeast

- Since the 2021 inspection, a network of tension cracks have developed 10 to 20 m behind Extensometer #1. Extensometers #3 and #4 have been installed behind the most recent tension cracks. The extensometer data is discussed on the next slide.

- On-going deformation of the dump could result in a rockfall hazard to the ramp. A berm is currently in place at the toe of the dump but its capacity and evidence of rockfall should be monitored.

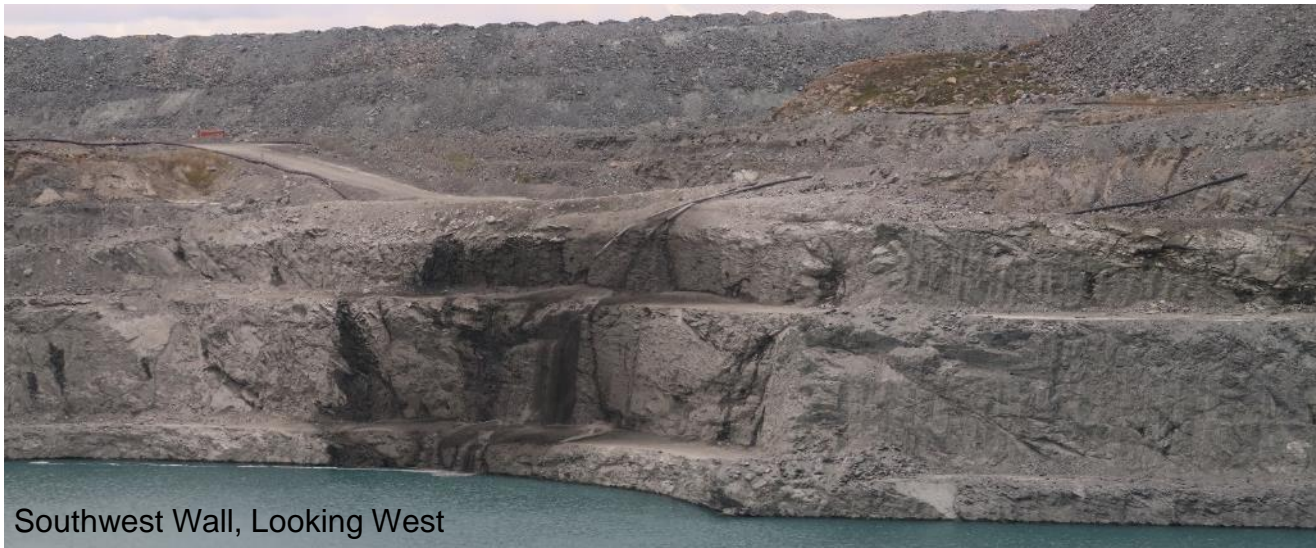
Southwest Wall, Looking West

- The wall consists of Ultramafics overlying Intermediate Volcanics and is intersected by the Bay Fault. Approximately three benches in the Ultramafics are exposed above the pit lake. The wall is within talik associated with the Third Portage Lake.
- Tailings are discharged from a line at the crest of this wall. There have been concerns about the potential for erosion of the benches or slope instability due to water infiltration. While evidence of limited erosion (crest loss) of the bench directly below the discharge point was observed, no evidence of slope instability was observed at the time of the inspection. Similarly, no settlement of the adjacent crest road was observed. The wall is performing well.
- Recommend continuing the monthly visual inspections to monitor the area for bench degradation, erosion, tension cracks, seeps, etc.

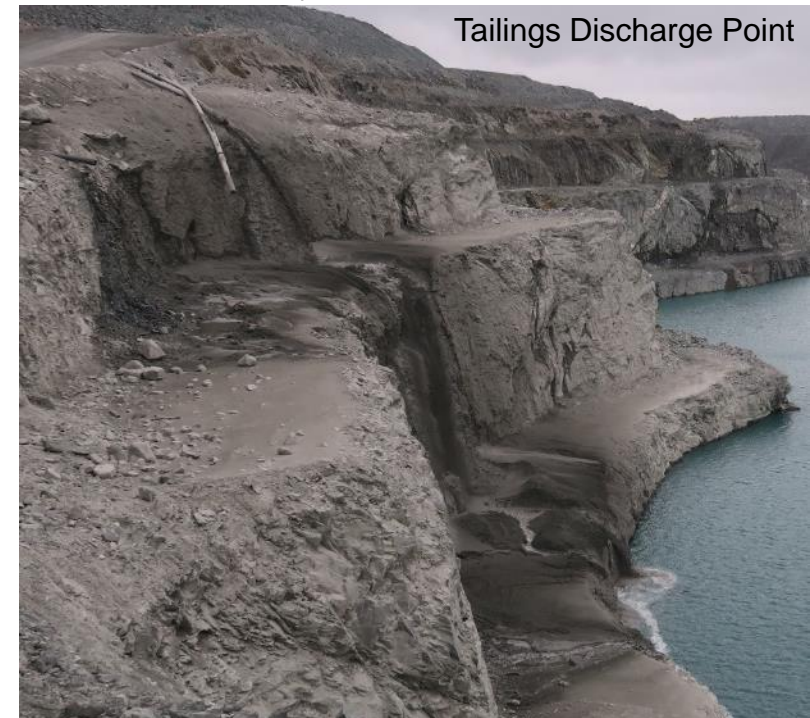
Tailings Discharge Point

Tailings are being discharged from the south end of the West Wall of the pit. Tailings are discharged over weak ultramafic rock which are susceptible to erosion and degradation of rock mass quality. Implement bi-weekly inspections (once every two weeks) of the ultramafic wall performance at the tailings discharge point to identify indicators of potential instability such as formation of tension cracks, erosion and degradation of the rock mass, bench scale instability.	Monthly inspections are completed by the Geotechnical Group. This frequency is considered appropriate based on the observed performance of the slope below the tailings discharge point to date.  Minor crest loss appears to have occurred on the bench directly below the discharge point since 2021.	See recommendation on on-going inspections.	N/A
Goose Pit, In-Pit Dump, and Tailings Management Facility	Continue regular monthly inspections and informal day-to-day inspections.	Monthly inspections are completed by the Geotechnical Group.  The walls of the Goose Pit continue to perform well and no geotechnical concerns were observed. Only the upper single bench remains visible above the current pit lake.	See recommendation on on-going inspections.	N/A

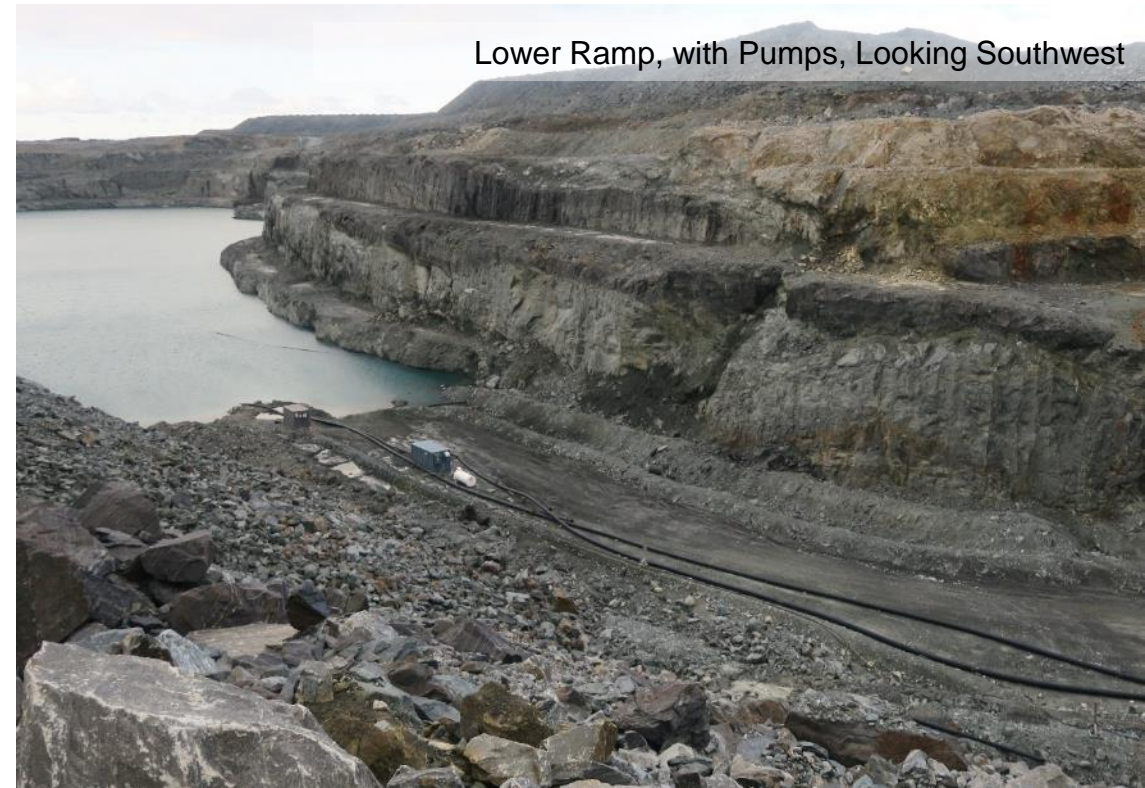
Lower Ramp, with Pumps, Looking Southwest

- The water management infrastructure is located on the outside of the ramp, which effectively reduces exposure. However, in the future it will need to be relocated further up the ramp, below some of the current rockfall hazards. Exposure to personnel and equipment will need to be re-assessed at that time.

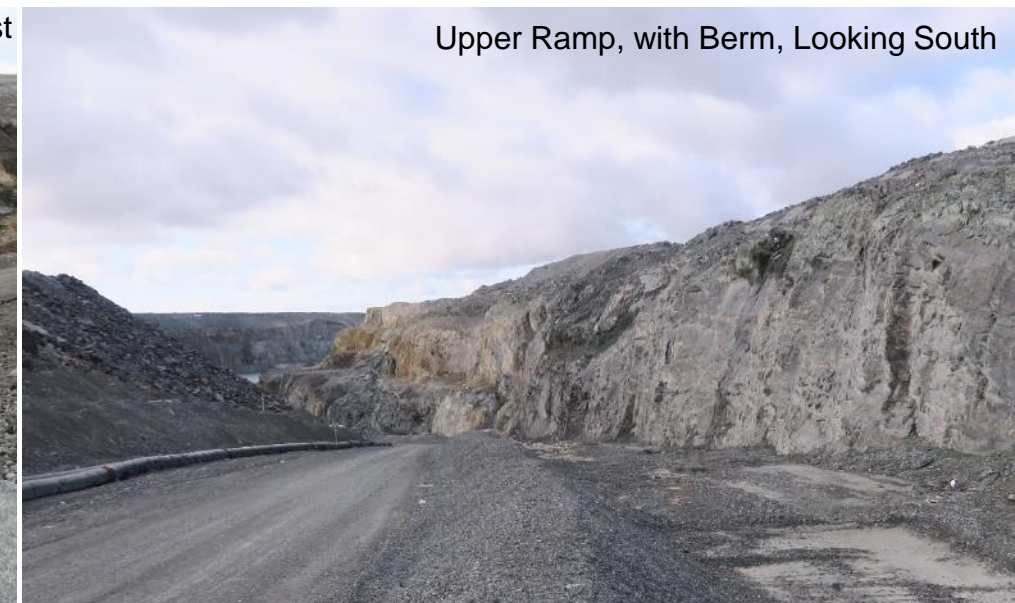
Upper Ramp, with Berm, Looking South

- Dump D is located along the eastern side of the ramp. Tension cracks are present along a portion of the crest above the ramp and wireline extensometers have been installed to monitor the dump (see previous slide on Dump D). Bulging of the toe was not observed. A rockfall berm is in place at the toe of the dump and has capacity. Geotechnical inspections and monitoring of the dump should continue while access to the ramp is still required.
- The Bay Fault intersects the Northwest Wall adjacent the ramp. Several rockfalls have occurred along the wall in the past and rockfalls are expected to continue to occur. Examples of several potential instabilities are shown on the next slide (numbered below for reference).

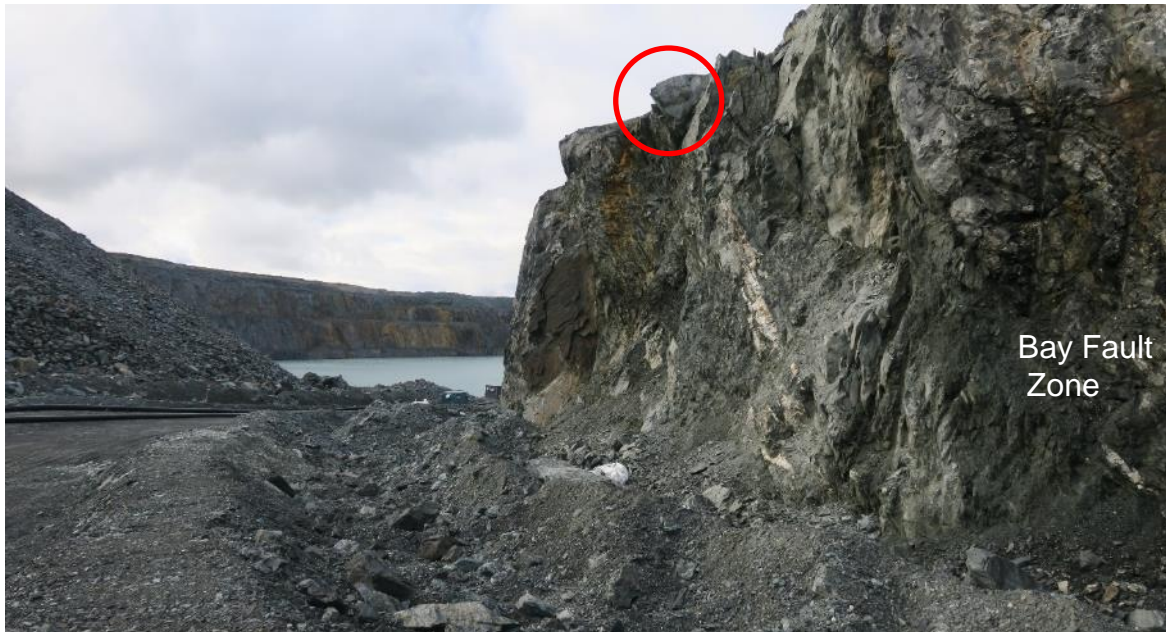
- The nose in the Northwest Wall is intersected by the Bay Fault. The zone of reduced rock mass quality associated with the fault has ravelled over time, resulting in rockfalls.
- A block was identified at the crest of the bench that represents a rockfall hazard. The block is expected to be retained by the rockfall berms.

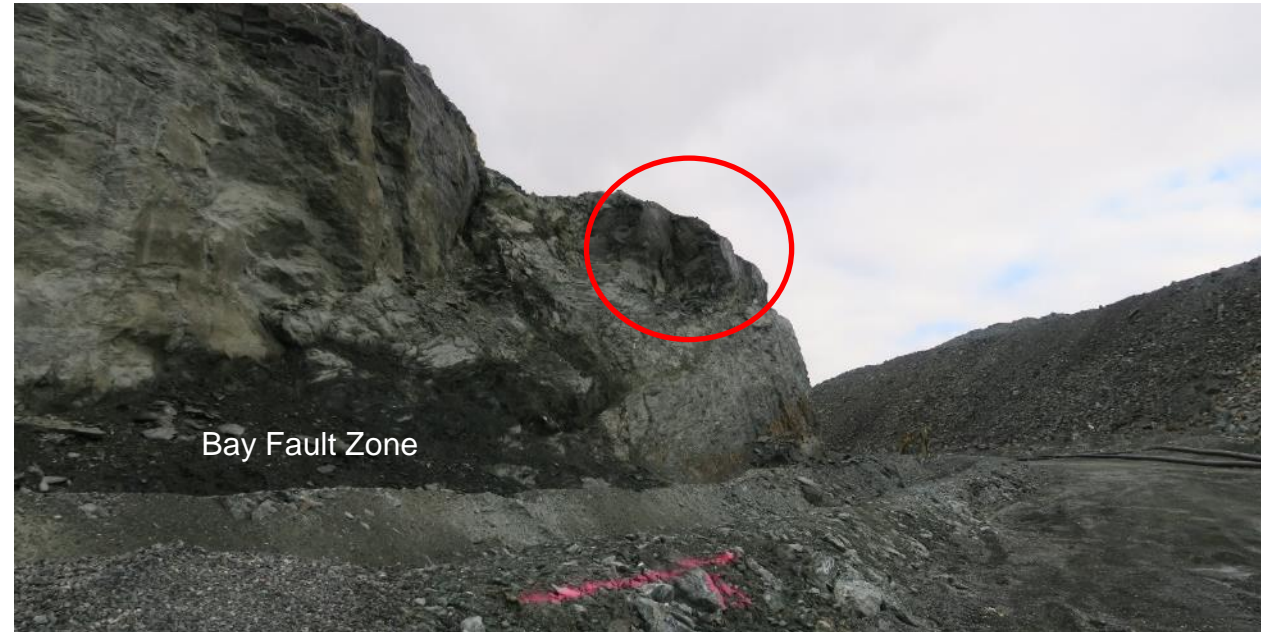
### Area 2 (Looking North)

- A large detached and potentially unstable block was identified on the southern side of the nose during the 2020 inspection. The block has the potential to overtop the rockfall berm and should continue to be monitored.
- A small rockfall is thought to have occurred at this area in June, 2022. A rock may have overtopped the berm. The size and capacity of the berm should be reviewed before the dewatering infrastructure is moved up the ramp to below this area.

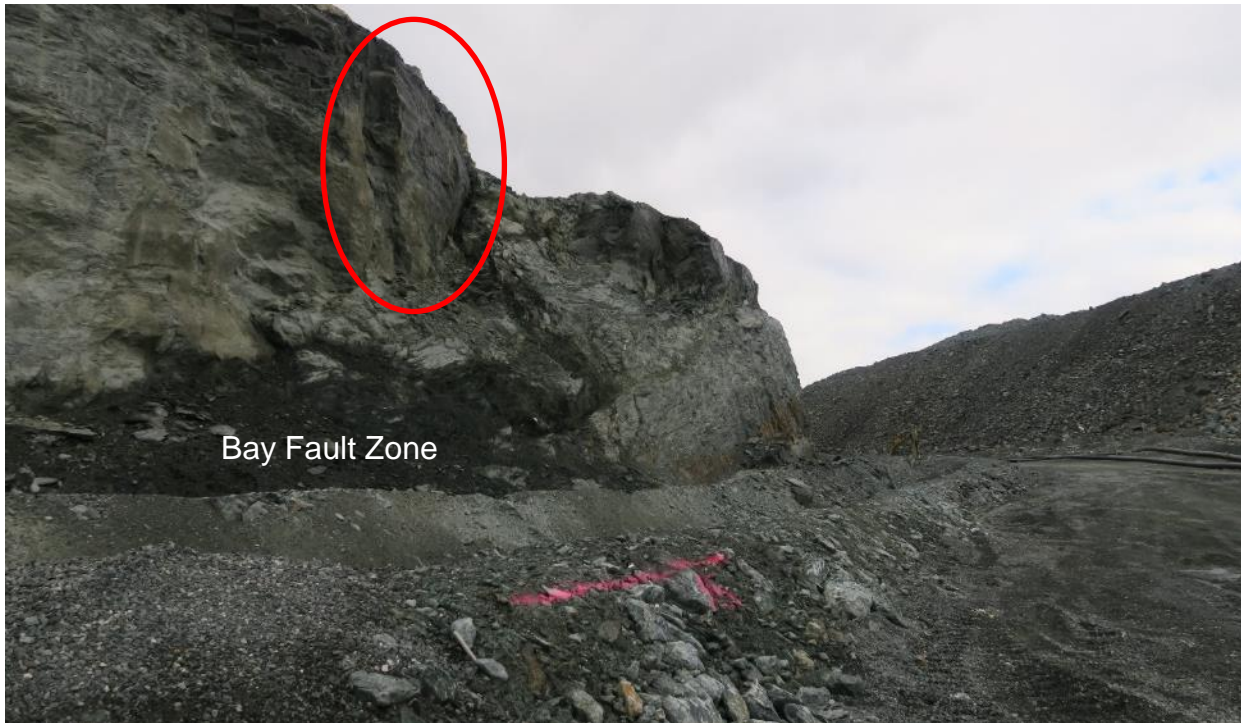
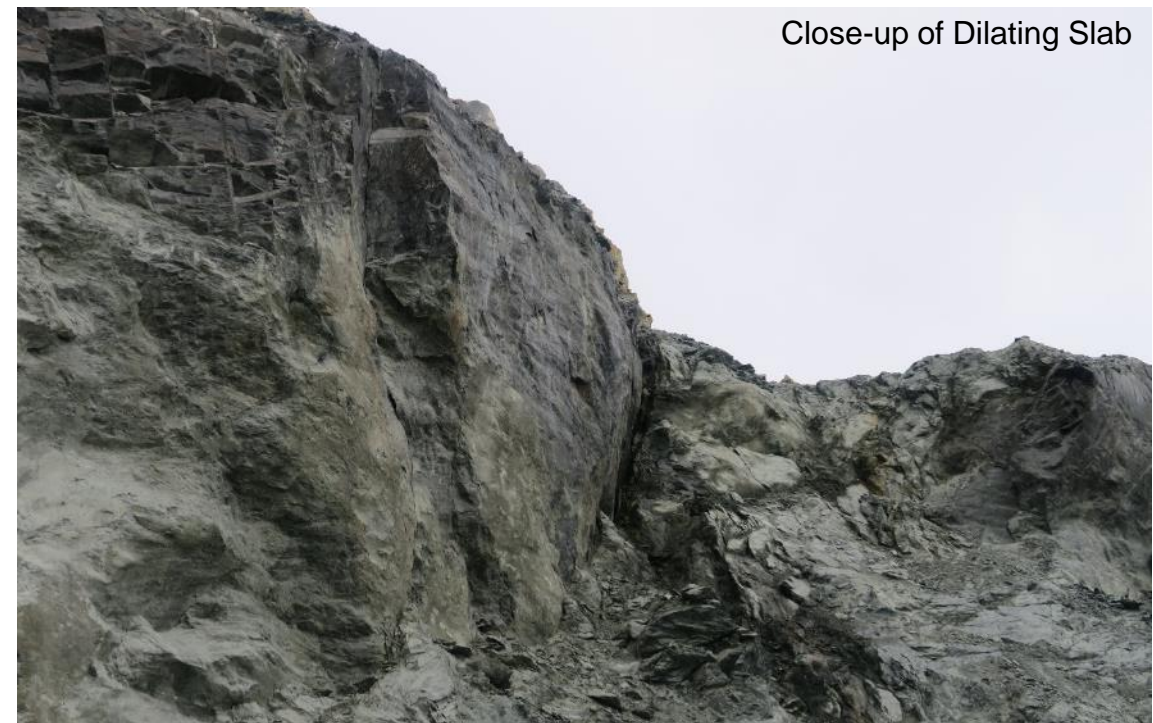
- A potentially dilating slab block was identified along the contact of the fault zone and represents a rockfall hazard.
- The block has the potential to overtop the rockfall berm and should continue to be monitored.

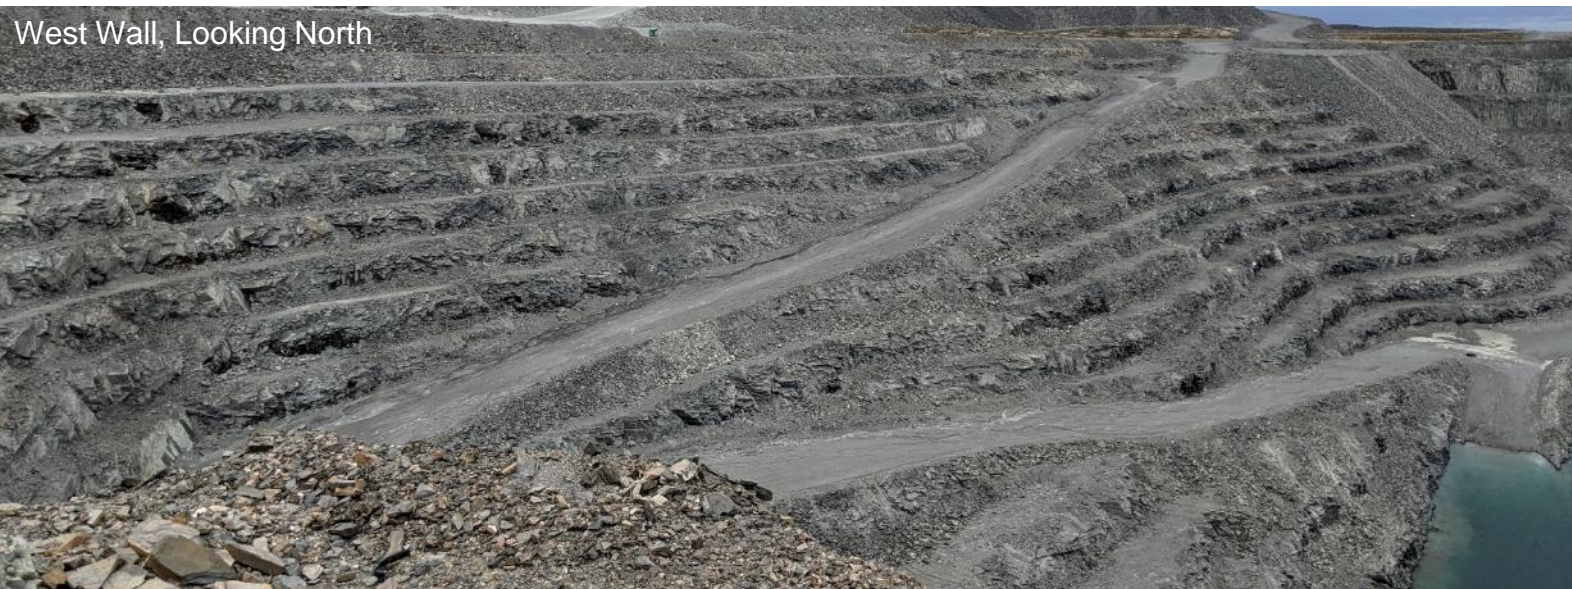
West Wall, Looking North

- While the ramp is inspected as part of the monthly geotechnical inspections, the condition of the ramp is not documented in the inspection report. The ramp should be included in the inspection report. The inspections should continue to consider the open pit walls and in-pit dumps, as well as the integrity of the Ring Road between the open pit and Vault Lake as a failure could result in a wave in the pit lake or inrush to the open pit.

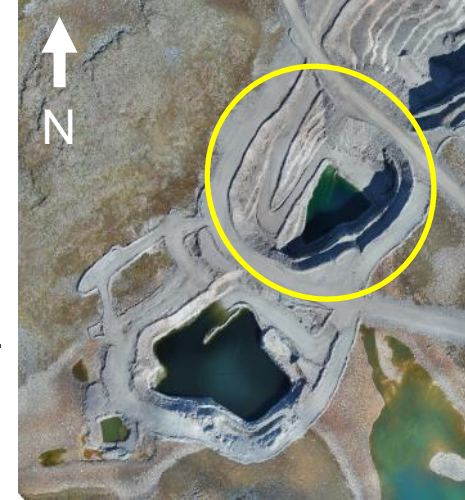
Looking Southwest

- The open pit is partially flooded, limiting the current rock exposures to a single bench. No particular concerns were noted.
- Access to the open pit is prevented by a berm.
- No evidence of instability was observed in the Amaruq AWR embankment.
- Water inflow, likely from the BB Phaser pit, was noted at the south end of the pit in 2021. No inflow was observed during the current inspection. The stability of the Amaruq AWR embankment could be adversely impacted if the water level in the Phaser pit increases and water ponds behind the embankment. A visual assessment of the water level in the open pit should be incorporated into the monthly inspections. Note that the pit lake elevation does not appear to have significantly changed since the 2021 inspection.
