Whale Tail Project 2019 Annual Geotechnical Inspection

Final Report (Rev. 01)

Agnico Eagle Mines Limited

2019 | 12 | 16

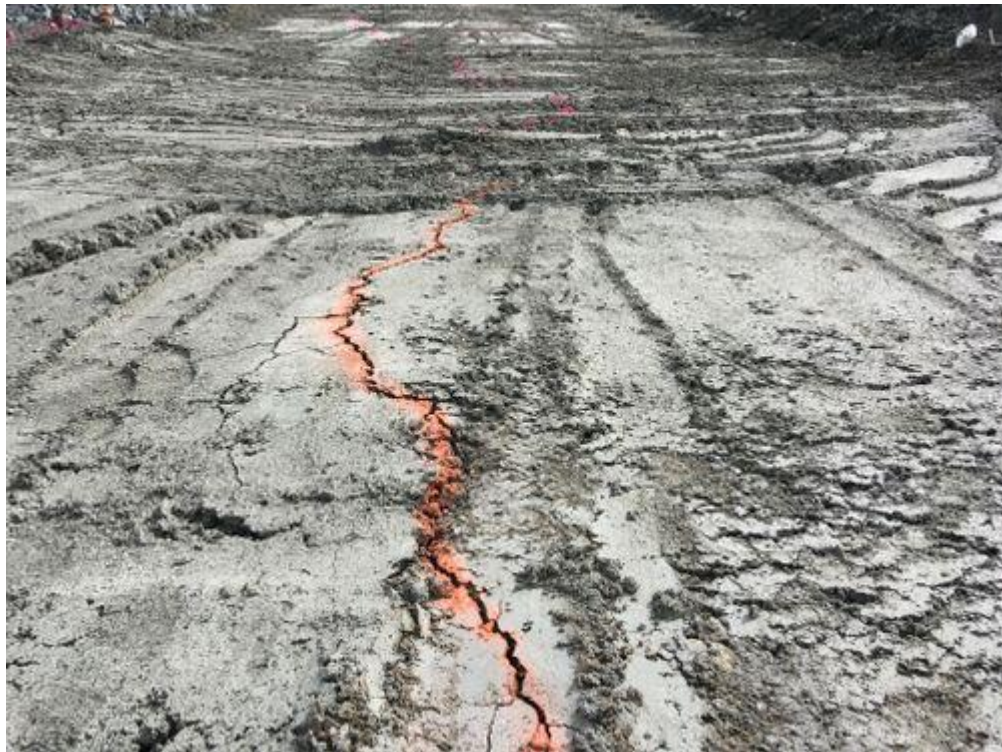
Observation 1

Location and component	Whale Tail Dike Crest
Reported observation	Cracking
Preventive or corrective actions to take	Follow up for cracks once the top rockfill platform is constructed up to elevation 159.0 m
Priority level	P-4: Best Management Practice – further improvements are necessary to meet industry best practices or reduce potential risks.
Observation date	2019-07-17

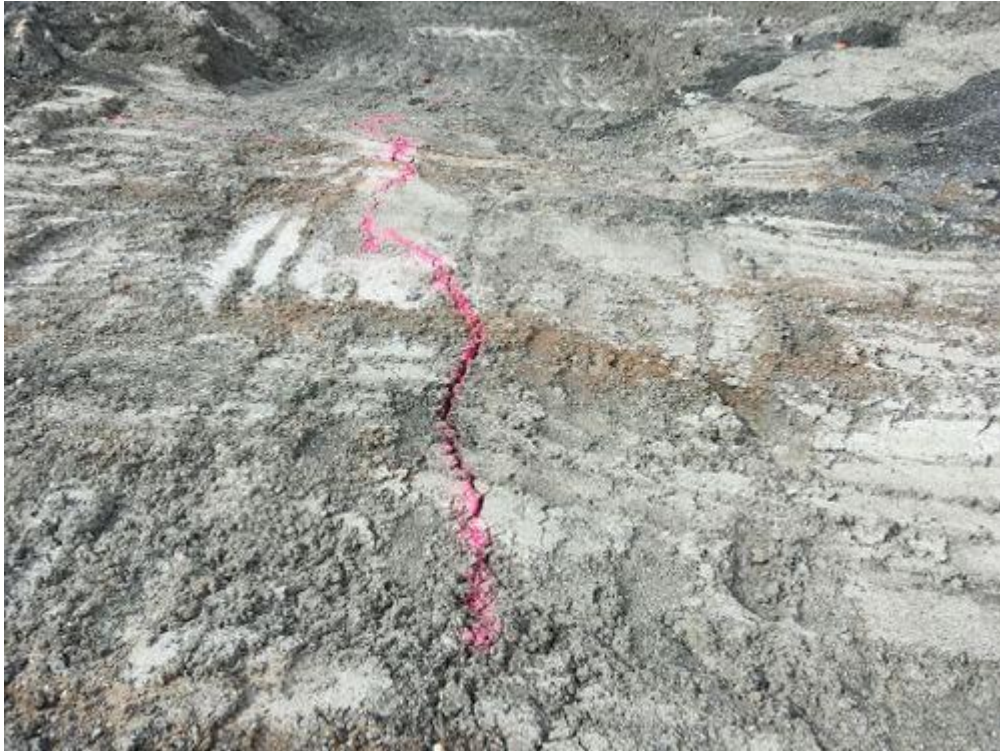
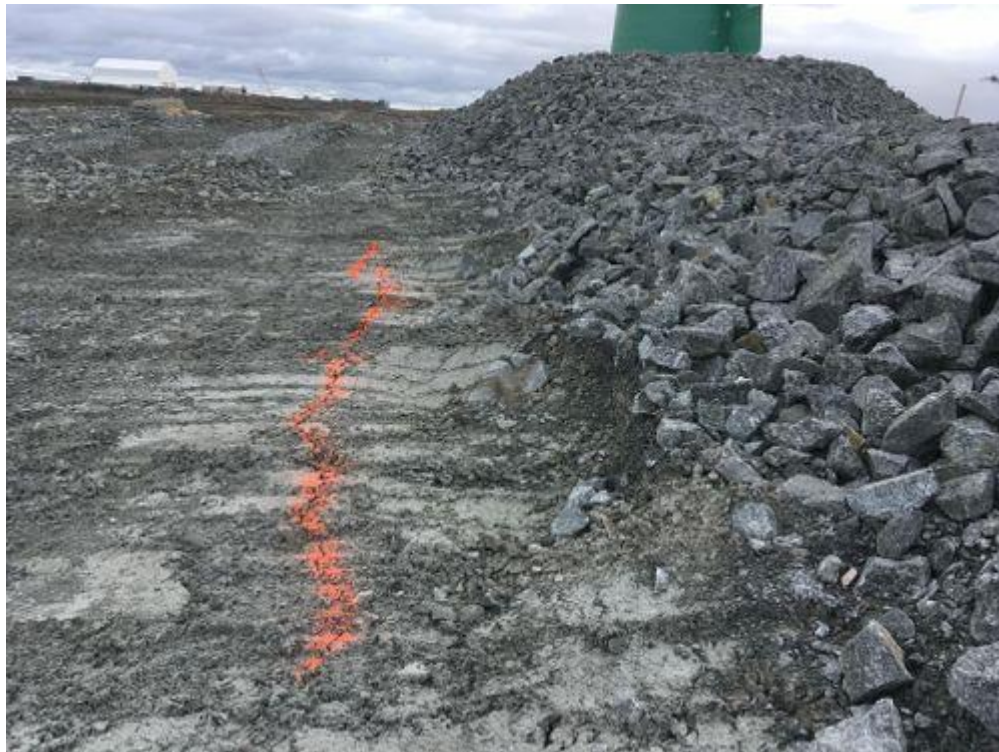
Observation 2

Location and component	Whale Tail Dike Crest
Reported observation	Cracks downstream of the cutoff wall
Preventive or corrective actions to take	Cracks are closer to the cutoff wall on the downstream side. Monitor any cracking evolution, reprofile if required
Priority level	P-4: Best Management Practice – further improvements are necessary to meet industry best practices or reduce potential risks.
Observation date	2019-07-17

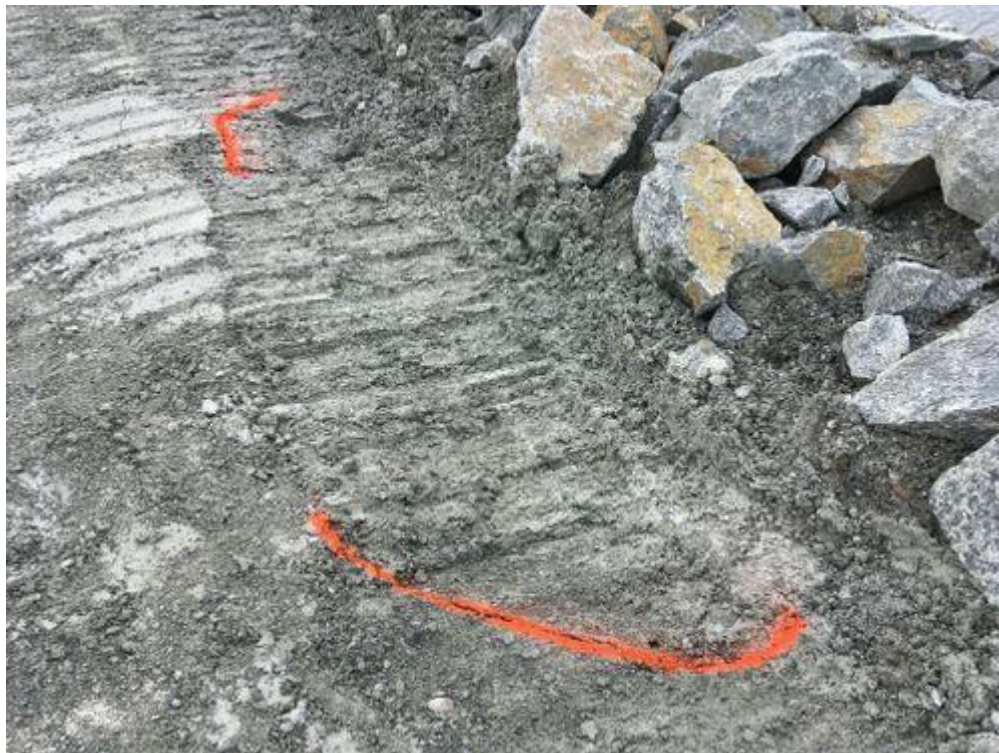
Location and component	Whale Tail Dike Crest
Reported observation	Subsidence and cracks
Preventive or corrective actions to take	Monitor any evolution of subsidence and cracking. Remove any deleterious materials and compact the additional rockfill layer
Priority level	P-4: Best Management Practice – further improvements are necessary to meet industry best practices or reduce potential risks.
Observation date	2019-07-17

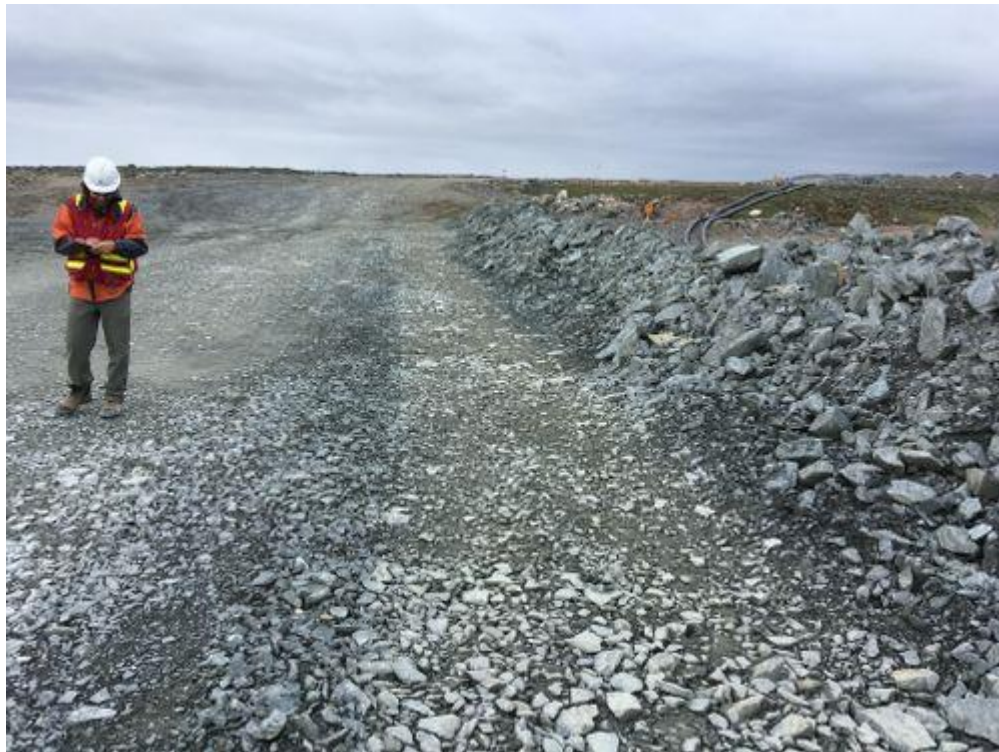
Location and component	Whale Tail Dike Crest
Reported observation	Differential settlement along the downstream edge of the western end of the crest
Preventive or corrective actions to take	Add some rockfill material and compact
Priority level	P-3: Single occurrences of deficiencies or non-conformance that alone would not be expected to result in structure safety issues.
Observation date	2019-07-17

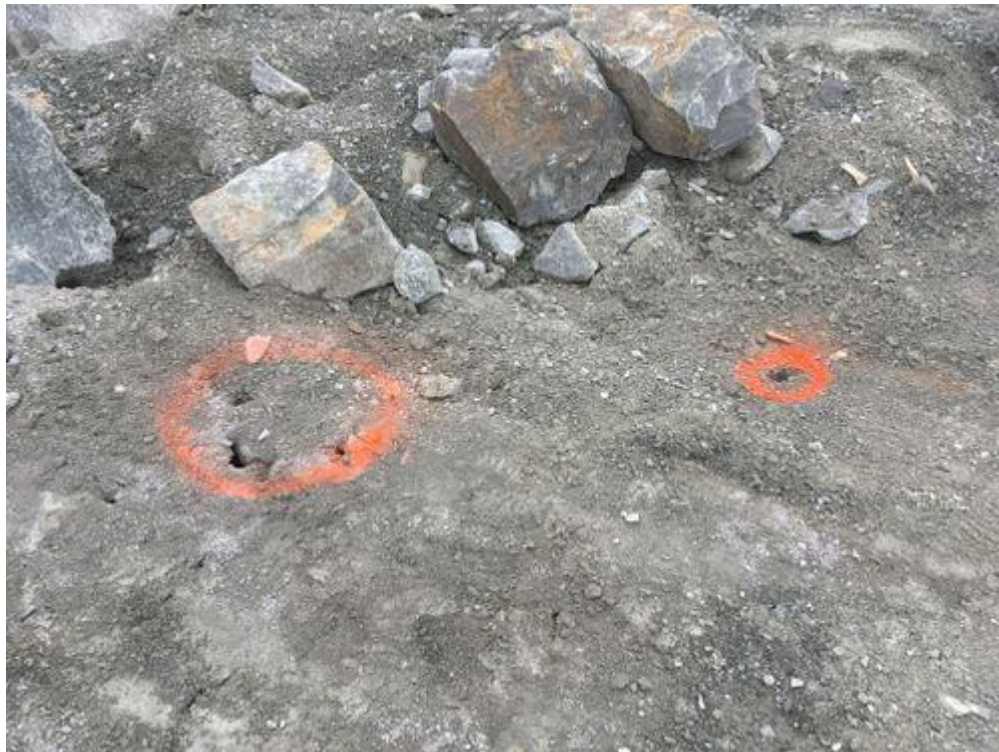
Location and component	Whale Tail Dike Crest
Reported observation	Small holes located close to the downstream safety berm
Preventive or corrective actions to take	Follow up any settlement at that location once the rockfill material is added on top
Priority level	P-4: Best Management Practice – further improvements are necessary to meet industry best practices or reduce potential risks.
Observation date	2019-07-17

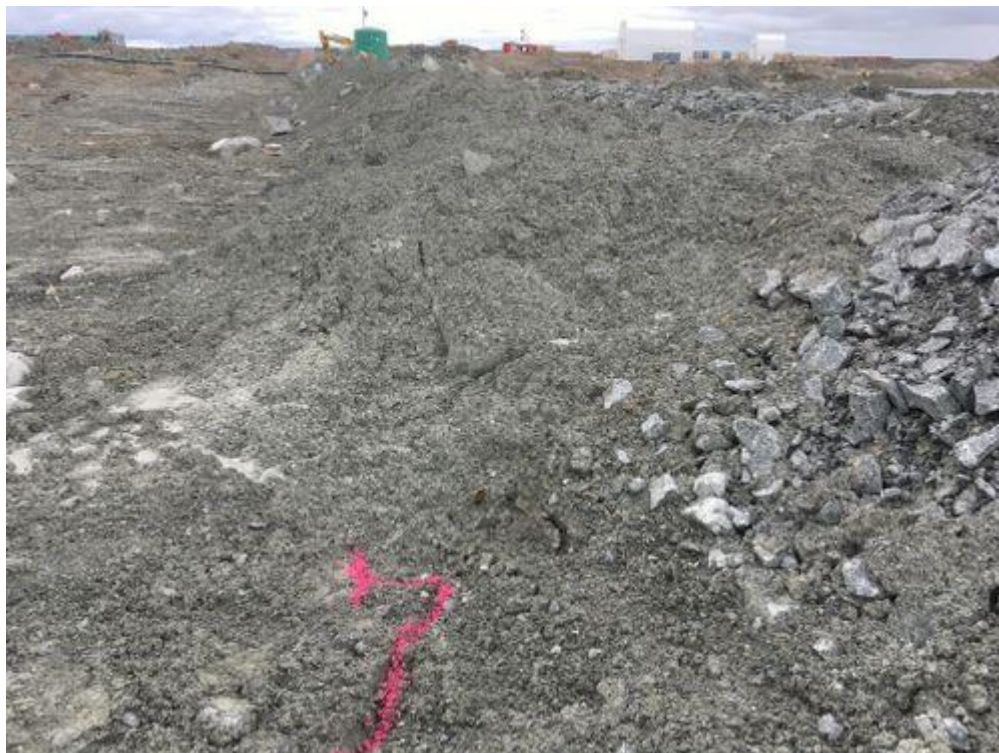
Location and component	Whale Tail Dike Crest
Reported observation	Presence of deleterious materials above elevation 157.0 m
Preventive or corrective actions to take	Remove deleterious materials above elevation 157.0 m
Priority level	P-3: Single occurrences of deficiencies or non-conformance that alone would not be expected to result in structure safety issues.
Observation date	2019-07-17

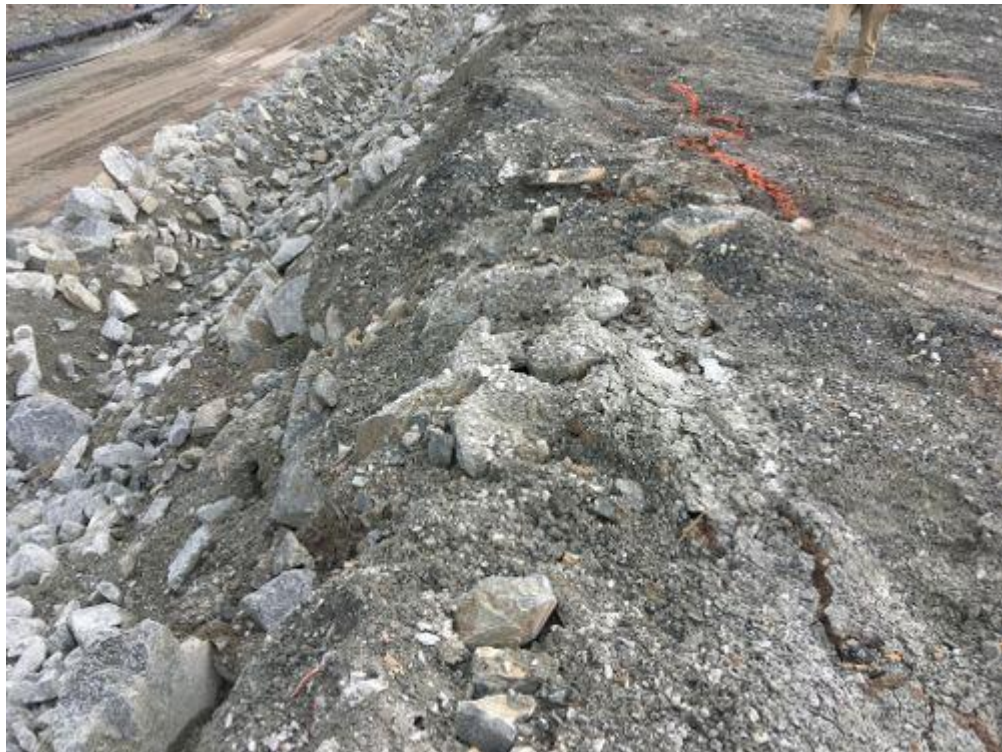
Location and component	Whale Tail Dike Downstream slope
Reported observation	Instability (cracks with local subsidence)
Preventive or corrective actions to take	Re-slope this section and complete earthworks (add and compact rockfill to final lines and grades)
Priority level	P-3: Single occurrences of deficiencies or non-conformance that alone would not be expected to result in structure safety issues.
Observation date	2019-07-17

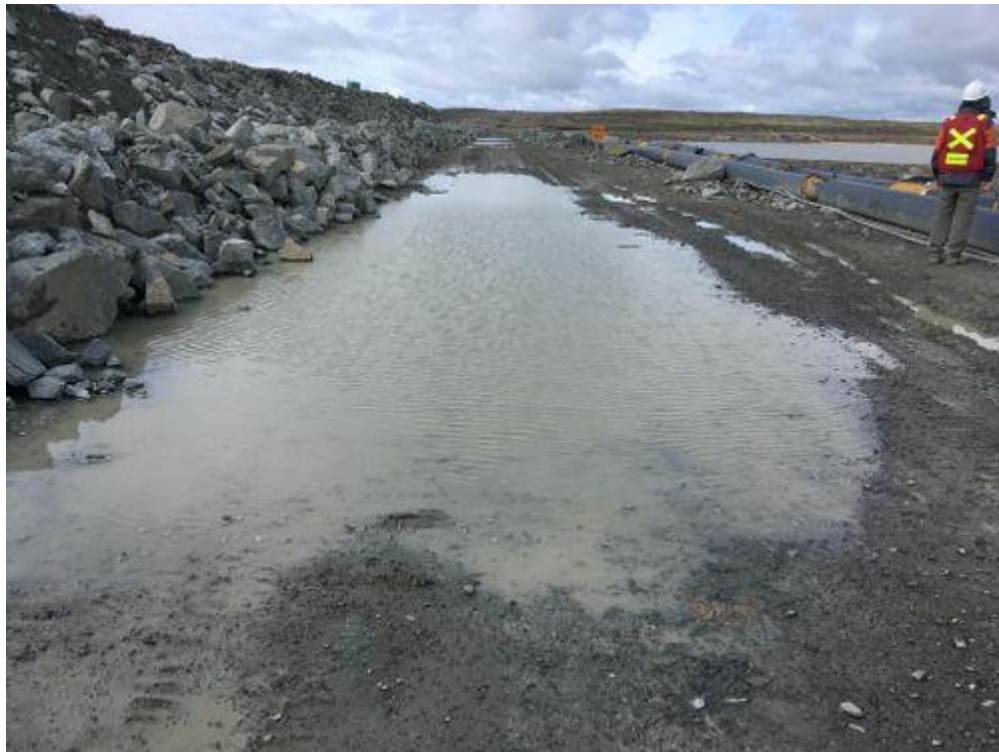
Location and component	Whale Tail Dike Downstream platform
Reported observation	Water accumulation
Preventive or corrective actions to take	Re-profile the platform toward the downstream so the water can drain away
Priority level	P-4: Best Management Practice – further improvements are necessary to meet industry best practices or reduce potential risks.
Observation date	2019-07-17

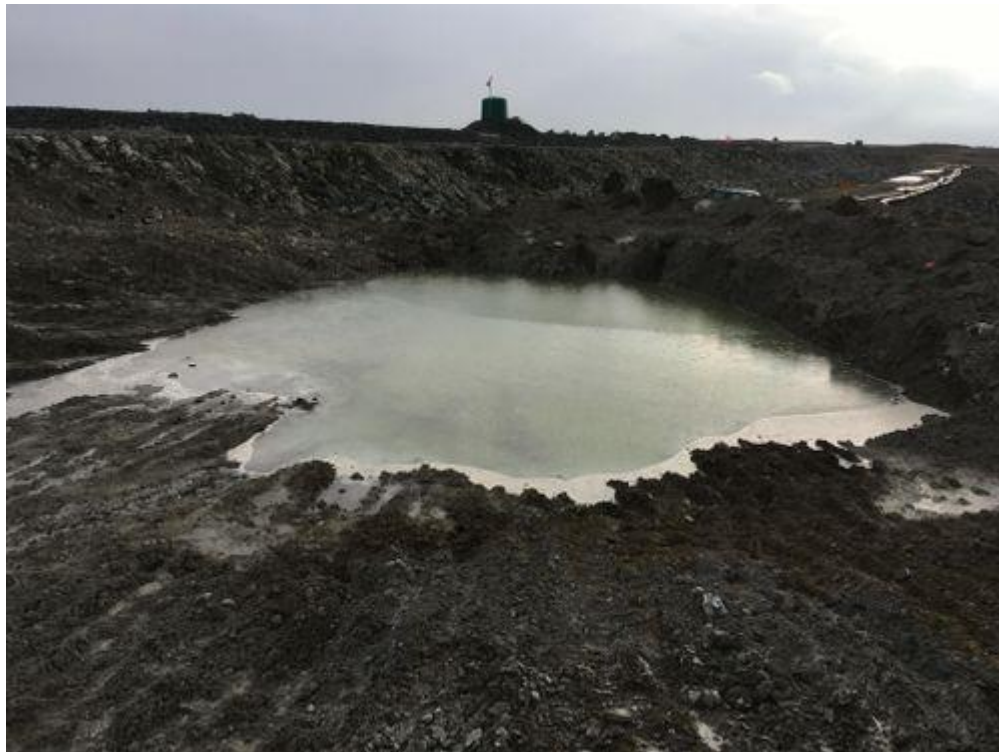
The presence of a dump of waste CB material was noted in the vicinity of observed greyish seepage. AEM should clean the area from cement and contaminated water as the dump is a potential source for migration of cement through the V-notch weirs used to monitor seepage water.

Location and component	Whale Tail Dike Downstream basin
Reported observation	Water is contaminated with cement (located on waste CB material).
Preventive or corrective actions to take	Empty the basin by pumping the water out and cap the hole to prevent runoff of contaminated water
Priority level	P-3: Single occurrences of deficiencies or non-conformance that alone would not be expected to result in structure safety issues.
Observation date	2019-07-16

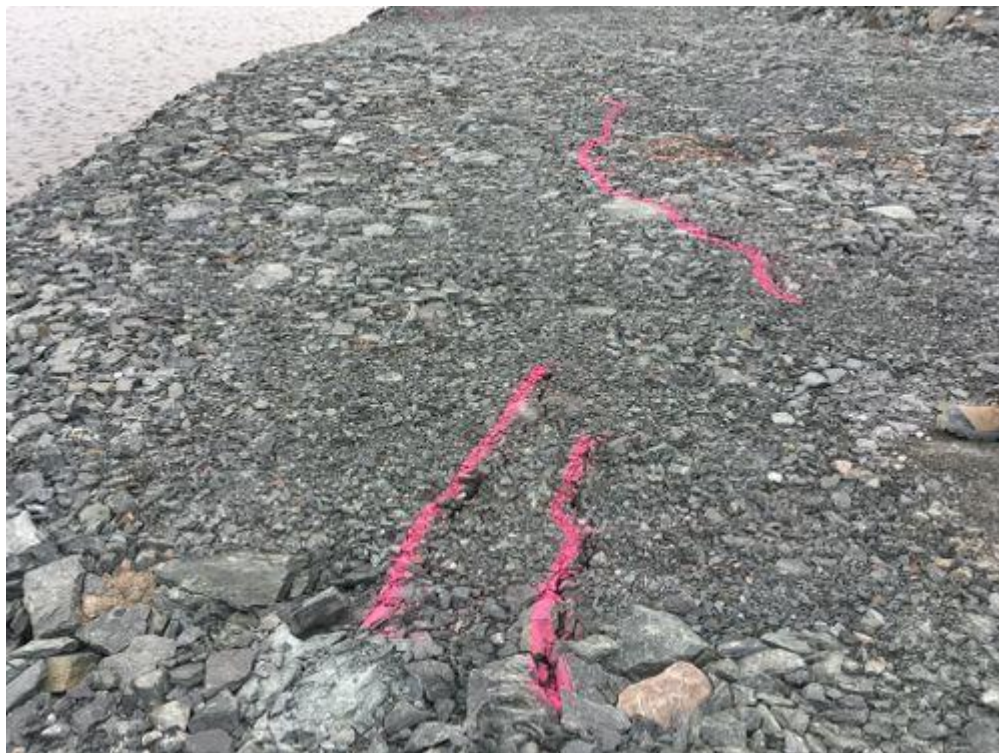
Location and component	North East Dike Upstream platform
Reported observation	Cracking
Preventive or corrective actions to take	Monitor any cracking evolution, reprofile if required
Priority level	P-4: Best Management Practice – further improvements are necessary to meet industry best practices or reduce potential risks.
Observation date	2019-07-18

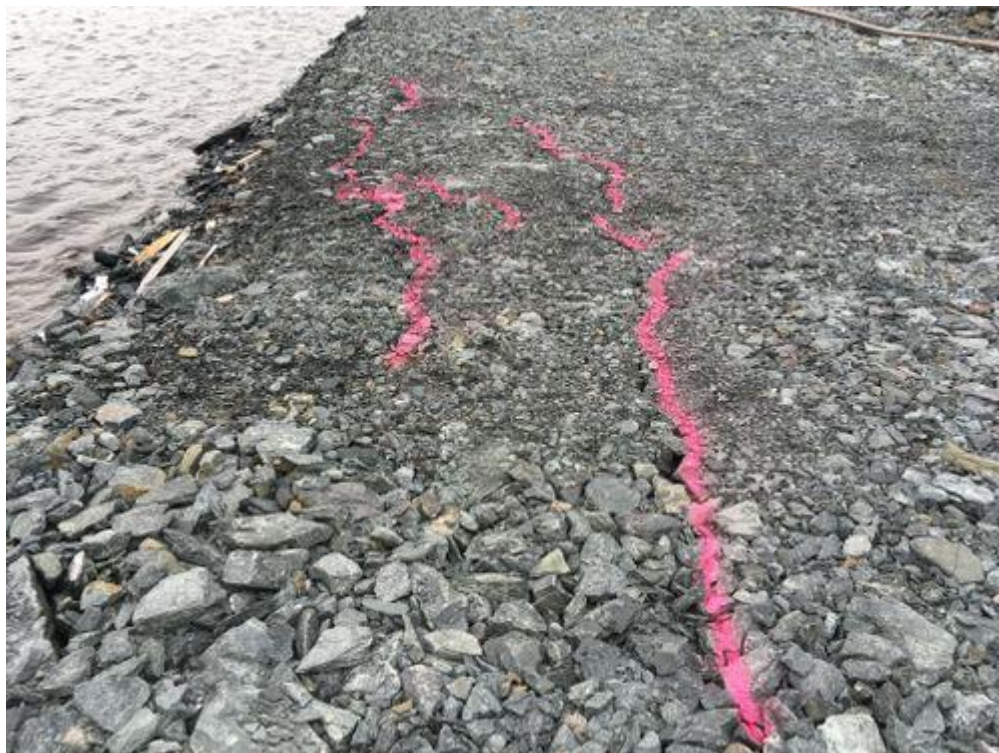
Location and component	North East Dike Upstream platform
Reported observation	Cracking
Preventive or corrective actions to take	Monitor any cracking evolution, reprofile if required
Priority level	P-4: Best Management Practice – further improvements are necessary to meet industry best practices or reduce potential risks.
Observation date	2019-07-18

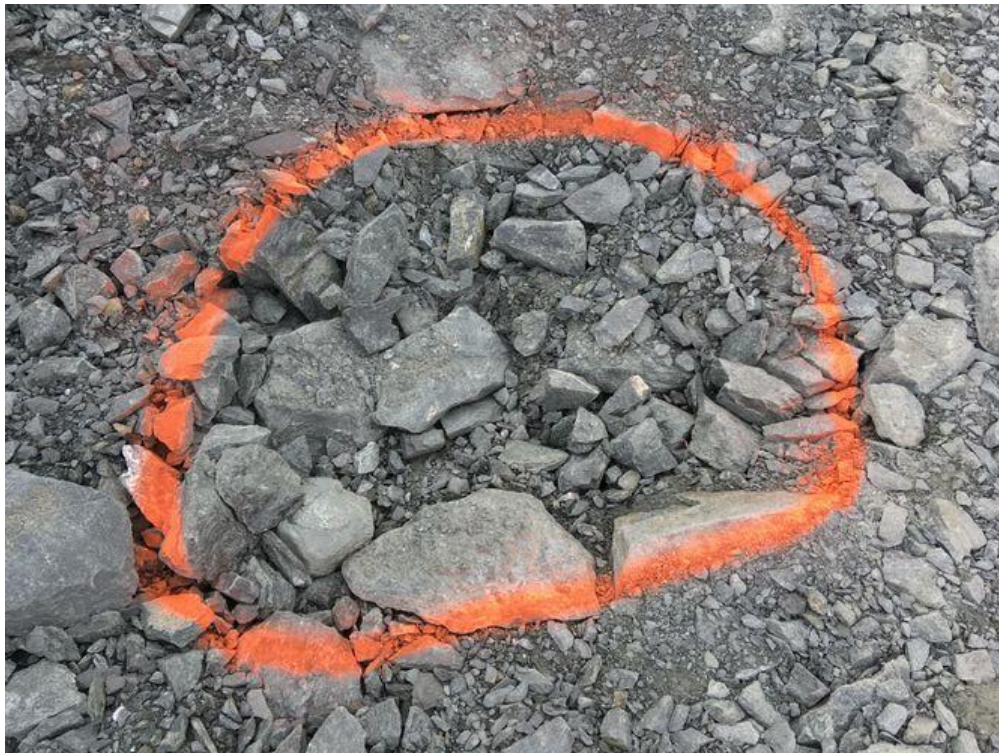
Location and component	North East Dike Crest
Reported observation	Potholes
Preventive or corrective actions to take	Monitor potholes, reprofile the crest if required
Priority level	P-4: Best Management Practice – further improvements are necessary to meet industry best practices or reduce potential risks.
Observation date	2019-07-18

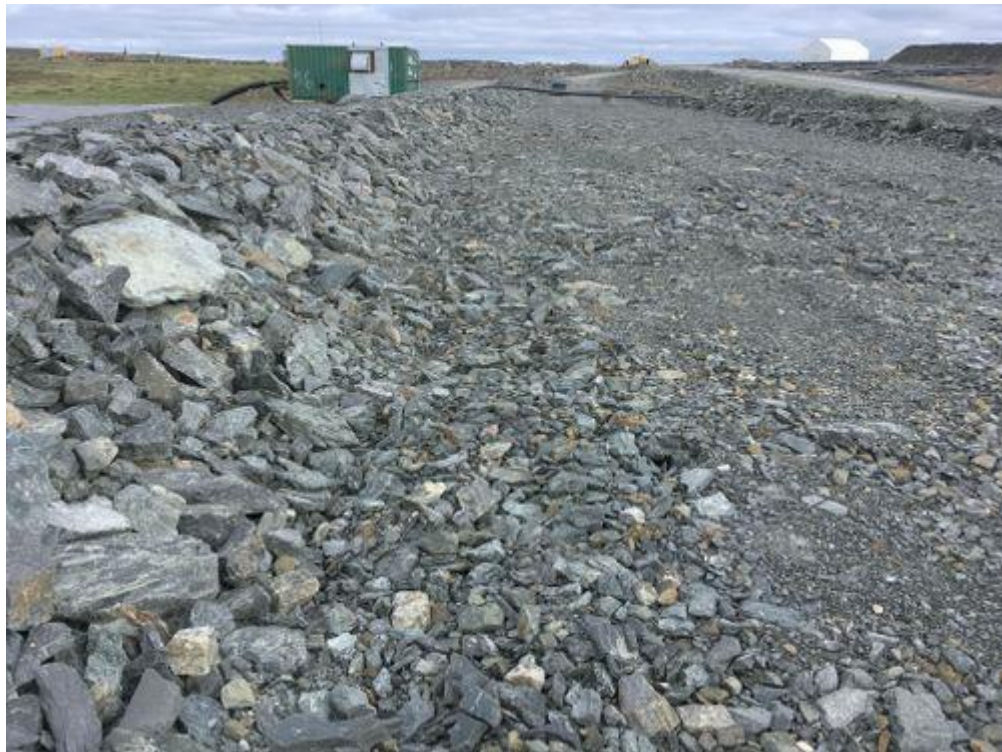
Minor deformations such as tension cracking along the upstream berm most likely due to thawing of the underlying tundra were observed. However, some settlements were observed on the crest close to the upstream safety berm. AEM should locate the position of the settlement with regards to the position of the bituminous geomembrane underneath to assess if the liner could be subject to tensile stresses. Some deformations along the downstream slope should also be monitored, especially where water is ponding at the downstream toe of the structure.

Location and component	North East Dike Crest
Reported observation	Settlement close to the upstream safety berm
Preventive or corrective actions to take	Review as-built survey and confirm that little or no deformations occur in the area the geomembrane is installed
Priority level	P-3: Single occurrences of deficiencies or non-conformance that alone would not be expected to result in structure safety issues.
Observation date	2019-07-17

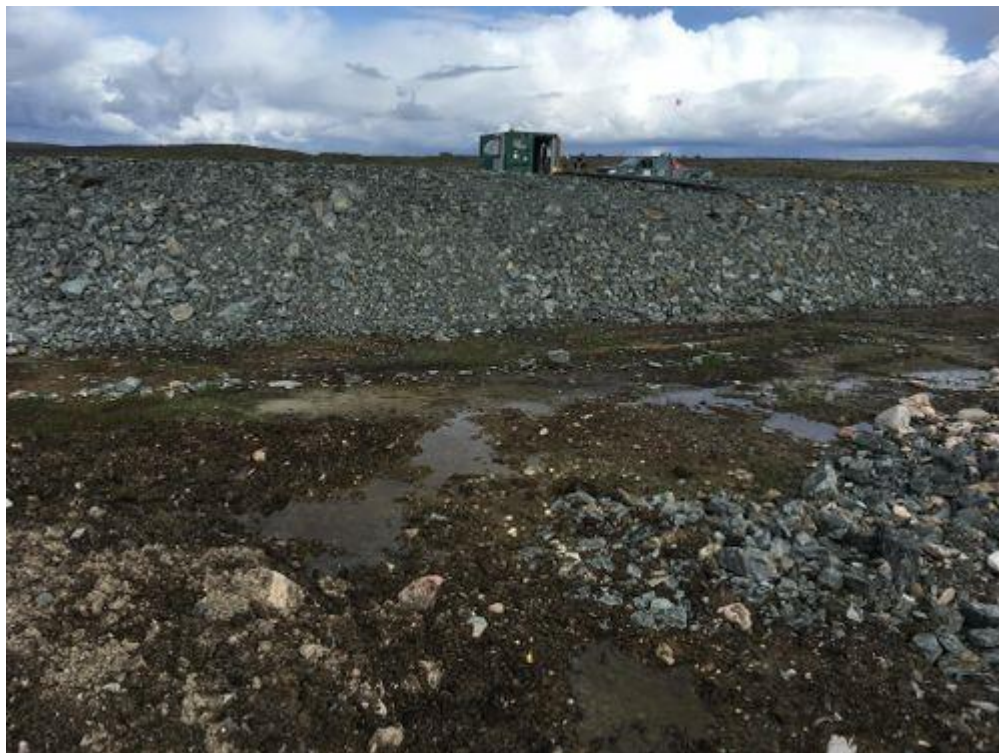
AEM mentioned that the presence of water ponding at the downstream toe may be due to local overtopping of the bituminous geomembrane when the upstream water level reached its maximum level. The water level had dropped to 156.47 masl on July 14, 2019 and no visual evidence could allow to conclude that the liner had been overtopped at the time of the inspection. No seepage was observed during the inspection; nevertheless, SNC-Lavalin recommends promoting drainage at the downstream toe area of the dike to be able to monitor potential seepage channels (if any) and to protect the permafrost close to the infrastructure.

Location and component	North East Dike Downstream toe
Reported observation	Water ponding
Preventive or corrective actions to take	Promote drainage away from the toe and monitor for any sign of seepage
Priority level	P-3: Single occurrences of deficiencies or non-conformance that alone would not be expected to result in structure safety issues.
Observation date	2019-07-18

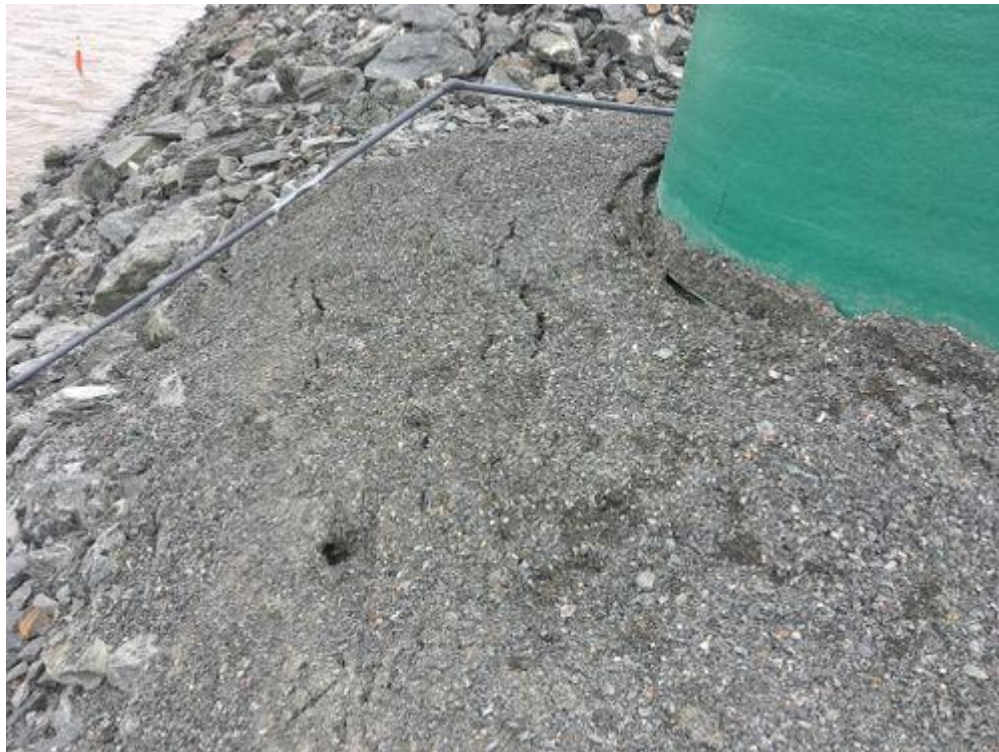
Location and component	WRSF Dike Upstream slope
Reported observation	Cracking
Preventive or corrective actions to take	Monitor cracking around the instrumentation shelter and reprofile if required
Priority level	P-4: Best Management Practice – further improvements are necessary to meet industry best practices or reduce potential risks.
Observation date	2019-07-17

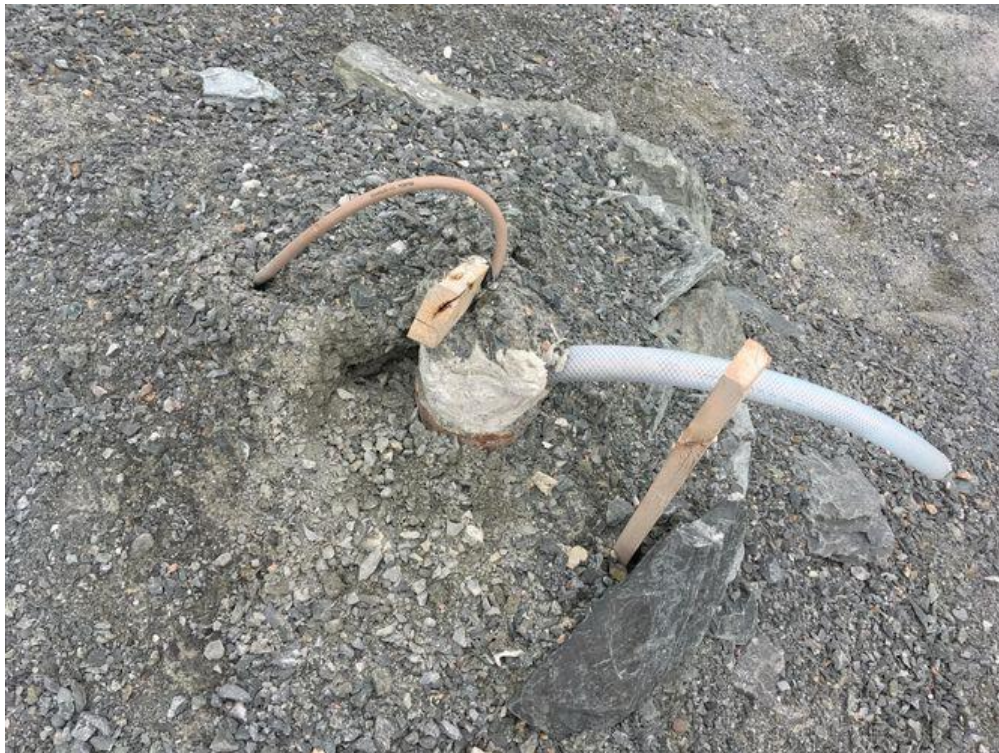
Location and component	WRSF Dike Thermistor
Reported observation	Exposed thermistor cable
Preventive or corrective actions to take	Protect the cable from weather and animals
Priority level	P-3: Single occurrences of deficiencies or non-conformance that alone would not be expected to result in structure safety issues.
Observation date	2019-07-17

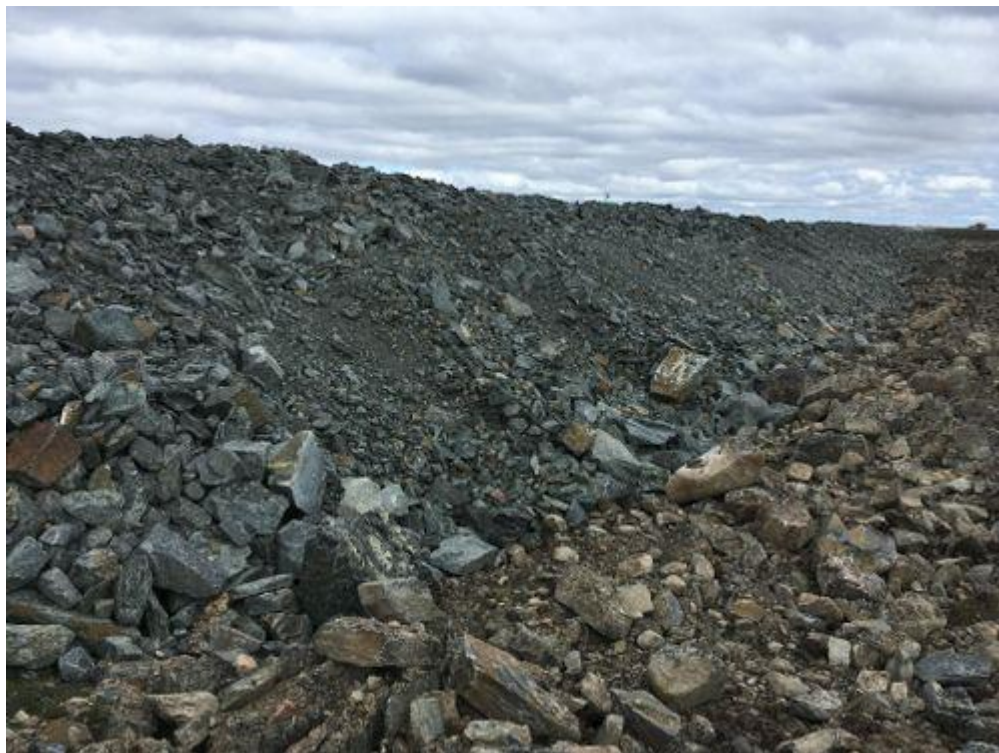
Location and component	WRSF Dike Downstream slope
Reported observation	Variability in the slope angle
Preventive or corrective actions to take	Monitor and profile the slope if any instability
Priority level	P-4: Best Management Practice – further improvements are necessary to meet industry best practices or reduce potential risks.
Observation date	2019-07-17

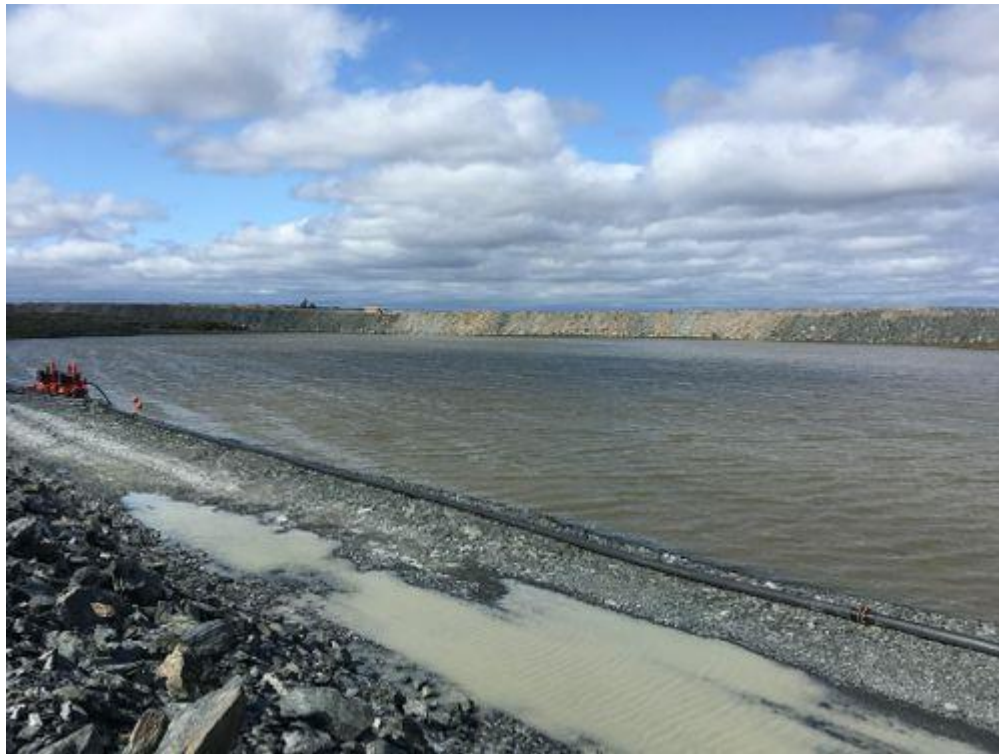
Location and component	WRSF Dike Upstream water level
Reported observation	Water elevation is above its operational level
Preventive or corrective actions to take	Continue monitoring on a daily basis until the water level decreases to its operational level
Priority level	P-4: Best Management Practice – further improvements are necessary to meet industry best practices or reduce potential risks.
Observation date	2019-07-17

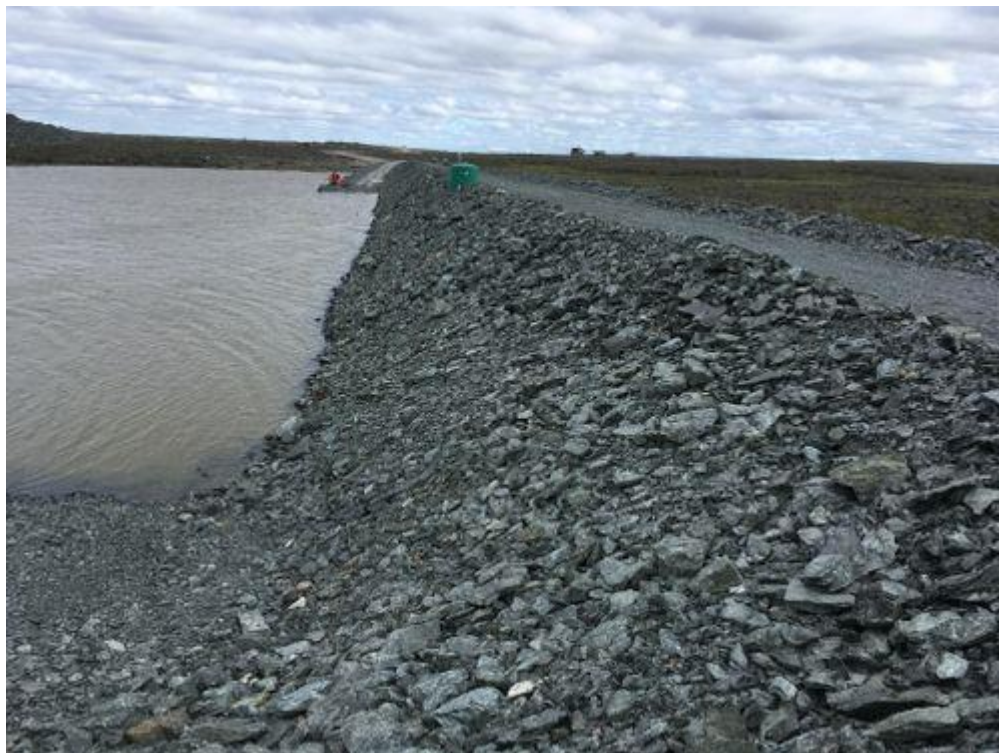
Location and component	WRSF Dike Upstream water level
Reported observation	Lack of operating stake
Preventive or corrective actions to take	Install a stake showing operating and maximum water levels
Priority level	P-4: Best Management Practice – further improvements are necessary to meet industry best practices or reduce potential risks.
Observation date	2019-07-17

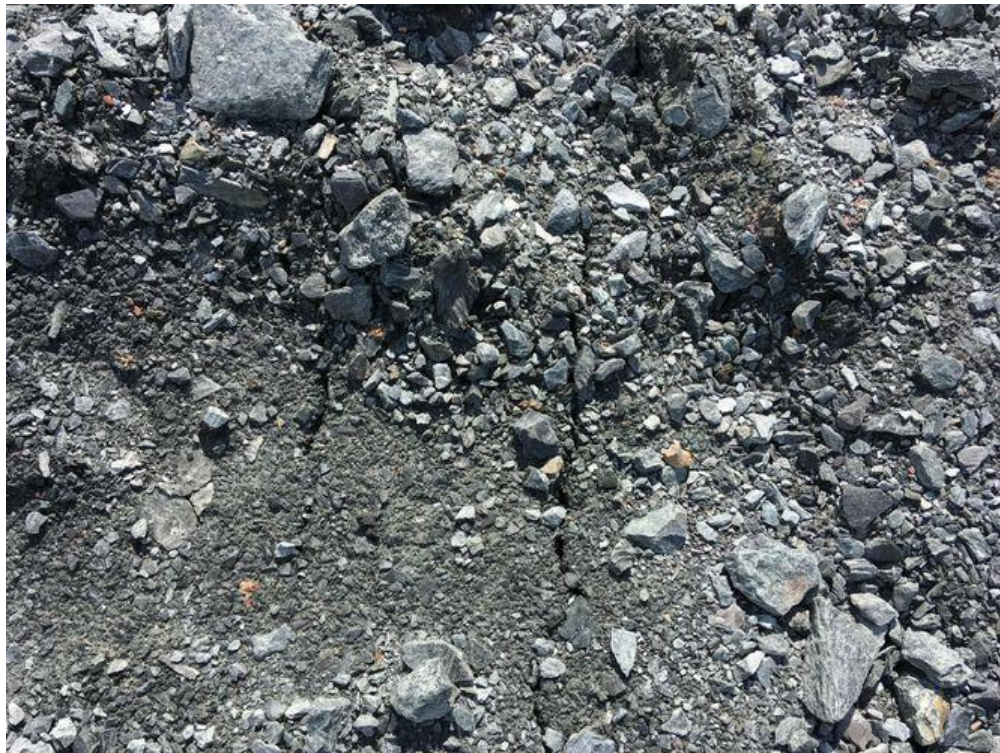
Location and component	Mammoth Dike Crest
Reported observation	Cracking
Preventive or corrective actions to take	Monitor any cracking evolution, reprofile if required
Priority level	P-4: Best Management Practice – further improvements are necessary to meet industry best practices or reduce potential risks.
Observation date	2019-07-17
