Whale Tail MDRB Meeting No 24 + Agnico responses

Report No 24B, Amaruq
Meadowbank Mine Dike Review Board
Meeting September 24-27, 2018

RESPONSE TO COMMENTS, MEADOWBANK DIKE REVIEW BOARD No.24 – AMARUQ REPORT

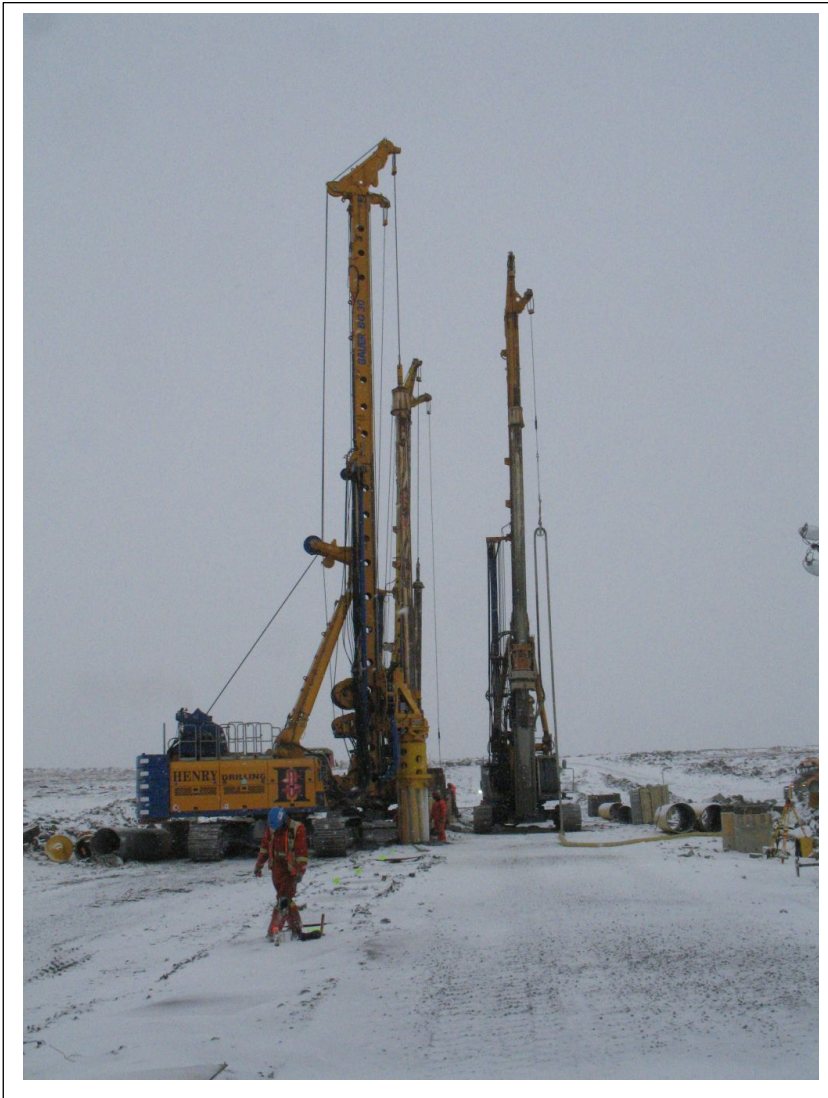
Photo No. 1 Caisson drilling machines on Whale Tail Dike

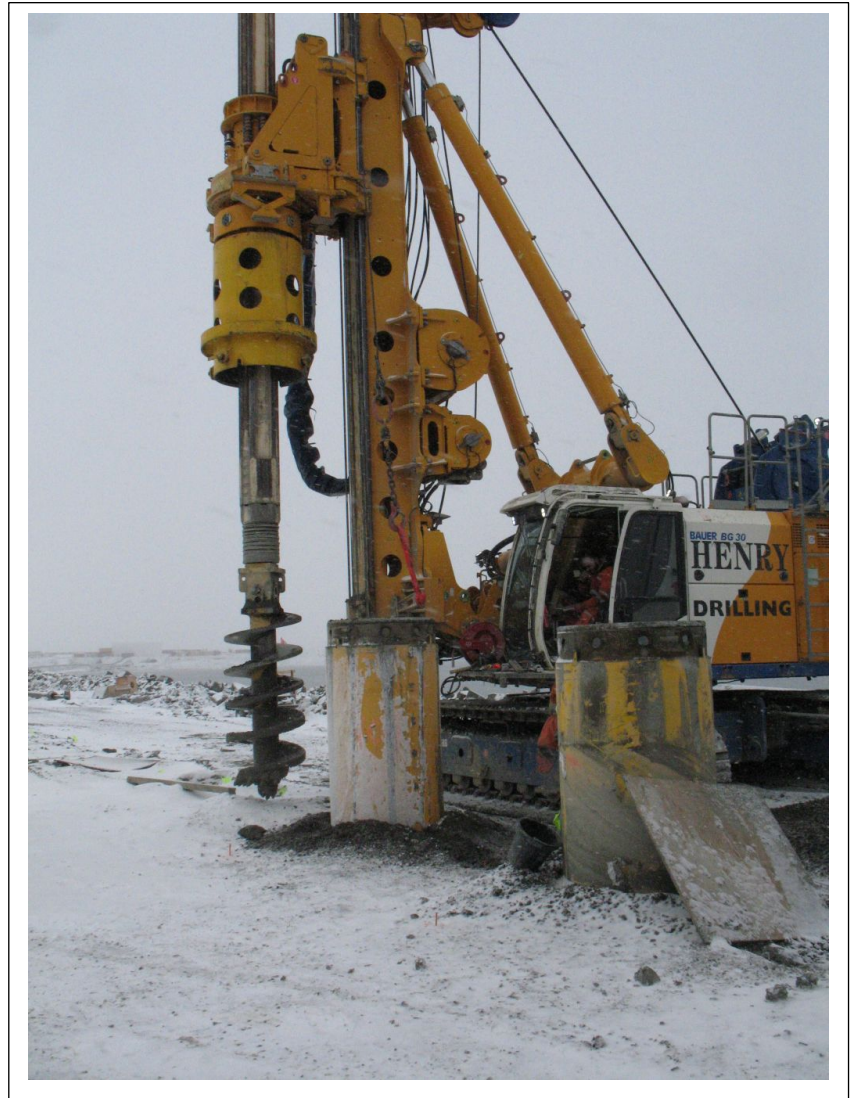
Photo No. 2 Auger for caisson clean-out

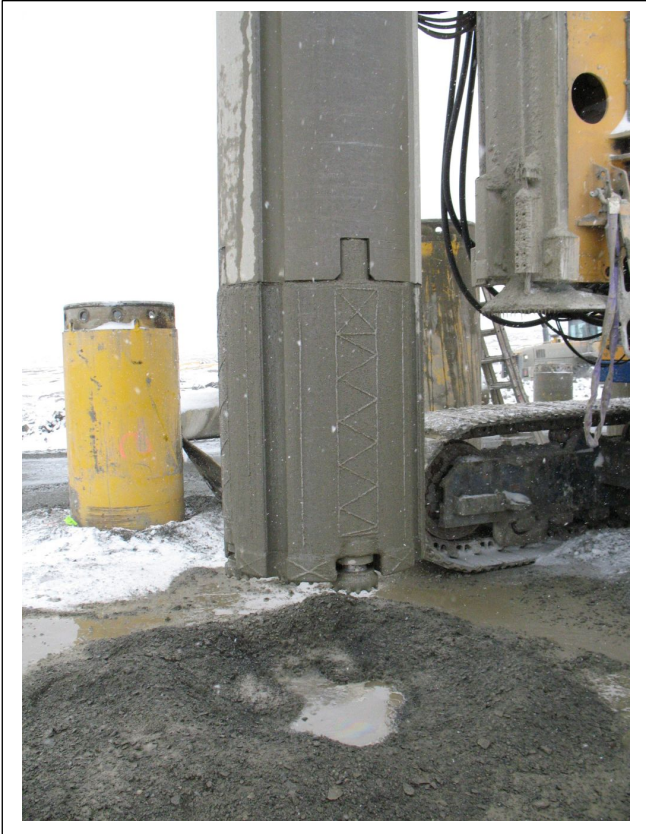
Photo No. 3 Rock socket drill

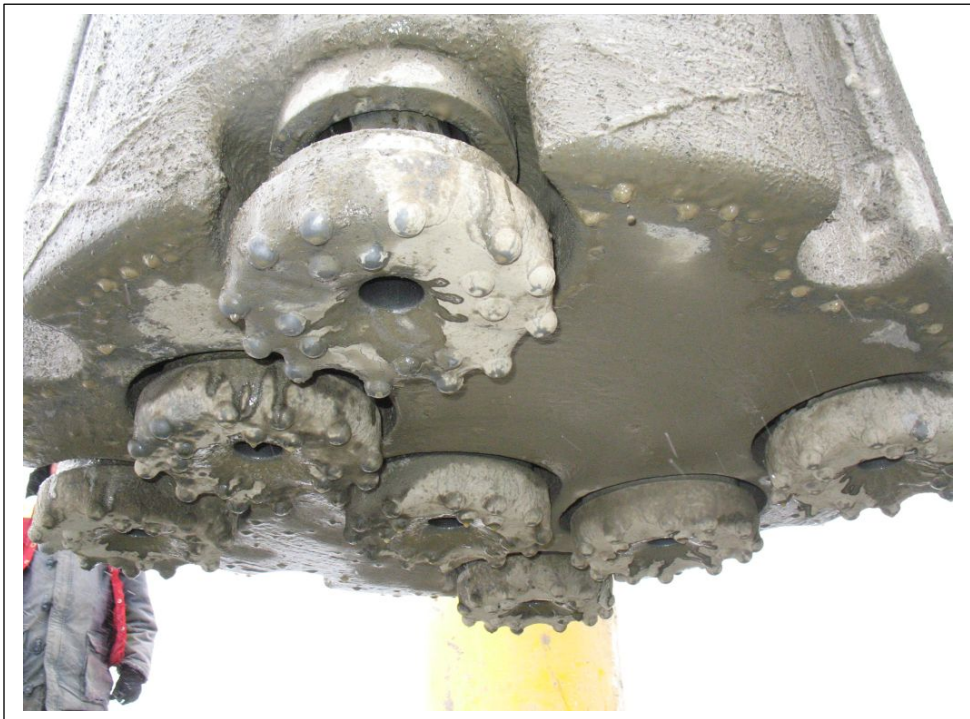
Photo No. 4 Tungsten carbide tipped hammer drill bits (7)

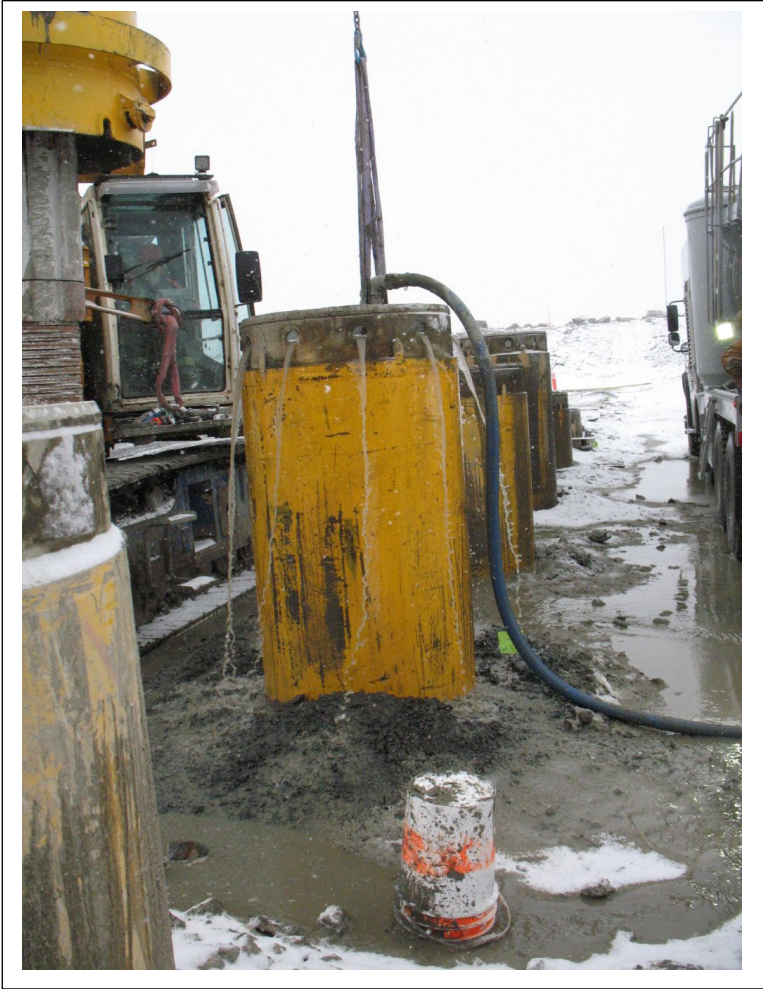
The Board was able to visit the dike and observe operations for the construction of the secant pile cut-off wall. The need for improved housekeeping with respect to management of overflow during tremie backfill of the casings was evident. There are two issues with this namely; environmental protection in the avoidance of water reaching the lake, and safety in the reduction of ice accumulation on the working platform during winter operations.

Photo No. 5 Overflow of water during tremie filling of secant piles with Cement-Bentonite slurry

This recommendation was transferred to the contractor responsible for the cut-off wall construction to improve the housekeeping in the work area. Additional safety procedures were put in place to ensure the safety of the worker (cleats were added as a mandatory PPE while working in the dike area). As for the environment protection, a water management plan has been put in place since the beginning of the dike construction and is followed in the field to ensure that the overflow tremie water does not reach the lake. Regular sampling of the lake water is conducted by the Environment Department and results are analyzed and communicated to the Engineering team.
