Whale Tail 2022 Annual Open Pit Geomechanical Inspection

March 17, 2023

RE: Meadowbank Complex - Amaruq Site - 2022 Annual Open Pit Geomechanical Inspection

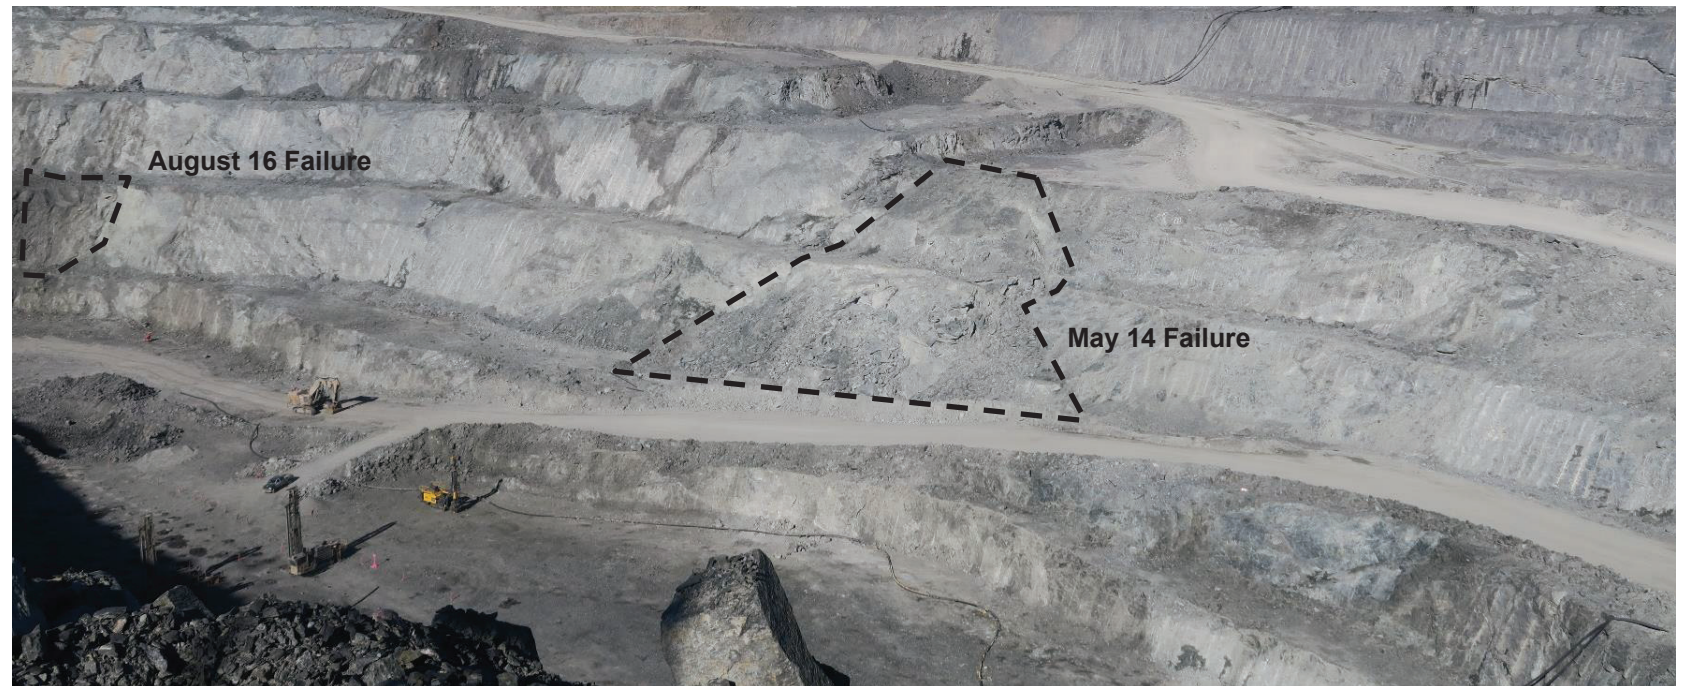
- Interim wall in Phase 1. Phase 1 has been the focus of production over the past year.
- The wall was established in the Komatiite, parallel to the foliation. As expected, a series of bench-scale failures have occurred in areas where the foliation locally dips at a shallower angle than the bench face.

- The implementation of a 55° pre-shear has improved slope performance and half barrels are visible in many areas. Bench-scale failures have and will continue to occur. AEM continues to complete extensive scaling in this sector in order to remove potential hazards and reduce the likelihood of a failure. This is endorsed.

- The bench failures almost always occur during freshet or the summer months.
- As a result, the development of the ramp along the this wall was prioritized during the 2021-2022 winter in order to minimize the rockfall risk to personnel. A berm was installed along the inside of the ramp prior to freshet.

- Two areas of instability have developed along this wall in 2022 (outlined in the image at right) and are described on the following slides.

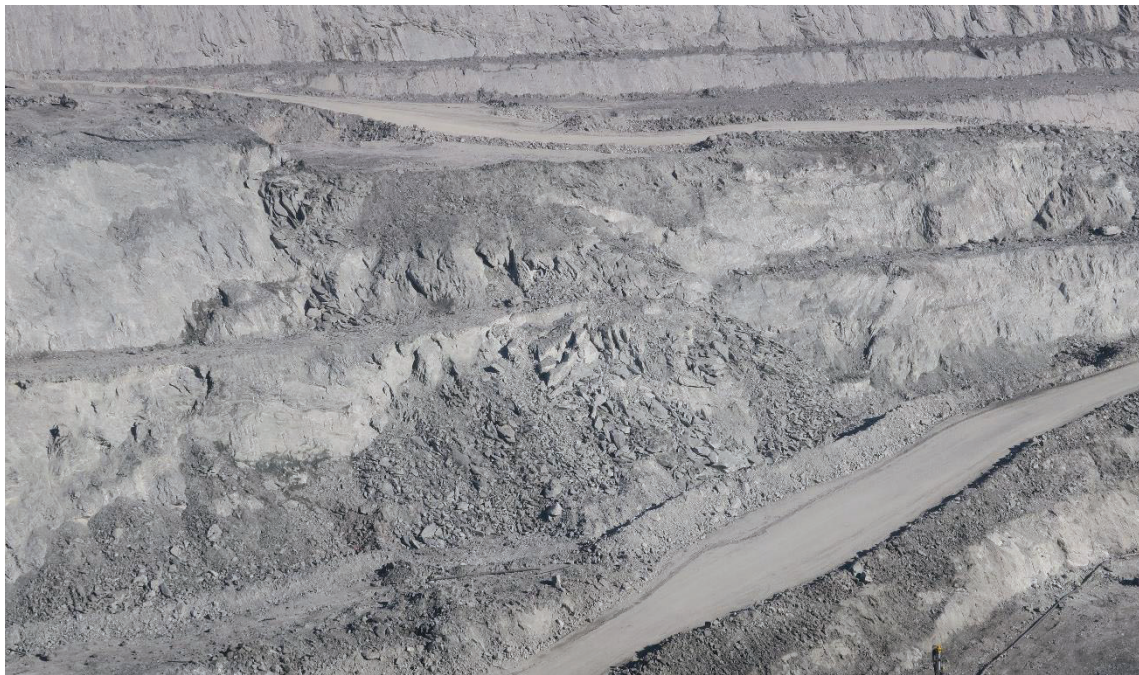
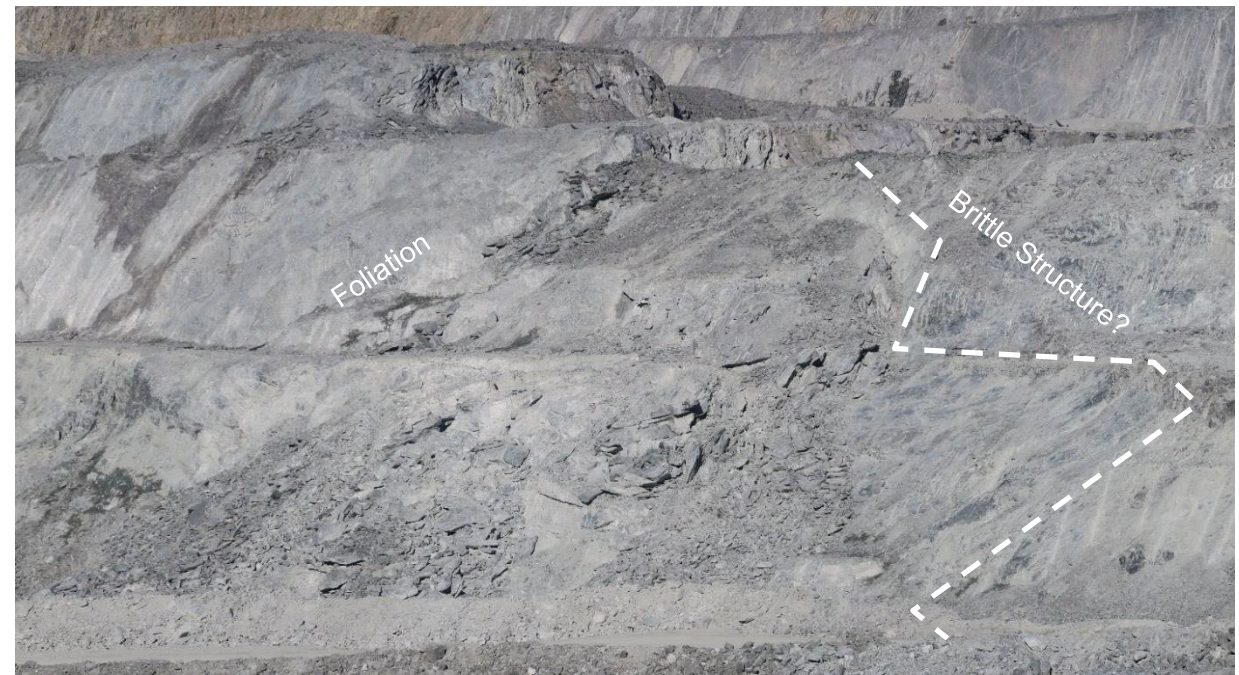
- A multi-bench failure has occurred progressively within the Komatiite over multiple events between May 14 and July 16, 2022.
- The area was identified as a potential instability during development and a berm constructed below the wall prior to freshet.
- The failure appears to be bounded by persistent structures. This could represent an undulation in the foliation, as similar geometries have resulted in bench scale failures in the past. The eastern contact appears to be more linear and may be a Brittle Structure.
- The failure mass continues to exhibit steady, gradual deformation in the radar data, in the order of 5 to 6 mm/day.

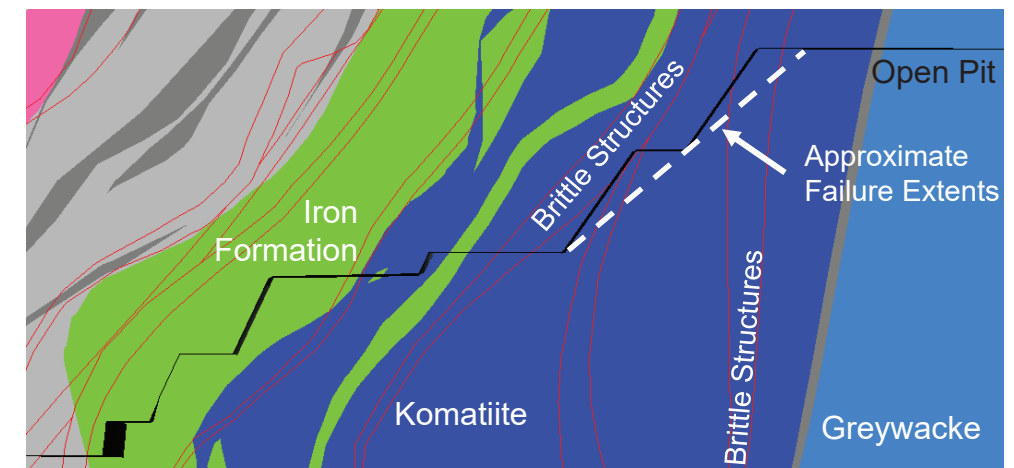
- A review of the lithology model suggests that the failure is unlikely to propagate significantly further back behind the crest due to the presence of the Greywacke.

- The potential for the failure to continue to propagate with depth was discussed as the structure defining the eastern boundary of the failure daylights below the ramp. The failure is larger than others along the Phase 1 North Wall and should be reviewed in greater detail to better understand the failure mechanism, likely contributing factors, and the potential for the failure to continue below the ramp. It may be possible to use the radar data to better understand the possible structural controls on the failure. A Maptek scan is recommended to document the failure geometry in detail.

- The Phase 1 pit will be used as a sump for managing water into 2024. Personnel will be travelling on the ramp below this failure during that time.
- Options for reducing the risk to personnel if the failure continues to progress were discussed. These include:

- Buttressing the failure. This would limit the ramp to single lane traffic but that is expected to be manageable.
 - Allowing the water level to rise a point on the ramp above the failure. This would allow the pumps to be located above the failure, removing the requirement for personnel to travel below the failure. However, the infiltration of water into the toe of the failure mass would like adversely influence the performance of the failure. The potential risks associated with storing this much water above the underground workings would also need to be reviewed.

- The failure should continue to be monitored with the radar and the berm maintained.
- Once mining of Phase 1 is complete, the risks associated with on-going access below the failure should be reviewed and mitigation measures implemented as appropriate.

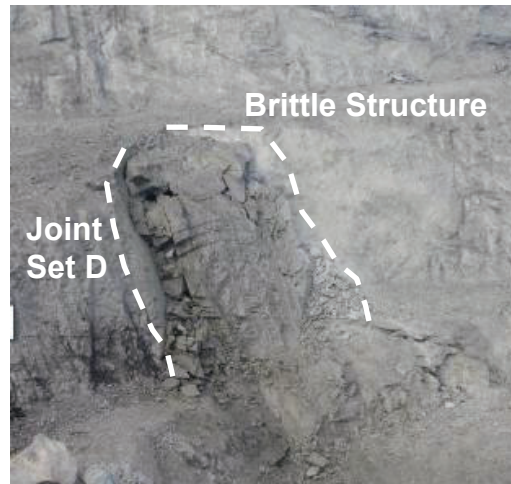
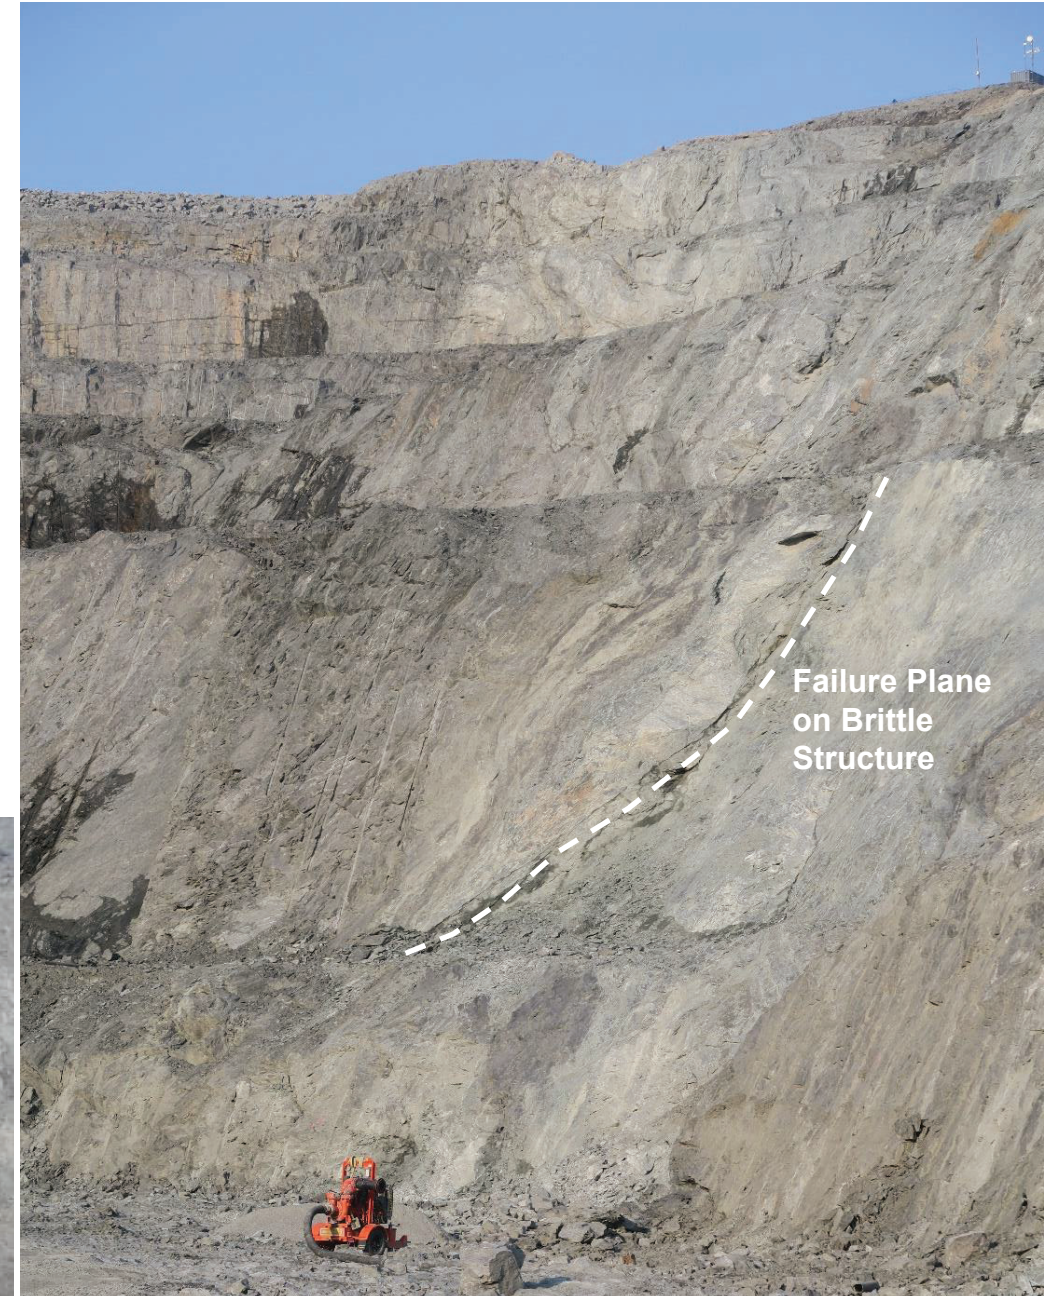
- During the site visit, a possible instability at the western end of the wall was identified based on trends in the radar monitoring data.
- A wedge is present on the wall, formed by a brittle structure and a cross-cutting structure (likely Joint Set D). The rock mass below the brittle structure is Komatiite but it is not clear if the wedge itself is Komatiite.
- The area was barricaded and access prevented. Due to the timing of the event, the pump shown in the photo was left within the barricaded area.
- After the site visit, a portion of the wedge failed in place on August 16 (see inset below). A small step-in with a berm has been left below the failure to allow mining to continue in the area.
The area should continue to be monitored.
- The failure will be mined out when Phase 1 is pushed back to the final pit configuration.

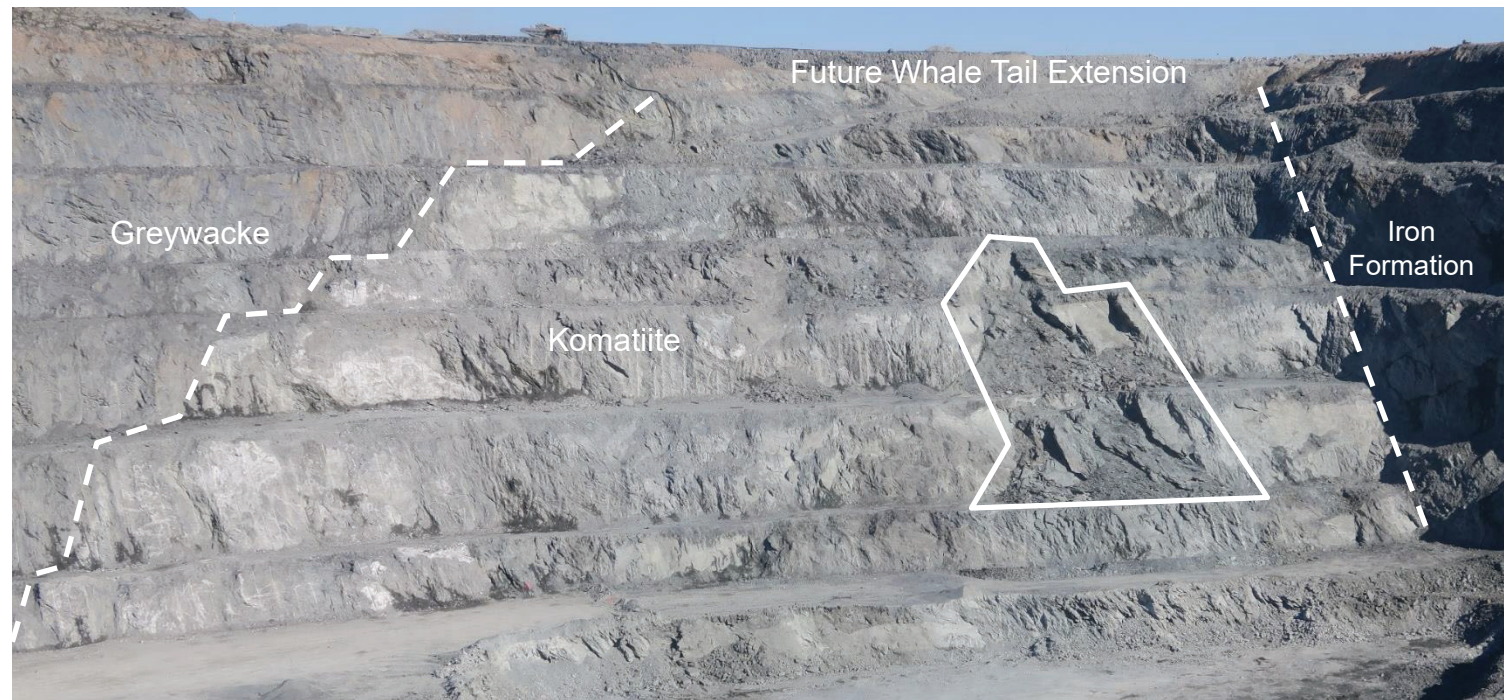
- Final wall in Design Sector D4K.
- This sector is within the Komatiite and has been characterized by a series of bench scale failures. The failures are currently understood to be a hybrid of failure on the foliation and failure of the weak rock mass, influenced by water (i.e., a combination of seepage within the talik and surface runoff) and the Brittle Structures.

- A revised slope design was developed in December 2021 and a pushback of the upper two benches completed to re-establish the slope. The pushback will eventually form part of the planned Whale Tail Extension to the northeast.

- The performance of the benches has improved with the revised slope design. Several bench-scale failures have occurred and will continue to occur.
- A series of bench-scale failures have occurred at the eastern end of the sector (outlined at right). The failures have almost, but not yet, linked up. This area is discussed on the following slide.

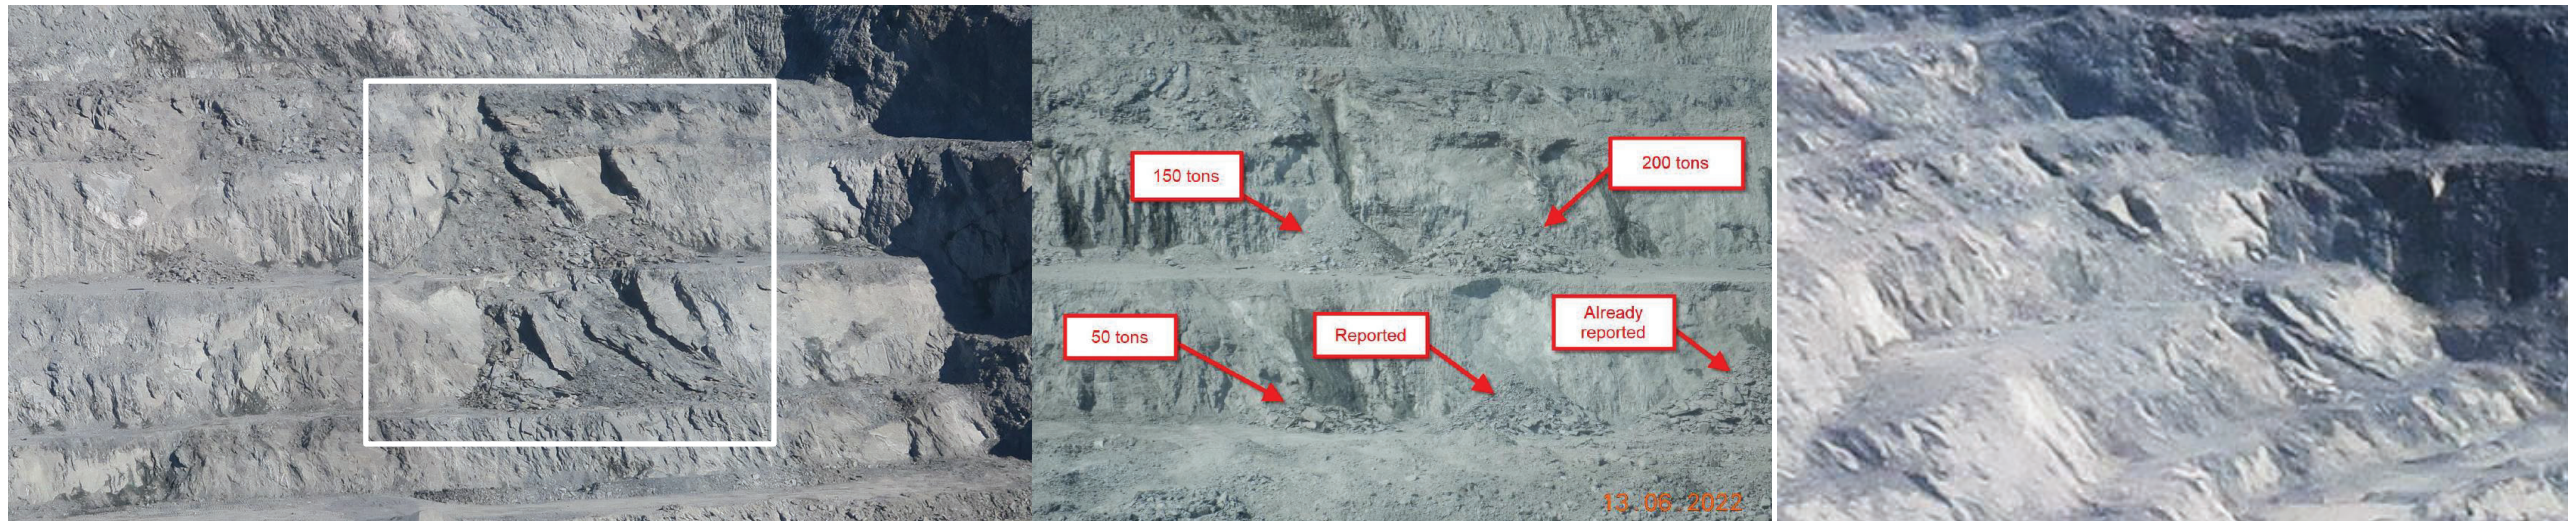
- Seven rockfalls and bench scale failures have been reported in this sector in 2022, ranging in tonnage between approx. 150 and 1500 tonnes. All but one are associated with a series of progressive failures associated with the area outlined in the left photo.

- The failures occurred during freshet, between May 28 and July 17, with most occurring in June. Failures were expected and a rockfall berm was constructed below this area prior to freshet.

- The middle photo shows the outlined area at the time of many of the initial failures in June. These failures were relatively small and several appear to be associated with surface water or erosion of the face (see next slide). The rock mass quality was noted to reduce as the rock mass thawed and these failures progressed over time. The failures on the two benches have almost linked up.

- The western limit of the failures appears to be defined by the foliation. The eastern limit of the failures appears to have a structural control (see right photo). This may be one of the brittle structures (see image at upper right, with brittle structures in red).

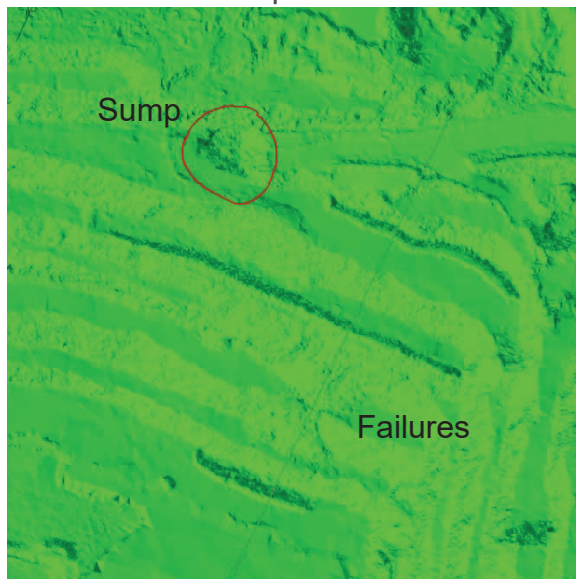
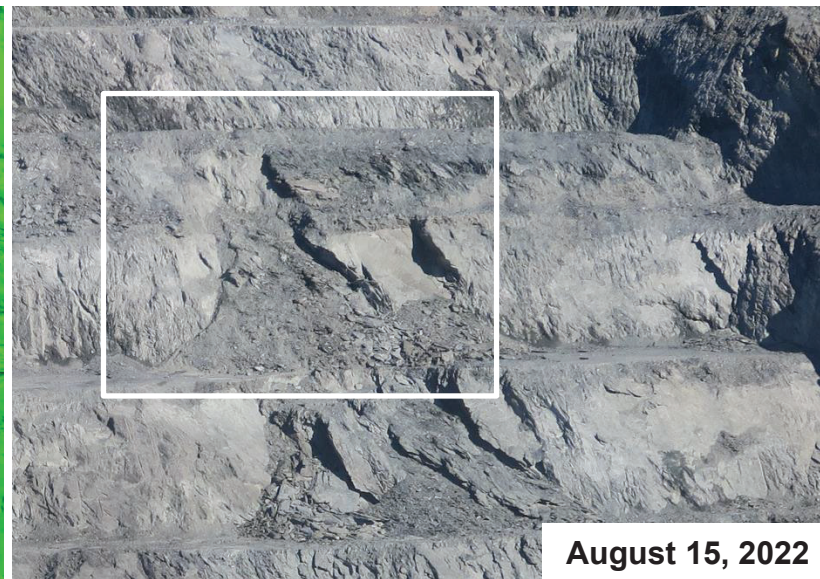
- The site team believes that the infiltration of surface water and the erosion of brittle structures in the bench face likely contributed to the initial failure in May.

- The pushback is located within the drainage for what was the northeastern lobe of Whale Tail lake and water reports to the area. An unlined sump has been established at the base of the pushback at the top of the slope (left photo). The sump is on the Komatiite-Greywacke contact, which is likely promoting infiltration.

- Photos prior to the failures show surface water running across the bench face and eroding the weak rock mass (right photo). The water appears to be concentrated along the potential structure bounding the western edge of the failures.

- It seems reasonable that water is contributing to the failures. It is recommended that surface water be diverted away from the area to the extent possible and that the sump be lined.

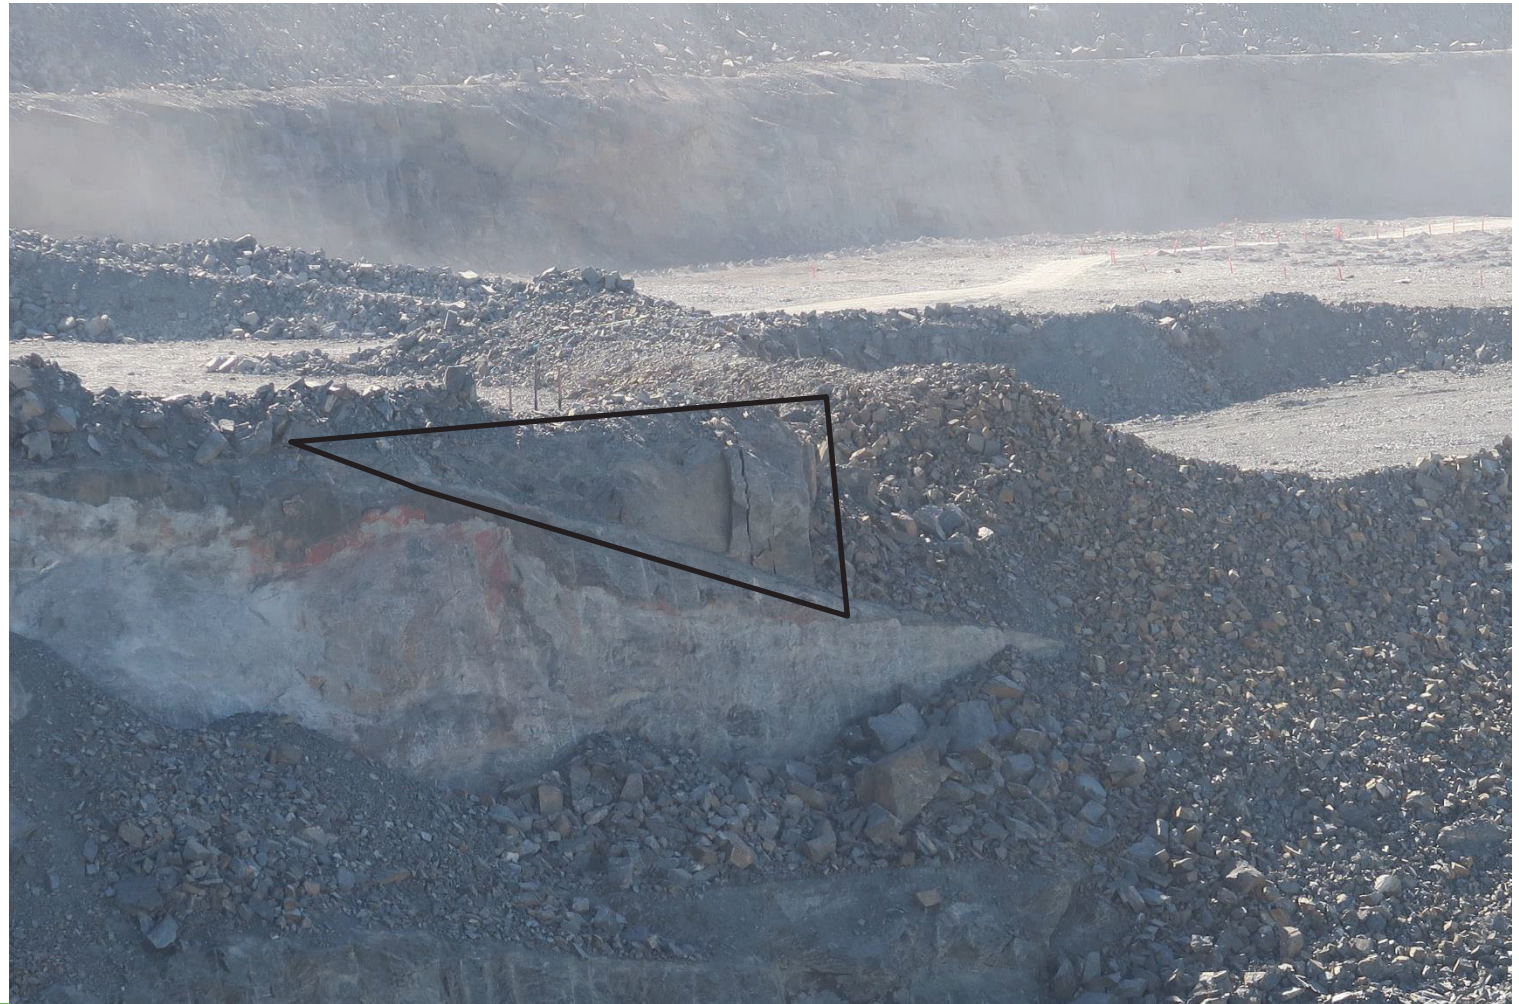
- A potentially unstable block is present along one of the curvilinear structures present in the south wall of the open pit.
- The western edge of the block has been unconfined by the pushback and it appears that fractures within the block have started to dilate.
- The area was previously used to anchor one of the dewatering lines (using the 3 vertical posts at the crest) but was recently decommissioned for operational reasons.
- Access above the block should be restricted until it is mined out. Consider leaving some muck against the block to buttress it during drilling and blasting. The area should be monitored when crews are working in the area.

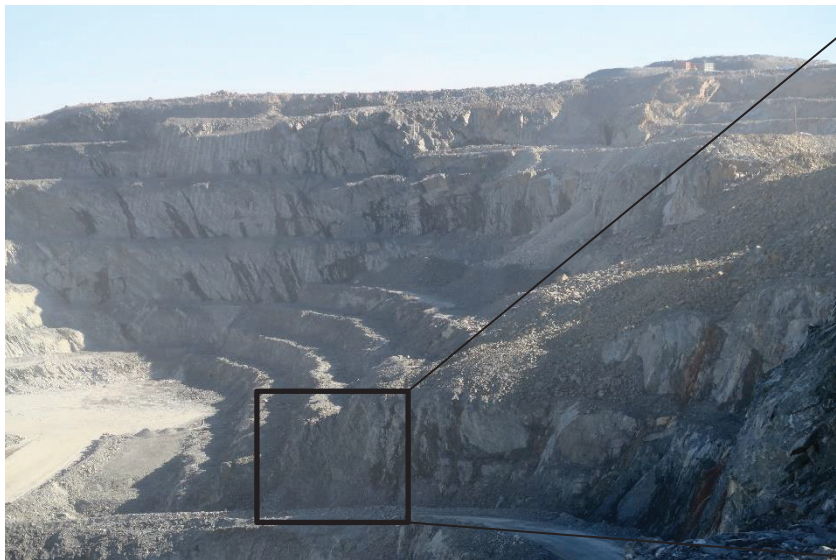
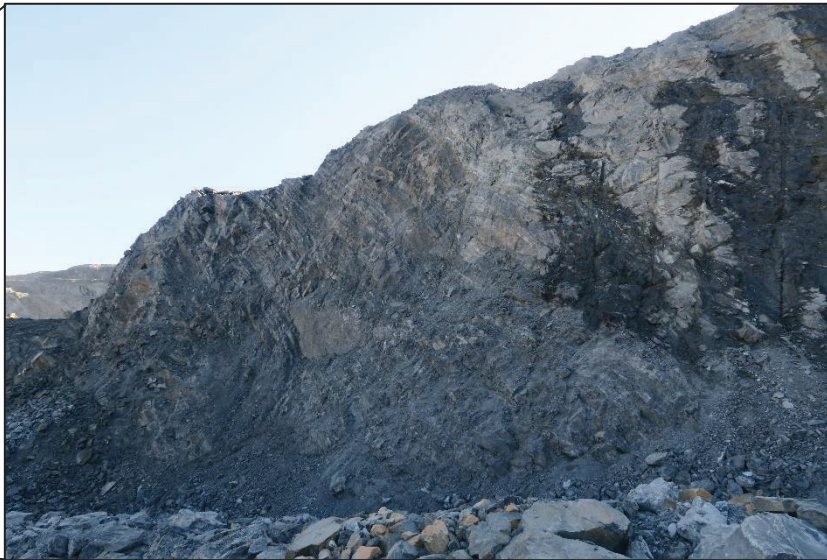
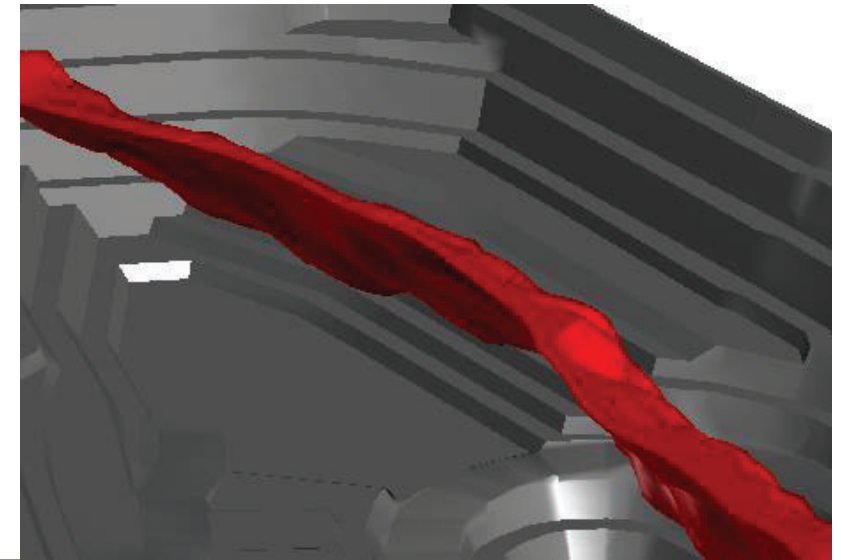
- A Brittle Structure was observed at the western end of the wall, adjacent the Phase 2 ramp.
- This structure (#3) is modelled along the northern contact of the South Limb Komatiite. The observed position, orientation, and thickness of the structure agree well with the 3D structural model.
- No particular stability concerns were noted.
- In general, the 3D structural model has not been validated against the exposures in the open pit. Recommend doing so to build confidence in the model as it is being used to inform key design decisions.

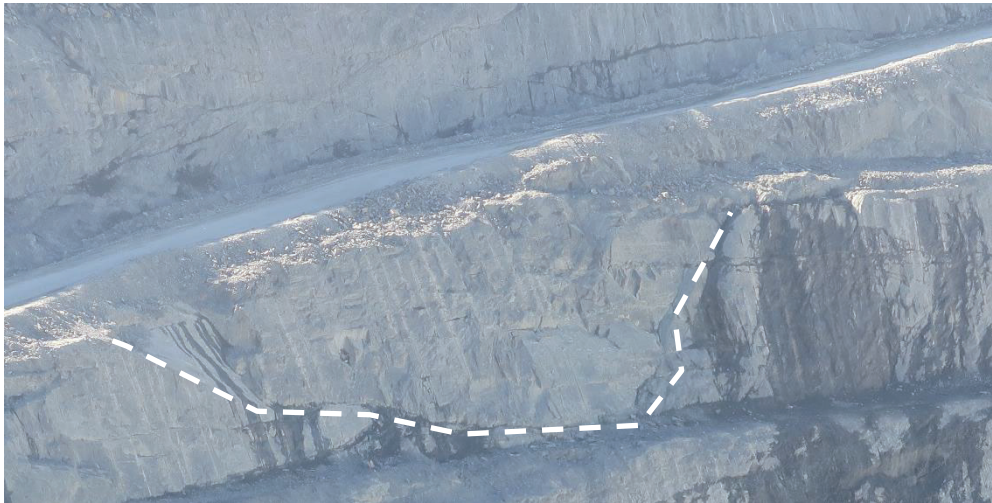
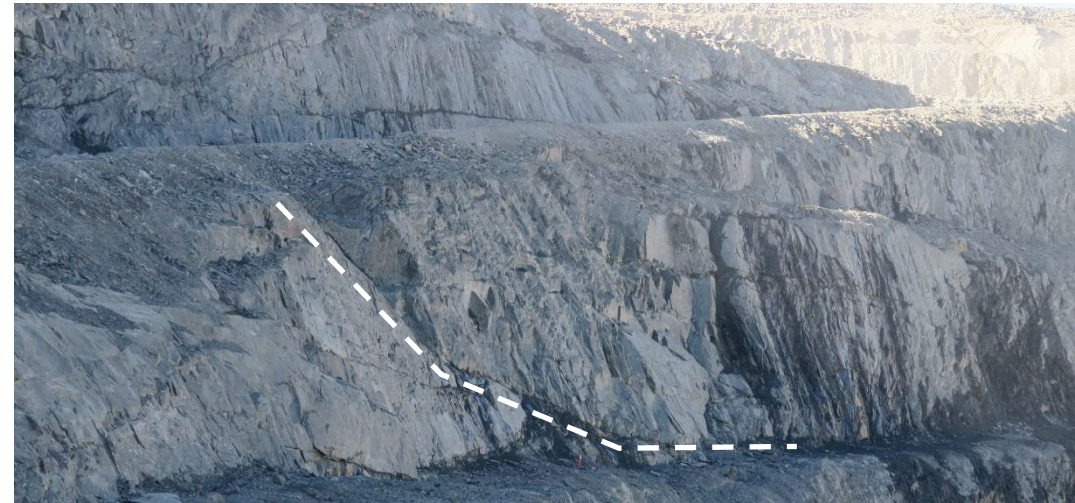
- As the wedge undercuts the ramp, it was recommended that instrumentation be installed to monitor any displacement. This has not been done. The fracture defining the eastern end of the wedge appears to have dilated (photo at lower right). Given the size and position of the block, the installation of instrumentation (e.g., wireline extensometer) to supplement the radar coverage continues to be recommended.

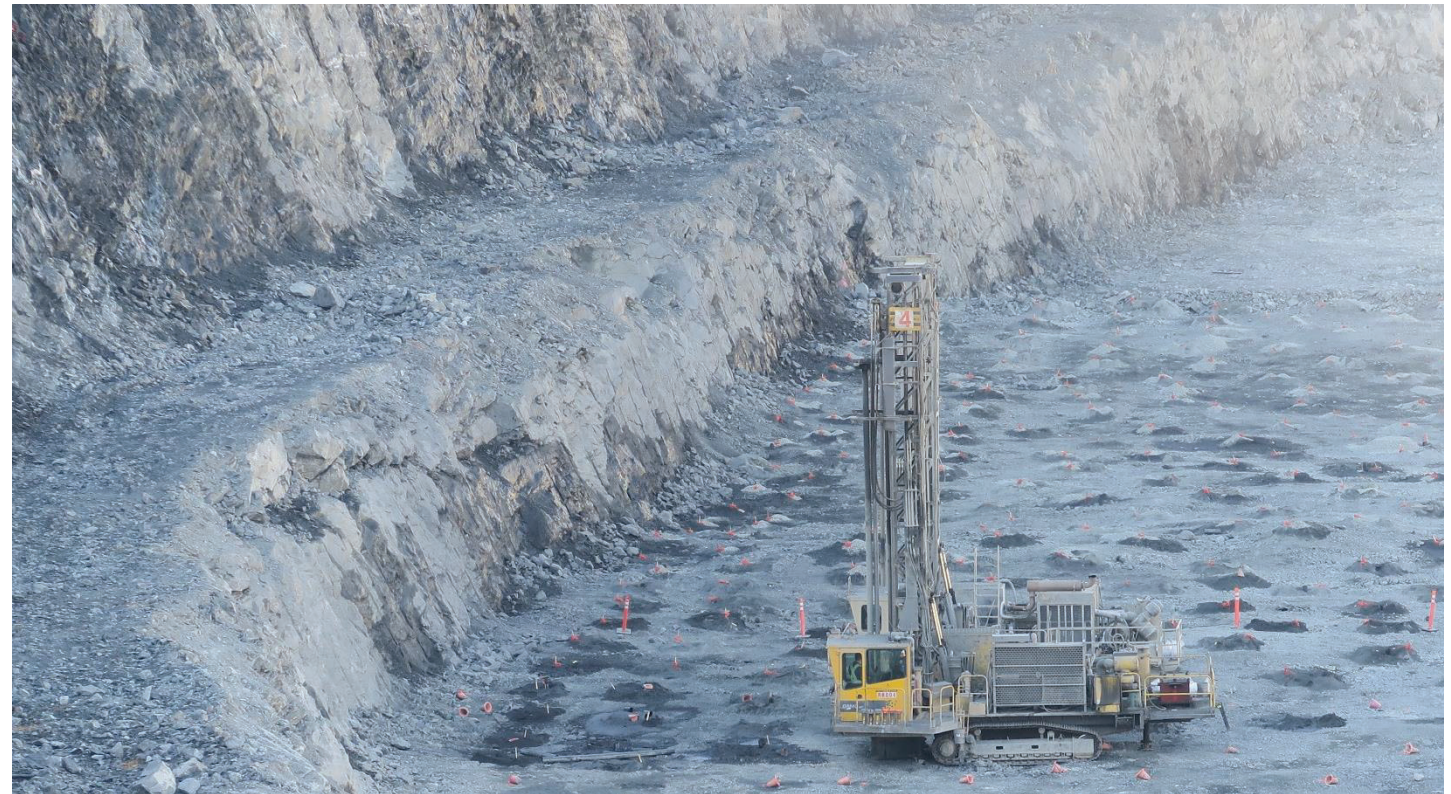
4. Loose and overhangs are present along the crest of the lowermost bench on the south wall (photo at lower right). This flitch was approved by Rock Mechanics (student) and drilling of the pattern for the next flitch was in progress. The flitch should not have been approved with these hazards present. None of the personnel working in the area reported the hazard.
 - While the crest needs to be scaled, the blastholes make scaling challenging. One possibility would be to carefully monitor the area during loading and then scale the flitch after the blast. The area should be noted on the hazard map.
 - The circumstances should be reviewed with both Rock Mechanics and operations personnel, as several opportunities to identify and correct the hazard were missed. Did the person signing off on the bench have sufficient experience to complete the Bench Approval?

Evidence of the north dipping structures that form the basis for Structural Domain 5 was observed at the eastern end of the lower wall, north of the Komatiite contact. Mapping is recommended to better define the extents of this structural domain.

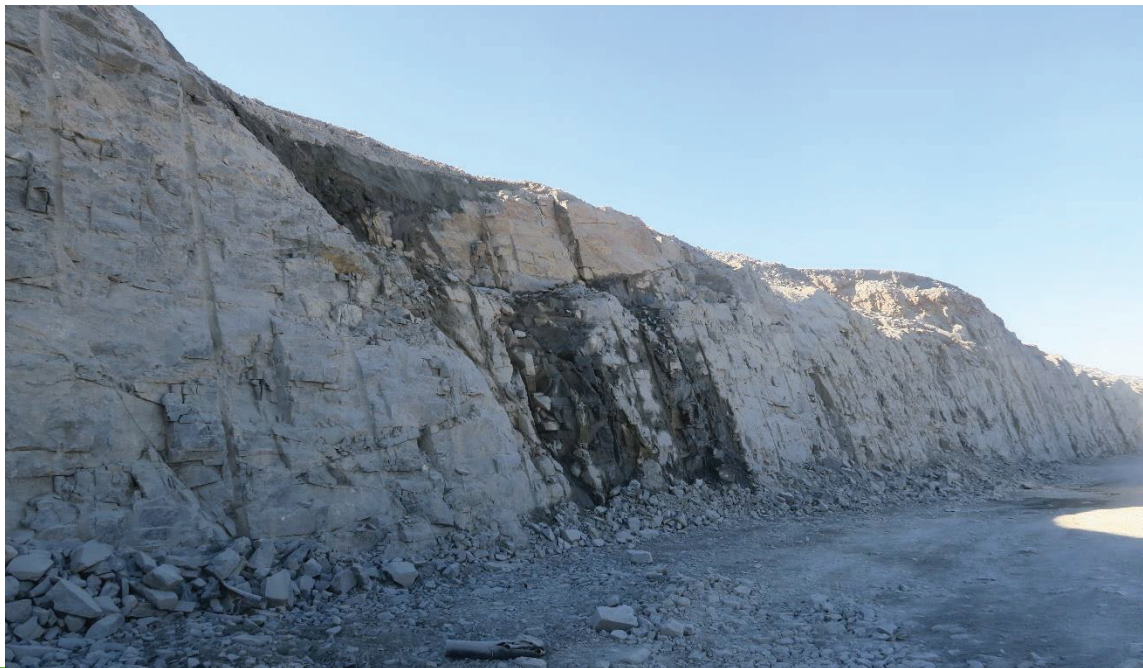
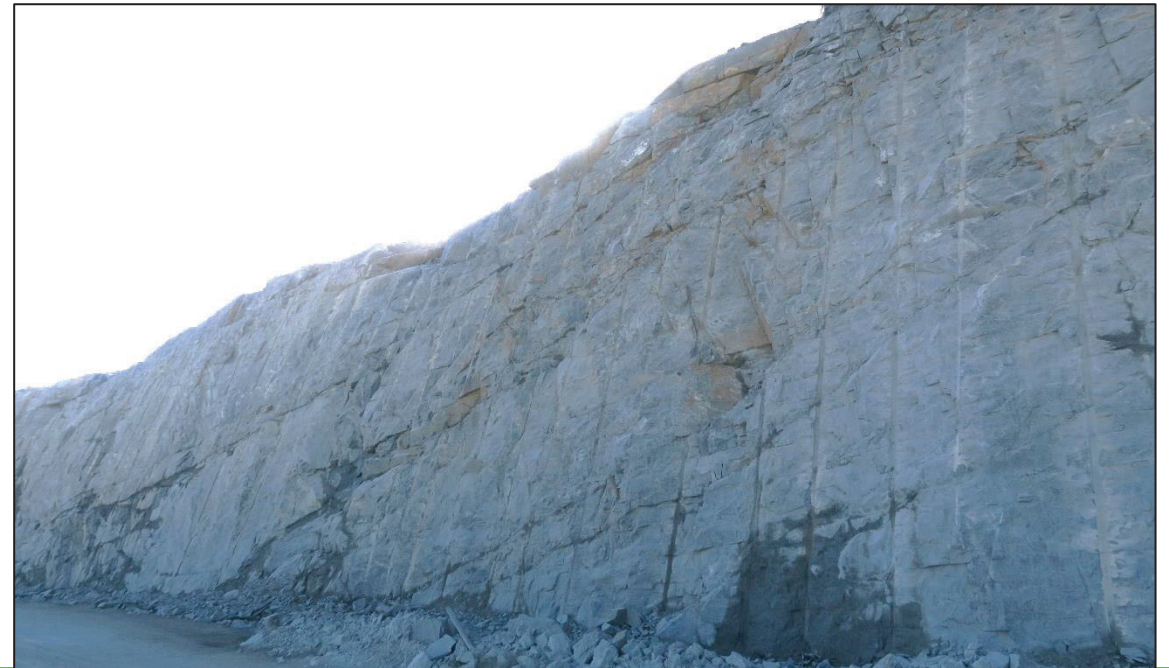
- The rock mass characteristics of the Diorite exposed in the upper benches is variable. Some areas are characterized by few discontinuities forming large blocks (photo at right). In other areas, more discontinuities and numerous small blocks are present (example on previous slide). The areas of lowest rock mass quality (photo at left) appear to be concentrated below the footprint of Whale Tail lake.
- In general, this variation in rock mass quality has not strongly influenced bench performance but has resulted in increased scaling or local rockfall hazards. Rockfall berms have been constructed below some of the blocky areas thought to represent the greatest hazard. This is endorsed.

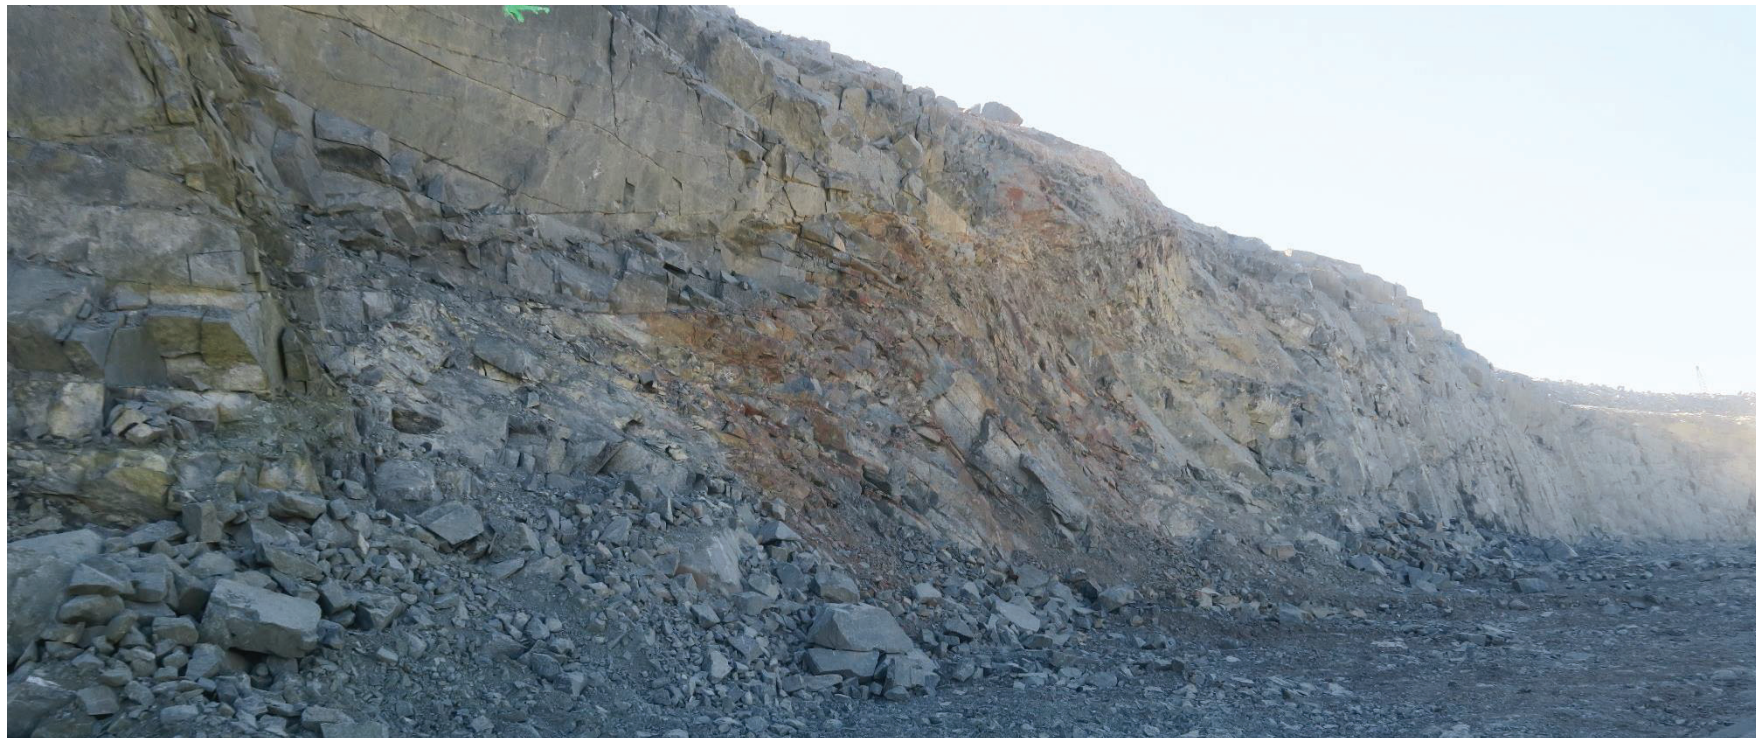
- A prominent fault, believed to be the Ramp Fault, has been exposed in the southeast wall of the Phase 3 Pushback.
- The fault is associated with a zone of reduced rock mass quality 1 to 2 m thick and 10 to 20 cm of gouge.
- A considerable amount of loose was present on the wall. It is understood that the wall had not yet been approved and that additional scaling will be recommended. This is endorsed.

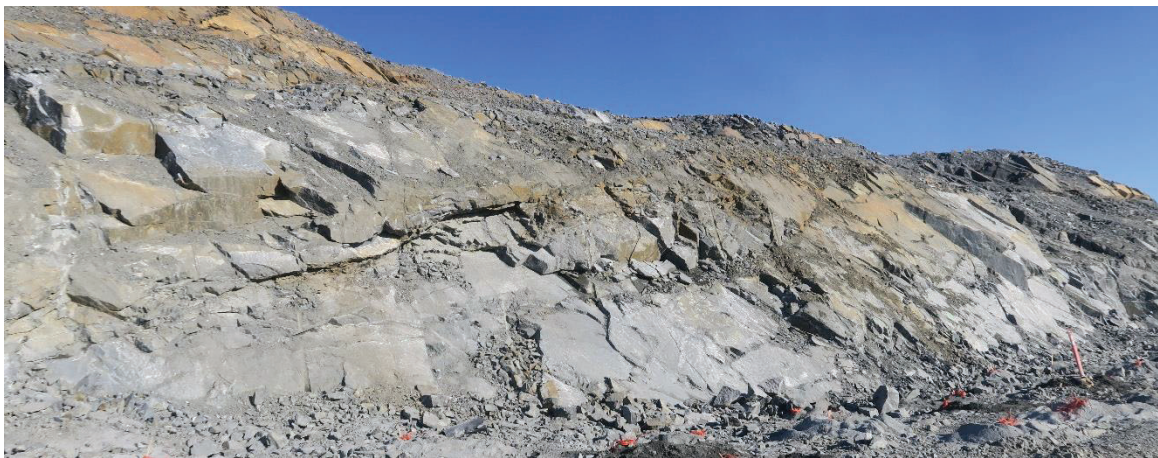
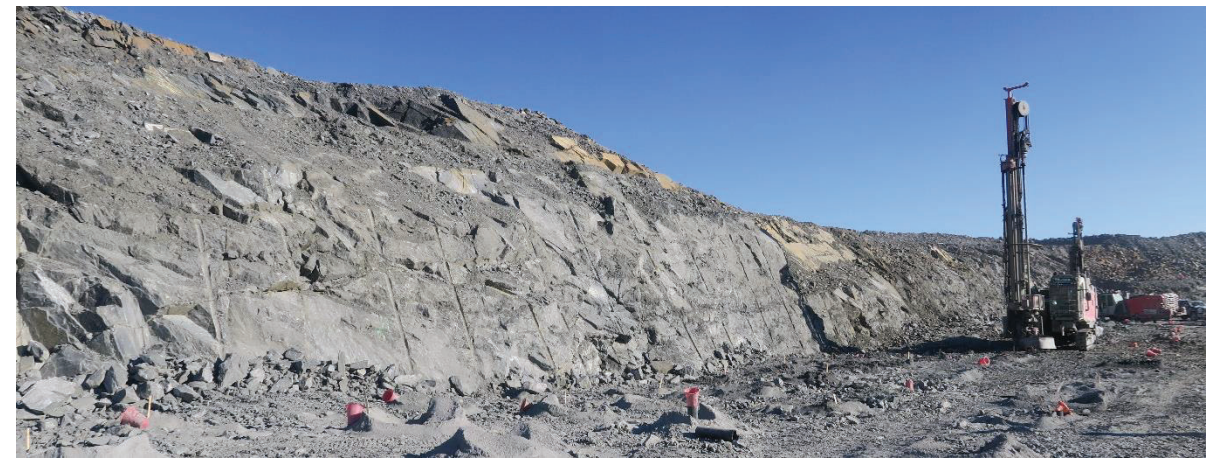
- The central portion of the bench has performed reasonably well (photo at right). Some crest loss, but half barrels visible over most of the face.
- The eastern portion of the bench has failed back to Joint Set C over almost the full height of the bench (photo at left). It is understood that this portion of the bench was scaled heavily, however some loose slabs were observed on the face that should be removed.

- It is not clear if the design BFA of 75° will be achievable for this sector. The remaining flitches of this bench need to be monitored and their performance documented. Once the bench is complete, a review should be completed to assess if the bench design is achievable or if it needs to revert to the shallower geometry (i.e., BFA of 50°).

- It is understood that the Rock Mechanics student was tasked to do the Bench Approvals for this sector. Given the importance and challenging nature of this sector, it is recommended that the Bench Approvals for this area only be done by experienced personnel.

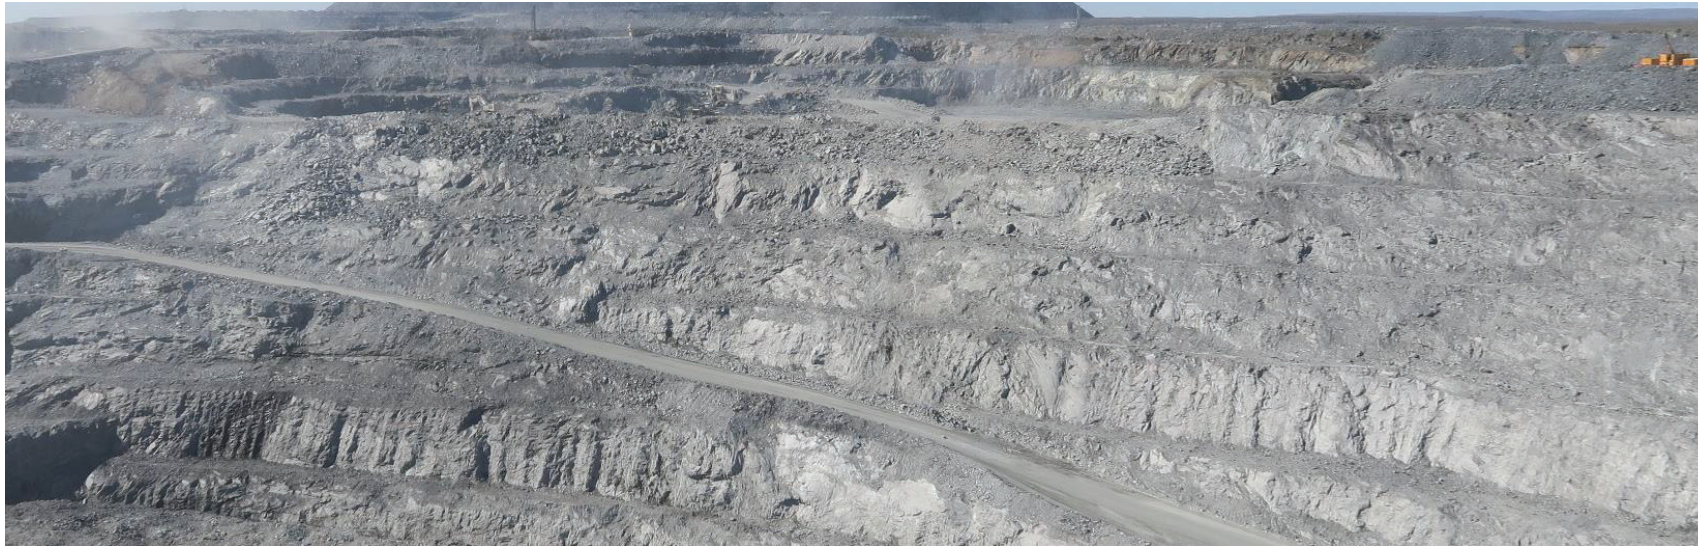
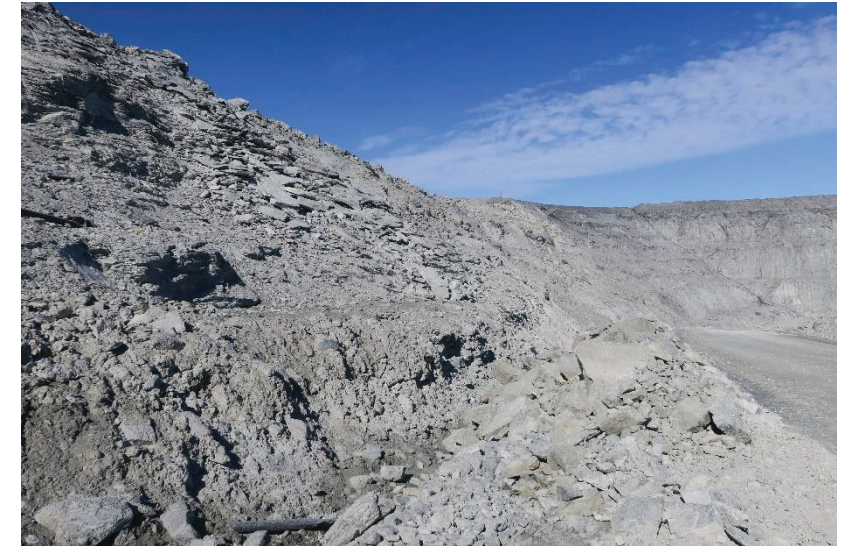
- The benches at the southern end of the upper wall failed back to the foliation during development. In some cases, there is effectively no catch bench width remaining.
- Mining of the IVR V2 open pit has resulted in spillover onto the northwest wall. The mine has adjusted the blasting practices to reduce this, but spillover is expected to continue.
- A rockfall berm has been established along the inside of the ramp and has capacity. The rockfall berm will need to be monitored and cleaned out as required as mining of IVR V2 continues.
- Mining of IVR V2 will ultimately remove the upper two to three benches of this wall, which will reduce the rockfall hazard in the long term.
