Whale Tail 2022 Annual Open Pit Geomechanical Inspection

March 17, 2023

RE: Meadowbank Complex - Amaruq Site - 2022 Annual Open Pit Geomechanical Inspection

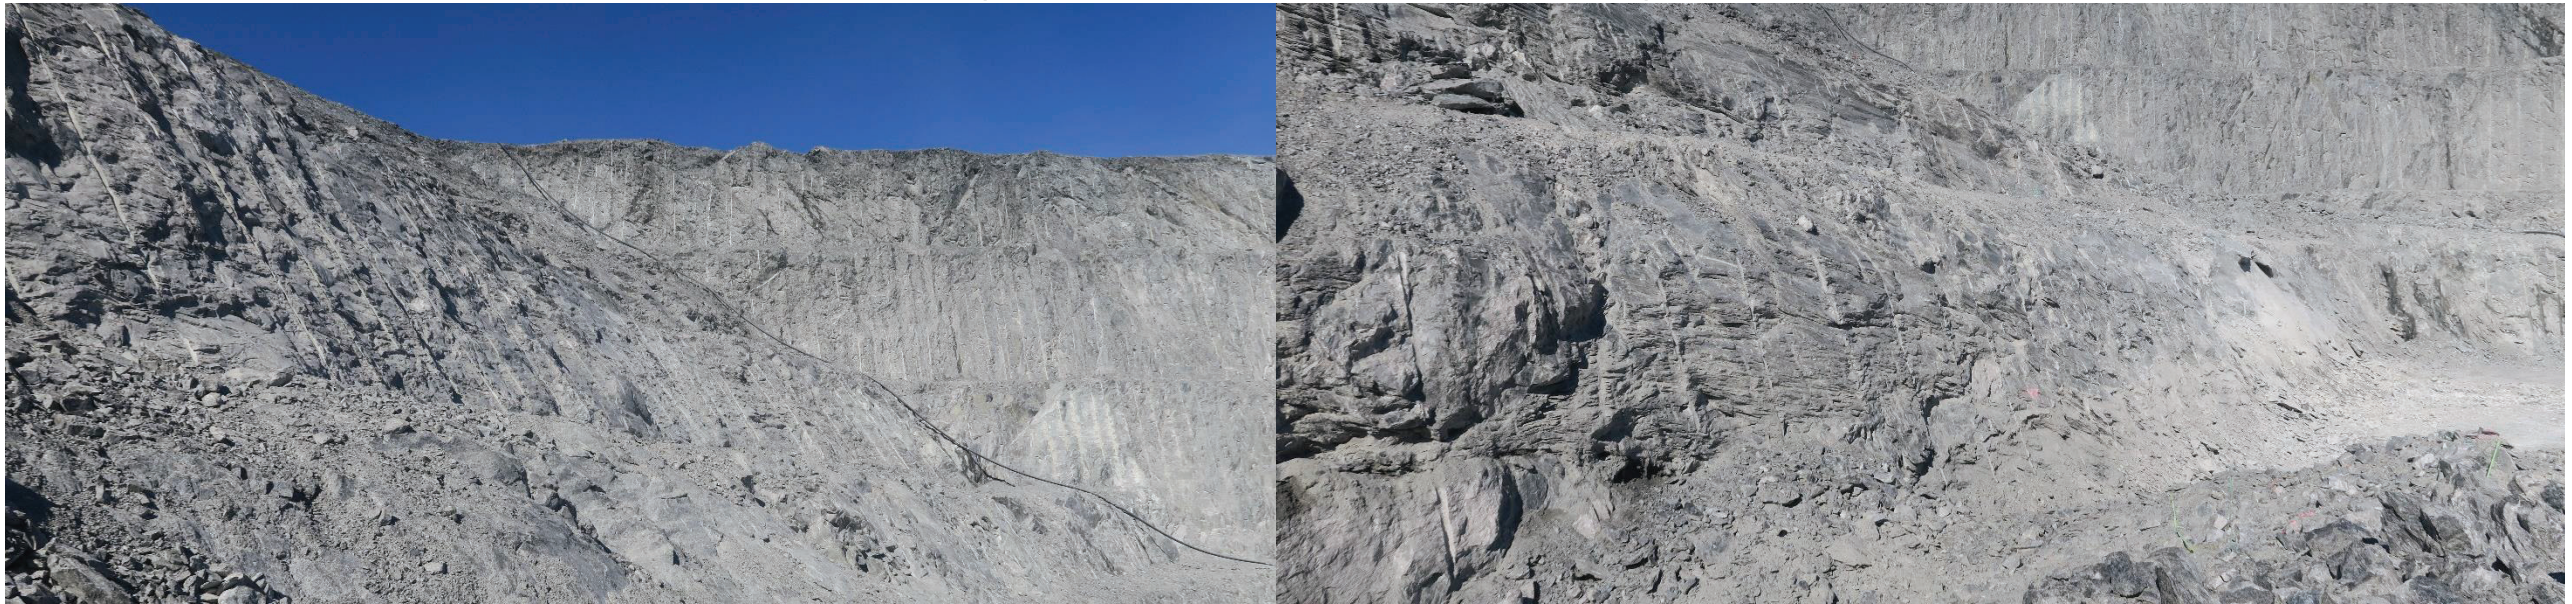
- The 65° pre-shear trial was done for the full length of the current bench. It performed well to the west of the brittle structure in the middle of the wall, with the bench face standing steeper than the dip of the foliation. This may be because the slope appears to be in the Mafic Volcanics in this area. East of the brittle structure (shown at lower right), the bench performance was marginal, with two bench-scale failures and increased crest loss. Subsequent to the site visit it is understood that additional bench-scale failure occurred in this area.

- The mine intends to use the 65° pre-shear for the remaining two to three benches. The bench performance suggests that this is aggressive, particularly to the east of the brittle structure. Based on the observed performance, it is recommended that the 55° pre-shear be used for future benches on this wall.

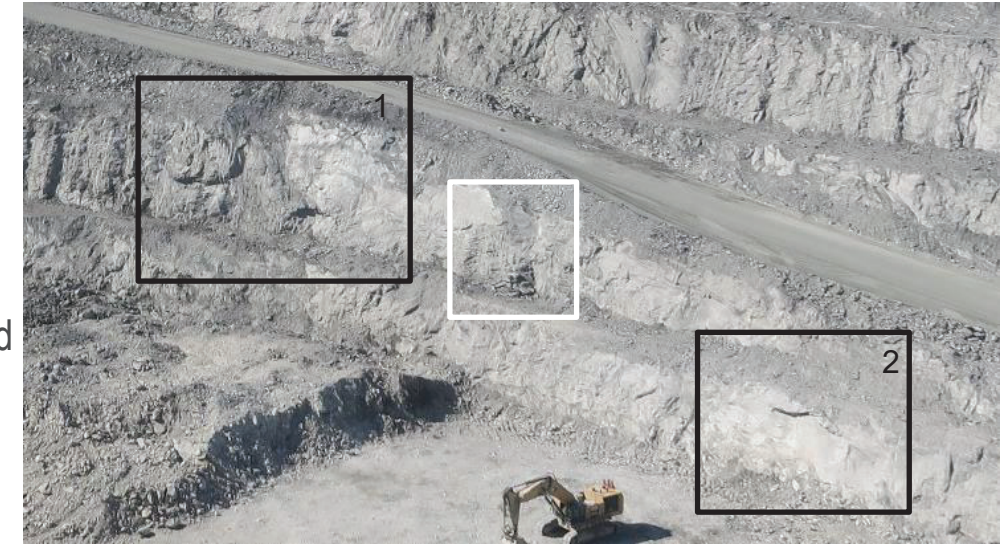
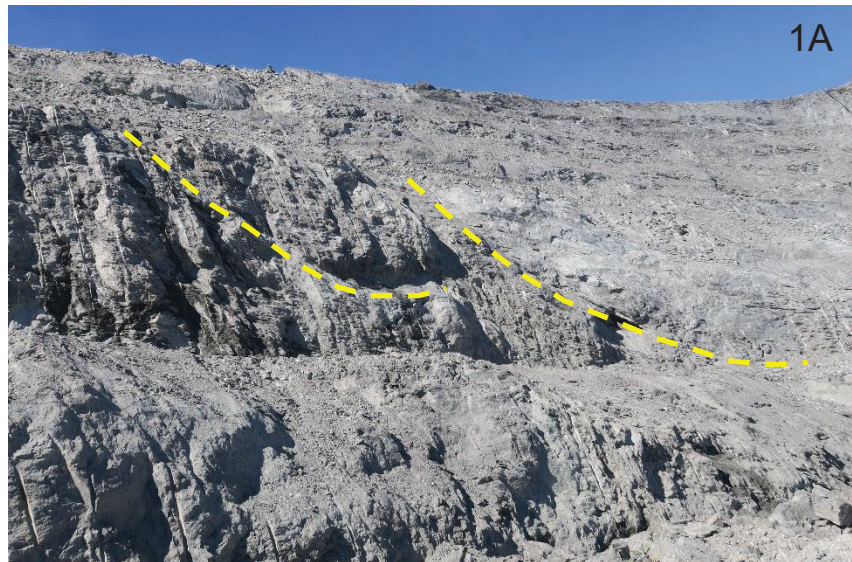
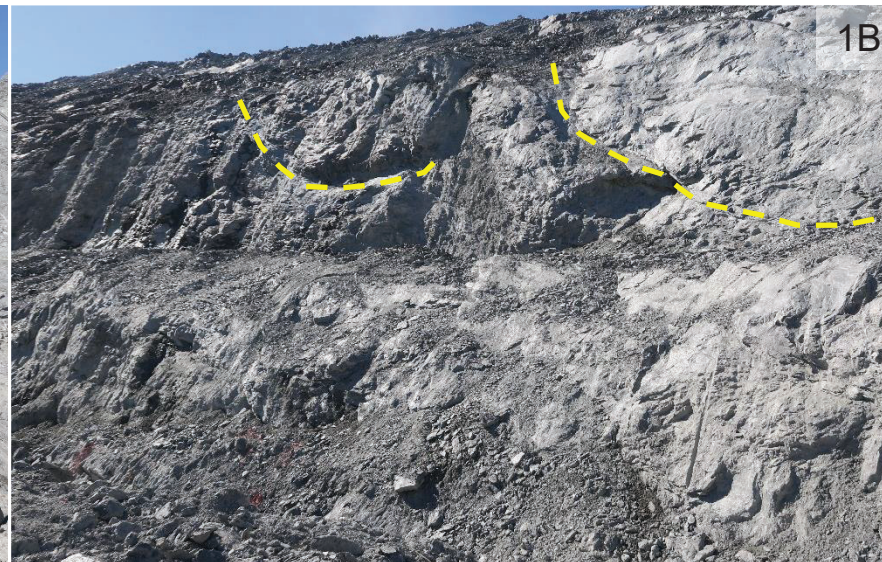
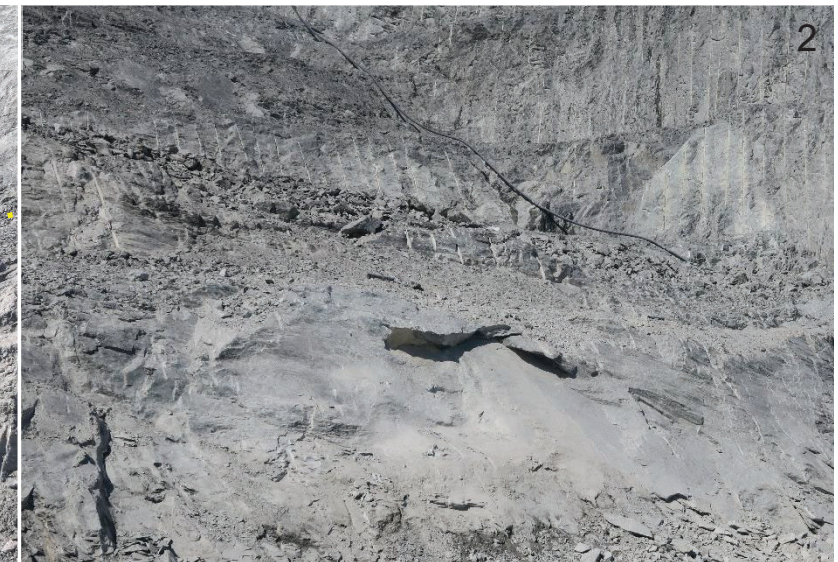
- In May, a 100 tonne wedge failure occurred directly below the ramp on the foliation and a cross-cutting structure (outlined in white). This was part of the 65° BFA trial.
- Several hazards were observed on the eastern end where the 65° BFA was used:
 1. The foliation has formed two slabs on the bench face of the second lowest bench (Photos 1A and 1B below), separated by what appears to be a brittle structure. These slabs are potential instabilities and should be a focus of future monitoring. It is understood that several rockfalls occurred in this area after the annual inspection.
 2. There is a local overhang on the lowest bench (Photo 2 below). Recommend scaling it down.

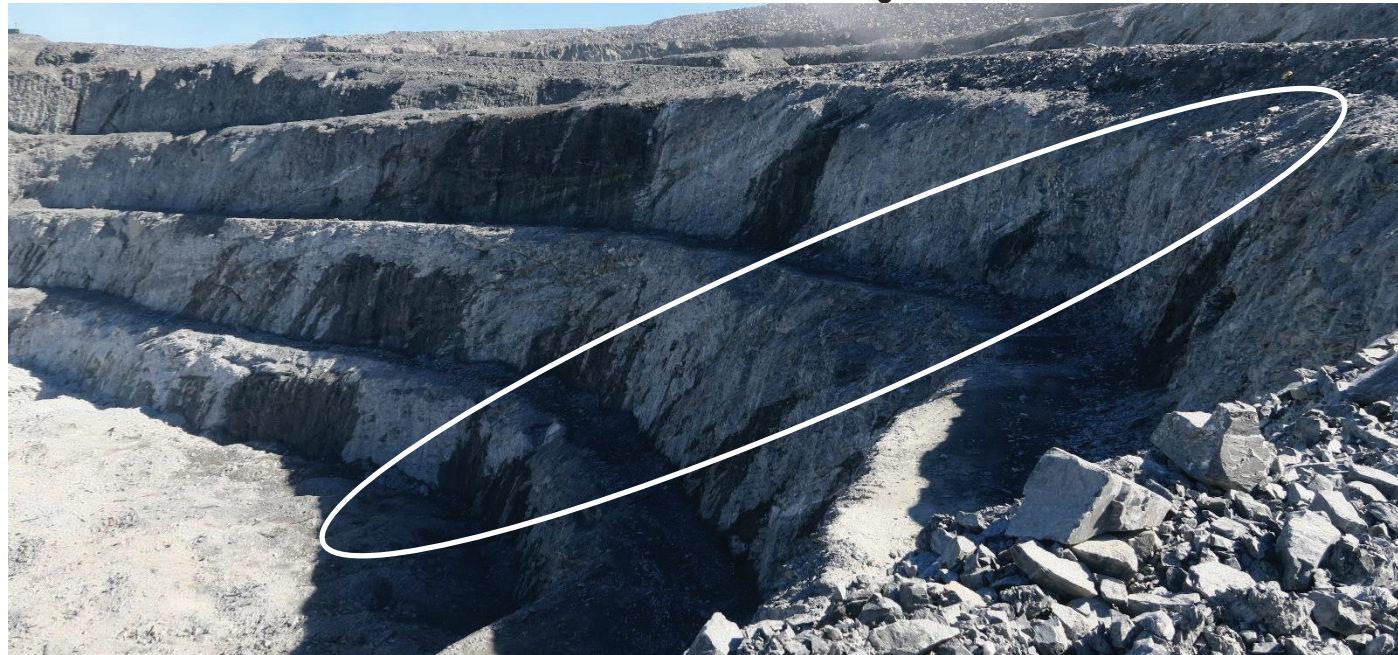
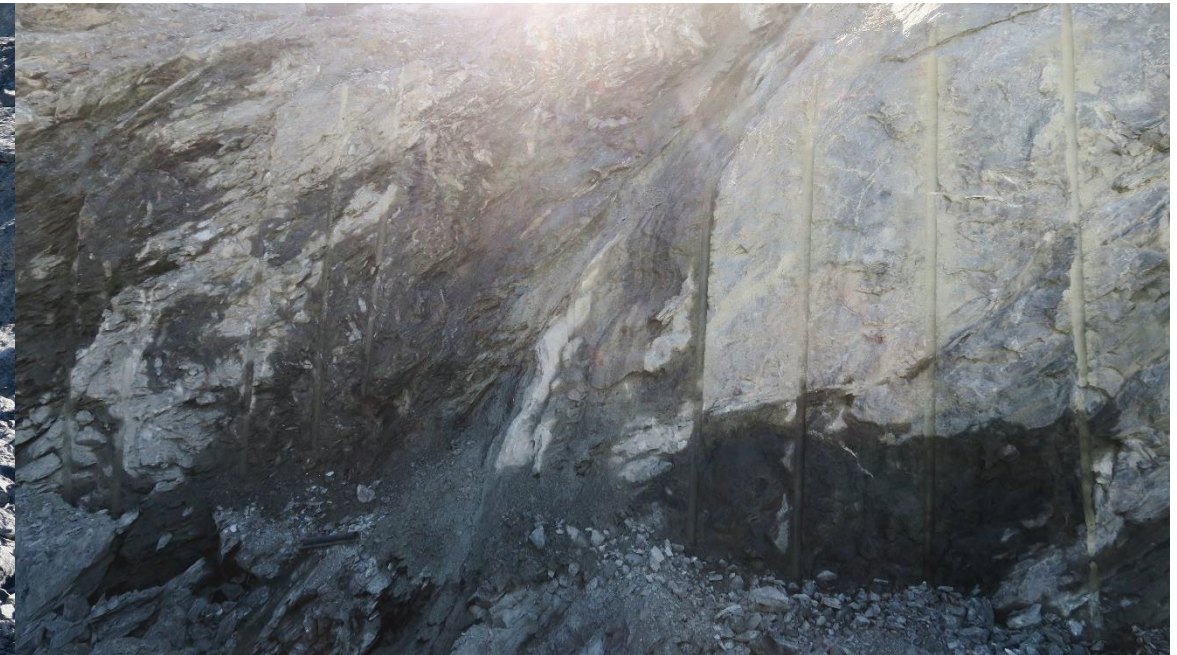
- Final wall in Design Sector V0D.
- The wall is generally performing well. While the benches are primarily within the Komatiite and Brittle Structures, the wall is oriented perpendicular to the foliation.
- Numerous seeps are present in the wall. As the pit is thought to be entirely within permafrost, the seeps are assumed to be in the active layer.
- In the southwest corner of the pit, the seepage is sufficient to have caused a prominent Brittle Structure to erode (circled at left with close-up at right). The area should be monitored for ravelling over time.

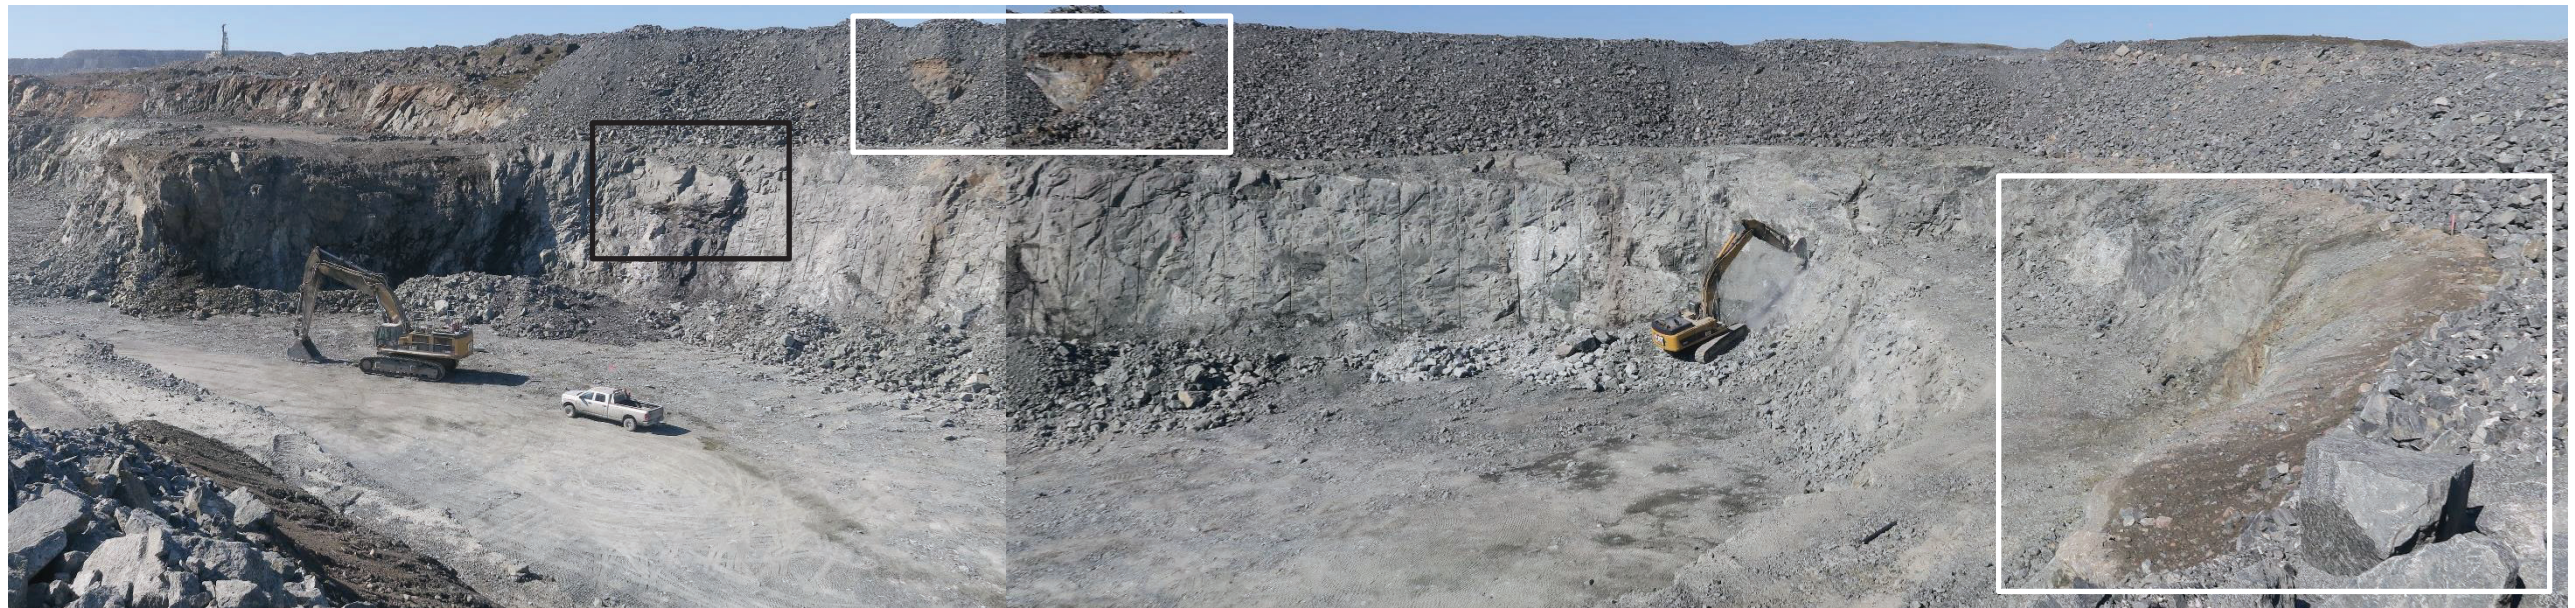
- Scaling of the end wall was in progress at the time of the inspection. Frequent hard toes were noted by the operator. The foliation is perpendicular to the wall in that area and significant scaling was required due to the presence of numerous small wedges/blocks. A potentially unstable block was observed on the wall (outlined below in black).

- A portion of the safety berm was missing at the end of the crest road where the photos below were taken. The berm should be re-established.

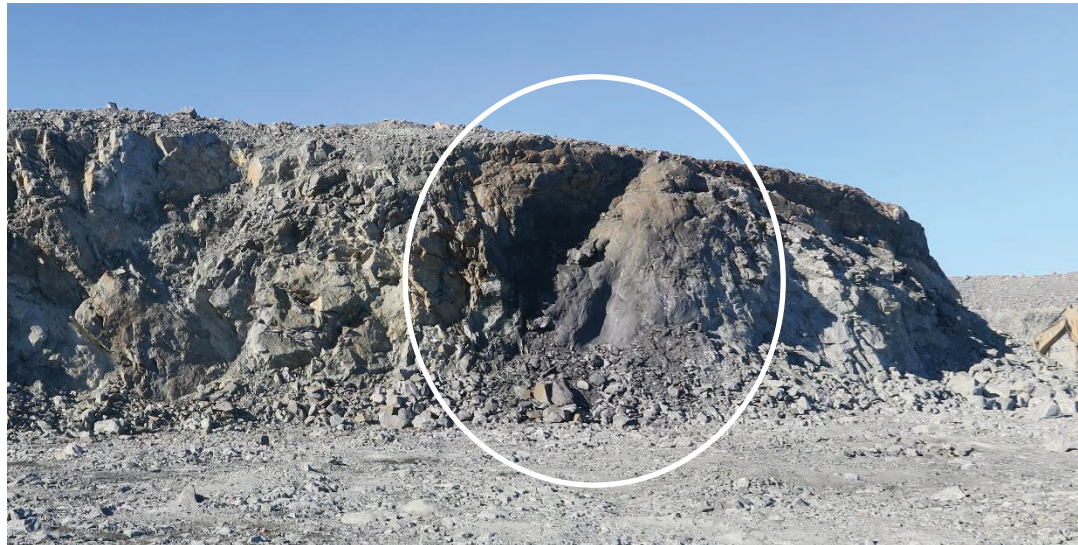
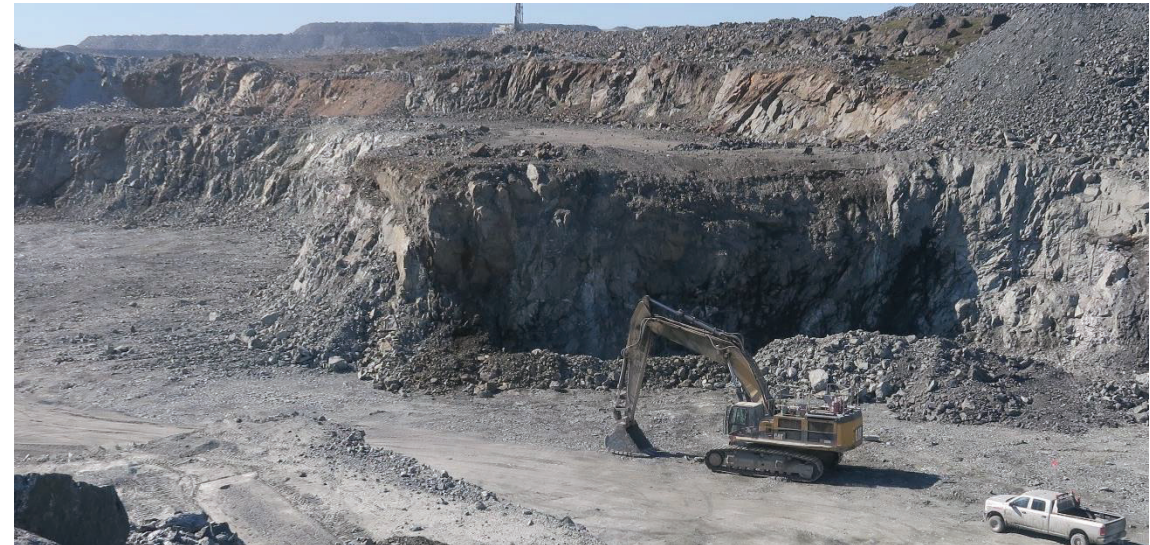
- A nose has been left in the final north wall adjacent the “Turtlehead” (shown in the photos below). The nose is intersected by a lens of Graphitic Chert aligned parallel to the north wall (circled in lower left photo).
- The creation of small, abrupt noses like this one should be avoided, particularly through contacts. The reduced confinement acting on the rock mass increases the potential for ravelling and instabilities over time.
- The nose may deteriorate further over time and should be specifically included in the visual inspection of the open pit.

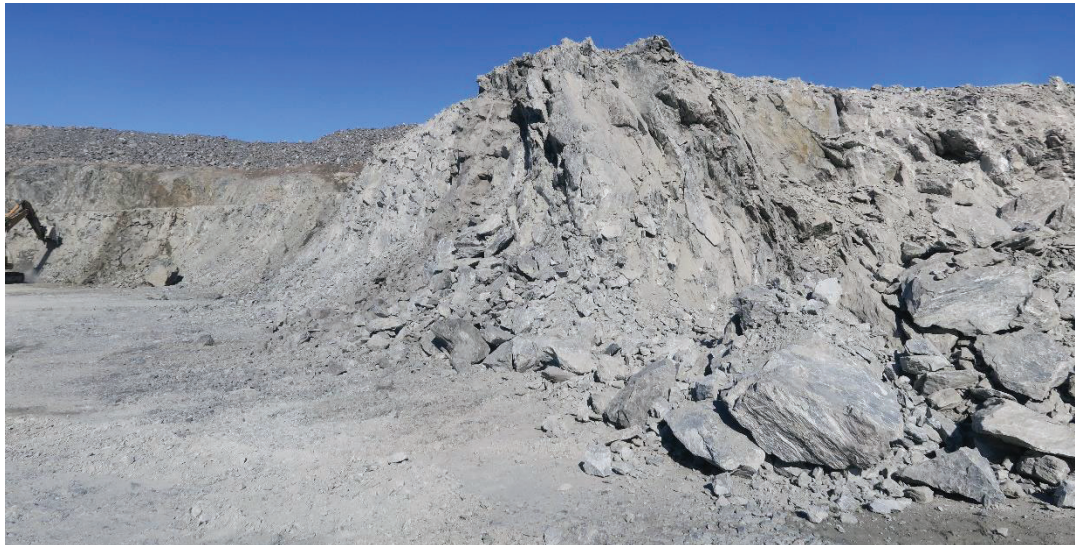
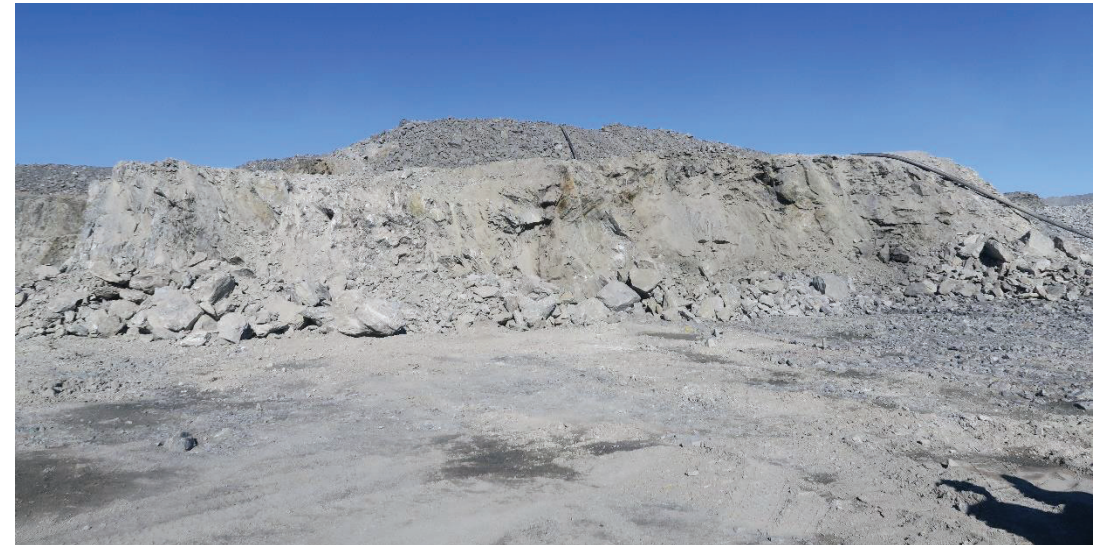
- A nose will be left on the uppermost bench at the point where the two open pits meet.
- The nose is in poor condition and had not been fully scaled at the time of the inspection. It should be scaled to reduce the rockfall hazard.
- The nose may deteriorate further over time and should be specifically included in the visual inspection of the open pit.

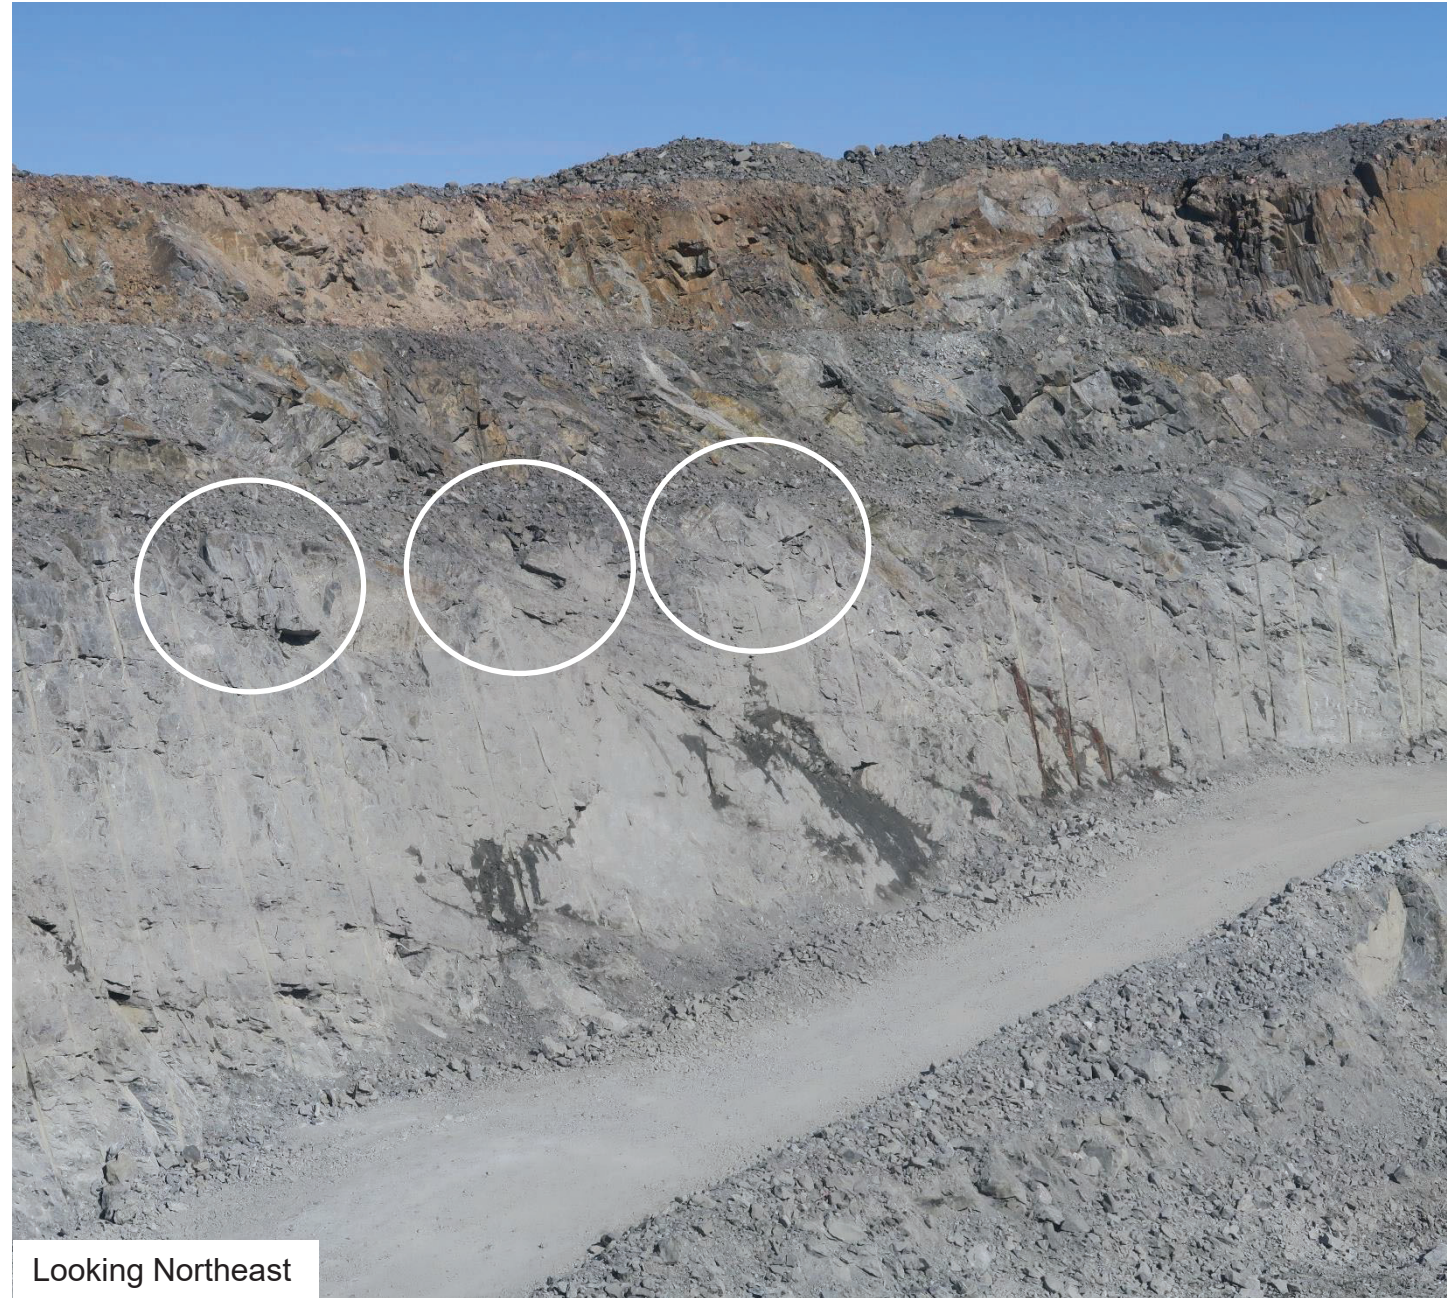
Looking Northeast

- Several rockfall hazards were observed along the northeast wall, above the ramp (circled at right).
- A thermal cap has not been constructed for the overburden between IVR West 1 and IVR West 2, and the overburden has started to slough. It is currently manageable, but if it progresses it could become a rockfall hazard.
- Recommend scaling the wall and constructing a rockfall berm along the inside of the ramp.
- The IVR V2 Extension is planned to merge with the east wall of this pit. The rockfall risk associated with spillover from blasting and the potential creation of noses at the breakthrough will need to be reviewed and managed.
