### **Meadowbank 2018 TSF As-built report**

**2018 CONSTRUCTION SEASON AS-BUILT REPORT  
TAILINGS STORAGE FACILITY  
MEADOWBANK GOLD PROJECT, NUNAVUT**

1897439-1578-R-Rev0

November 2018

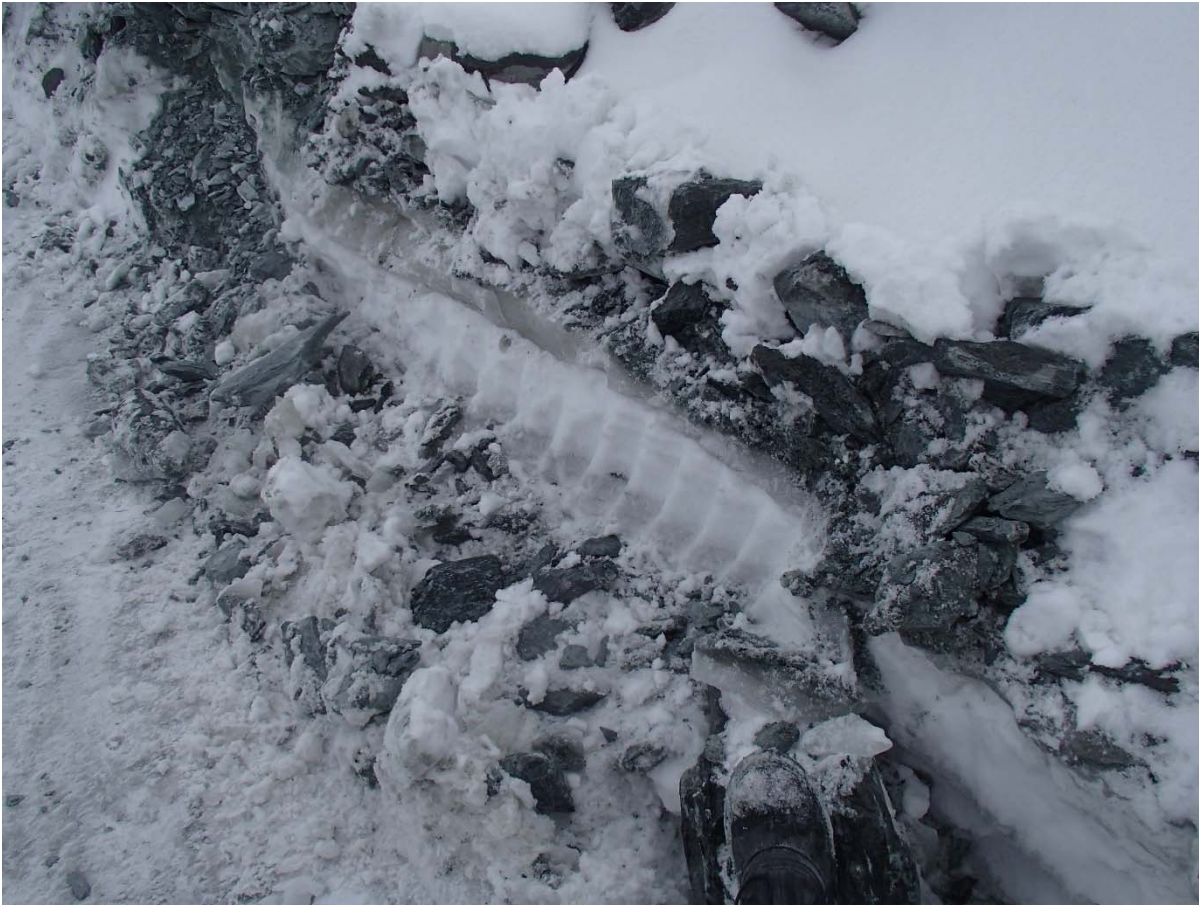
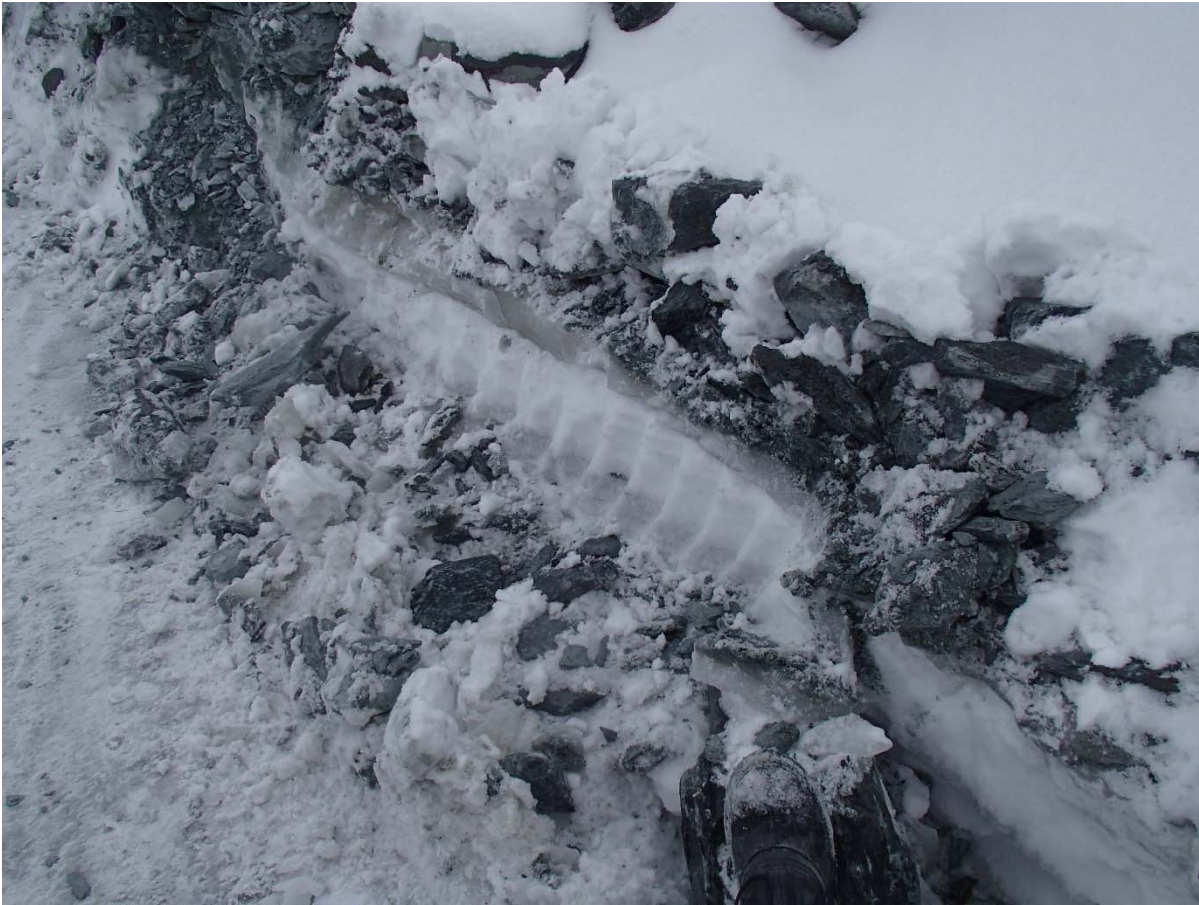
**Photograph NCIS-004: View of the scraped upstream side of the UM rockfill lift at El. 152 m further to the north: the snow layer is only observed at the toe and is approximately 0.5 m thick.**

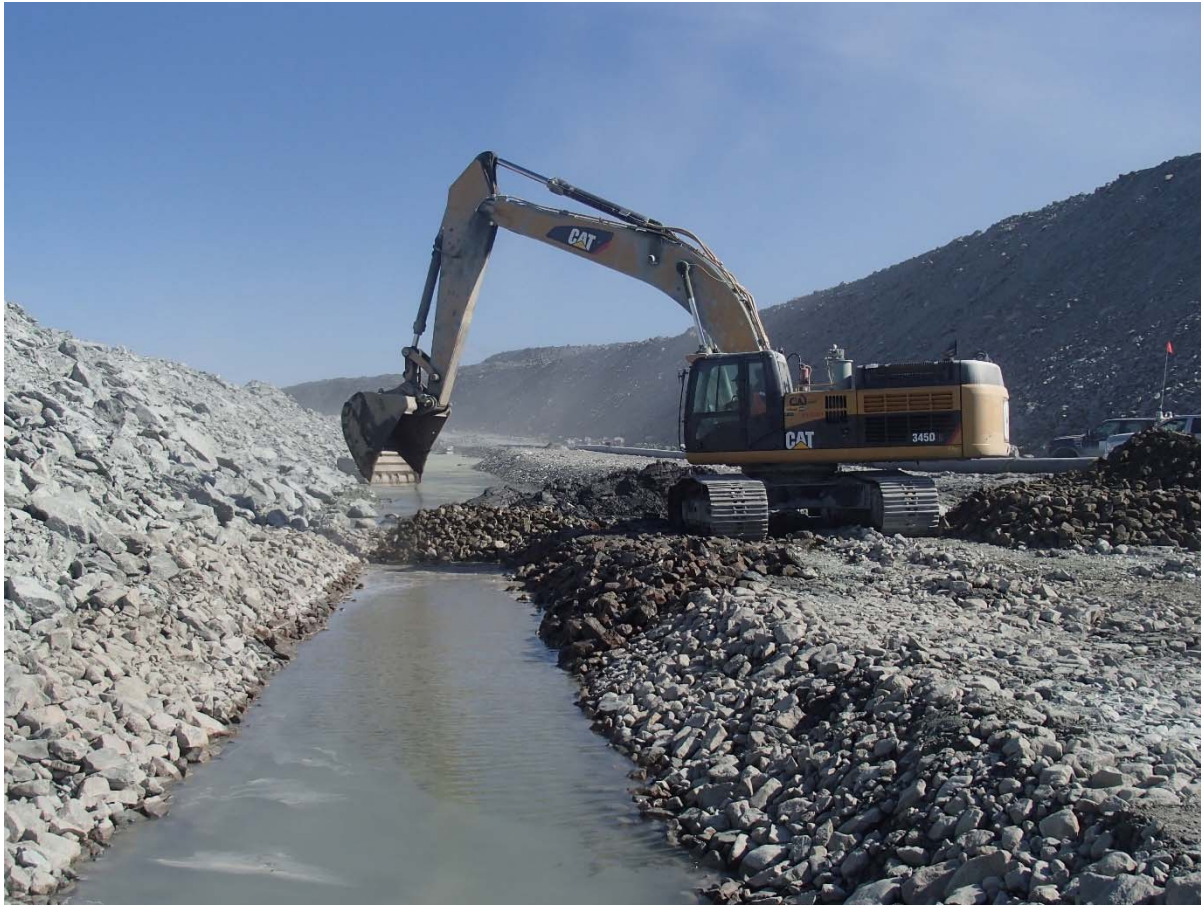
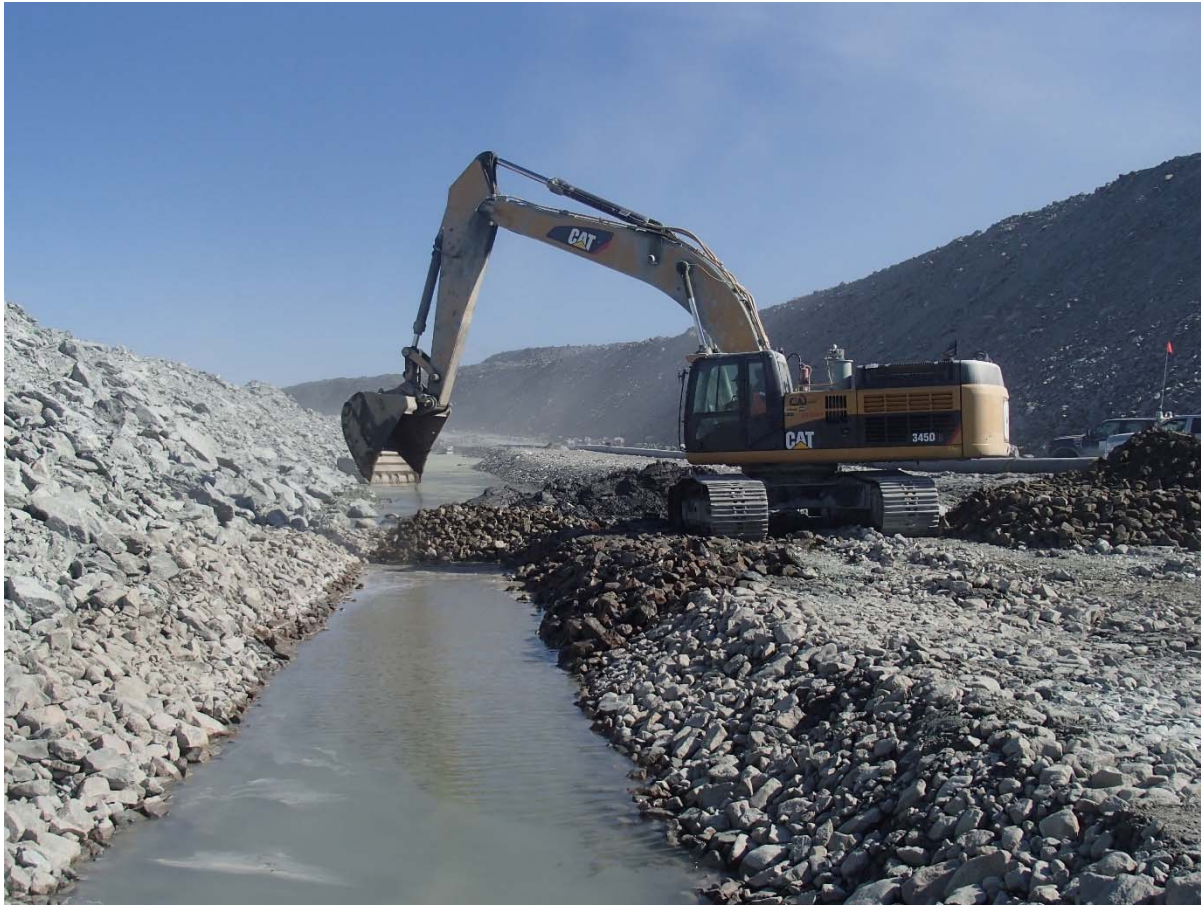
**Photograph NCIS-125: From Sta. 3+050/+26 m (approx.), looking NE. Corrections to the north sump: removal of approx. 0.5 m of tailing and till sieving reject material on the bottom of the excavation. The erosion protection material was replaced.**

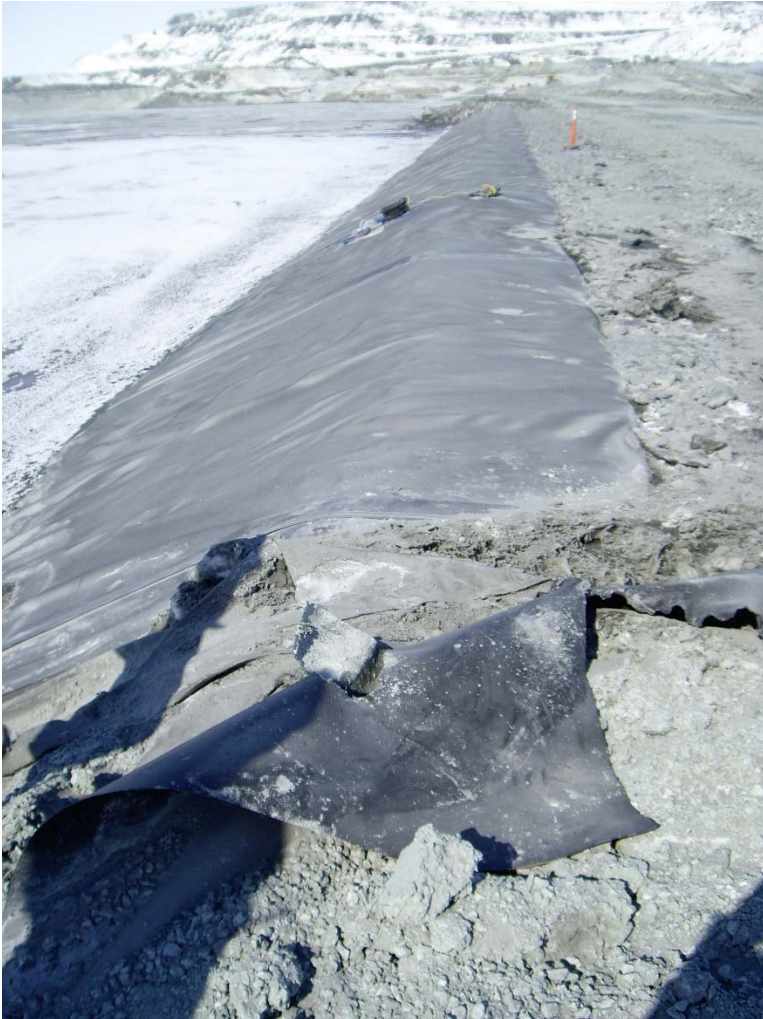
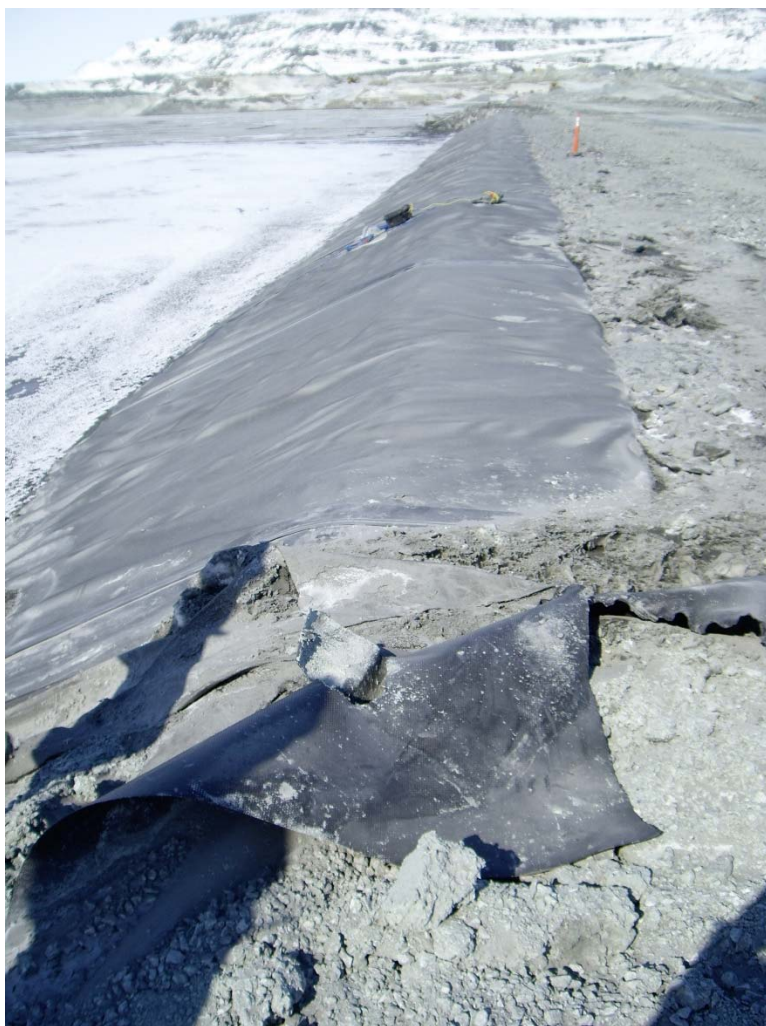
Photograph CD-1796: From Sta. 0+650/-28 m, looking N. Damaged geomembrane near a deposition finger on Central Dike.

*Photograph CD-1796: From Sta. 0+650/-28 m looking N. Damaged geomembrane near a deposition finger on Central Dike.*

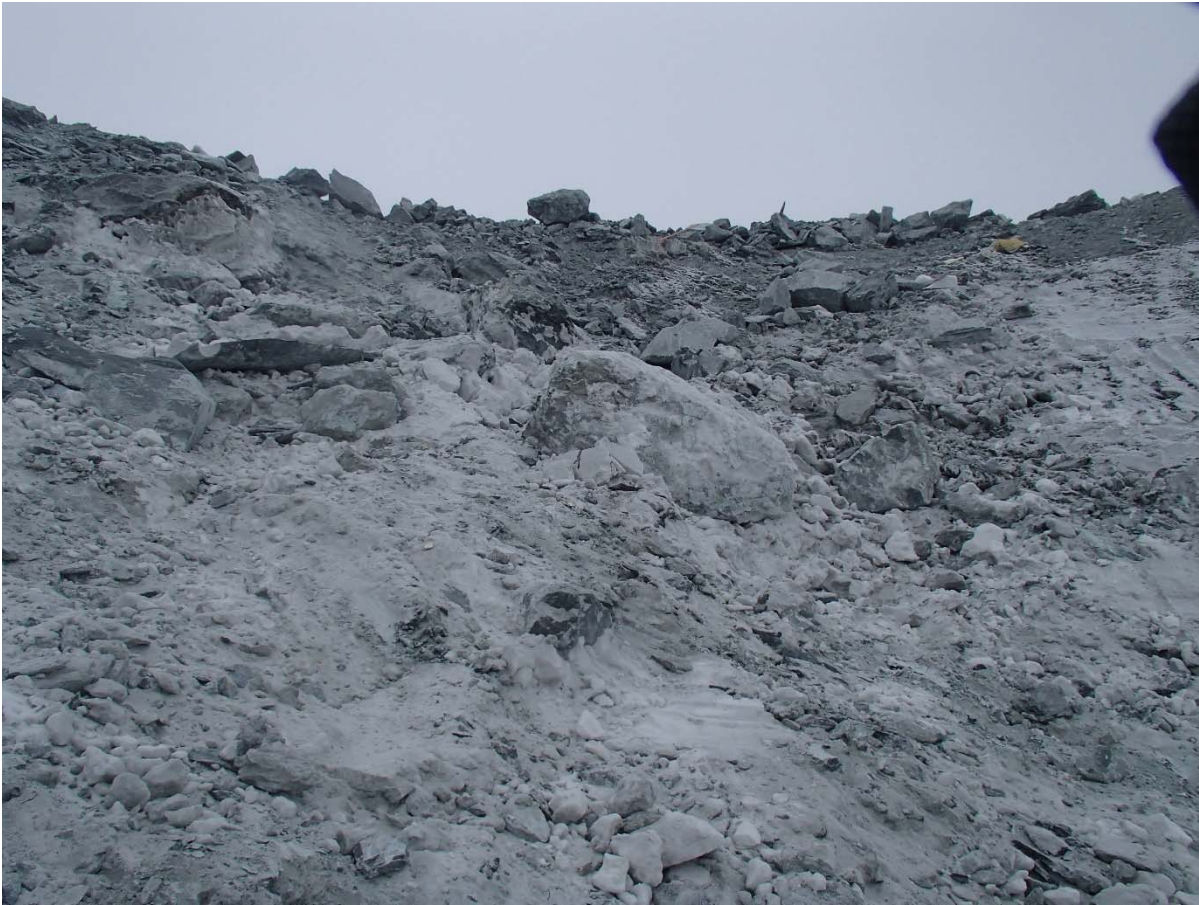
**Photograph CD-1804: From Sta. 40+790/-2 m looking S. Presence of oversize boulders on the existing slope at the junction between SD5 and Central Dike.**

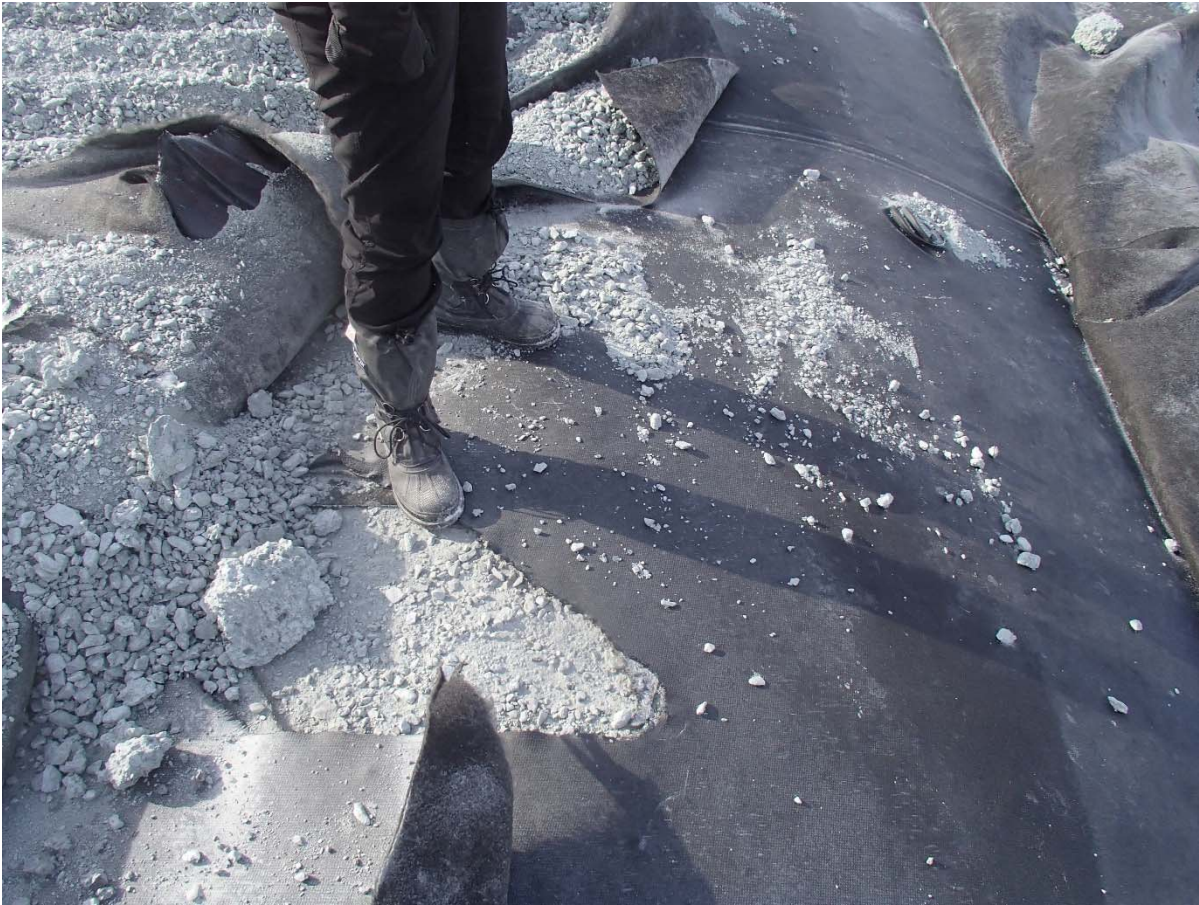
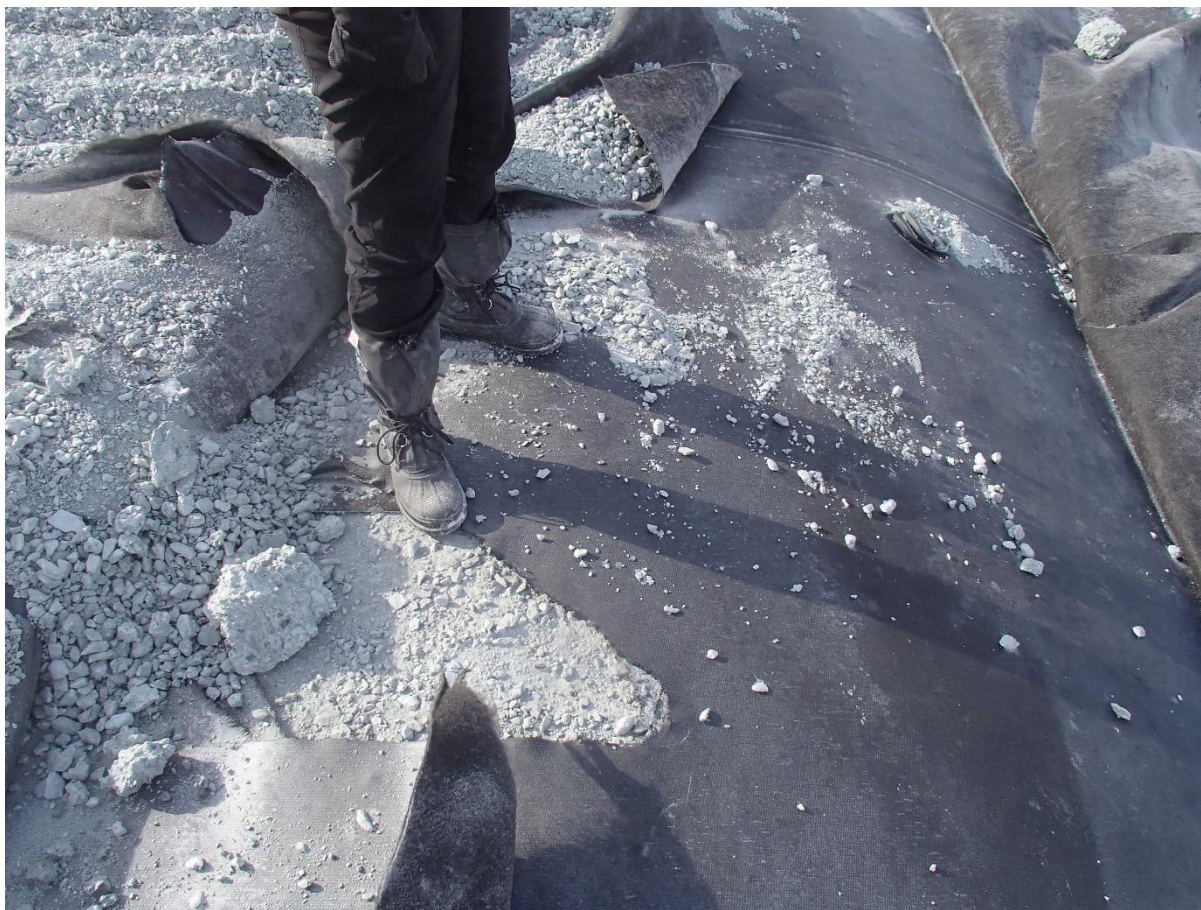
**Photograph CD-1833: From Sta. 0+390/-25 m, looking S. Damaged geomembrane near a deposition finger on Central Dike at Sta. 0+390 m.**

**Photograph CD-1833: From Sta 0+390/-25 m, looking S. Damaged geomembrane near a deposition finger on Central Dike at Sta. 0+390 m.**

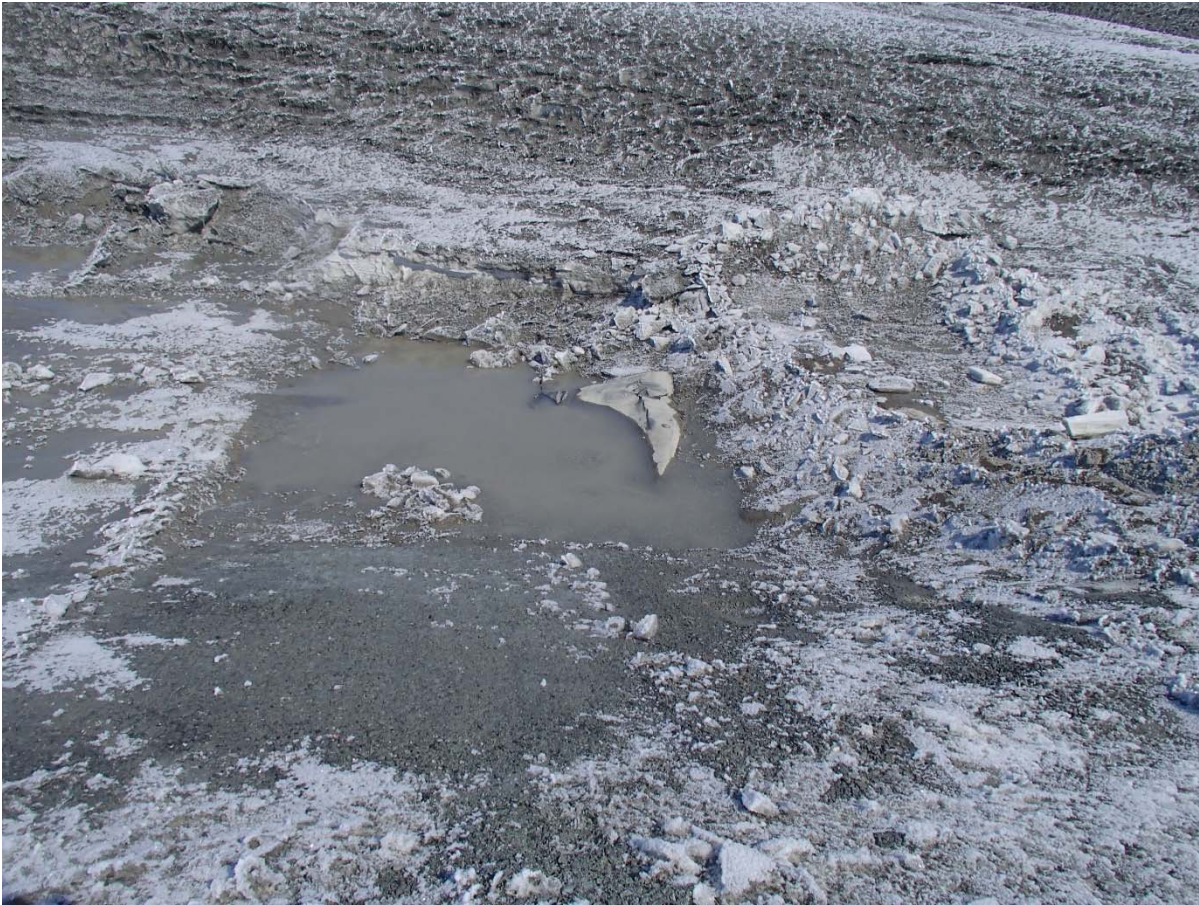
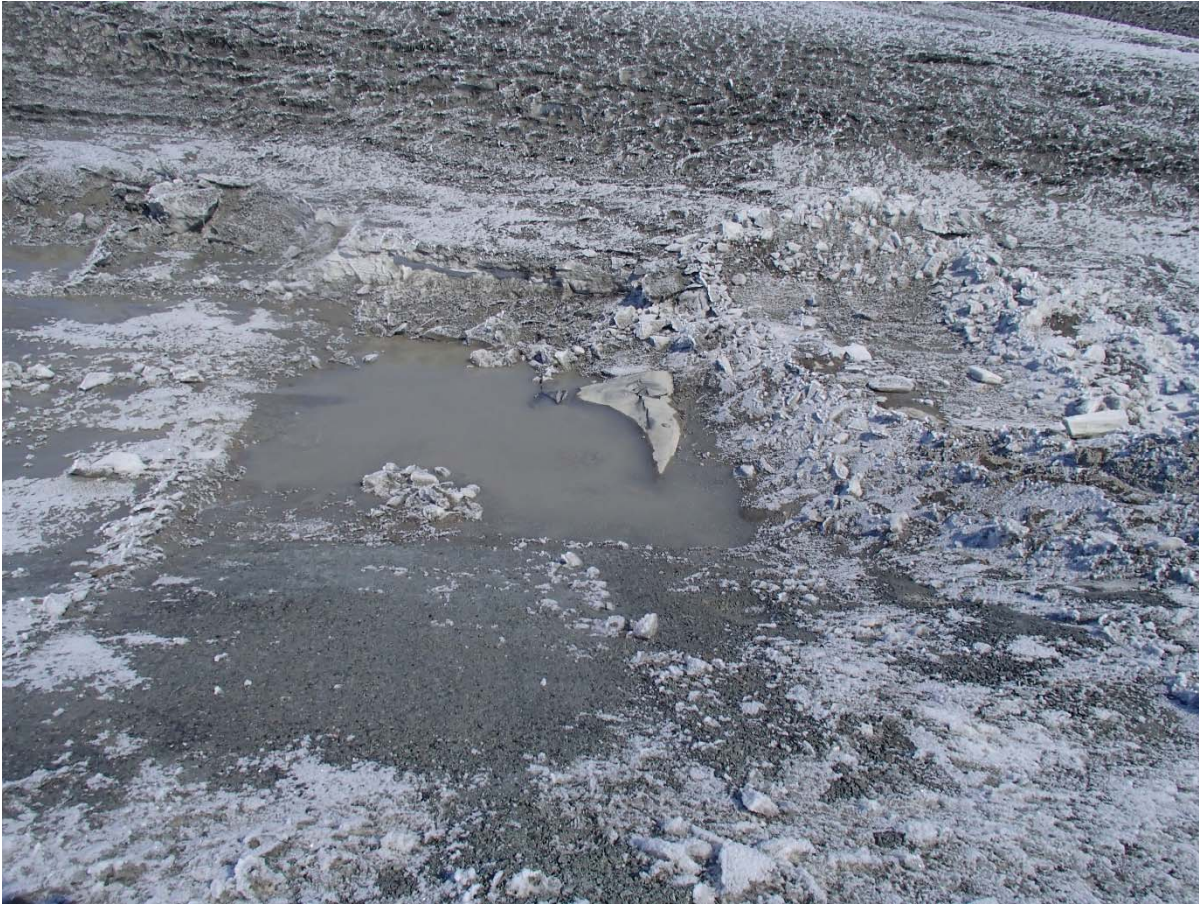
**Photograph SD3-302: From Sta. 20+595/42 m, looking NE. View of water ponding on the first compacted sieved till layer of upstream toe liner tie-in. A portion of exposed damaged LLDPE liner is visible.**

Photograph SD3-302: From Sta. 20+595/42 m, looking NE. View of water ponding on the first compacted sieved till layer of upstream toe liner tie-in. A portion of exposed damaged LLDPE liner is visible.

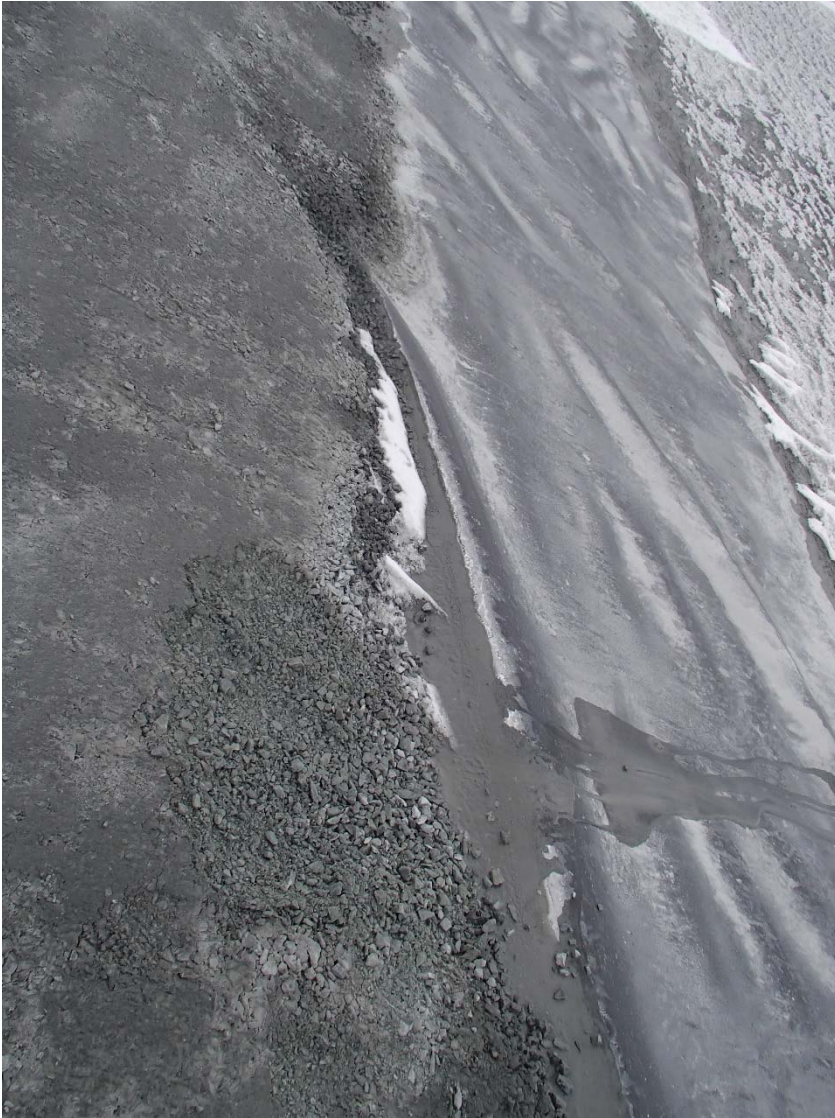
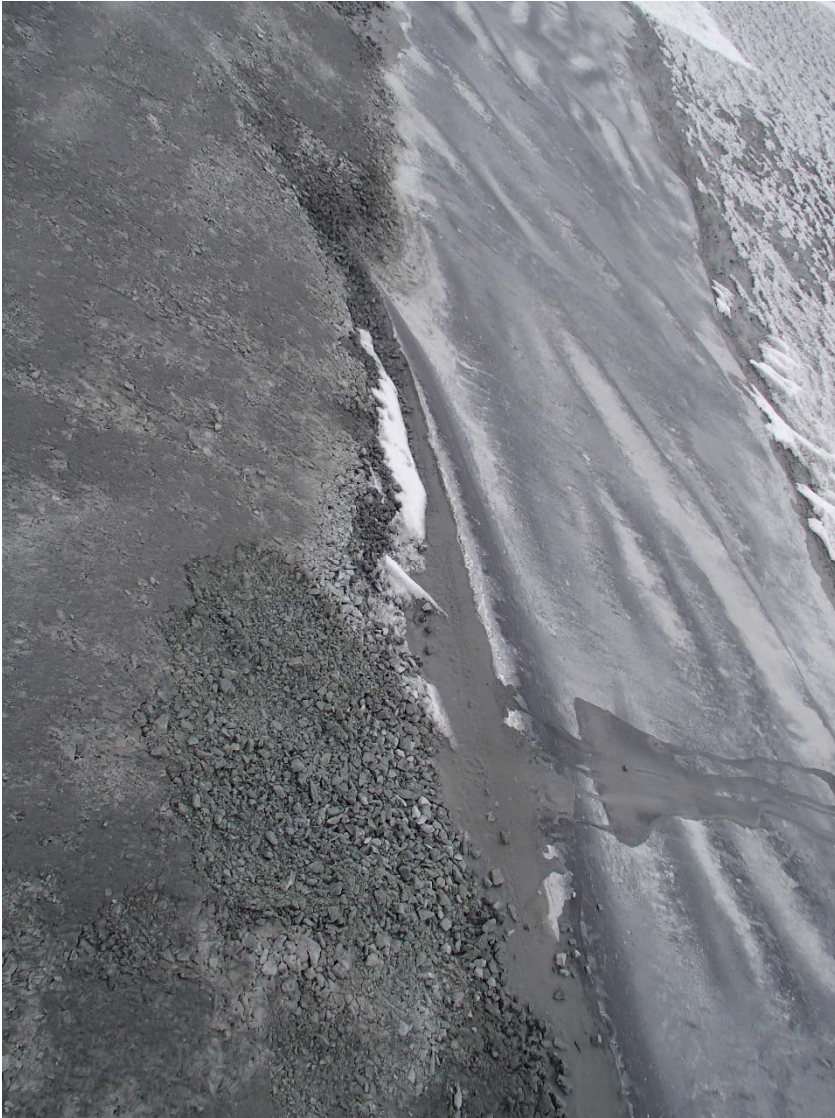
**Photograph CD-1858: From Sta. 0+970/-45 m, looking S. View of the bottom of the fine filter upstream slope. Some material is missing to achieve a smooth slope.**

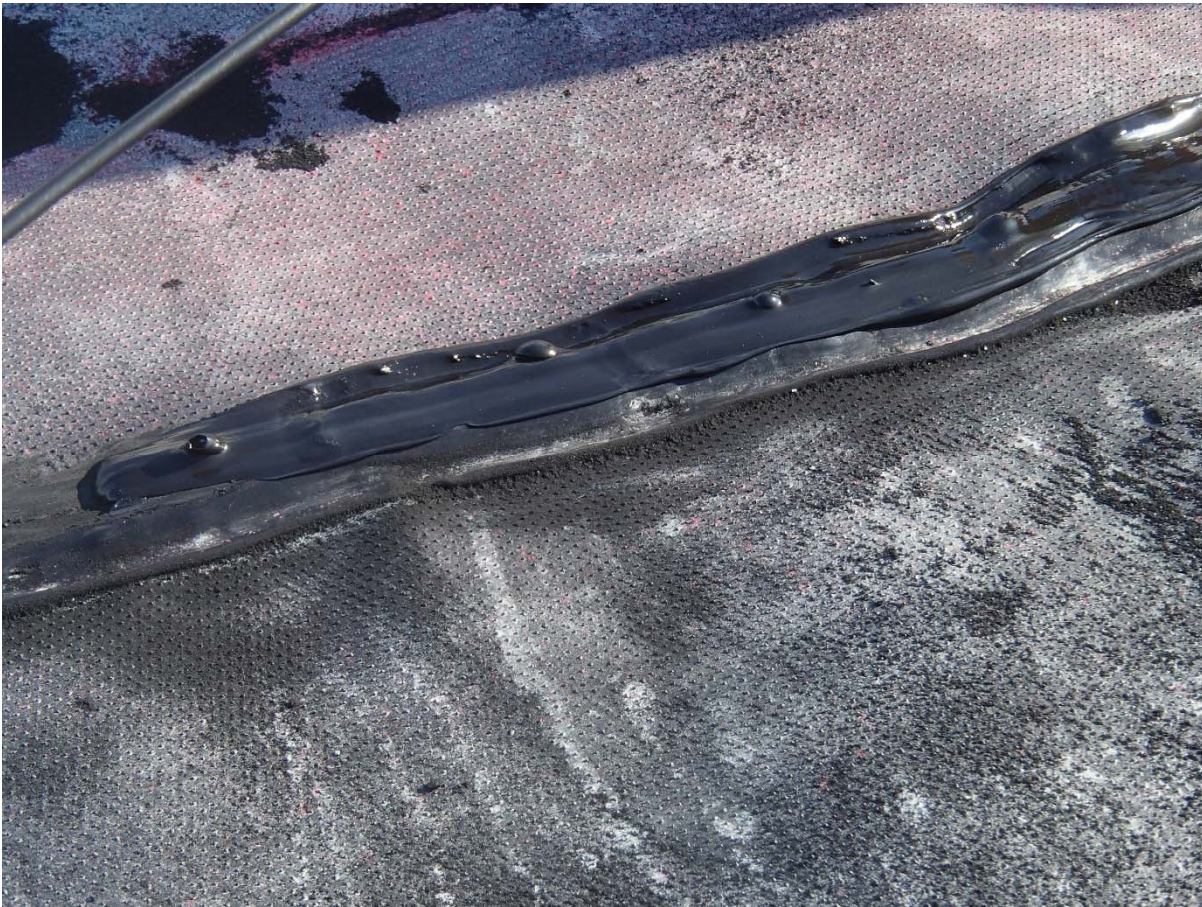
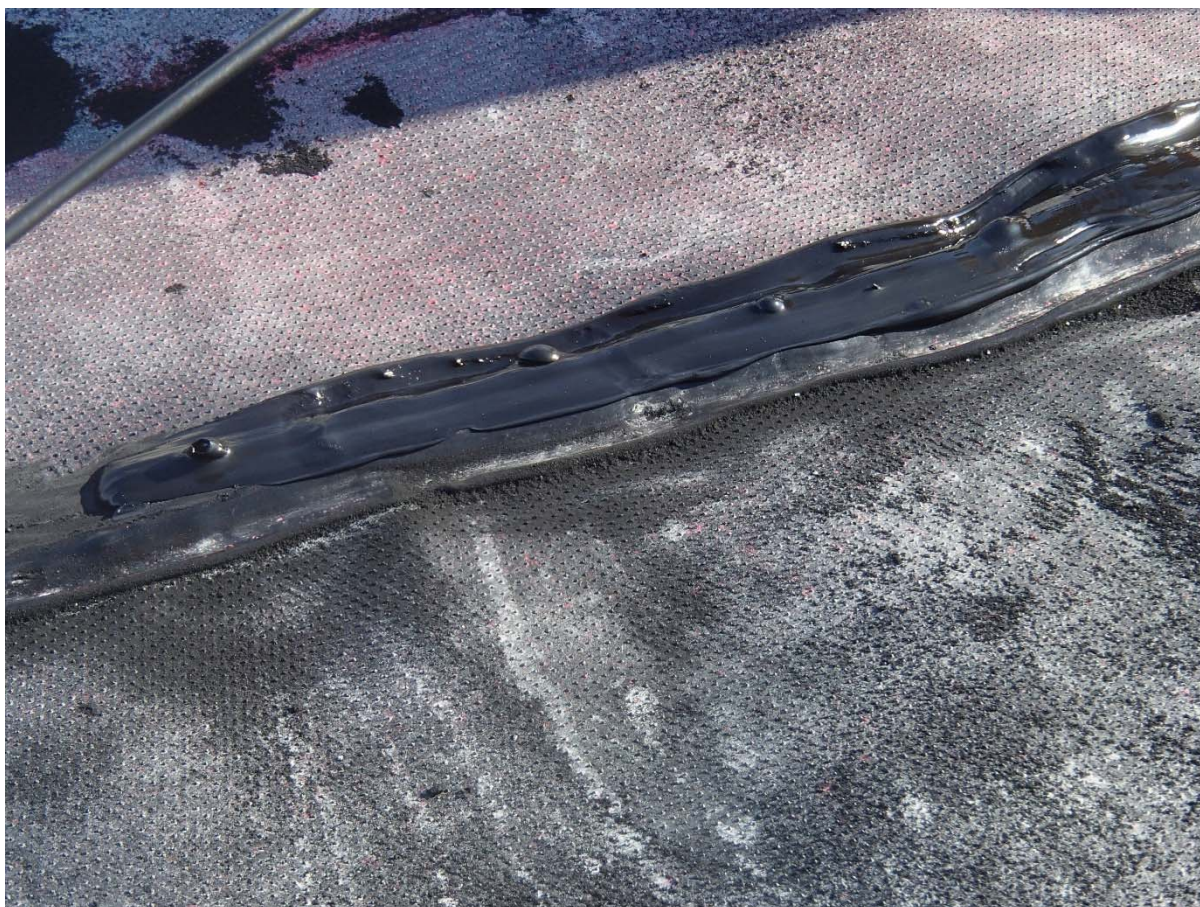
**Photograph CD-1864: From Sta. 40+700/-38 m. View of bubbles formed in the extrusion weld because of humidity.**

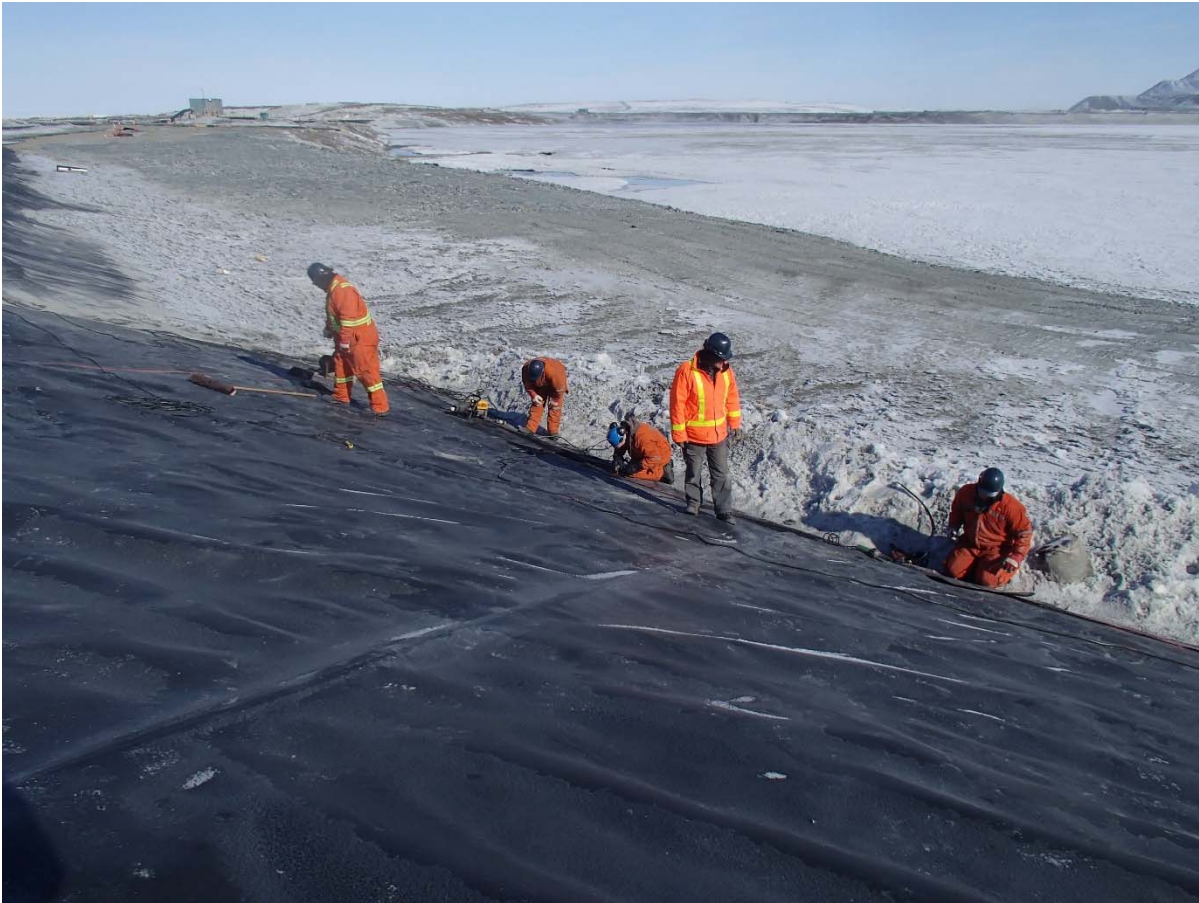
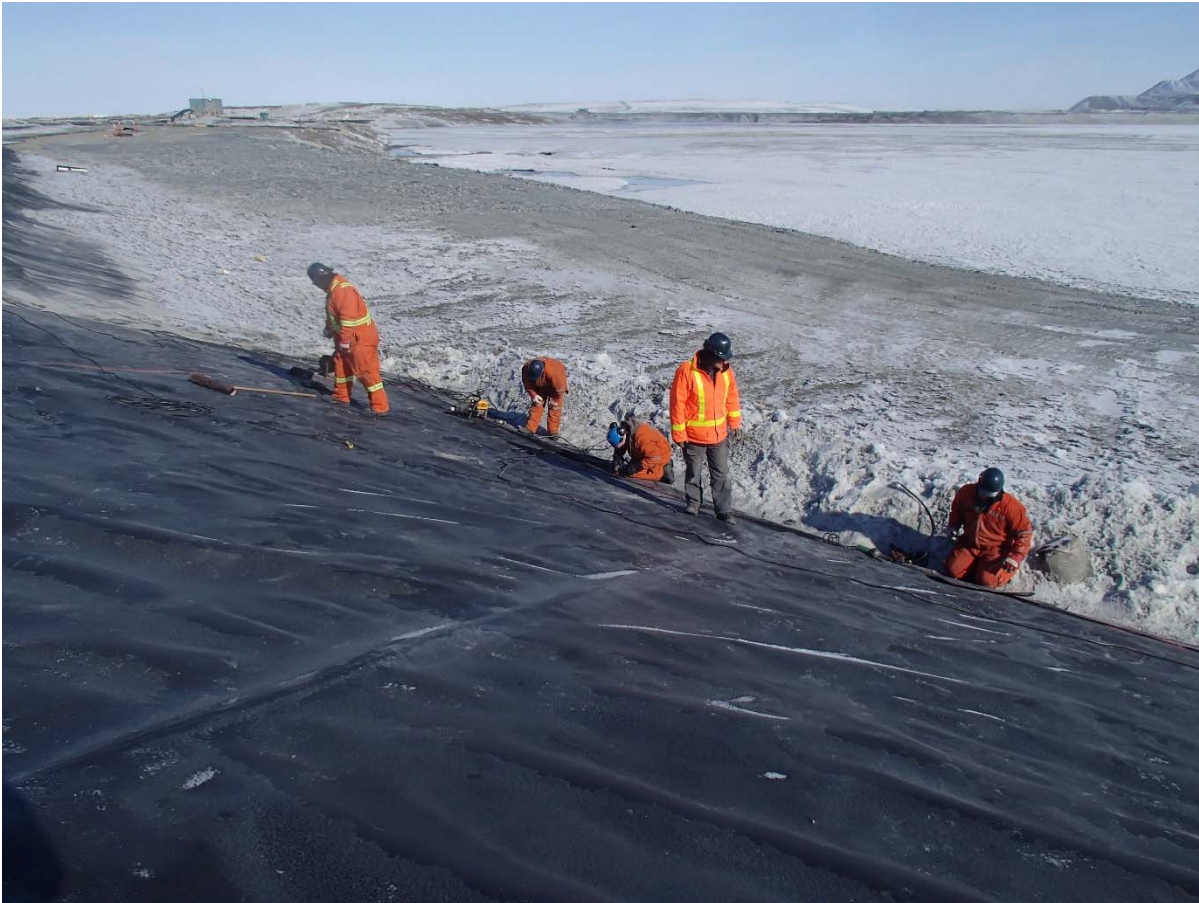
**Photograph CD-1865: From Sta. 40+740/-35 m, looking NW. Repairs on the extrusion fillet seam at the bottom of the LLDPE liner panels between Sta. 40+680 m and 0+950 m, on panels 802 to 807, and 811 to 813.**

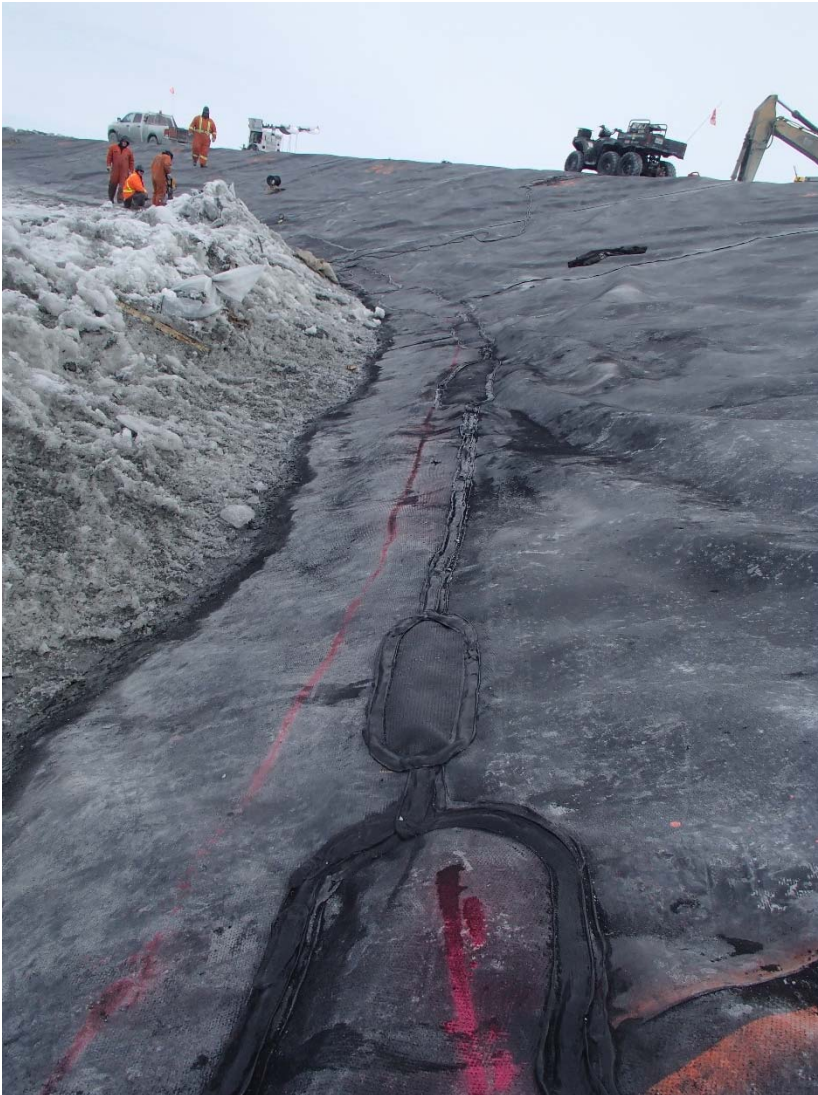
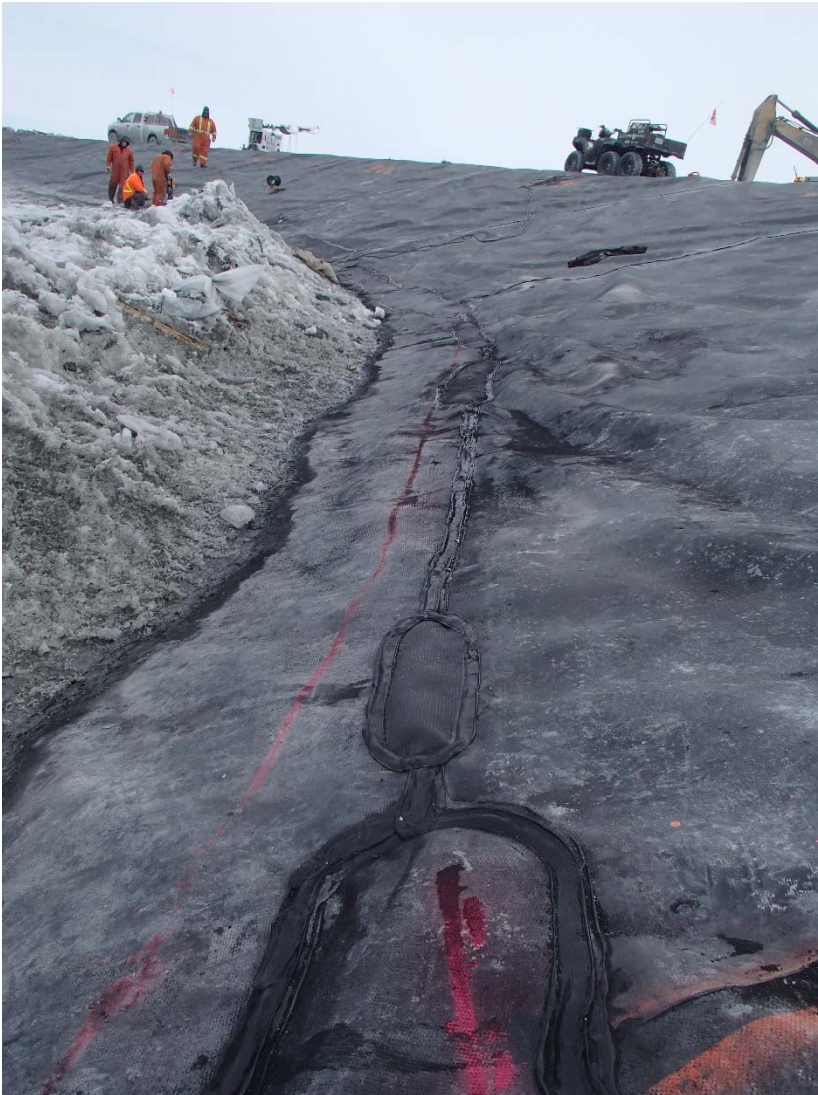
Photograph CD-1867: From Sta. 40+680/-37 m, looking E. View of repair patches on the extrusion weld at the bottom of the panels.

**Photograph CD-1867: From Sta. 40+680/-37 m, looking E. View of repair patches on the extrusion weld at the bottom of the panels.**

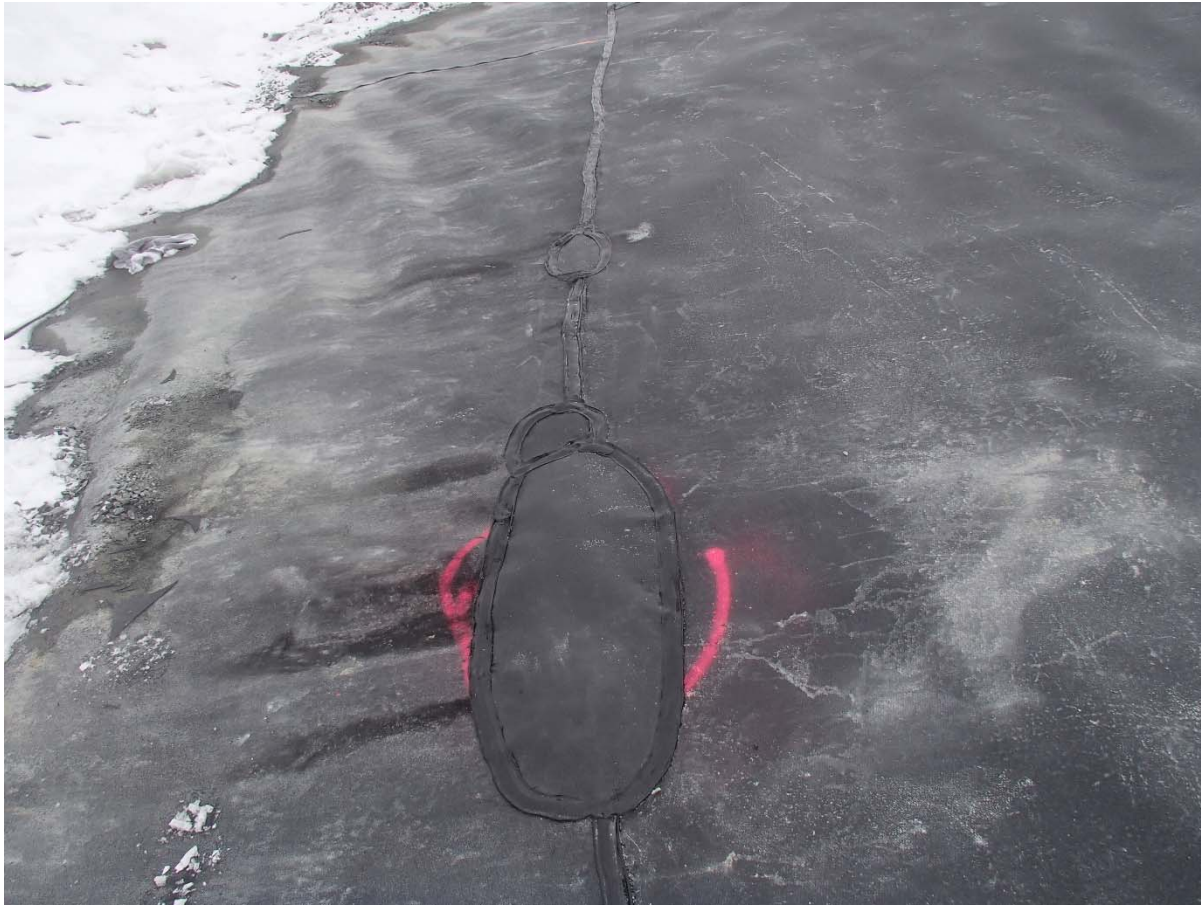
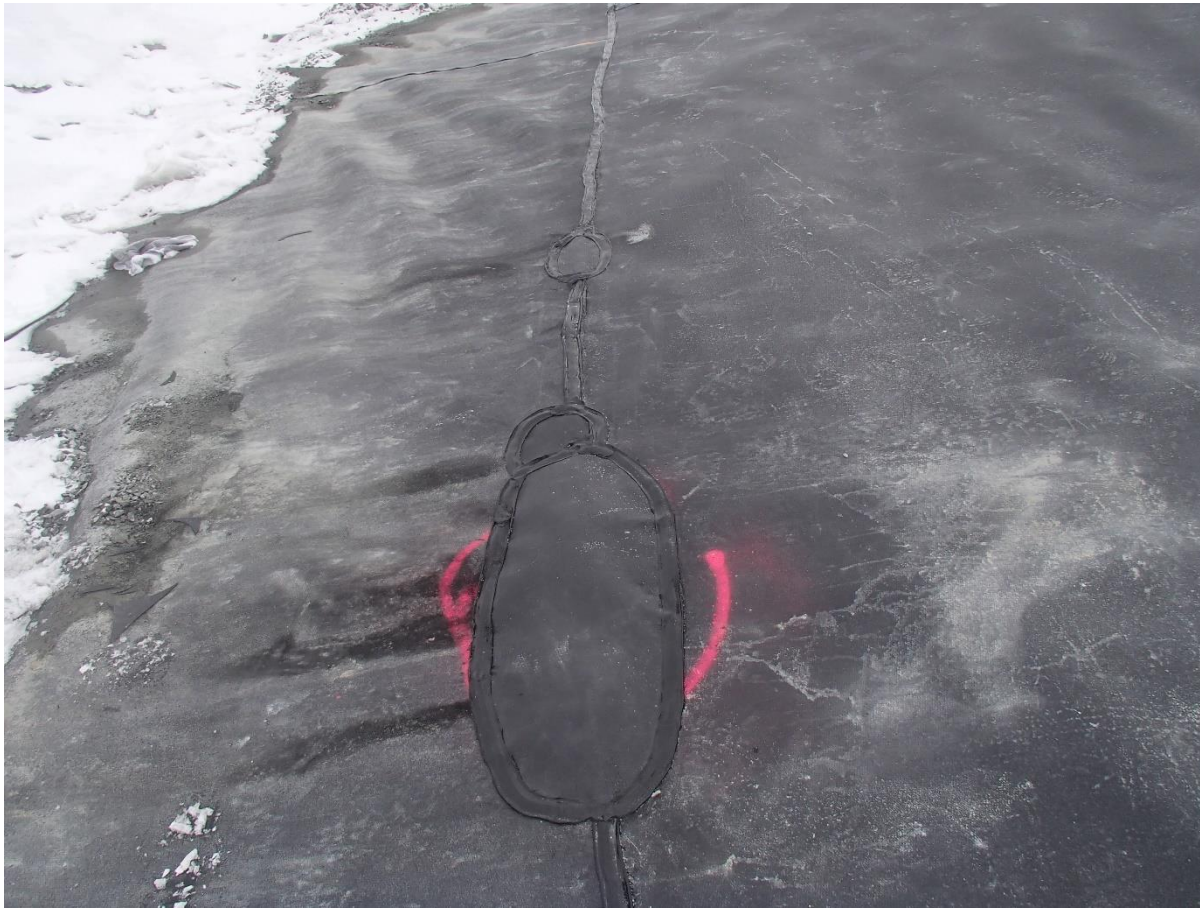
**Photograph CD-1876: From Sta. 0+820/-26 m, looking N. View of repair patches on the extrusion weld at the bottom of panel 838.**
