### **Meadowbank 2018 TSF As-built report**

**2018 CONSTRUCTION SEASON AS-BUILT REPORT  
TAILINGS STORAGE FACILITY  
MEADOWBANK GOLD PROJECT, NUNAVUT**

1897439-1578-R-Rev0

November 2018

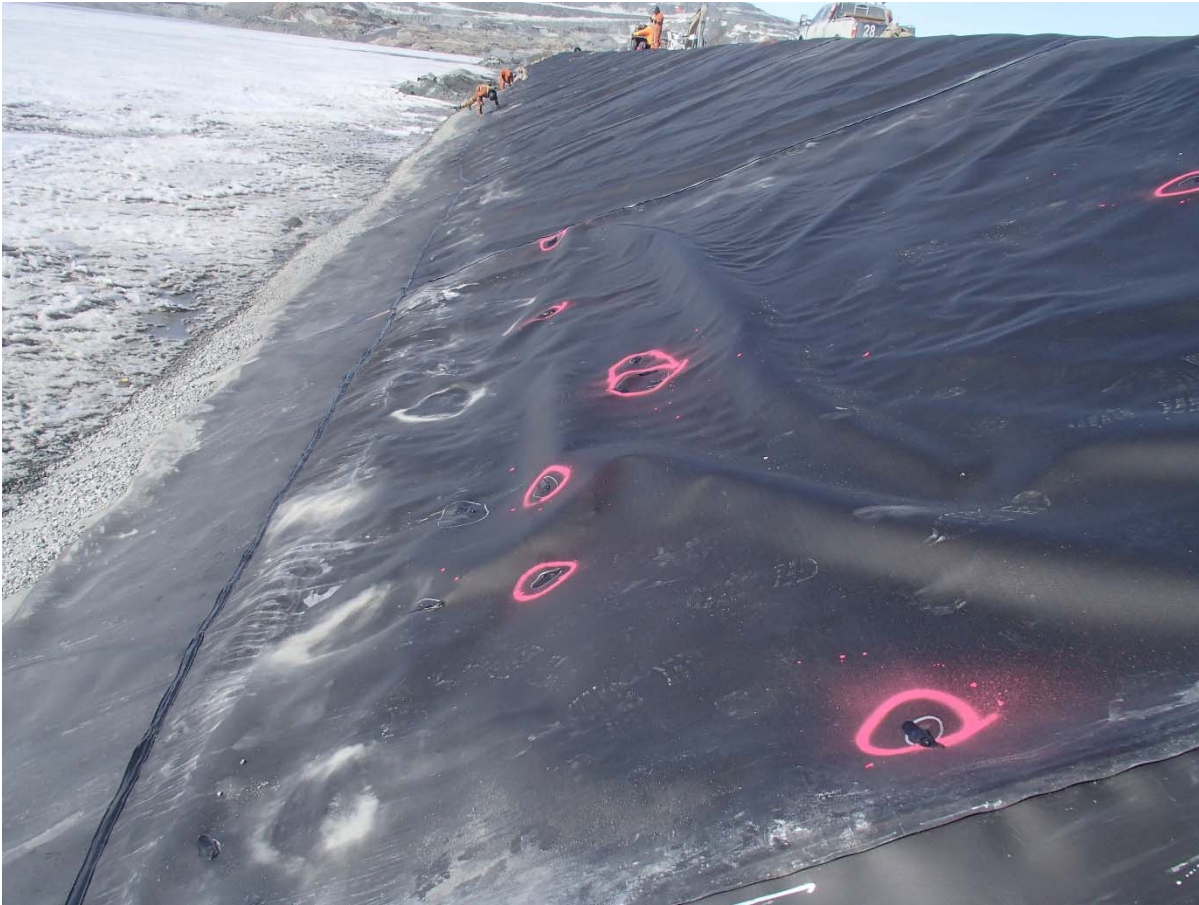
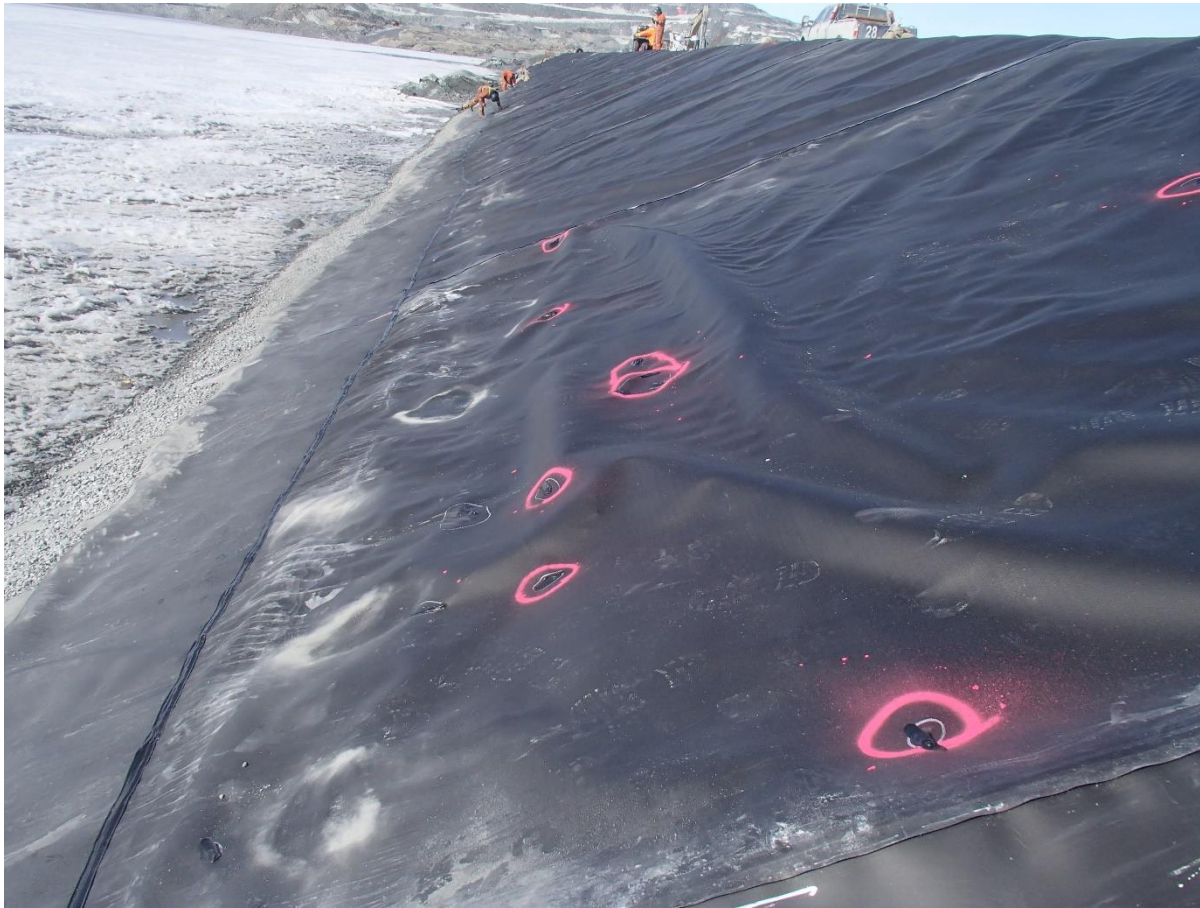
Photograph CD-1879: From Sta. 0+735/-28 m, looking N. View of the repaired holes on panel 850.

**Photograph CD-1879: From Sta. 0+735/-28 m, looking N. View of the repaired holes on panel 850.**

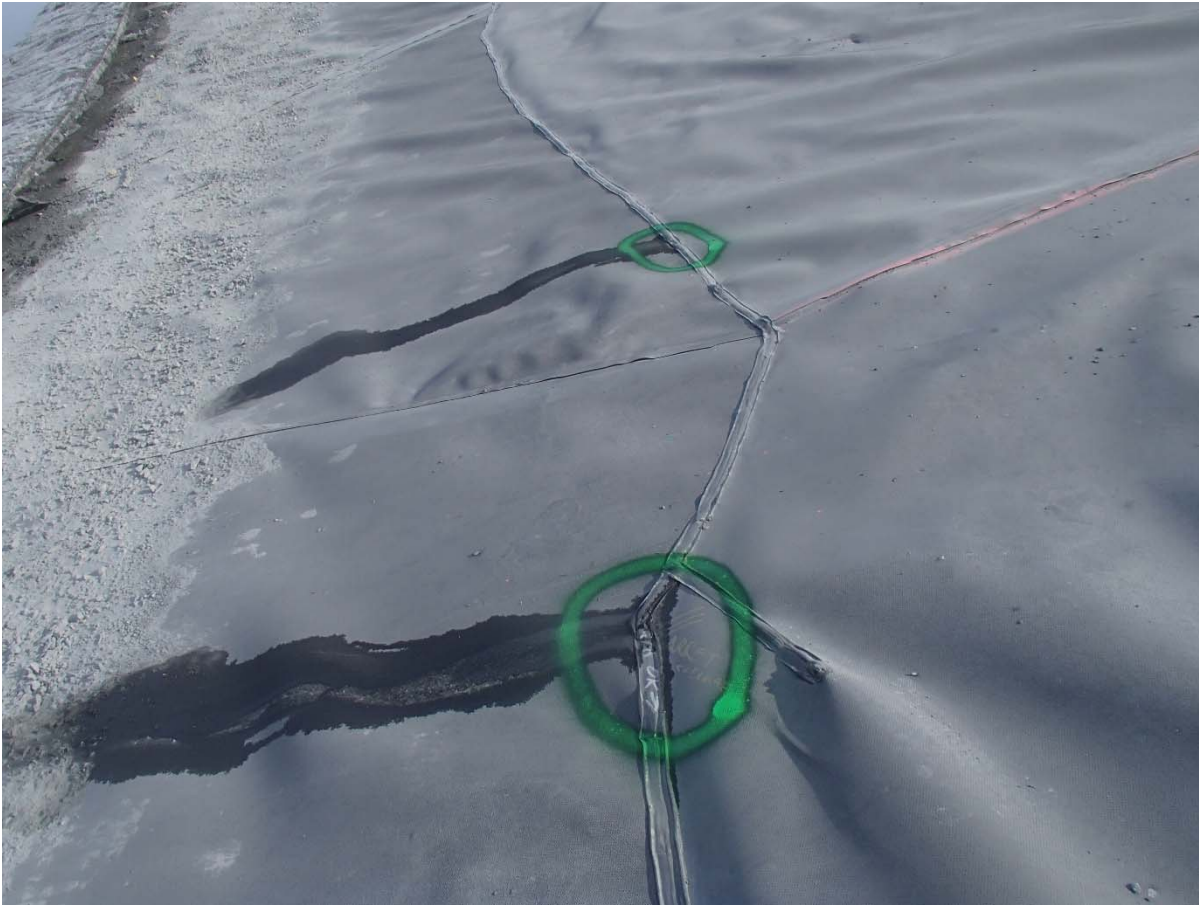
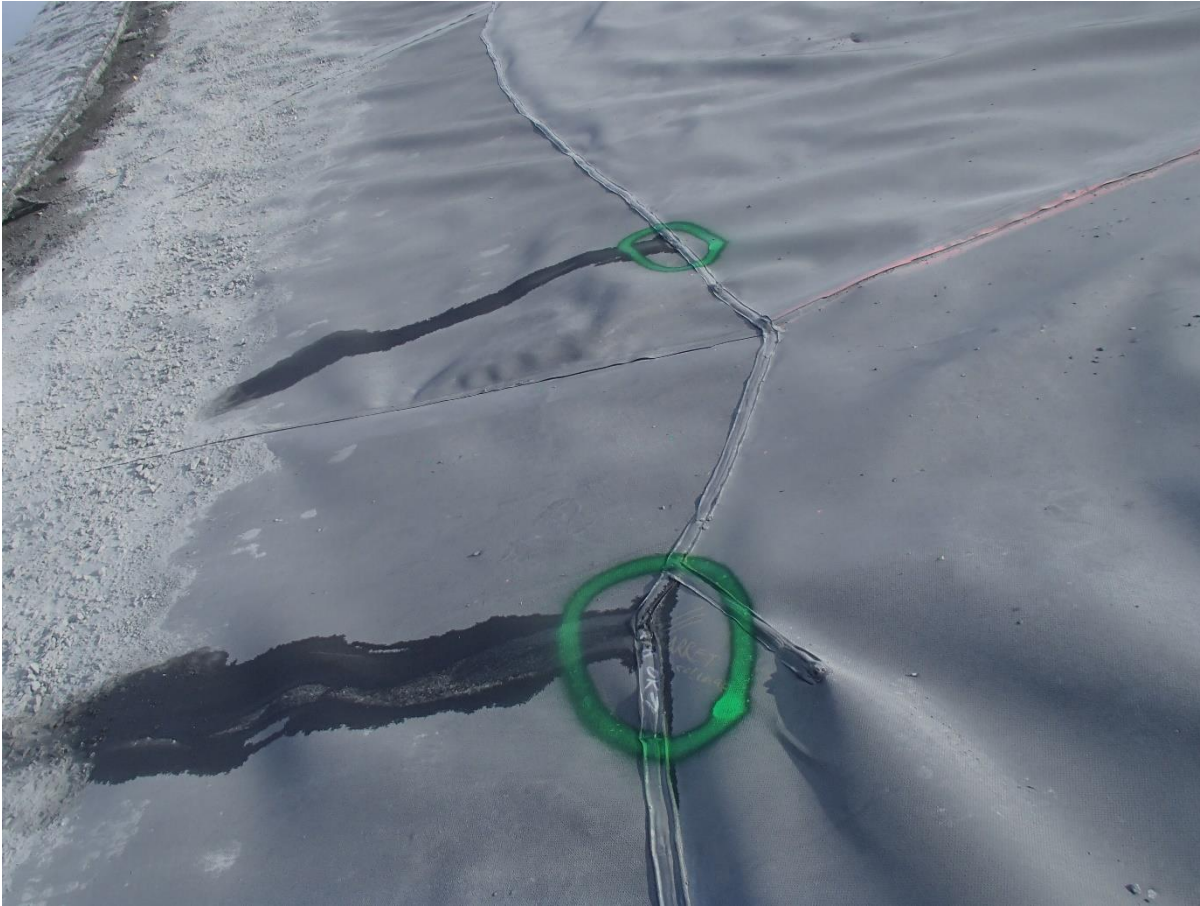
**Photograph CD-1891: From Sta. 0+960/-28 m, looking N. View of leaking extrusion fillet seam before their repair on panels 816 and 818.**

**Photograph CD-1891: From Sta. 0+960/-28 m, looking N. View of leaking extrusion fillet seam before their repair on panel 816 and 818.**

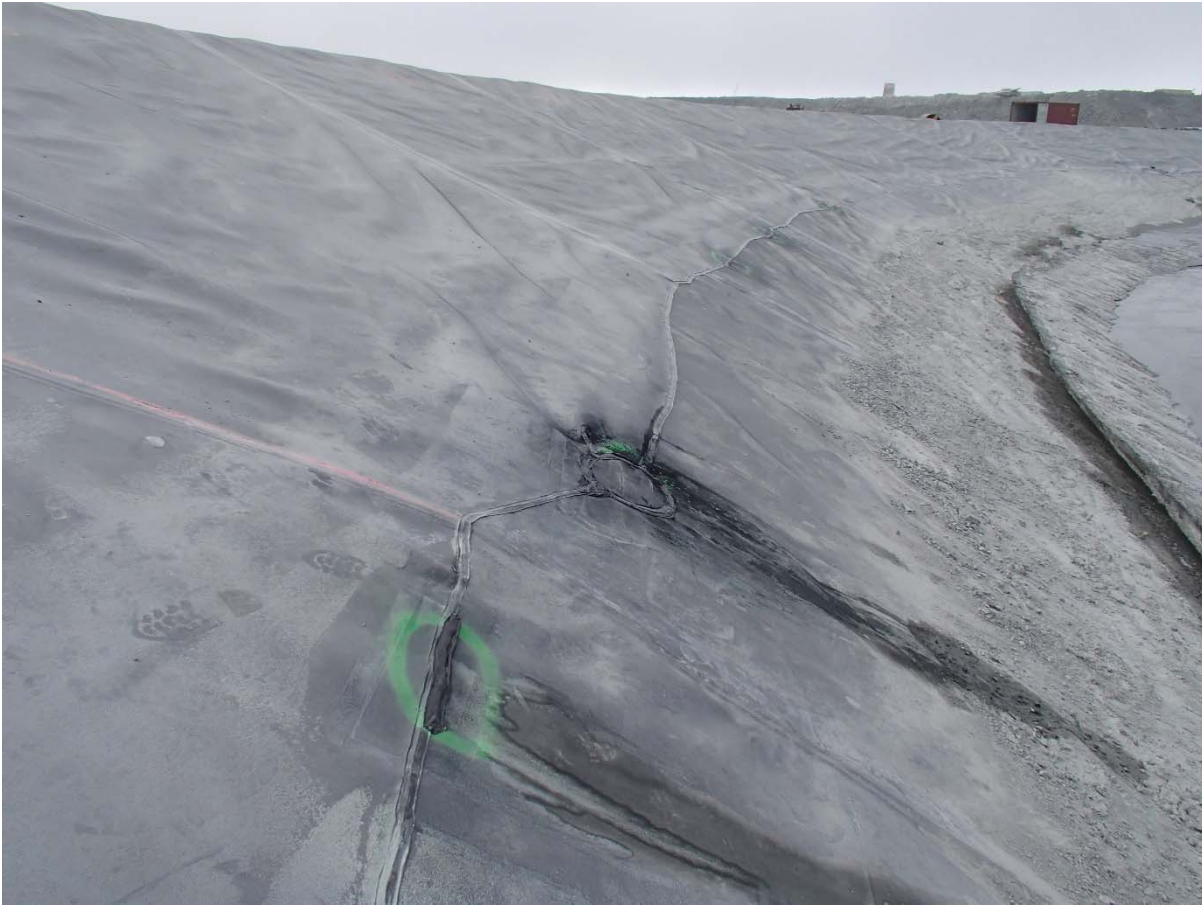
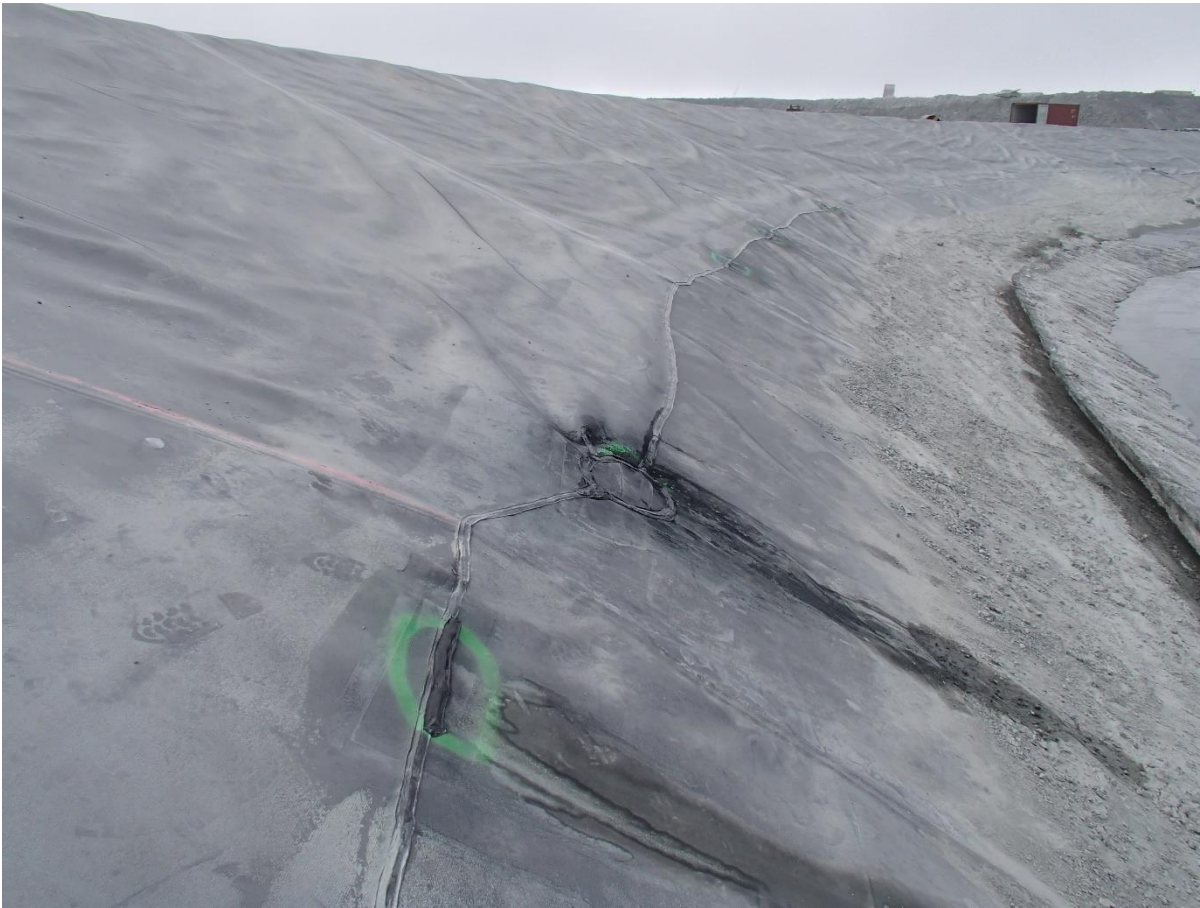
**Photograph CD-1893: From Sta. 0+950/-27 m, looking SW. View of repair patches on the extrusion weld at the bottom of panels 803, 807, 808, 810, 814, 815, 816 and 818.**

**Photograph CD-1893: From Sta. 0+950/-27 m, looking SW. View of repair patches on the extrusion weld at the bottom of the panels 803, 807, 808, 810, 814, 815, 816 and 818.**

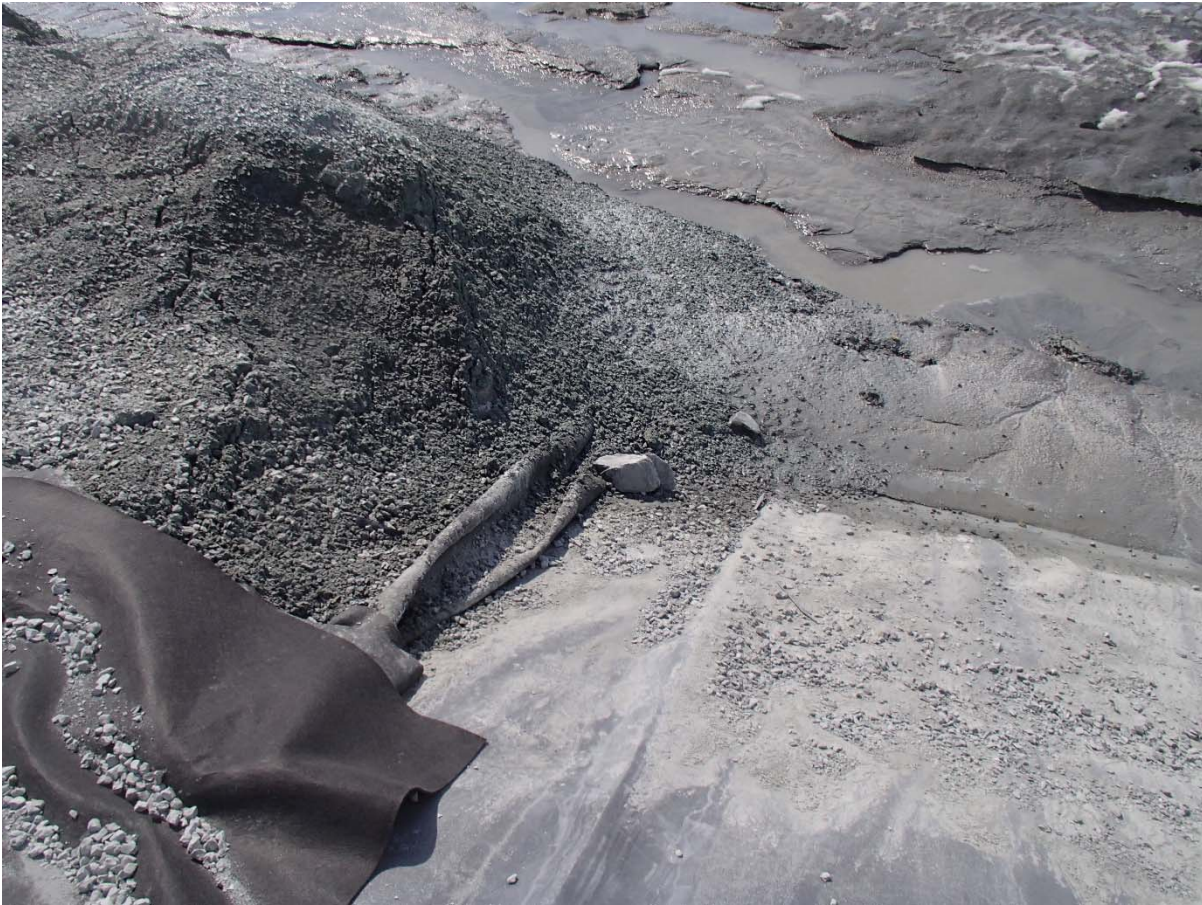
**Photograph CD-1894: From Sta. 0+800/-28 m, looking E. View of a rock in direct contact with the LLDPE liner following the construction of the deposition fingers on Central Dike.**

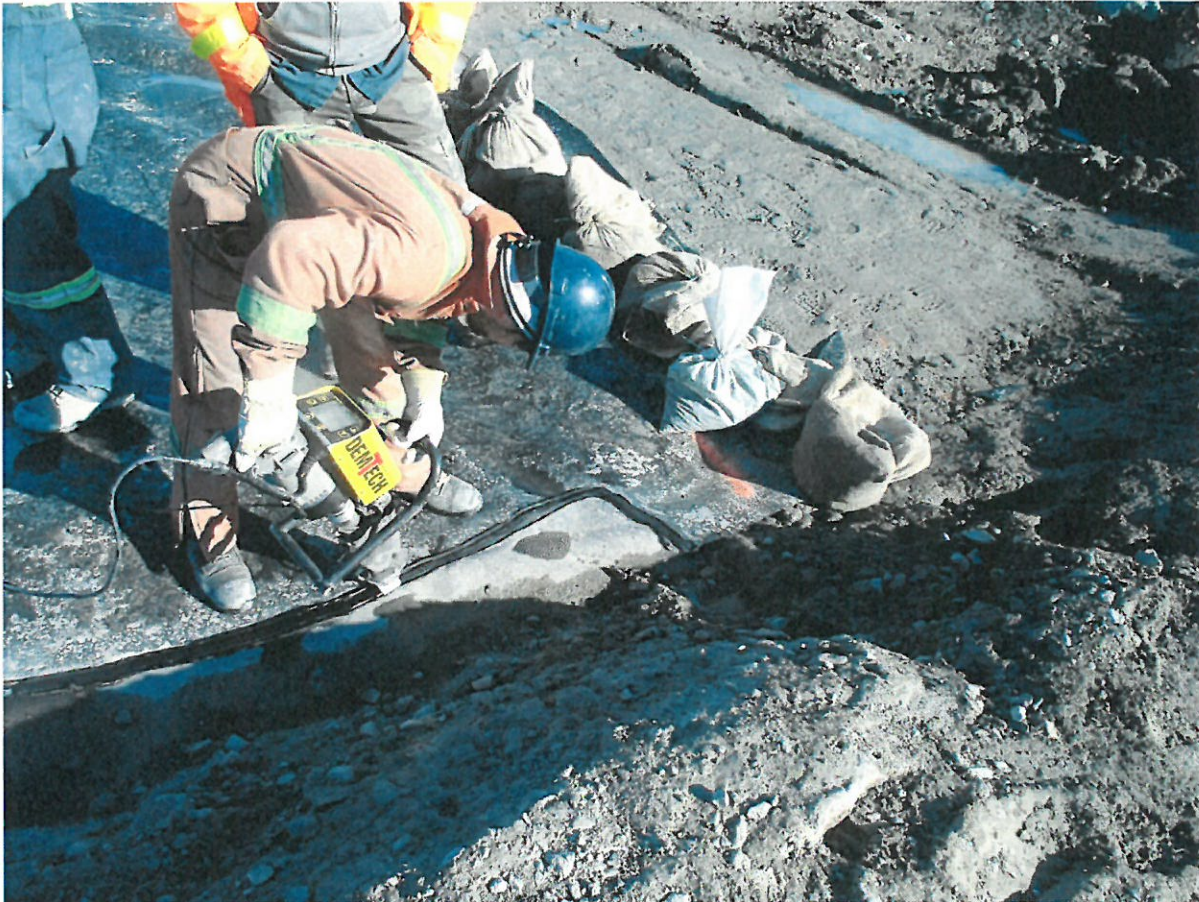
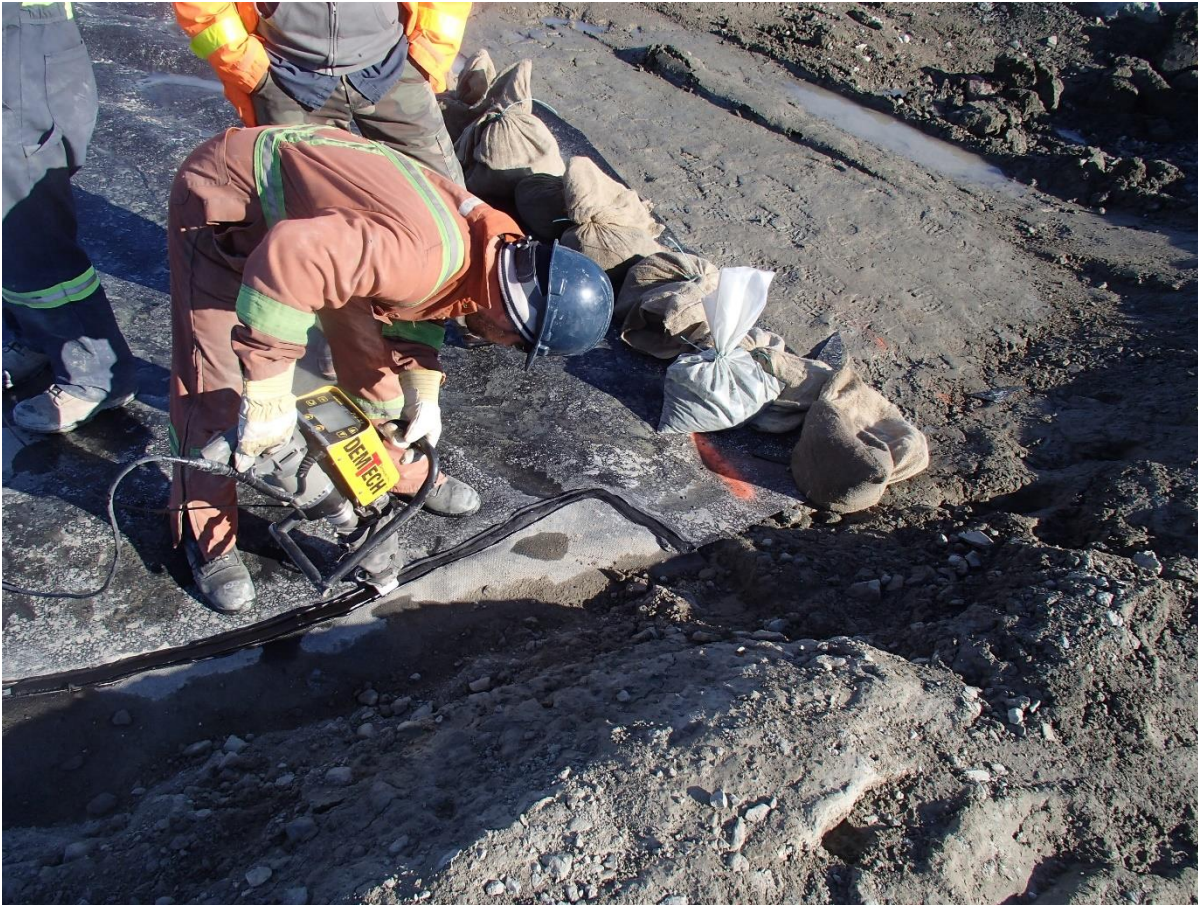
Photograph SD3-316: From Sta. 20+610/-45 m, looking NW. Repairs on the extrusion fillet seam between LLDPE panel 965 and the existing LLDPE panel at Sta. 20+600 m (approx.).

**Photograph SD3-316: From Sta. 20+610/-45 m, looking NW. Repairs on the extrusion fillet seam between LLDPE panel 965 and the existing LLDPE panel at Sta. 20+600 m (approx.).**
