Appendix 14

Meadowbank and Whale Tail MDRB Report No.30

October 31st, 2022

Report No 30
Meadowbank Mine Dike Review Board (MDRB)
Site visit September 13th to 16th, 2022.

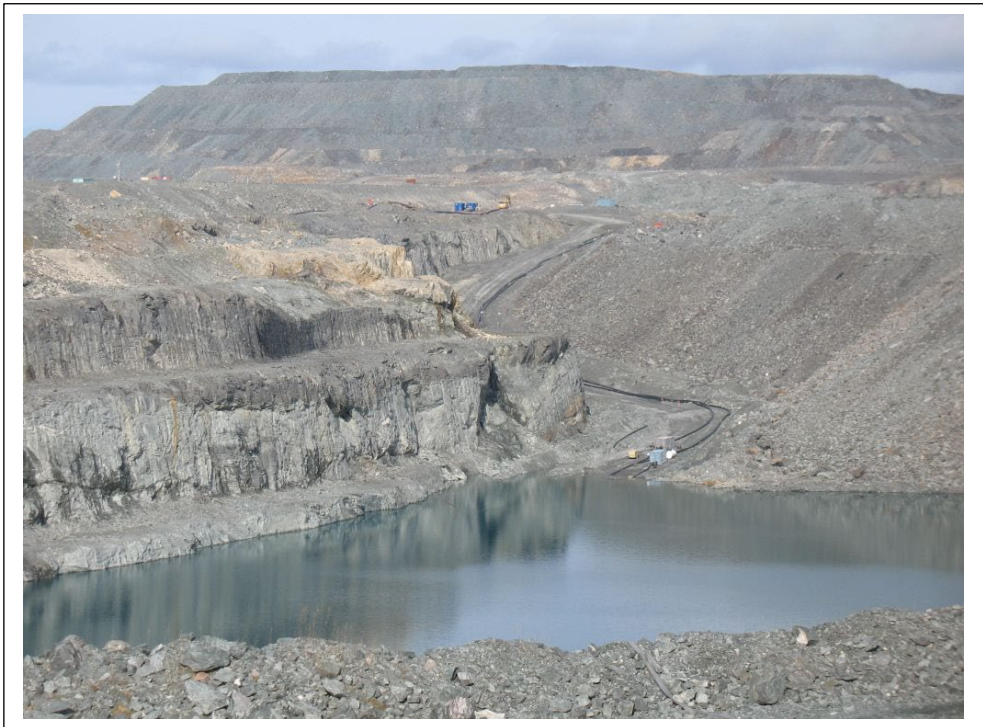
Photo #2 Reclaim pumps in Pit E

The reclaim of supernatant water is currently from Pit E (photo #2). As in previous years, some problems with reclaiming the supernatant water arose during the winter season. This exacerbates the fresh water consumption that AEM is endeavouring to minimize. AEM has the situation in hand and there are no comments from the Board.

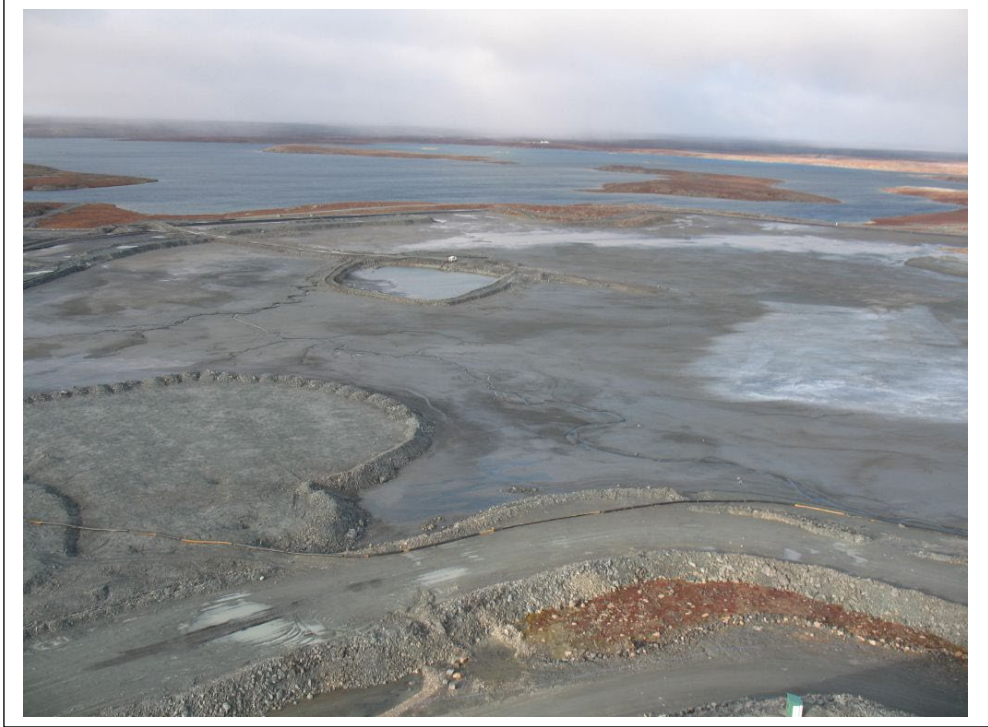
Photo #3 North Cell of TSF

No “landscaping” deposition was made into the North Cell (NC) (photo #3) or the South Cell (SC) of the Tailings Storage Facility (TSF) during 2022. As stated in previous reports, the Board agrees that warm weather deposition is appropriate to prepare the final tailings surface for NPAG capping rockfill. The central parts of both cells are unfrozen at depth and consolidation settlement is likely occurring. The reclaim sump in the NC (photo #4) is operational for run-off control and for any future deposition.

MDRB#30-4	Tailings Management	2022	No "landscaping" deposition was made into the North Cell (NC) (photo #3) or the South Cell (SC) of the Tailings Storage Facility (TSF) during 2022. As stated in previous reports, the Board agrees that warm weather deposition is appropriate to prepare the final tailings surface for NPAG capping rockfill.	AEM agrees that additional tailings deposition needs to be performed at the North Cell and South Cell to prepare the final tailings surface and is planning to complete this deposition in future summers; more details to come on this with the new tailings deposition plan to be released in the upcoming months.	Closed	-
MDRB#30-5	TSF	2022	At SD-1, the thermistor string T-3 is no longer functional. However, the foundation and the tailings upstream of the structure are frozen. The Board does not see a necessity to replace this instrument.	AEM agrees.	Closed	-
MDRB#30-6	TSF	2022	AEM has suggested that the ditch at the toe of saddle dams SD-2, SD-4 and SD-5 be backfilled with rock to reduce the accumulation of water (run-off from outside the TSF) and the Board concurs.	AEM will include this work as part of the list of items to be considered for progressive closure.	Closed	-

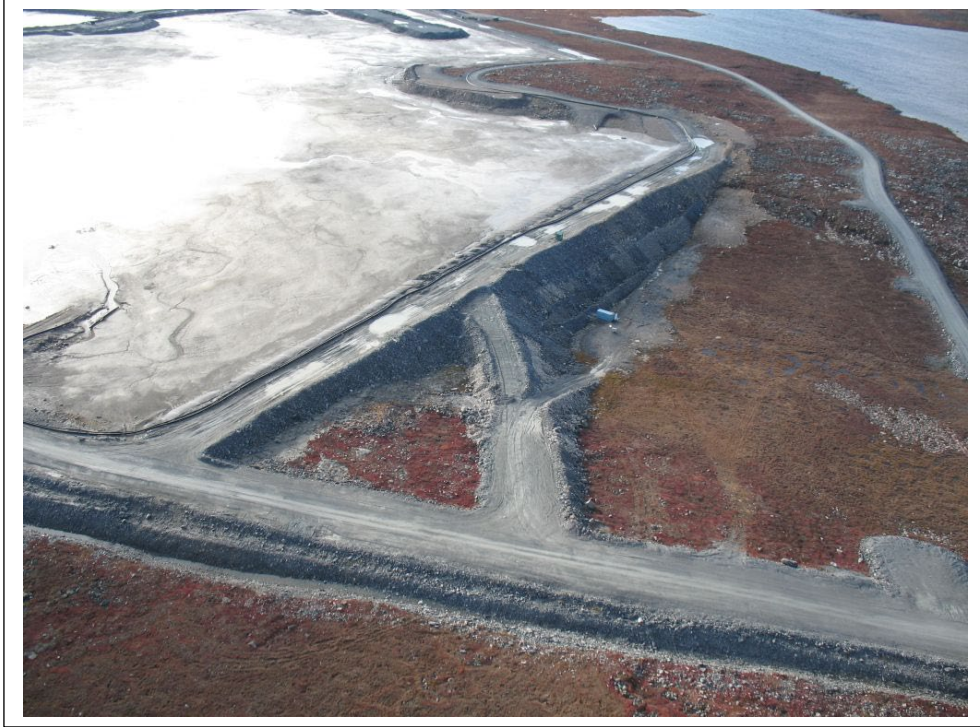
Photo #5 Saddle Dam SD-1

A pump station is being maintained at the toe of SD-1 (photo #5) to collect any run-off (contact water) and to discharge the same to the NC as necessary.

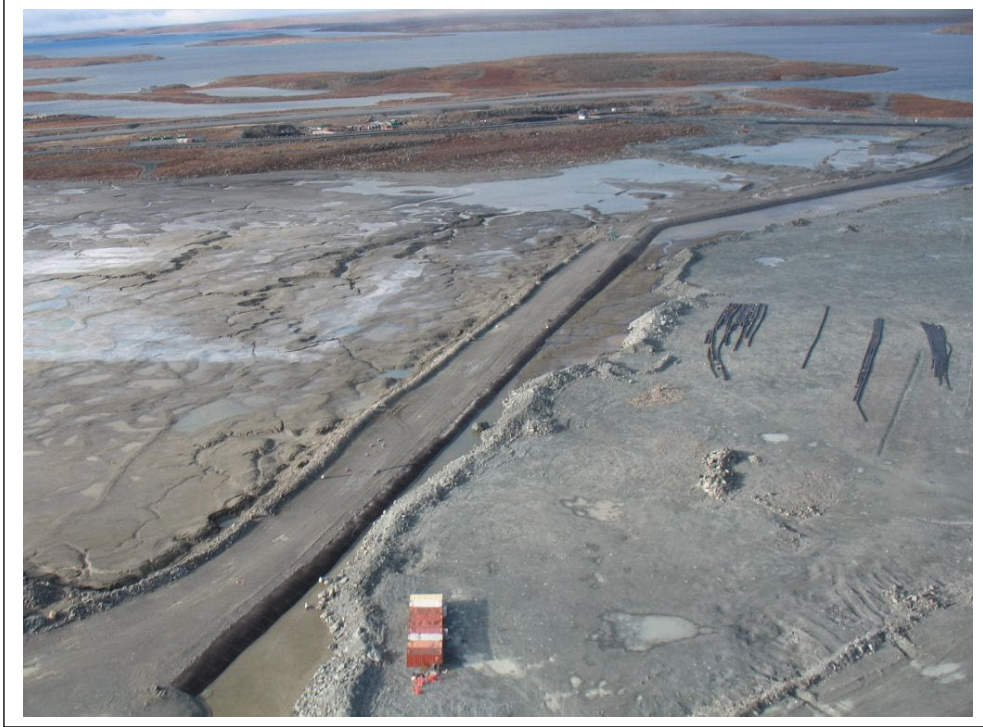
Photo #7 Stormwater Dike

The situation at Stormwater Dike (photo #7) is little changed from last year. An area of shallow ponded water is noted at the west end. Down drag of ice or frozen tailings adhering to the liner is a possibility however, as the tailings deposit is at or about the maximum planned elevation little consequence is envisaged. Nevertheless, "landscaping" tailings deposition and/or the placement of finer material should precede the placement of the capping rockfill along the upstream crest.

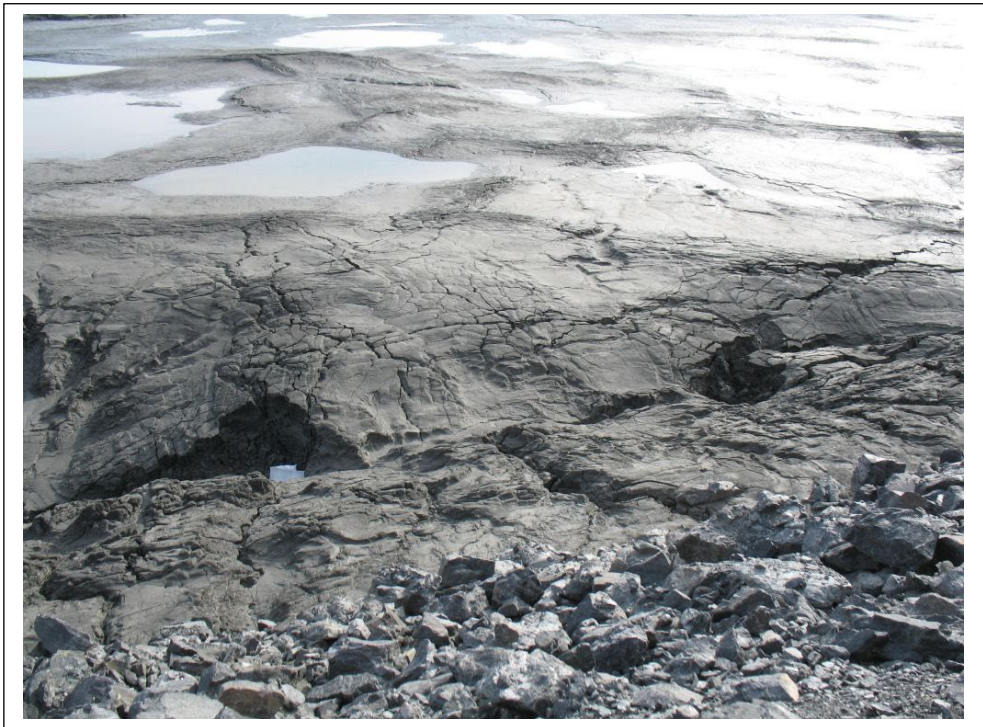
Photo #8 Toe of Stormwater Dike

As far as the downstream toe of the Stormwater Dike is concerned, the eastern end is characterized by a very uneven tailings surface (photo #8) and the western end by seasonally ponded water. All run-off (and supernatant water during tailings deposition) ultimately reports to the sump adjacent to SD-3. Consequently, there is a constant source of water to recharge the groundwater in the talik zone (remnant of 2nd Portage Lake). Water draining through this talik zone reports to the pond downstream of Central Dike. One of the aims in the water management plan is to minimize this flow. The Board recommends that consideration be given to relocating the sump further south, along a rock outcrop that could be a potential site for the spillway, and to deposit additional tailings along the toe of Stormwater Dike to encourage permafrost aggradation.

Recommendation Number	Location	Year ⁽²⁾	Recommendation	Action Plan/Follow-up	Status	Completion Date
MDRB#30-9	TSF	2022	As far as the downstream toe of the Stormwater Dike is concerned, the eastern end is characterized by a very uneven tailings surface (photo #8) and the western end by seasonally ponded water. All run-off (and supernatant water during tailings deposition) ultimately reports to the sump adjacent to SD-3. Consequently, there is a constant source of water to recharge the groundwater in the talik zone (remnant of 2nd Portage Lake). Water draining through this talik zone reports to the pond downstream of Central Dike. One of the aims in the water management plan is to minimize this flow. The Board recommends that consideration be given to relocating the sump further south, along a rock outcrop that could be a potential site for the spillway, and to deposit additional tailings along the toe of Stormwater Dike to encourage permafrost aggradation.	AEM agrees with the Board that additional tailings deposition along the downstream toe of Stormwater Dike should be considered; this will be examined in the new tailings deposition plan to be released in the upcoming months as mentioned in recommendation MDRB#30-4. Relocating the sump adjacent to SD-3 to be further south along the rock outcrop will be considered; however given the topography of the area this may be a challenge. Moving the spillway to this location is being considered in the feasibility level TSF Closure Landform study. More information on this study will be provided to the Board during the next MDRB meeting.	Open	May-23

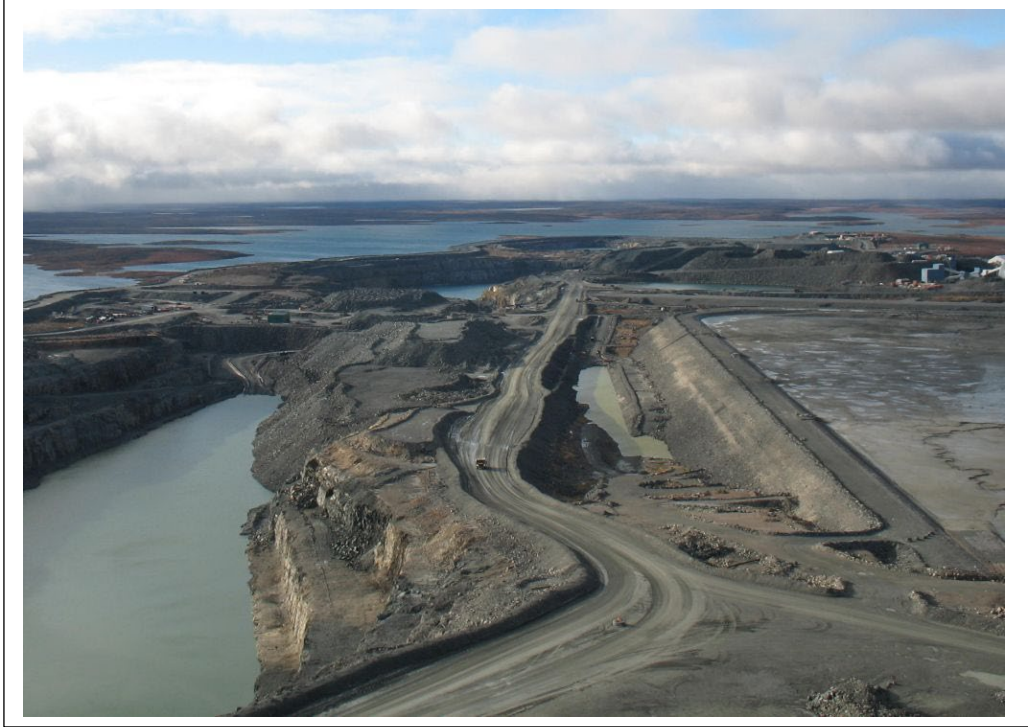
Photo #9 Central Dike

The base seepage flow from Central Dike (photo #9) is around 60 m³/h (Minimum of 20 m³/h recorded during the winter) and the thermistors indicate stable conditions. Piezometric values show a small rising trend possibly due to changes in conditions in the surrounding areas such as the water level in Pit A. The yellow Trigger Action Response Plan (TARP) designation is appropriate for this structure.

MDRB#30-10	Central Dike	2022	The base seepage flow from Central Dike (photo #9) is around 60 m ³ /h (Minimum of 20 m ³ /h recorded during the winter) and the thermistors indicate stable conditions. Piezometric values show a small rising trend possibly due to changes in conditions in the surrounding areas such as the water level in Pit A. The yellow Trigger Action Response Plan (TARP) designation is appropriate for this structure.	AEM agrees and will continue close monitoring of Central Dike and adapt the TARP level if required based on this monitoring.	Closed	-
MDRB#30-11	Bay Goose Dike	2022	Some maintenance work on the crest has been carried out to fill depressions that, by and large, have been present since just after construction. Safety windrows (bumpers) have been added along the crest of the slopes that will have the unfortunate side effect of accumulating snow in the winter season. The Board appreciates that levelling the crest will have a beneficial influence on surface run-off but suggests that additional areas be leveled to promote runoff and that openings be made in the windrows to minimize water ponding when the rockfill in these structures is frozen.	AEM agrees that additional leveling needs to take place on the crest of Bay Goose Dike and is working to arrange this work to be done for summer 2023. It will be investigated if openings should be made in the bumpers following observation of snow management in the winter of 2023.	Open	Sep-23

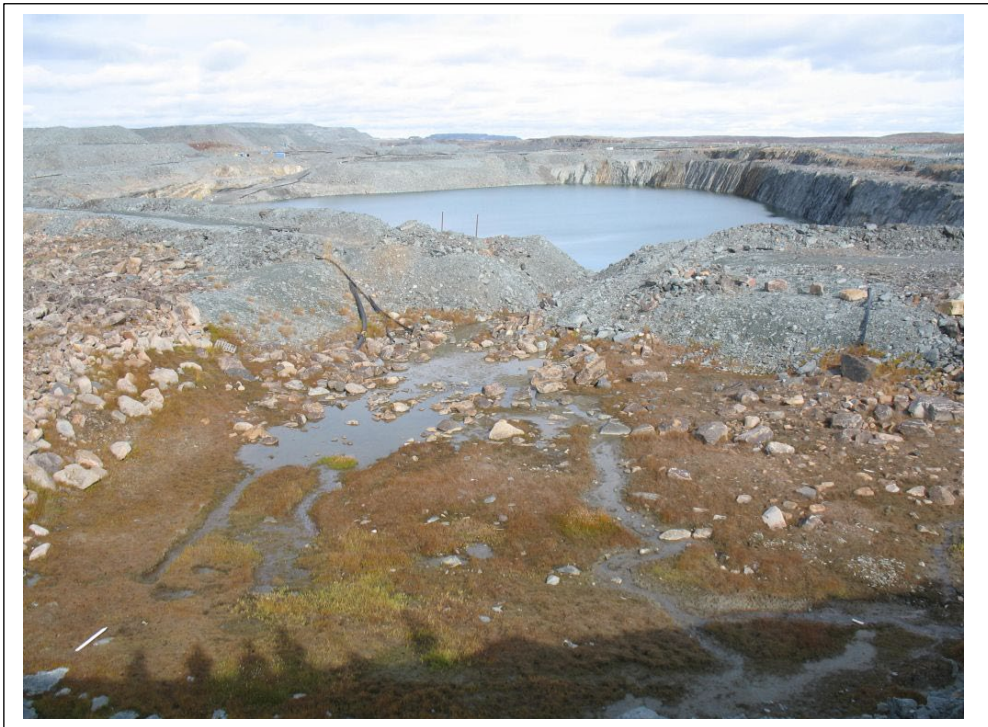
Photo #10 Seepage from Bay-Goose Dike

The Bay-Goose Dike is performing as intended. No adverse trends are noted in the instrumentation. Seepage is observed at the toe in some locations (photo #10) as has been the case in the past.

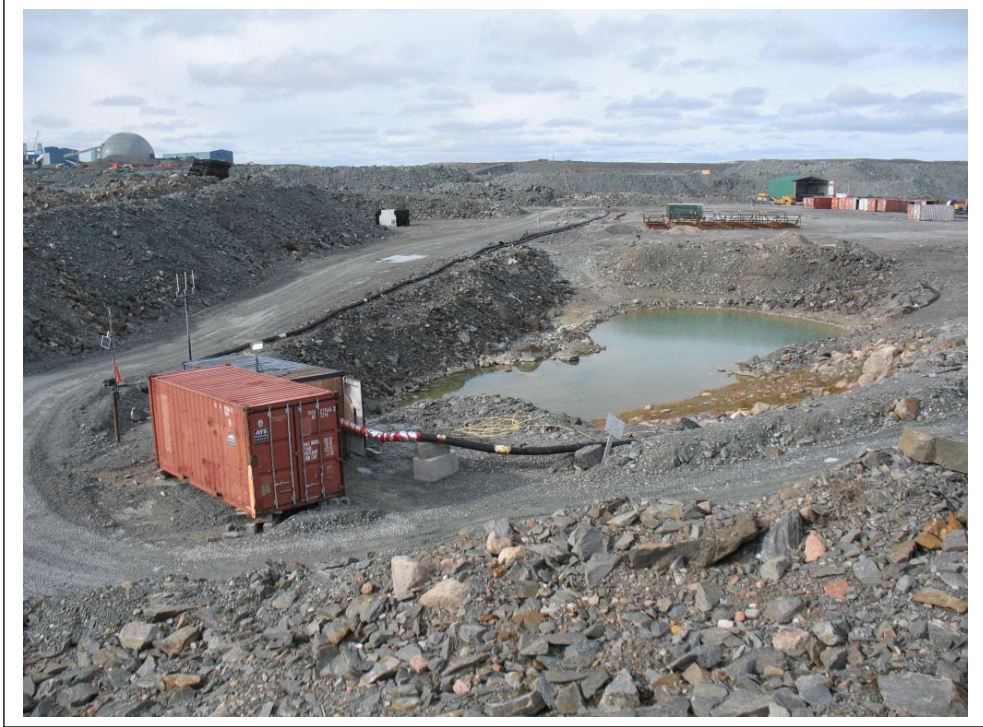
As was described in the previous report, (Meeting #29) at East Dike, the continuing ingress of freezing in the foundation, as seen from the temperature measurements, is apparently also manifested by restricted seepage flow outlet points. This structure, one of the oldest at Meadowbank, has been the focus of surveillance over the last twelve months with additional thermistors and piezometers having been added in the South Channel (photo #11) to facilitate interpretation of the condition. The surface and seepage drainage has been improved; however, groundwater flow continues to by-pass the pump sump at certain times during the winter. The Board continues to support the hypothesis that the change in flow paths is associated with ground freezing.

Photo #11 Pump installation at East Dike south channel

MDRB#30-12	East Dike	2022	The surface and seepage drainage has been improved; however, groundwater flow continues to by-pass the pump sump at certain times during the winter. The Board continues to support the hypothesis that the change in flow paths is associated with ground freezing. AEM has already acted upon the recommendation to enhance the drainage into the sump during the winter months so that ongoing monitoring of seepage rates can be continued.	AEM has continued working to fix the drainage to the sump pump at East Dike; the vertical collection culvert was partially excavated in early November and had additional drainage holes drilled into it. The East Dike flowmeter is also in the process of being replaced to prevent the erratic data seen in the past.	Open	Dec-22
MDRB#30-13	East Dike	2022	As was noted in 2021, water flows onto the Pit E ramp and for a short period in early summer, reached an estimated flowrate of 100 m ³ /h. The build-up of an ice dam in the waste rock pile and subsequent release is a possible explanation. Continuing surveillance is warranted; however, the Board sees no immediate cause for concern with respect to dike integrity.	AEM agrees with the Board and will continue monitoring the Pit E ramp for water flows and changing conditions.	Closed	-

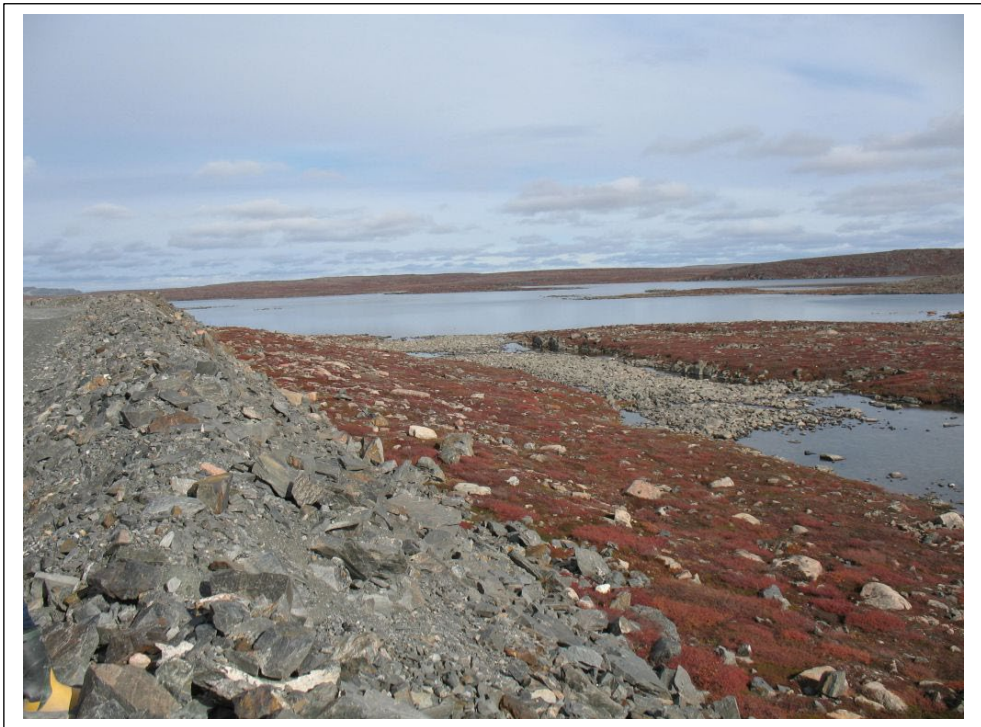
Photo #12 Channel from 3rd Portage Lake to 2nd Portage Lake

Under natural conditions (prevailing), there is a 1 m difference between 3rd Portage Lake and 2nd Portage Lake (photo #12). Consequently, when the area enclosed by East Dike and Bay-Goose Dike will be flooded at closure, a head difference may be created across East Dike in a direction opposite to the way for which it was designed and operated. The closure plans will have to consider this situation or the case including a breach in East Dike as well as in Bay-Goose Dike with the head difference occurring through the waste rock in Portage Pit. Alternate arrangements involving raising of the water level in 2nd Portage Lake may also be possible. It is understood that maintaining the current water level in 3rd Portage Lake will be a critical consideration.

Recommendation Number	Location	Year ⁽²⁾	Recommendation	Action Plan/Follow-up	Status	Completion Date
MDRB#30-15	Closure	2022	Under natural conditions (prevailing), there is a 1 m difference between 3rd Portage Lake and 2nd Portage Lake (photo #12). Consequently, when the area enclosed by East Dike and Bay-Goose Dike will be flooded at closure, a head difference may be created across East Dike in a direction opposite to the way for which it was designed and operated. The closure plans will have to consider this situation or the case including a breach in East Dike as well as in Bay-Goose Dike with the head difference occurring through the waste rock in Portage Pit. Alternate arrangements involving raising of the water level in 2nd Portage Lake may also be possible. It is understood that maintaining the current water level in 3rd Portage Lake will be a critical consideration.	The Closure team will be examining the pits flooding plan and the dike(s) breaching strategy in more detail as it ramps up the closure planning and studies in the upcoming year. AEM agrees on the potential of a breach in East Dike and that it may be the best way to deal with the head difference between 3rd Portage Lake and 2nd Portage Lake and will further assess the feasibility of this option.	Open	Oct-24

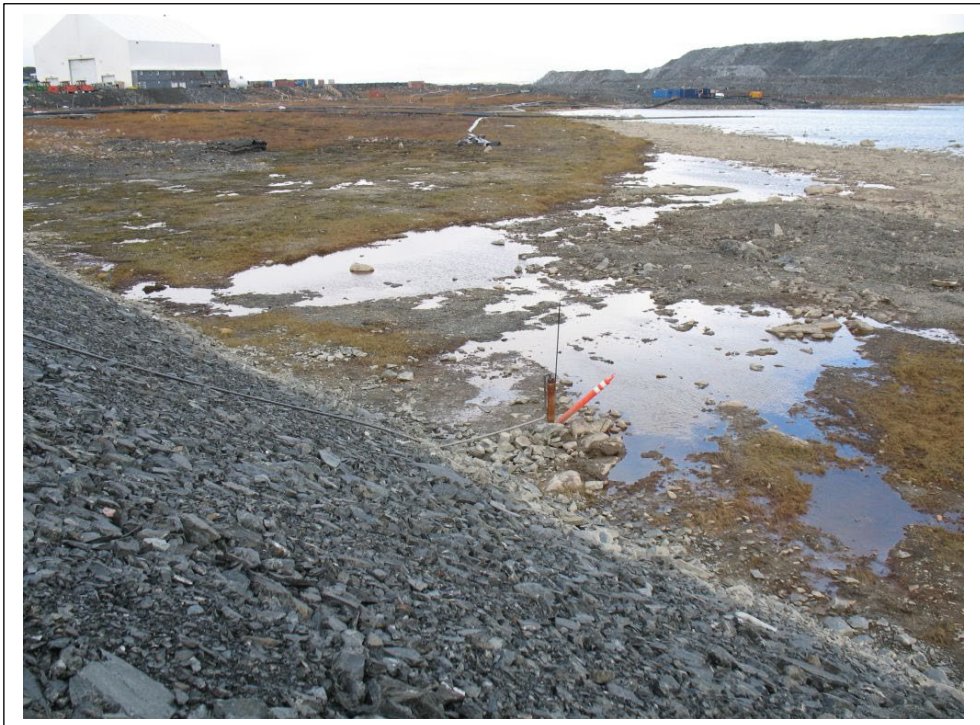
Photo #14 IVR Dike D/S toe

The water accumulation at the downstream toe due to inadvertent valve operation was seemingly without consequence for the dike (photo #14).

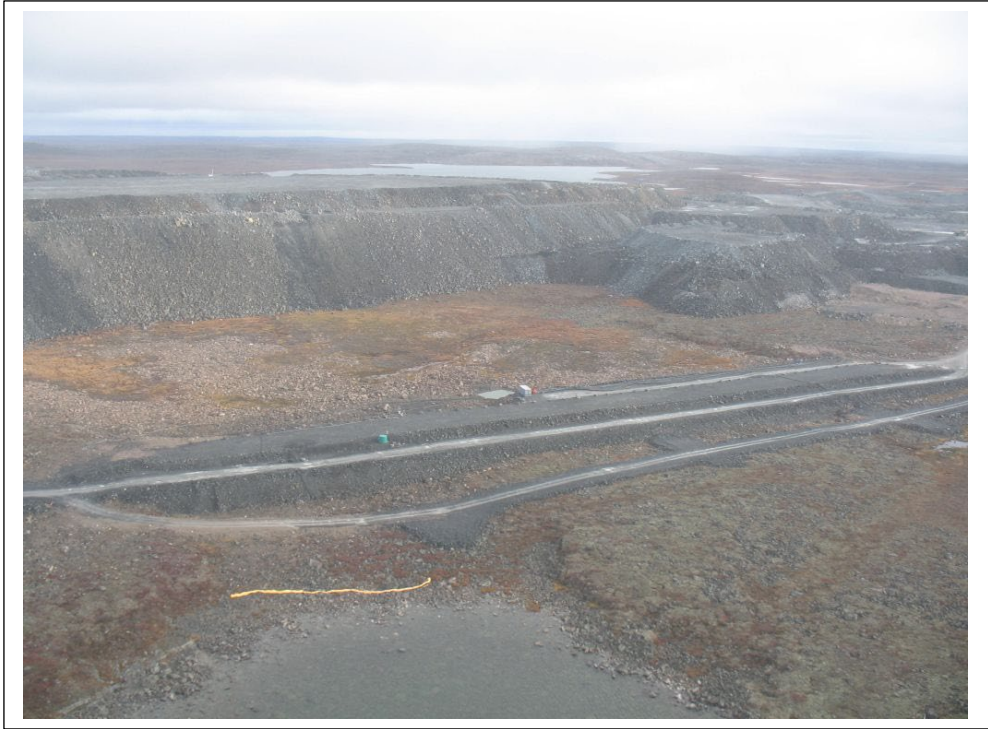
Photo #15 WRSF Dike

The structure (photo #15) is performing well. With no periods of high water in Mammoth Lake being recorded this last spring, the foundation remained in a frozen state. Also, there has been little or no ponded water on the upstream side.

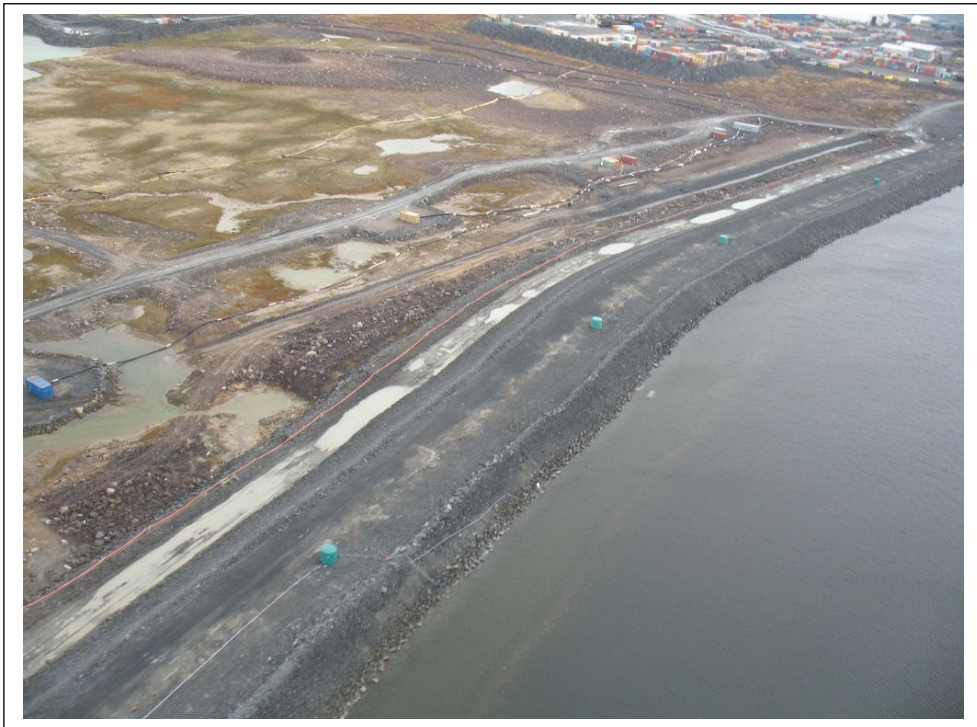
The dike (photo # 16) has been in operation since 2019. An initial grouting program extending from Stn. 0+180 to 0+516 was carried out in the unfrozen bedrock prior to dewatering the northern sector of Whale Tail Lake. Seepage and thaw of the foundation, particularly towards the East abutment, were noted shortly after commissioning. A remedial grouting program was undertaken from Nov 2019 to March 2020 and covered the stretch from Stn. 0+487 to 0+748. This had a successful outcome, insofar as considerable reduction in seepage, was achieved. However, seepage flow rates are not accurately documented, given that part of the seepage reports by surface flow to the attenuation pond and part becomes groundwater recharge. The seepage collection ditch, shown on photo #16 was modified in 2022 such that all surface water emanating from the dike toe now reports to the two weirs A and B (photos #17, 18 and 19) installed in series where a flow of about 100 m³/h is recorded. A few springs located downstream of the ditch are missed but from a temporary weir (C) the flow rate is estimated to be approximately 25 m³/h. There has been an improvement in the seepage collection system but the catchment is quite large and surface runoff “noise” in the measurements during periods of rain or snowmelt are likely. Good records of temperature and precipitation will be necessary to facilitate interpretation of data.

Photo #16 Whale Tail Dike. Seepage collection ditch

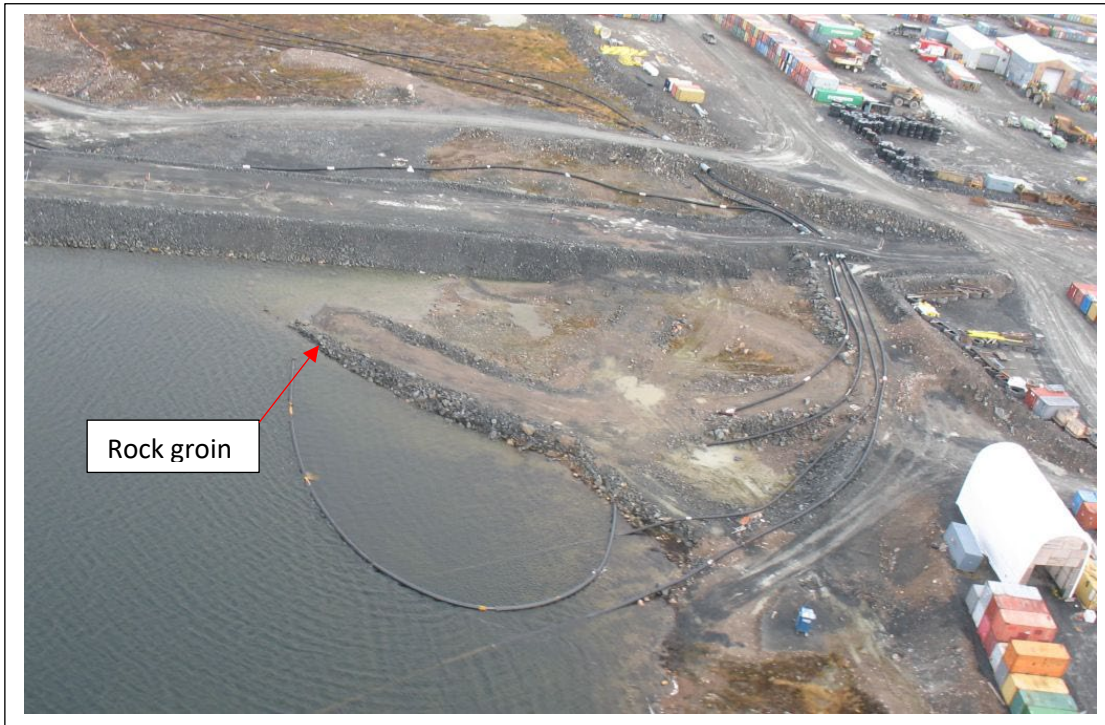
Photo #20 Whale Tail Dike. East abutment

The on-site team has been monitoring deformation of the embankment in the vicinity of the East abutment (photo #20) and the Board was able to observe the situation. Foundation preparation for the dike involved the excavation of overburden and ground ice in the abutment area. This

ensured that the central part of the cross-section was constructed on rock or ice-poor till. However, ground ice remained in the toe areas both upstream and downstream. It is hypothesized that “warm” water in the raised southern part of Whale Tail Lake applied a heat flux to the residual ground ice and thaw induced settlement was the result. This settlement along the toe on the upstream side has resulted in open water ingress along the abutment toe, likely accelerating the thermal degradation. Quite severe cracking is the manifestation (photos #21 and #22) that has appeared due to ground subsidence. The thermal degradation may be occurring in the abutment bedrock below the core zone as well, potentially resulting in the seasonal spikes in piezometer at Stn. 0+701 P2.

The Board recommends the construction of a berm in this location. The rock groin seen in photo #20 could be continued to meet the dike embankment thus providing protection against wave attack and the area behind this groin filled with sand and gravel material to chase water out of the depression in order to facilitate ground freezing during the upcoming winter season. A lift of about 1 m thickness is proposed initially with additional granular fill added in late winter. Migration of sand particles into the dike fill would not be detrimental and would actually reduce inflow and outflow of water.

MDRB#30-16	WTD	2022	There has been an improvement in the seepage collection system but the catchment is quite large and surface runoff "noise" in the measurements during periods of rain or snowmelt are likely. Good records of temperature and precipitation will be necessary to facilitate interpretation of data.	AEM collects detailed records of temperature and precipitation and will use them in conjunction with the Whale Tail Dike seepage measurements to aid in interpretation.	Closed	-
MDRB#30-17	WTD	2022	The Board recommends the construction of a berm in this location. The rock groin seen in photo #20 could be continued to meet the dike embankment thus providing protection against wave attack and the area behind this groin filled with sand and gravel material to chase water out of the depression in order to facilitate ground freezing during the upcoming winter season. A lift of about 1 m thickness is proposed initially with additional granular fill added in late winter. Migration of sand particles into the dike fill would not be detrimental and would actually reduce inflow and outflow of water.	Following MDRB#30 AEM designed and constructed the first stage of the berm on the upstream east abutment of Whale Tail Dike. The second stage of the berm will be added in late winter. An update on the construction and performance of this berm will be given during the next MDRB meeting. AEM would like to thank the Board for their recommendations on the design of this berm.	Ongoing	Apr-23

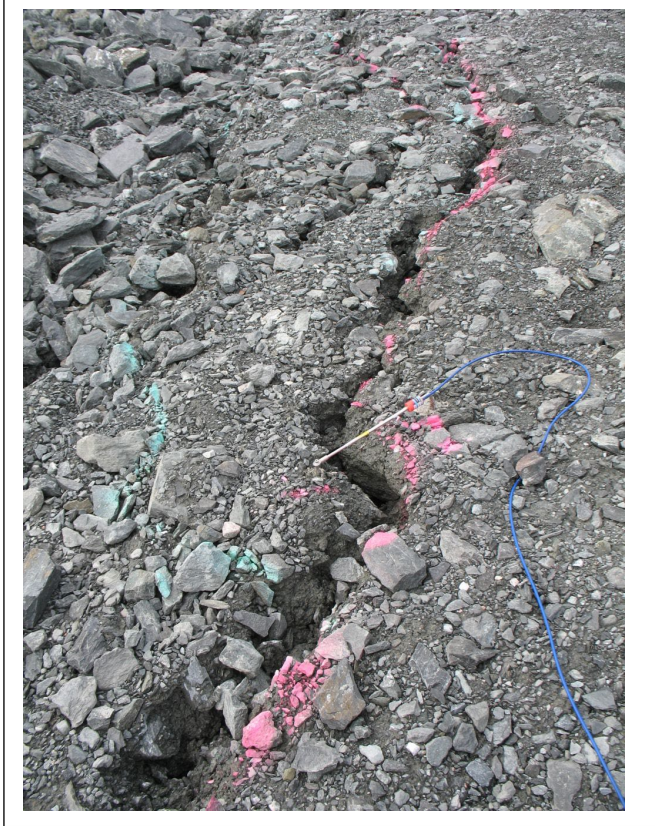
Photo #21 East abutment. Cracking on crest

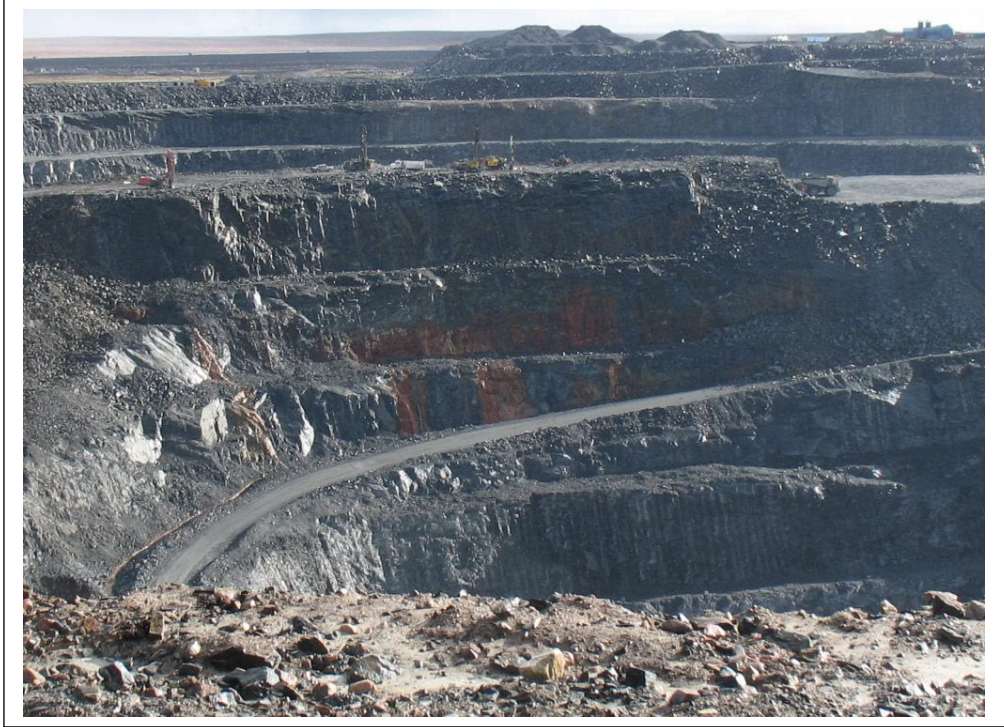
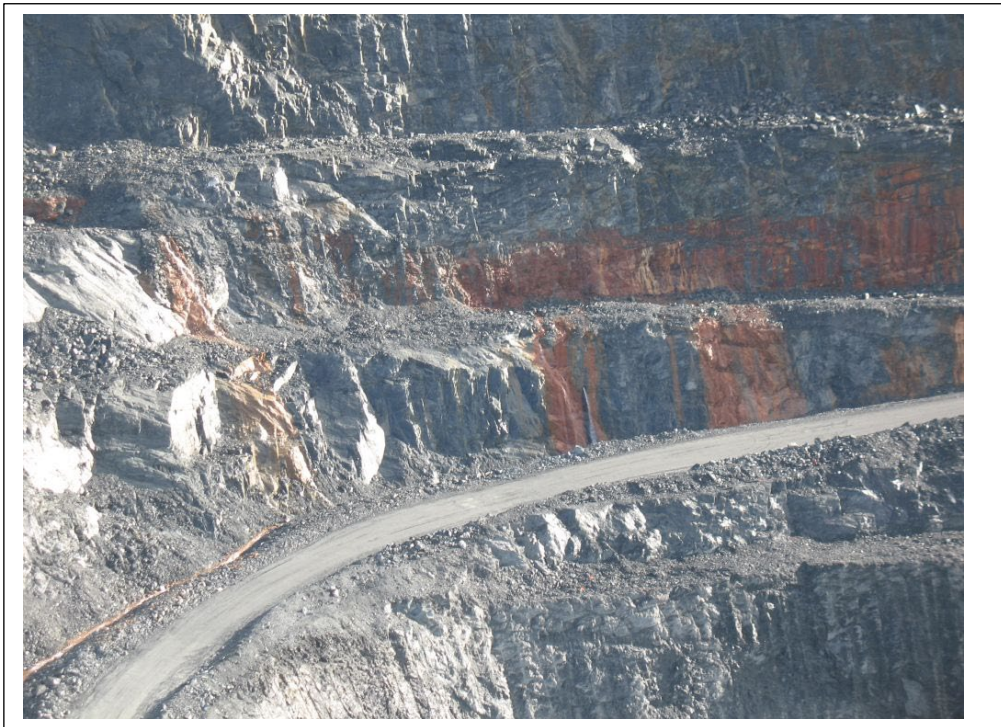
Seepage from the Whale Tail Dike area reports to the attenuation pond located in the vicinity of the Whale Tail Pit (South side). Seepage is noted on the south-east wall of the Whale Tail Pit (photo #23 and #24) and significant ice accumulation has been observed above the ramp. A push-back of this wall is currently underway as can be appreciated in the upper part of photo #23. The intent is to excavate a sump on the wide bench and to control by pumping the water flow that daylight on this North facing pit wall. This may be an optimal solution. However, depending on hydro-geological conditions, and the shape of the drawdown cone, water may still exit on to the pit wall at a lower elevation. If geological mapping reveals a significant conductor, the drilling of a pump well could be considered.

Photo #23 Whale Tail Pit, south wall

Photo #24 Whale Tail Pit, south wall, zoom

Recommendation Number	Location	Year ⁽²⁾	Recommendation	Action Plan/Follow-up	Status	Completion Date
MDRB#30-21	Whale Tail Pit	2022	The intent is to excavate a sump on the wide bench and to control by pumping the water flow that daylights on this North facing pit wall. This may be an optimal solution. However, depending on hydro-geological conditions, and the shape of the drawdown cone, water may still exit on to the pit wall at a lower elevation. If geological mapping reveals a significant conductor, the drilling of a pump well could be considered.	AEM has evaluated this option with Golder in 2021. It was found at the time that the hydrogeological condition of the pit would not be favorable to this mitigation technique. More details on this study could be shared with the Board at their request.	Closed	-
MDRB#30-22	TSF	2022	A re-arrangement of the SC of the TSF may be useful to reduce groundwater recharge and minimize seepage which exits at Central Dike.	AEM agrees that re-arranging the South Cell could be beneficial for water management, particularly for the Central Dike seepage. Additional tailings deposition needs to be performed at the South Cell to prepare the final tailings surface and high priority will be given to improving water management; more details to come on this with the new tailings deposition plan to be released in the upcoming months as well as the results of the ongoing study on the closure landform.	Ongoing	-
