### **Whale Tail MDRB Report No 25B**

Report No 25B, Amaruq  
Meadowbank Mine Dike Review Board  
Meetings September 9-11 and November 27, 2019

## 2.0 WHALE TAIL DIKE

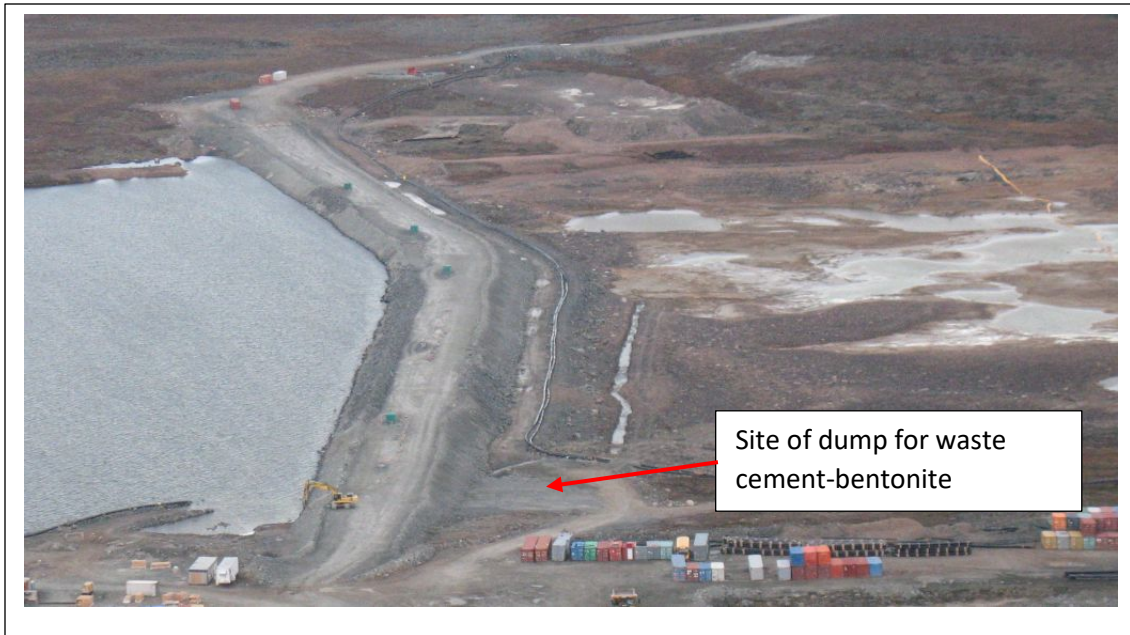
Aerial views of Whale Tail Dike are presented in Photos Nos 1 and 2. The downstream exposed lakebed has been drained by pumping, whereas the upstream (south) basin has filled due to runoff in the catchment and partly from water pumped back to the south basin. The water level had risen from 152.5 m to 155.7 m at the time of the site visit. Consequently, areas on the abutments have been submerged and a hydraulic gradient created across the Whale Tail Dike and its foundation.

Photo No. 1 Whale Tail Dike viewed from the East (Decreasing station)

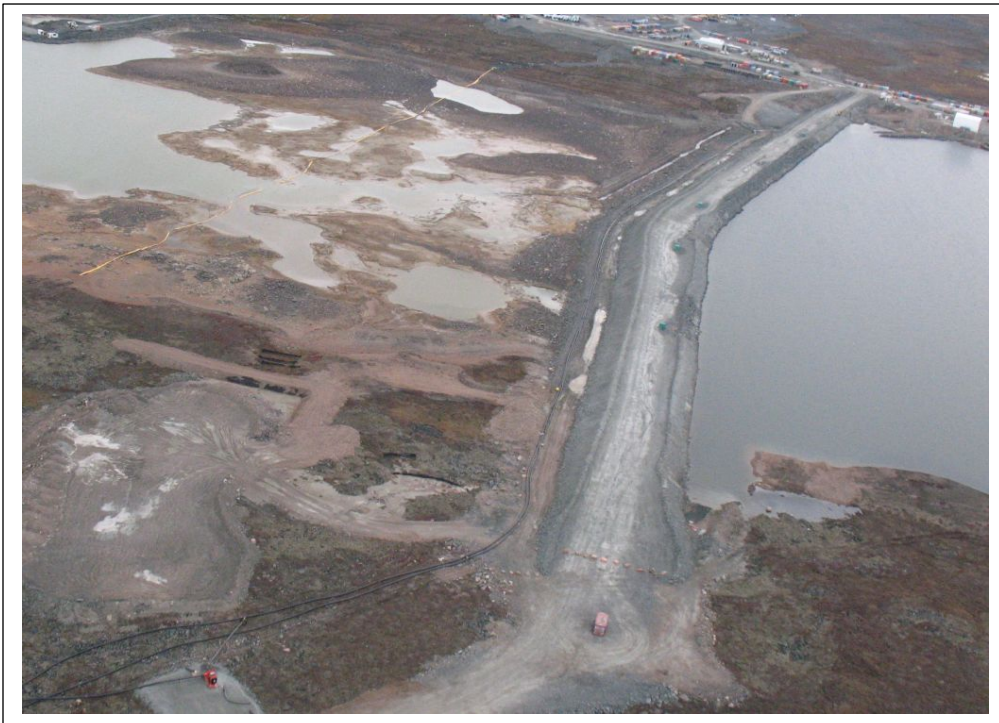
Photo No. 2 Whale Tail Dike viewed from the West (Increasing station)

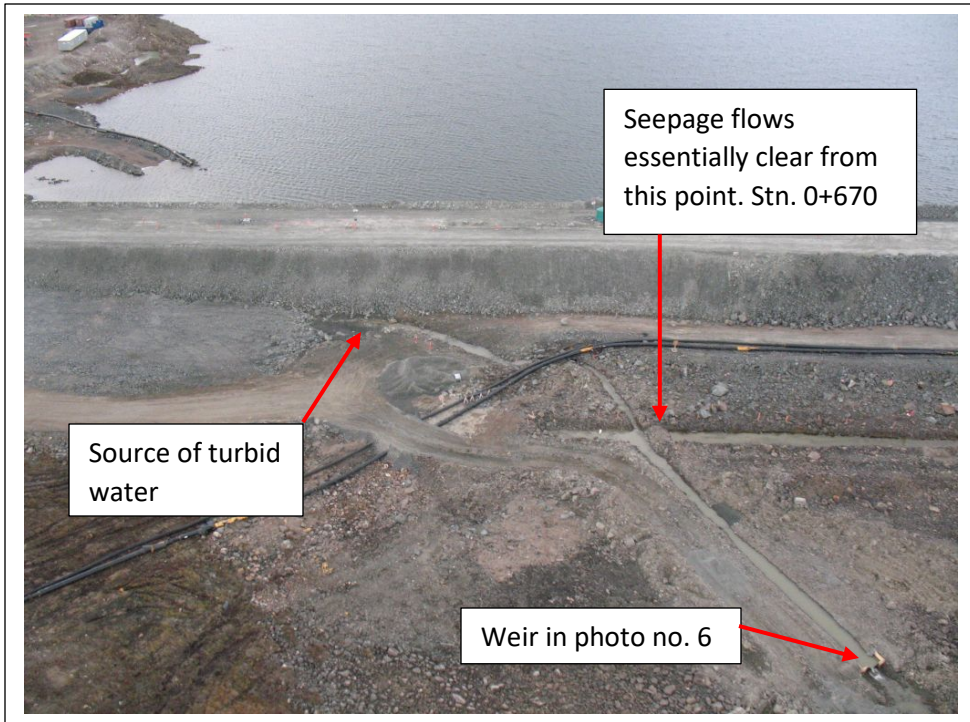
Seepage has been observed since the creation of this hydraulic gradient. Turbid water was noted near the east abutment soon after the start of drawdown whereas water discharged at the downstream toe near the dam centre from Stn. 0+670 towards the west abutment is clear (Photo no. 3). Examination of the area near the east abutment shown in photo no. 4 shows clear water discharging at the toe of the dam and sediment laden water from the waste dump side. It appears that this dump, used for the disposal of cement-bentonite waste during construction, is the probable source of sediment in the discharge water. Although much of this material has subsequently been removed, disturbance due to excavation activities has released additional sediment. The flow of the turbidity laden water is captured separately (photo no. 5) and measured at the V-Notch weir shown in photo no. 6.

Important questions were raised as to the source of the turbidity and the potential effect on the integrity of the dike cut-off. Cement-bentonite when cured has been demonstrated to be able to resist erosion under gradients similar to that at the Whale Tail Dike. The Board is of the opinion that the source of seepage water is more likely to be through discontinuities in the bedrock rather than windows in the cut-off wall.

Photo No. 3 East sector of Whale Tail Dike

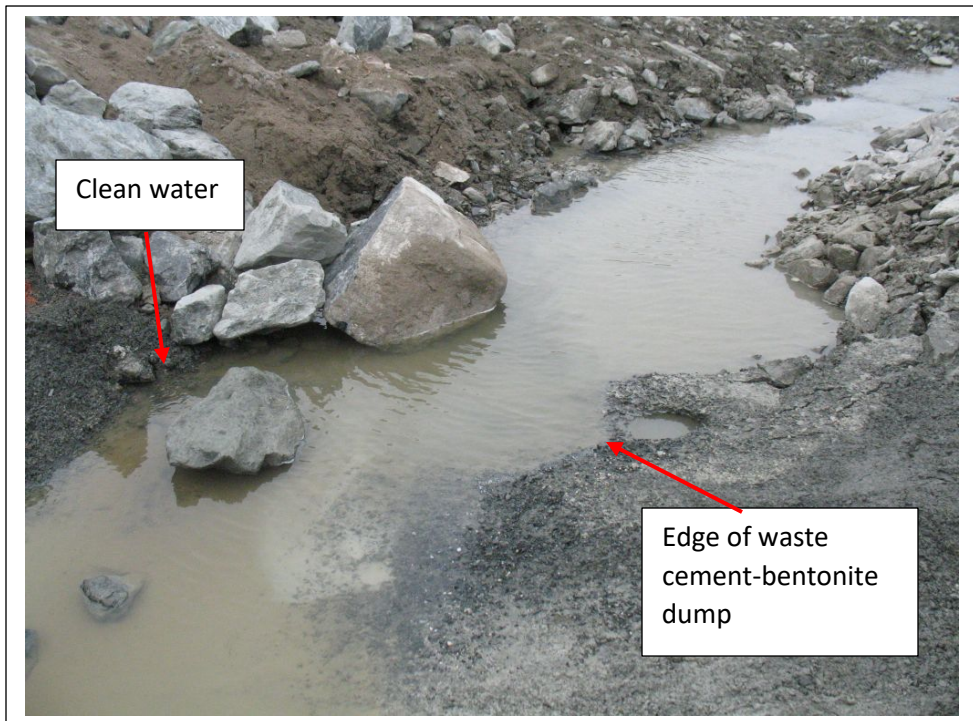
Photo No. 4 Source of turbid water

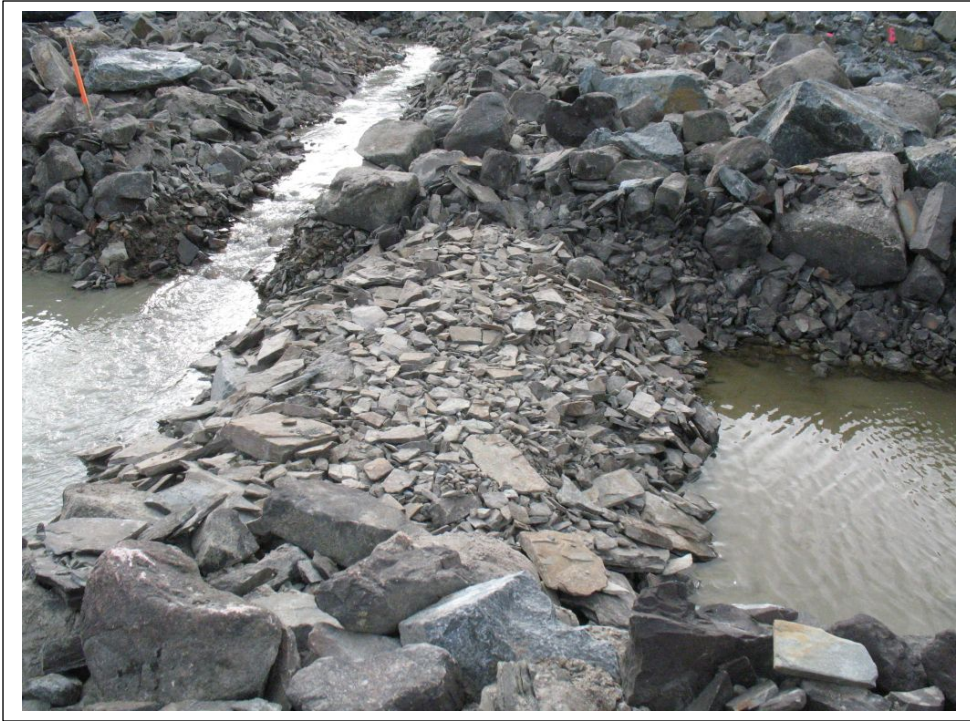
Photo No. 5 Dike to separate clean flow from turbid flow

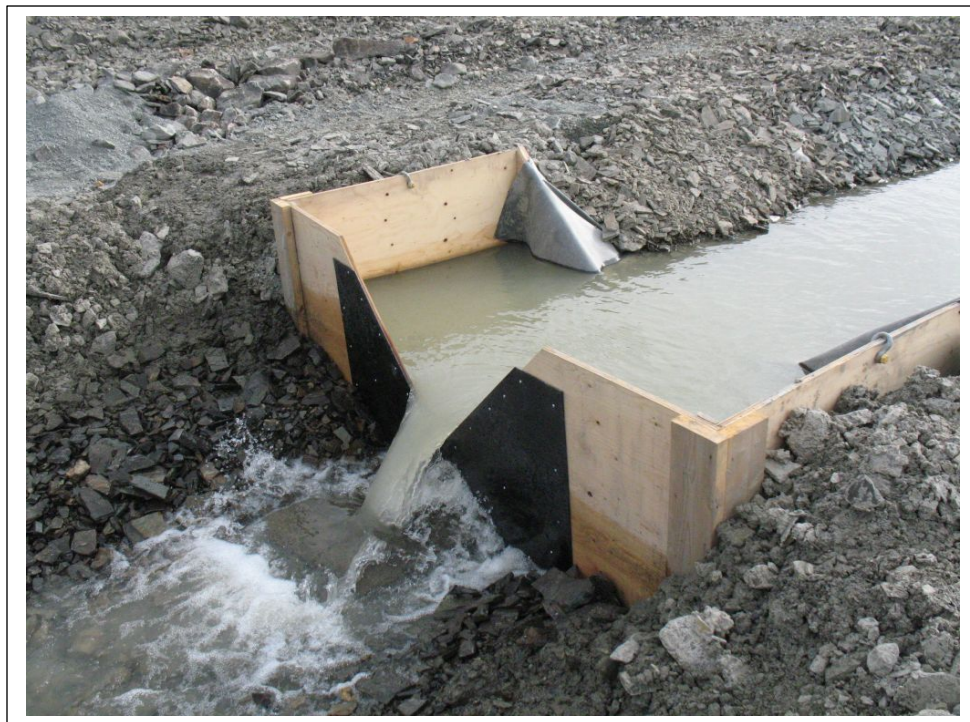
Photo No. 6 V-Notch weir for turbid flow

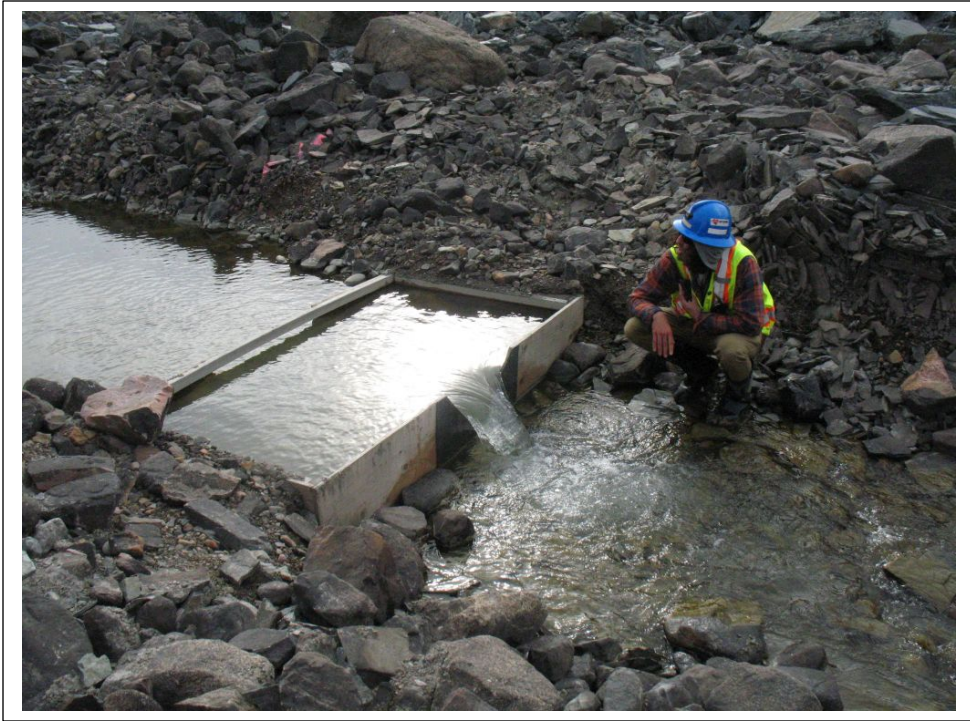
Several springs were noted over the remainder of the dike toe area but the water is clear. Temporary weirs were set up to measure the flow rates as shown in photos nos. 7 to 9. The western sector shown in photo no. 10 is not, as yet, instrumented. Small sand boils are also observed in this latter area (Photo no. 11).

Photo No. 7 V-Notch weir for clean water flow at Stn. 0+560

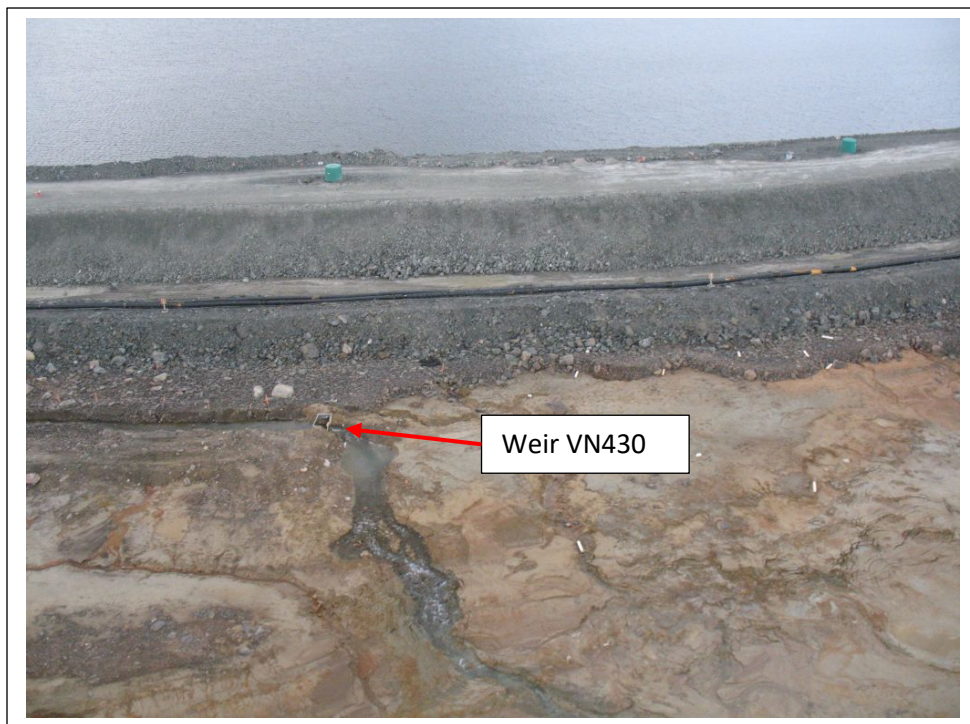
Photo No. 8 Central sector of Whale Tail Dike

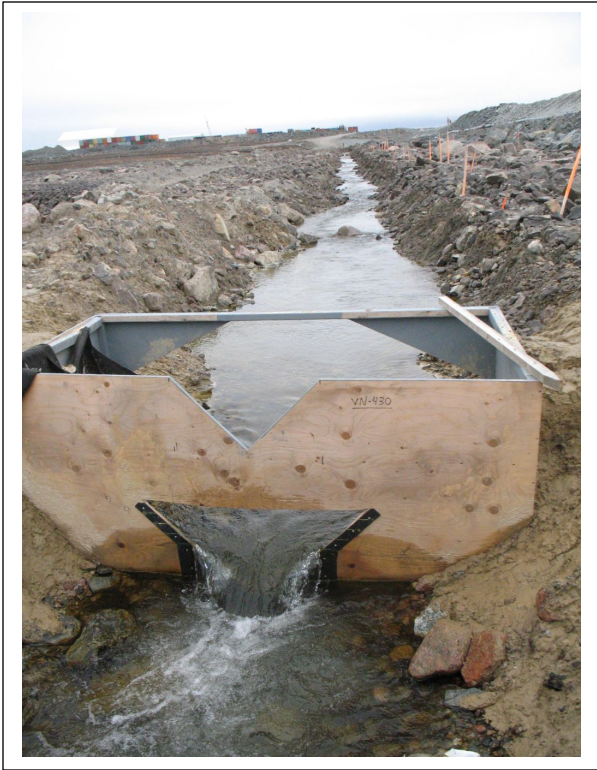
Photo No. 9 V-Notch weir for clean water flow at Stn. 0+430

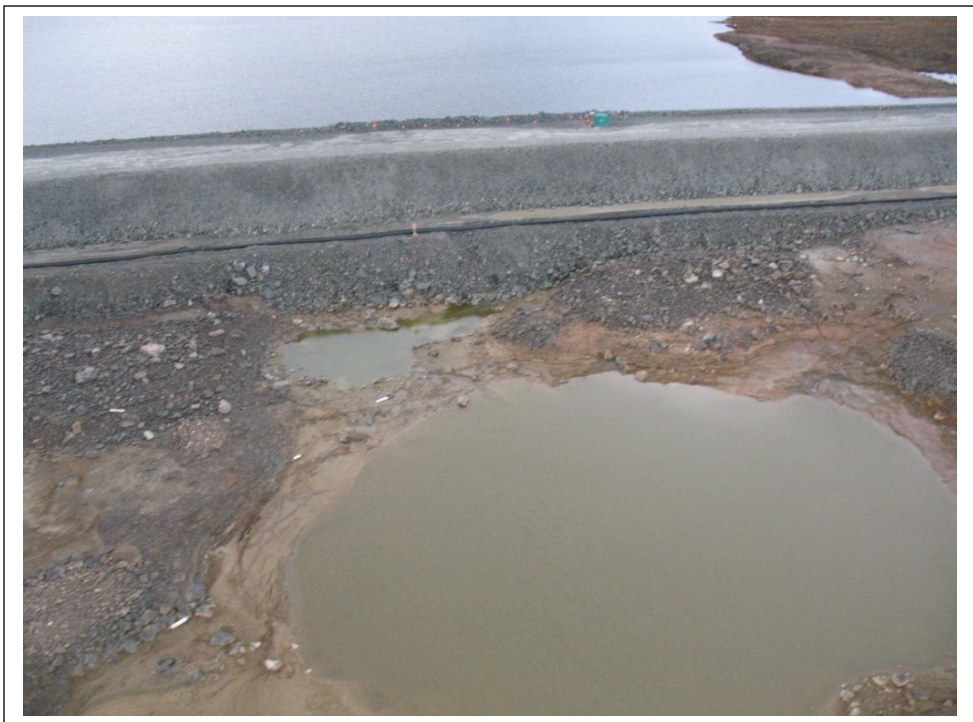
Photo No. 10 Western sector of Whale Tail Dike

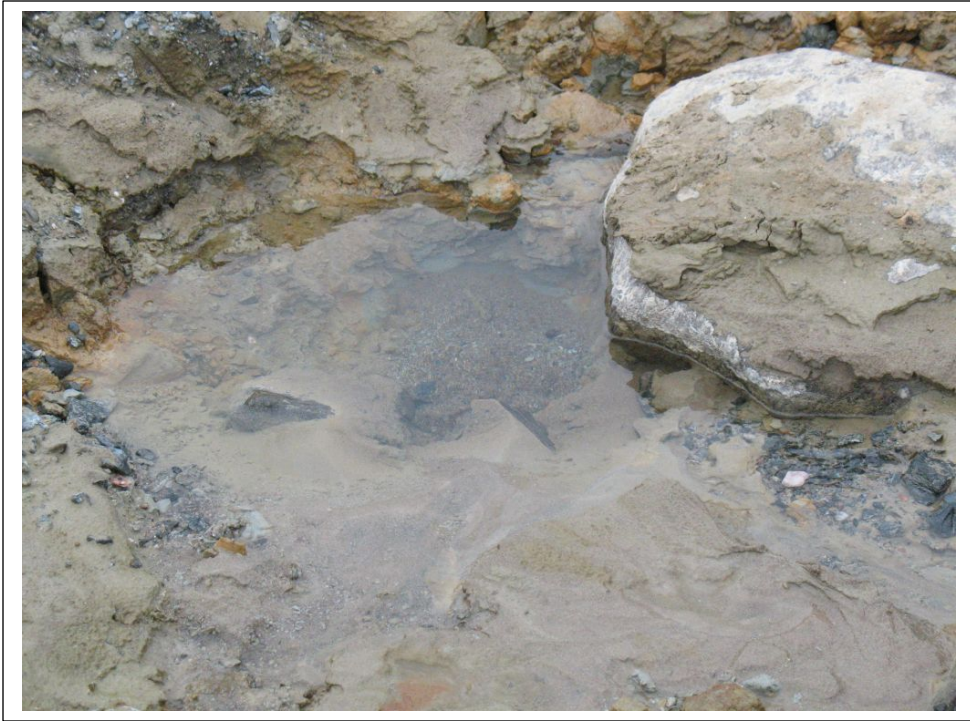
Photo No. 11 Sand boils in western sector

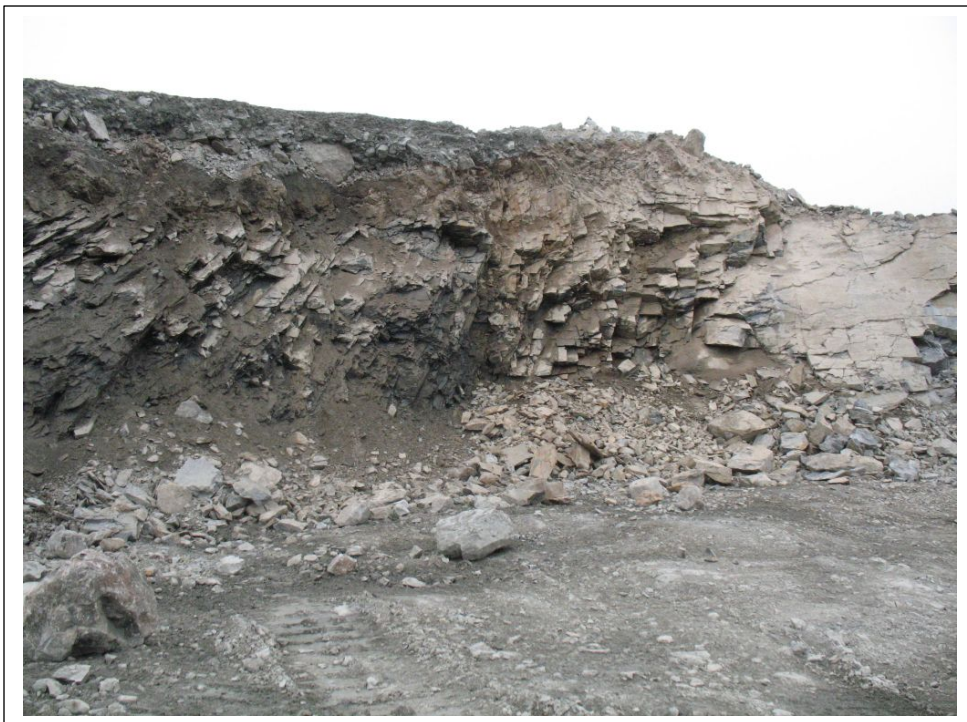
An exposure of Greywacke rock in the mine pit (Photo no. 12) may be illustrative of the fractured rock probably present below the eastern abutment of the Whale Tail Dike. Preliminary results of a "Willowstick" geophysical survey, released at the time of the Board visit, would tend to lend additional credence to the hypothesis of seepage flow through fractured and recently thawed rock. AEM is currently assessing the potential of achieving a reduction of flow by grouting. The Board endorses this work and sees the Willowstick survey results as enabling the exploratory drilling and grouting to be more focused.

Photo No. 12 Exposure of greywacke in Whale Tail Pit

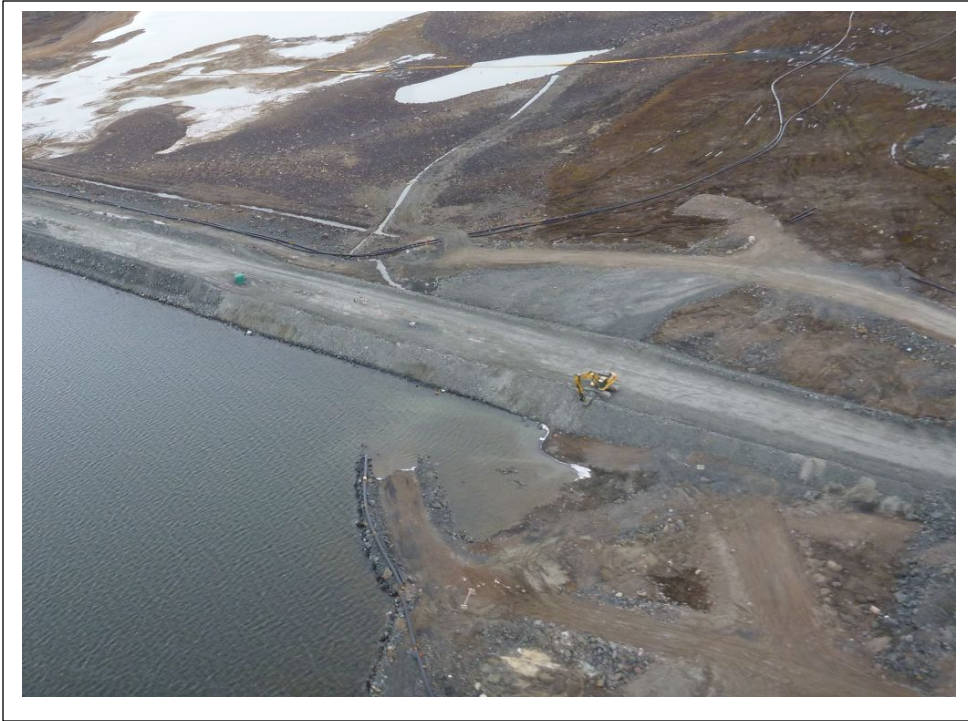
The Board also sees merit in enhancing the potential for freeze back to contribute to seepage reduction. Areas such as the submerged upstream east abutment, shown in photo no. 13, could

Photo No. 13 South Whale Tail Pond in vicinity of east abutment

be covered with low permeability, well graded granular fill (esker sand and gravel rather than rockfill) to minimize water heat flux and augment the surface area exposed to cold air temperatures in the upcoming winter season. A similar approach is suggested for the downstream side of the dike, both at the abutment and on the lakebed.

The Board wishes to reiterate its recommendation to add granular material or fine rockfill in the area at the east abutment on the upstream side where excavations have exposed the foundation to the water of the south Whale Tail lake. The fill should be placed to an elevation above the maximum estimated full head in the lake such that the fill surface is exposed to winter conditions that will encourage re-establishment of permafrost.

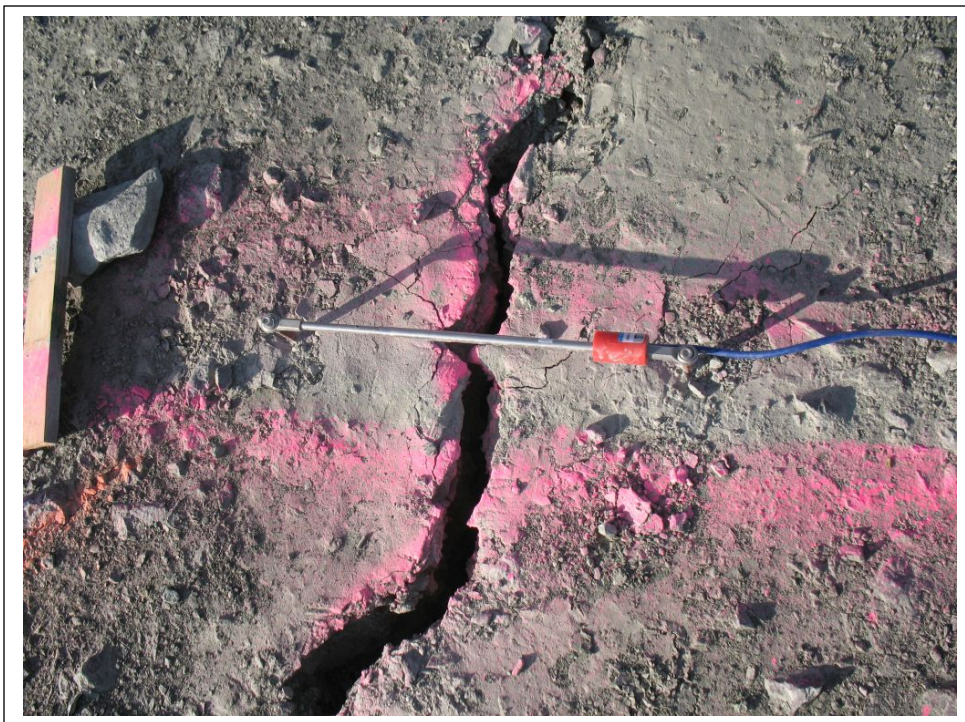
The cracks that have been observed on the dike crest (Photo no. 14) are also believed to be the result of thaw settlement in the overburden which remained below the upstream and downstream shells (see figure 1). Deformation of the dike has been noted in the results of the inclinometer measurements. This is likely also related to thaw settlement under the shells and to the application on the cut-off wall of hydrostatic thrust. The addition of a few survey monuments would permit monitoring of future movement on the outer edges of the crest.

Photo No. 14 Crackmeter at Stn. 0+715

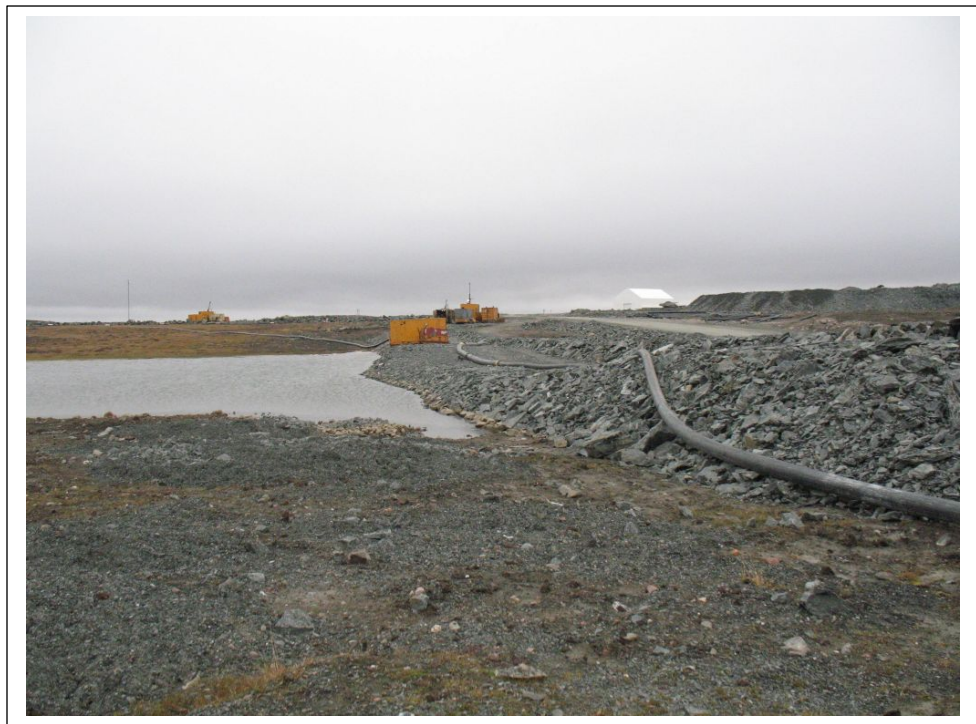
The North East (NE) dike was constructed to capture flows from a catchment to the north-east of the Whale Tail Pit and permit evacuation by pumping of this water before its entry to the pit area. Heavy rain during the 2019 season and slower than anticipated mobilization of pumping capacity led to encroachment on the freeboard during freshet. Seepage was noted downstream of the eastern sector of the dike. A pond still abuts against the upstream toe berm as shown in photo

Photo No. 16 Pond upstream of eastern sector of North East Dike

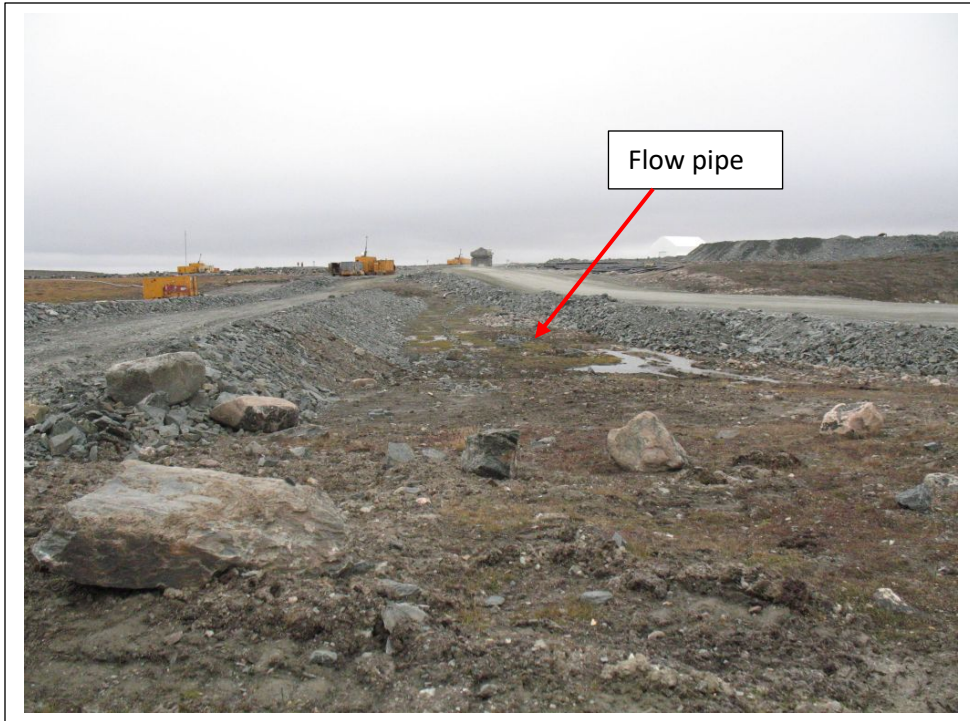
no. 16. Photos nos.17 and 18 show the flow pipe currently monitoring the ongoing seepage. There are no other instruments in this structure and therefore, the permafrost condition of the foundation cannot be verified. However, the presence of flow indicates the potential for permafrost degradation. This dike will have a short life-span (intent 2 years) and monitoring, together with enhanced pumping capacity for the 2020 freshet, may suffice. No additional information provided at the November meeting changes this view.

Photo No. 17 Location of flow pipe in photo no. 18

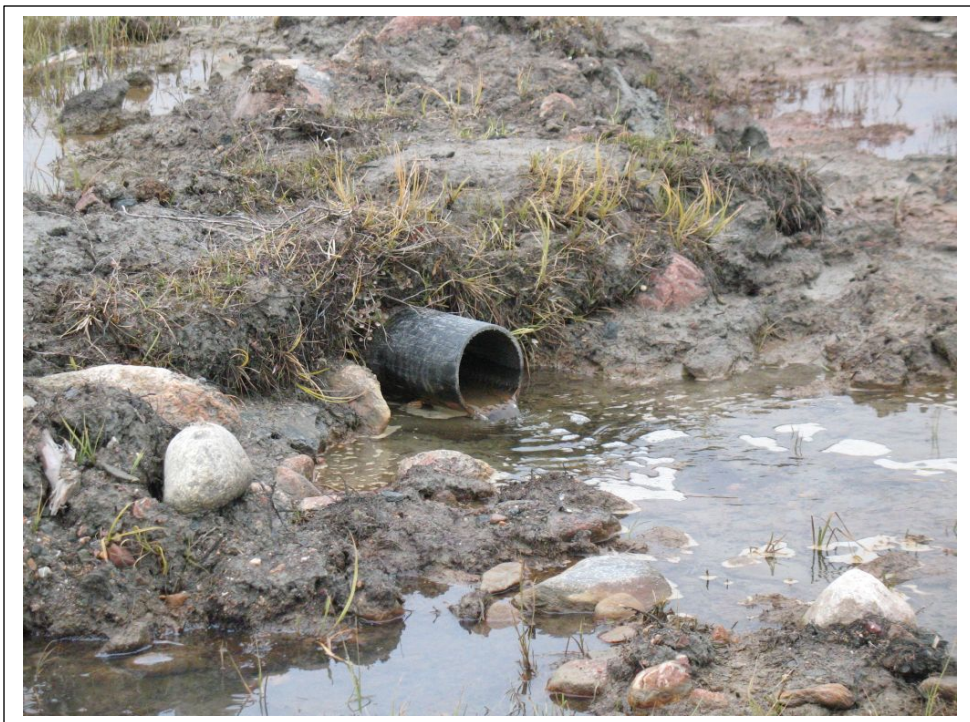
Photo No. 18 Seepage flow from NE Dike

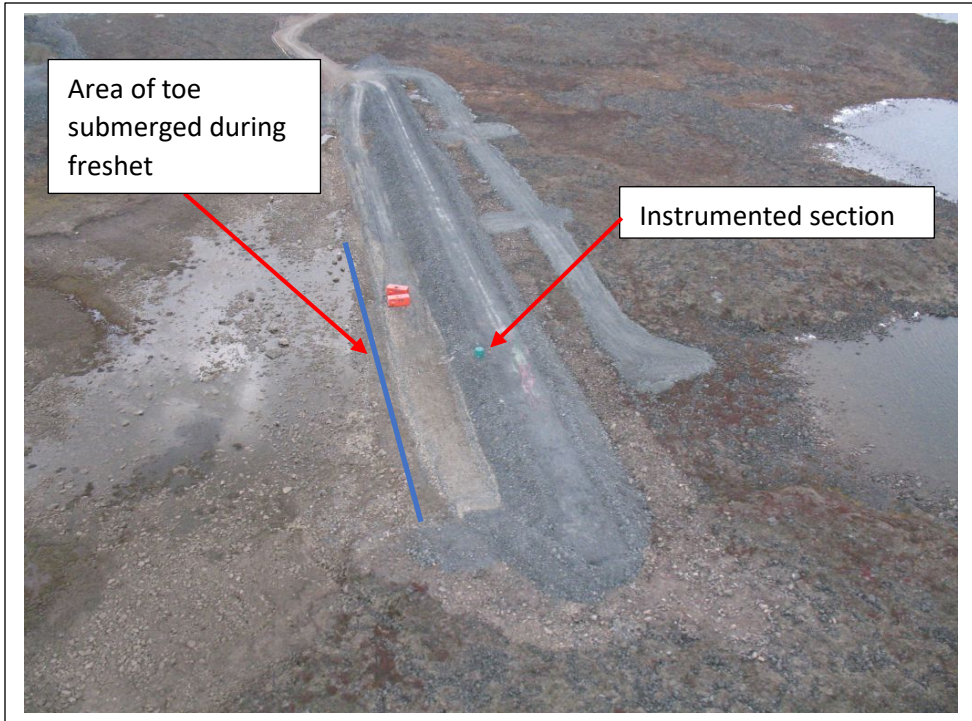
The extent of upstream toe submergence can be appreciated from photos nos. 19 and 20. What is also noticeable in the lower photo is the irregular surface that indicates where thaw settlement has occurred. The instrumented section (photo no. 19) may not be fully representative of the condition beneath the dike. The Board concurred with the suggestion to add thermistor strings to the east and the west of this point. The Board also suggested that the upstream berm be widened and thickened with granular material (sand and gravel) which would have three benefits:

Photo No. 19 WRSF Dike

1. Facilitate snow removal and enhance aggradation of ground freezing;
2. Reduce exposure to "warm" water during freshet; and
3. Reduce seepage rates in the event of the presence of a window.

AEM has prepared plans to add a zone of low permeability fill to the upstream berm as discussed with the Board at the November meeting. The Board emphasized the need to construct the fill of homogeneous well graded material and that the upper finished surface should be thick enough to remain well above the maximum potential water level and should be sloped into the reservoir. There will also be a need to adequately protect the existing instrument installations during this construction activity.

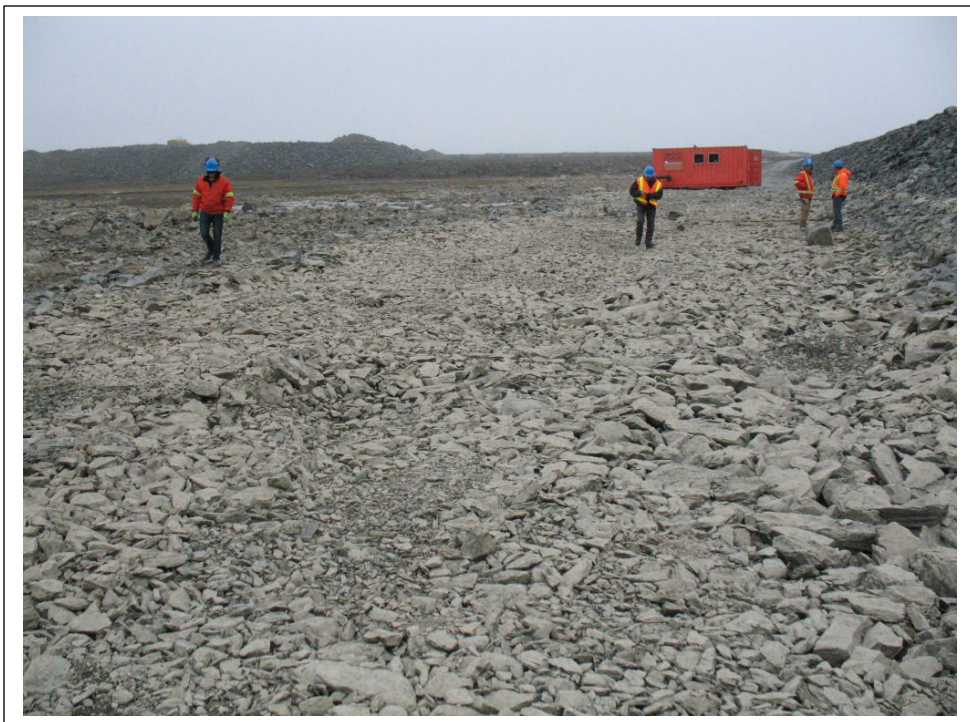
Photo No. 20 Upstream berm of WRSF Dike

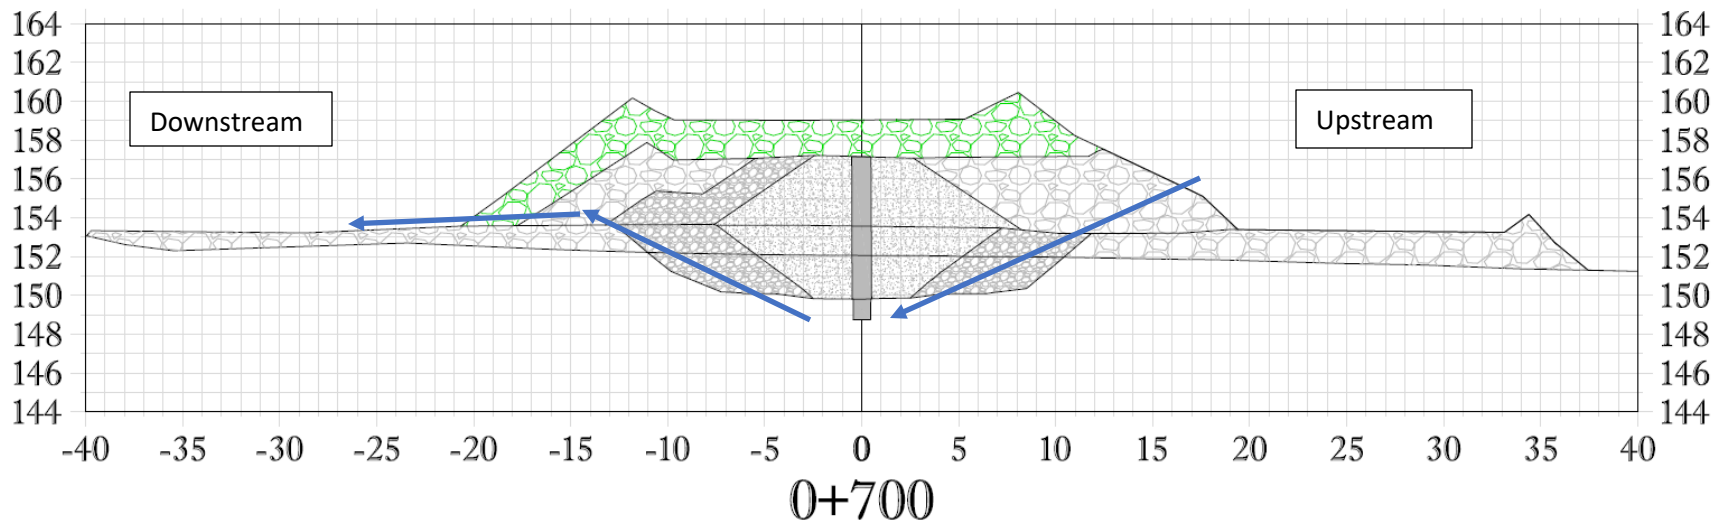
The abutments and much of the eastern side of the lakebed (shallow water) were in a permafrost condition. The Board had previously cautioned that the foundation rock in a permafrost condition is not amenable to grouting and, indeed, none was attempted beyond Stn. 0+516. A section through the dike is shown in figure 1. Ice rich overburden was excavated in the central portion down to bedrock and was replaced by fine and coarse filter material prior to the construction of the cut-off wall. The presence of "warm" lake water, particularly with the raising of the south basin, has initiated thaw of the ice in rock discontinuities which developed into a continuous process whereby seepage flow and the attendant heat flux led to an extension of the area of thawed foundation rock through which flow can take place.

Figure 1 Cross-section of Whale Tail Dike at Stn. 0+700 showing potential seepage pathways
