Appendix 25

Meadowbank GN spill reports

January 4th, 2018, Bac 7 Hydraulic Oil spill
(GN Report No 18-005)

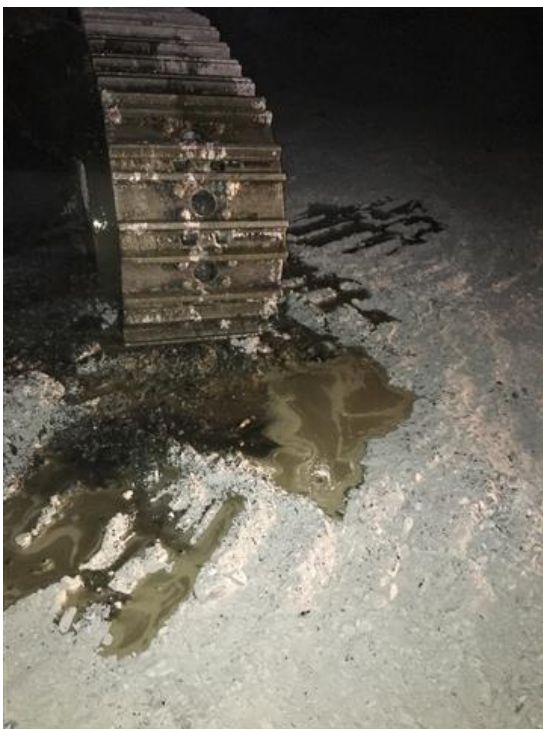
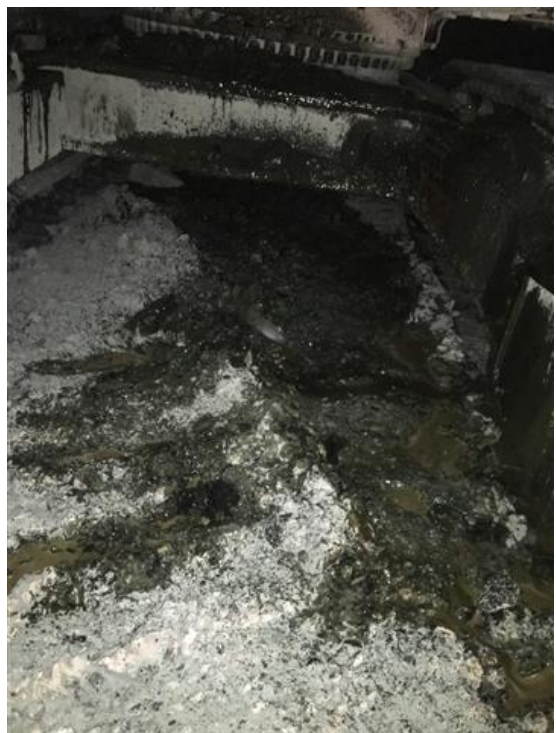
During the operation of his equipment, the operator saw a leak of Hydraulic Oil coming from the hammer. He stopped immediately the equipment.

The vibration, while we use the hammer, caused a friction between the hose and a metal part. With the pressure in the hose, this one busted and leaks happened.

The hoses are inspected as part of the preventive maintenance program done on site. Routine visual inspection of the hydraulic system is also performed during pre-operations checks.

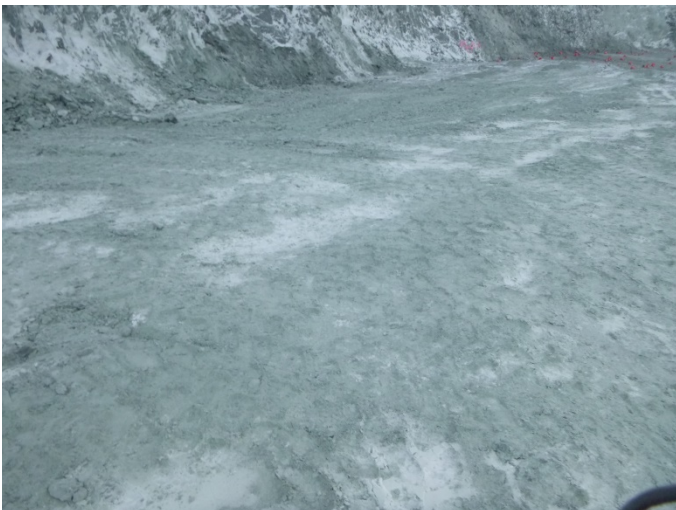
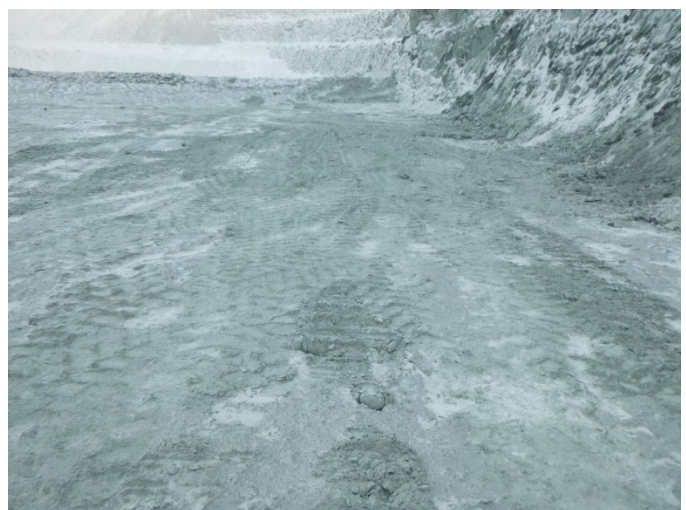
When the operator saw the leak, the equipment has been immediately stopped. He called a mechanic to fix the problem. All the contaminated material was collected and disposed in the landfarm.

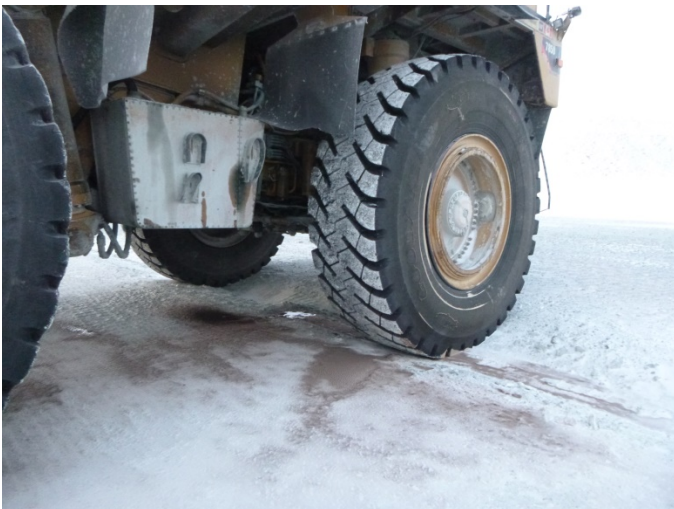
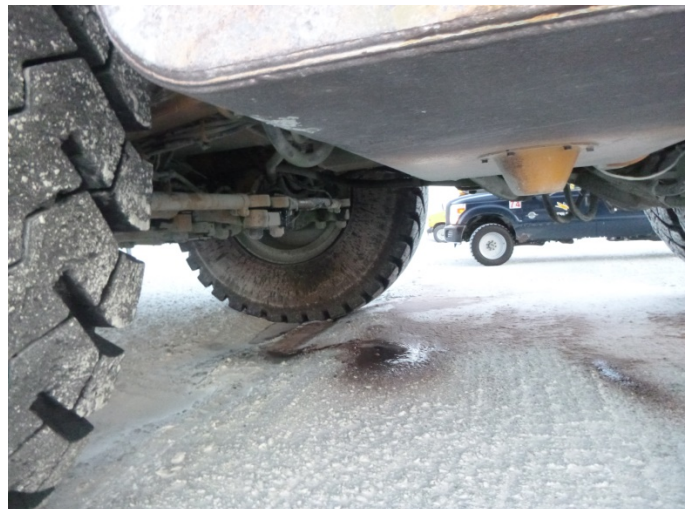
At the beginning of the shift, the operator took out his parking brake but the red light stayed on in the dash. The other truck drive beside, told him to stay there because he have a leak. The operator stopped the engine right away. Outside he saw the leak coming

The spill occurred after hydraulic hose broken on the hauling equipment.

The hydraulic system including hoses and fittings are inspected as part of the preventive maintenance program done on site. Routine visual inspection of the hydraulic system is also performed during pre-operations checks.

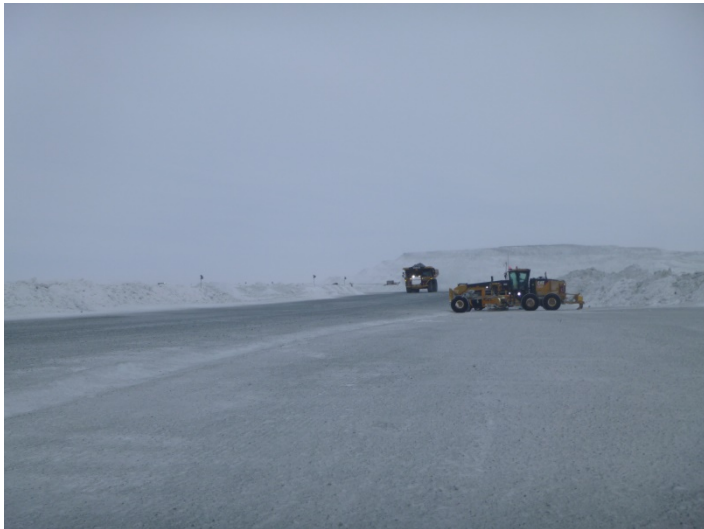
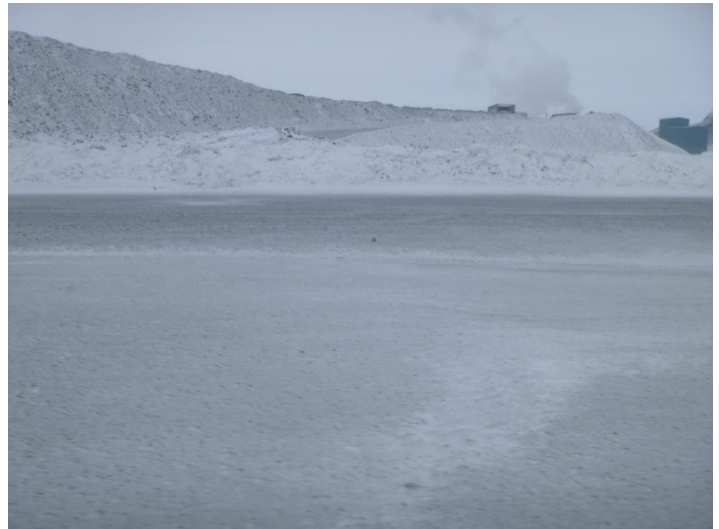
All contaminated material was collected and brought to the landfarm.

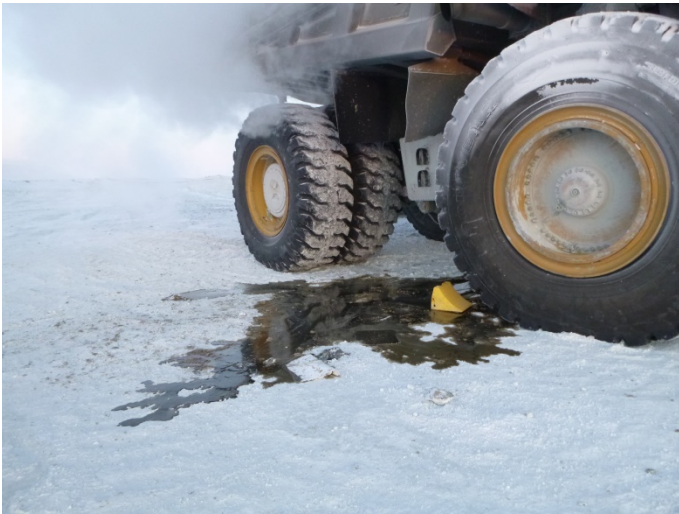
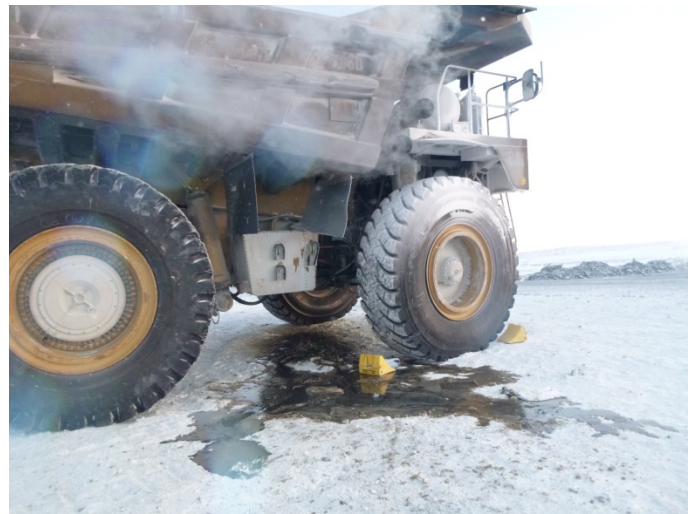
Haul Truck 20 was on standby because a brake issue. The engine was running idling to maintain enough heat in a very cold weather. A worker passed close to the Haul truck and saw a leak under the equipment. He called the maintenance shop to fix the problem.

The spill occurred after rear wheel seal broken.

The hydraulic system including hoses and fittings are inspected as part of the preventive maintenance program done on site. We keep the motor of the haul truck running during a very cold weather, it help to maintain a good oil temperature and it put less stress on the seal.

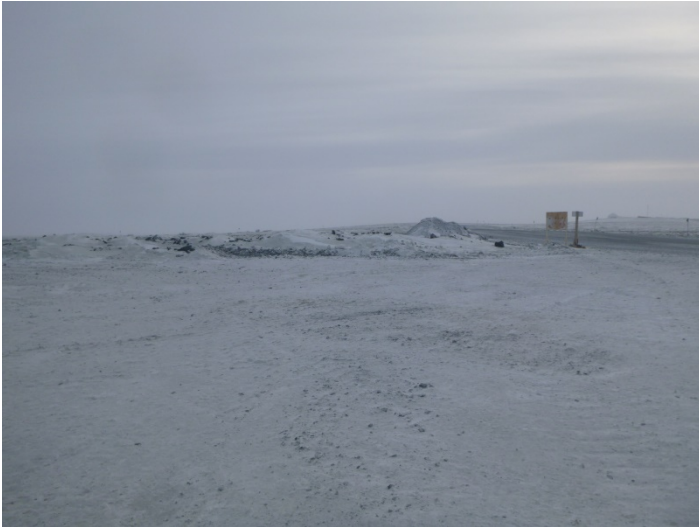
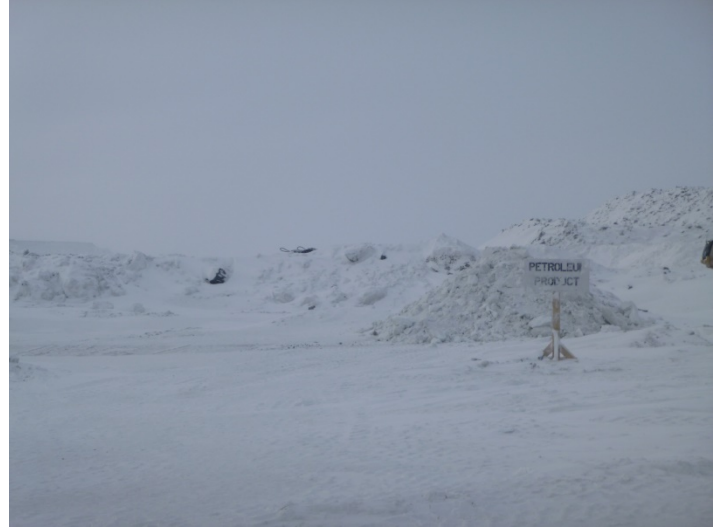
All contaminated material was collected and brought to the landfarm.

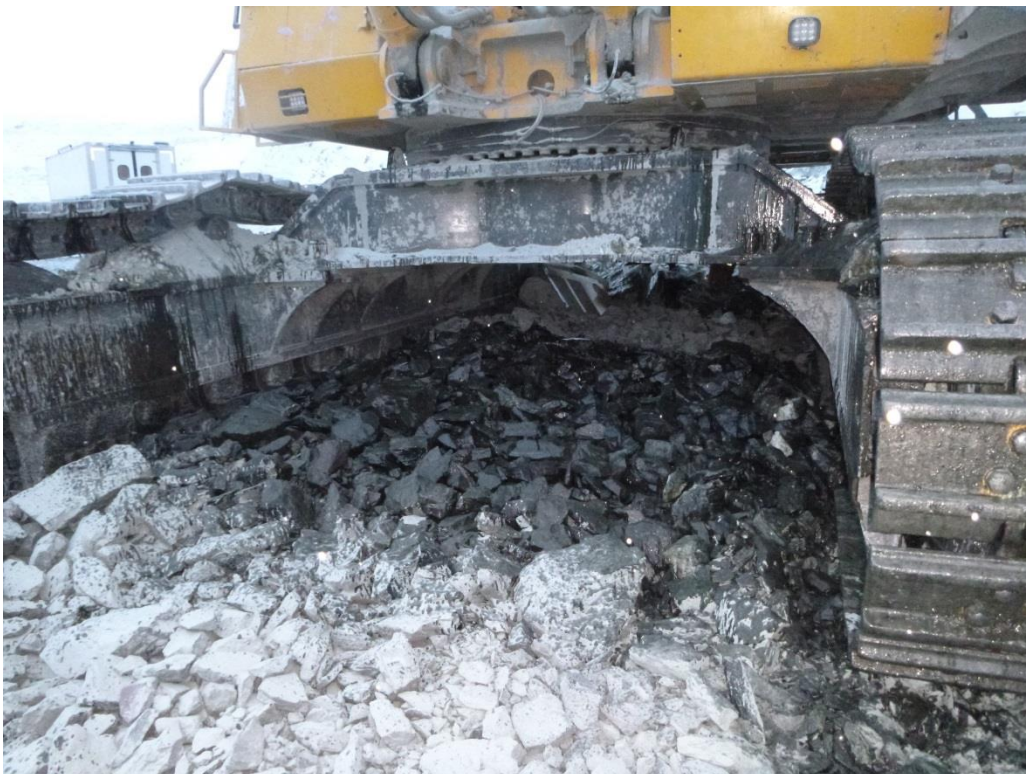
During loading operations in Pit E3, an hydraulic line on the backhoe failed and caused fluid to be spilled on the ground.

The spill was caused by the failure of a hose on one of the lines of the main hydraulic pump.

The hydraulic system, including hoses on equipment, is inspected as part of the preventive maintenance program done on site. Pre-operation checks also include visual inspection of the hydraulic system.

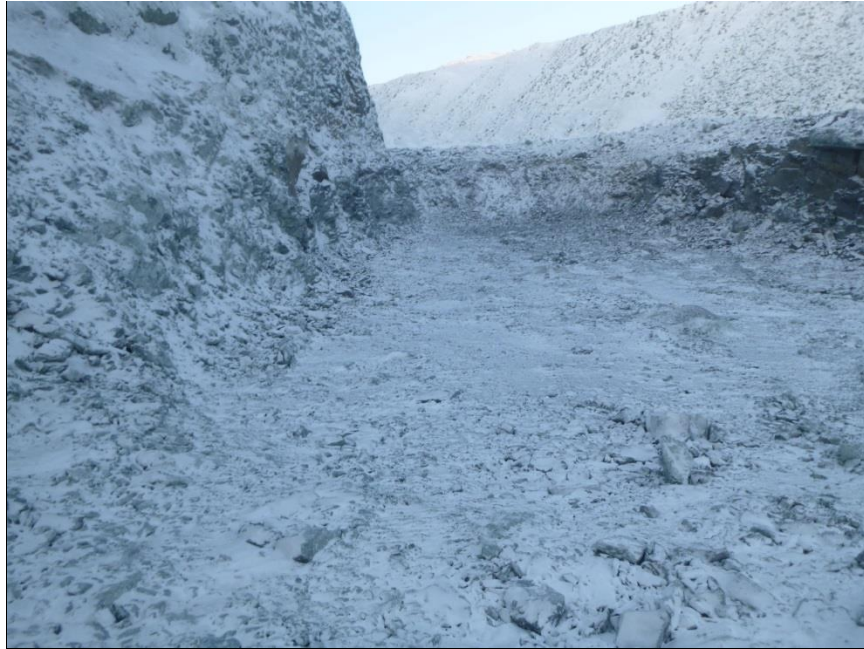
The equipment was stopped as soon as the operator noticed the leak, thus stopping the spill. Upon field repair, the equipment safely was removed from the area and the contaminated area collected. A section of the loading zone being ore, the majority (75%) of the collected material was brought to the crusher to go through the milling process. The remainder of the material was brought to the Landfarm area.

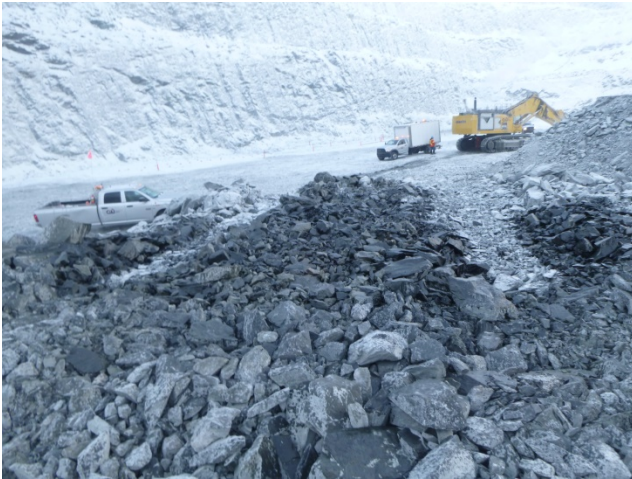
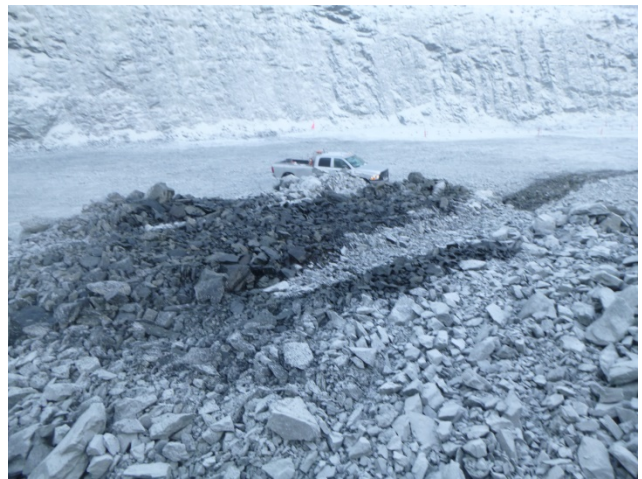
The shovel was mucking on a pad of marginal and the grade control technician saw some oil and smoke coming from the shovel. The operator saw it too and brought the shovel out of the pad for future repair. The oil made a major trail on the ground and the trail is probably on the waste material or marginal

The spill occurred after hydraulic "O"Ring failure on the equipment.

The hydraulic system including hoses and fittings are inspected as part of the preventive maintenance program done on site. Routine visual inspection of the hydraulic system is also performed during pre-operations checks.

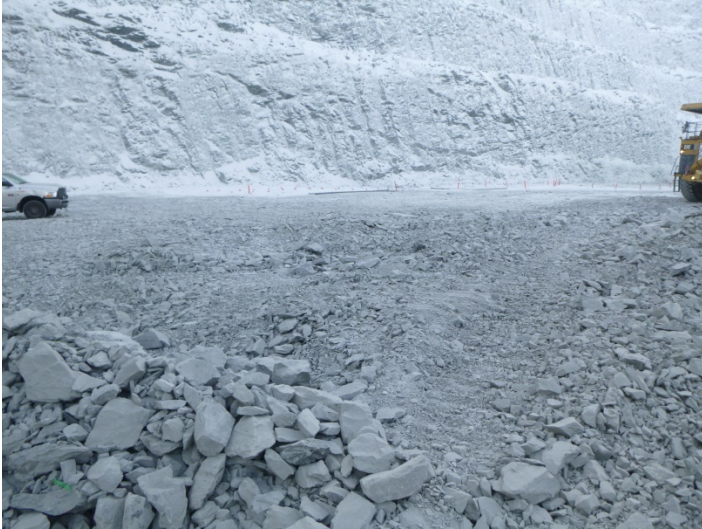
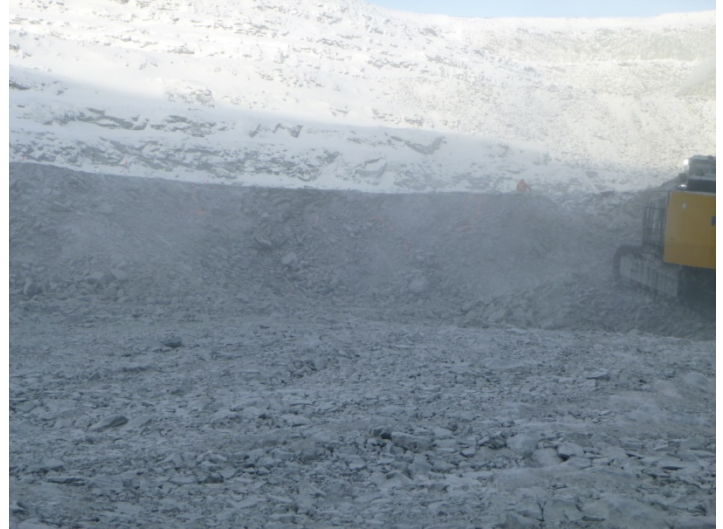
All contaminated material was collected and brought to the crusher.

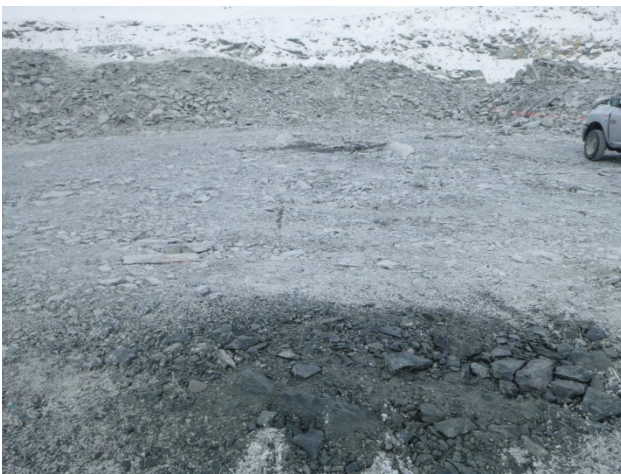
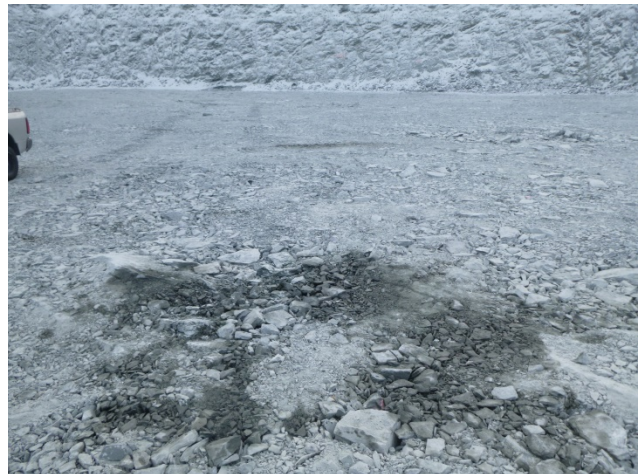
During the day shift, the stick had a small leak. But it was getting worst during a night shift and it the maintenance had decided to stop the shovel and brought it to the shop to fix the problem.

The spill occurred after hydraulic "O-ring failure on a cylinder of the equipment.

The hydraulic system including hoses and fittings are inspected as part of the preventive maintenance program done on site. Routine visual inspection of the hydraulic system is also performed during pre-operations checks.

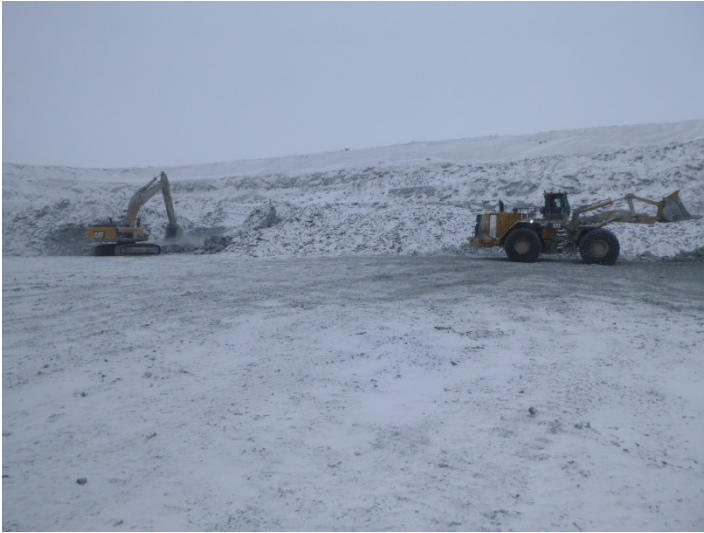
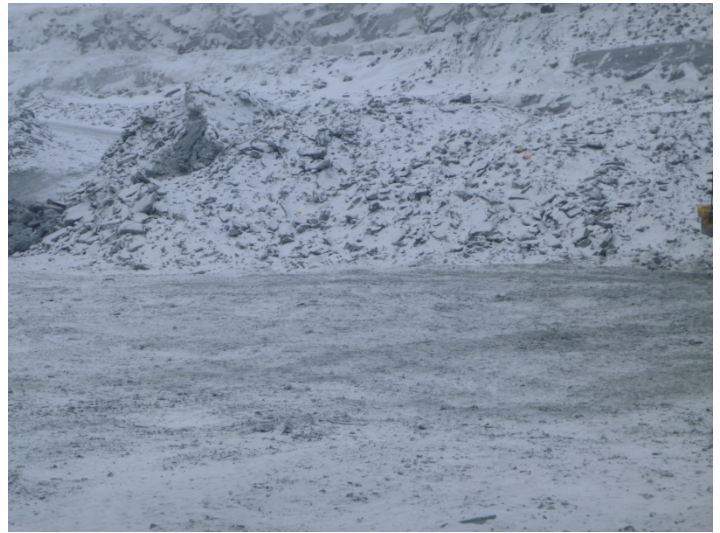
All contaminated material was collected and brought to the crusher.

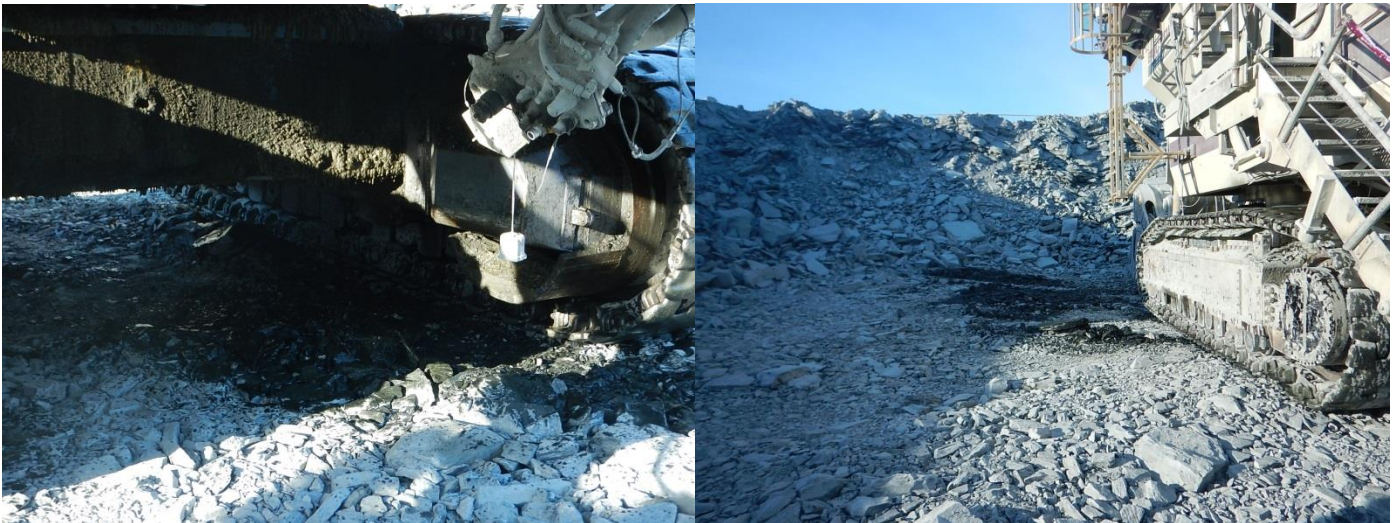
During loading operations in **Phaser Pit**, the driver of the haul truck noticed a spill from the loading equipment, BAC11, and called the operator to notify him of the situation. The machine was safely moved out and stopped for repairs and cleanup.

The spill was caused by the failure of a O-ring on the hose on one of the lines of the main hydraulic pump.

The hydraulic system, including hoses on equipment, is inspected as part of the preventive maintenance program done on site. Pre-operation checks also include visual inspection of the hydraulic system. This equipment BAC11, was also brought in for complete and full maintenance, including the hydraulic system.

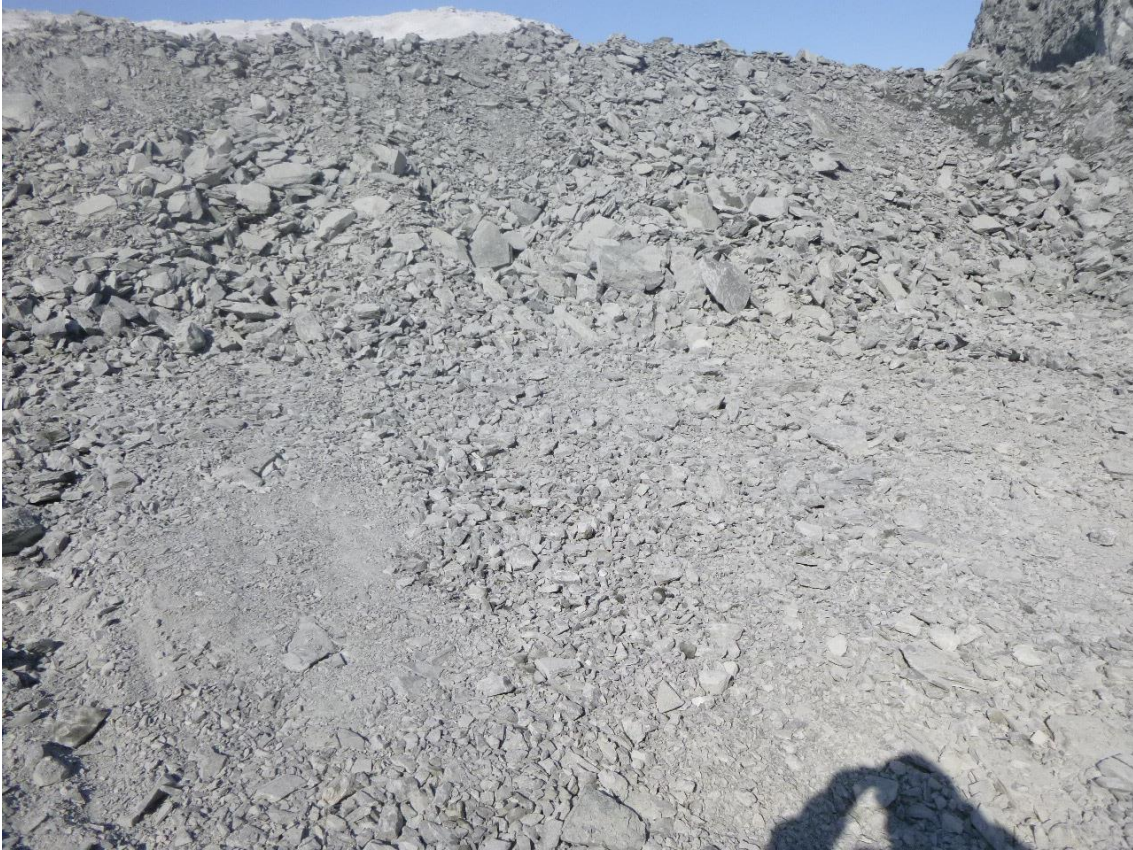
The equipment was stopped as soon as the operator noticed the leak then moved for field repairs and to proceed to clean-up of the area. The contaminated material collected was brought to the Landfarm.

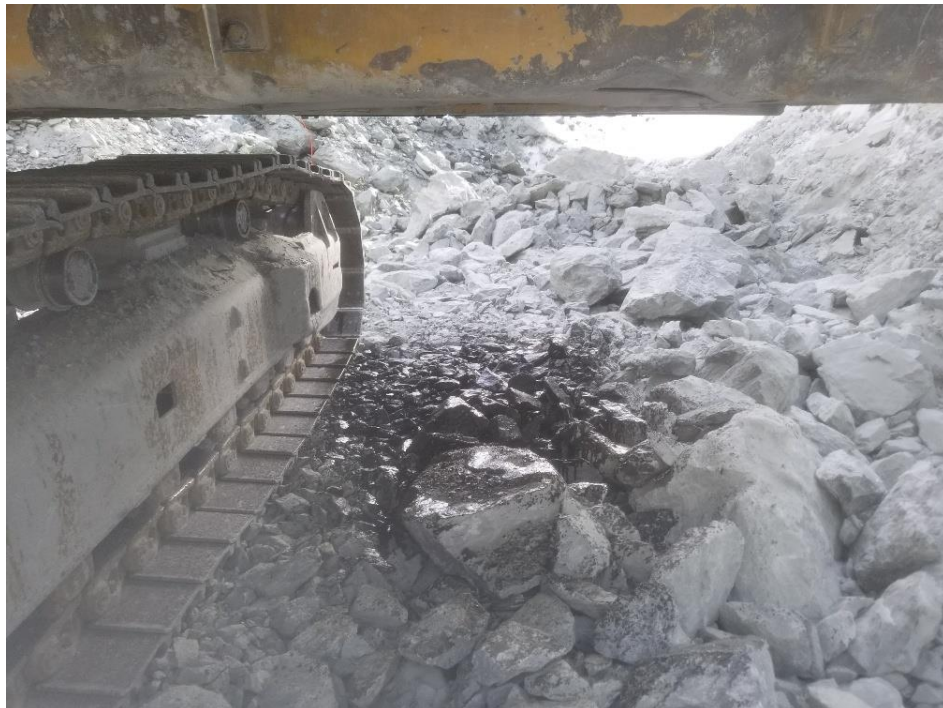
During operations in Pit A the hydraulic pump of the backhoe failed and caused hydraulic oil to spill in the ground.

The spill was caused when a rock underneath the unit damaged the hydraulic pump of the equipment.

Operators were reminded of ensuring a clear work area to prevent rock damage during loading and cleaning operations and performing proper and continuous work area inspections during work shift.

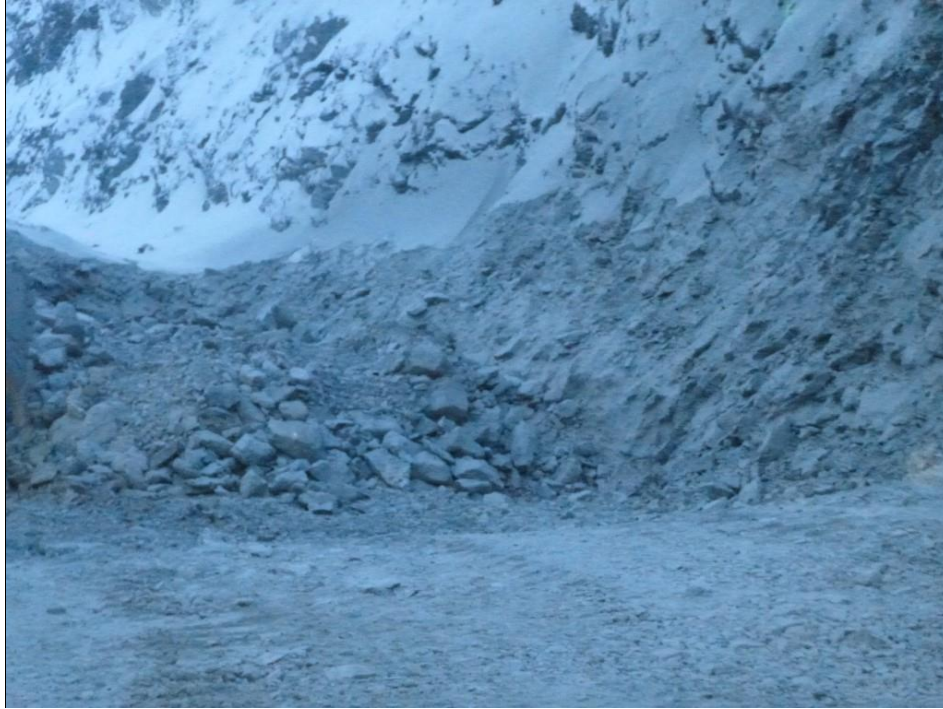
The equipment was stopped as soon as the operator noticed the leak. Once repaired, the area was scrapped clean. Being ore, it was collected and brought to the crusher to go through the milling process.

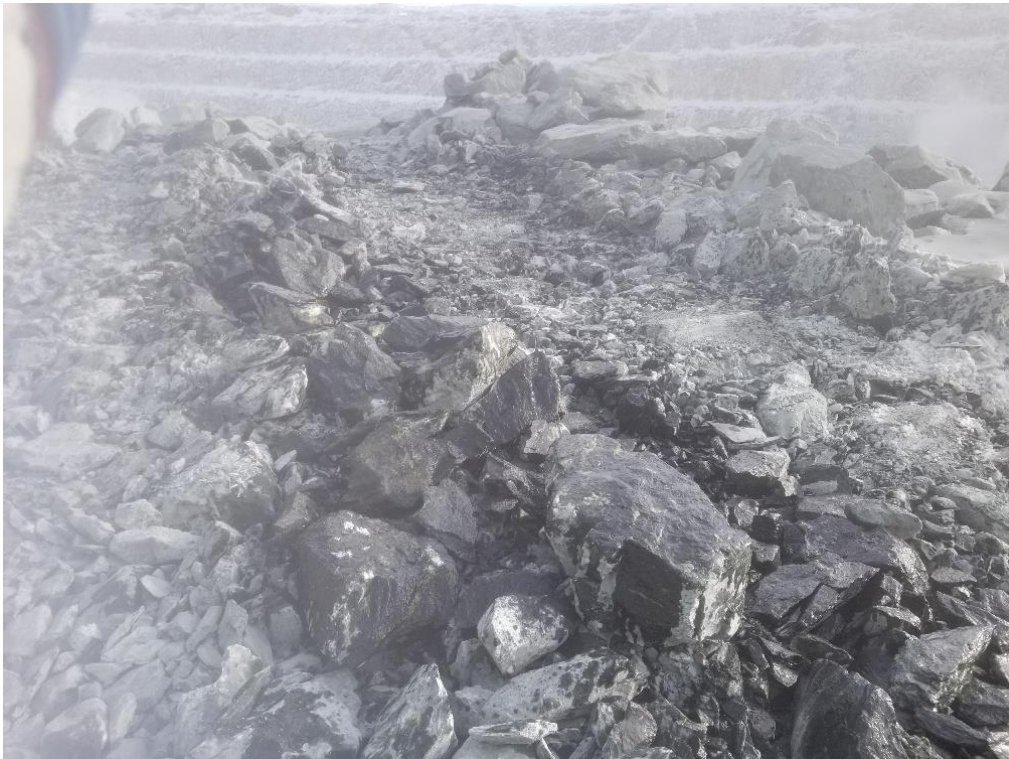
The spill was caused when steel supporting pipe on the main boom stick broke causing hydraulic oil to be spilled on the ground.

The hydraulic system, including hoses on equipment, is inspected as part of the preventive maintenance program done on site. Pre-operation checks also include visual inspection of the hydraulic system.

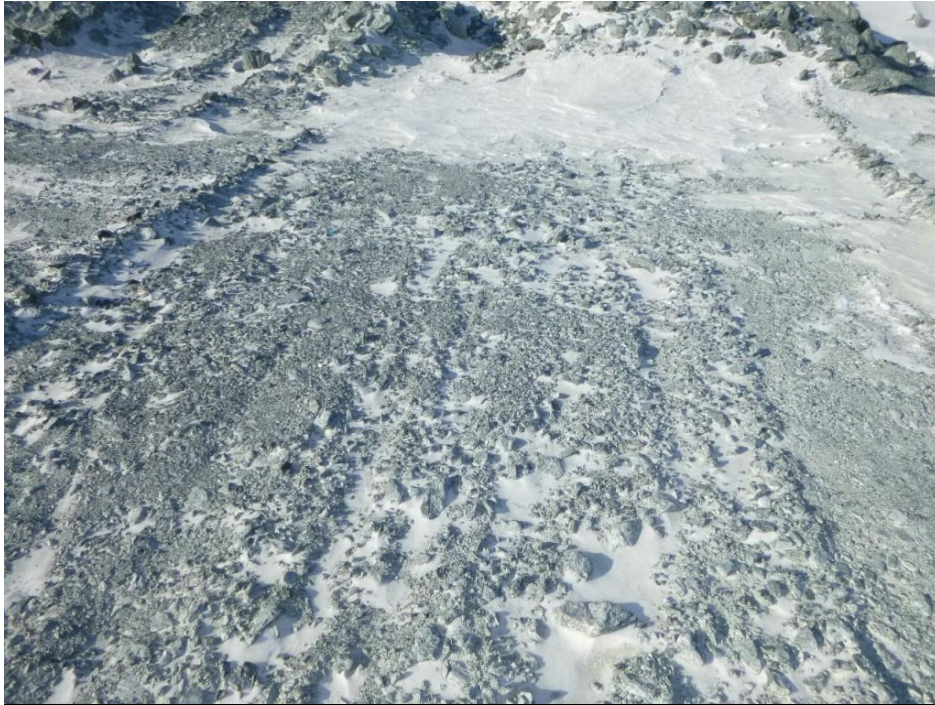
The equipment was stopped immediately for field repairs. Once completed, the area was scrapped clean and contaminated material was brought to the Landfill.

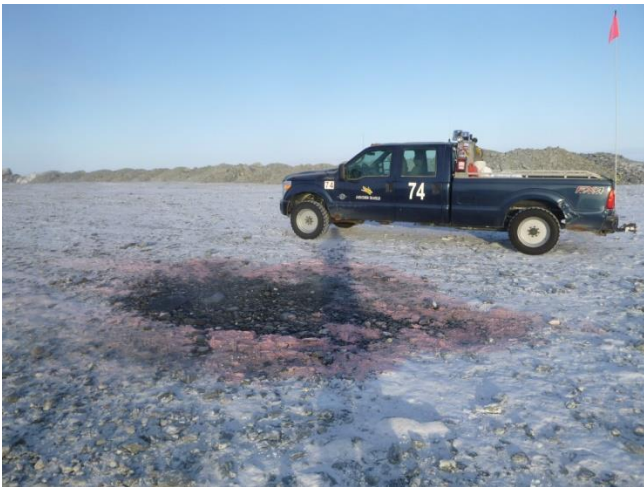
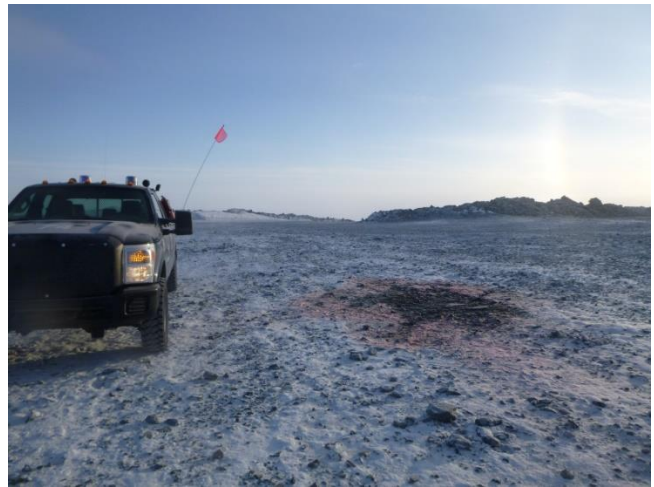
A bearing from the radiator fan has broken. The fan hit the radiator and punctured it. The radiator has emptied from his content. The operator called a mechanic department to repair it.

The spill was caused when the bearing from the radiator broke and hit the radiator.

The coolant system, including hoses, radiator on equipment, is inspected as part of the preventive maintenance program done on site. Pre-operation checks also include visual inspection of the coolant system.

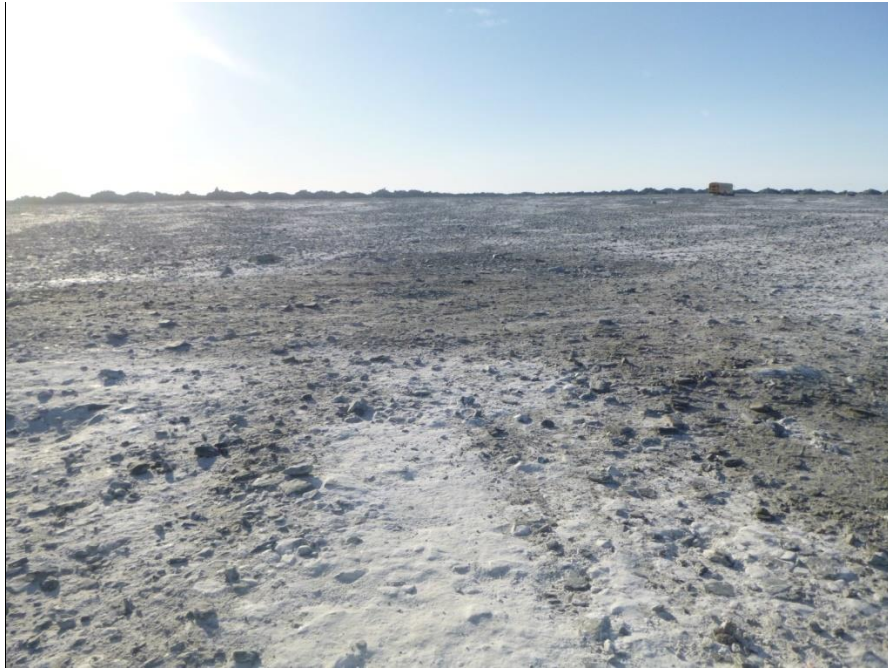
The equipment was stopped immediately and the maintenance was advised for repairs. All contaminated material was brought to the proper place.

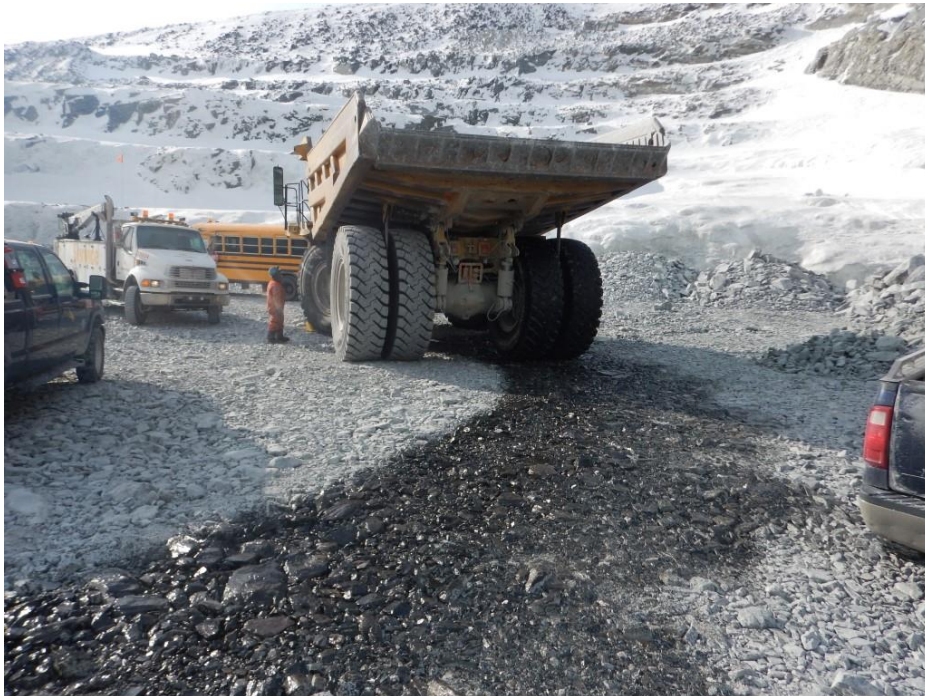
The spill was caused when the hoist cylinder on the hauling equipment failed during operations, causing hydraulic oil to be spilled on the ground.

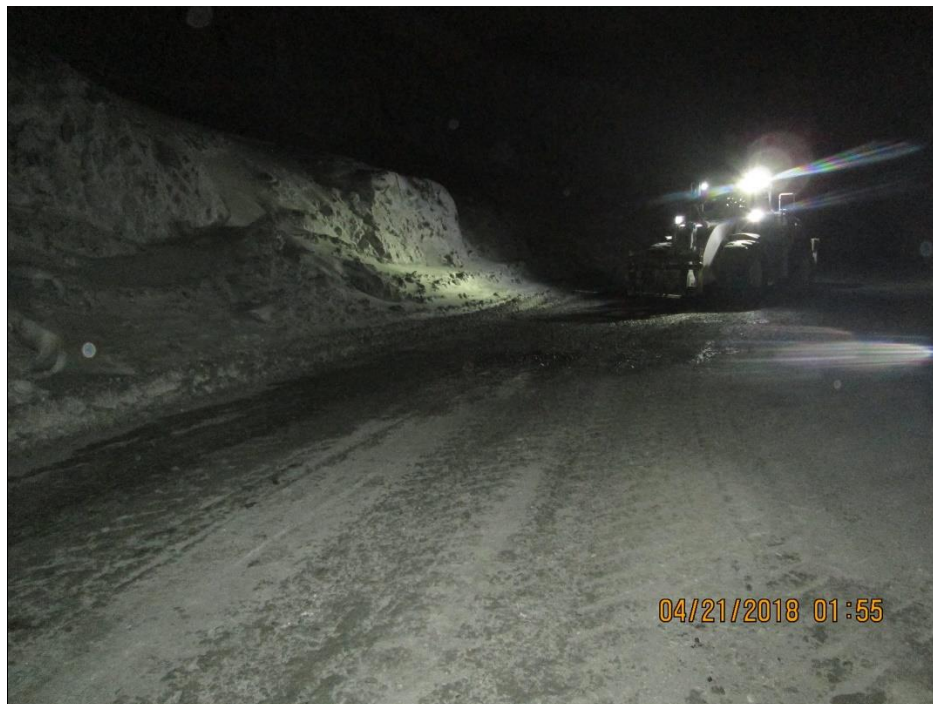
The spill was caused by the failure of coolant hose.

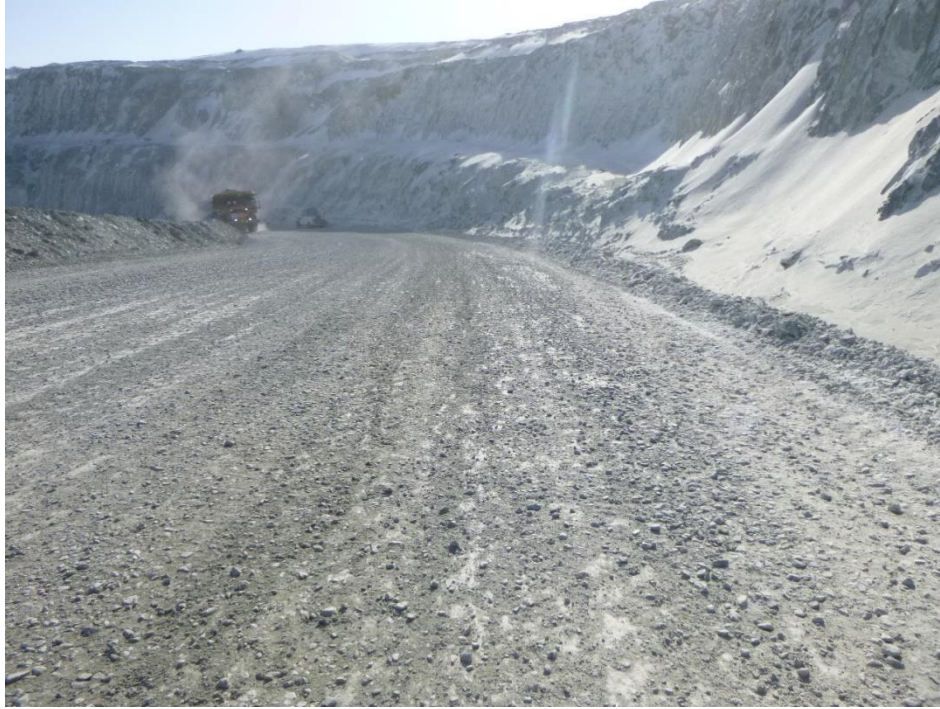
The equipment was stopped and the contaminated material was recovered by a 980 loader and brought to the tailings area

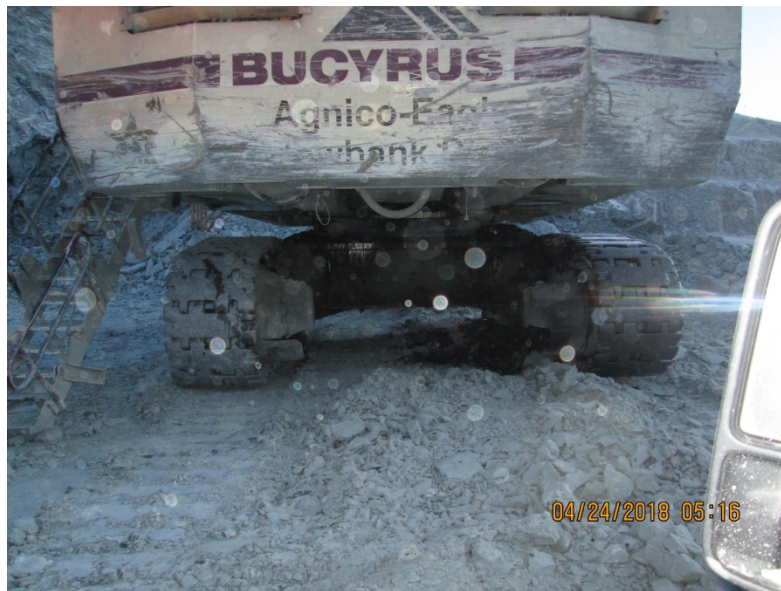
The spill was caused by the O'ring failure on hydraulic system.

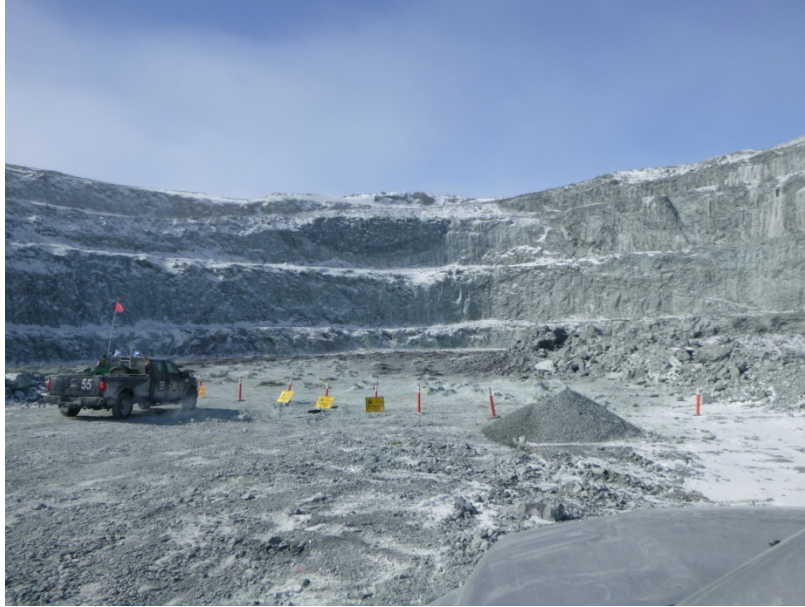
The equipment was stopped and once repaired and moved, the contaminated material was recovered by an excavator and brought to the landfarm
