Appendix 26

Whale Tail GN spills reports

2018-01-29 AMQ-WWTS Waste water Exceedence

Amaruq, Sewage pipe rupture

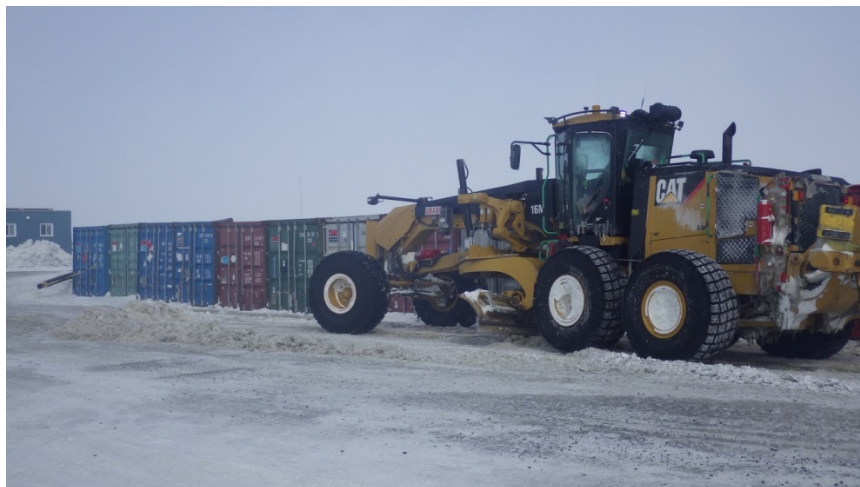
Figure 1: Grader scrapping up the frozen ground

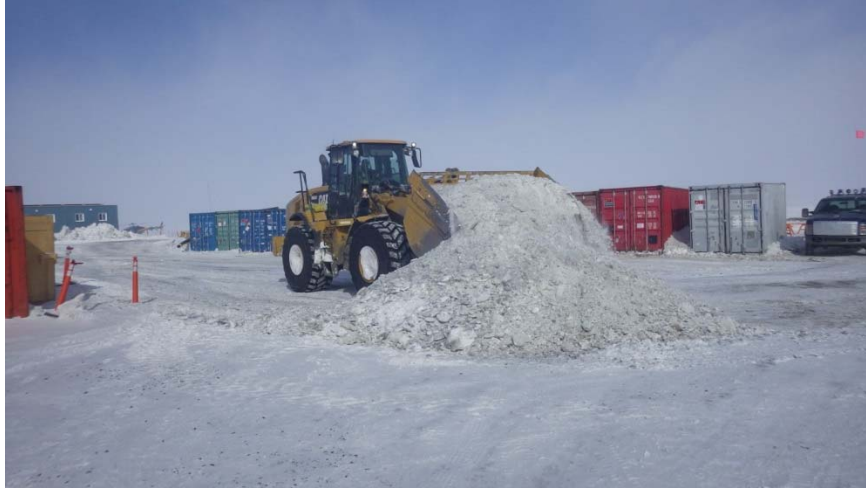
Figure 2: Loader piling up the frozen waste water

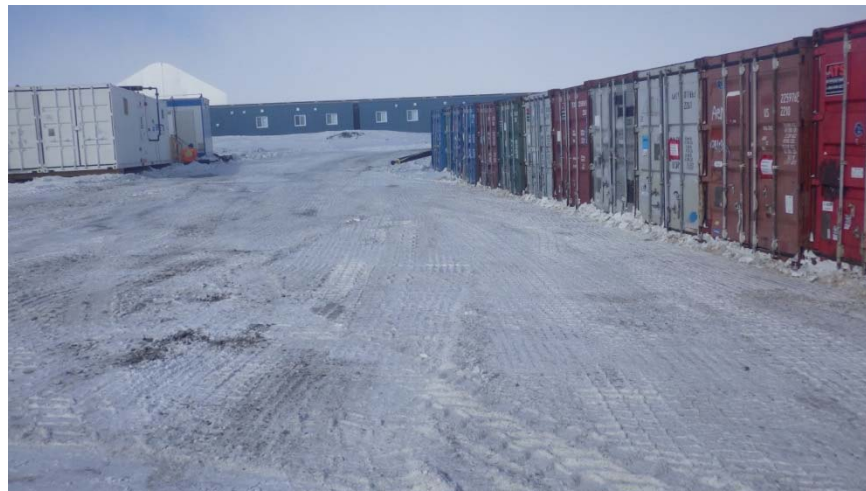
Figure 1: The affected area (road) after the clean-up

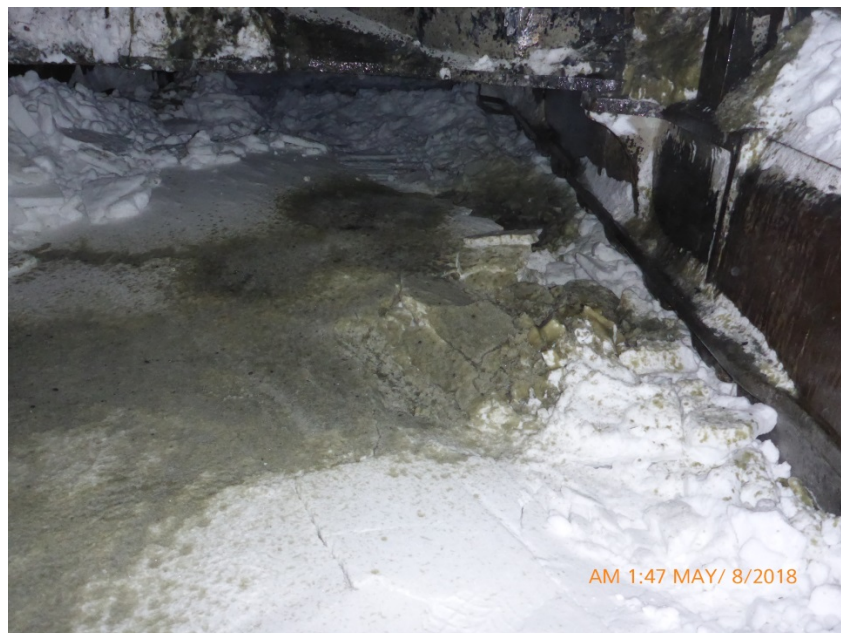
On May 8th 2018, during operations on Pad C of the Amaruq camp, an excavator hydraulic hose burst caused a 130 hydraulic oil spill.

The spill was caused by the hydraulic hose burst caused by the swing of the excavator.

The equipment was stopped and absorbent pads were placed over the affected area. Once the mechanical problem was solved, the equipment was moved and a loader picked up the contaminated soil. The contaminated soil was brought to the Meadowbank mine landfarm.

The Hydraulic system, including hoses on equipment, is inspected as part of the preventive maintenance program done on site. Pre-operation checks also include visual inspection of the hydraulic system.

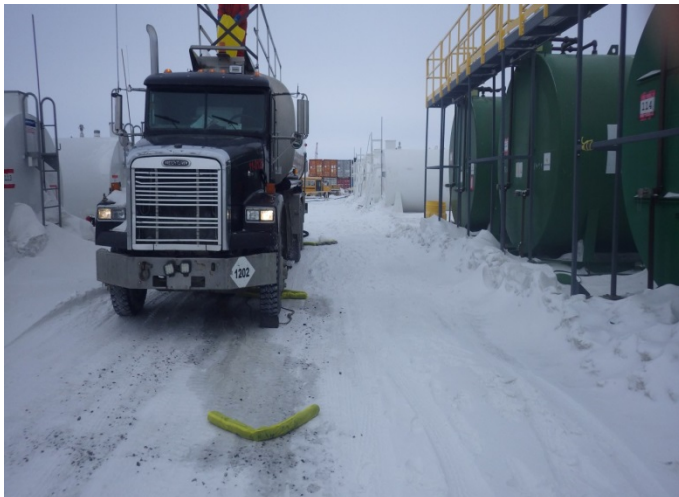
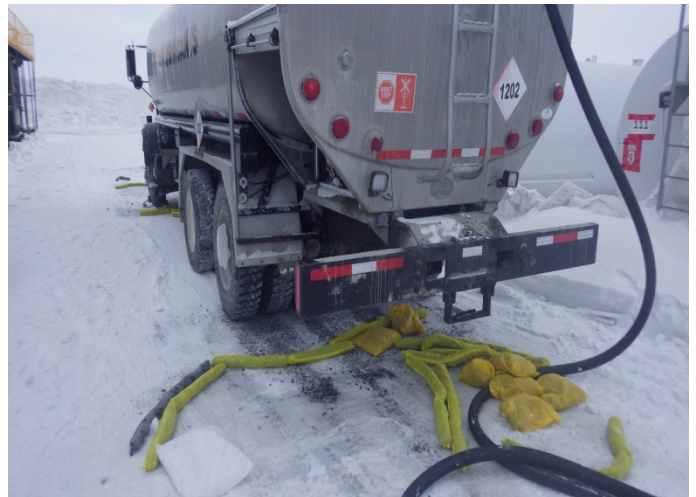
The spill was caused due to workers omitting to open fuel compartment traps to allow proper fuel transfer to the next compartments.

When the spill was noticed, the worker immediately opened the trap. The fuel was recovered using absorbent sheets and the contaminated ground was scrapped using a backhoe. The soil was brought to the Meadowbank mine landfarm.

Workers were reminded to always follow procedures and stay focused while performing a task.

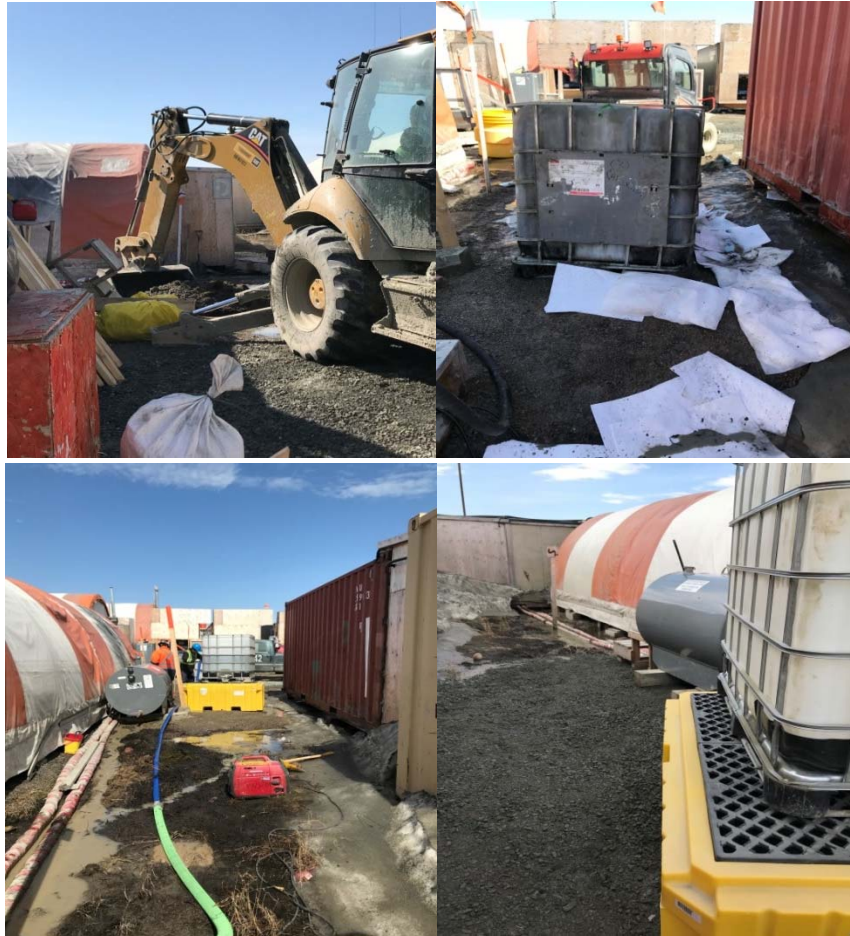
The spill was caused due to an undetected hole in the bottom of the tote used for the fuel transfer.

When the spill was noticed, the worker immediately stopped the transfer. The fuel spill was contained using absorbent sheets and booms. The remaining contaminated water from the melting snow was pumped into a tote for proper disposal. The contaminated ground was scrapped using a backhoe and was stored at the temporary berm; it will be brought to the Meadowbank mine landfarm.

As indicated in the spill contingency plan, a secondary containment should always be used under a tote. Workers were reminded to always follow procedures and stay focused while performing a task.

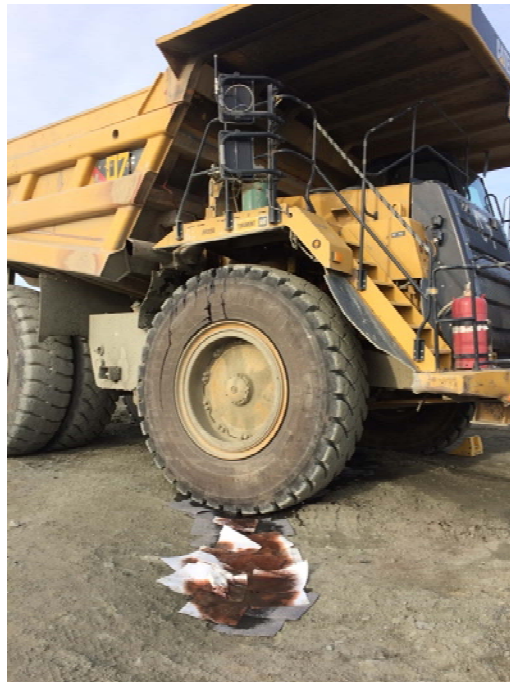
During loading operations at WTP, a leak was noticed from a haul truck. Hydraulic oil was found to be spilling from a hydraulic hose.

An o-ring failed on the hydraulic hose on a haul truck working at the Whale Tail Pit crusher area, causing hydraulic oil to be spilled on the ground.

The equipment was immediately stopped. Absorbent pads were laid out to contain the spill on the ground. Once the truck was fixed and moved out of the area, the ground was scrapped clean and contaminated material was brought to the Meadowbank Landfarm area.

Regular pre-operation checks are completed on equipment also including visual inspection of the hydraulic hoses.

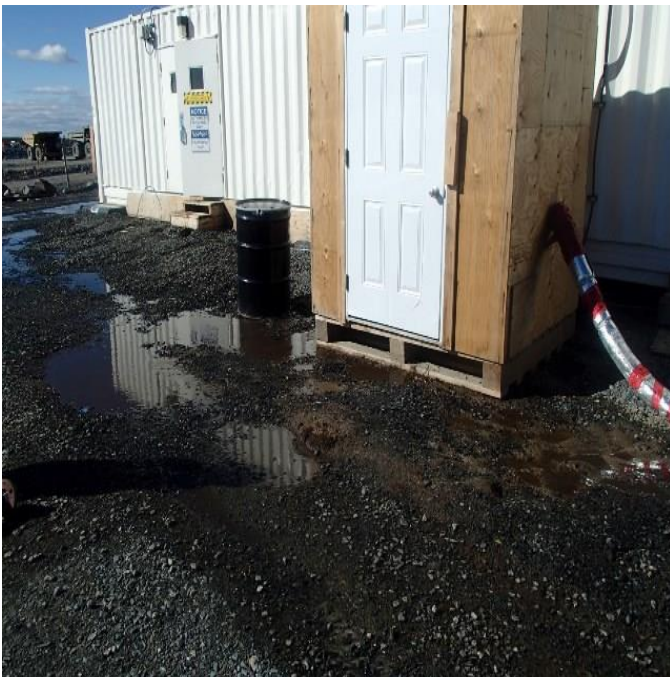
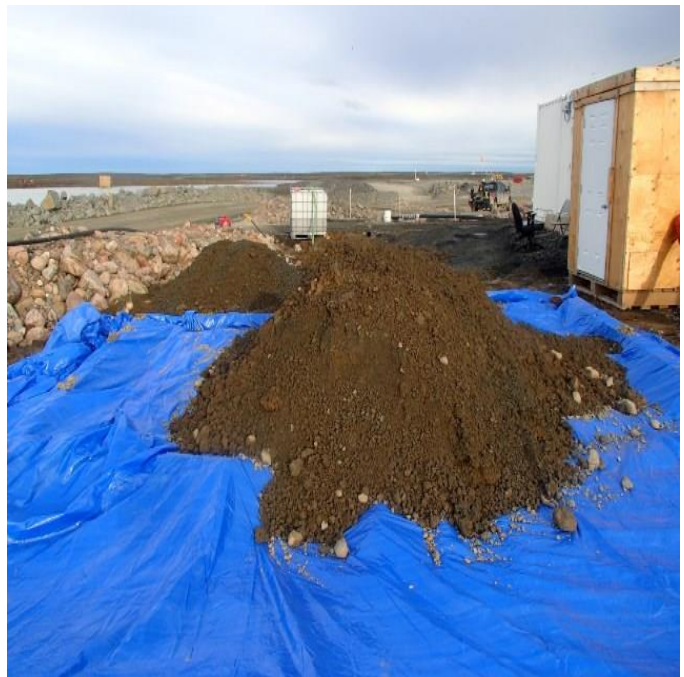
During operation of the waste water treatment system a 4" mechanical coupling failed, causing the pipe at the bottom of the tank to come off.

A 4" mechanical coupling at the bottom of the Pre Anox tank failed. The spill was initially reported as 1.4 m³ but after further analysis, the final spill total was 3.0 m³.

The operator put the pipe back in place and locked the mechanical coupling. A small berm was created around the spill area and a sump was created so the sewage water could be picked up with the vacuum truck. The vacuum truck was also used to collect sewage water that had not seeped out of the 40' sea cans that house the 3 tanks (Pre Annox/Aeration/Post Annox). Once the sewage water was collected, the contaminated material on the ground was collected and brought to the Meadowbank land farm.

Routine inspections on the tanks are completed and supports have been placed under each pipe in the event of a mechanical coupling failure.

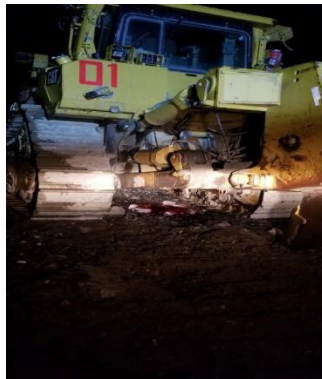
The dozer pushed the granular material during the road construction operation when he hit a rock causing damage to the filter. The oil has spread on the ground.

The spill was caused by the damage to the dozer after a bad contact with a rock.

The equipment was immediately stopped and all contaminated soil has been removed and brought in the bin at Amaruq before to be transfer to the landfarm at Meadowbank.

The discussion with the operation was done to make sure that they are aware of the danger to work on the bad conditions. The equipment was repaired.

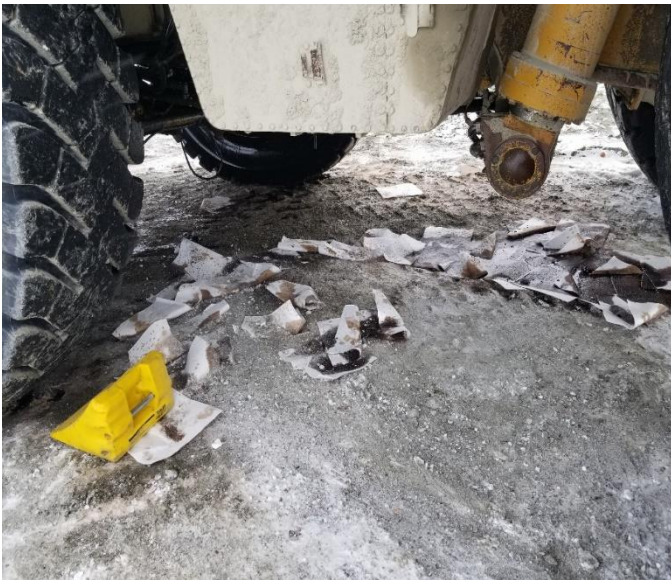
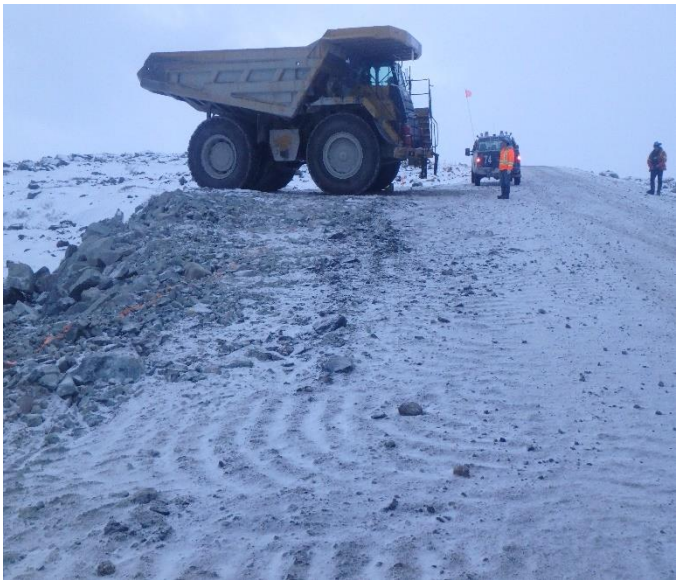
While parked on the WTP road, the hydraulic pump on a haul truck failed causing oil to leak on the ground.

Hydraulic pump failed on a Haul truck on the WTP road causing hydraulic oil to spill on the ground.

The equipment was immediately stopped. Absorbent pads were laid out to contain the spill on the ground. Once the truck was fixed and moved out of the area, the ground was scrapped clean and contaminated material was brought to the Meadowbank Landfarm area.

Regular pre-operation checks are completed on equipment also including visual inspection of the hydraulic systems.

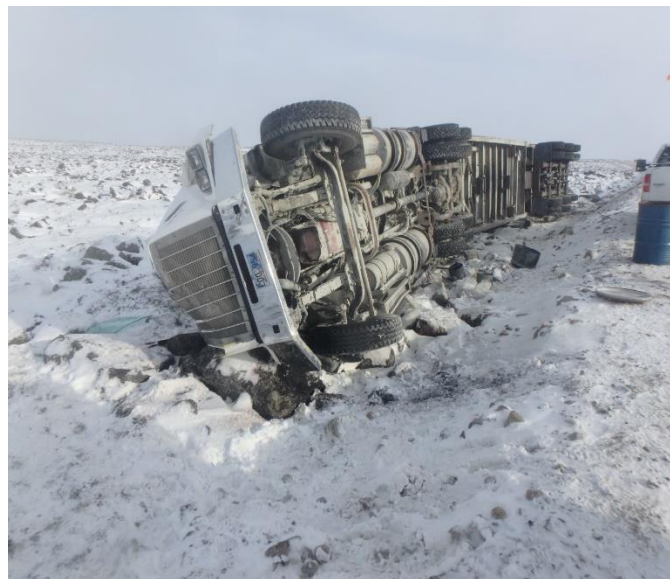
A tractor-trailer traveling north bound from Baker Lake to Whale Tail site went off the WTP road at km 51. The tractor was tipped on its side and diesel fuel was slowly leaking from the cap on the fuel tank.

The tractor-trailer was tipped on its side and diesel fuel was slowly leaking from the cap on the fuel tank.

Absorbent pads were laid out to contain the spill on the ground as well as a containment drum. Once the truck was placed back on the road and moved out of the area, the ground was scrapped clean and contaminated material was brought to the Meadowbank Landfarm area.

Investigation on the cause of the incident is ongoing.

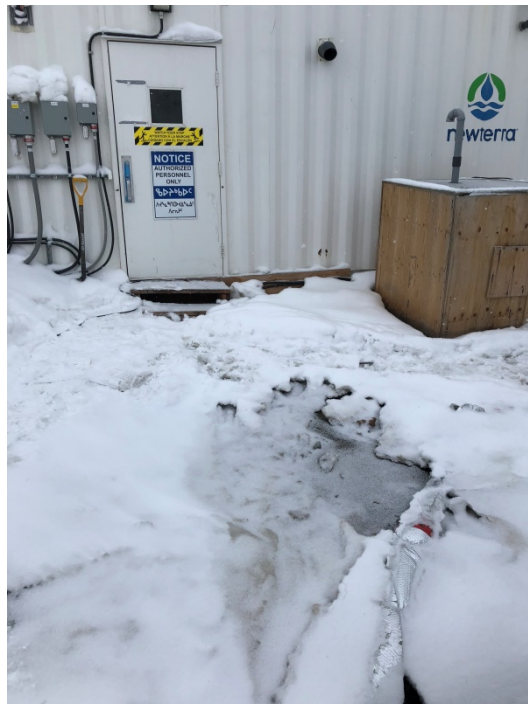
The malfunction of the raw sewage tank #203 water pump float created an overflow of the tank into the sea can and spilled onto the ground next to it.

The spill was caused by a malfunction of water pump float.

An inspection of all the pump floats of the system will be performed. The float will be changed for a new one if damaged. Daily maintenance and inspections of the Floats will be performed to eliminate possible future risk of spills

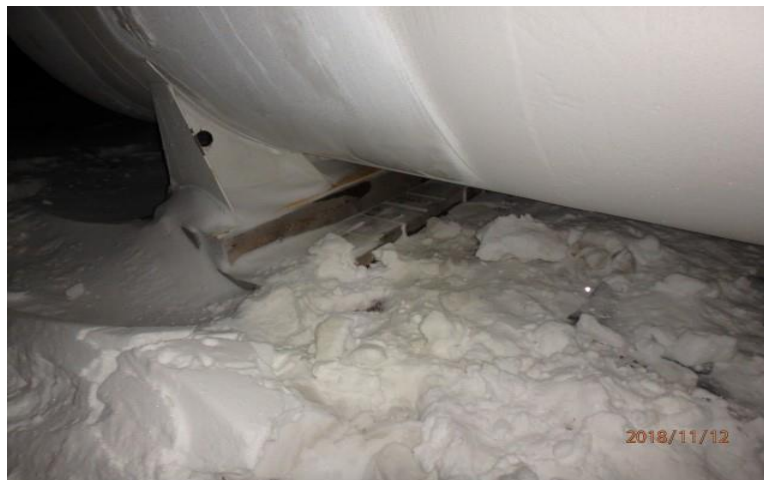
The spill was caused by an overflow during fuel transfer from fuel tanker to fuel tank.

The operator hit the emergency stop on the pump. Contaminated material was pick up w/hand shovels and absorbent pads were laid down on the ground.

Review procedures with all employees/operators involved in the transfer of fuel.
