Appendix 28

Meadowbank 2022 GN spills reports

NT-NU SPILL REPORT

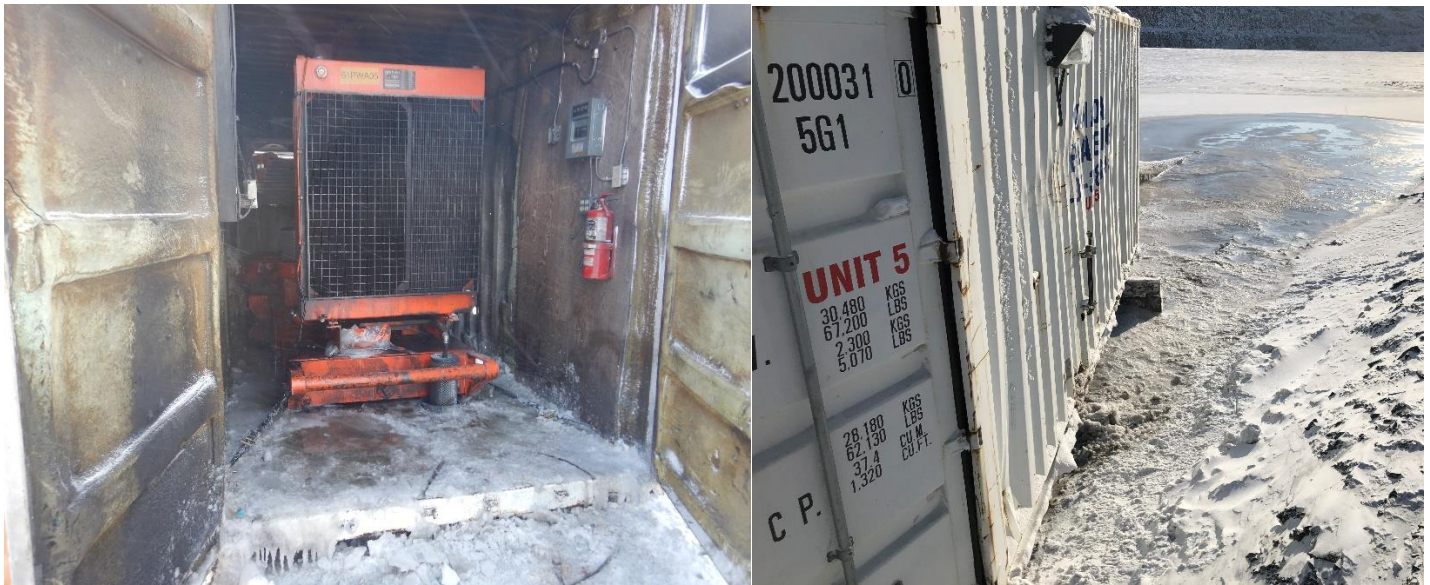
During operations at Meadowbank, upon arrival of the pump maintenance crew at the reclaim station it was noticed that the equipment fuel tank had failed emptying its contents in the Pit E tailing storage facility.

Further investigation revealed that the fuel tank of the pump had been damaged by debris on the floor during the transfer of the equipment into its shelter (sea can).

To prevent the incident from occurring in the future the technique used to transfer the pump into its shell was re-evaluated and changed. Furthermore, a reminder was communicated to workers to complete a visual inspection of all work area as part of the inspection phase prior to starting a task.

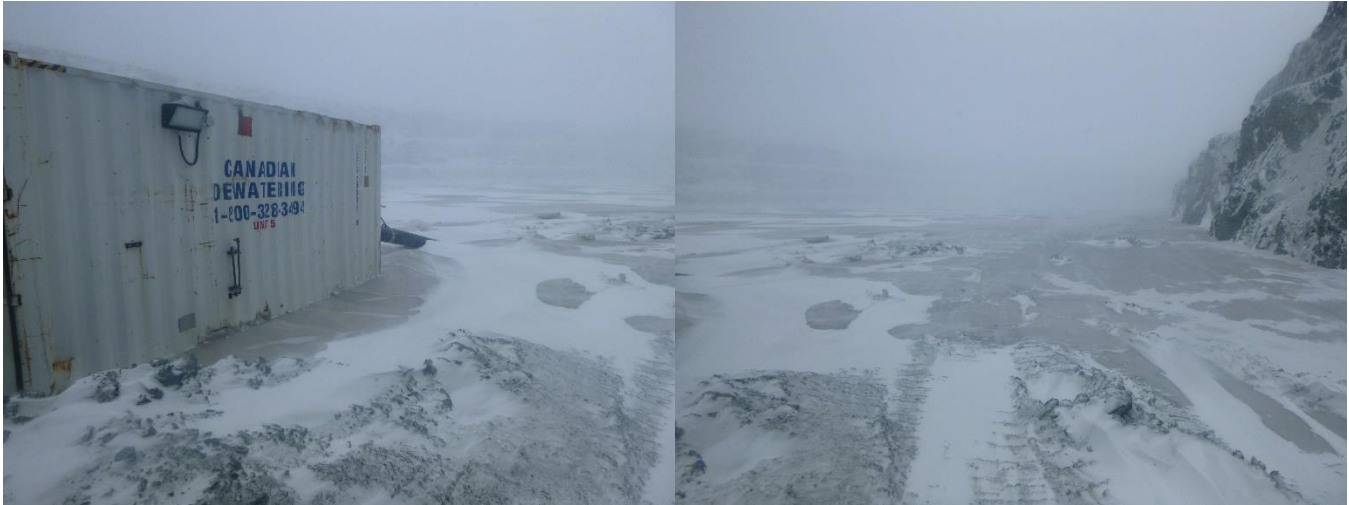
The spilled contaminant was fully contained within the tailing storage facilities. As per the section 5.5 of the Spill Contingency Plan Version 13, (AEM, 2021) spills over 100L of petroleum hydrocarbon contaminated snow may be placed within the TSF.

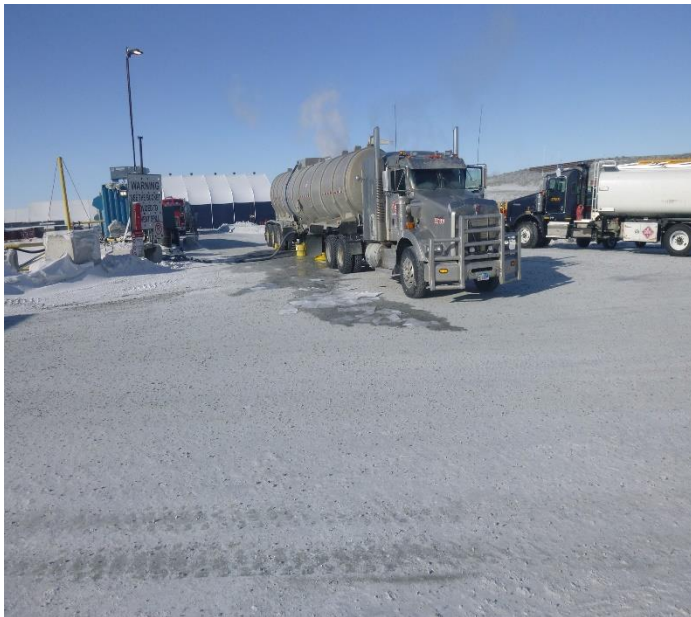
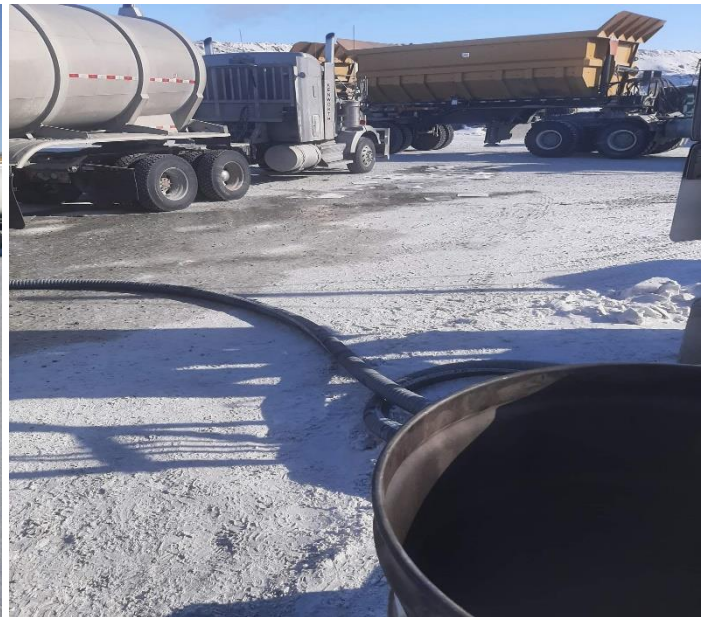
During operations at Meadowbank, an Arctic Fuel driver was refueling tanker #40 at the Meadowbank Tank Farm. The driver went back into the truck during the refueling and fuel overflowed out of the top fuel compartment and onto the ground.

The spill was caused by human error. During refueling, driver protocol is to be on top of the tanker while another person on the ground oversees the shut off valve.

An investigation into the root causes of the spill is being completed. Furthermore, the refueling protocol was communicated to all Arctic Fuel drivers.

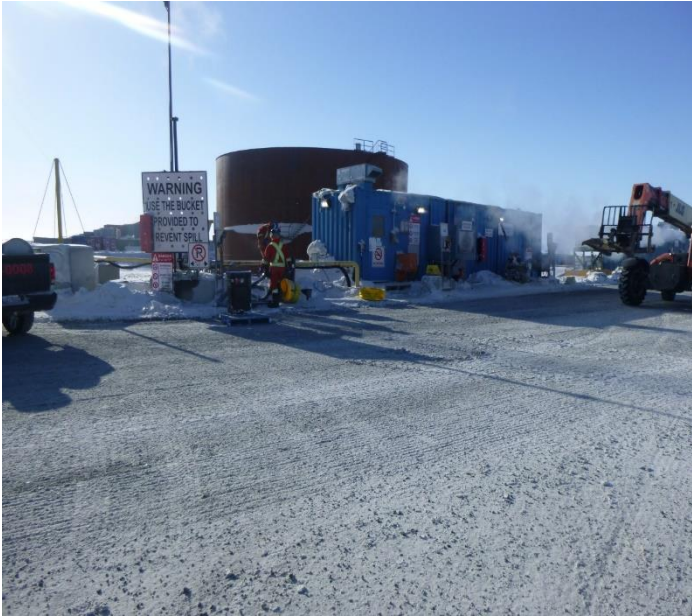
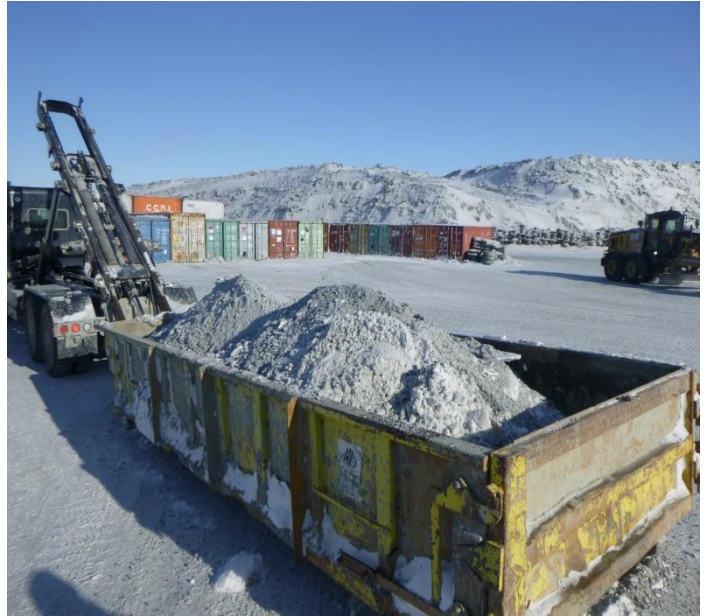
Spill pads were immediately placed on the ground and a grader was called to scrape the area clean. Approximately 10m³ of contaminated snow and material was collected and brought to the Meadowbank Landfarm.

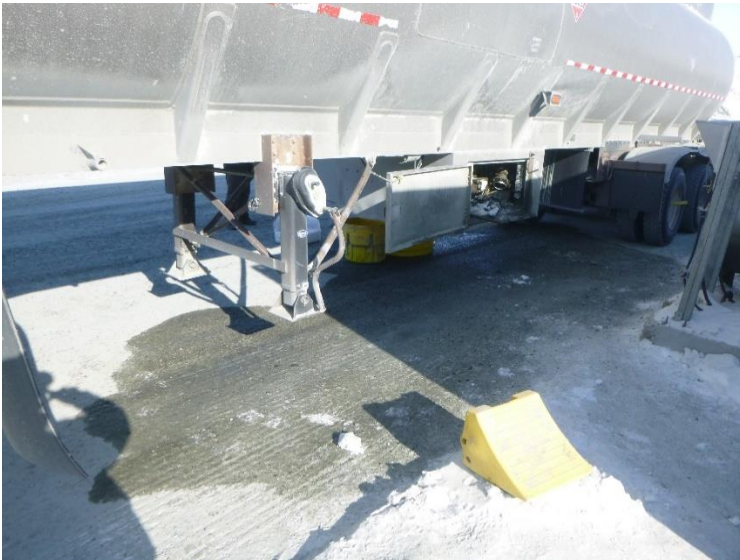
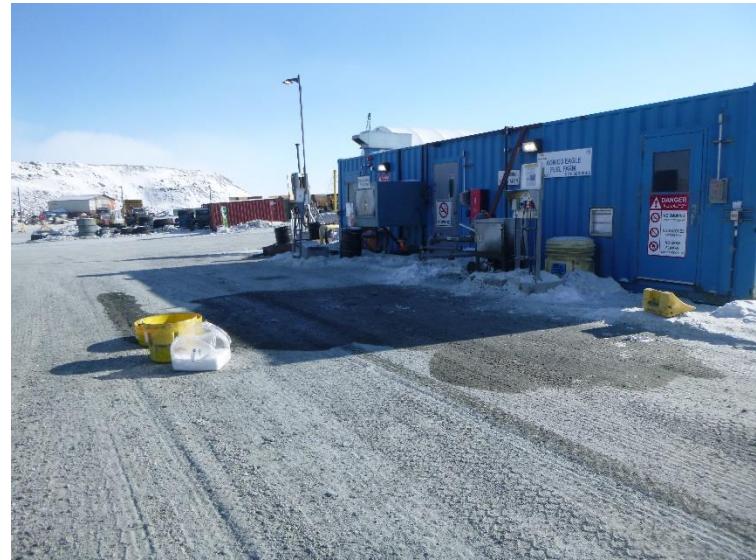
During operations at Meadowbank, an Arctic Fuel driver had finished unloading his tanker to the Meadowbank Tank farm. The driver initiated its departure while the docking station was still attached on the equipment, causing the tanker connector to rupture. The damage caused the remaining fuel of the reservoir to leak onto the ground.

An investigation into the root causes of the spill has been completed. The procedure for offloading is being updated to ensure drivers perform a circle check before leaving tank farm. This procedure will then be communicated to all Arctic Fuel drivers. Furthermore, the incident will be reviewed with both crews on site.

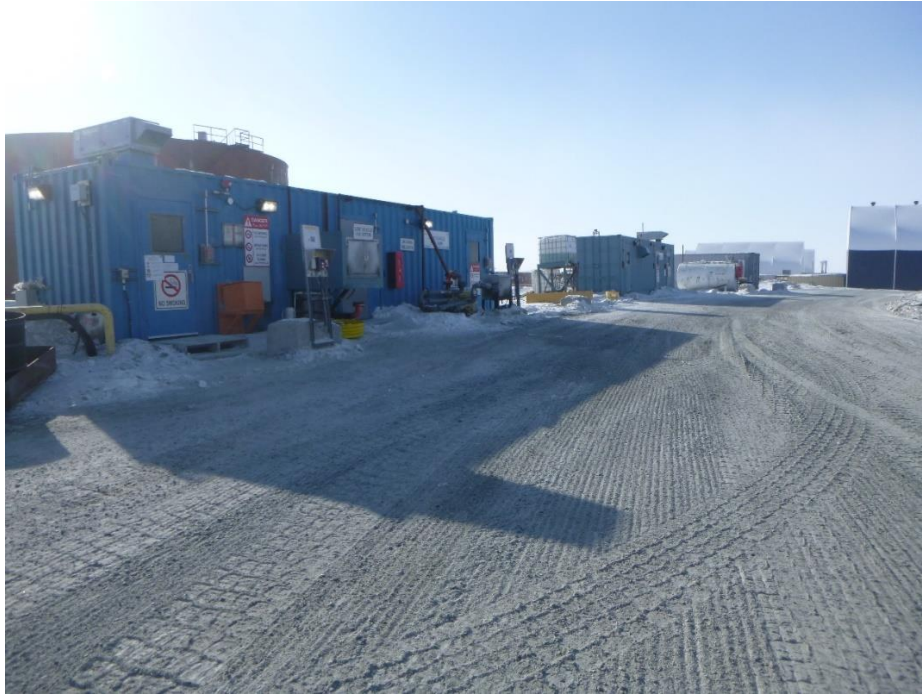
Spill pads were placed on the ground and an excavator was immediately brought at the tank farm to scrape the contaminated snow and material. Approximately 5m³ was collected into a roll off and was brought to the Meadowbank landfarm.

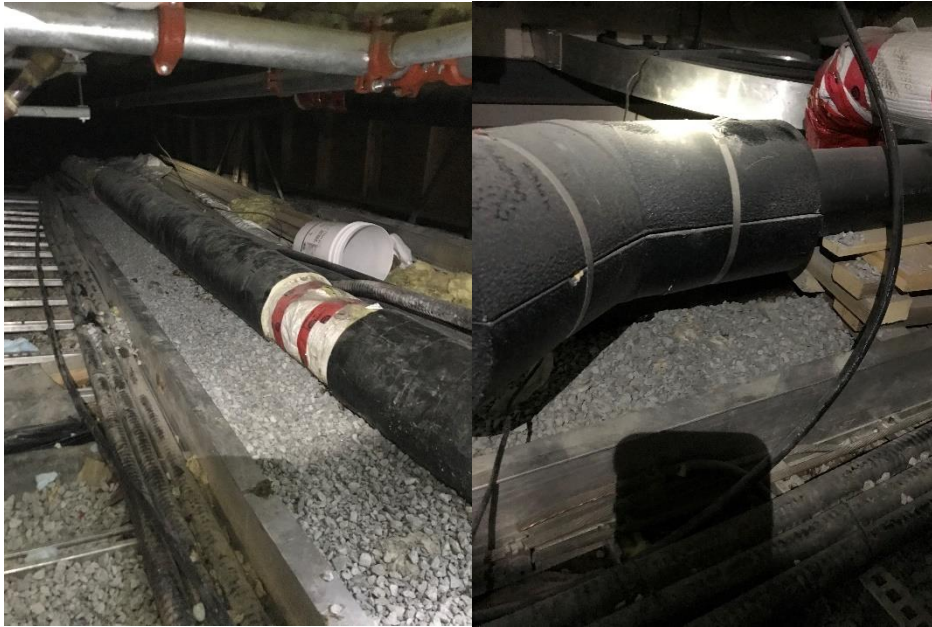
Monthly visual inspection of all sewage piping was conducted as part of regular maintenance activities. Hands shovels and equipment were used to manually excavate the contaminated area under the wing. The contaminated material was disposed of appropriately at the Hazmat area.

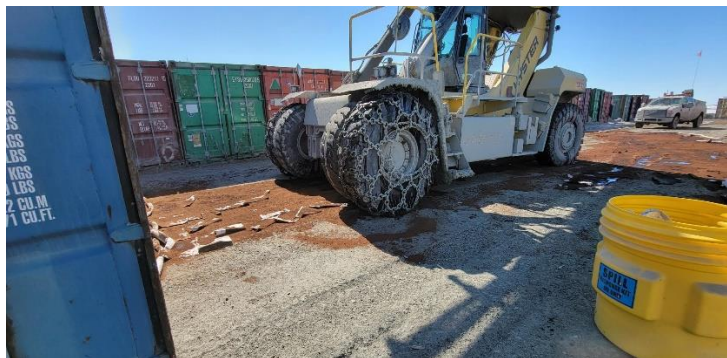
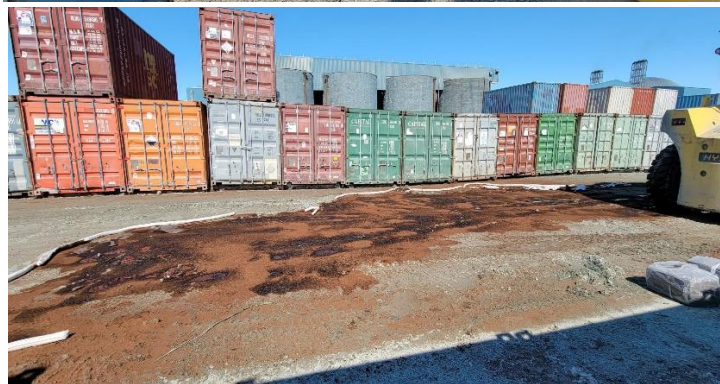
During operations at Meadowbank, a hydraulic hose of the container handler failed causing a total of 525L of hydraulic oil to leak on the warehouse sea cans storage pad.

A routine visual inspection of all systems is performed during pre-operation checks as a part of the preventative maintenance program.

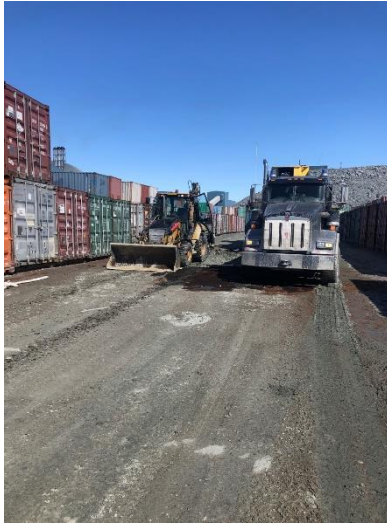
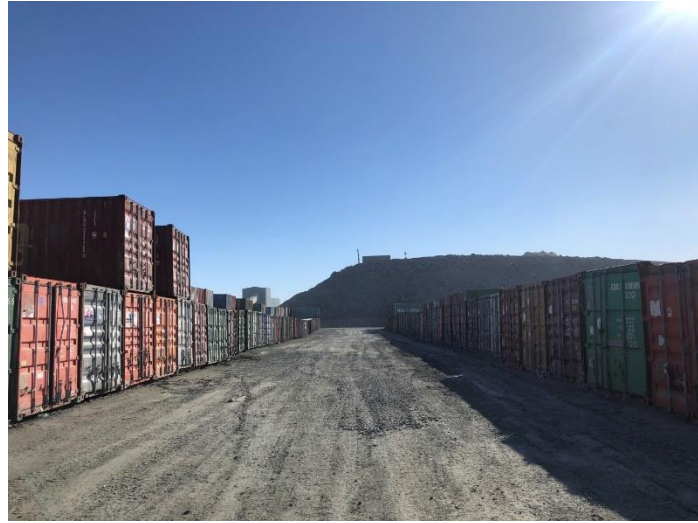
The operator immediately shut down the equipment and called the environment department. A combination of absorbent booms and peat moss were placed around the equipment to capture as much oil as possible. The used spill response material was disposed appropriately at the Hazmat facility and approximately 8m3 of contaminated soil was brought to the Meadowbank landfarm.

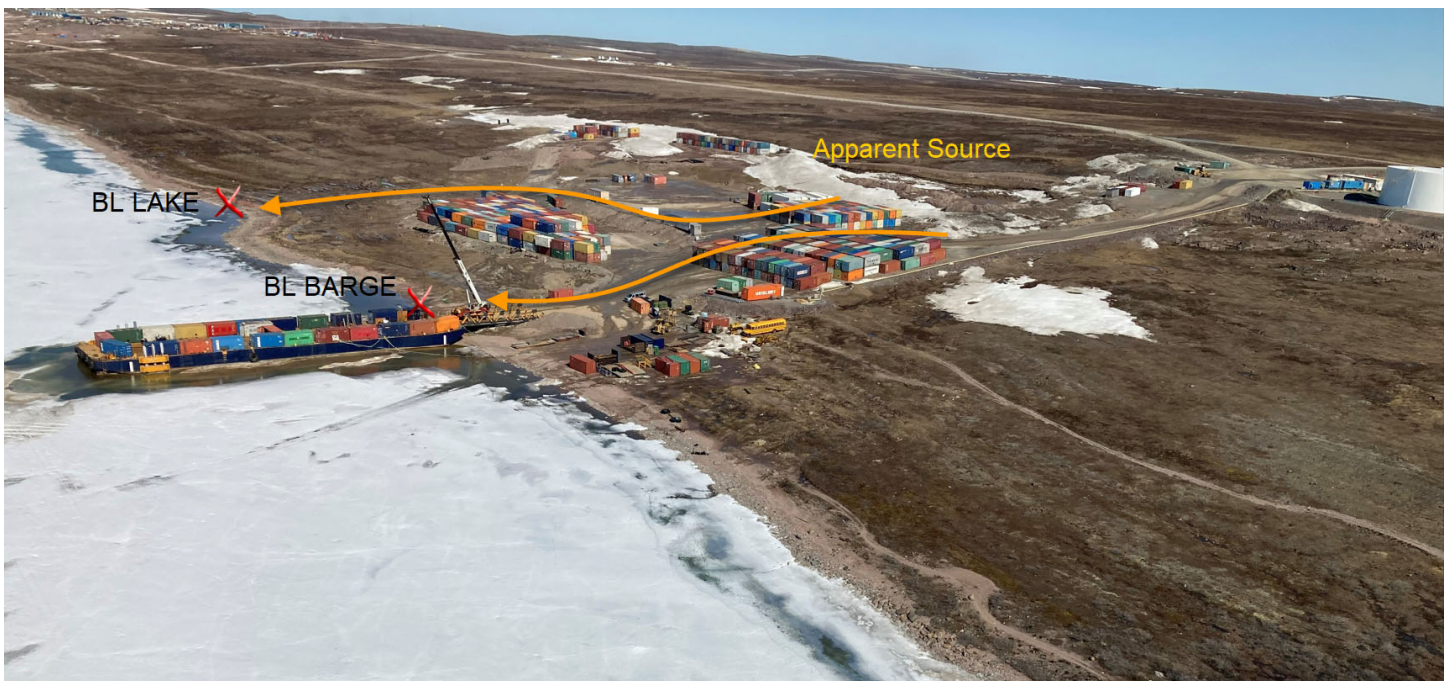
Figure 1. Overall Layout - Aerial Picture (2022/06/07)

During an inspection of the Baker Lake Marshalling Facilities by an environmental technician, two turbid flows of water were observed entering into the thawed shore of Baker Lake, creating apparent plumes of TSS along the shore. The flows of water appeared to flow through the Agnico Eagle facilities, where heavy equipment were travelling to prepare the area for the upcoming maritime shipping season. The visible plumes in Baker Lake were mostly contained within a few feet from the shoreline, and water appeared clear a few meters into the lake. The two plumes are hereafter referred to as “BL-BARGE” for the flow of water that entered on the West side of the dock (64°18'17.68" N, 95°57'11.11" W), and “BL-LAKE” for the flow of water further West (64°18'20.23" N, 95°57'22.77"W). See figure 1 below for general site layout information and flow path estimate.

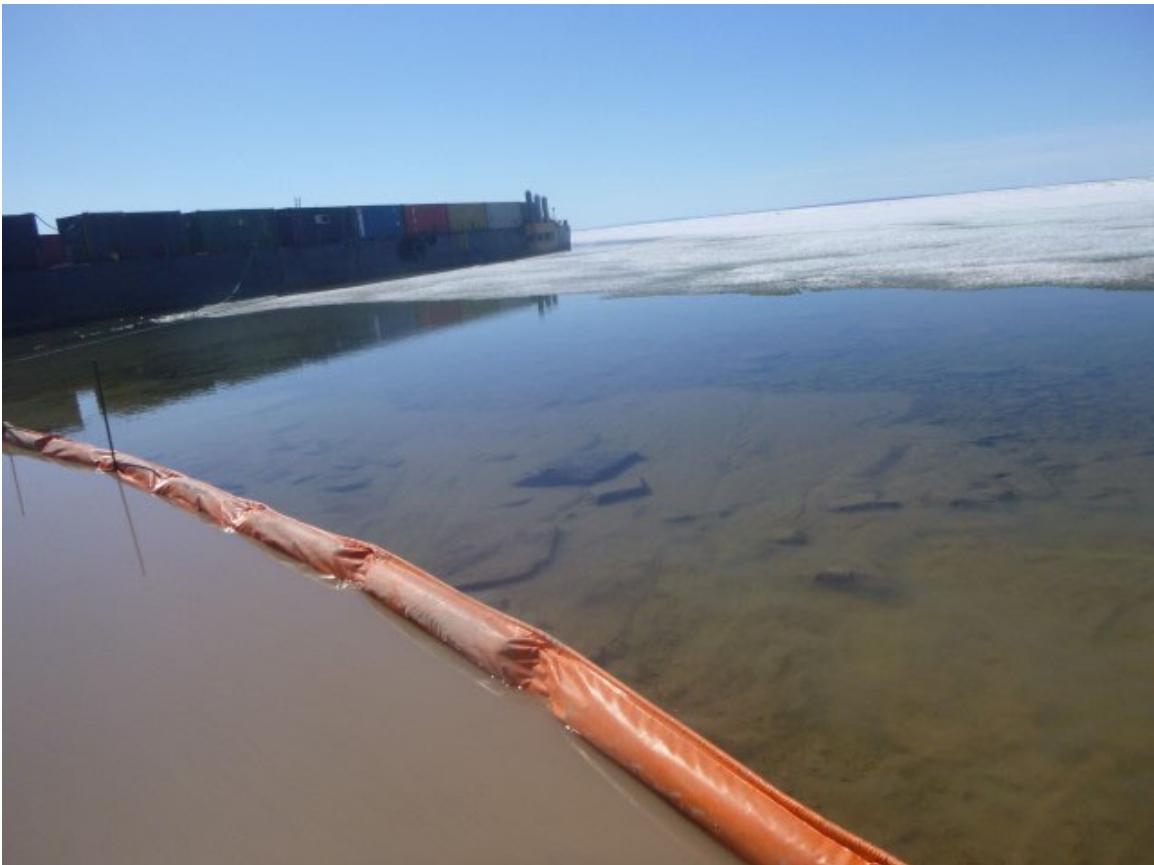
Figure 5. Contained turbidity & sediments at BL-BARGE (2022/06/10)

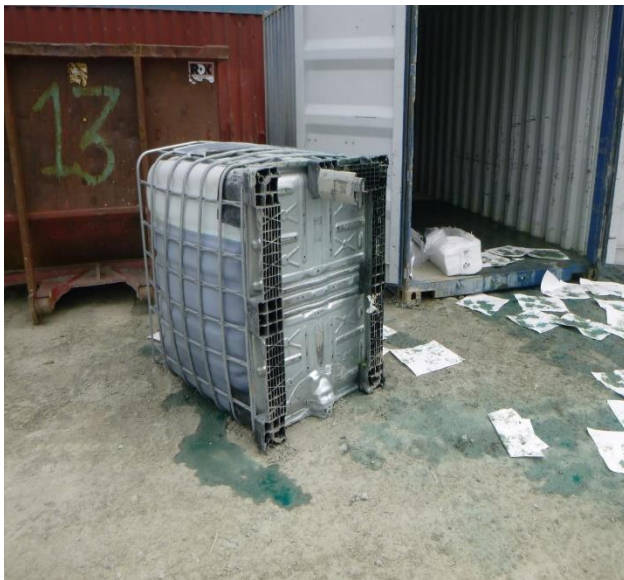
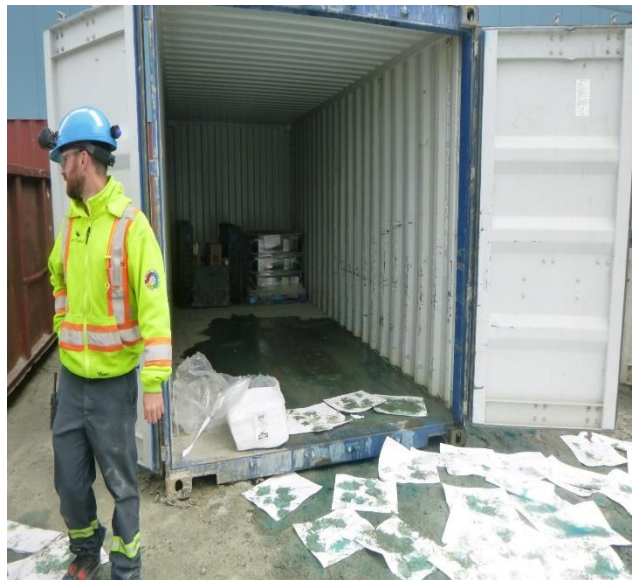
During operations at the Meadowbank site, an operator was placing a tote into a shipping container near the Maintenance shop and did not notice the metal support bracket around the tote was damaged. When the tote was placed into the shipping container, the damaged bracket punctured the tote next to it causing diesel exhaust fluid to spill onto the floor of the container as well as the ground.

An investigation into the root causes of the spill has been completed. The procedure for offloading is being updated to ensure drivers perform a circle check before leaving tank farm. This procedure will then be communicated to all Arctic Fuel drivers. Furthermore, cameras will be procured and installed on the telehandlers, allowing for additional visibility for the operators.

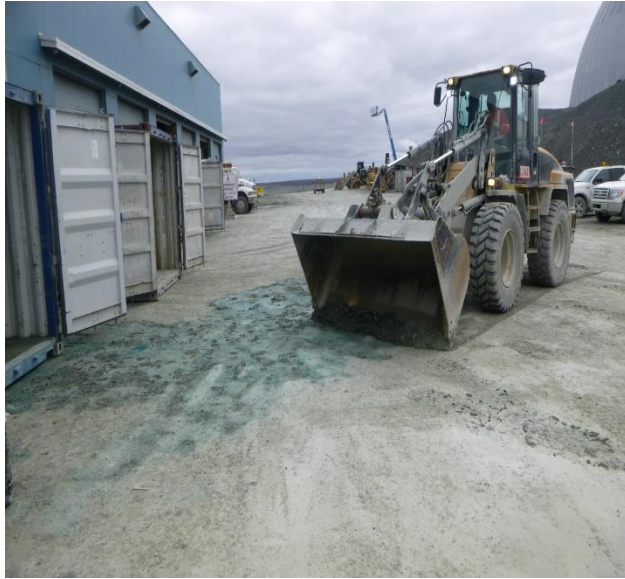
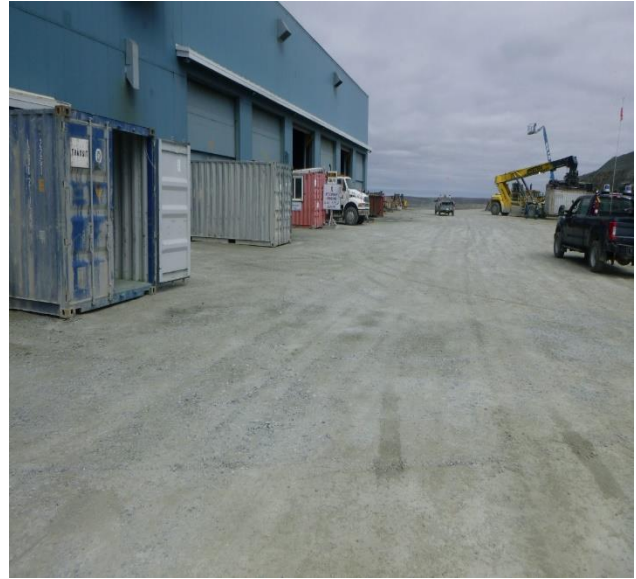
Spill pads were placed on the ground and a loader was immediately brought at the maintenance shop area to scrape the contaminated material. Approximately 1m³ was collected into a roll off and was brought to the Meadowbank landfarm.

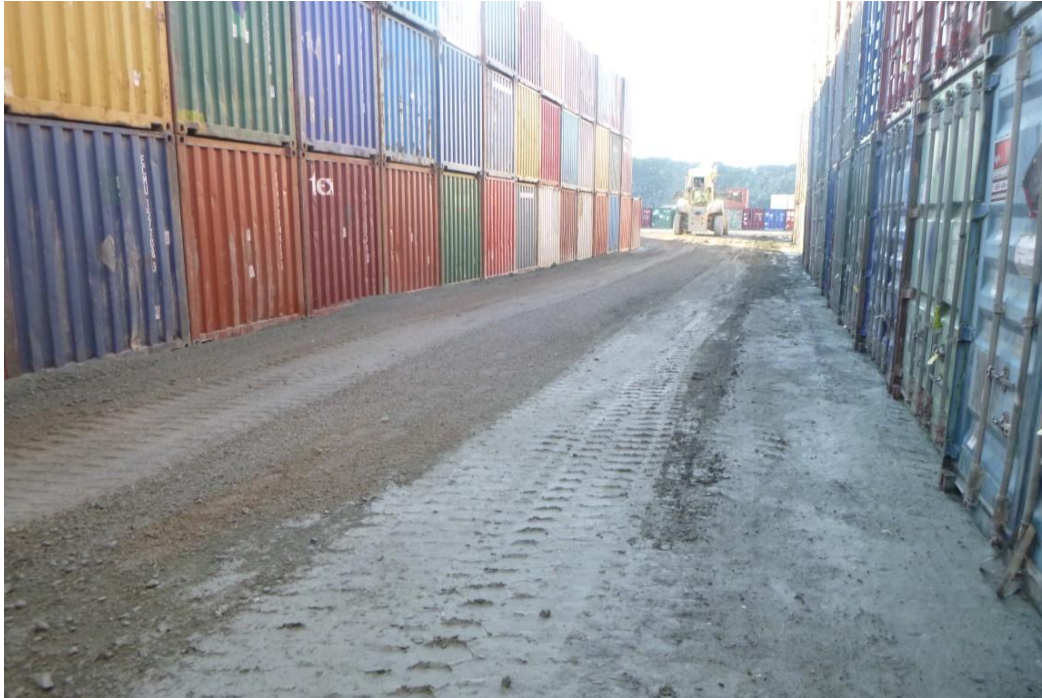
The equipment was parked by the operator and absorbent pads were immediately placed under the hose to capture as much oil as possible. The environment department was called to assess the spill and mechanics to repair the equipment. Approximately 2 cubic meters of contaminated material was collected and brought to the landfarm.

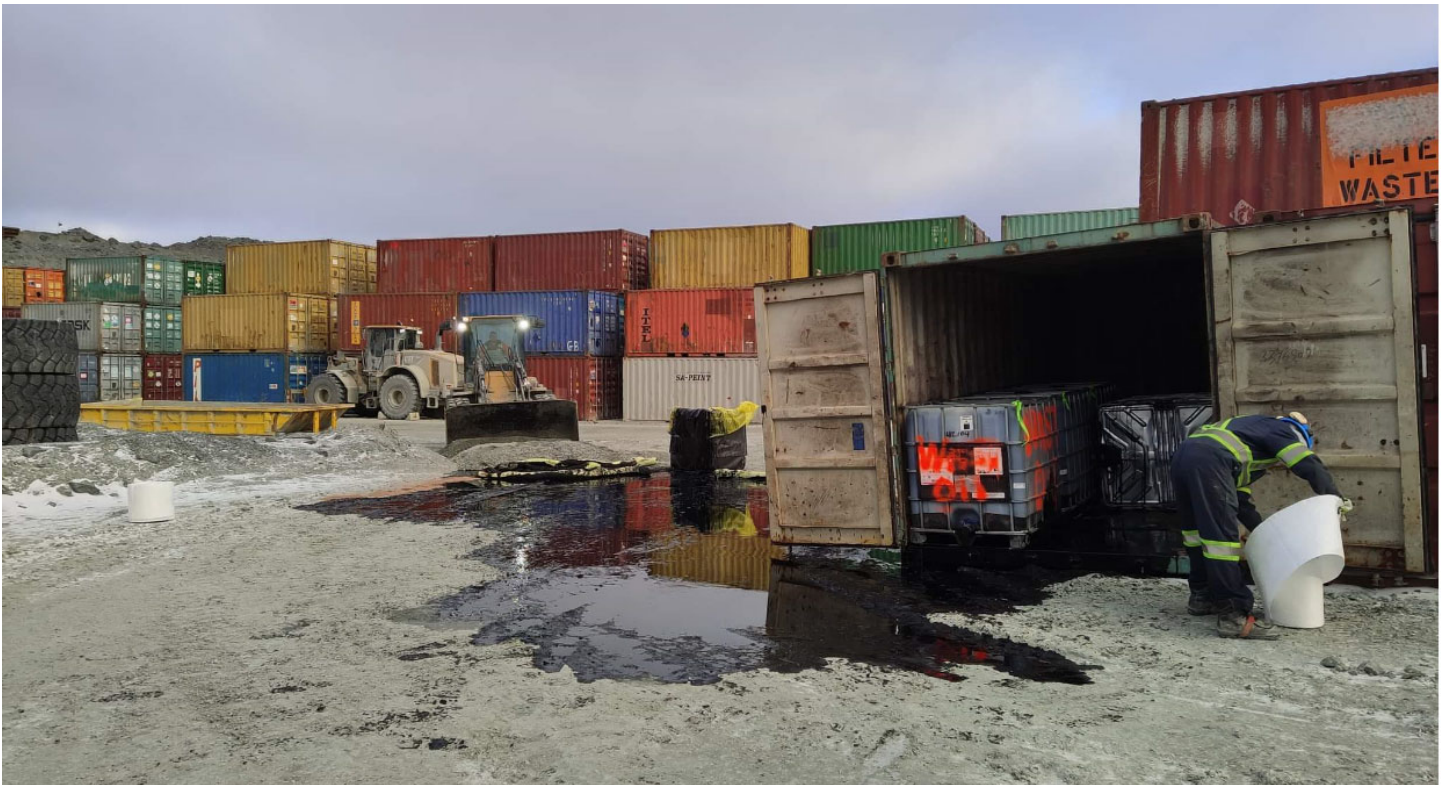
During operations at the Meadowbank Project, a tote containing 1000L of waste oil was punctured by an equipment during the process of storing the reservoir in a sea can, causing a total of 750L of oil to leak onto the ground of the pad.

The procedure was reviewed to include the proper method and equipment attachment to be used for the task and will be presented to all the operators.

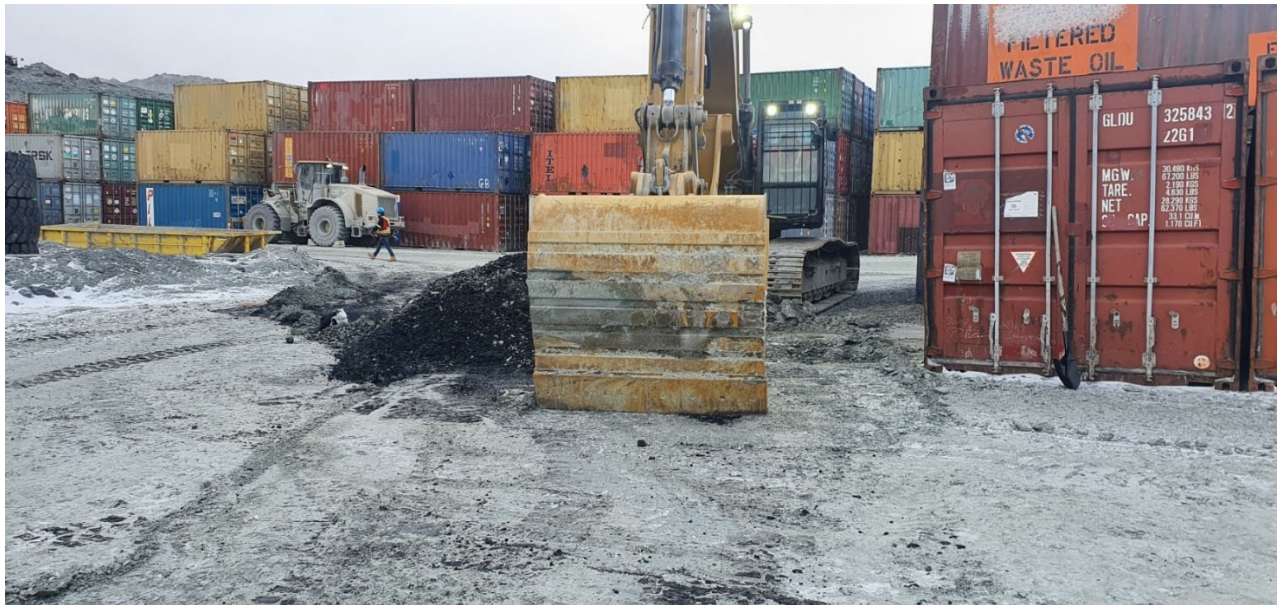
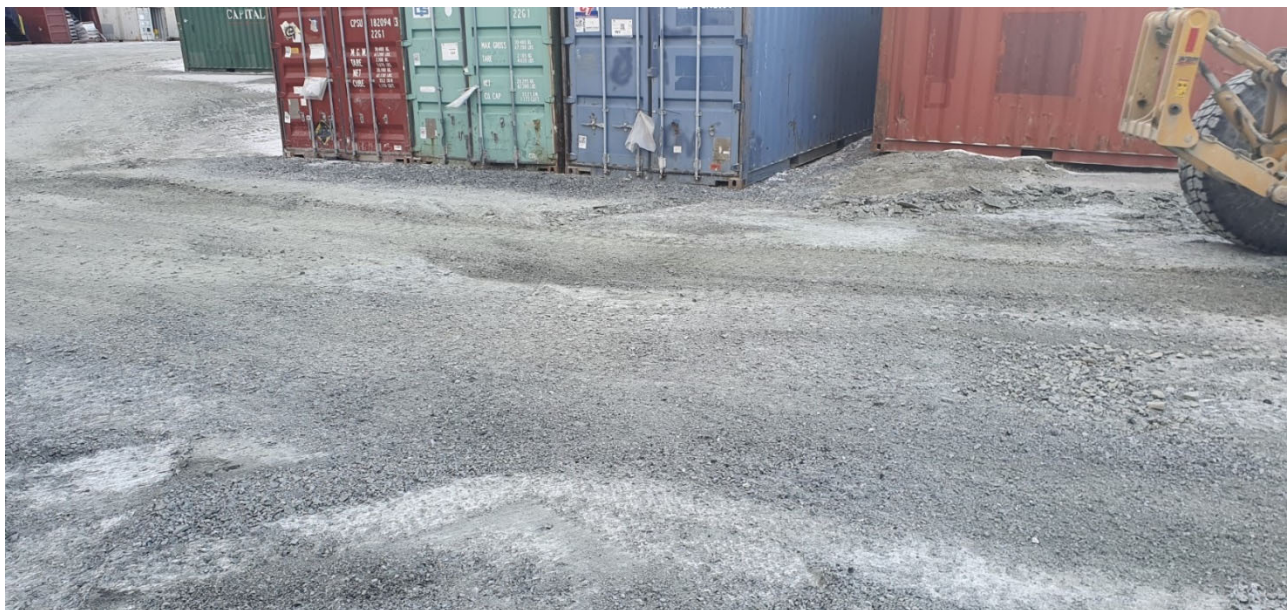
The tote was flipped over to prevent additional oil from leaking out of the container and a berm was built to halt the spill from going further. Absorbent material was used to collect as much oil as possible before removing approximately 10 cubic meters of contaminated soil with an excavator. The contaminated material was brought to the Meadowbank landfarm.

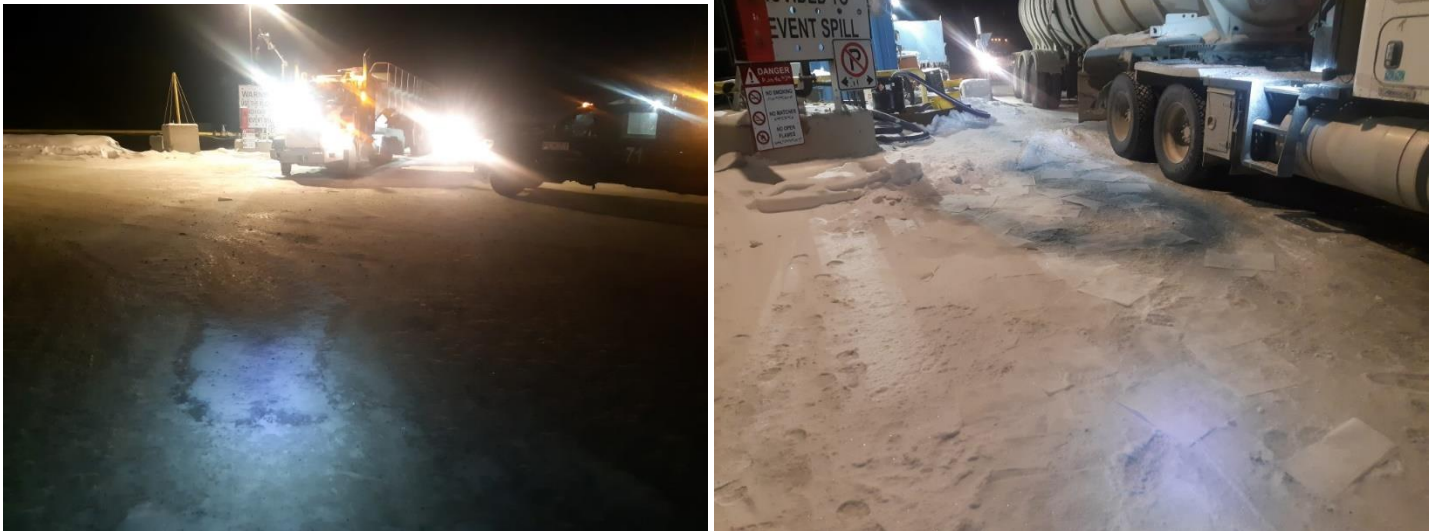
During operations at Meadowbank, an Arctic Fuel driver was refueling tanker #45 at the Meadowbank Tankfarm. The driver went back into the truck during refueling and fuel overflowed out of the air vent.

Refueling protocol was communicated and reviewed with all drivers. Furthermore, AEM is evaluating alternative refueling systems to avoid overflows.

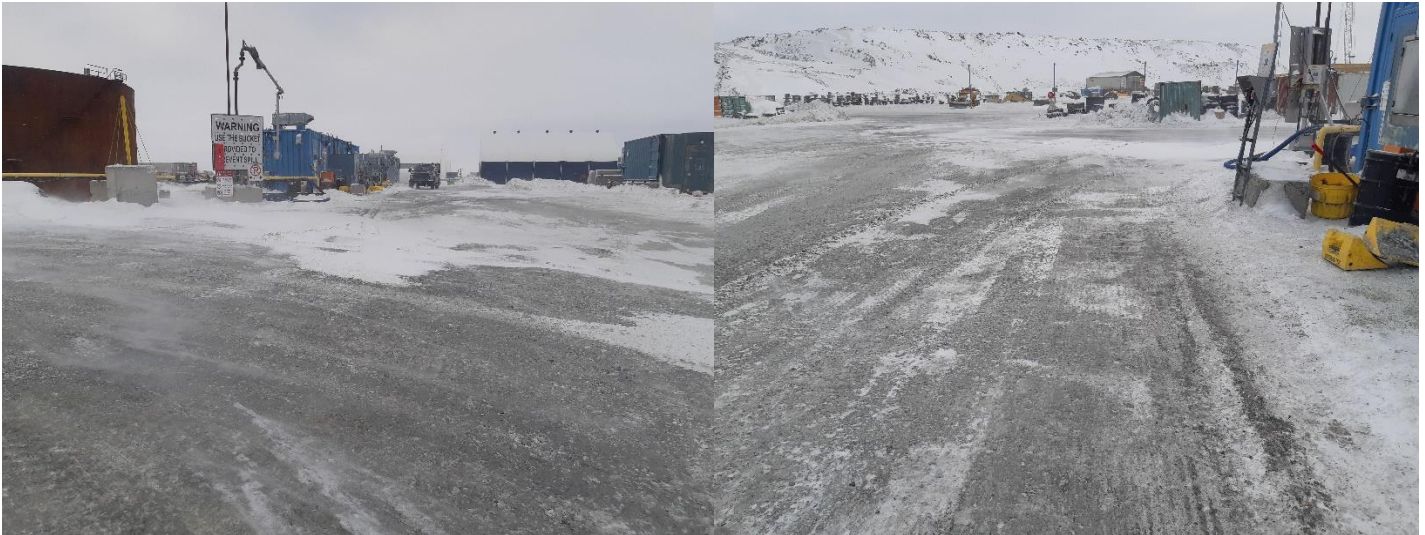
Spill pads were immediately placed on the ground and the contaminated snow and material was scraped up. Approximately 6m³ was collected and brought to the Meadowbank landfarm.

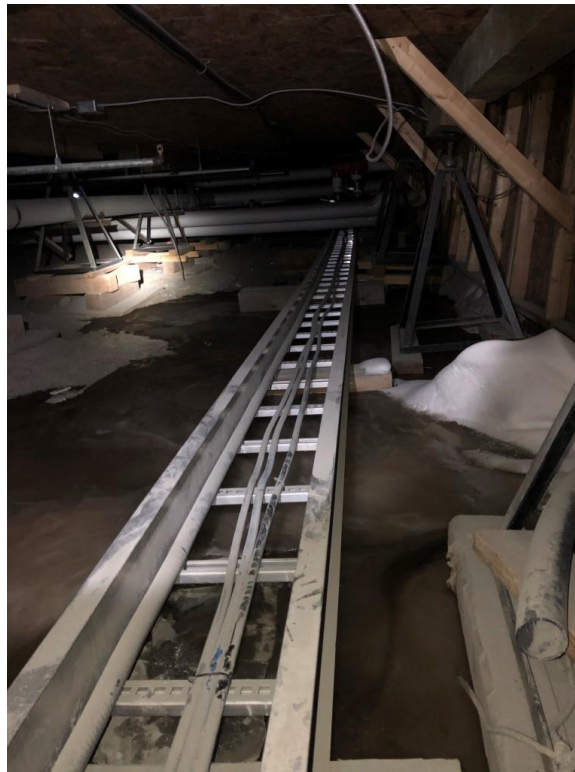
During an inspection of the sewage piping under the Meadowbank Camp, a worker discovered a slow leak of sewage coming from the drain line. Upon further investigation, it was found that the sewage line shifted and loosened the coupling.

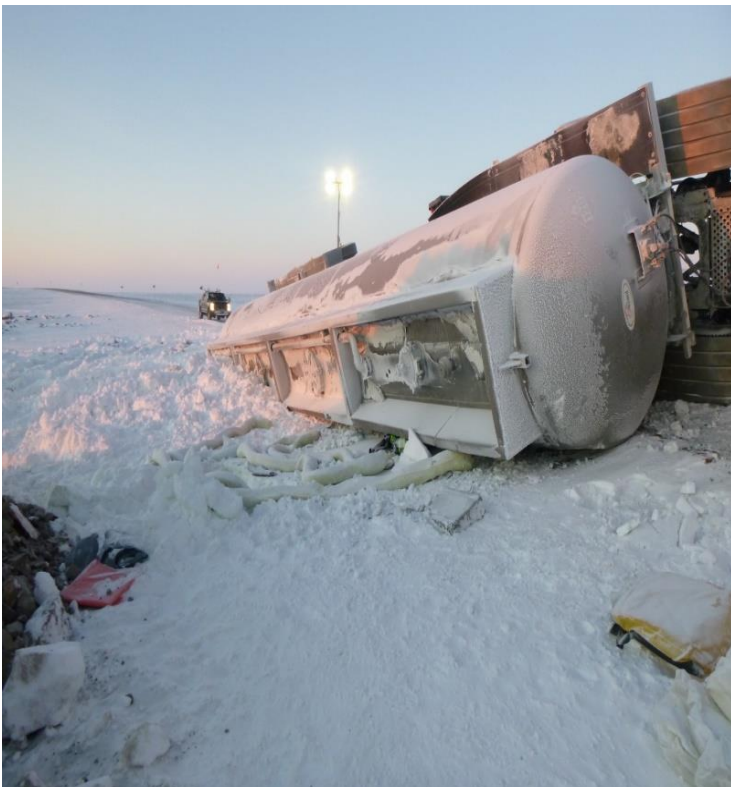
During operations at the Meadowbank Complex, two fuel tankers operated by Arctic Fuel Services Ltd. met along the All-Weather access road (AWAR). When the tankers crossed each other on the road, the northbound tanker moved to the shoulder of the road but lost sight of the edge of the road and tipped over. Upon the impact with the ground, the reservoir was pierced in 3 locations causing a spill of 29,000L of diesel fuel. The driver was not significantly injured in the accident.

Figure 1. Tanker overturned at KM87 (2022-11-29)

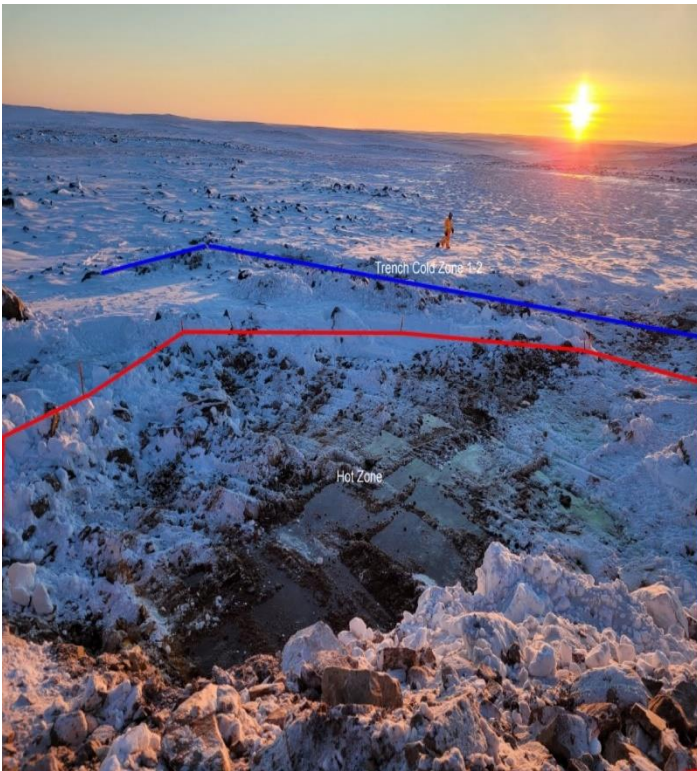
Figure 2. General view of incident from the road (2022-11-29)

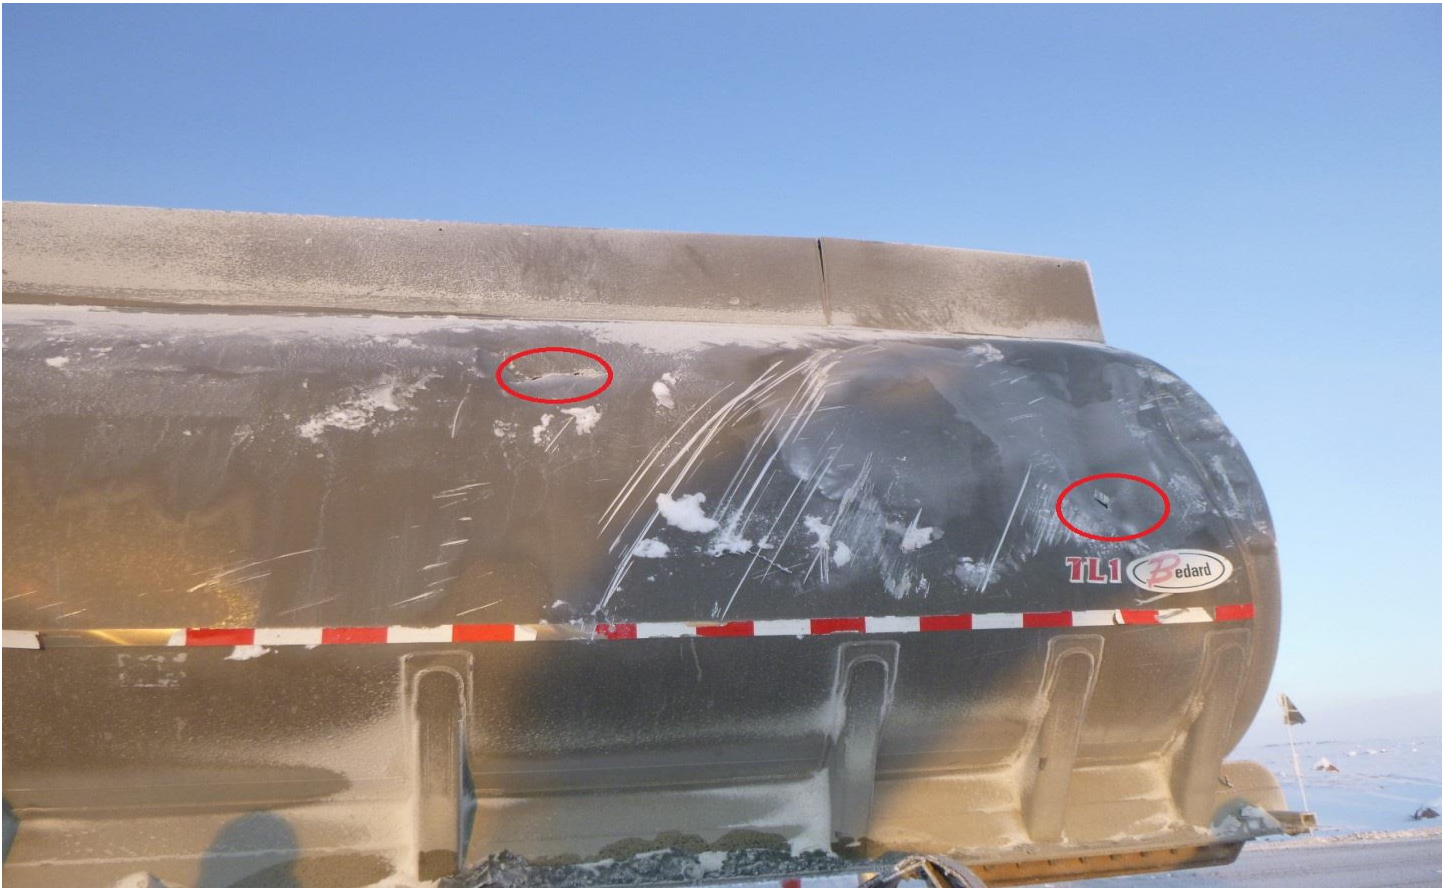
Figure 7. Damaged areas of tanker - 2022-11-30

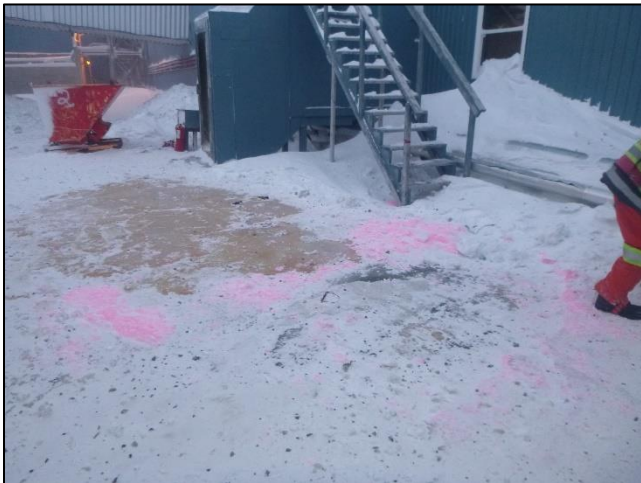
During operations at the Meadowbank complex, a code 1 was initiated after visible flames were observed at the warehouse and the Emergency Response Team was called to put out the fire. The adjacent corridor that connects the camp facilities to the warehouse was dismantled to prevent the propagation of the fire to the campsite causing the glycol present in the heating system to leak.

Photo 1: Taken facing Southeast of the Fire
