Appendix 29

Whale Tail 2022 GN spills reports

2022-01-06 WTP 10L Sewage

GN reference #: 2022-006

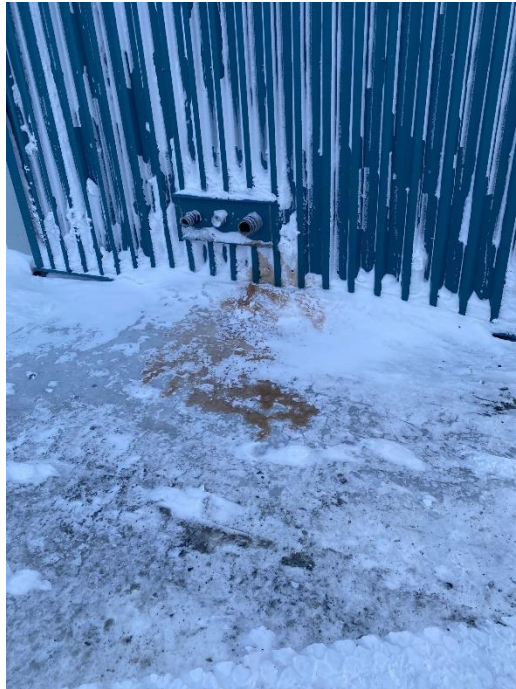
During the transfer of sewage between the emulsion facility offices and the sewage truck at the Whale Tail Pit Project, some blackwater residue leaked onto the ground under the connection through the action of disconnecting the hose.

Figure 1. Emulsion facility, dated January 6th

Inadequate manipulation of equipment by the operator.

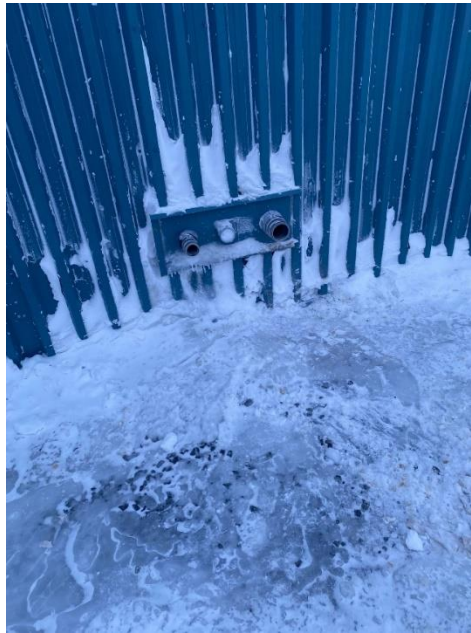
Figure 2. Emulsion facility after clean-up

The environment department notified the operator supervisor which immediately dispatched workers to chip away the ice and excavate the remaining material. Contaminated material was disposed of at the Meadowbank tailings area.

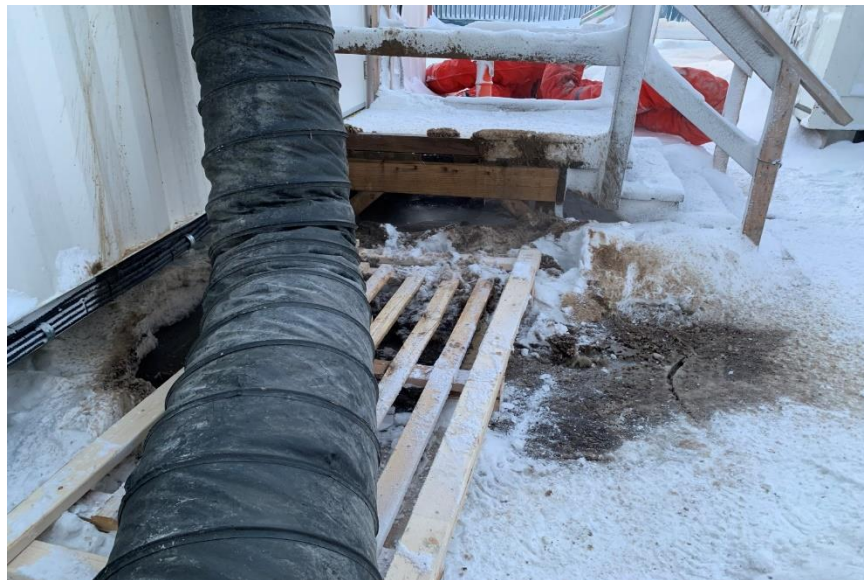
During operations at Whale Tail Pit project, a worker was trying to thaw a 2-inch frozen pipe going from MBR3 to the screening room tank at the Sewage Treatment Plant. Worker unflanged the pipe to verify if it was still frozen and asked the operator to start the pump. Once the pump started, sewage began to spill onto the ground.

A shut off valve was installed on the pipe to prevent sewage from spilling. Environmental awareness regarding reportable substances was reinforced.

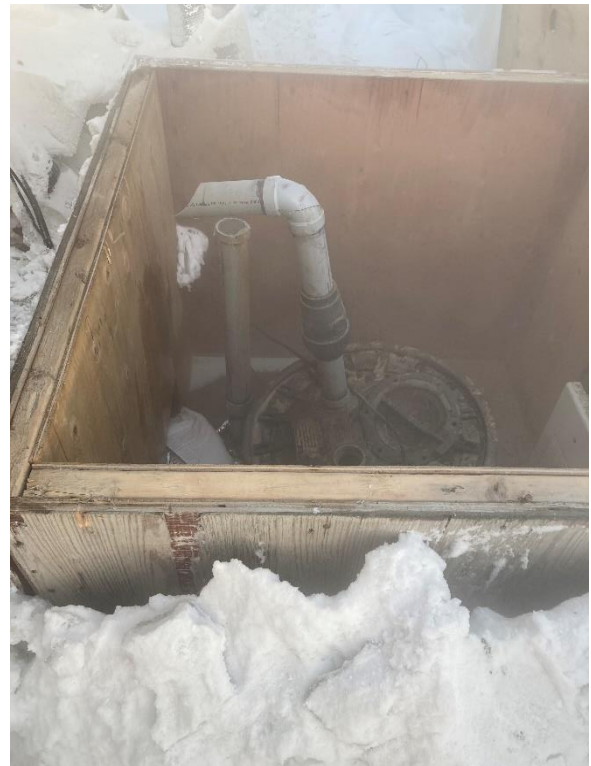
Figure 2. Broken piping causing spill – 2022-02-03

Equipment failure/damage

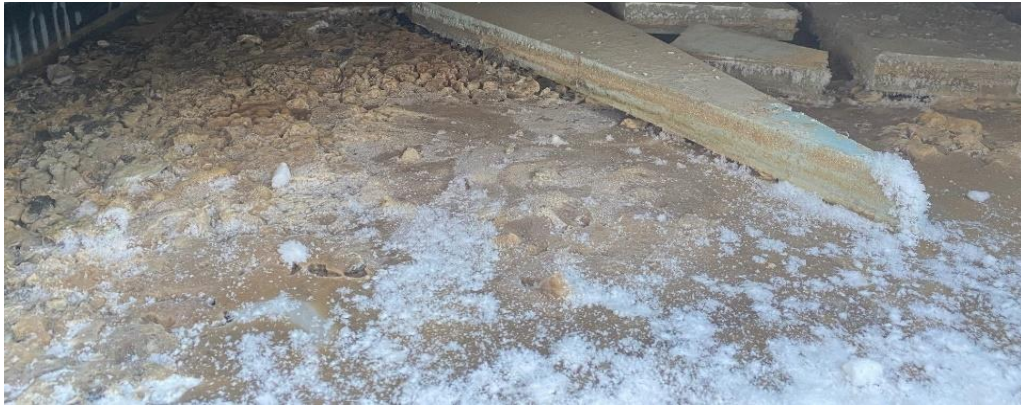
Figure 3. Grease under the wing ~24 hours post spill – 2022-02-04

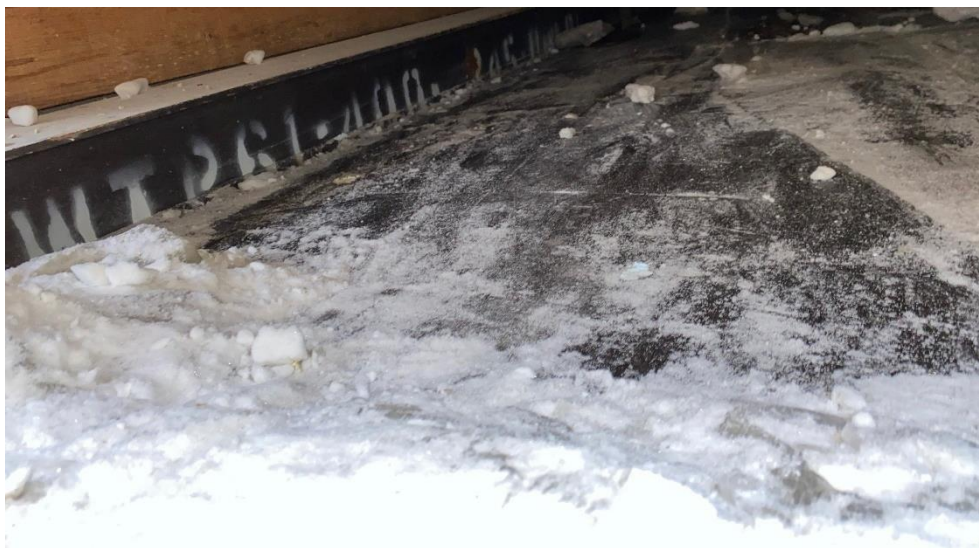
Figure 4. Grease Spill after cleanup efforts

Workers immediately used the sucker truck to remove ~1000L of grease from the ground. Hand shovels and equipment was used to clean the spill area. Approximately 1.5 m³ of contaminated snow and material was disposed of at the Meadowbank tailings area. Due to the location, time and nature of the spill additional remediation work will occur in the spring when the ground has thawed to allow for better recovery of contaminated material.

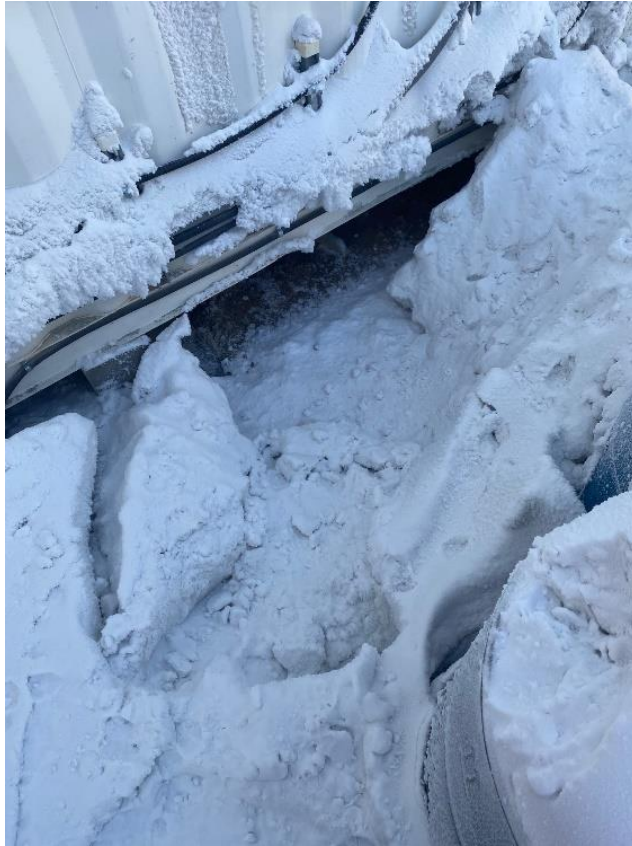
Figure 5. Grease Spill after cleanup efforts – 2022-02-05

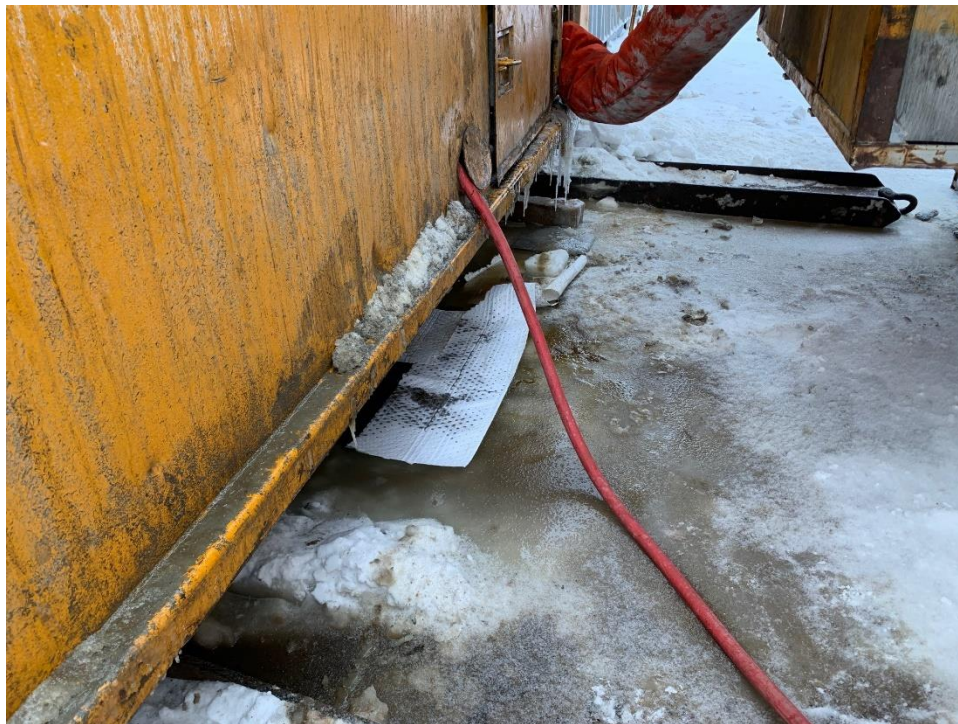
During operations at Whale Tail pit, operators of SH92 Drill noticed a puddle of hydraulic oil under the drill on Mammoth Lake.

A small pin hole was found in one of the hydraulic lines.

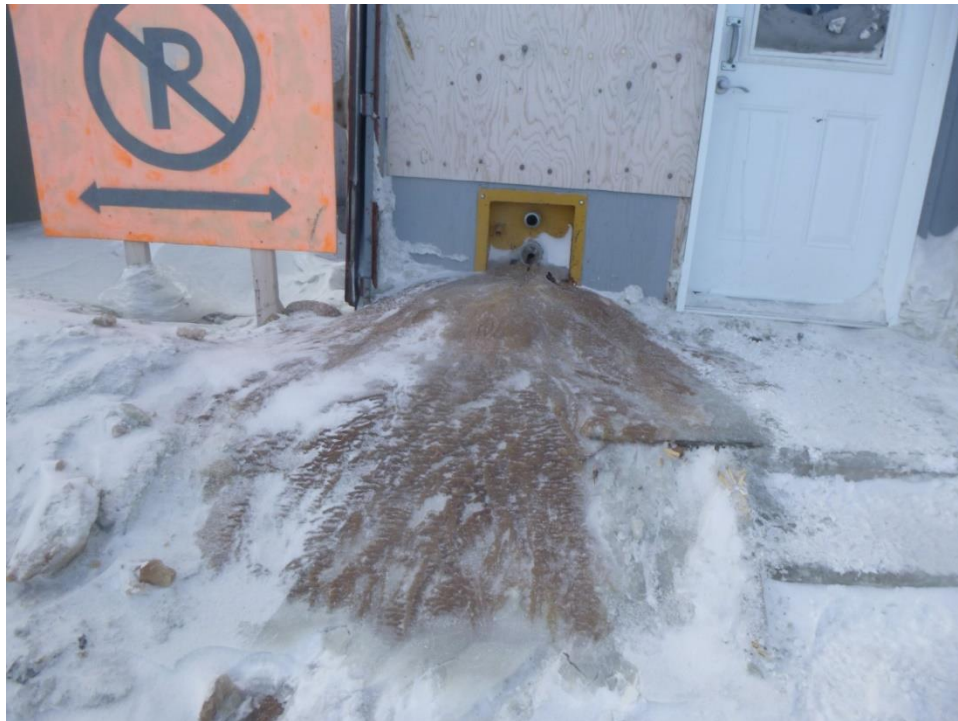
During the transfer of sewage between the contractor offices and the sewage truck at the Whale Tail Pit project, the operator did not properly close the reservoir valve prior to leaving the area causing a slow leak of sewage onto the ground.

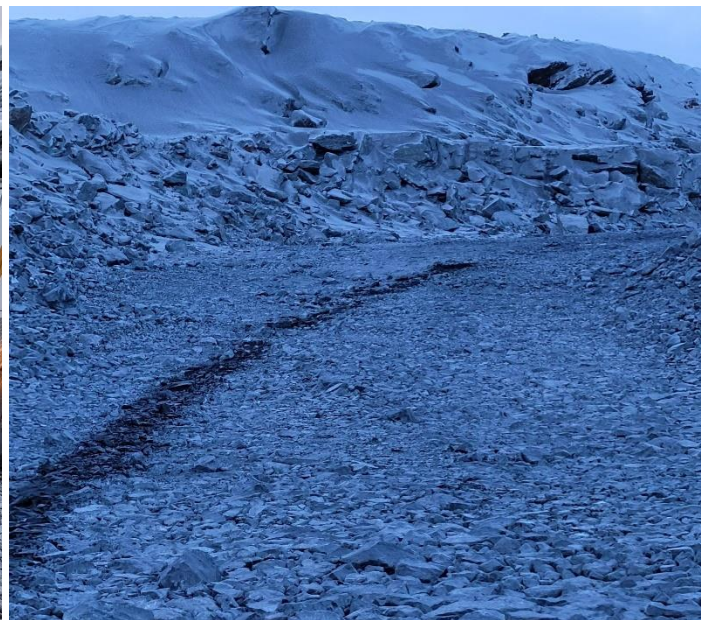
During operations at the Whale Tail pit project, the service truck ran over a rock while going up the IVR pit ramp. The rock tipped and ruptured the fuel tank causing fuel to spill onto the ground.

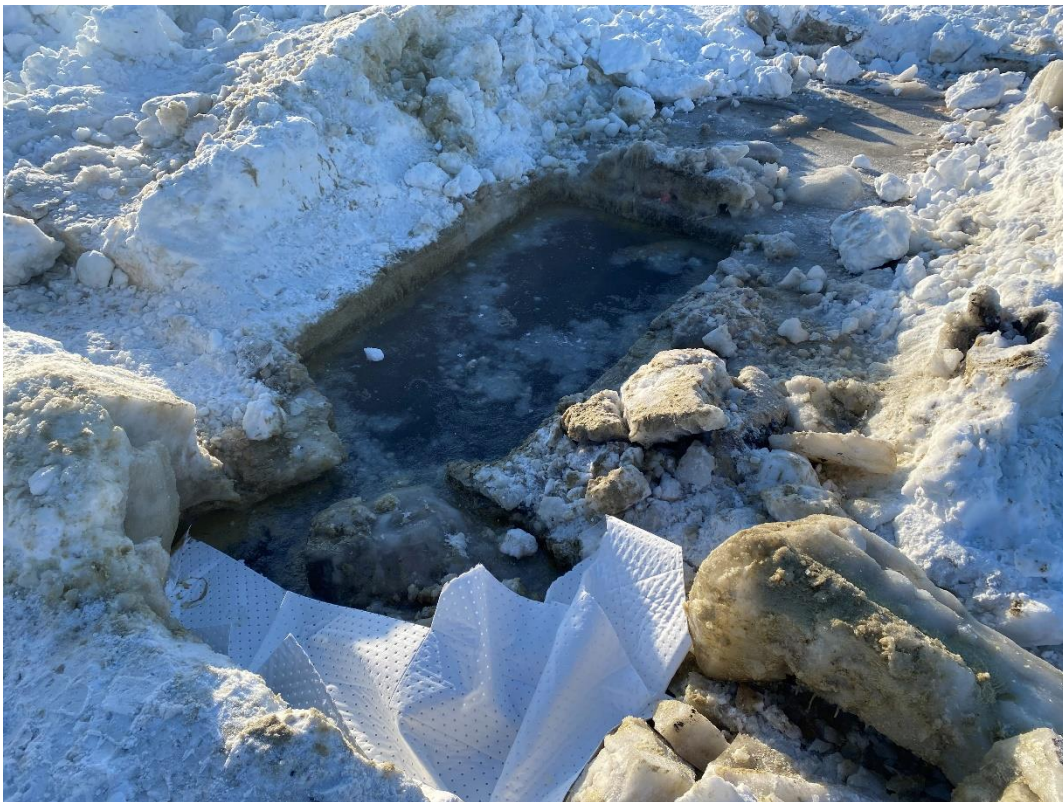
During operations at Whale Tail pit, a post drill hole inspection found the presence of hydraulic oil and fuel at the drill location. The drill was immediately suspended until the causes of the spills were determined.

Due to a loose hydraulic fitting on the foot clamp of the drill and failure of secondary containment under the drill hydraulic oil leaked out onto the ice and was not visible until the drill move was complete.

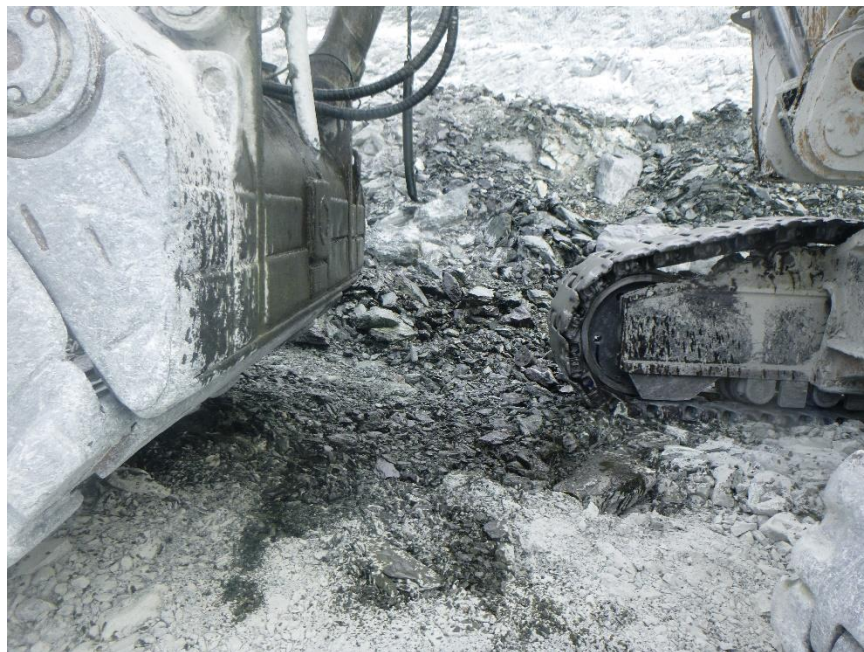
During operations at Whale Tail Pit project, a hydraulic hose of the excavator failed, causing a total of 150L of hydraulic oil to leak on the IVR pit floor.

Excavator hydraulic hose failure.

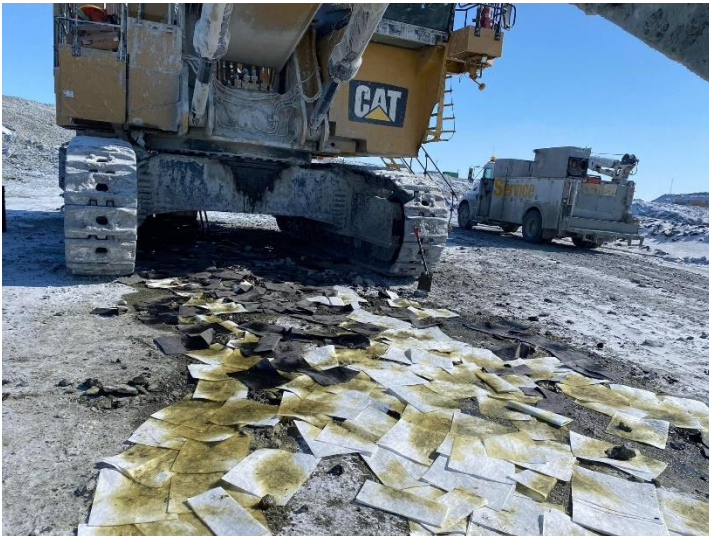
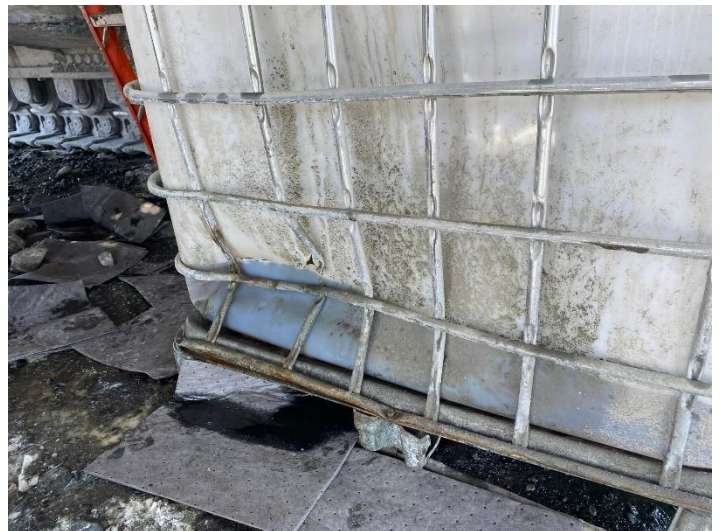
During operations at Whale Tail Pit project, the maintenance team was draining the hydraulic oil from an excavator into used totes to perform routine maintenance, one of the totes was discovered to be damaged and as result 300L of hydraulic oil to leak on the IVR pit maintenance pad.

Damaged equipment

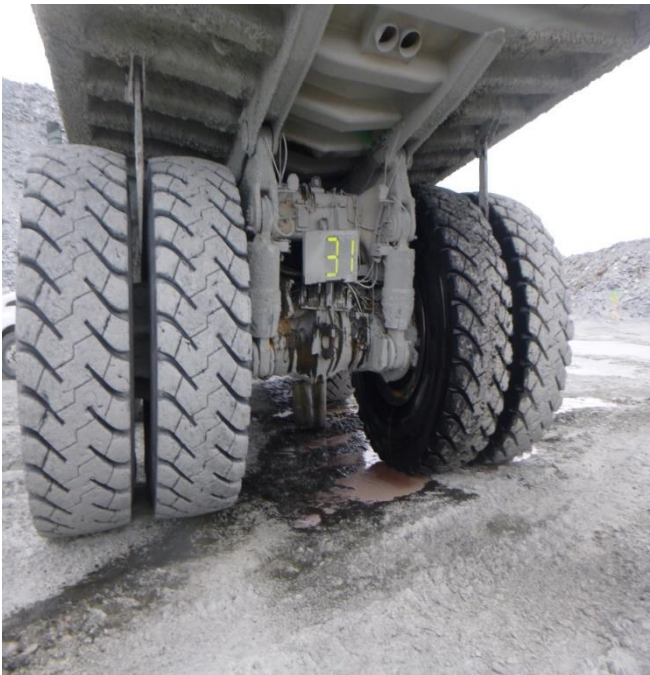
During operations at Whale Tail Pit project, a hydraulic hose of the haul truck failed causing a total of 400L of hydraulic oil to leak on the ground between IVR Rock Storage Facility main ramp and the heavy equipment parking.

Hydraulic Hose Failure

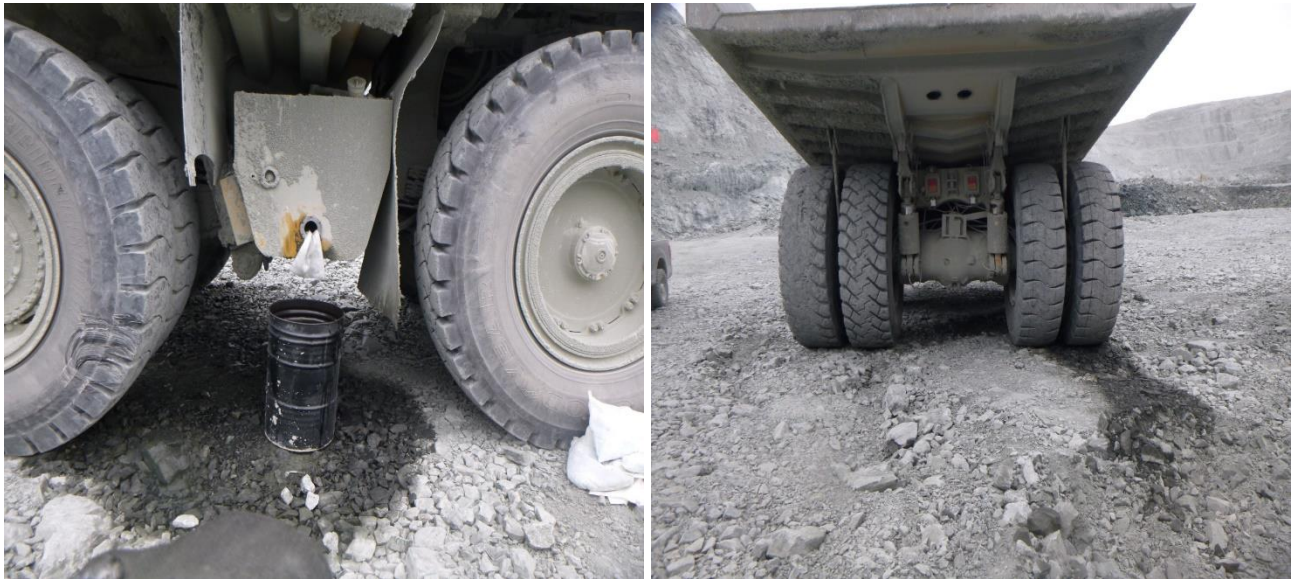
During loading operations at Whale Tail Pit project, a rock rolled off the dig face and struck the haul truck Wiggin's nozzle causing the fuel tank to spill on the floor of the Whale Tail pit.

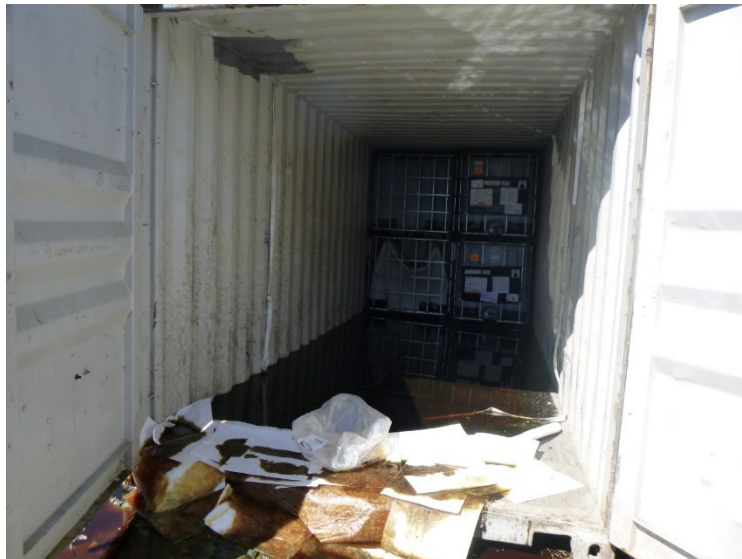
During operations at the Whale Tail Project, a tote containing 1000L of engine oil was punctured by an equipment during the process of removing the reservoir from the sea can, causing a total of 800L of oil to leak on the ground of the warehouse sea cans storage pad.

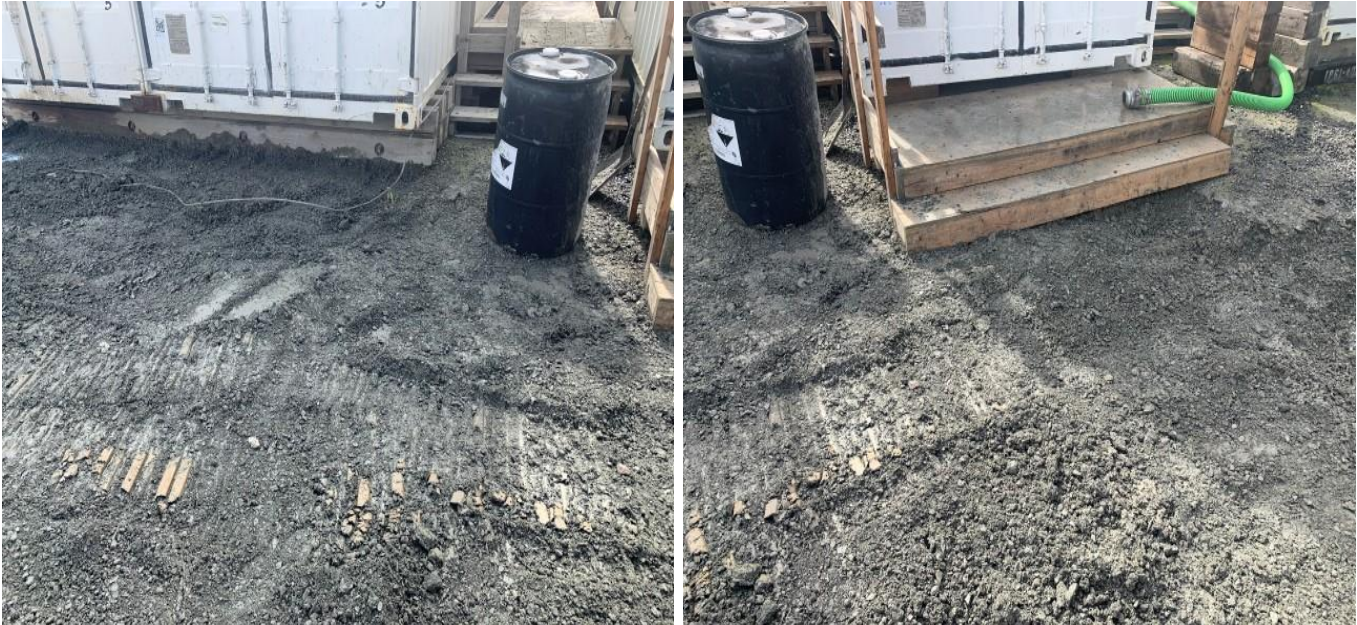
It was determined the level probe and float failed during start up after the electrical shut down.

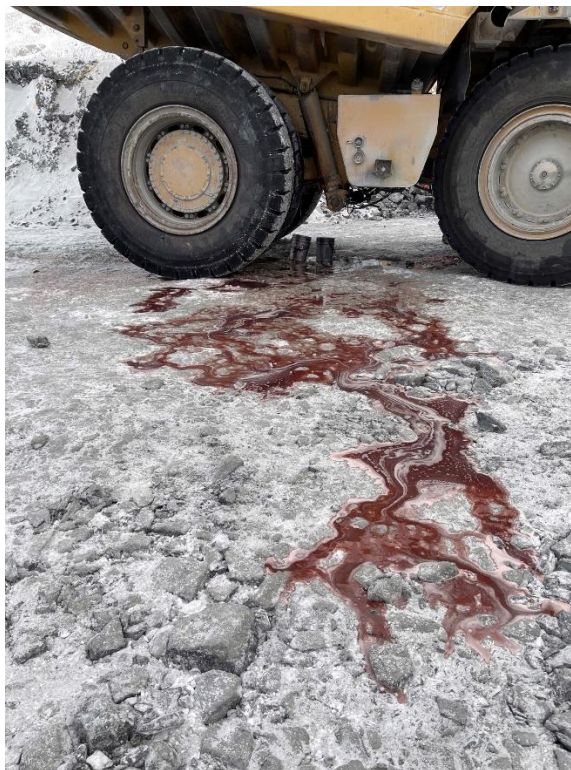
During operations at the Whale Tail Project, the drive shaft failed on a haul truck causing a total of 220L of hydraulic oil to spill on to the ground at the bottom of Phase 1 in the Whale Tail Pit.

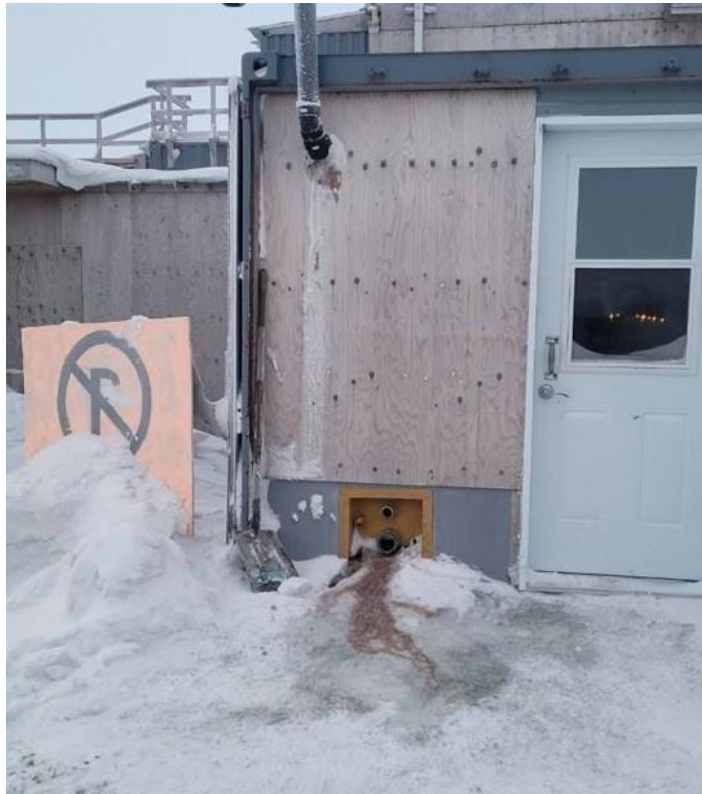
During an inspection of the Amaruq camp, a small quantity of frozen sewage was observed on the ground near the sewage transfer pipe.

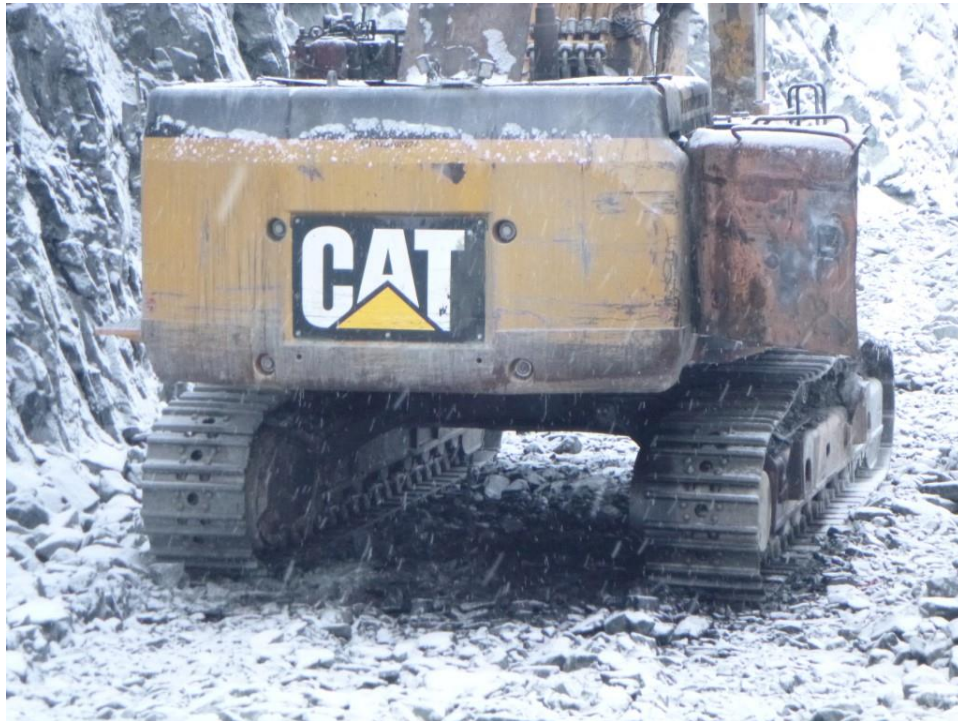
During operations at the Whale Tail pit project, the excavator was performing work in Whale Tail pit phase 3 when it caught fire. The Emergency Response Team was called to put out the fire.
