Appendix 31

Meadowbank 2019 GN Spill Reports

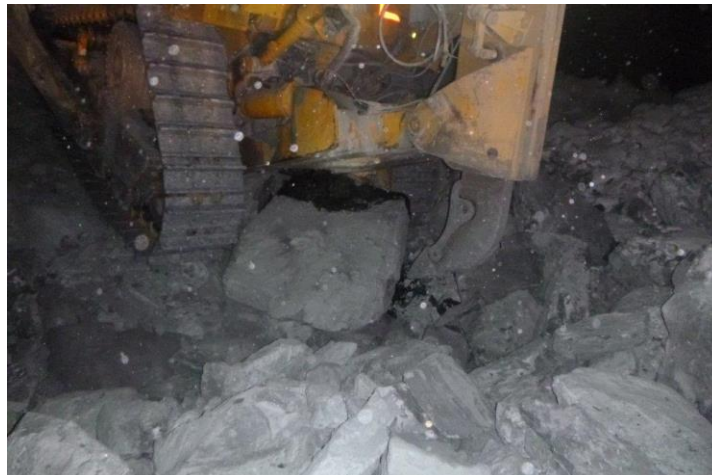
Dozer was pushing at the rock and went too far, ran over boulders and knocked off the transmission screen cover causing a transmission oil leak of 150 liters.

The spill was caused by a damaged transmission oil cover.

Operators have been reminded about the risks of going over larger rocks.

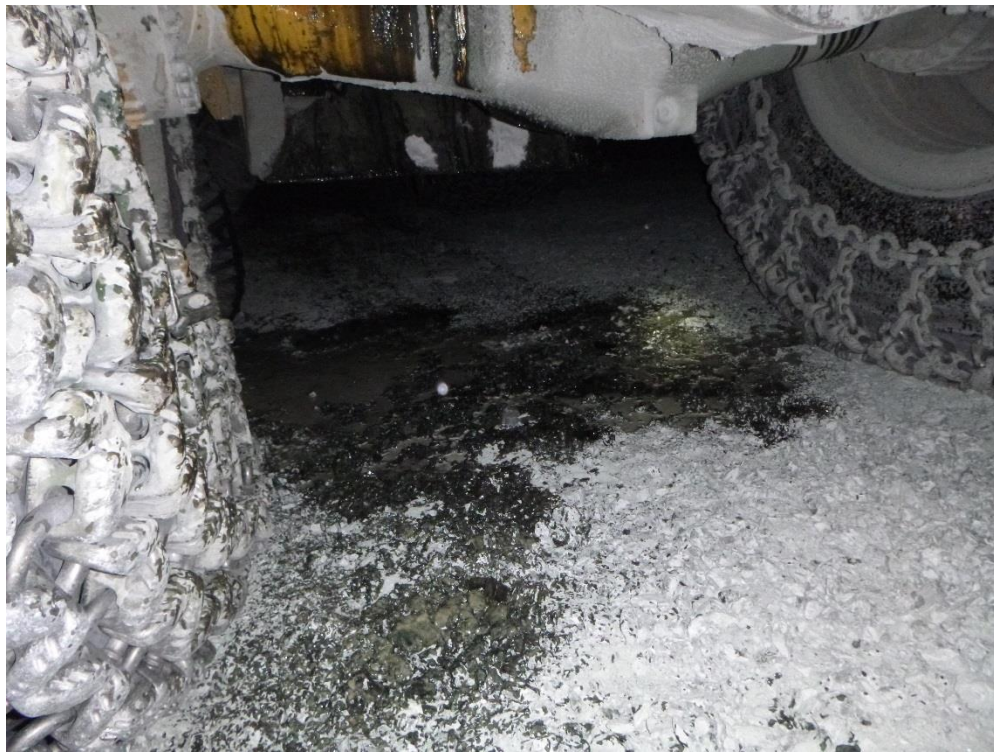
During operations at Pit E3, the transmission on the loader failed causing transmission oil to spill on the ground.

Operations during intense cold temperatures create extra stress on equipment mechanics and precipitated the failure of the loader transmission.

Existing cold weather procedures in place in relation to operating equipment in extreme conditions, including extra care taken in operating loading equipment during these situations. Regular pre-operation checks are completed on equipment also including visual inspection.

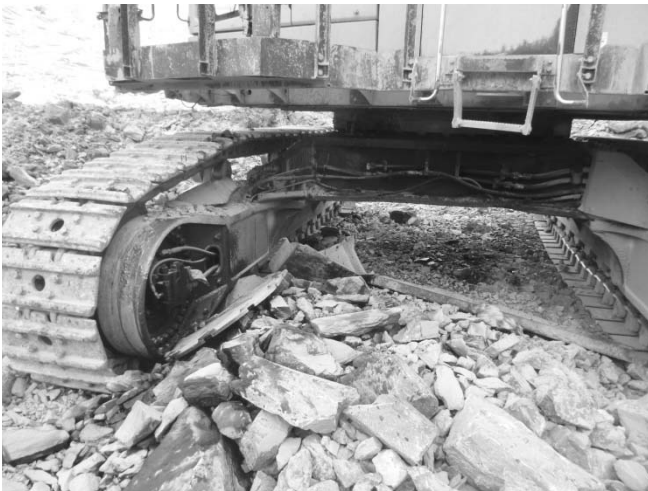
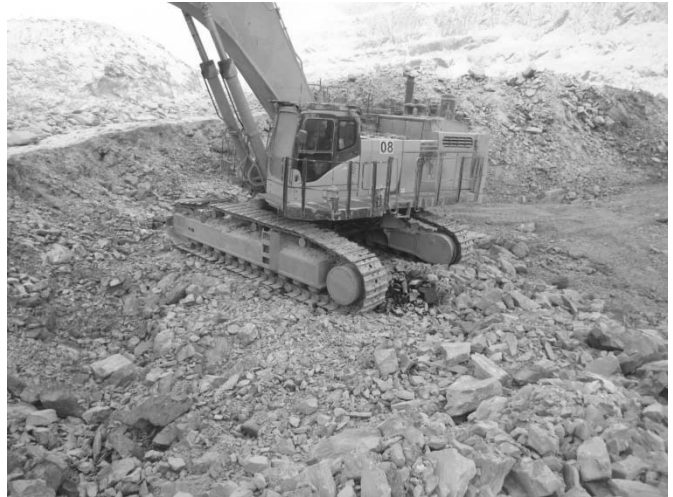
During operations at Pit E3, Backhoe was moving to excavate rock, when the travel motor guard came in contact with a boulder causing the hydraulic hose to break.

The spill was caused by busted line after a contact with a rock.

The hydraulic system is inspected as part of the preventive maintenance program done on site. Pre-operation checks also include visual inspection of the equipment.

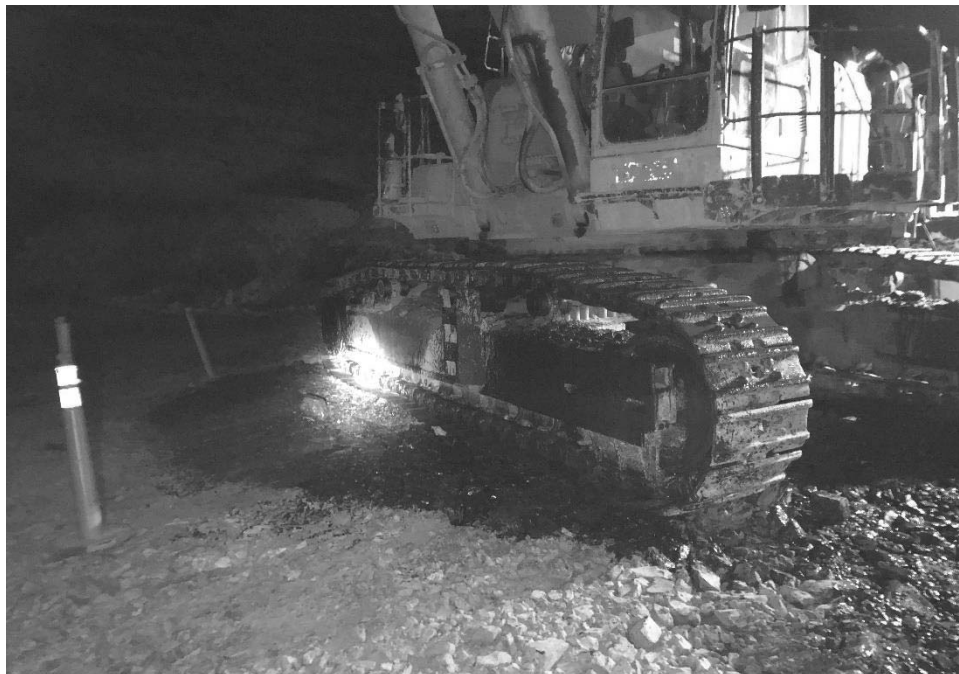
During operations at Pit E3, the main hydraulic line broke causing oil to spill on the ground.

The spill was caused by broken hydraulic line.

The hydraulic system is inspected as part of the preventive maintenance program done on site. Pre-operation checks also include visual inspection of the equipment.

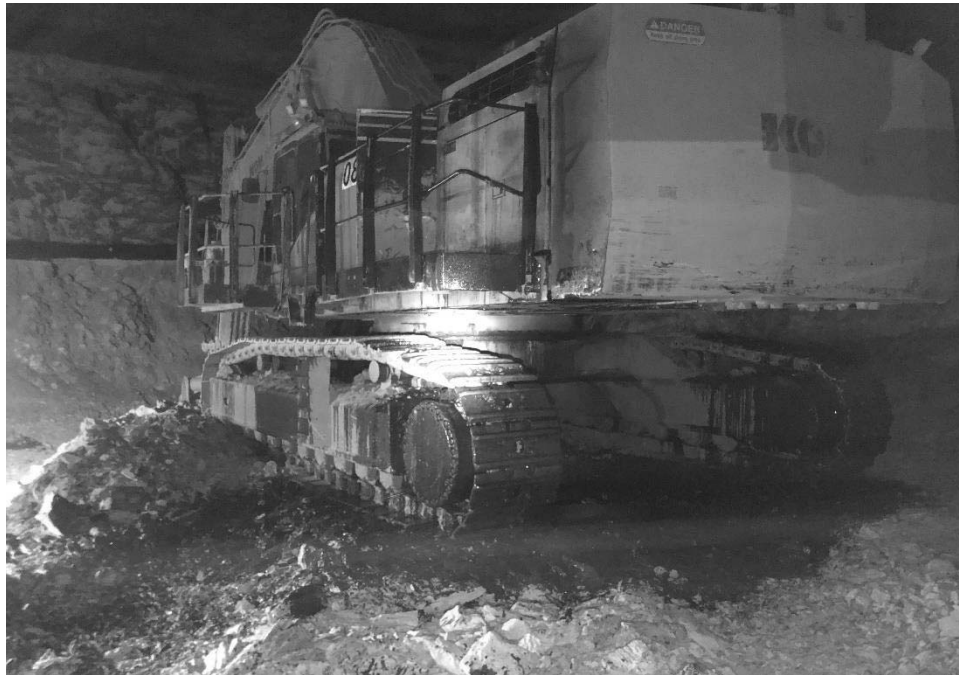
During operations at Pit E3, two hydraulic lines broke causing oil to spill on the ground.

The spill was caused by two broken hydraulic lines.

The hydraulic system is inspected as part of the preventive maintenance program done on site. Pre-operation checks also include visual inspection of the equipment.

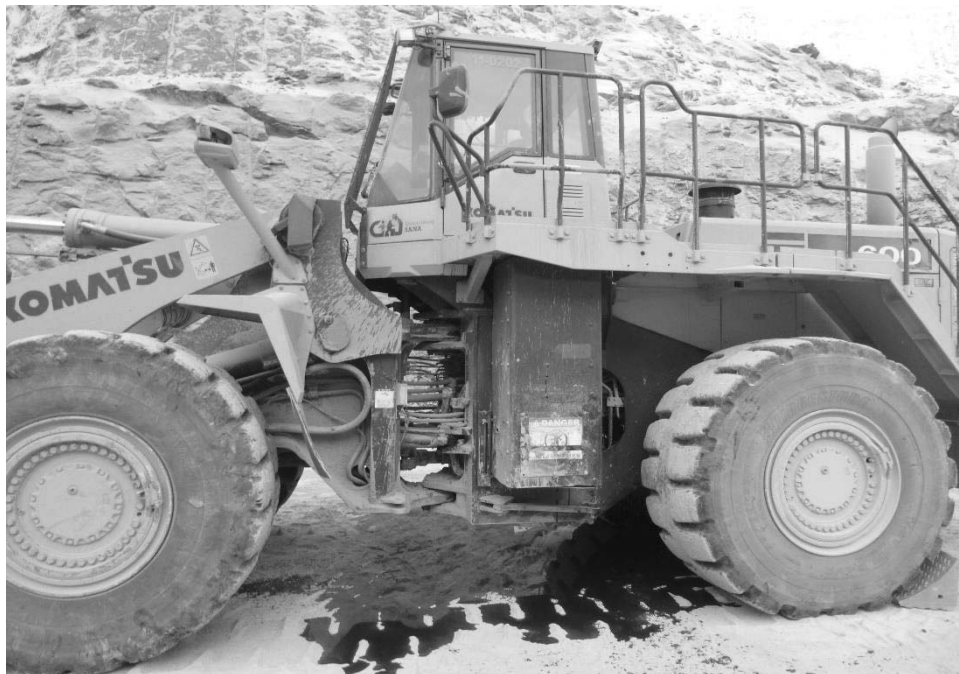
During operations at Pit E, a hydraulic line on the loader failed causing hydraulic oil to spill on the ground.

Hydraulic line failure on loader

Equipment was shut down and maintenance was called to repair the hose. All the contaminated material was scraped up and brought to the landfarm.

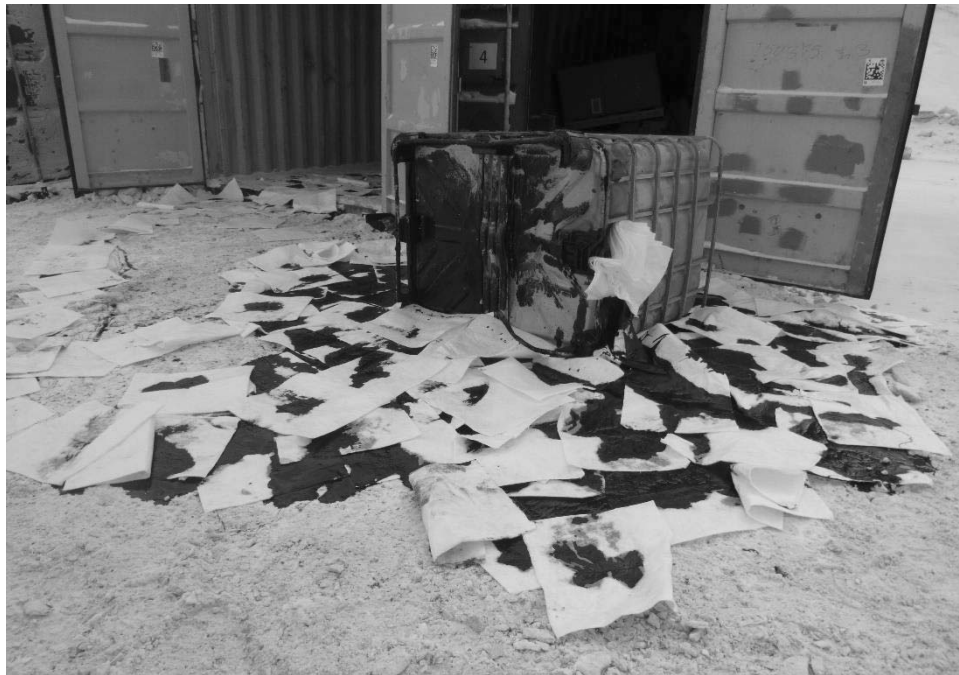
During operations at Meadowbank maintenance area, operator was moving a waste oil tote into a sea-can and did not have the forks of the zoom boom lined up properly. The forks punctured the tote and caused to spill inside the sea-can and on the ground.

Zoom boom forks puncturing the waste oil tote caused the spill.

Procedure for moving totes was reviewed by warehouse operators which also includes visual inspection of the equipment and work area.

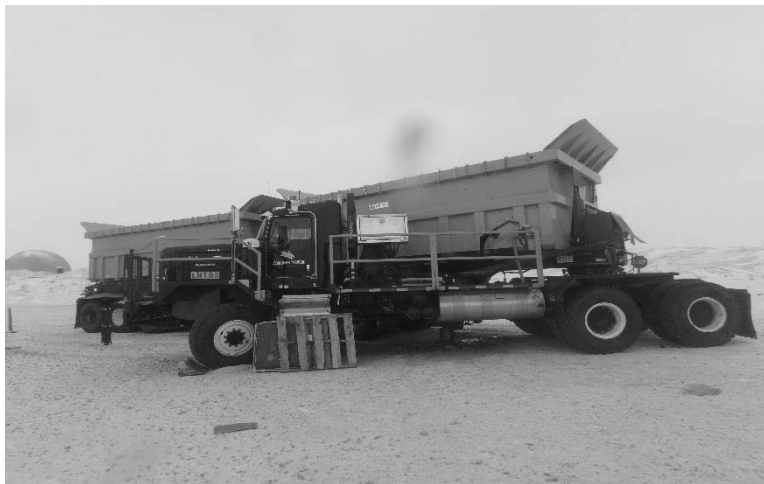
During operations at Meadowbank, a long haul truck was turning at an intersection and due to slippery road conditions, the LHT jackknifed causing the diesel fuel tank to puncture and spill onto the ground.

The truck jackknifed due to slippery road conditions and punctured the diesel fuel tank.

All drivers were reminded of speed limits on the Meadowbank site roads. Daily maintenance of the road is done by the mine operations. The slippery area was scraped with a grader and fresh gravel was spread on the roadway.

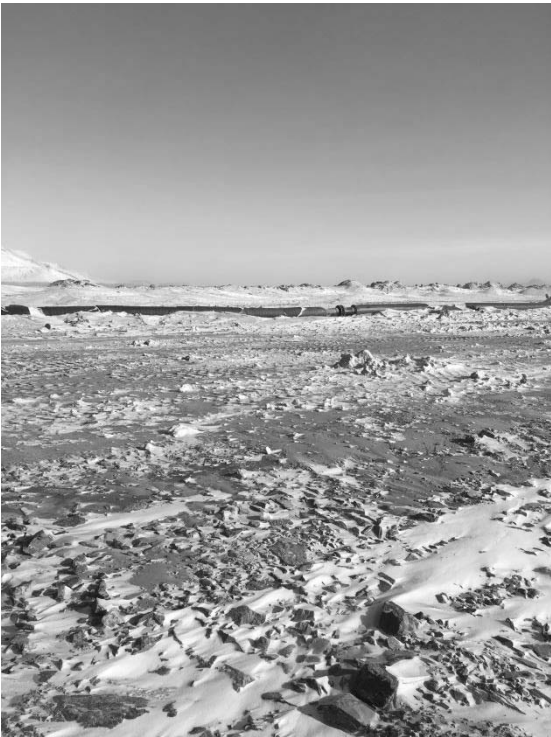
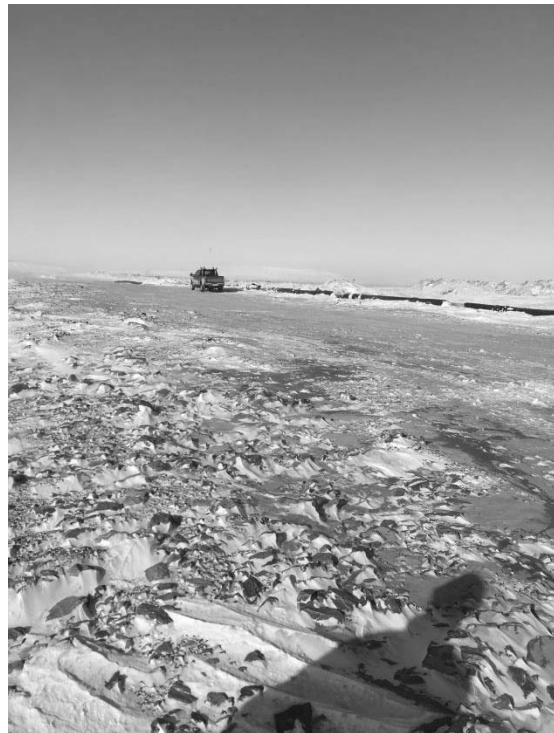
During start up of the booster pump after moving the tailings deposition point, a tailings pipe broke near a flange. Approximately 85 m³ went on the dike.

An improvement in the communication, with the control room, will help to prevent a spill in the future.

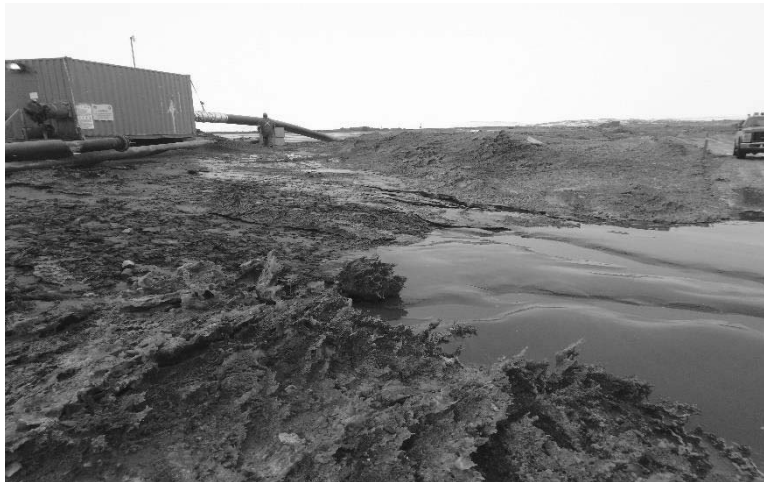
A planned electrical shutdown of the Tailings storage facility “pig launcher” station occurred on the morning of May 8th. During restart of the system that afternoon, the wrong valve was opened remotely by the Mill Control room, discharging tailings at the top of Saddle Dam 4 by the pig launcher station.

An improvement in the communication with the control room, ensuring lock out/tag out on valves will help to prevent a spill in the future.

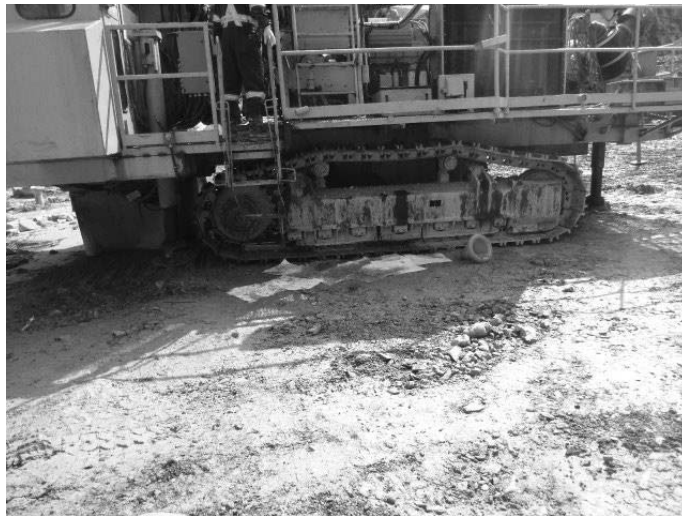
During operations at Pit E in Meadowbank, a hydraulic fitting on drill RBD06 failed causing a spill on the drill pattern.

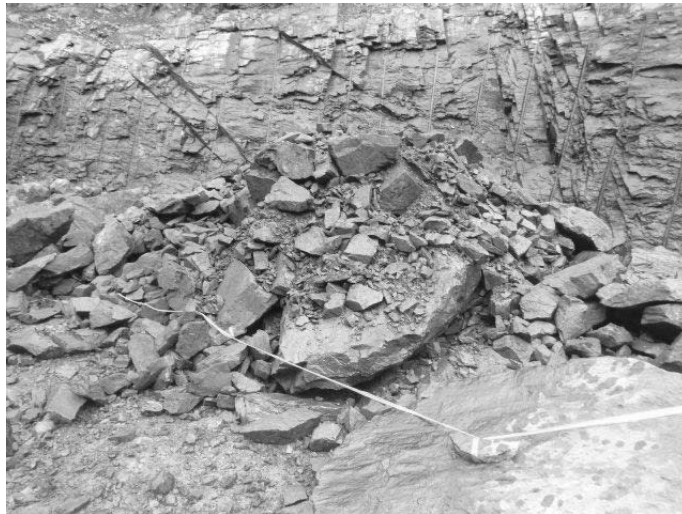
During operations at Pit E, a hydraulic hose on the backhoe hammer failed causing a spill.

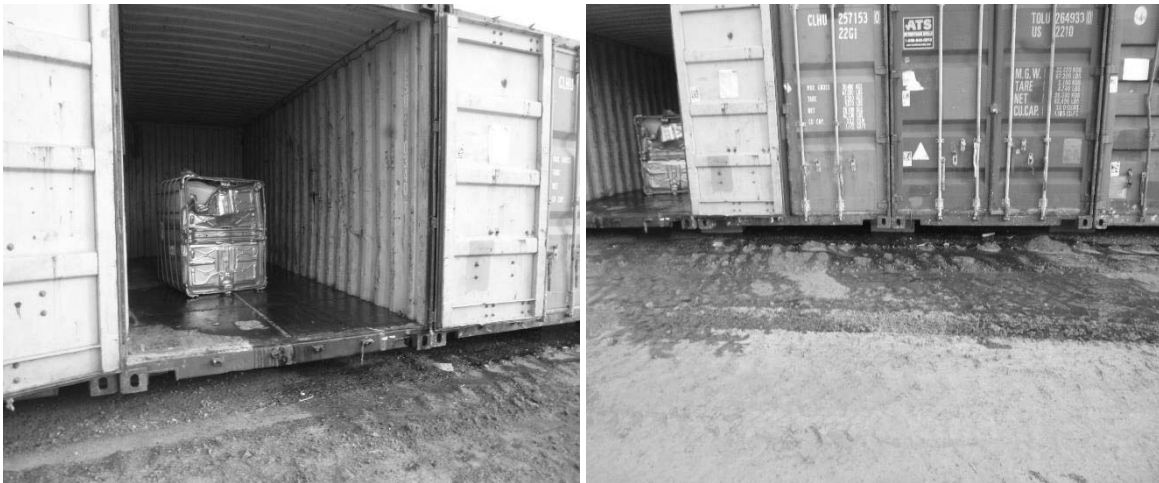
During operations at Meadowbank, an operator was removing a tote of glycol/rust inhibitor from a sea-can and punctured the tote.

All fork lift/zoom boom operators will review procedure for removing material from sea-cans.

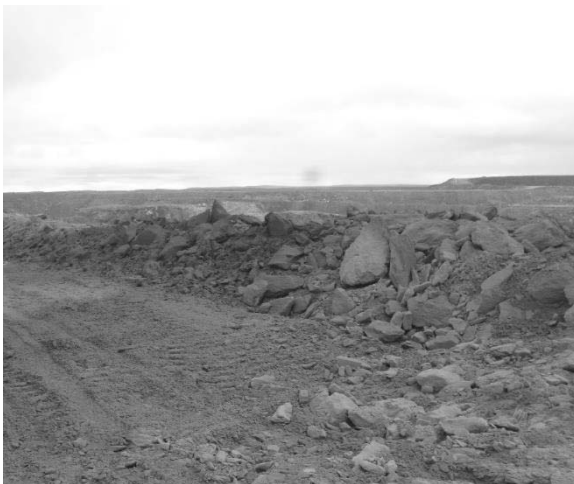
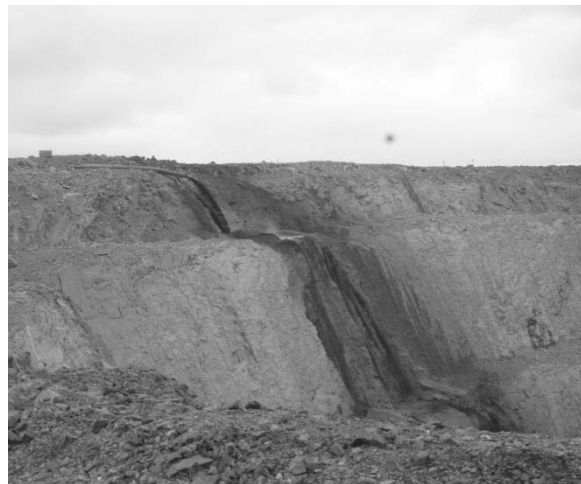
During an inspection of the goose pit tailings deposition point at Meadowbank, it was observed that some tailings had splashed outside of the berm surrounding the goose pit tailings storage facility.

Any future deposition points along the upper bench of the goose pit TSF will have a similar berm constructed to prevent any tailings splash back during high winds.

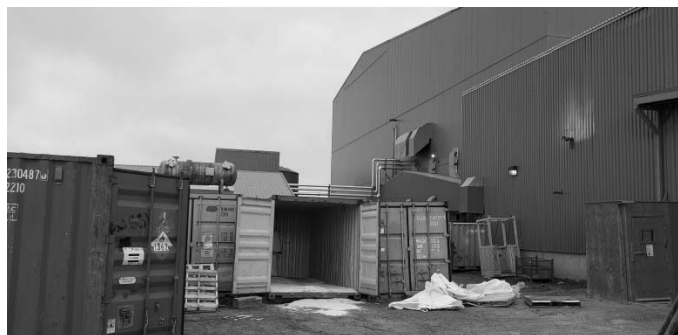
The spill was caused by a human error when the operator during the operation.

The operators are trained for these tasks. They need to follow the procedure.

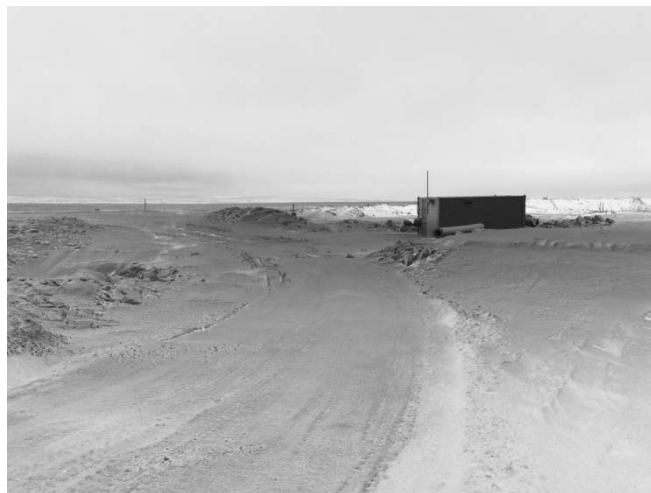
On October 11th at 10:00 am, during an inspection of the Goose pit tailings deposition point, it was observed that some reclaim water had splashed outside of the berm surrounding the Goose pit tailings storage facility. Based on the visual areas impacted by the drizzle reclaim water, it was estimated to approximately 150 liters. During this inspection, we noticed possible impacts on the downstream of the dike towards Third Portage Lake (N: 65°01'12.57" W 96°01'54"). As due diligence, a toxicity test and water sample was taken in the Third Portage Lake, in proximity of the impacted zone. Agnico remains confident that a very limited volume, if any, was ever directed to the receiving environment. As the vast majority, of the water was observed close to the discharge point.

An improvement in the end point discharge has been done. The pipe was extended down to reduce the wind effect on the discharge.

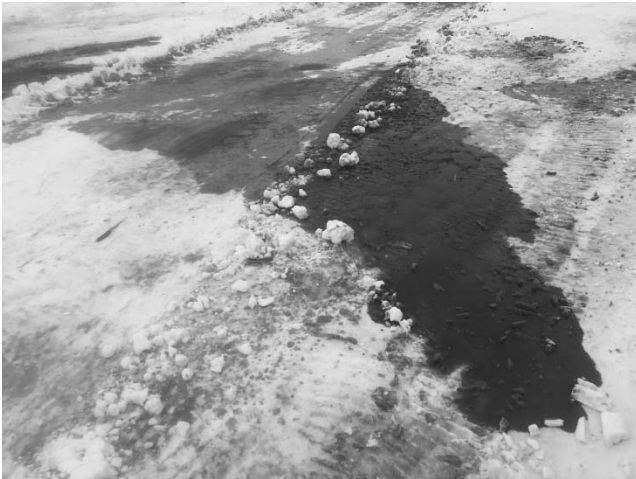
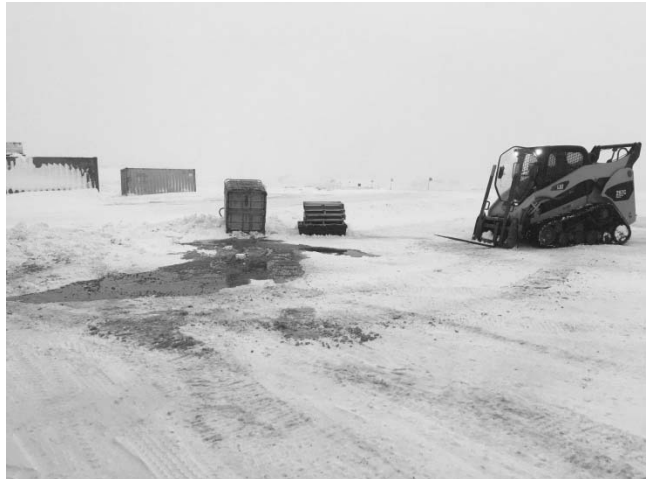
During operations at Meadowbank, an operator was moving a tote of transmission fluid. When the operator put the tote on the ground the discharge spout on the tote broke off causing fluid to spill on the ground.

All fork lift/zoom boom operators will review procedure for removing material from sea-cans.

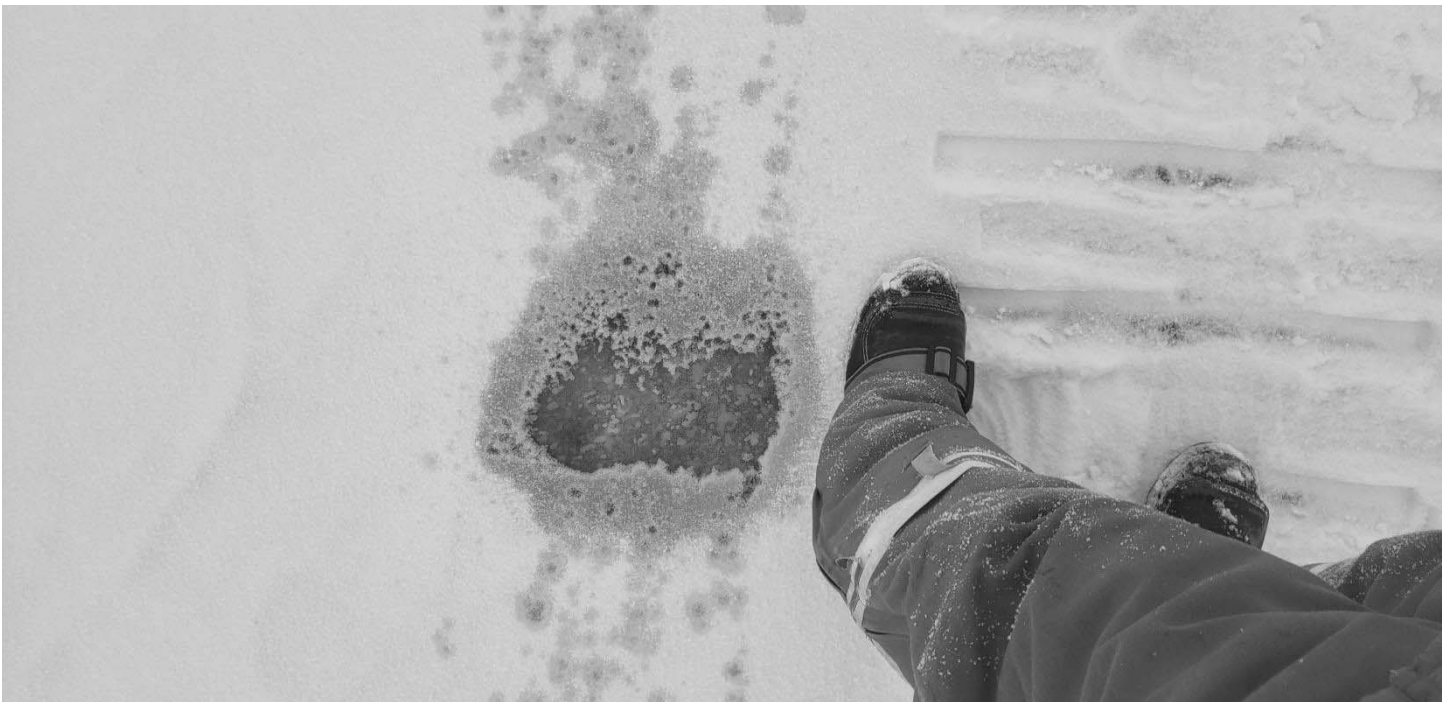
During operations at Meadowbank, while travelling across Third Portage Lake, the coolant hose on ATV07 failed causing coolant to spill on the snow and ice.
