Appendix 32

Whale Tail 2019 GN Spill Reports

GN reference #: 2019-001

Please find the following information as a follow up to the spill report submitted January 2, 2019 by Agnico Eagle. This detailed report is submitted to the Inspector in compliance with the conditions under the Nunavut Water Board License NWB-2AM-WTP1826, Part H, Item 8c.

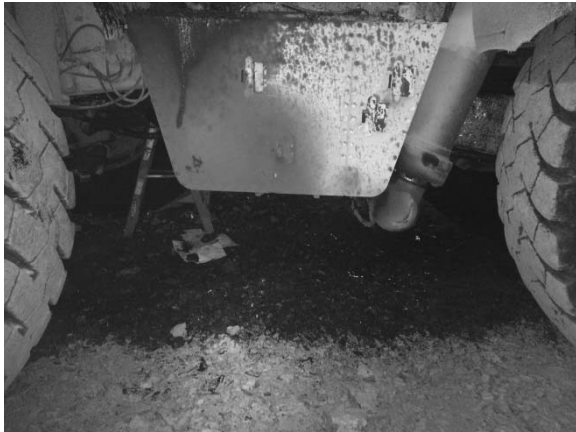
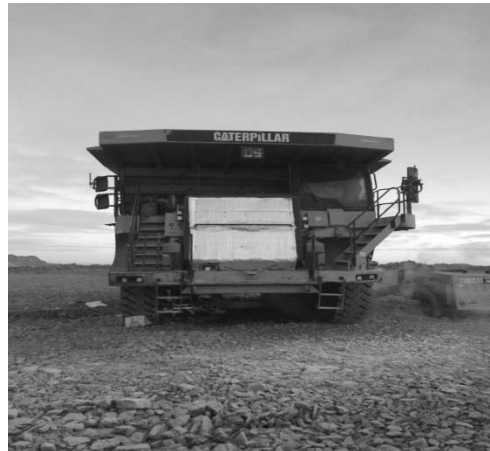
During operation at the Whale Tail Pit waste rock storage area, an hydraulic hose of the haul truck failed causing hydraulic oil to be spilled on the ground.

The leak was caused by a failure of an hydraulic hose.

The driver stopped his truck as soon that he saw the leak and he called a mechanic to fix it. All contaminated soil has been removed and place on the proper place. It was brought at the landfarm at Meadowbank.

The hydraulic system including hoses and fittings are inspected as part of the preventive maintenance program done on site. Routine visual inspection of the hydraulic system is also performed during pre-operations checks.

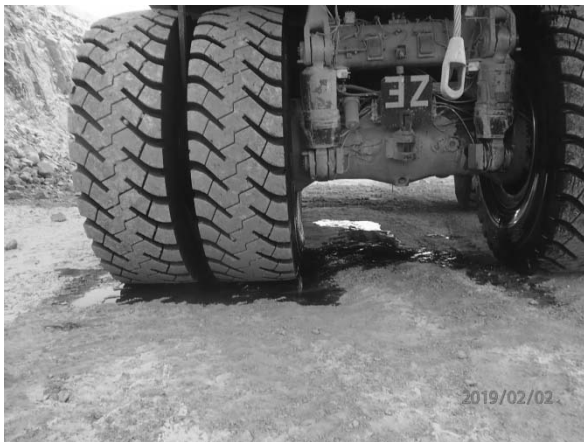
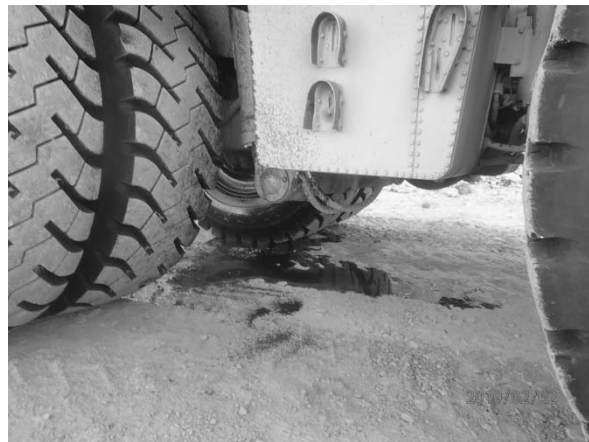
While he went up on the ramp, an operator saw an oil trace. He called the Haul truck driver to ask him if he can check under his truck. The driver stopped his truck and go to see if he had problem. He saw the oil leaking from equipment and he called a mechanic to fix it.

The leak was caused by a cone bearing failure.

The driver stopped his truck and go to see if he had problem. He saw the oil leaking from equipment and he called a mechanic to fix it. All contaminated soil has been removed and place on the proper place. It will be brought at the landfarm at Meadowbank.

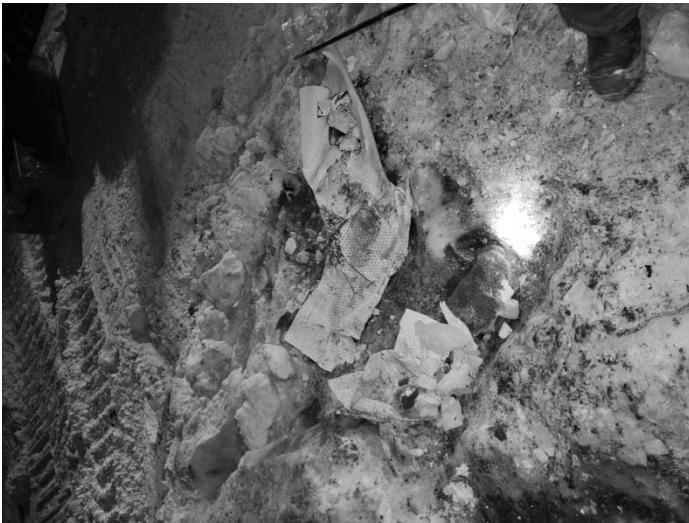
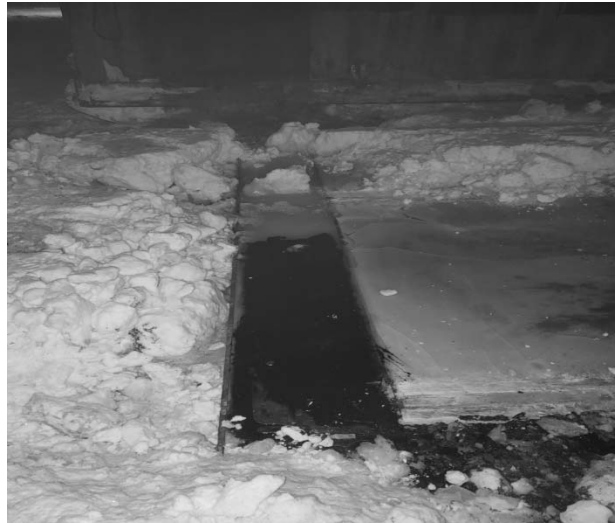
While the drill SH-47 was operating on the Whale Tail North lake, the motor broke down, engine oil leaked from the vent causing a spill in the secondary containment inside the drill but 4 liters of oil has overflowed the containment and goes on snow.

The spill has been caused by mechanical issue with the motor.

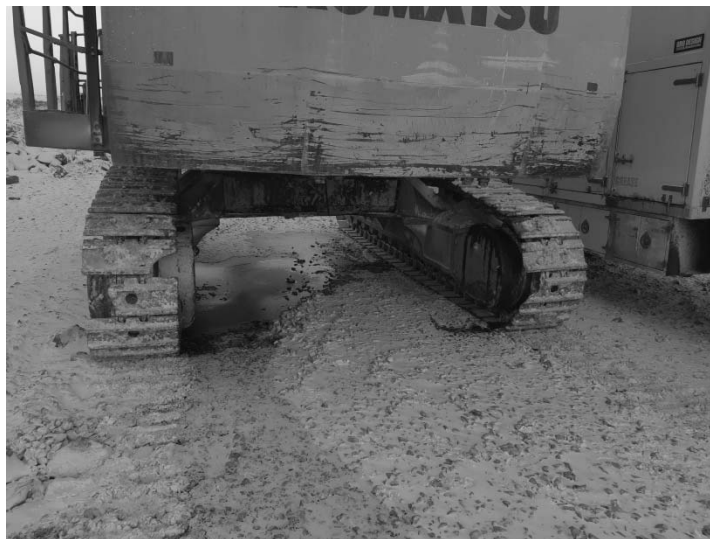
The leak was caused by a faulty coupling on the hydraulic hose.

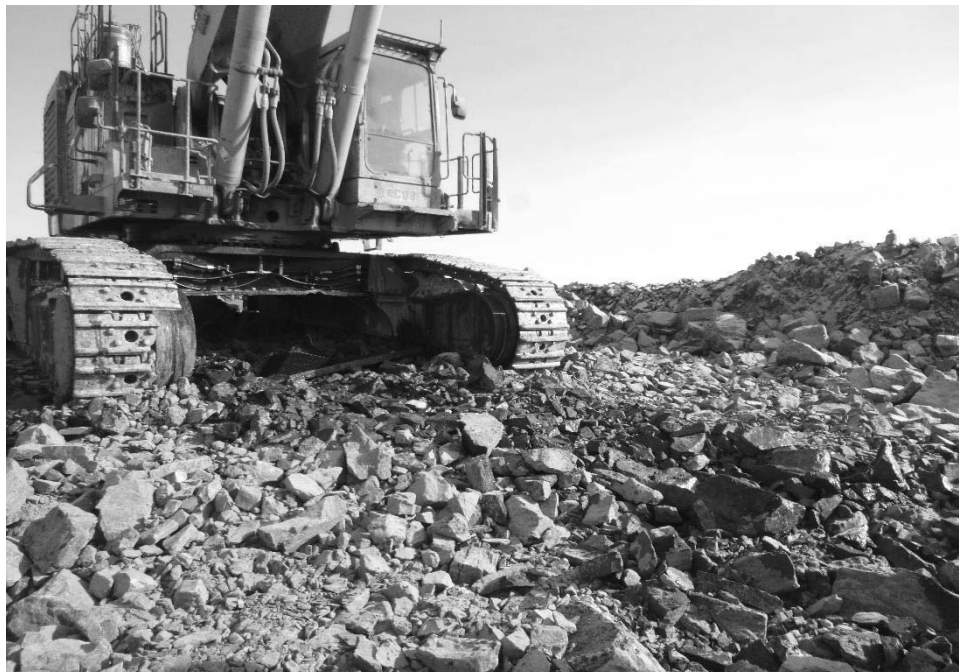
During operations at Whale Tail pit, a fitting on the main hydraulic line of backhoe failed, causing hydraulic oil to spill on the ground.

Failed fitting on the main hydraulic line on backhoe.

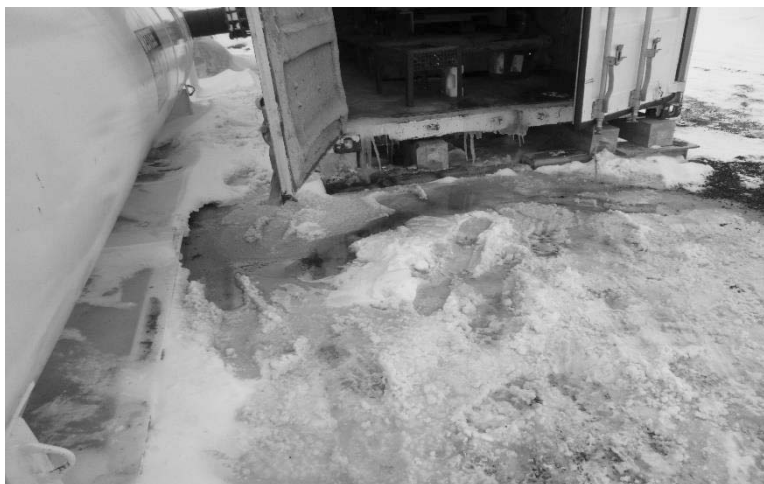
Fitting on the fuel feed line to the dewatering pump failed.

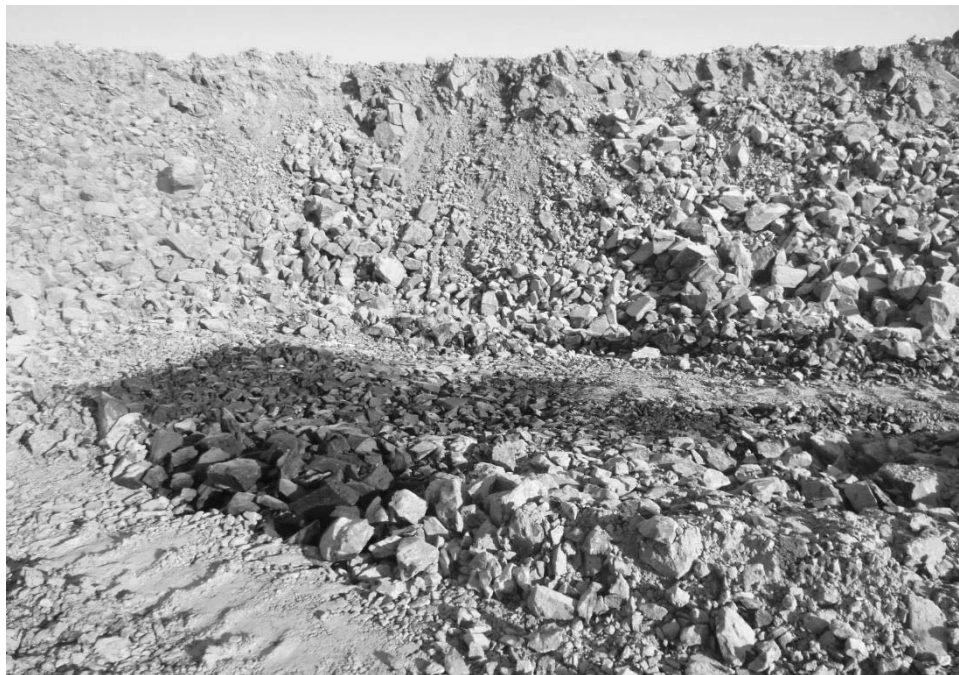
During operations, the flange bolt broke on the hydraulic hose of BAC13 causing hydraulic oil to spill on the ground.

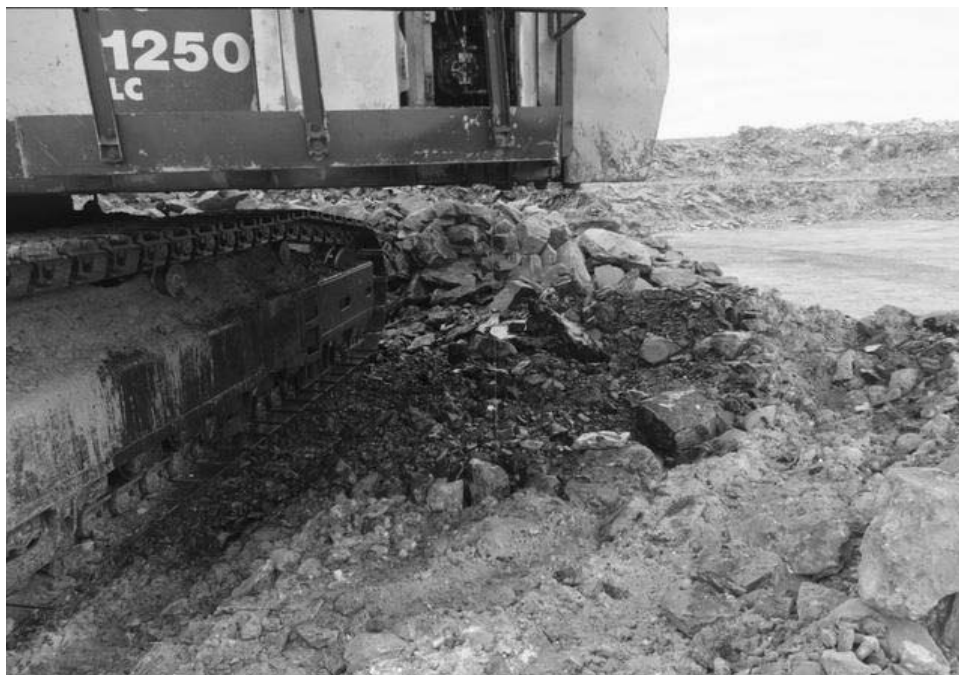
Main hydraulic line of 1250 backhoe failed.

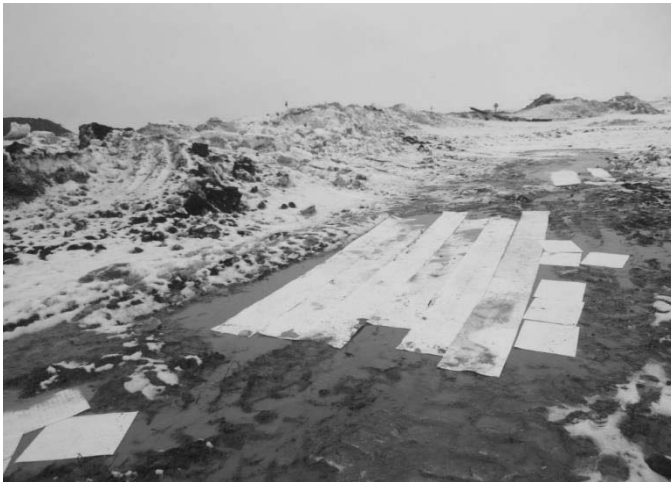
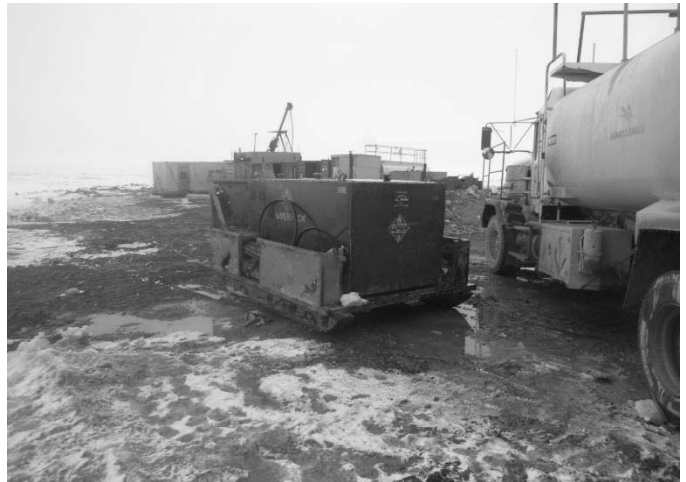
During operations the fuel truck was refilling the diamond drill over pack with diesel fuel. During pumping the worker left his work place to get material from his pick up truck. When he noticed the overflowing of diesel fuel, he immediately rushed back to the pump and stopped the pump.

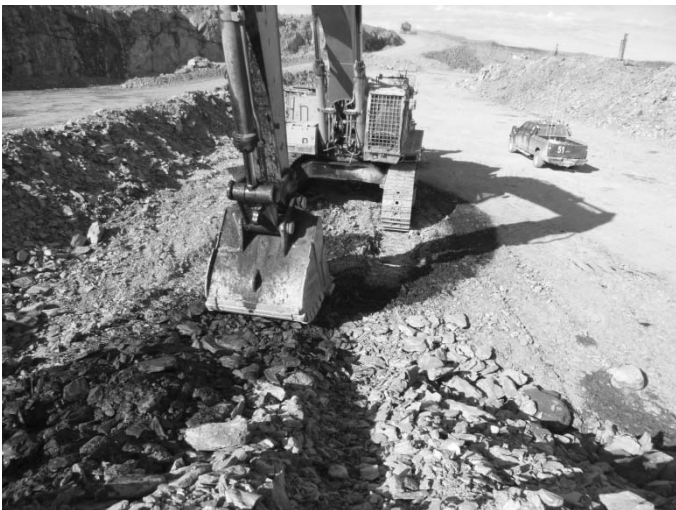
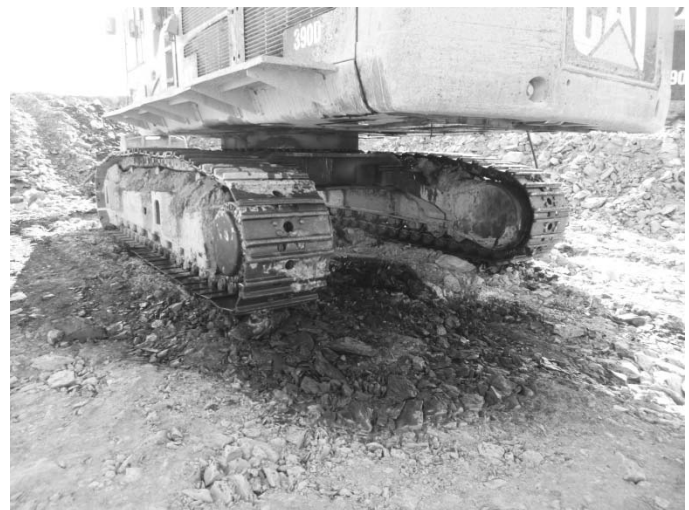
During operations the hydraulic system hose of BAC09 busted due to mechanical failure. The equipment was shut down and the contaminated material was picked up and brought to the landfarm at Meadowbank.

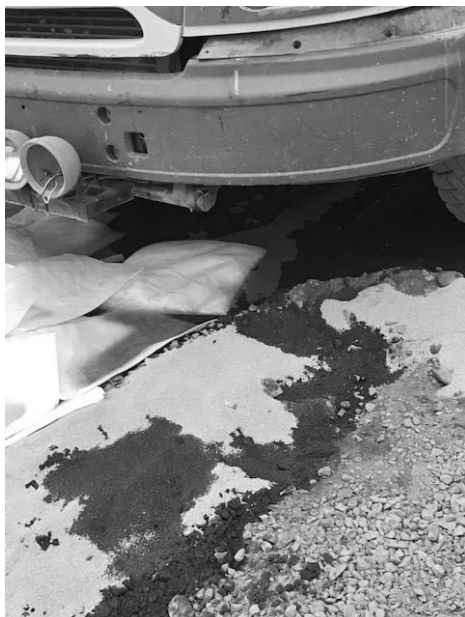
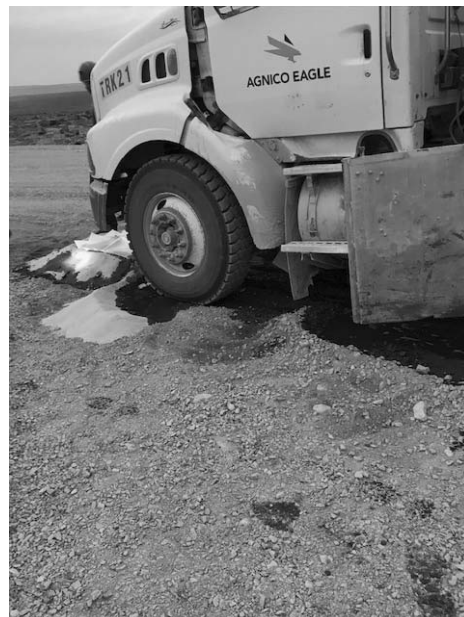
The leak was caused by broken pipe.

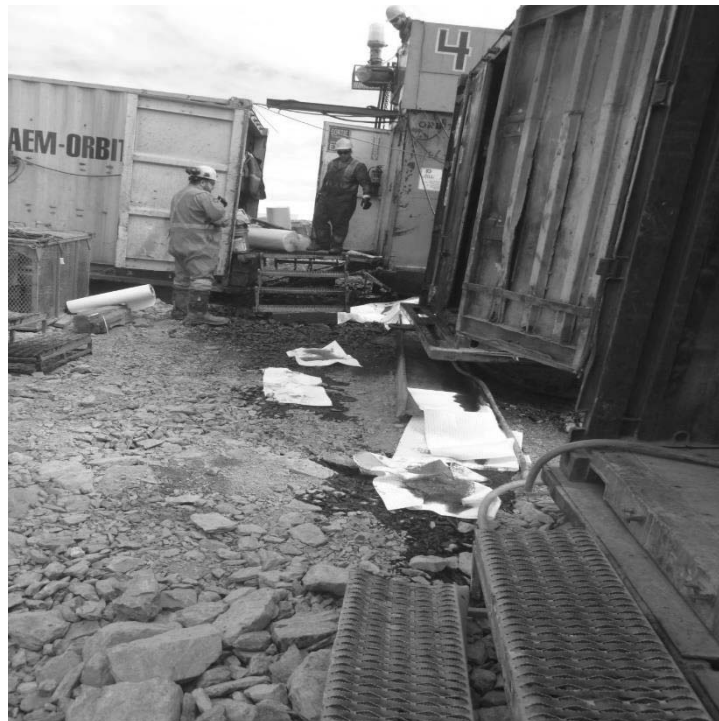
The spill was caused by broken hydraulic hose.

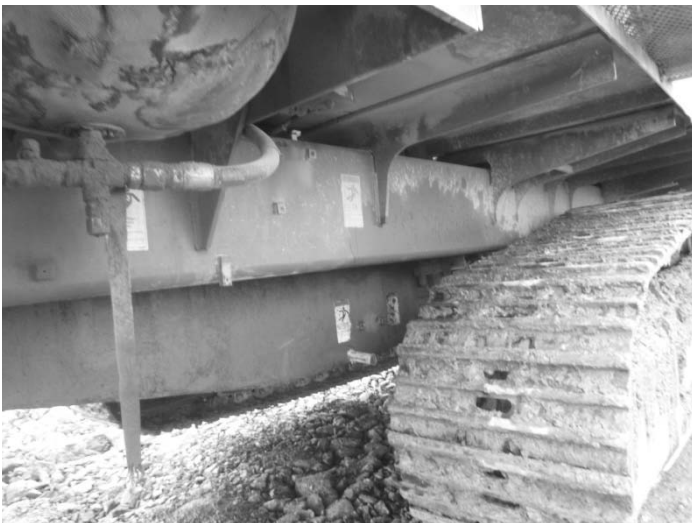
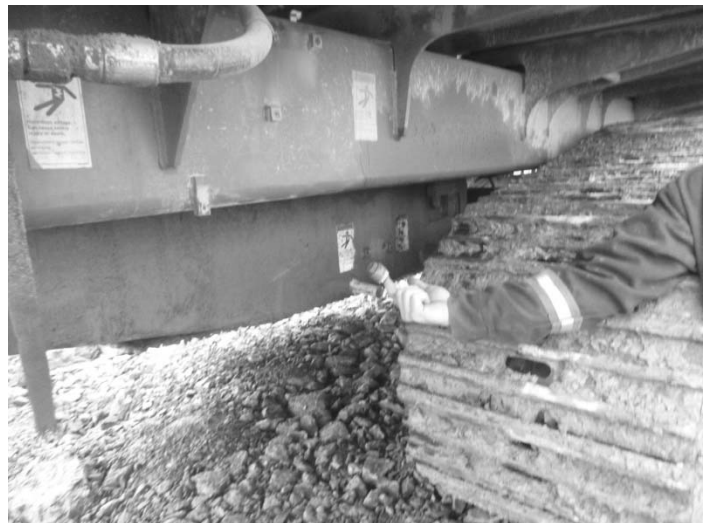
During operations at Quarry 2 of Whale Tail pit project, a rock on RBD04 drill got stuck between the track and fuel tank causing damage to the fuel tank drain plug.

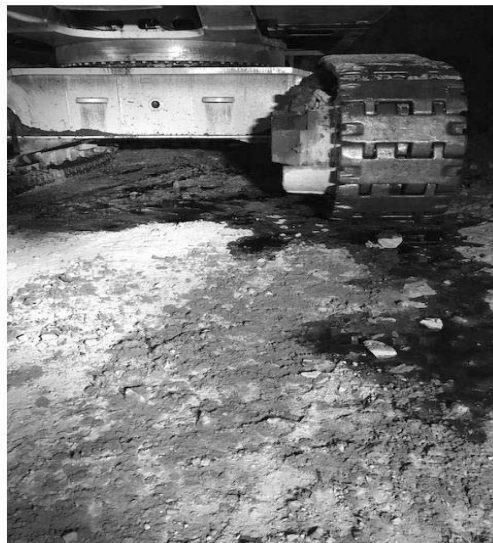
The spill was due to the mechanical failure of the hydraulic hoses.

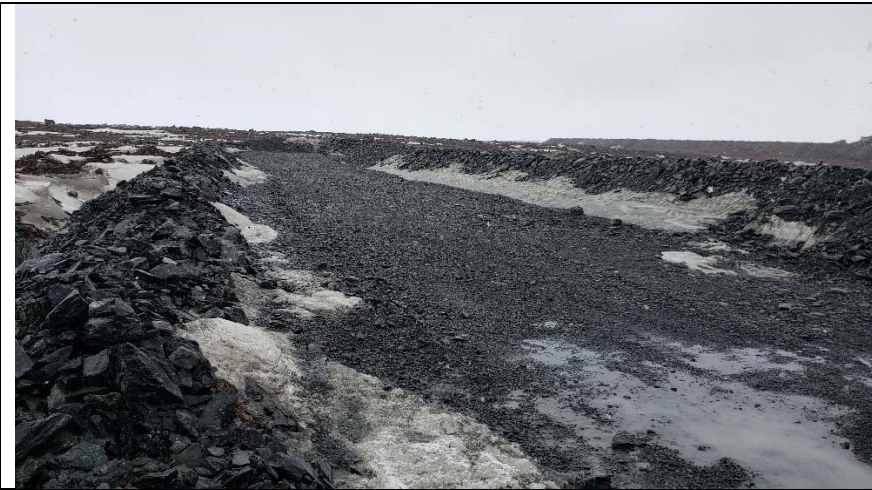
CR1: Rolling surface. Small puddles at surface, no damages

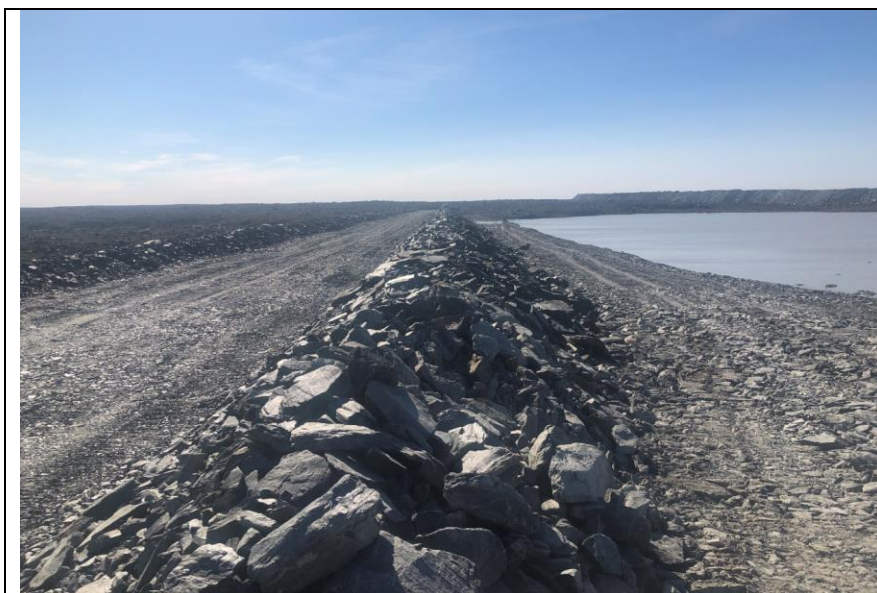
CR1: Rolling surface. Small puddles at surface, no damages

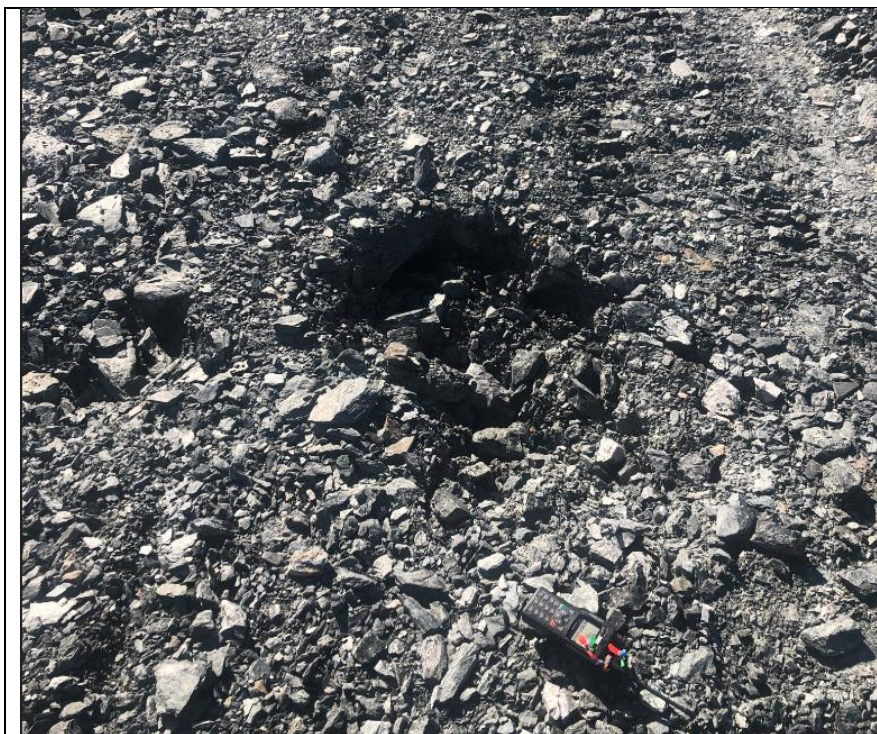
CR2: Rolling surface. Small puddles at surface, no damages

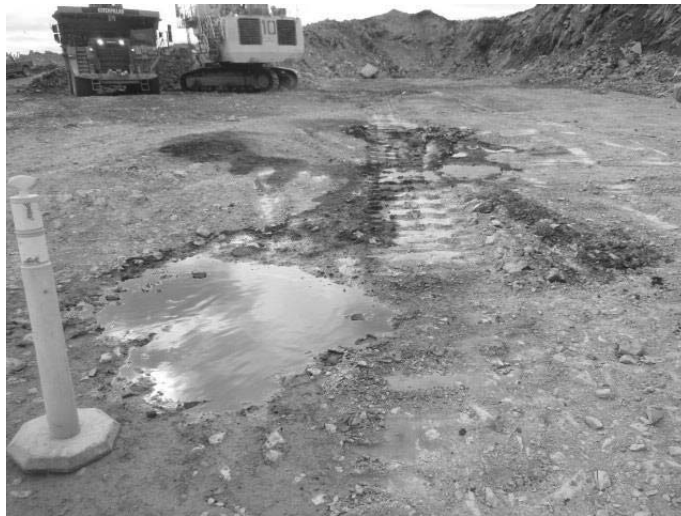
During operations at Whale Tail pit, the hydraulic hose at the rear of BAC13 broke due to mechanical failure causing hydraulic oil to spill on the ground.

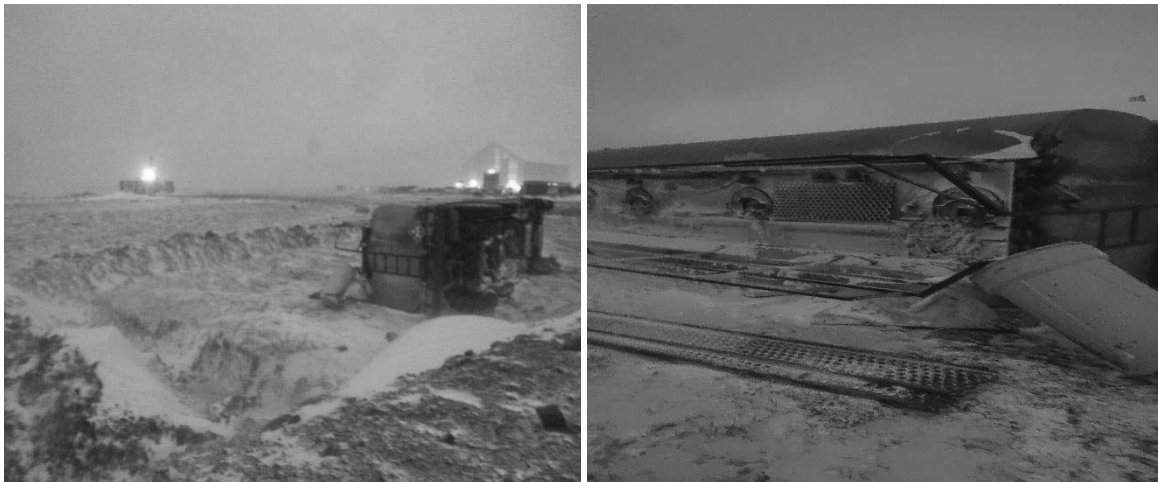
Fuel truck operator was returning from his fuel run at Whale Tail pit when he lost sight of the road due to poor visibility (blowing snow) and went off the road, tipping on its side. The fuel tank did not rupture but fuel was leaking out of the breather vents.

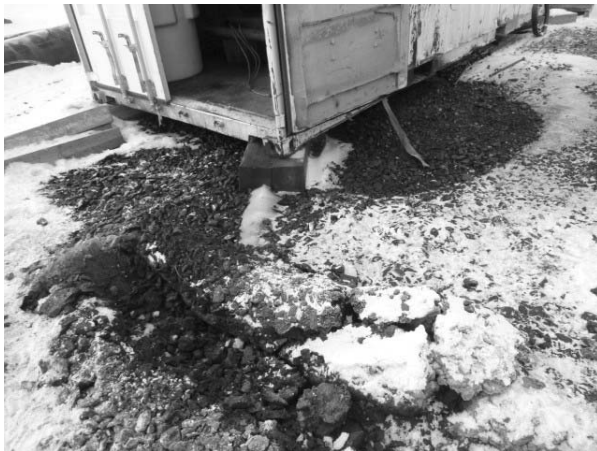
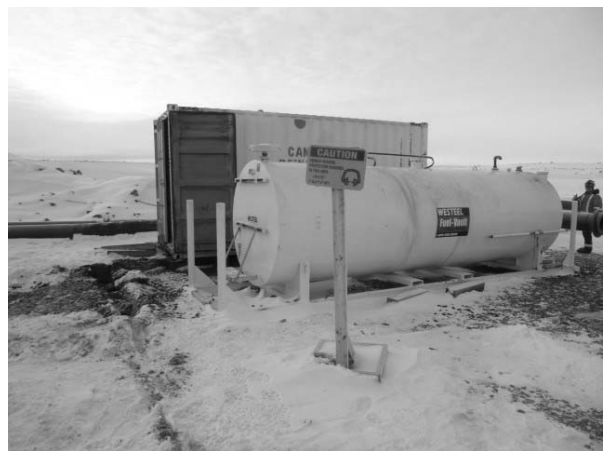
During dewatering operations at Whale Tail pit project, the fuel line on dewatering pump PWA02 let go creating the fuel return line to leak inside the pump sea can on the dewatering pad.

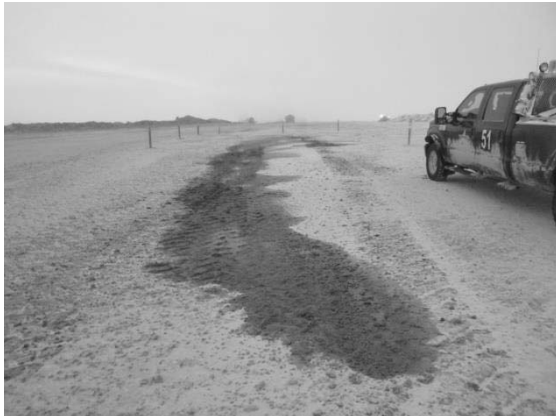
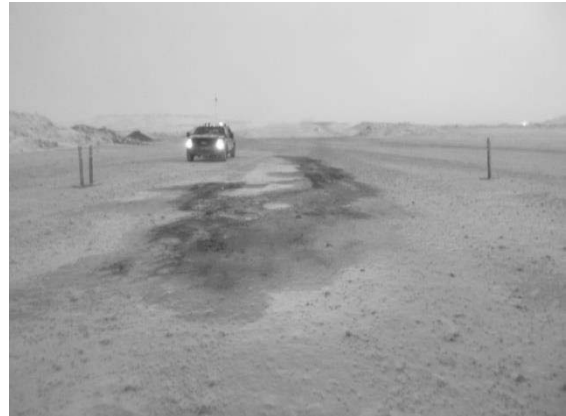
During operations at the Waste Rock Storage Facility, the fan of the haul truck had contact with the radiator, causing a coolant leak.

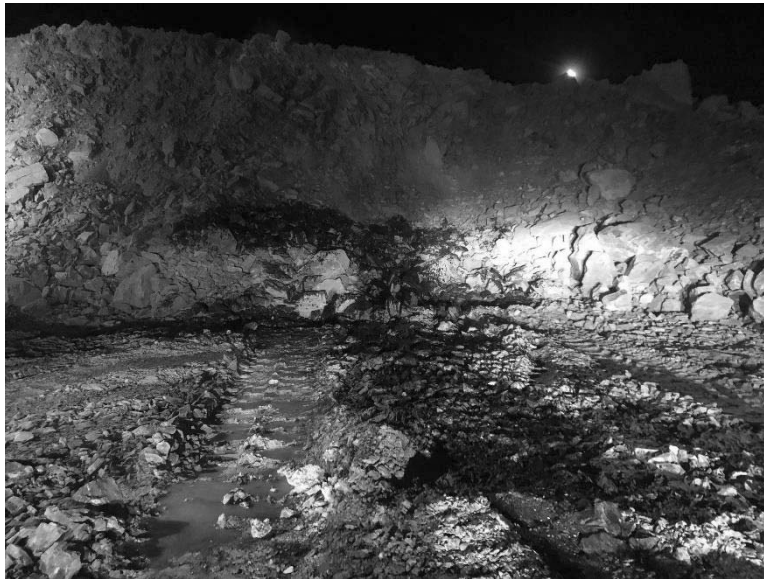
During operations at Whale Tail pit, the hydraulic hose for the clam of the bucket on BAC13 failed, causing hydraulic oil to spill on the ground.

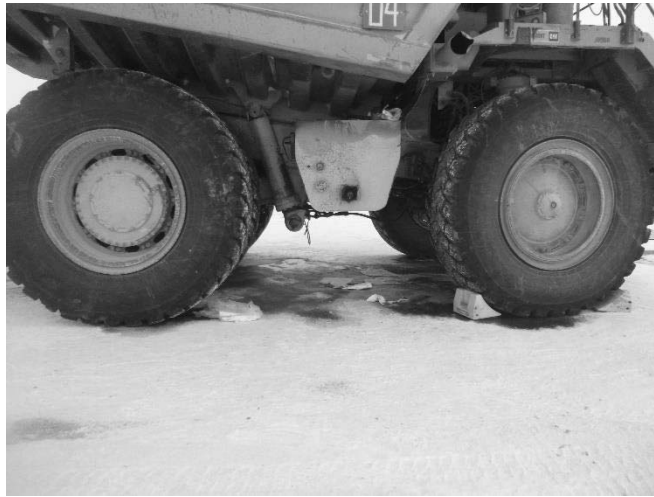
During operations at the Waste Rock Storage Facility, the hydraulic system the haul truck failed. The equipment was immediately shutdown to prevent further spillage.
