Meadowbank 2019 Landfarm Report

MEADOWBANK GOLD PROJECT

2019 Landfarm Report

Prepared by:
Agnico-Eagle Mines Limited – Meadowbank Division

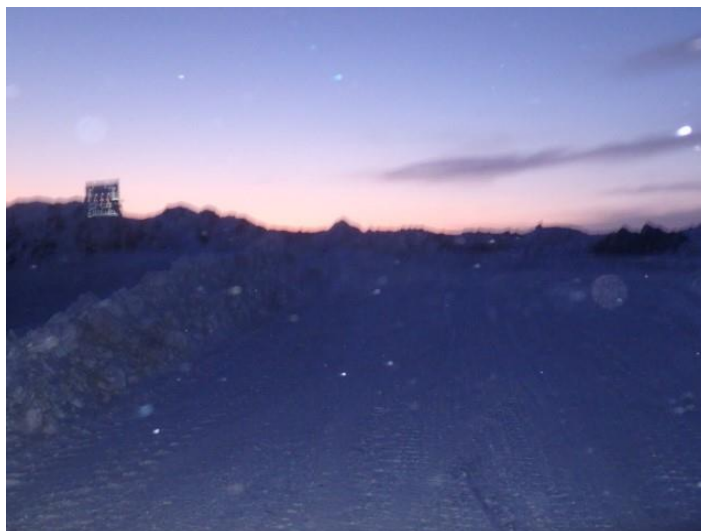
Photo 1: conformant at the time of inspection

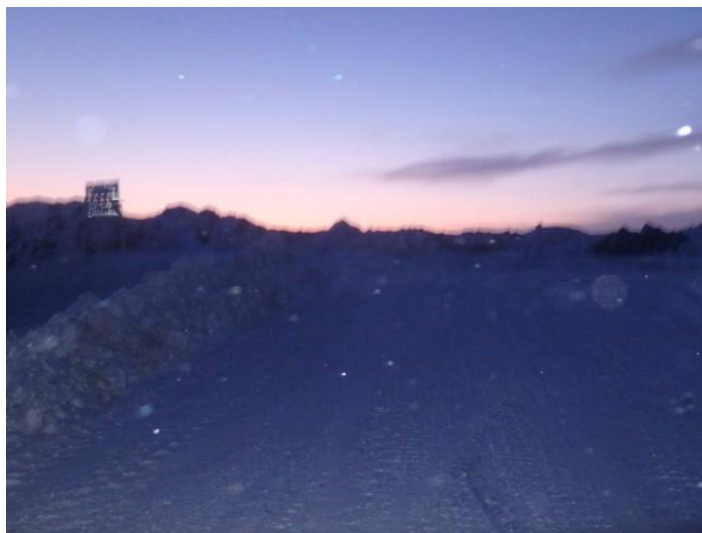
Photo 1: conformant at the time of inspection

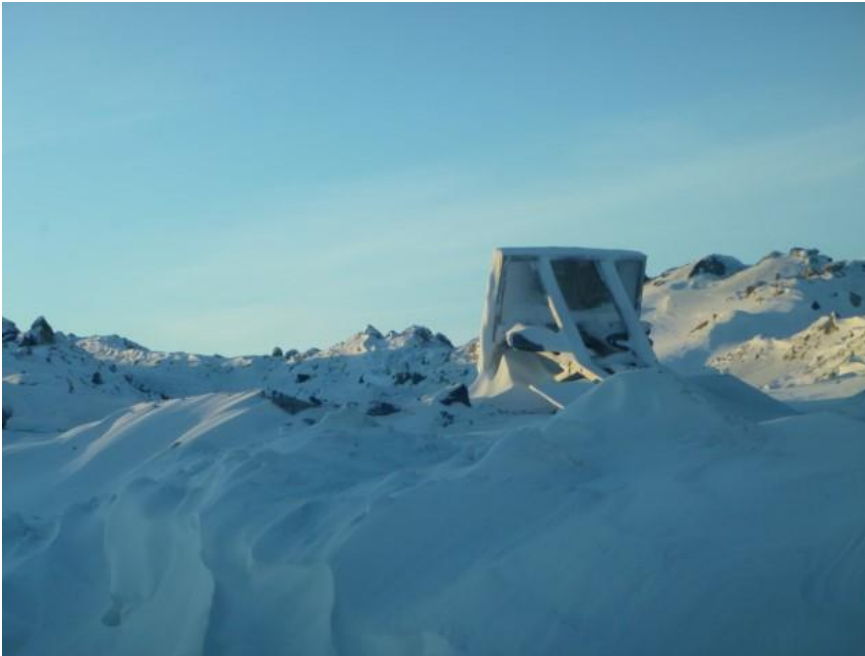
Photo 1: Sign posted to inform of a waste disposal facility fell down.

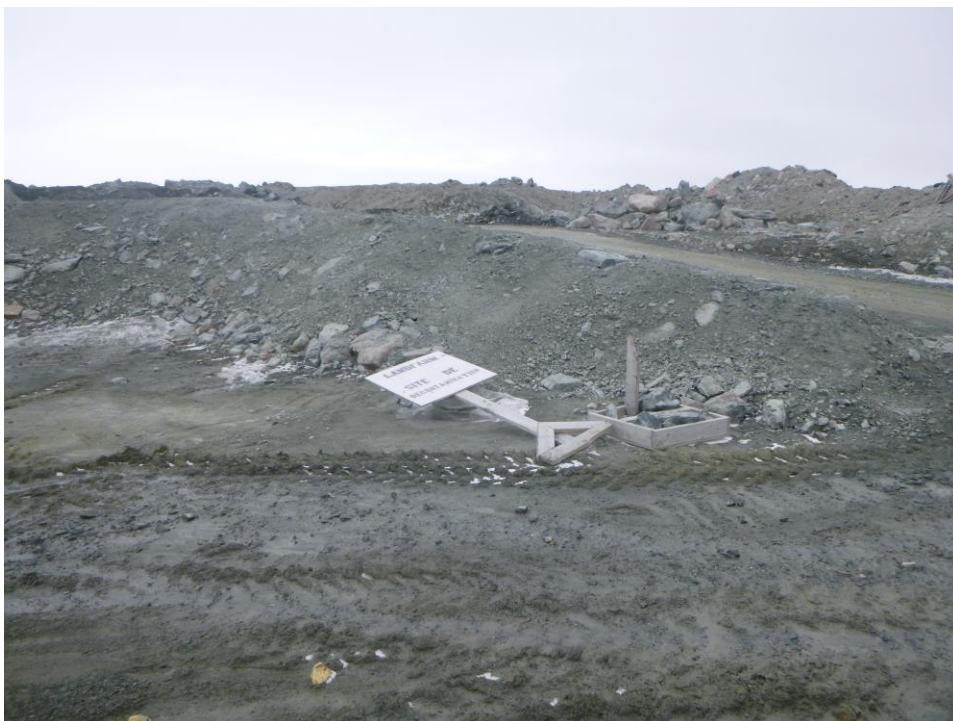
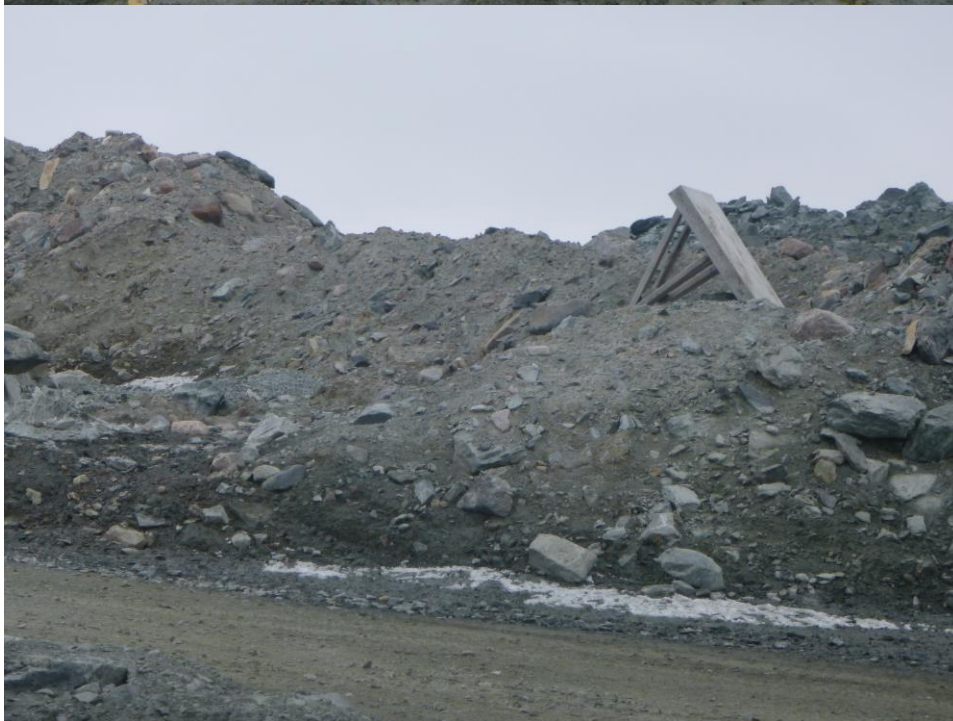
In Compliance with	Subject	Conform	Non-conform	N/A	Comments
NWB Part B Item 10	Sign posted to inform of a waste disposal facility in English, French, and Inuktitut.	X			One sign has fallen another is broken.
NWB Part D Item 29 MBK SCP NIRB Condition 26	Are there any visual spills that can enter any water body?	X			
NWB Part F Item 6 and Item 8	Does the water need to be pumped? If yes, estimated volume in m ³ , analyse water and 10 days notification give to NWB?			X	No water
NWB Part F Item 9 NIRB Condition 12	Discharge of water >30m from ordinary high water mark			X	
NWB Part F Item 9 NIRB Condition 12	Discharge of water not causing erosion			X	
NWB Part F Item 9 NIRB Condition 12	Discharge of water not directly flowing to water body			X	
NWB Part F Item 19 NIRB Condition 12	Waste disposal area >30 m from high water mark			X	
NWB Part I Item 9	Monitoring signs are posted in English, French, and Inuktitut.		X		French sign fell and no Inuktitut sign

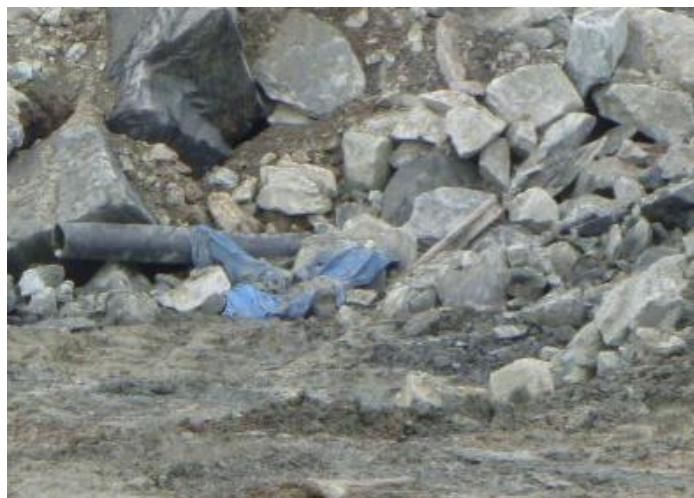
Picture 1: Plastic pipe and tarp

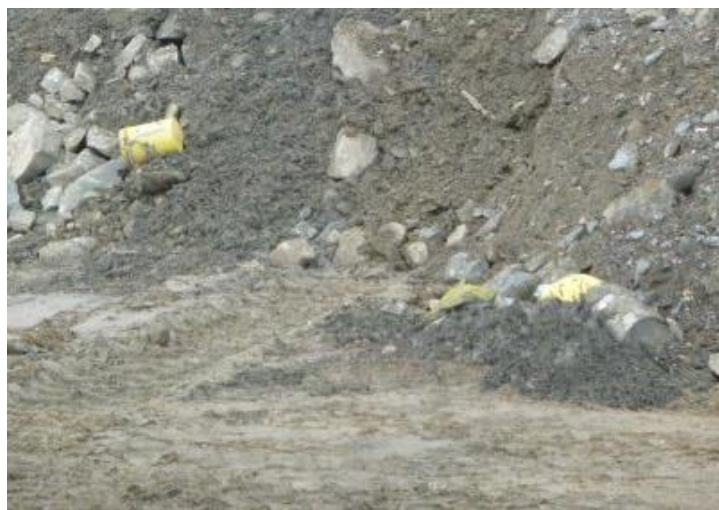
Picture 2: Material

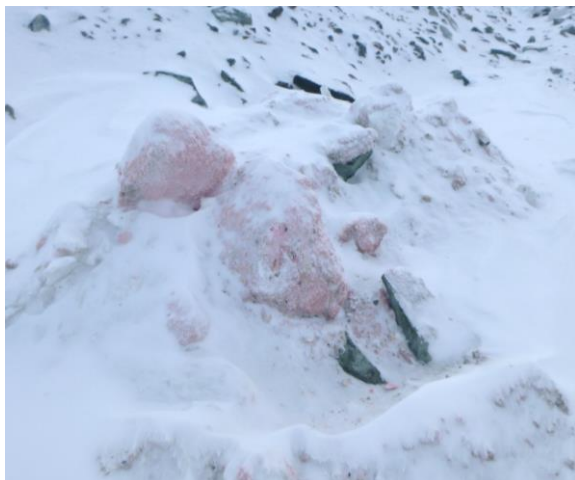
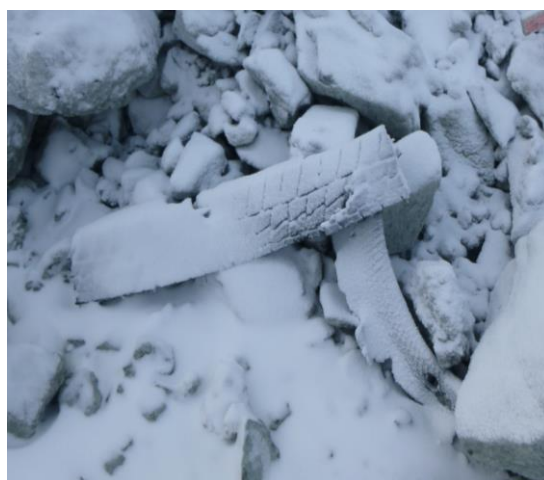
Picture 1 & 2: Materials that belong to the landfill were found in the landfarm.

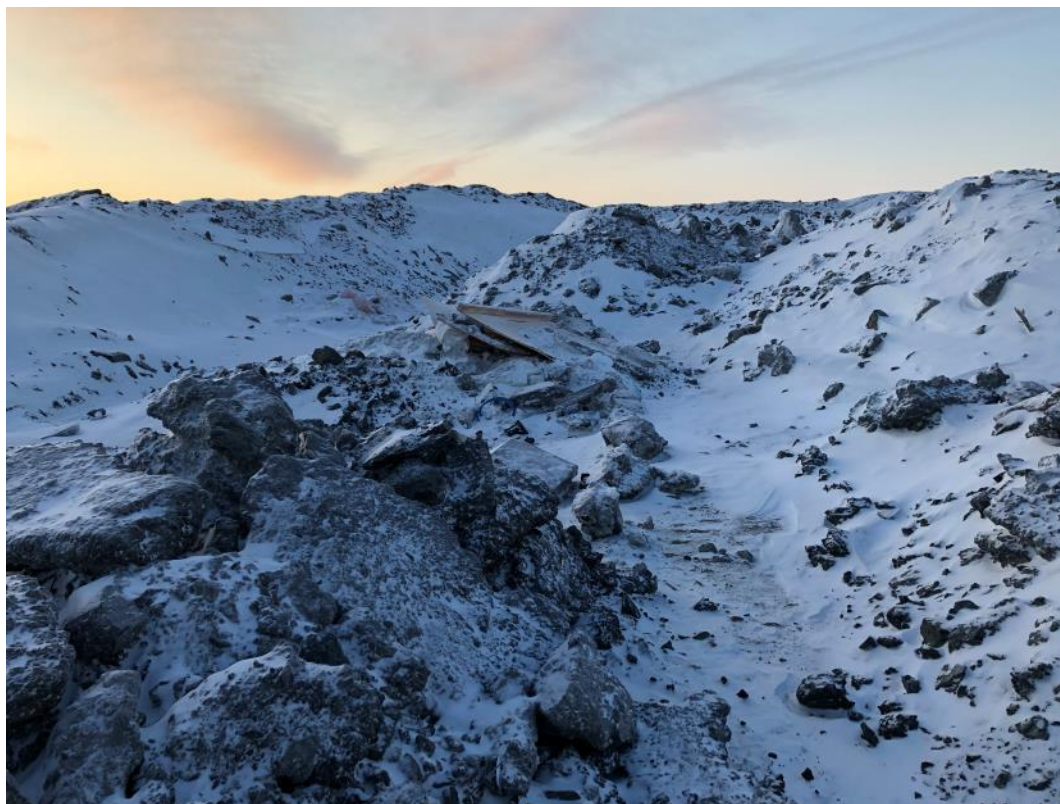
Photo #1: Wood debris and general waste and the landfarm.

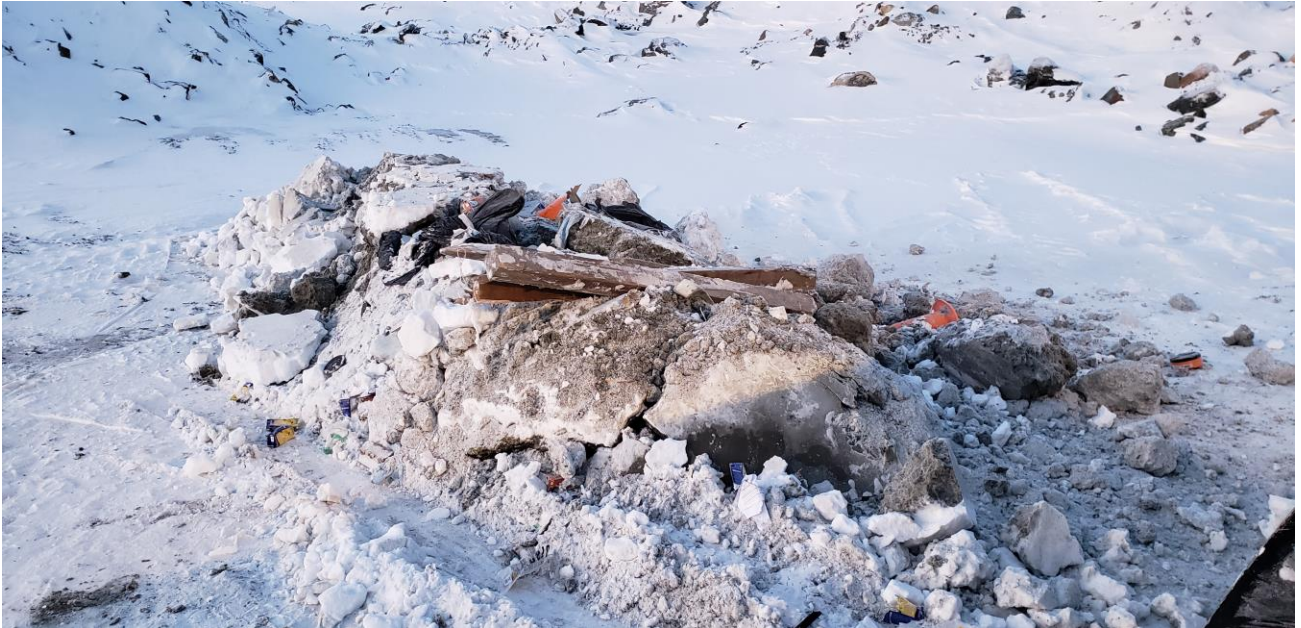
Photo 1: Wood and food waste mixed with contaminated soil
