Meadowbank 2019 Annual Pit Slope Performance Review

2019 ANNUAL PIT SLOPE PERFORMANCE REVIEW

MEADOWBANK MINE, NUNAVUT

OCTOBER 11, 2019

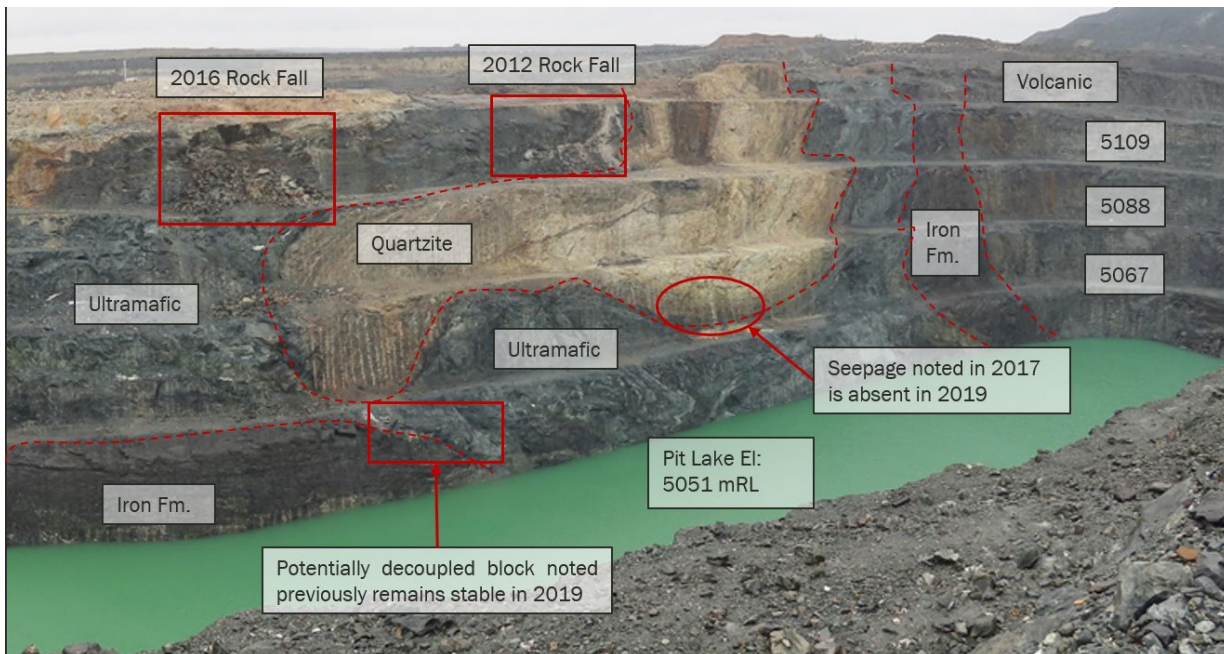
Photograph 4-3: Pit A west wall (2019)

The pit walls continue to perform well, and no additional accumulation of material was noted on the west, north, or east benches that are still exposed.

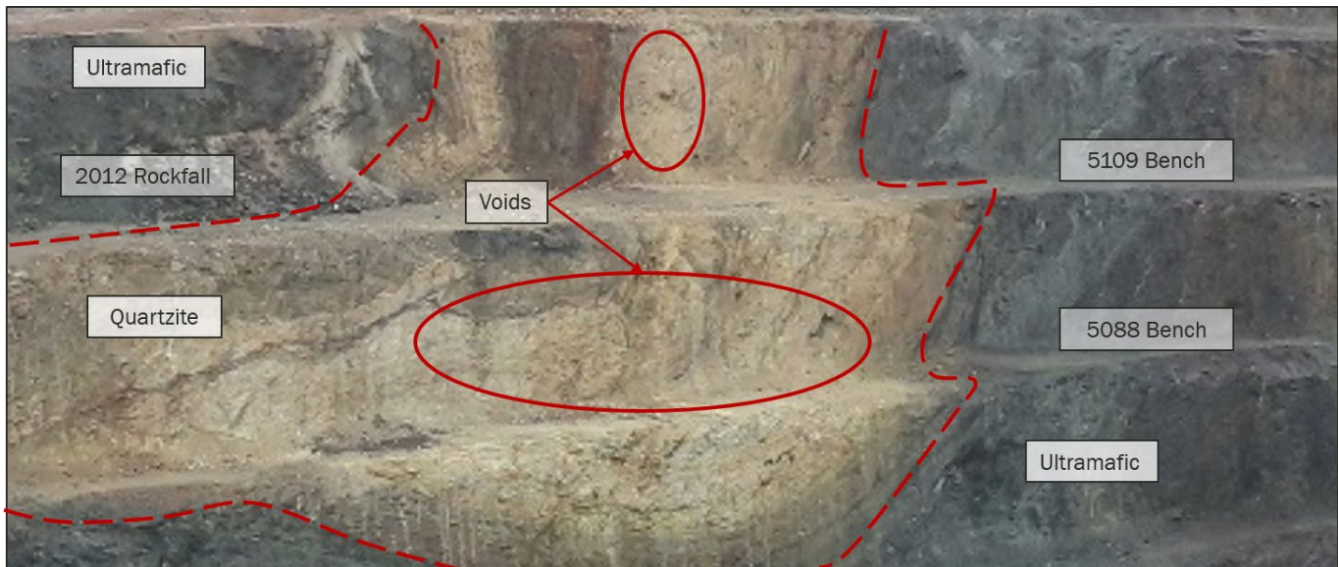
Photograph 4-4: Voids in quartzite above Pit A west ramp (2019)

The quartzite stratigraphy observed in the Pit A west wall contains several large voids identified during previous inspections. There has been no significant accumulation of material on the benches since the 2018 inspection.

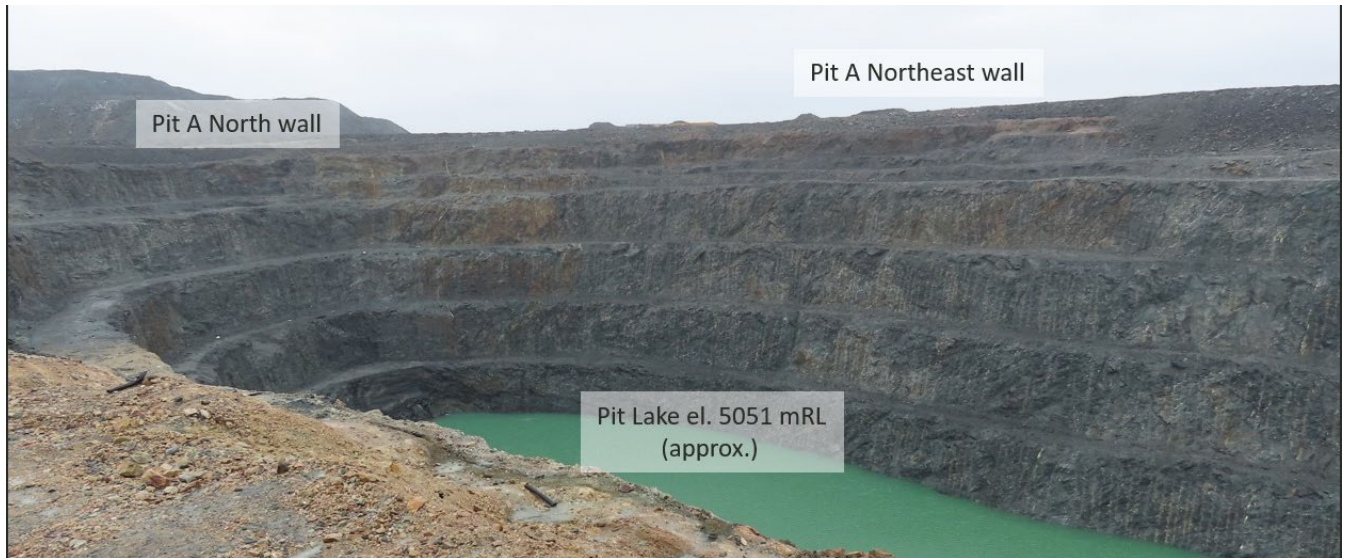
Photograph 4-5: Pit A north to northeast wall (2019)

The north through northeast walls of Pit A continue to perform well. There are no noticeable changes from 2018 to 2019. No additional accumulation of loose or raveling material on the catch benches was noted during the site visit.

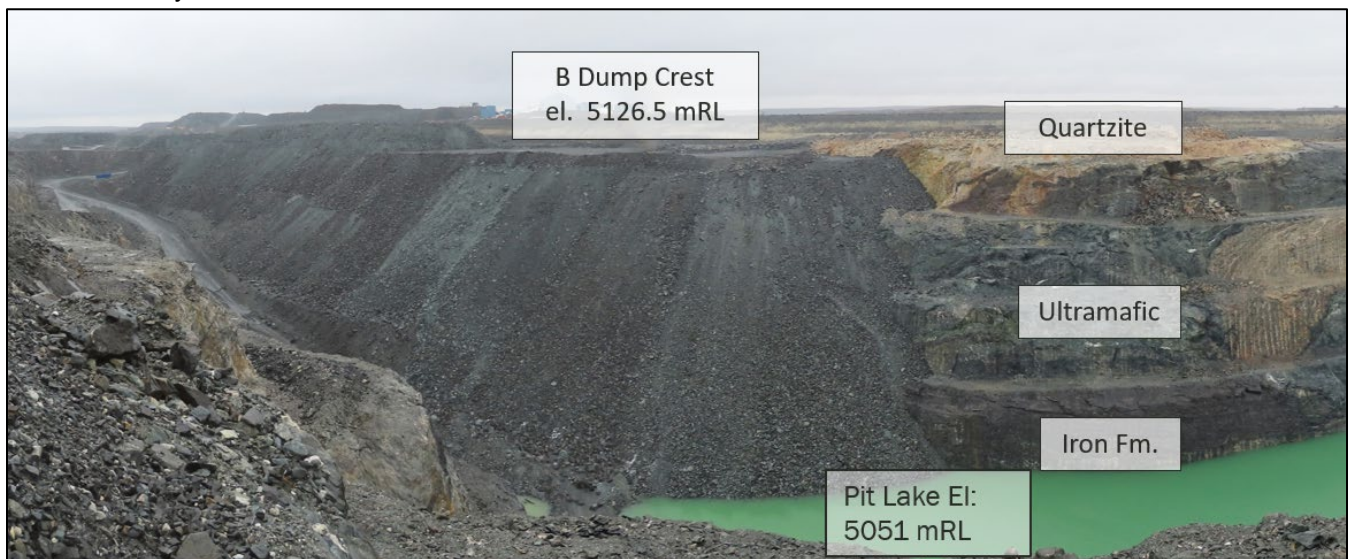
Photograph 4-8: Pit B west wall (2019)

The general performance of the west pit wall is shown in the following photograph. There is no evidence of large-scale instability for the west wall of Pit B.

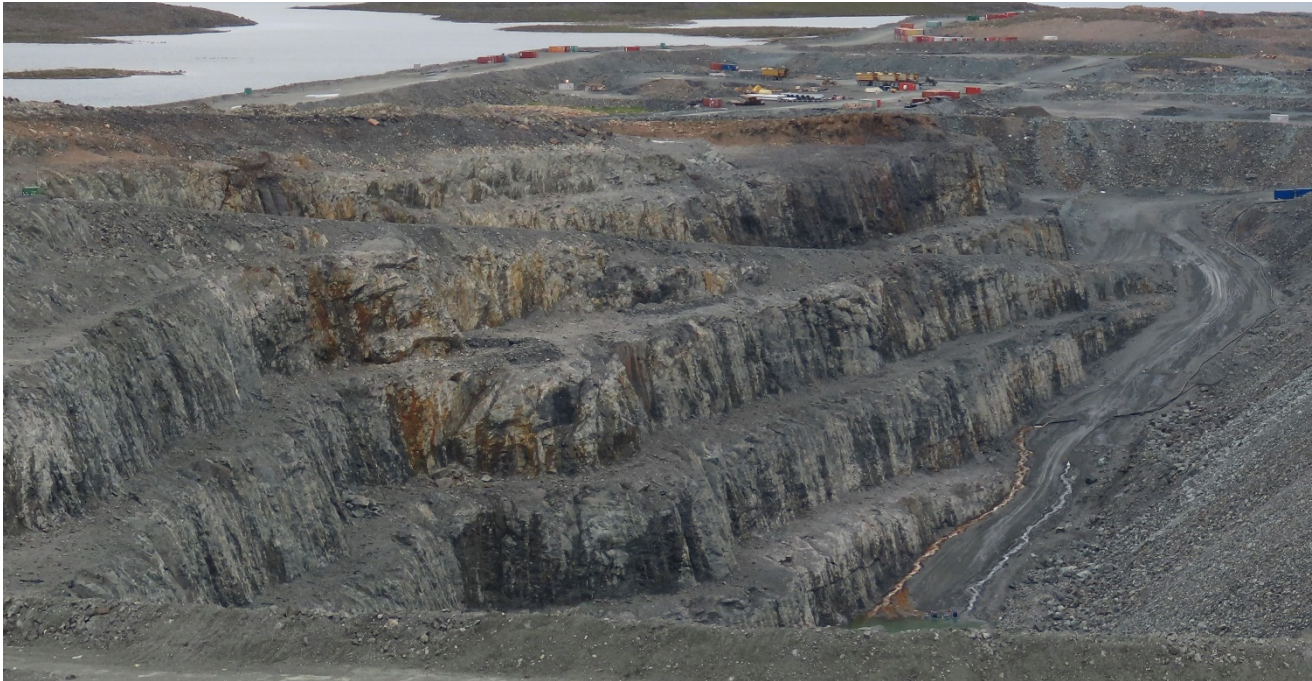
Photograph 4-9: Pit B east wall, looking south (2019)

The east wall of Pit B was inspected from several viewpoints as well as from within the pit. The wall continues to perform satisfactorily. Benches are generally clean with little accumulation of material.

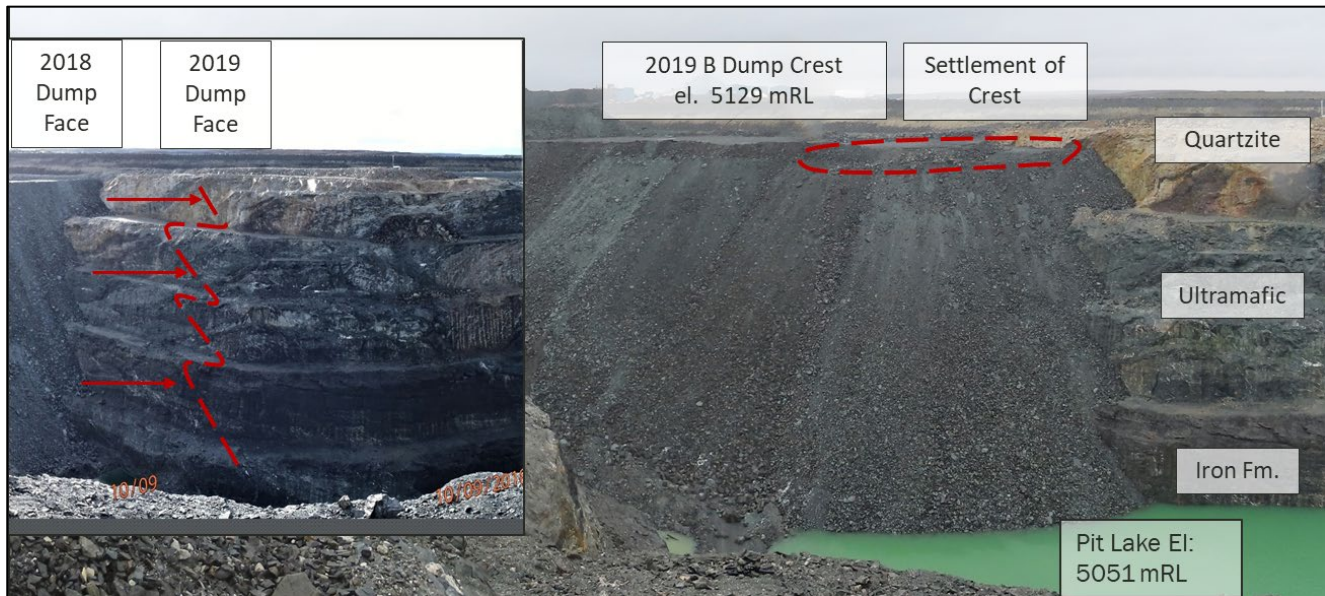
Photograph 4-10: B Dump looking southwest showing 2019 northward advance of dump face

Since the 2018 site visit, the Pit B Dump has been advanced northward along the west wall of Pit B by an estimated 40 m to 50 m. The development of crest settlement and the formation of tension cracks lead to a decision to halt dumping and the dump is now inactive. A wireline extensometer was used to monitor dump movement rates, which never exceeded normal movement rates as per AEM waste dump monitoring protocol. No evidence of dump instability was noted on the dump face, such as bulging or shallow failures. However, as pit water rises it is possible that shallow surface failures could occur, and the dump face should be visually monitored as part of regular geotechnical inspections.

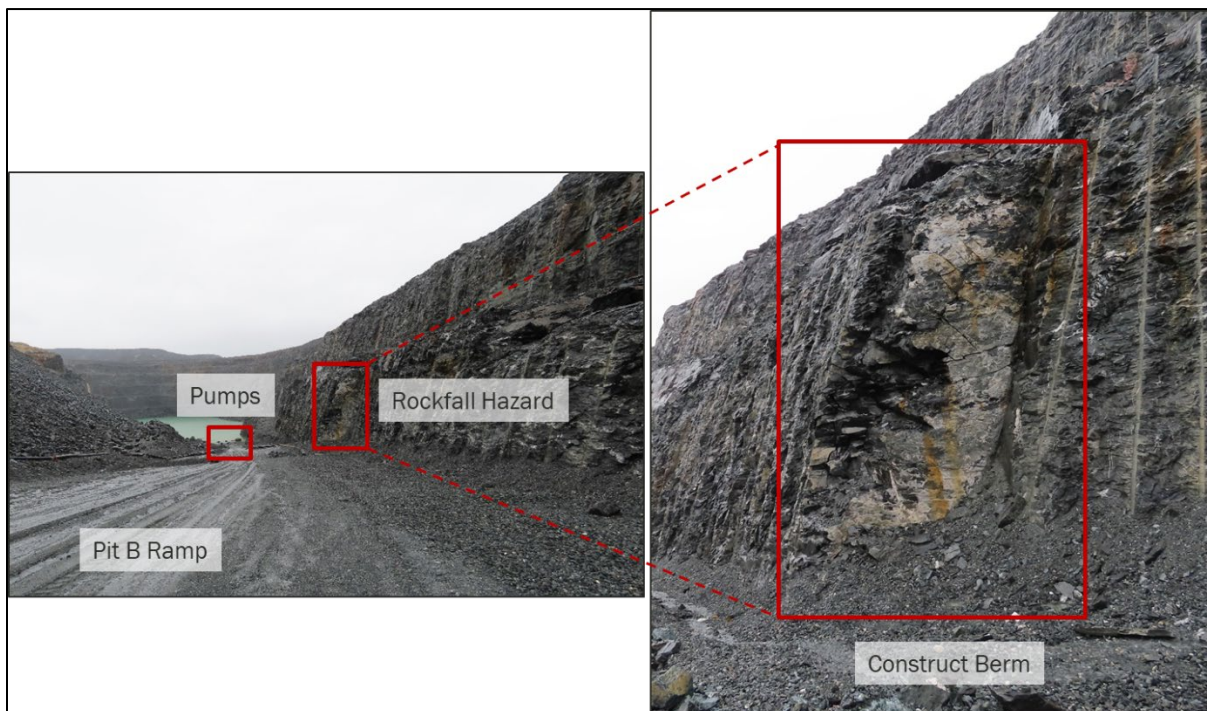
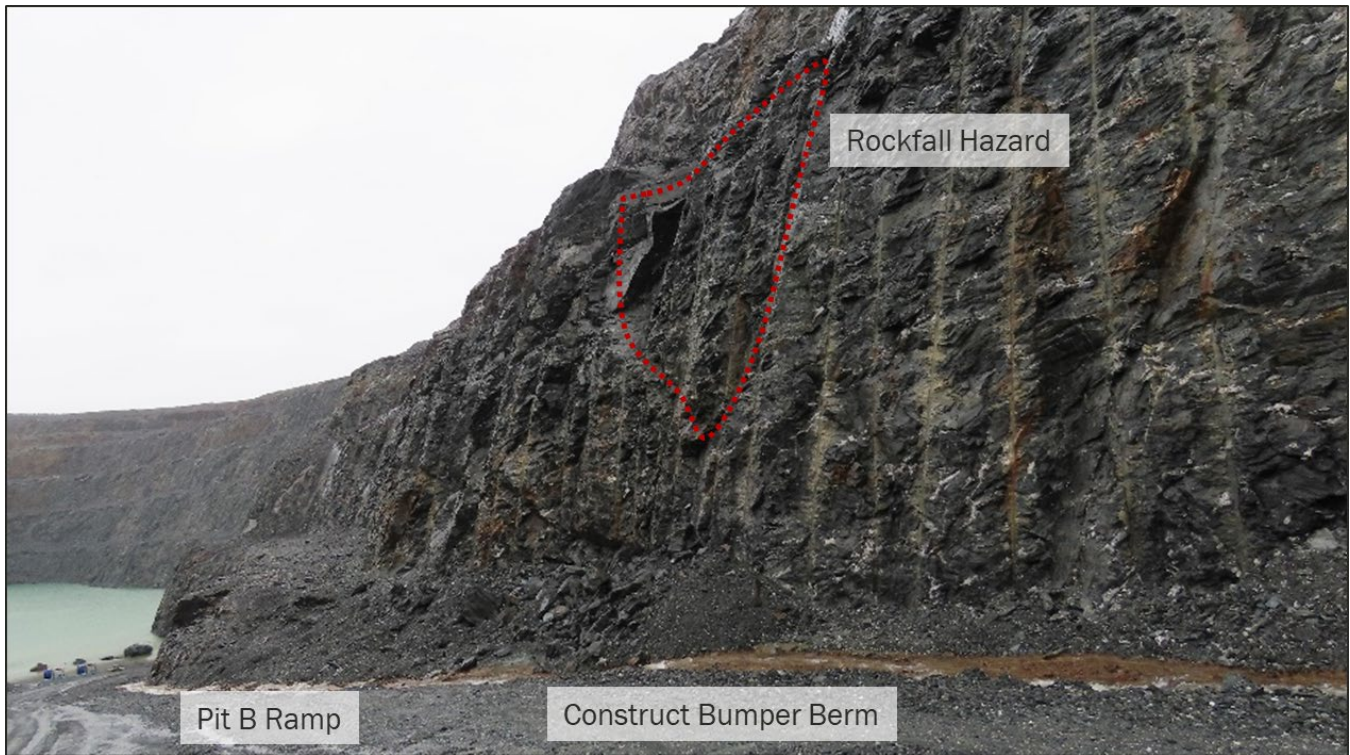
Two areas were identified requiring remedial measures due to the presence of potential rockfall hazards directly adjacent to the reclaim/discharge lines, and hence potentially accessible by personnel. These are shown in the following photographs.

Photograph 4-12: Pit B ramp rockfall hazard

Photograph 4-13: Pit B ramp rockfall hazard

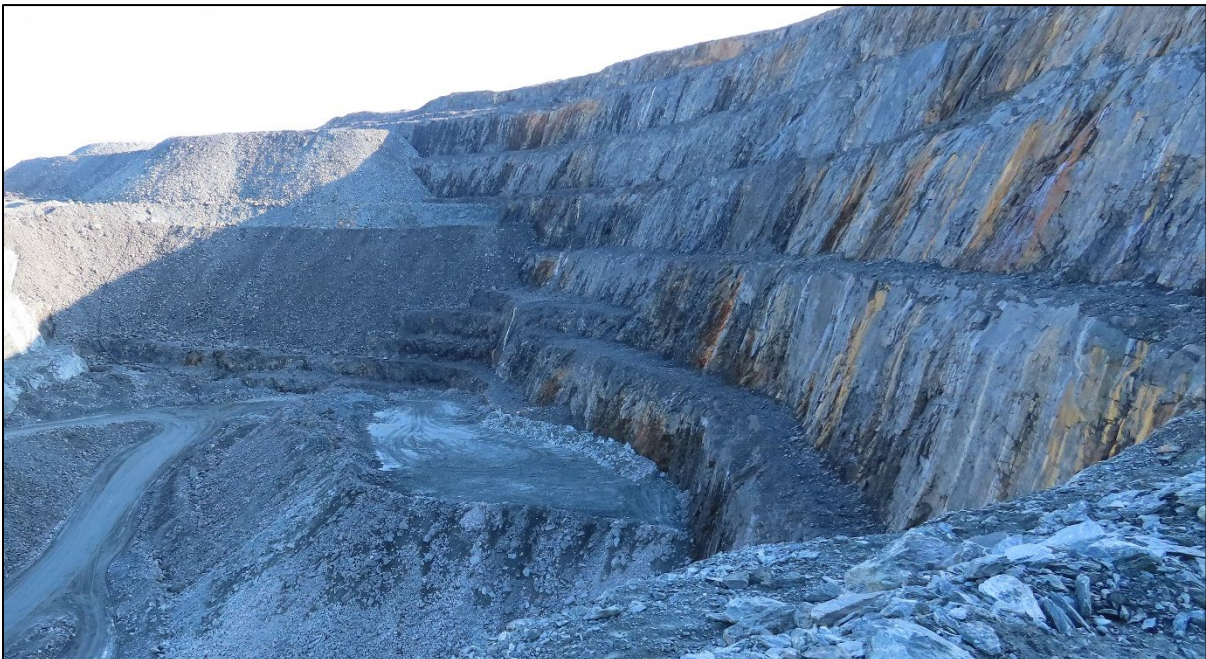
Photograph 6-2: Pit E east wall performance (2019)

The main structural control for the east wall is the steeply west dipping stratigraphy and sub-parallel foliation which bench face angles either break to or are excavated to. The bench and overall wall performance continue to be satisfactory within the good quality intermediate volcanic rock. Final benches have been cleaned and scaled appropriately. There has been no noticeable deterioration of the final benches since mining of this wall was complete.

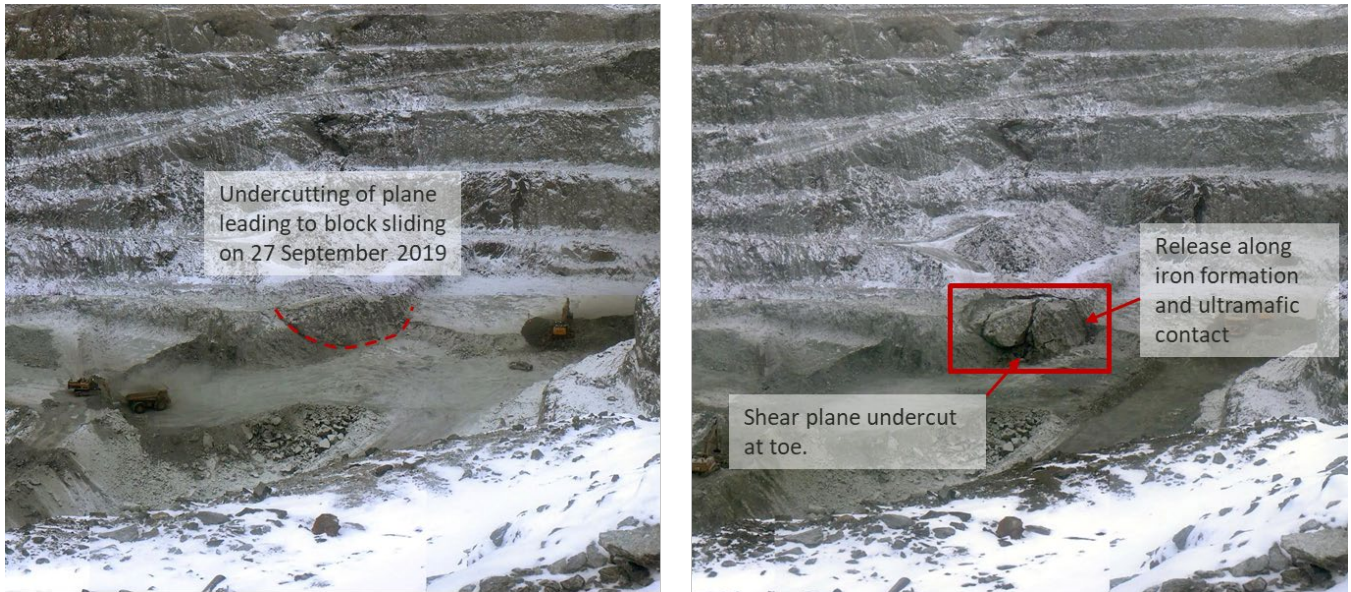
Photograph 6-7: September 27 2019 failure

A total of 4 rockfall events occurred between September of the 2018 inspection (13 September 2018) and August of the 2019 inspection, all within ultramafic rock. A significant failure (>10,000 tonnes) occurred on 27 September 2019 involving a bench scale failure of ultramafic rock released along its contact with iron formation. The failure was predicted, and the area was bermed off until it was safe for re-entry to scale the failed material.

On September 27 2018, a significant rock fall event occurred, approximately 10,100 tonnes. The event occurred within ultramafic rock, and was indicated by the radar system. The event was associated with the shear zone known to exist within the ultramafic rock comprising a significant portion of the south wall and has been interpreted to have resulted from undercutting of a steep west dipping plane. During the 2018 site visit, the general area was visited on the 5032 mRL bench, and the shear zone noted. At that time, the steep west dipping plane was buttressed, and hence stable. Subsequently, the 5032 mRL bench continued to be mined down and eventually undercut the west dipping plane. Undercutting of the plane, coupled with the presence of the sheared ultramafic and iron formation contact, allowed freedom for the block to slide on the shear plane.

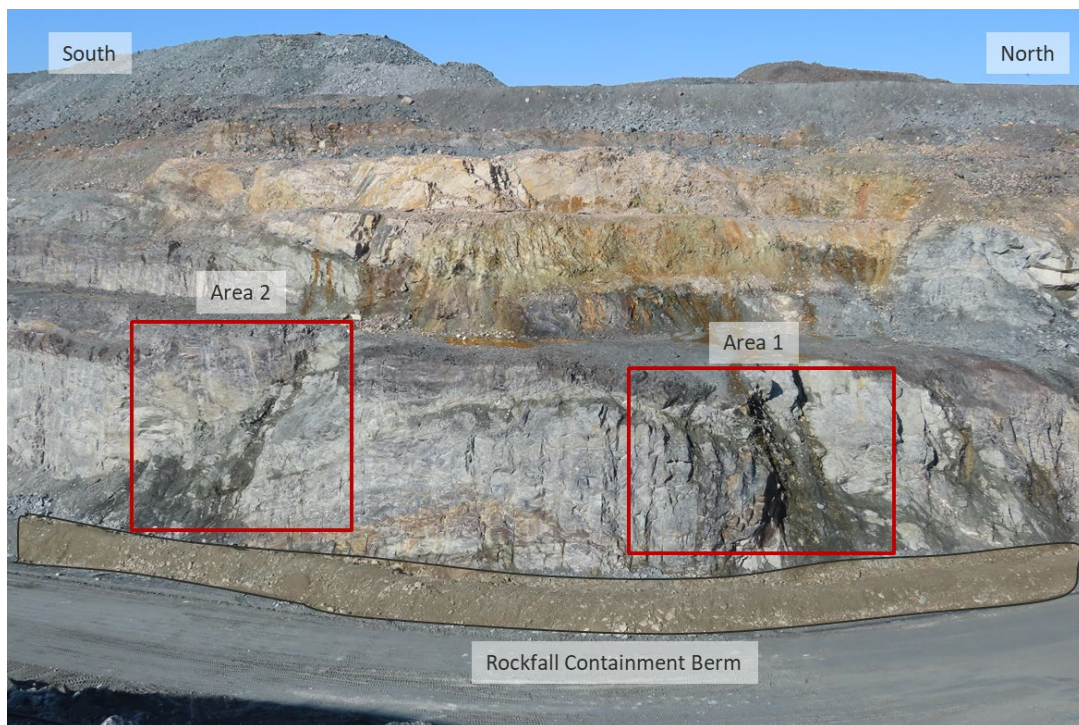
Photograph 6-12: Pit E west wall ramp summary hazard identification (2019)

Nine key areas of potential instability observed immediately adjacent to the West Wall Ramp continue to be monitored. An unexpected rock fall in 2018 that overtopped the rockfall containment berm along the inside of the ramp has been cleaned. A new failure occurred in association with poorer rock mass quality associated with the Bay Fault, near geotechnical Area 1 and 2. AEM proactively bermed off this area to prevent access.

The Pit E ramp descends southward into the pit along the west wall. Nine key areas of geotechnical hazards identified during previous inspections continue to be monitored and are discussed below.

The rockfall containment berm along the inside edge of the ramp has been re-established to an effective height for containing rockfall runout, as recommended during the 2018 site visit.

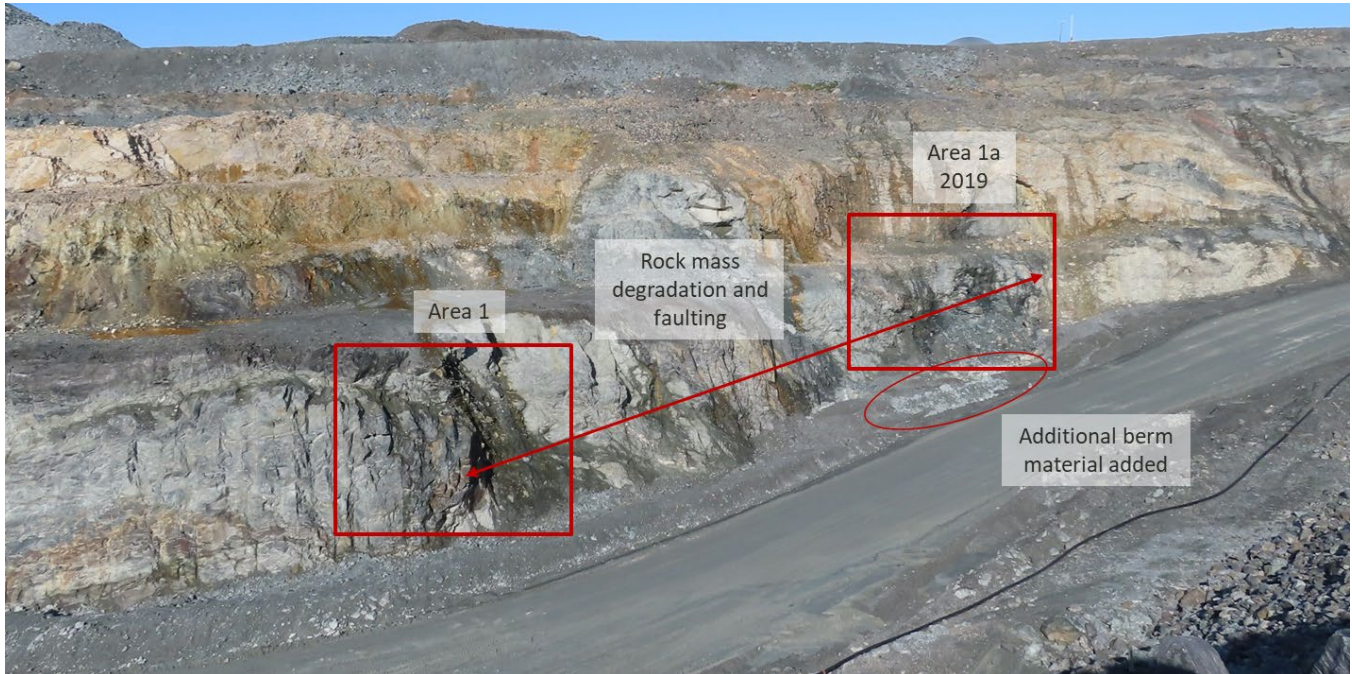
Photograph 6-15: Portage Pit West Ramp Area 1a instability

During 2019 additional instability was noted approximately 20 m to 30 m north of Area 1, along the West Wall Ramp, and associated with a degraded rock mass affected by the Bay Fault or a fault splay. The area was noted as potentially unstable, and additional rockfill material was placed along the inside ramp edge. This is shown in the following photograph.

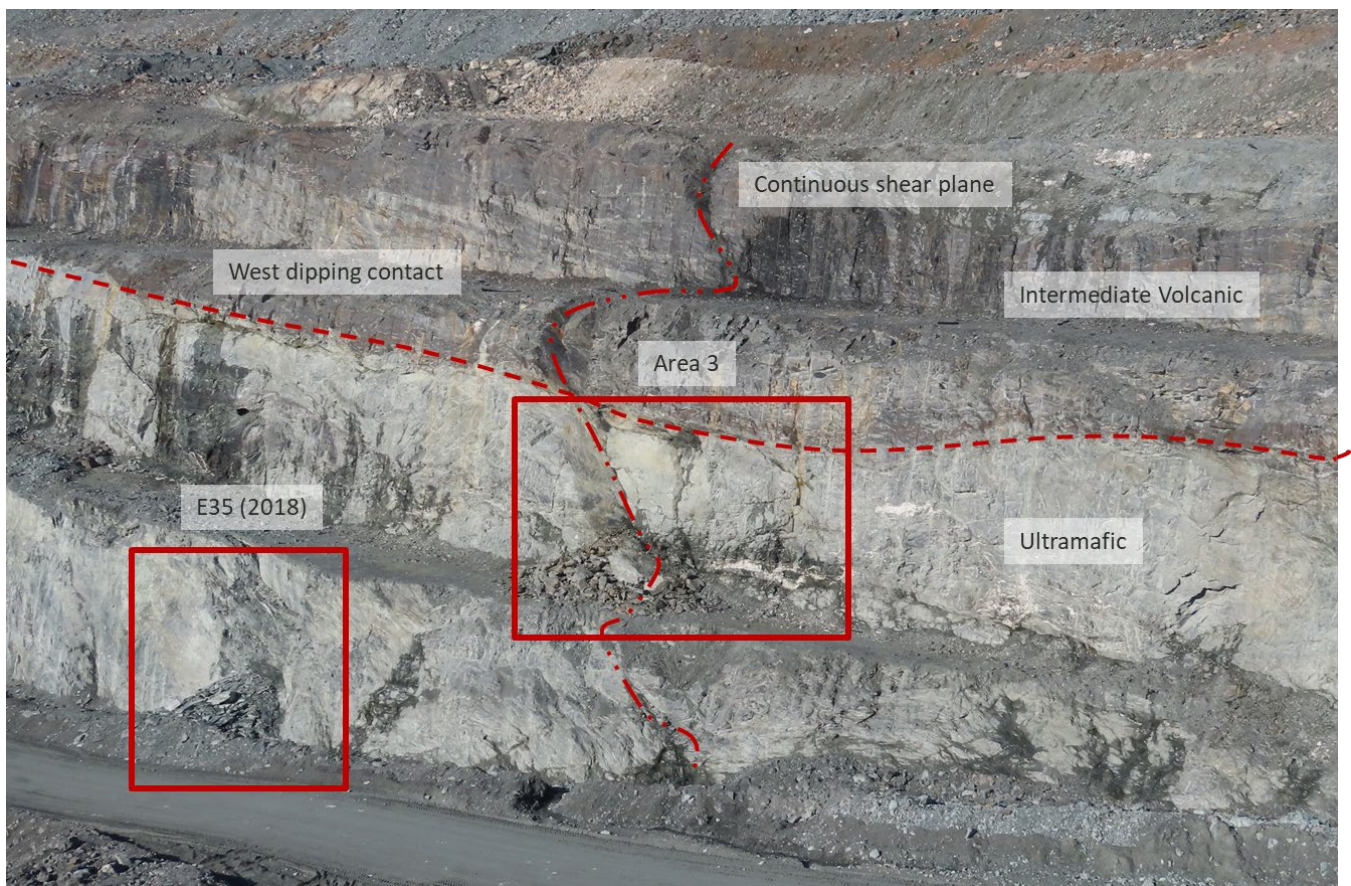
Photograph 6-16: Pit E Ramp Area 3 (2019)

Area 3 is defined by a moderately to steeply north dipping continuous shear plane that strikes into the west wall of the pit above the ramp, and cross cuts the contact between the ultramafic rock and the overlying intermediate volcanic rock. At the contact, the combination of the continuous plane and associated open features, the west dipping contact, and vertically oriented jointing has resulted in historical rockfalls. A review of this area during the 2019 site visit shows no increase in accumulated material on the bench below. This is shown in Photograph 6-16.

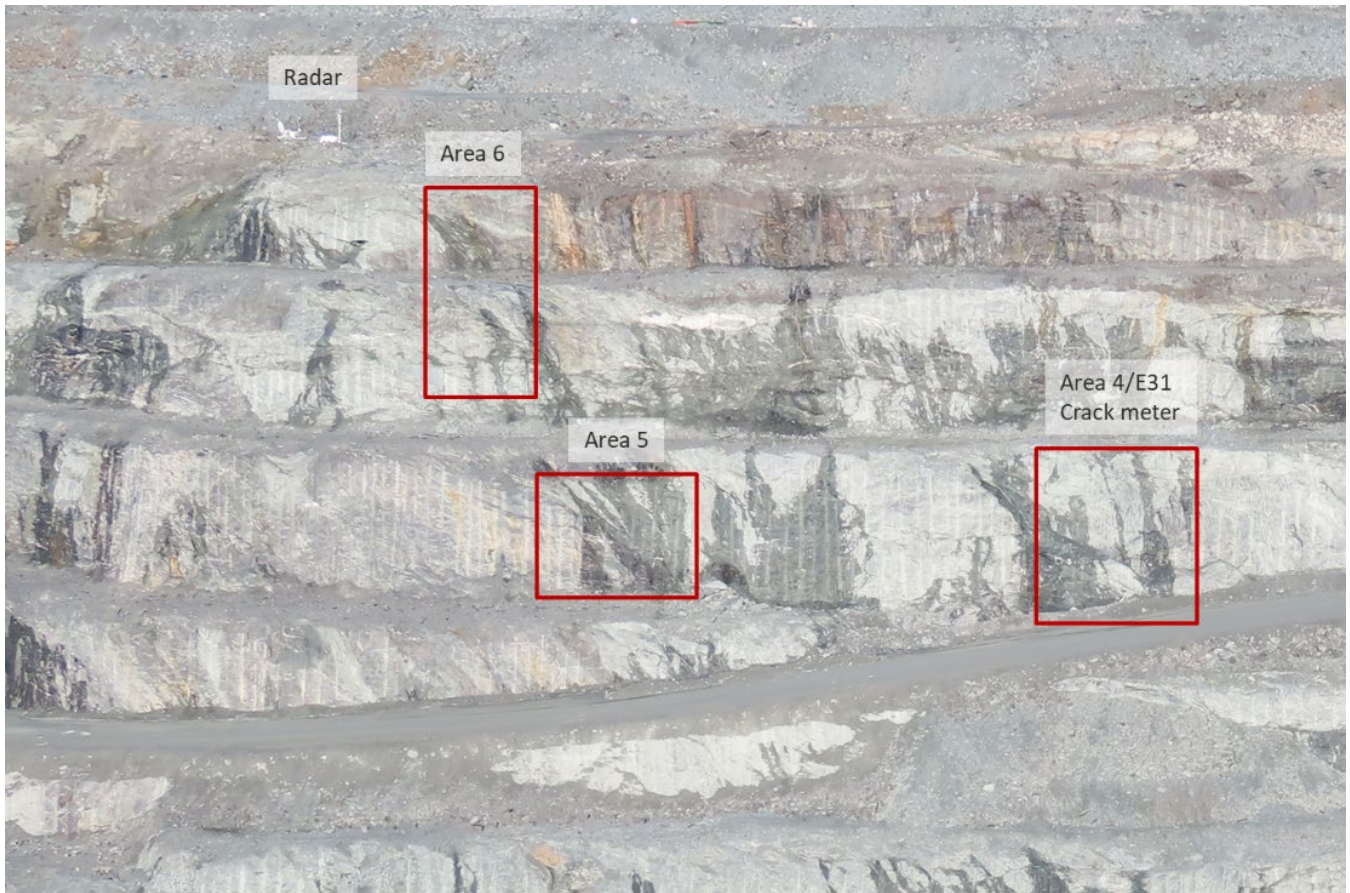
Photograph 6-18: Pit E Ramp Areas 4,5, and 6 (2019)

No new material was observed to have accumulated beneath each of these areas since the 2018 inspection.

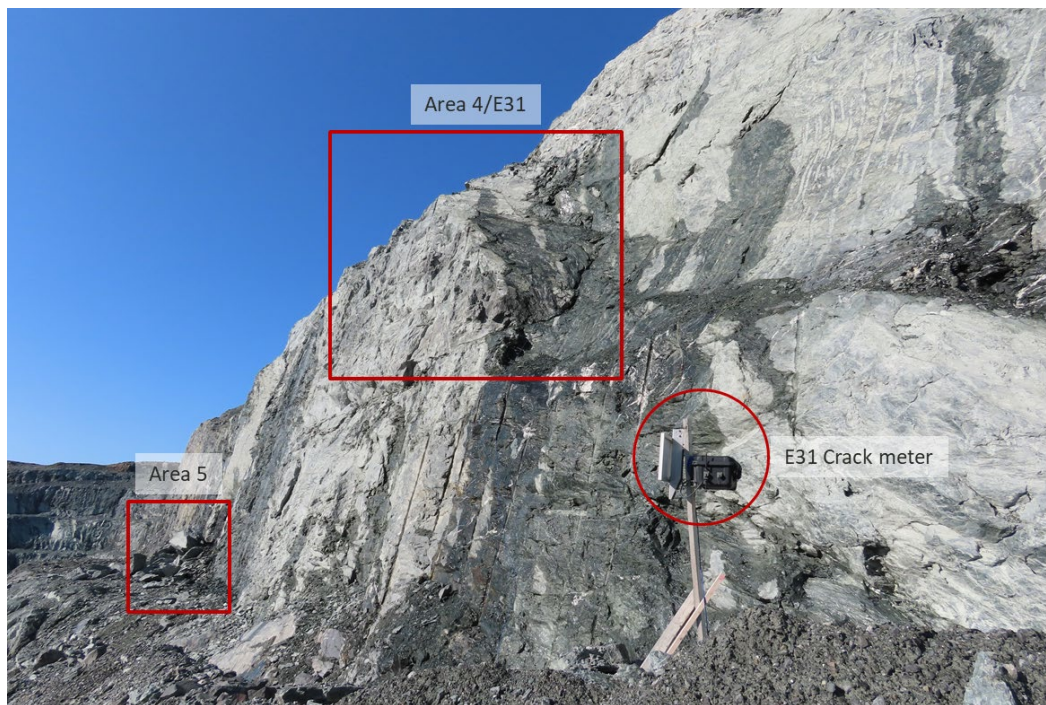
Photograph 6-19: Area 4/Zone E31 crack meter monitoring (2019)

A crack meter installed through the back plane of a wedge identified as Area 4 continues to monitor for any movement and none has been recorded.

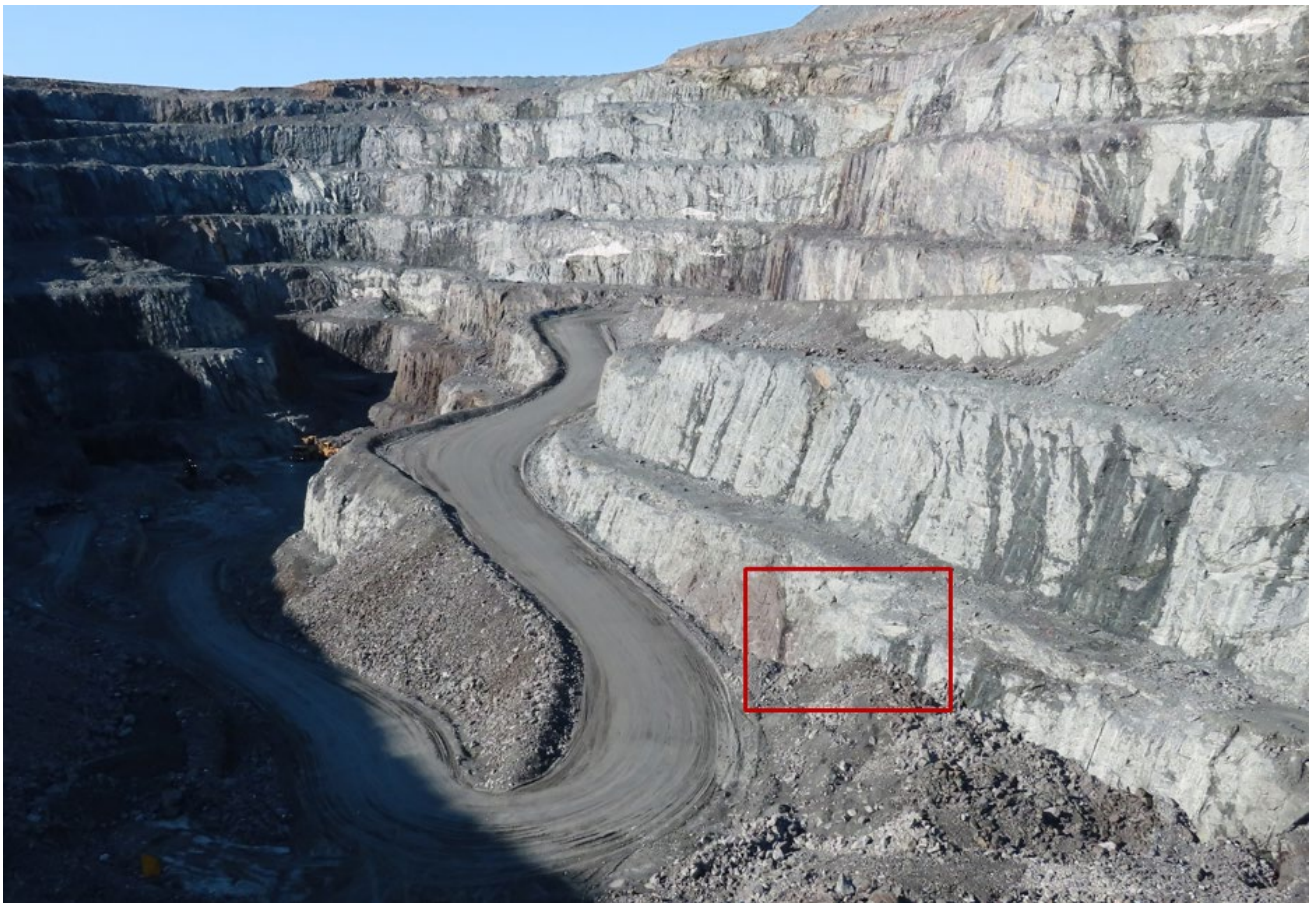
Photograph 6-20: Pit E Ramp Area 7 at bottom of ramp (2019)

The potential instability is characterized by strongly sheared ultramafic rock in contact with iron formation, with associated shear planes dipping out of the bench face. Some of the sheared planes are open and appear to form potential wedge and planar mechanisms. It was noted during the 2019 site visit that this area is now partly buttressed with backfilled waste rock, and no longer presents a hazard.

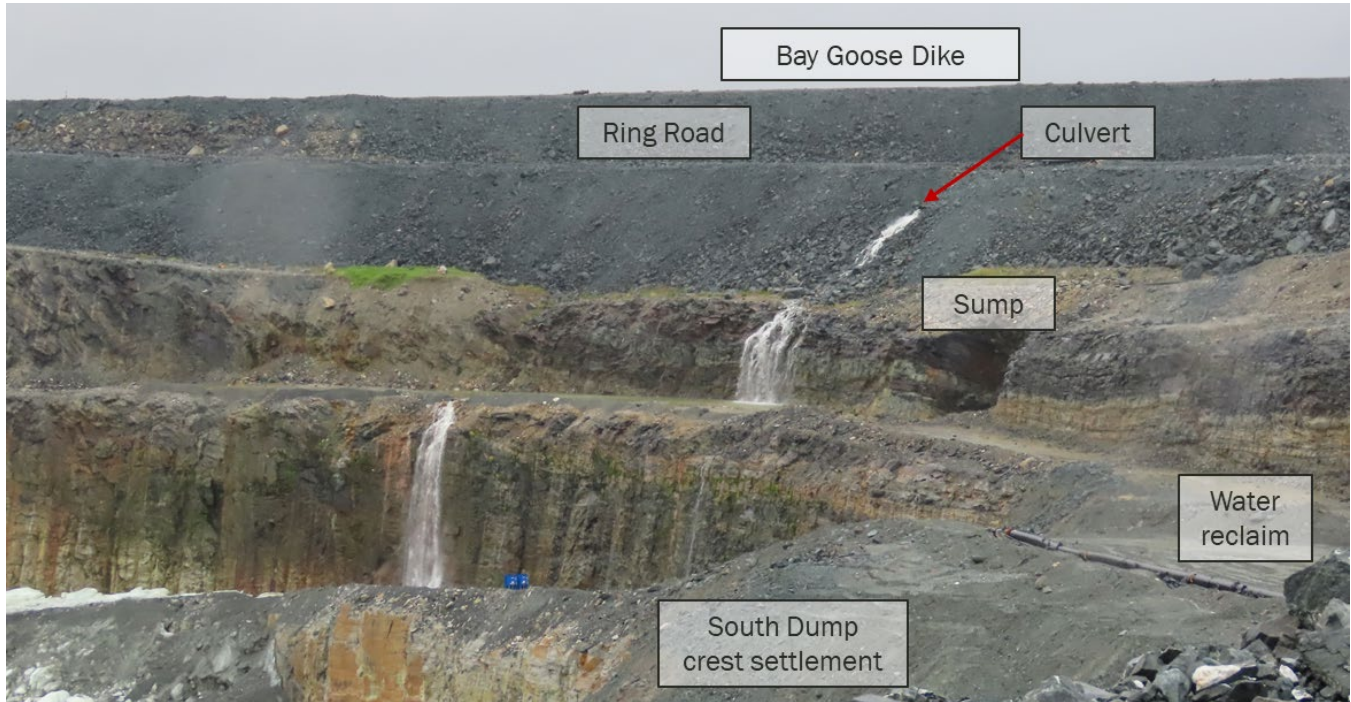
Photograph 7-4: Discharge of water from the water management pond between the ring road and Bay Goose Dike

A water reclaim line runs beside the ramp, on its outside edge. At the time of the site visit water was being discharged from the west-southwest corner pit crest, from a runoff storage area between the pit crest and the Bay Goose Dike. Heavy rainfall occurred in the 2 weeks prior to the site visit, and the discharge in this water storage area was directed toward the pit. No erosion of the rock or crest areas was noted in response to the discharge.

Water is being discharged from the southwest corner of the wall, from a water management and storage pond behind the crest. The crest area where the water is being discharged was reviewed, and no indication of crest erosion was noted. Once reaching the ramp, the water is directed down the inside edge of the ramp to the pit lake.

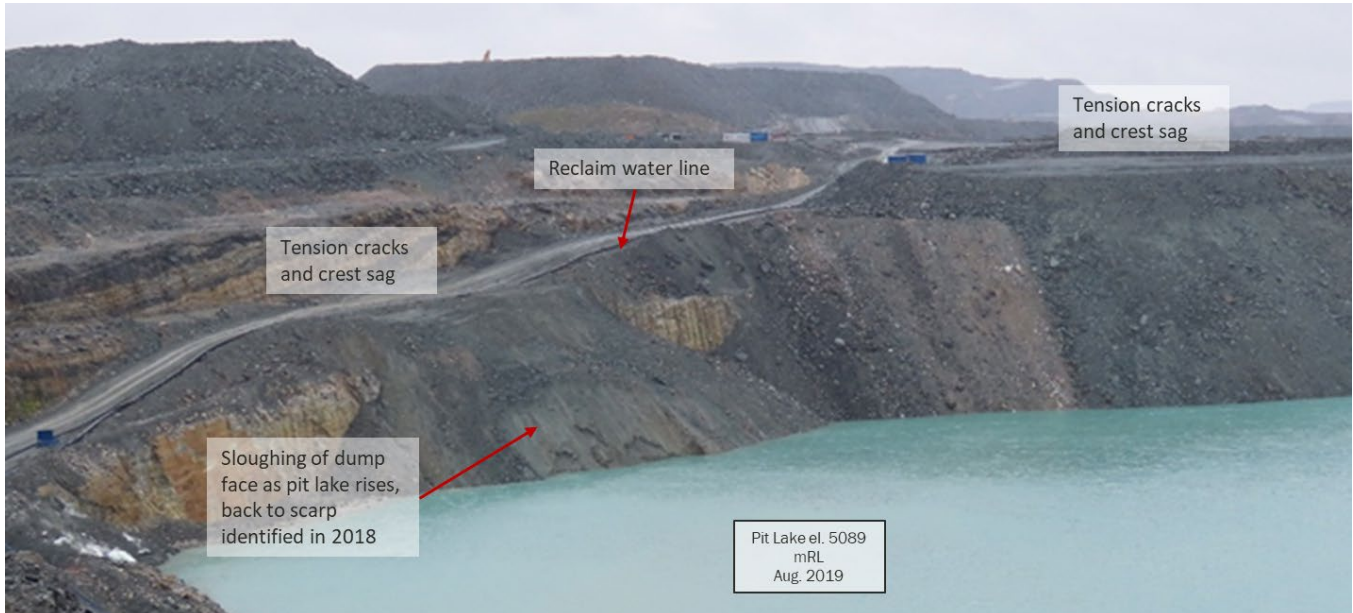
Photograph 7-8: Goose Pit waste rock dumps (2019)

The in-pit waste rock dumps at the Goose Pit have been inactive since 2017. The toe of the dumps extends out into the Goose Pit Lake. Tension cracks on the North and South Dump platform were first noted during the 2015 inspection and continue to develop. This could be in response to the increasing pit lake elevation.

The in-pit waste rock dumps at the Goose Pit have been inactive since 2017. The toe of the dumps extends out into the Goose Pit Lake.

Since the Goose Pit is currently being used for tailings deposition, and there remains a need to access the pit by the ramp on the south wall for pump control panel access and pump maintenance, it is suggested that wireline extensometers be reinstalled on the North and South Dump platforms to monitor movement rates. If a dump failure were to occur, it could potentially create a wave surge. The extensometers should be monitored daily, following the waste dump monitoring protocol established by AEM.

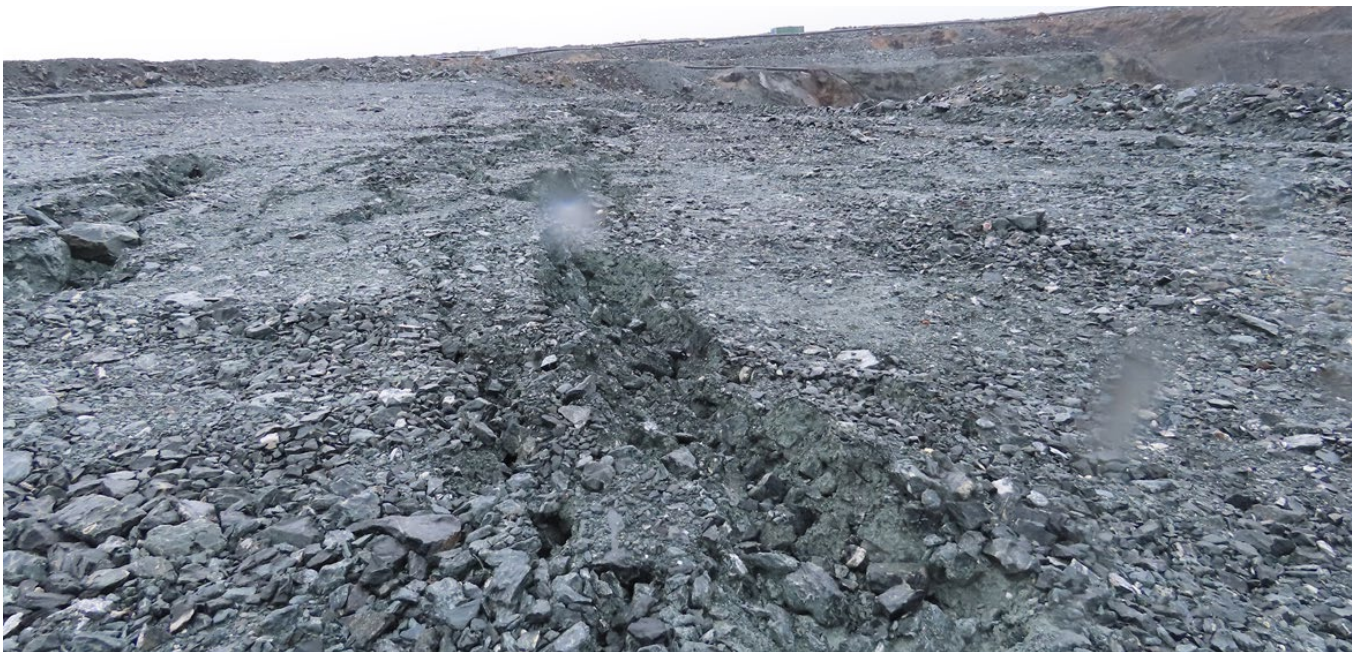
Photograph 7-9: Tension cracks and crest sag Goose Pit North Dump (2019)

Tension cracks and crest sag continue to be evident on the North Dump crest. Currently, there is no active monitoring of the dump crest because the dumps are inactive. As such it is difficult to determine if any additional displacement has occurred since the 2018 inspection.

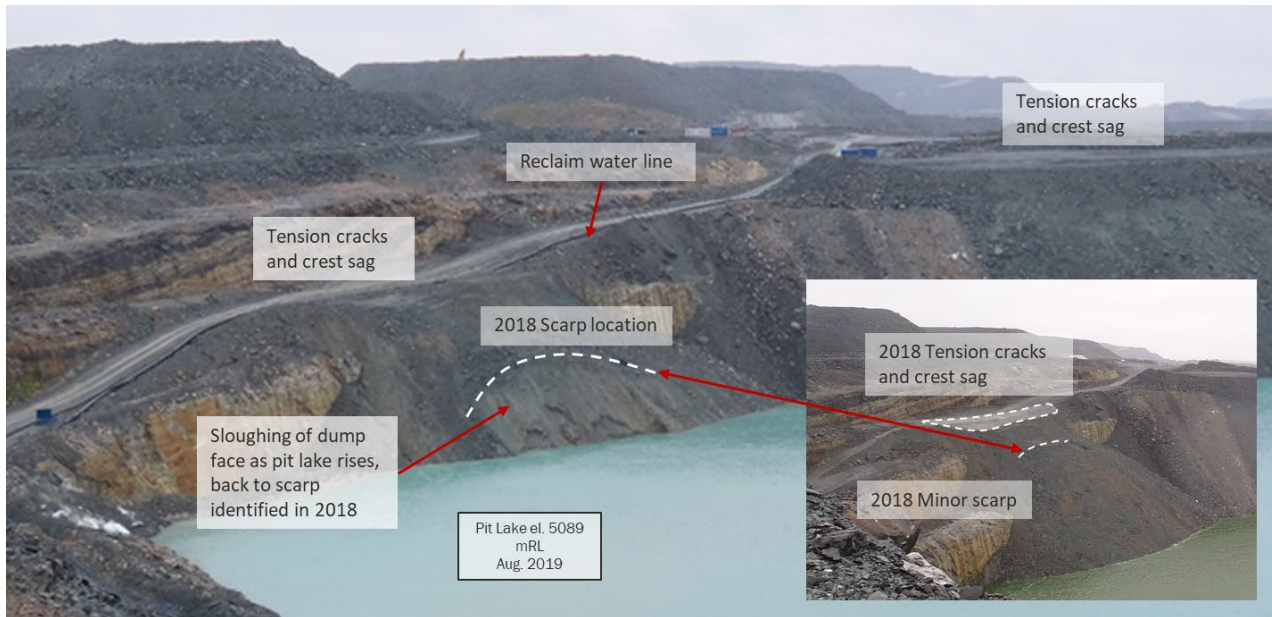
Photograph 7-10: Sloughing of Goose Pit South Dump face (2019)

During the 2018 site visit a failure scarp was observed to be forming on the South Dump face, as the pit lake was rising. In 2019, the dump face had sloughed back to the scarp that was identified in 2018. There is significant settlement noted in the South Dump platform. The presence of the water reclaim pipe prevents vehicles and personnel from accessing the platform.

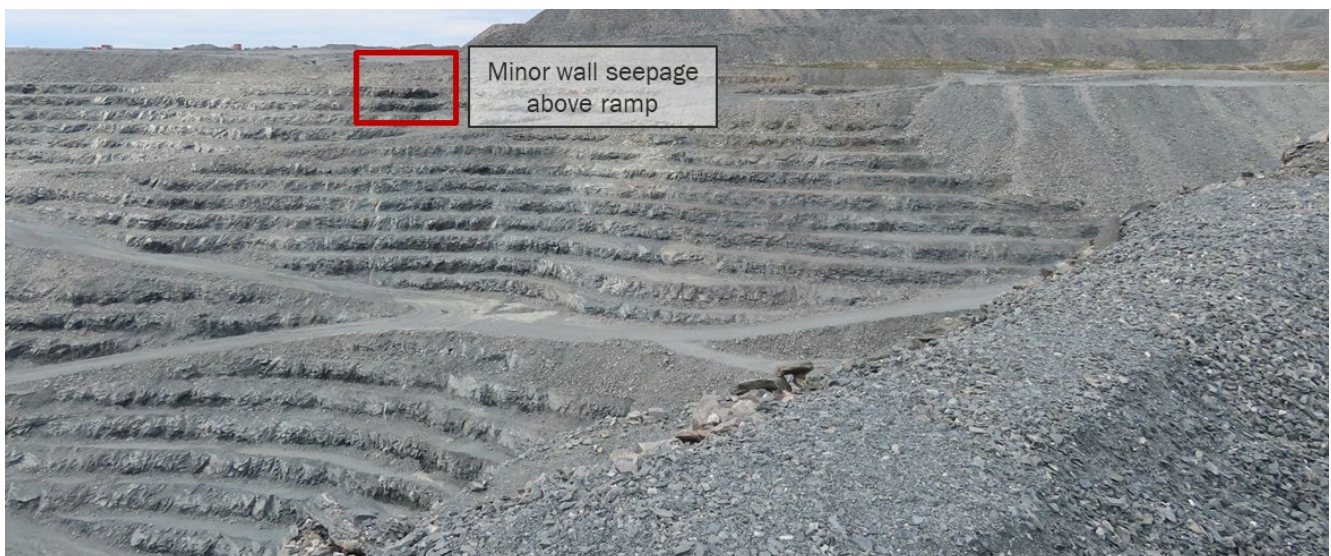
Photograph 8-1: Minor wall seepage noted on west footwall of Vault Pit (2019)

During the 2019 site visit, water seepage on the footwall (formerly called west wall seepage) was noted in an area above the ramp which has been flowing at a very low rate since mining of the pit began.

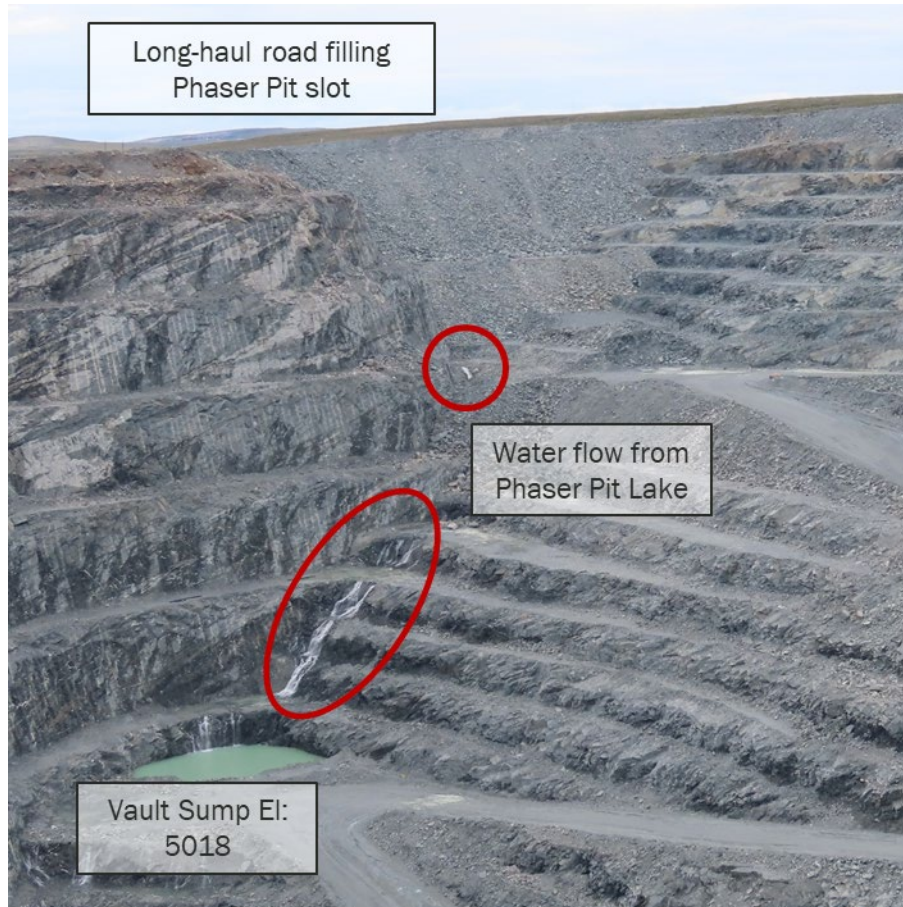
Photograph 8-4: Inflow to Vault Pit from Phaser Pit

It was noted that the water from Pond D (the former Vault Lake) behind the southeast pit wall crest flows freely through the ring road at the crest, and spills over into the pit. The flow is uncontrolled. During operation of the pit, the water elevation in Pond D was pumped down to control the development of the ice wall from the 5109 mRL. It should be expected that a significant ice curtain will develop this year because of this, however the pit is inactive, and this is unlikely to be a concern. The ring road in the area of the flow was inspected for settlement or distress and no visible signs were noted. The road is constructed with coarse rockfill. Water flows relatively freely through the road.

The ring road at the south to southeast pit crest and separating Pond D from its inflow to Vault Pit was inspected during the site visit for signs of settlement or distress and no visible signs were noted. It was discussed that indications of impact to the ring road related to water flow through the road fill material might include settlement of the road surface, the development of tension cracks at the road edge, and potentially sinkholes depending on the materials used to construct the road. The road is constructed with coarse rockfill. Water flows relatively freely through the road. Since the water flow is not through an engineered structure such as a culvert, it was recommended that the road access be bermed off or decommissioned to prevent full use of the road to travel around the pit.

This area should be included in regular geotechnical inspections. During spring freshet, it is possible that ice damming of the upstream embankment could result in over-topping of the road surface. Therefore, it was recommended that the road access be bermed off or decommissioned to prevent full use of the road to travel around the pit.
