Meadowbank 2019 Annual Pit Slope Performance Review

2019 ANNUAL PIT SLOPE PERFORMANCE REVIEW

MEADOWBANK MINE, NUNAVUT

OCTOBER 11, 2019

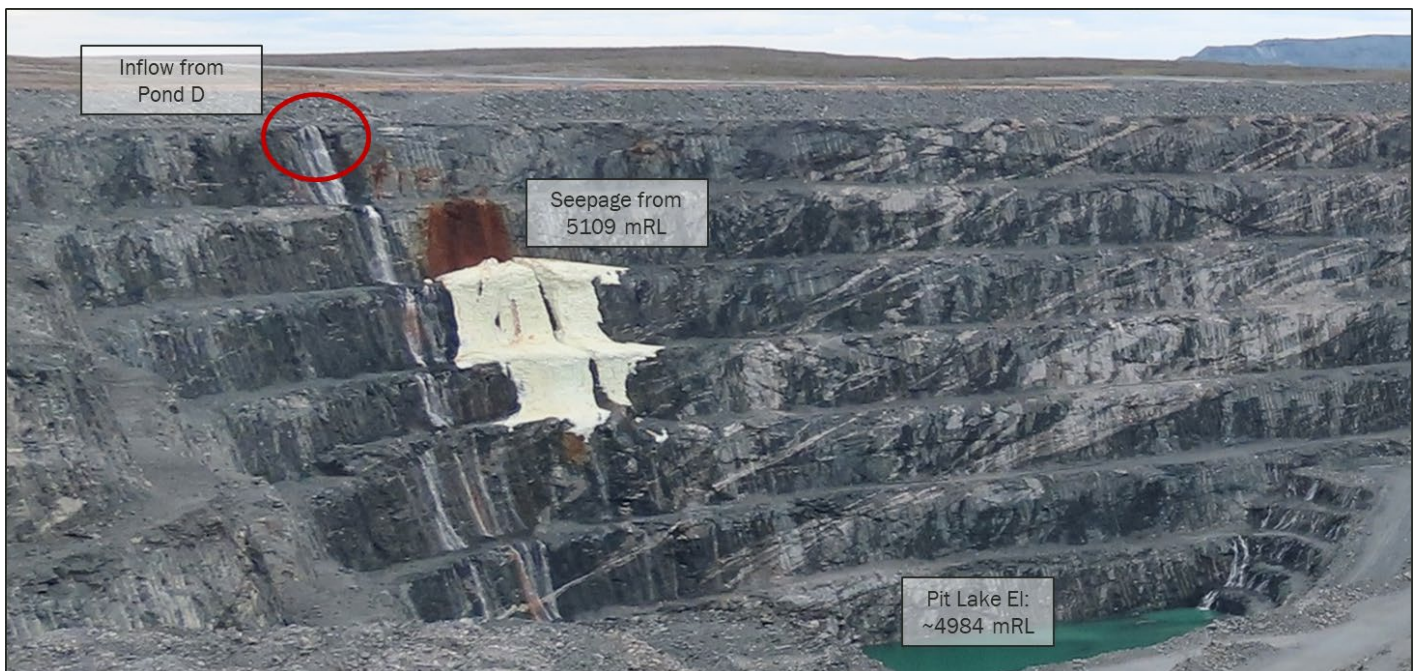
Photograph 8-12: Vault Pit seepage from southeast pit wall 5109 bench (2018)

During mining, AEM managed the water elevation in Pond D (former Vault Lake) at a low level to assist in lowering water levels behind the wall. During the 2019 inspection, it was noted that the water elevation in Pond D has been allowed to rise and was at an elevation of 5134 mRL. Consequently, water is flowing freely through the ring road and discharging from the crest of the 5130 mRL bench.

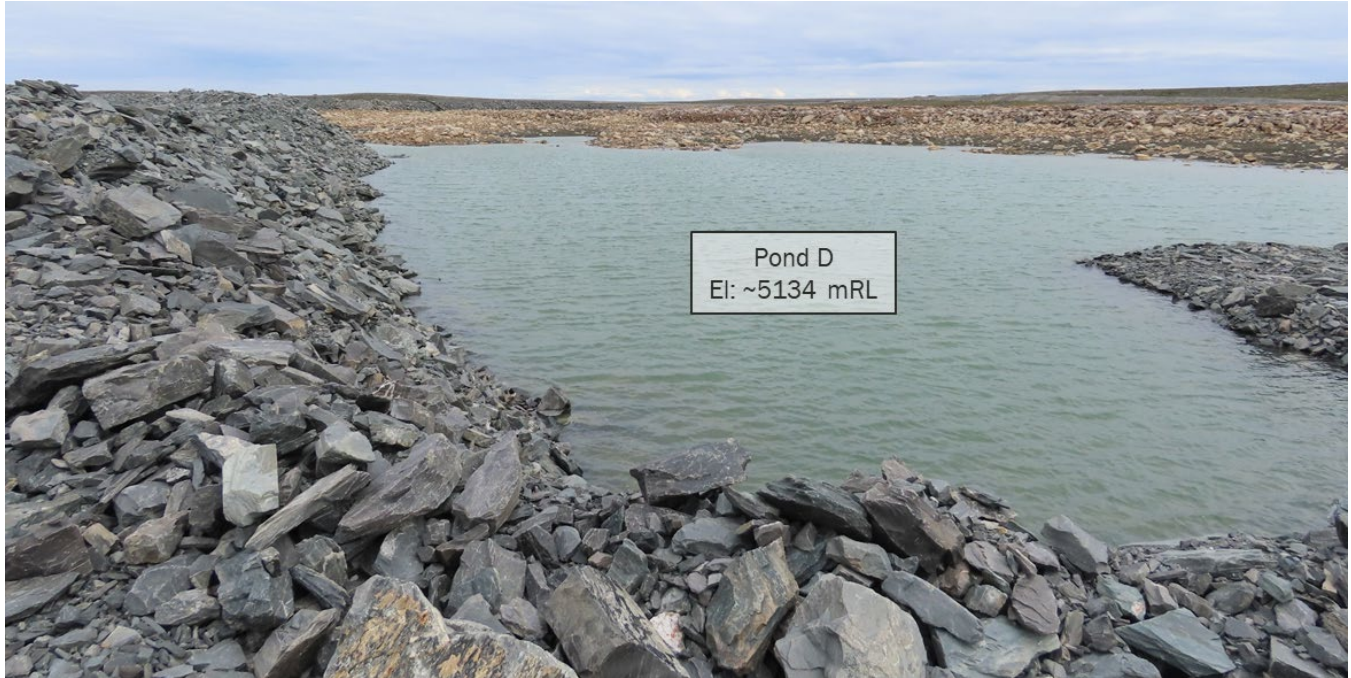
Photograph 8-13: Pond D water elevation 5134 mRL

Pond D will continue to rise if not actively pumped down, and ice could dam the upstream side of the ring road creating a risk of over-topping of the ring road leading to significant downstream erosion of the road structure and possibly failure.

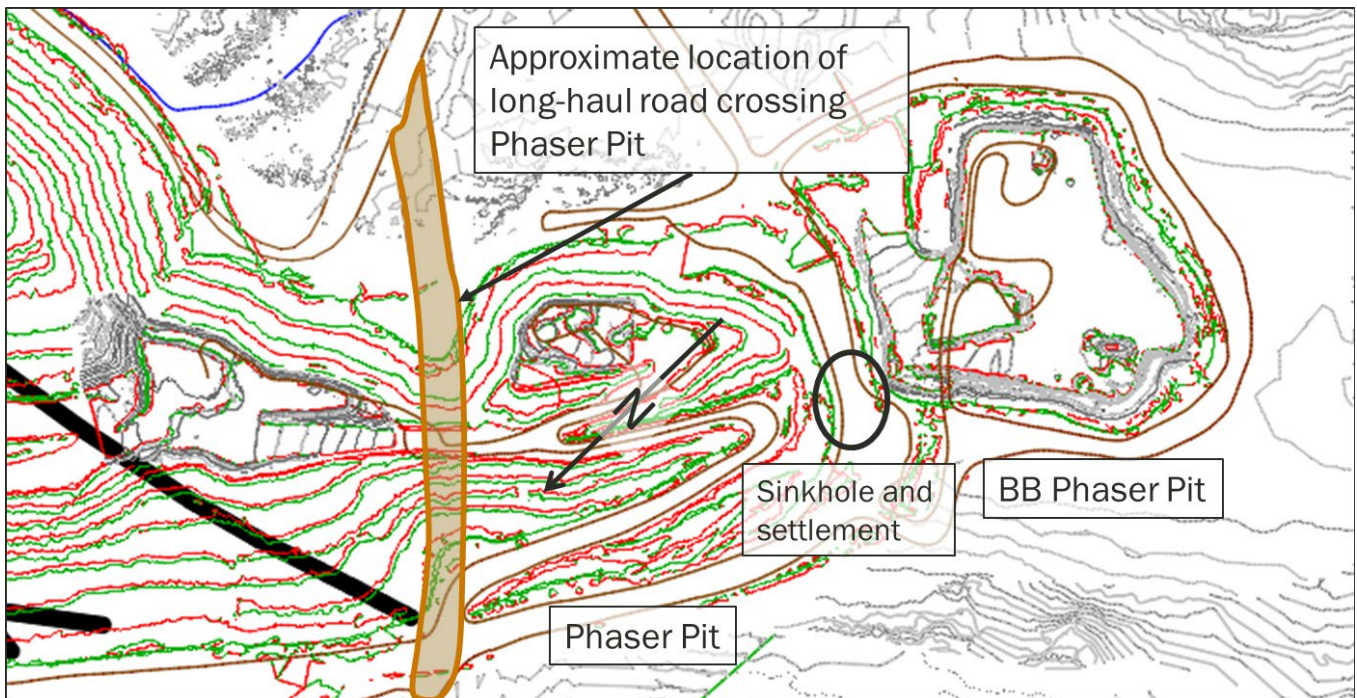
Figure 8-4: Location of sinkholes in road at BB Phaser Pit (2019)

During the inspection of BB Phaser Pit, sinkholes were noted to be developing on the access road that separates the two pits. The general location of the sinkholes is shown on the following figure. The road is no longer considered active but is still accessible. It was discussed with AEM that the road should be deactivated and bermed off to remove it from future use.

During the inspection of BB Phaser Pit, sinkholes were noted to be developing on the access road that separates the two pits. The general location of the sinkholes is shown on the following figure. The road is no longer considered active but is still accessible. It was discussed with AEM that the road should be deactivated and bermed off to remove it from future use.

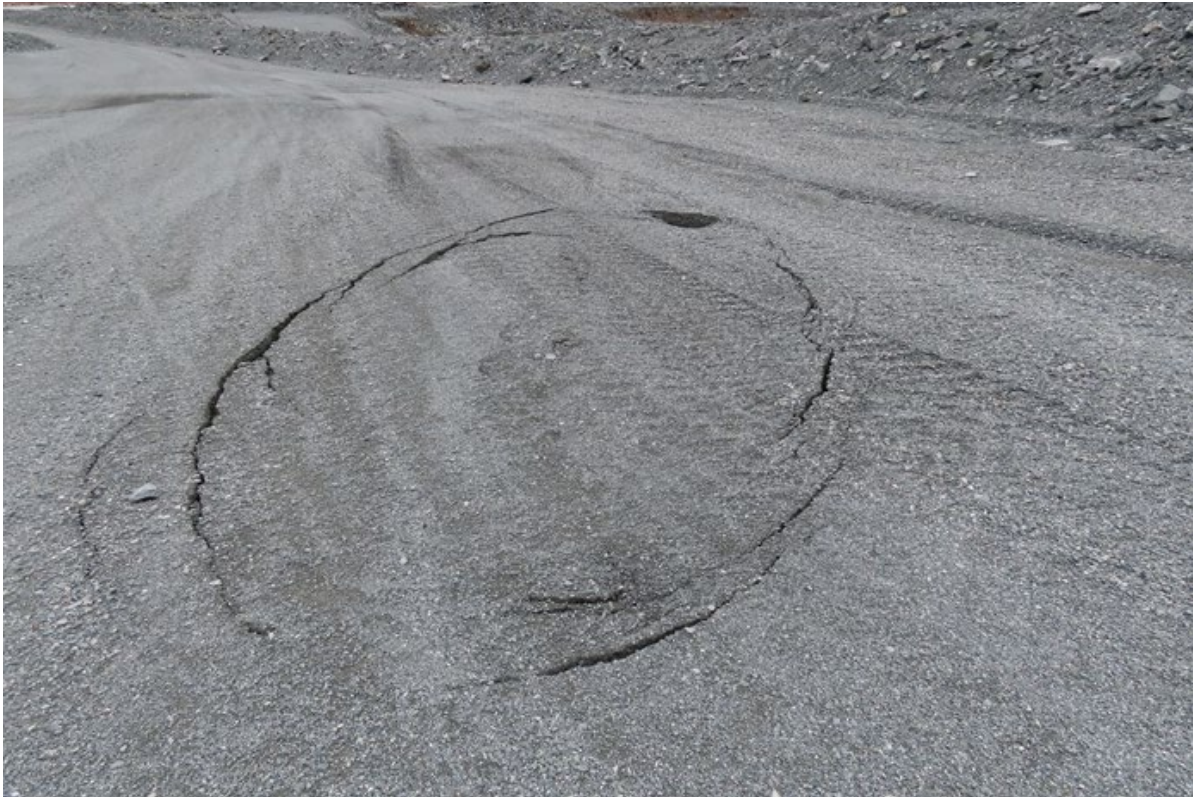
Photograph 8-23: Sinkhole formation on road between BB Phaser and Phaser pits

Photograph 8-22: Sinkhole development and settlement of road surface between Phaser Pit and BB Phaser Pit

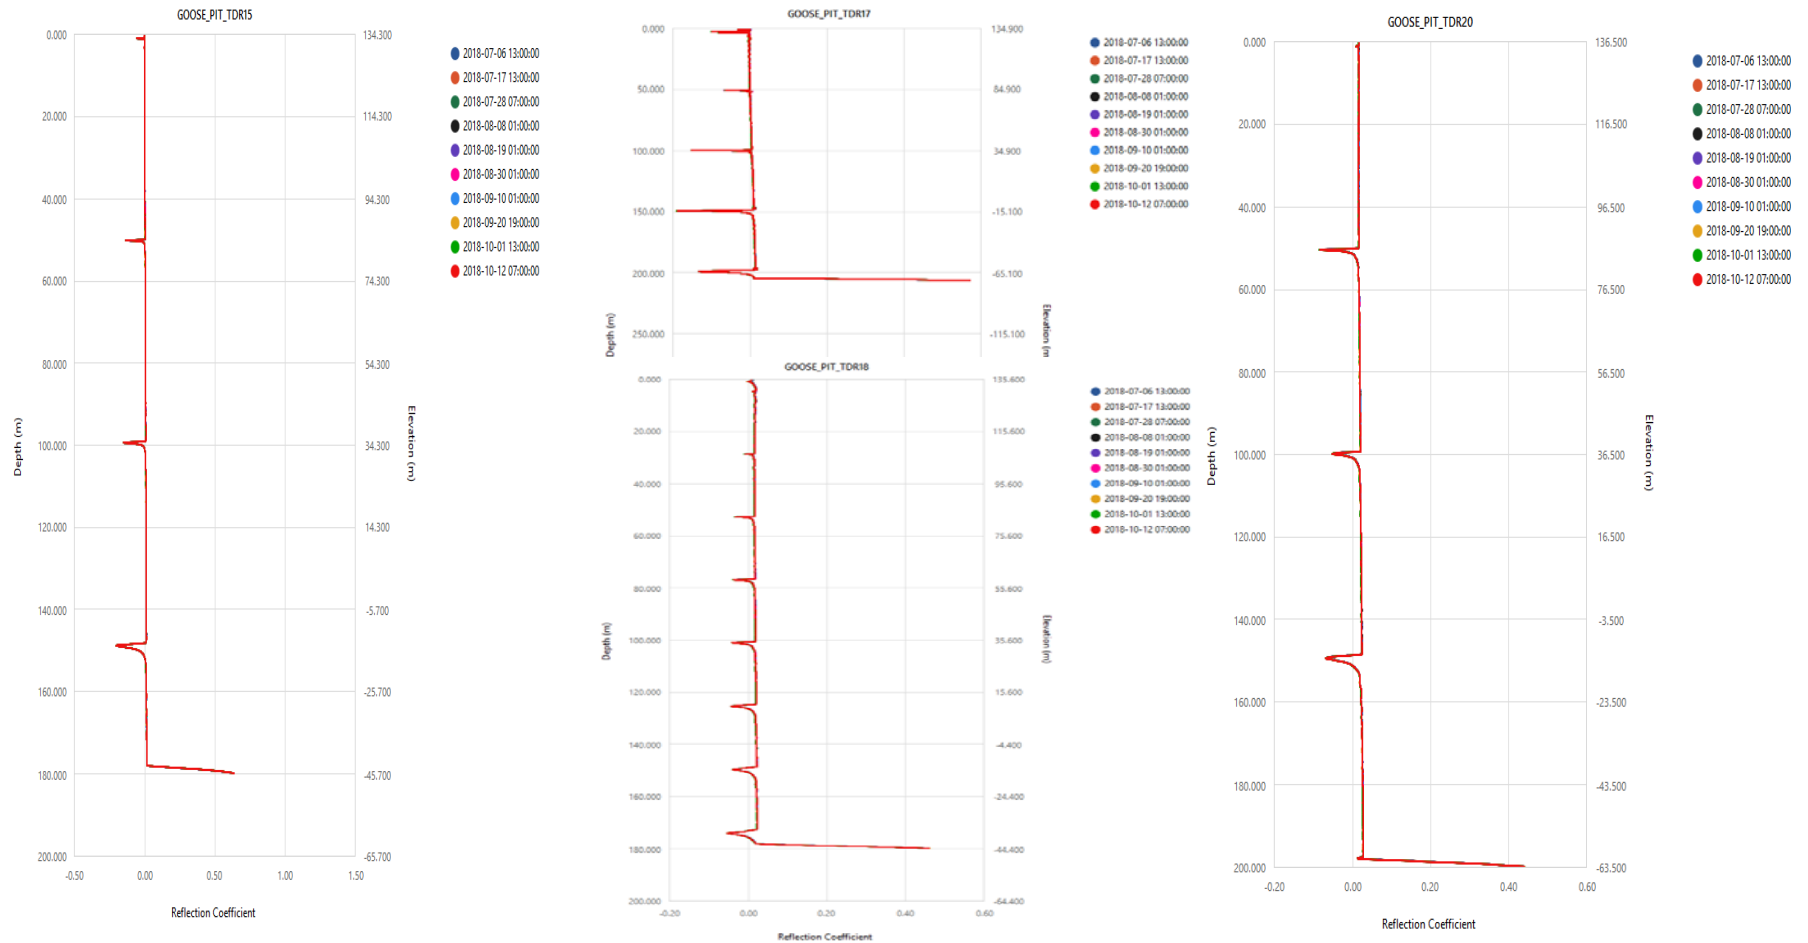
- No sign of deformation was observed in these TDRs.
- Anomalies from the TDR logger are still presents and were disregarded in the presented graphs. We are currently still trying to find a solution for this problem but it does not compromise the data integrity.

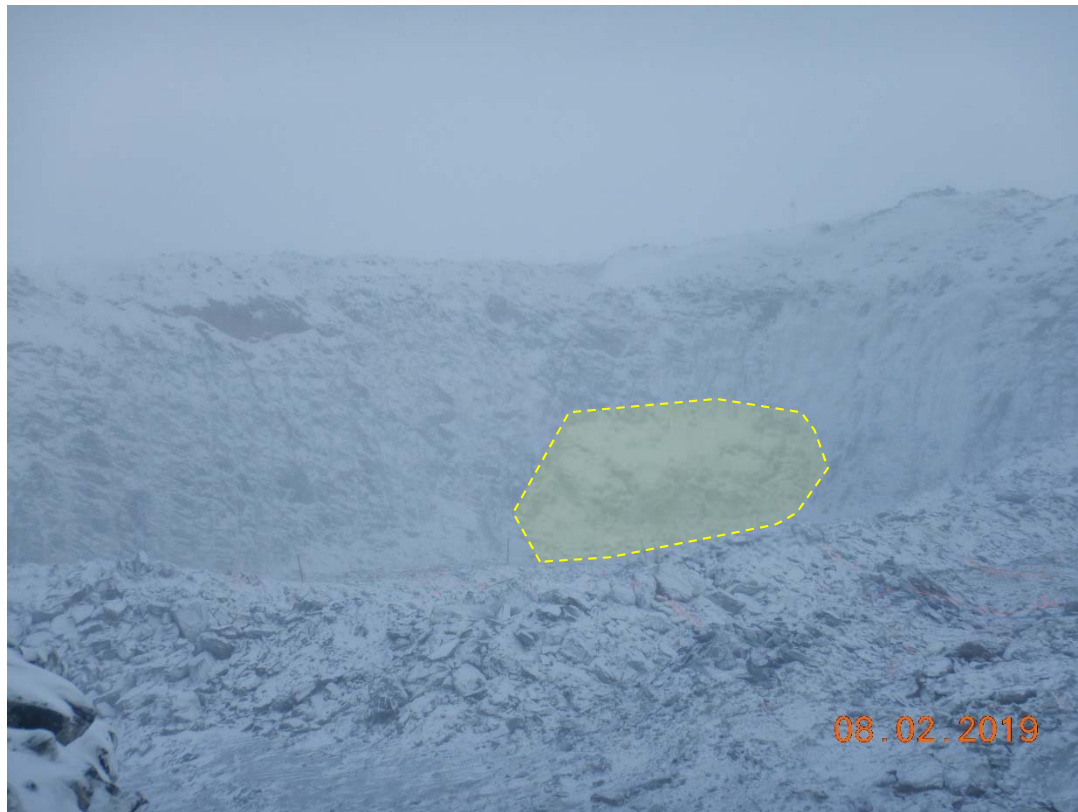
Zone BB13: BB Phaser, North East Wall: Fair dimension toe covering the corner; Hammering is recommended if possible.

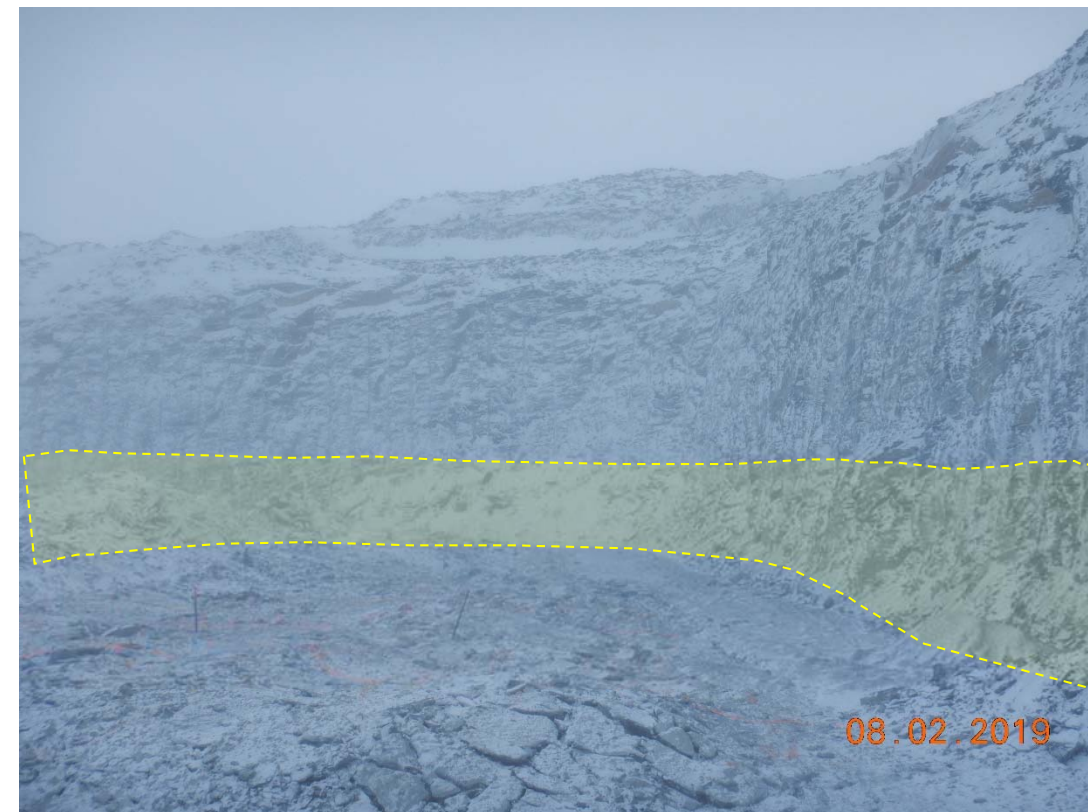
Zone BB14: BB Phaser, South West Wall: Lightly scale the wall and pick up debris.

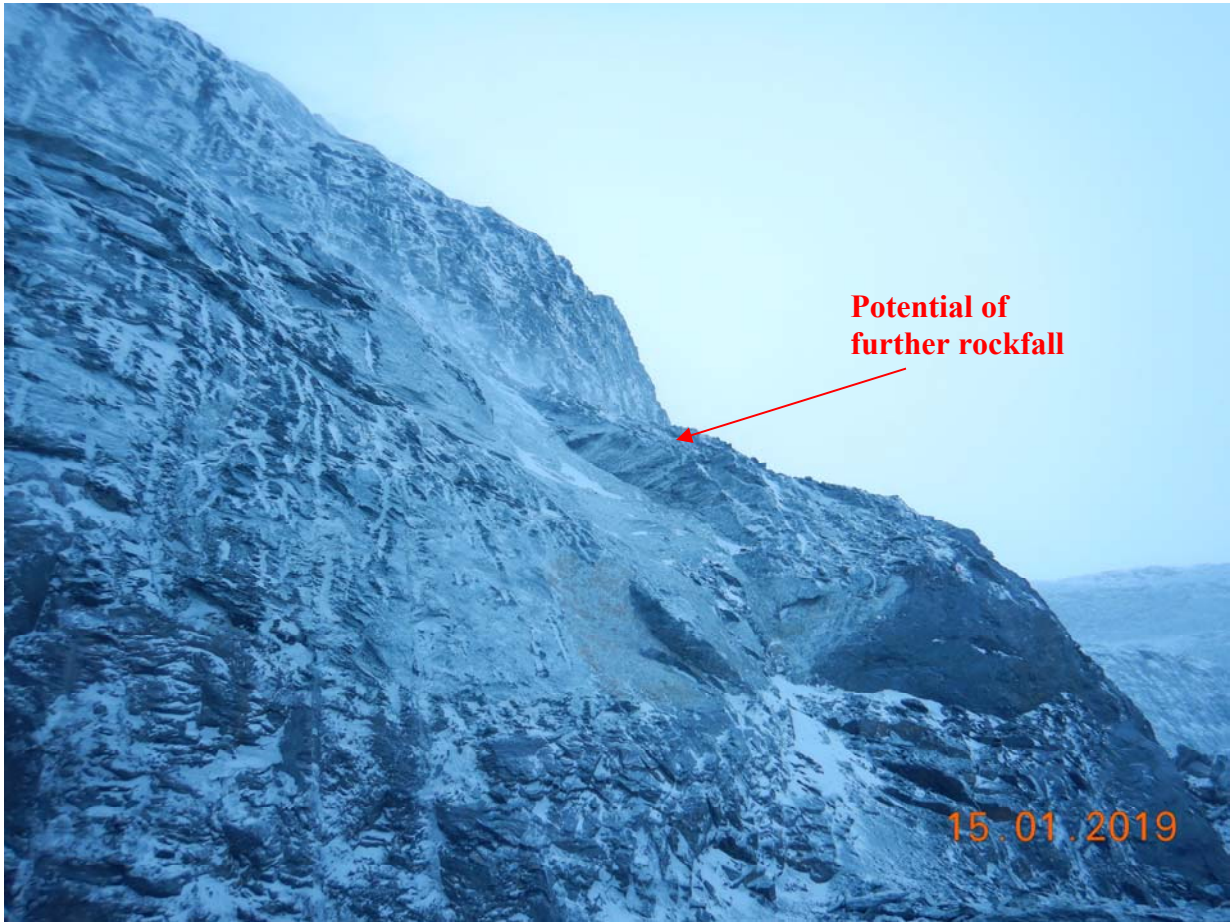
Fig.2: Photo showing potential of further material becoming loose.
