Whale Tail Open Pit 2019 Annual Inspection

RE: Amaruq Mine - Whale Tail Open Pit - 2019 Annual Inspection

Amaruq Project – Whale Tail Open Pit

2019 Annual Inspection

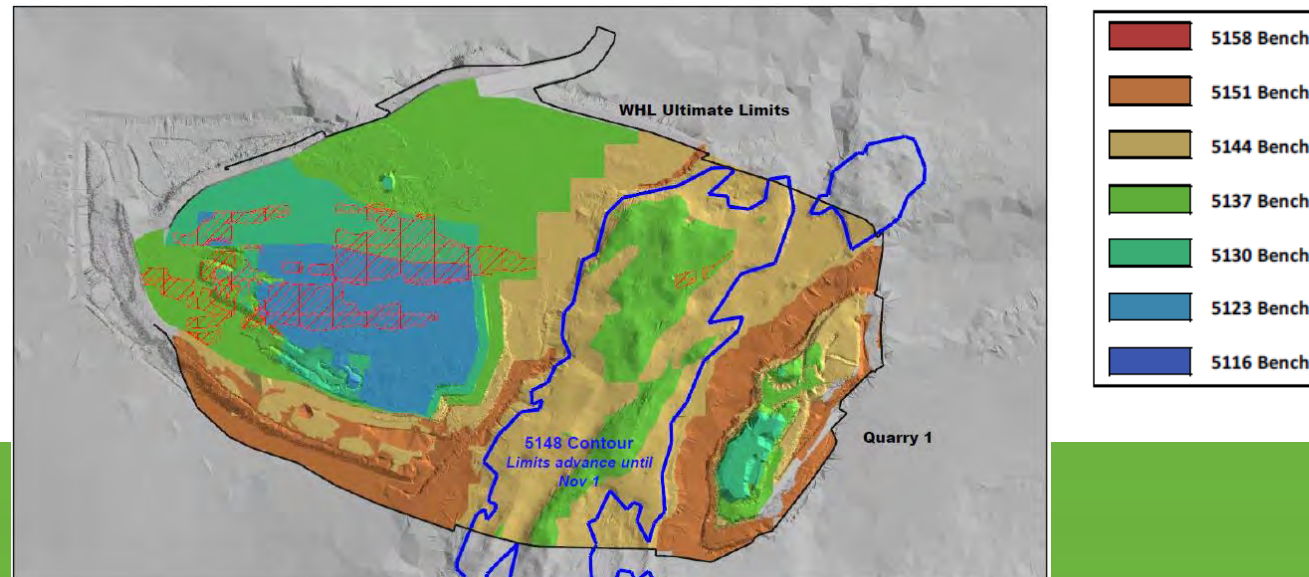
- Note that numerous areas were observed with loose material or overburden at the crest of the bench. The bi-weekly inspection reports also frequently note the need for scaling or the presence of loose. It is important that the benches are scaled as they are developed, particularly for the final walls. Do scaling practices need to be reviewed with the crews?

- Attenuation Pond 5 (AP5) and Quarry 1, on the east side of Whale Tail Lake, will form part of the Whale Tail Open Pit once the lake is drained and stripping continues. These areas were visited on September 9. Both AP5 and Quarry 1 are currently being used for water storage and are flooded. As a result, access is restricted and a detailed inspection was not completed.

- Note that the interim benches are excavated as single 7 m high benches.

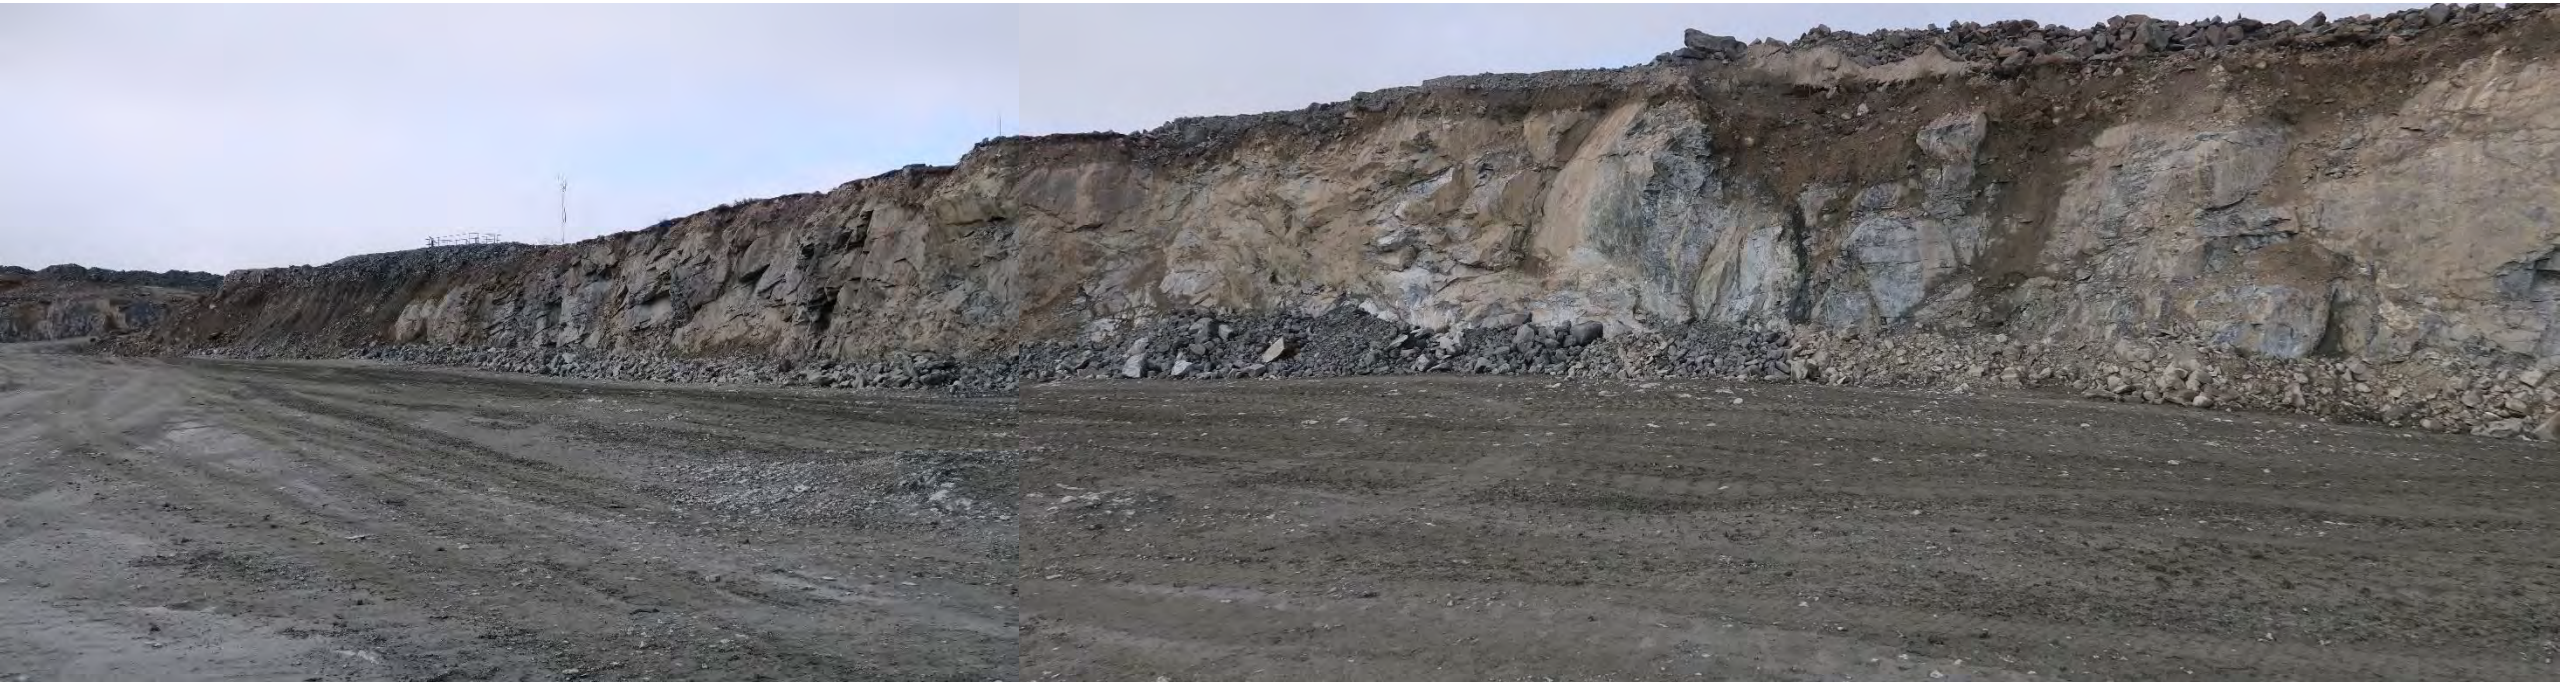
Northwest Wall

- First bench of the final wall in the Komatiite. Design Sector A1.
- Wall did not perform well and had to be scaled several times.
- Komatiite is of surprisingly good quality, and is not strongly foliated. This is at the upper end of the expected rock mass quality distribution for this unit.
- Western end of wall (at left in image below) is primarily in till. Next bench in that area predicted to be in Komatiite and intersect Brittle Structures. It is likely to perform poorly.

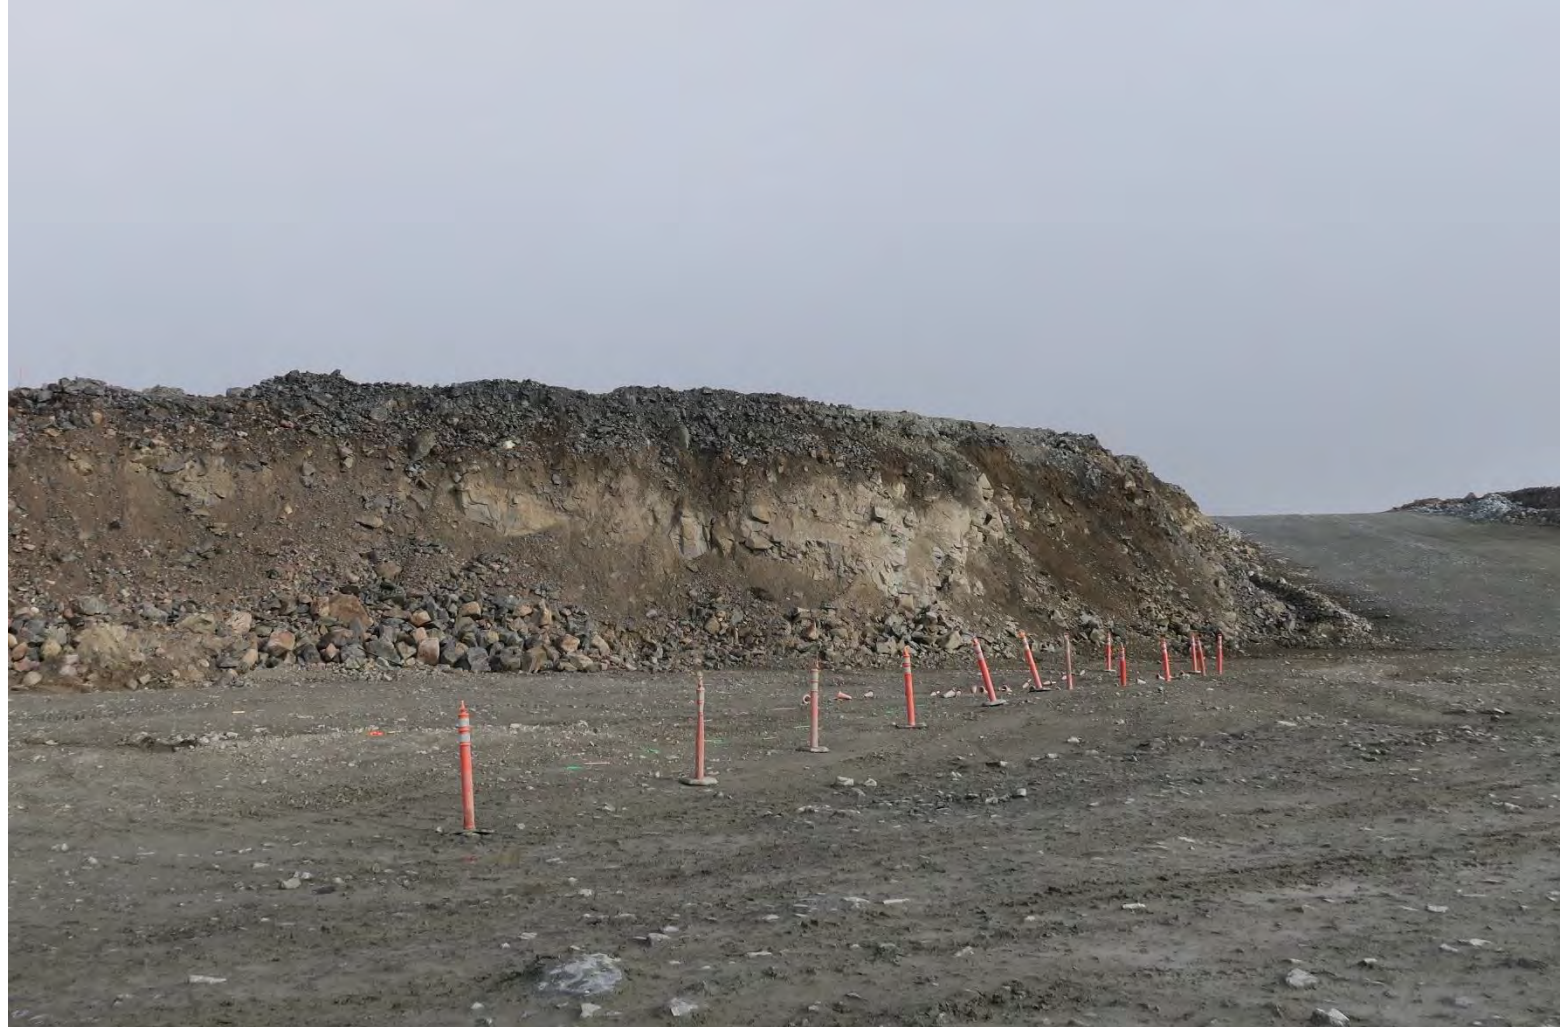
North Wall (5151 Bench)

- First bench of the final pit wall in the Greywacke. Design Sector A1.
- There is unconsolidated till at the crest of the bench, and the rock forming the bench itself is broken up. Pre-shear was not used.
- The management of the overburden is discussed on the following slide.
- It is recommended that pre-shear holes be completed for all final walls.

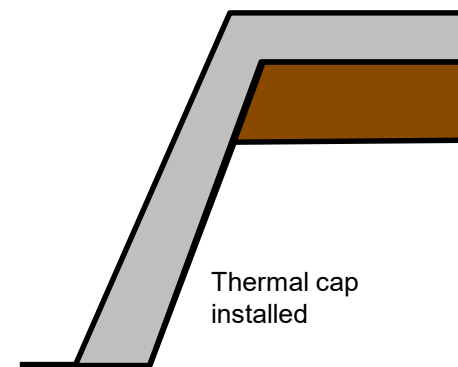
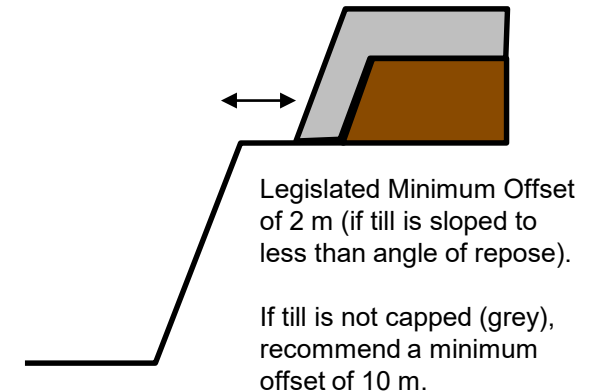
North Wall – Overburden Management

The management of overburden at the crest of the slope was discussed. This applies to all of the walls; not just the North Wall.

- In most cases, the mine intends to cap the till with NAG, including buttressing the bench face.
- The alternative is to strip the overburden back from the crest of the slope.
 - An offset of 10 m was recommended in the FS.
 - The NU mine act requires a minimum 2 m offset, and that the till be graded at an angle less than the angle of repose.

1. **Overburden** - Overburden was observed at the crest of the open pit slopes in numerous areas. The overburden represents a rockfall hazard, especially in the summer months when the active layer thaws. It is understood that AEM intends to construct a thermal cap for the overburden using waste rock in most cases. Two cap designs were discussed: one that covered only the overburden and one that covered the first 7 m high bench as well as the overburden. In either case, the Nunavut Mine Health and Safety Act (2011) requires a minimum offset of 2 m between the toe of the overburden or cap and the crest of the bench. KP recommends a minimum offset of 10 m in cases where a thermal cap will not be installed or where the installation of the cap will be delayed.

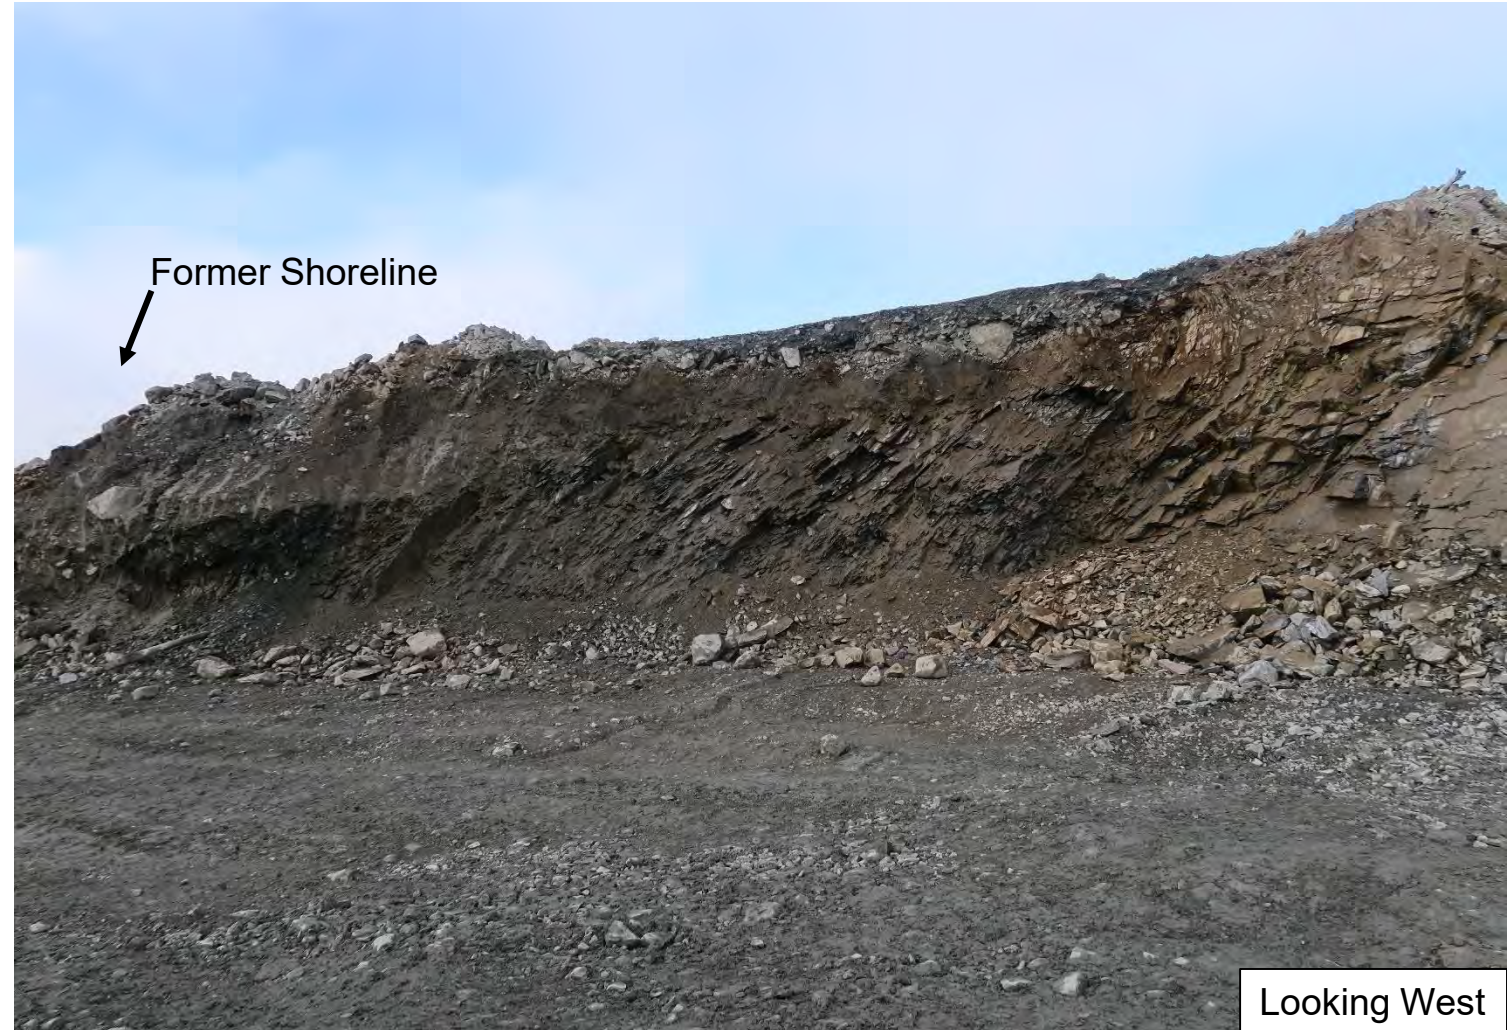
North Wall (5144 Bench)

- Interim wall in the Greywacke.
- Performance is similar to 5151 bench, with bench geometry controlled by dip of the foliation (55°).
- At the western end of the bench, the slope approaches what was the northern shore of the western lobe of Whale Tail Lake. In the active face, the rock mass becomes progressively lower in quality with much tighter foliation spacing as it approaches the former shoreline. Plan is to mine out this material, which is the preferred approach.

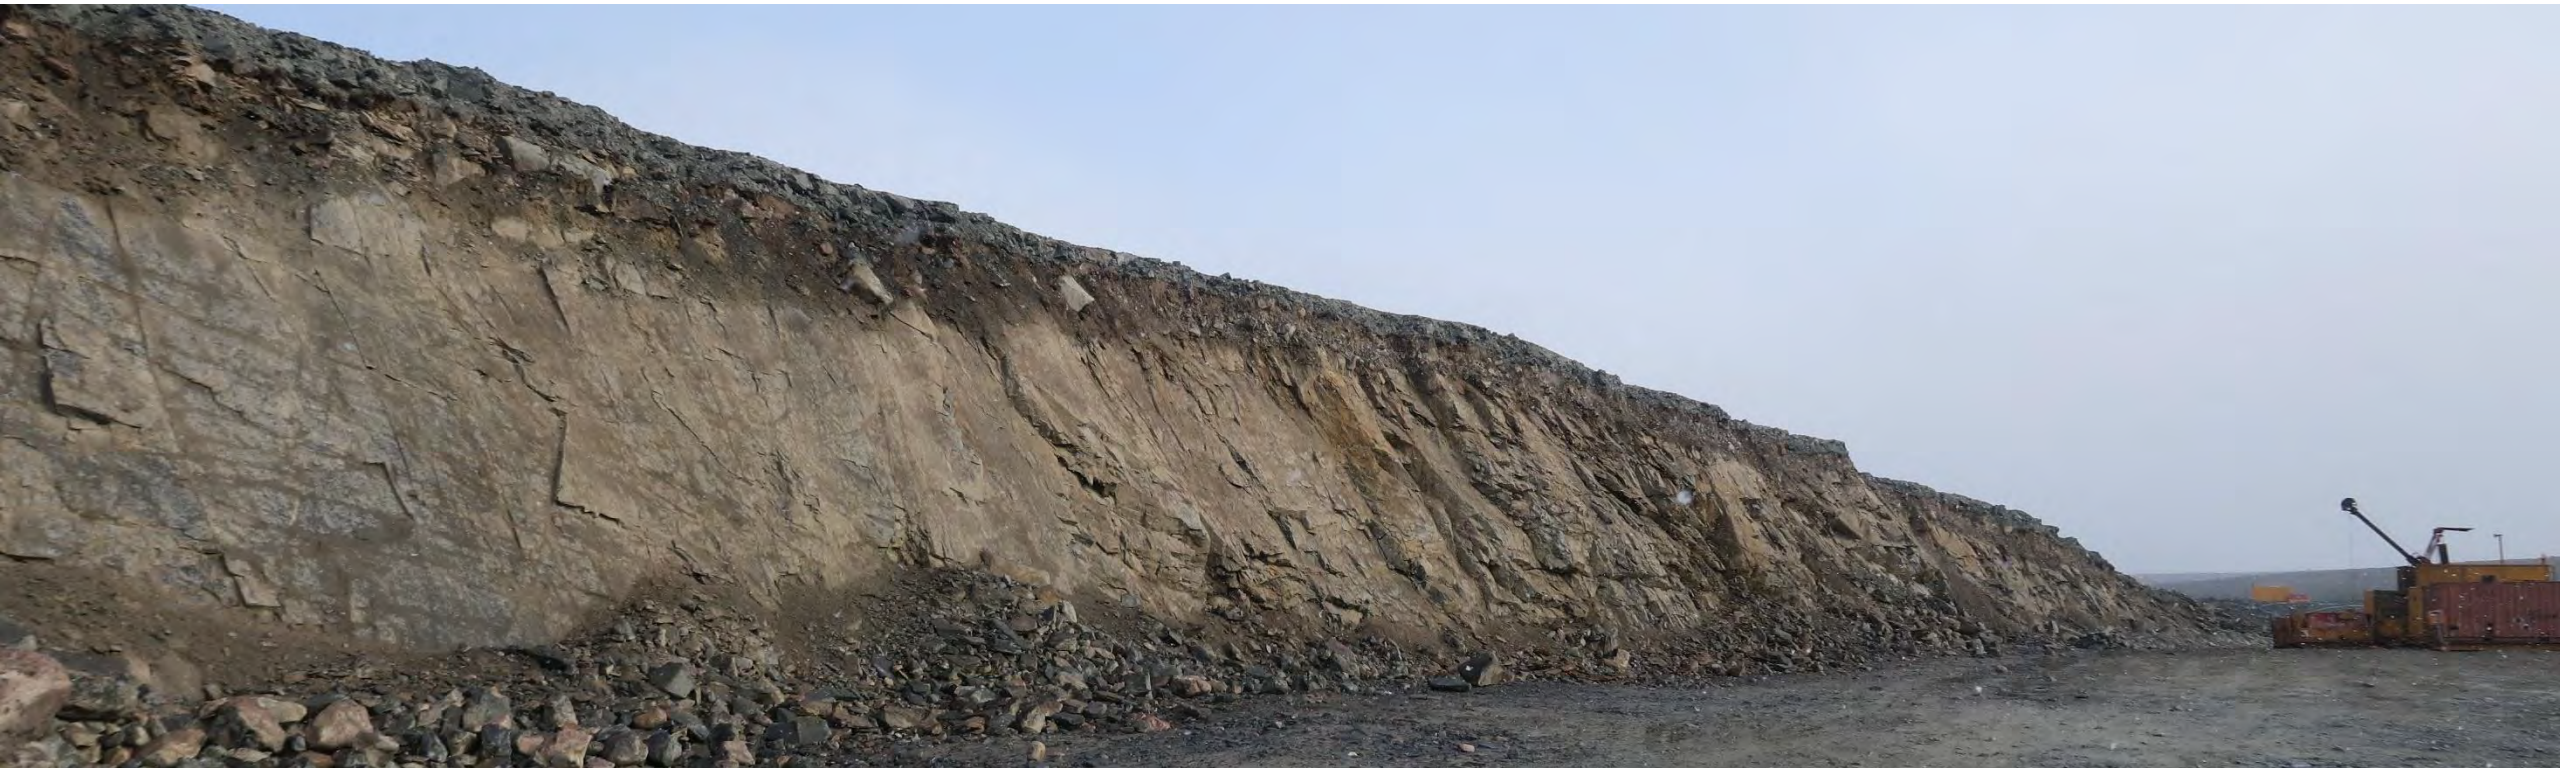
Northeast Wall

- First bench of the final pit wall in the Greywacke. Design Sector A1.
- The bench performance is controlled by the dip of the foliation, as expected. Bench face angle is approximately 65° , consistent with design.
- Recommend using Maptek Scanner to document bench performance and foliation dip.

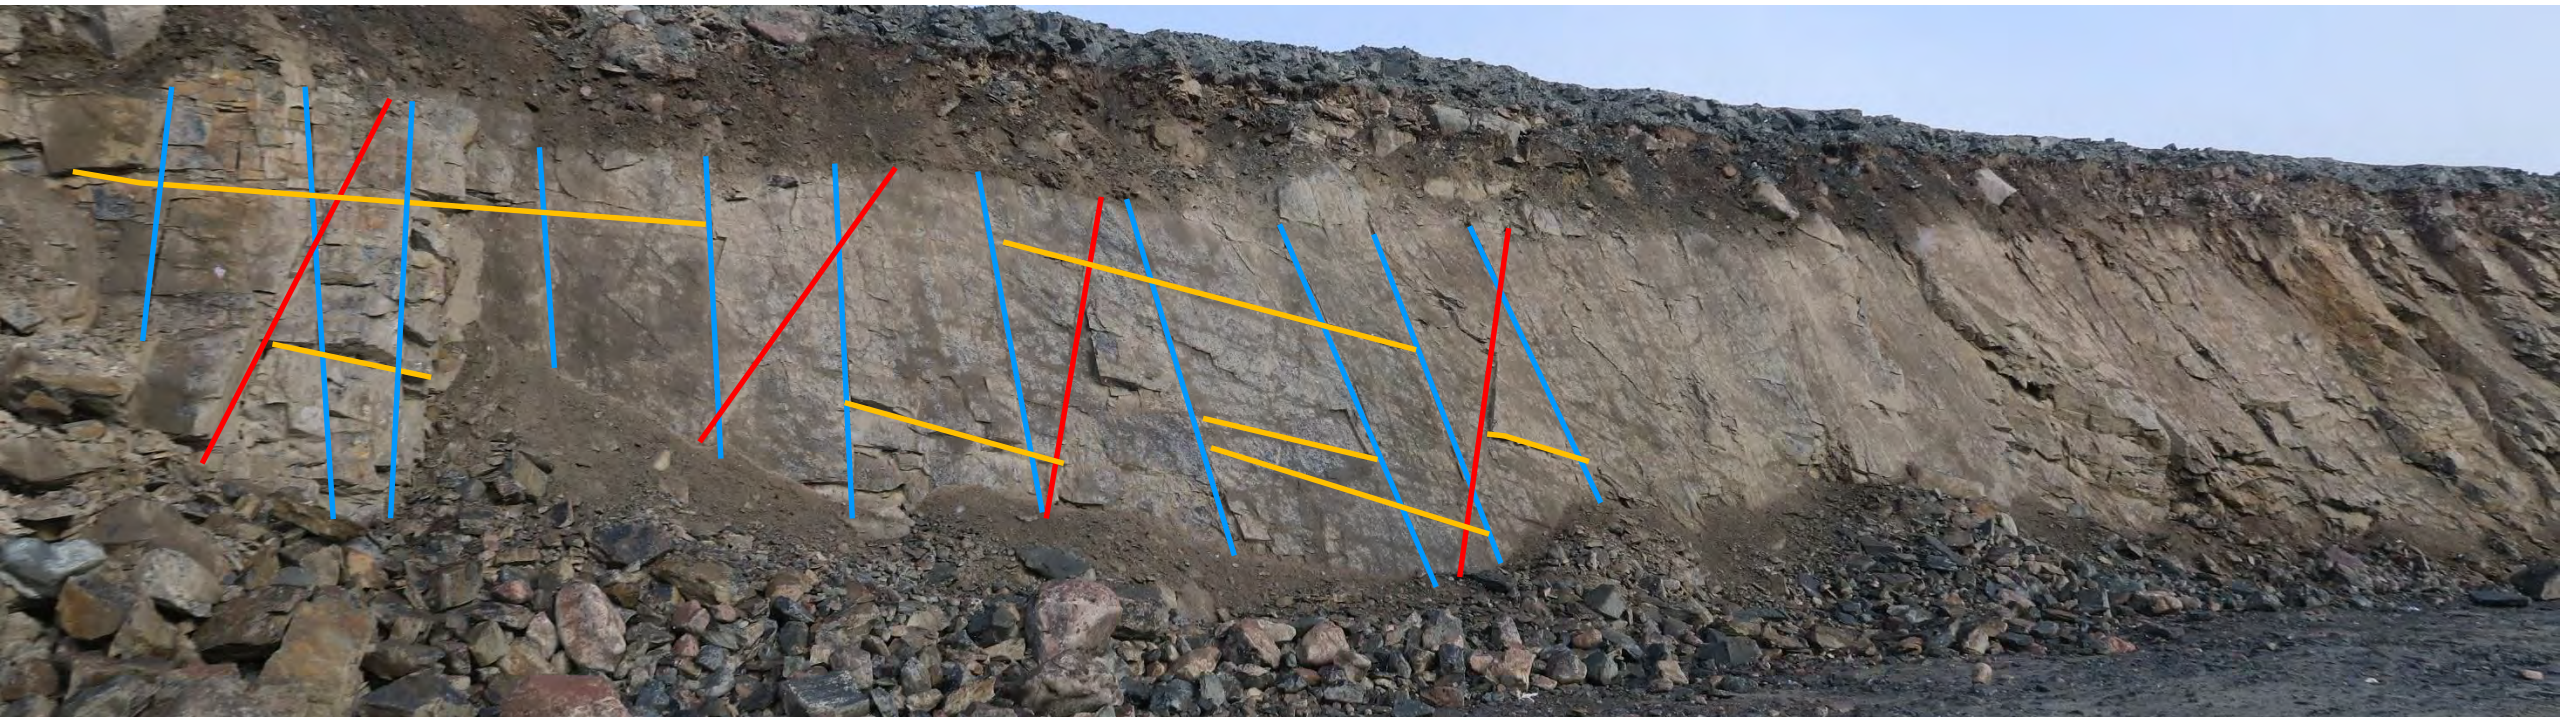
Northeast Wall – Observed Structure

- Joint Set A (Foliation) – Defines the bench face. Dips to the south at approx. 65° (to be confirmed with Maptek). Persistent at 7 m bench scale.
- Joint Set D – Vertical set perpendicular to the foliation. Persistent at 7 m bench scale. Approx. 2 m Spacing.
- Joint Set C – Sub-horizontal set. Dips to the north. Variable persistence and spacing.
- New Set – Dips to the West at approx. 60° . Persistent at 7 m bench scale. Approx. 4 to 5 m spacing. Need to monitor and see if this set is common.

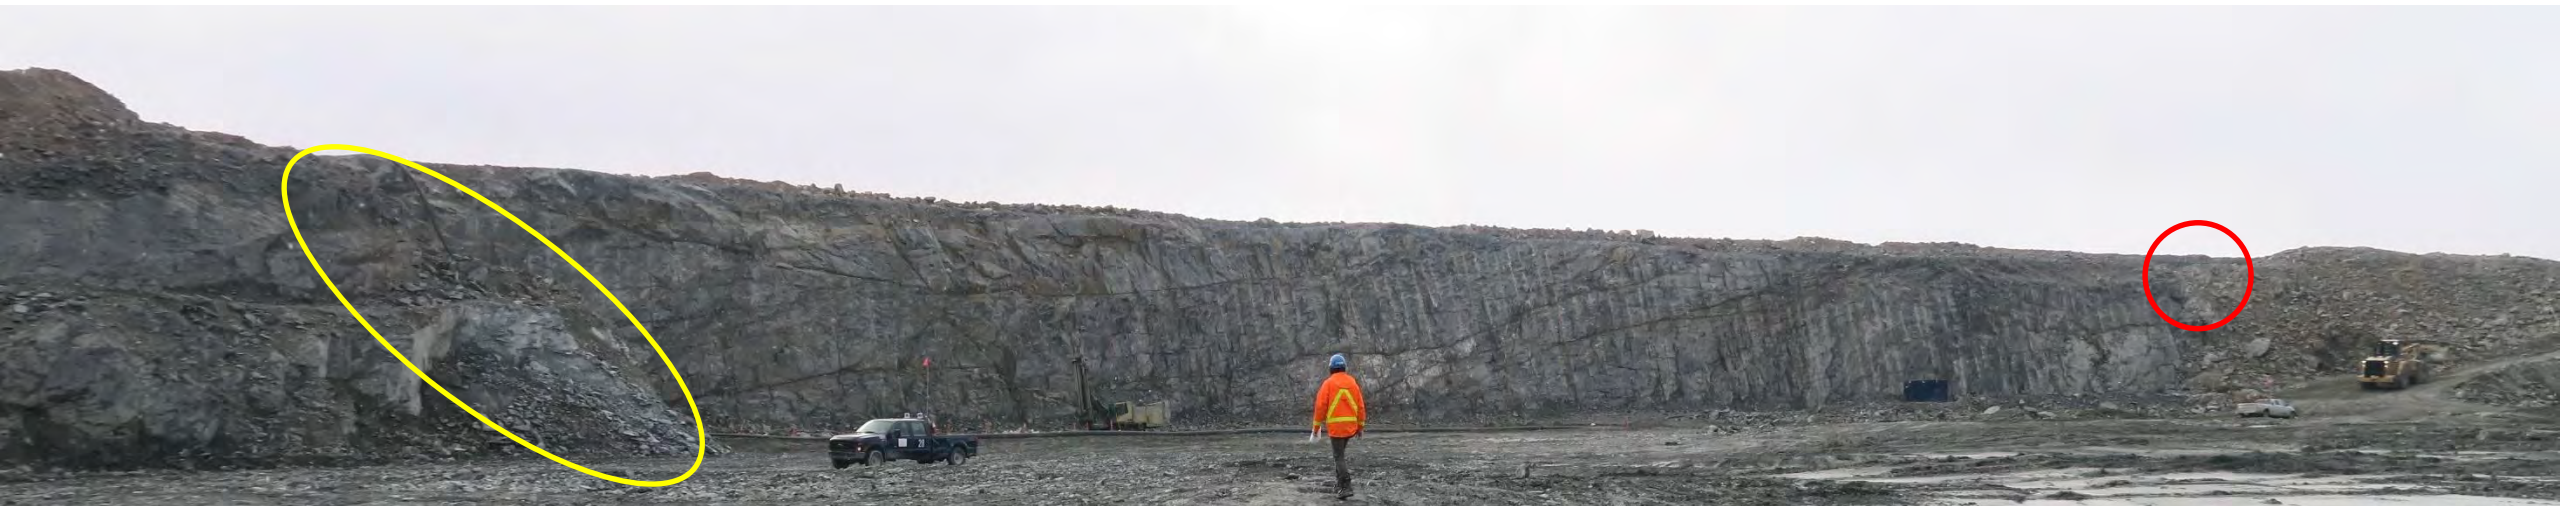
South Wall

- Interim Wall in the Diorite
- A 21 m bench has been established. There is a 7 m bench of till and fractured bedrock above, offset by a 30 to 80 m temporary step-out. The till has slumped along most of the length of the wall but has been contained by the step-out.
- The 21 m bench is performing very well, with half-barrels visible.
- A potential loose block was observed at the western end of the wall (circled in red), adjacent a previous FoG that has been blasted. There is a berm directly below the block but it should be scaled down if possible.
- There is a nose at the eastern end of the wall (circled in yellow). The nose has ravelled and there are a large number of loose blocks on the crest of the south/western side of the nose. The area has been flagged as a hazard requiring scaling and a berm but neither has been completed to date.

- a. Nose at the eastern end of the South Wall. The nose has ravelled and a number of loose blocks were observed on the crest of the benches in this area. AEM has identified the need for scaling and a berm in this area, but neither had been completed at time of visit. These measures should be implemented as a priority. It is recommended that AEM also avoid the creation of noses where possible, as they are prone to ravelling.

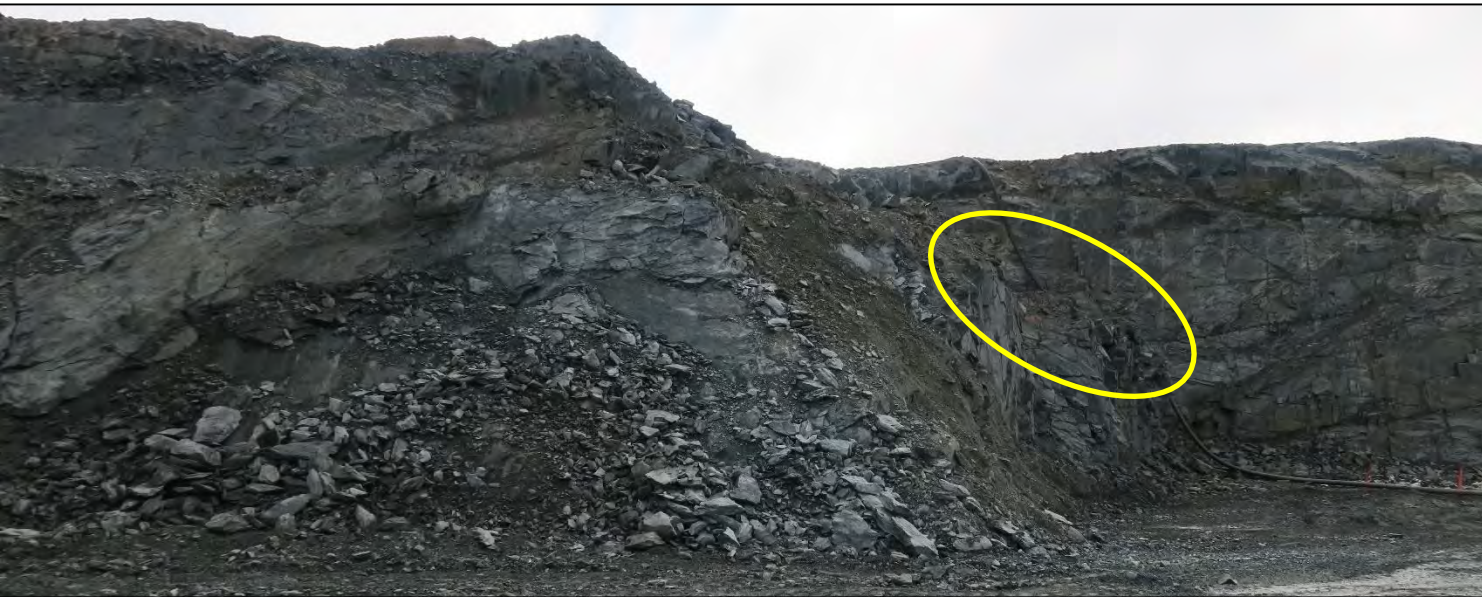
- Potentially loose block at west end of South Wall shown at right. The area is bermed.
- Loose blocks adjacent nose at east end of South Wall shown below. The area is not bermed.

- b. South Wall block at west end by previous failure. Bermed off but should be knocked down.
3. **East Wall Buttress** - A 3 m high rockfill buttress has been built along the east wall of the open pit. During the summer it is understood that the lake level was within 0.1 m of overtopping the crest of the open pit. The buttress was constructed in an effort to stabilize the saturated till at the crest of the wall. The water level in the lake has since subsided and the lake is planned to be dewatered by the end of 2019. Stability analyses have not been completed for the buttress and a Factor of Safety has not been calculated and compared to AEM's acceptance criteria. If there is a potential for the water level to rise again, this observation would escalate to Priority 1 and it is recommended that stability analyses be completed to confirm the buttress design.

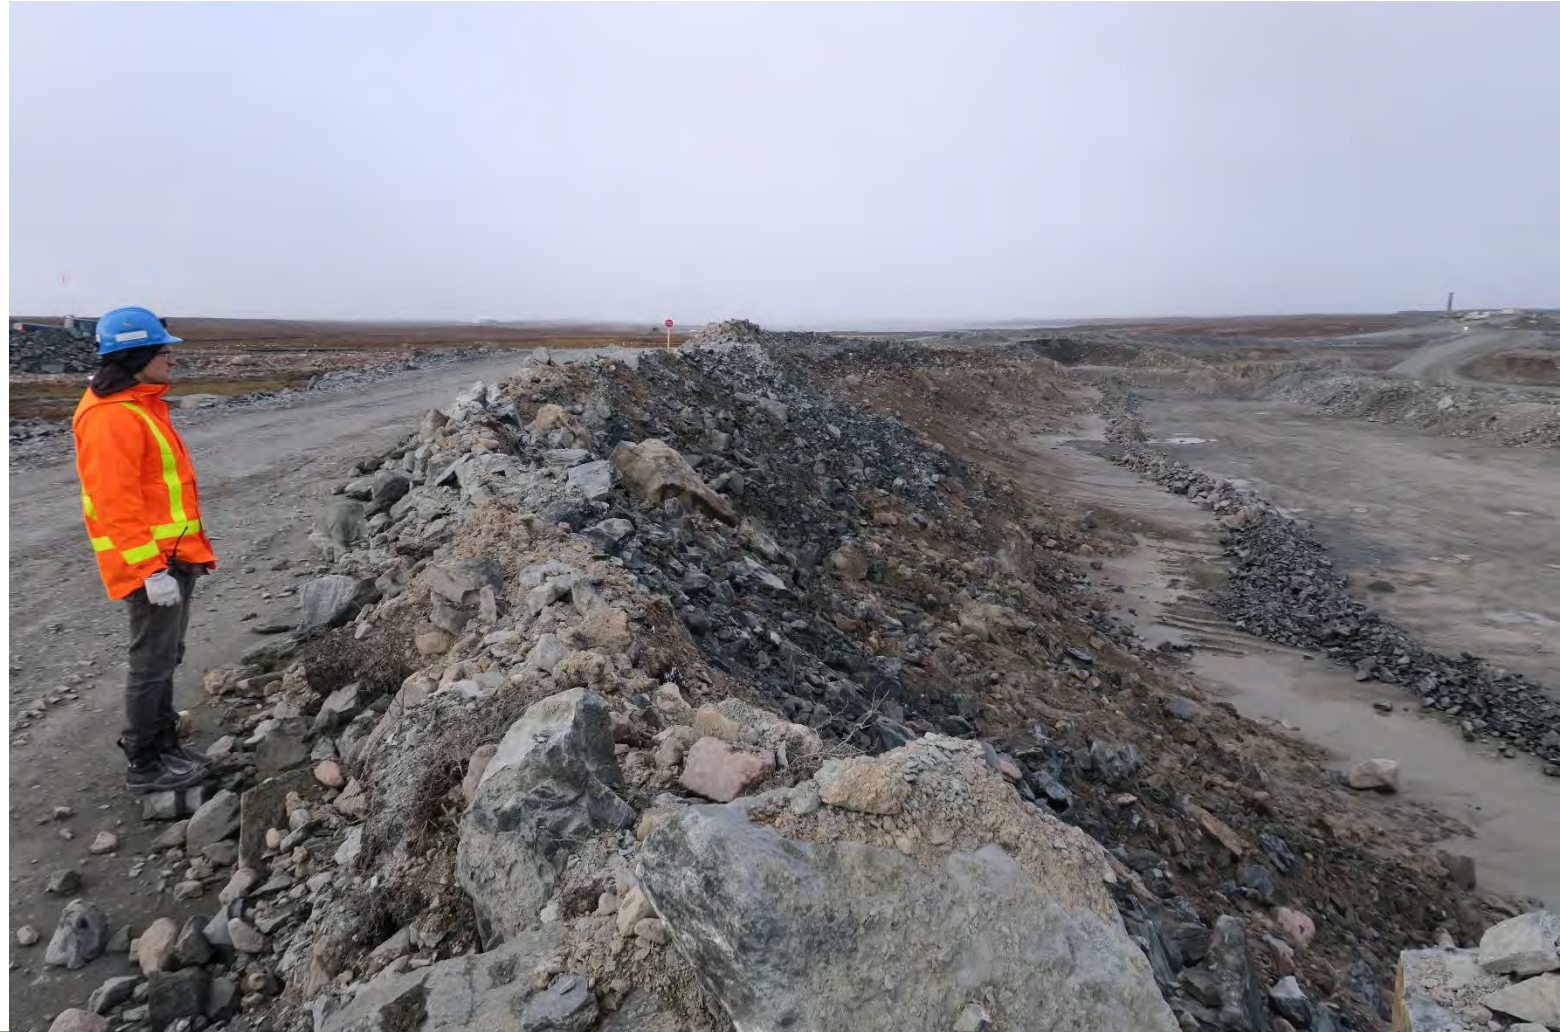
South Wall - Till

- The till at the crest of the South wall has slumped repeatedly, in one instance reaching the berm of the road at the crest of the pit.
- The mine has kept the failed material in place at the toe of the slope to act as a buttress.
- The till slope and the road are inspected as part of the bi-weekly open pit inspections. If further slumps are observed, the inspection frequency should be increased and consideration given to closing the road.
- It is understood that the till will be covered with a thermal cap once the final wall position is established.

1. **South Wall Till Slope** - The till at the crest of the south wall has slumped repeatedly. The till is offset from the crest of the rock slope by more than 10 m and does not pose a significant hazard to personnel within the open pit. However, the till has failed back to the berm of the road along the south wall of the open pit. The slope and road are inspected on a bi-weekly basis. If further slumps are observed the frequency of inspection should be increased and consideration given to closing the road.

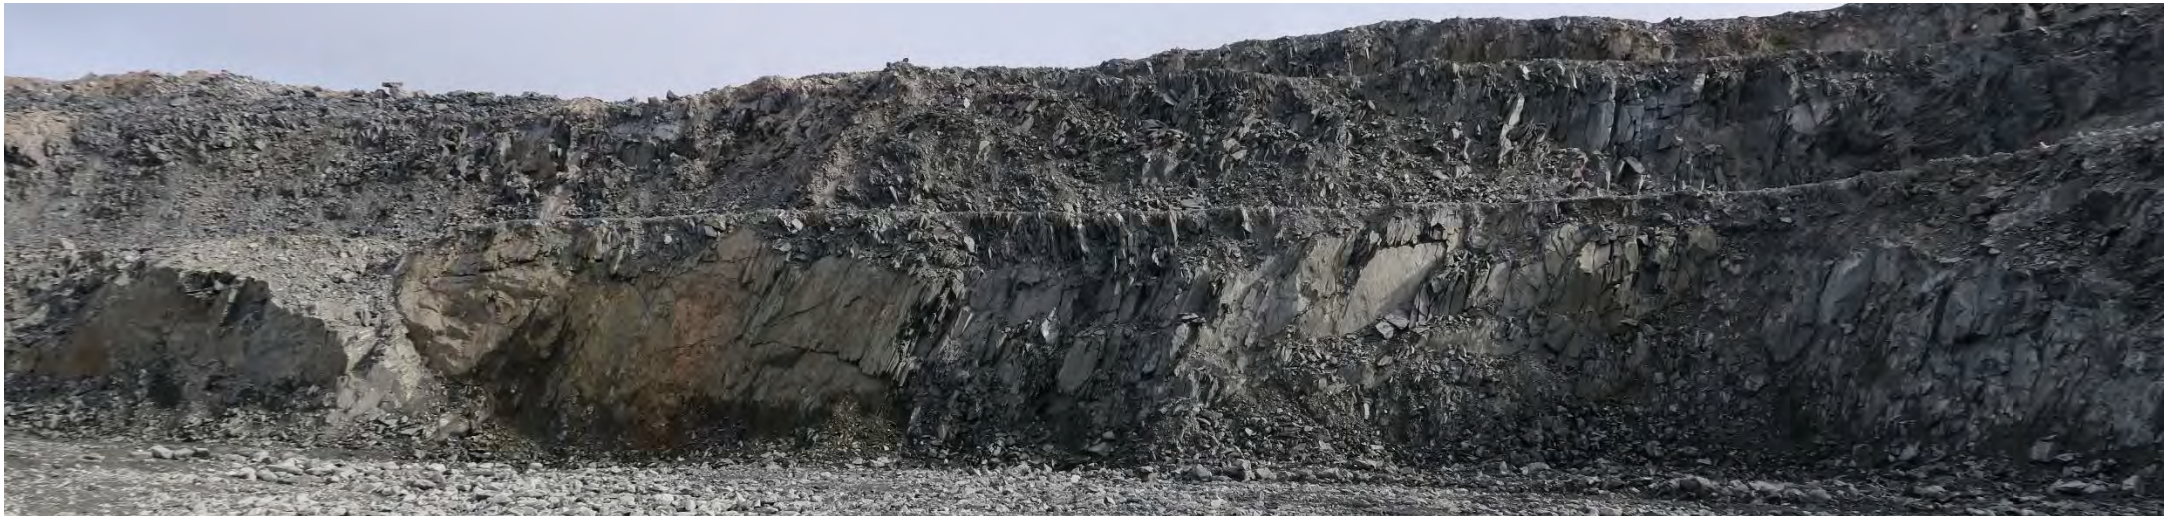
East Wall

- Interim wall with current exposures of the Diorite, Mafic Volcanics, Komatiite (South Limb), Chert and Iron Formation (from South to North). Eventually the Komatiite (North Limb) and Greywacke will be exposed at the northern end of the wall. As a result, this wall provides a good opportunity to observe the characteristics of the different lithologies at a bench scale.
- The Mafic Volcanics (below) have performed relatively well, aside from loose at the crest. The rock mass is similar to the Greywacke. The bench geometry is often controlled by structure, particularly the foliation. However it does not have the well-defined orthogonal structure of the Diorite.
- The Chert, Iron Formation and Komatiite are shown on the next slide. The Diorite is shown on the slides for the South Wall.

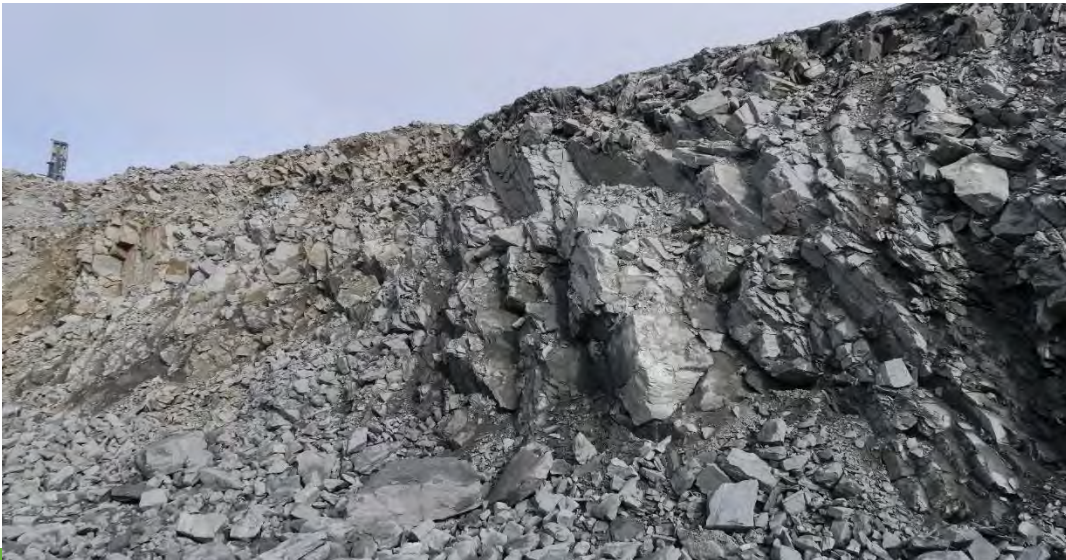
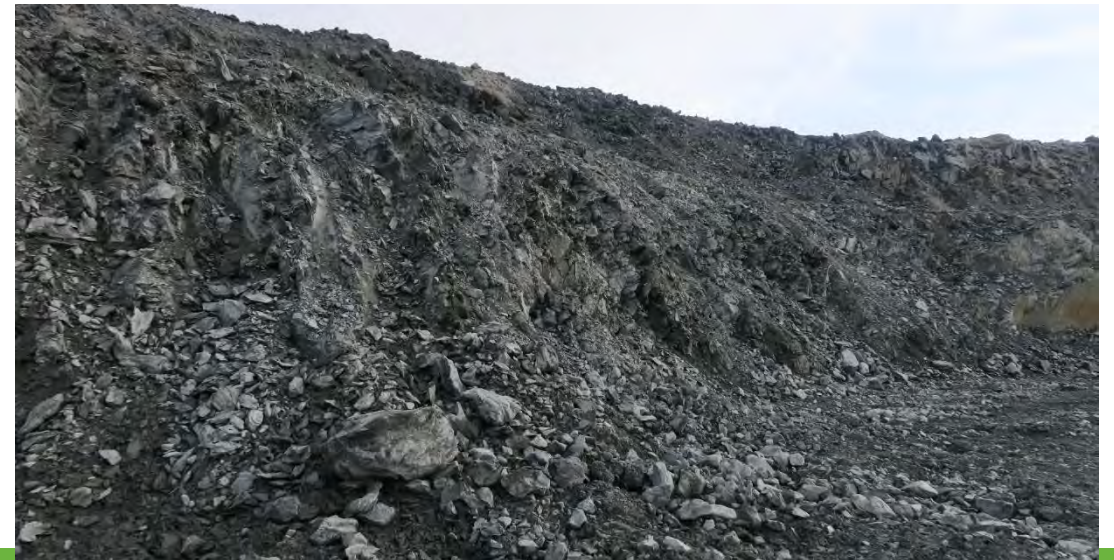
- Komatiite (South Limb) is shown at lower right. Chert and/or Iron Formation (difficult to visually distinguish between them) is shown at lower left.
- There has been significant blast damage to these units. No pre-shear was used as it is an interim wall. It is also understood that a higher powder factor was used in these areas. Need to use a different approach for the final walls if the design geometry is to be achieved.

- The Komatiite is highly disturbed. The foliation is prominent and several shears were observed. It is soft enough that teeth marks from the shovel are visible in places. This is more consistent with the expected characteristics of the Komatiite (compared to the Northwest Wall).

- The Chert and/or Iron Formation has performed much more poorly than expected, with numerous small (tens of cm) tabular blocks. This may be due to blast damage, though a few small shears (<5cm) were observed parallel to the foliation. It is important to document how other walls in this unit perform.

2. **Blasting Trials** - Significant blasting-induced damage was observed in some of the interim walls (e.g. the east wall), particularly within the weak komatiite. This has resulted in very poor bench performance and substantial back-break. It is understood that a higher powder factor was used in these areas. It is recommended that blasting trials be completed to refine the blasting practices used for different lithologies.

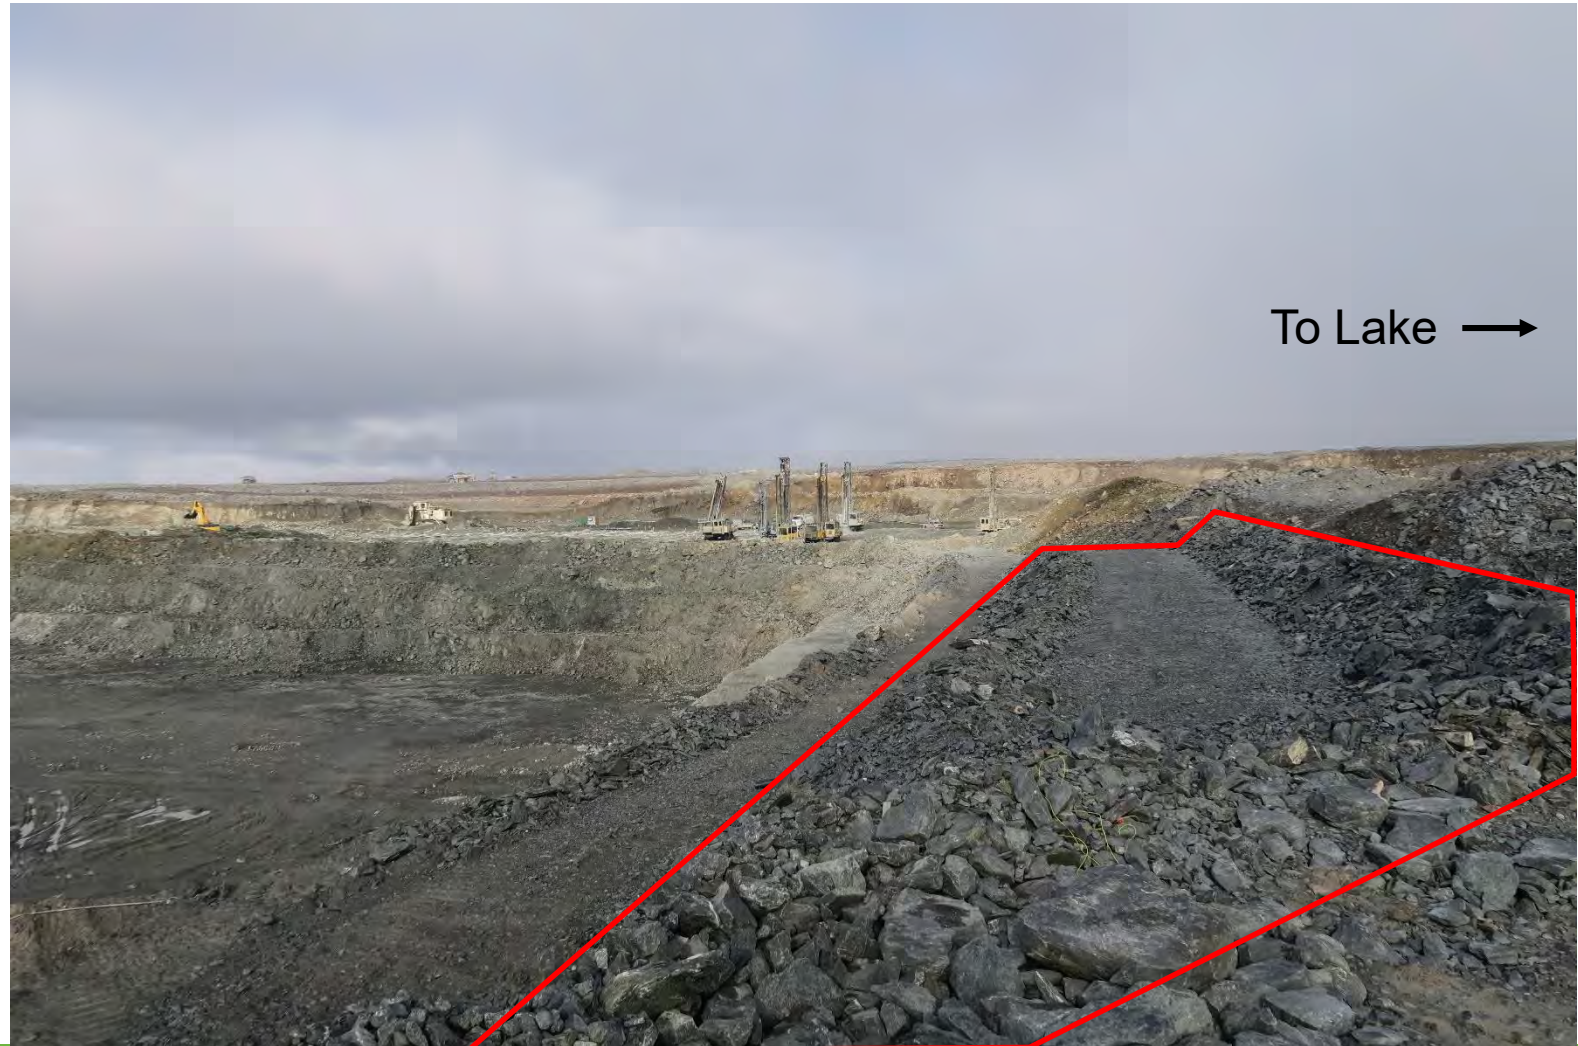
East Wall Buttress

- East wall is approximately 80 to 100 m from Whale Tail Lake.
- Dewatering of the lake is behind schedule, and over the summer the lake was within 0.1 m of the crest elevation of the open pit. The lake is currently several meters below the crest.
- The till in the uppermost bench of the east wall was saturated and the geotechnical team identified the potential for a slope failure. A waste rock berm ~3 m high was placed against the till (outlined in red at right) and regular inspections were implemented.
- If there is a potential for the water level to rise again, recommend completing a simple stability analysis to confirm the buttress design.

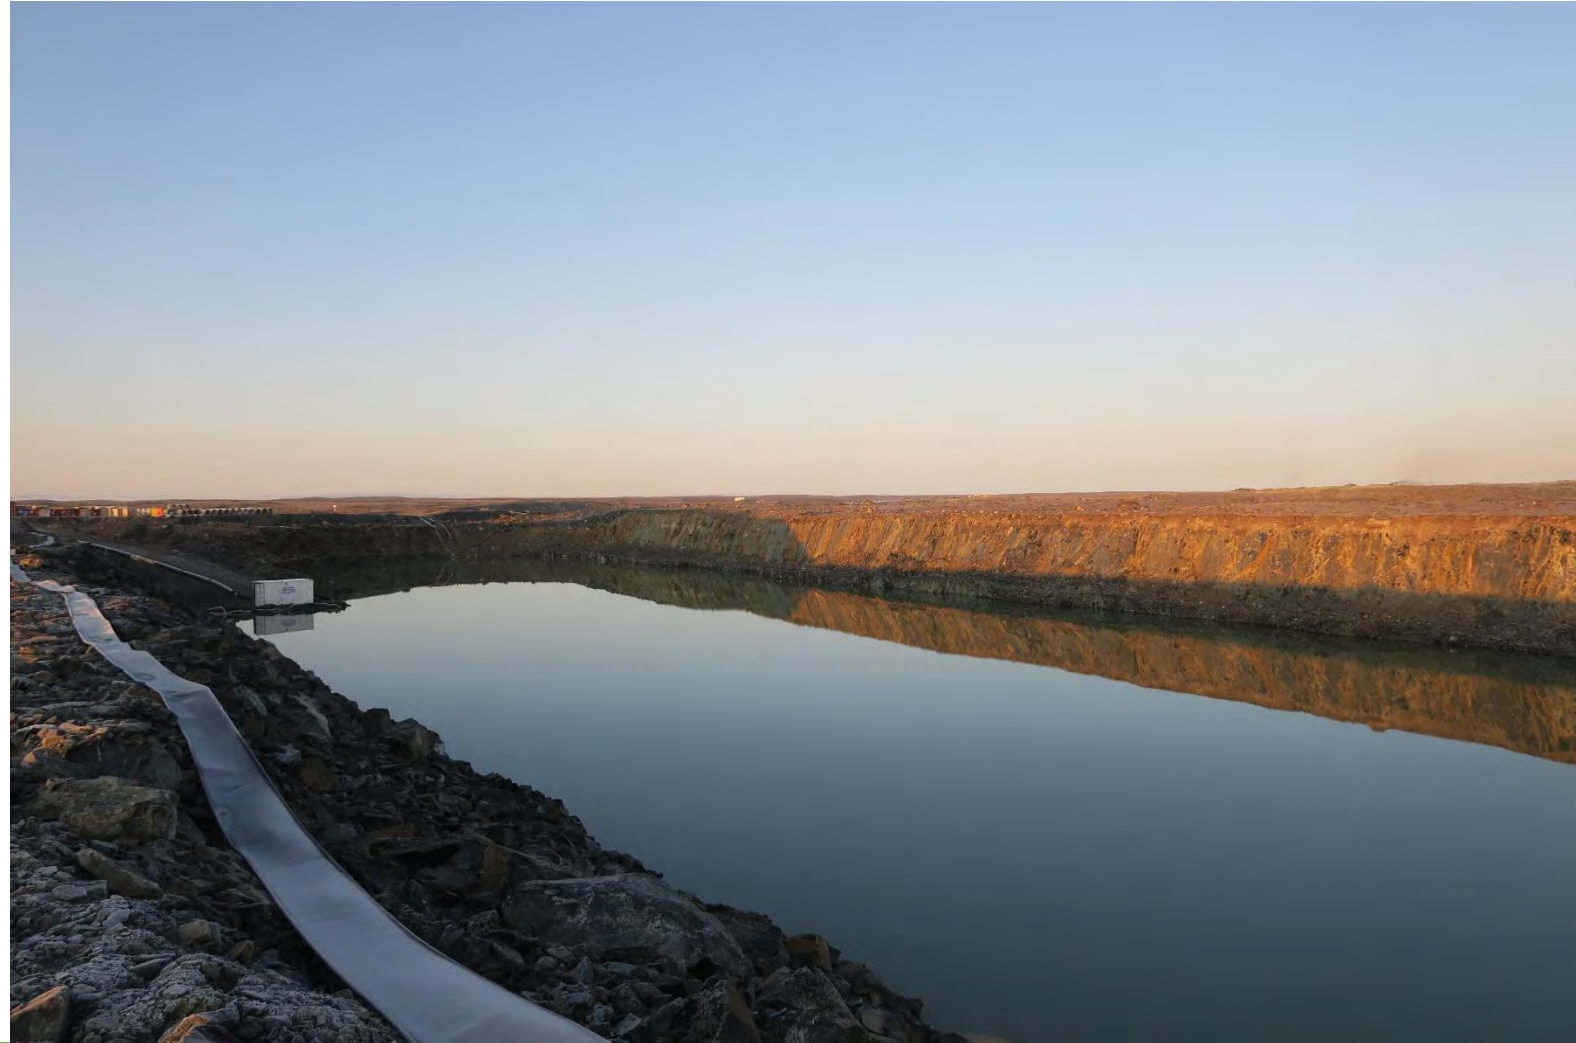
- AP5 is currently flooded. A detailed inspection was not completed.
- Geotechnical inspections should be completed by the mine during and immediately after dewatering.
