Whale Tail Open Pit 2019 Annual Inspection

RE: Amaruq Mine - Whale Tail Open Pit - 2019 Annual Inspection

Amaruq Project – Whale Tail Open Pit

2019 Annual Inspection

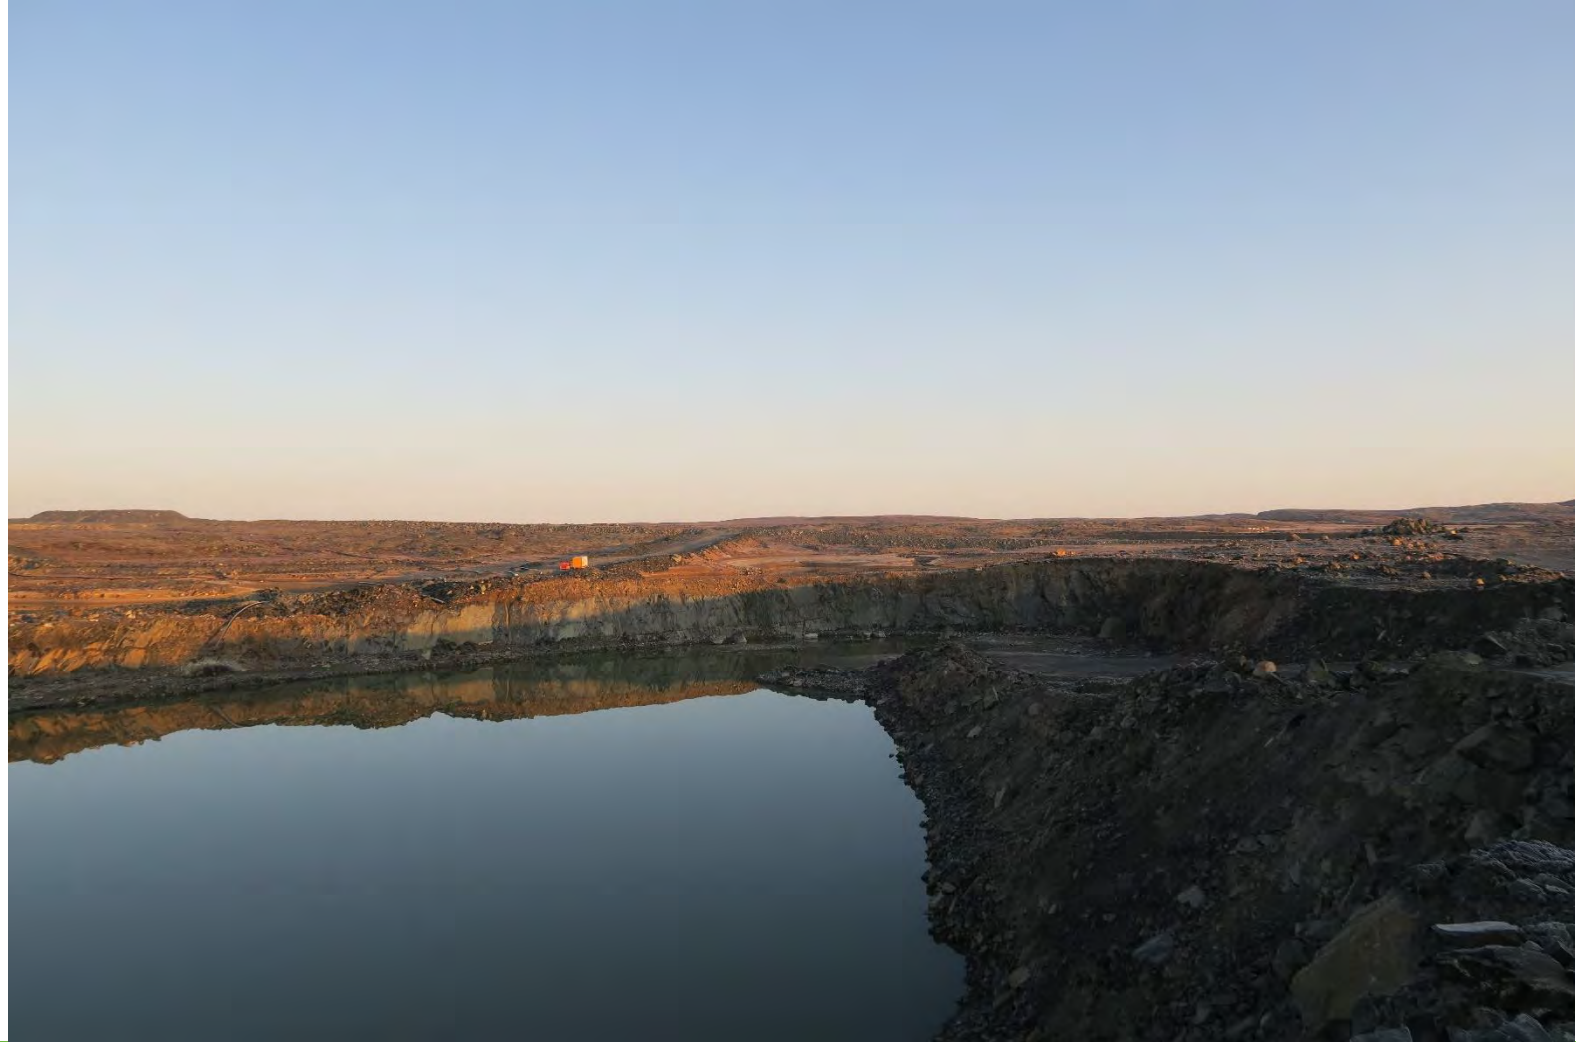
- Quarry 1 is currently flooded. A detailed inspection was not completed.
- Geotechnical inspections should be completed by the mine during and immediately after dewatering.

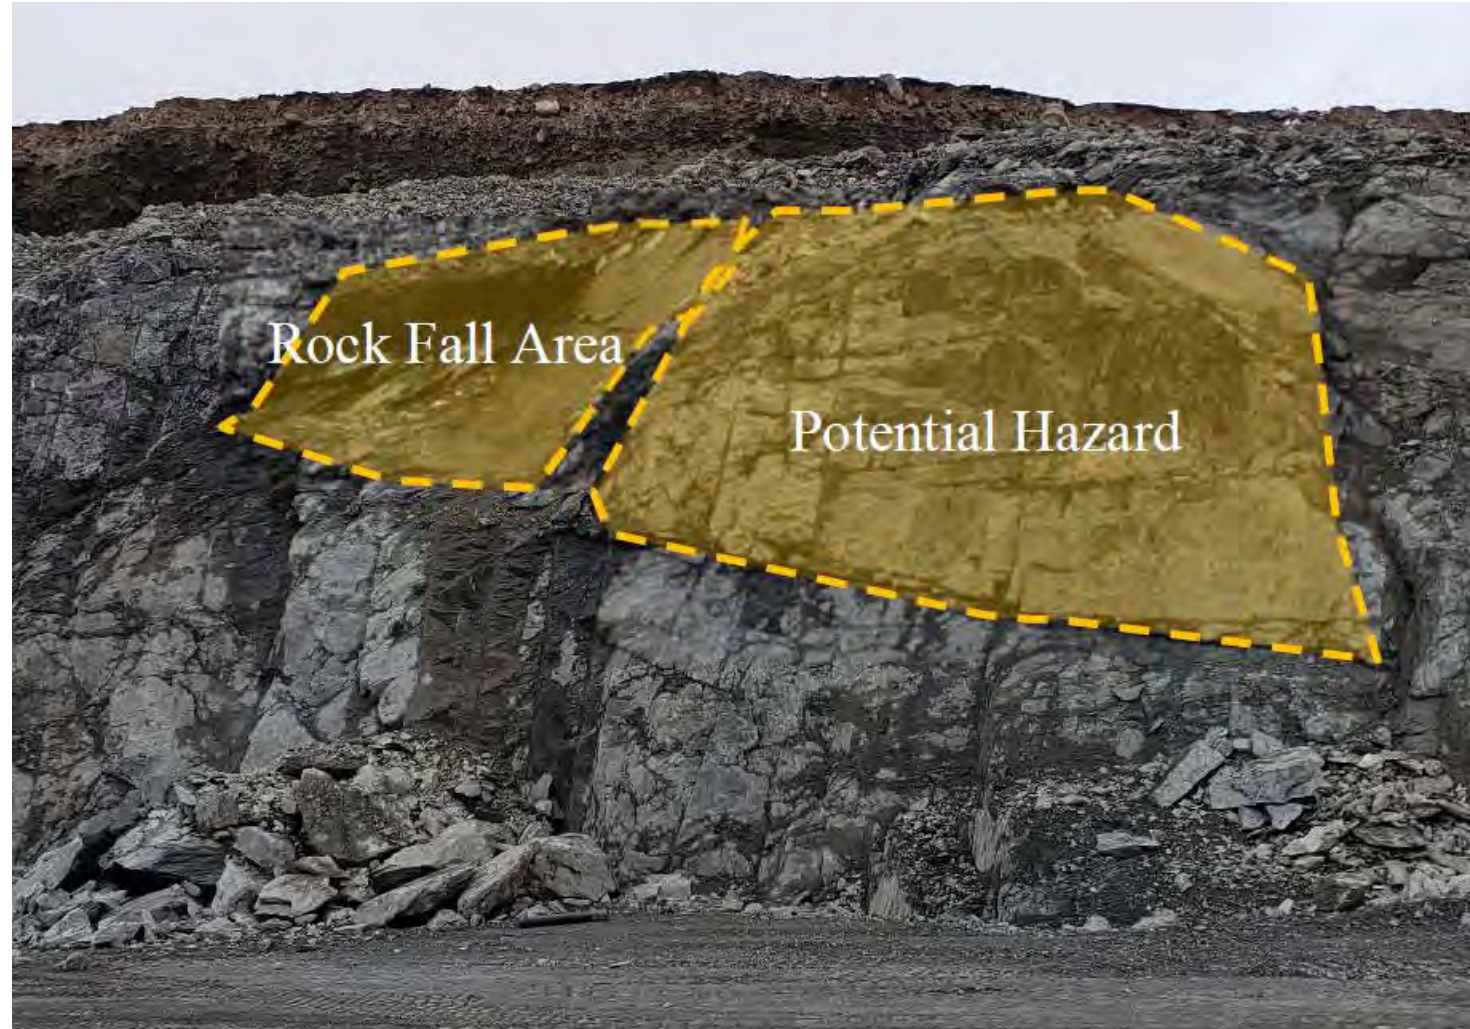
- The Fall of Ground that occurred on the southwest wall of the open pit on June 9, 2019 was reviewed.
- A wedge of approx. 385 tonnes failed along the sub-horizontal Joint Set C ($38^\circ / 258^\circ$, dip / dip direction). The orientation of the second release plane is not clear. It may be the foliation, which is subvertical and dips into the wall in this area.
- The area as since been blasted.
- As a note, the Rock Fall Log is a good tool for documenting slope performance and provides an opportunity to learn from previous failures. It would be helpful to document the Failure Mode (e.g. planar, wedge, rockfall, circular failure, etc.) and, for kinematic failures, the Joint Sets involved.

7. **Fall of Ground Database** - Unusual occurrences and falls of ground are documented in a database, which is an important practice. It is recommended that the database be expanded to document the failure mode (e.g. planar failure) as well as the joint sets involved (in the case of a structural or complex failure mode).
