Whale Tail Follow up Letter WRSF

January 27th, 2020

**Re.: Agnico Eagle Whale Tail Project – WRSF Flow Follow up (2019-333) -
Additional Information**

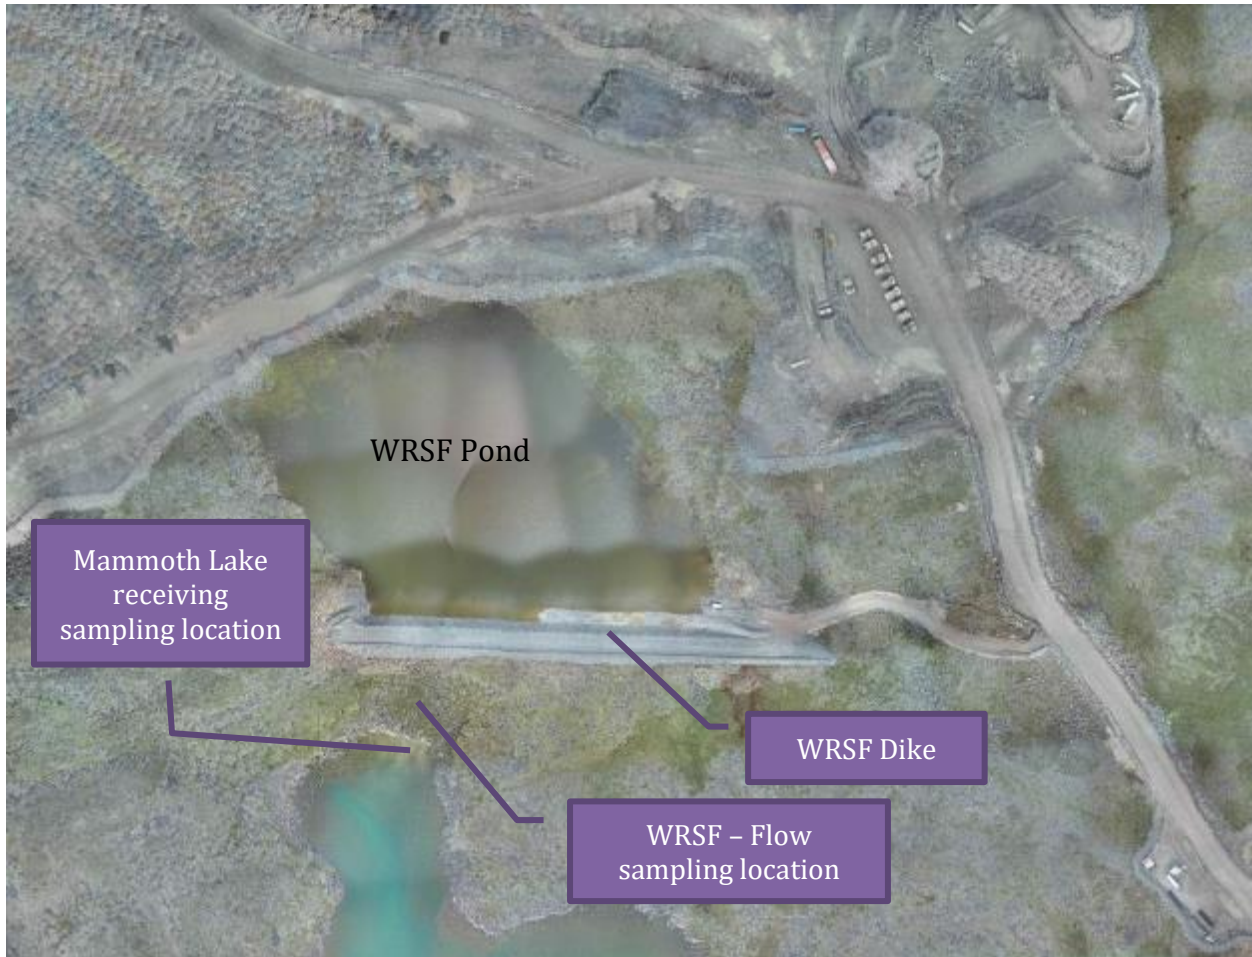
Figure 1: WRSF Flow and Receiving Environment Location

Agnico Eagle Mines Limited – Meadowbank Division (Agnico Eagle) informed you via email on August 25, 2019, that during a routine inspection of the Whale Tail WRSF Dike carried out on August 24, 2019 at 10:30 am, a water flow was observed at the toe of the dike flowing toward Mammoth Lake (UTM 14W 0605380 7255454) (see Figure 1).

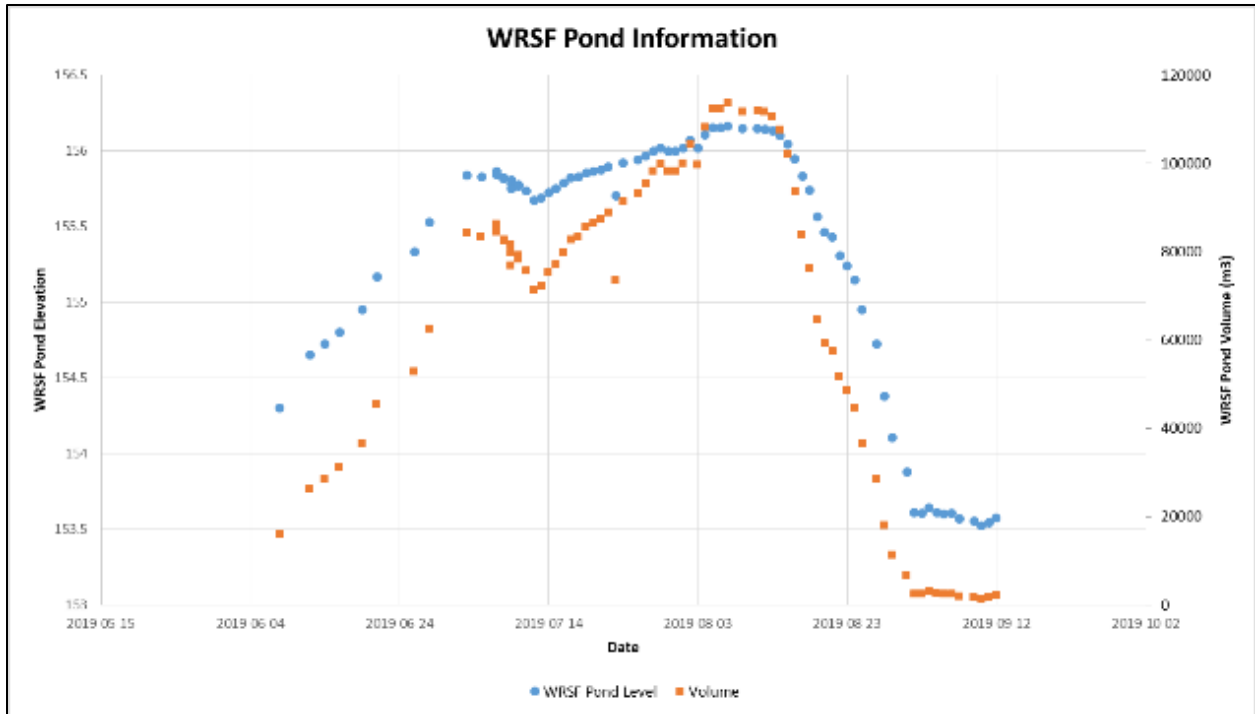
Figure 2: WRSF pond water elevation and associated volume

The initial estimate provided of the quantity of water released from the flow through the WRSF pond dike between August 15 and September 1 was approximately 15,000 m³. Verification of pumping rates, along with bathymetry of the WRSF pond and the water elevation, have enabled us to refine this estimate. As shown on Figure 2, on August 15, the volume of water in the pond was estimated at 99,657m³. From that volume, 38,135m³ was pumped to Quarry 1 to empty the pond. This meant that the rest of the water, or approximately 61,500m³, had seeped through the dike. This estimate is intended to be conservative.

At peak conditions, the flow has been estimated to be approximately 172 m³/hour. These estimates have been done by comparing the actual rate of decrease of the pond level compared to the expected rate of decrease of the pond resulting only from the pumping activities.

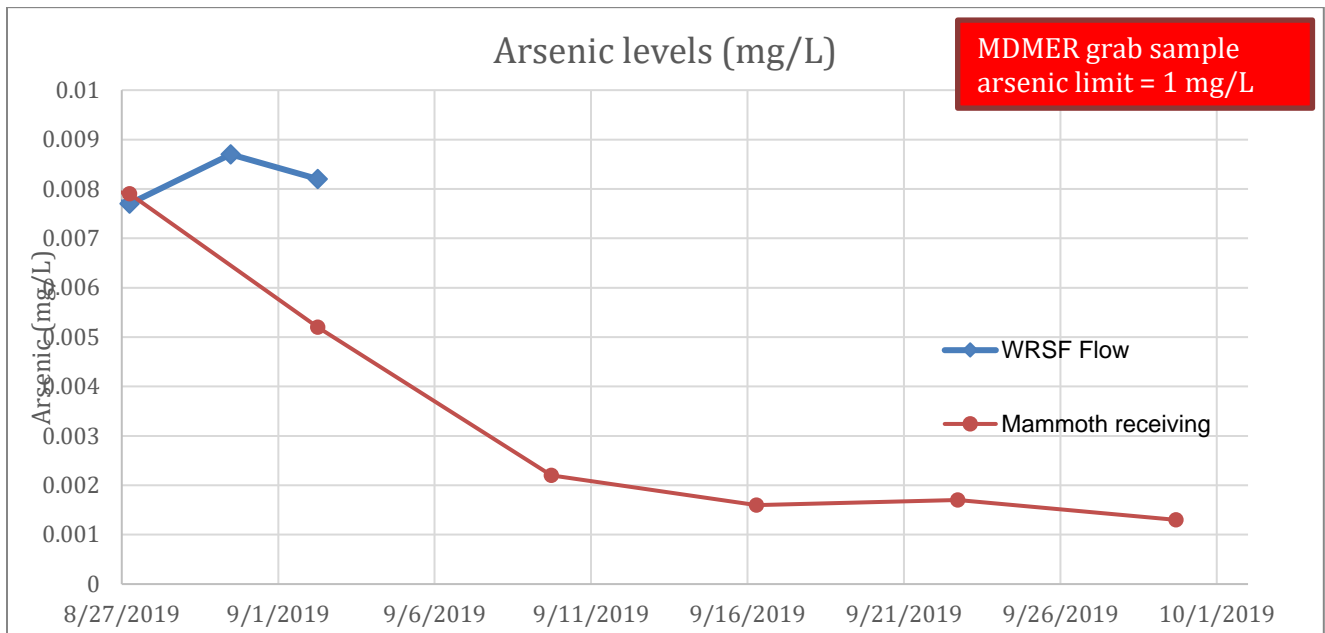
Figure 3: Arsenic Concentrations in Water of Mammoth North

dike as the water in the WRSF pond was pumped out (pond empty by September 1st). Arsenic concentrations, the main parameter of concern identified during the Environmental Assessment process of the Whale Tail Project, are shown in Figure 3 below in both the seepage flow and in the receiving water, as an example to show the low concentrations of arsenic relative to the MDMER limit for discharge.

At no time did water quality in either the location, WRSF flow or Mammoth Lake Receiving, exceed any of the MDMER prescribed limits or Water License criteria.

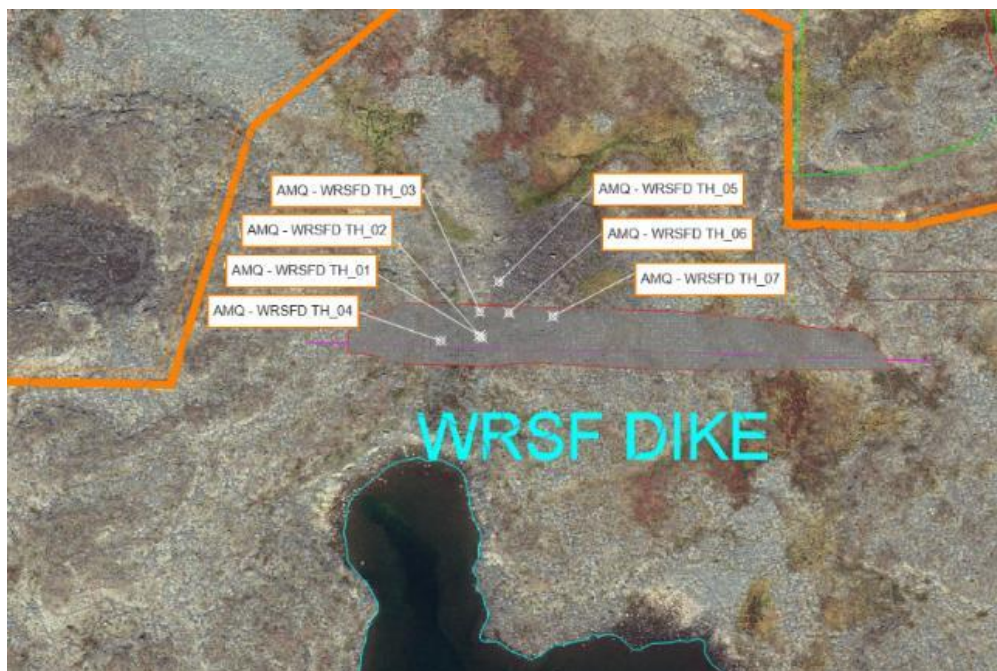
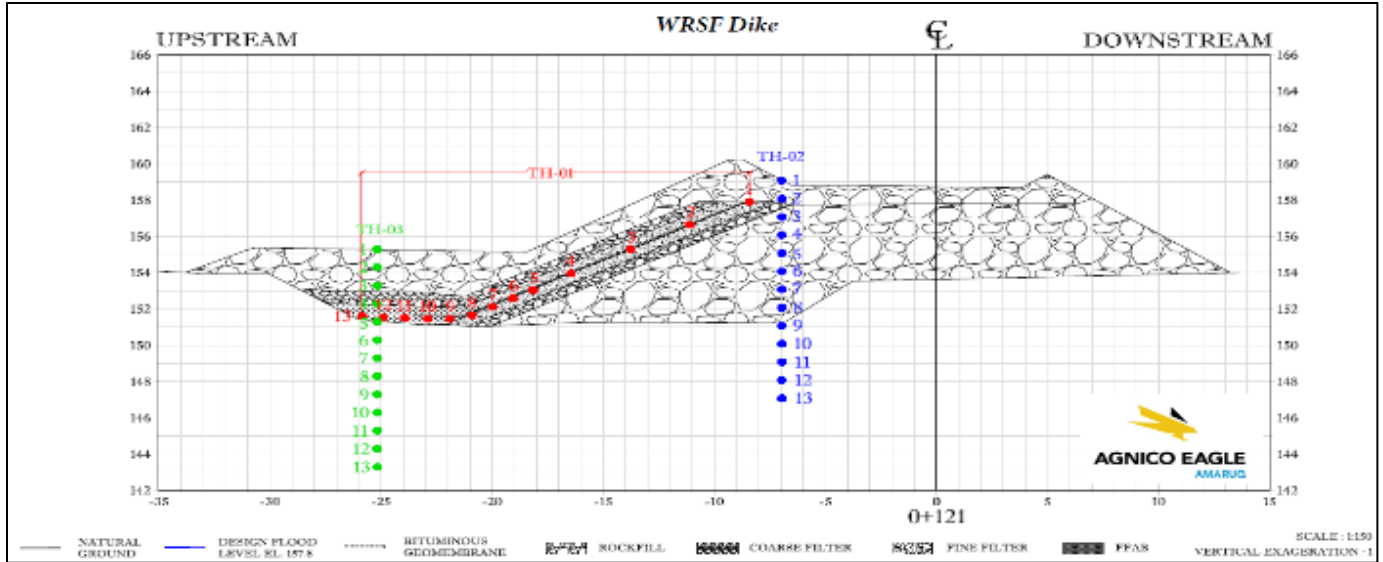
Installation of additional thermal monitoring instrumentation was completed in October 2019 in response to the seepage event. In addition to the existing 3 thermistors (TH-01, TH-02, TH-03), 4 new vertical instruments were installed (TH-04, TH-05, TH-06, TH-07). Locations are detailed in Figures 4 and 5 below. Figures 6 to 12 show collected data for the thermistors along with a short explanation of each instrument configuration and an interpretation of each thermistor data set. All data are logged into an existing data collection system.

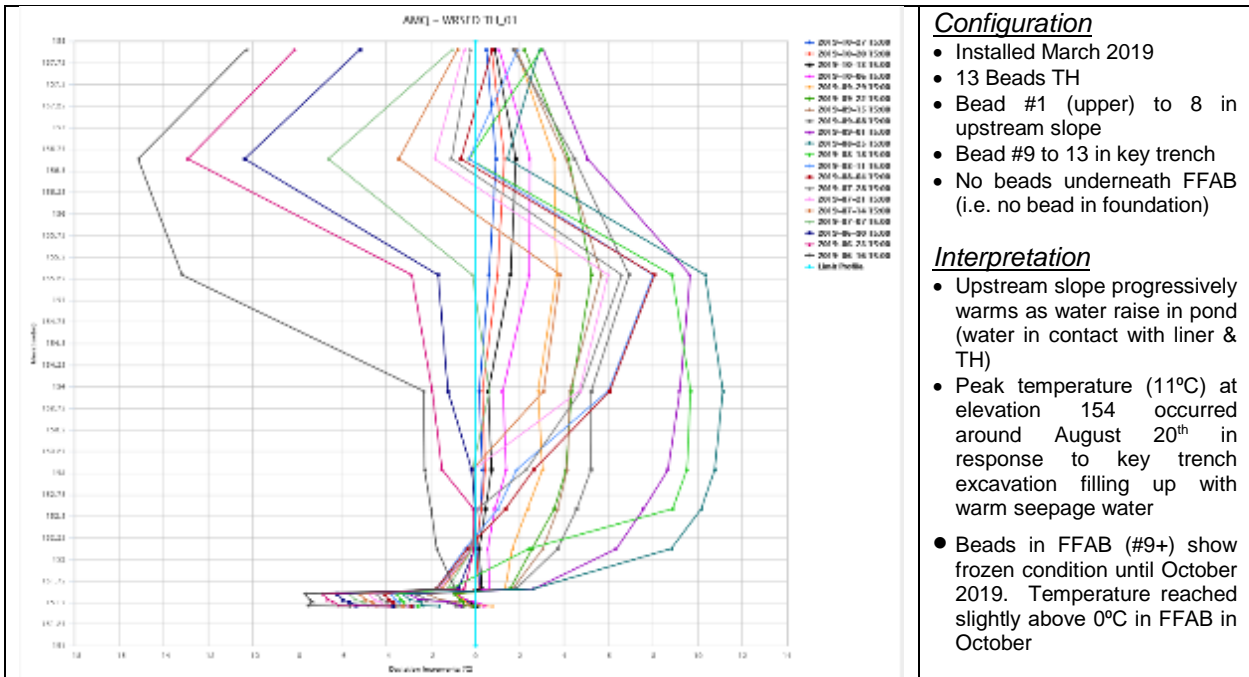
Figure 6: WRSF Temperature profile of thermistor TH-01

- Installed March 2019
- 13 Beads TH
- Bead #1 (upper) to 8 in upstream slope
- Bead #9 to 13 in key trench
- No beads underneath FFAB (i.e. no bead in foundation)

- Upstream slope progressively warms as water raise in pond (water in contact with liner & TH)
- Peak temperature (11°C) at elevation 154 occurred around August 20th in response to key trench excavation filling up with warm seepage water
- Beads in FFAB (#9+) show frozen condition until October 2019. Temperature reached slightly above 0°C in FFAB in October

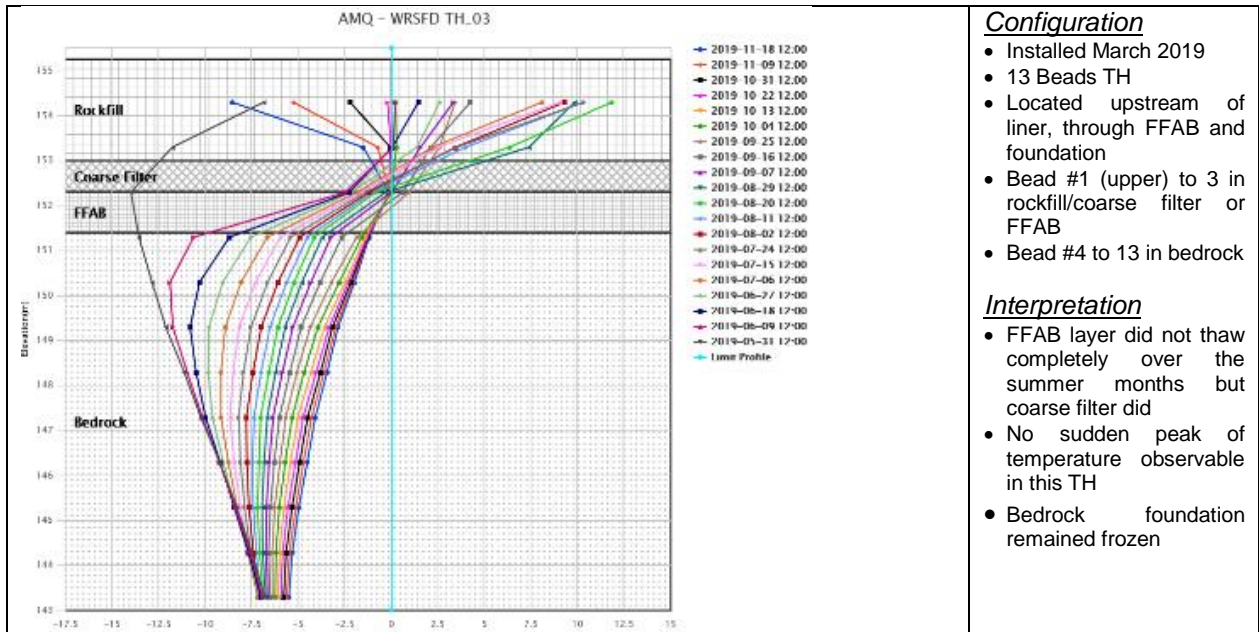
Figure 8: WRSF Temperature profile of thermistor TH-03

Thermal monitoring results suggest that thawing of the dike foundation occurred, resulting in an increase of its hydraulic conductivity that led to the seepage. Thawing of the foundation has probably been induced by the higher than anticipated accumulation of water in the pond coupled with an insufficient thermal protection on the upstream toe of the dike.

Over the summer, the pond experienced high water levels (still within design limits) resulting from higher than anticipated precipitation. These sustained high water levels led to warming/thawing of the key trench plug (FFAB, Fine Filter Amended with Bentonite) at approximately elevation 152.5 m as shown in Figure 8 (TH-03). Thawing of the key trench created a sudden pathway for water to migrate downstream.

- The water level in the WRSF pond will be maintained at a low level throughout 2020 as per recommendation from the MDRB as a precautionary measure and to ensure protection of the freeze-back of the key trench;
- Permafrost penetration will be promoted during winter 2019-2020 by implementing a series of additional measures to increase the robustness of the infrastructure and in particular the upstream toe against permafrost degradation:
 - Strategic snow removal to keep the toe more exposed to winter conditions;
 - Keeping a low water level (if any) in the pond during winter and summer months;
 - Placing additional thermal cover material on the upstream portion of the dike; and
 - Assessing freeze back performance with periodic instrumentation review;
- A more robust downstream water collection system will be designed and constructed; and
- Thermistors monitoring will continue.

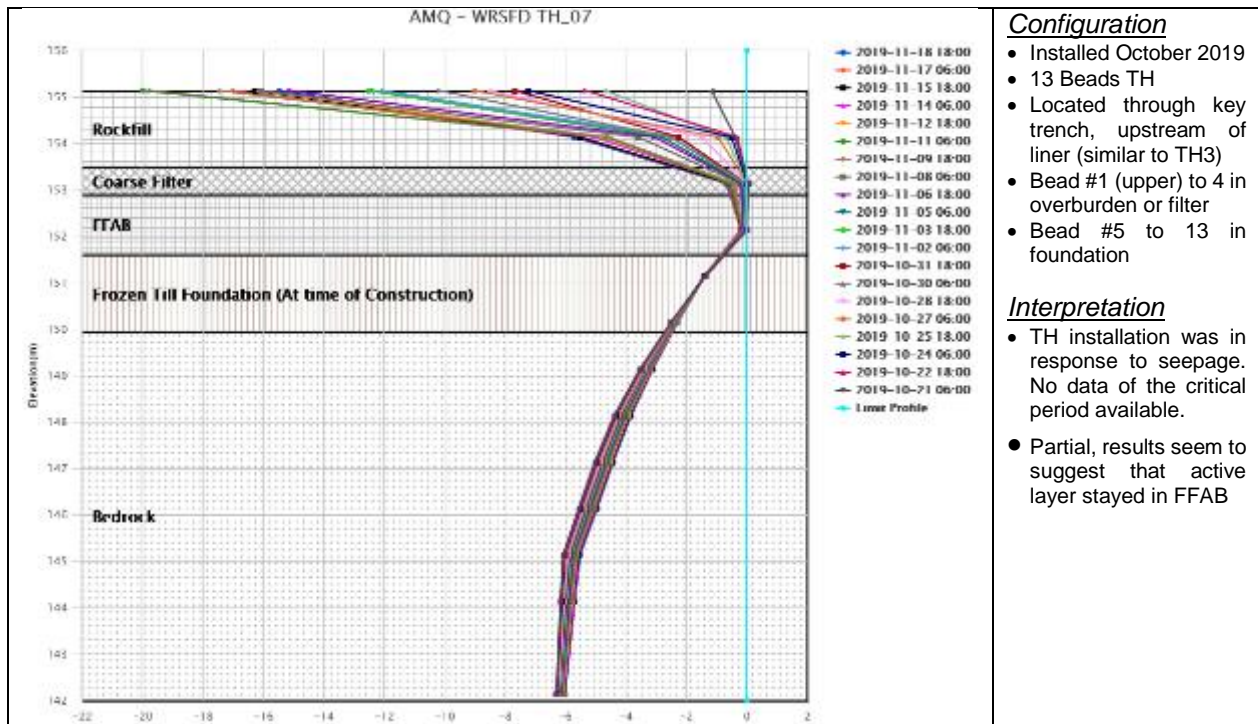
Figure 12: Temperature profile of thermistor TH-07

- Installed October 2019
- 13 Beads TH
- Located through key trench, upstream of liner (similar to TH3)
- Bead #1 (upper) to 4 in overburden or filter
- Bead #5 to 13 in foundation

- TH installation was in response to seepage. No data of the critical period available.
- Partial, results seem to suggest that active layer stayed in FFAB
