Meadowbank 2018 Annual Review of Portage and Goose Pit Slope Performance

2018 ANNUAL PIT SLOPE PERFORMANCE REVIEW

MEADOWBANK MINE, NUNAVUT

ISSUED FOR USE
704-ENG. ROCK03053-02

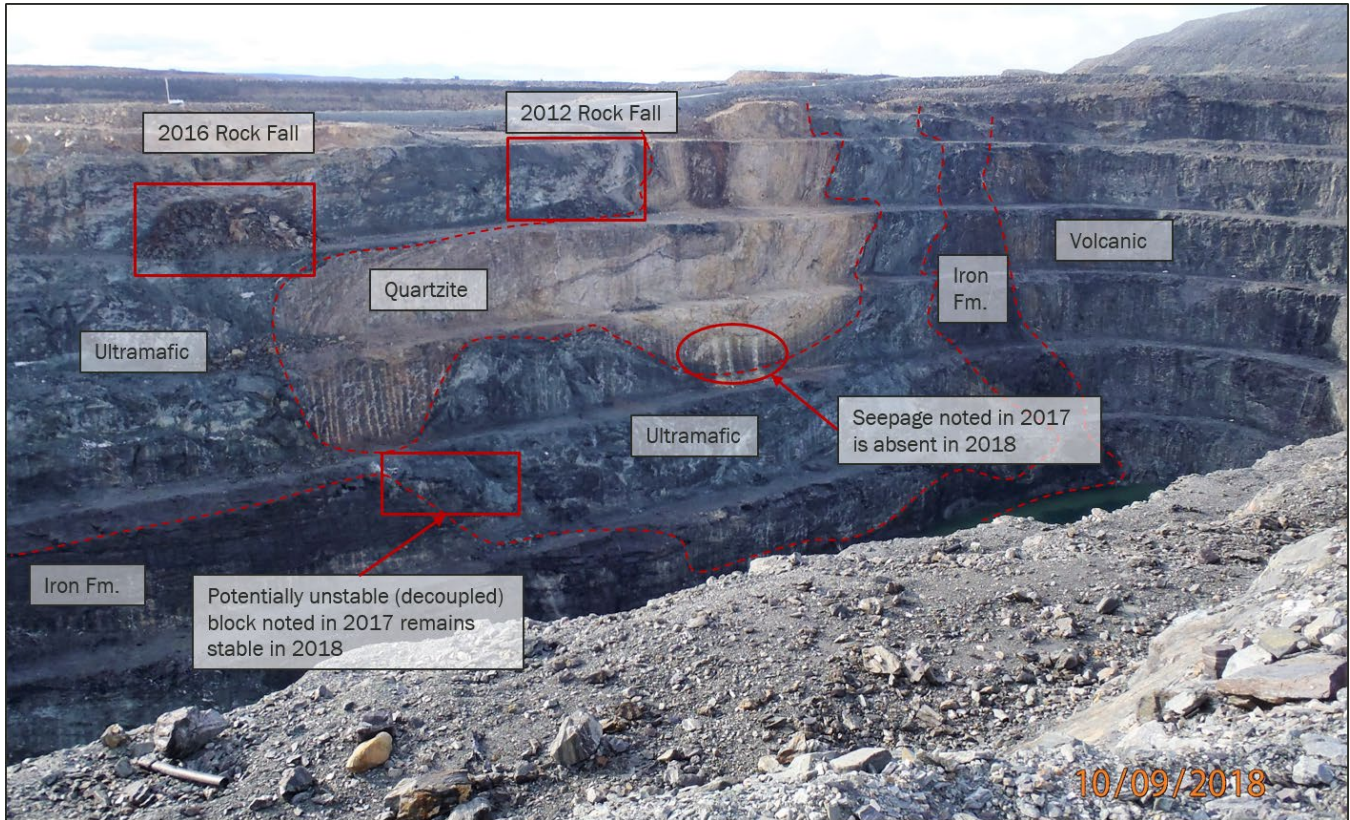
Photograph 4-3: Pit A west wall (2018)

The following Photograph 4-3 shows the west and north wall of Pit A at the time of the inspection.

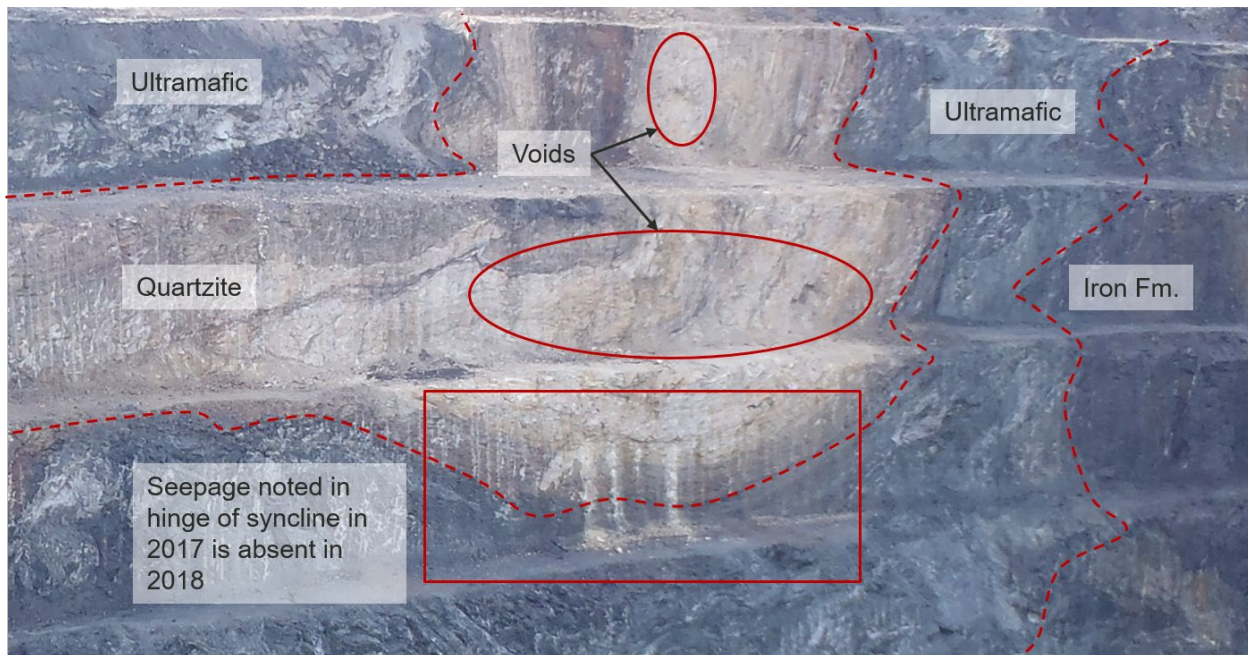
Photograph 4-6: Voids in quartzite above Pit A west ramp (2018)

The quartzite stratigraphy observed in the Pit A west wall contains several large voids identified during previous inspections. There has been no significant accumulation of material on the benches since the 2017 inspection. Seepage that was noted along the synform axis of the quartzite in 2017 is absent in 2018.

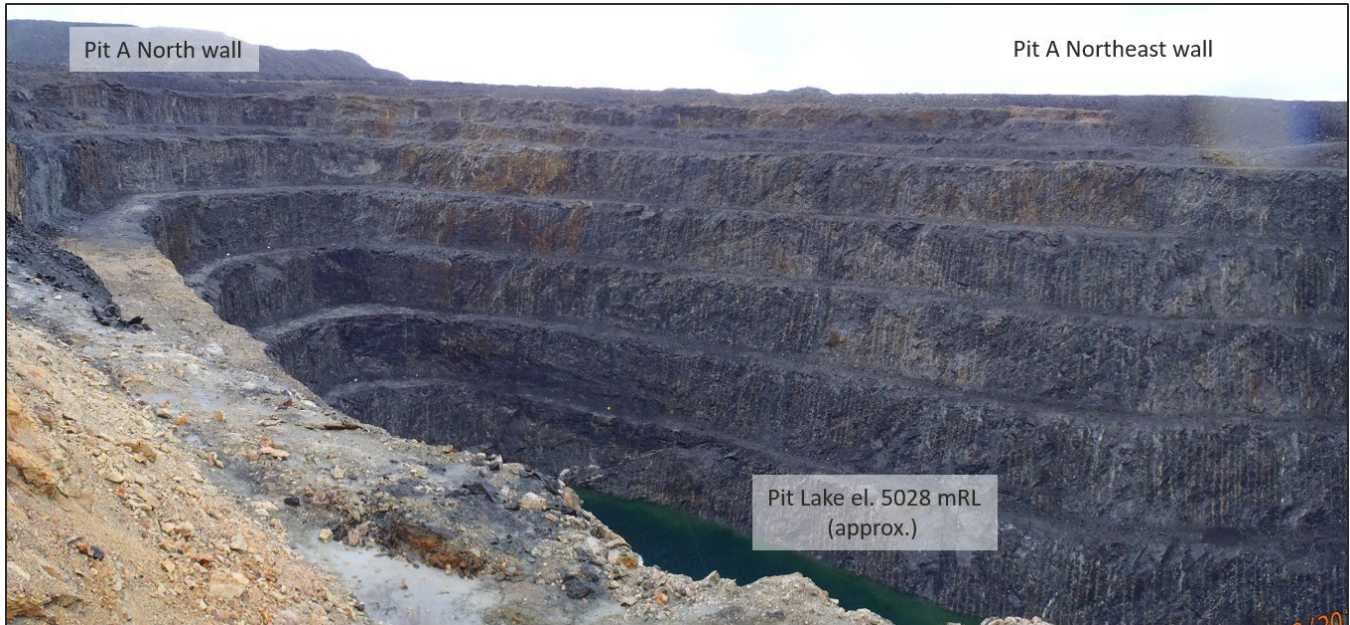
Photograph 4-8: Pit A north to northeast wall (2018)

The north through northeast walls of Pit A continue to perform adequately. There are no noticeable changes from 2017 to 2018. Very little accumulation of loose or raveling material on the catch benches was noted during the site visit.

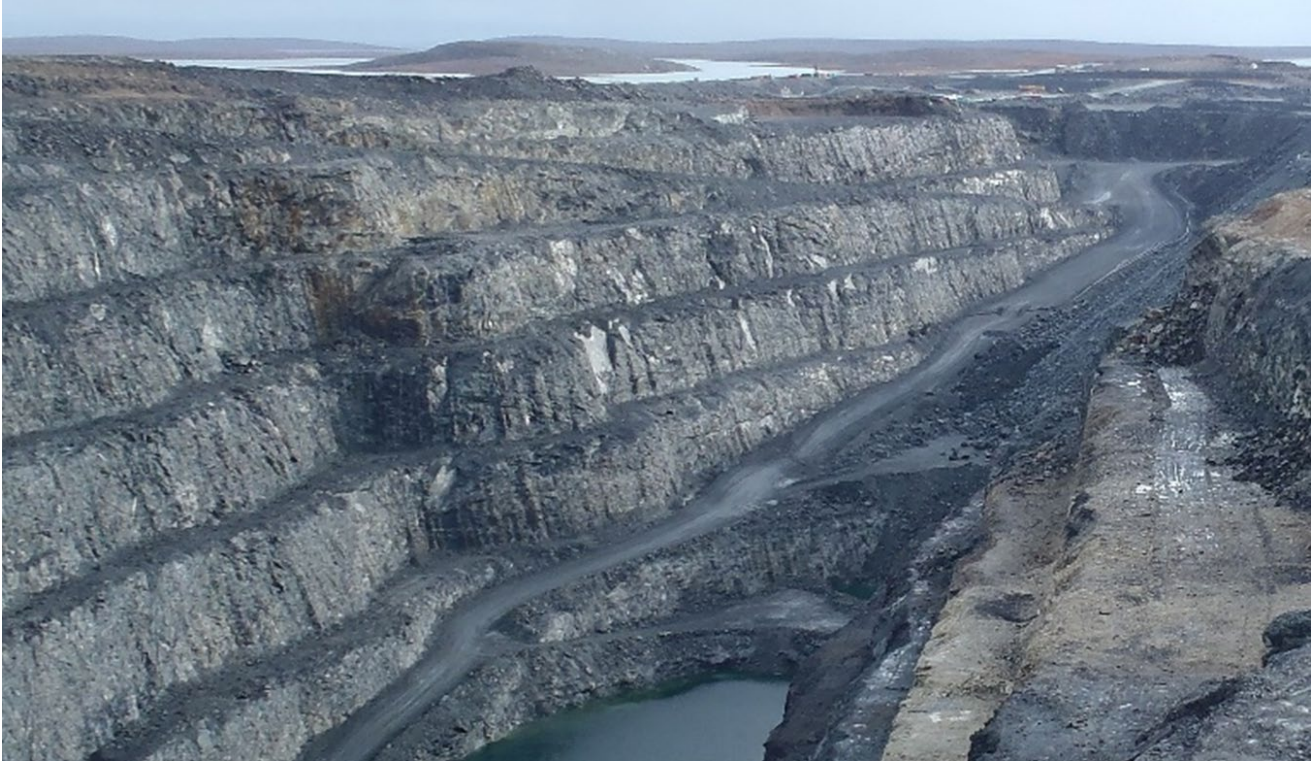
Photograph 4-12: Pit B east wall, looking south (2018)

The east wall of Pit B was inspected from several viewpoints as well as from within the pit. The wall continues to perform satisfactorily. Benches are generally clean with little accumulation of material.

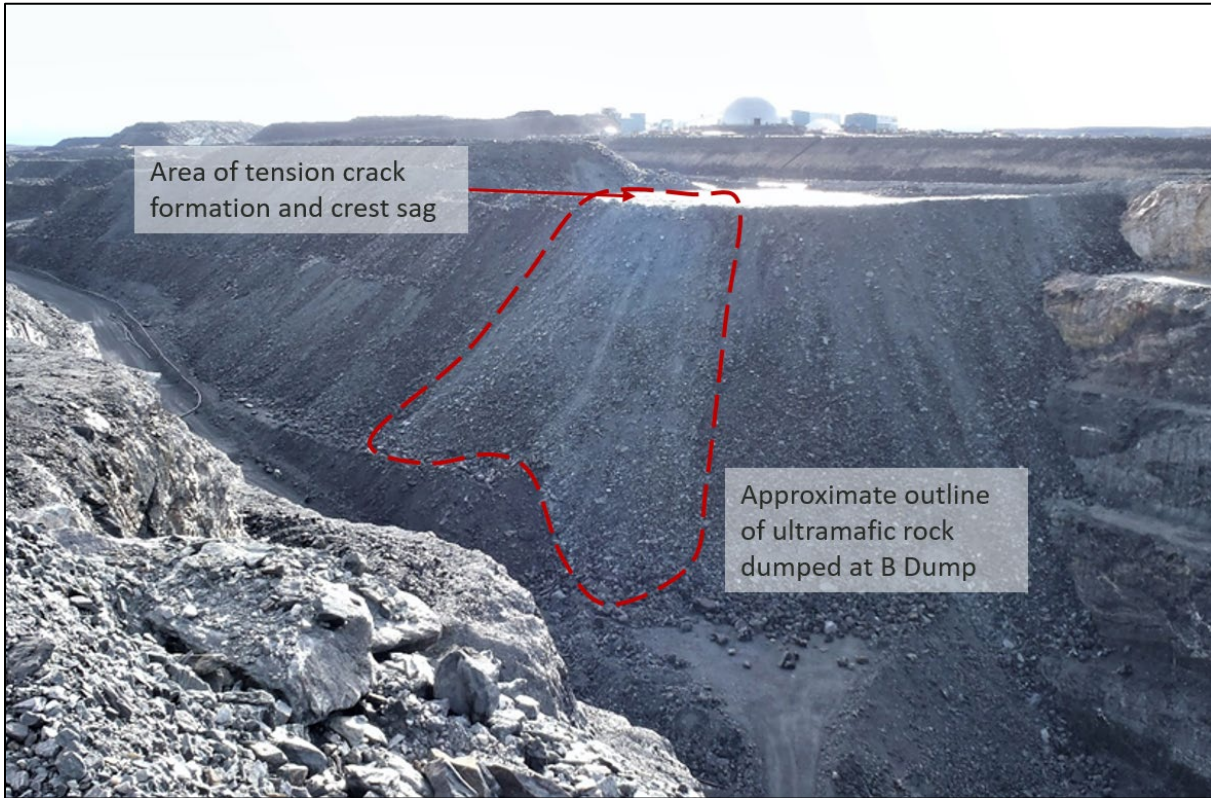
The tension cracks and associated sagging of the platform at the dump crest is shown in Photographs 4-13 and 4-14.

Photograph 4-13: B Dump looking southwest and outline of approximate ultramafic rock

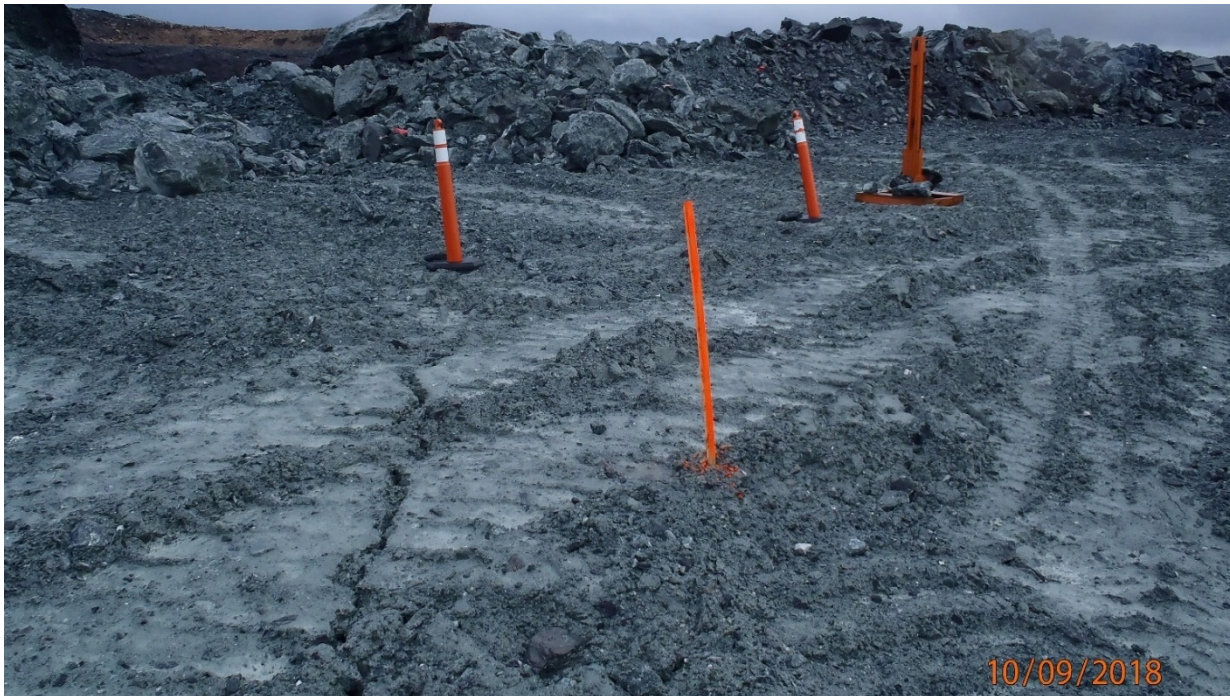
Photograph 4-14: B Dump platform showing sag, tension cracks, and simple wireline extensometer

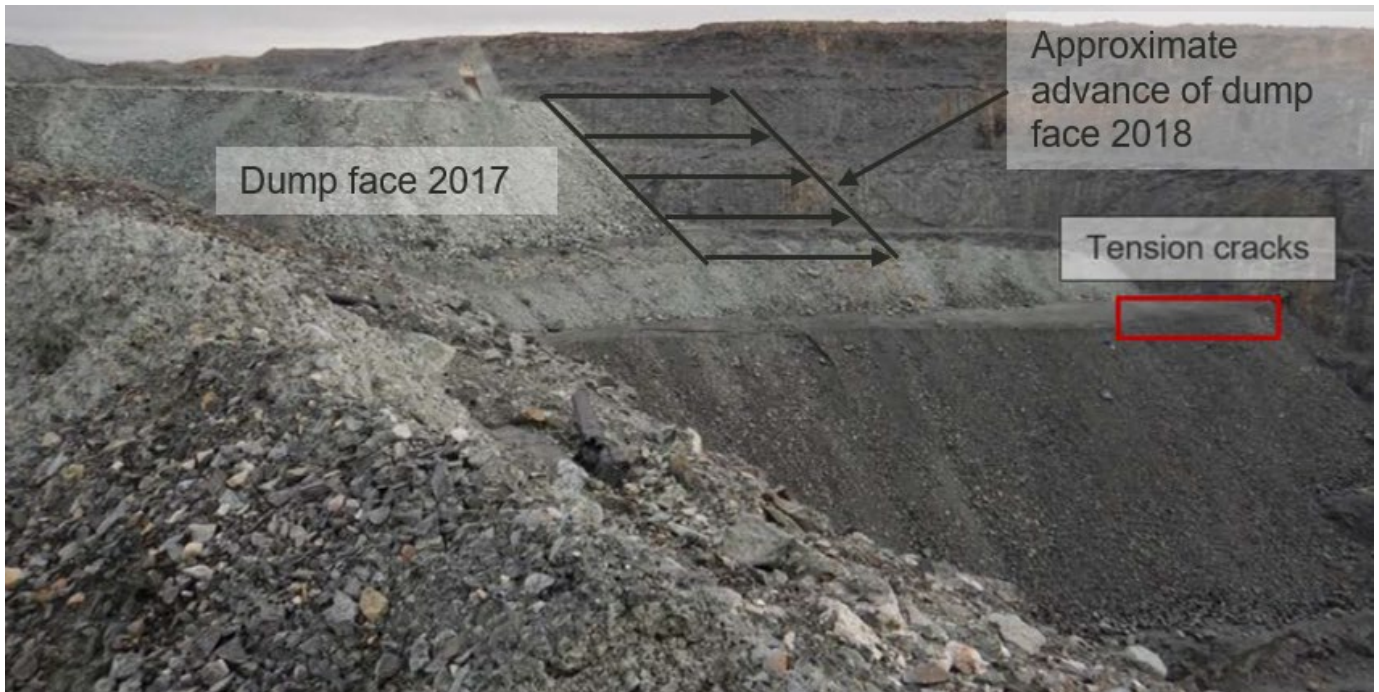
An area of tension cracks that was observed on the D Dump platforms during the 2016 and 2017 inspections has increased, and this may be a result of the advancement of the 5126 platform southward over the 5088 platform. Both radial (perpendicular to dump crest) and transverse (parallel to dump crest) were observed. These are shown in the following photograph.

Photograph 5-2: Pit D dump showing 2017 dump face and approximate advance 2018 dump face location

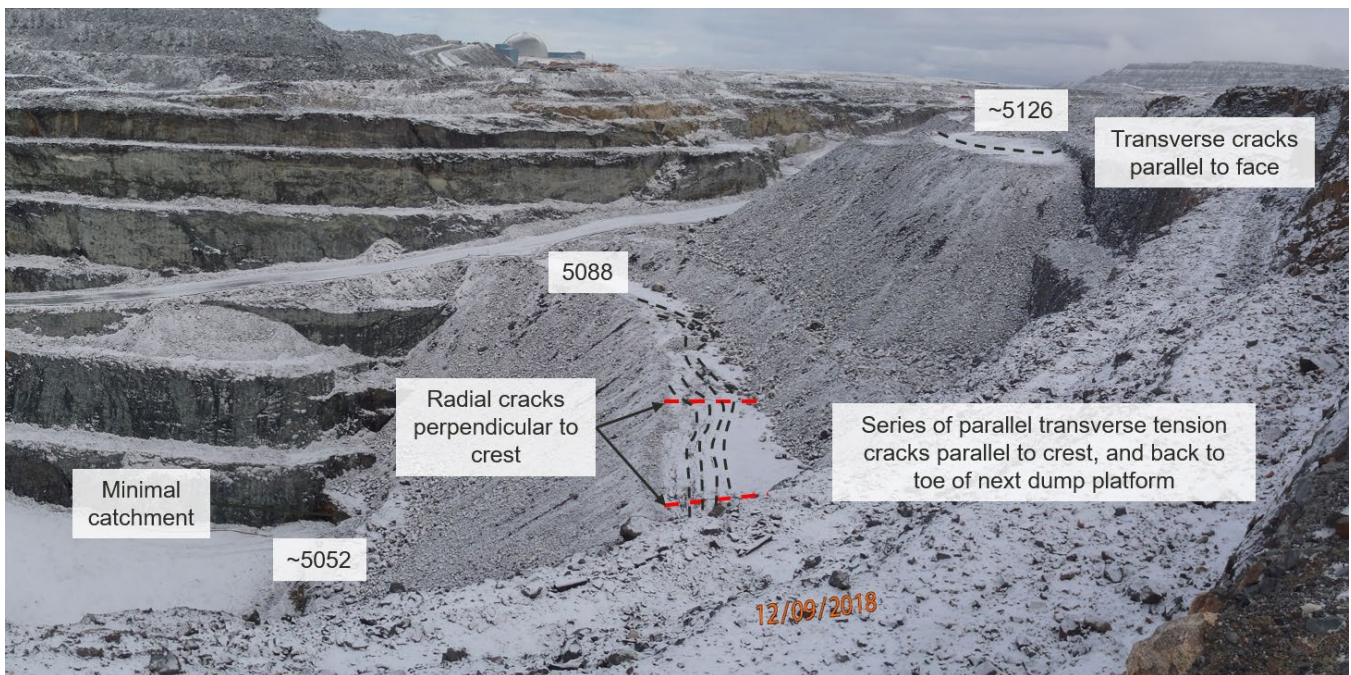
Photograph 5-3: Pit D dump viewed from east pit crest showing area of transverse and radial cracks on the 5088 mRL platform

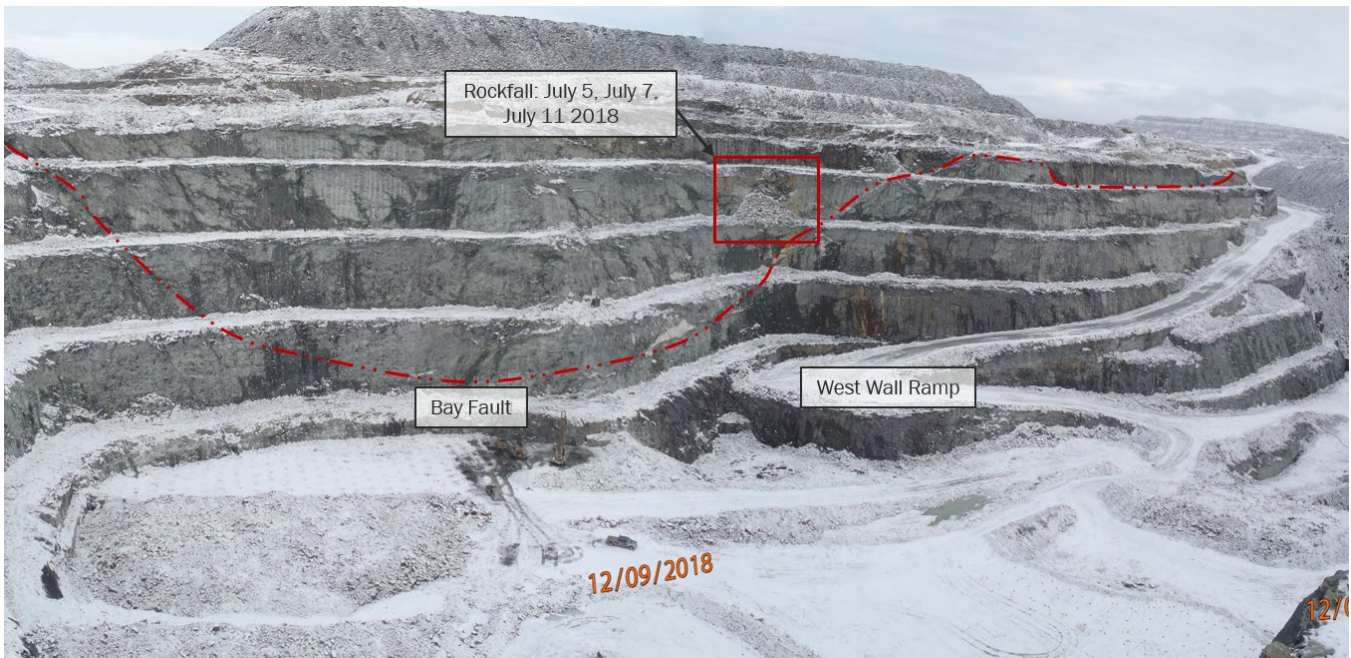
At the south end of the west wall, the contact of the ultramafic rock and overlying intermediate volcanic rock is inclined into the wall, which is beneficial for overall slope stability, but results in bench-scale instability of the underlying ultramafic rock. Local rock falls creating small overhangs have occurred as the ultramafic rock separates from the overlying volcanic contact, followed by sliding along a steeply east dipping orthogonal joint set. This potential instability is contributed to by the presence of the Bay Fault and parallel shear planes within the ultramafic rock, which are also inclined steeply into the west wall. Photograph 6-11 shows the west wall at the time of the 2018 site visit. An area of rockfall events on July 5, 7, and 11 2018, directly above seepage faces and associated with the steeply west dipping Bay Fault and associated shear planes.

Photograph 6-11: Pit E west wall showing seepage and Bay Fault (2018)

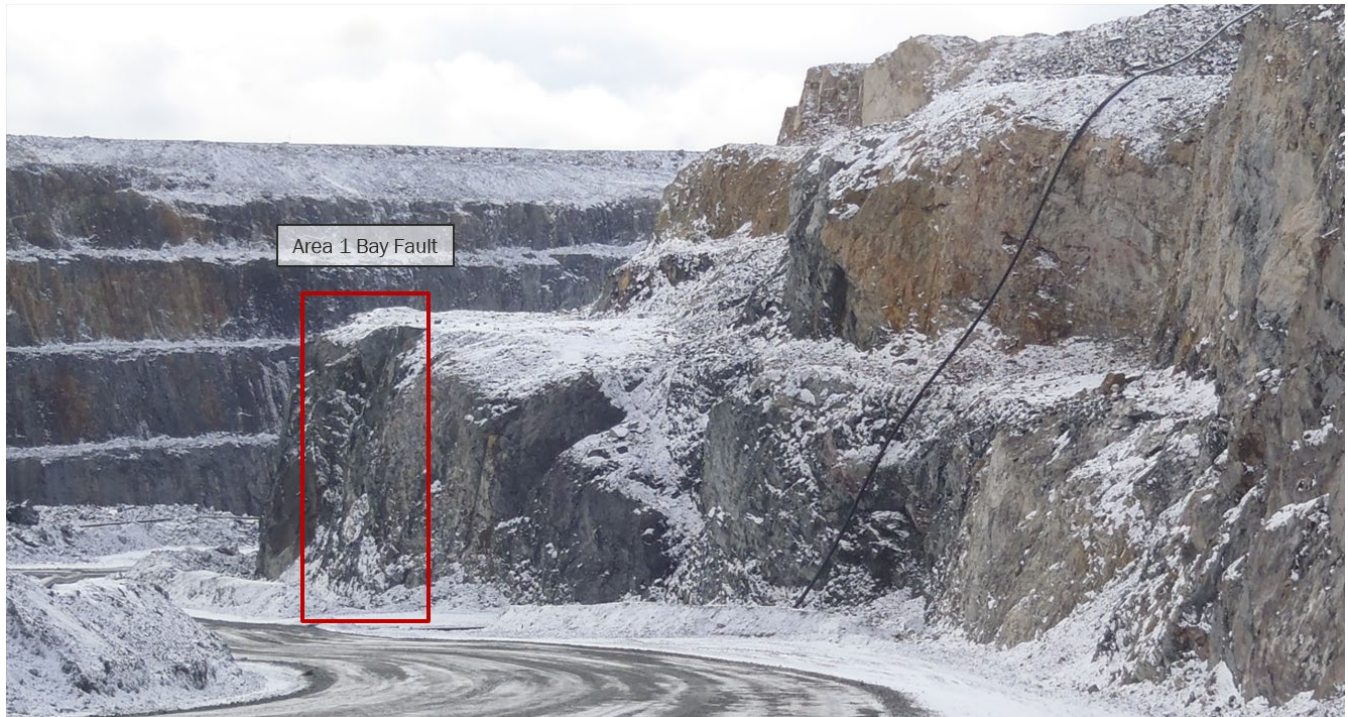
The West Wall Ramp enters the Portage Pit along the west side of the pit, and ramps down to the south towards Pit E3/E5. The ramp passes beneath an area of wall that was experienced several rock falls in 2014 (Area 1 and Area 2). The area of wall is associated with a fault zone – the Bay Fault or a splay off that fault trend - trending along the west wall of the pit. This fault, or shear, is several metres wide, and steeply inclined to the west. No changes to the performance of the wall above the ramp in this area were noted.

Photograph 6-16: Pit E Ramp Area 1 above ramp - Bay Fault or splay (2018)

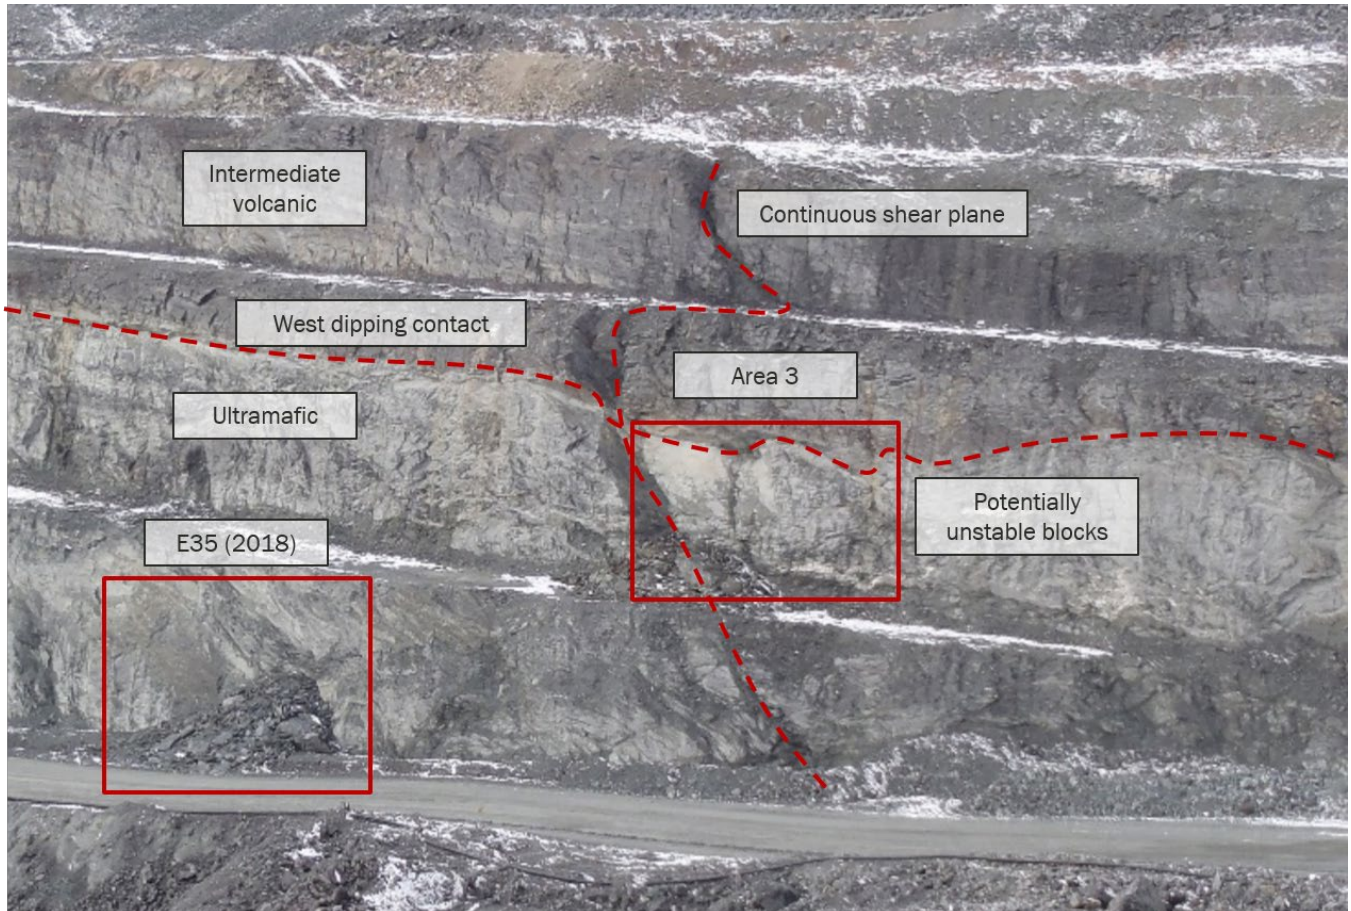
Photograph 6-18: Pit E Ramp Area 3 (2018)

No increase in the material accumulating at the toe of Area 3 was noted during the 2018 inspection.

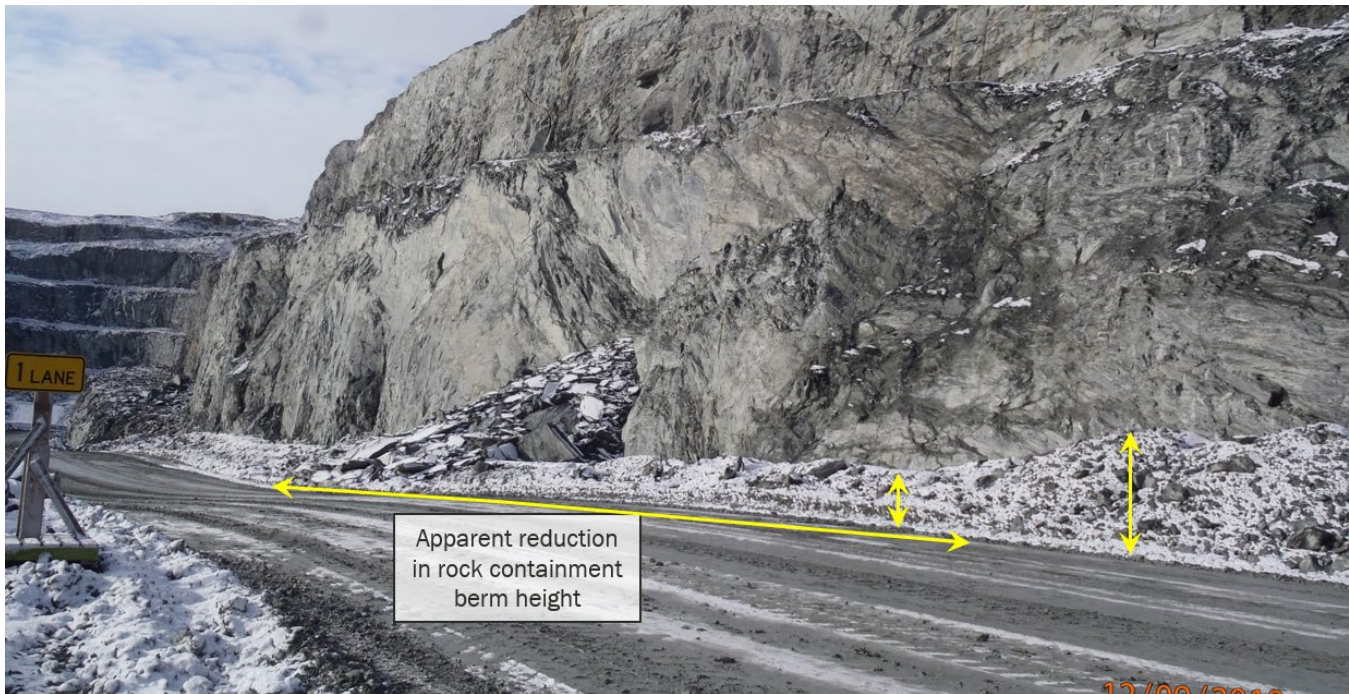
A review of the area during the site inspection noted an apparent reduction in the height of the rockfall containment berm along the inside ramp. This might result from long term natural settlement of the tabular rockfill material used to construct the berm. This is shown in Photograph 6-19.

Photograph 6-19: Zone E35 rock fall

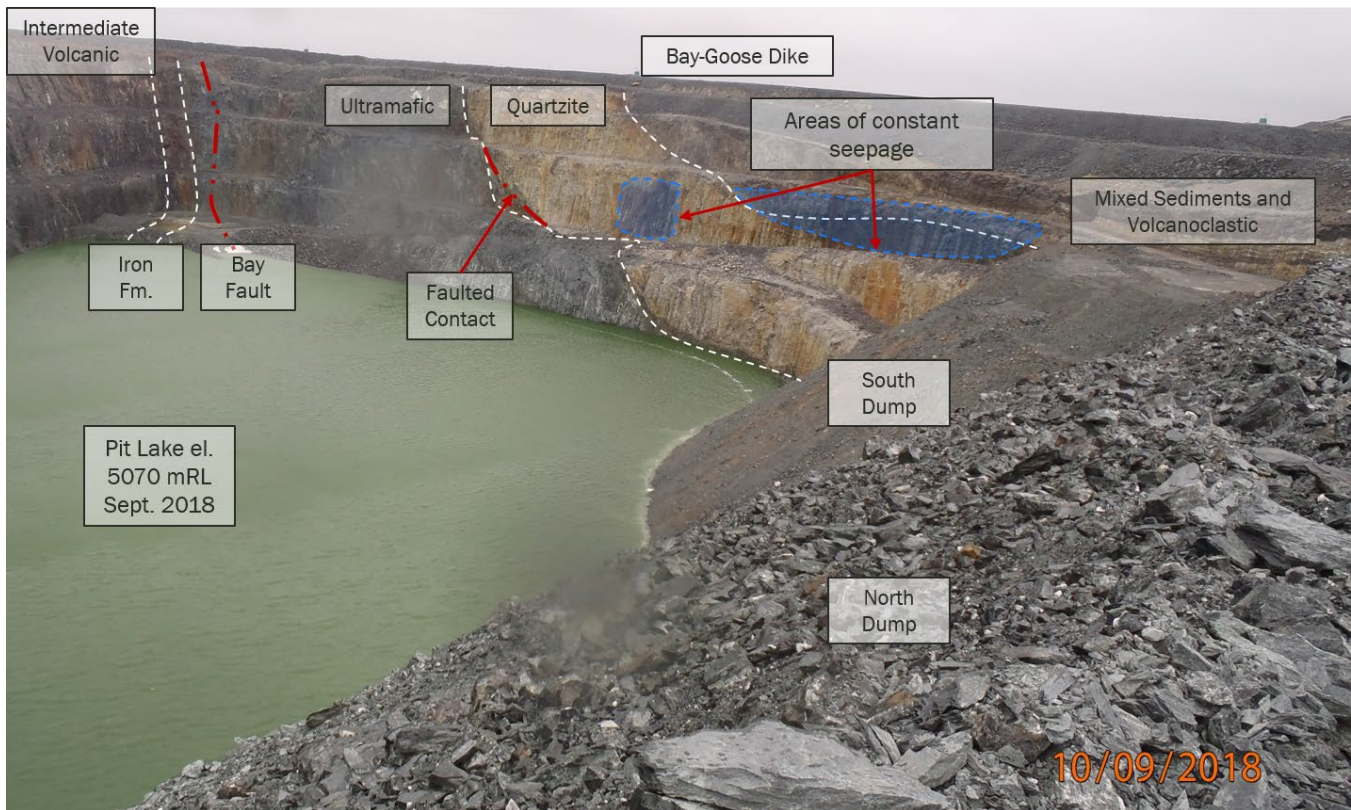
During the 2018 inspection, a fault was identified at the contact between the ultramafic and quartzite, and it was noted that the fault gouge associated with the fault was being eroded, resulting in a widening gap.

Photograph 7-2: Goose Pit south wall (2018)

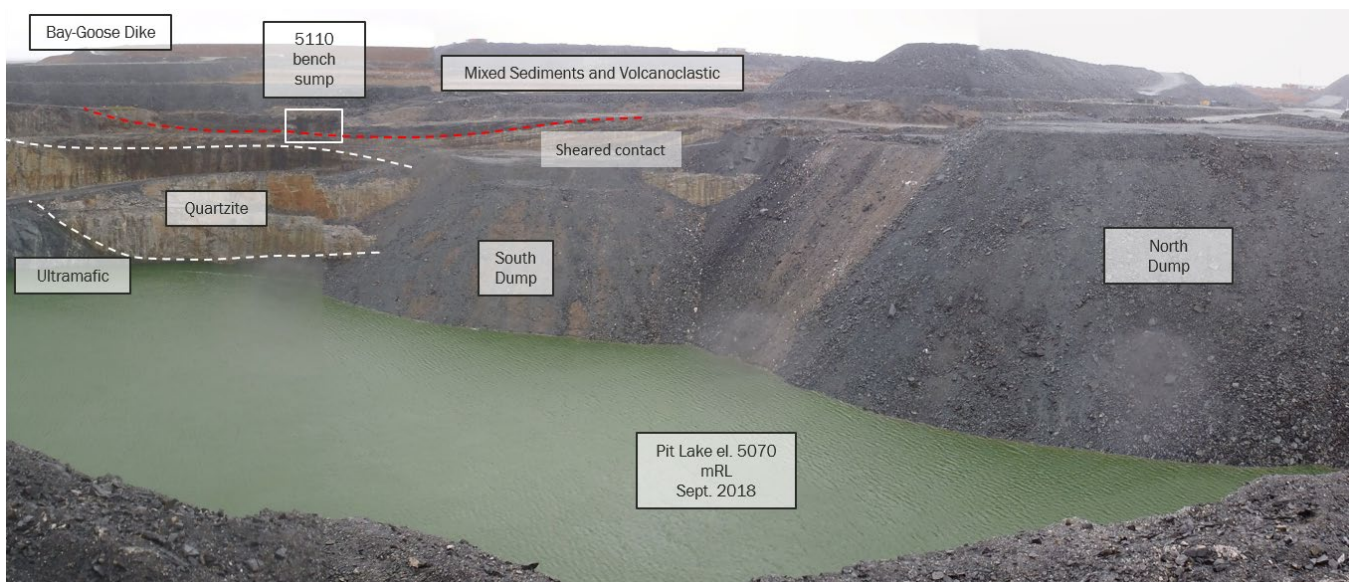
Photograph 7-5: Goose Pit west wall (2018)

There are no observable changes to the hydrogeological regime. The volcanoclastic and quartzite rock immediately below the sheared contact remains saturated, and water continues to seep from the face above the ramp, as well as from the bench faces below the ramp.

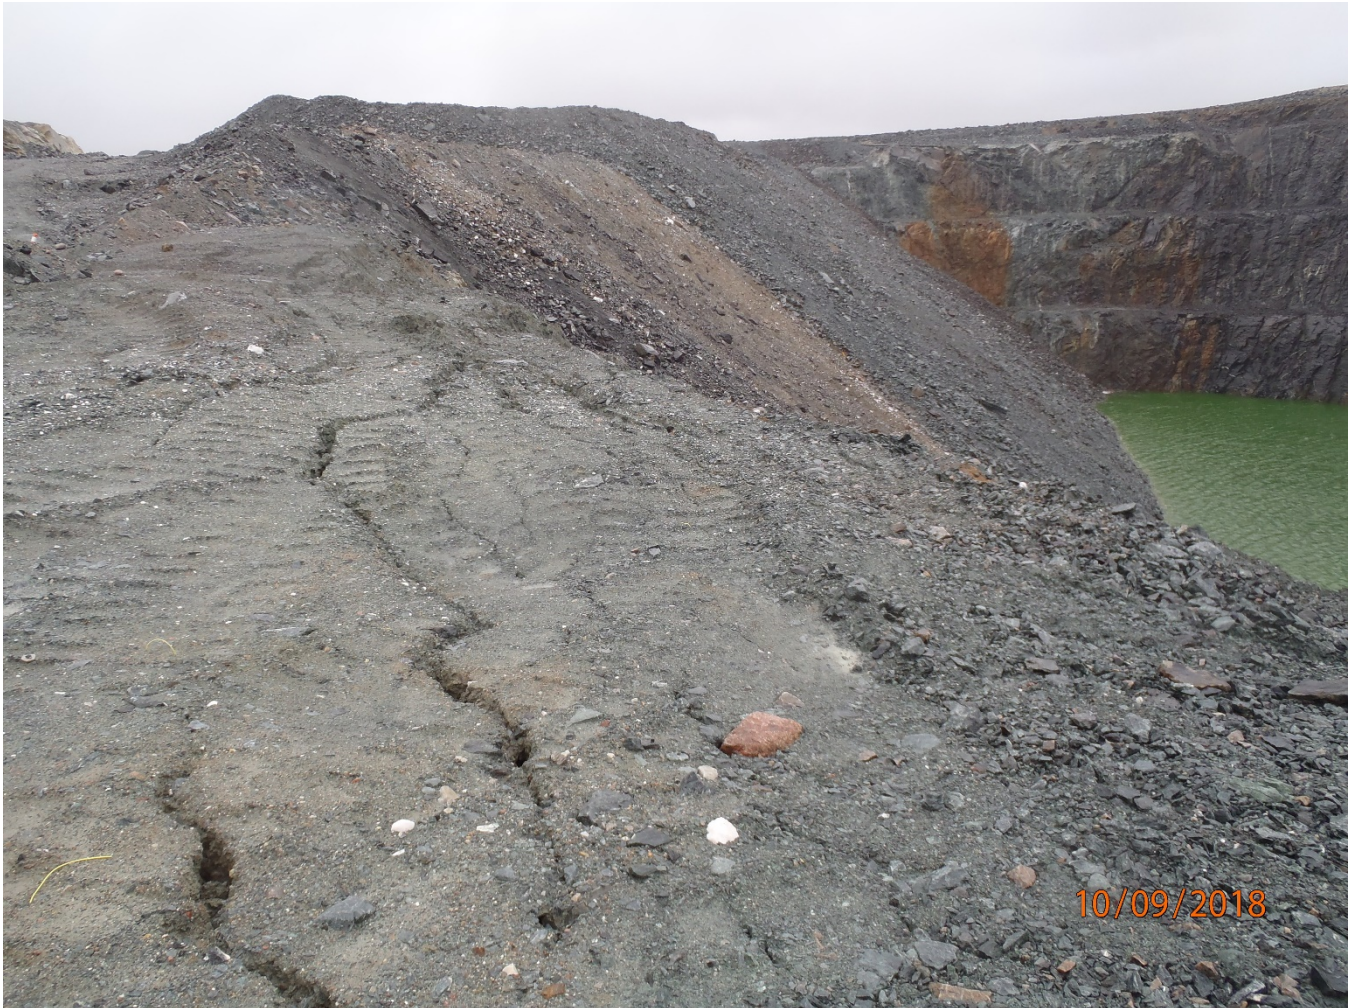
Photograph 7-7: Tension cracks at crest of Goose South Dump

Prior to commencing of active dumping a dump inspection should be carried out, and an action plan developed that might include frequent inspections of the crest area, and the installation of additional instrumentation as required.

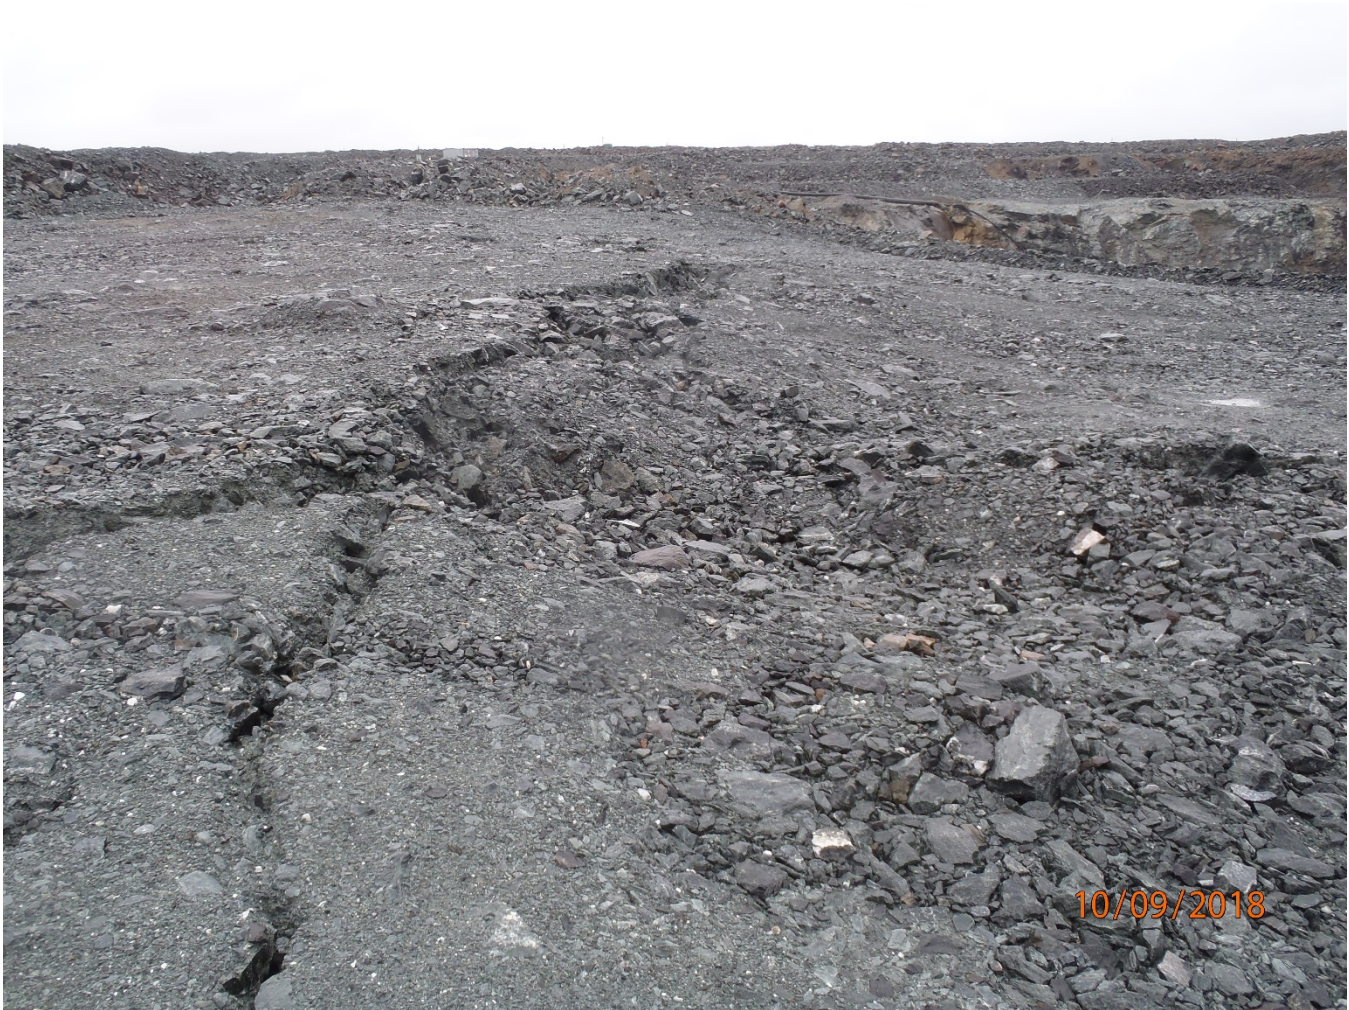
Photograph 7-8: Tension cracks at crest of Goose North Dump

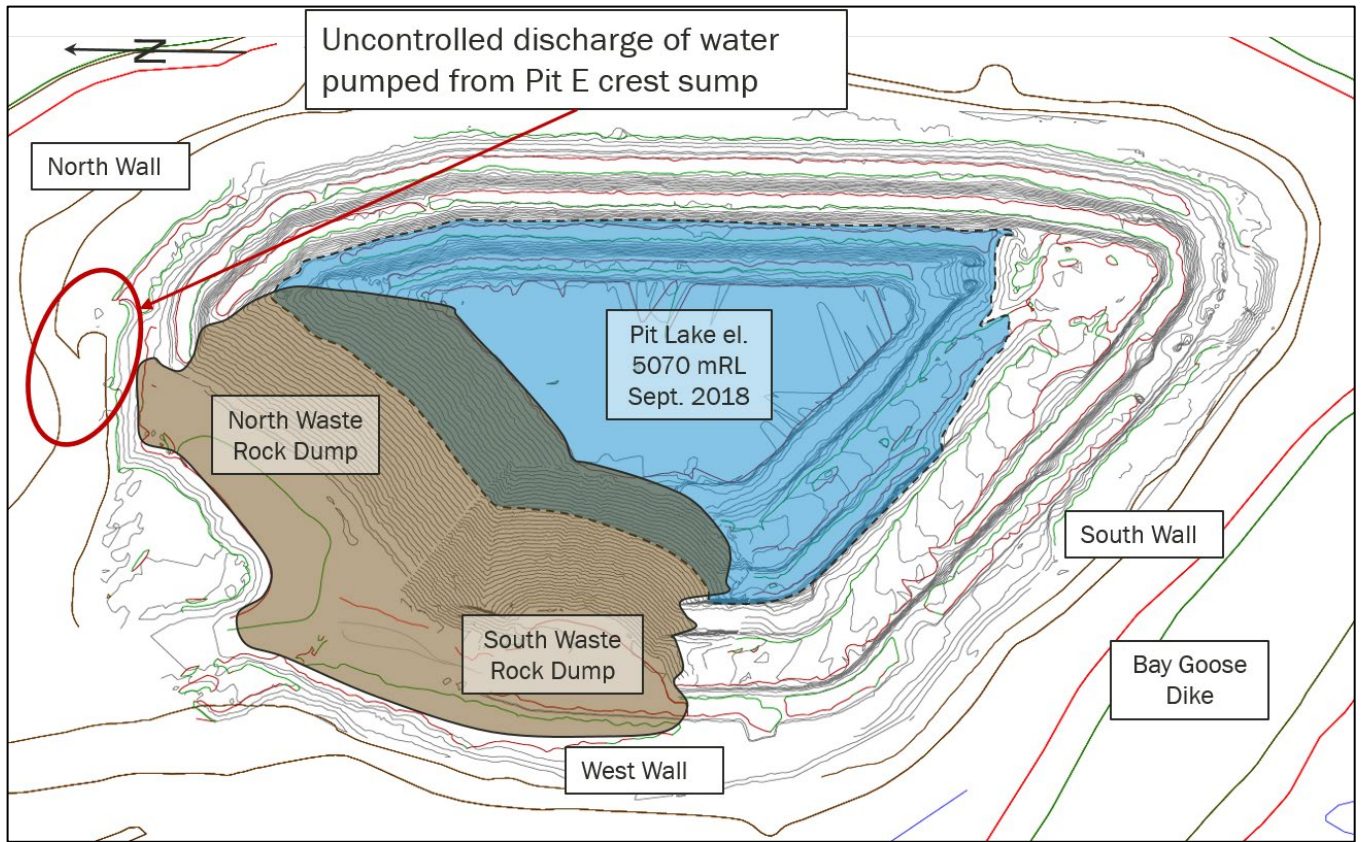
During the site inspection, it was noted that water was being discharged on to the ring road and thermal cap at the north pit crest, and flowing through the rockfill before spilling on to the rock face. Water was also flowing along the ring road to spill over the edge of the pit. The water was being pumped from a sump at the crest of Pit E. It is understood this was only a temporary discharge; however this could still affect the integrity of the ring road and should be avoided. Any water discharge should be directed on to the pit wall face, and not through the rockfill materials at the crest. During the site visit this process was stopped. The location of the water release is shown on the following figure.

Figure 7-3: Location of uncontrolled water discharge at north pit crest of Goose Pit

During the inspection, it was noted that water was being discharged on to the ring road and thermal cap at the north pit crest in an uncontrolled manner. The water was being pumped from a sump at the crest of Pit E. This was a temporary occurrence; however uncontrolled water discharge should be avoided. This was discussed with AEM during the site visit. It was also noted that an existing water discharge line over the edge of the pit at the north end is underlain by kinematically unstable rock blocks in the bench face. When the discharge line is to be moved, equipment and personnel should stay back from the crest in this area.

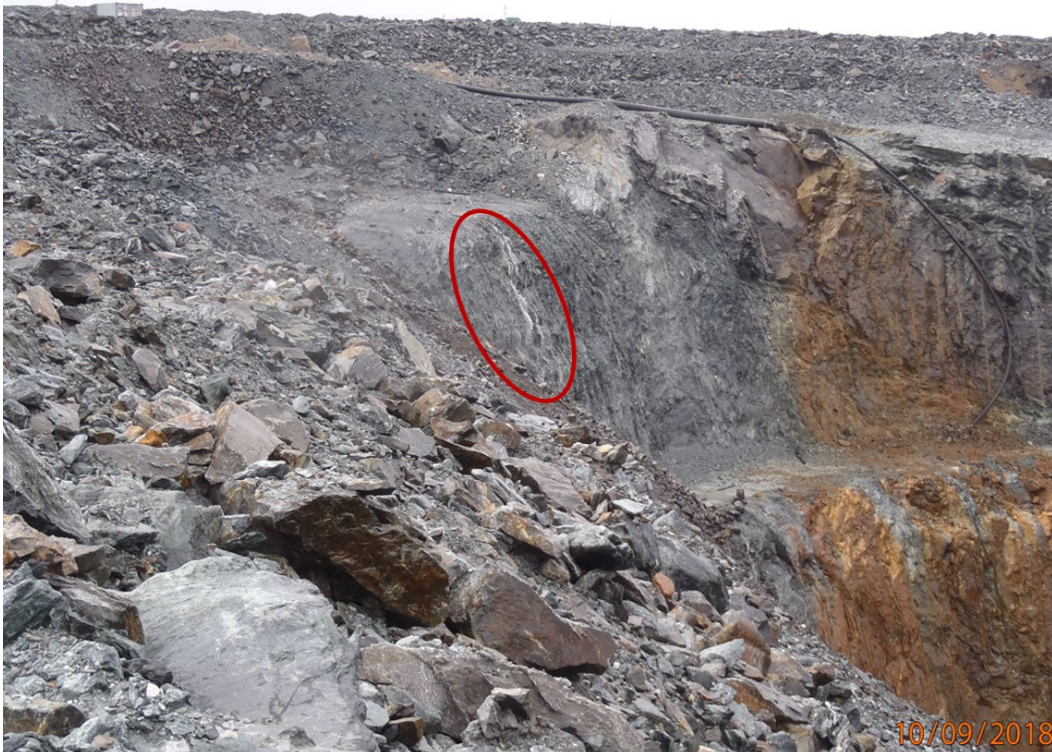
Photograph 7-11: Goose Pit uncontrolled water discharge on north pit wall

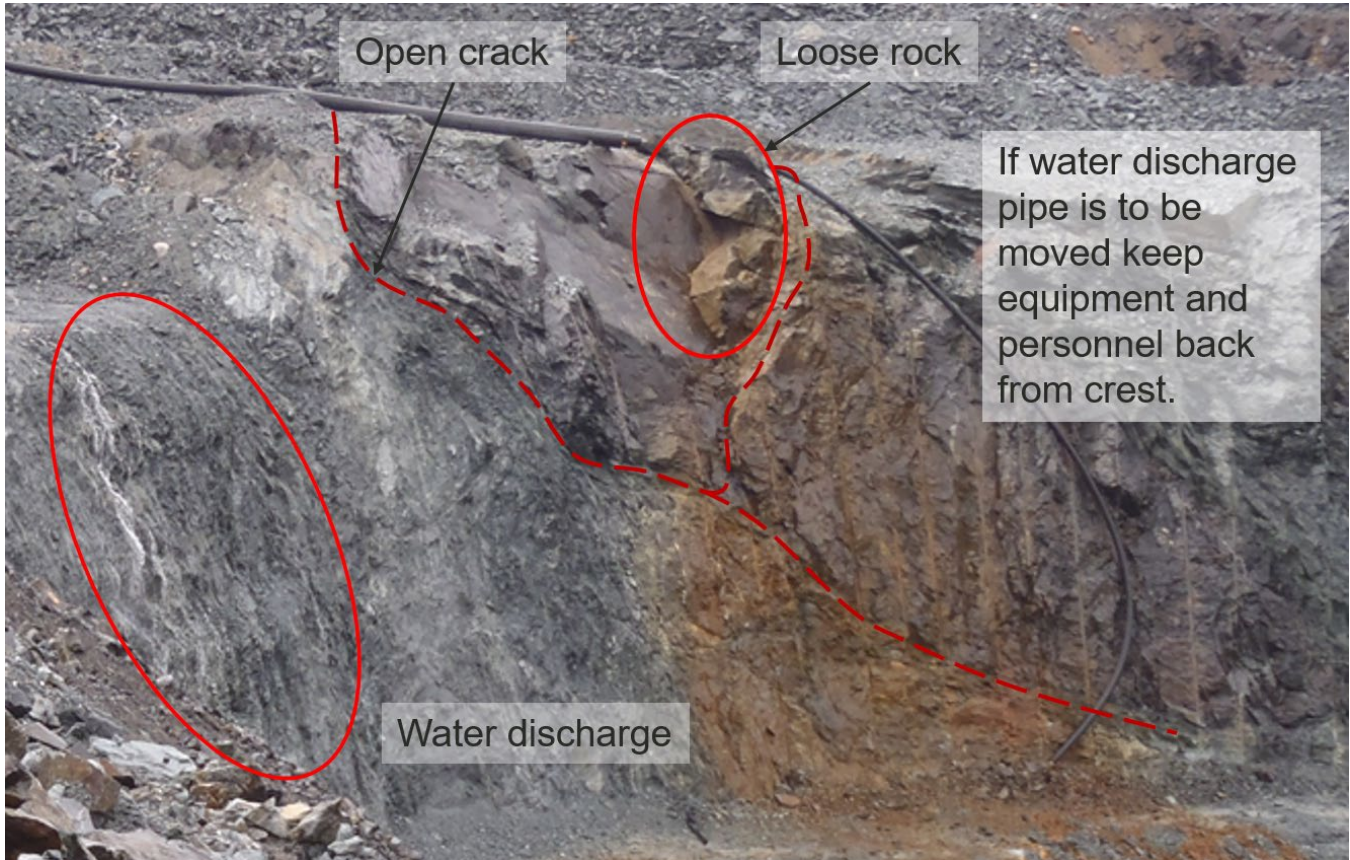
During the review of this area it was also noted that an existing water discharge line to the east is situated on some loose rock material at the pit crest. This was noted to AEM so that if and when this water line is moved, care be taken to keep equipment and personnel back from the crest in this area.

Photograph 7-12: Unstable rock beneath water discharge pipe at north end of Goose Pit

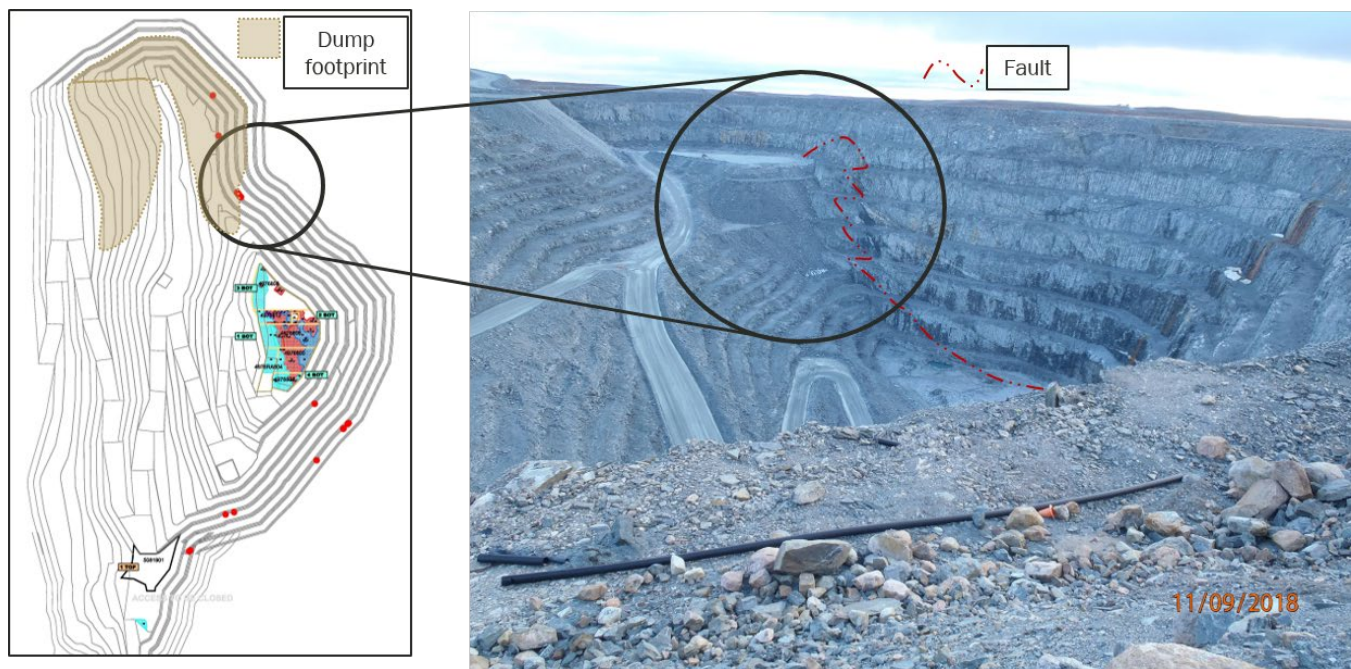
A series of widely spaced faults and open continuous joints dip into the nose area at steep angles. This area continued to be monitored during mining, but now is being backfilled as a waste rock dump, effectively buttressing this area and eliminating the risk.

Photograph 8-10: Vault Pit east highwall nose and fault (2018)

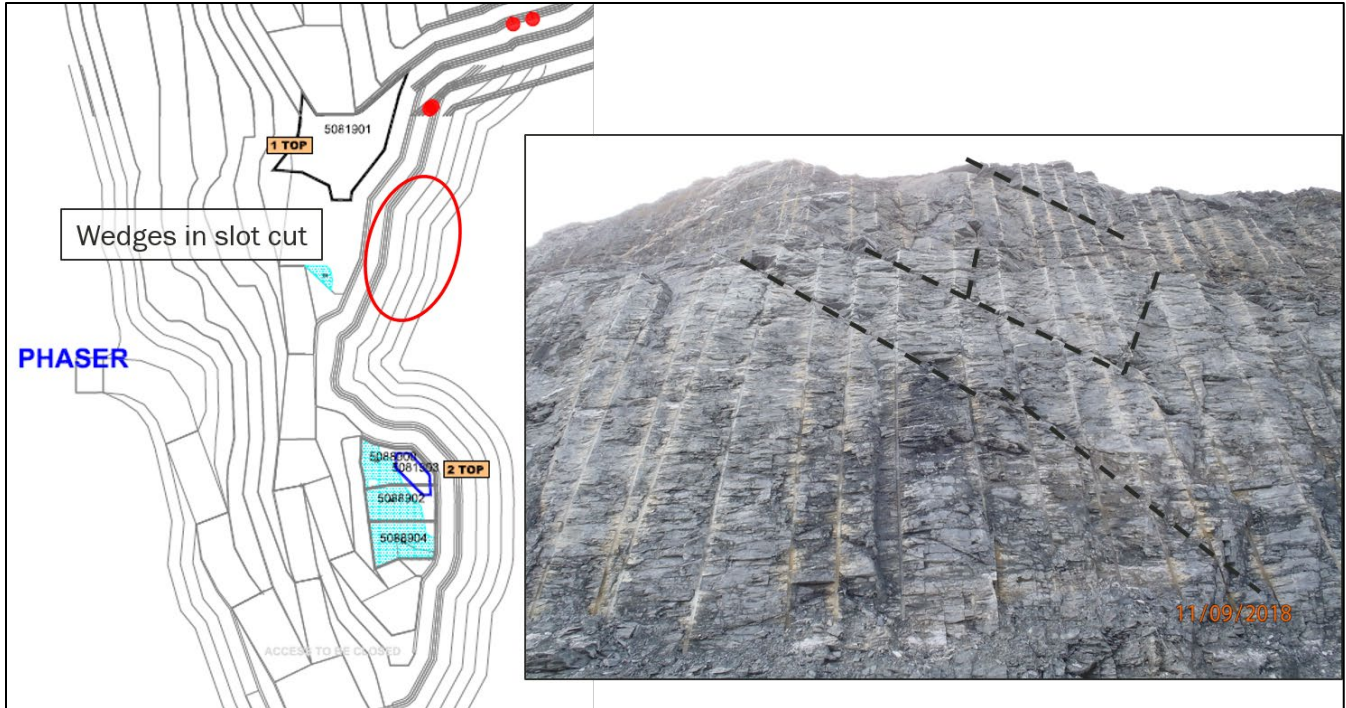
Photograph 8-13: Wedges in east-southeast bench face of slot cut to Phaser Pit
