Meadowbank 2018 Annual Review of Portage and Goose Pit Slope Performance

2018 ANNUAL PIT SLOPE PERFORMANCE REVIEW

MEADOWBANK MINE, NUNAVUT

ISSUED FOR USE
704-ENG. ROCK03053-02

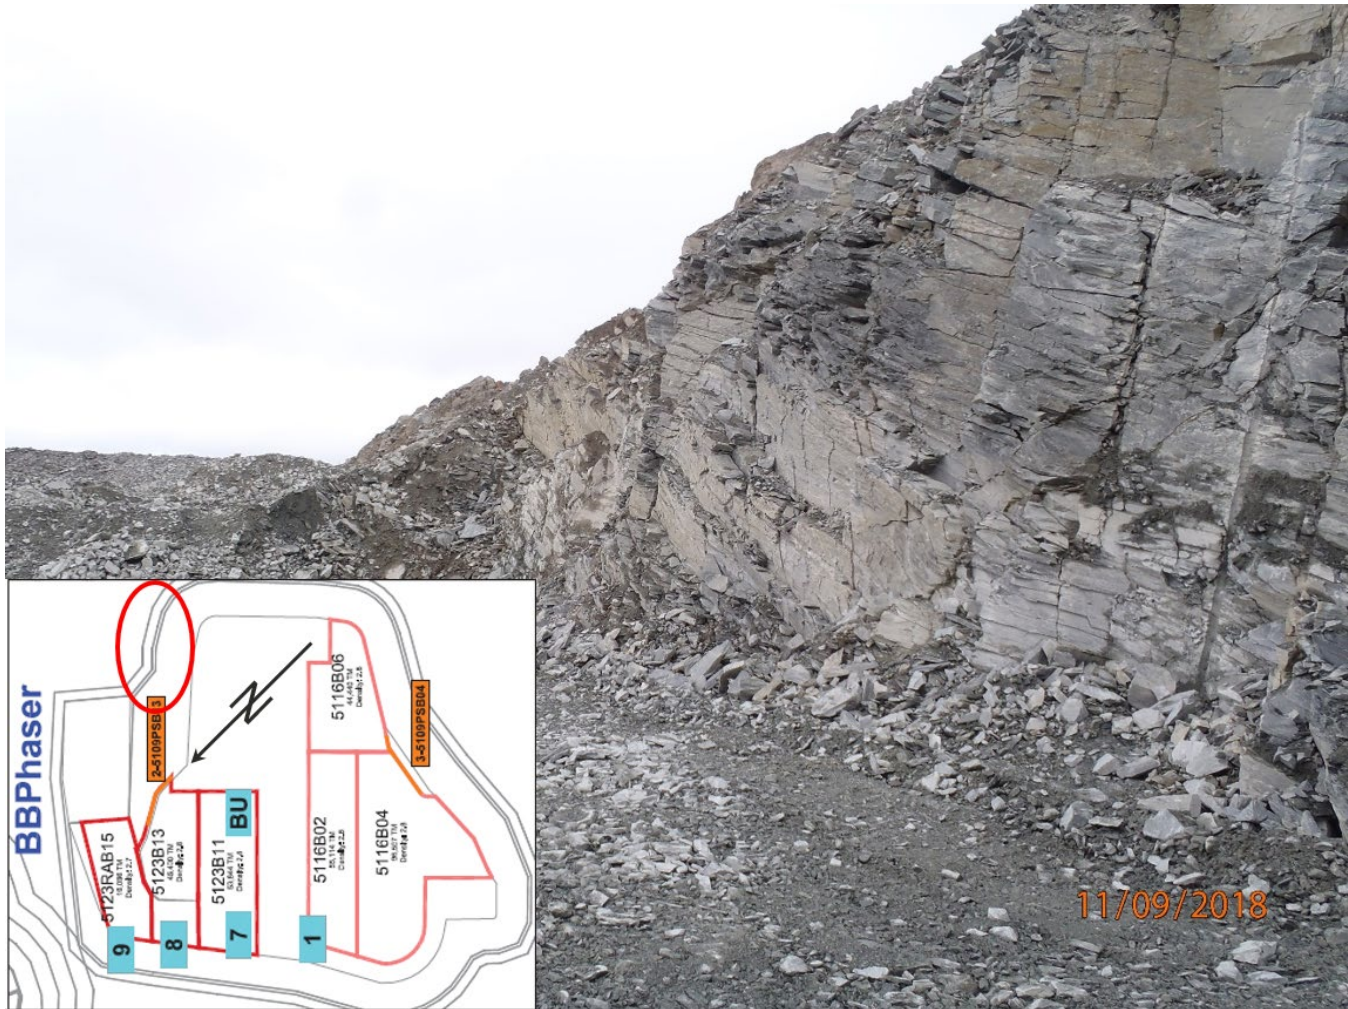
Photograph 8-21: BB Phaser Pit east to north end wall showing continuous orthogonal joint surfaces
