# **Meadowbank and Whale Tail 2018 Annual Geotechnical Inspection**

# 2018 Annual Geotechnical Inspection

*Meadowbank Gold Mine, Nunavut*

18101627-1583-R-Rev0

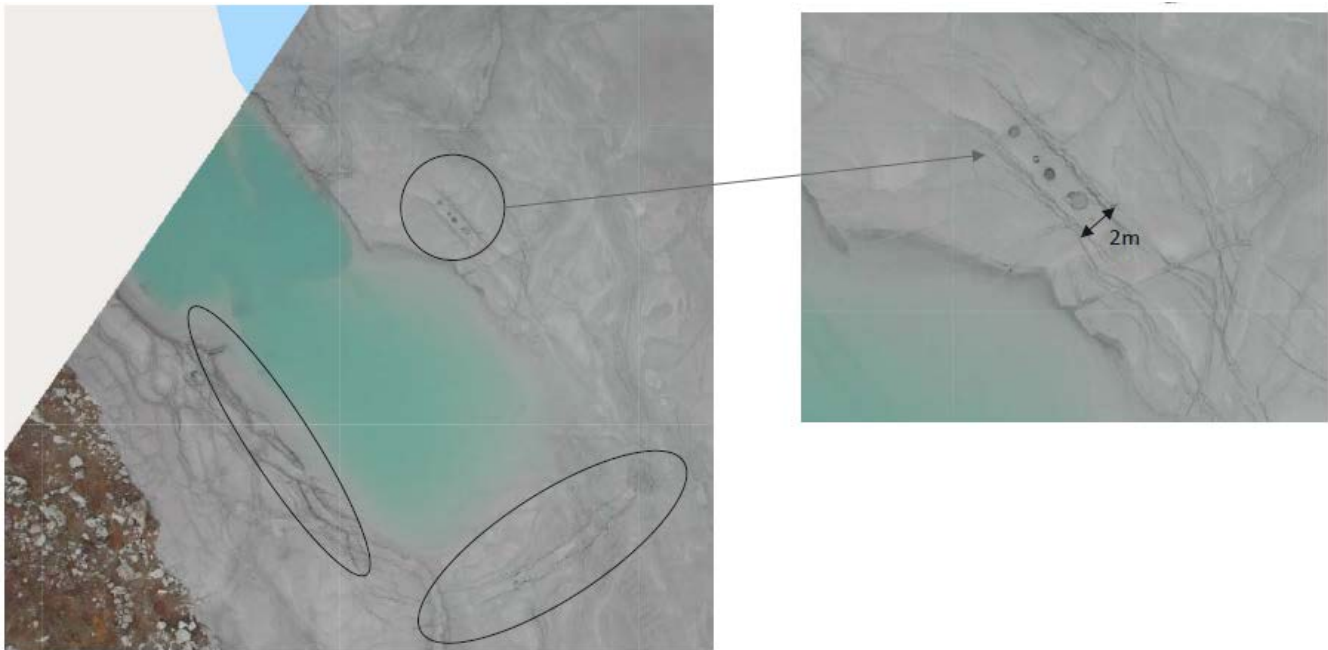
**Figure 1: Aerial view of the depressions observed in the tailings (source: AEM)**

A set of 1 to 2 m wide circular depressions scattered in a horseshoe-shaped area was visible in the tailings of the South Cell, off the north-western extremity of Saddle Dam 4 (see Figure 1). It is assumed that this pattern indicates a fracture zone on the bedrock floor from which the seepage under Central Dike may originate. The circular depressions are a sign of tailings migration through the TSF foundation.

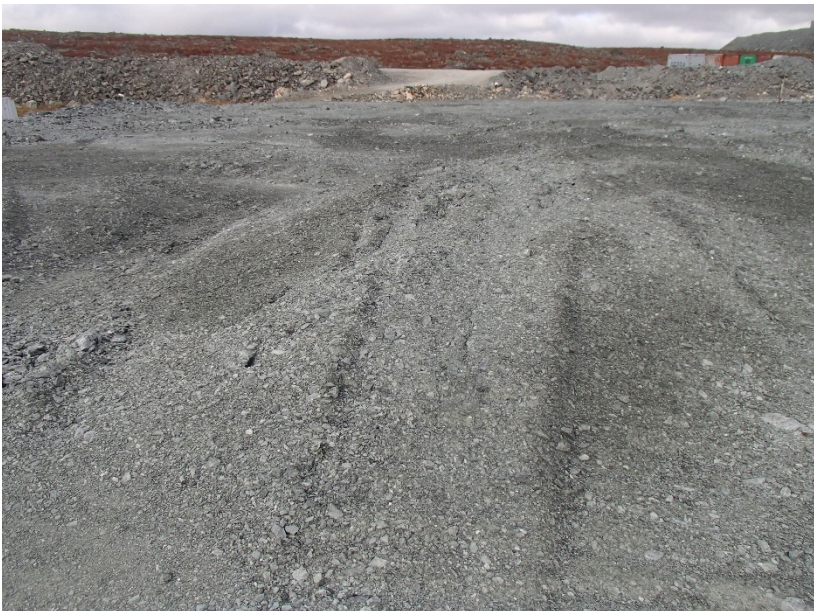
**Photograph A3-47 Bay Goose Dike**

**Description:** From approximately Sta. 32+025 (south abutment) looking east at the crest. Zone of high magnitude settlement in the ultramafic cap. The tension cracks seem no longer active.

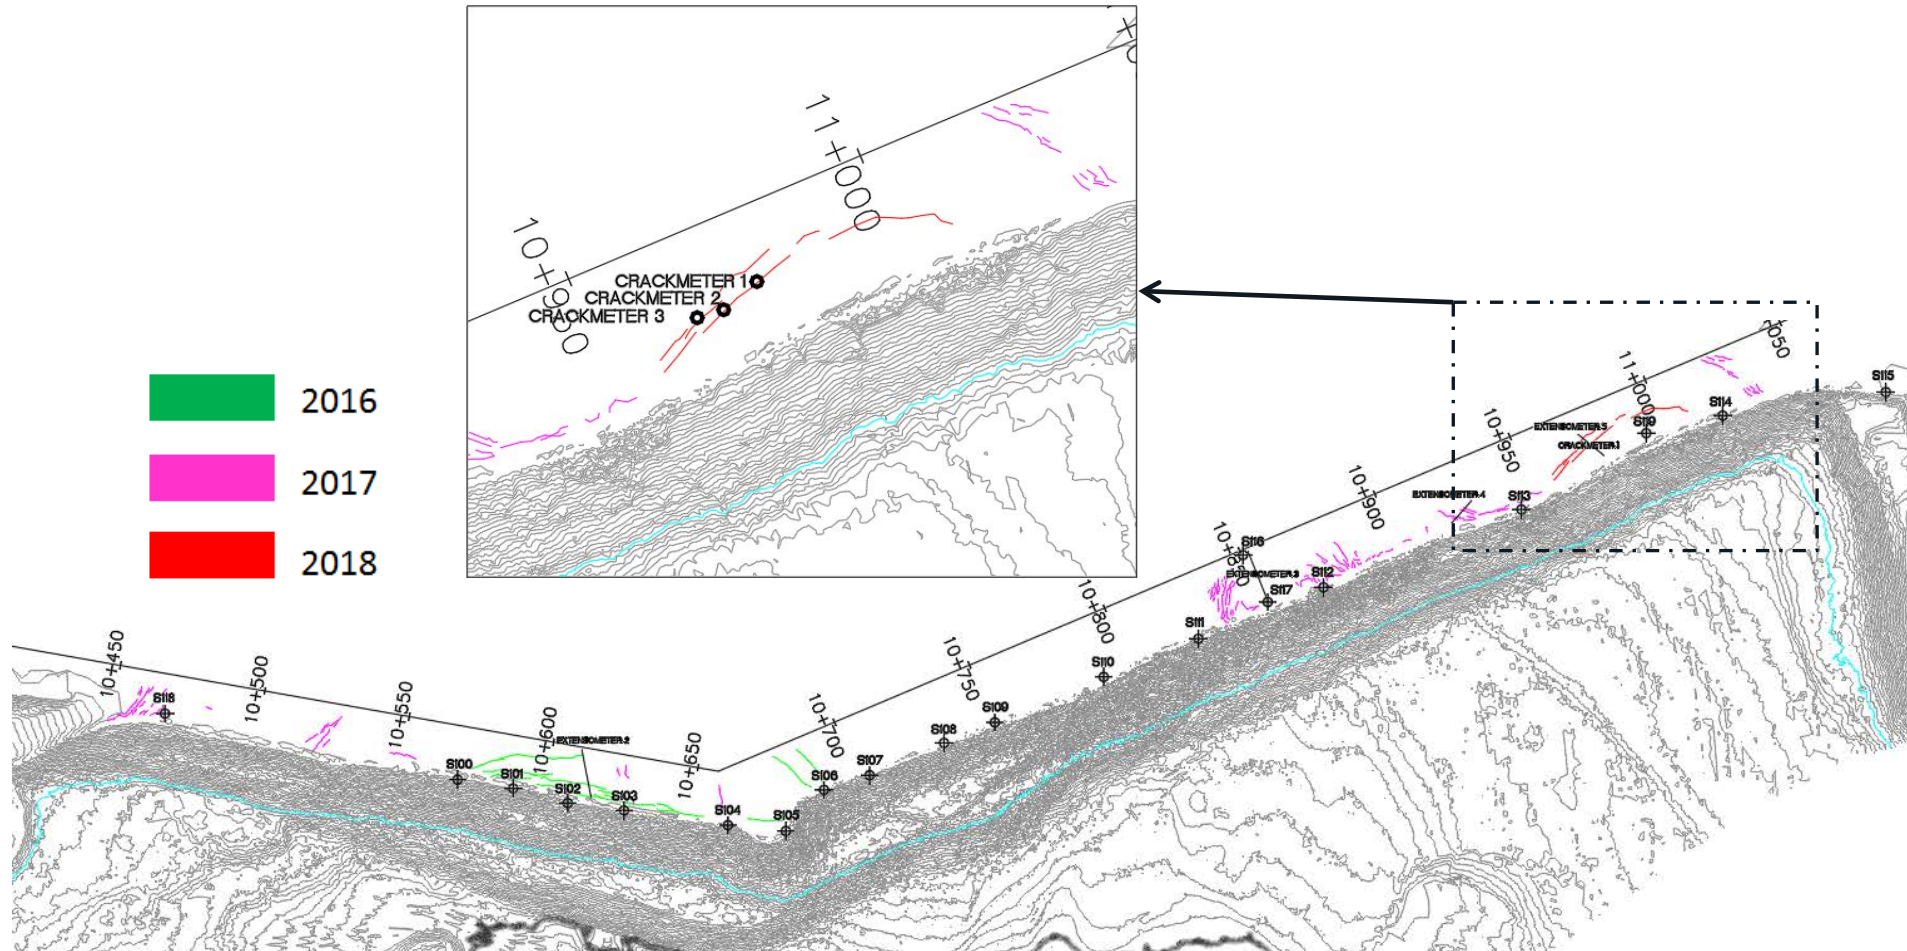
### Cracks Evolution on Stormwater dike, from 2016 to 2018

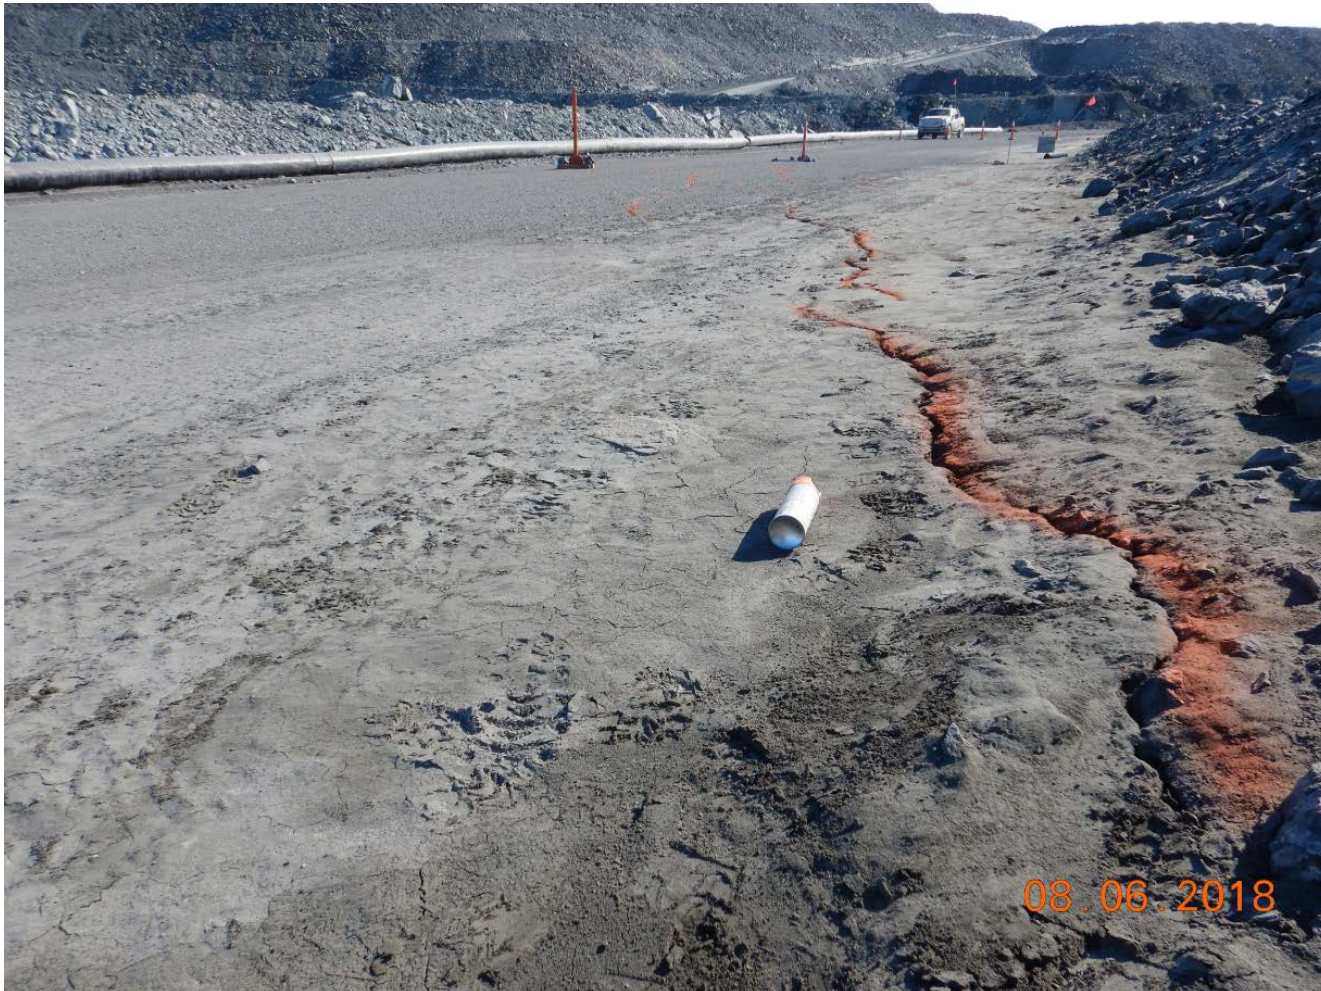
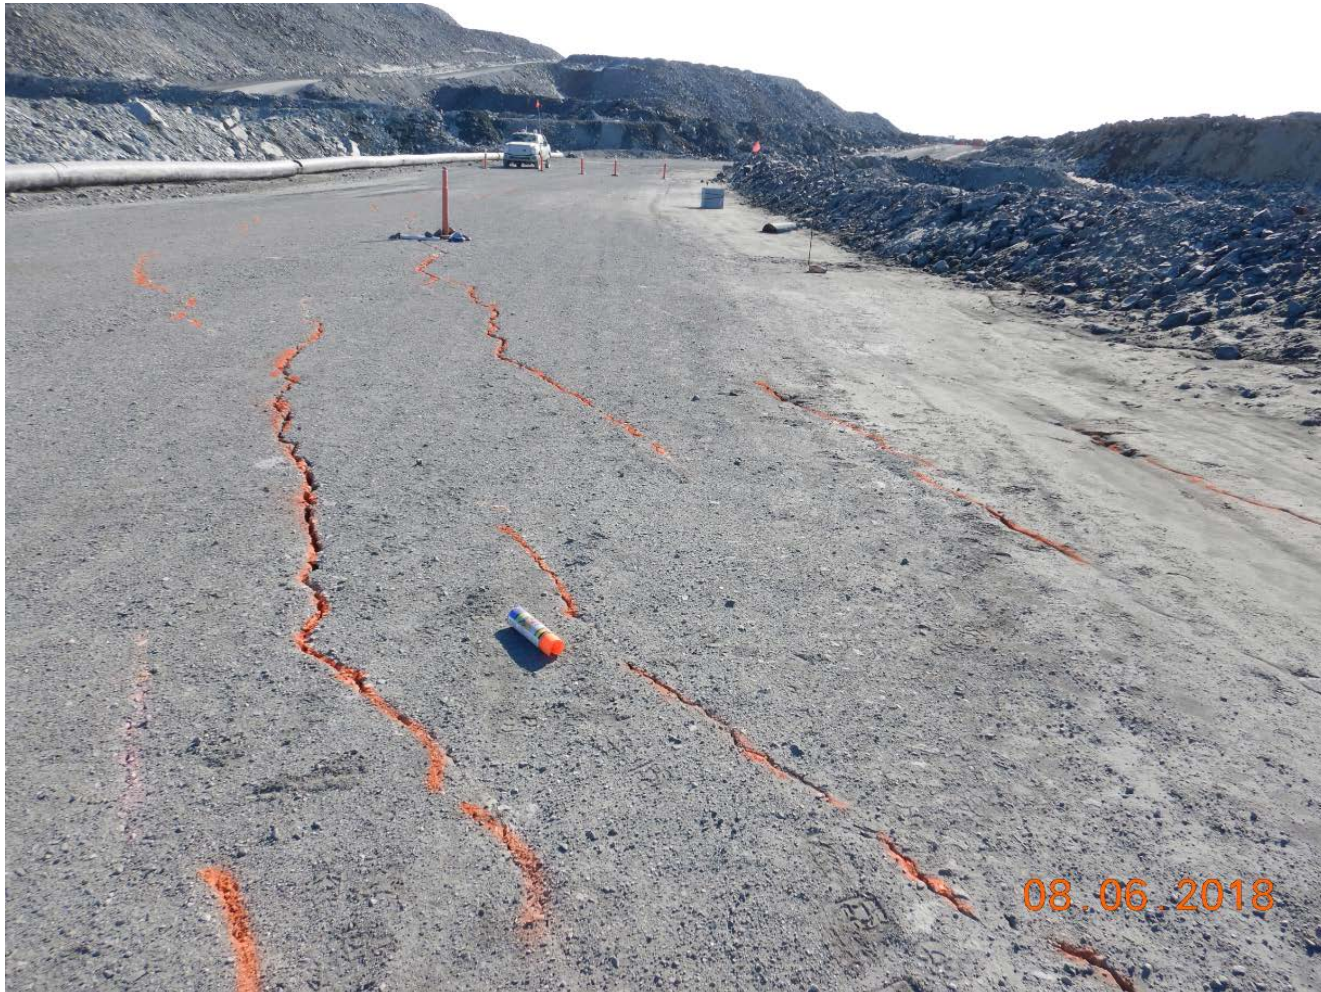
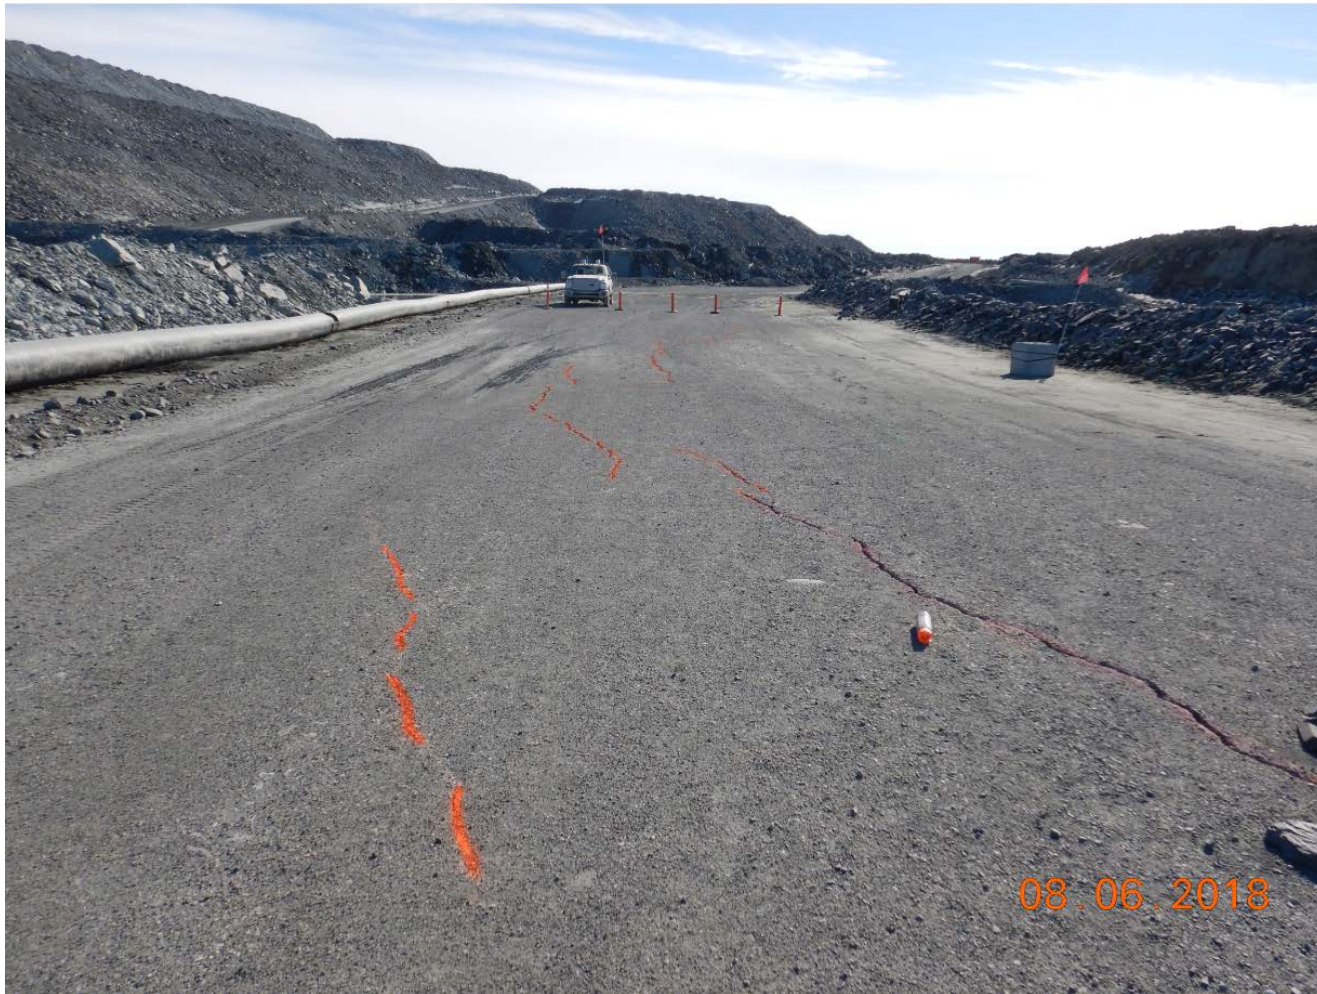
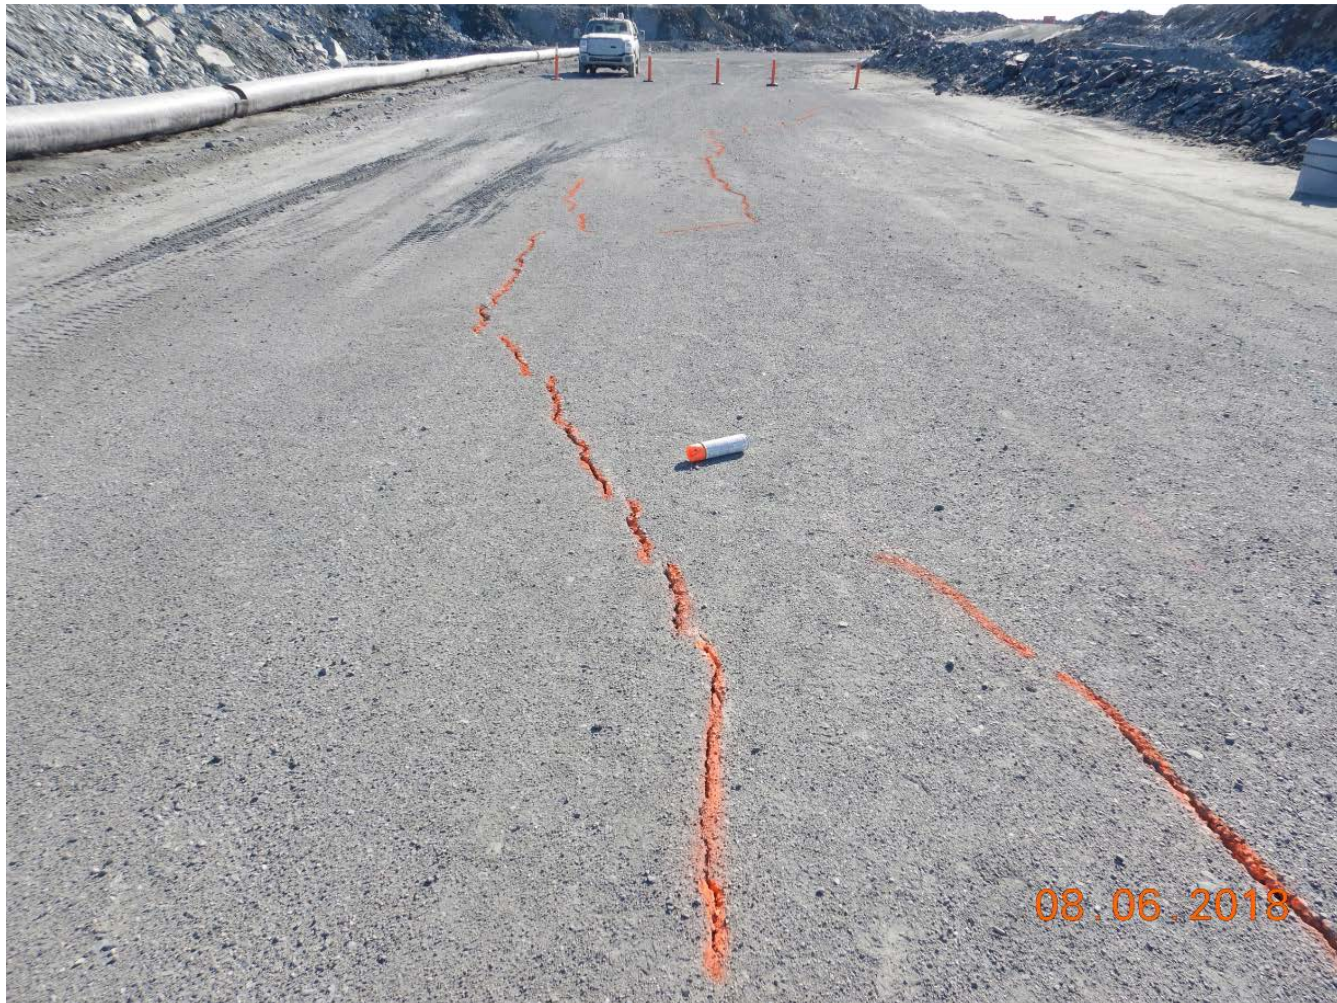
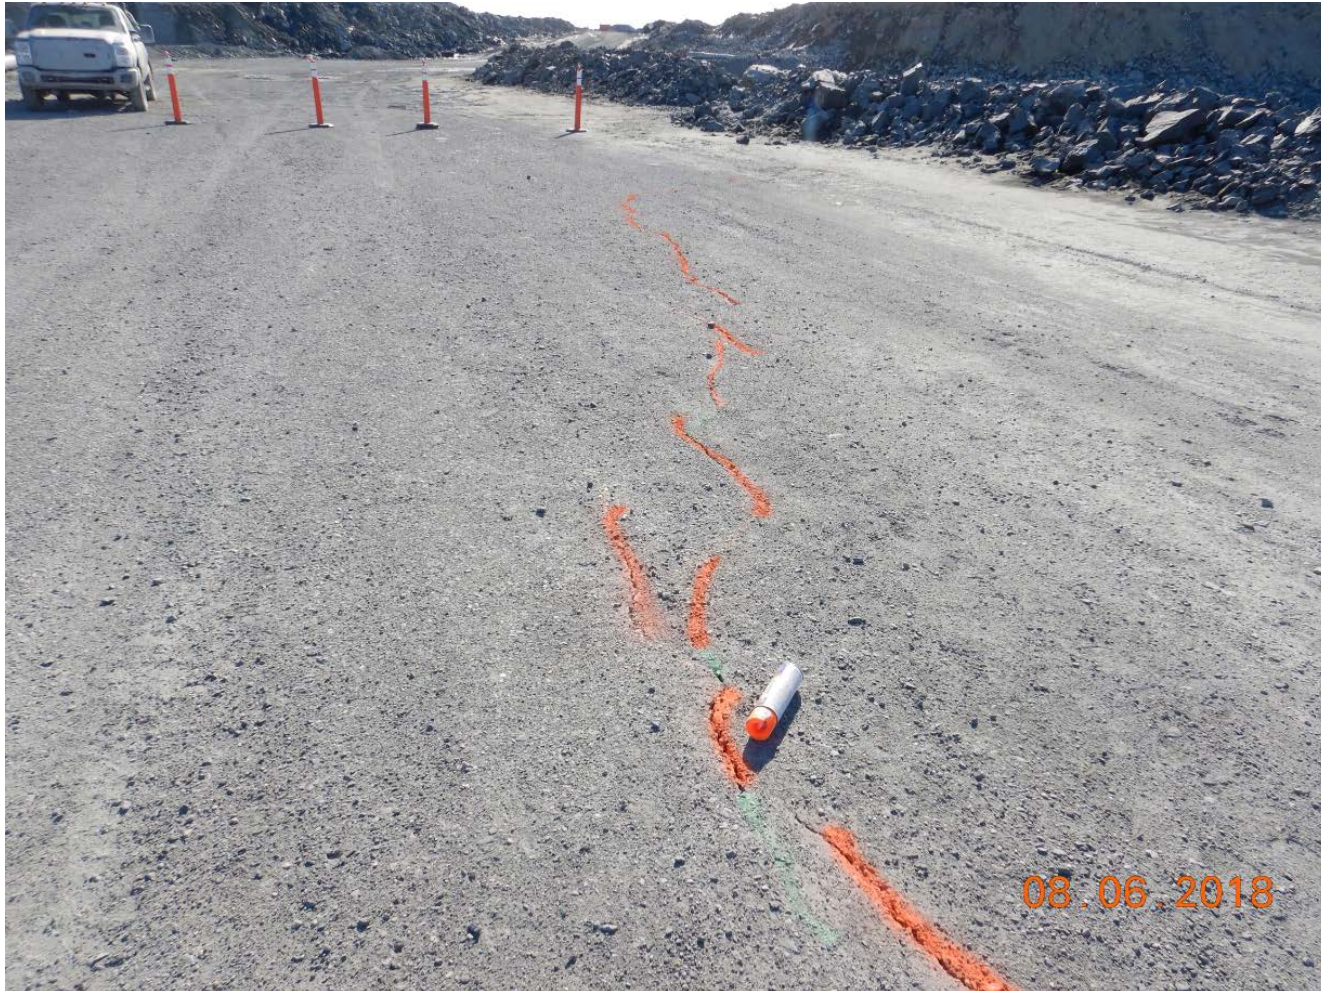
### New cracks formed between station 10+950 and 11+000

- Observed initially on April 27th 2018
- Appeared at the end of the winter with warmer temperature
- Cracks width varying approximately from 1cm to 4 cm
- No significant visual changes since April 27th 2018

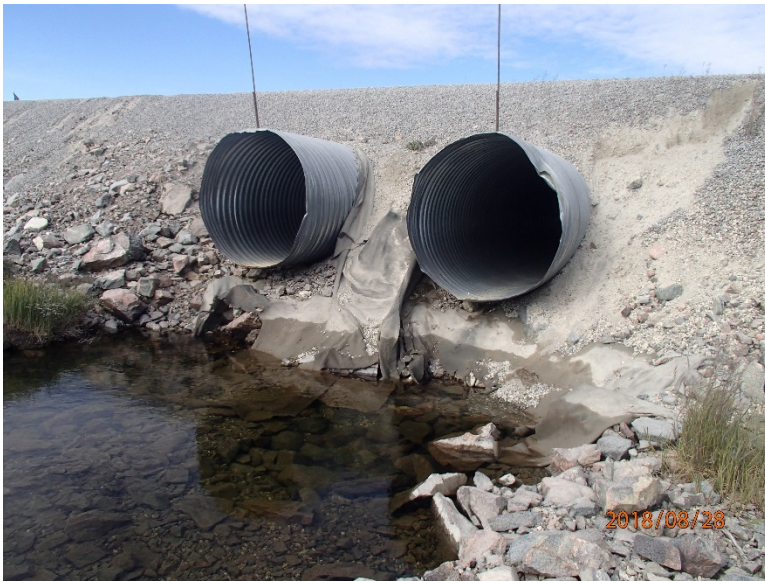
**Photograph D1-3: PC-17A km 8+830**

**Description:** View of the culverts inlet. No sign of degradation since last year.

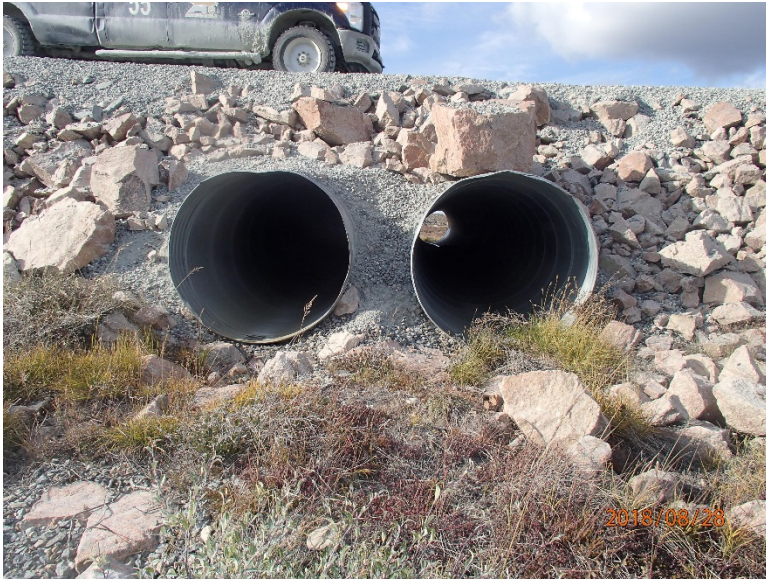
**Photograph D1-21: R-21 km 87+300**

**Description:** View of the culverts inlet. Both culverts are slightly collapsed in the middle. In stable condition, but should have been installed lower to avoid erosion issue.

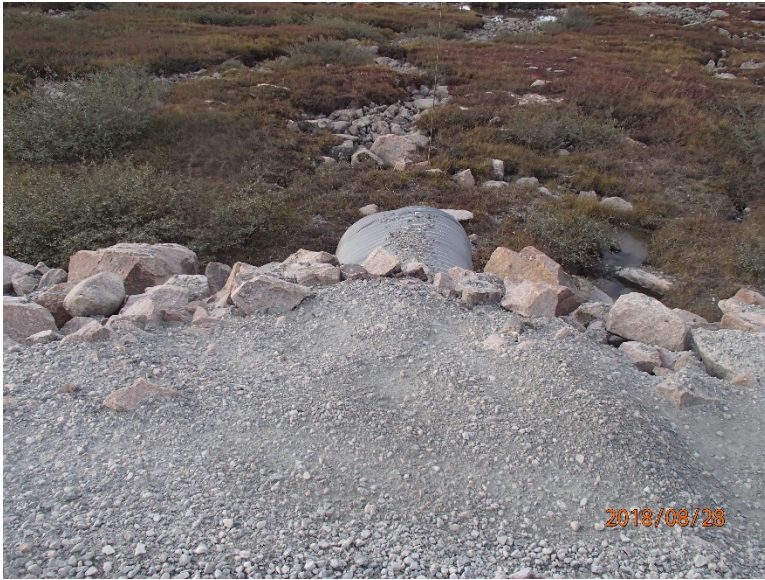
**Photograph D1-23: R-23 km 93+600**

**Description:** View of the culvert inlet. The culvert is installed too high and there is a low flow of water through the road rockfill. In good condition.

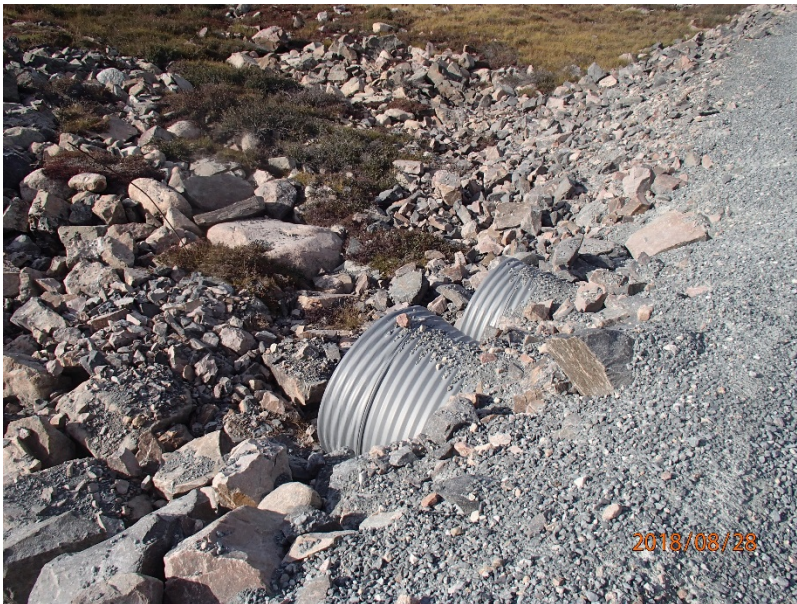
**Photograph D1-24: R-24 km 98+100**

**Description:** View of the culvert outlet. The culvert is installed too high and there is a low flow of water through the road rockfill. In good condition.

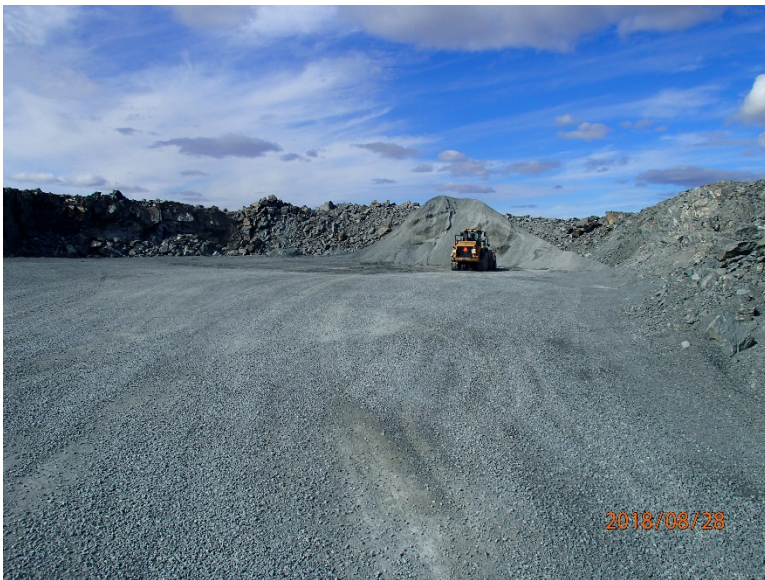
**Photograph F1-14: Quarry 9 – km 44+600**

**Description:** View of west and south walls. Presence of loose blocks at the base of the wall.

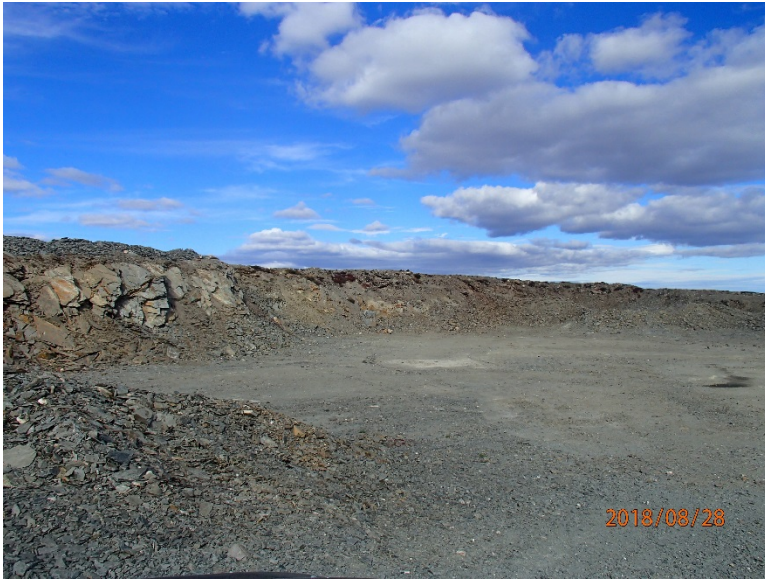
**Photograph F1-15: Quarry 10 – km 48+900**

**Description:** View of north and east walls. View of a pile of loose material.

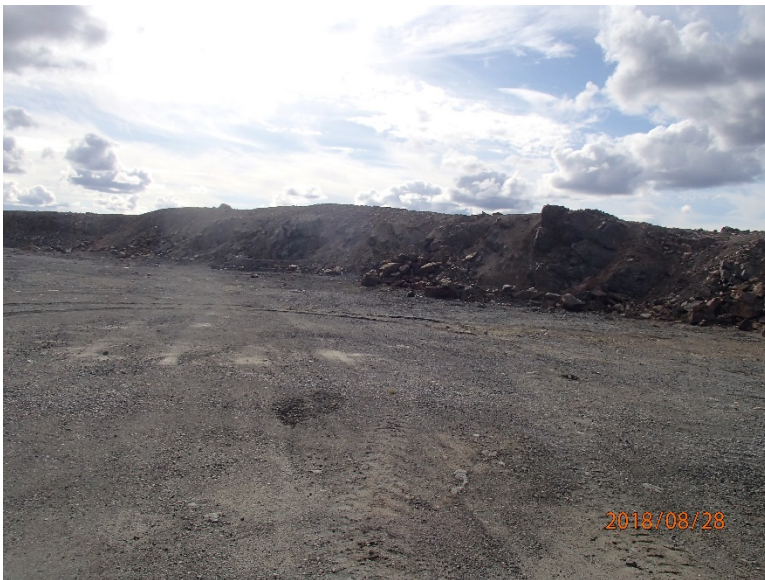
**Photograph F1-28: Quarry 16 – km 70+400**

**Description:** View of the south and west walls. Presence of loose rocks on steep wall.

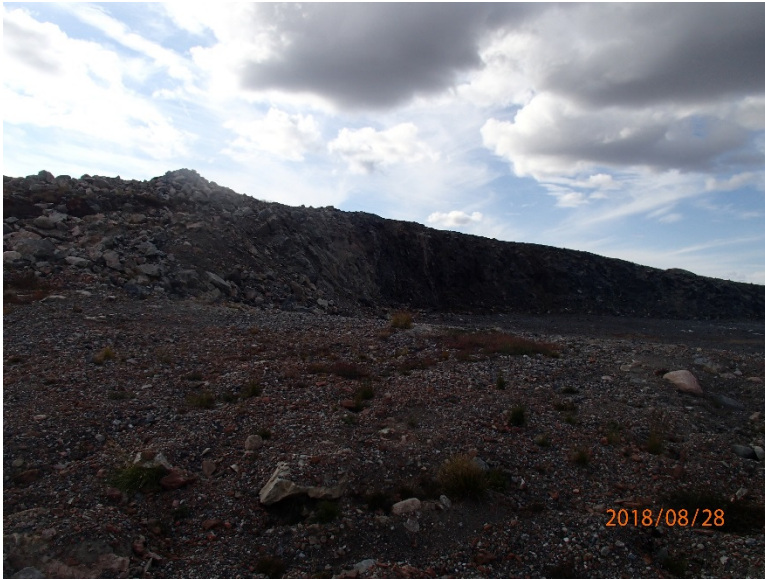
**Photograph F1-29: Quarry 18 – km 80+200**

**Description:** View of the east wall. Presence of loose rocks on steep wall.

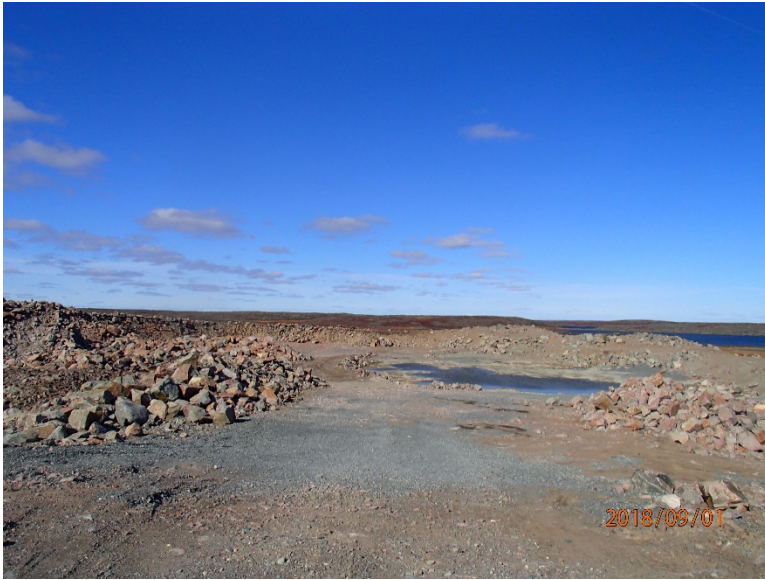
**Photograph F2-3 Eskers and Quarries 2 – km 25+000**

**Description:** View of Quarry 10.5. Loose rock is present on the steep wall.

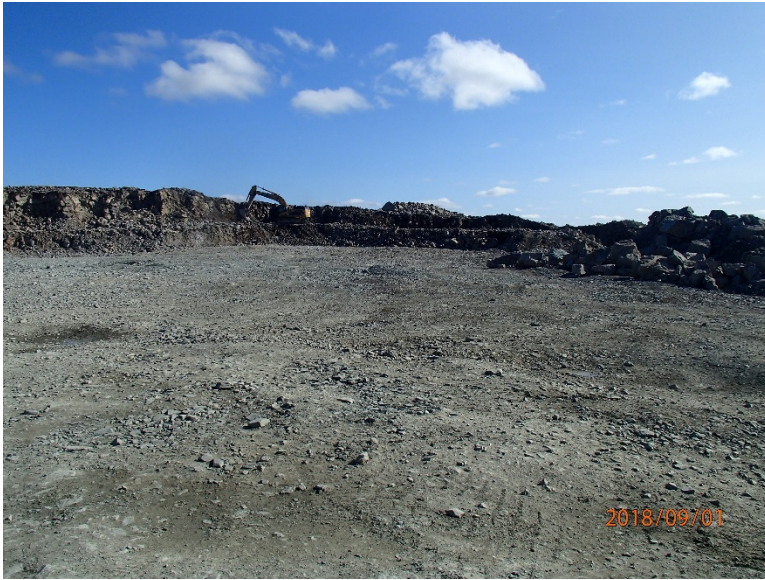
**Photograph F2-5 Eskers and Quarries 3 – km 30+180**

**Description:** View of Quarry 30.5. Most walls are in unstable condition.

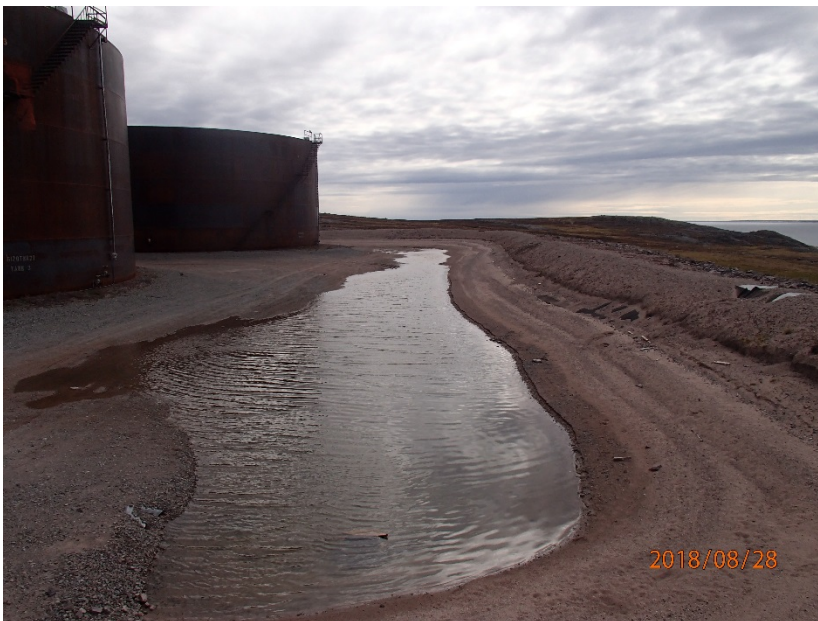
**Photograph G1-8 Baker Lake Tank Farm**

**Description:** Looking northeast. The geomembrane between the south side of tank 2 and 3 is damaged.

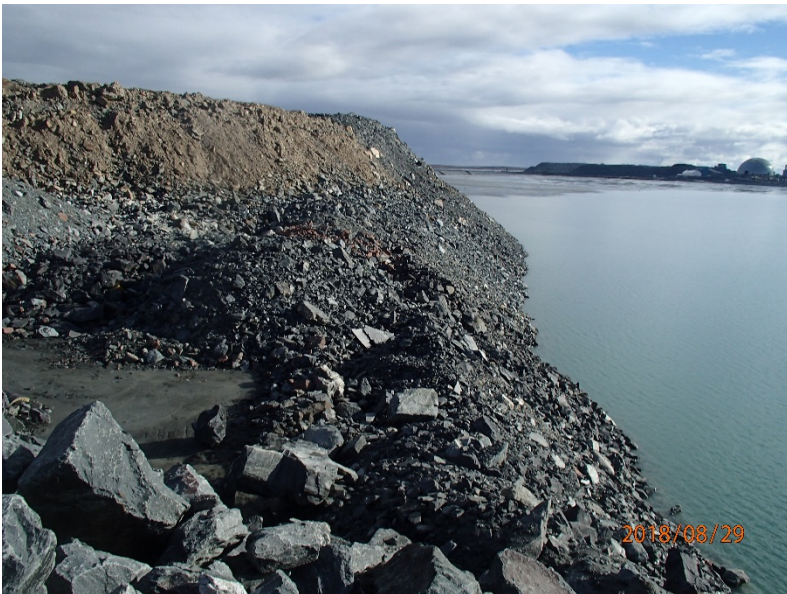
**Photograph H6-6 Contaminated Soil Storage and Bioremedial Landfarm Facility**

**Description:** From the northeast extremity of the South Cell, looking northwest at the Contaminated Soil Storage and Bioremedial Landfarm Facility. Sign of superficial slope failure.
