Appendix 70

Meadowbank and Regulators 2019 Regulators Inspection Reports

CIRNAC Inspection Report - Water License 2AM-WTP1826 April 2019

CIRNAC Inspection Report - Water Licence 2AM-MEA1526 April 2019

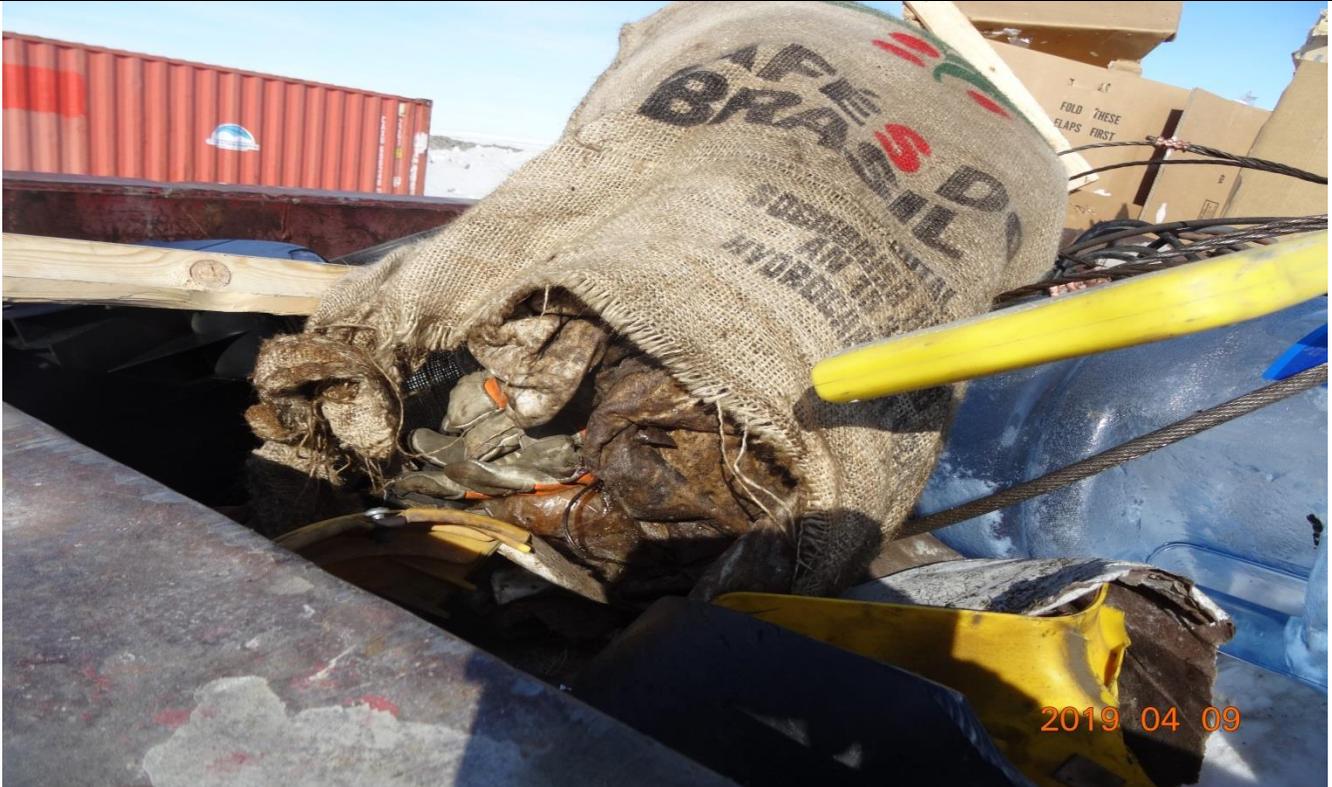
During the inspection of this facility it was noted that there was a large metal bin full of debris to be hauled to the landfill. The inspectors quickly inspected the bin to ensure compliance of material approved to be deposited in the landfill and found items such as used oil rags, open and use lube tubs, oil filters, and hazardous waste containers. (*see photos 2 - 4*) These items are considered hazardous waste and must be removed from the landfill bin prior to being hauled to the landfill.

Description: Oil saturated material within metal bin marked for landfill

SECTION 2	<input type="checkbox"/> Comments	<input type="checkbox"/> Non-Compliance with Act or Licence	<input checked="" type="checkbox"/> Action Required
<ul style="list-style-type: none"> The Inspector is requesting that AEM ensure all hazardous material be held in secondary containment as required by the licence <i>Part H Item 3</i>. The Inspector is requesting that AEM remove all unauthorized items/ material from the landfill bin as these items are considered hazardous material. As required by the licence <i>Part F Item 16</i>

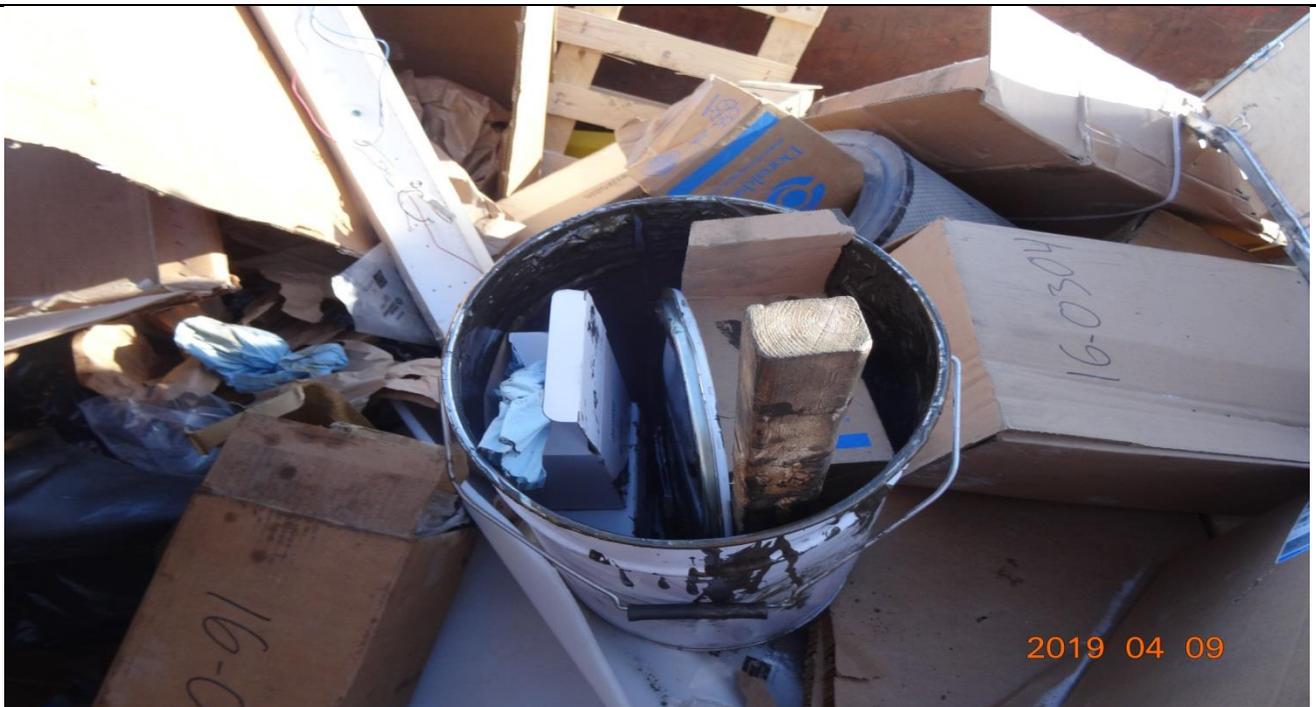
Description: Lube pail containing, Lube and other material saturated in lubrication also found within metal bin marked for the landfill

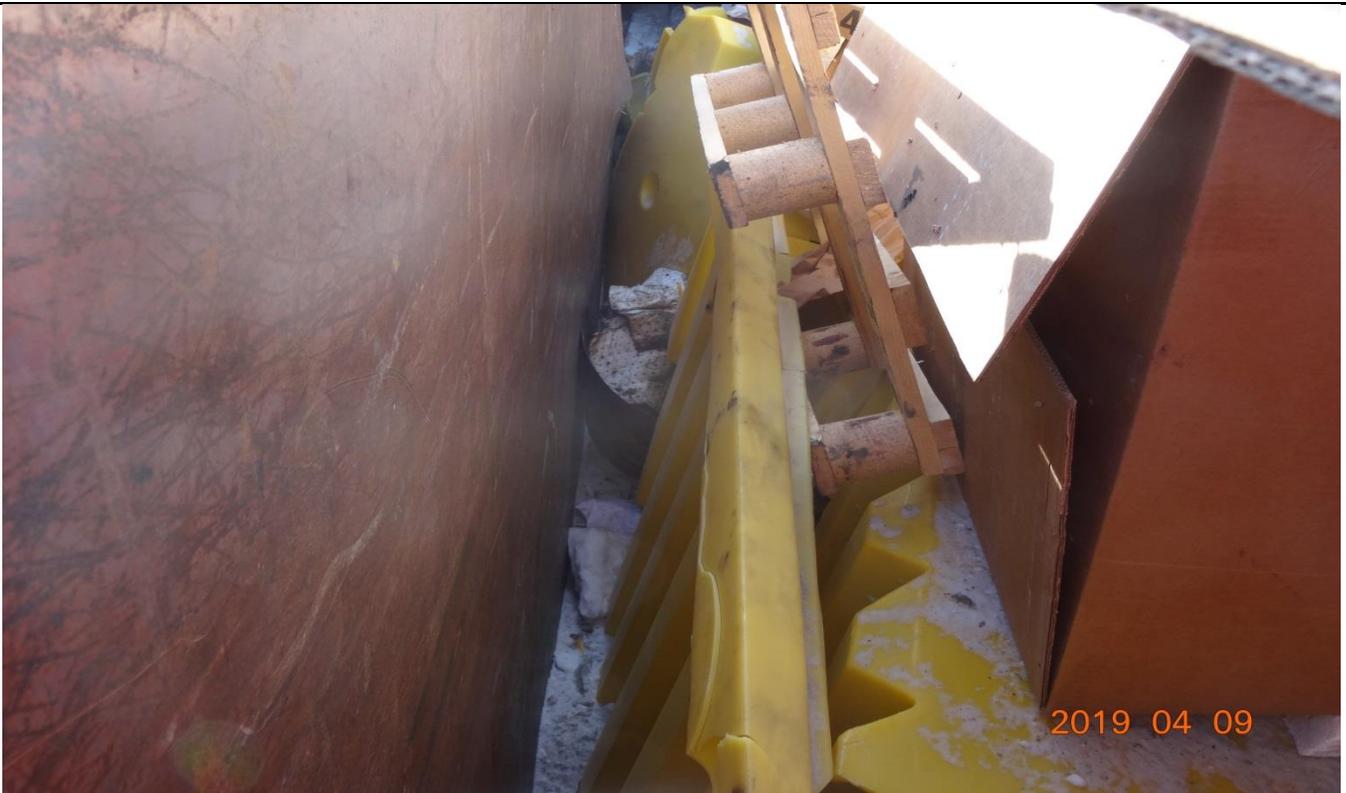
Description: Used oil pig rag found within the Metal bin marked for the landfill

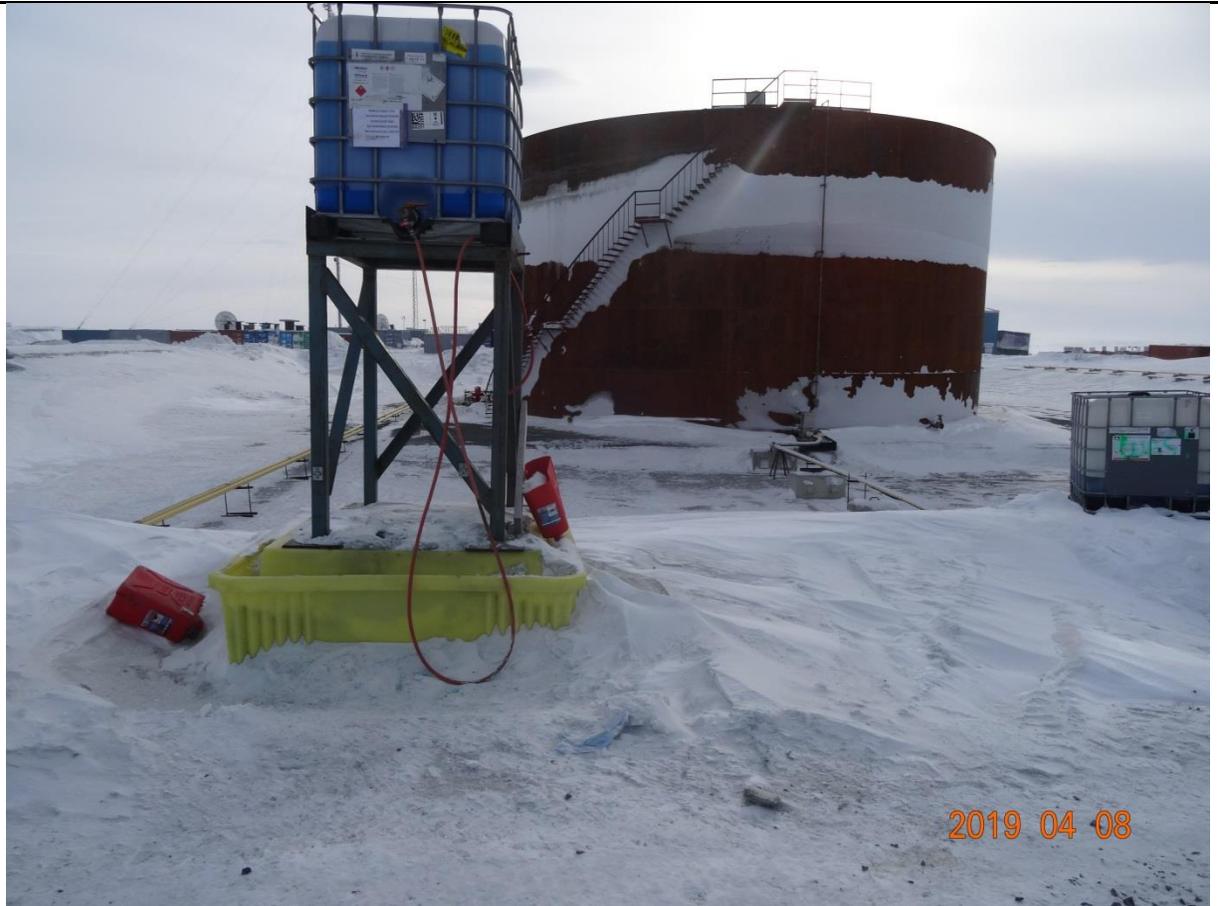
Photo Log # 2	Location (NAD 83 DD MM SS.SS)
Photo #2	N W

The refueling station is situated parallel to the tank farm. This facility is not lined; the inspectors noted a tote of windshield washer fluid placed on top of a stand for gravity feeding. The tote is within secondary containment however, there is evidence that the fluid is still leaking onto the ground there was also another tote located behind the washer fluid not within containment (*see photo#2*). The inspector is advising that AEM clean up the spilled material <100L prior to the next site inspection.

Description: Raised windshield washer fluid and blue snow sitting in front of the tote. Second tote not within secondary containment located behind windshield washer fluid.

- The inspector is requesting that AEM remediate all spills identified during the course of this inspection. As these are concerns regarding due diligence and the handling of hazardous material.

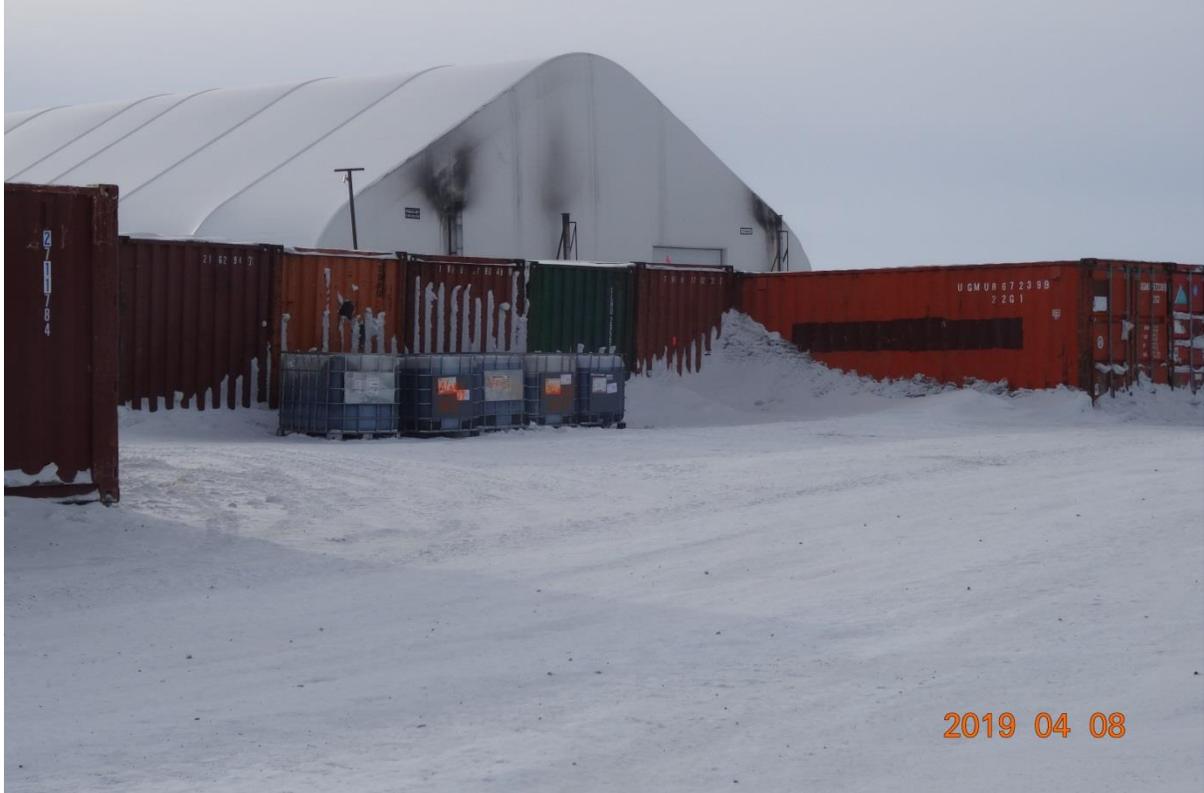
During the inspection of the AEM site the Inspectors came across the Waste Oil Filtration Building. Within this building AEM is running a waste oil filtration plant to filter and remove debris from used oil to reuse in heating units and other machinery as AEM sees fit. The inspectors noted that the filtered oil is then held in a tote and put outside (*see photo#3*). The Inspectors also noted that though temporary, when oil or any other hazardous material is being stored in a way that may enter the environment that all hazardous material must be stored in secondary containment as required by applicable standards and acceptable industry practice.

Description: Totes not in secondary containment located outside of the Waste Oil Filtration Facility

- The inspector is requesting that AEM place all fuel and chemicals within adequate secondary containment as required by the license *Part H Item 3*.
- The inspector is requesting that AEM remove all unauthorized material with in the Landfill as these are considered to be hazardous waste. As per the Water License *Part F Item 16*.

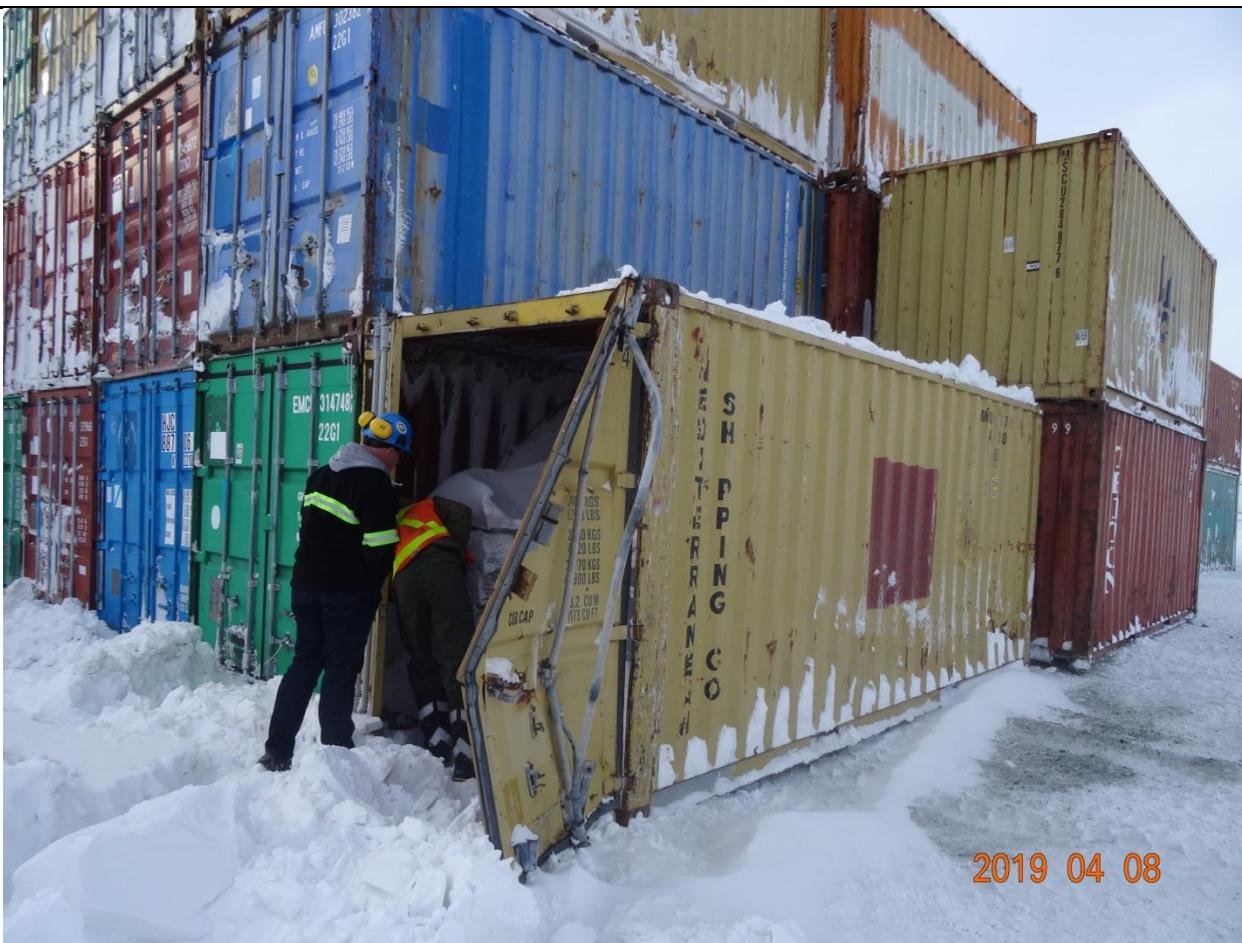
Photo Log # 4

During inspection of this Laydown Area it was noted that a sea can that has been significantly damaged which contains several totes of diesel exhaust conditioning fluid. (*See photo#4*). The totes have not been damaged; however, the damaged sea can is no longer acting as secondary containment for the fluid in the totes. The Inspector has advised AEM Environmental staff that the totes must be moved indefinitely.

Description: AEM representative Tom THOMSON and CIRNAC Inspector Jonathan MESHER look at the damaged sea can located at the Warehouse Laydown Area.

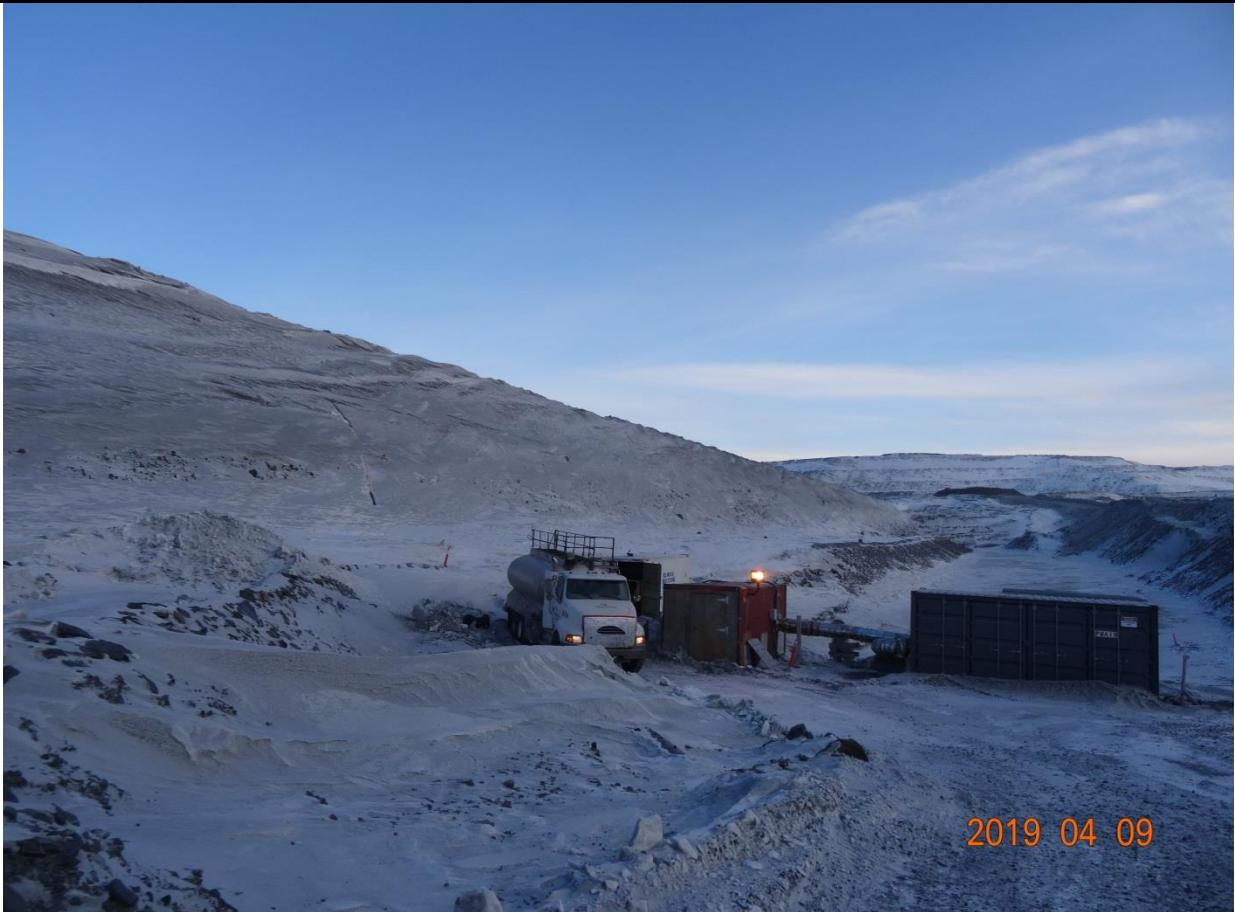
During the course of this inspection the Inspectors had been advised that the Central Dyke is actively leaking from the Tailings Storage Facility (TSF) into a ditch between the east bound road leading to the Vault pit and the Central Dyke (*see photo#5*). AEM is also controlling the water level within the ditch by way of pumping the water back into the TSF. Currently AEM has pumped 183,072m³ of water that has seeped through the dyke back into the TSF.

The Central dyke has been leaking since tailings deposition started in the south cell, in November 2014. AEM conducted daily internal inspections of the downstream toe of the central dyke as part of the Geotechnical inspection program. This is when a small amount of water was discovered against the downstream toe of the central dyke, which was contained between the central dyke and the west road. AEM is reporting that the seepage is within the footprint of the mine and away from the receiving environment.

AEM considers the Seepage from the Central Dyke to be under control as AEM has the pumping capacity to deal with the seepage flow rate. AEM reports that the integrity of the infrastructure has not been compromised and no tailings have been found outside the perimeter of the South Cell TSF.

Description: Central Dyke is seen here on the left side of the photo. The ditch containing the seeped water is directly behind the pump house shipping containers.

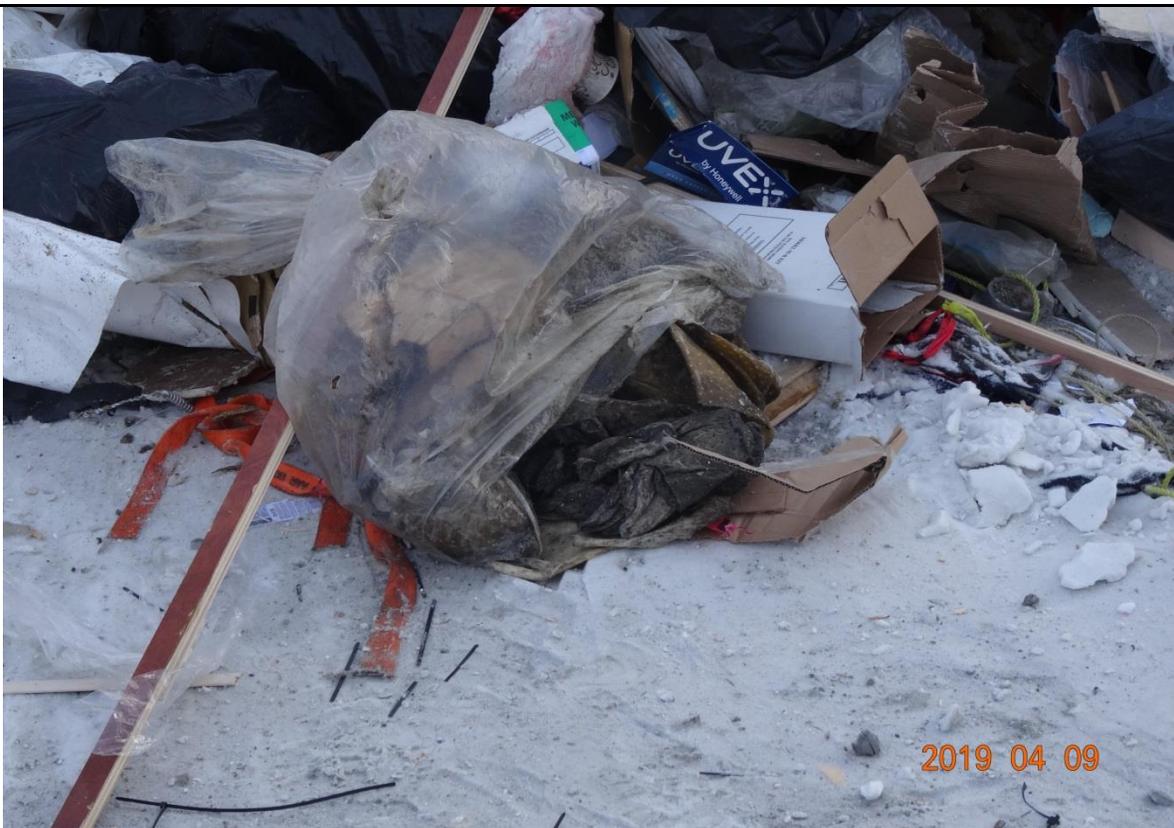
Photo Log # 6

During the inspection of this facility the Inspectors noted unauthorized debris including but not limited to used oil rags, AA batteries, and a miniature insta-berm saturated in what appears to be engine oil (*see photo#6&7*) with in the Landfill. The Inspector is requesting that AEM remove these items from the Landfill as these items would be considered to be hazardous waste.

Description: Oil absorbent pads and used oil rags found within the Landfill

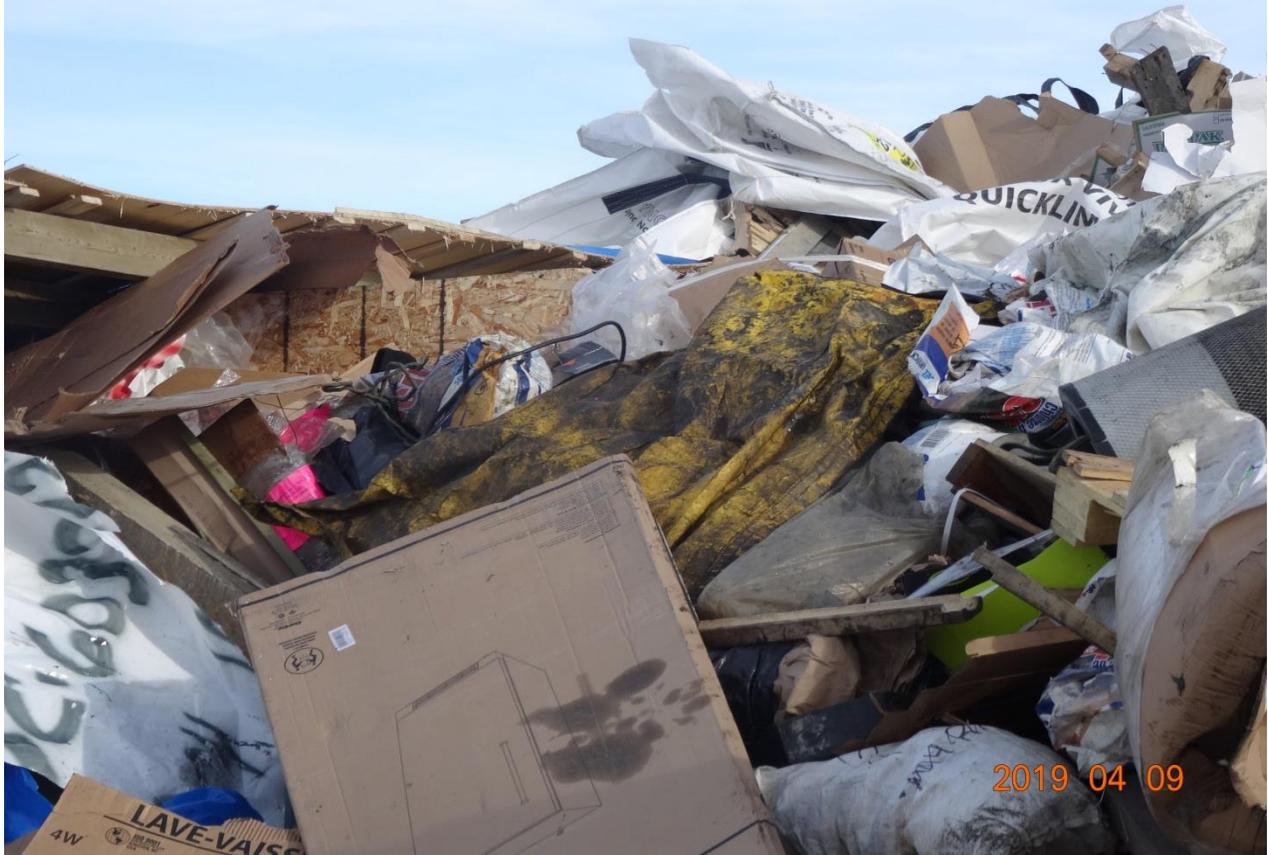
Description: insta-berm saturated in oil within the landfill

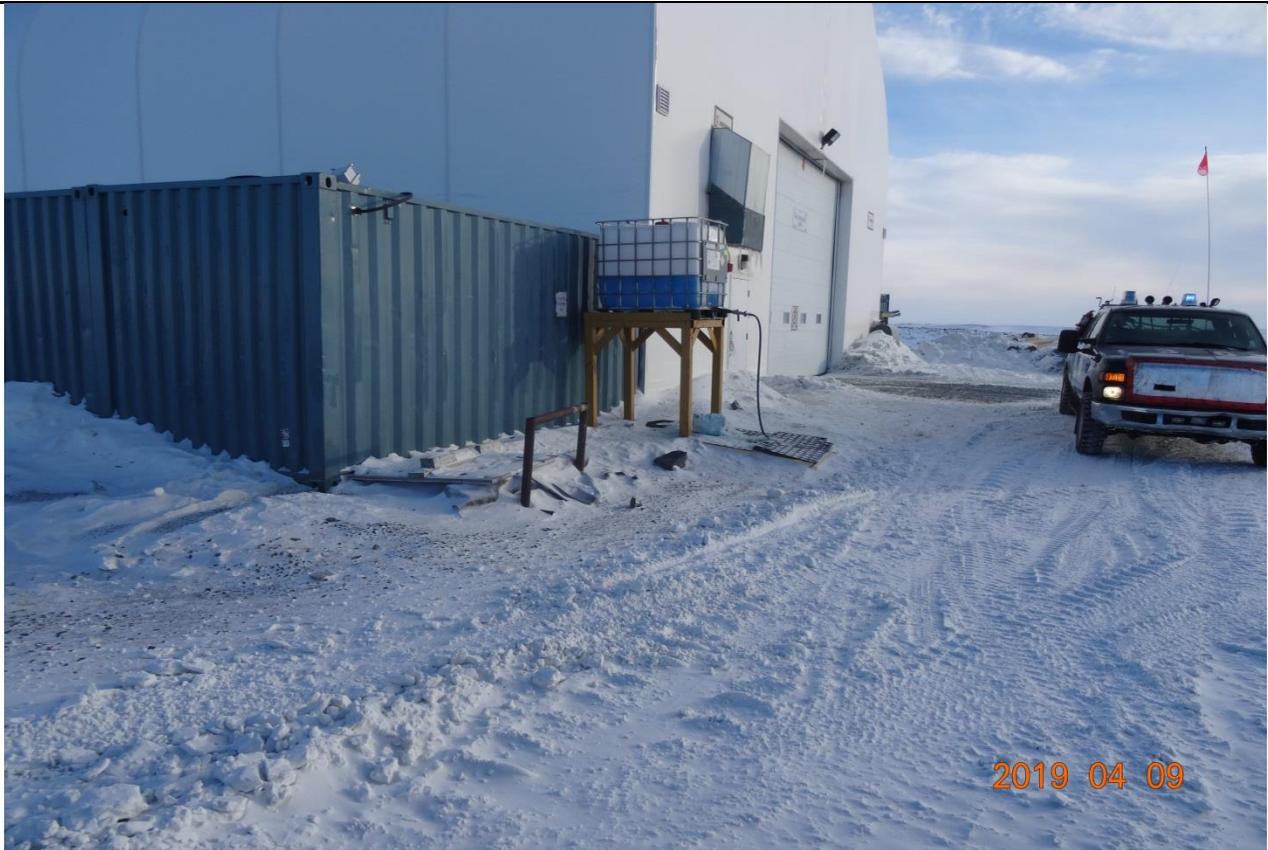
Photo Log # 8

This maintenance shop is located between the Meadowbank and Vault pit. This area is used as a parking lot for heavy equipment, lay down for maintenance vehicles and material. During the inspection the inspectors noted a windshield washer fluid tote raised off the ground for easy access to fill equipment. This tote is within secondary containment but it also has some fluid that leaked on to the ground (see photo#8). The inspectors noted that some fluid is dripping from the heavy equipment vehicles onto the ground throughout the parking area of this facility. It is recommended that this fluid be cleaned up prior to freshet to ensure no unauthorized deposits of waste spread to the surrounding environment.

Description: Vault maintenance shop. Raised windshield washer fluid in secondary containment however, the fluid is still managing to travel outside of containment.

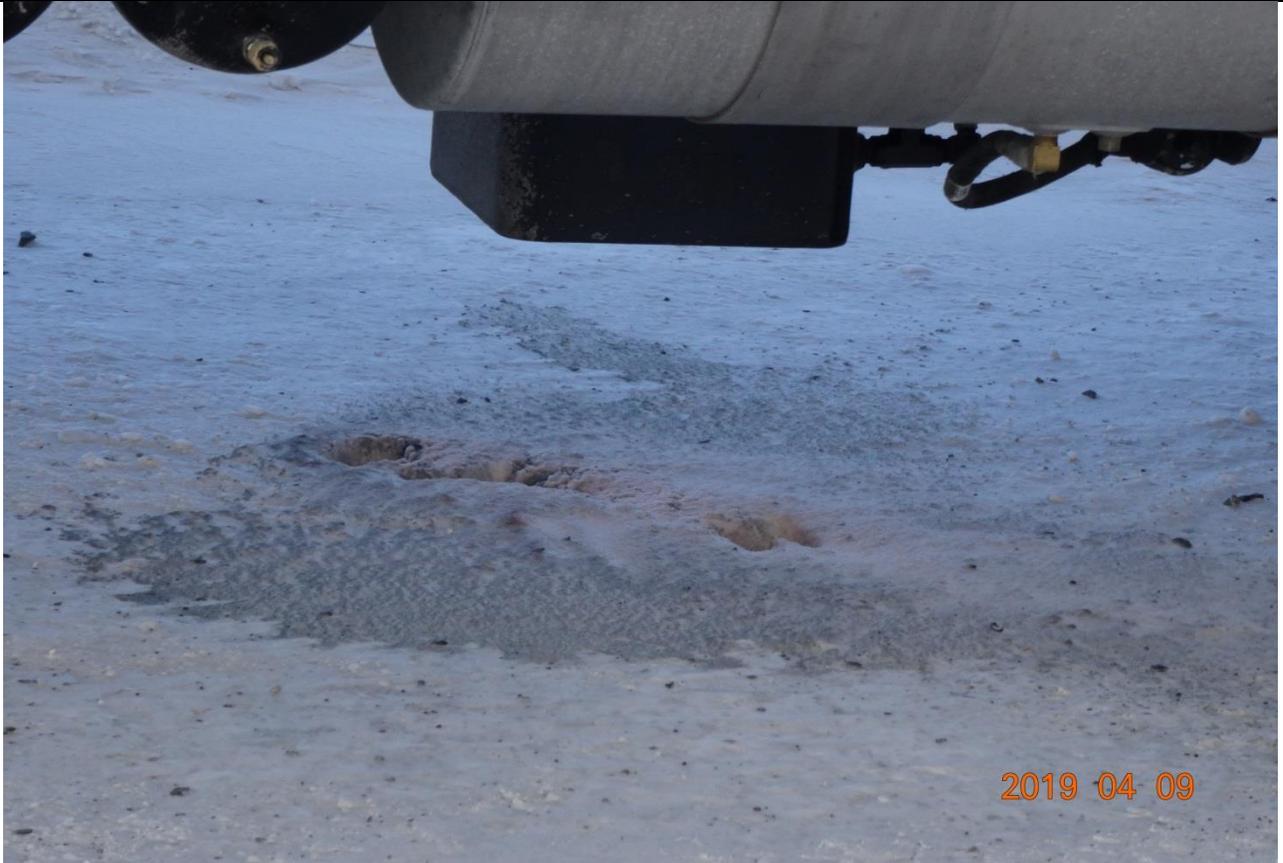
The inspectors visited the FGL contractor's area. This area appears to be in good order however the Inspectors noted oil stains under multiple heavy equipment vehicles.

Description: Stained snow under heavy equipment

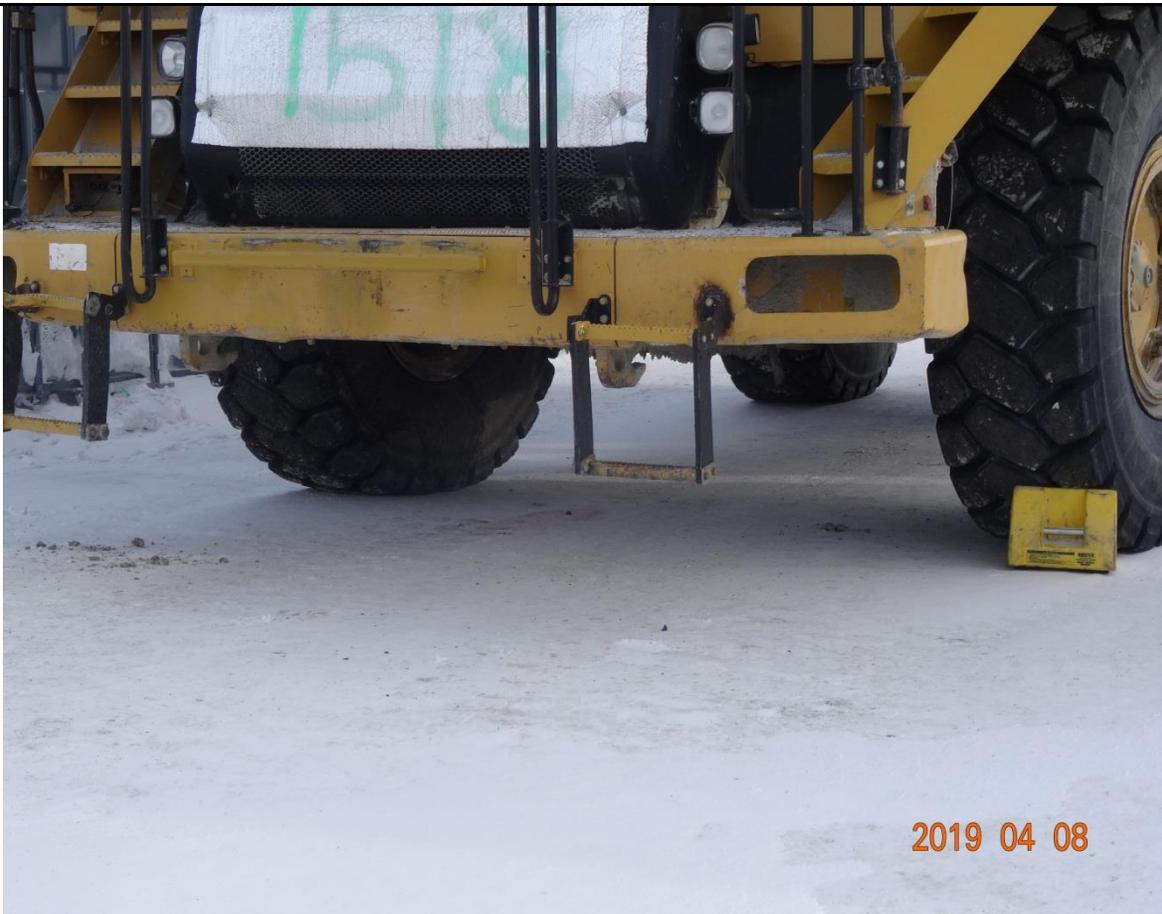
Photo Log # 10

Description: Stained snow under heavy equipment

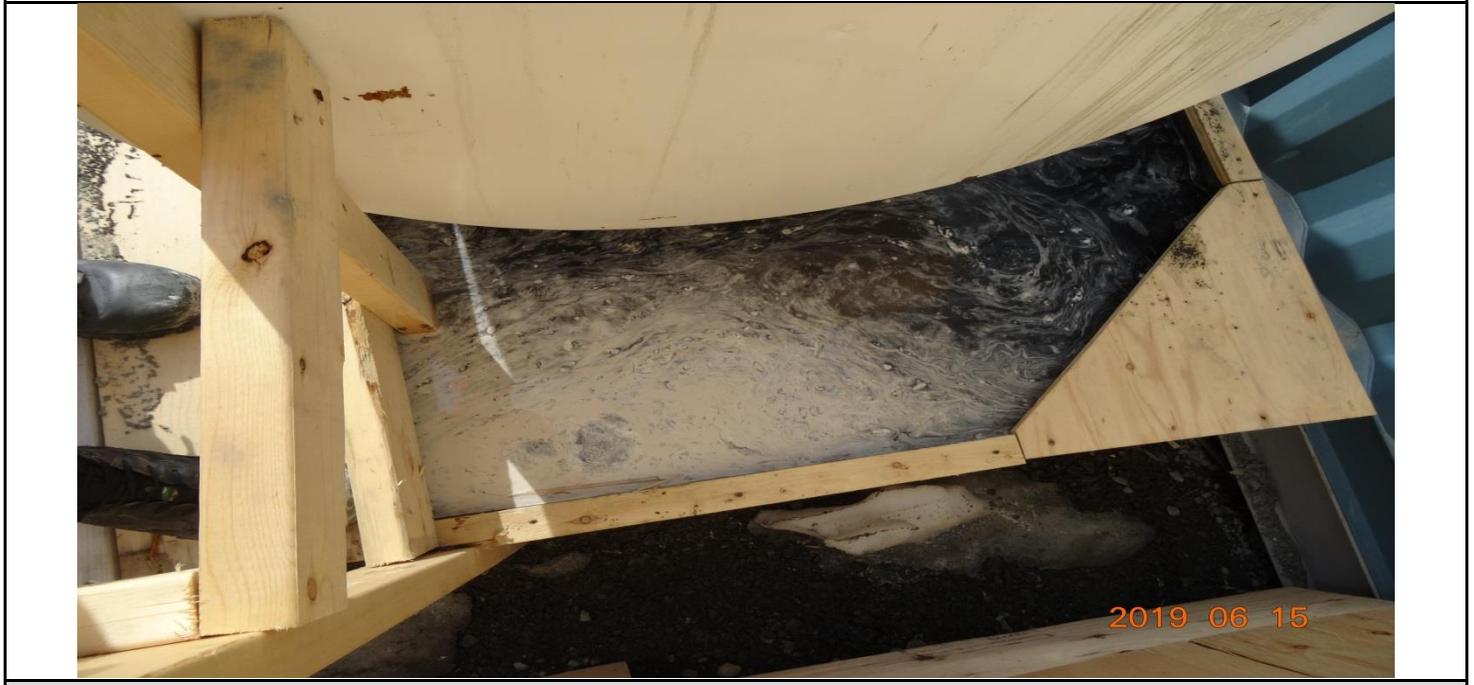
Photo Log # 2	Location (NAD 83 DD MM SS.SS)
Photo #2	N W

Description: white substance found in water in the secondary containment. Containment catchment appears to be at full capacity.

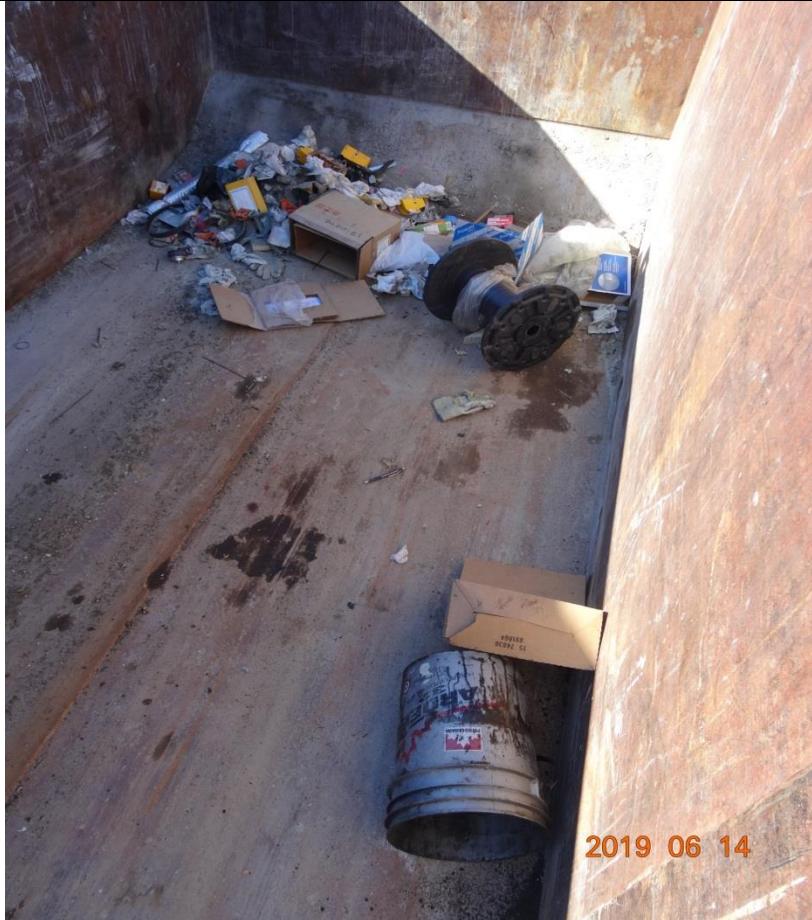
Description: used oil rags and oily bucket found within garbage bins on FGL contractors site

- The inspector is requesting that AEM remove all hazardous material from garbage bins prior to being deposited to the Landfill.

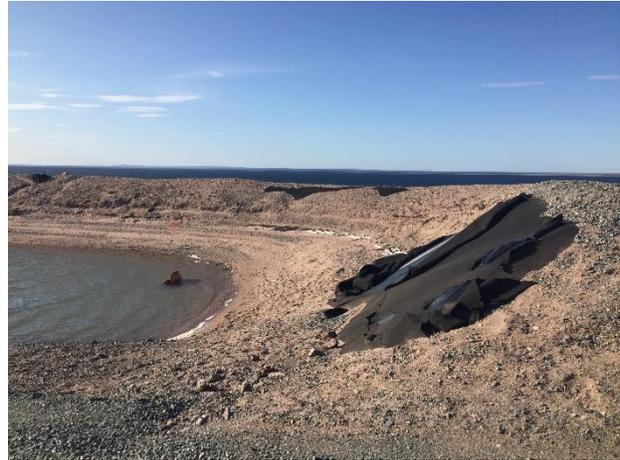
Water was observed within the secondary storage containment facilities for the fuel tank farms but there was no visible sheen on the water or discernable hydrocarbon odours at either the Baker Lake or the Meadowbank site fuel facilities (see [Photo 29](#) to [Photo 32](#)). The liner at the Baker Lake Fuel Storage facility was exposed and it was noted by Agnico Eagle staff that this may be due to the amount of rainfall over the summer that washed away the gravel that usually covers the liner. No indication was provided on whether or not the liner would be fixed or covered with gravel.

Photo 30: Exposed Liner at the Baker Lake Fuel Tank Farm

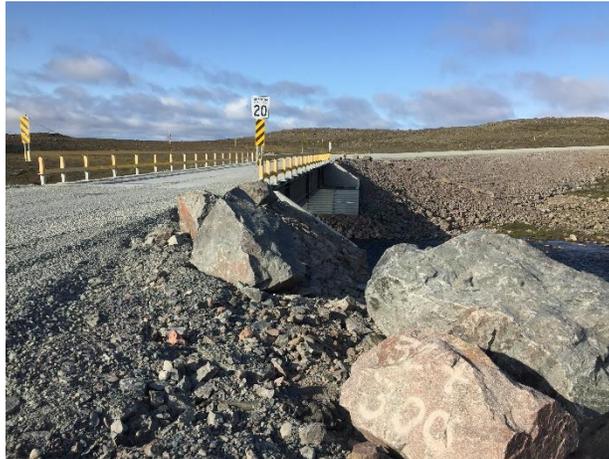
pads, and other miscellaneous spill response equipment are anticipated to be located at all the bridges in the coming year.

Photo 37: Spill response equipment not observed at one of the bridges along the Amaruq Haul-road

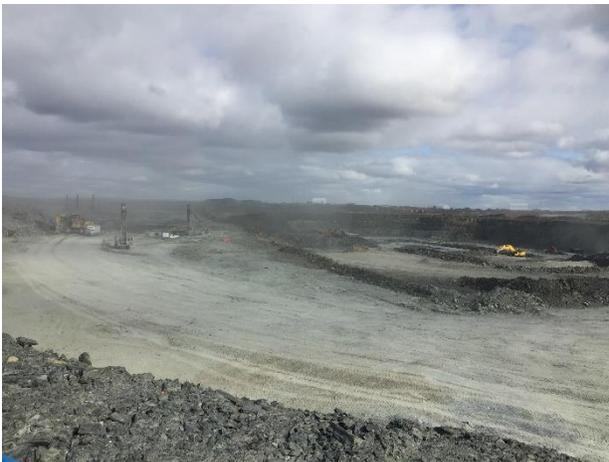
During the site visit, it was noted that dust suppressants were not being applied to the whole AWAR (see [Section 3.2.3.2](#) for further discussion), along the haul-road to the Whale Tail site nor at the Whale Tail site. Agnico Eagle noted that water is the only dust suppressant being used along the Haul-road; however, none was applied due to the heavy rains received. Further, it was observed during the site visit that no dust suppressants were applied at the Whale Tail site including at the North Basin Pit which was later confirmed by the Agnico Eagle staff (see [Photo 41](#), [Photo 49](#) and [Photo 50](#)). The reason for not applying suppressants at the time was due to the heavy rains received in August. Dust monitoring continues to be conducted along multiple stations along the Haul-road which was observed during the site visit (see [Photo 51](#)).

Photo 49: Dust over the North Basin Pit

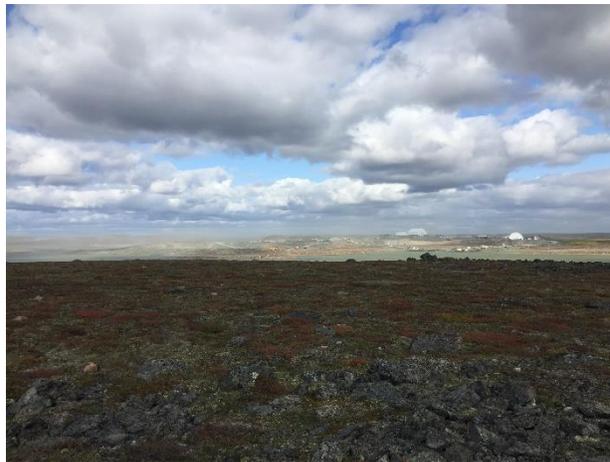
Photo 50: Dust over the Whale Tail site
