# **Meadowbank 2019 Annual Geotechnical Inspection**

# 2019 Annual Geotechnical Inspection

*Meadowbank Gold Mine, Nunavut*

19123067-1588-R-Rev0

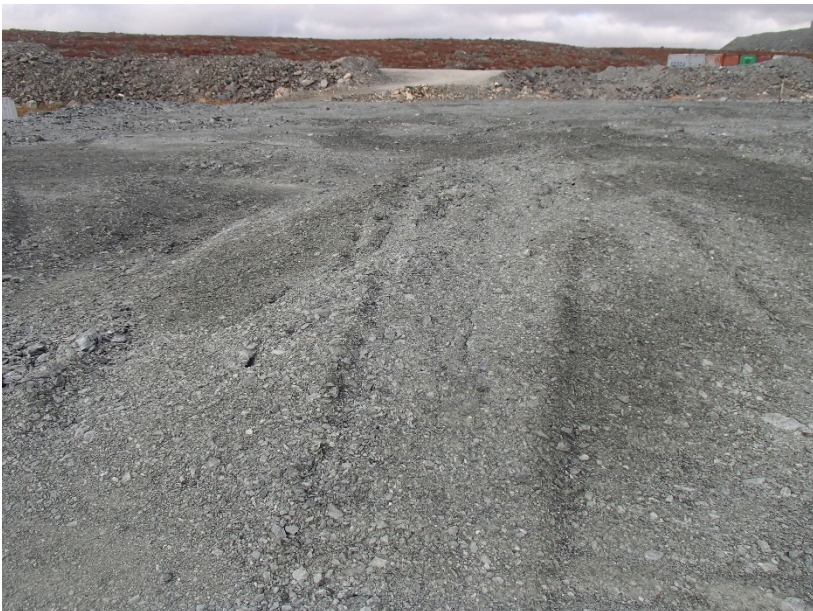
**Photograph A3-42 Bay Goose Dike**

**Description:** From approximately Sta. 32+025 (south abutment) looking east at the crest. Zone of high magnitude settlement in the ultramafic cap. The tension cracks seem no longer active.

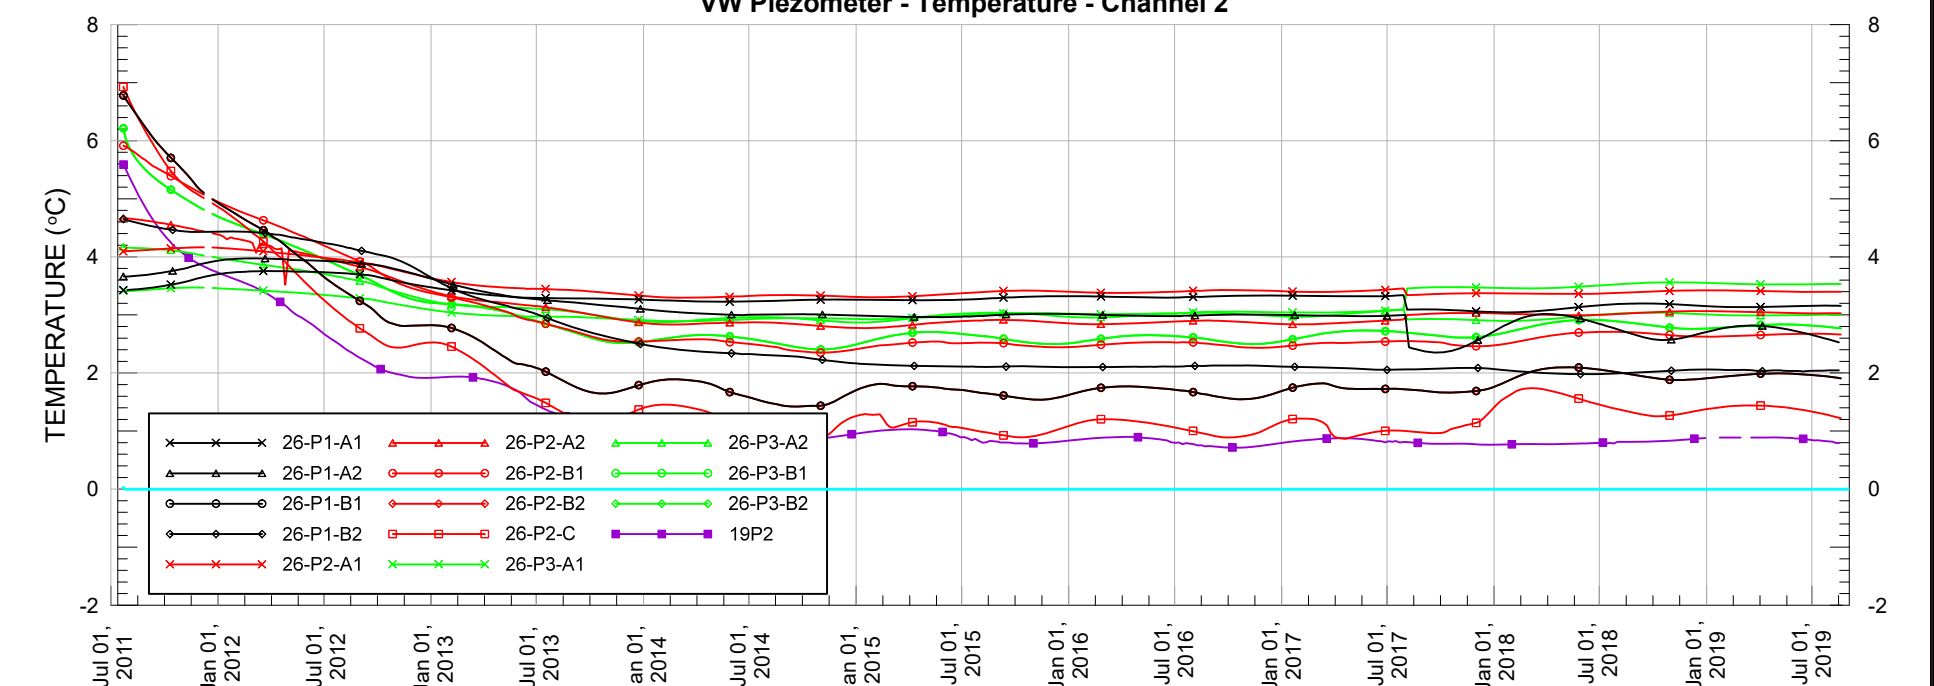
**VW Piezometer - Temperature - Channel 2**

**NOTES:**  
 1. The rise in temperature and PWP was interpreted as the permafrost at the toe of the dike blocking the seepage path which led to this events. Will continue to monitor in the field and the instruments. Now that ice has melted the PWP has decreased as the seepage path is no longer blocked.

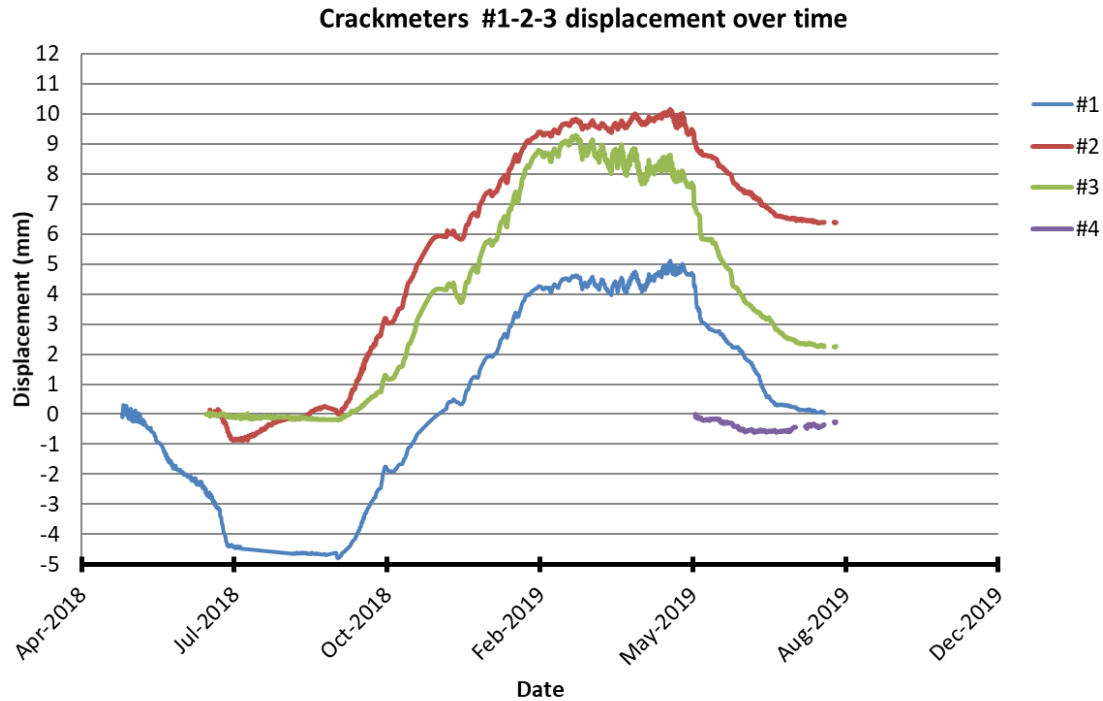
## Crackmeter 1-2-3 (10+ 975)

All of the crackmeter are showing stable result without significant trend during the past month. All of them have been disable by wildlife during the period and were repaired. However, crackmeter # 1 is still not functioning. We will repair it again.

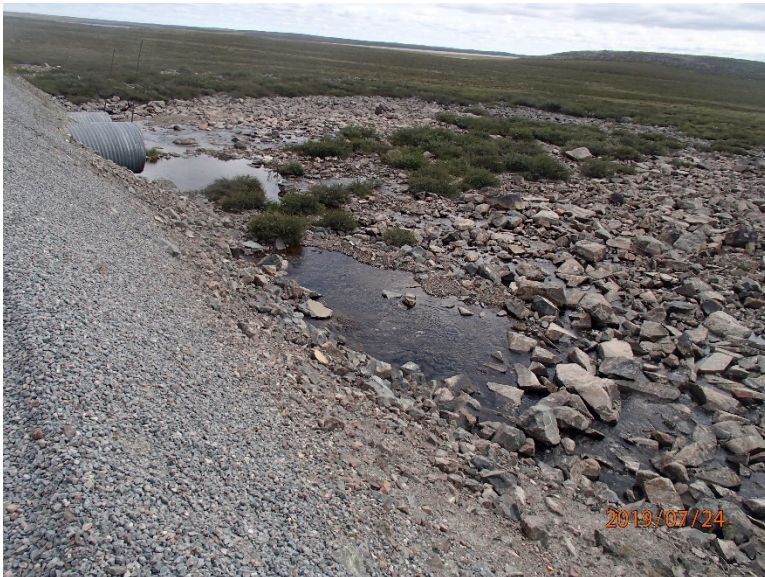
**Photograph D2-2: PC-17A km 8+830**

**Description:** View of the culvert outlet. Good condition.

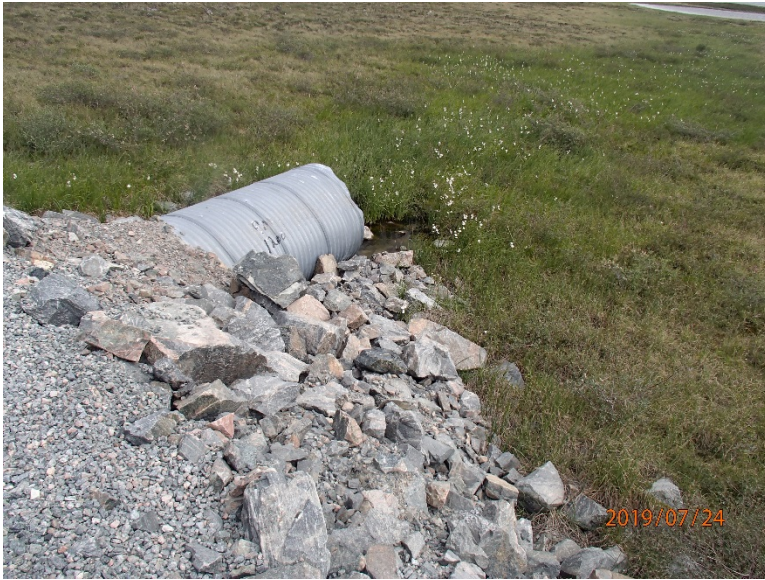
**Photograph D2-3 R-04 km 12+050**

**Description:** View of the culverts outlet. No sign of degradation since last year but the flow moved further south (5-10 m from culvert).

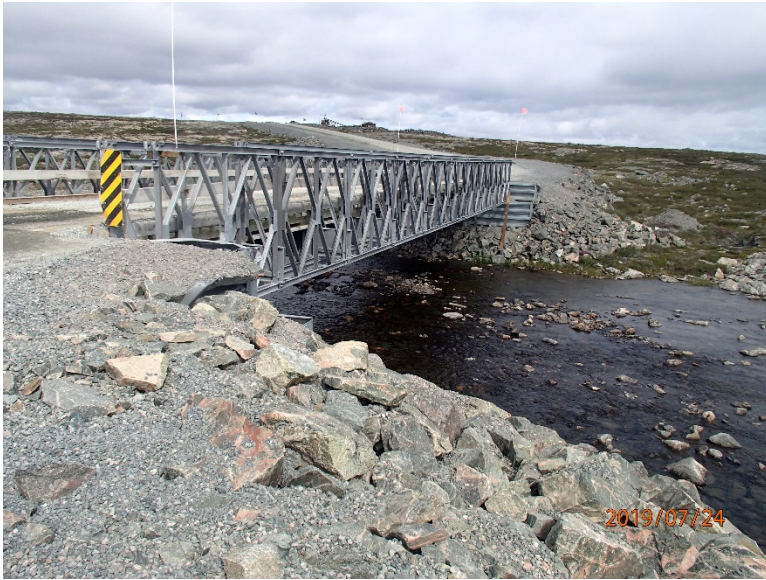
**Photograph D3-5 Bridges 3 – R06 km 23+100**

**Description:** Looking at the south abutment. Minor damage to the bin wall.

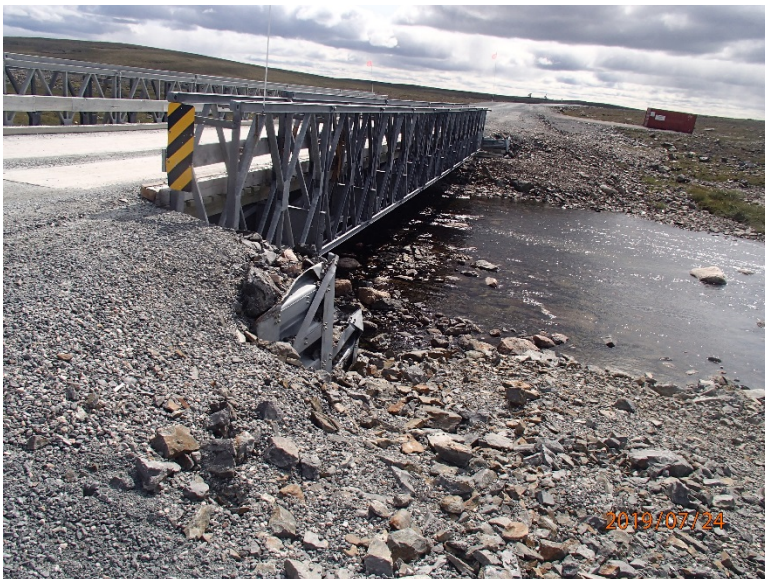
**Photograph D3-10 Bridges 5 – R15 km 69+200**

**Description:** Looking at the north abutment. Damage to the bin wall likely caused during snow removal activities. Bridge is tipping toward the west side on the abutment.

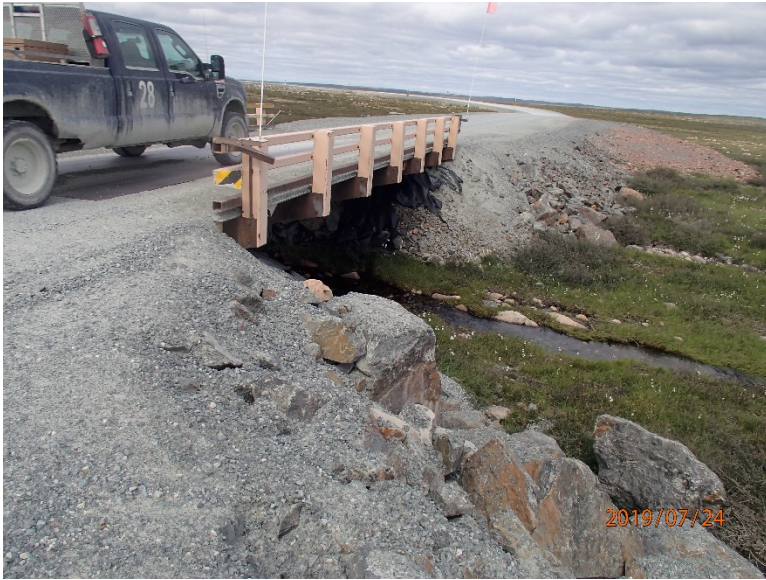
**Photograph D3-11 Bridges 6 – R16 km 73+800**

**Description:** Looking at the south abutment. Damage to the bin wall likely caused during snow removal activities. Bridge is tipping toward the west side on the abutment.

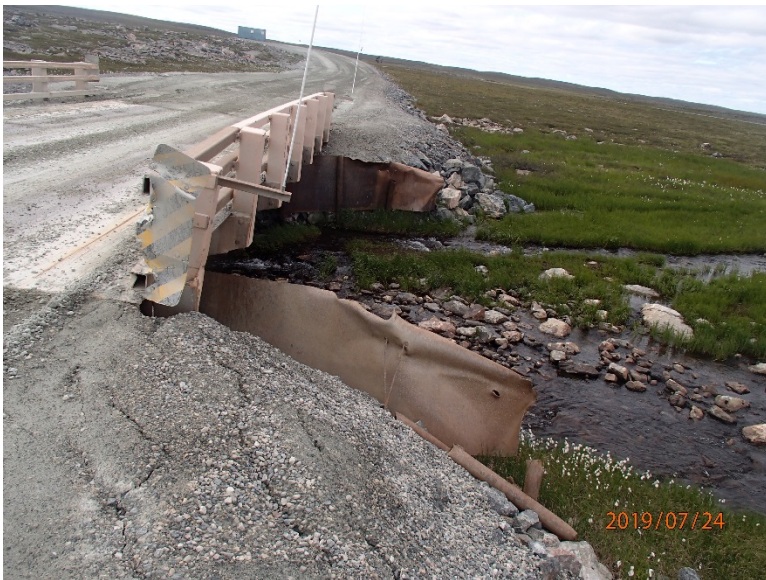
**Photograph D3-16 Bridges 8 – R19 km 83+150**

**Description:** Looking at the north abutment. Minor damage to steel plate due to snow removal activity.

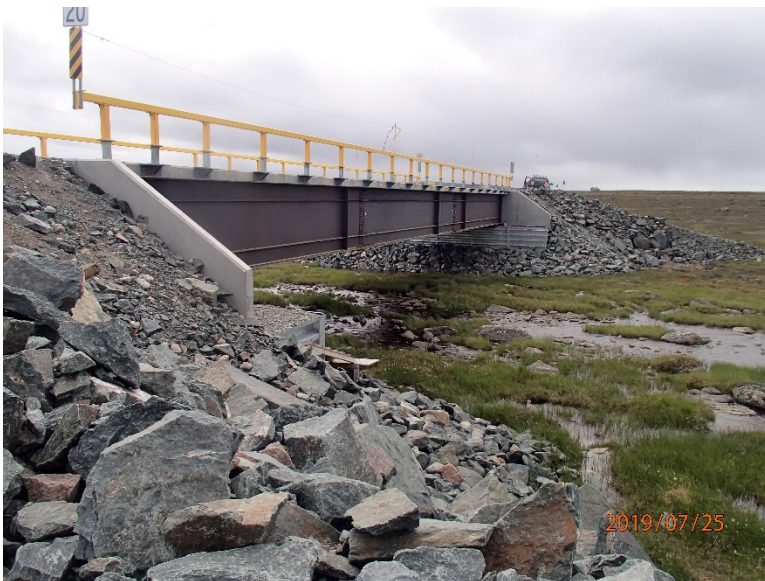
**Photograph E3-18 Bridges 9 – km 44+800**

**Description:** Looking at the north abutment. A crack is present in the concrete on the western side.

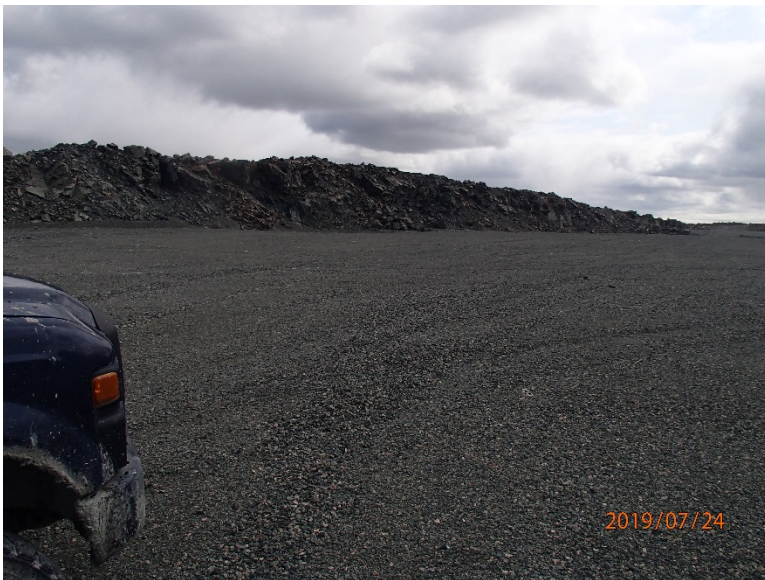
**Photograph F-4: Quarry 3 – km 23+700**

**Description:** View of west wall. In good and stable condition but would need additional cleaning locally.

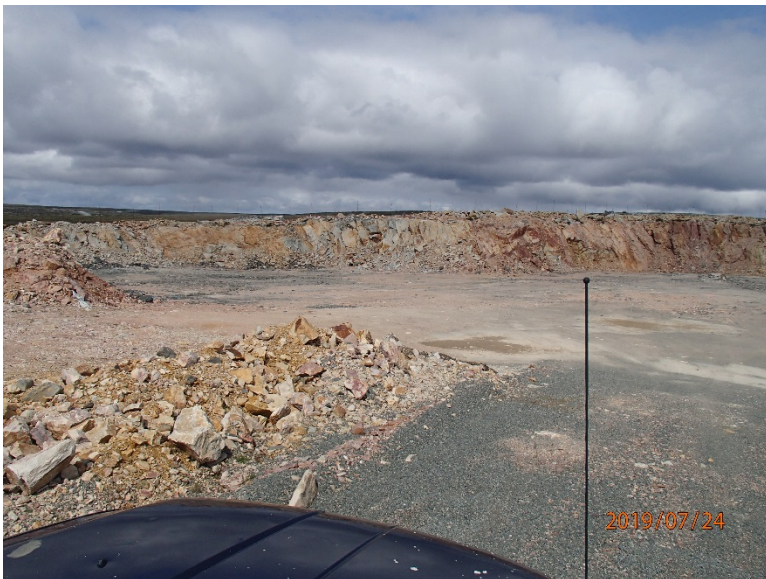
**Photograph F-8: Quarry 5 – km 34+650**

**Description:** View of north and east walls. Rock walls are in good and stable condition, except for a small portion on the east side.

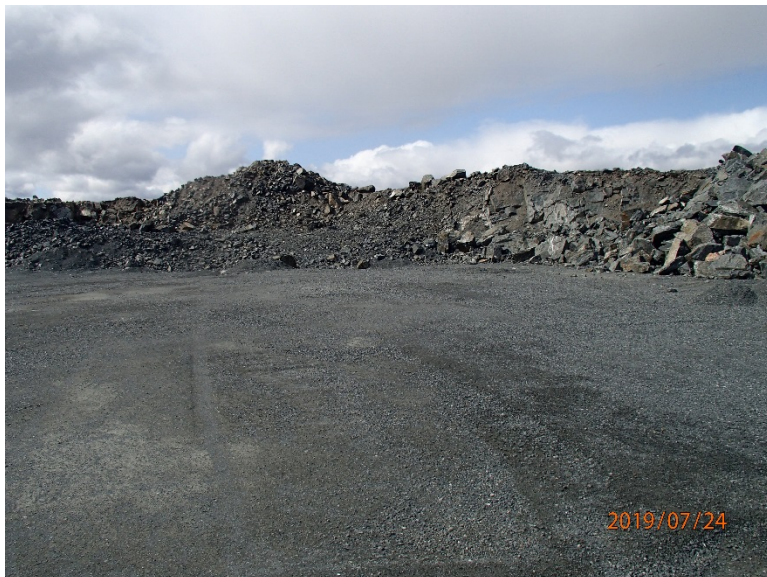
**Photograph F-12: Quarry 8 – km 42+950**

**Description:** The quarry walls are in unstable condition. Scaling is recommended before resuming activities..

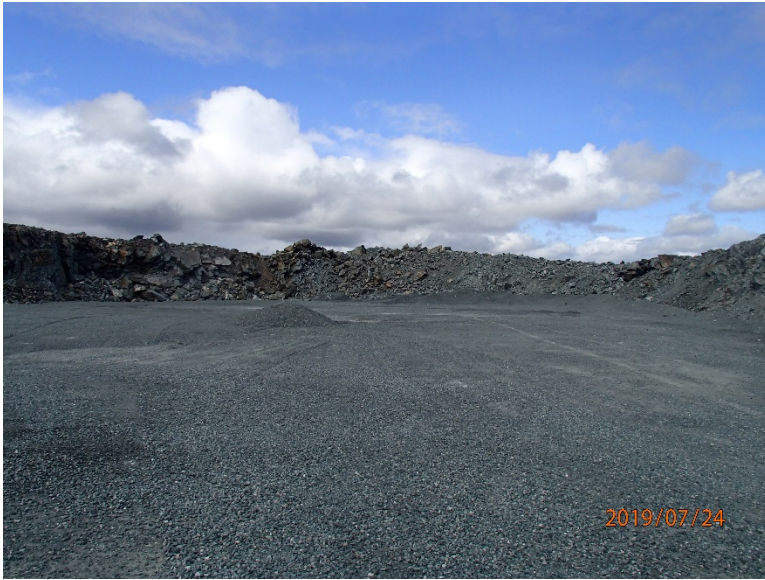
**Photograph F-15: Quarry 9 – km 44+600**

**Description:** View of west and south walls. Presence of loose blocks at the base of the wall.

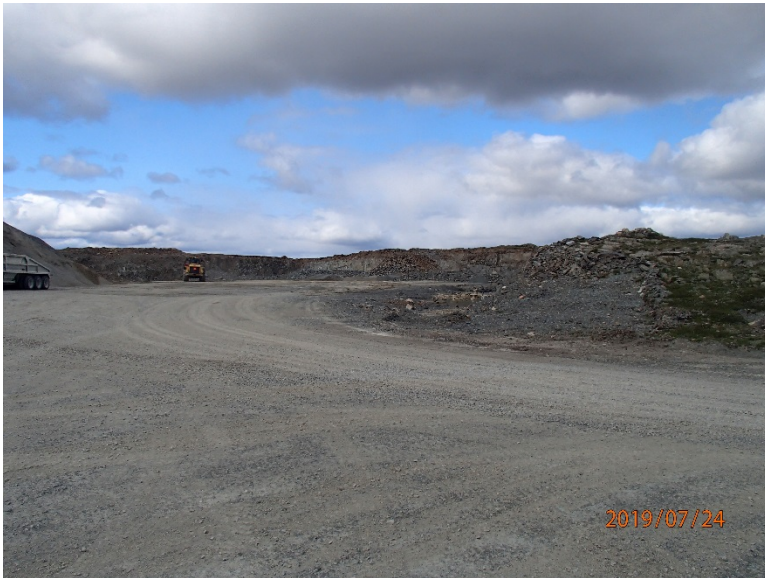
**Photograph F-16: Quarry 11 – km 53+500**

**Description:** View of north and east walls. View of a pile of loose material.

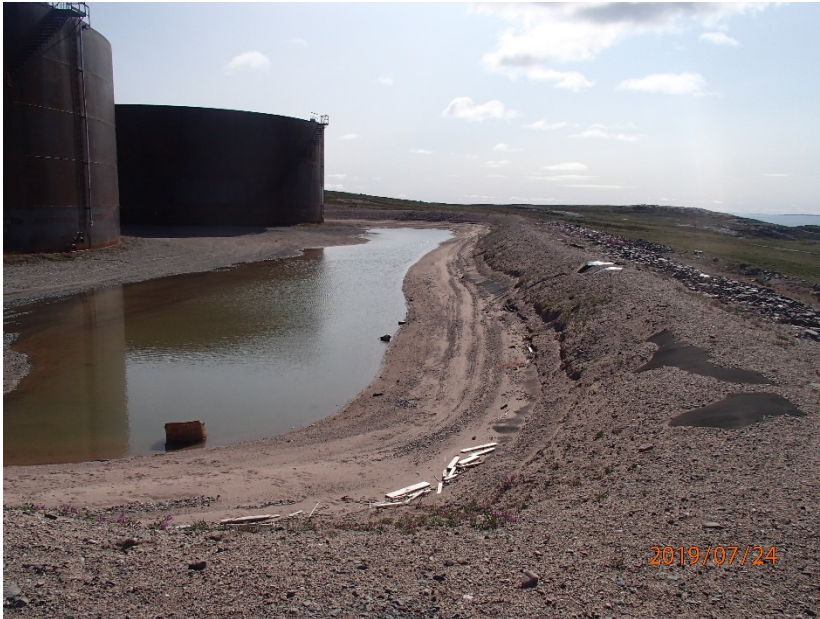
**Photograph G1-7 Baker Lake Tank Farm**

**Description:** Looking southwest. The geomembrane between the south side of tank 2 and 3 is damaged.

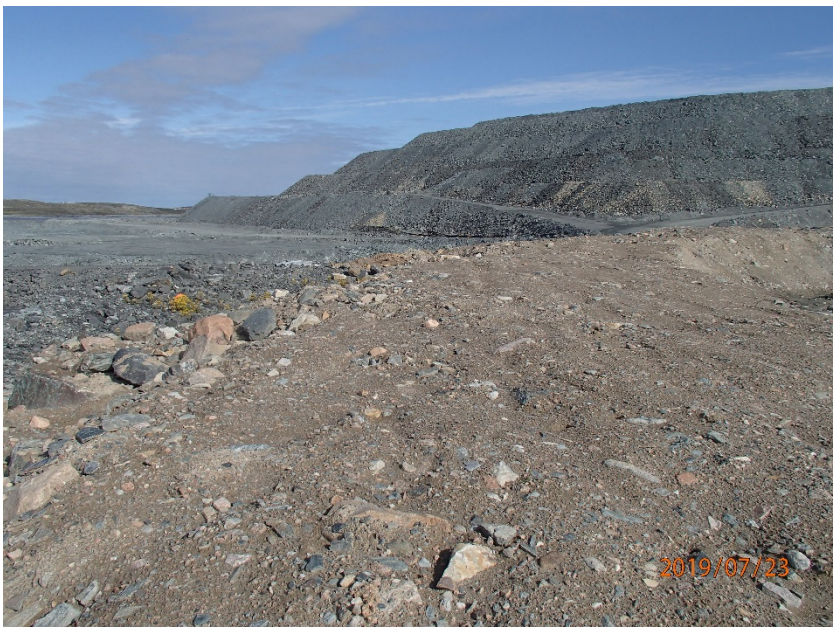
**Photograph H5-2 Contaminated Soil Storage and Bioremedial Landfarm Facility**

**Description:** From the northeast extremity of the South Cell, looking southeast at the Contaminated Soil Storage and Bioremedial Landfarm Facility. Signs of superficial slope failure are disappearing.
