Meadowbank MDRB Meeting No 24 + Agnico responses

October 24th, 2018

Report No 24A
Meadowbank Mine Dike Review Board
Meeting September 24-27, 2018

RESPONSE TO COMMENTS, MEADOWBANK DIKE REVIEW BOARD No.24 – MEADOWBANK REPORT

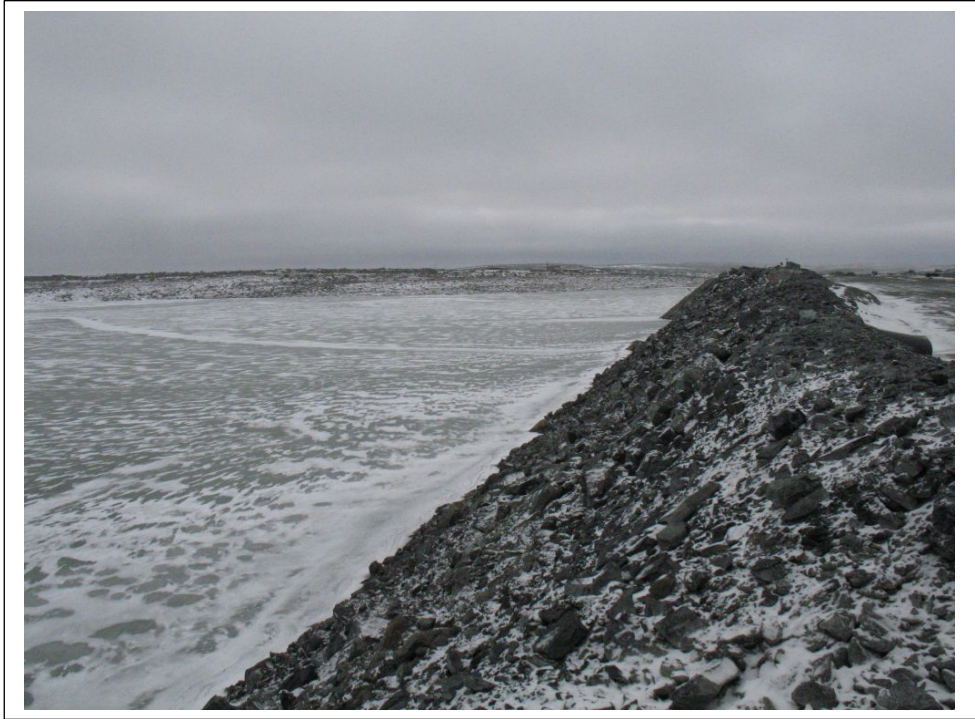
Photo No. 1 South cell supernatant pond at toe of Stormwater dike. View to West.

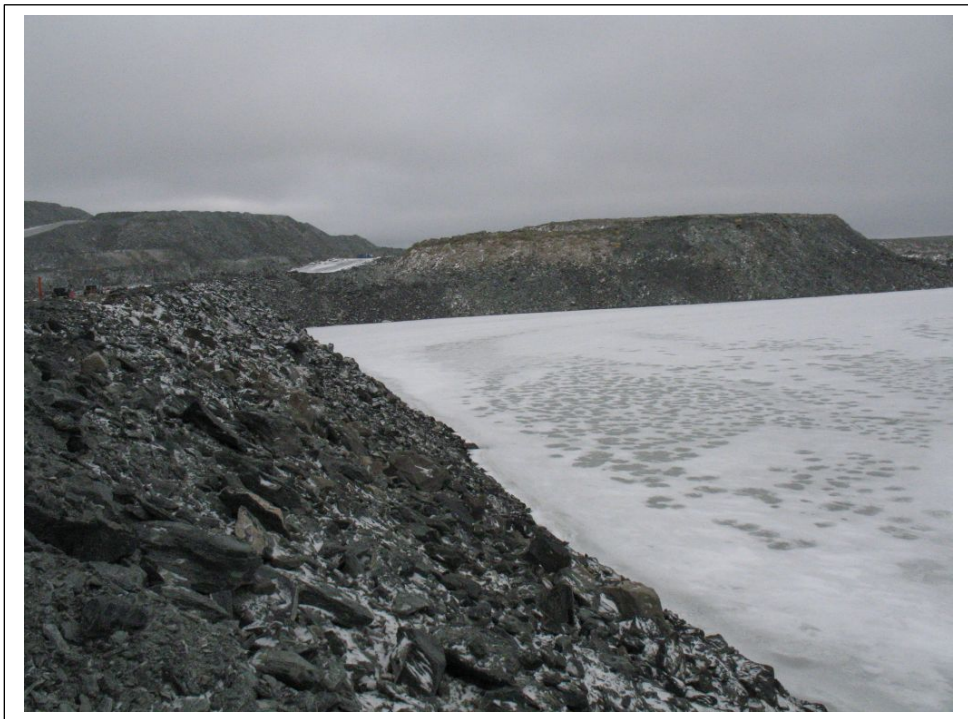
Photo No. 2 South cell supernatant pond at toe of Stormwater dike. View to East.

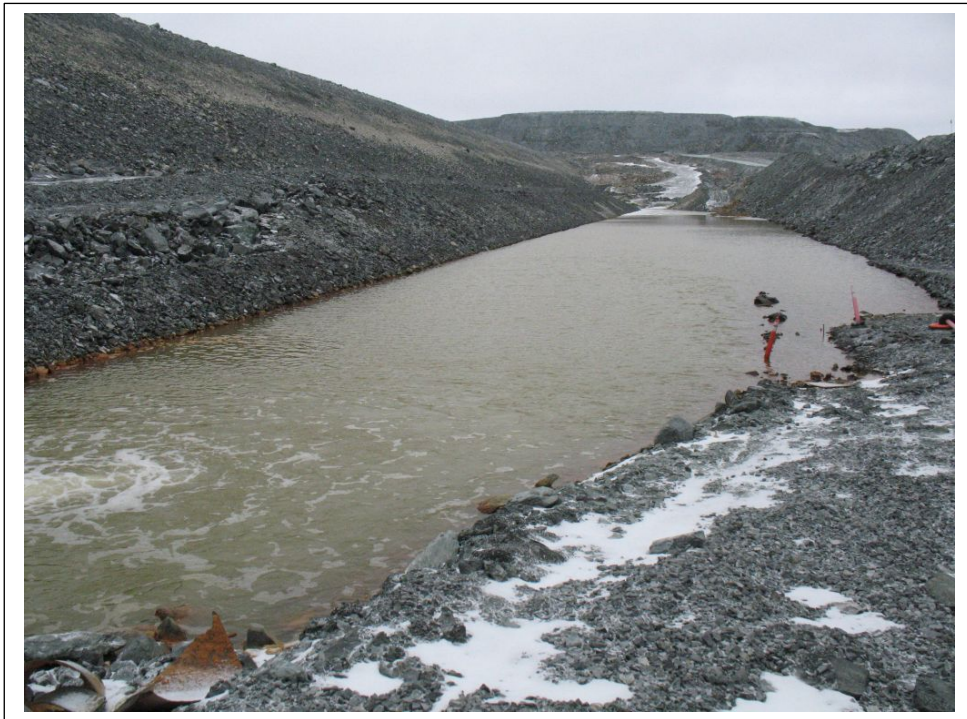
The Board was advised of the temperature related re-appearance of orange coloured chemical/bacteriological deposits in the seepage collection pond at the Central Dike toe. These were visible at the time of the visit (Photo #4).

Photo No. 4 Pool downstream of Central Dike

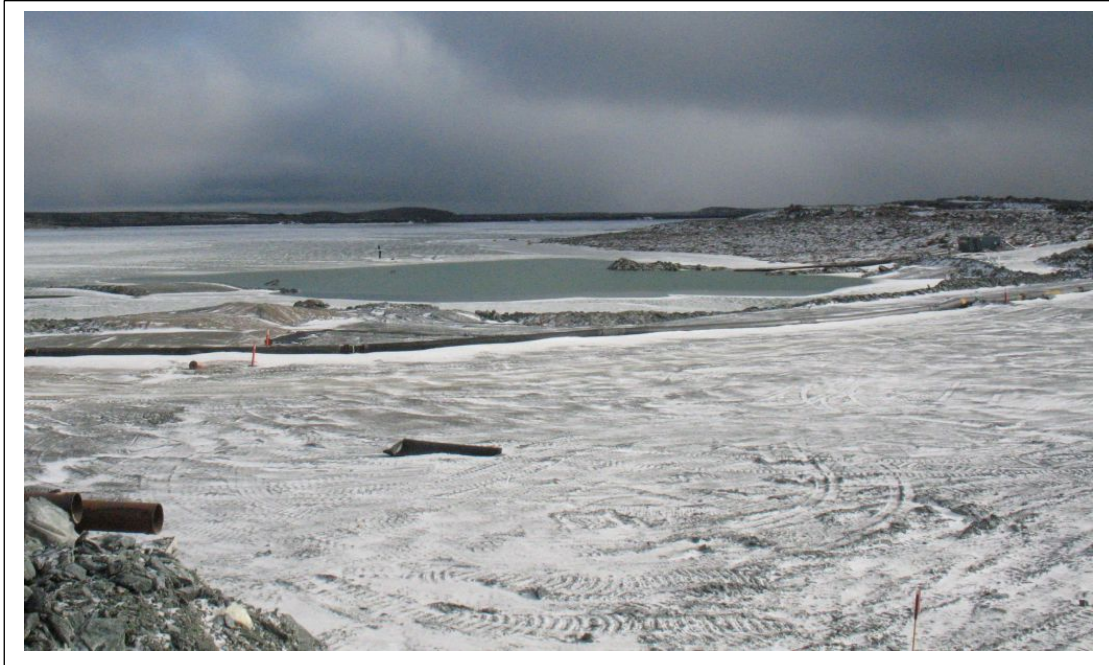
- Enhance the tailings cover on the south bank;
- Ensure beach protection of the Central Dike liner;
- Place material to the extent possible against the Stormwater dike toe;
- Establish the supernatant pond in the North-West corner to facilitate closure; and
- Ensure that, in the meantime, tailings do not compromise the functioning of the reclaim water pump intake (Photo # 5).

Photo No. 5 Reclaim water pump. Saddle Dam 3 in foreground

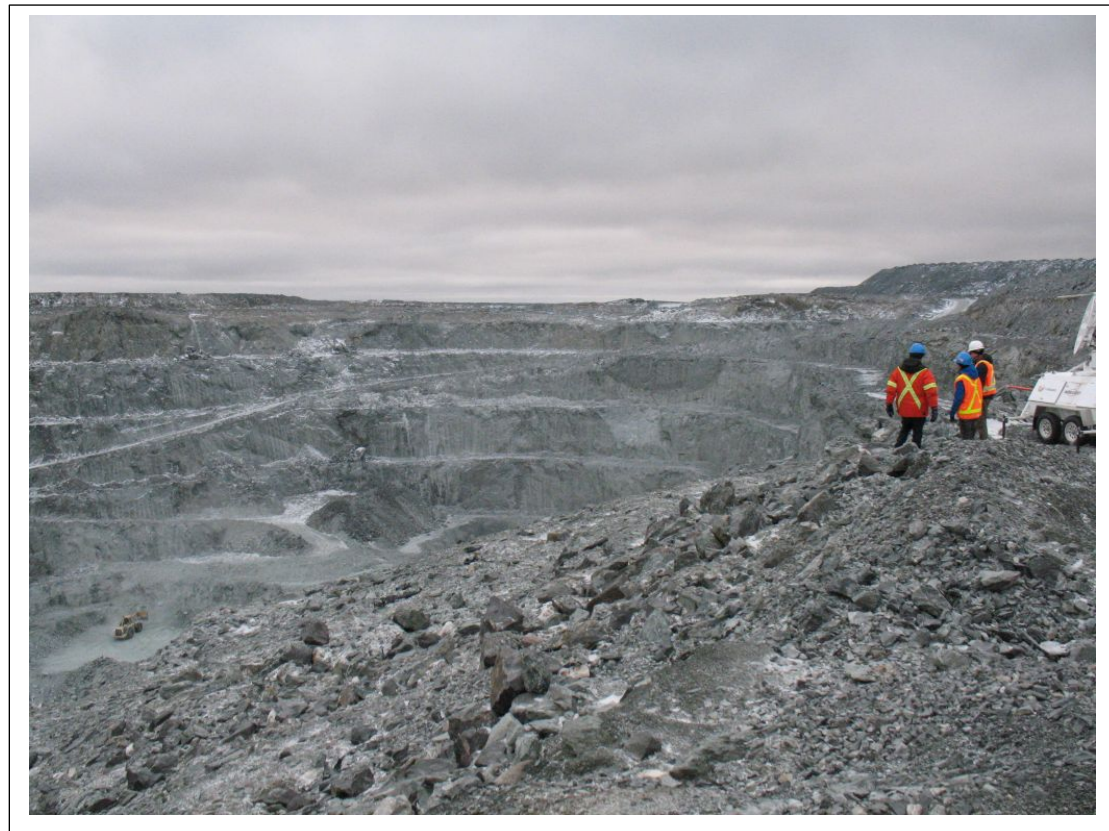
The monitoring by AEM continues to be of good standard including the use of radar for early indication of any movement. Rock falls continue to occur particularly in the ultramafic formations in Portage Pit E but overall pit slope performance is judged to be good. (see photo #6)

Photo No. 6 Push back area of Portage Pit E. Radar movement detector at right.

The Board recommends that the experiences with the management of pit slope stability, and particularly the history of the radar predictions of rock falls, be documented as a technical guide for future regional mining activities in similar geologic domains.
