**Report: 2017 Annual Geotechnical Inspection**

February 2018

# 2017 Annual Geotechnical Inspection Meadowbank Gold Mine, Nunavut

**Report Number:** 1784282-1574-RPT-Rev0

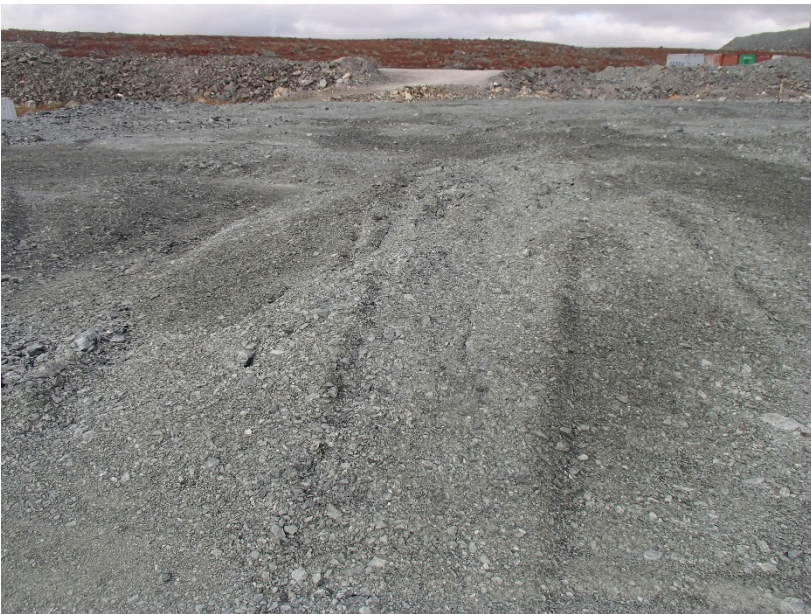
*Photograph A3-46 Bay Goose Dike*

**Description:** From approximately Sta. 32+025 (south abutment) looking east at the crest. Zone of high magnitude settlement in the ultramafic cap. The tension cracks seem no longer active.

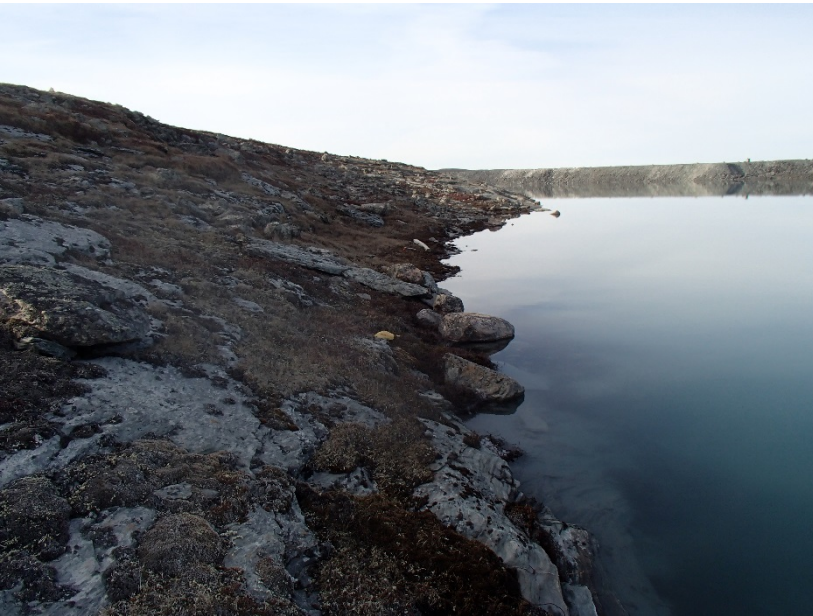
*Photograph B1-22 Tailings Storage Facility*

**Description:** View of the bedrock on the northwestern extremity Saddle Dam 4. Important surface cracks are visible.

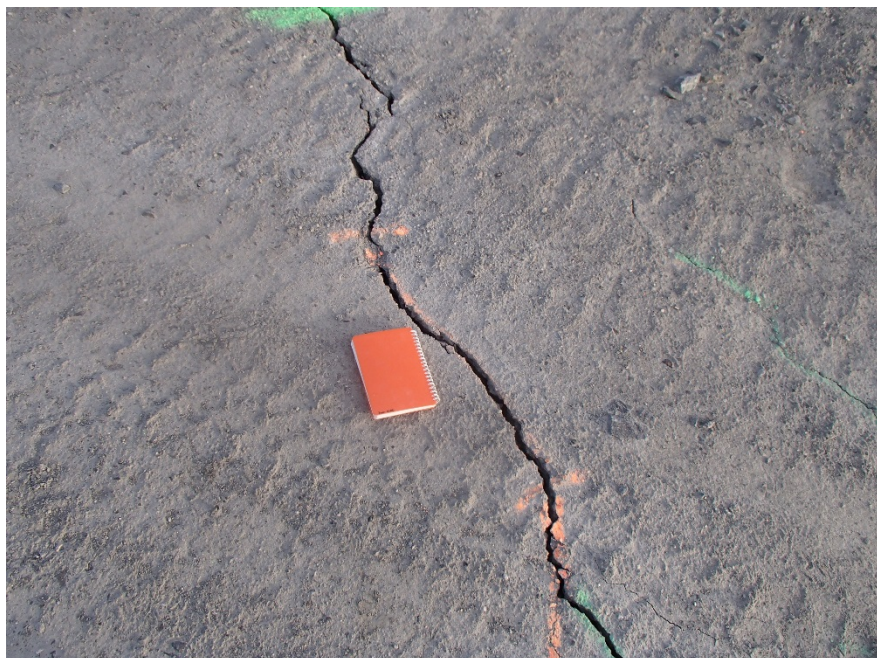
*Photograph B7-8 Stormwater Dike*

**Description:** From approximately Sta. 11+075, looking southwest at the downstream slope. Oblique tension fractures extending from side to side of the dike are present in this zone.

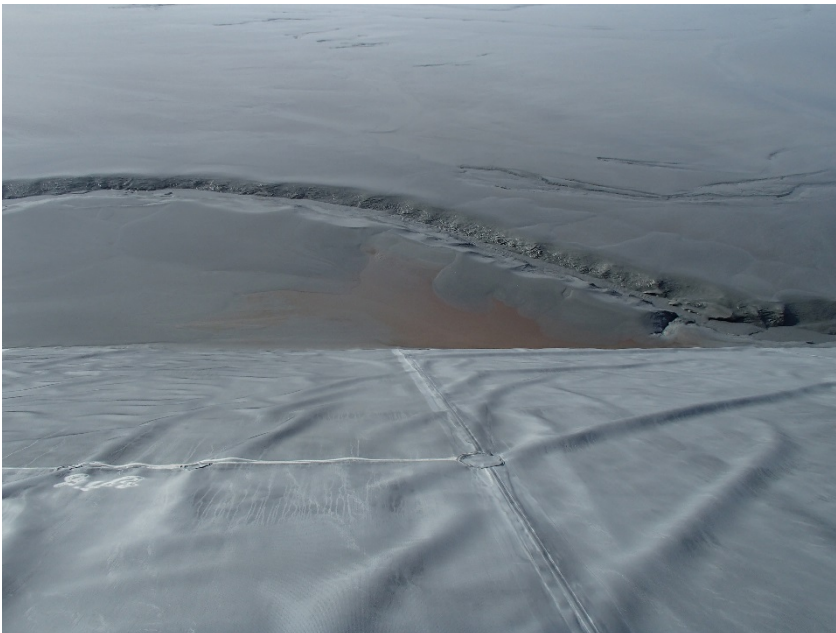
*Photograph B7-4 Central Dike and Saddle Dam 5*

**Description:** From approximately Sta. 0+370 looking west at one of the deposition points. The Teranap is damaged and some material has been eroded. The LLDPE liner has not been affected.

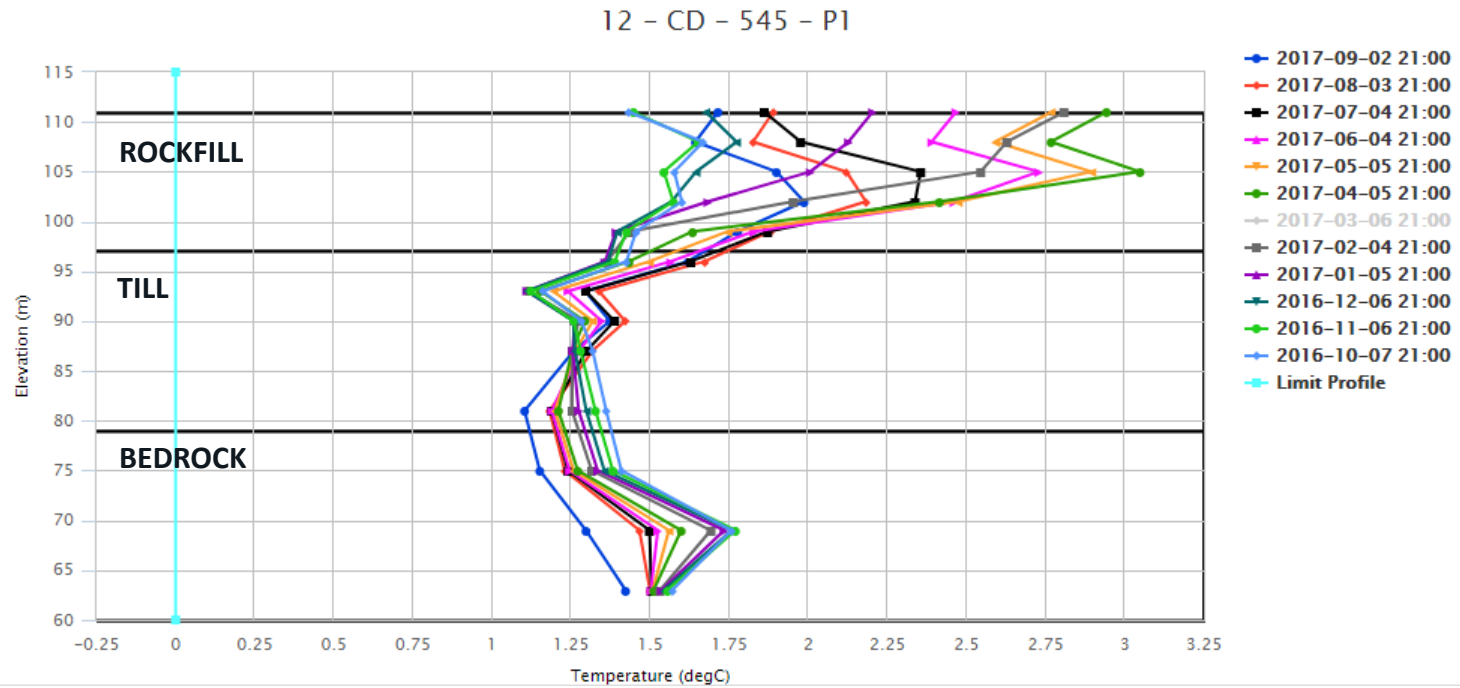
# THERMISTOR 545-P1

- 545-P1 thermistor is showing the same temperature profile than last year. Warmer peak observed at elevation 70m since the installation.
- Temperature in the bedrock/till unit is in between 1.1 and 1.75° C.

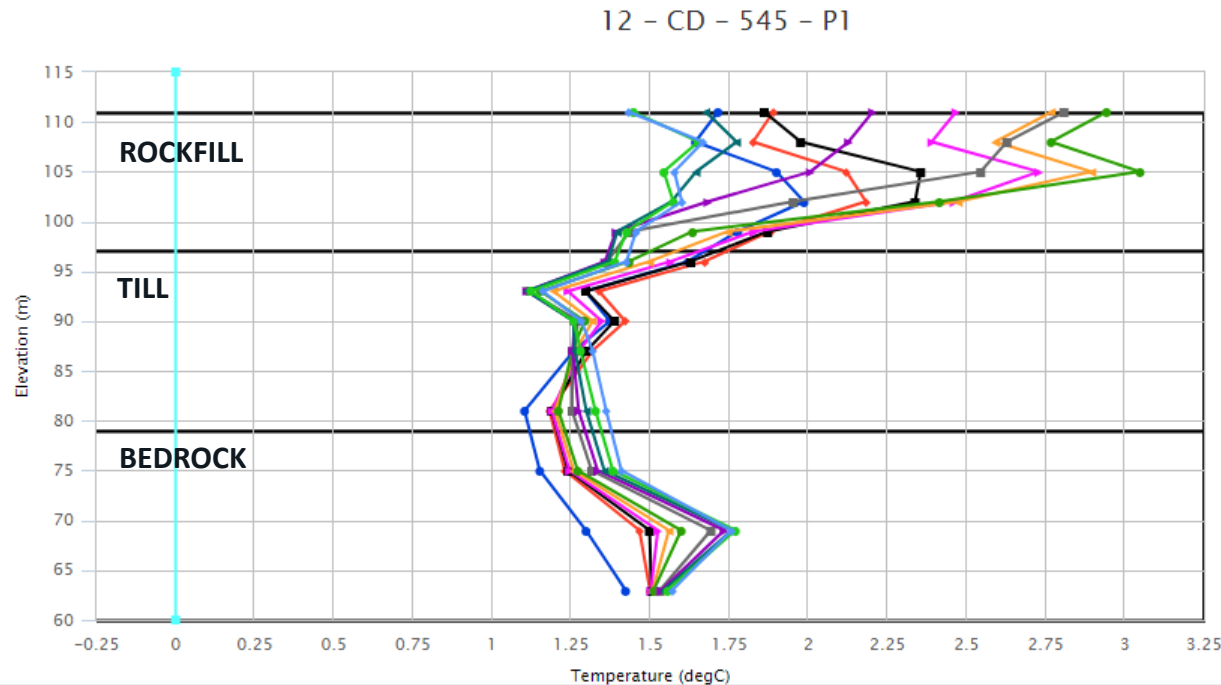
# THERMISTOR 545-P1

- 545-P1 thermistor is showing the same temperature profile than last year. Warmer peak observed at elevation 70m since the installation.
- Temperature in the bedrock/till unit is in between 1.1 and 1.75° C.

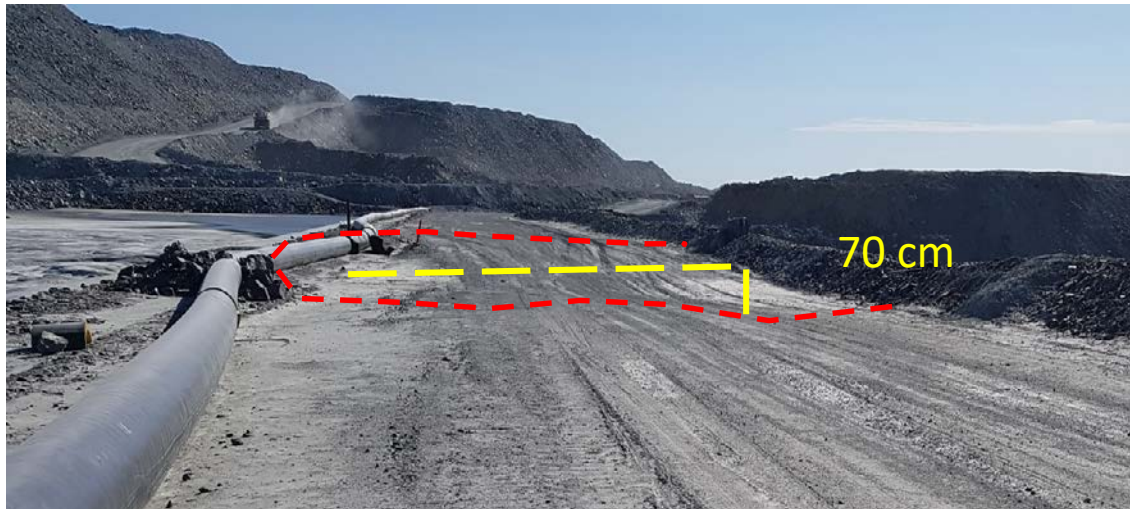
GRID REFERENCE: NAD 83, UTM ZONE 14.

- ➔ Observed initially on July 5th 2017
- ➔ Depression present in previous year but deeper and larger amplitude this year
- ➔ Cracks were not present before

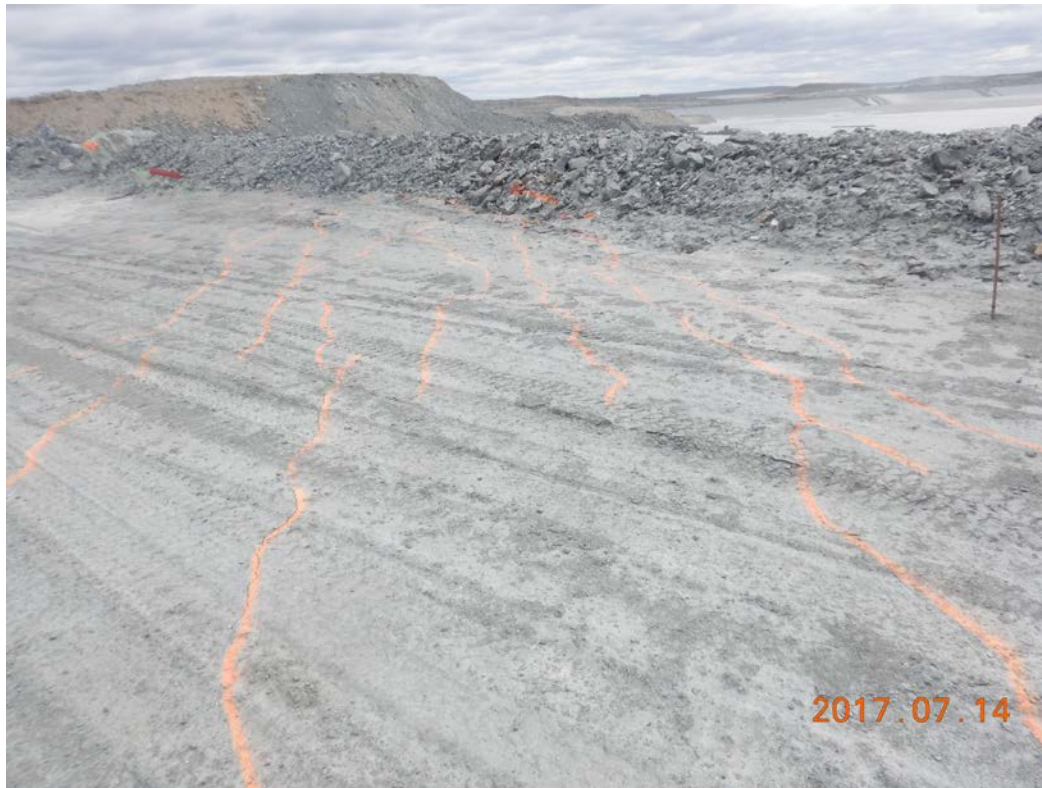
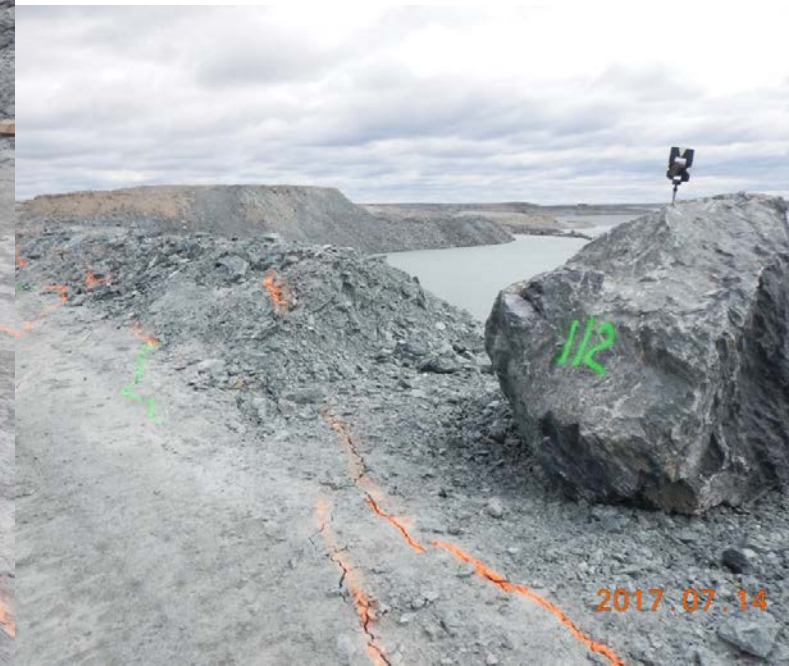
# PICTURE OF MOVEMENT – 10+800 TO 10+950

- Cracks crossing the crest at 40° from CL
  - Did not progressed much during summer
- Longitudinal cracks along the crest
  - Constantly opened to up to 5cm wide

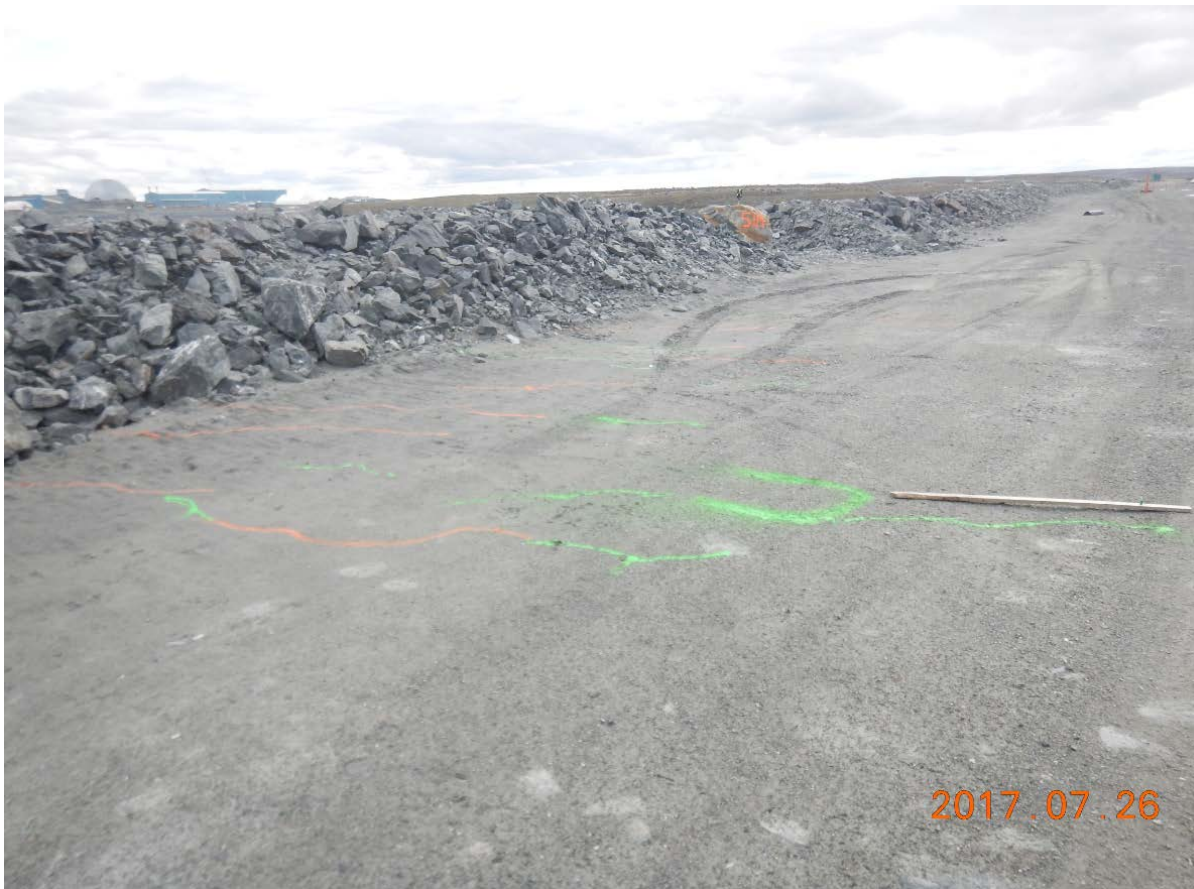
# PICTURE OF MOVEMENT – 11+050

- Observed initially on July 15th 2017
- Appeared when water reached the toe in the area
- Crack width relatively small (<1cm)
- Cracks did not progressed

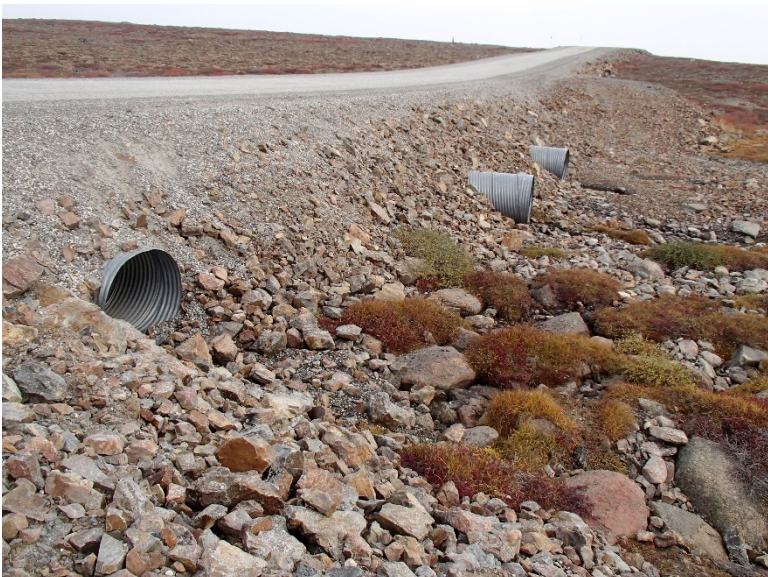
*Photograph D1-54: R-14 km 67+840*

**Description:** View of the culvert inlet. In good condition. Outlet is buried (no photo) and must be cleaned.

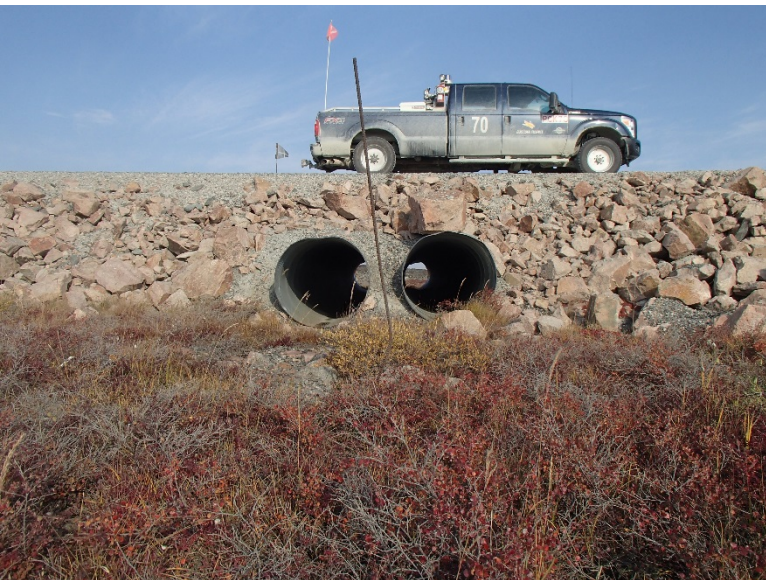
*Photograph D1-64: R-21 km 87+300*

**Description:** View of the culvert outlet. Outlet is a little bit twisted. The middle of the culvert is slightly collapsed. Water flows beneath the culvert. The culvert is in stable condition.

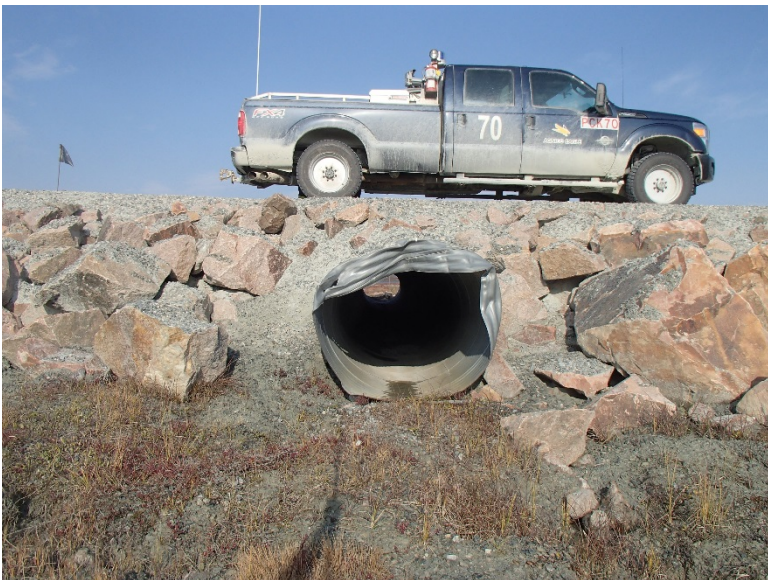
*Photograph D1-66: R-23 km 93+600*

**Description:** View of the culverts outlet. Both culverts are slightly collapsed in the middle. In stable condition, but should have been installed lower to avoid erosion issue.

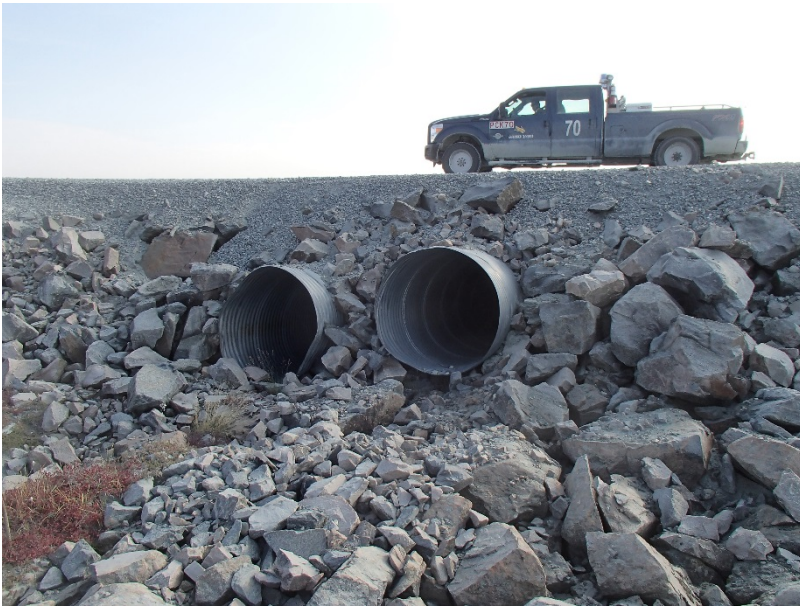
*Photograph D1-68: R-24 km 98+100*

**Description:** View of the culvert outlet. The culvert is installed too high and there is a low flow of water through the road rockfill. In good condition.

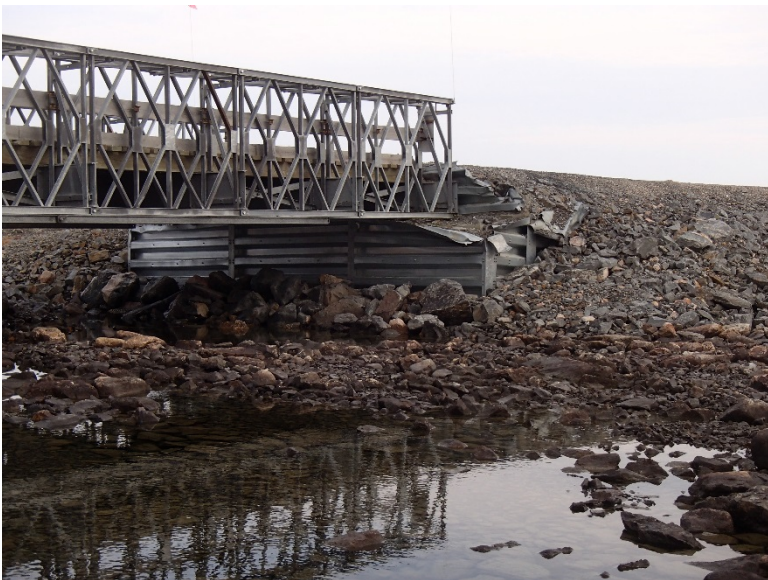
*Photograph D2-20 Bridges 6 – R15 km 69+200*

**Description:** Looking at the south abutment from downstream. Damage to the bin wall likely caused during snow removal activities. Bridge is tipping toward the west side on the abutment.

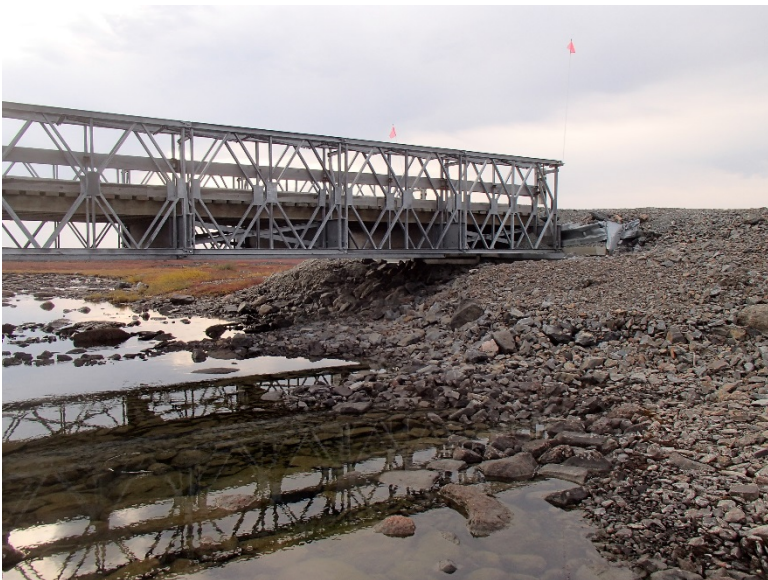
*Photograph D2-22 Bridges 6 – R15 km 69+200*

**Description:** Looking at the north abutment from upstream. Damage to the bin wall likely caused during snow removal activities. Bridge is tipping toward the west side on the abutment.

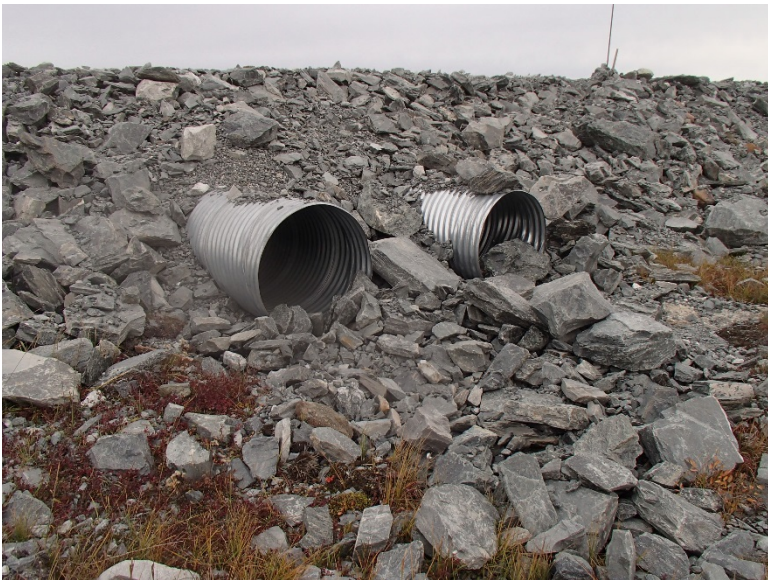
*Photograph E1-2: Culvert #39 km 9+193*

**Description:** View of culvert inlet, damaged in the middle.

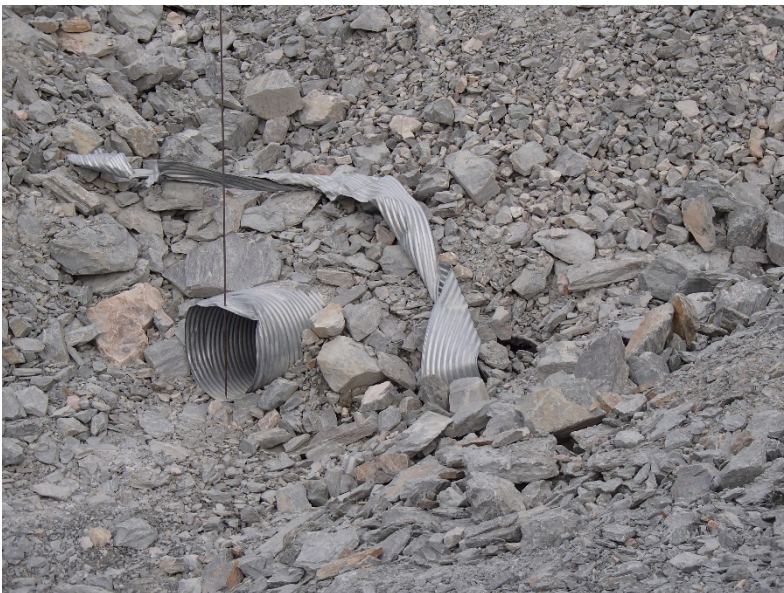
*Photograph H1-6 Vault Road Culverts*

**Description:** Culvert on the NP1 side at 639 214 E / 7 216 189 N on Vault Road. Culvert broken and partially obstructed.

It is recommended to monitor at freshet the performance of the five culverts installed on Vault Road, as three of them are partially collapsed in the middle. One of them had an entirely obstructed inlet and one of them had a collapsed outlet.
