Report: 2016 Annual Geotechnical Inspection

2016 Annual Geotechnical Inspection Meadowbank Gold Mine, Nunavut

Agnico-Eagle Mines Limited
Meadowbank Division
PO Box 540
Baker Lake, Nunavut X0C 0A0

Report Number: Doc 1549 1662181 Rev0

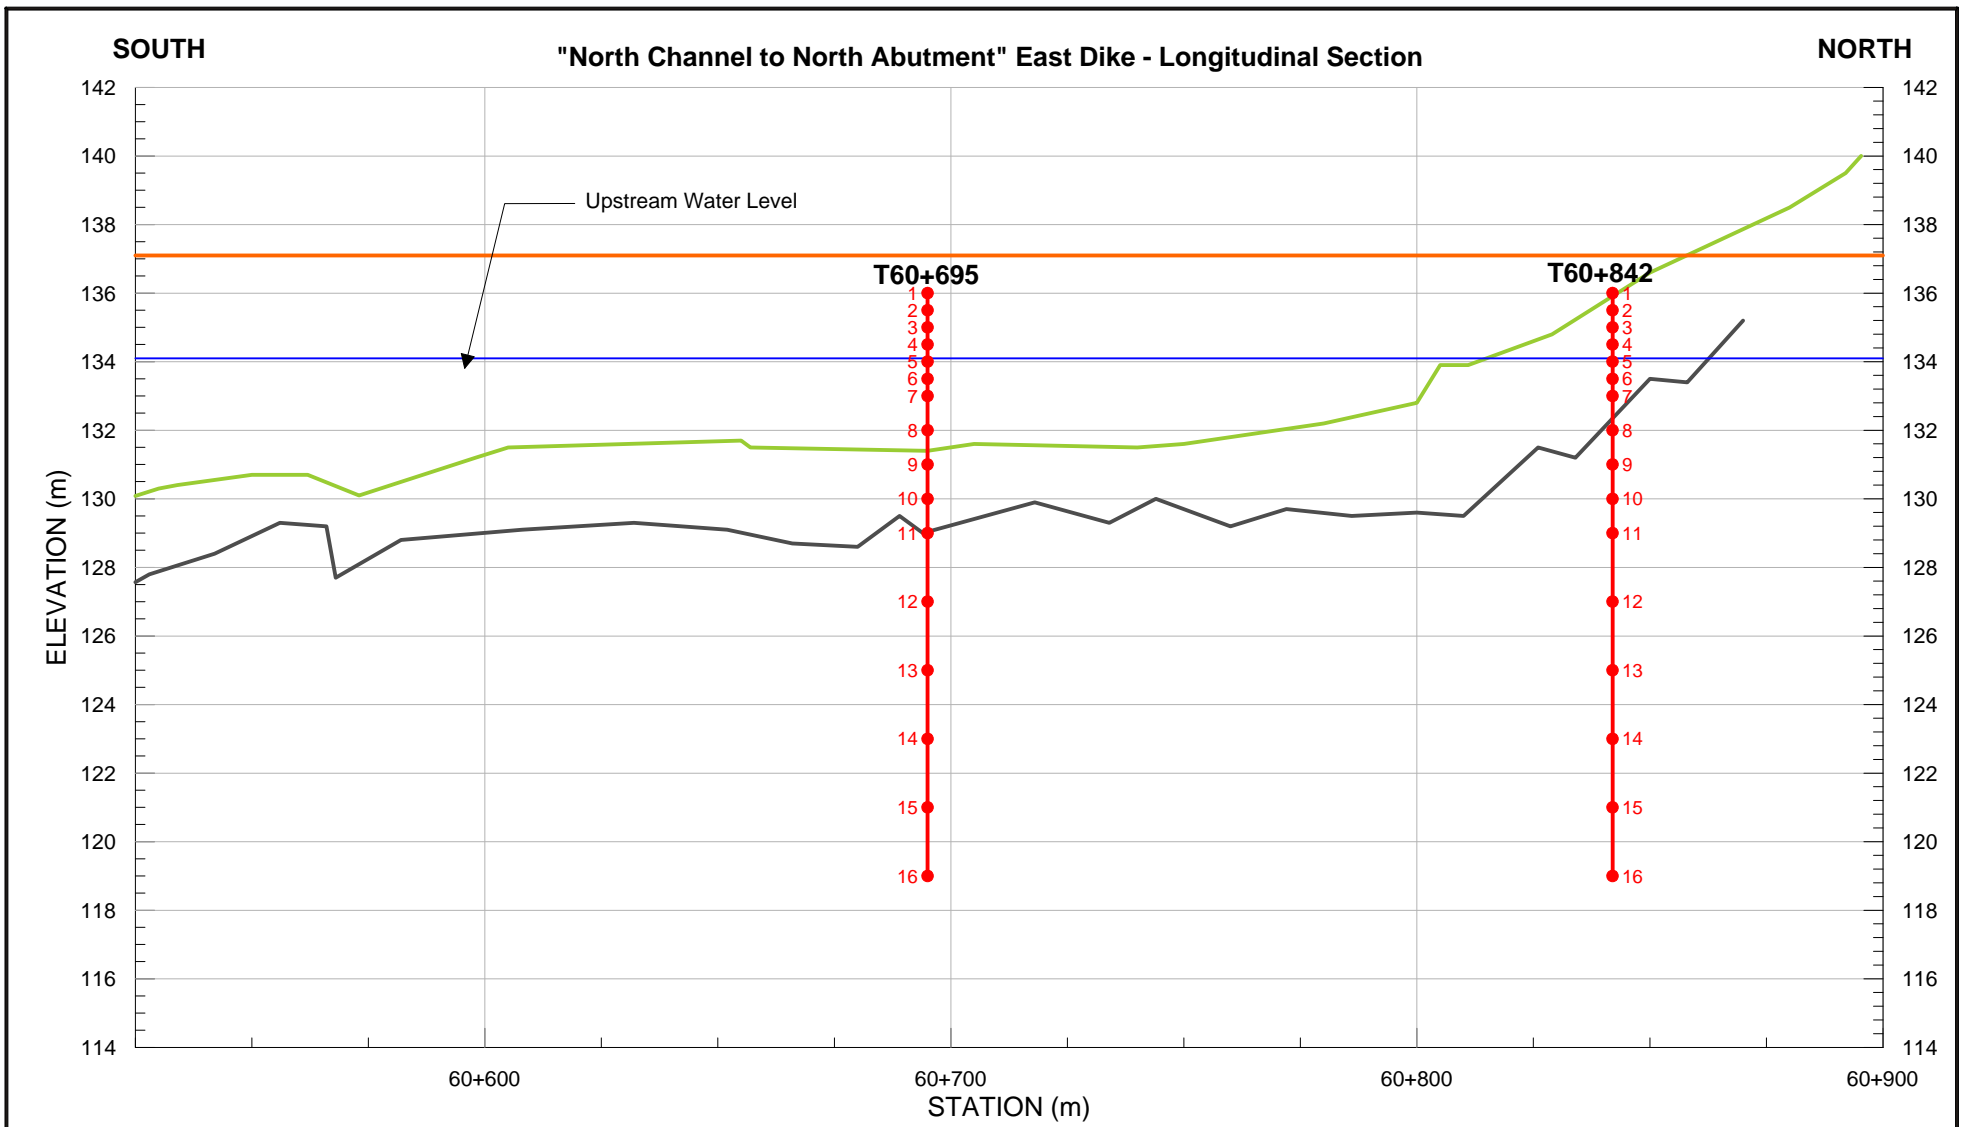
PROJECT		AGNICO EAGLE MINES LIMITED MEADOWBANK GOLD PROJECT NUNAVUT		
TITLE		BAYGOOSE DIKE 30+000 to 30+550 - TEMPERATURE DATA (Aug 31/15 to Aug 31/16)		
	PROJECT No.		PHASE No.	
	DESIGN	TD	20JAN14	SCALE AS SHOWN
	CADD	TD	20JAN14	REV.
	CHECK			
	REVIEW			FIGURE 61

NOTES:
 1. Beads 2 and 4 on T60+842 do not seem to be working properly.

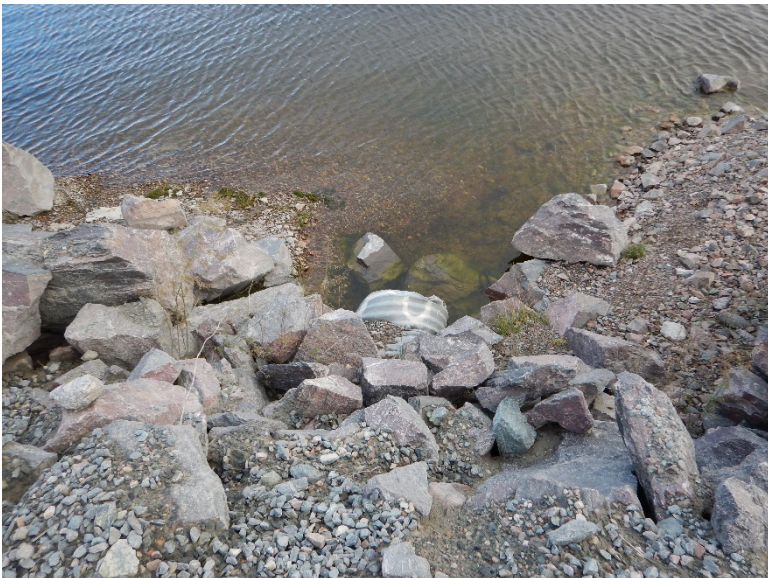
Photograph D1-2: PRC1 km 0+430

Description: View of culvert inlet, in good condition no sign of obstruction.

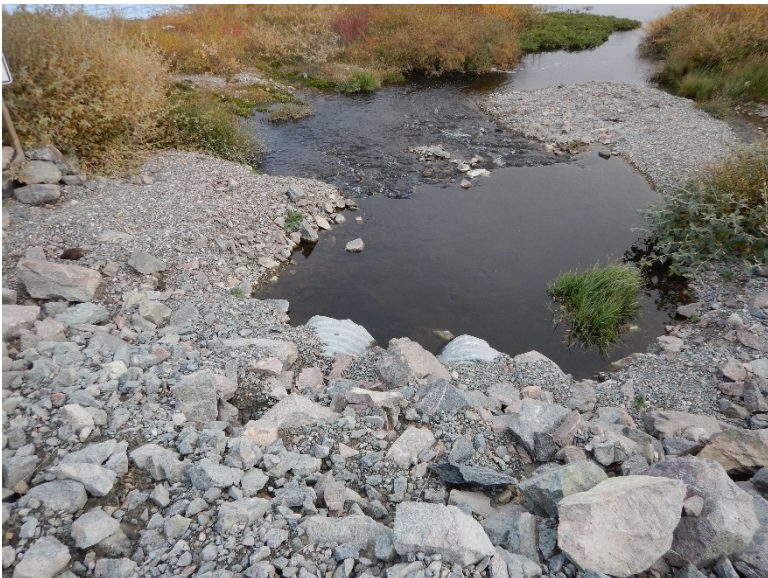
Photograph D1-4: PRC2 km 0+470

Description: View of culverts inlet. In good condition.

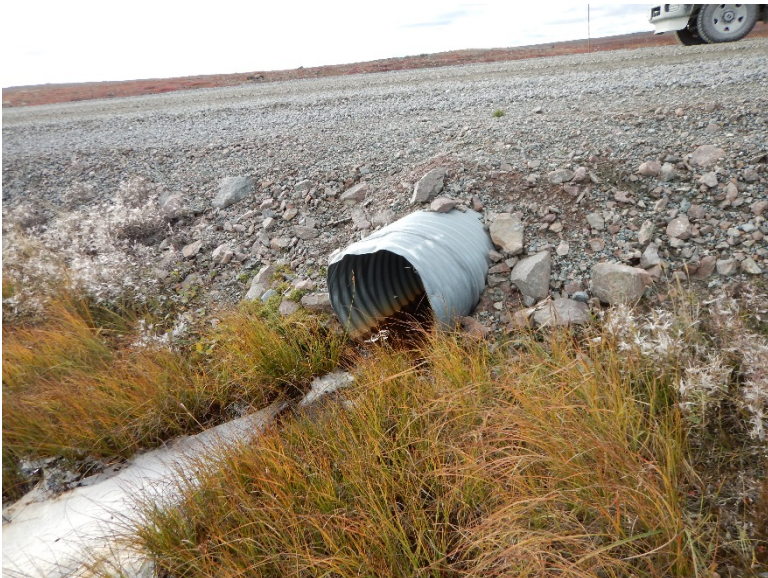
Photograph D1-6: PRC3 km 1+380

Description: View of culvert inlet. In good condition.

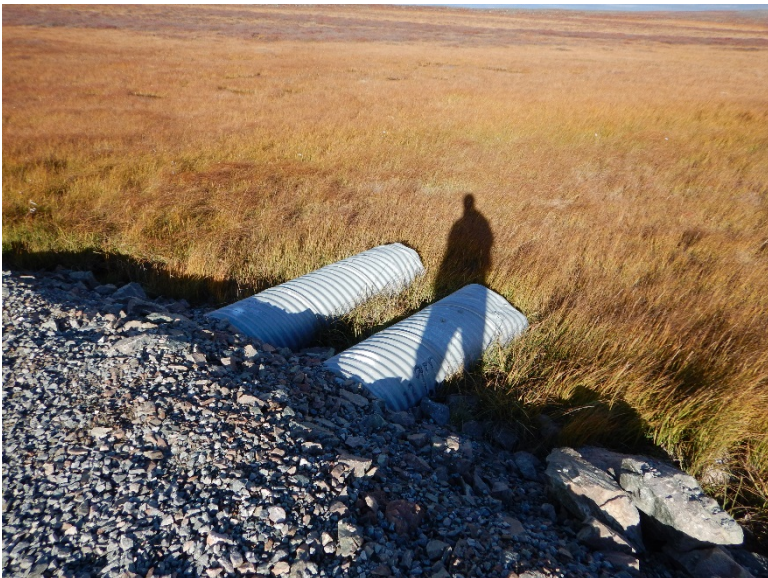
Photograph D1-10: PC-14 km 4+260

Description: View of the culverts inlet. Culverts is too damaged to be functional.

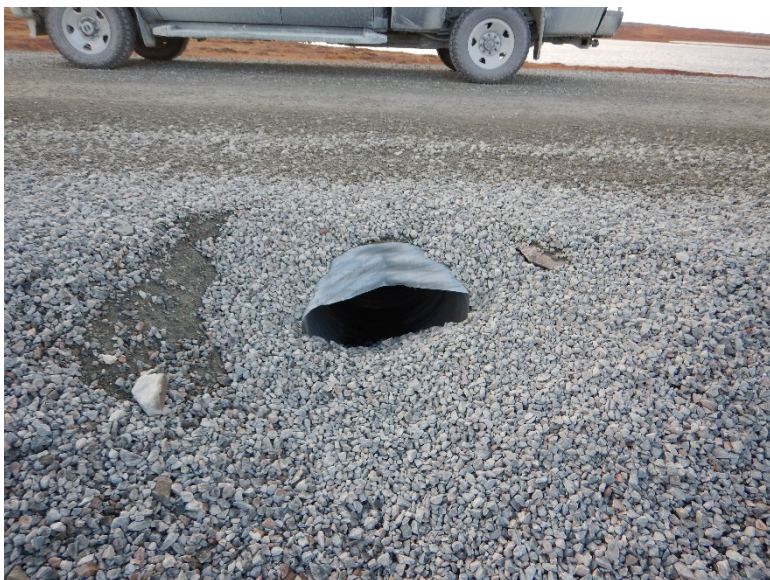
Photograph D1-12: unnamed km 5+700

Description: View of the culvert inlet. Good condition, inlet is short in length as the road rolling surface is at the edge of the inlet.

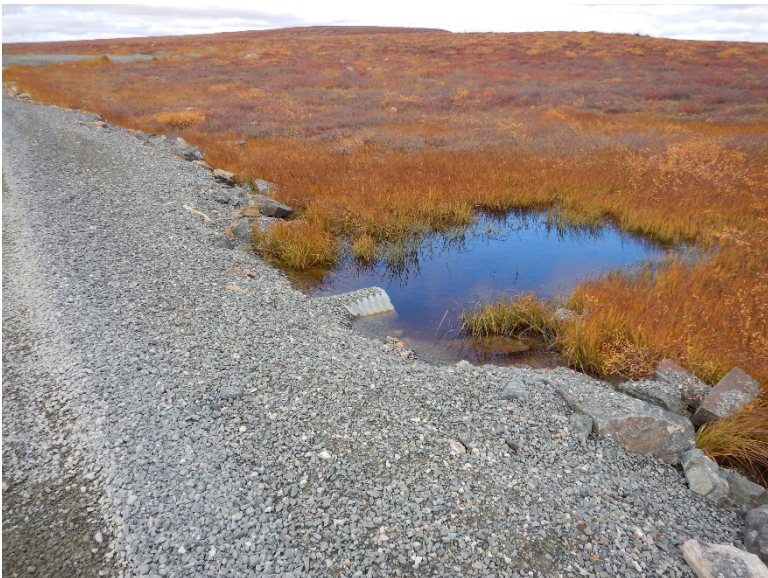
Photograph D1-54: PC-12 km 41+300

Description: View of the culvert inlet. In good condition, almost submerged.

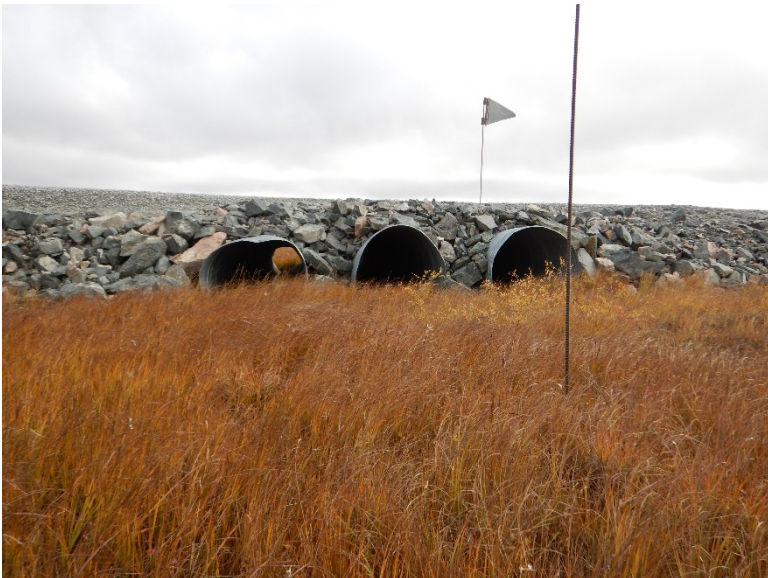
Photograph D1-60: R-18A km 80+950

Description: View of the culverts inlet. In good condition. The southern culvert inlet is partially buried.

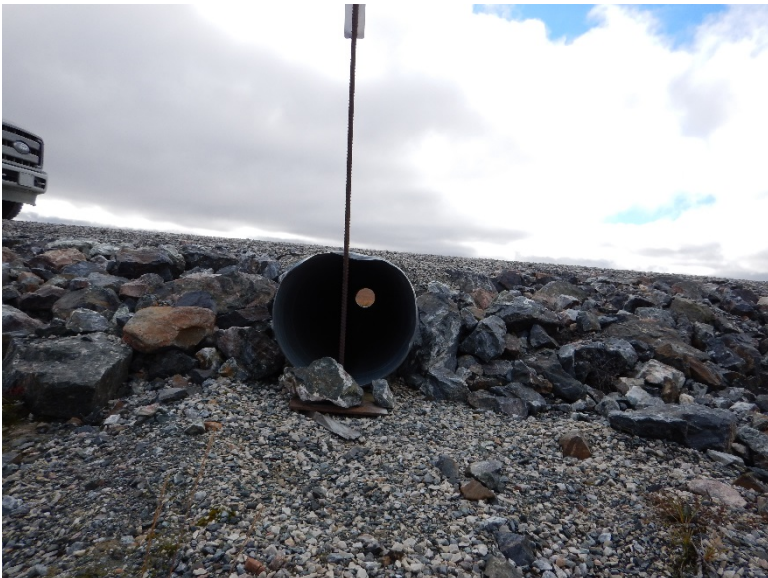
Photograph D1-62: R-18B km 80+950

Description: View of the culverts inlet. In good condition, installed above the ground surface.

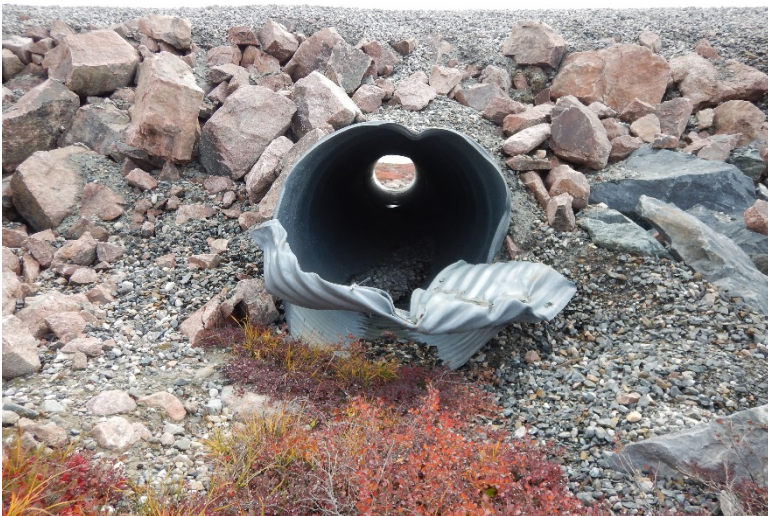
Photograph D1-64: R-20 km 85+490

Description: View of the culvert inlet. The middle of the culvert is slightly collapsed. The inlet is installed above the ground surface and water flows beneath the culvert. The culvert is in stable condition.

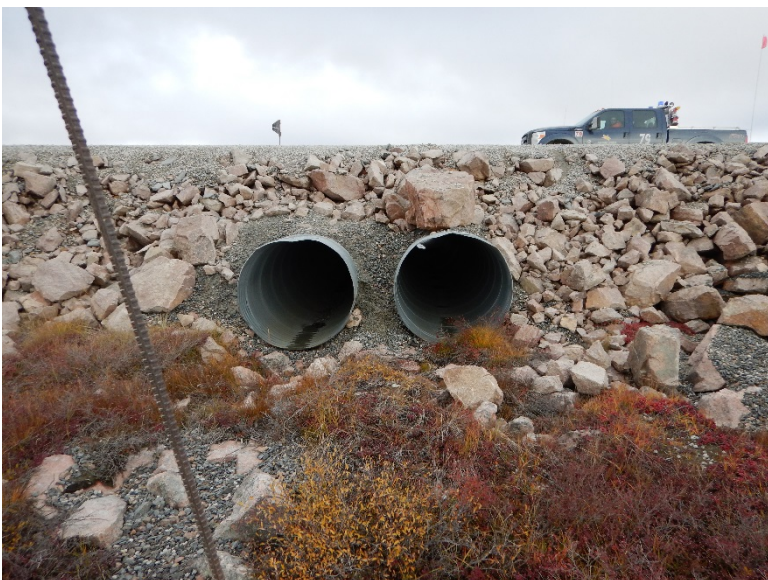
Photograph D1-66: R-21 km 87+300

Description: View of the culverts inlet. Both culverts are slightly collapsed in the middle. In stable condition, but should have been installed lower to avoid erosion issue.

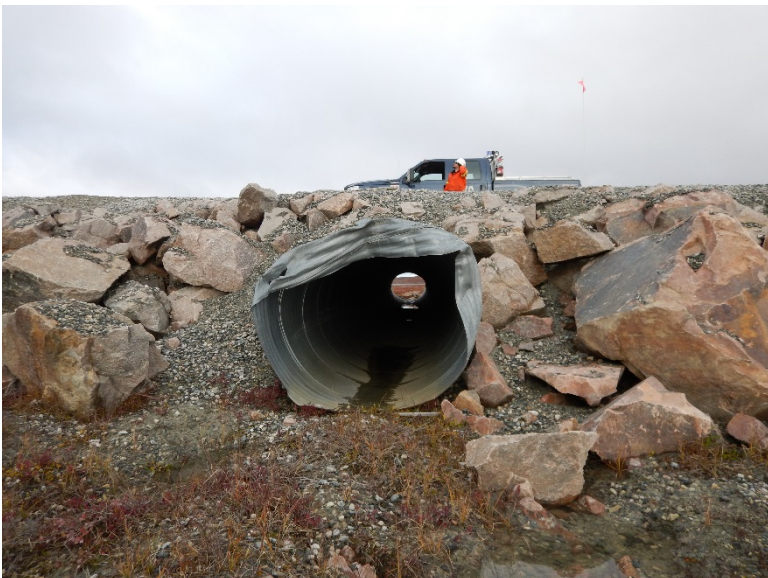
Photograph D1-68: R-23 km 93+600

Description: View of the culvert inlet. The culvert is installed too high and there is a low flow of water through the road rockfill. In good condition.

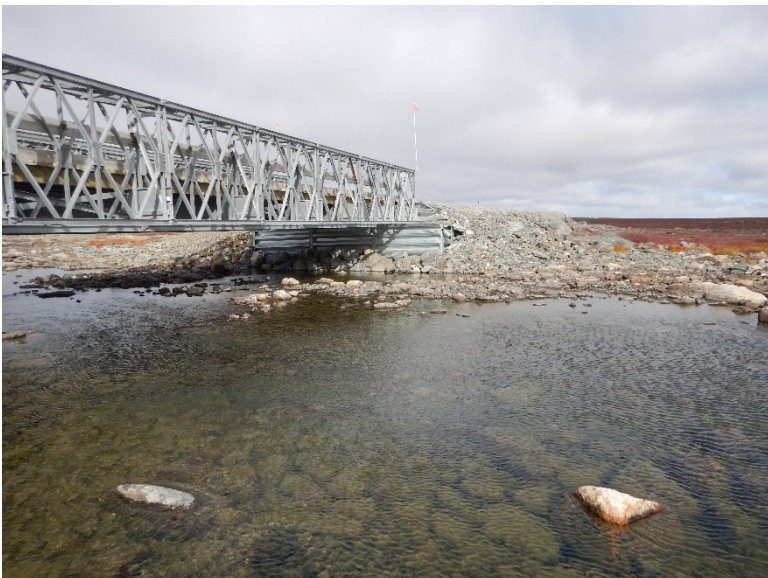
Photograph D2-16 Bridges 6 – R15 km 69+200

Description: Looking at the south abutment from downstream. Damage to the bin wall likely caused during snow removal activities. Bridge is tipping toward the west side on the abutment.

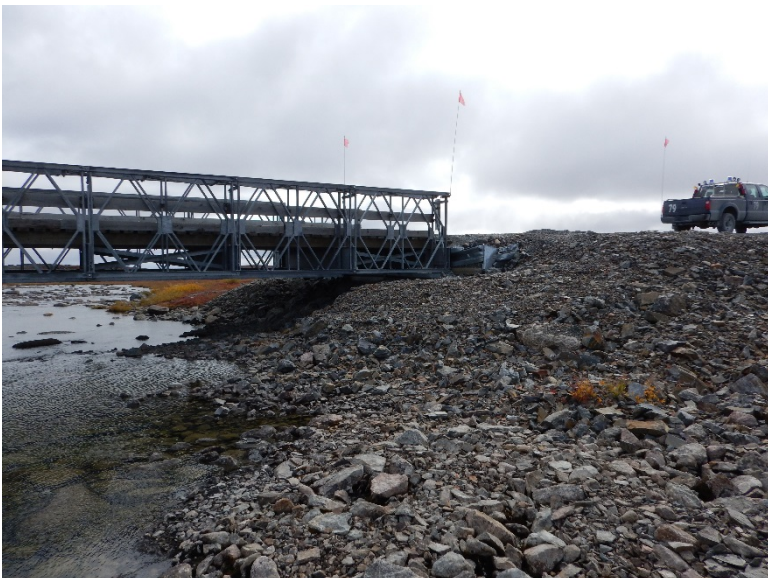
Photograph D2-18 Bridges 6 – R15 km 69+200

Description: Looking at the north abutment from upstream. Damage to the bin wall likely caused during snow removal activities. Bridge is tipping toward the west side on the abutment.

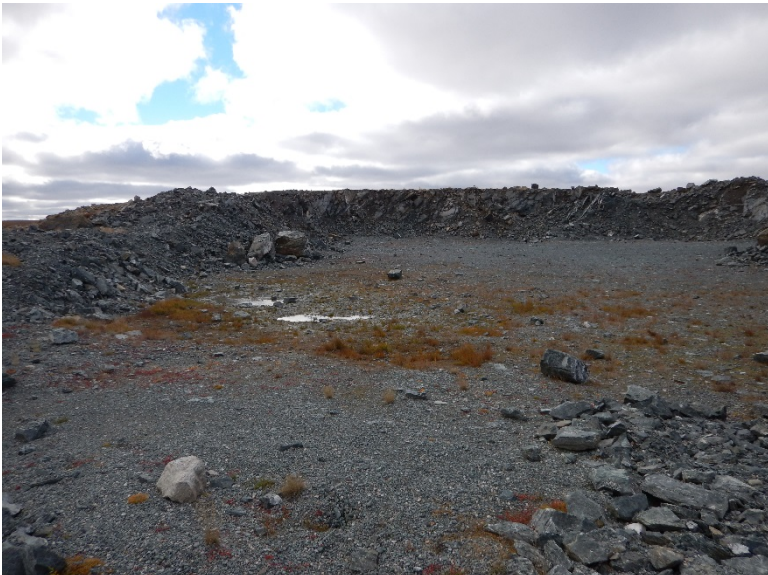
Photograph E1-16: Quarry 8 – km 42+950

Description: View of north wall. Loose blocks were removed.

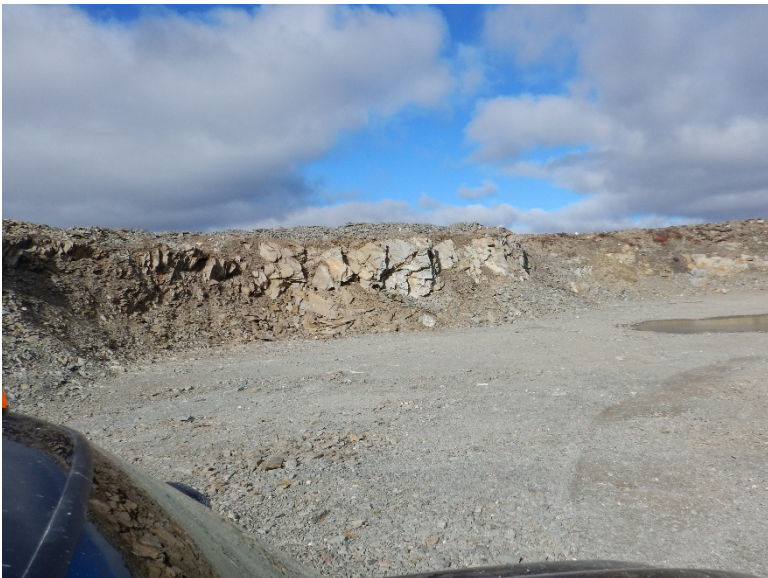
Photograph E1-20: Quarry 10 – km 48+900

Description: View of north and east walls. View of a pile of loose material.

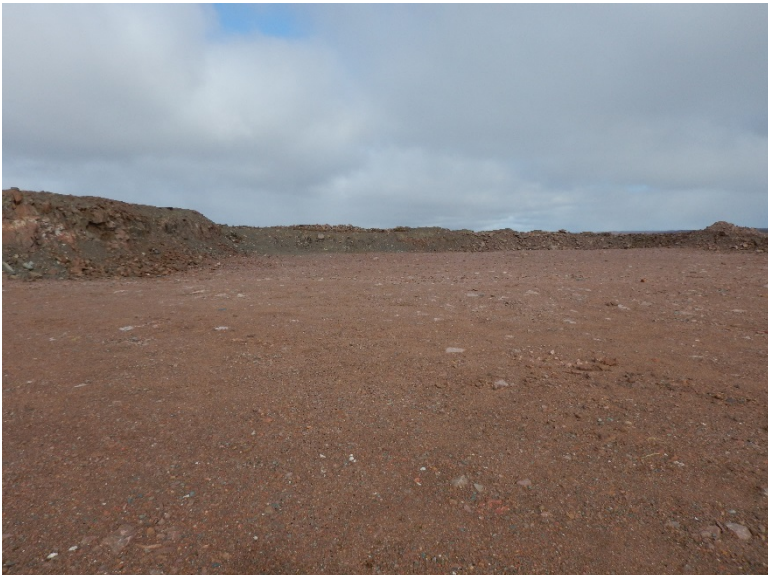
Photograph E1-34: Quarry 17 – km 72+800

Description: View of the east and south walls. Presence of loose rocks on steep wall.

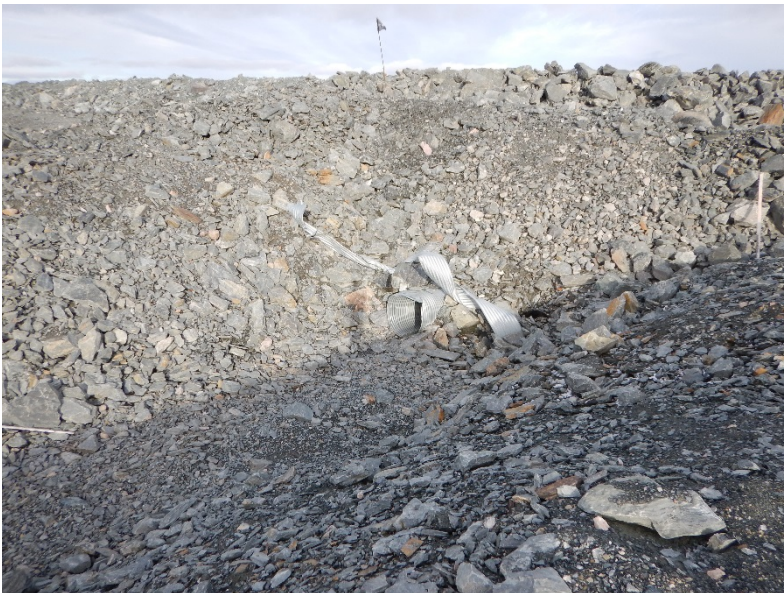
Photograph G1-6 Vault Road Culverts

Description: Culvert on the NP1 side at 639 214 E / 7 216 189 N on Vault Road. Culvert broken and partially obstructed.

It is recommended to monitor at freshet the performance of the five culverts installed on Vault Road, as three of them are partially collapsed in the middle. One of them had an entirely obstructed inlet and one of them had a partially obstructed outlet.
