## **Appendix B2**

### **Meadowbank Dike Review Board Reports**

Report No 20  
Meadowbank Mine Dike Review Board  
Conference call March 23<sup>rd</sup>, 2017

Report No 21  
Meadowbank Mine Dike Review Board  
Meeting July 19, 2017

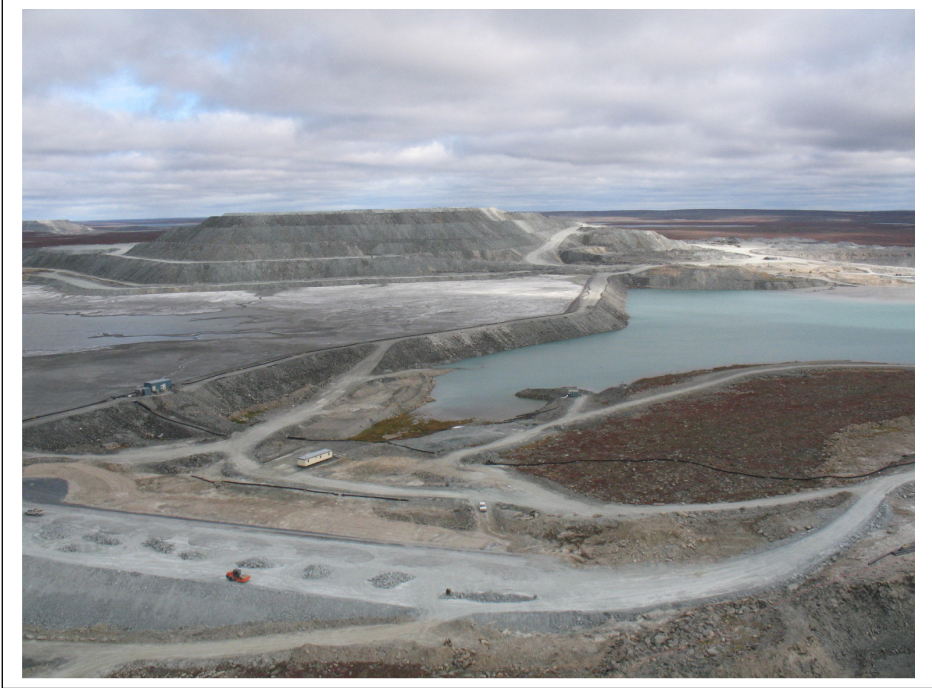
As the South Cell pond level rises (131 m in September 2016, 137 m in September 2017) inundating a greater length of the Stormwater Dike footprint (Photo #1), additional thaw settlement could be expected. This effect has materialized and additional movements and cracking have been observed since July 2017. Settlement at the downstream side of the crest has attained 70 cm (Photo #2), though it is noted that the deformation on the upstream side is considerably less and the integrity of the Coletanche liner is not jeopardized. Furthermore, the tailings deposited in the North Cell adjacent to the liner are now frozen. The area influenced by cracking now extends from Stn. 10+425 to Stn. 11+050. Additional prisms mounted on large boulders (Photo #3) and wire extensometers have been added to complement those installed in 2016.

Photo #1 Stormwater dike

In the previous report the Board recommended filling the cracks on the crest with bentonite to prevent ingress of rainwater, it would be advisable to continue this operation for the recent cracks. The finer cracks could be filled with bentonite but the wider ones could be treated with a bentonite-sand mixture to reduce shrinkage. This action would reduce the risk of pressures in the back scarp that could accelerate deformation.

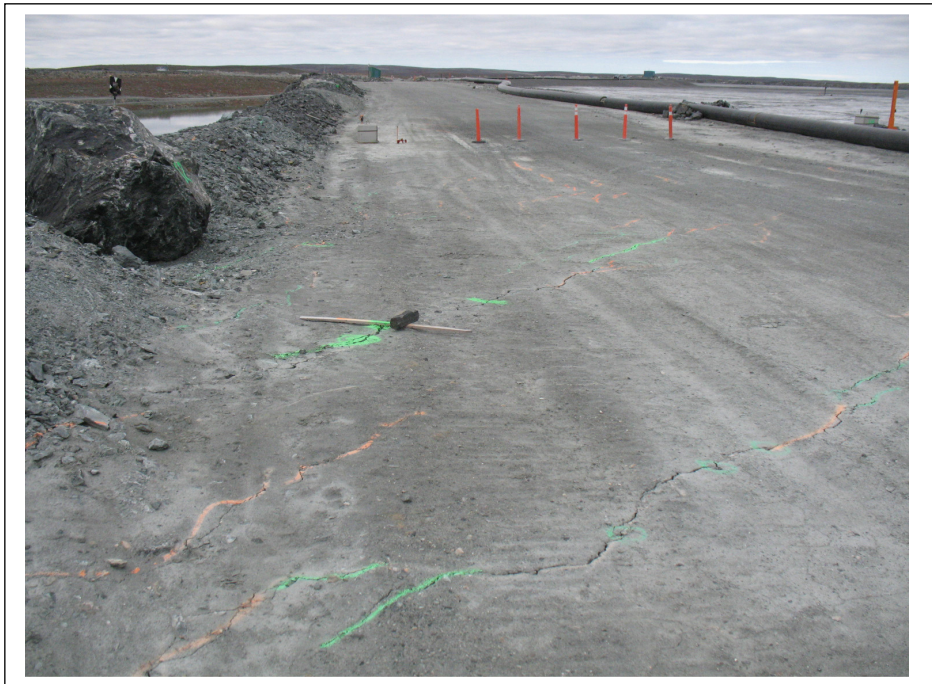
Photo #2 Location of new depression. 70cm max settlement on D/S (left)

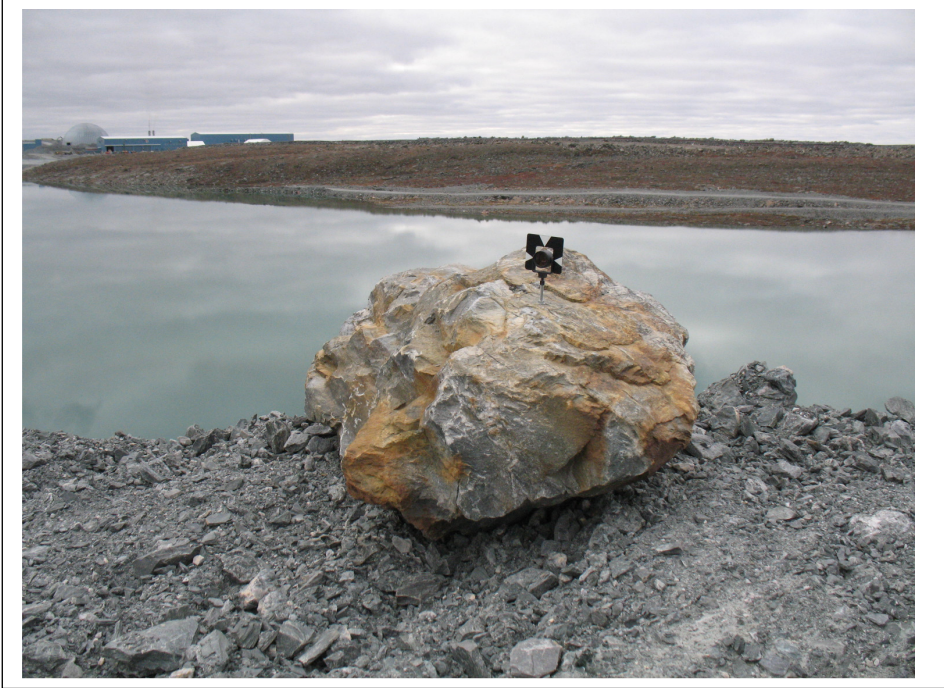
Photo #3      Typical survey prism mounted on large boulder

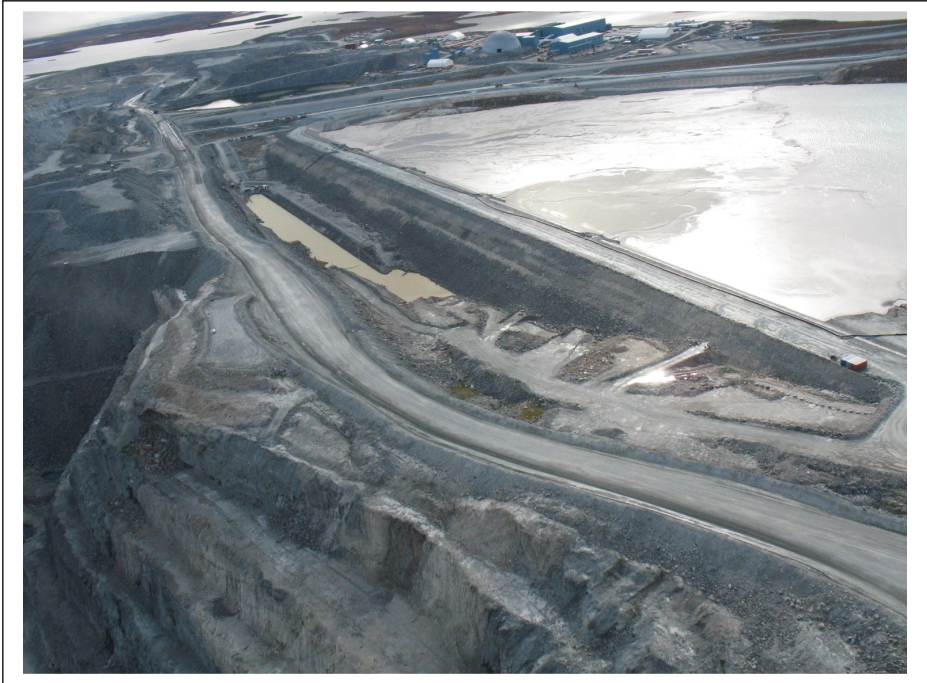
The Board had been previously advised (Teleconference Meeting No. 20) of the appearance of chemical/bacteriological deposits in the seepage collection pond at the Central Dike toe (Photos #4 and #6). The comprehensive monitoring, both visual and by instrumentation, is ongoing. The situation seems to be basically stable given the boundary conditions of south cell pond rise and continued tailings deposition.

Photo #4 Central Dike. Portage Pit to the left of photo.

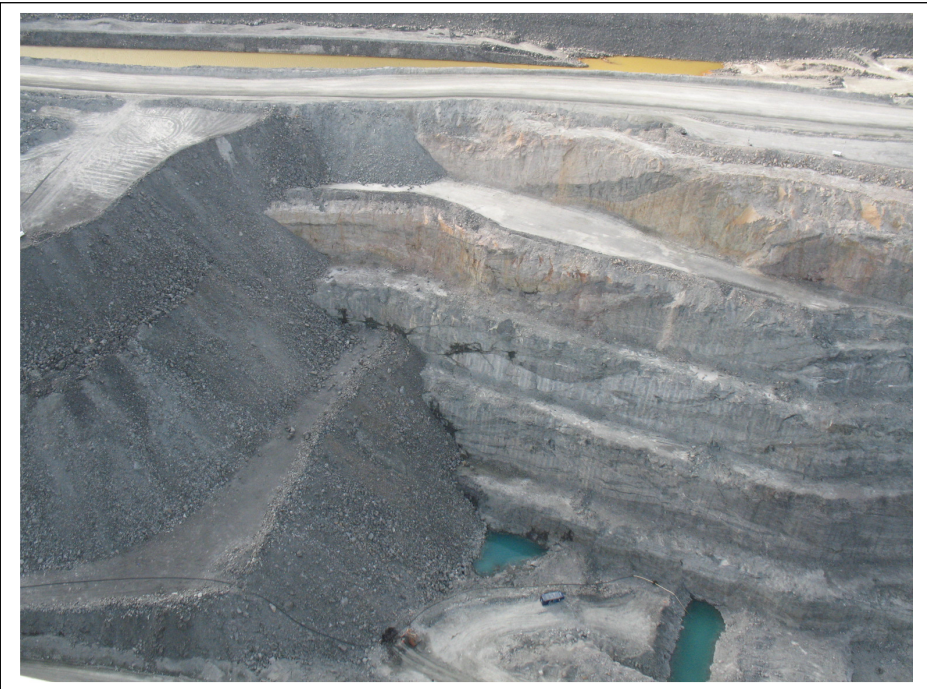
Photo #5 Wall of Portage Pit downstream of Central Dike

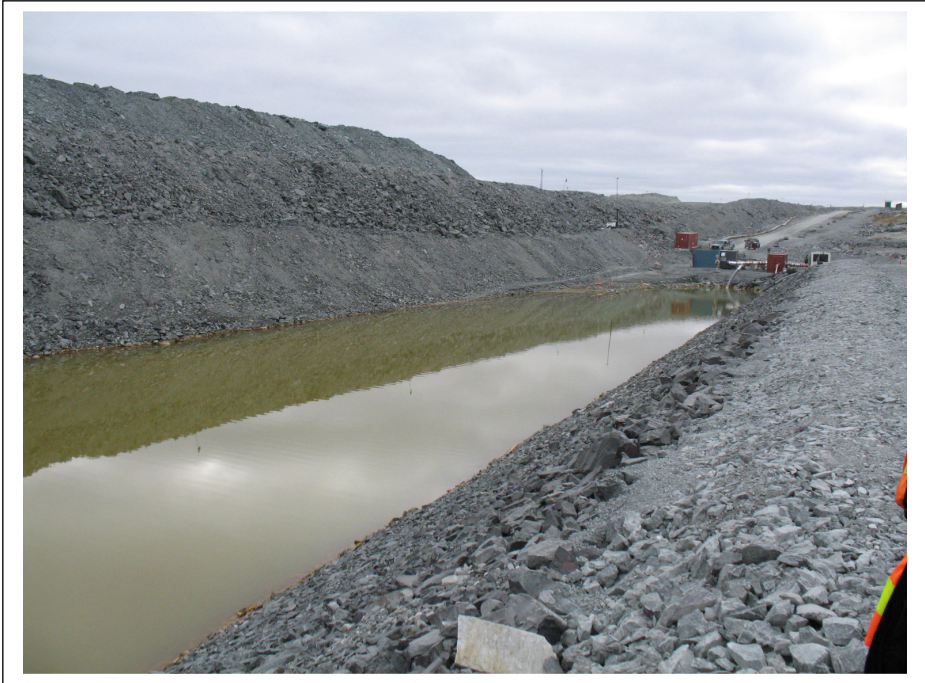
At the downstream toe of Central Dike, the current turbidity level was noted and it is readily apparent that little detailed observation of local flows is possible. Rockfill baffles across the pool may assist observation during the summer period but would be of little use during the winter and would exacerbate ice accumulation. Consequently, reliance has to be placed on frequent monitoring of pumping flow rates and the results of water sampling. A rapid determination of turbidity and/or TSS is obviously part of the procedure.

Photo #6 Seepage collection pond at toe of Central Dike

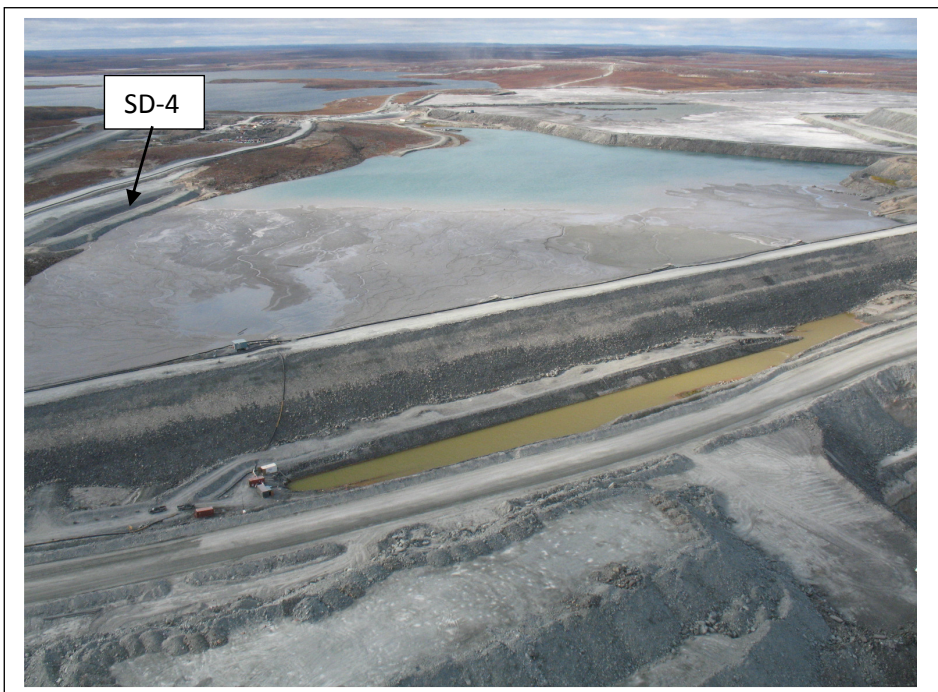
Photo #7 South Cell of TFS

The Board recommends continuation of a deposition plan to encourage beaching along the SD-4 to SD-3 shoreline (Photo #7).

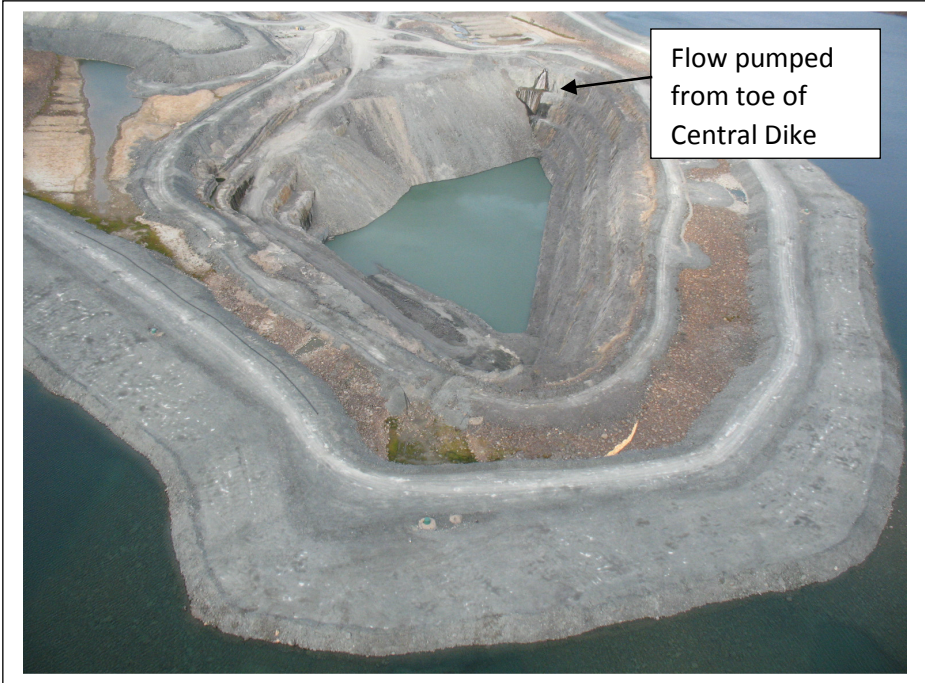
Ice walls are observed at some locations with accumulation depending on water source and orientation, particularly on the north facing wall of Goose Pit, where less control of surface water is exerted compared to the mining period.

Photo #8 Goose Pit

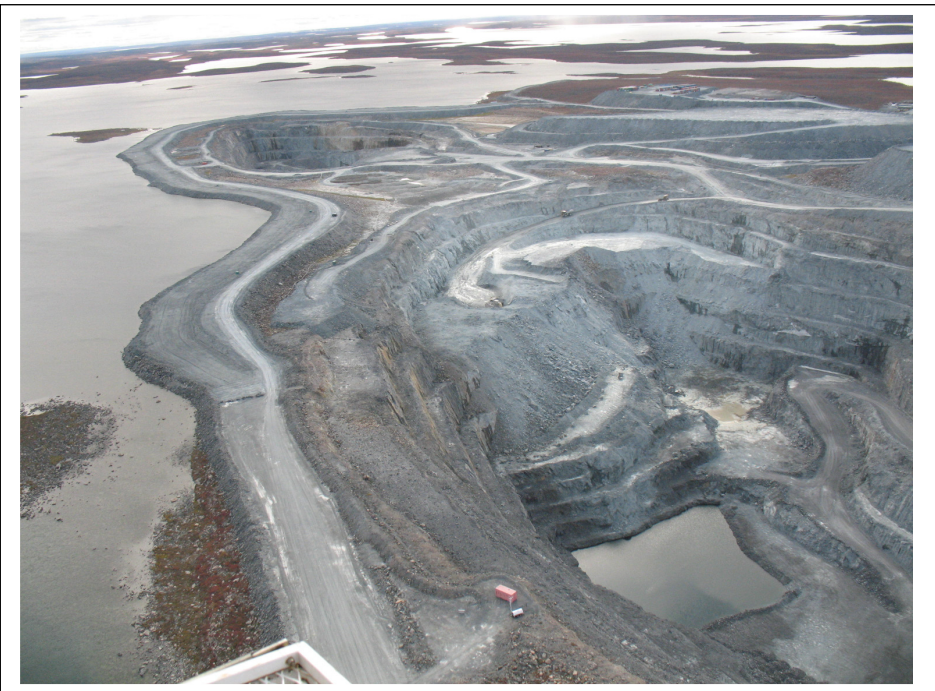
As far as Portage Pit E is concerned, where push-back is on-going (Photo #9), instability of the Ultramafics is also noted but overall pit slope performance is judged to be good. In-place inclinometers and Time Domane Reflectometer cables have been added to the instrumentation. Reliability of the inclinometers is considered marginal possibly due to inadequate grout installation of the casing. A Trigger Action Response Plan has been developed for the operation of this pit.

Photo #9 Push-back in Portage Pit E5
