### **Annual Review of Portage and Goose Pit Slope Performance**

# 2016 ANNUAL PIT SLOPE PERFORMANCE REVIEW MEADOWBANK MINE, NUNAVUT

DECEMBER 21, 2016

ISSUED FOR USE  
704-ENG. EARC03050-01

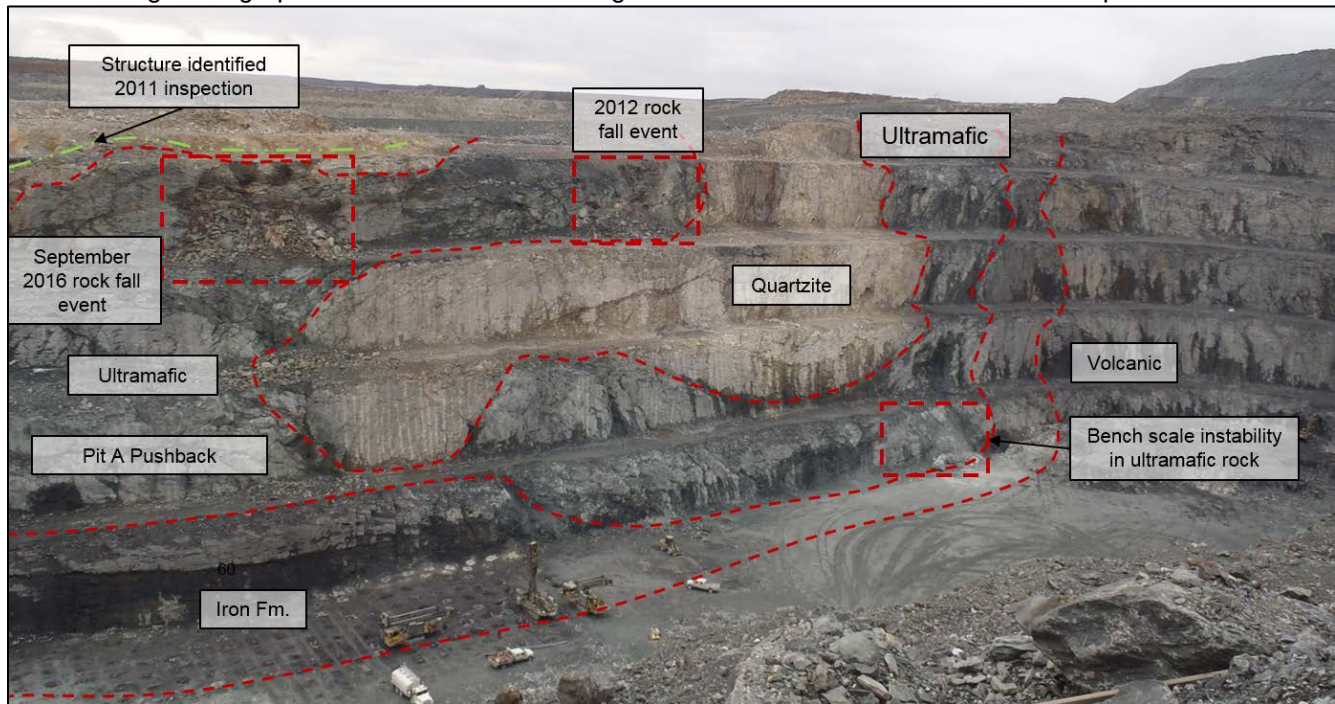
Photograph 4-3: Pit A west wall (2016)

An area of instability of the lower west wall observed during the 2014 inspection continues to ravel, and some new material has accumulated at the toe of the slope (shown in Photograph 4-3, Photograph 4-4, and Photograph 4-5). A hard toe in iron formation remains at the base of the slope, undercutting out-dipping planes. Poor quality and strongly sheared ultramafic rock between quartzite and iron formation continues to ravel. More ultramafic rock has been exposed along the lowermost bench because of mining down of the pushback area. This has resulted in loss of catchment locally.

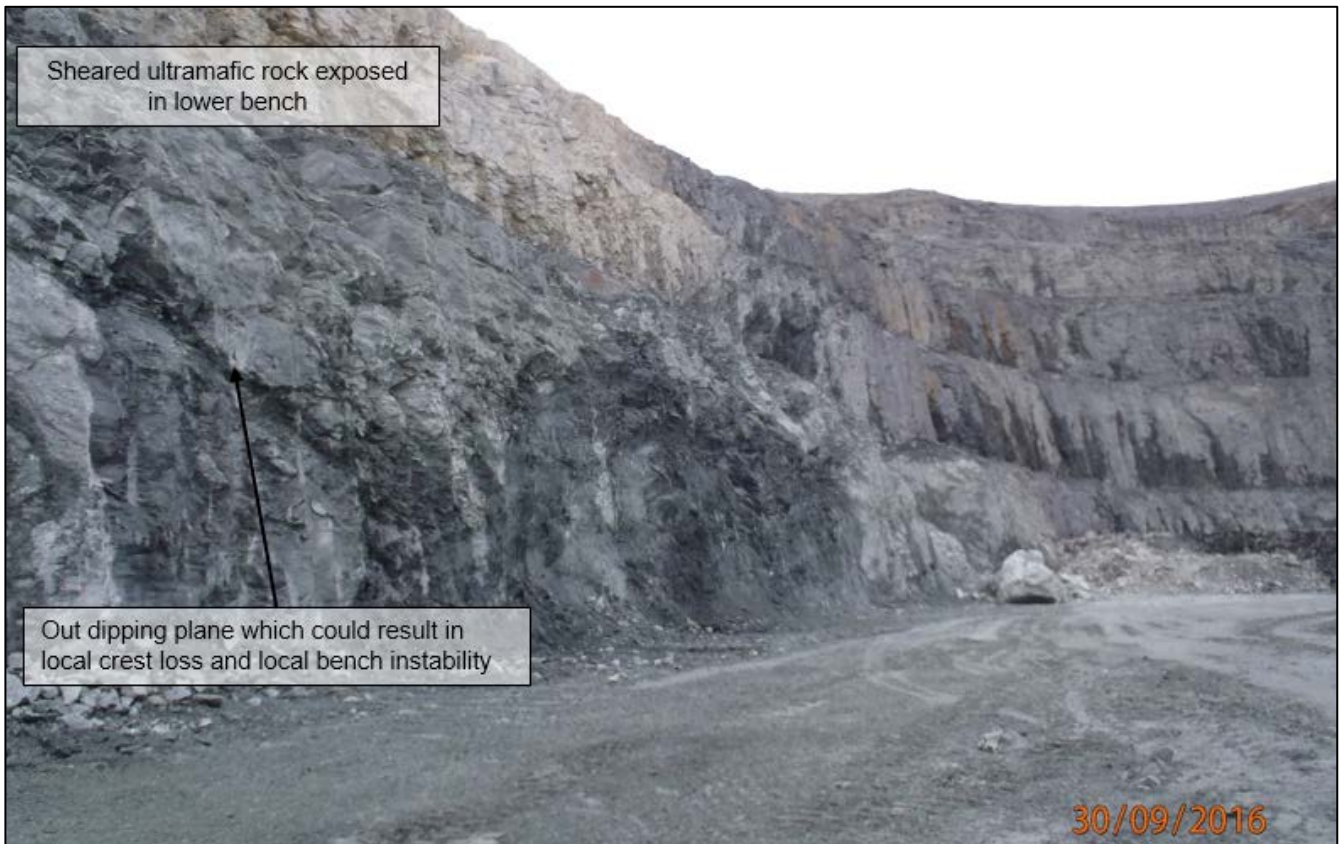
Photograph 4-6: Ultramafic rock exposed at toe of Pit A west wall

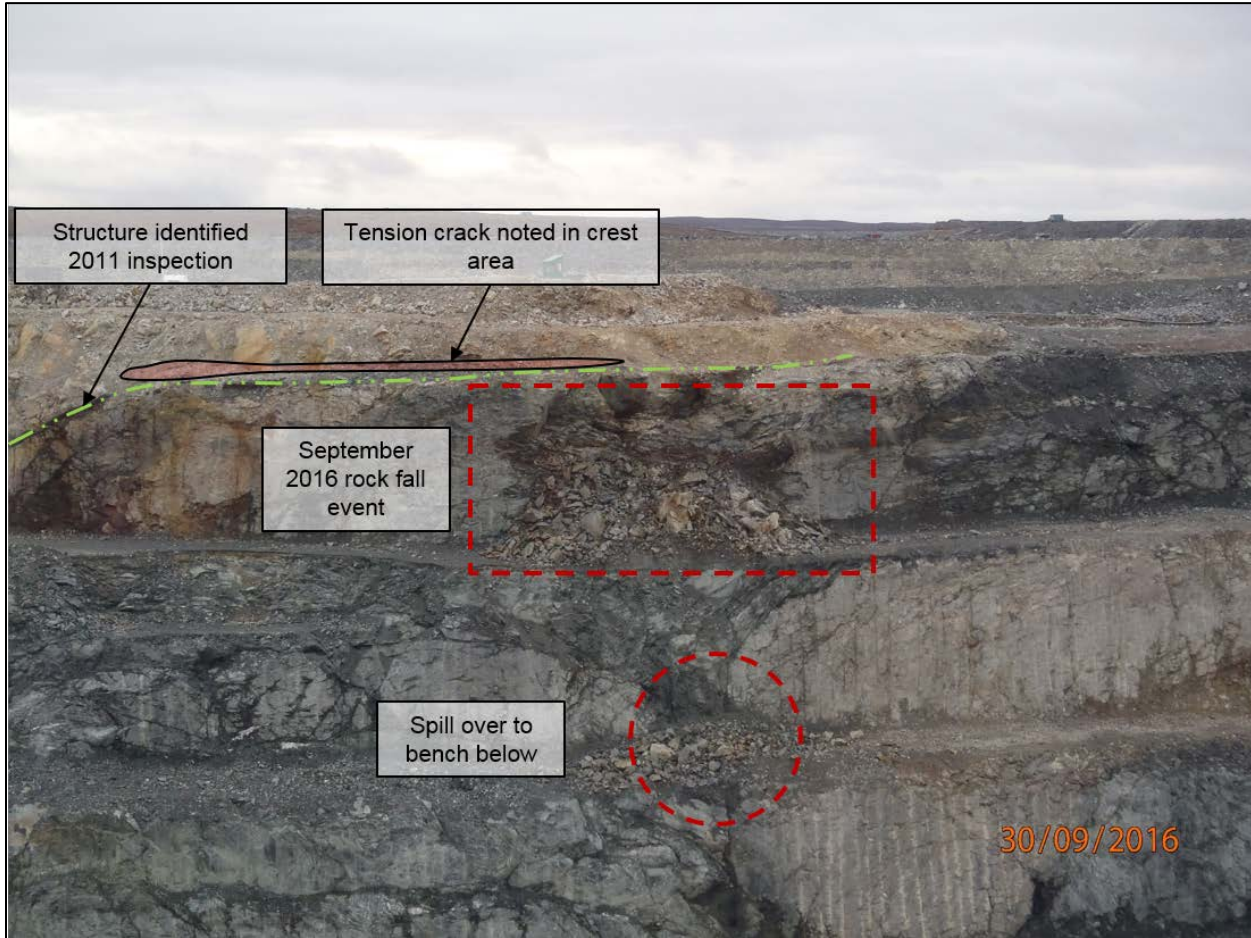
A rock fall event occurred on 26 September 2016 on the 5109 bench of the west wall of Pit A. The area is shown in Photograph 4-6 above. The volume of failed material is estimated by AEM at 1,500 m<sup>3</sup>. The rock fall occurred following a pit blast, and some material spilled over on to the 2 benches below. The contributing factors appear to be the following:

- A structure identified during the 2011 site inspection trends behind the uppermost bench, dipping into the wall at around 60 degrees, and adjacent to the contact between ultramafic and quartzite rock. It was observed that the orientation of the structure was such that it could lead to bench scale toppling, but was unlikely to result in large scale overall slope failure. The structure is infilled by loose silt and sand material.
- Parallel sheared structures trend parallel to the wall.
- The footwall rock type is ultramafic, serpentized, strongly sheared, and poor quality.

The event appears to be associated with toppling failure related to the west-dipping sheared structures acting as back-release surfaces for the poor quality ultramafic rock. The poor quality of the ultramafic rock is contributed to by intense folding of the stratigraphy in this area, and by faulting.

Photograph 4-8: Rock fall event September (2016)

- Mark the tension crack location and extents with paint, survey these in, and plot on map.
- Continue monitoring the wall using the GroundProbe radar until it is moved back to Pit E3.
- Install simple crack extensometers to monitor possible lateral ground movement of the crest area.
- Continue visual monitoring and recording of observations as part of regular site geotechnical inspections.
- Minimize exposure time at the toe of the slope.
- Maintain a safe working distance in accordance with the internal AEM safe work procedure for work close to pit walls.

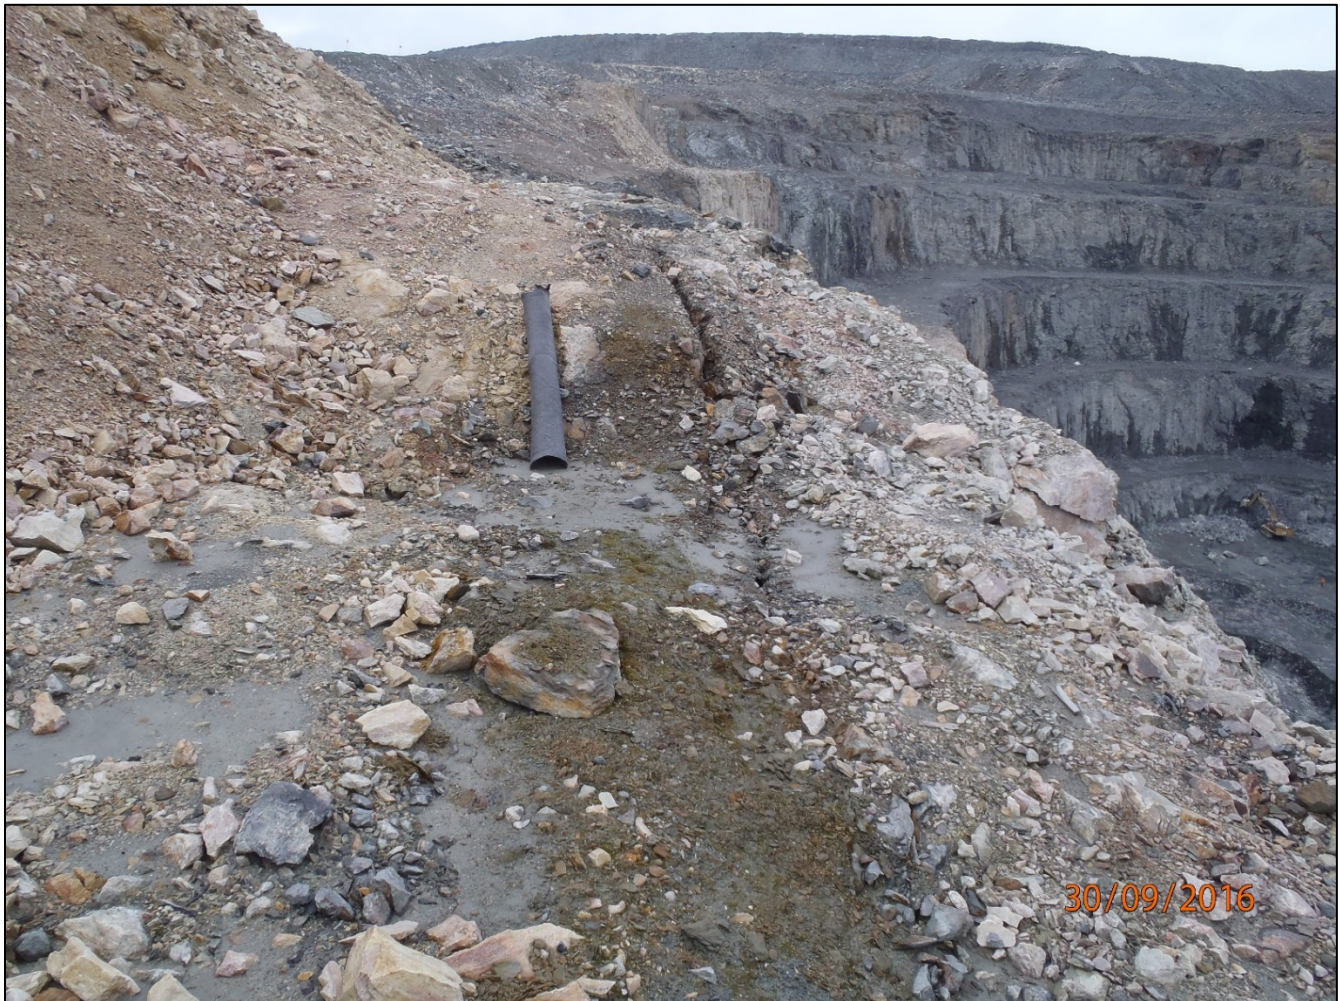
The crest of the bench was visited, and a tension crack was observed along the crest of the bench, associated with the structure identified in 2011.

*Photograph 4-9: Bench above Pit A 2016 rock fall showing formation of tension crack*

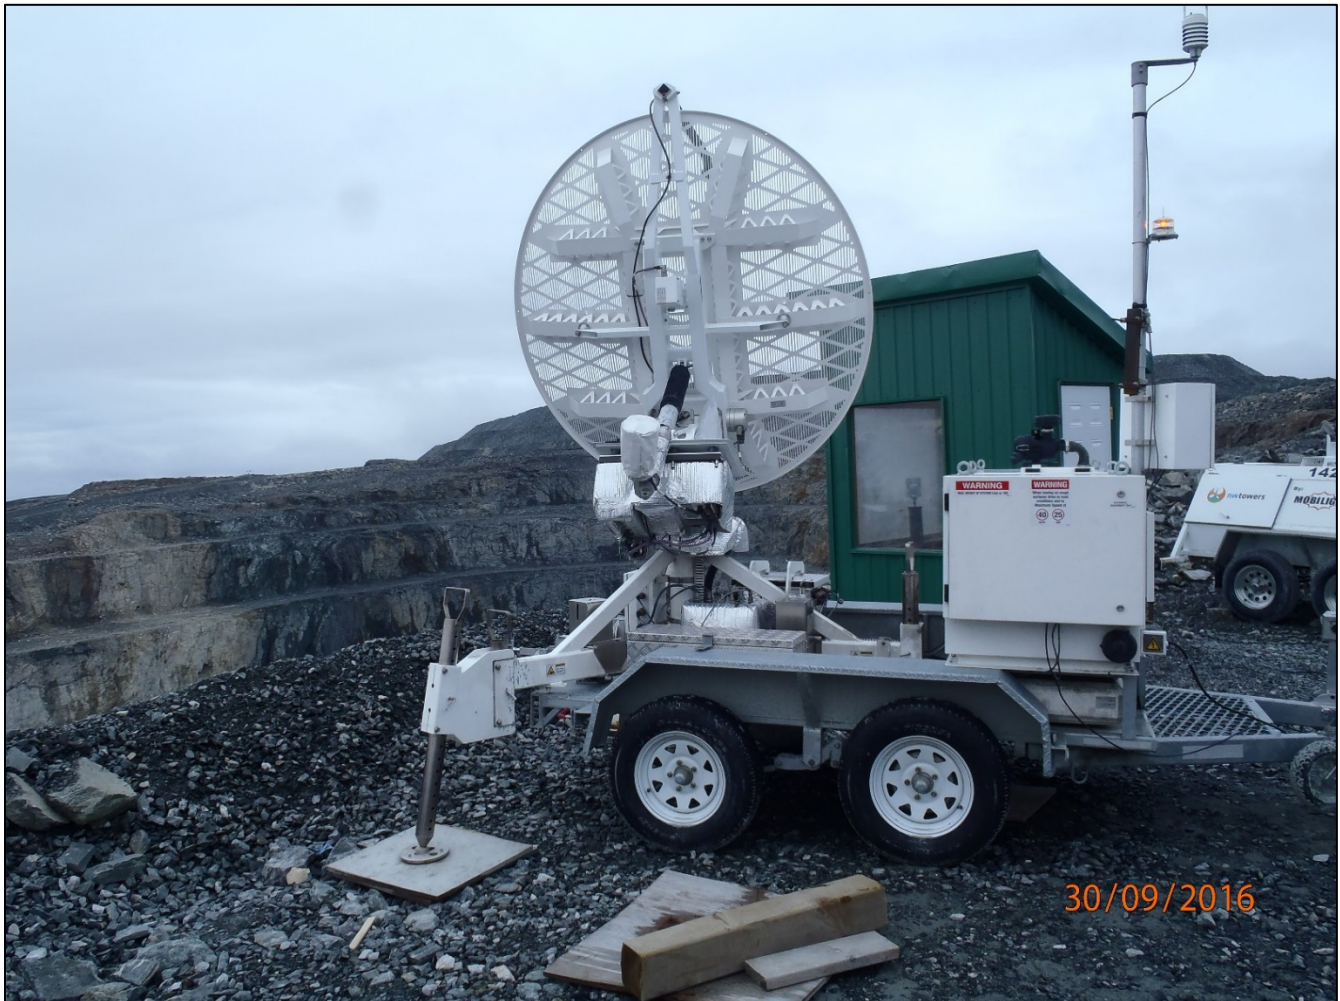
At the time of the inspection, AEM had set up a GroundProbe radar system on the east wall opposite the failure to monitor ground movement. The radar will be moved back to Pit E3/E4 once mining begins in that pit again.

*Photograph 4-10: GroundProbe radar monitoring the west wall of Pit A, from the east wall crest*

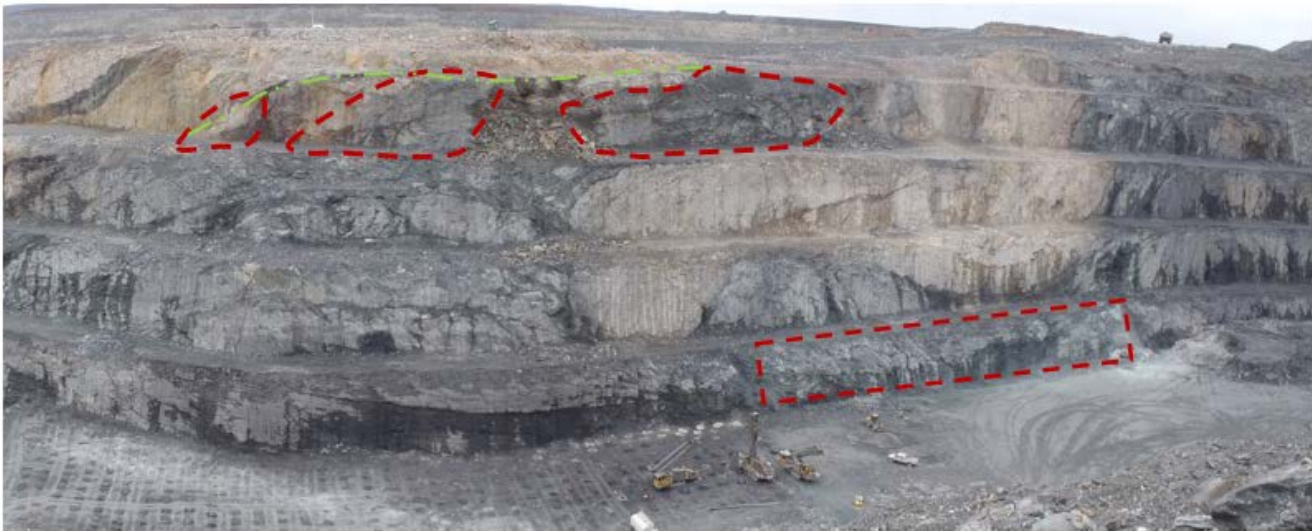
Raveling of the upper west pit wall benches adjacent to the sheared structure may continue and so monitoring of this area should be part of the ongoing geotechnical inspections. Areas where raveling of material could continue along the upper benches are identified in the following Photograph 4-11. As with the previous failures any material that would ravel is expected will be retained on the catchment benches.

Photograph 4-11: Areas of potential bench-scale instability along the Pit A west wall

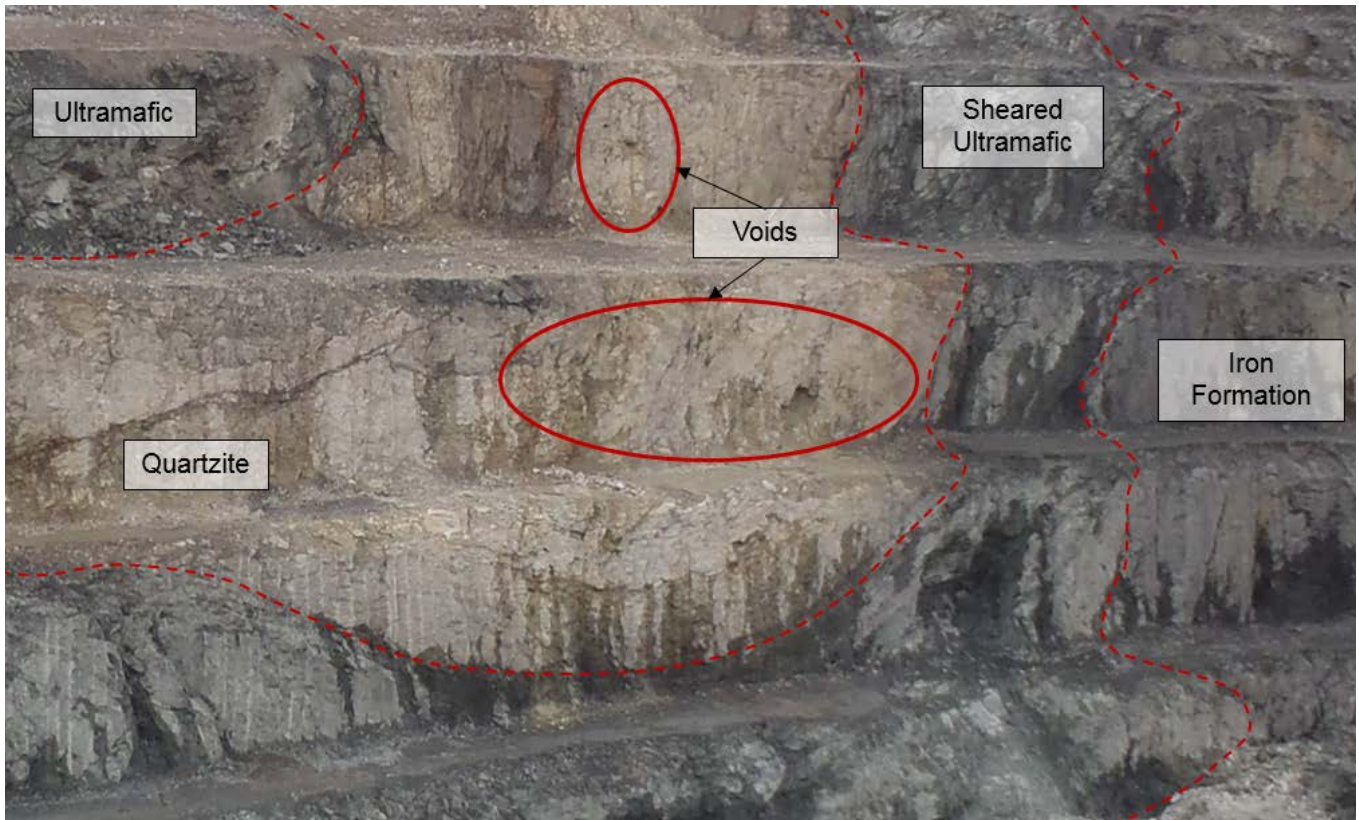
The quartzite stratigraphy observed in the Pit A west wall contains several large voids identified during previous inspections. These have been the source of local raveling, and previously the ramp access to the pit passed beneath these. The ramp access has since been removed, and raveling of rock from these areas no longer presents a hazard as material will be retained on the catch benches.

Photograph 4-12: Voids in quartzite above Pit A west ramp (2016)

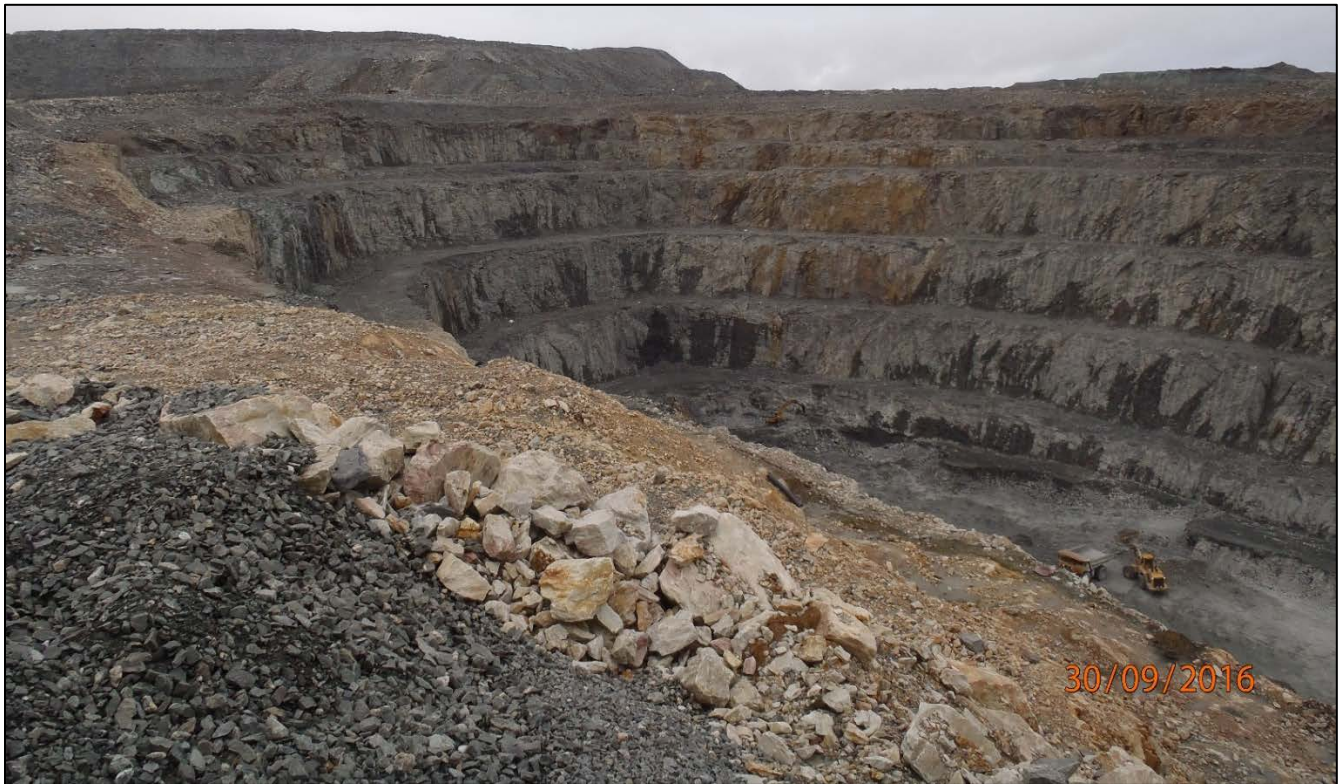
The north through northeast walls of Pit A continue to perform adequately. Very little accumulation of loose or raveling material on the catch benches was noted during the site visit.

*Photograph 4-13: Pit A north to northeast wall (2016)*

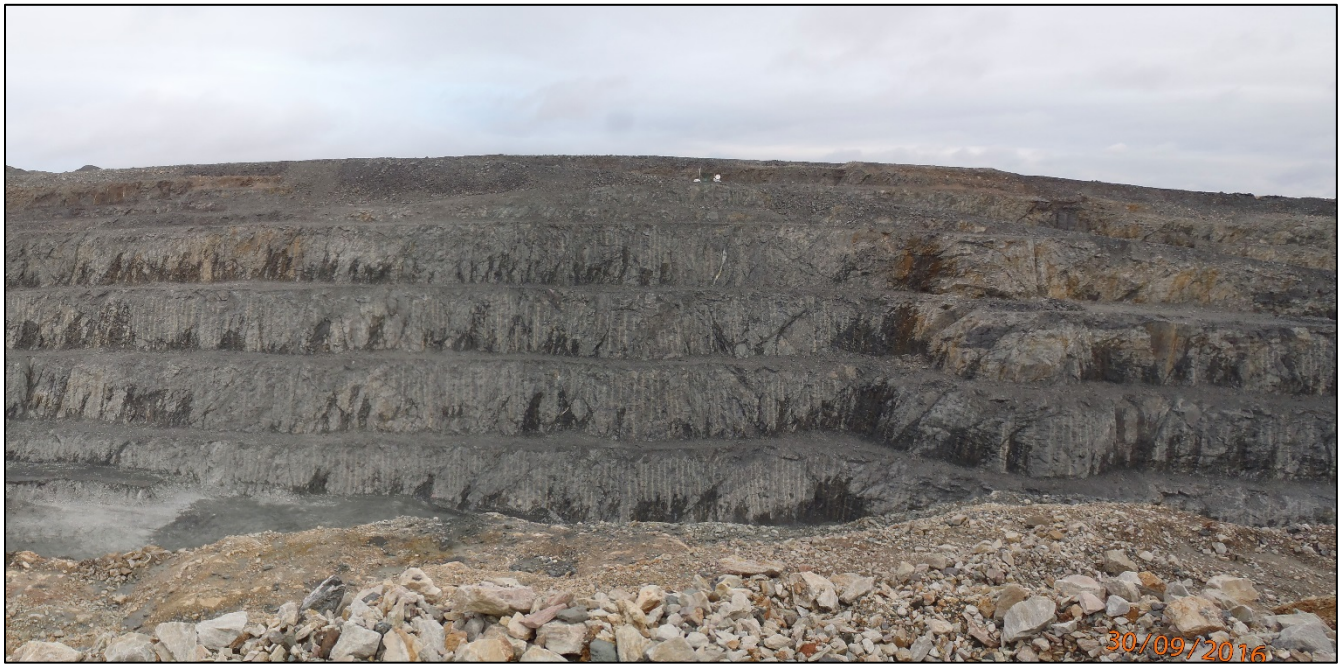
The east wall of Pit A continues to perform adequately. It is well scaled, with steep bench face angles, and minimal accumulations of material on the catch benches.

Photograph 4-14: Pit A east wall performance (2016)

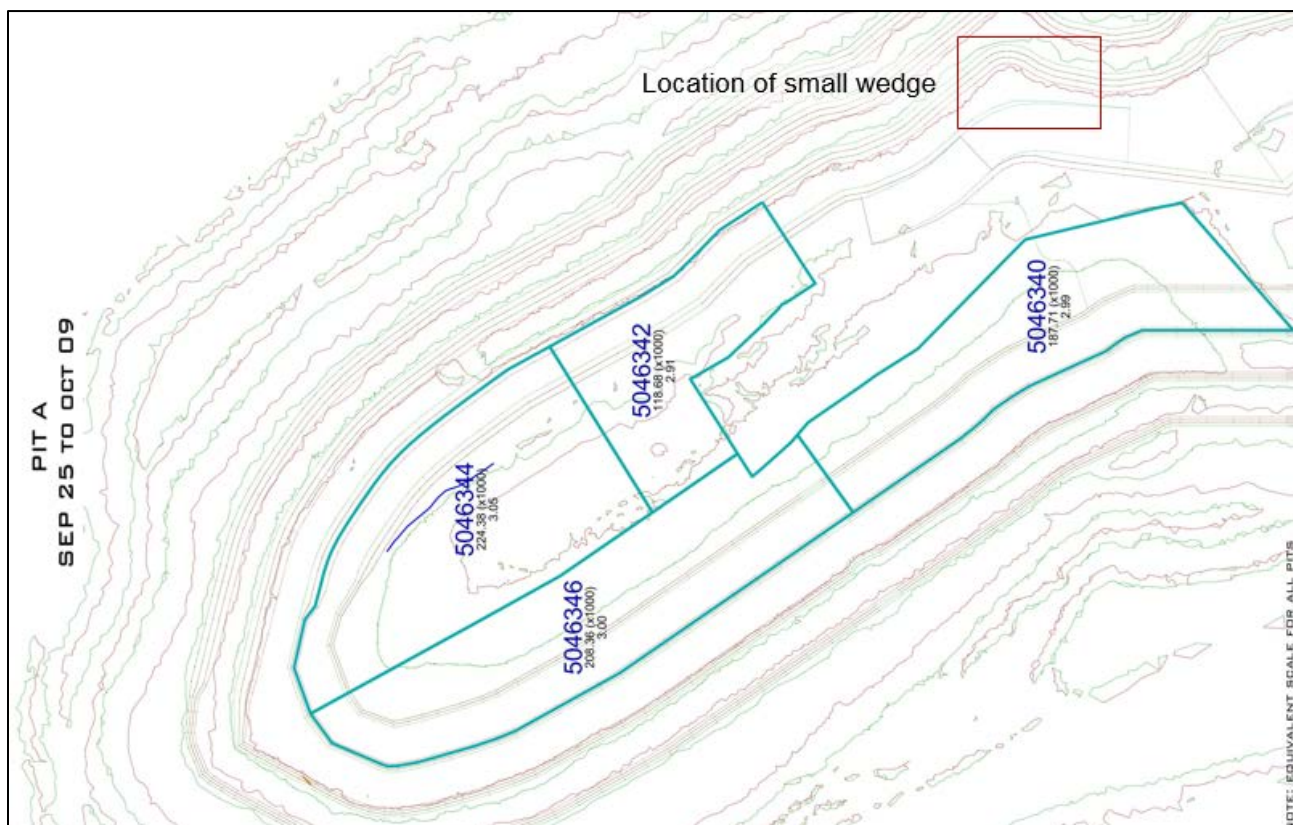
During the site visit, a small wedge was observed in the transition from the Pit A east wall to Pit B east wall. The location is shown in the following figure.

Figure 4-1: Small wedge above stockpiled material

The northwest through northeast end walls and the east wall continue to perform well. A small wedge was noted above a stockpile located on the east wall ramp. It was recommended this be removed and that a bumper berm be placed to prevent personnel and equipment from entering under the wedge location.

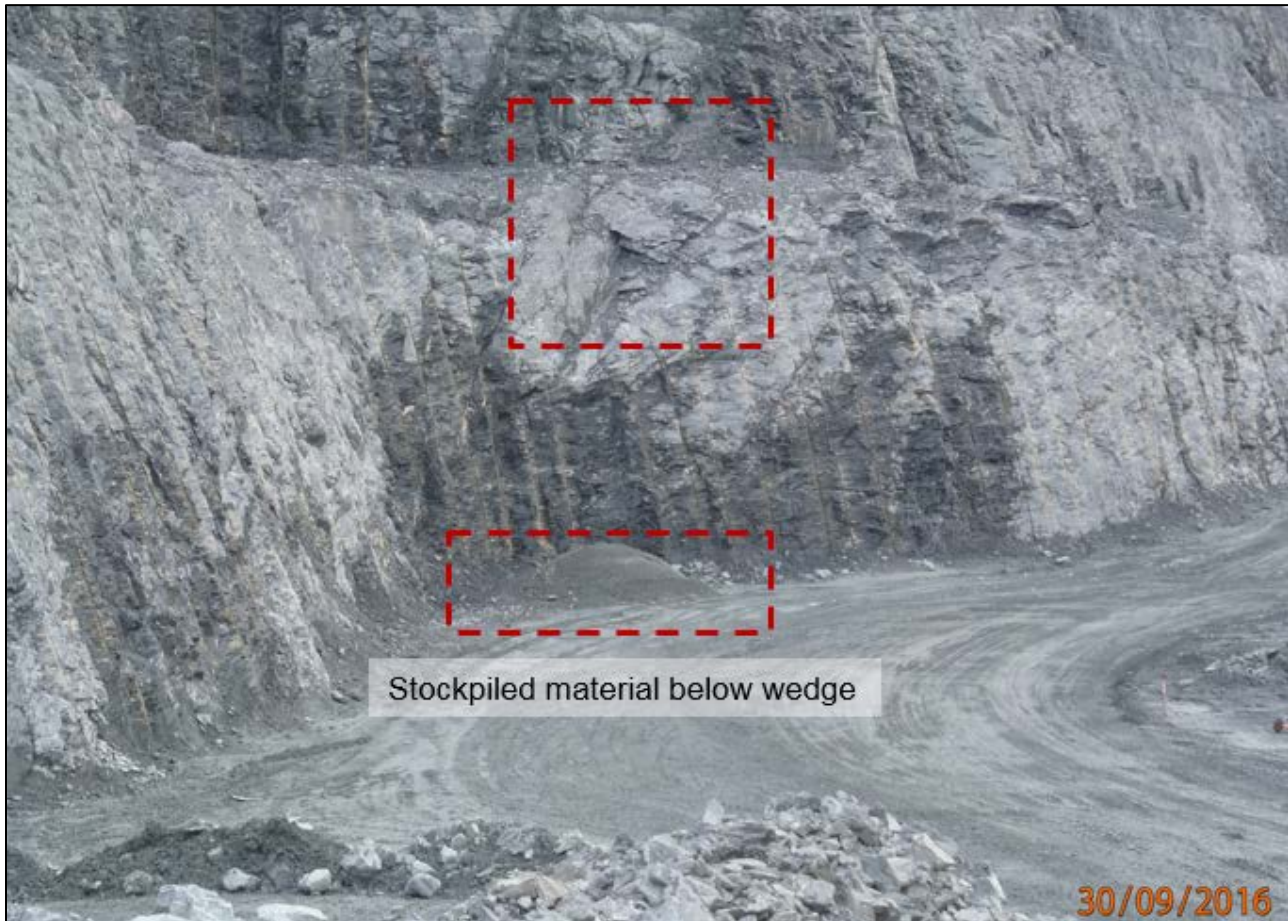
*Photograph 4-15: Wedge above stockpiled material*

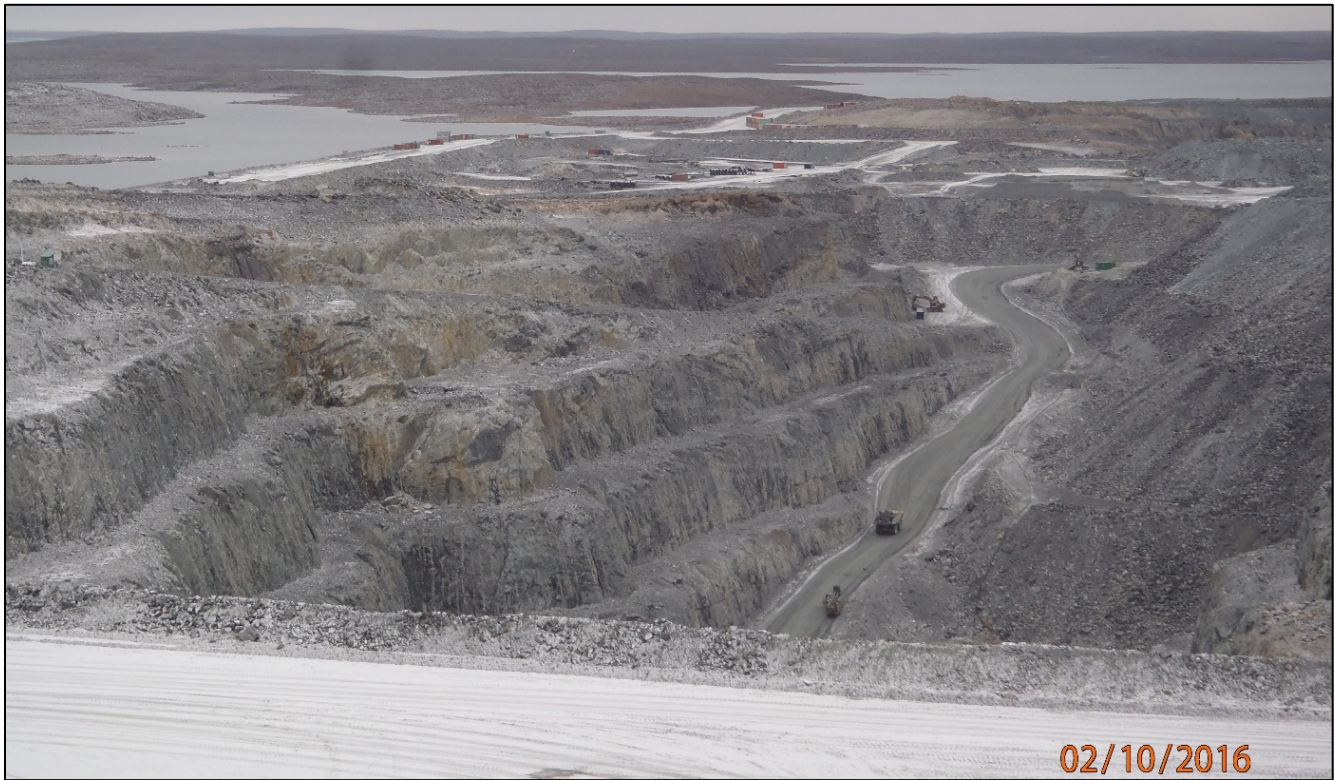
The east wall of Pit B was inspected from several viewpoints as well as from within the pit. The wall continues to perform satisfactorily. Benches are generally clean with little accumulation of material.

Photograph 4-18: Pit B east wall performance, looking south from viewpoint (2016)

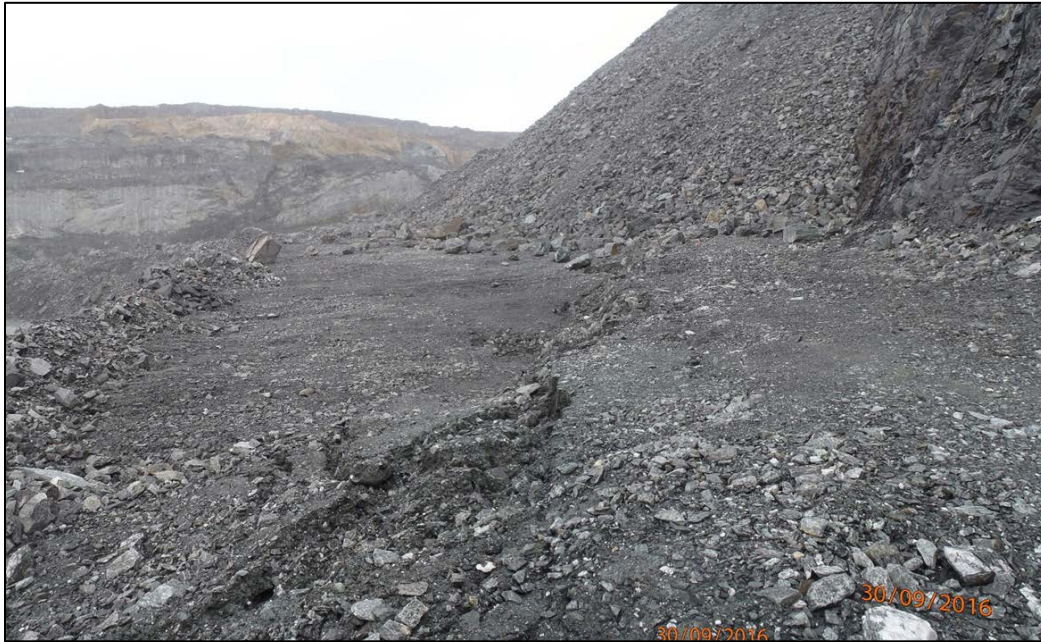
interpreted as differential settlement at the boundary between materials of differing strength properties (the waste rock dump material and the strong rock benches along the east wall of the pit). Nevertheless, these should be monitored for any indication of increasing settlement or movement. There are no signs of distress in the dump face, and no observed tension cracks noted along the dump crest through the central portion of the dump area.

*Photograph 5-3: Tension crack and settlement at eastern margin of lower platform, Pit D Dump (2016)*

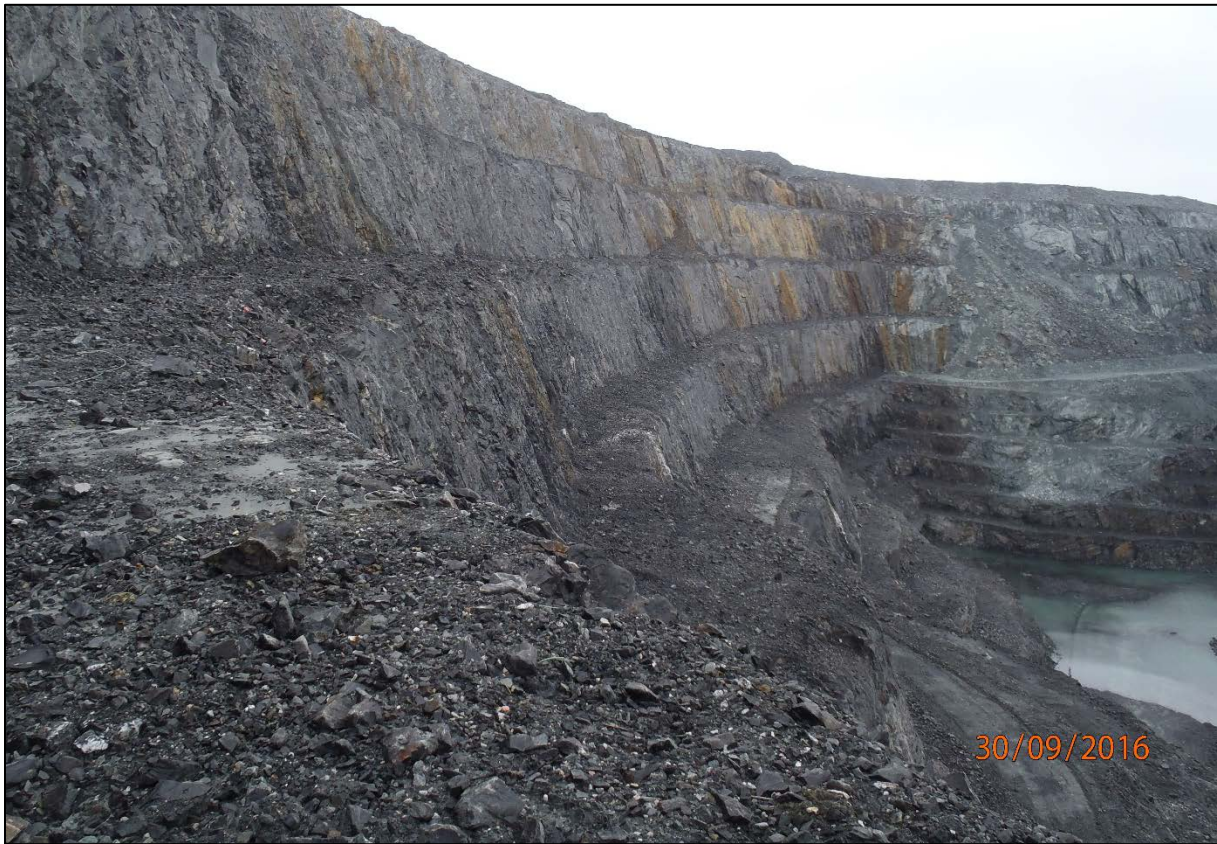
The Pit E3 east wall is excavated in good quality intermediate volcanic rock. The main structural control for the east wall is the steeply west dipping stratigraphy and sub-parallel foliation. Bench face angles have been excavated generally parallel to the dominant structural orientation, and the bench and overall wall performance continues to be satisfactory. Final benches have been cleaned and scaled appropriately. Occasional bench-scale rock falls have occurred in association with local undercutting of wedge and plane geometries; the material from these local failures has been retained on the catchment benches.

**Figure 6-1: East wall showing good bench and wall performance (2016)**

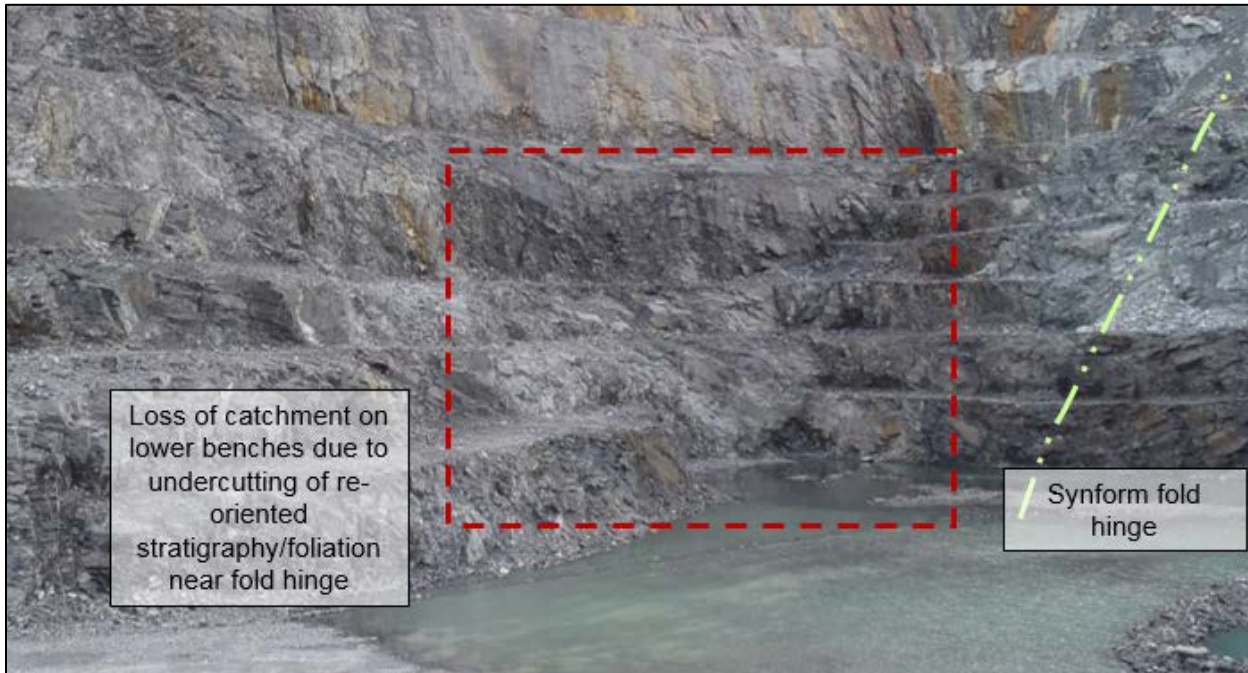
This shallower orientation of the stratigraphy and foliation as exposed in the lower benches is related to folding about a synformal structure trending into the south wall of the pit.

Photograph 6-2: Loss of catchment on lower benches in Pit E3 (2016)

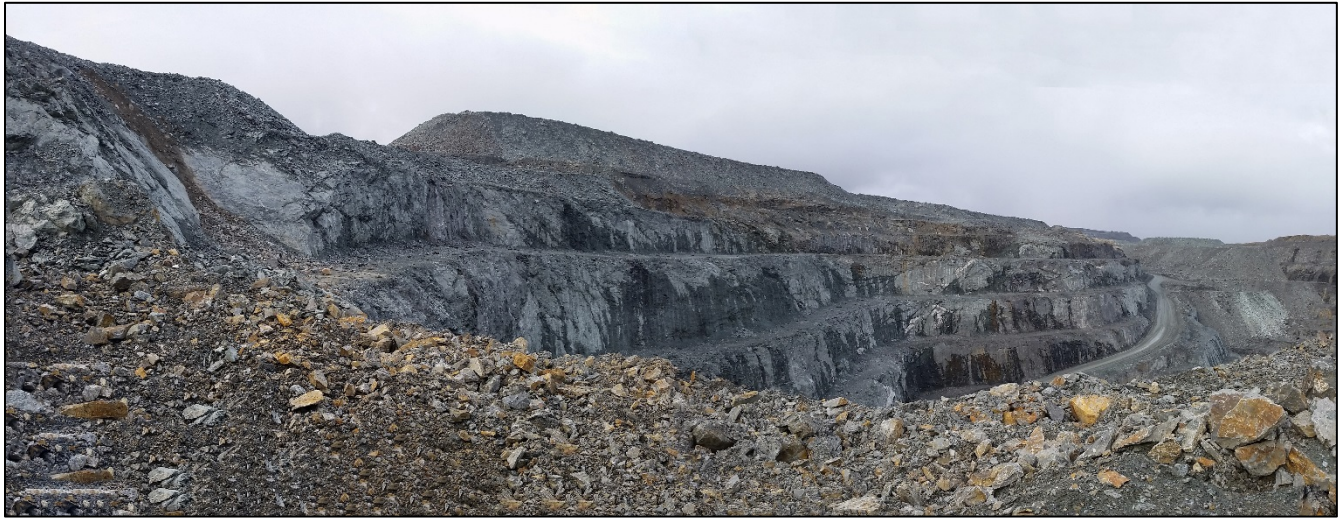
Currently the performance of the west wall benches is generally satisfactory, particularly in the upper benches excavated in the stronger rock types, although some crest loss is noted. The bench face angles are steep, with wide catch benches, and these are adequate for retaining the material that has failed.

*Photograph 6-5: Pit E3 west wall upper benches (2016)*

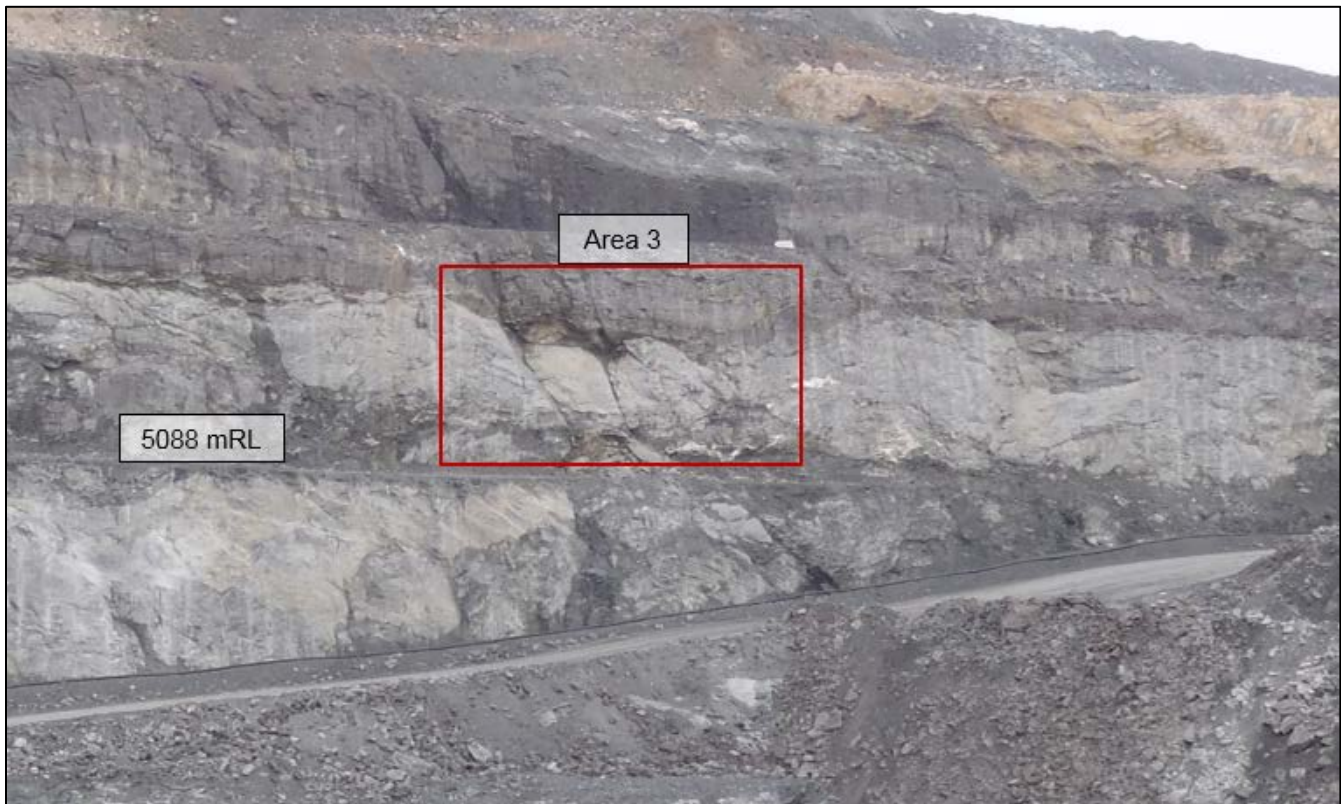
material accumulating at the toe was noted during the 2016 inspection. The combination of the 5088 mRL bench, and the containment berm on the ramp is adequately managing the potential for rock fall in this area.

Photograph 6-10: Pit E3 Ramp Area 3 wedge (2016)

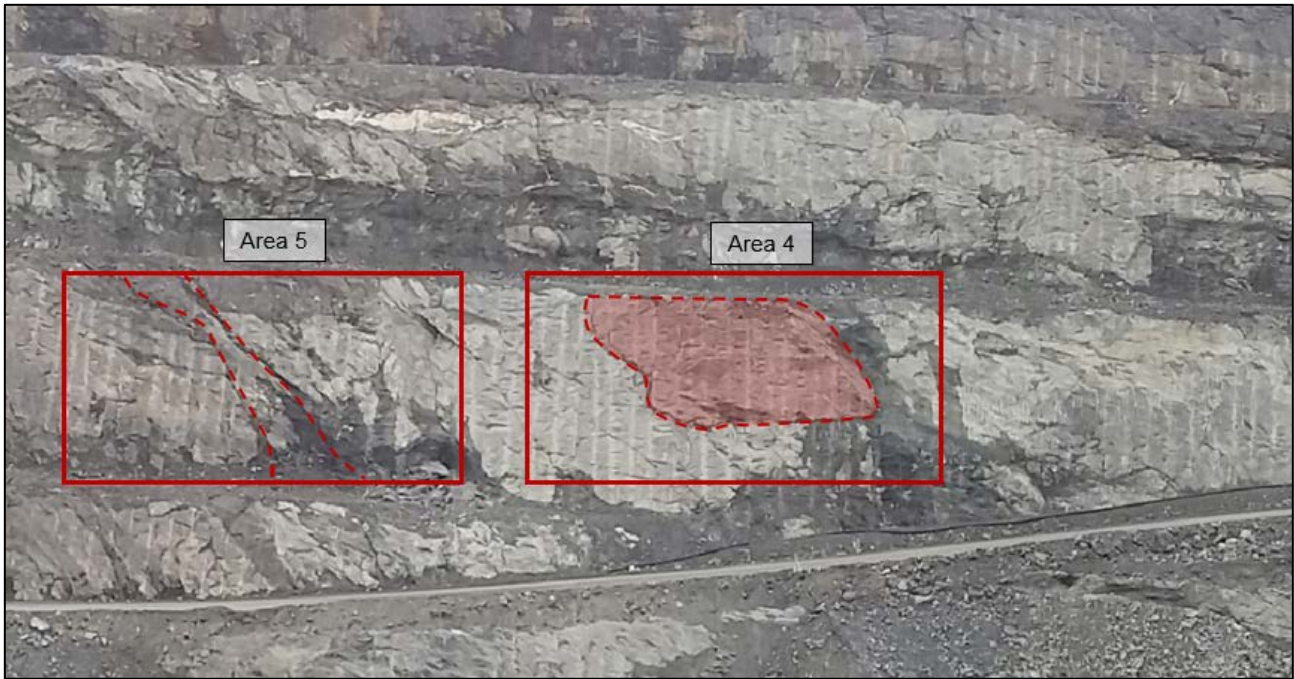
Area 5 is defined by a series of closely spaced bench-scale joints trending into the wall, and forming steeply plunging wedges.

Photograph 6-11: Pit E3 Ramp Areas 4 and 5 (2016)

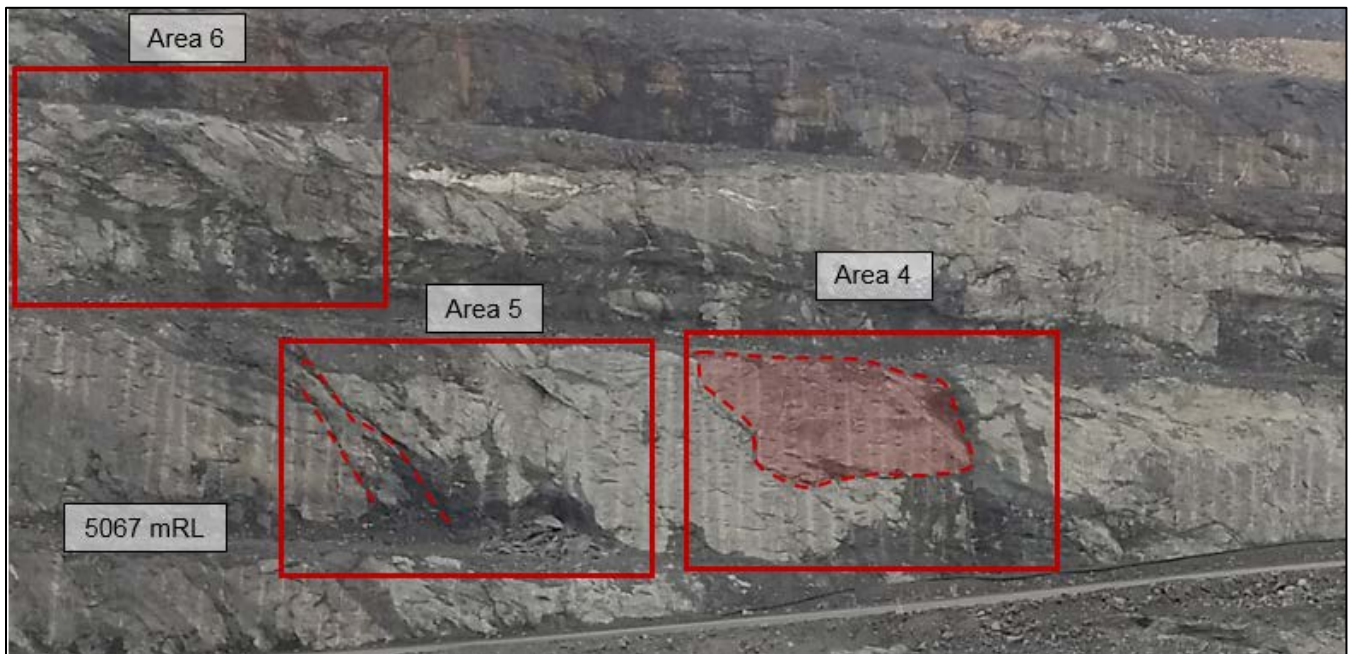
Area 6 is located above the 5088 mRL bench, and is a vertical extension of the closely spaced jointing of Area 5. These are steeply north dipping shear joints, which intersect the volcanic rock. The close spacing and continuous nature of these joints may result in increased raveling of material particularly during freshet and spring thaw.

Photograph 6-13: Pit E3 Ramp Area 6 (2016)

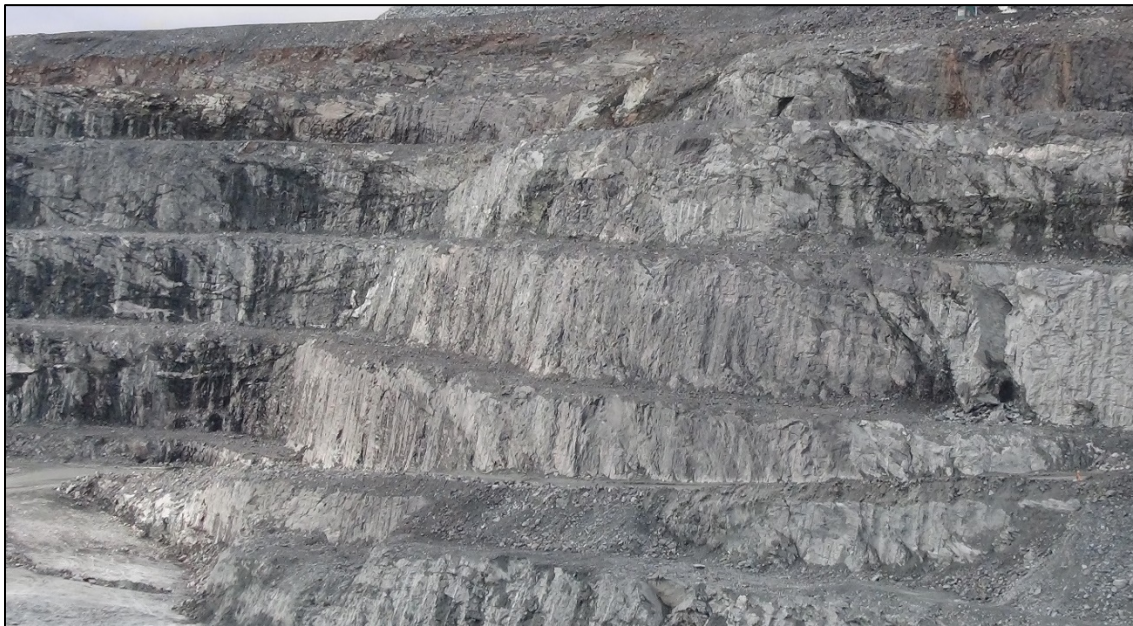
As the West Wall Ramp continues to descend into the pit to the south past Areas 5 and 6, the quality of the ultramafic rock improves as does the bench performance. This is seen in the following photograph.

*Photograph 6-14: Pit E3 west wall ramp south end (2016)*

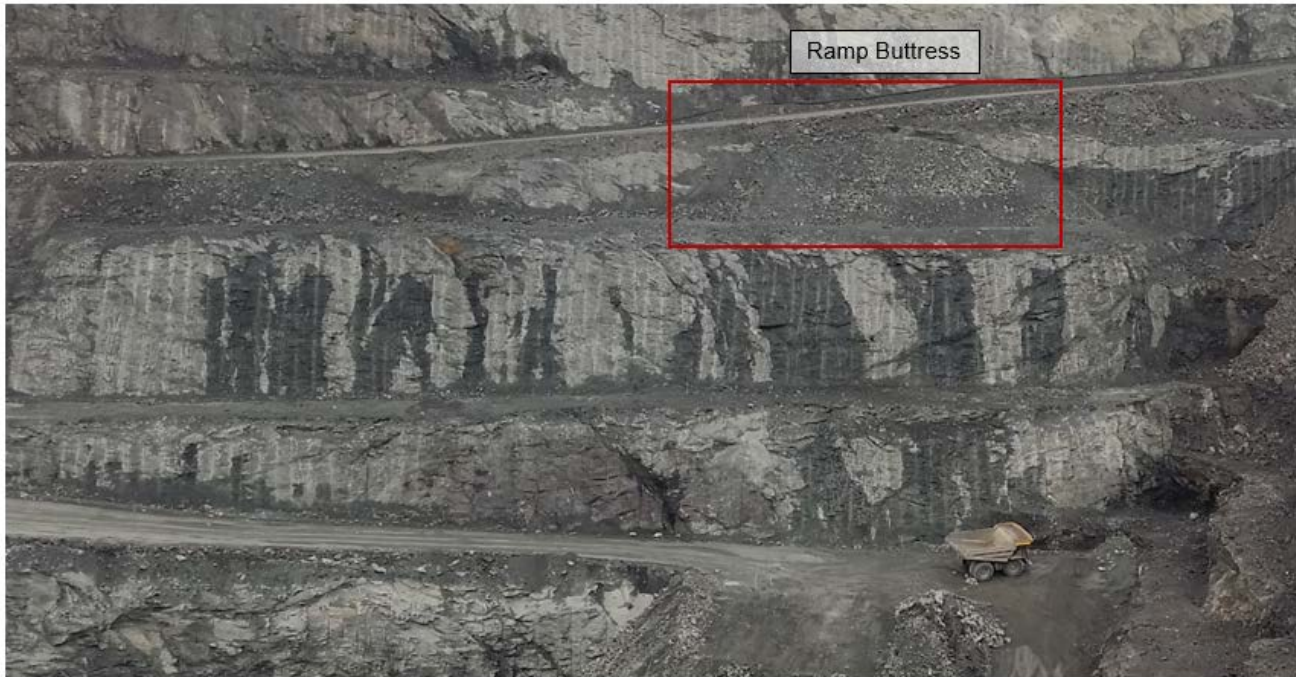
The ramp instability identified in 2015 by AEM and associated with the lower wall ultramafic rock in the benches below the ramp was mitigated with the construction of a counter-balancing rock fill berm to support the ramp. This was documented during the 2015 inspection. The berm continues to be effective at stabilizing the ramp.

Photograph 6-15: Pit E3 west wall ramp buttress and step-in (2016)
