### **Annual Review of Portage and Goose Pit Slope Performance**

# 2016 ANNUAL PIT SLOPE PERFORMANCE REVIEW MEADOWBANK MINE, NUNAVUT

DECEMBER 21, 2016

ISSUED FOR USE  
704-ENG. EARC03050-01

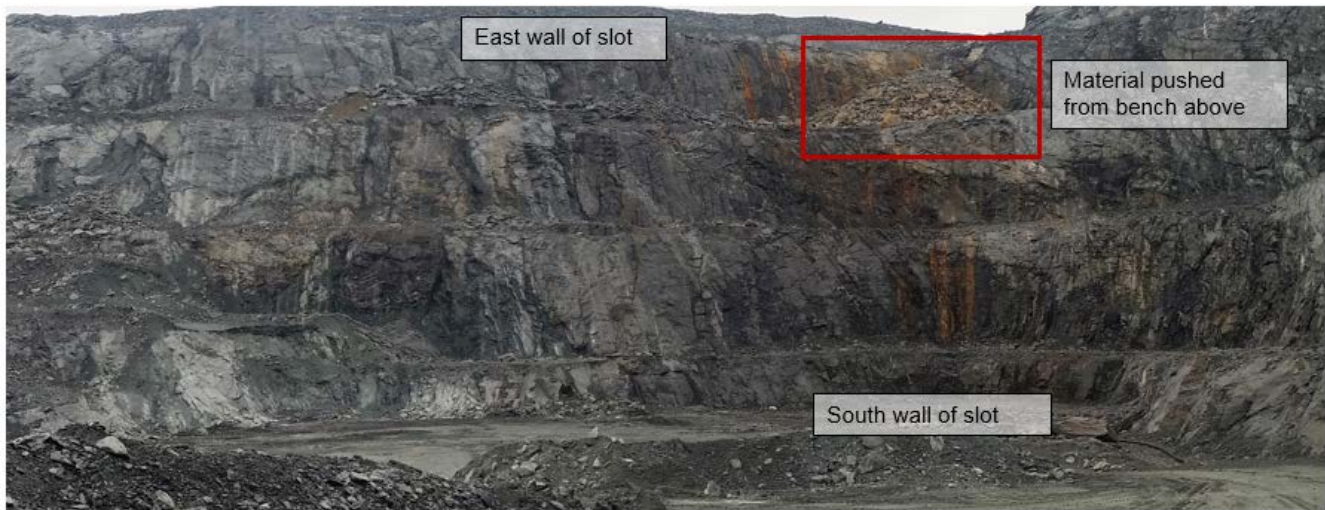
The topmost bench of the south wall of the slot reveals an adversely oriented, continuous planar structure dipping to the northeast at a moderate angle which was scaled out during mining. As the east wall of the pushback transitions into the Pit E3 south wall, continuous north dipping joint planes result in catchment loss where these have been undercut by bench face angles.

Photograph 6-16: Pit E3 south slot pushback looking south (2016)

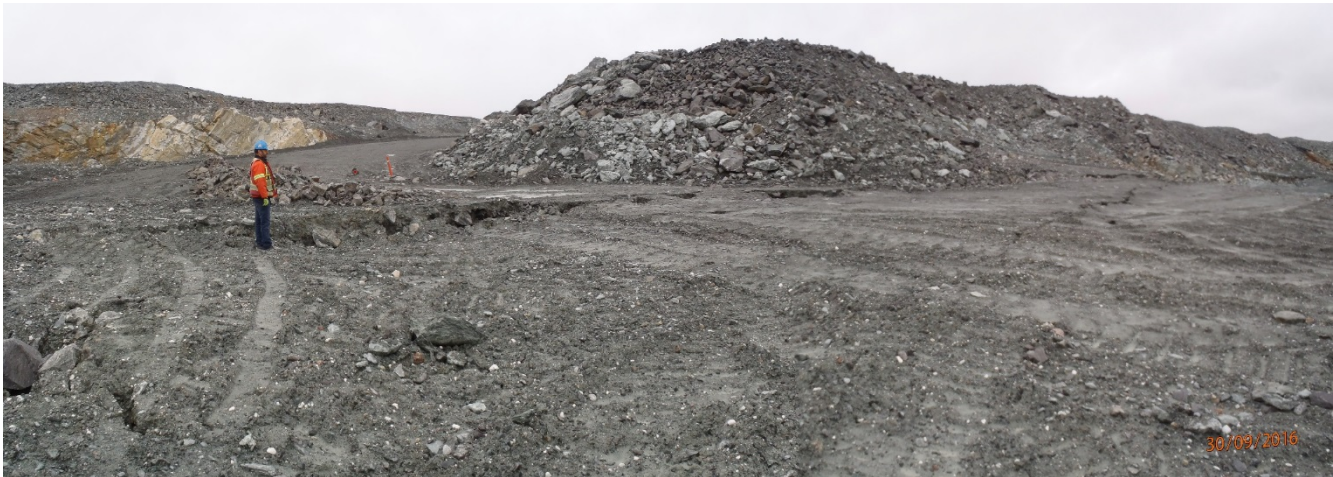
Several large tension cracks were noted during the 2015 inspection on the dump platform, between 10 m and 20 m back from the dump crest. The tension cracks are curvilinear and extend the full width of the dump platform. It was noted during the 2015 inspection that approximately 30 cm of vertical displacement across the cracks and lateral separation (opening) had occurred. During the 2016 inspection, it was observed that the vertical displacement across the cracks has increased due to dump crest settlement. Additional tension cracks were also observed.

Photograph 7-5: Goose Pit dump crest and tension cracks, September 2016

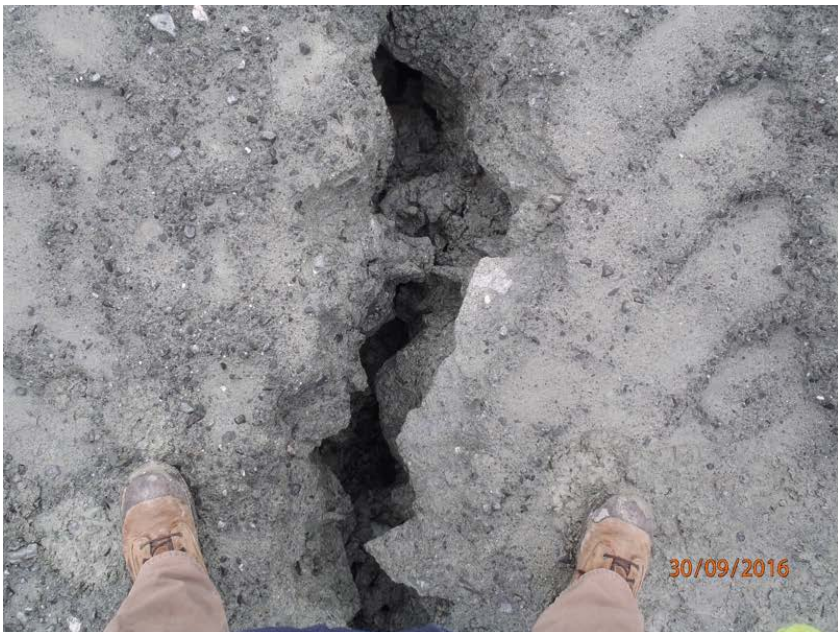
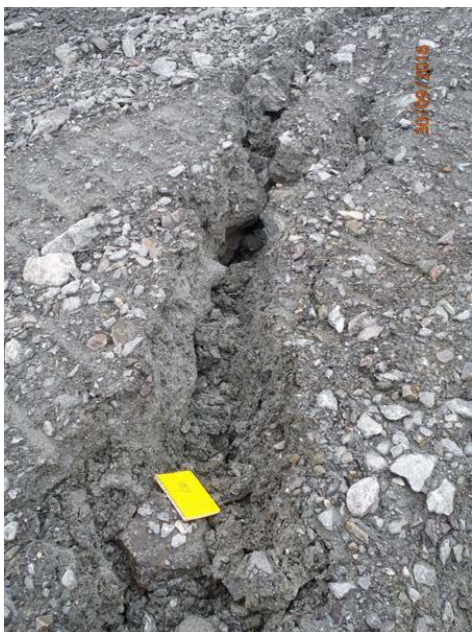
Photograph 7-6: Opening of tension cracks on dump platform (September 2016)

Based on discussions with AEM, much of the dump platform settlement occurred following the introduction of water to the north end of the dump platform area from pumping from Pit E3. The water line was relocated to discharge over the bedrock face of the north wall of the pit, rather than on to the dump platform.

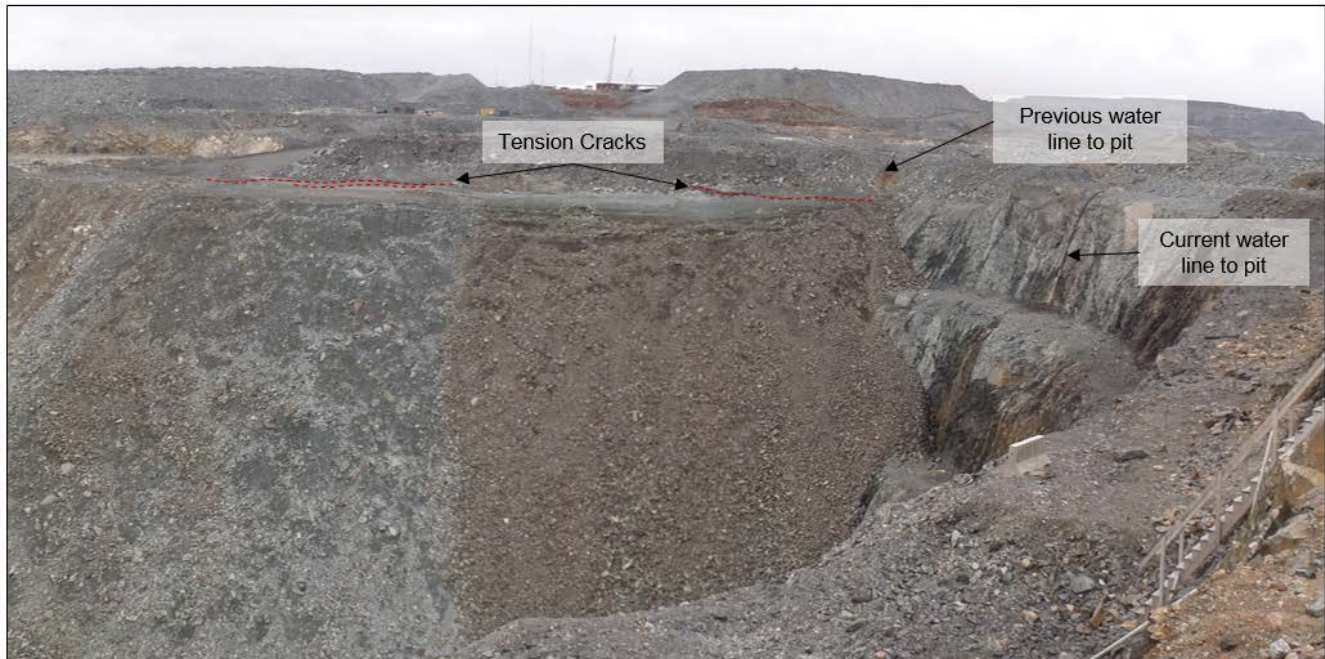
**Figure 7-2: Location of tension cracks in Goose Pit dump platform (September 2016)**

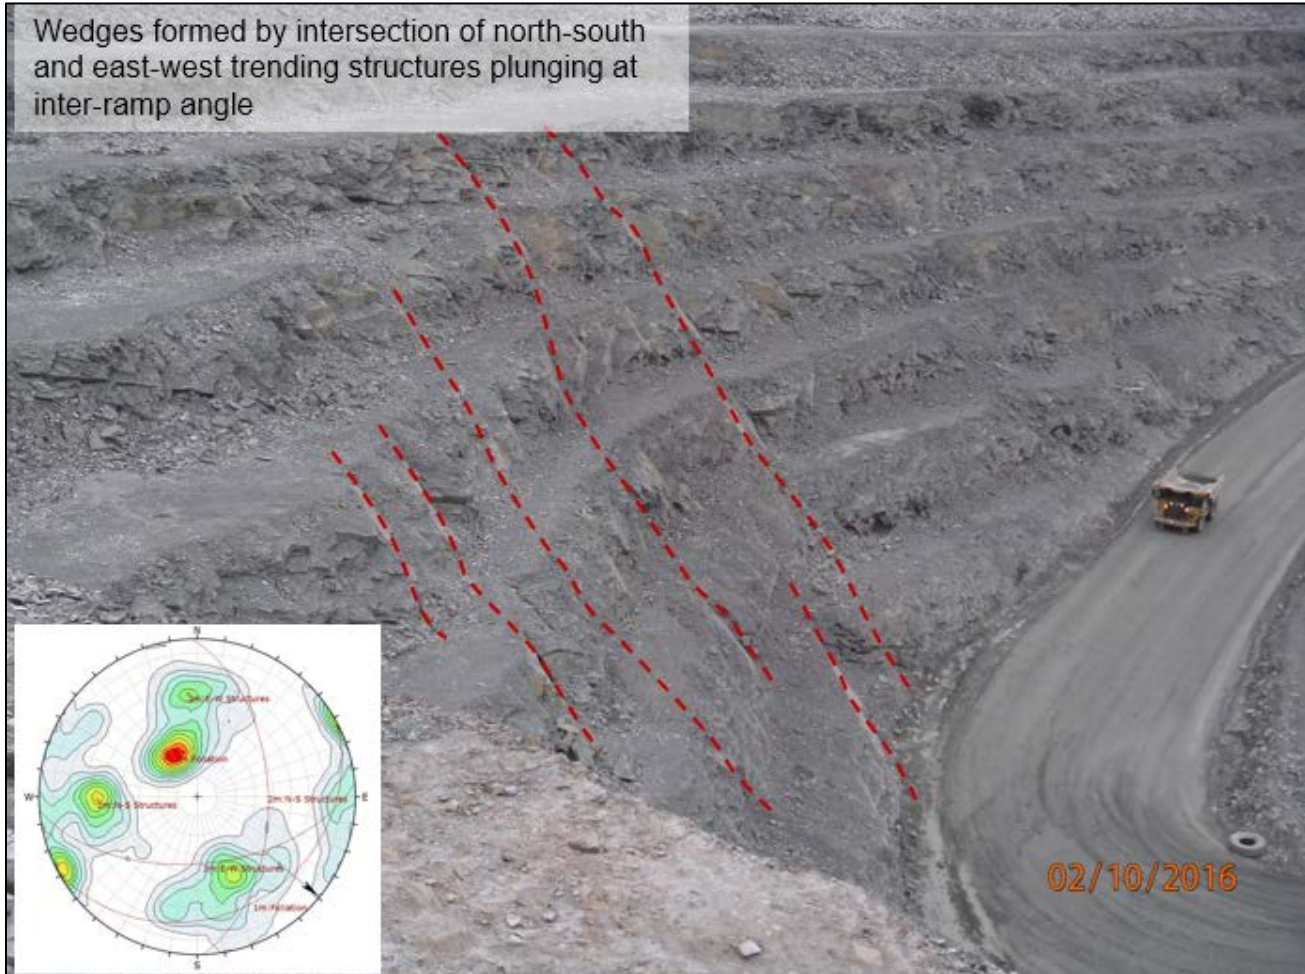
At the south end of the wall a series of closely spaced continuous fault structures trend into the wall at high angles. These are part of the east-west trending family of faults and sub-parallel joints which dip to the south at about 55 degrees. These features form narrow wedges with north-south trending faults and sub-parallel joints. The plunge of these wedges ranges from about 30 degrees to about 60 degrees, and where undercut by the inter-ramp angle have formed multiple bench features. These features are narrow and widely spaced, and because of the shallow inter-ramp angle result in only raveling of limited extent is observed.

Photograph 8-3: Vault Pit grid west footwall slope south end wedges

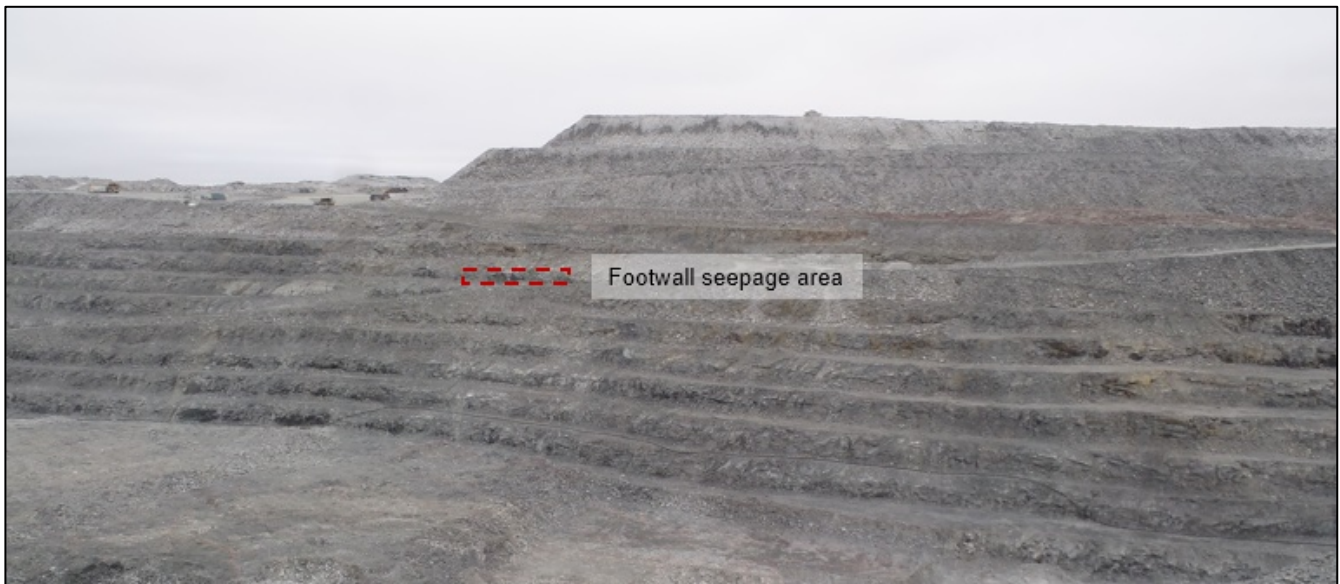
An area of seepage adjacent to the ramp identified during the 2015 inspection continues to produce small volumes of water. At the time of the 2016 inspection water was observed seeping along the foliation fabric. The seepage is concordant with the foliation, and may be derived from hydraulic connection by the major east-west and north-south structures to talik beneath the dewatered Vault Lake. The seepage flow is low and does not appear to be affecting the bench-scale stability of the rock above the ramp. It is possible that with time some increased raveling of material will occur. This area should continue to be monitored as part of regularly scheduled geotechnical inspections, and a bumper berm developed if necessary. It is possible that over time this area will fully drain once the storativity of the talik is depleted.

Photograph 8-4: Vault Pit footwall seepage

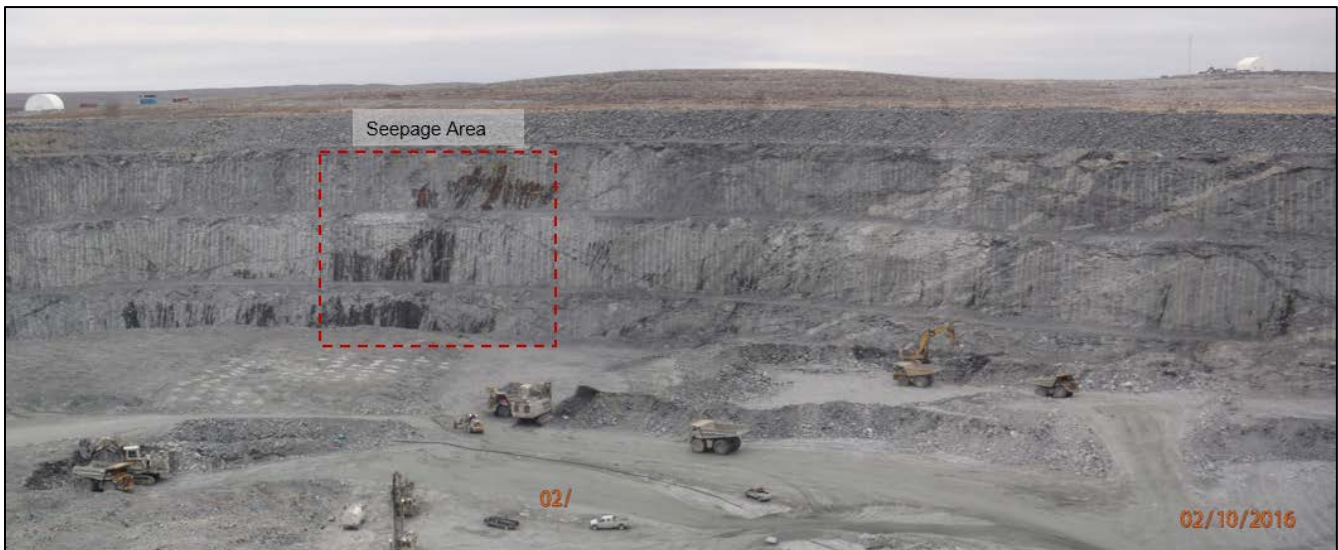
Photograph 8-10: Seepage from the southeast highwall near 2015 inflow

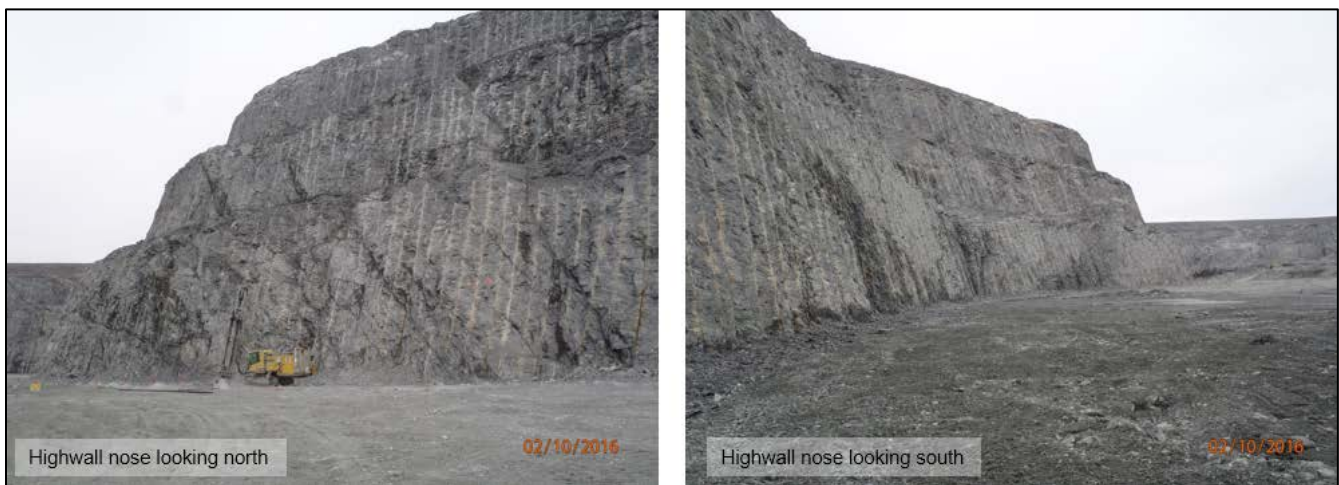
Photograph 8-12: Faults and widely spaced open joints dipping into nose of highwall

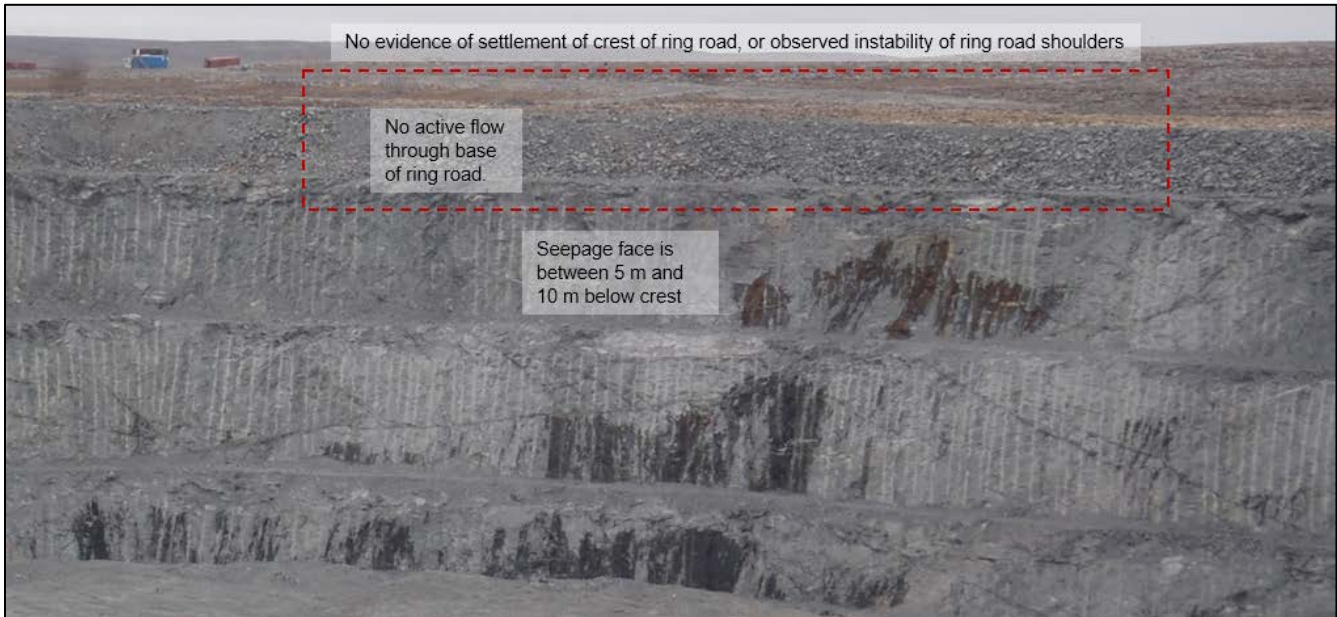
Photograph 8-15: Seepage in southeast wall of Vault Pit

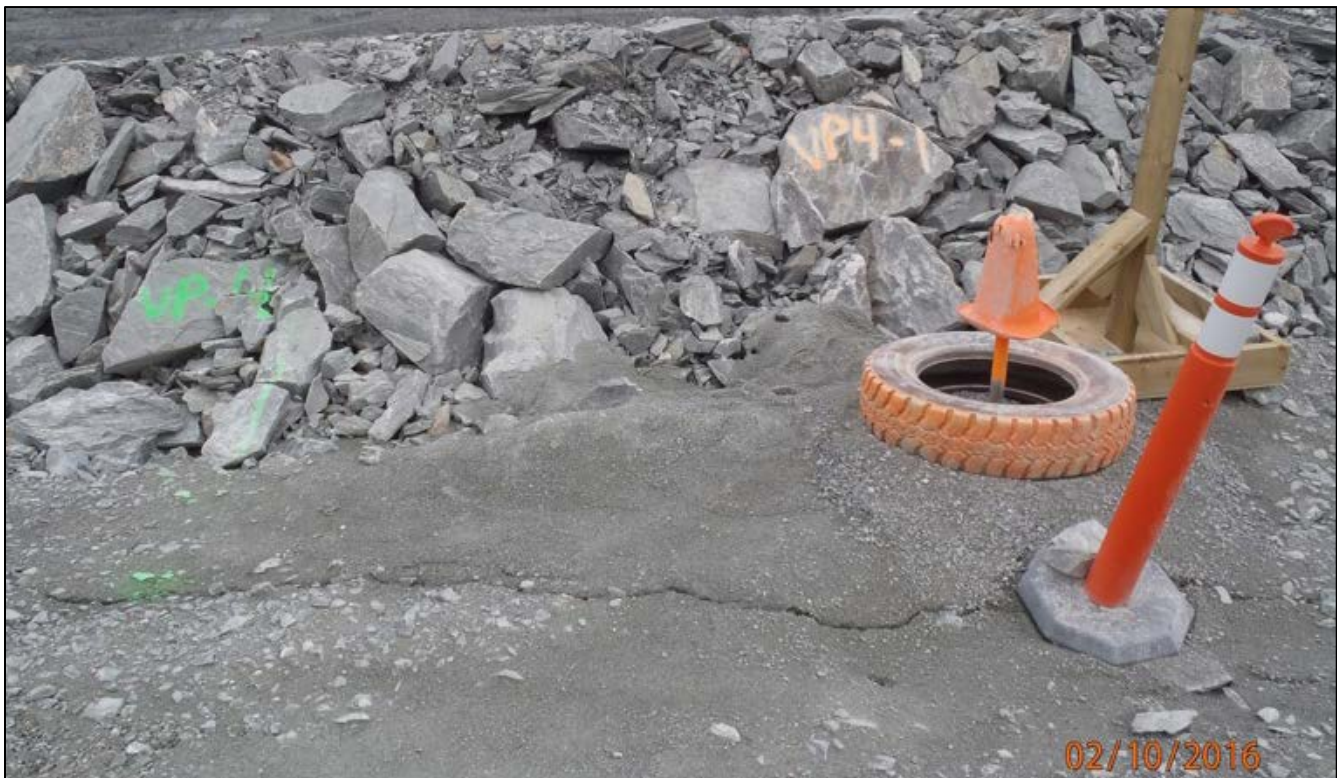
During the 2016 site inspection, the wall was observed generally to be dry. Although seepage is noted in the general area of the wall adjacent to the previous inflow, this not significant. The ring road appeared to be stable, with some minor settlement around the 2015 inflow area. Some minor tension cracks were noted at the crest of the road, parallel with the road alignment, and these are interpreted to be related to minor settlement at the road margins. The water level in Vault Lake appears to be managed at a low level, helping to reduce any further inflows through the ring road itself.

Photograph 8-16: Minor tension cracks noted in ring road near 2015 inflow

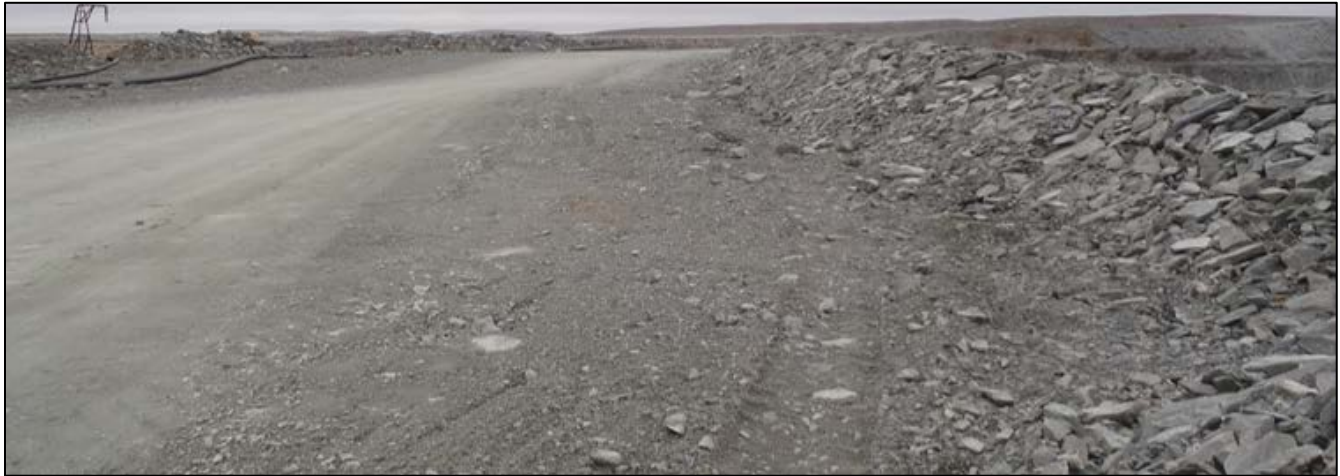
*Photograph 8-17: Minor swale observed in ring road near 2015 inflow*

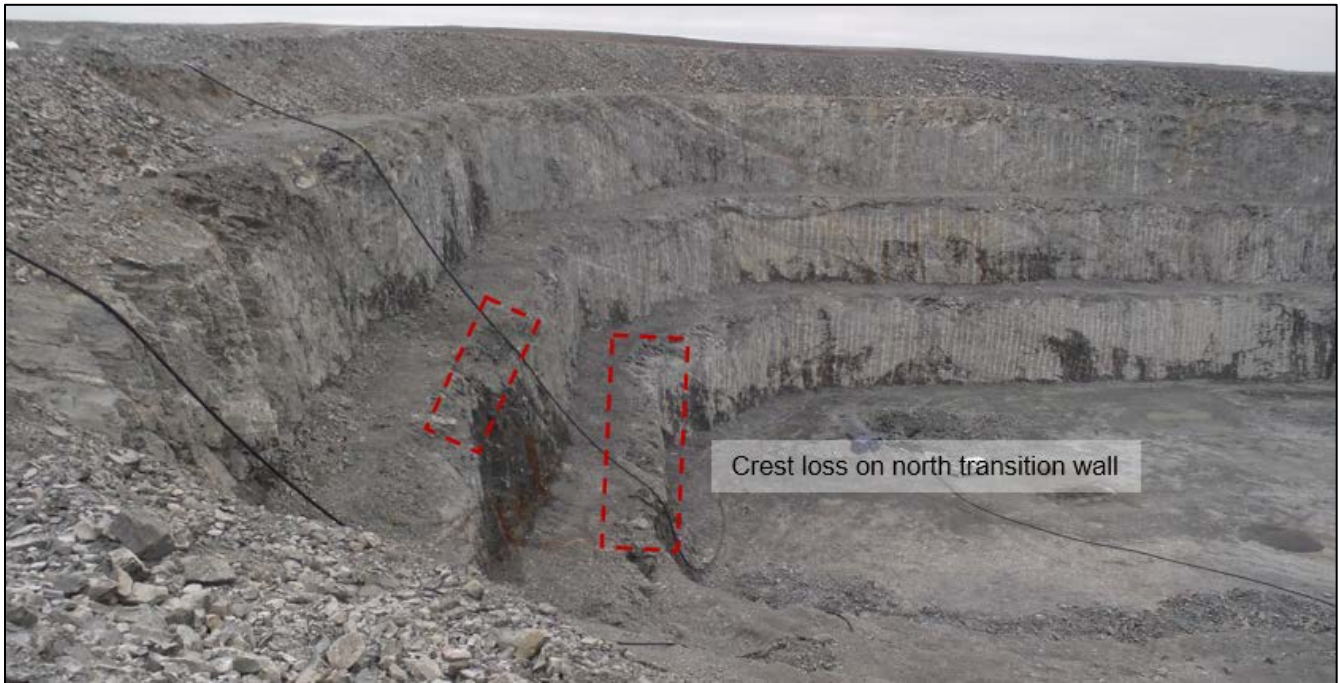
*Photograph 8-20: Crest loss on north transition wall*

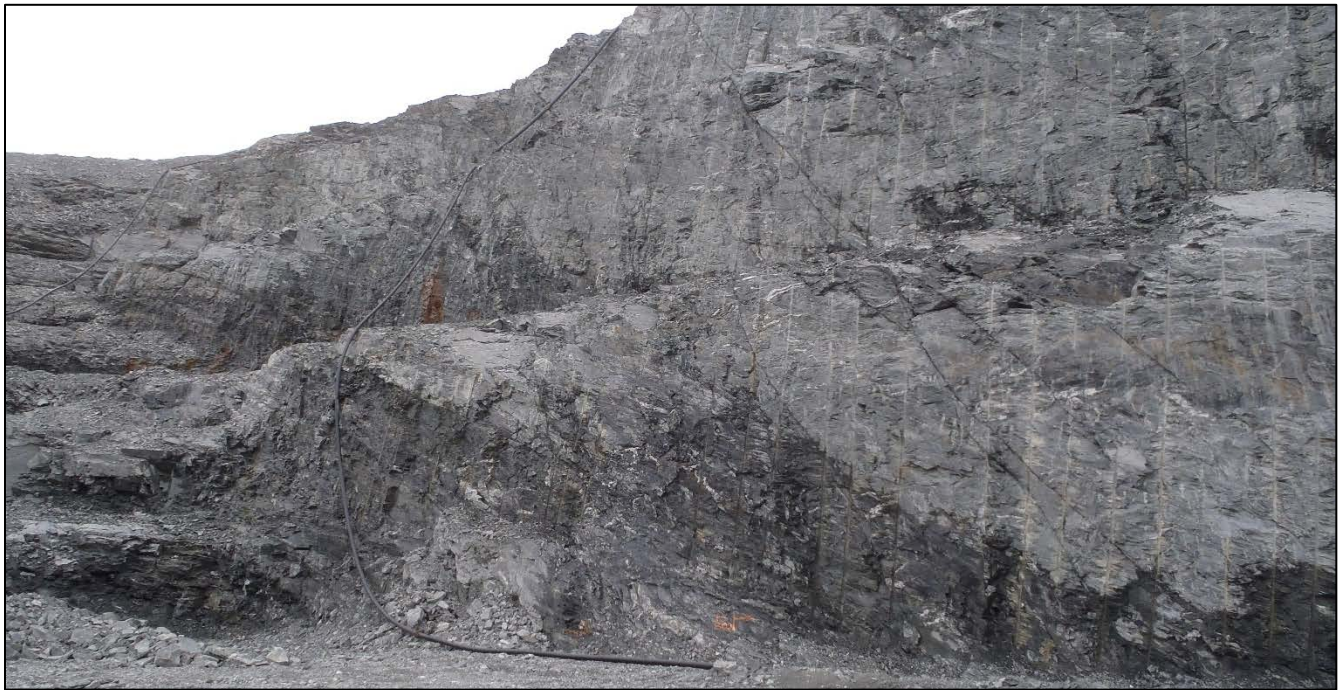
*Photograph 8-22: Vault Pit north transition wall seepage along southeast dipping foliation planes*

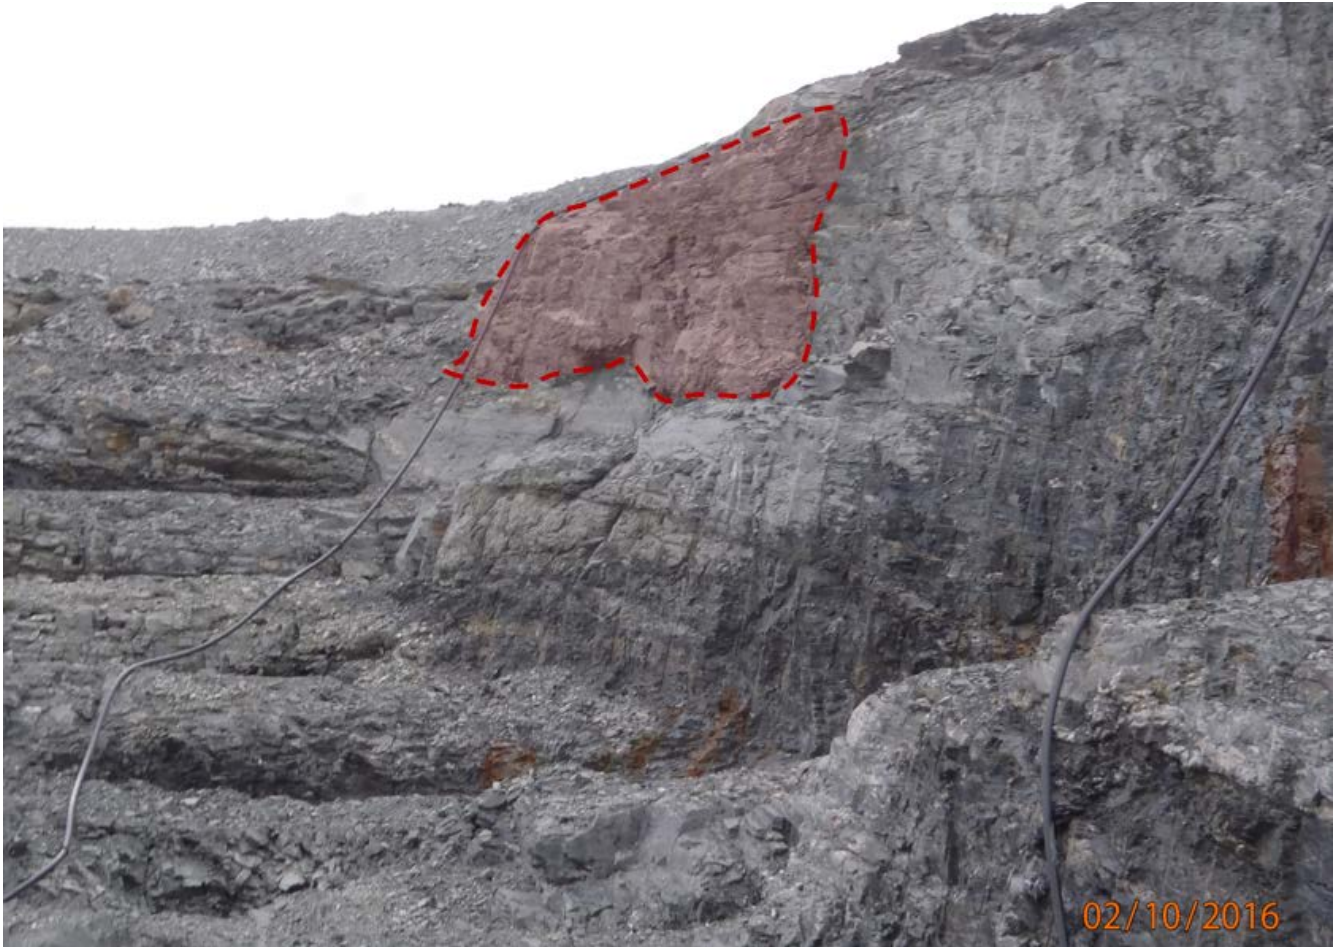
*Photograph 8-24: Vault Pit north transition wall wedge*
