### **Annual Review of Portage and Goose Pit Slope Performance**

# 2017 ANNUAL PIT SLOPE PERFORMANCE REVIEW MEADOWBANK MINE, NUNAVUT

DECEMBER 22, 2017

An annual site visit to inspect the performance of the pit walls of the open pits at Agnico Eagle Mines Ltd.'s (AEM) Meadowbank Mine was carried out by Tetra Tech Canada Inc. (Tetra Tech) during the period 25 September 2017 to 28 September 2017. A detailed summary of recommendations is presented in Section 9.

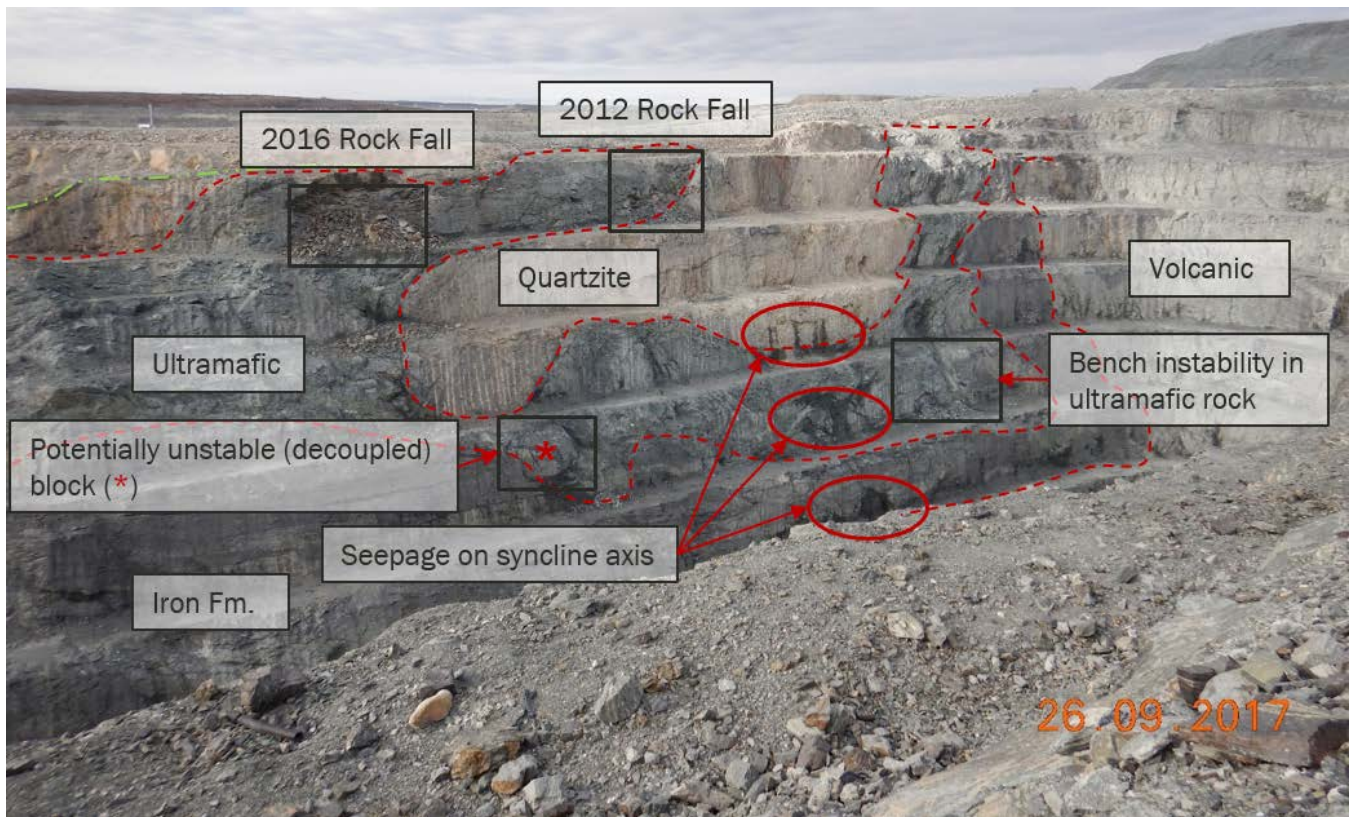
**Photograph 4-3: Pit A west wall (2017)**

The following Photograph 4-3 shows the west through north wall of Pit A at the time of the inspection.

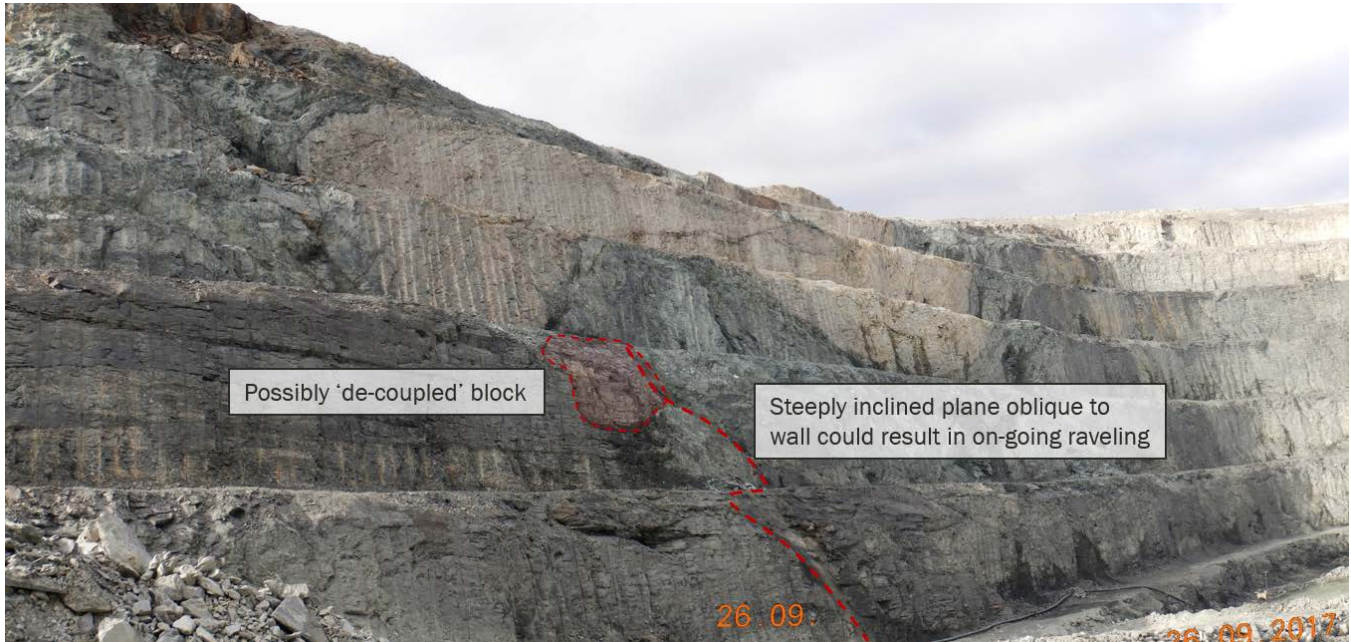
*Photograph 4-4: Pit A lower west wall bench performance in iron formation*

Since the 2016 inspection, benching down of the west wall has been generally within the iron formation, and the lower benches are performing well as shown in Photograph 4-4 below. A steeply inclined, undulating plane which strikes obliquely into the wall was noted, and this may be a source of on-going raveling of material, although currently the bench face is performing well. A possibly de-coupled rock block is also visible, as shown in the photograph, and this should be monitored.

The following actions are recommended:

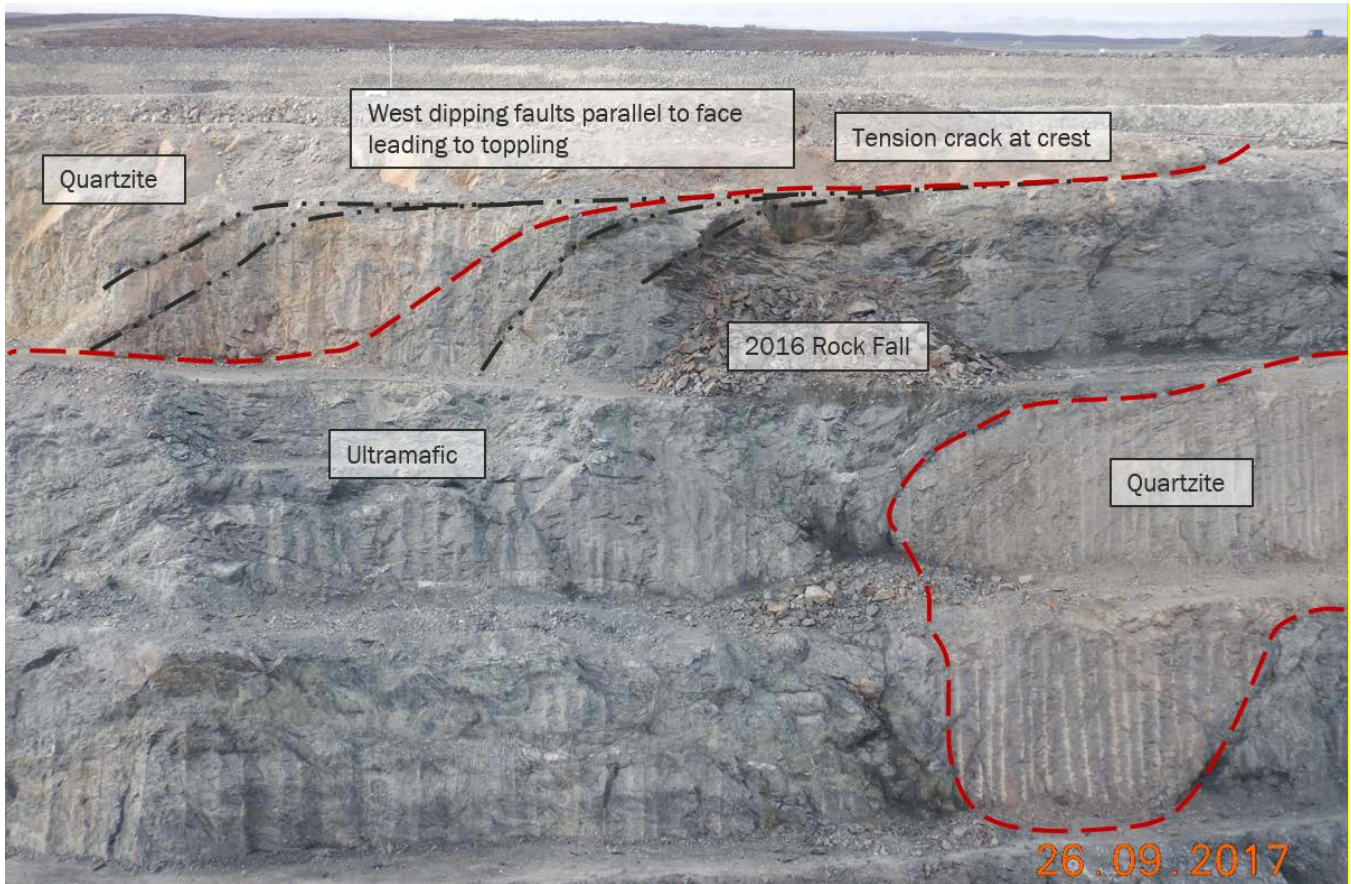
*Photograph 4-5: Pit A West Wall 2016 rock fall and tension cracks*

Contributing to these rock fall events is a series of parallel fault features that trend behind the uppermost bench, dipping at around 60 degrees, and approximately parallel to the contact between the ultramafic and quartzite rock. These features were identified during the 2011 inspection along which potential toppling could develop, which is what occurred during the 2012 and 2016 rock fall events. The rock type in the footwall of these features is ultramafic, serpentized, strongly sheared, and consequently poor quality.

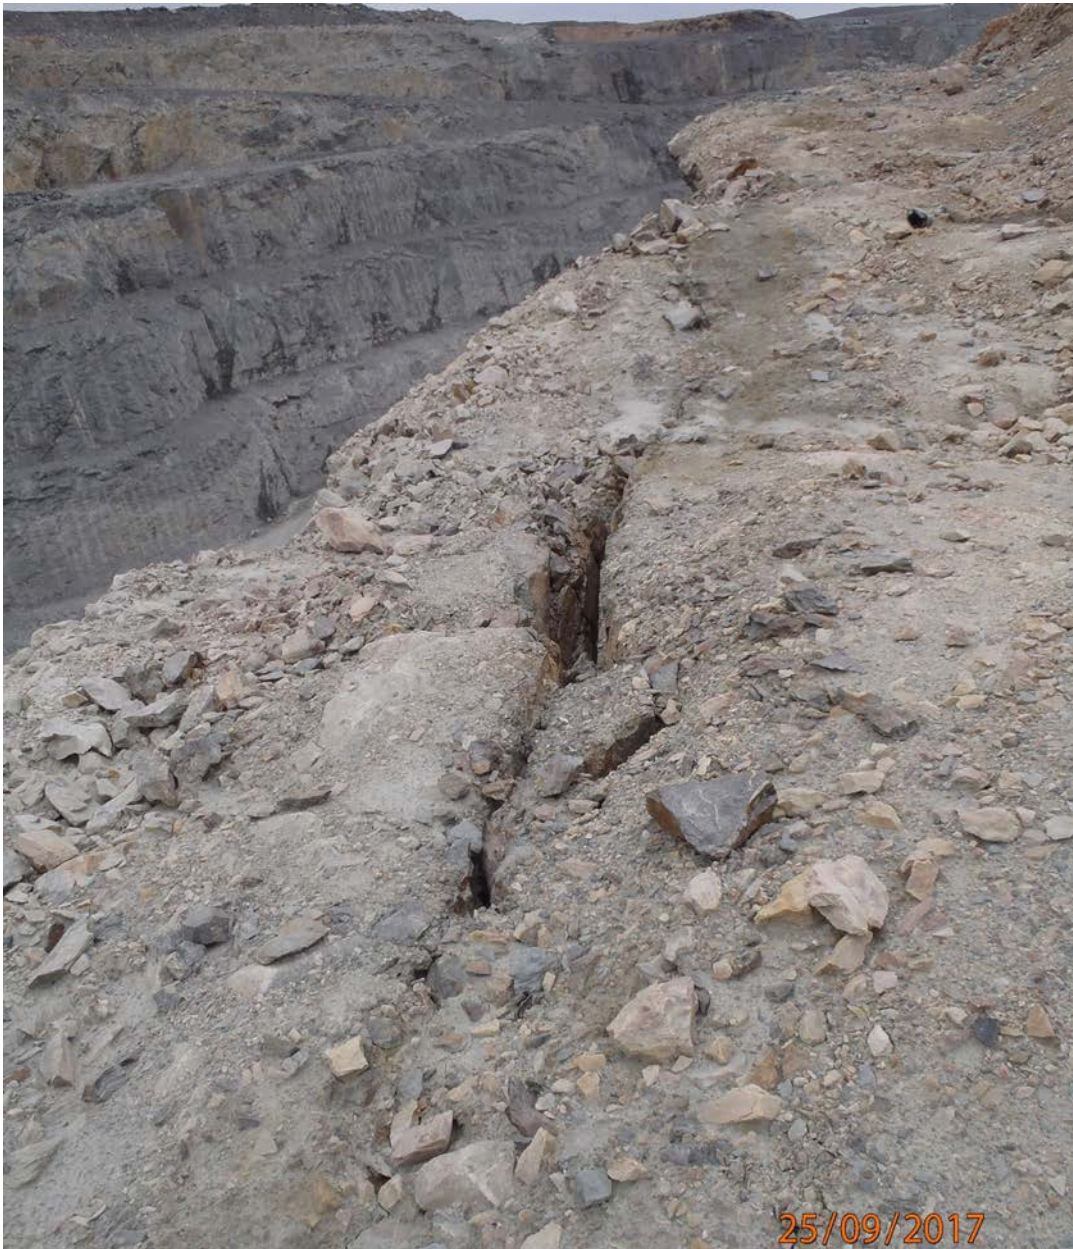
**Photograph 4-6: Bench above 2016 rock fall showing tension crack**

A tension crack is located at the crest of the bench and associated with the faults behind the wall. The location is shown on Photograph 4-6.

The following actions are recommended until mining is finished at Pit A:

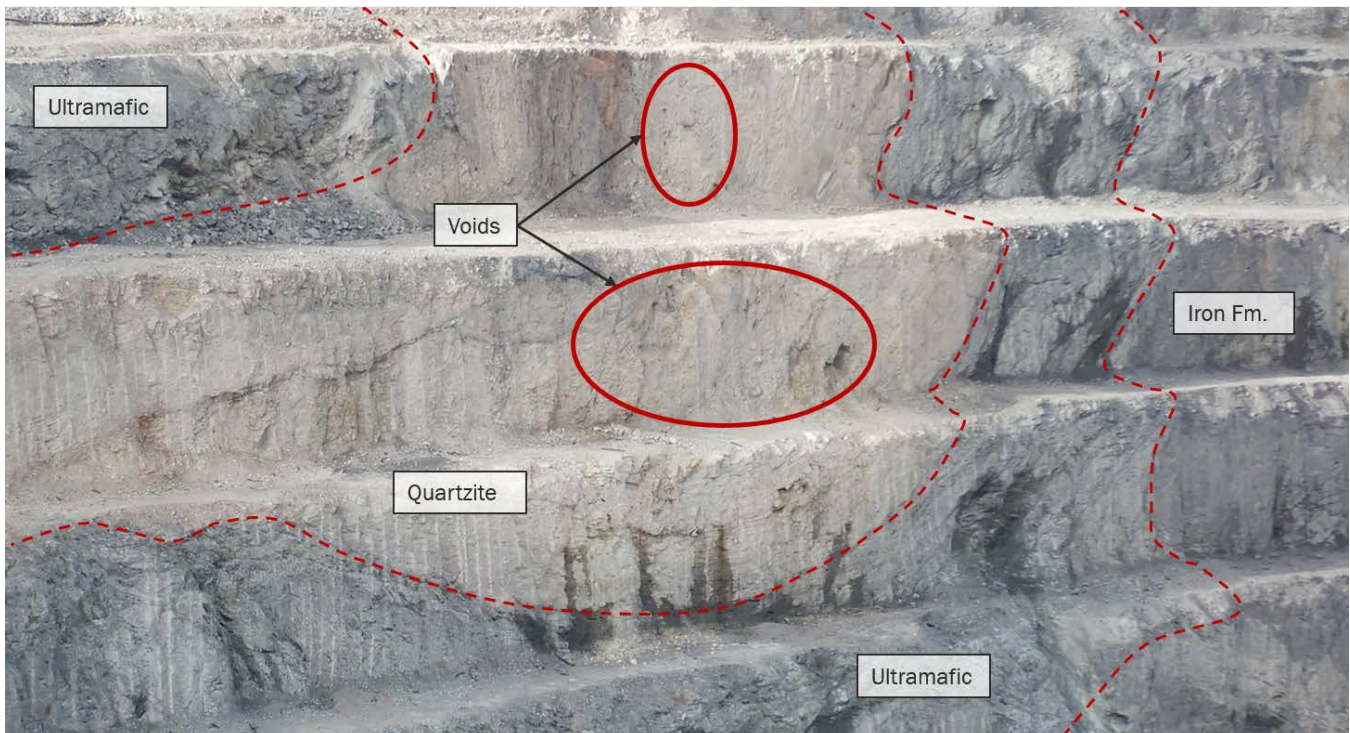
*Photograph 4-7: Voids in quartzite above Pit A west ramp (2017)*

The quartzite stratigraphy observed in the Pit A west wall contains several large voids identified during previous inspections. There has been no significant accumulation of material on the benches since the 2016 inspection.

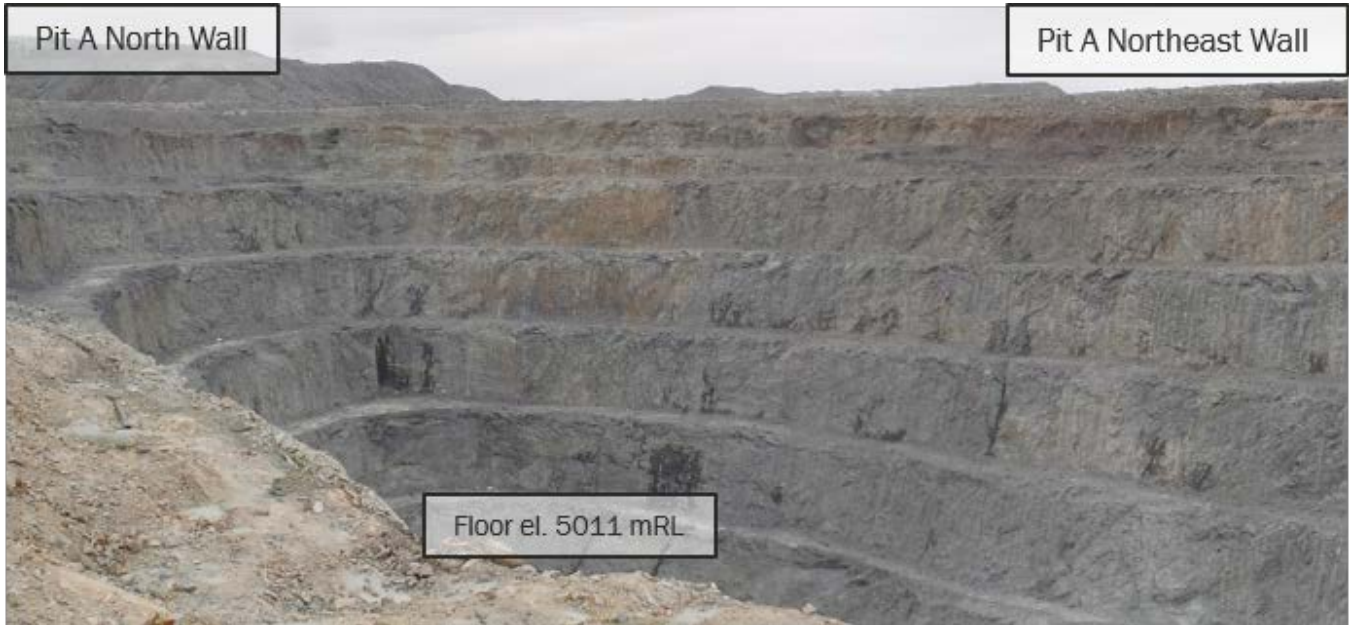
*Photograph 4-8: Pit A north to northeast wall (2017)*

The north through northeast walls of Pit A continue to perform adequately. Very little accumulation of loose or raveling material on the catch benches was noted during the site visit.

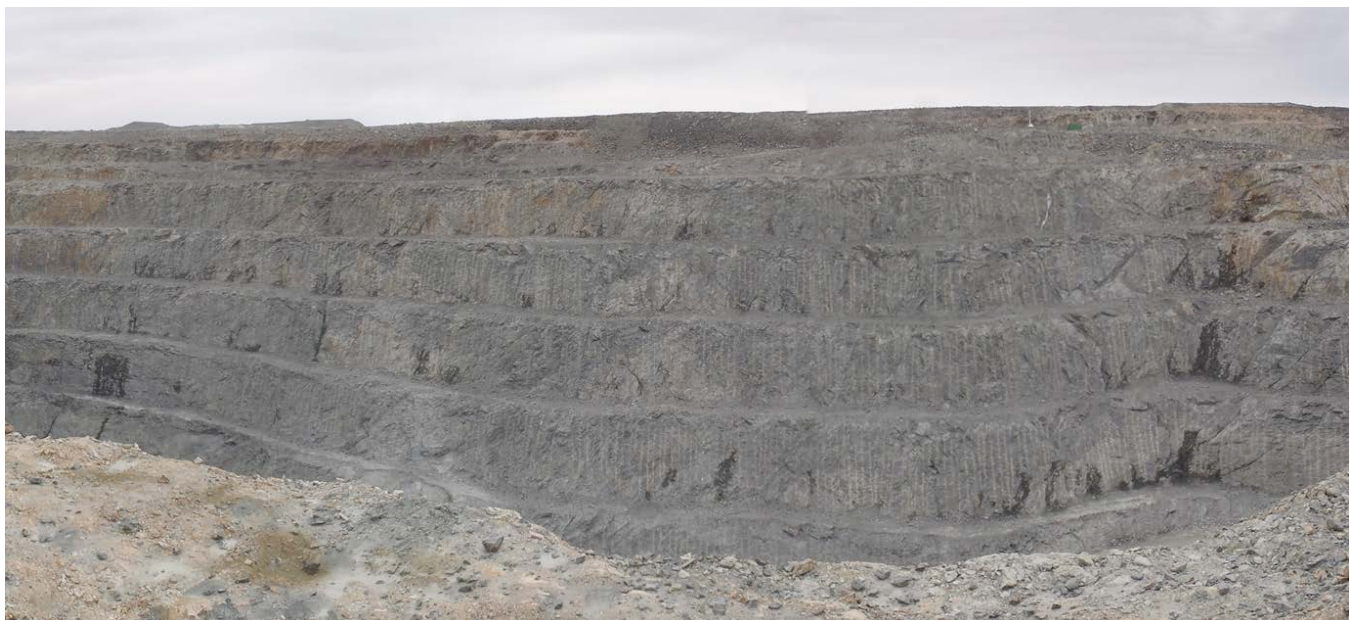
*Photograph 4-9: Pit A east wall upper benches (2017)*

The upper benches of the Pit A East Wall continue to perform satisfactorily, as shown in Photograph 4-9.

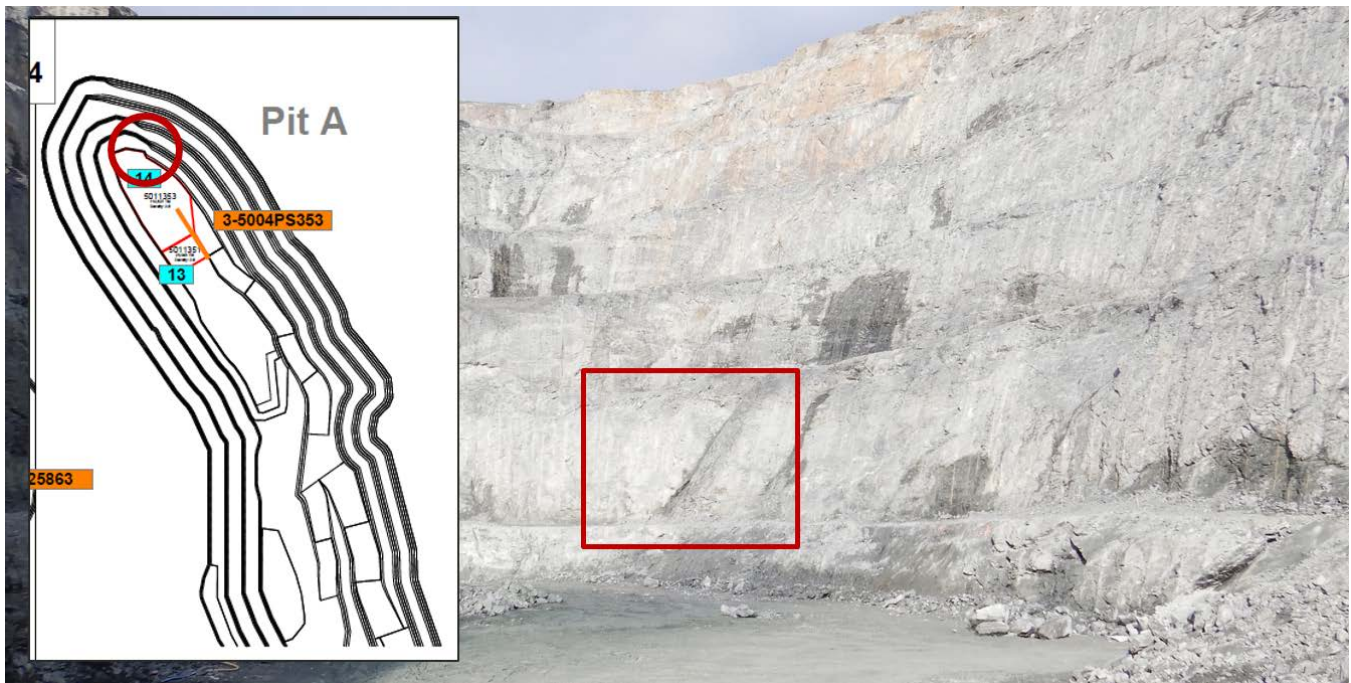
*Photograph 4-10: Pit A east wall, June 17 2017 wedge*

A wedge failure was reported on 17 June 2017 at the base of the pit slope, near the transition from the northeast to east wall as shown in Photograph 4-10

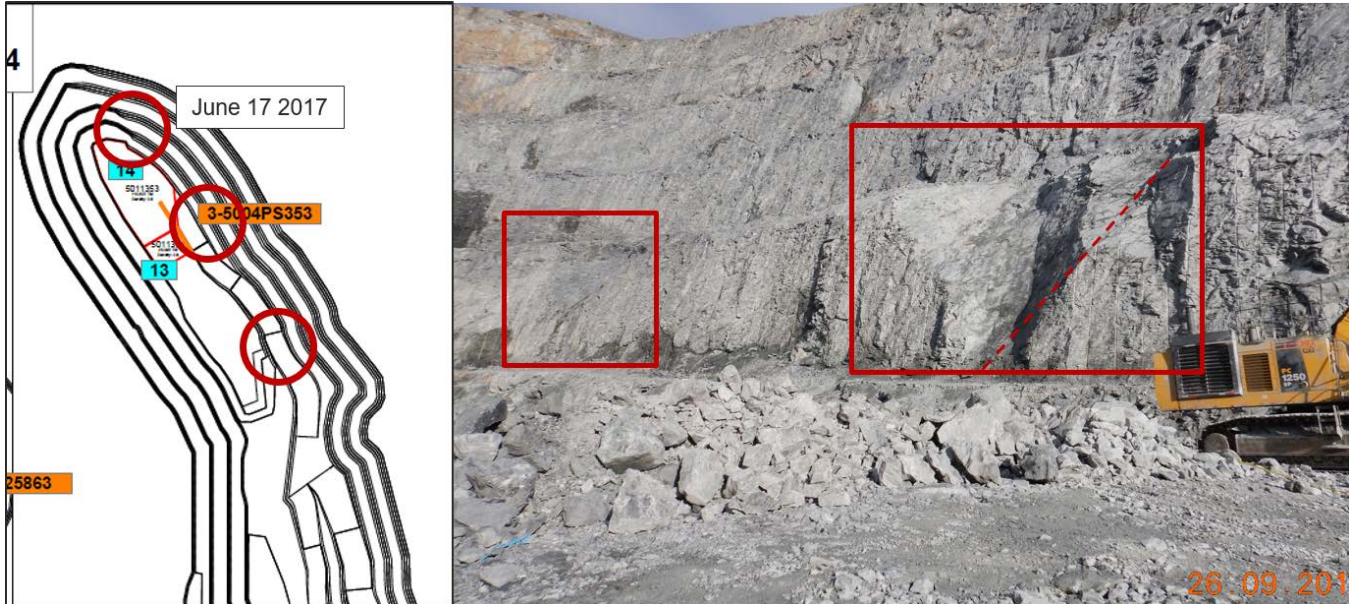
*Photograph 4-11: Pit A east wall, north end additional wedges (2017)*

Additional bench scale wedges were encountered while mining the lowermost bench, comprised of similar structure. These were scaled out as the bench was mined down. As there is the potential for additional wedges to form in this lower bench, access to the area should be limited and operators should be aware of potential wedge instability. This area should be included with regular geotechnical monitoring.

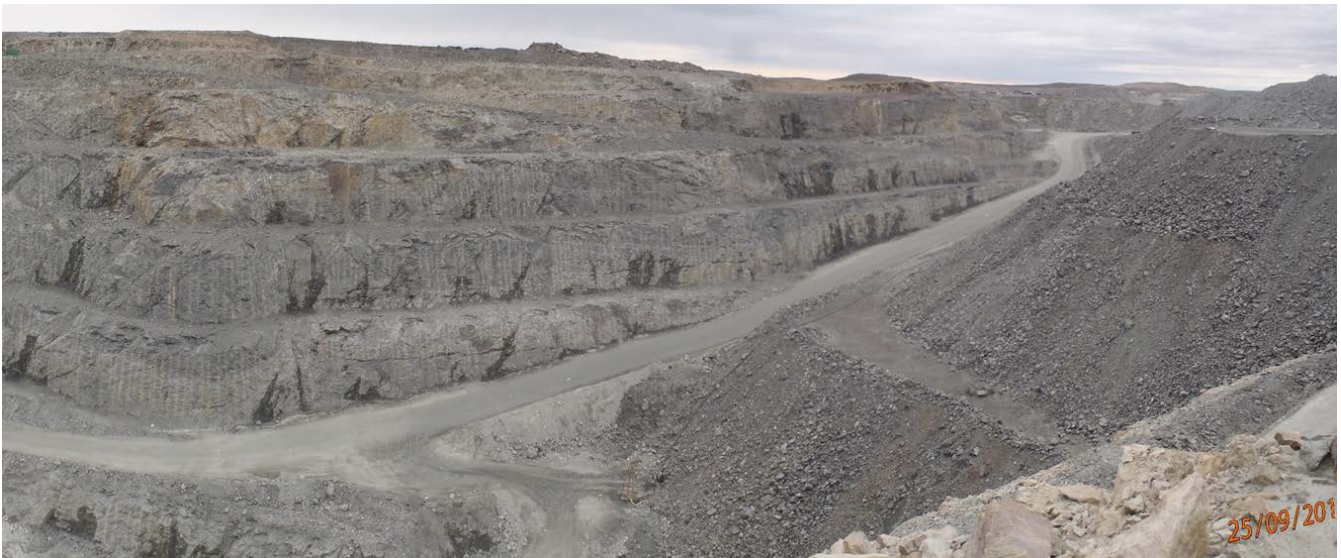
*Photograph 4-14: Pit B east wall, looking south (2017)*

The east wall of Pit B was inspected from several viewpoints as well as from within the pit. The wall continues to perform satisfactorily. Benches are generally clean with little accumulation of material.

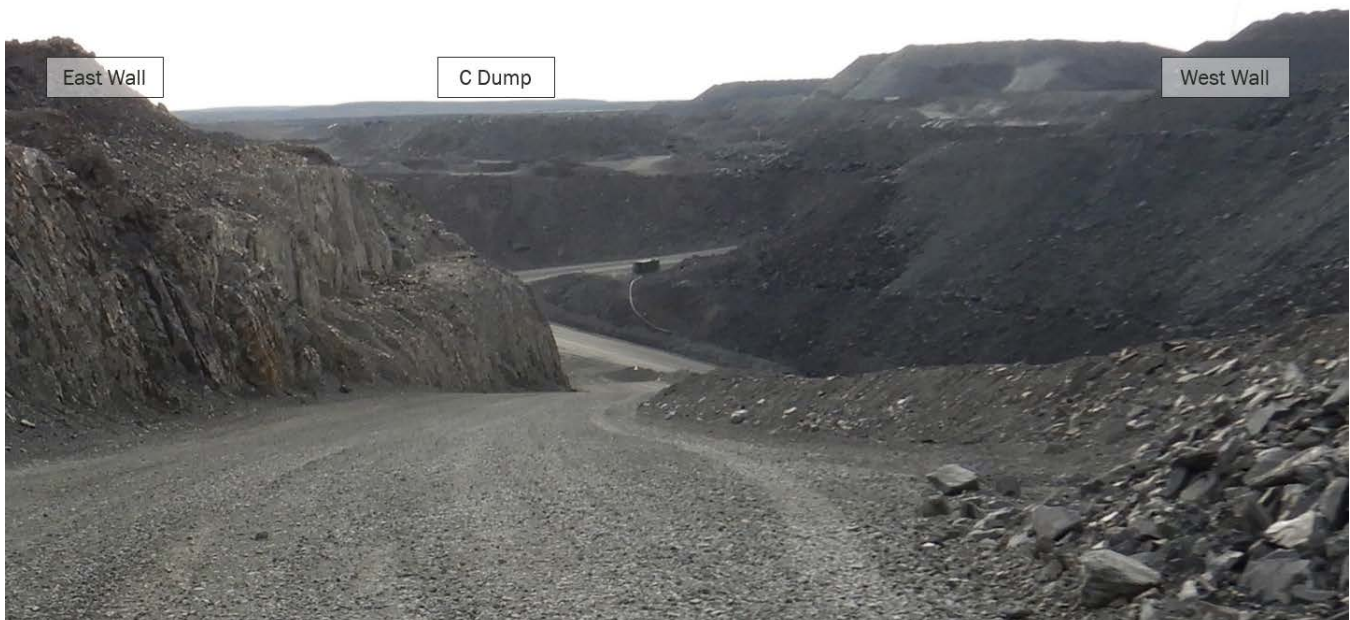
*Photograph 5-1: Pit C waste rock dumps looking south (2017)*

The main dump platform for Pit C is used for storing stockpiles of stemming material. The Pit C dump platform was visited only briefly and was noted to be performing satisfactorily.

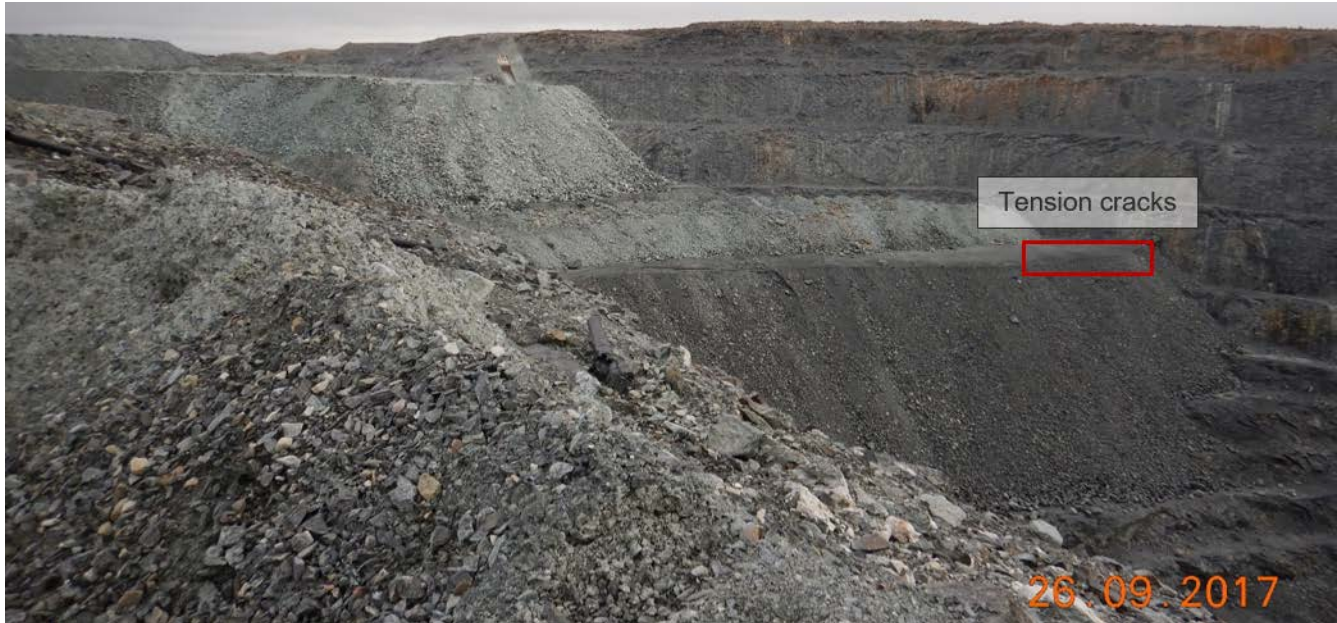
*Photograph 5-2: Pit D dump, viewing northeast from crest of Pit E (2017)*

The Pit D dump continues to be active, and extends across the Pit E floor. This is shown in Photograph 5-2 which also shows active dumping from the crest area

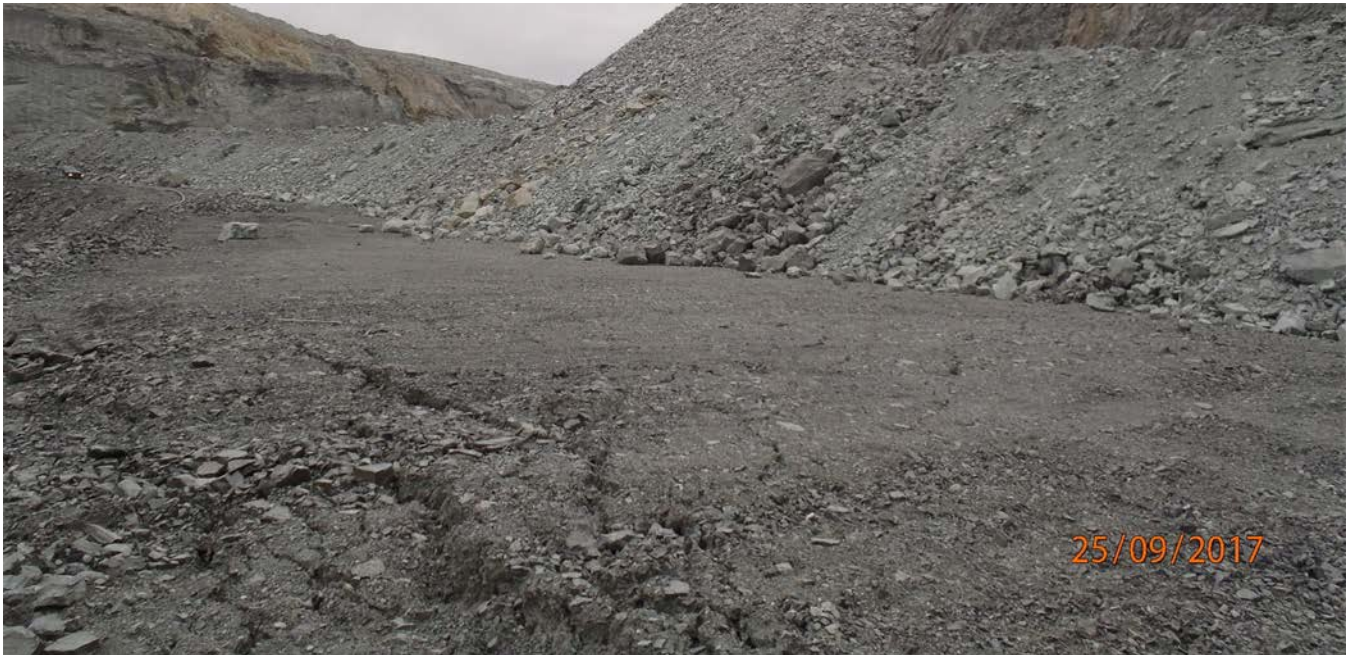
*Photograph 5-3: D dump tension cracks at eastern margin of lower dump (2017)*

An area along the eastern edge of the lower dump platform visited during the 2016 site inspection was noted to have tension cracks formed at the crest. This area was visited again in 2017. Tension cracks are still present in the crest area but have do not appear to have not developed further. The tension cracks are at the eastern edge of the dump platform where it abuts the east wall of Pit E. It is possible that the tension cracks are the result of some differential settlement between the dump material, and the dump material that is overlying the rock benches of the former pit wall. These are not considered indicative of overall instability; no other indicators of large slope instability such as bulging of the dump face were noted.

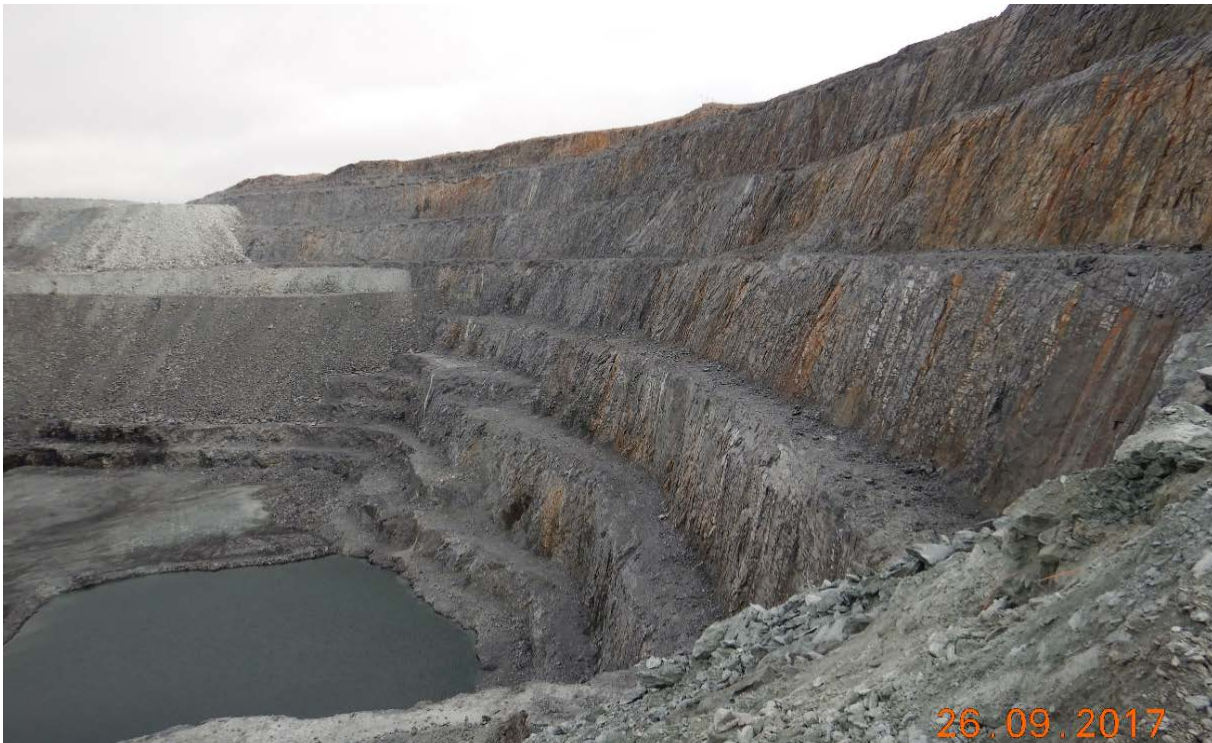
*Photograph 6-3: Pit E east wall performance (2017)*

The Pit E east wall is excavated in good quality intermediate volcanic rock. The main structural control for the east wall is the steeply west dipping stratigraphy and sub-parallel foliation. Bench face angles have been excavated generally parallel to the dominant structural orientation, and the bench and overall wall performance continues to be satisfactory. Final benches have been cleaned and scaled appropriately. There is no noticeable accumulation of additional debris on the benches or deterioration in wall performance since the 2016 inspection.

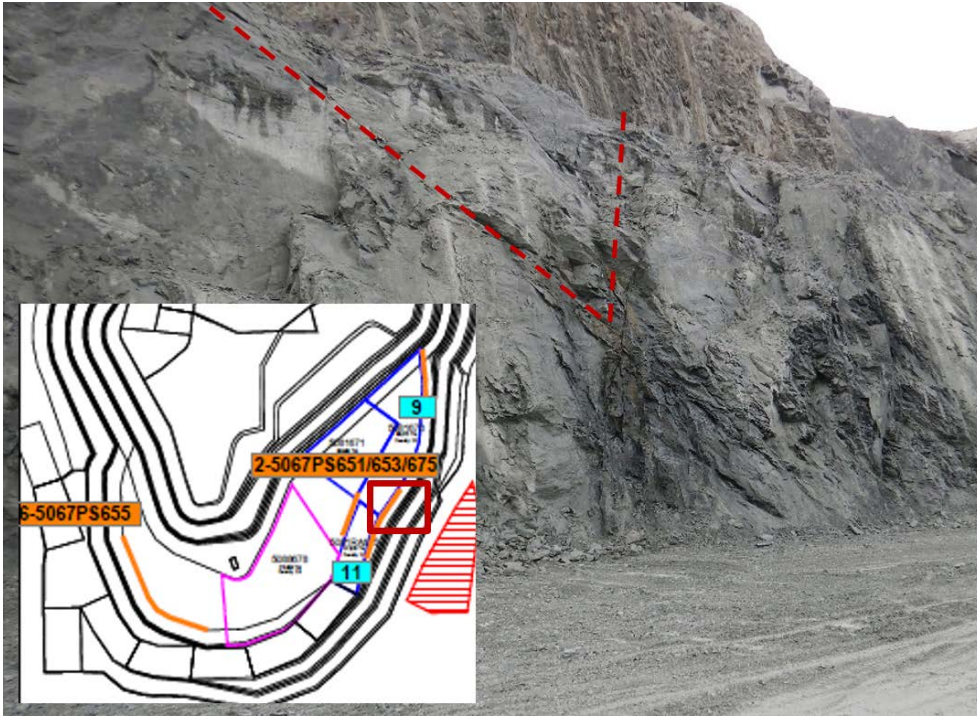
*Photograph 6-5: Pit E wedge above south ramp*

A bench scale wedge was noted along the south ramp access, shown in the following photograph. This was discussed with AEM during the site visit, and a bumper berm was constructed below the wedge to control access in the area.

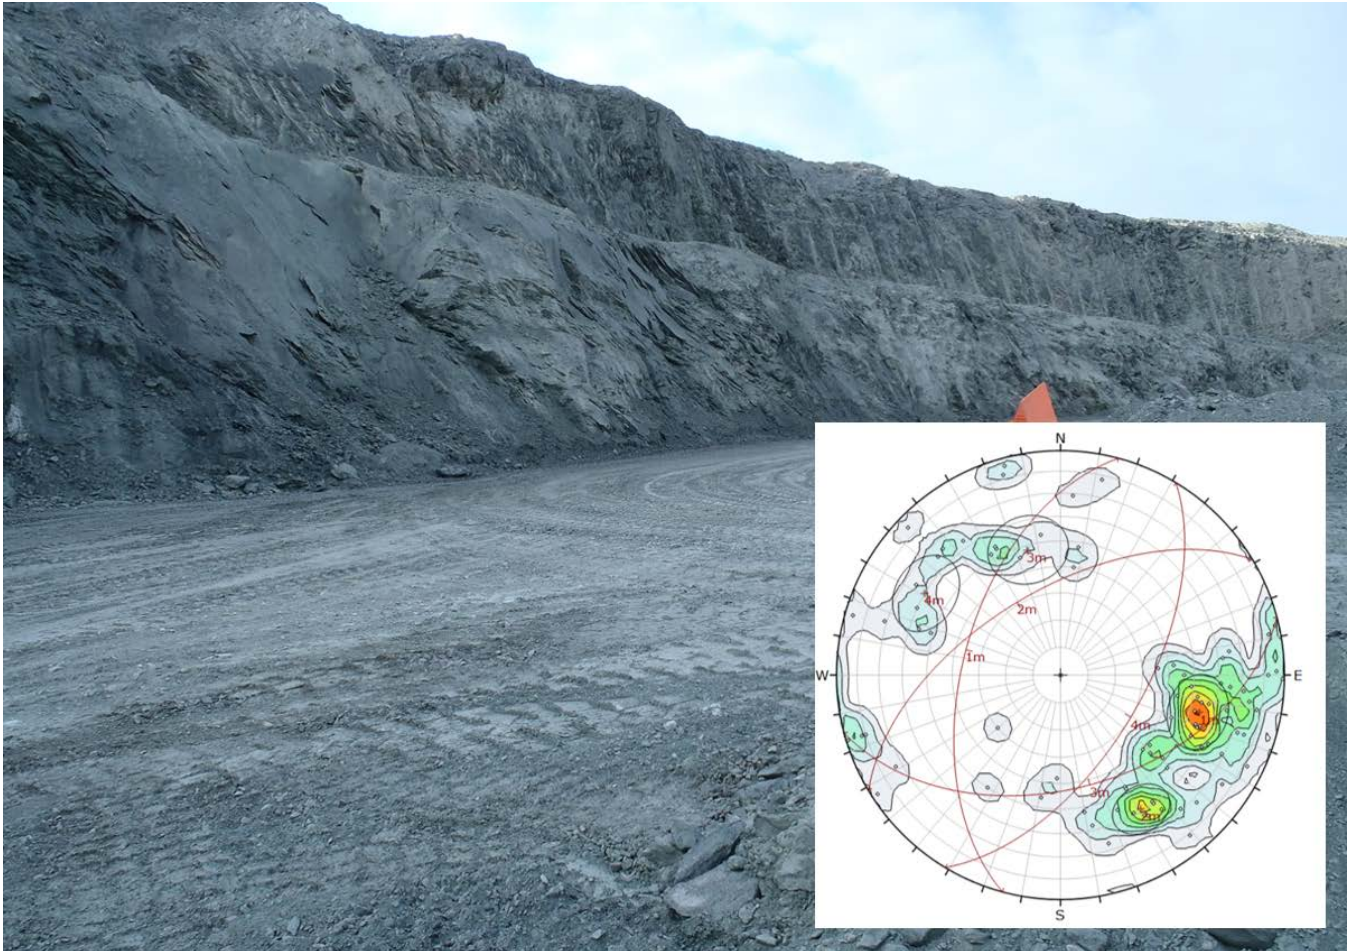
**Photograph 6-6: Pit E5 ramp mapping data (2017)**

AEM have adopted a recommendation from the Tetra Tech (2017) study to carry out mapping of the general rock structure to compare with the anticipated conditions based on geotechnical drilling. The following Photograph 6-6 shows a stereonet of the mapping data, combined with a photograph of the ramp south wall showing the planar foliation structure.

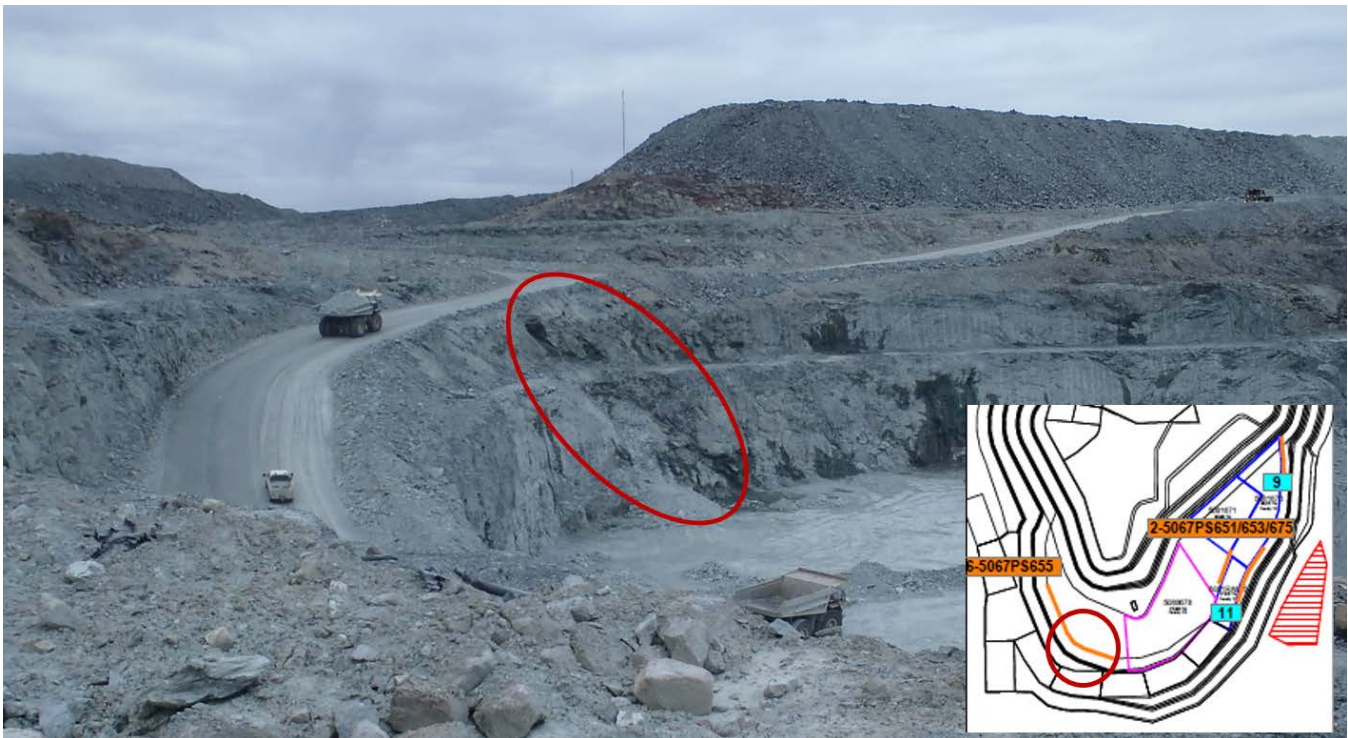
**Photograph 6-7: Raveling of material below south ramp entry (south ramp wedge)**

During the site visit an area at the entry point of the haul ramp to the south end of the pit was noted to have significant raveling of material resulting in the accumulation of material on the bench below. This is shown in the following Photograph 6-7. This was discussed with AEM during the site visit, as on-going raveling could result in undercutting of the ramp access. It was recommended that this area (south ramp wedge) be included in the regular geotechnical inspections, and specifically to inspect for the formation of tension cracks along the outside edge of the ramp. In addition, this area should be included in monitoring by the radar system.

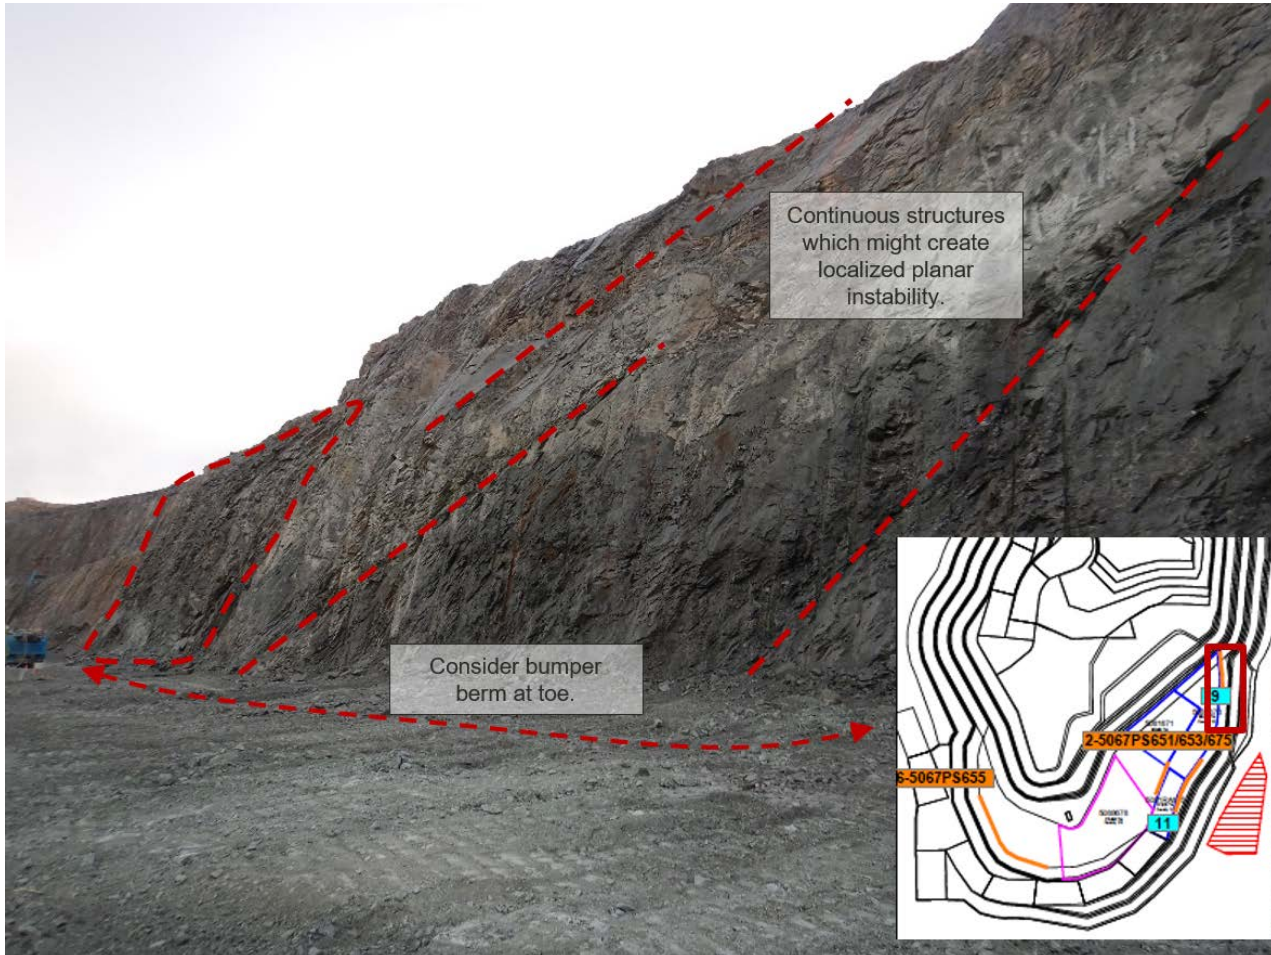
**Photograph 6-8: Planar structure above south wall ramp switchback**

Several outward dipping planes were noted above the switchback of the ramp. Some of these were scaled out during development of the ramp. The observed planes are oblique to the wall orientation, and do not directly daylight in the bench face. Nevertheless there is some potential for planar instability in this area. Given that the ramp switchback is directly below this area, it should be included as part of regular geotechnical inspections to identify if any instability is developing. This area was not covered by the GroundProbe radar alarm mask, and it was recommended to set the alarm mask to cover this area during monitoring. Safe set back distances from this area of the wall should be established, and a bumper berm restricting entry beneath the wall should be considered.

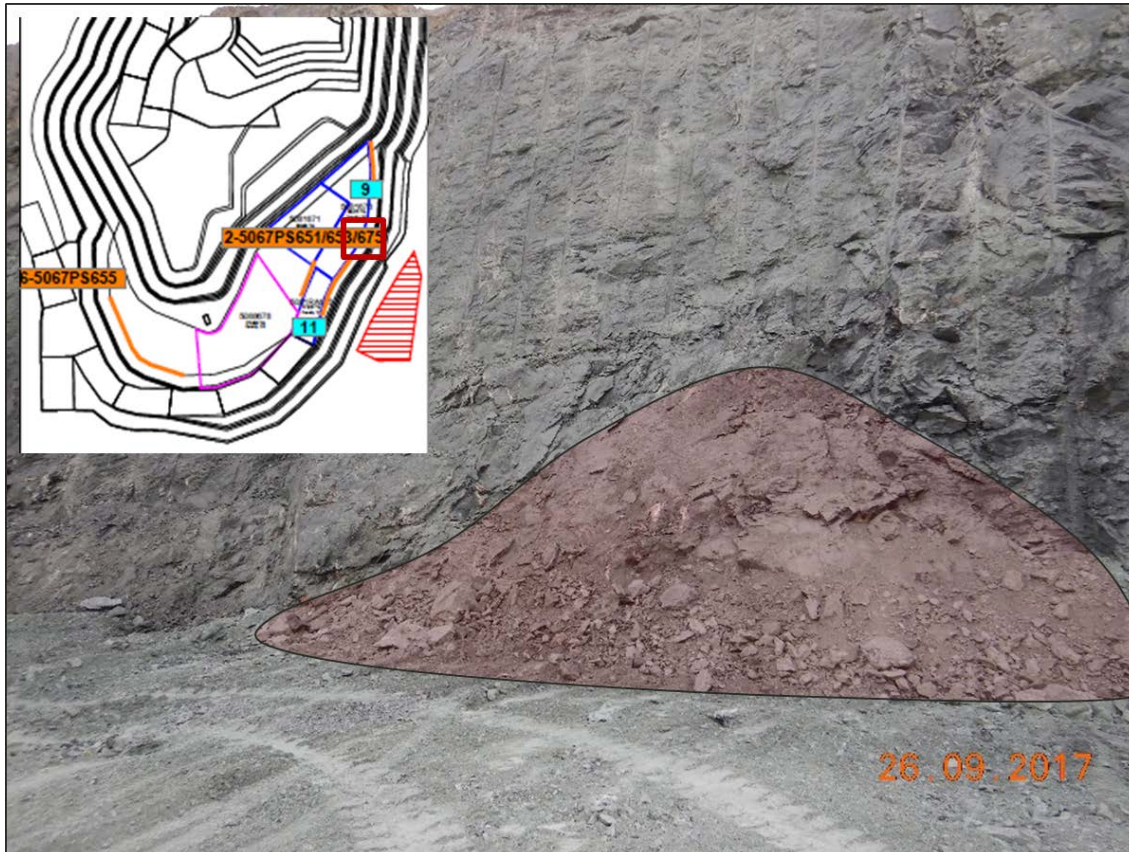
*Photograph 6-9: Pit E hard toe remaining on south wall access ramp*

One hard toe was noted during the inspection along the ramp. AEM identify these during the regular geotechnical inspections on site, and communicate to operators for removal. During the site visit AEM indicated they were aware of this but the equipment required to hammer out was currently under repair.

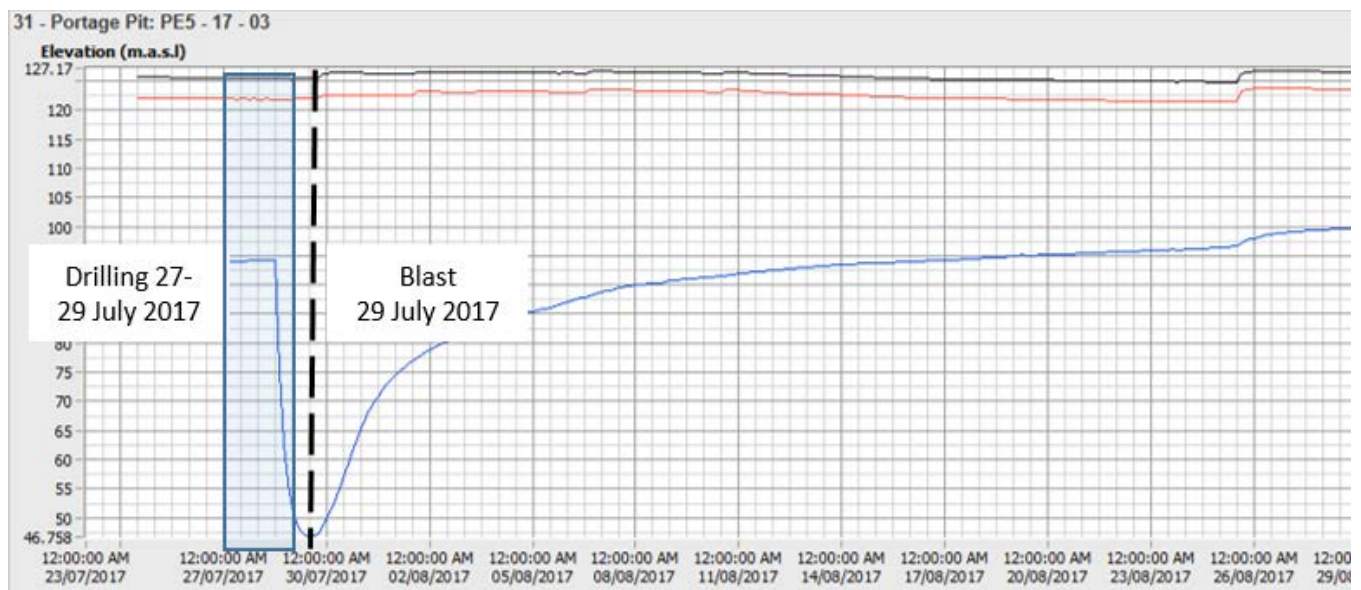
Figure 6-2: Instrument PE-17-03 piezometer response to drilling

During the review of the piezometer data an unusual response was first noted in 17-03B. A sudden drop in pressure head (almost 50 m) occurred around the July 28 2017, followed by a relatively rapid recovery to pre-drilling conditions by August 17 2017. A brief and limited review of blast records indicated that a blast pattern at the toe of the south wall slope was drilled from July 26 to July 29. A review of the records showed that the holes began dry, but were drilled wet from July 27 to July 29. This corresponds to the rapid (almost instantaneous) drop in pressure noted. The pattern blast was on August 29. AEM have noted that the spatial relationship between the blast pattern drilling and the location of the piezometer E5-17-03A is an important consideration for evaluating the response. Piezometer E5-17-03A was installed at the end of the inclined hole, and consequently is located vertically beneath the blast pattern. The remaining piezometers within PE-17, located higher in the hole, did not have the same response.

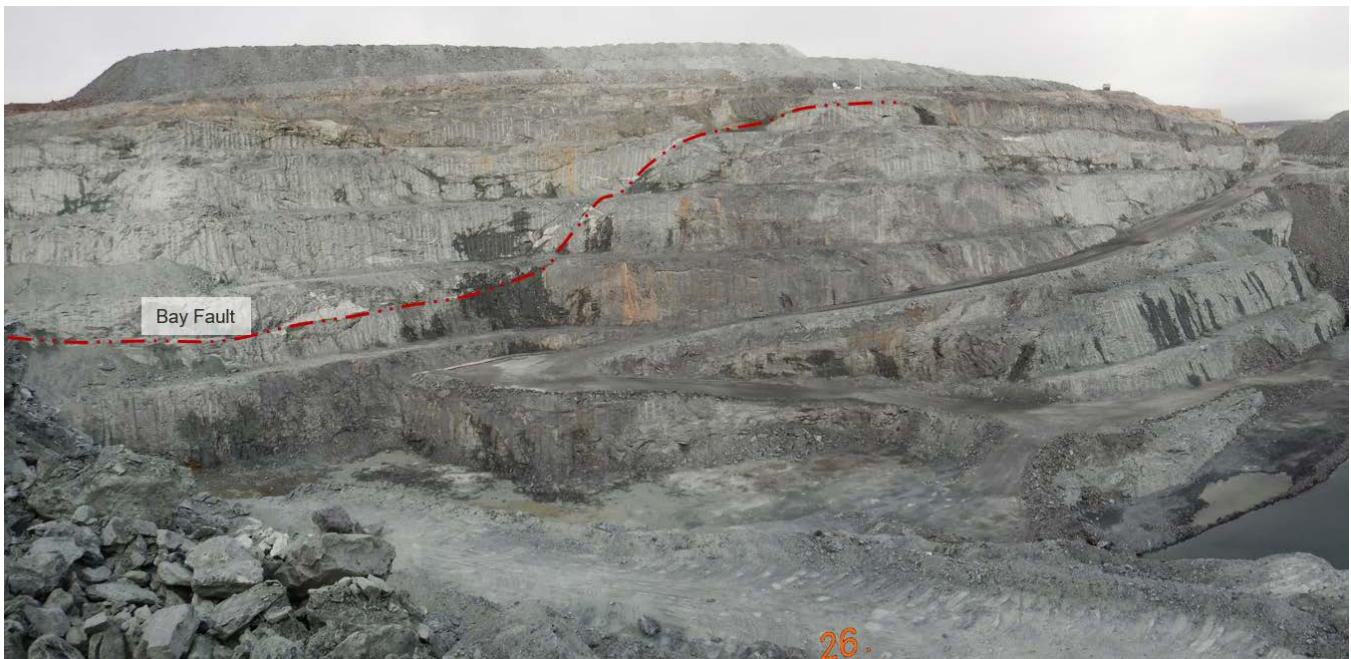
*Photograph 6-11: Pit E west wall showing seepage and Bay Fault (2017)*

At the south end of the west wall, the contact of the ultramafic rock and overlying intermediate volcanic rock is inclined into the wall, which is beneficial for overall slope stability, but results in bench-scale instability of the underlying ultramafic rock. Local rock falls creating small overhangs have occurred as the ultramafic rock separates from the overlying volcanic contact, followed by sliding along a steeply east dipping orthogonal joint set. This potential instability is exacerbated by the presence of shear zones and the Bay Fault within the ultramafic rock, which are inclined steeply into the west wall.
