### **Annual Review of Portage and Goose Pit Slope Performance**

# 2017 ANNUAL PIT SLOPE PERFORMANCE REVIEW MEADOWBANK MINE, NUNAVUT

DECEMBER 22, 2017

An annual site visit to inspect the performance of the pit walls of the open pits at Agnico Eagle Mines Ltd.'s (AEM) Meadowbank Mine was carried out by Tetra Tech Canada Inc. (Tetra Tech) during the period 25 September 2017 to 28 September 2017. A detailed summary of recommendations is presented in Section 9.

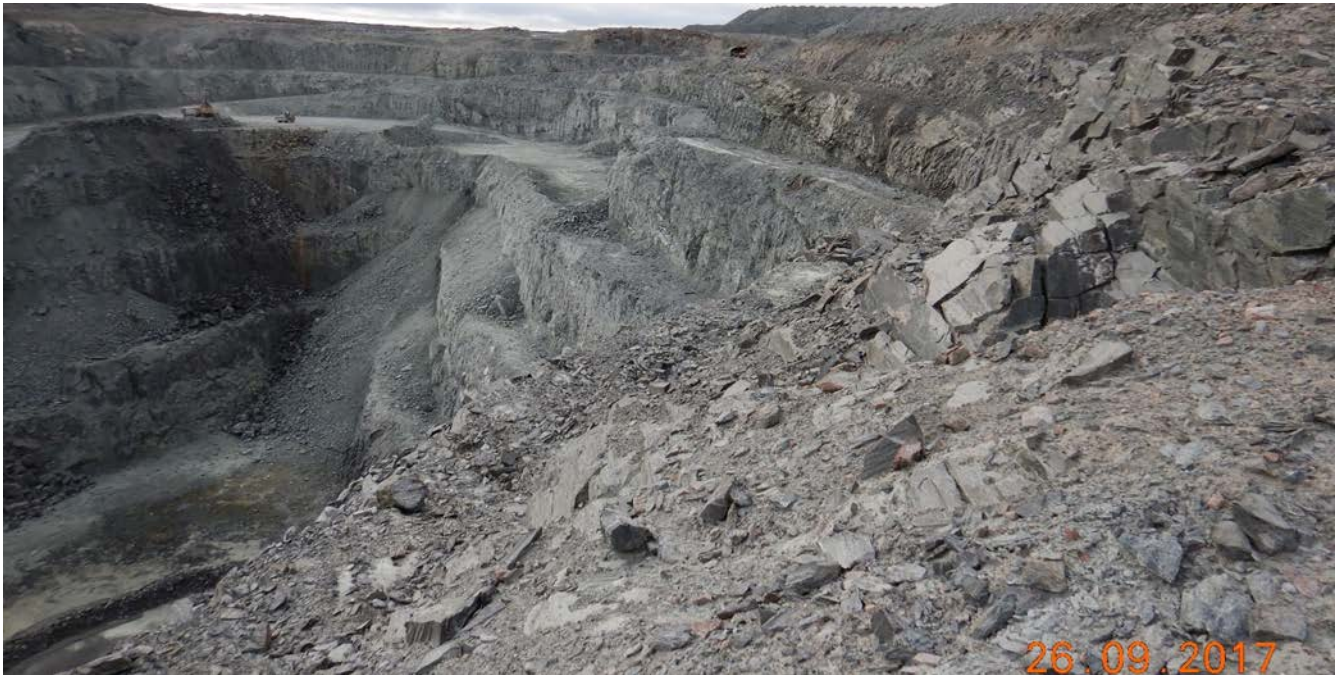
*Photograph 6-12: Pit E west wall south end upper benches (2017)*

Mining down of the Pit E pushback area has now started to fill some of the benches. Since there currently are no mining activities being carried out below the pushback, this is not considered to be a hazard. These benches will be mined out, as new final benches are created during mining.

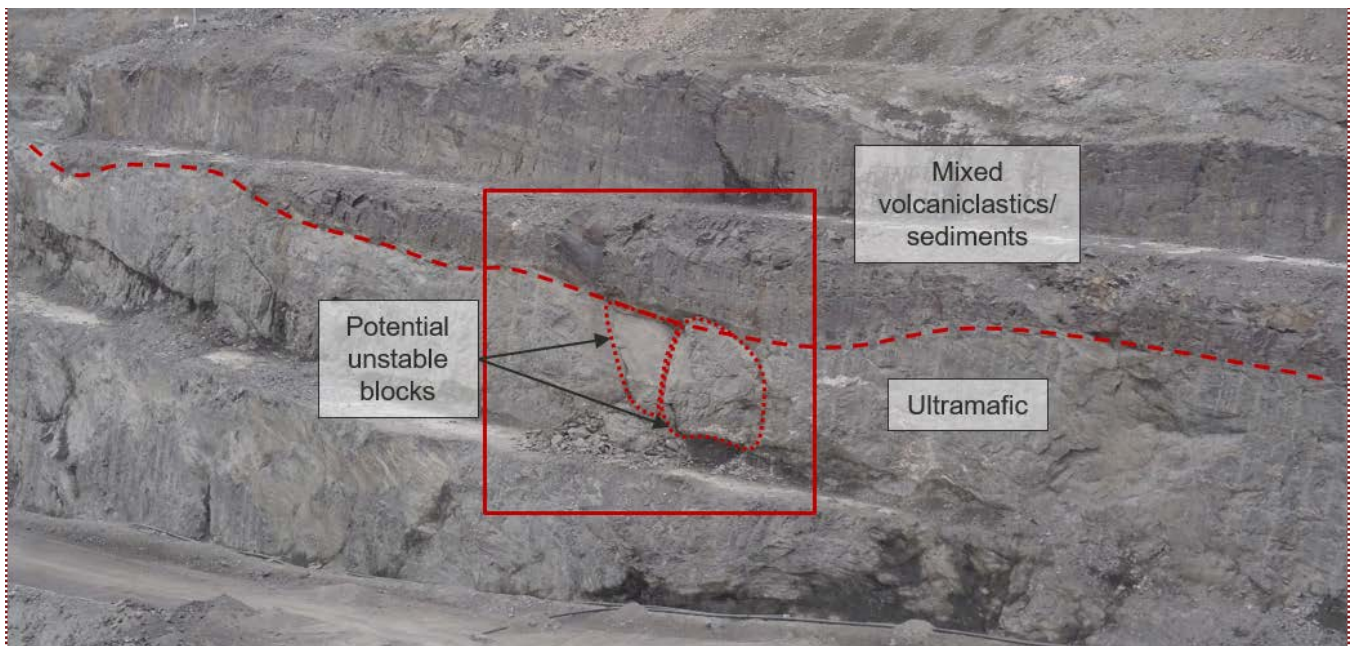
*Photograph 6-17: Pit E ramp Area 3 wedge (2017)*

No increase in the material accumulating at the toe was noted during the 2017 inspection. The combination of the 5088 mRL bench, and the containment berm on the ramp is adequately managing the potential for rock fall in this area. A location of additional instability has been highlighted previously that might eventually fail with time due to freeze-thaw processes.

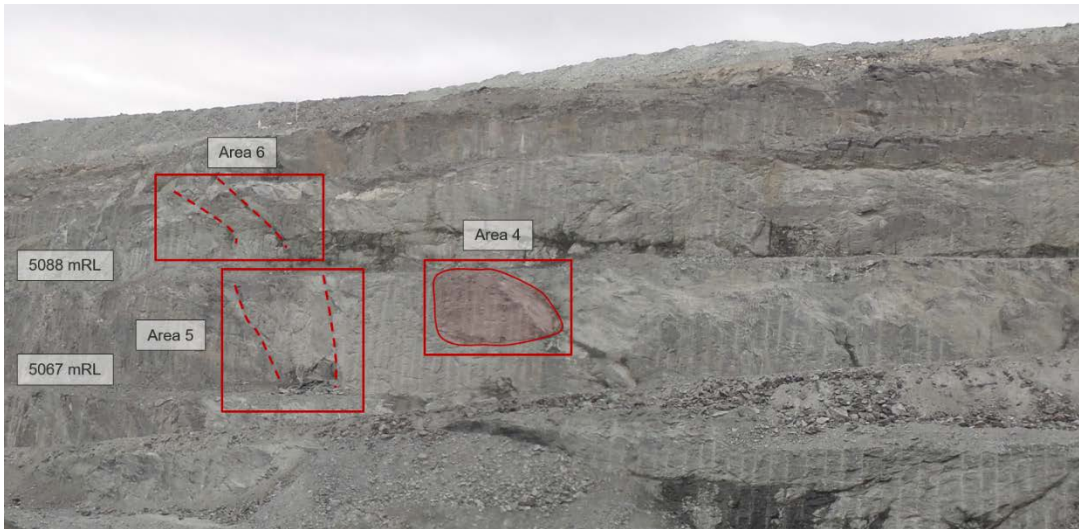
**Photograph 6-18: Pit E ramp Areas 4, 5, and 6 (2017)**

Area 6 is located above the 5088 mRL bench, and is a vertical extension of the closely spaced jointing of Area 5. These are steeply north dipping shear joints, which intersect the volcanic rock. The close spacing and continuous nature of these joints may result in increased raveling of material particularly during freshet and spring thaw. No new material was observed to have failed on to the 5067 bench since the 2016 inspection.

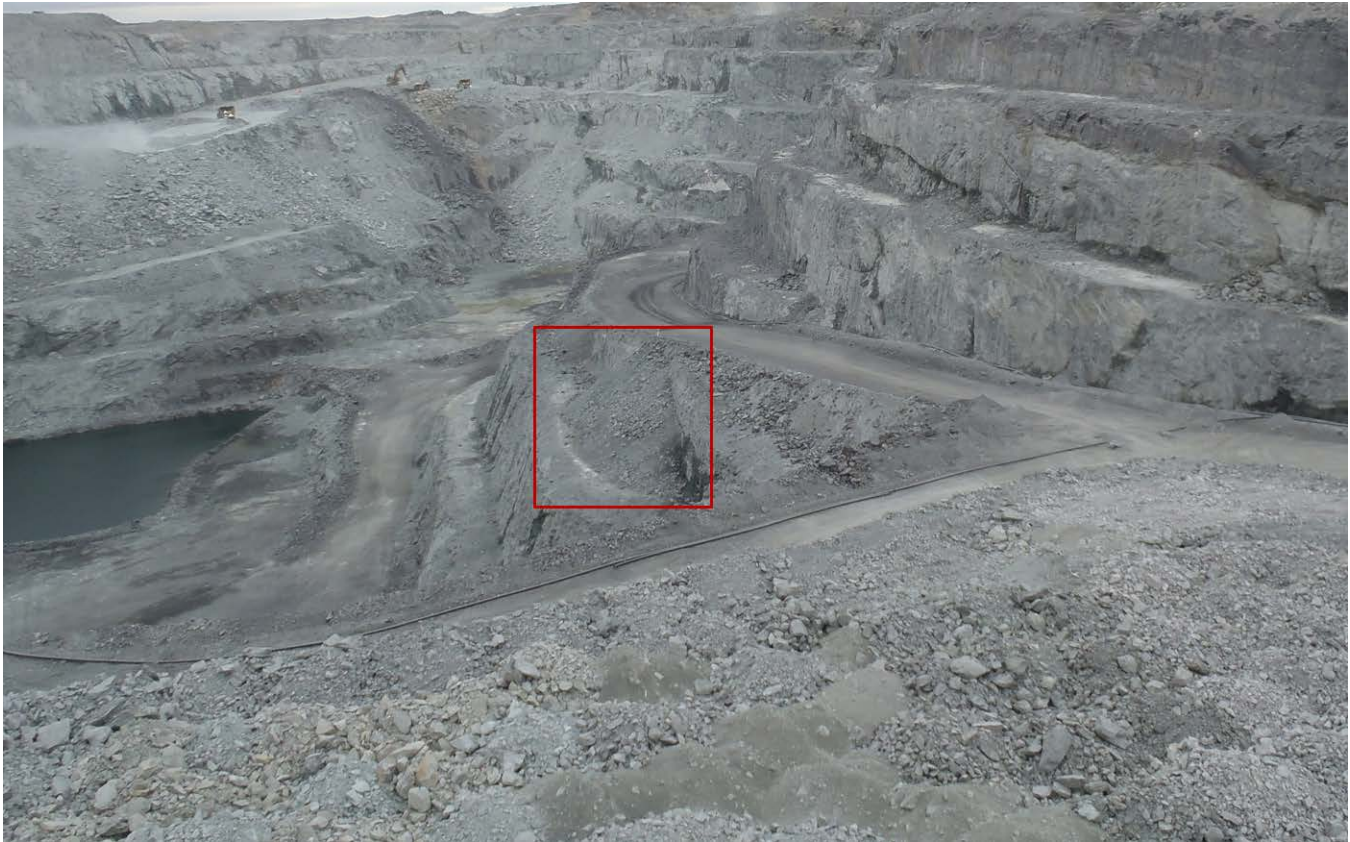
*Photograph 6-21: Pit E west wall ramp buttress and step-in (2017)*

A ramp instability identified in 2015 by AEM and associated with the weak ultramafic rock in the lower wall benches below the ramp was mitigated with the construction of a counter-balancing rock fill berm. This was documented during the 2015 inspection. The berm continues to be effective at stabilizing the ramp. There is no indication of deformation within the buttress or the ramp surface, or tension cracks along the ramp crest.

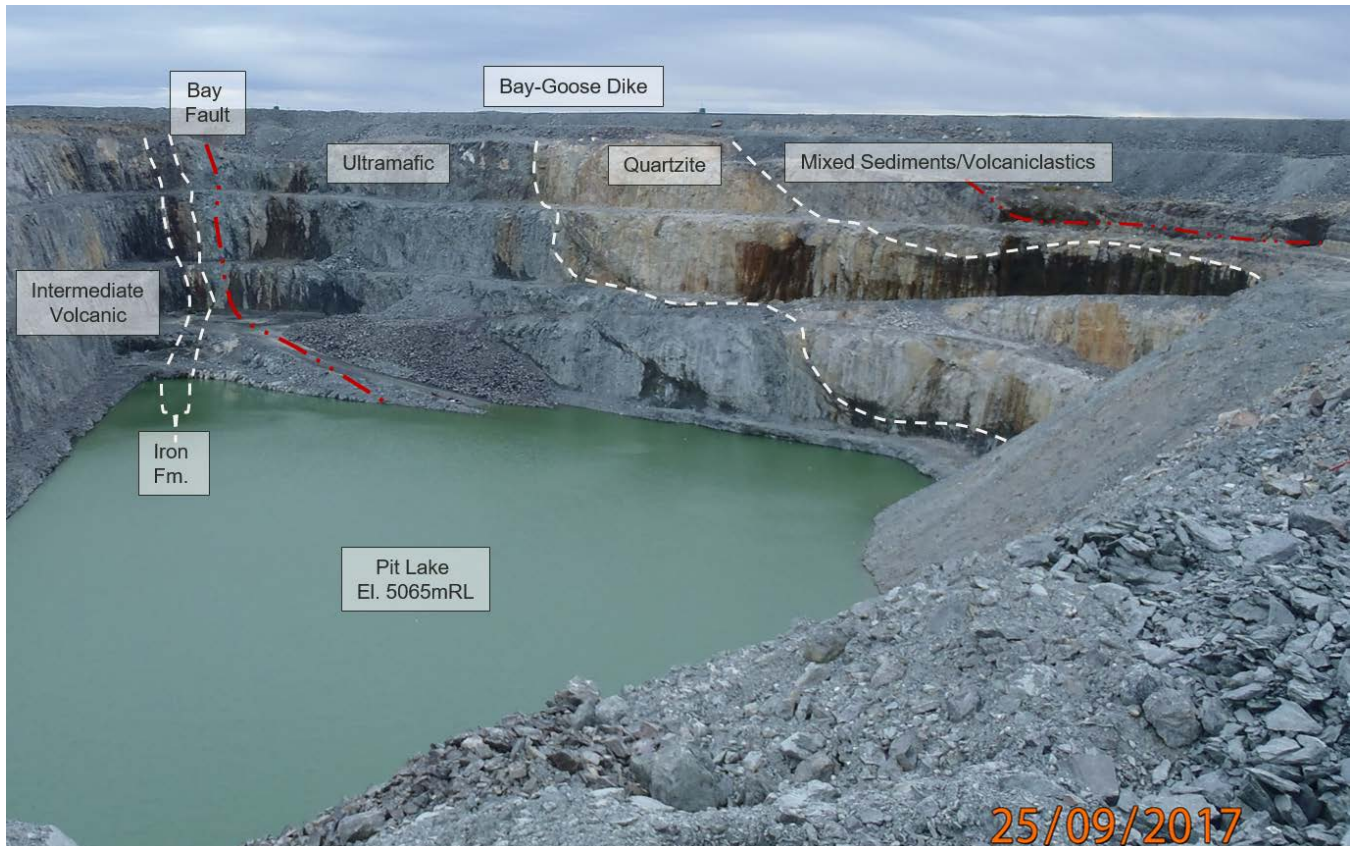
*Photograph 7-2: Goose Pit south wall (2017)*

The south wall of the Goose pit comprises iron formation and intermediate volcanic rock in the east, transitioning through a sequence of iron formation, ultramafic rock, quartzite, and mixed volcanoclastic sediments in the west. The most prominent structural feature is the Bay Fault which intersects the south wall of the pit, within the ultramafic rock. The various lithological units are shown in the following photograph.

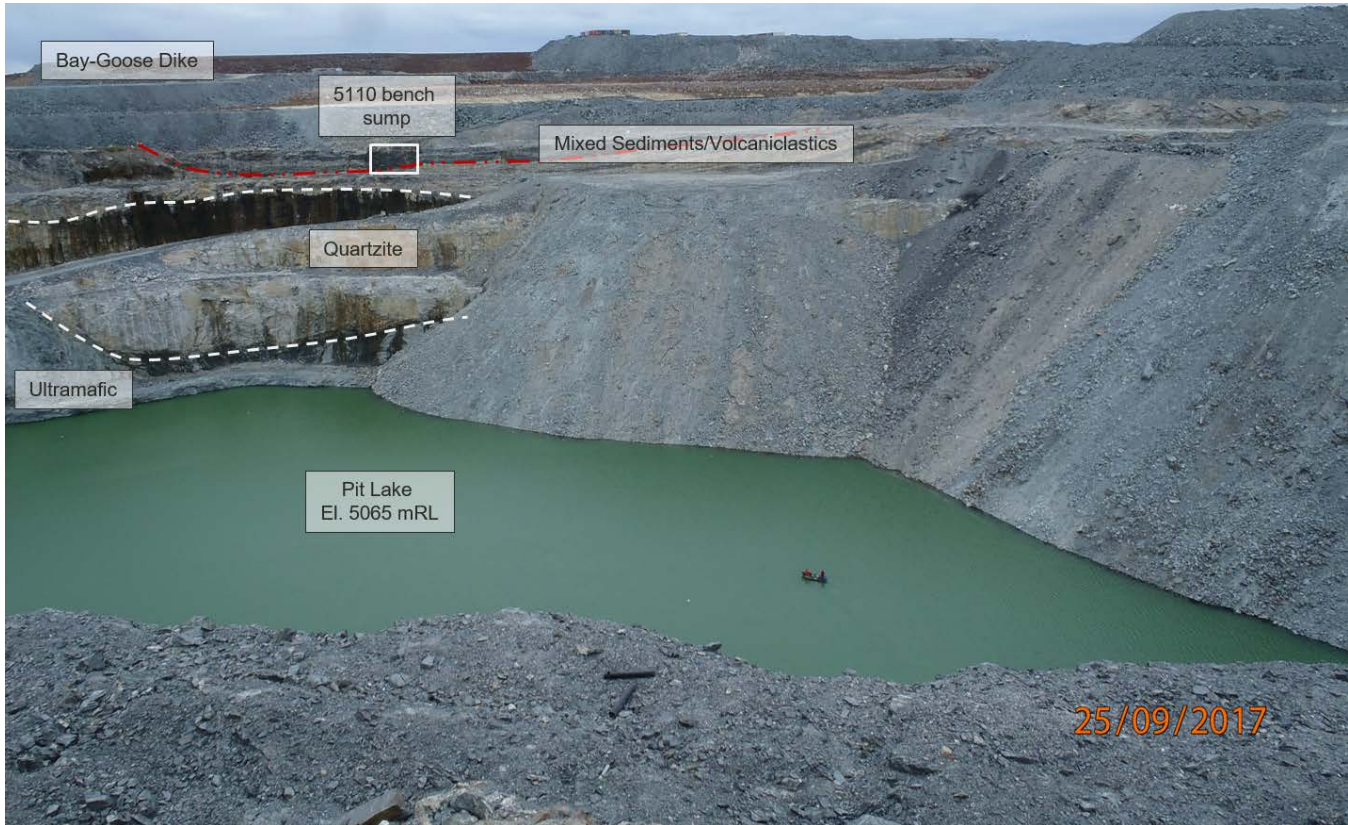
*Photograph 7-3: Goose Pit west wall (2017)*

The upper west wall of the Goose Pit is comprised of mixed sedimentary and volcanoclastic rocks at the crest, overlying quartzite. The lower benches of the pit expose poor quality ultramafic rock. The stratigraphic contacts dip at moderate angles into the pit wall to the west. The ultramafic rock is characterized by relatively closely spaced sheared joints or foliation, dipping at steep angles to the east. Localized failures occur where these are undercut by bench face angles. The quality of the ultramafic rock degrades over time with exposure to air and water.

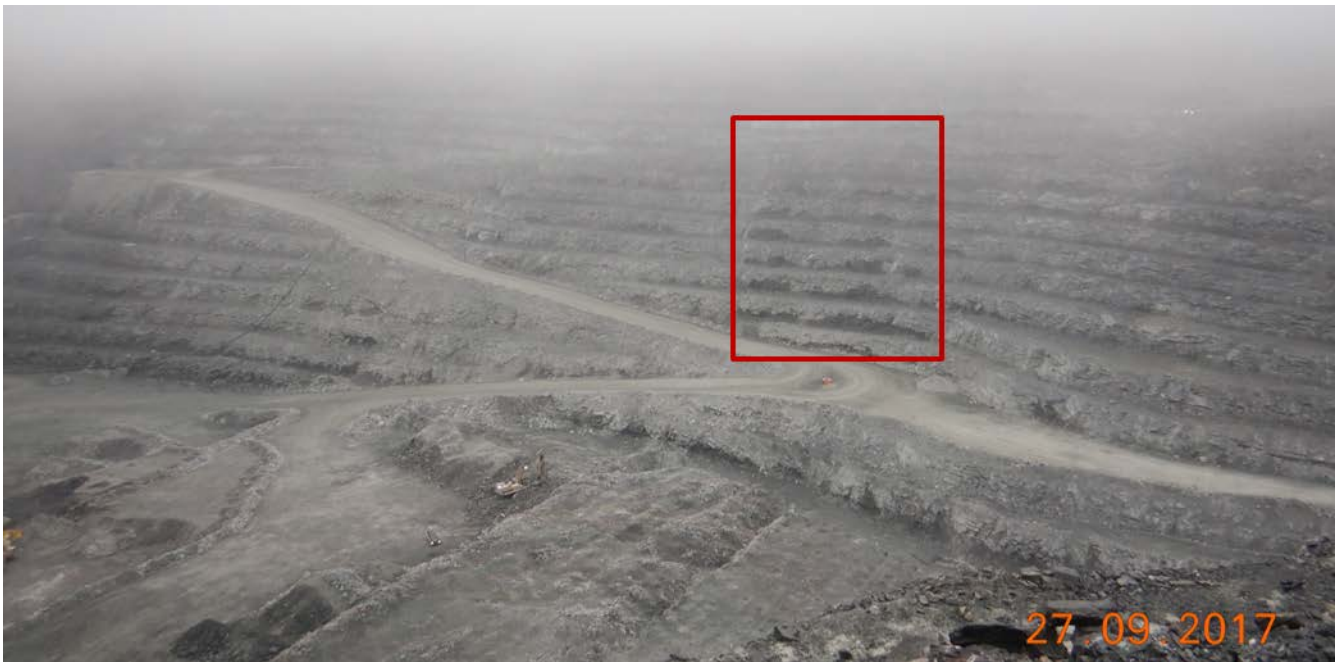
*Photograph 8-3: Vault Pit west wall seepage*

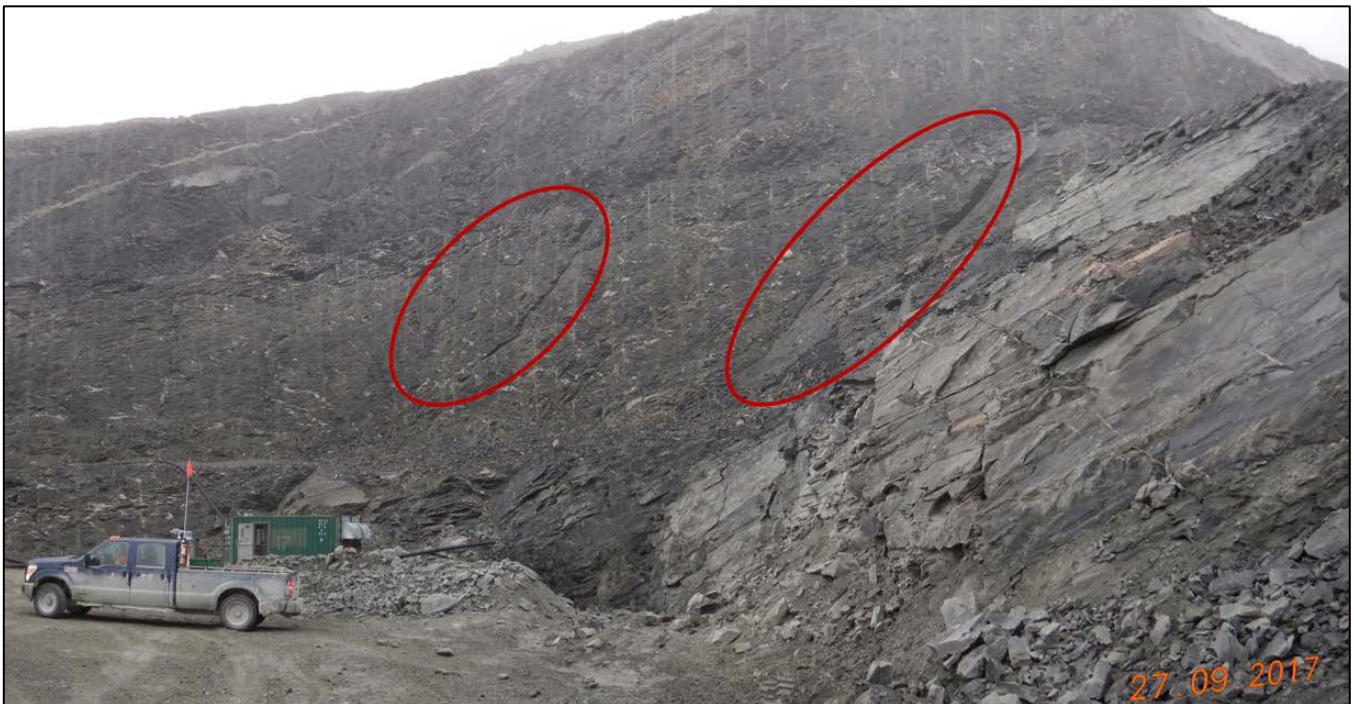
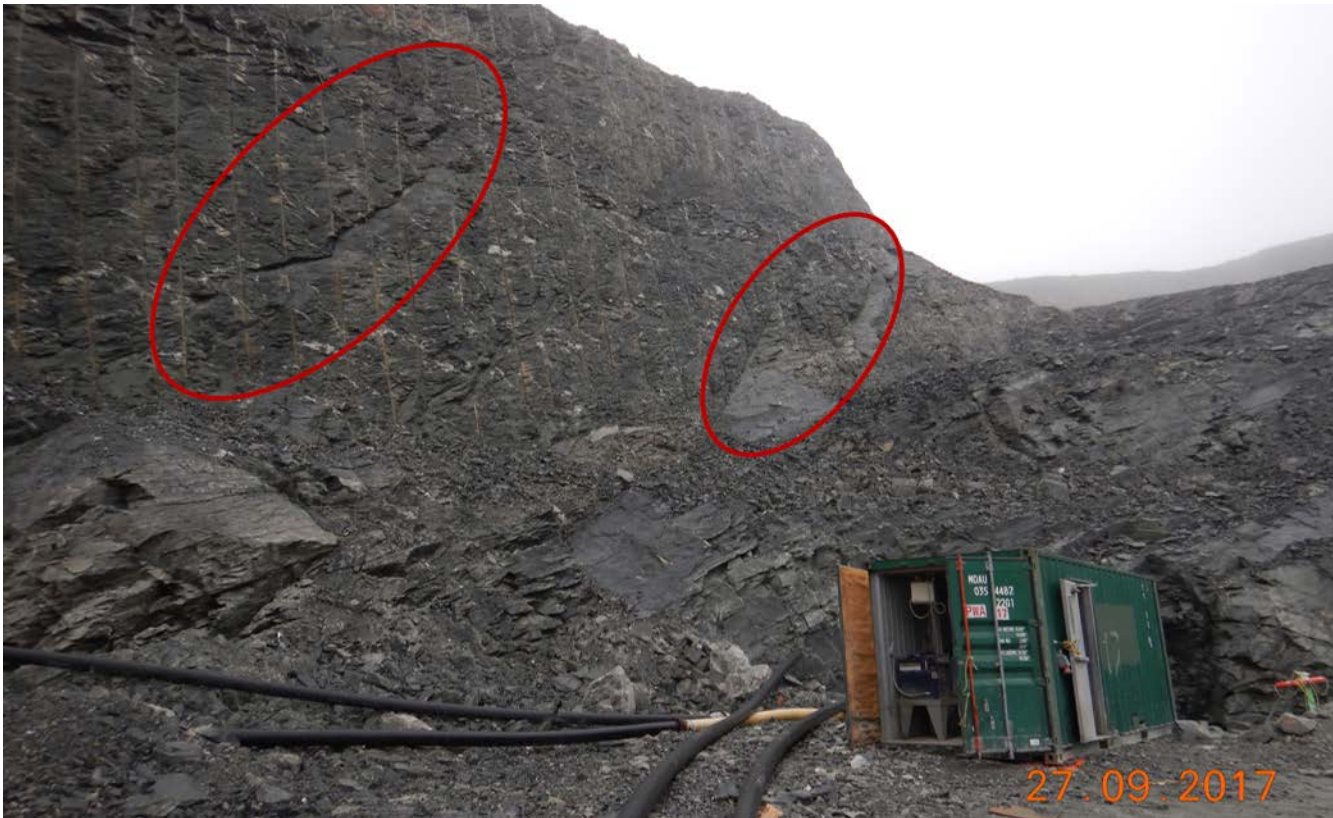
The stratigraphy intersects the south wall at right angles. A small sump is in the southwest corner of the pit and manages water in this area. Two outward dipping planes were noted above the sump area, forming shallow slivers of potentially unstable rock. The planes strike slightly obliquely to the wall, and while they are kinematically free on their north side, they do not appear to have a side release plane on the south side so the likelihood of failure is low. Nevertheless, it is possible with annual cyclic freeze-thaw that these could become destabilized and ravel. Since these features are directly above the sump area and associated equipment, and the area is regularly visited by personnel, these should be identified on a geohazard map for the pit and their presence communicated to anyone visiting the sump area.

**Photograph 8-5: Vault Pit south ramp sump and out dipping planes**

**Photograph 8-6: Vault Pit sump and out-dipping planes**

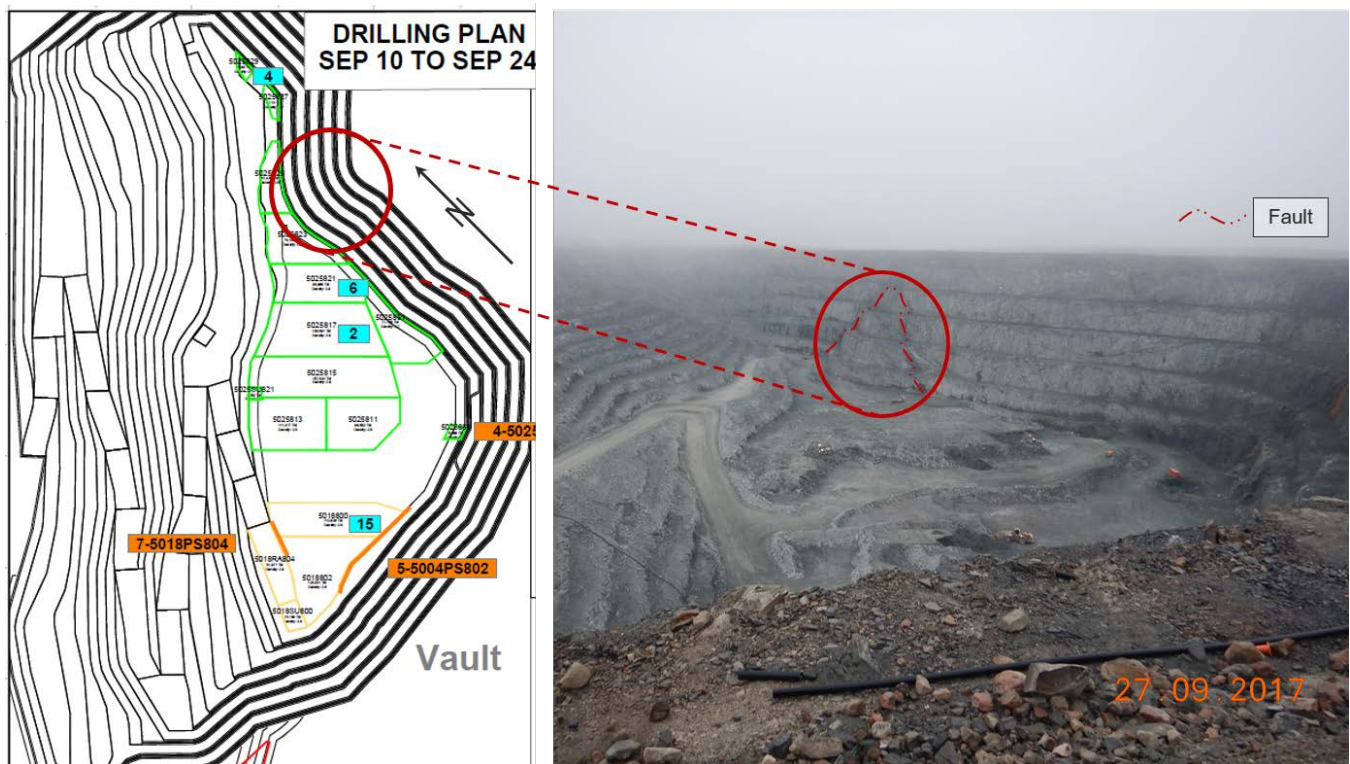
A rock 'nose' in the highwall near the northeast end of the wall is formed from a change in wall orientation. This sector of the wall was developed within permafrost. Widely spaced faults and open continuous joints dip into the nose area at steep angles which could conceivably lead to toppling. The competency of the intermediate volcanic rock at the Vault deposit, and the wide spacing of these features suggests this is unlikely to develop. However, this should continue to be monitored. There is currently one prism installed in this area and additional prisms should be installed.

Prisms are being installed on the highwall slope face. An area of the highwall forms a nose due to the reorientation of the wall. A fault trends across this feature, dipping into the wall at a steep angle. While toppling failure is unlikely, additional prisms should be installed on this portion of the wall below the fault (currently there is only one installed).

Photograph 8-12: Vault Pit east highwall nose and fault (2017)

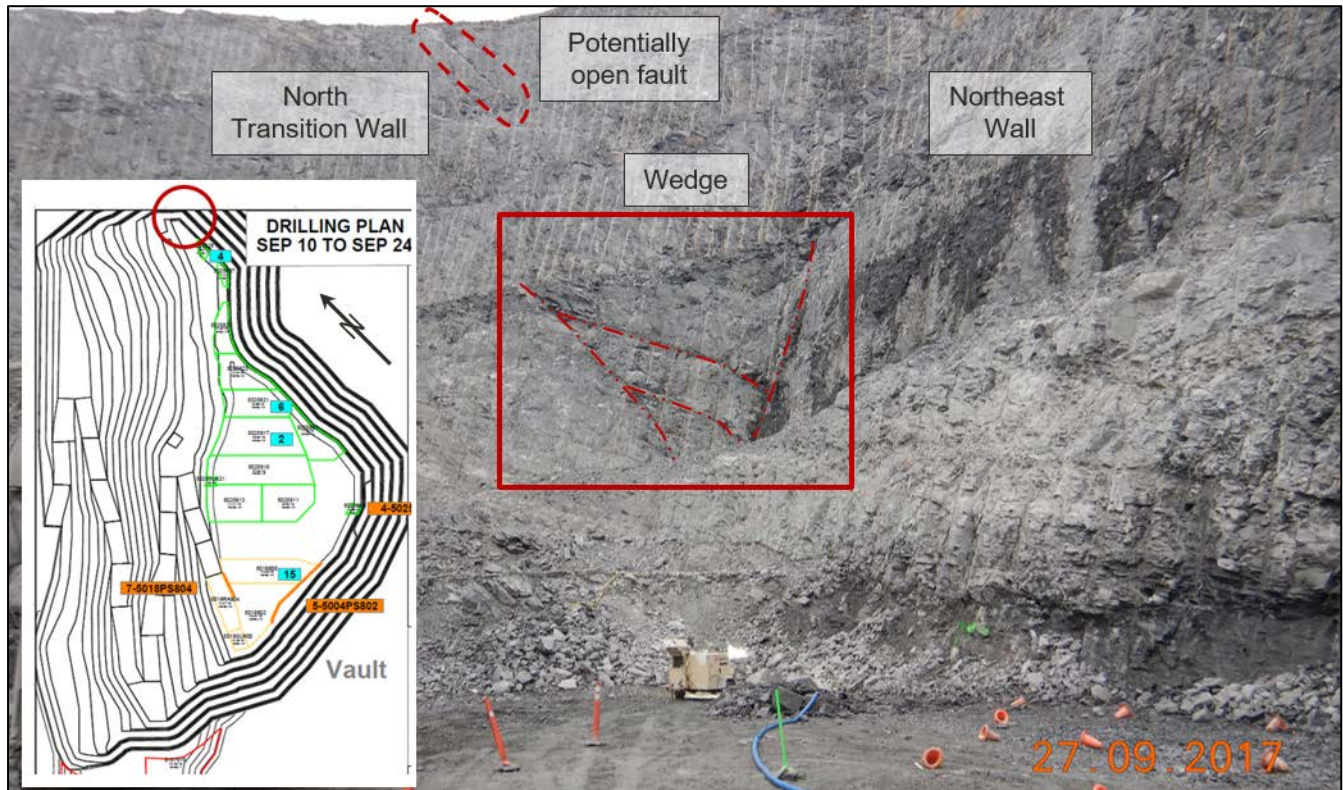
A potential bench scale wedge was noted at the north end of the east wall, where it intersects the north wall at a right angle. This was discussed with AEM during the site visit for continued visual monitoring, and limiting access beneath this area of wall. Mining in this area of the pit is almost complete.

*Photograph 8-17: Vault Pit wedge in northeast wall*
